**RE: British Columbia Utilities Commission (BCUC or Commission)
British Columbia Hydro and Power Authority (BC Hydro)
Electrical Explosion Incident – Marine Building, Downtown Vancouver**

I am writing to provide the results of BC Hydro's investigation into the explosion and fire that occurred in one of BC Hydro's underground vaults (Vault No. 73) on the 300 block of Burrard Street in Vancouver at approximately 6:00 pm on February 24, 2023. Two members of the public were injured, and several businesses were damaged.

12. The scope of this report is to document the investigation of the cause of the explosion and fire that occurred on February 24, 2023 (collectively, the “Incident”).

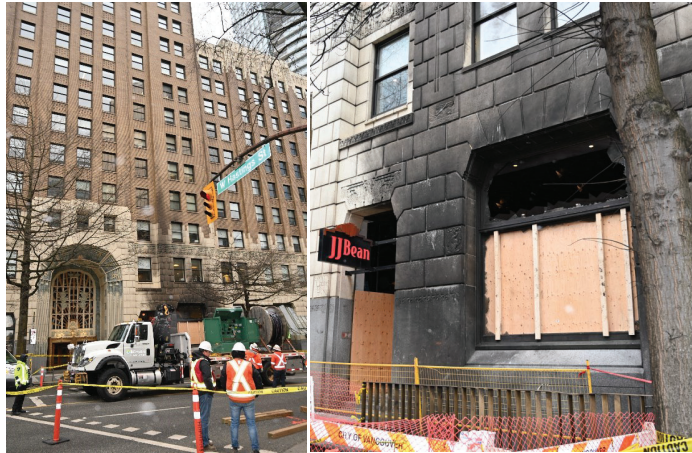
32. The primary fire damage to the Marine Building was on the east façade, opposite V73. The main entrance to the building was set back from the street and no significant observations of explosion or fire damage were noted. V73 was located opposite of the east building façade that protruded beyond the remainder of the façade. Immediately to the north and south of the JJBean Café, the building façade stepped back.

33. The façade configuration meant that the predominant heat and fire damage was localized to a portion of the east façade of the building around the JJBean tenant space. Smoke damage was visible on the lower five storeys of the building façade, dominantly in front of the JJBean tenant and opposite V73 [Figure 8 and Figure 9].

Figure 8: Marine Building façade damage.

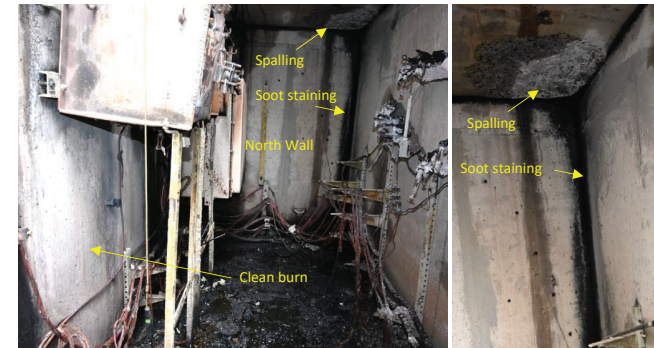
Figure 13: V73 north wall.

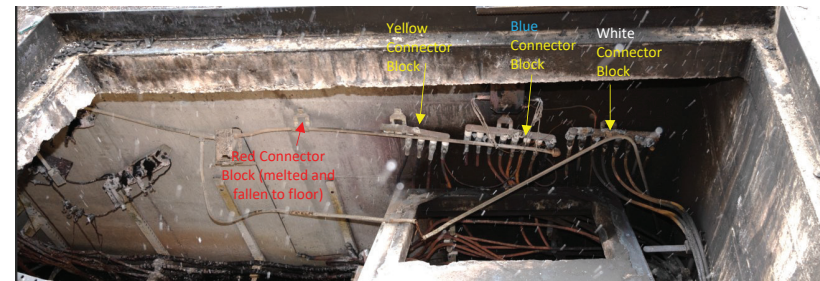
Figure 15: East wall at the south showing cable connector blocks for different phases, and missing red phase connector block.

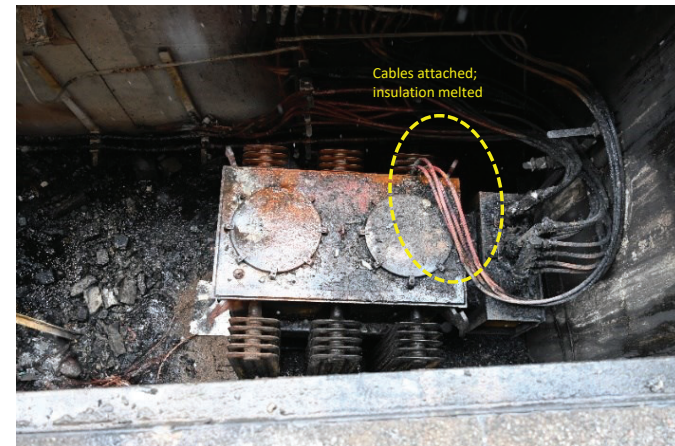
51. In summary, there is no indication of electrical failure on the interior or exterior of the transformer. The physical damage to the transformer is therefore a consequence of the Incident.

Figure 19: Transformer in the vault.

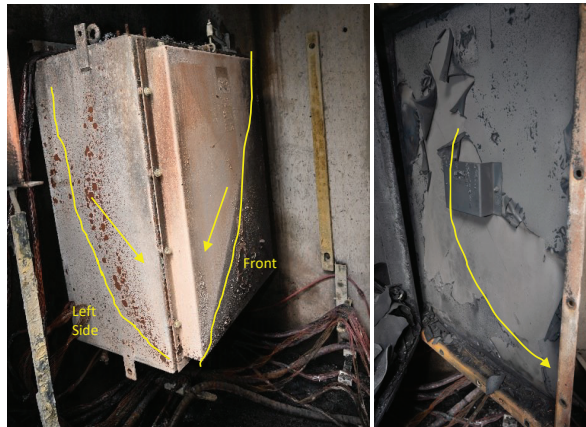
Figure 24: Front-left side of CLF (left); inside of cabinet door (right).

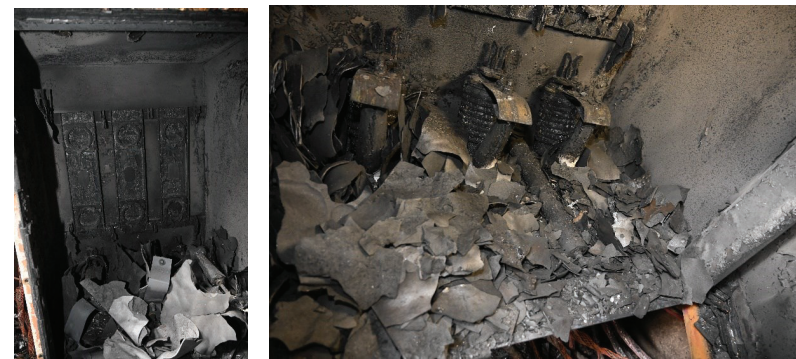
58. Further examination of the fuses was completed by Powertech (see Appendix H). No observations associated with the fuse damage or transformer damage are indicative of being causal with respect to the incident, and all damage was as expected due to exposure from a fire or pre-existing conditions due to age.

Figure 27: CLF cabinet inside (left); fuses and components found in debris at bottom (right).

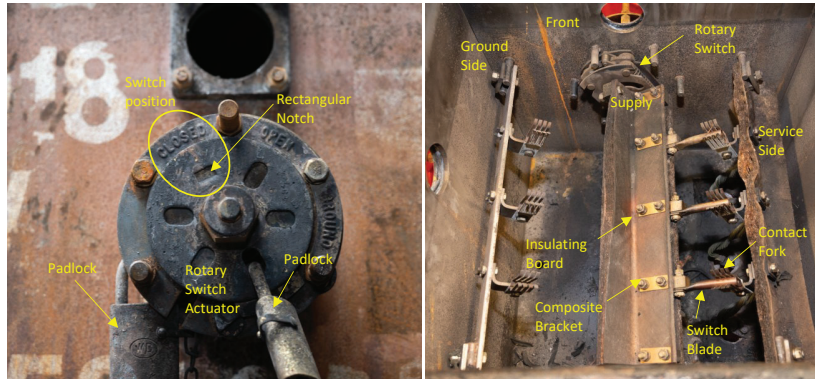
Figure 28: SW2018 position as found (left); and after the switch lid was removed (right).

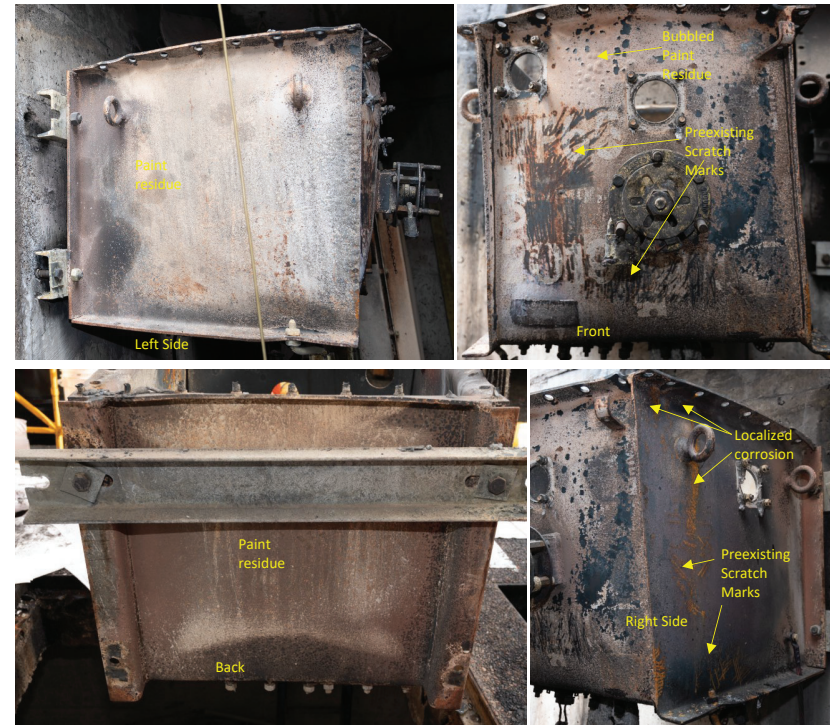
Figure 34: Images showing the perimeter faces of the SW2019 housing.

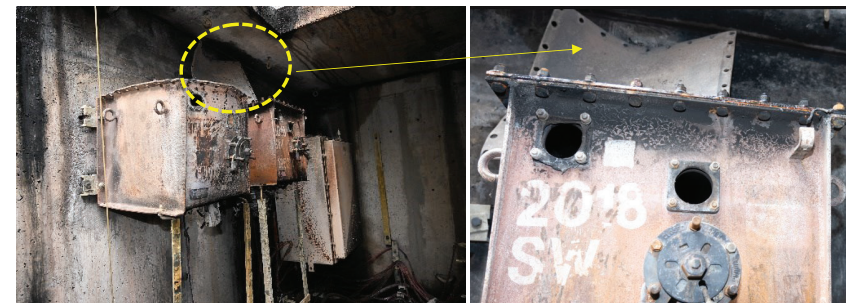
Figure 35: SW2019 lid on SW2018.

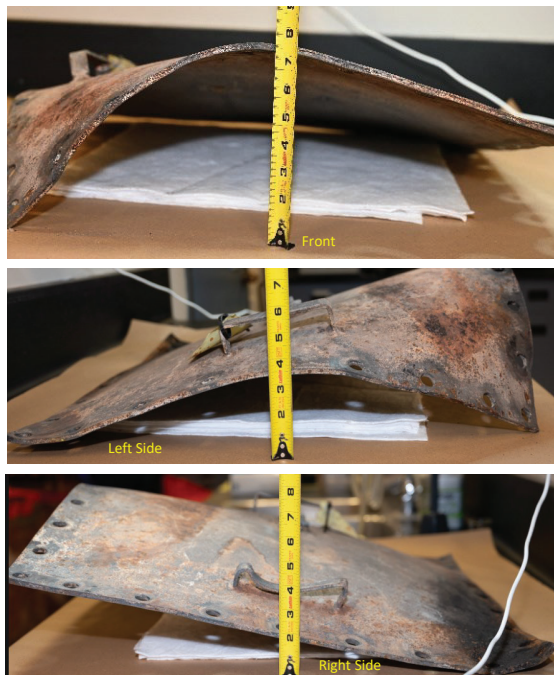
Figure 37: SW2019 lid deformation, observed during a laboratory examination.

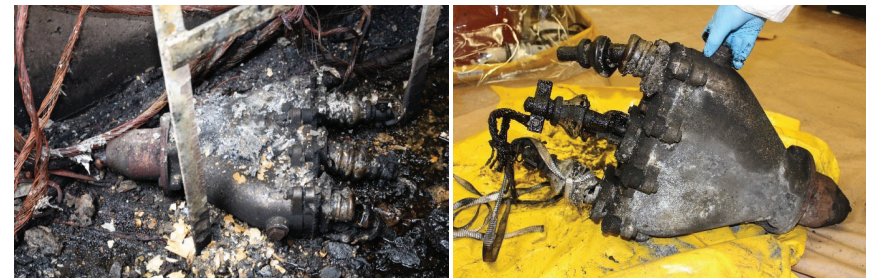
- The PILC connector was still attached to its termination and was located on the ground below SW2019 [Figure 40 - left]. The cables were severed at either end of the connector, but was otherwise intact and not thermally degraded [Figure 40 - right] in a comparable manner to SW2018 where the connector was intact but the termination was melted away.

Figure 40: SW2019 PILC Connector and Termination as found (left); in laboratory (right).

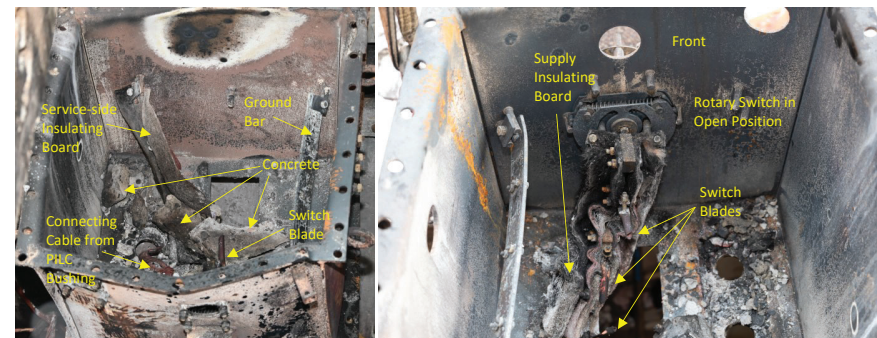
83. Based on the above, there is no evidence to suggest that a physical malfunction of the switches' internal operating components would have caused arcing leading to the explosion. However, the above analysis established that the probable cause of the explosion was contaminated oil allowing electricity to be dissipated into the oil through partial discharges (PD). In a PD, the oil absorbs the energy, but releases combustible gases into the head of the tank that are explosive in the correct operating environment. The potential for PD and contaminated oils is discussed at length in the Powertech Report and is not repeated here. The following sections discuss the further potential for contamination of the oil.

Figure 41: Interior of switch immediately post-incident (left); image of the front face of the switch box post-removal (right).

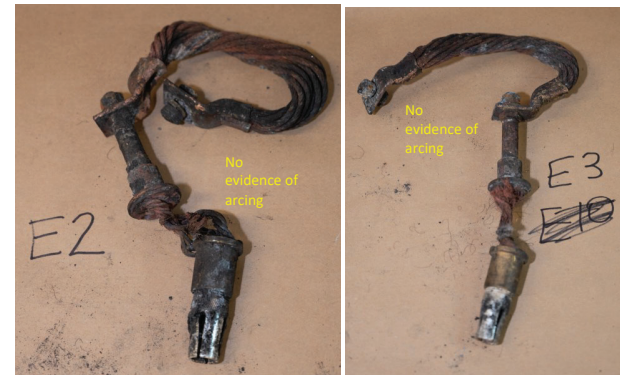
Figure 44: Elbow connector cables found in debris immediately below SW2019.

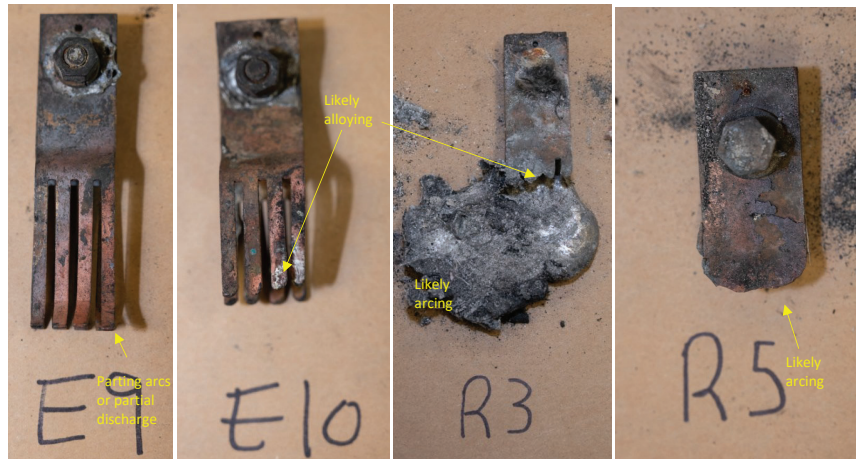
Figure 43: Contact forks found in debris underneath switch (left two), and debris south of switch (right two).

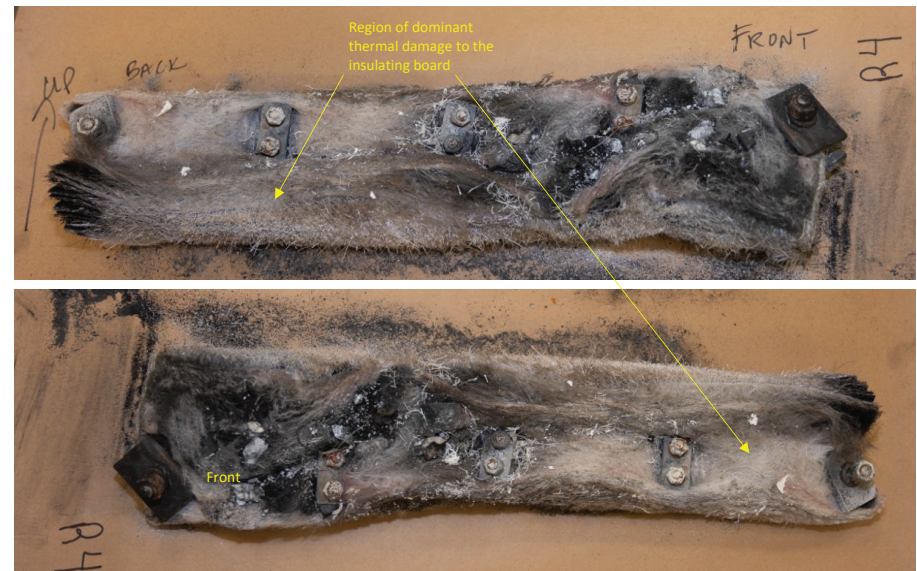
Figure 45: Images of insulating board on the service side of the switch, showing expansion of the fiberboard due to heat exposure.

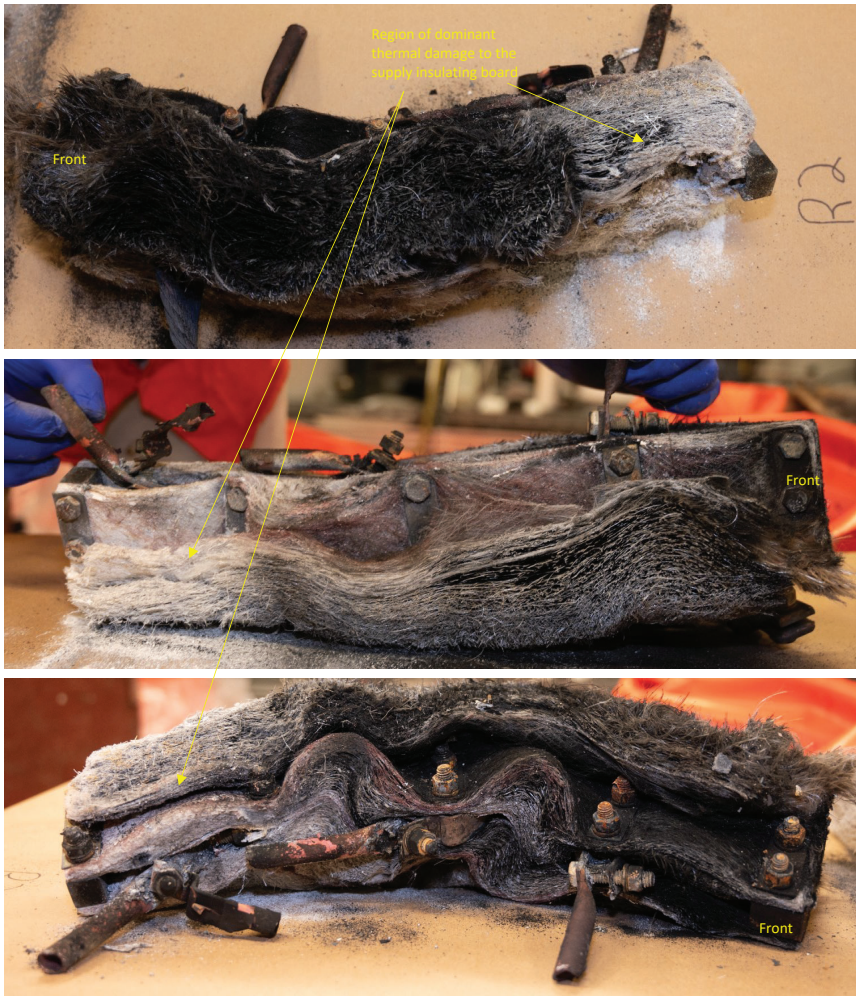
Figure 46: Images showing different views of supply insulating board with remaining blades and greater damage to the board at the back of the switch.

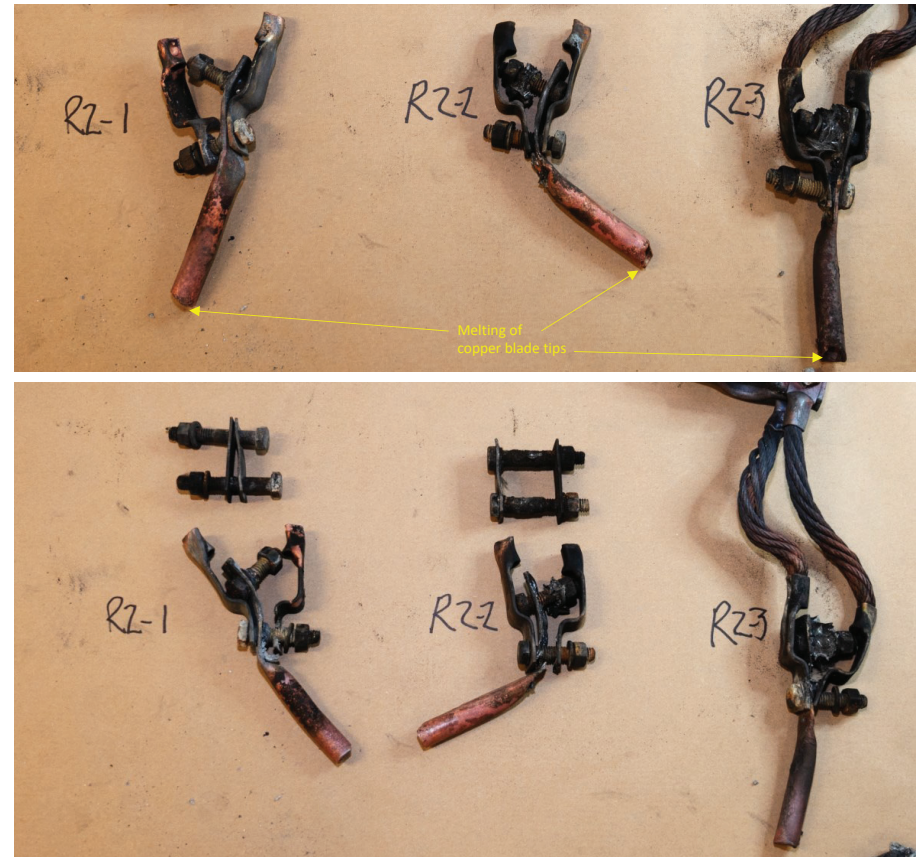
Figure 47: Blades from supply side of switch (two perspectives flipped 180 degrees).

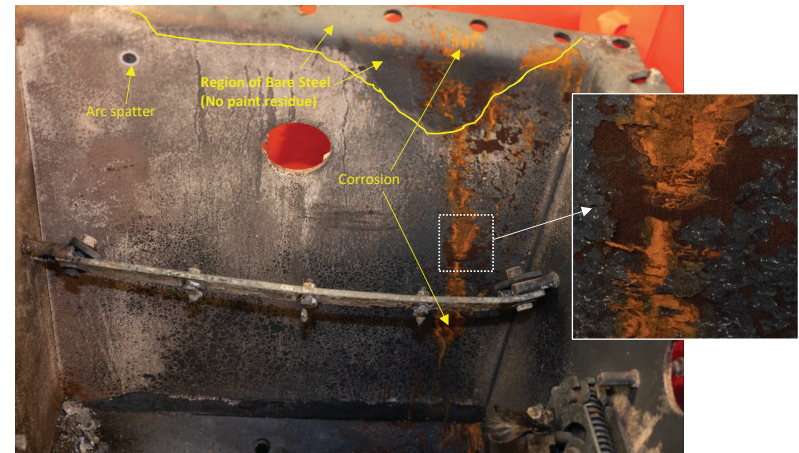
Figure 51: Arc spatter zone on interior right wall of SW2019 and corrosion region with blow-up inset.

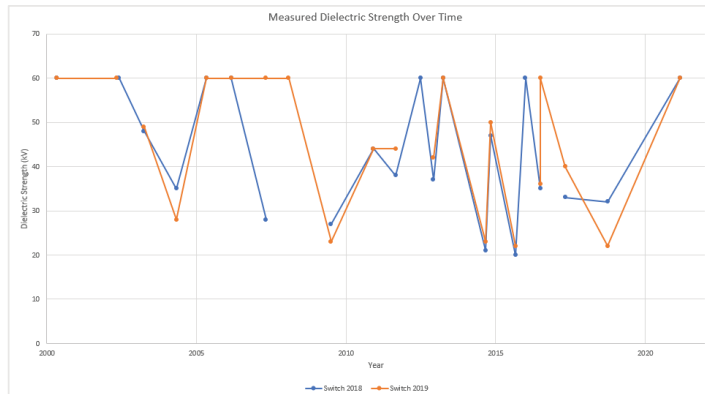
107. Historical data for dielectric strength in the Oil Quality Historical Report was charted in **Figure 56**, along with the oil change history, assuming the dielectric strength for new oil is 60 kV as suggested by C57.106-2006 for new circuit breaker insulating oil after being energized. (Data from the Maintenance logs from 2009 shows multiple data points at 60 kV, after an oil change, which supports the idea that the new uncontaminated oil after being energized has a dielectric strength of 60 kV as suggested in the Guide.)

Figure 56: Measured Oil Dielectric Strength.

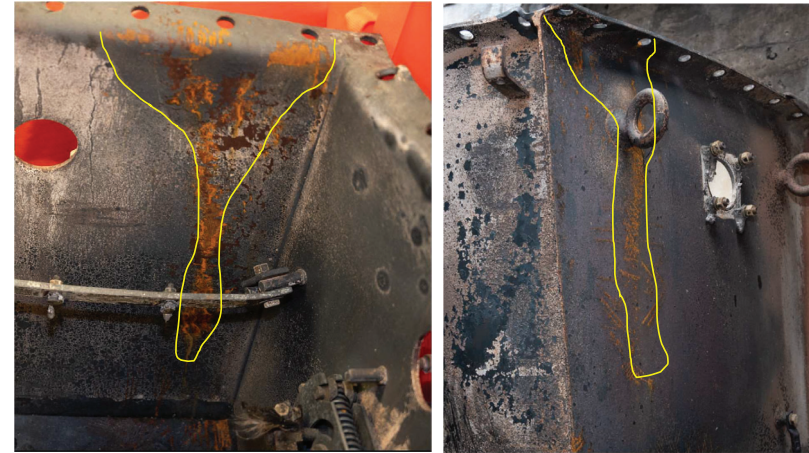
- The contamination occurred due to a leaking gasket in the lid of the switch. This was caused by incompatible products and potential contamination of the seal, compromising the nitrogen pressurization, and etching the surface of the enamelled paint inside the switch.

- This allowed for corrosion to occur in the steel below the surface of the paint allowing particles of iron and iron-oxide to mix with the oil, leading to partial discharges and the accumulation of combustible gases in the tank, which ignited and caused the explosion and subsequent fire.

- Corrosion/rust residue from other areas within the switch housing were more spotted and closer to the surface, indicating it likely developed after the explosion and fire.

Figure 57: Corrosion region on inside and outside of the switch housing aligning with three bolt openings.

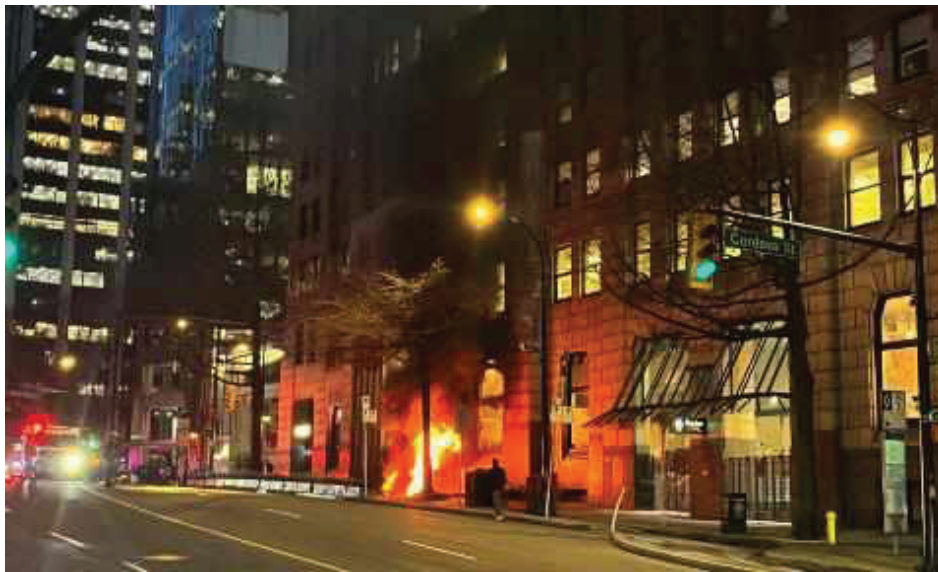
A sustained fire was also observed inside the vault, after the initial explosion. Once the burning in the vault was completed, it was observed that a transformer, two switches, a fuse box, and cables all located from inside Vault 073 were damaged from the fire. It could also be observed, from the street, that the switch 2019 had no lid on top and appeared void of oil and most internal components. Later in the evening, metal plates were placed on the street openings to isolate the contents of the vault. The area was then fenced off and with security personnel posted for the night.

Figure 1. Photo of fire emanating from Vault 073 on February 24, 2023

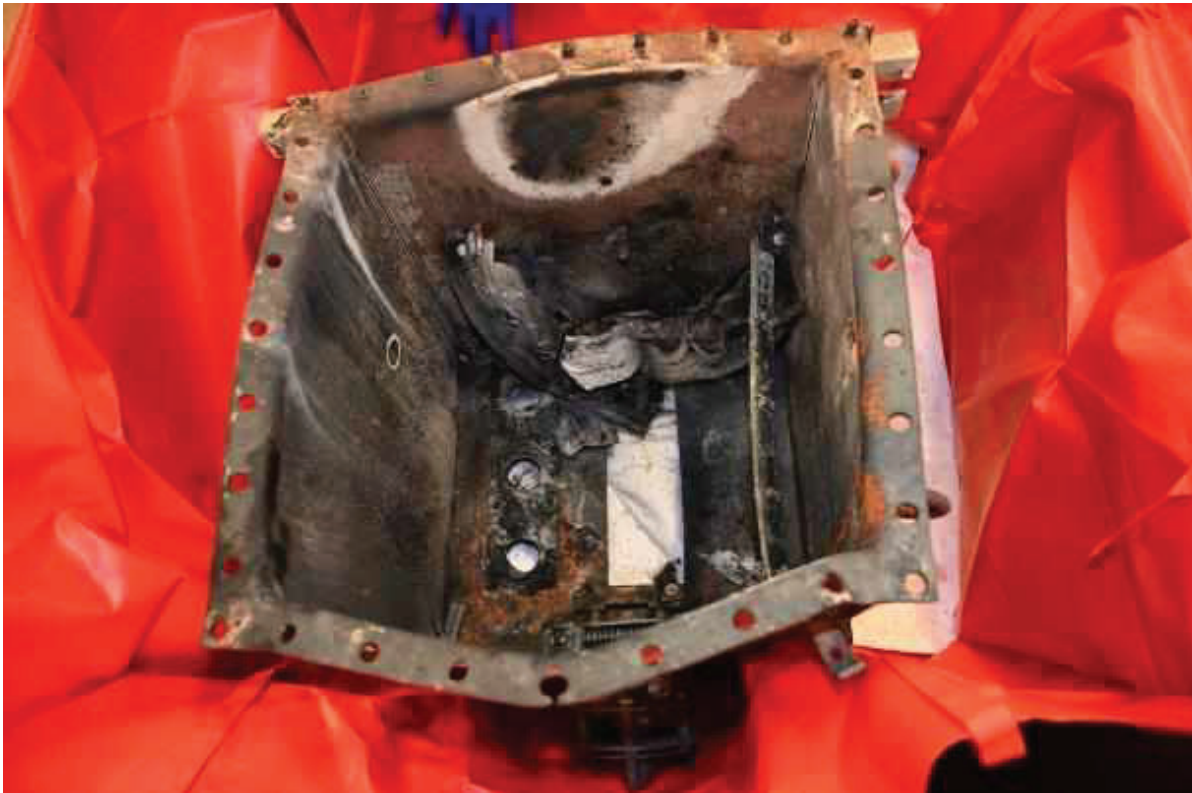
Figure 2. Top down view into switch 2019 (as received)

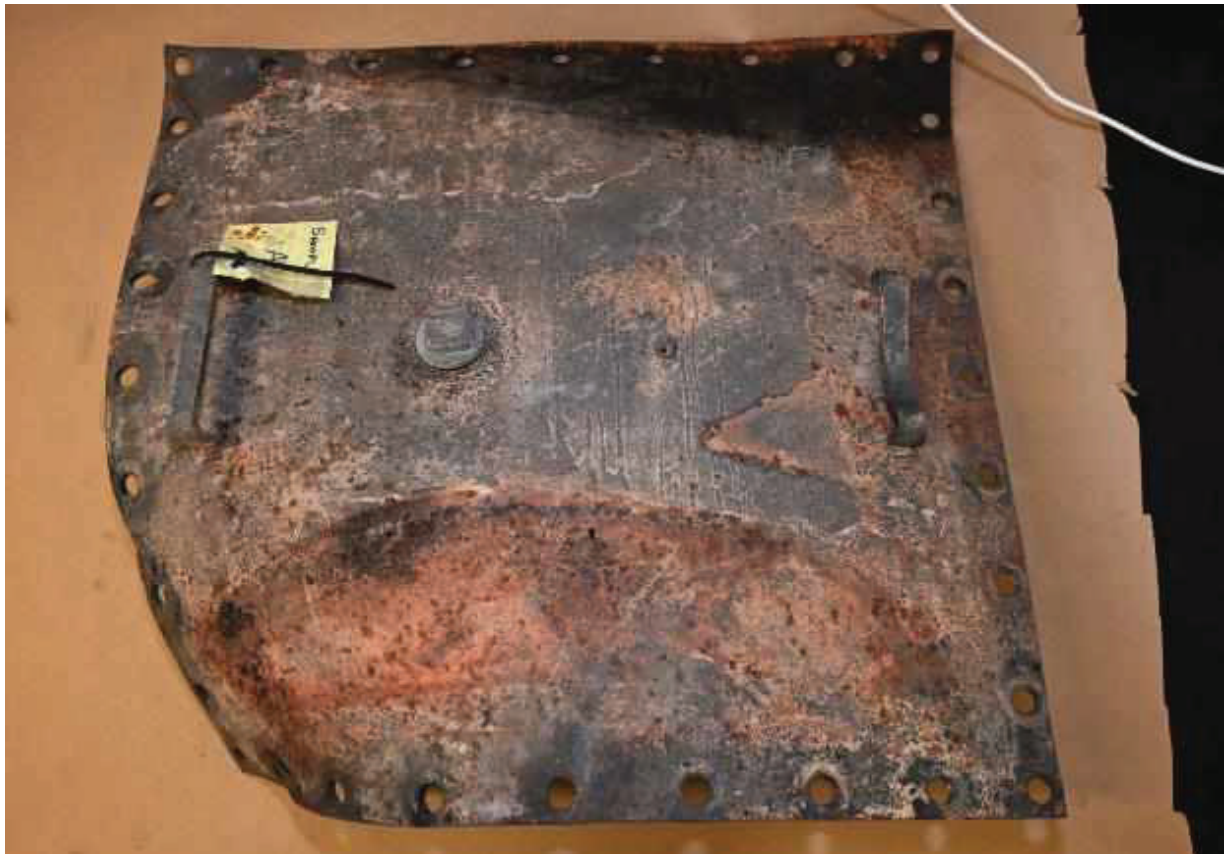
The lid from the switch was collected as a separated sample item (was not attached to the switch during sample collection), and all the bolts that were used to hold down the lid were not present, with the exception of the back row, which was composed of threaded pins that were part of the tank. Additionally, it was observed that the metal on the bolt holes on the front centre and front right were deformed. The second to last bolt hole on the front right was both bent and appeared twisted at the edge facing the front (Figure 3). Figure 4 presents a photo of the lid from switch 2019.

Figure 4. Bent lid from switch 2019

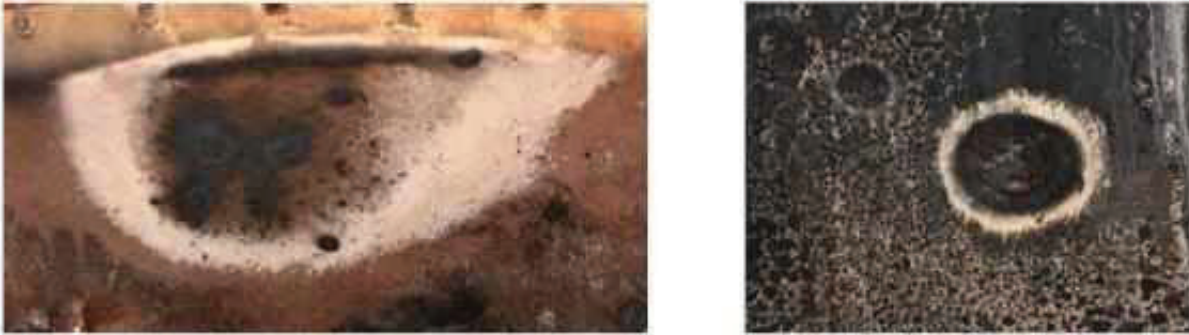
At the back of the switch 2019 tank, a large, dark, discoloured patch with a white ring was observed (Figure 5). A similar small, dark patch with a white ring was also observed approximately halfway up on the left inside the tank. In both cases, small metallic-appearing deposits were in the middle of the dark patches/rings. These observations are consistent with a hot material contacting the wall, transferring heat outwards, damaging the paint on the inside of the tank in a radial fashion.

Figure 5. Close up of white rings on inside of the switch 2019 tank

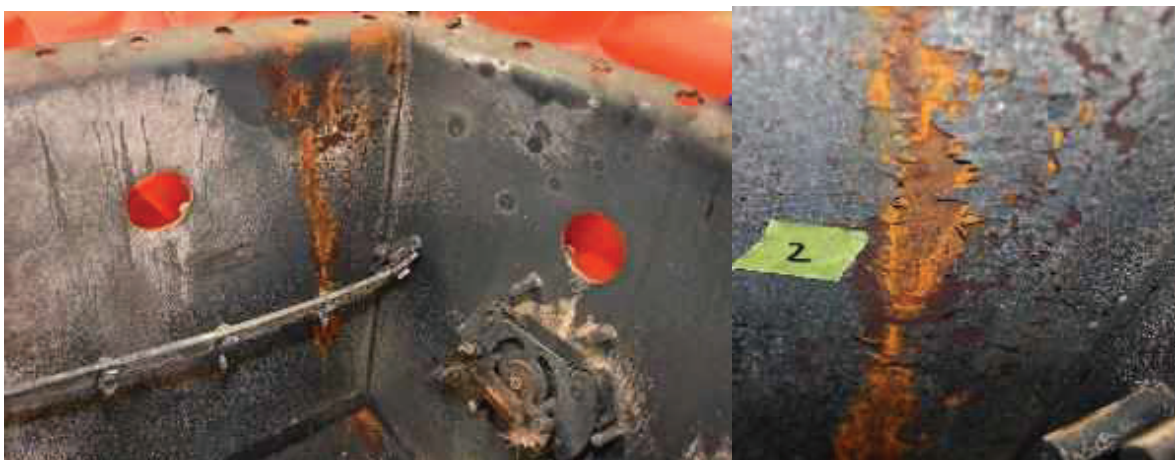
At the front of the right side of the tank, a distinguishing path of orange discolouration and material flaking was observed from the top edge of the tank to approximately one-quarter from the bottom of the tank (Figure 6). Additionally, localized spotted sections of orange-brown flecks along the back edge to the right back corner of the switch 2019 tank, as well as the back left corner itself also showed signs of orange-brown discolouration. The ground bar, some of contacts (showing various degrees of damage), and the switching mechanism remained inside the tank of switch 2019, along with was carbonized pieces (charcoal) of material, soot and dirt, as received at Powertech.

Figure 6. Close up photos of orange-brown areas inside of switch 2019 tank

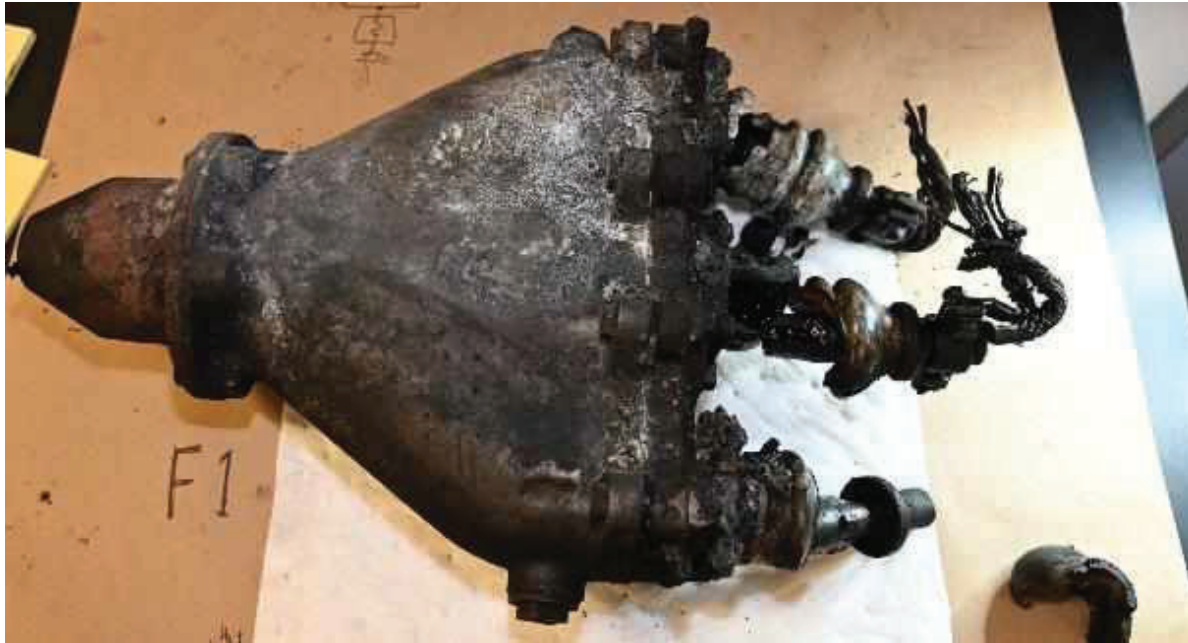
Upon retrieval of switch 2019 and corresponding recovered components from the vault, the PILC termination that is found bolted to the bottom of a non-damaged switch was intact and on the ground of the vault, below the switch 2019 housing. The damage to the top of the PILC termination, the broken insulators, is consistent with the termination dropping and rebounding off the ground (Figure 7).

Figure 7. PILC termination from switch 2019

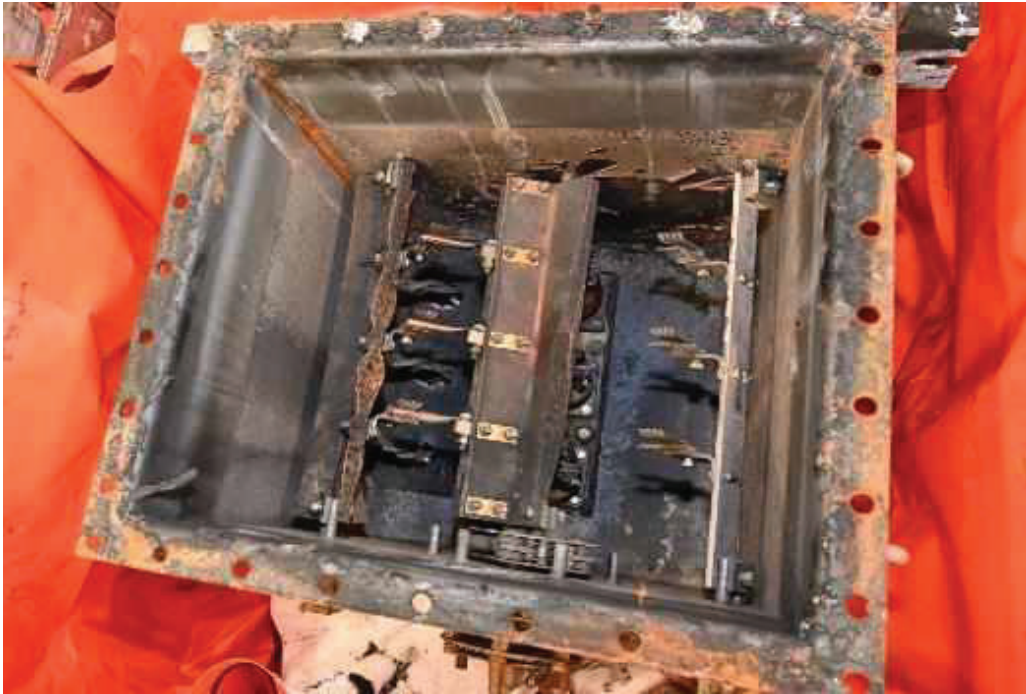
When fully removing the lid of switch 2018, the internal components were discoloured by carbon particles/soot from the vault fire, but were intact, showing minimal signs of physical damage (Figure 8).

Figure 8. Top down view into switch 2018 (as received)

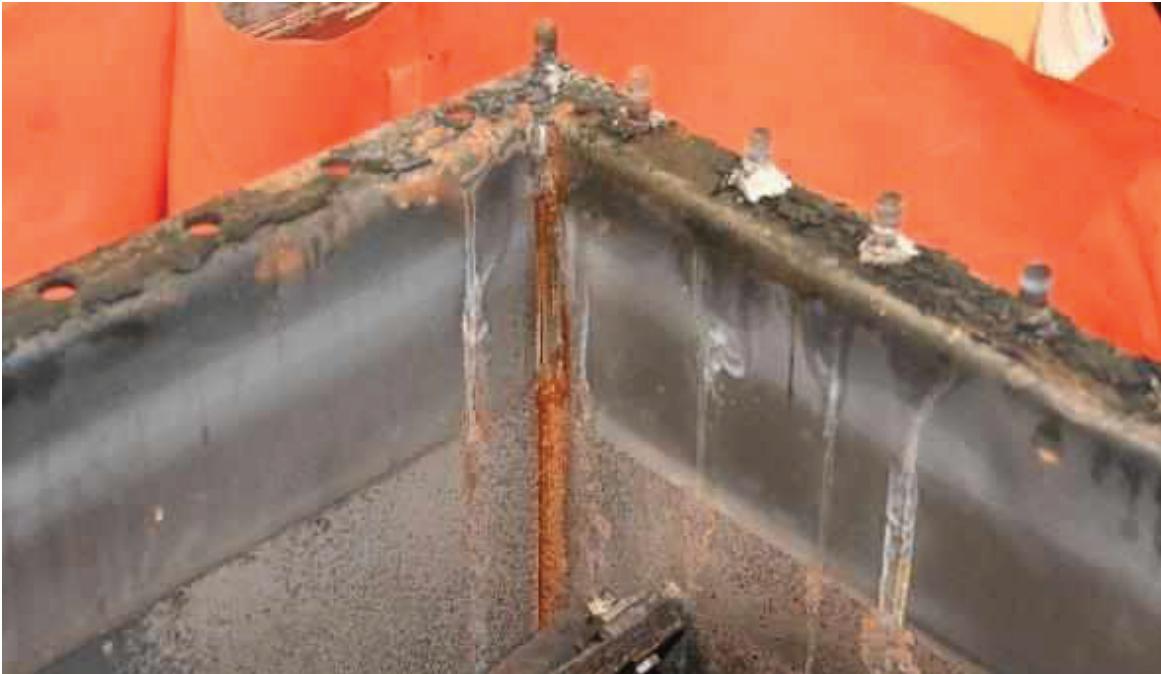
Similar to the inside of the tank of switch 2019, the back left corner of the switch 2019 tank showed some orange-brown residue on the edge and down the inner corner wall, as well as along the front edge of the tank. However, unlike switch 2019, the orange-brown residue was more superficial (i.e., not as deep into the metal). Additionally, in all observations, the orange-brown residue in switch 2018 was not a continuously connected path from the edge of the tank down the side of the inner walls (Figure 9).

Figure 9. Close up of orange-brown residue on walls of switch 2018

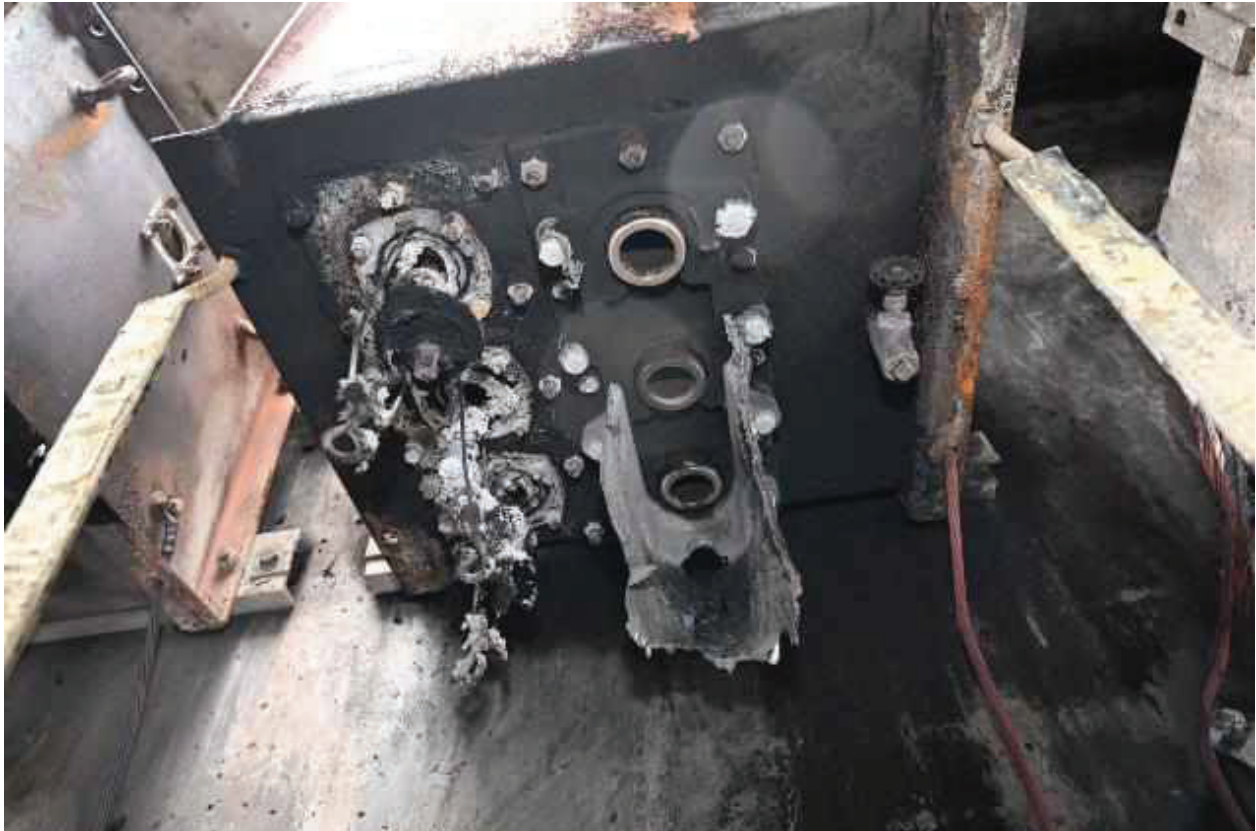
On the back wall of switch 2018, a thin, top peeling layer was observed. Analysis of the layer identified it as a degraded epoxy-based base layer (i.e., organic; carbon-based) that was the coating for the inside of the switch tank. A fully intact, non-degraded white coating sample from another switch from another vault (vault 055, switch 1595) was also analyzed and was identified as an epoxy-based enamel. This supports that switch 2018 (and switch 2019) contained an epoxy-based enamel coating in the tank. Epoxy-based enamel paints typically have a degradation range of 200-350°C. By the top coating inside the tank of switch 2018 chipping and peeling (and not being present in places at all), it indicates that the inside of the tank of switch 2018 did also experienced temperatures in excess of 200°C. Additionally, by the coating not being present at the bottom of the tank, not being present on most of the walls, and appearing degraded propagating from the bottom to the top, indicates the predominant heat source originated from the bottom of switch 2018. Since the PILC termination and cables entering the tank melted under the switch (Figure 10), it provided an opening for the oil from inside the switch to leak out and propagate the fire in the vault.

Figure 10. Underside of switch 2018 (in field)

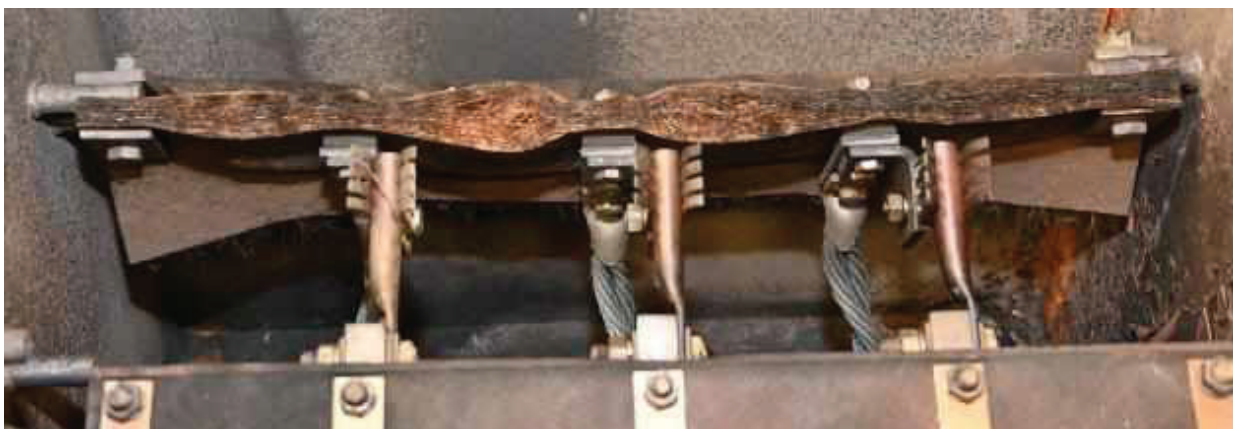
In addition to the missing and degraded paint inside the switch 2018 tank, the fibreglass contact bar on the left side of the switch was discoloured and expanded in sections (Figure 11), and the gasket beneath the lid had carbonized, being completely consumed in sections (Figure 12). These observations also indicate that the inner components of the tank were exposed to high temperatures ($>200^{\circ}\text{C}$) for a prolonged period of time.

Figure 11. Insulating bar from switch 2018 showing expansion due to being exposed to high external heat

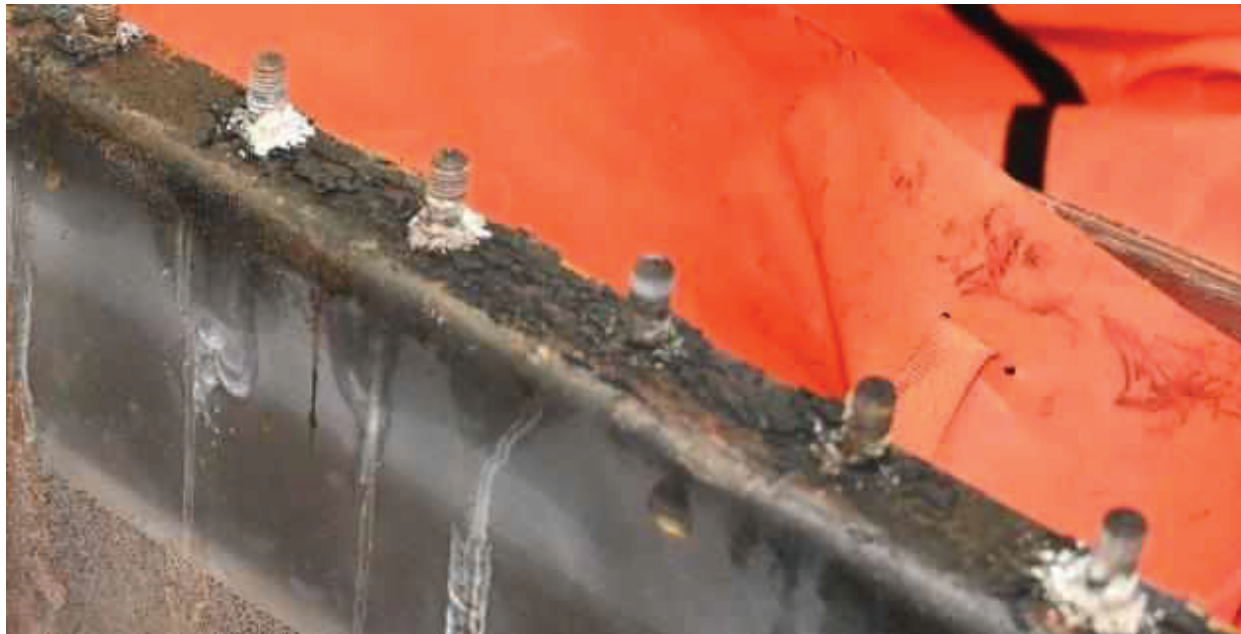
Figure 12. Close up of a region of carbonized and damaged gasket of switch 2018

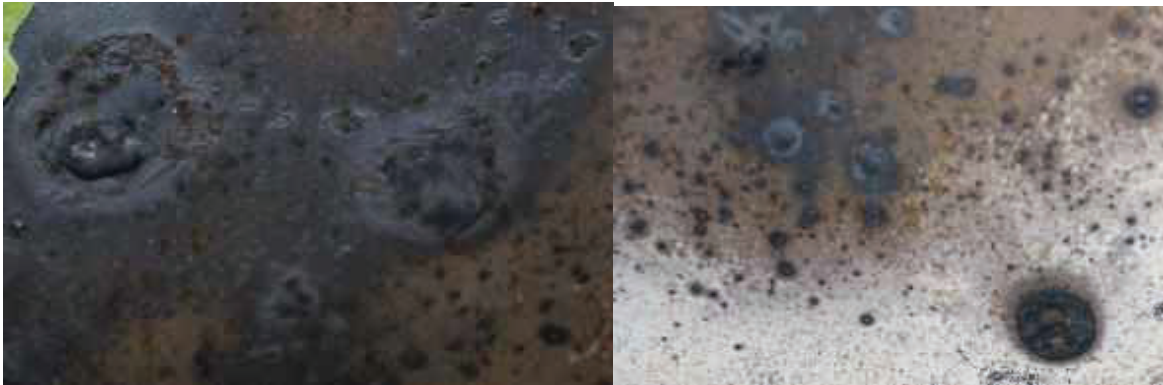
In several locations on the walls of switch 2019, metallic-like globule splatters were observed (Figure 13). In order to determine the composition of the metallic-like globule splatters on the walls of switch 2019, the residues were collected by using specialized silica-carbide abrasive discs and rubbed against the bulbous deposits.

Figure 13. Selected photos of metallic-like splatter on the tank walls of switch 2019

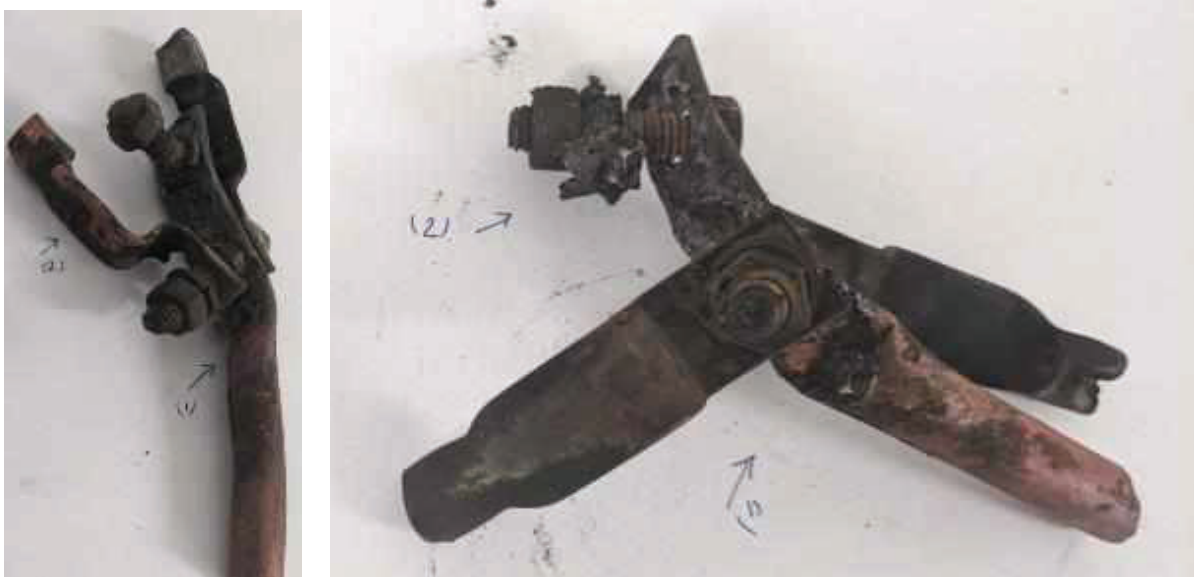
To try to determine the source of the metallic-like globule splatters, SEM-EDS analysis of two contacts from switch 2019 were performed (Figure 14). The bulk of the blades were determined to be almost exclusively copper, with minor amounts of aluminum, tin, and zinc on their surfaces. However, at the connection point of the blade to the switching device, the o-rings and bolts were observed to have similar presence of aluminum and copper, with minor amounts of iron, magnesium, and tin.

Figure 14. Blade assemblies analyzed from switch 2019

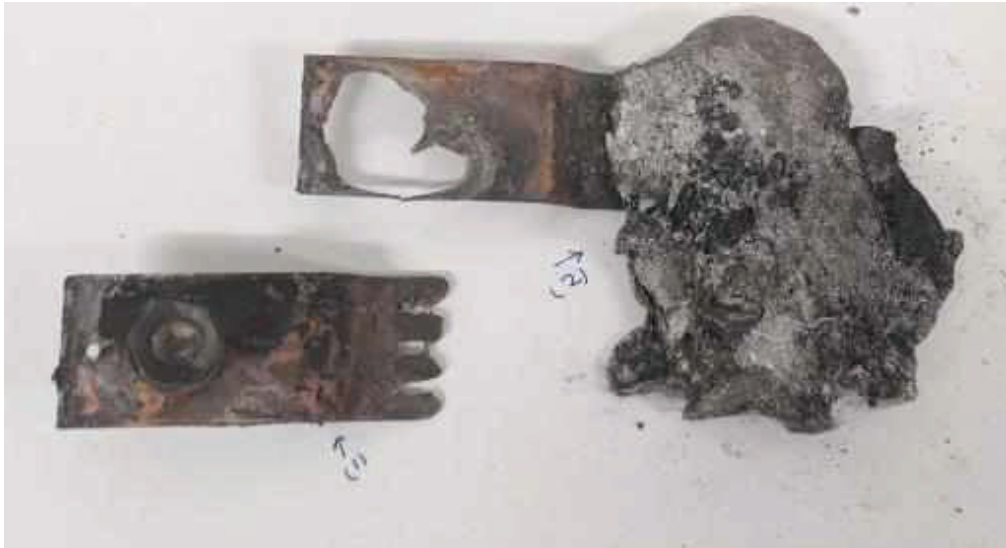
In addition to analyzing the blades for elemental composition in switch 2019, two selected contacts were analyzed. As shown in Figure 16, both contacts showed damage.

Figure 16. Selected contacts analyzed by SEM-EDS for elemental analysis
Left: Bare Contact; Right: Contact with metallic mass at the end

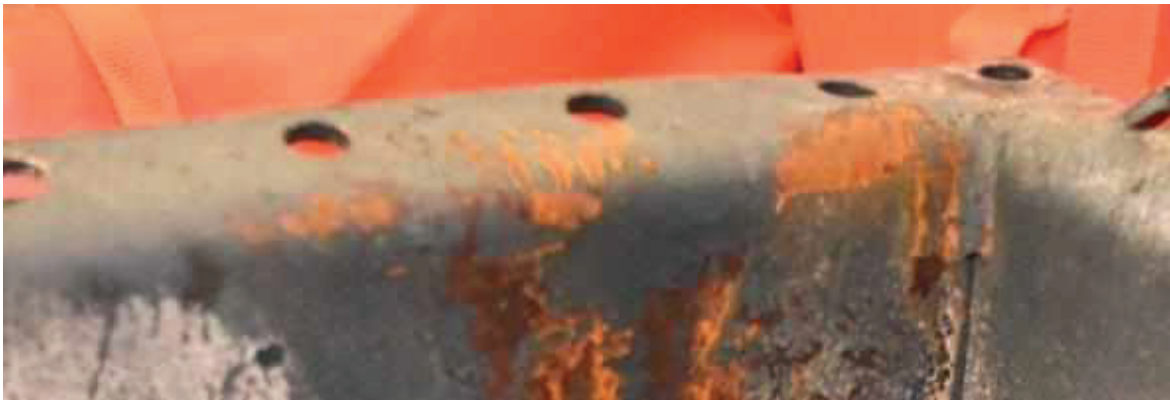
Figure 24. Damage at edge of tank right front

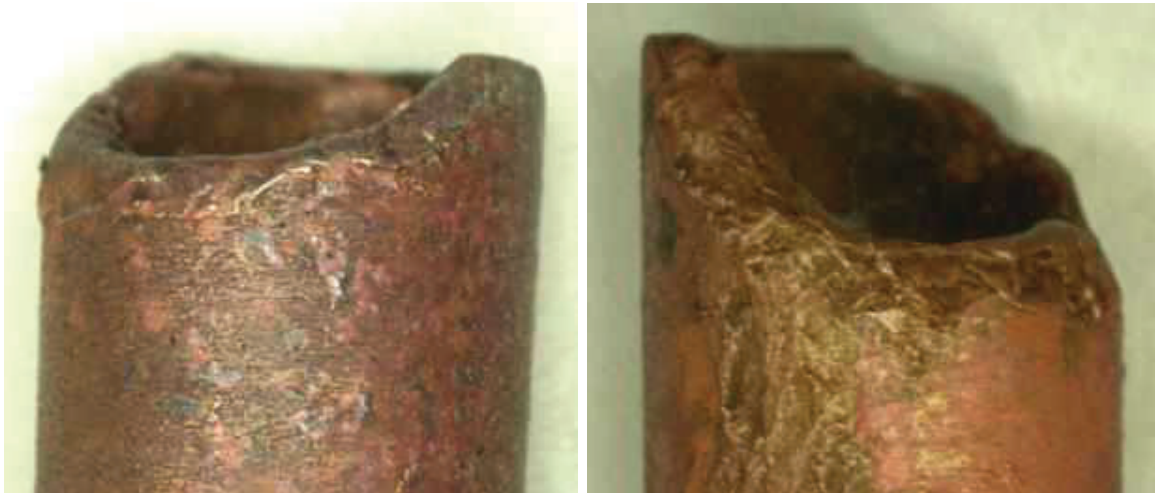
Figure 31. Microscope photos of two different example tips of copper blades from switch 2019

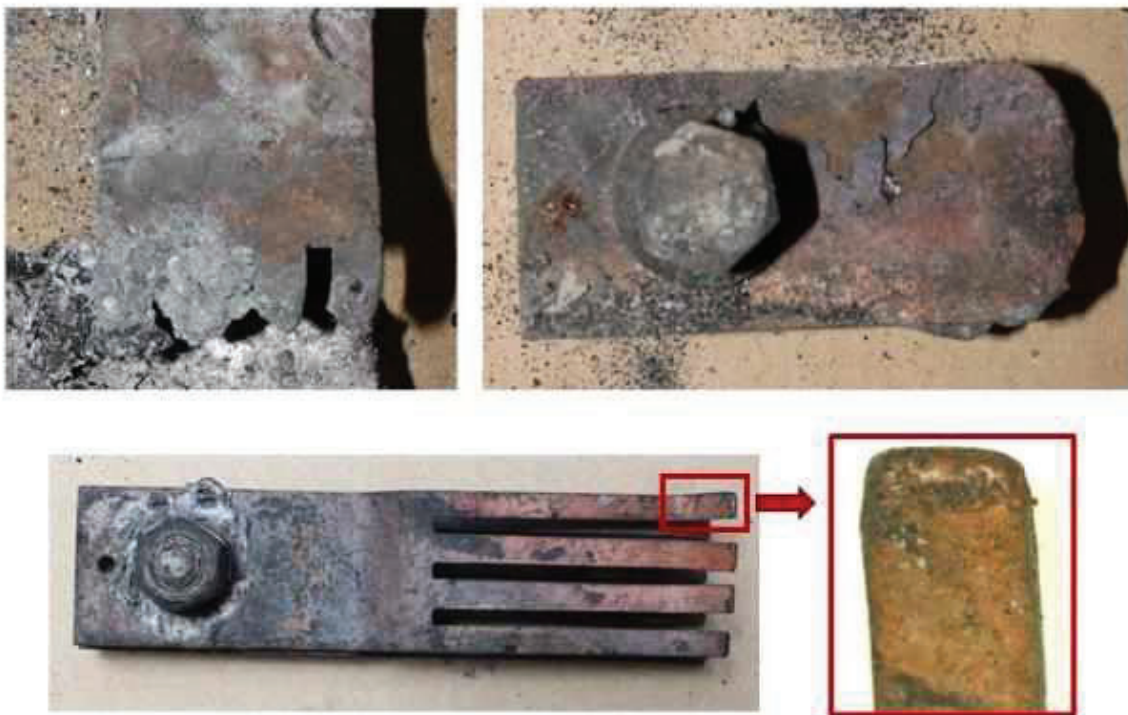
Figure 32. Photos of two different example forks of from switch 2019
