Distribution Line Strategy and Standards

Underground Vault Inventory

**A Strategy to Manage Safety Risks Associated
with Underground Equipment in Street Vaults**

Issued: July 2016

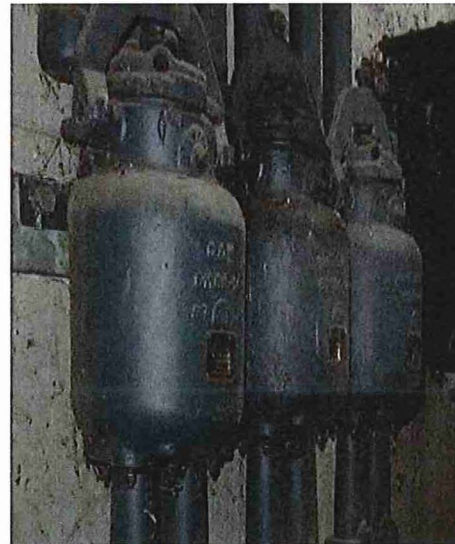
Figure 2 - Oil fused cut outs

- Cutouts (aka Oil Fuse Cutout)
 - G&W oil filled device designed to provide isolation and overcurrent protection which is often not recognized by crews. These are likely to contain PCBs. These have never been maintained. In some cases these may be gang operated but this is not clear. This equipment is from the 1960's and has no spare parts or replacements available.

- Since the oil fused cutouts were installed around 50 years ago, it is likely that they contain PCBs and thus should be removed from service as opportunities arise. BC Hydro must meet a deadline of no PCBs greater than 50 ppm by December 31, 2025.
- There is an opportunity to proactively address WSBC regulation 9.4 by investigating non-oil type transformers for confined spaces.
- When installing new equipment into existing vault, the civil structures must be assessed to ensure its suitability for the life of the new equipment and to ensure that the condition and the size of the structures can accommodate the new equipment.

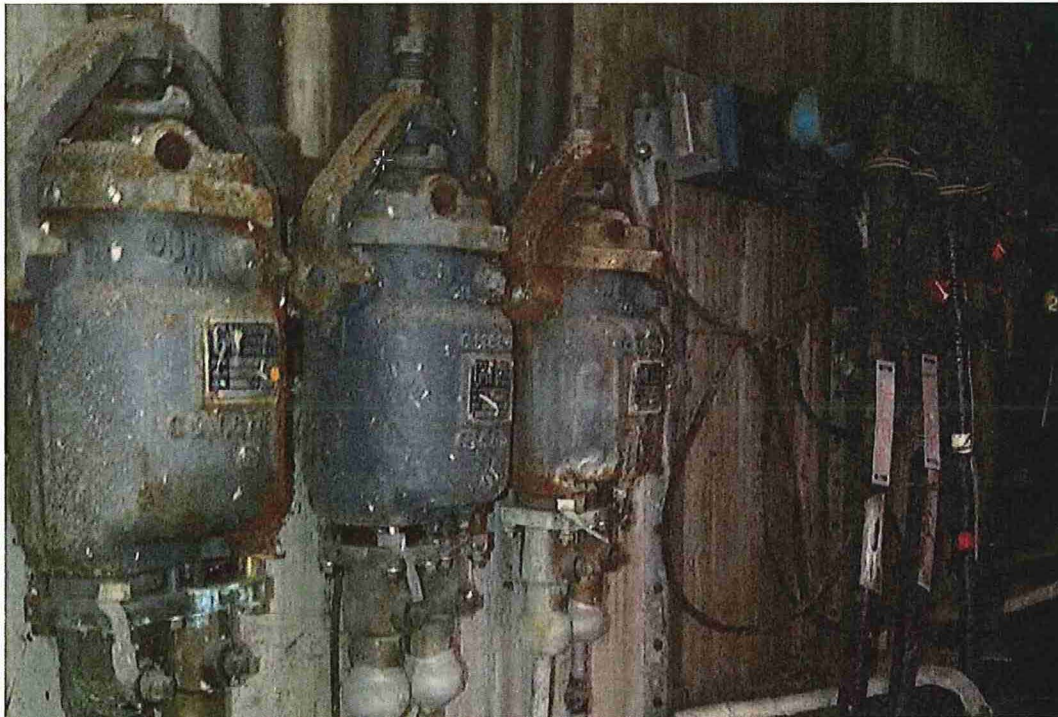
Figure 10 - Open loop vault 1, Oil fuse cutout and junction bar shown
