## Explosion & Fire on Burrard Street at BCH V73

### Explosion & Fire Analysis Reconstruction

**Our File Number:** 2300129  
**Date of Report:** June 7, 2023  
**Revision:** 0  
**Report #:** 001  
**Date of Incident:** February 24, 2023

**Prepared for:** Ms. Nicole Prior  
Senior Manager, Legal Services  
BC Hydro  
6911 Southpoint Drive, Podium A03  
Burnaby, BC V3N 4X8

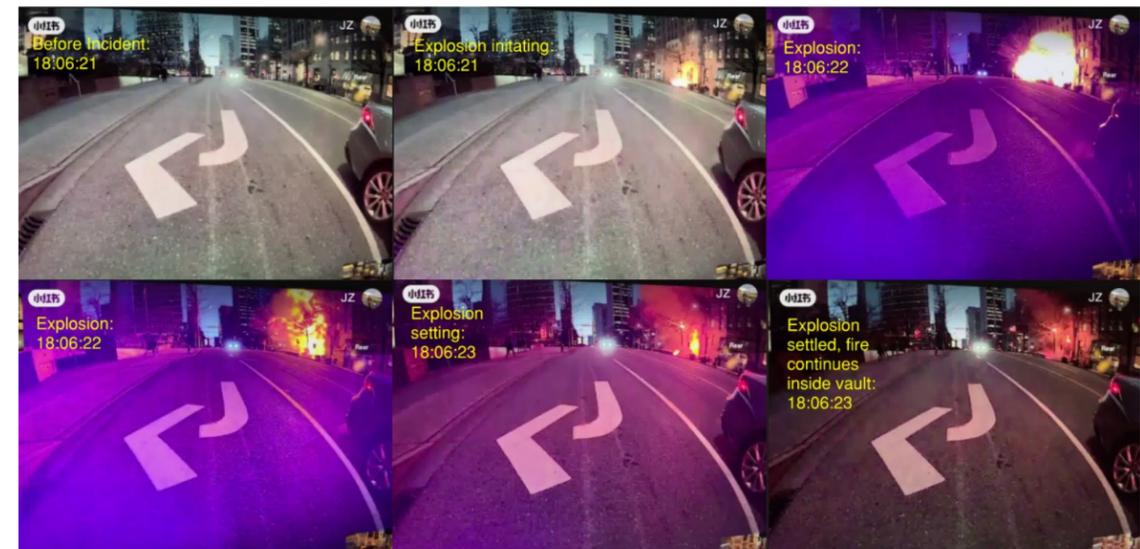
26. The video footage captures the initial explosions and flame looking backward from the vehicle. Still captures of the video illustrate the incident in **Figure 7**. The imaging captures the explosion, which occurred over approximately 2 seconds, before subsequently burning. No visible irregularities prior to the explosion are observable in the video. Time estimates are best estimates based on time in video image and frame counting.

Figure 7: Still captures from video footage of explosion event.

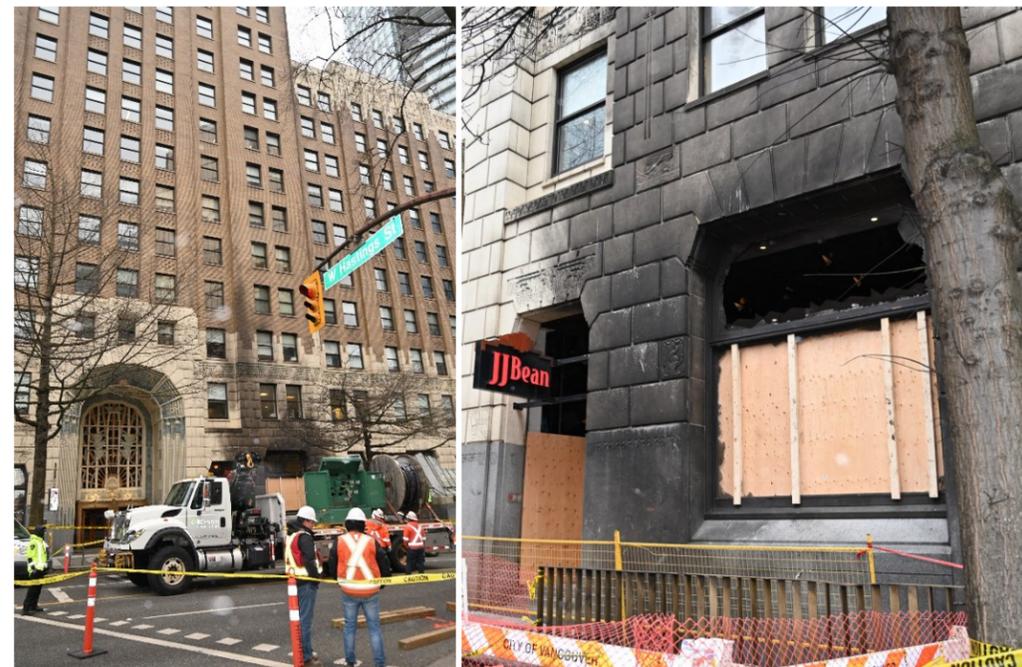
33. The façade configuration meant that the predominant heat and fire damage was localized to a portion of the east façade of the building around the JJBean tenant space. Smoke damage was visible on the lower five storeys of the building façade, dominantly in front of the JJBean tenant and opposite V73 [Figure 8 and Figure 9].

Figure 8: Marine Building façade damage.

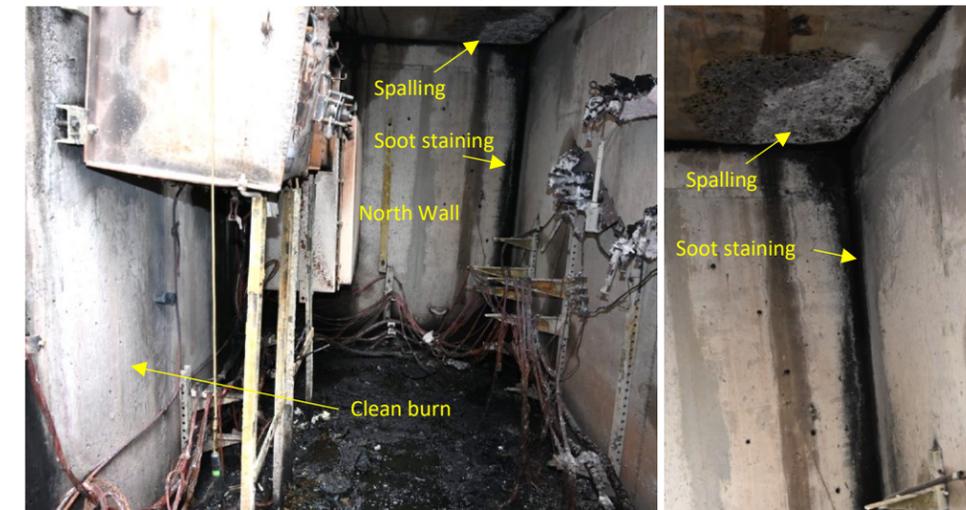
37. The north wall of V73 was not structurally damaged and had limited soot deposition except in the northeast corner, below a small region of spalled concrete [Figure 13]. Similarly, the east wall at the north end had limited soot deposition.

Figure 13: V73 north wall.

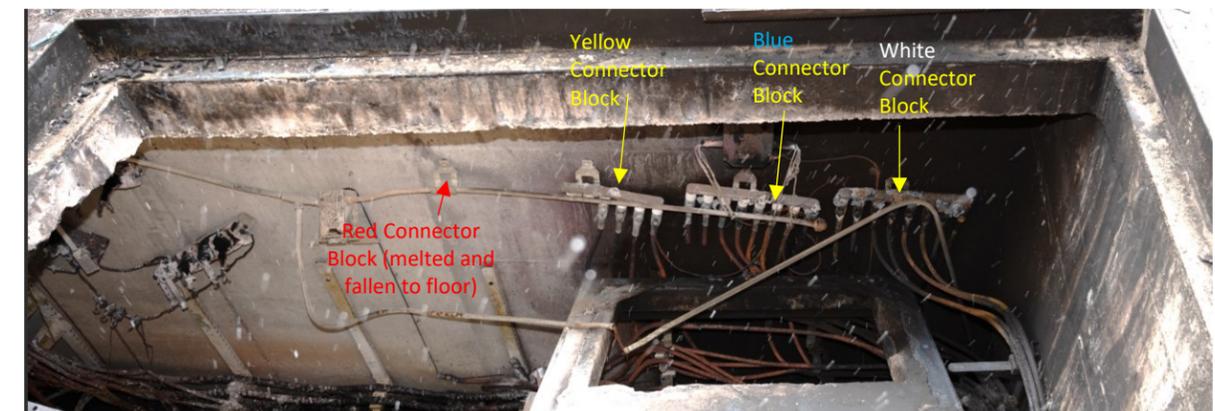
39. On the east wall, there is greater damage to the center opposite SW2019 extending south to the region of the vault between SW2019 and the transformer [Figure 15]. The red-phase cable connector block had melted to the floor along with the connecting cables. A portion of the yellow-phase connector block was also damaged and had fallen to the floor at the north end.

Figure 15: East wall at the south showing cable connector blocks for different phases, and missing red phase connector block.

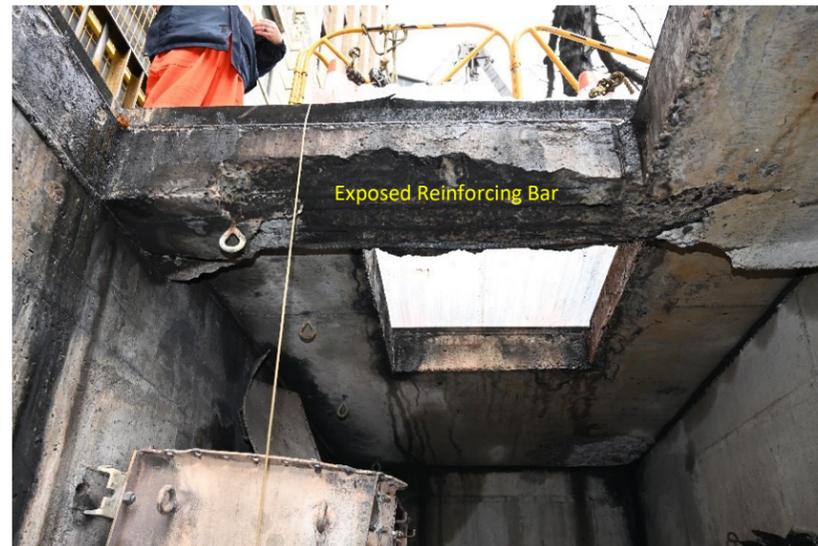
40. Although there was some minor spalling in the northeast corner, the greatest damage to the vault concrete enclosure was to the midsection where large portions of concrete had spalled, exposing the reinforcing bar [Figure 16].

Figure 16: Vault structural damage.

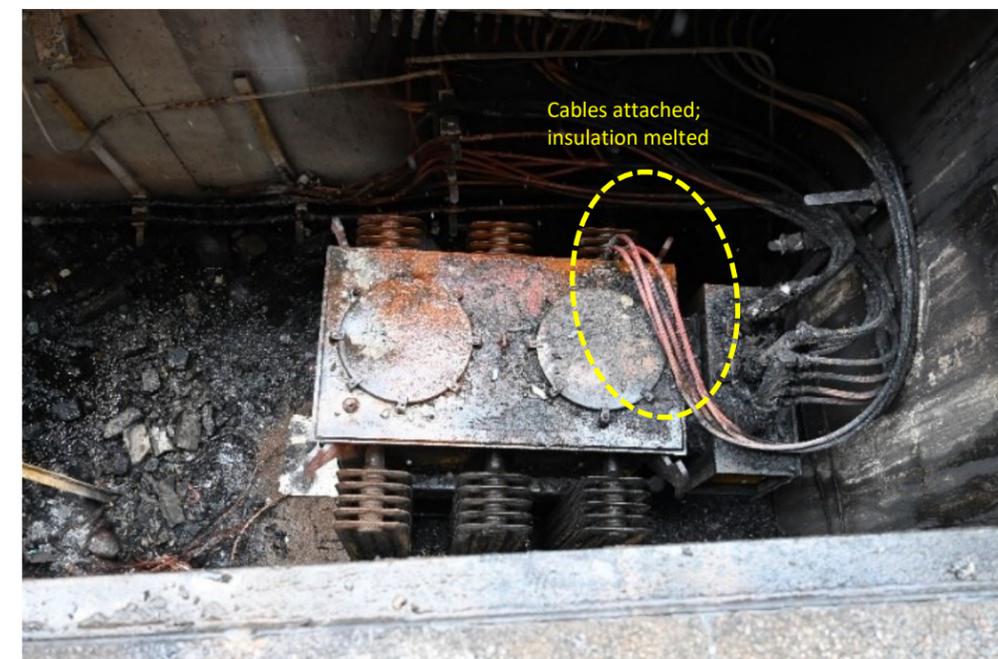
46. Post-Incident, the cable conductors remained intact and connected to the transformer [Figure 19]. The three supply cables were no longer connected to the transformer and were on the ground in front of the transformer [Figure 20]. The paint on the transformer was heat damaged above the point of cable entry (yellow line superimposed on the figure). This aligns with the transformer being oil-filled above this line, meaning the oil remained in the transformer post-explosion prior to evaporating during the fire.

Figure 19: Transformer in the vault.

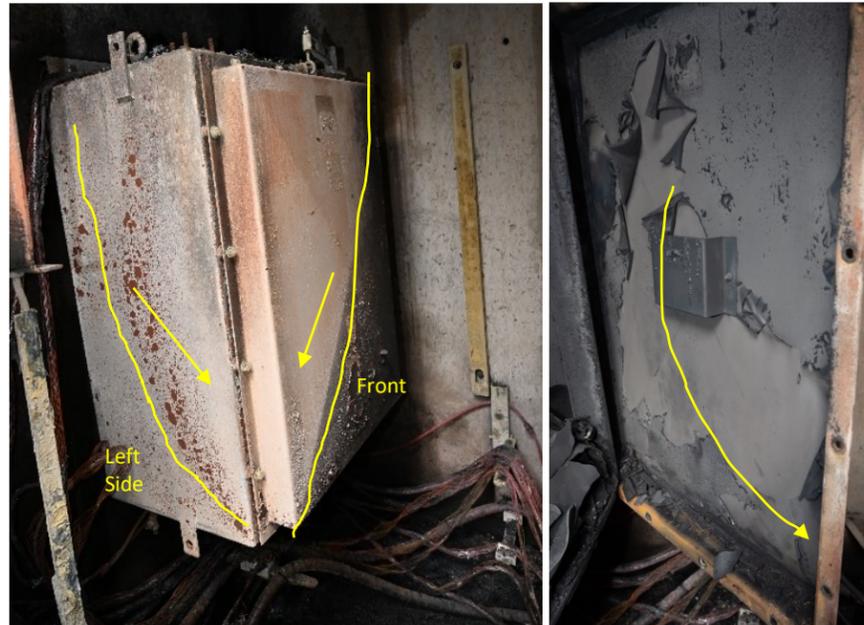
Figure 24: Front-left side of CLF (left); inside of cabinet door (right).

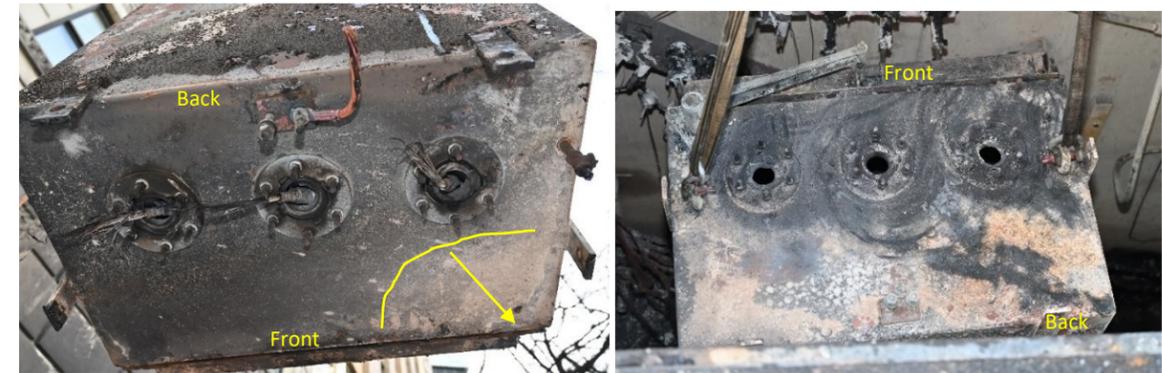
Figure 26: Bottom of CLF cabinet showing broken cables (left); top of CLF cabinet (right).

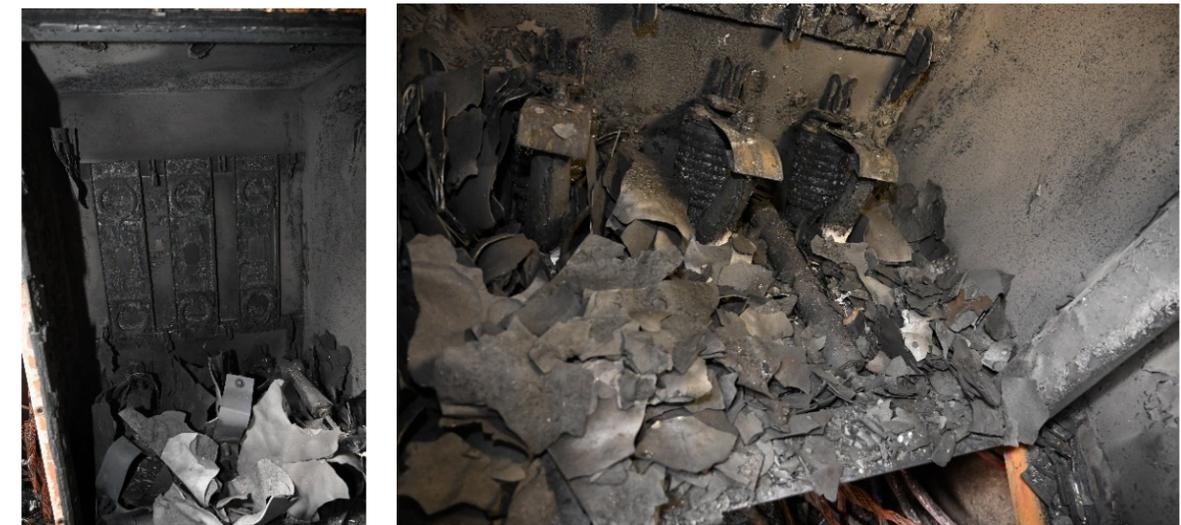
Figure 27: CLF cabinet inside (left); fuses and components found in debris at bottom (right).

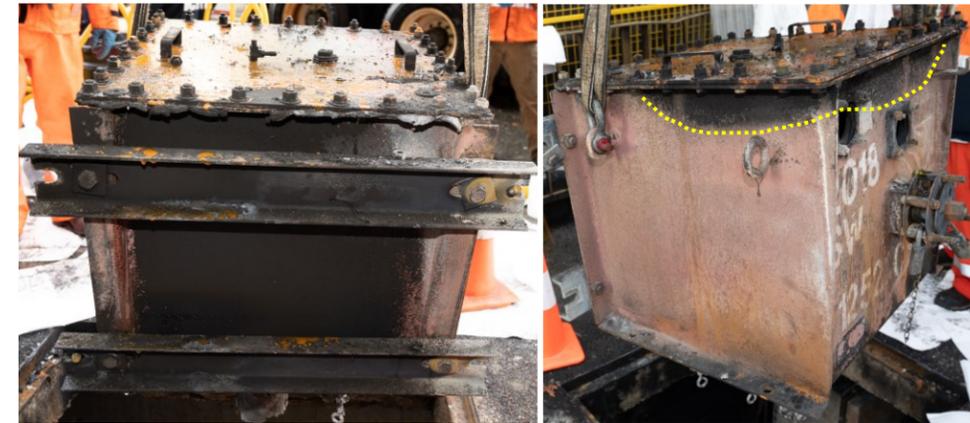
- 65. In summary, the physical damage to SW2018 is consistent with fire exposure. No indications of failure were identified that are indicative of it being the cause of this incident.

Figure 30: SW2018 back of housing - west side against the wall (left); left side and front (right).

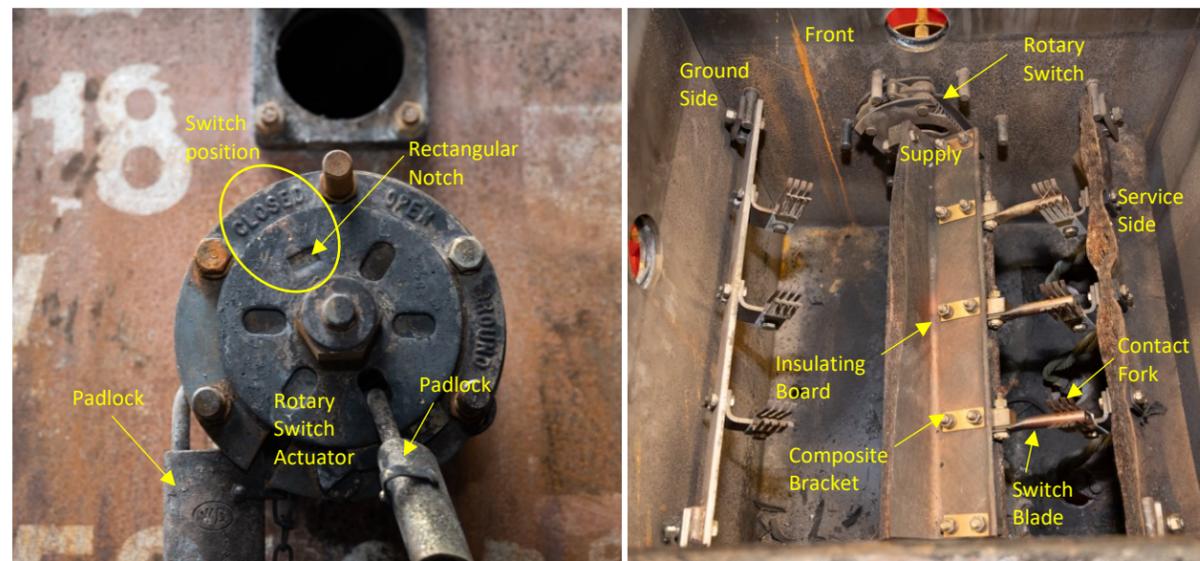
Figure 28: SW2018 position as found (left); and after the switch lid was removed (right).

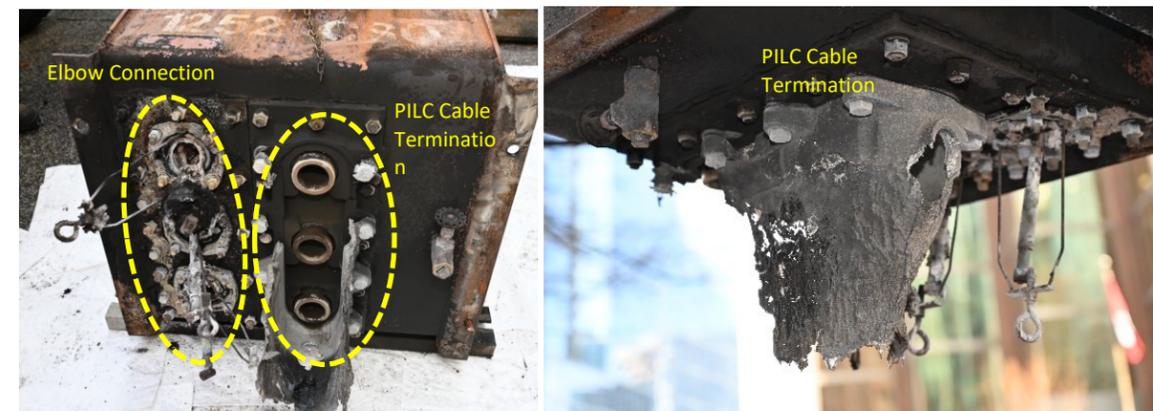
Figure 31: SW2018 external walls (a) front face; (b) bottom side.

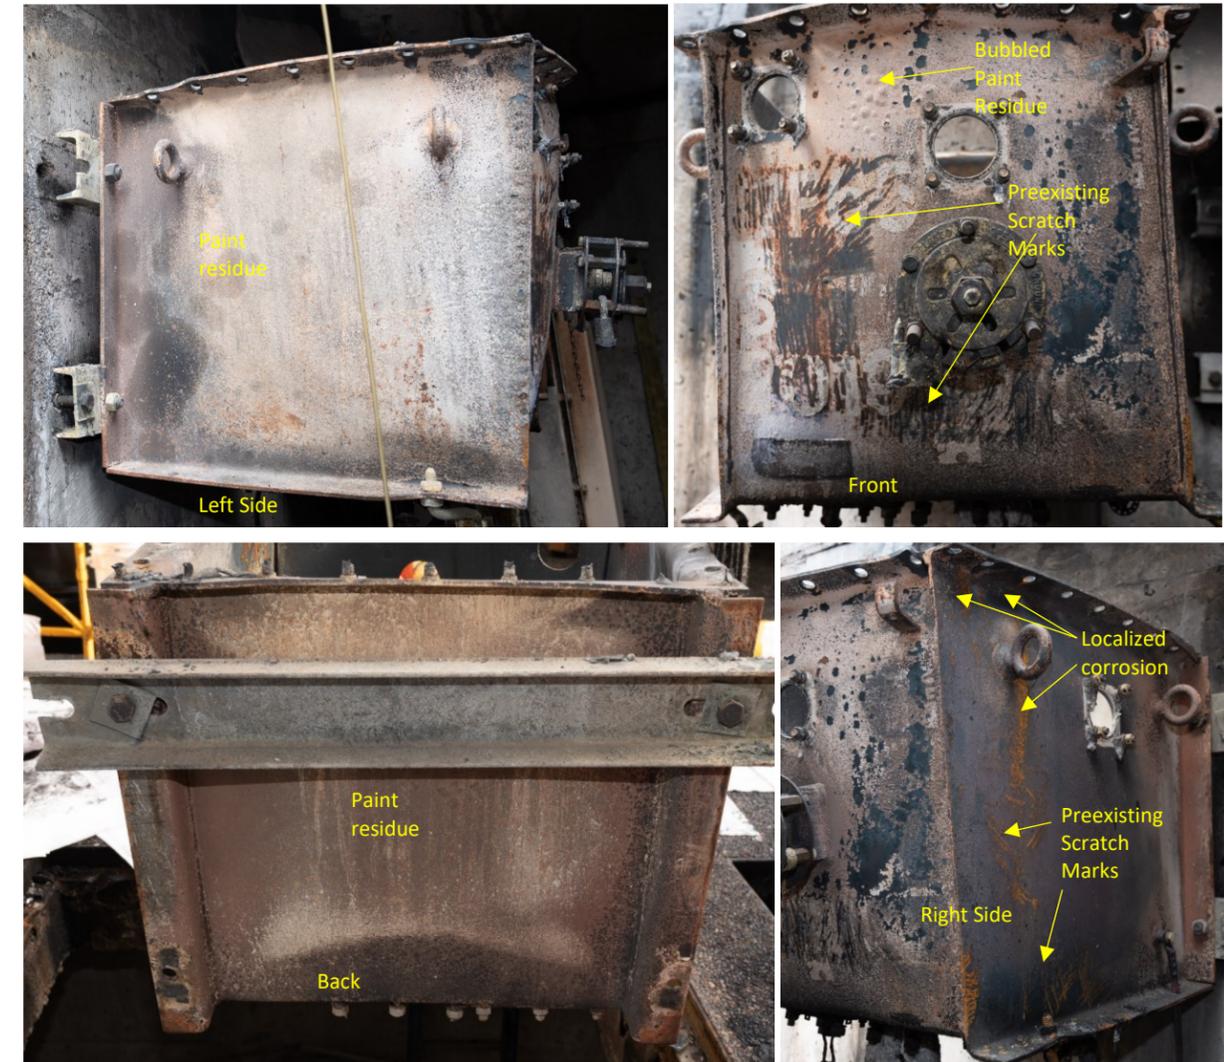
Figure 34: Images showing the perimeter faces of the SW2019 housing.

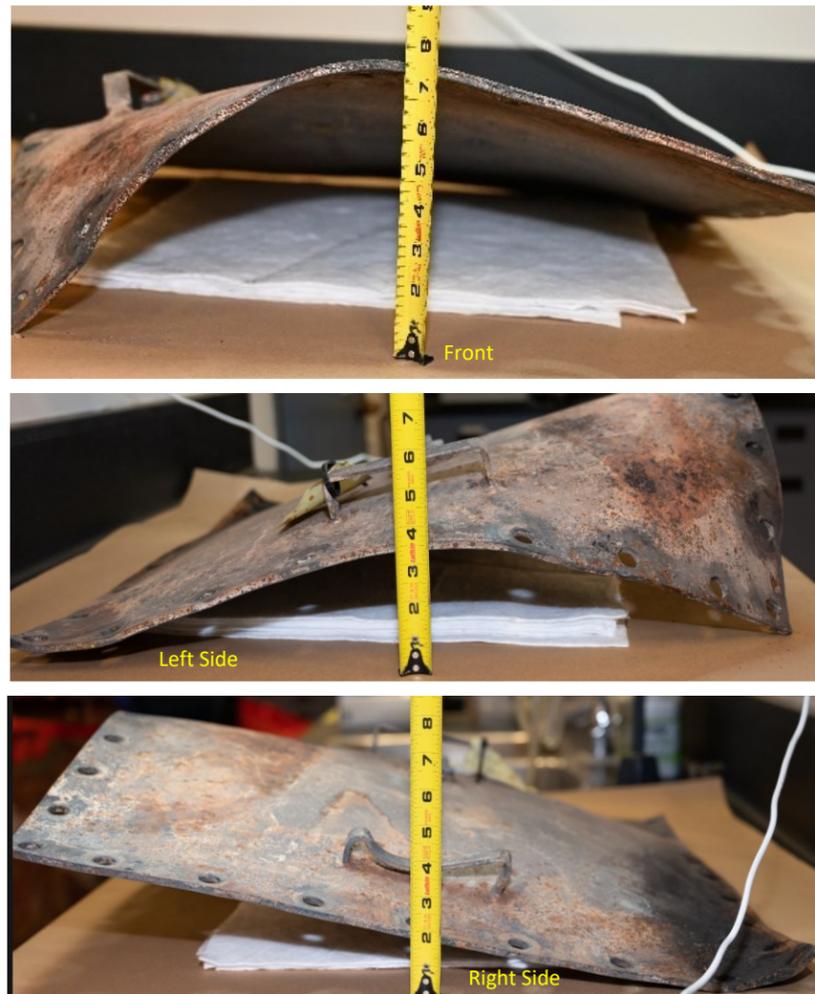
Figure 37: SW2019 lid deformation, observed during a laboratory examination.

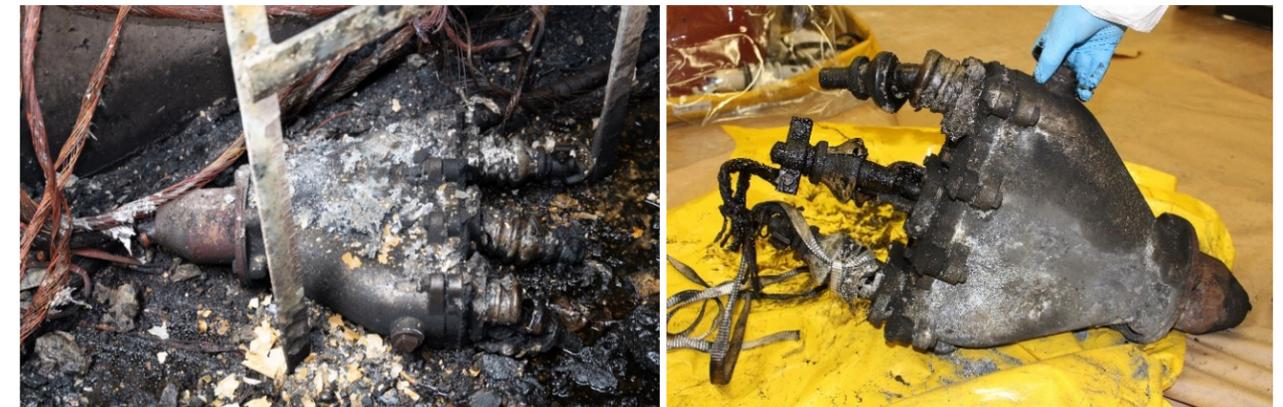
Figure 40: SW2019 PILC Connector and Termination as found (left); in laboratory (right).

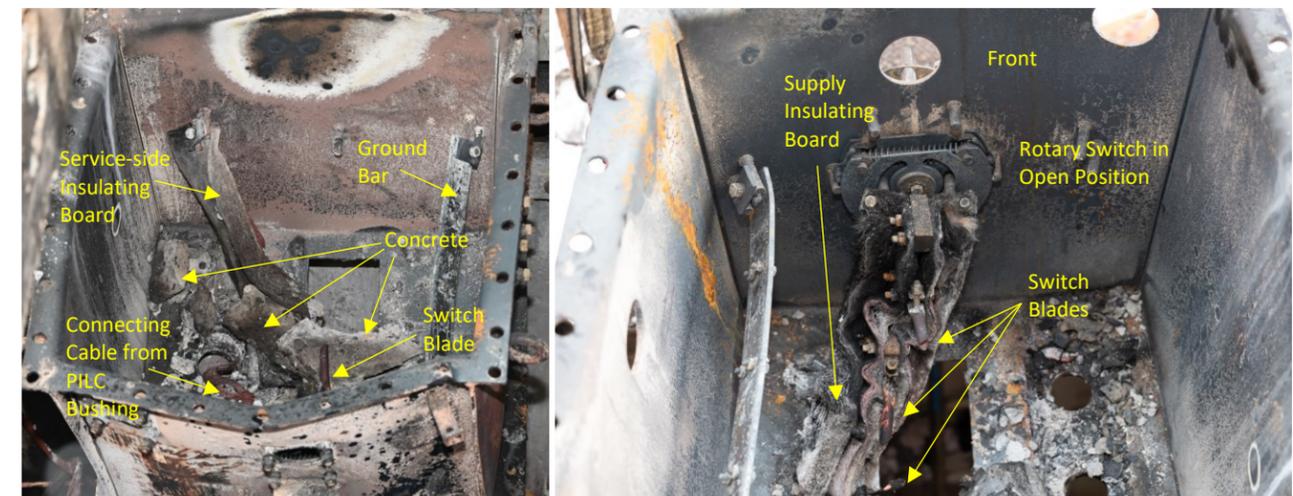
Figure 41: Interior of switch immediately post-incident (left); image of the front face of the switch box post-removal (right).

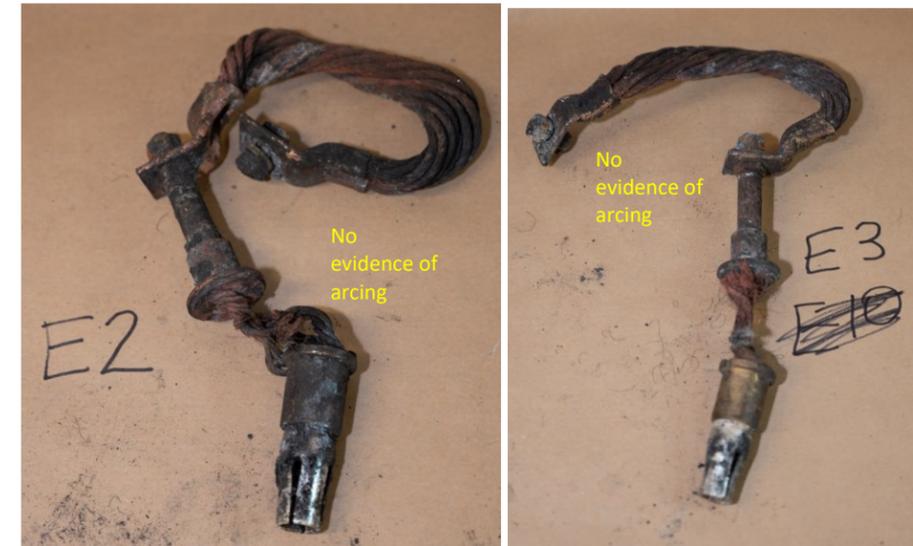
Figure 44: Elbow connector cables found in debris immediately below SW2019.

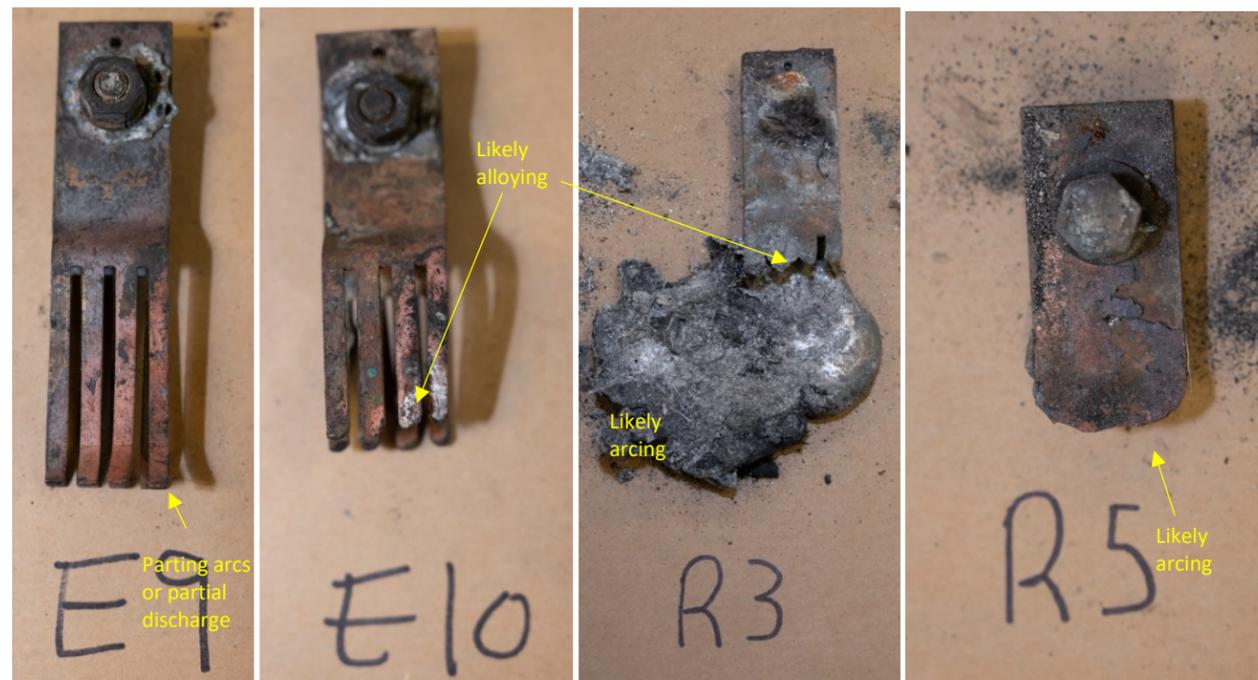
Figure 43: Contact forks found in debris underneath switch (left two), and debris south of switch (right two).

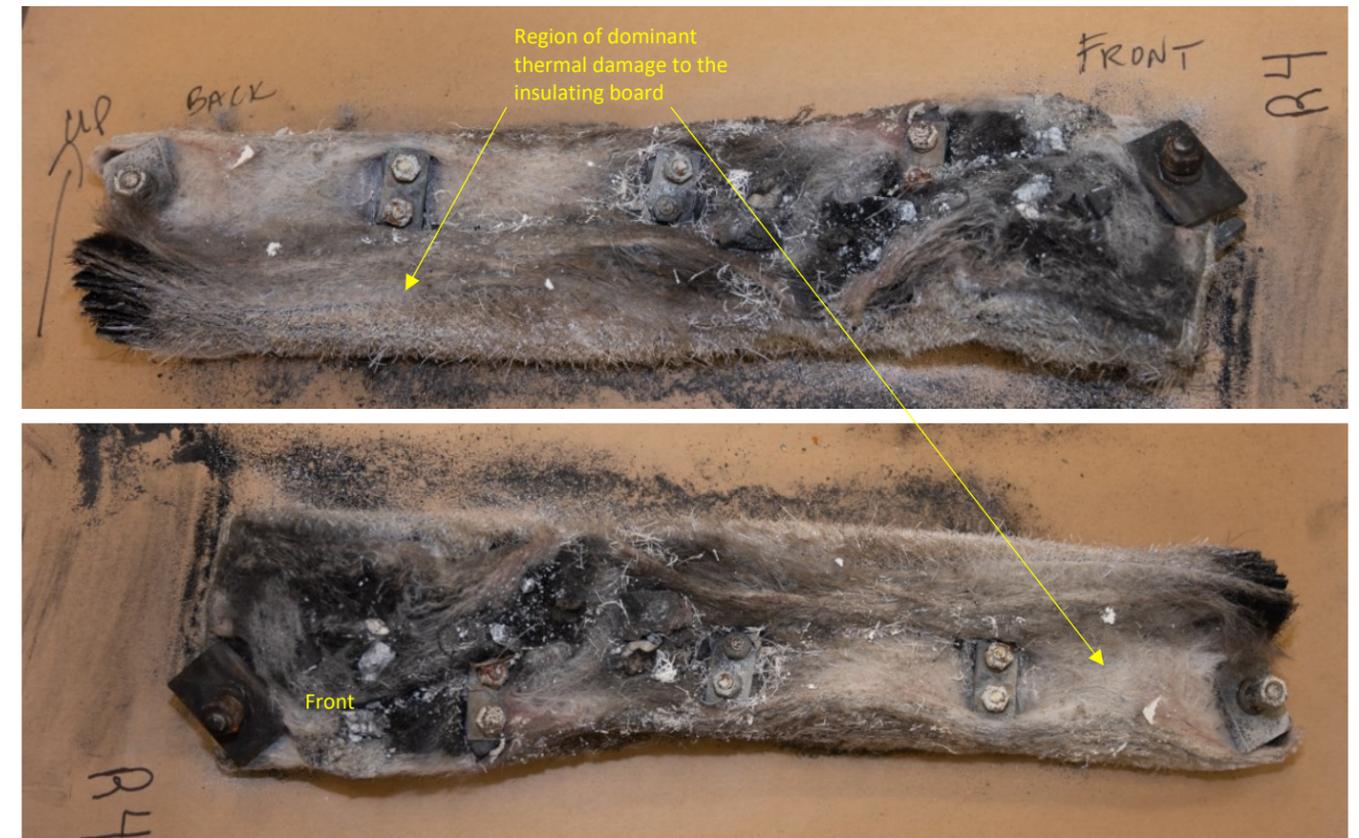
Figure 45: Images of insulating board on the service side of the switch, showing expansion of the fiberboard due to heat exposure.

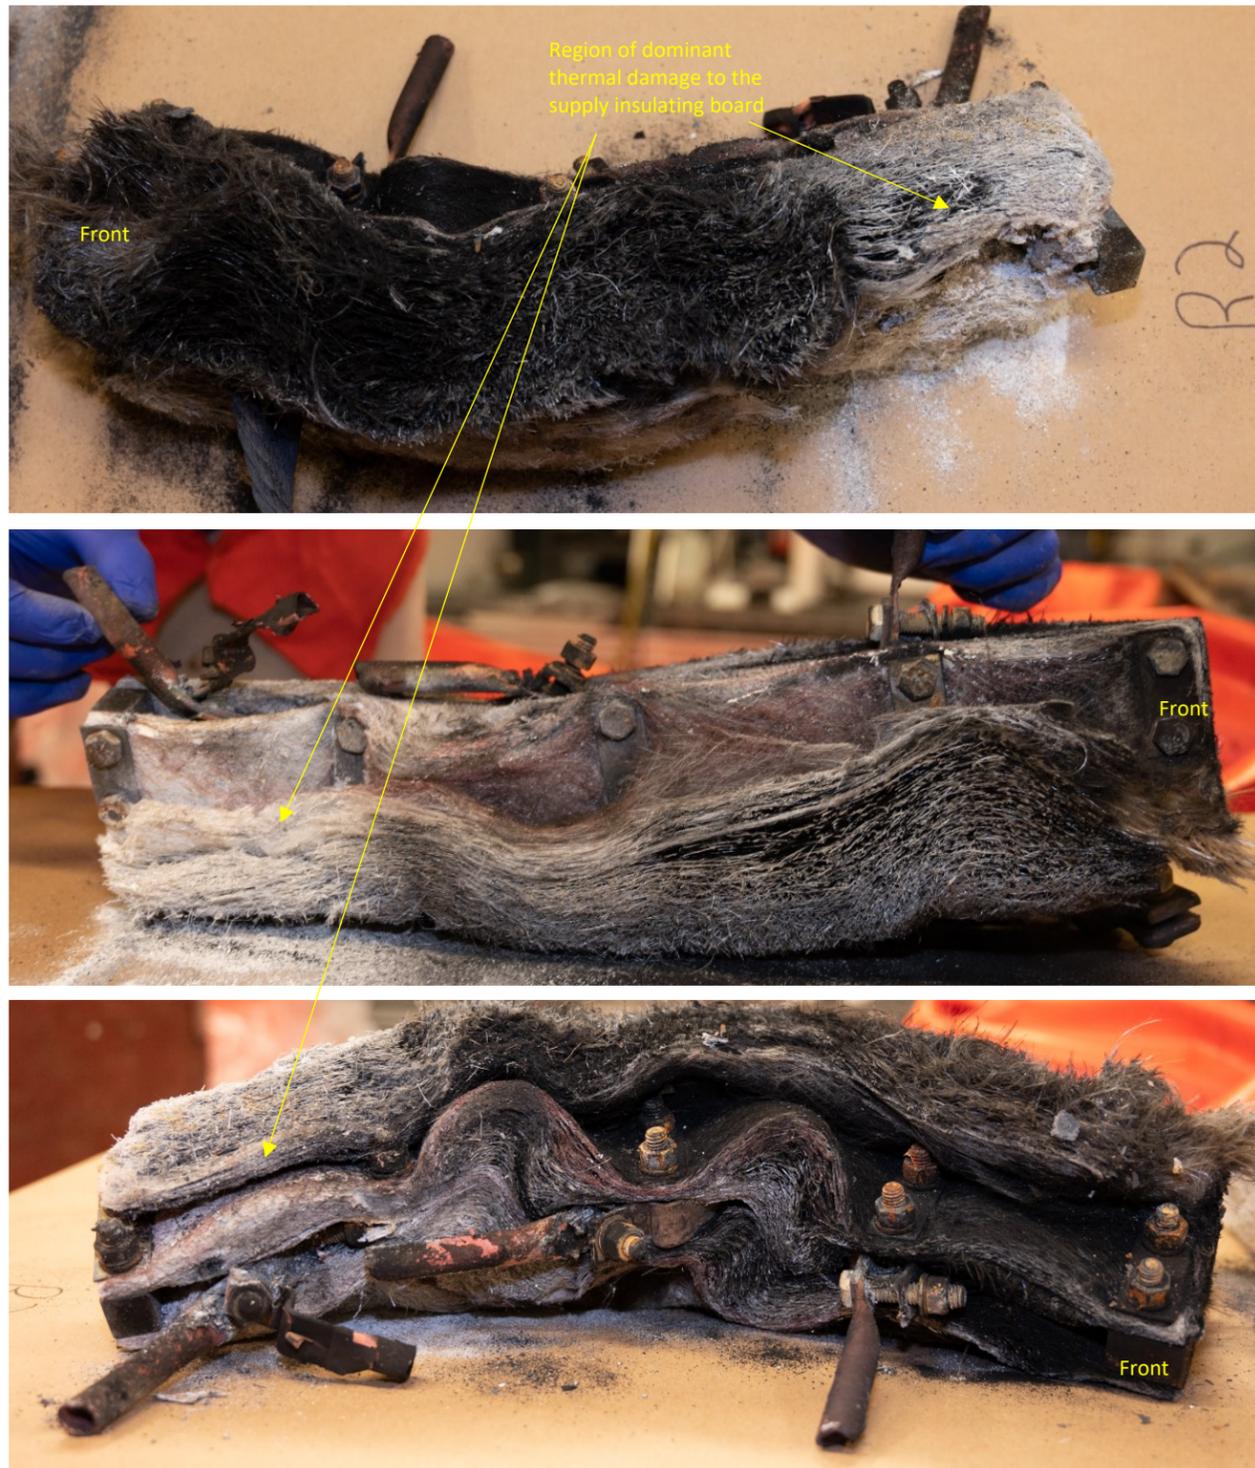
Figure 46: Images showing different views of supply insulating board with remaining blades and greater damage to the board at the back of the switch.

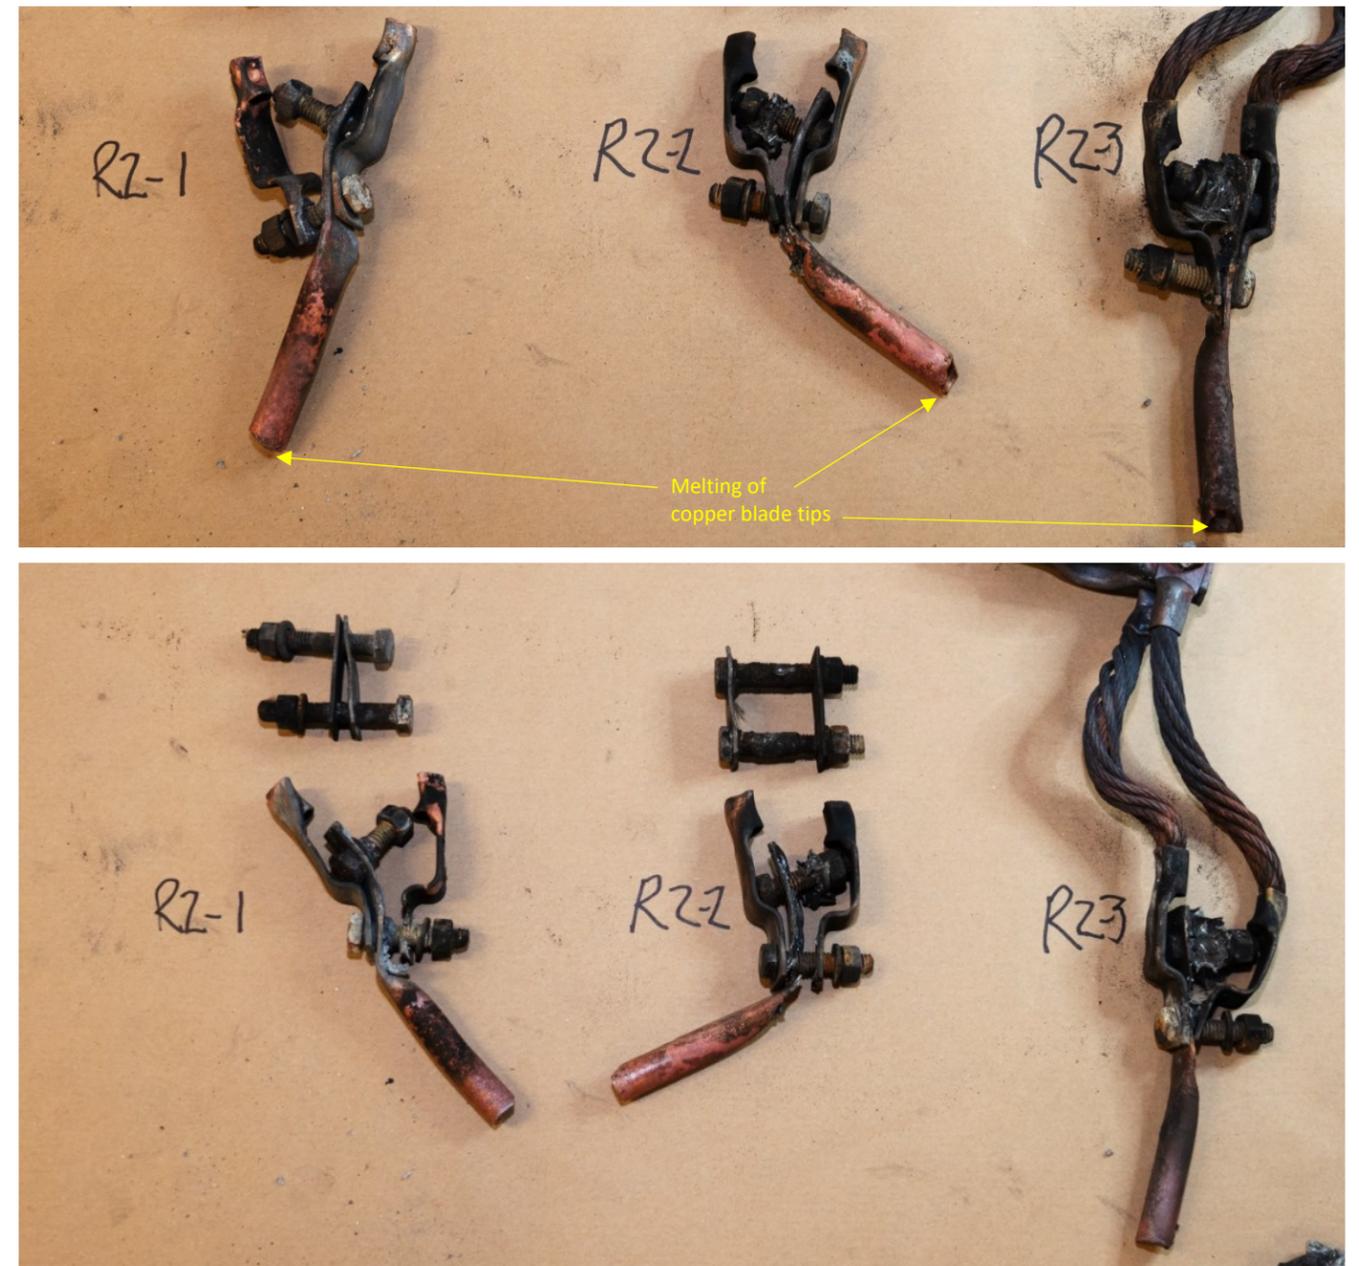
Figure 47: Blades from supply side of switch (two perspectives flipped 180 degrees).

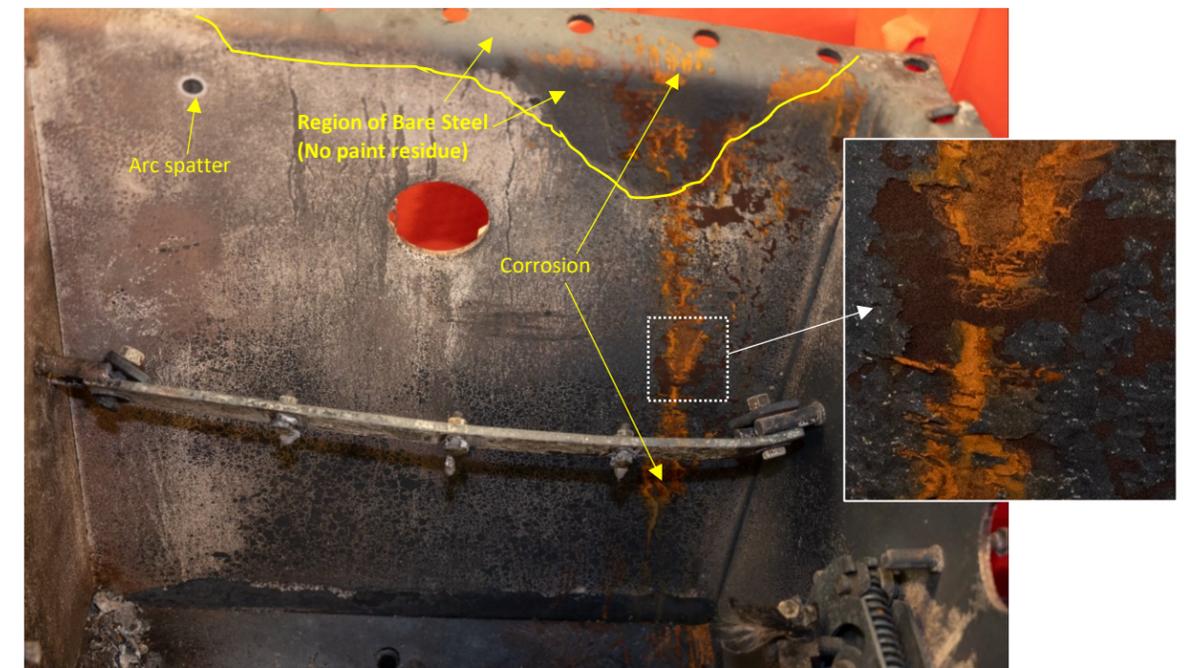
Figure 51: Arc spatter zone on interior right wall of SW2019 and corrosion region with blow-up inset.

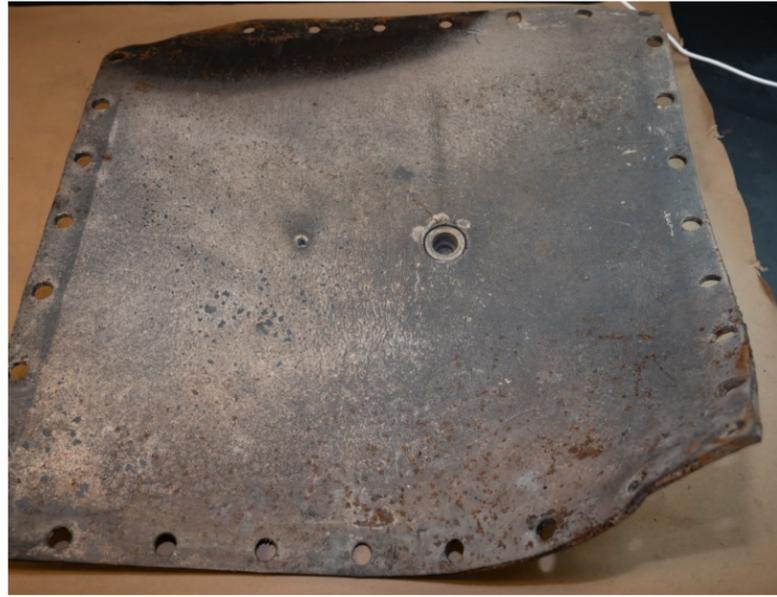
Figure 52: Underside of the lid from SW2019.

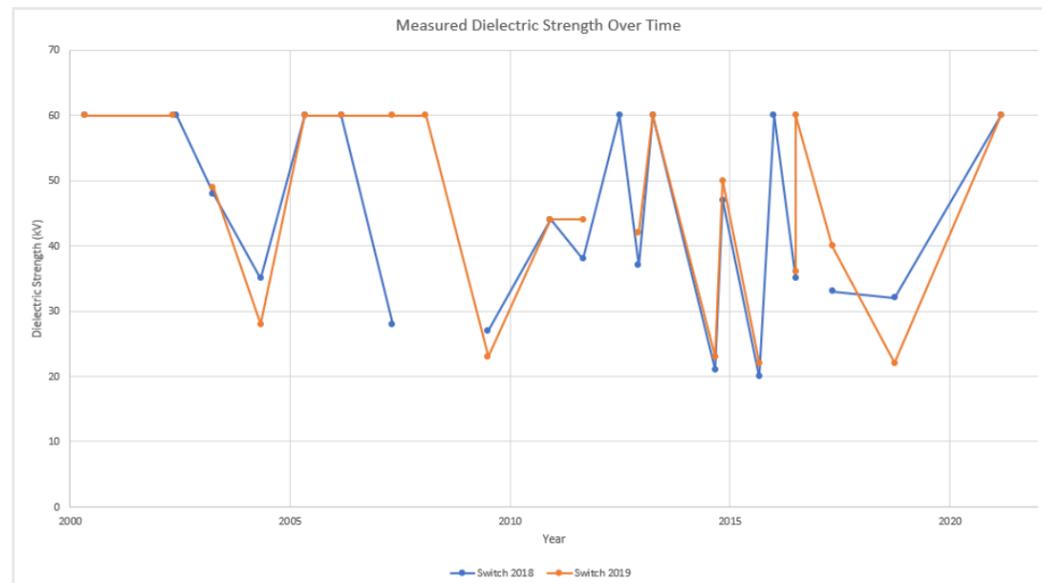
107. Historical data for dielectric strength in the Oil Quality Historical Report was charted in **Figure 56**, along with the oil change history, assuming the dielectric strength for new oil is 60 kV as suggested by C57.106-2006 for new circuit breaker insulating oil after being energized. (Data from the Maintenance logs from 2009 shows multiple data points at 60 kV, after an oil change, which supports the idea that the new uncontaminated oil after being energized has a dielectric strength of 60 kV as suggested in the Guide.)

**Figure 56:** Measured Oil Dielectric Strength.

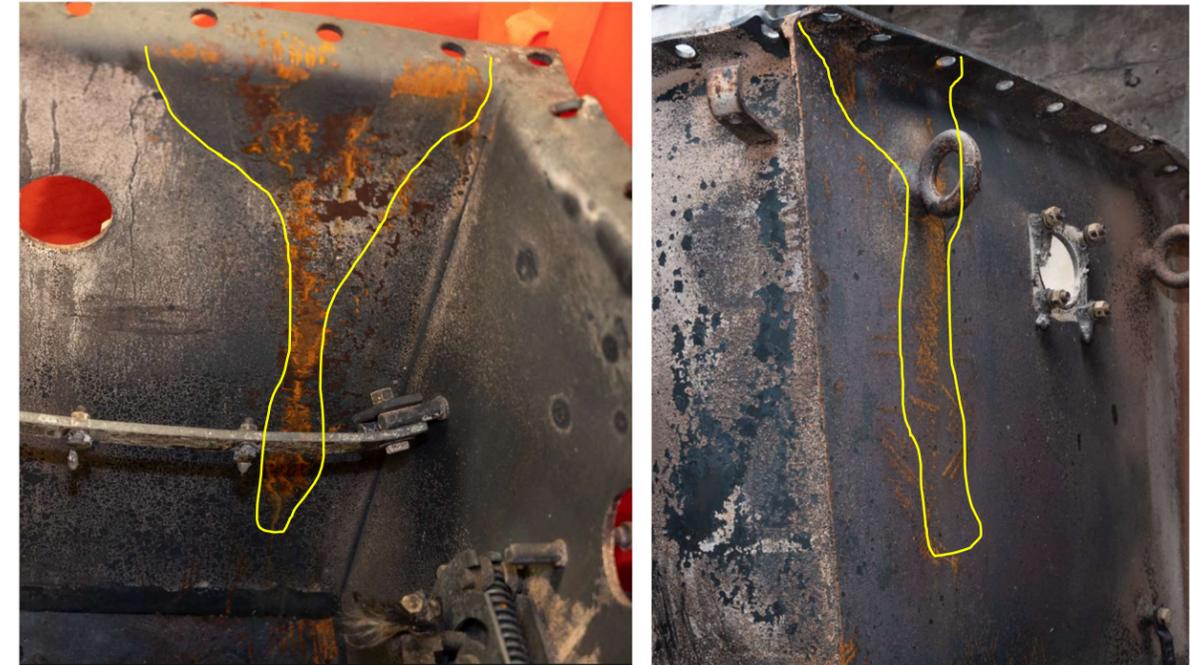
- Corrosion/rust residue from other areas within the switch housing were more spotted and closer to the surface, indicating it likely developed after the explosion and fire.

Figure 57: Corrosion region on inside and outside of the switch housing aligning with three bolt openings.

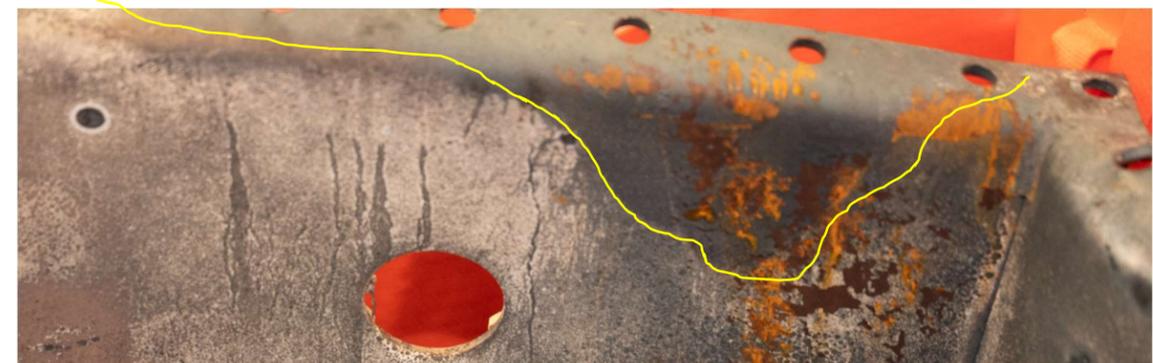
- Collection of degraded enamel just outside the no-paint region had a different spectral pattern than other paint areas in the tank indicating a chemical degradation by more than just thermal exposure from the fire.

Figure 58: Region where no epoxy-enameled paint remained post-Incident.

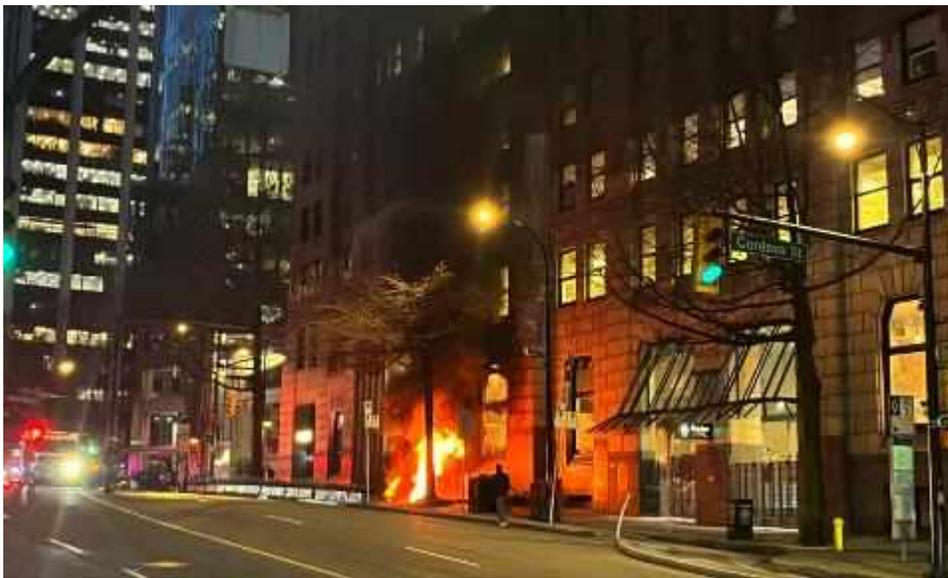
**Figure 1. Photo of fire emanating from Vault 073 on February 24, 2023**

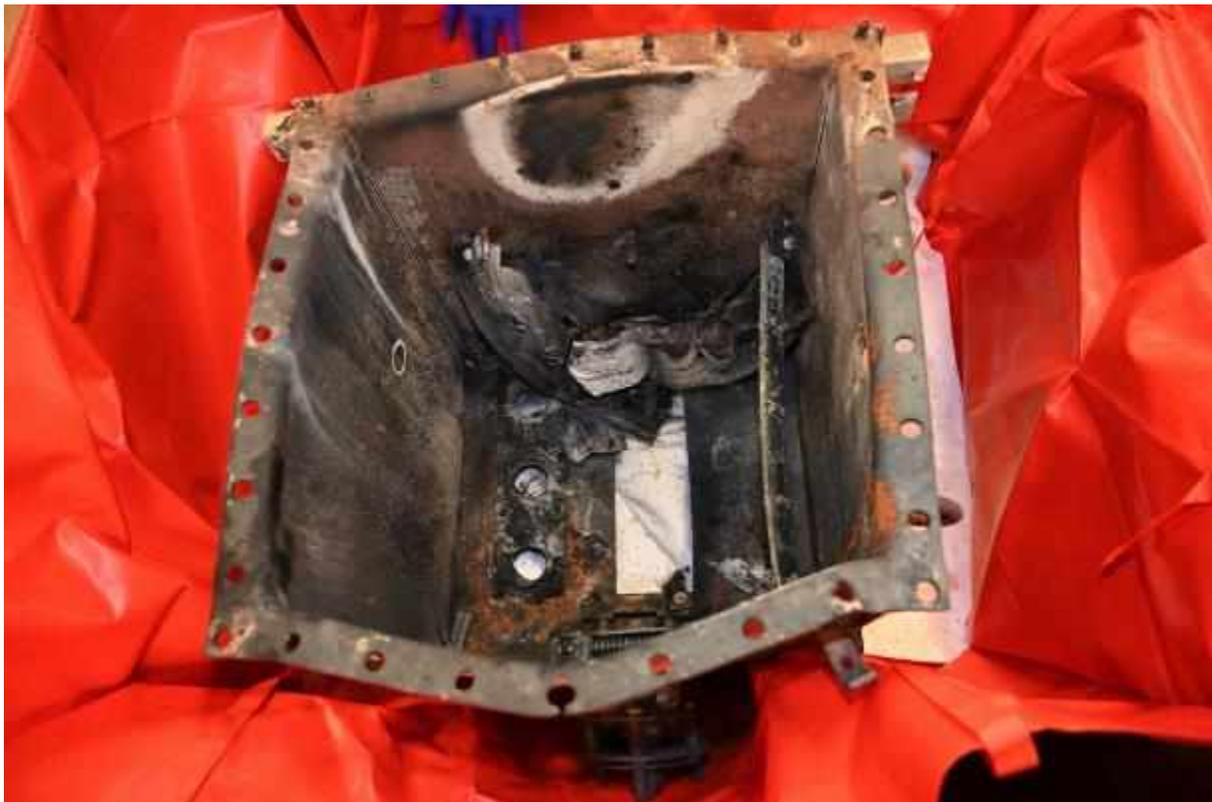
**Figure 2. Top down view into switch 2019 (as received)**

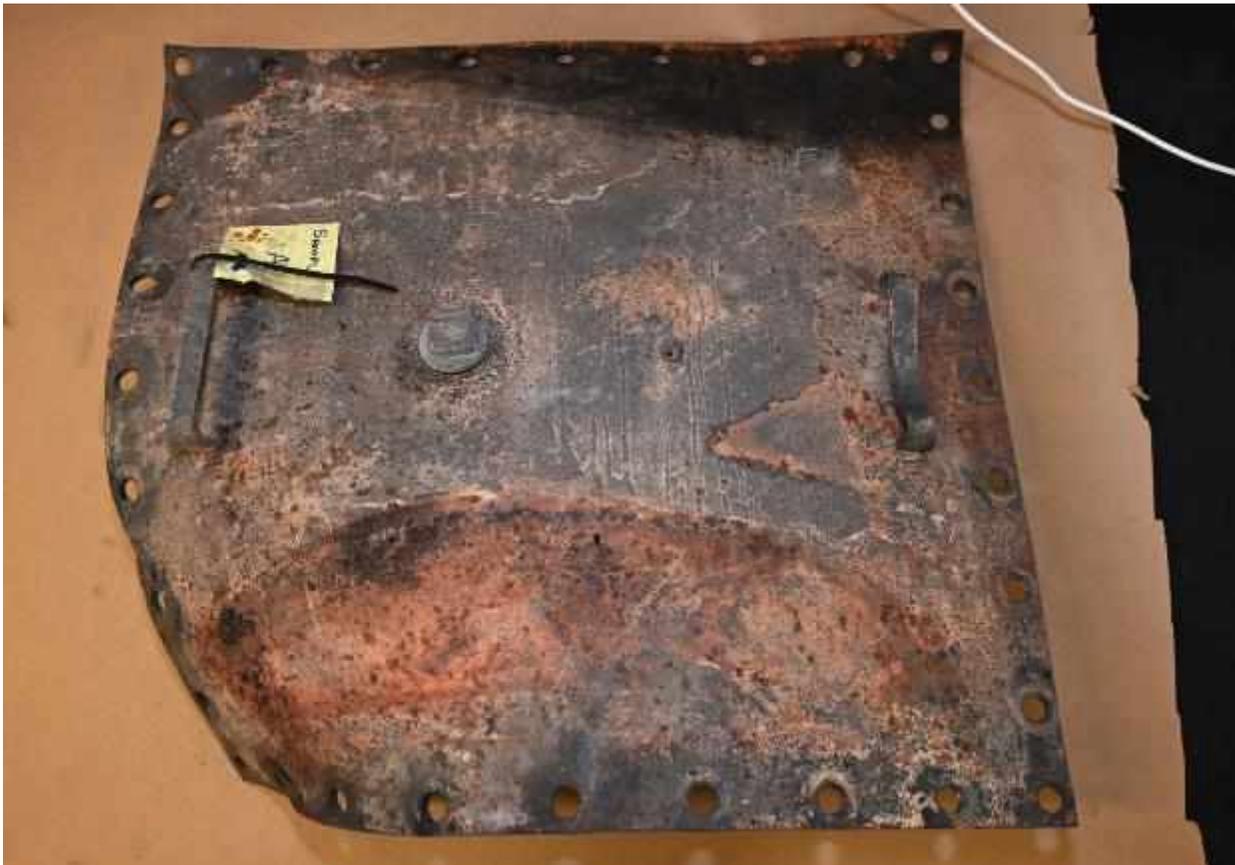
Figure 4. Bent lid from switch 2019
