## Explosion & Fire on Burrard Street at BCH V73

### Explosion & Fire Analysis Reconstruction

**Our File Number:** 2300129  
**Date of Report:** June 7, 2023  
**Revision:** 0  
**Report #:** 001  
**Date of Incident:** February 24, 2023

**Prepared for:** Ms. Nicole Prior  
Senior Manager, Legal Services  
BC Hydro  
6911 Southpoint Drive, Podium A03  
Burnaby, BC V3N 4X8

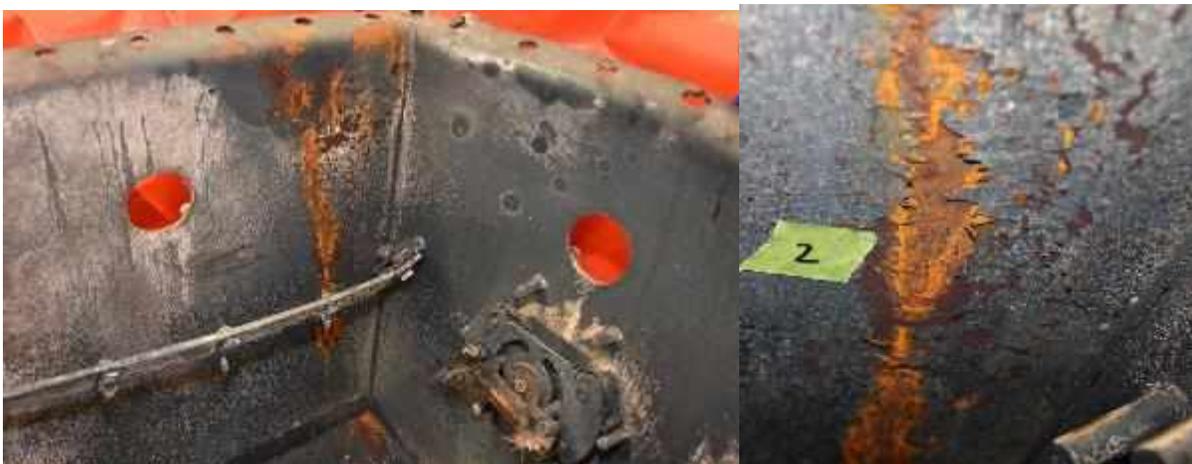
At the front of the right side of the tank, a distinguishing path of orange discolouration and material flaking was observed from the top edge of the tank to approximately one-quarter from the bottom of the tank (Figure 6). Additionally, localized spotted sections of orange-brown flecks along the back edge to the right back corner of the switch 2019 tank, as well as the back left corner itself also showed signs of orange-brown discolouration. The ground bar, some of contacts (showing various degrees of damage), and the switching mechanism remained inside the tank of switch 2019, along with was carbonized pieces (charcoal) of material, soot and dirt, as received at Powertech.

**Figure 6. Close up photos of orange-brown areas inside of switch 2019 tank**

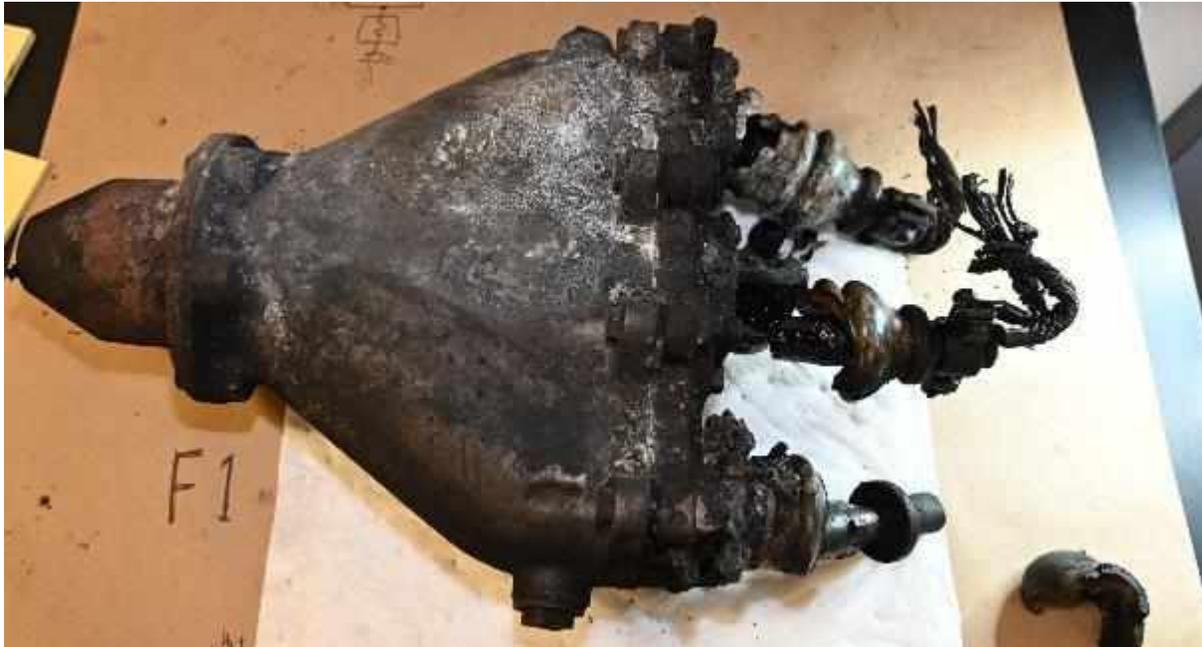
Upon retrieval of switch 2019 and corresponding recovered components from the vault, the PILC termination that is found bolted to the bottom of a non-damaged switch was intact and on the ground of the vault, below the switch 2019 housing. The damage to the top of the PILC termination, the broken insulators, is consistent with the termination dropping and rebounding off the ground (Figure 7).

**Figure 7. PILC termination from switch 2019**

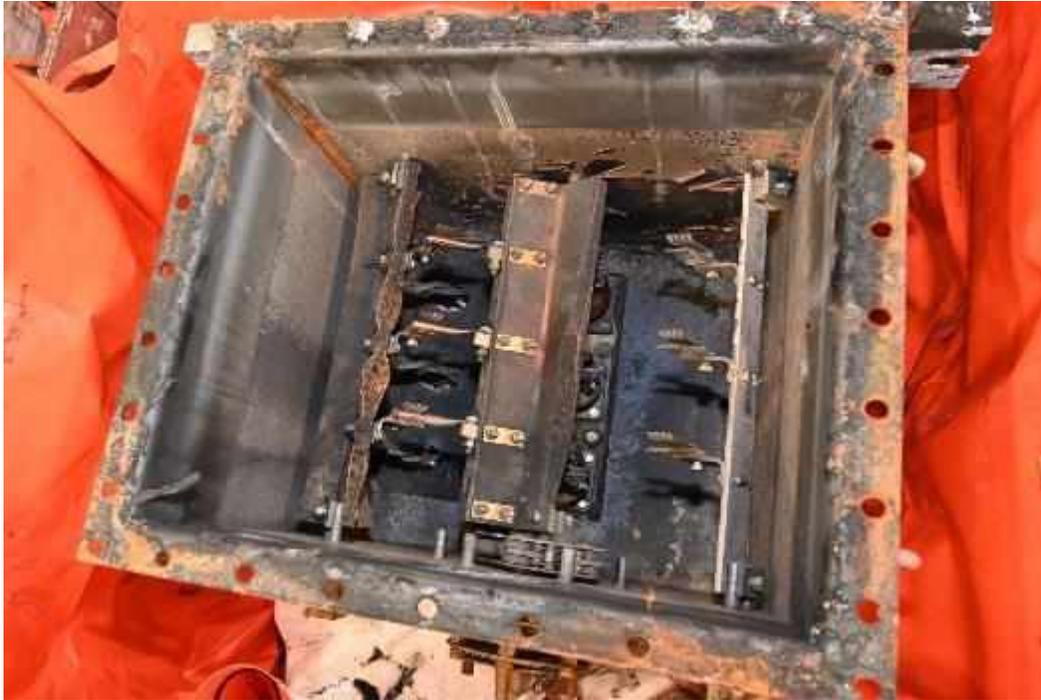
When fully removing the lid of switch 2018, the internal components were discoloured by carbon particles/soot from the vault fire, but were intact, showing minimal signs of physical damage (Figure 8).

**Figure 8. Top down view into switch 2018 (as received)**

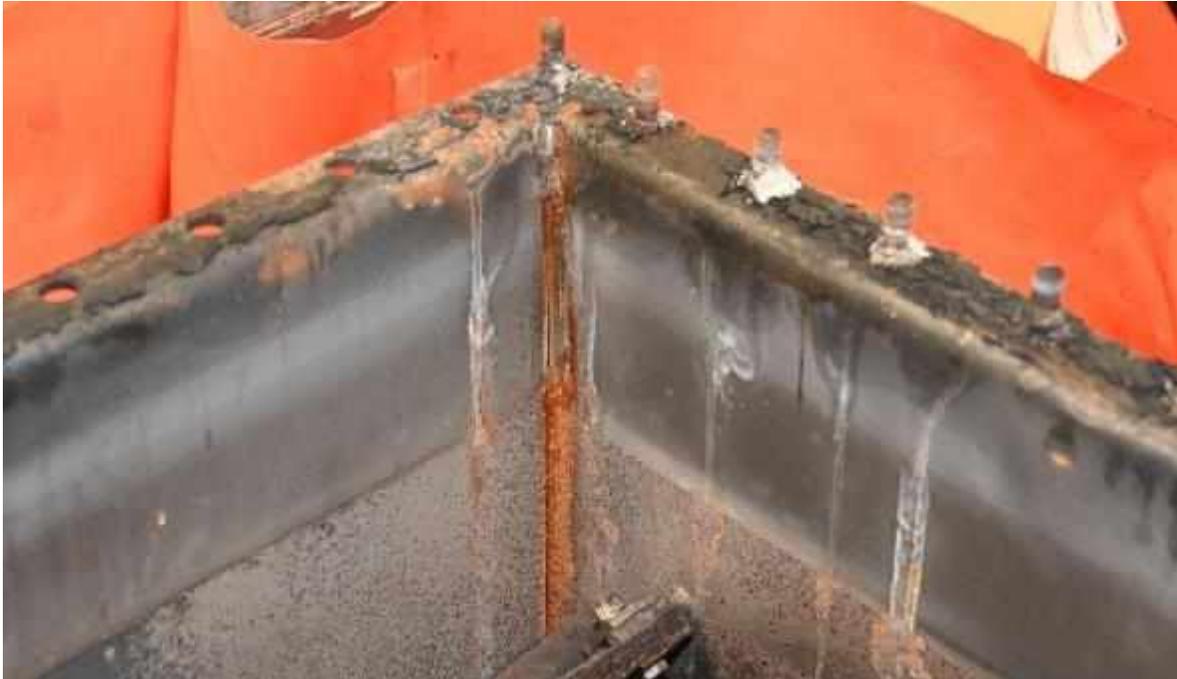
Similar to the inside of the tank of switch 2019, the back left corner of the switch 2019 tank showed some orange-brown residue on the edge and down the inner corner wall, as well as along the front edge of the tank. However, unlike switch 2019, the orange-brown residue was more superficial (i.e., not as deep into the metal). Additionally, in all observations, the orange-brown residue in switch 2018 was not a continuously connected path from the edge of the tank down the side of the inner walls (Figure 9).

**Figure 9. Close up of orange-brown residue on walls of switch 2018**

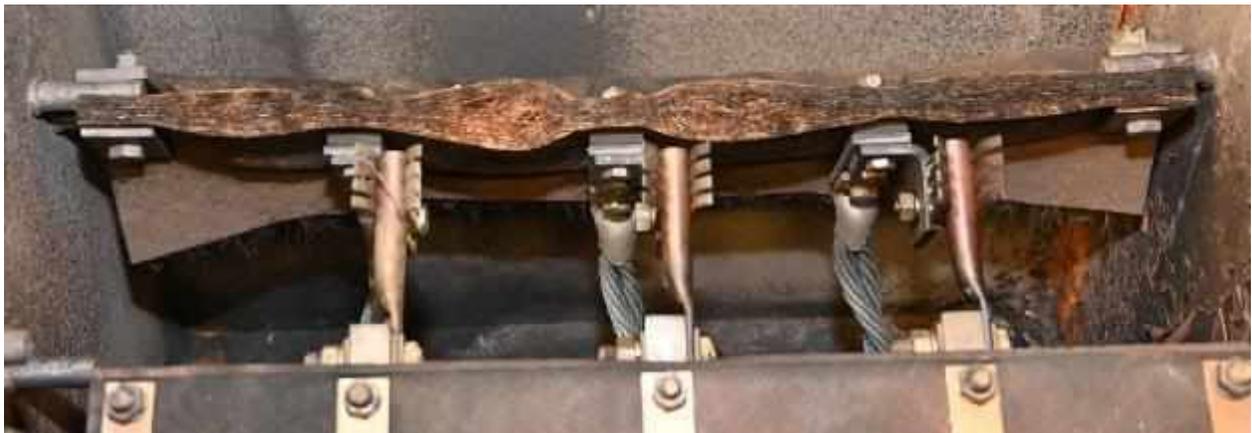
In addition to the missing and degraded paint inside the switch 2018 tank, the fibreglass contact bar on the left side of the switch was discoloured and expanded in sections (Figure 11), and the gasket beneath the lid had carbonized, being completely consumed in sections (Figure 12). These observations also indicate that the inner components of the tank were exposed to high temperatures ( $>200^{\circ}\text{C}$ ) for a prolonged period of time.

**Figure 11. Insulating bar from switch 2018 showing expansion due to being exposed to high external heat**

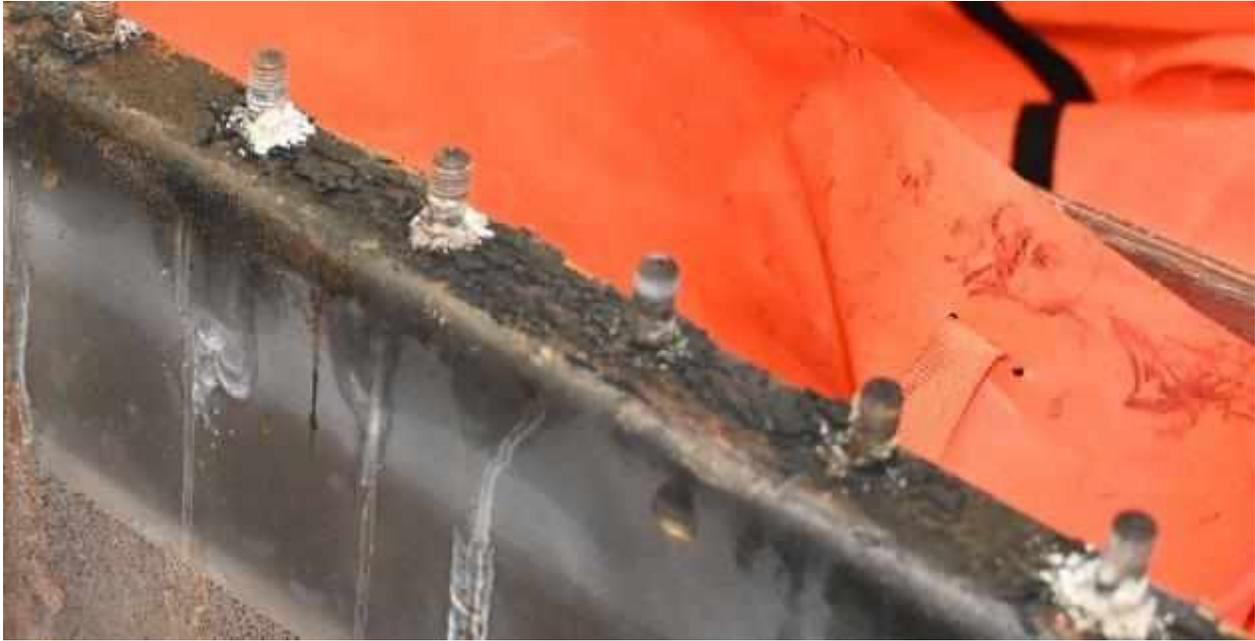
**Figure 12. Close up of a region of carbonized and damaged gasket of switch 2018**

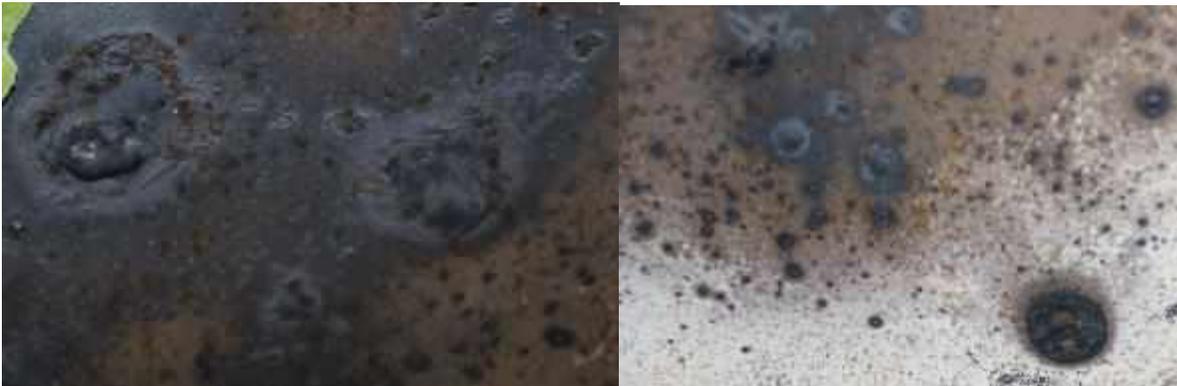
In several locations on the walls of switch 2019, metallic-like globule splatters were observed (Figure 13). In order to determine the composition of the metallic-like globule splatters on the walls of switch 2019, the residues were collected by using specialized silica-carbide abrasive discs and rubbed against the bulbous deposits.

**Figure 13. Selected photos of metallic-like splatter on the tank walls of switch 2019**

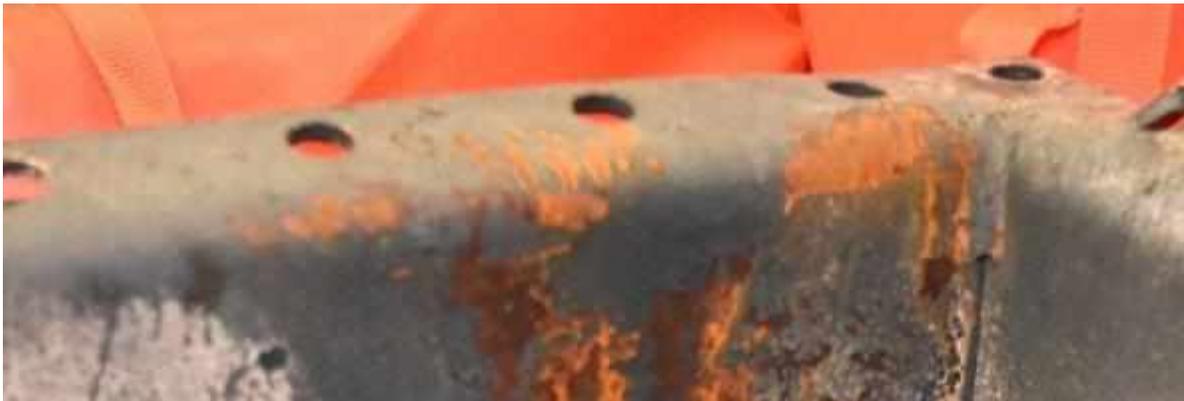
**Figure 24. Damage at edge of tank right front**

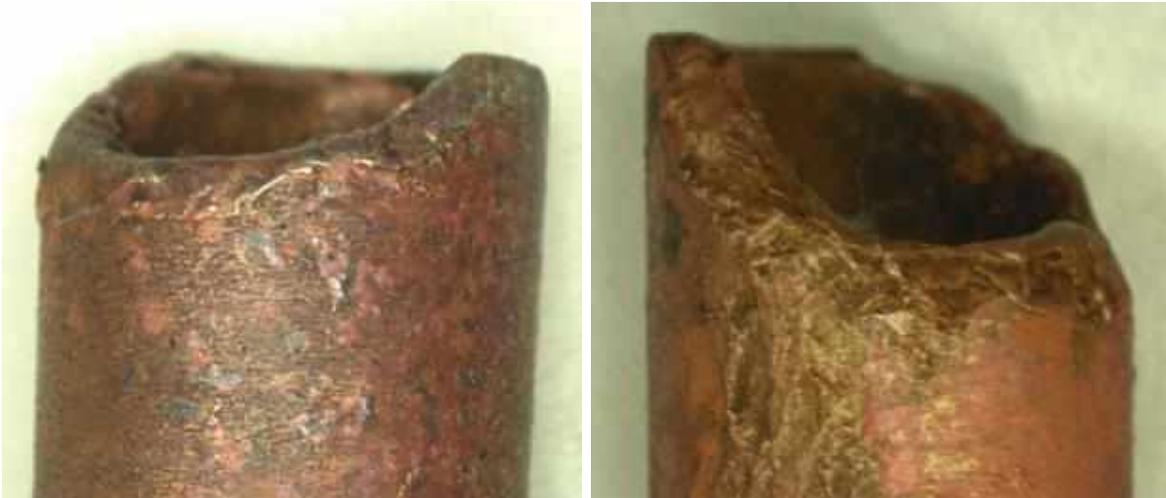
**Figure 31. Microscope photos of two different example tips of copper blades from switch 2019**

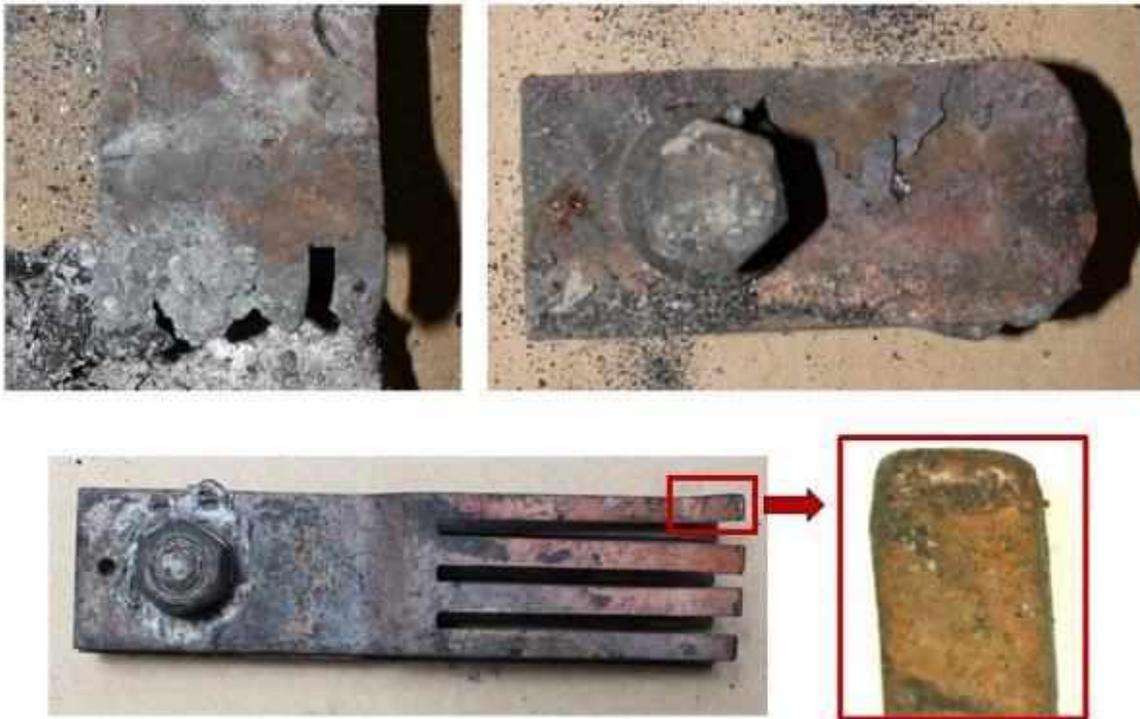
**Figure 32. Photos of two different example forks of from switch 2019**
