**02SH35**

**IRELAND CREEK SIDETCHANNEL**

**FINAL REPORT**

Date: April 12, 2003

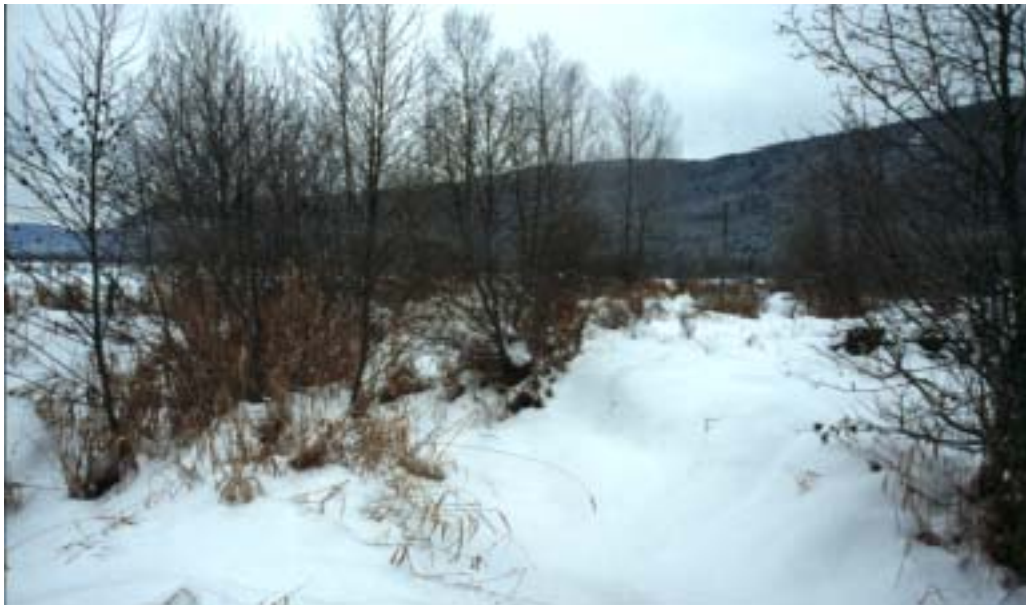
Pete Huwer operates a hog farm, 2804 Mabel Lake Road. The upper third of the channel runs between the road running from the house and hog barns and pasture. There were some alder growing along the old creek bed before construction (Figure 1).

Figure 1: The upper channel before construction. The old streambed was dry most the year but retained some riparian vegetation.

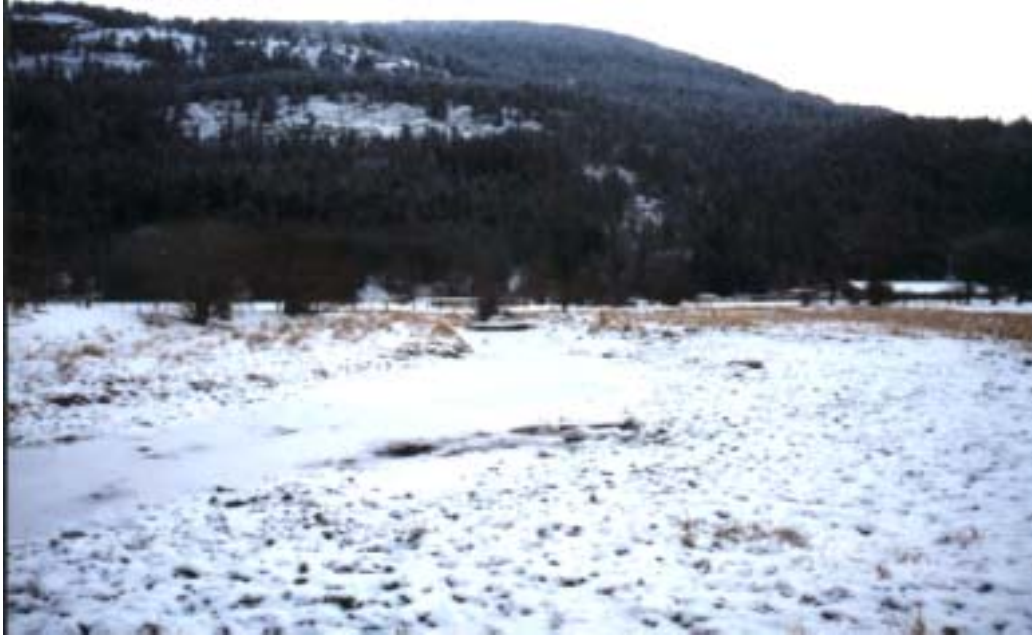
Joe Huwer, 2856 Mabel Lake Road, raises cattle. The cows had complete access to the old channel so that there was no riparian vegetation. The banks were heavily trampled before construction (Figure 2).

Figure 2: The lower creek bed was accessible by livestock that denuded and trampled the banks.

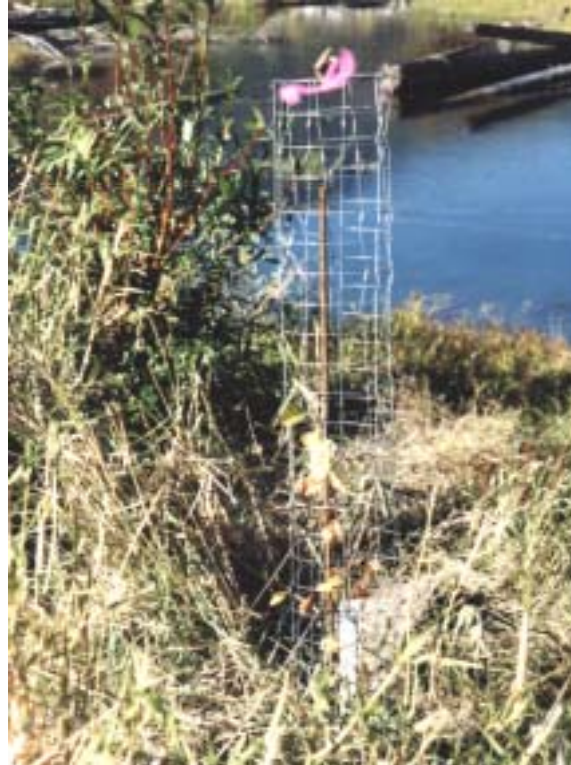
Figure 3: Stucco wire supported by 1.2 m lengths of 10mm rebar is used to support the trees and shrubs that are vulnerable to browsing by deer. The wire cages also help to protect the plant from being smothered by the reed canary grass in the fall and winter when it becomes matted by snow. The wire cage is marked with flagging so the plants can be easily located in the tall grass for watering during the summer months.

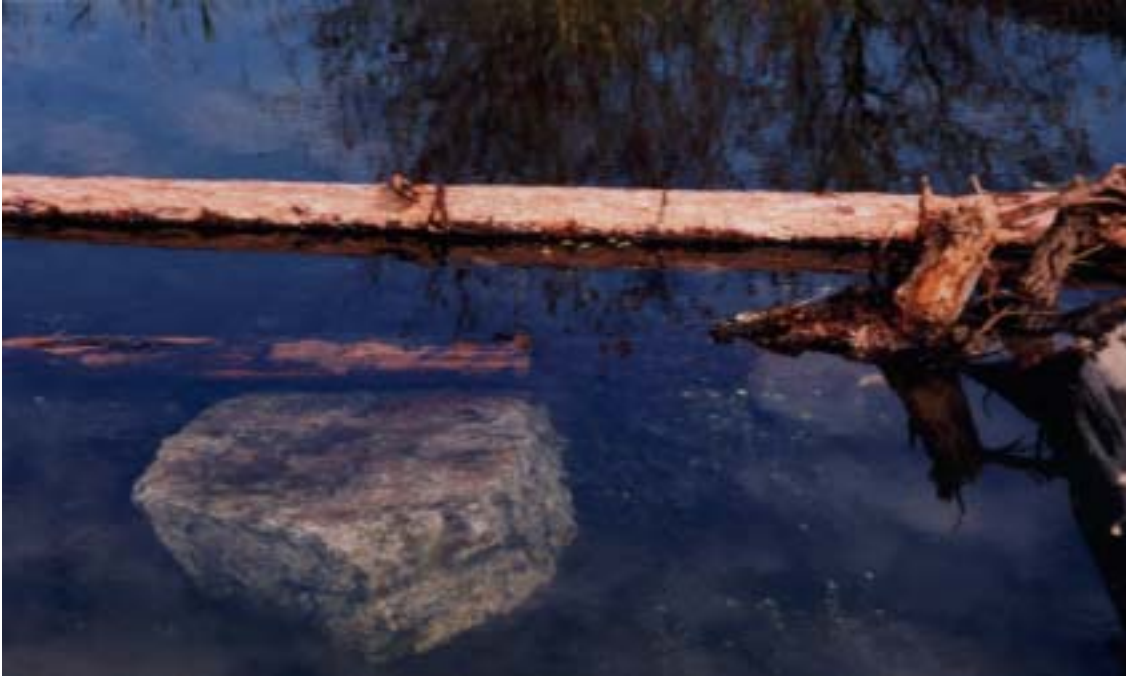
Figure 4: Chain was epoxied to holes drilled into large rocks and stapled to one or both ends of a tree. Short lengths of chain were used on approximately half the wood to provide in-stream cover. These logs are submerged even during low water. Effort was made to keep the chain hidden for aesthetic value.

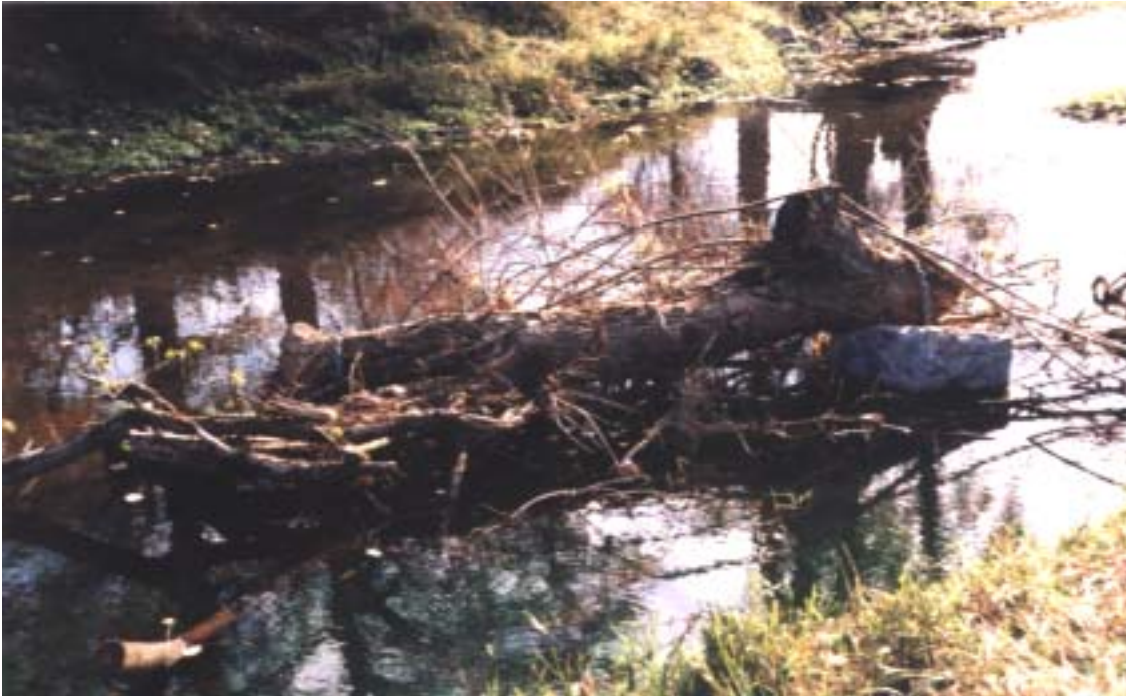
Figure 5: Brush was piled in pool areas and held in place by logs placed on top of the pile. The logs were anchored weighted with rock.

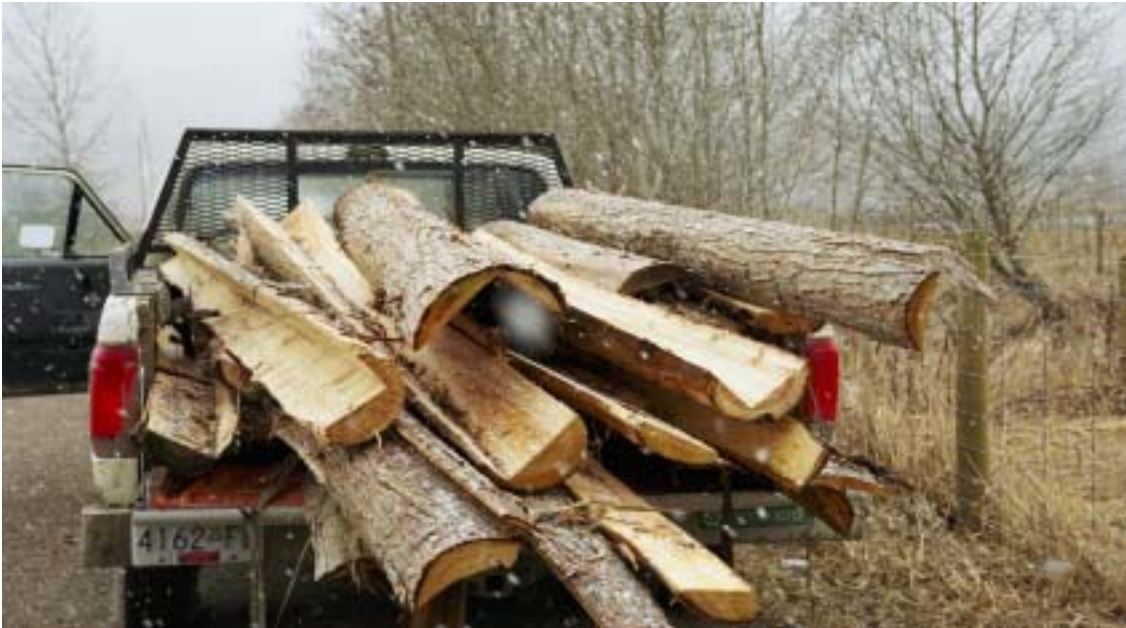
Figure 6: Cedar slabs used for complexing. The two-sided slabs are light enough to install by hand and resemble whole logs when placed in the water. The cavity provides more in-stream cover than whole logs.

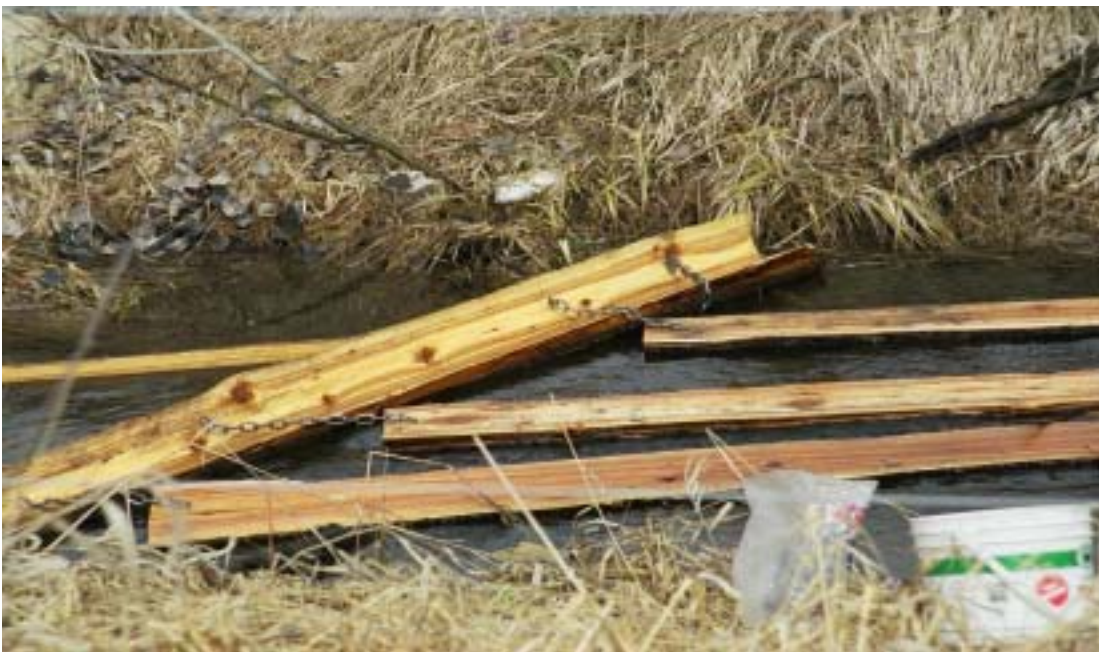
Figure 7: The slabs can be chained underneath so the chain is not visible.

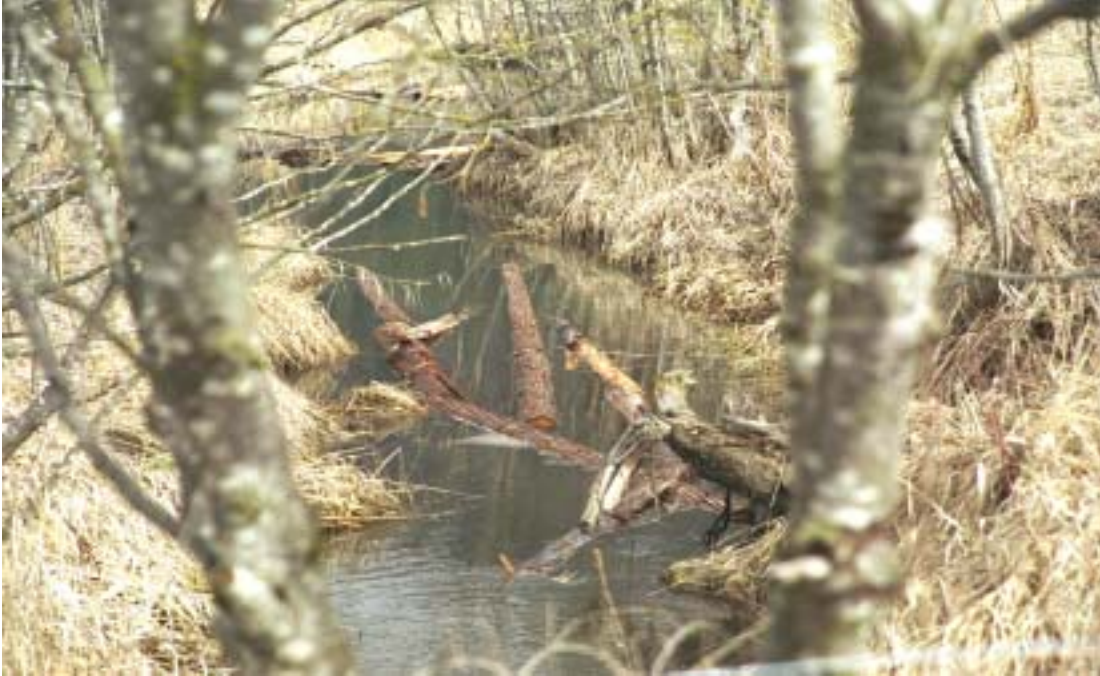
Figure 8: The slabs were chained together and anchored to the bank in various configurations to give them a random appearance. This method allowed the placement of woody debris in areas where there were not machine accessible. There is very little disturbance of either the riparian area or the stream using this method.

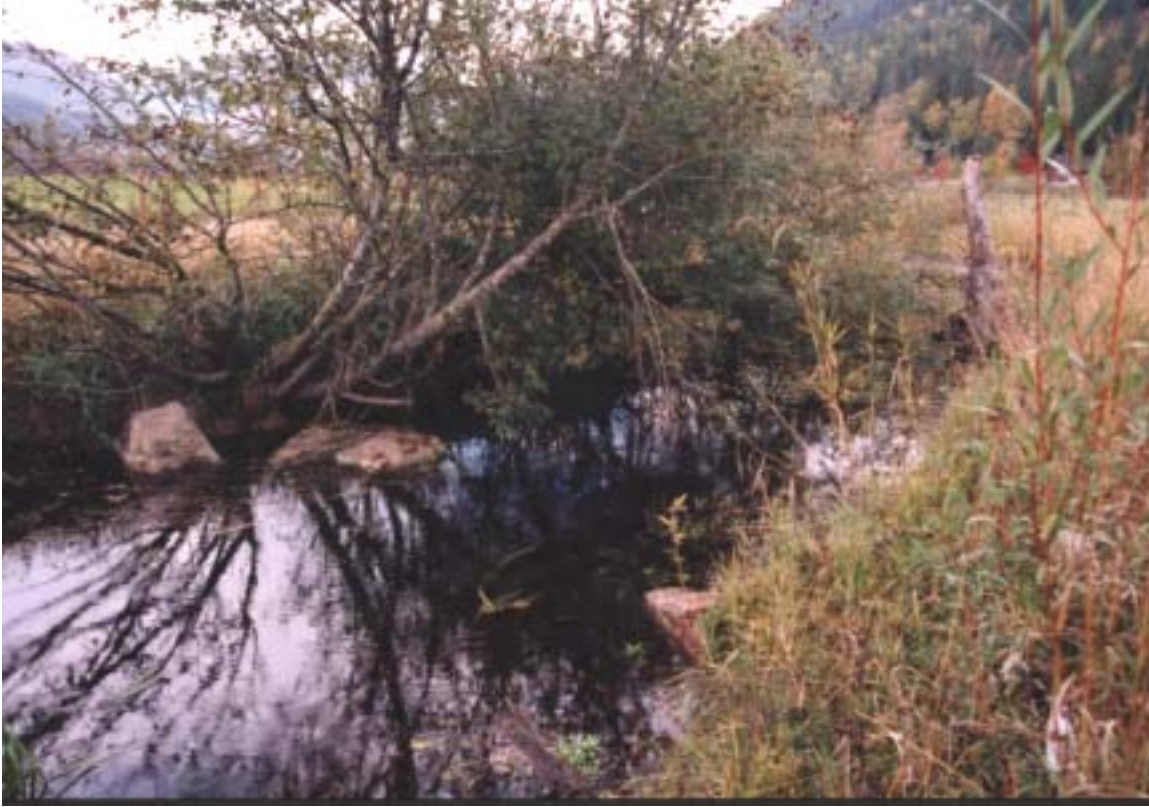
Figure 9: Large rocks placed in the side channel improve both the habitat and aesthetic values of the stream.

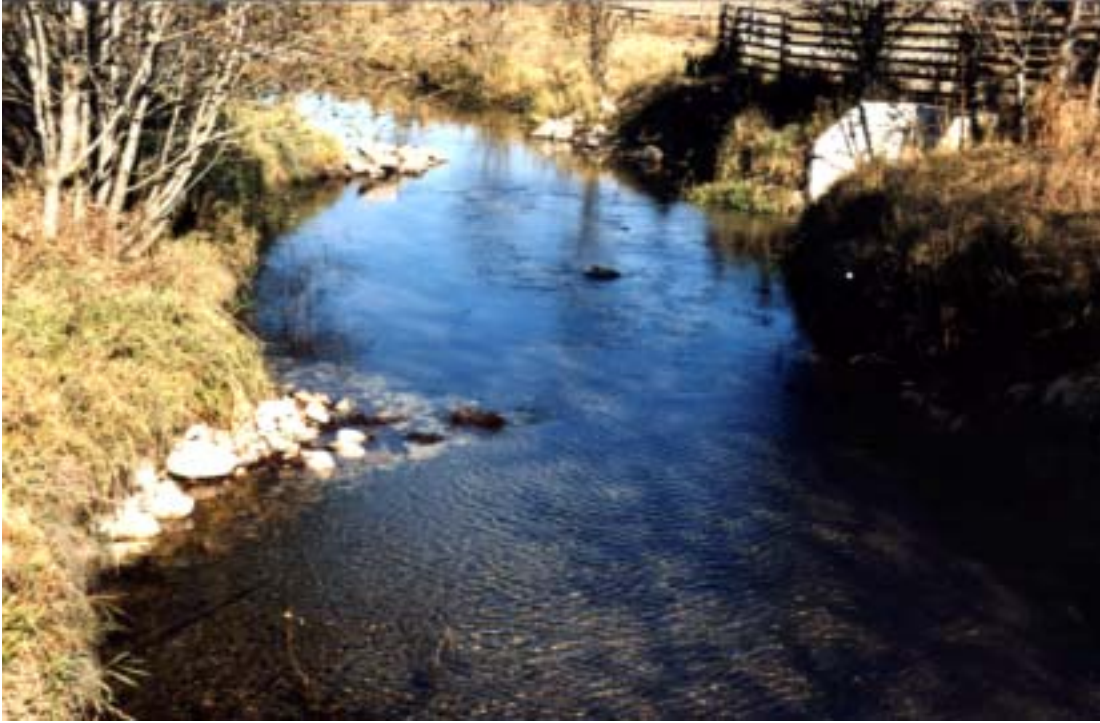
Figure 10: A low profile bend-away upstream of the intake kicks the thalweg to the right bank. The rocks located downstream were in place prior to construction.

A low profile bend-away weir was built in Ireland Creek approximately 10 m upstream of the intake structure. The bendaway kicks the thalweg over to the right bank so that it sweeps the area in front of the intake. This small structure was enough to clear the sediment from in front of the intake. Previously a sandbar had been obstructing the water during the low summer flows (Figures 10-12). With the water sweeping the intake, the low flow into the channel was approximately  $2 \text{ m}^3/\text{s}$ .

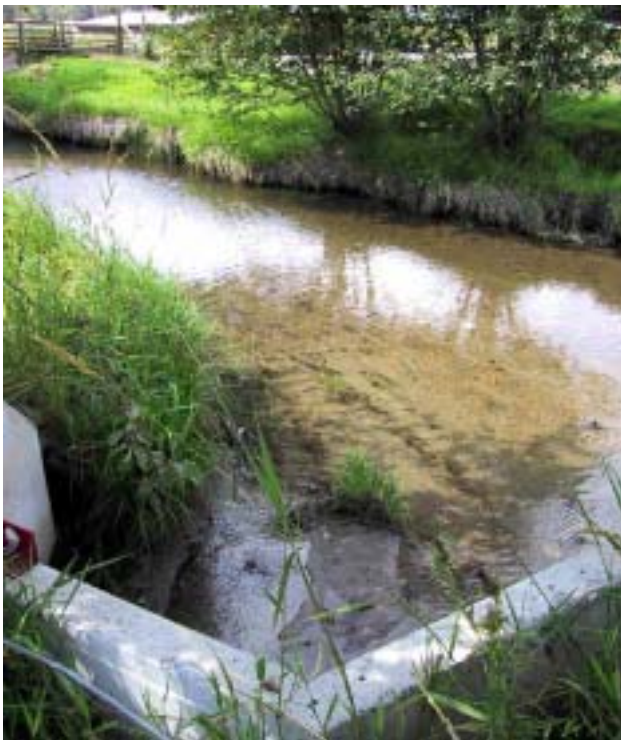
Figure 11: Sediment was partially obstructing flow into the intake. The intake was installed outside the work window so was set back into the bank, separated from the by a thin berm. This berm was not completely washed away during freshet. Sediment subsequently collected around what remained of the bank.  
June 01

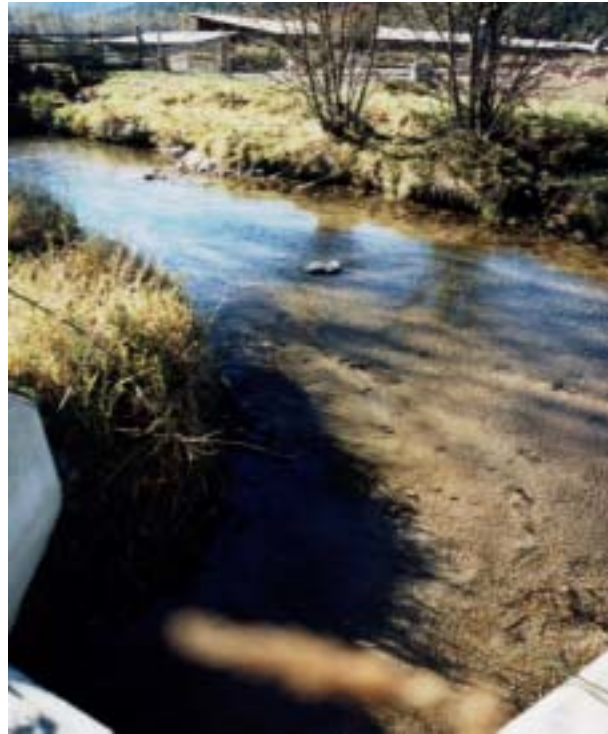
Figure 12: The bend-away has been built moving the thalweg toward the right bank of the creek. This has washed the collected sediment away from the intake. Sept 02

- A bendaway weir was built upstream of the intake to direct the thalweg towards the intake. The bendaway has caused the thalweg to move towards the intake side of the stream, removing the sand that was partially obstructing the intake. The structure is small enough that the sensitive upstream neighbor was satisfied that would not affect his property.

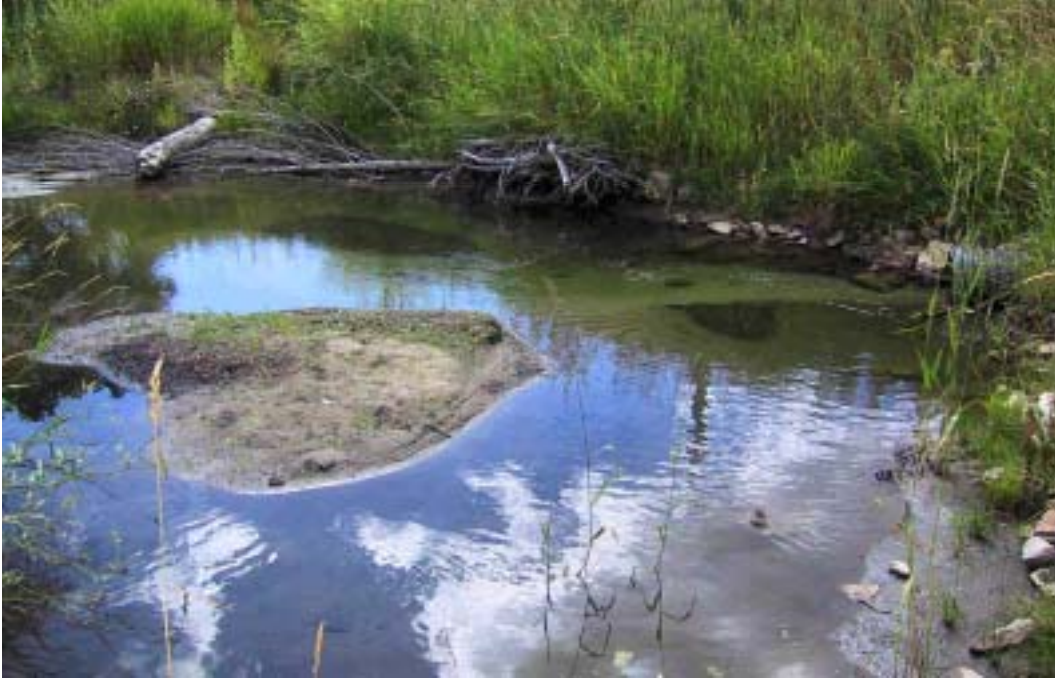
The sediment pond was cleaned. Ireland Creek has large amounts of suspended sediments during freshet and after hard rains due to land clearing higher in the watershed. Approximately 1.5 m of sediment had collected in the sediment pond since it's construction in 2000. This was removed by the excavator and trucked to a low spot in an adjoining field (Figures 13-14).

Figure 13: Sediment has filled the collection pond at the intake structure. June 01

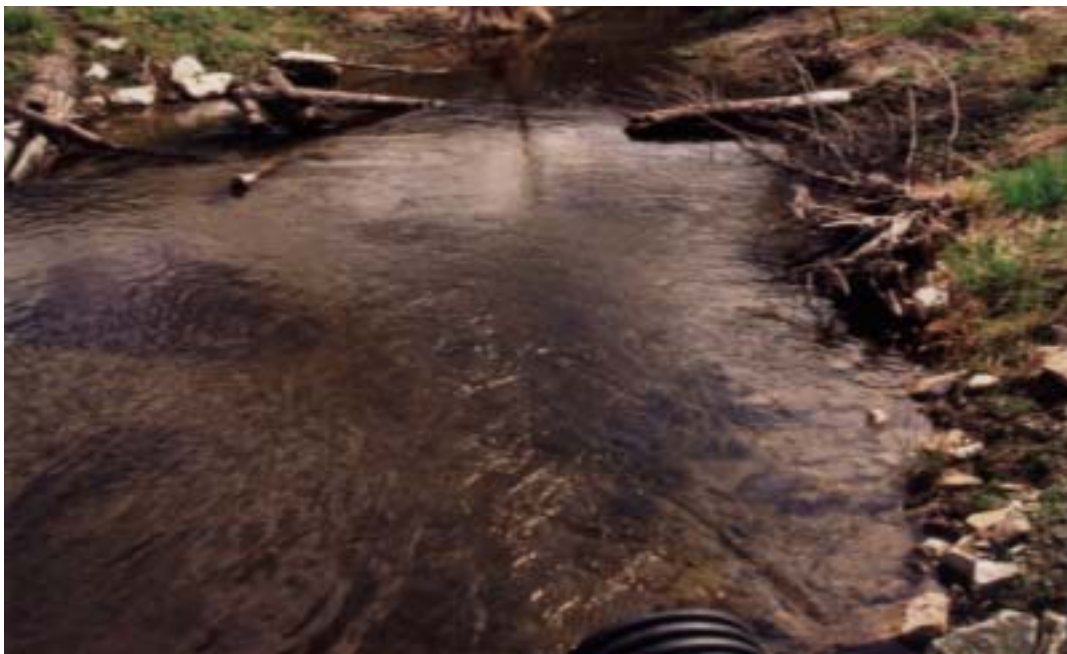
Figure 14: The collection pond after the sediment was removed. September 02

The intake was closed and water pumped from Ireland Creek to the side channel downstream of the pond. A cloth fence was placed downstream of the pond and upstream of the fresh water being pumped in. Fry were moved using minnow traps and nets before dredging started. A platform of rock was placed at the edge of the sediment pond so that the excavator could sit on the level at the pond's edge to remove the sediment and place it in a dump truck. A gate was put in the fence for easy access. The landowner owns a small excavator and is willing to clean the pond in the future at his own expense now that there is easy access and a position to work from.

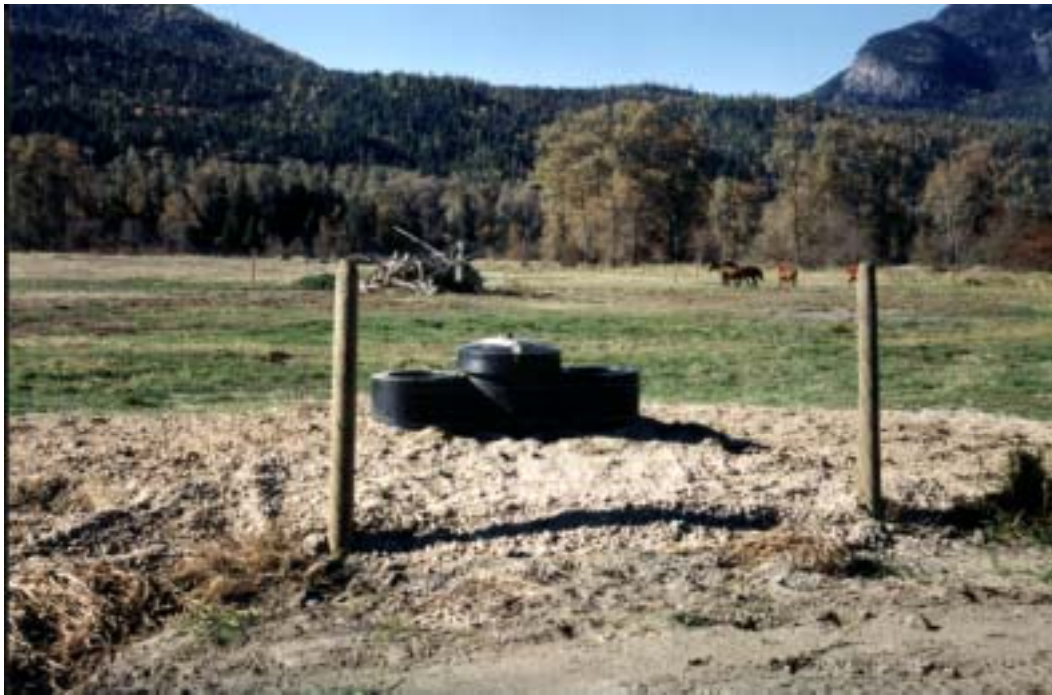
Figure 15: The waterer was installed outside the fenced riparian area. The tank is largely underground and the above ground part of the structure is insulated. The water stays ice-

free to  $-15^{\circ}$  C. It is no longer necessary to allow cattle access to the side channel, reducing the amount of sediment within the channel.

An off-channel cattle waterer was installed (Figure 15). This waterer uses ground temperature to keep the water from freezing in the winter. Two of these waterers were purchased in the initial phase of the project but only one installed. Livestock still had access to a site in the lower third of the channel. Installing the waterer eliminated livestock access to the channel. Installation involved burying a water line from a nearby barn under the side channel and burying the waterer itself. The landowner supplied the backhoe and labor.

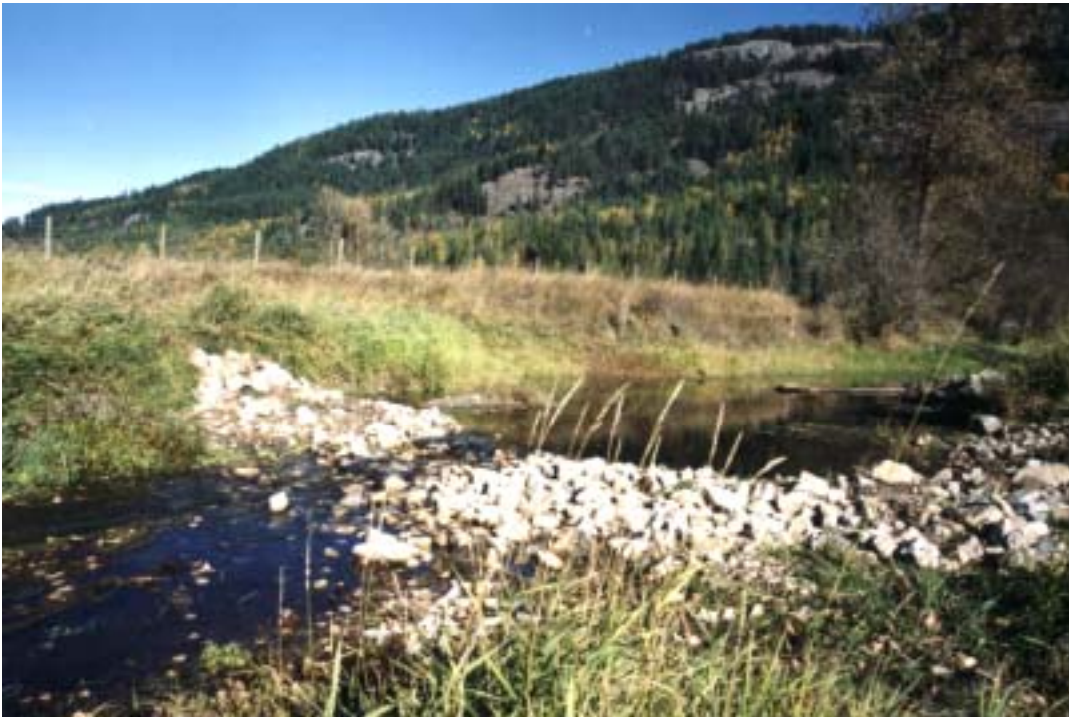
Figure 16: A riffle was built on the lower end of the channel to raise the water level by 30 cm. The creek and water table levels were the lowest the landowner (since 1970) had seen them. Placing the weir at the intake to increase the flow to the side channel and building the riffle on the lower end increased habitat values.

A riffle was built approximately 100 m upstream of the confluence of the side channel and the Shuswap River. This raised the water level approximately 20 cm behind the riffle effecting about 200 m of channel (Figure 16). The water level in the Shuswap River and the water table were lower this year than it has been in several years reducing the habitat area in the lower end of the side channel. The riffle would be submerged during higher river flows.

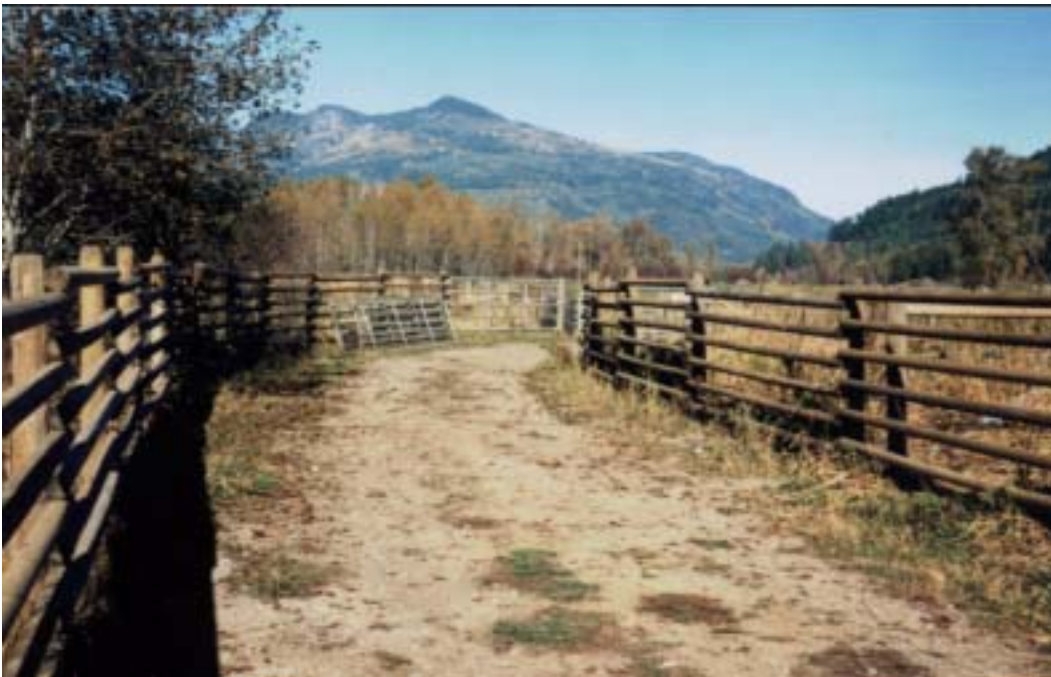
Figure 17: Rails were placed at the uppermost crossing where hogs are frequently moved. The bottleneck pressure was too much strain on just the page wire fence.

Gates were added to the riparian enclosure and the weak spot in the main fence at the crossing between the intake and the sediment pond was reinforced with rails (Figure 17).
