Peace Project Water Use Plan

Williston Reservoir Trial Tributaries Implementation Year 9

2019 - 6 Mile Creek Engineering Inspection Report

Site Inspection Report

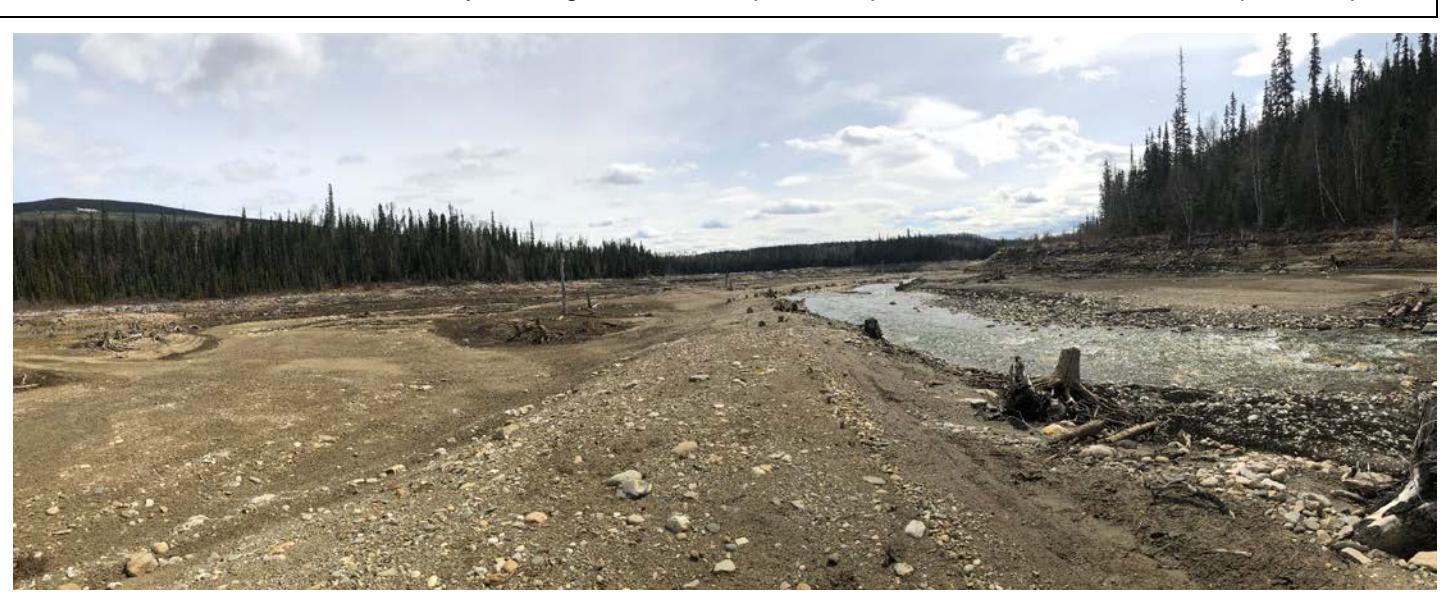
- As observed in 2016, the works are continuing to perform well, and the creek is still maintaining a single thread.
- Due to the low reservoir level and creek flows, all the berms were exposed and could be fully inspected. The water level of the reservoir was not able to be surveyed as it was too low and far from the project site at the time of the work. The reservoir level was estimated to be between approximately 656.7 m and 656.8 m (on May 7 and 8, 2019).

PHOTO 1 (Panoramic): Single Thread Channel Looking Downstream from Berm 'B' (repeat of 2016 Ph#1)

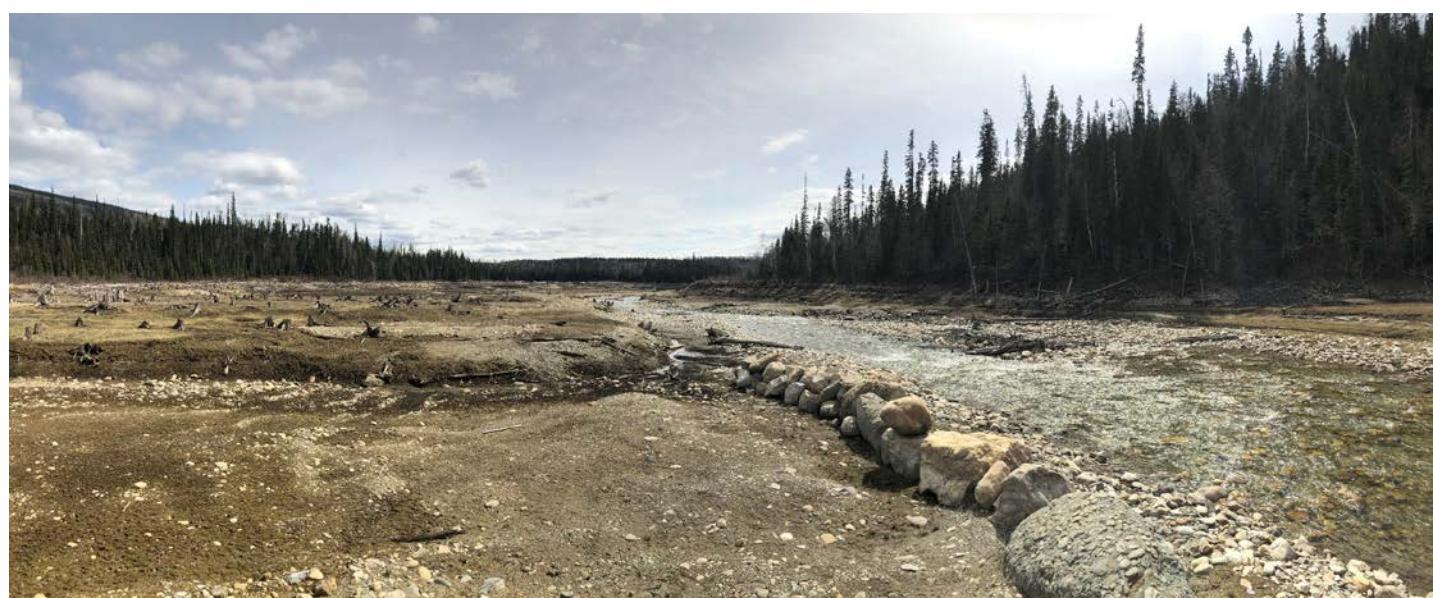
PHOTO 2 (Panoramic): Single Thread Channel Looking Downstream from Downstream End of Berm 'C' (repeat of 2016 Ph#2)

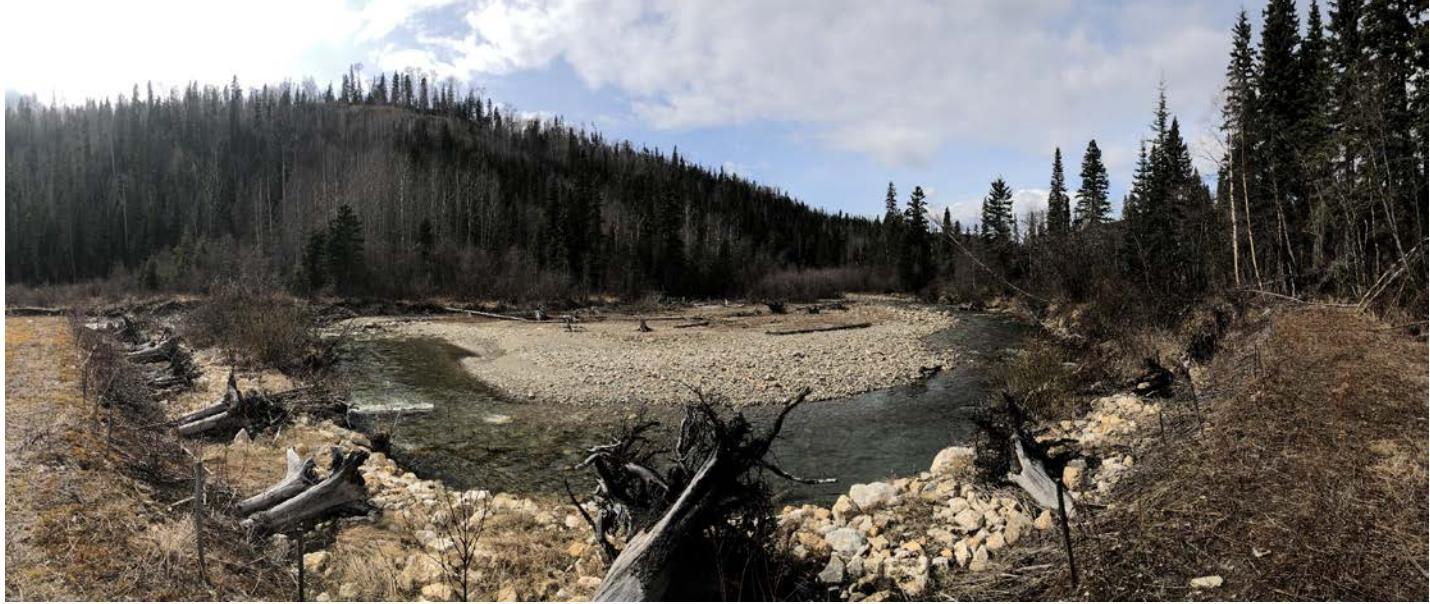
- The upstream most berm (Berm 'J') continues to effectively prevent an avulsion around the lower works.
- There appears to be more flow in the right side channel between Berm 'F' and 'G', and some significant channel erosion has happened on the right bank of the right side channel across from the downstream end of Berm 'G'. This is not presently a concern, but should be monitored.

PHOTO 3 (Panoramic): Channel Along Sharp Bend Along Berm 'J' (Note Panoramic Exaggerates Bend) (repeat of 2016 Ph#3)

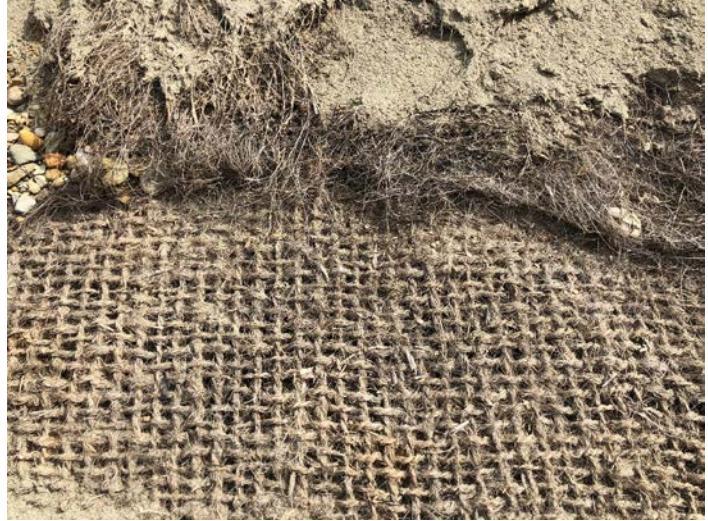
- The erosion control matting (ECM) has almost completely deteriorated (as expected).
- The large woody debris (LWD) has remained stable reinforcing the berm toe and appears to be creating some habitat complexity along the creek in some areas, as intended. There were some sections of LWD that have become partially buried by sediment and so appear to be not providing fish habitat in the active creek with water levels at the time of site visit.

PHOTO 4: Deteriorating ECM (above) & Coir Soil Wraps in Good Condition (below) (repeat of 2016 Ph#4)

- As the ECM has a relatively short lifespan and has deteriorated significantly, the berm surfaces covered by the ECM, may experience some erosion. These areas should be monitored during future annual monitoring. If significant erosion occurs, then BC Hydro could consider protecting those areas.

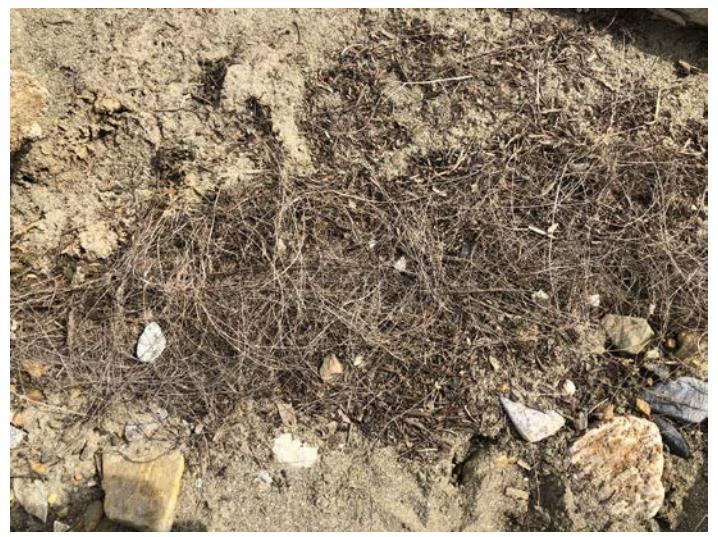
PHOTO 5: Decomposing ECM (repeat of 2016 Ph#5)

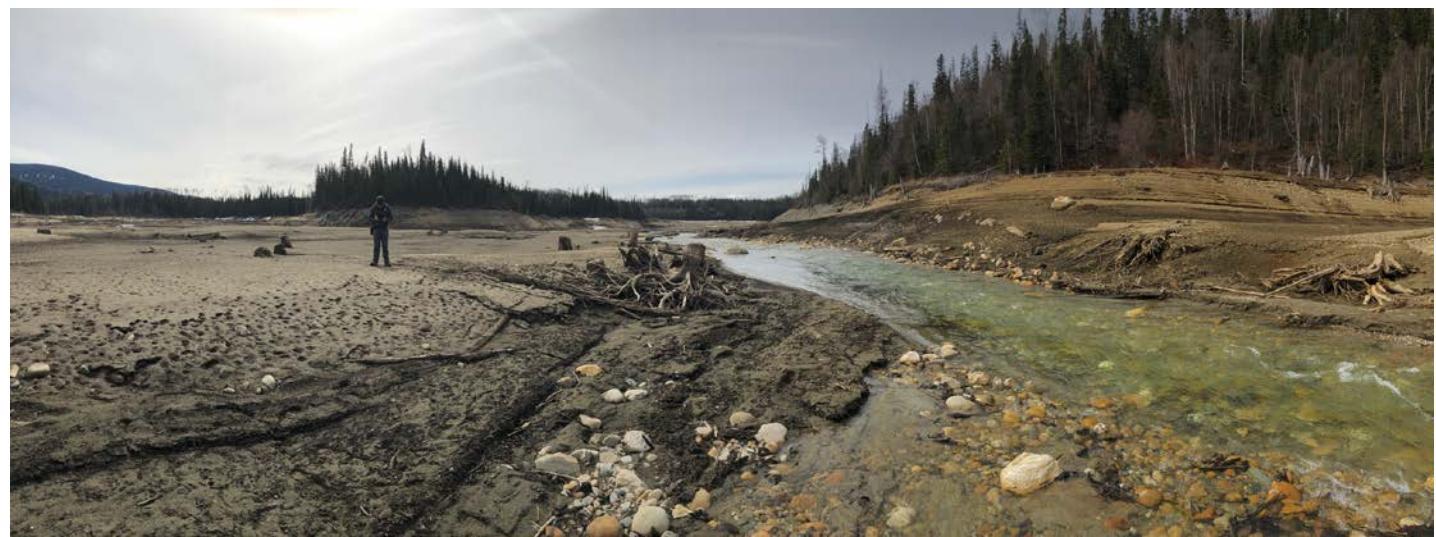
- Berm 'A' was fully exposed due to the low reservoir and creek levels (it was submerged in 2016).
- This berm is considered to be less critical than the upper berms relative to the overall function of the works.
- Berm A is in good condition. No erosion has occurred to the berm core, and it is continuing to effectively block off left side secondary channels.

PHOTO 6 (Panoramic): Looking Downstream at Berm 'A'

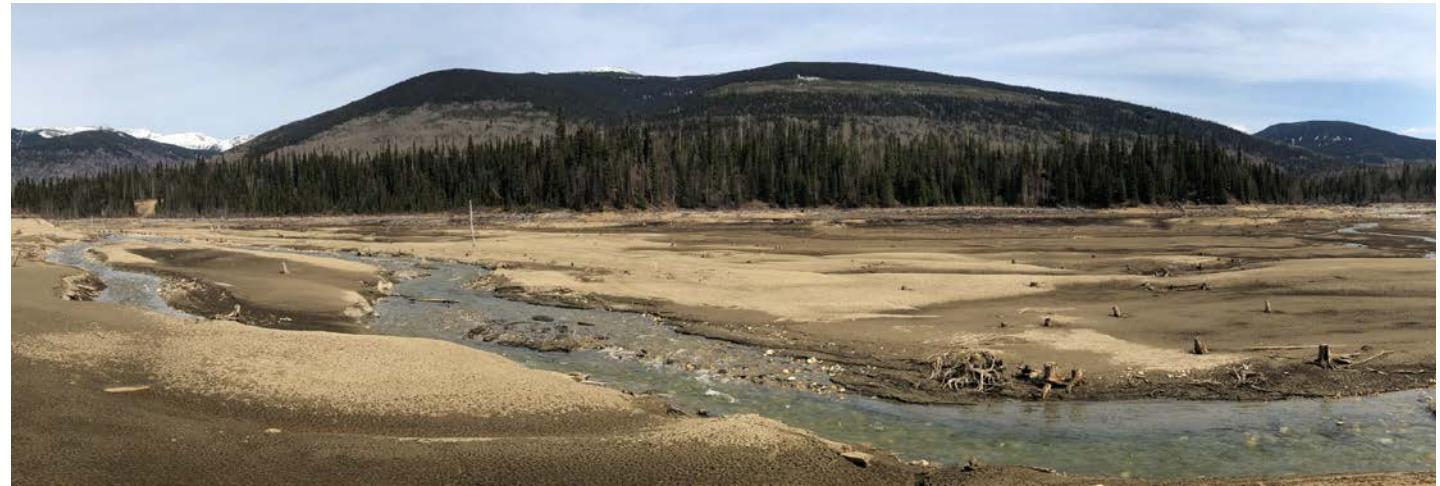
PHOTO 7 (Panoramic): Looking at Berm 'A' from Across the Creek (Right Bank)

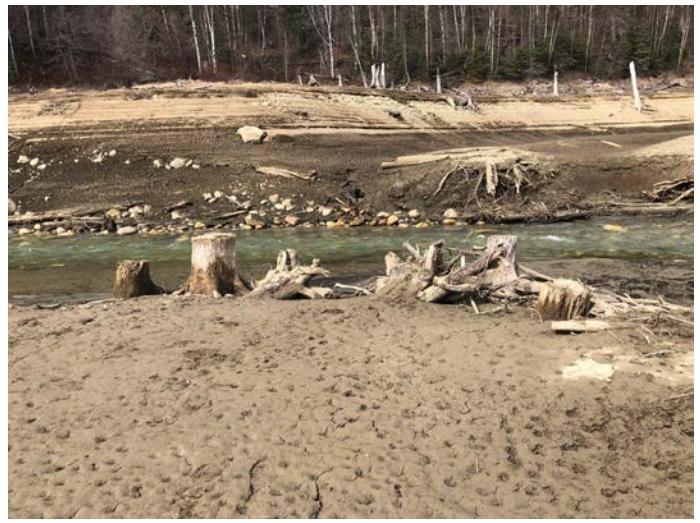
PHOTO 8: Looking at Berm 'A' from Left Bank

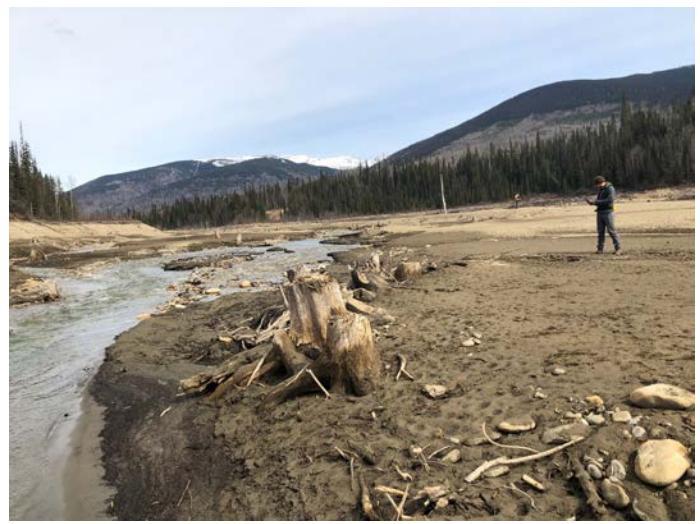
PHOTO 9: Looking Upstream at Berm 'A'

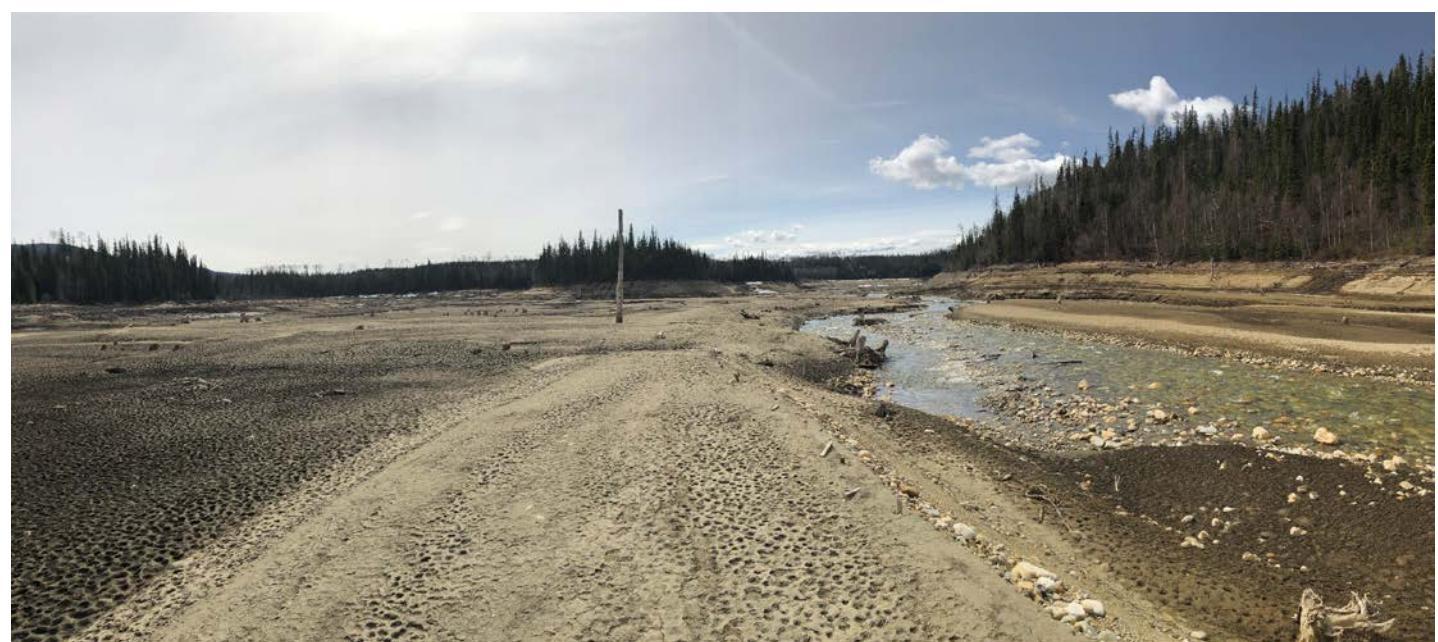
PHOTO 10: Looking Downstream at Berm 'A' and Berm 'G' (repeat of 2016 Ph#6)

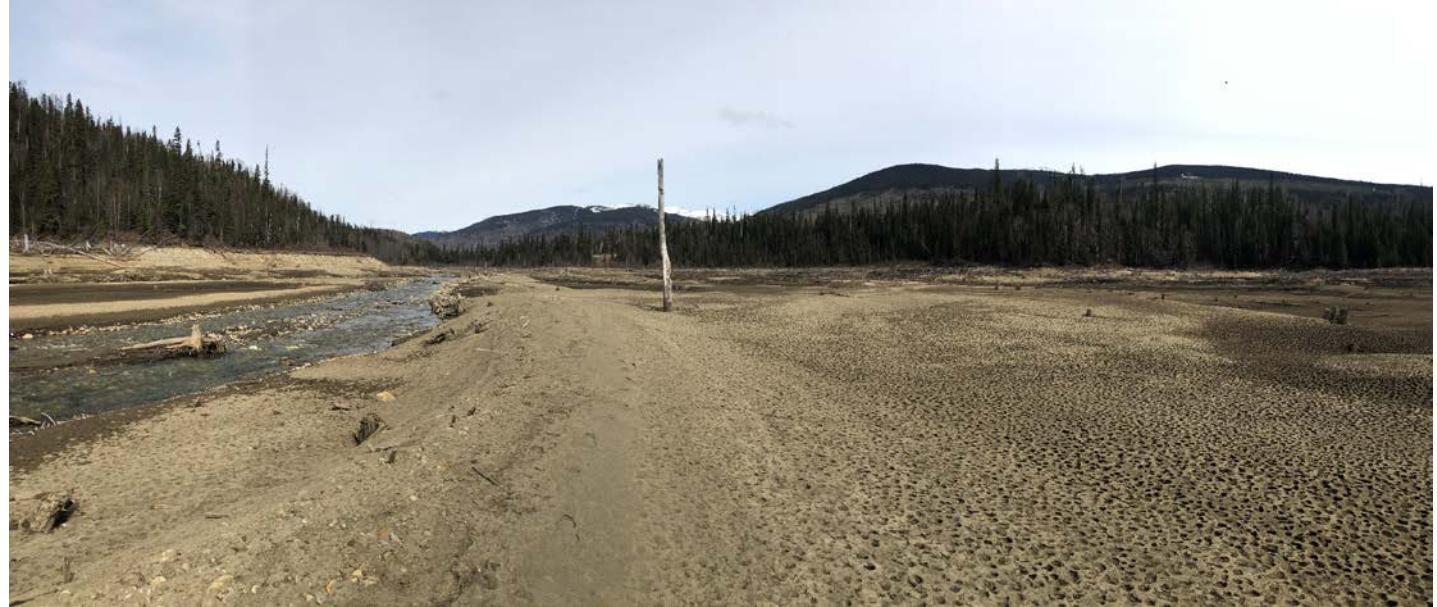
- Berm 'G' was fully exposed due to low reservoir and creek levels (it was mostly submerged in 2016).
- The berm crest appears to be generally in good condition and there is no significant berm settlement or erosion to the majority of the berm crest and profile based on the survey (see Profile on DWG 1000-C1800064-R3, and Sections 0+800 through 0+820 on 1000-C1800068-R1). The limited local erosion noted in 2016 (see Section 0+800) has not noticeably increased.

PHOTO 11 (Panoramic): Looking Upstream at Berm 'G' (repeat of 2016 Ph#7)

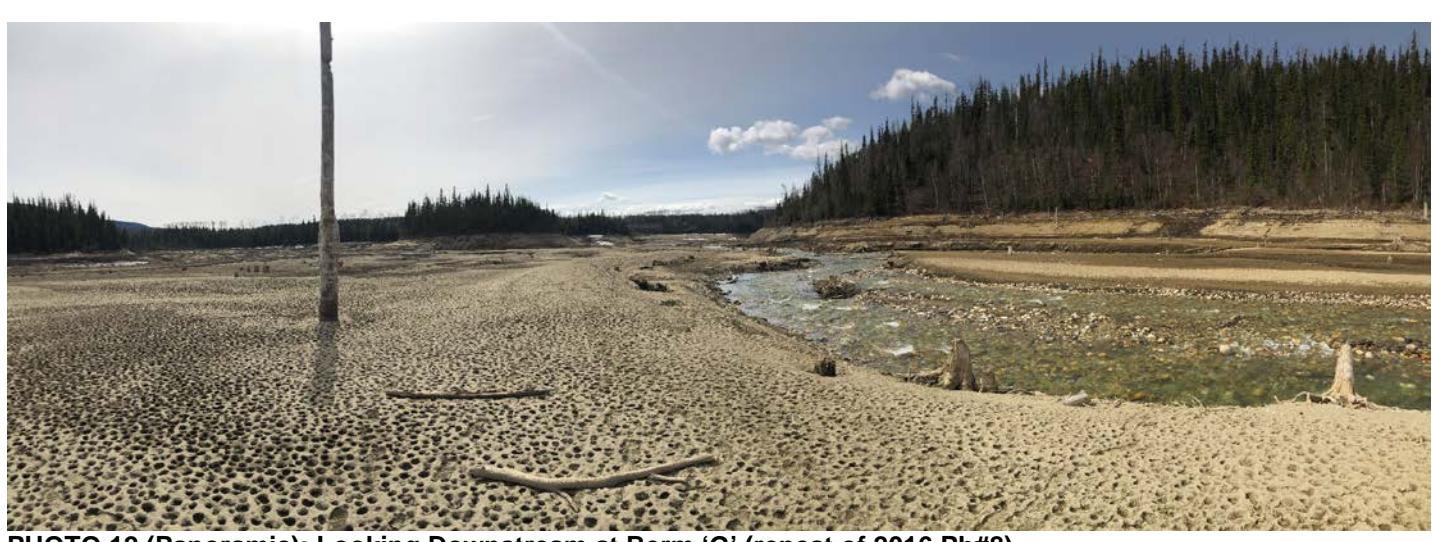
PHOTO 12 (Panoramic): Looking Downstream at Berm 'G' (repeat of 2016 Ph#8)

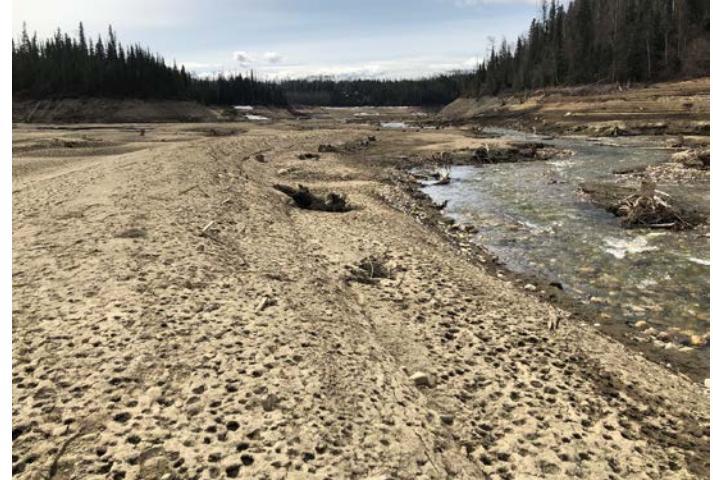
PHOTO 13: Survey of Toe of Berm 'G' on Creek Side (repeat of 2016 Ph#9)

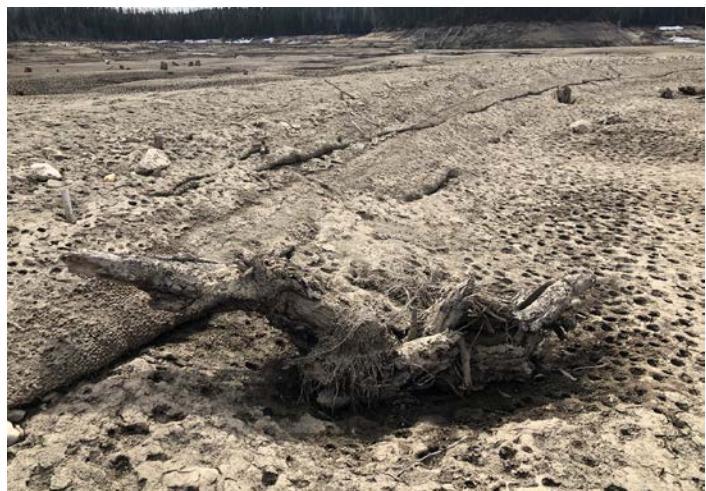
- The coir geogrid fabric is still intact and in good condition where visible.
- The large woody debris (LWD) was in good condition and is protecting the berm, however some sections of the LWD have become partially buried by sediment and so appear to not be providing fish habitat in the active creek with water levels at the time of site visit.

PHOTO 14: Berm 'G' Coir Geogrid & LWD, and sedimentation (repeat of 2016 Ph#10)

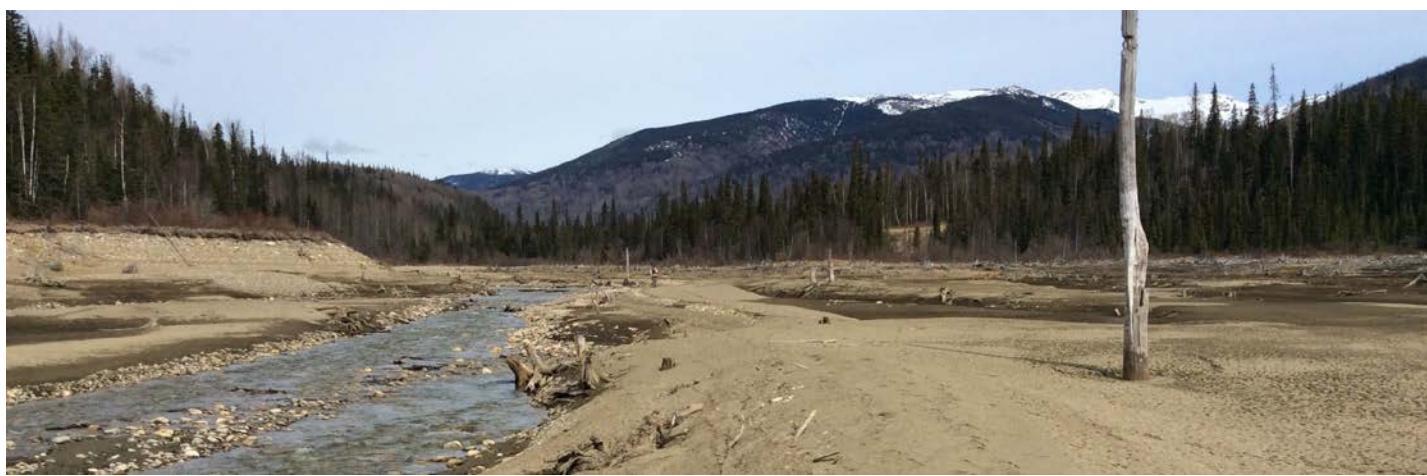
- There appears to be more flow on the right side channel across from Berm 'F' and 'G'. This is not a present concern.

PHOTO 15 (Panoramic): Looking Upstream from Berm 'G' to Berm 'F'(repeat of 2016 Ph#11)

- Future monitoring should also consider the relative flow split to the right side channel between Berm 'F' and 'G', and the erosion on the right bank of the right side channel across from the downstream end of Berm 'G'. At present it is not a concern to the works.

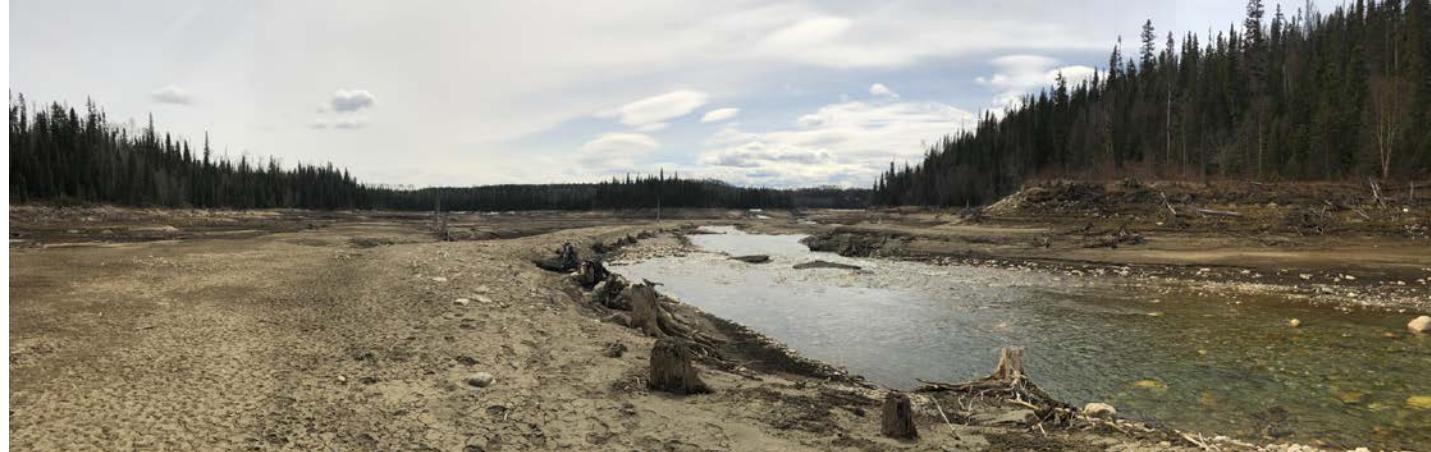
PHOTO 16 (Panoramic): Looking Downstream at Berms 'D' and 'F'

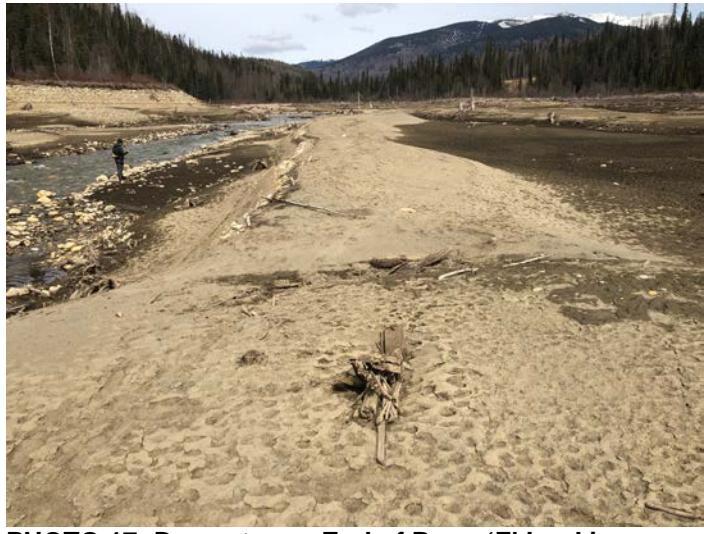
- Exposed coir geogrid material used in the soil wraps is in good condition and functioning well.
- Erosion appears to have occurred downstream of the berm where the ground is 'natural' (see Photo 17).

PHOTO 17: Downstream End of Berm 'F' Looking Upstream. Possible Erosion Downstream of Berm in 'Natural' Area (wet area in centre of Photo) (repeat of 2016 Ph#12)

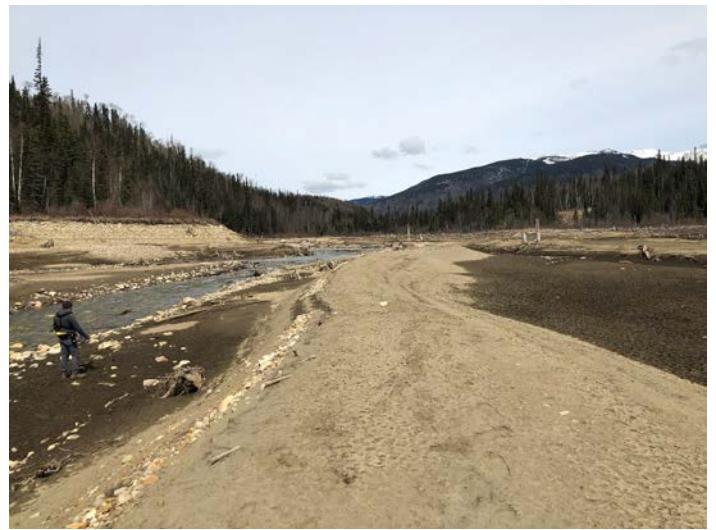
PHOTO 18: Berm 'F' Looking Upstream (Note Damaged/Decomposing ECM) (repeat of 2016 Ph#13)

- There is very little accumulation of woody debris.
- Some isolated pieces and logs observed, such as at Berm 'F' as noted in Photo 18 above.

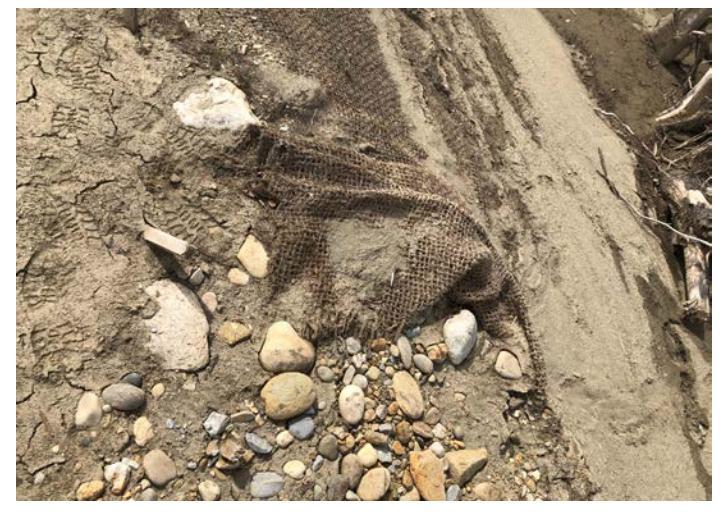
- Coir geogrid tie-in at upstream end of Berm 'F' has become exposed at the tie-in with Berm 'D'. This could result in a local failure of the coir in the future, and should be monitored. (See Photo 19).

PHOTO 19: Coir Geogrid Matting becoming loose at the tie in between berm 'F' & 'D'

- In future inspections monitor the two areas of interest for the coir geogrid matting: at the exposed tie-in location between Berms 'D' and 'F'; and at the damaged coir at the downstream end of Berm 'C'.

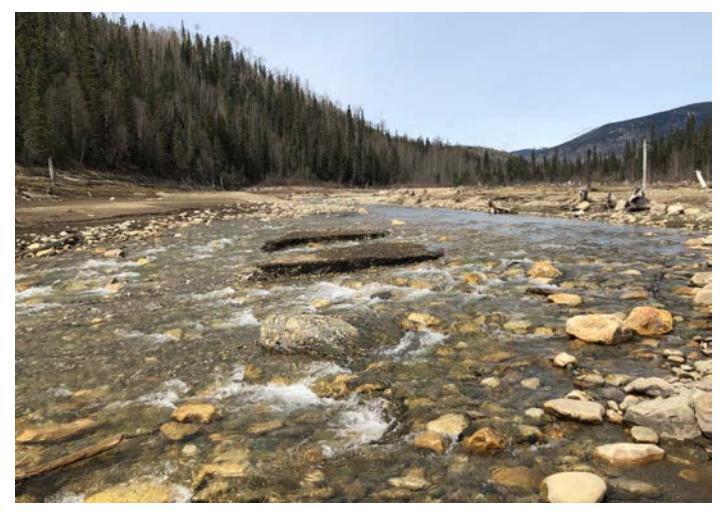
PHOTO 20: Sediment and Riffile at Approx. 0+640

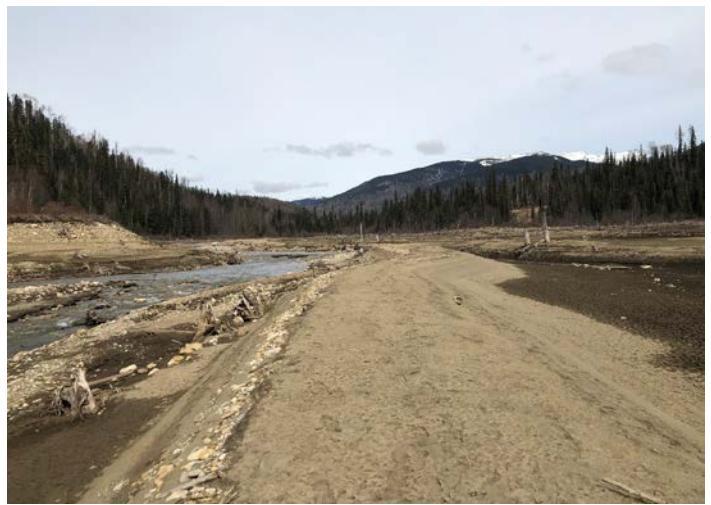
PHOTO 21: Berm 'F' Looking Upstream (Note Damaged/Decomposing ECM) (repeat of 2016 Ph#14)

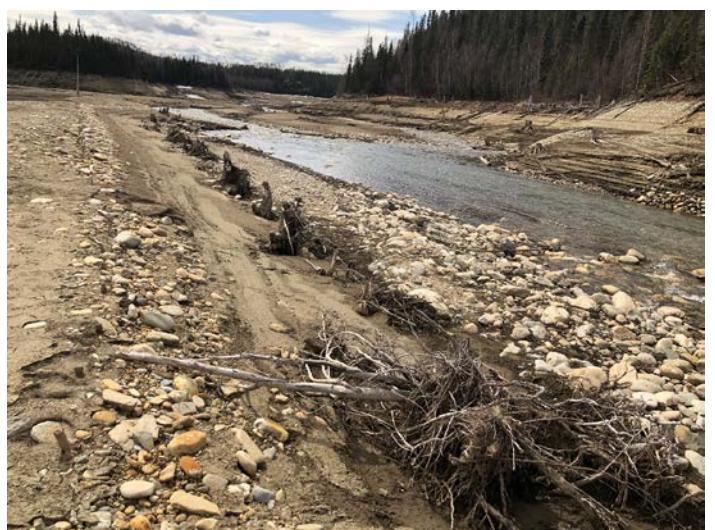
PHOTO 23: LWD and Channel Erosion and Deposition Looking Downstream (repeat of 2016 Ph#16)

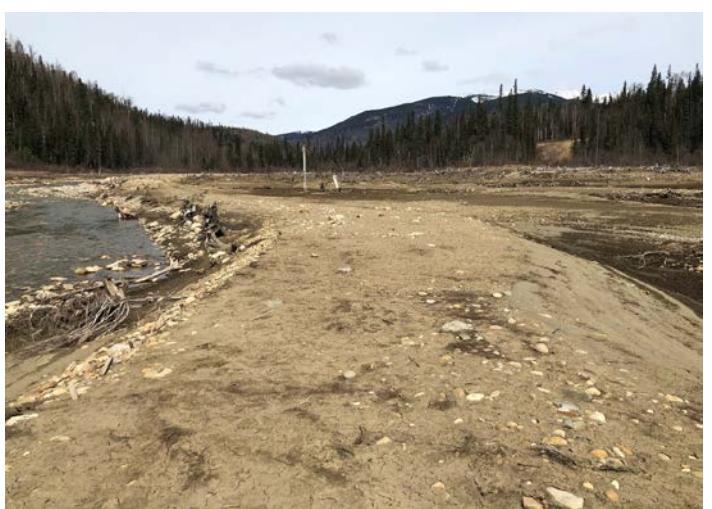
PHOTO 22: Upstream End of Berm 'F' Looking Upstream (repeat of 2016 Ph#15)

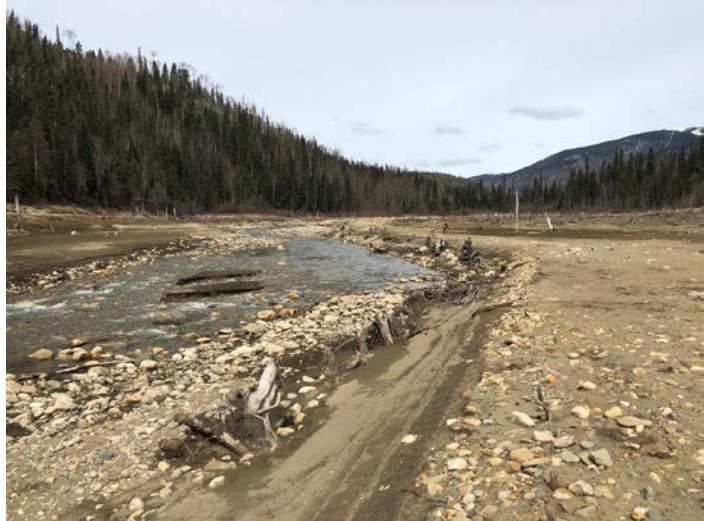
PHOTO 24: LWD and Channel Erosion and Deposition Looking Upstream (repeat of 2016 Ph#17)

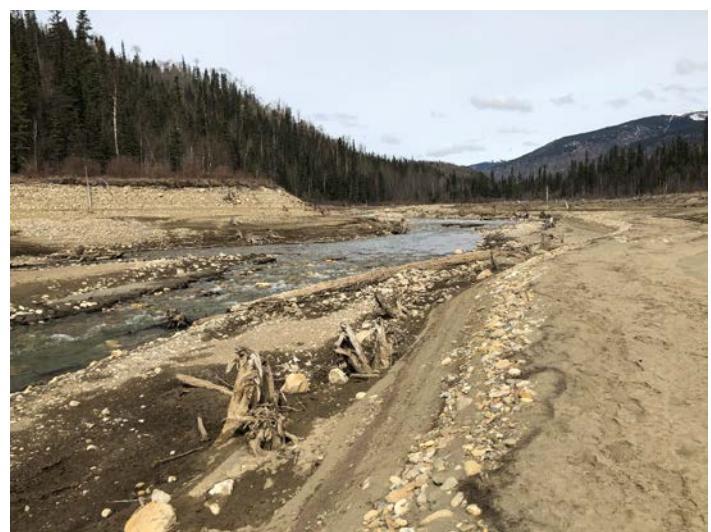
PHOTO 25: Deposited Log Along LWD and Deteriorating ECM (repeat of 2016 Ph#18)

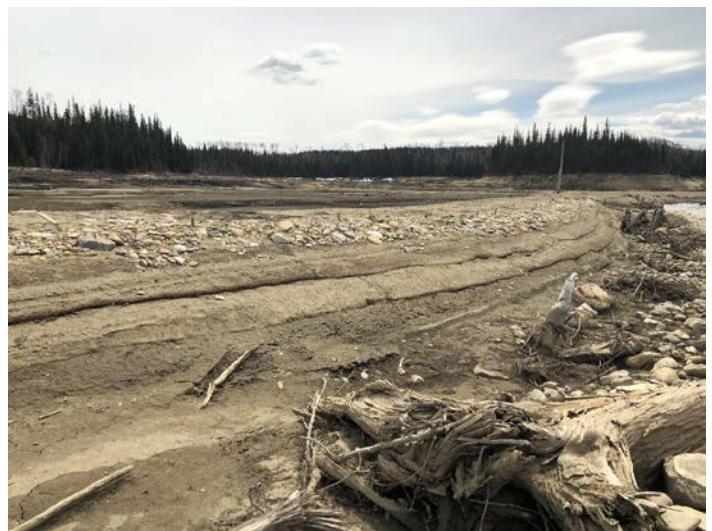
PHOTO 26: Coir Geogrid "Soil Wrap" Layers in Good Condition. Note Upper Layer is ECM (repeat of 2016 Ph#19)

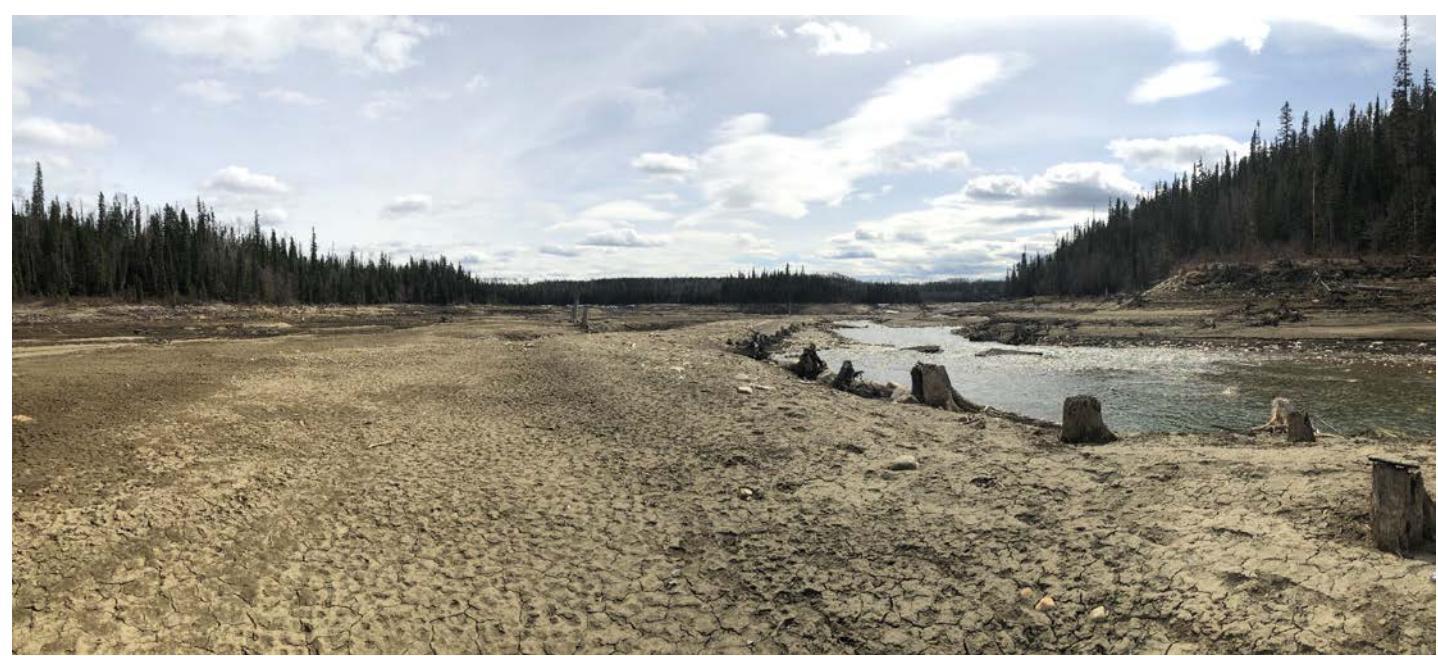
- The berm in good condition. No significant settlement or erosion was observed in the field or noted in the survey (see Profile on DWG 1000-C1800063-R3, and Sections 0+620 and 0+640 on DWG 1000-C1800068-R1)
- The LWD is in good condition and is not displaced.
- The ECM (erosion control matting) has mostly deteriorated and there is little remaining.
- The creek eroded pools and deposited gravel material around LWD.
- This berm does not have coir soil wraps as erosion protection on its face as a variety of methods were utilized in this trial. There is no evidence of erosion observed on the berm face, however if it were to occur, then additional longitudinal LWD or coir soil wraps could be installed.

PHOTO 27 (Panoramic): Looking Downstream at Berm 'D' (repeat of 2016 Ph#20)

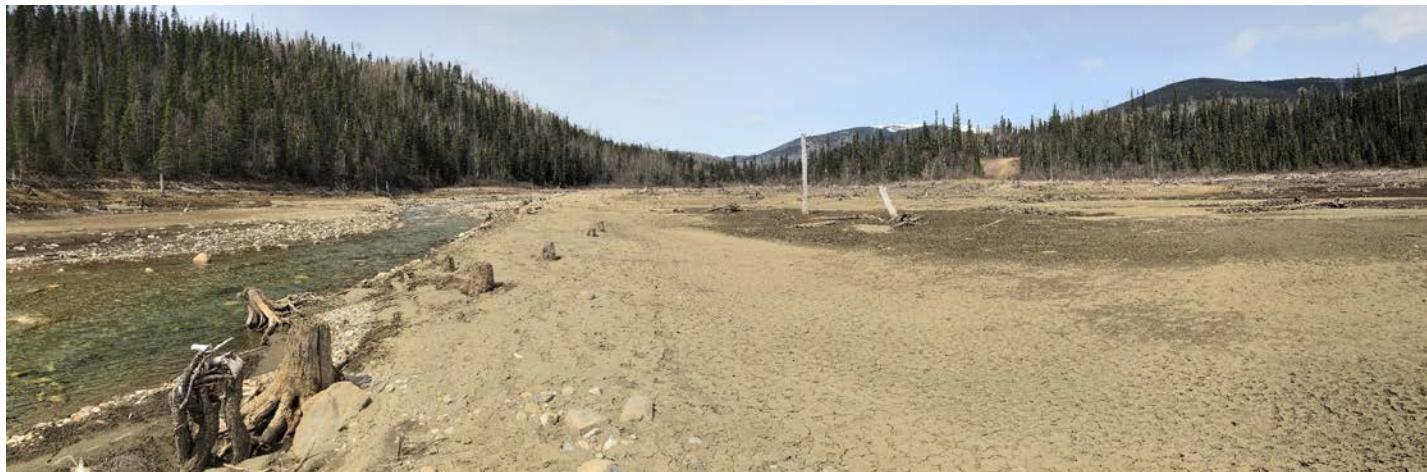
PHOTO 28 (Panoramic): Looking Upstream from Upstream End of Berm 'D' (repeat of 2016 Ph#21)

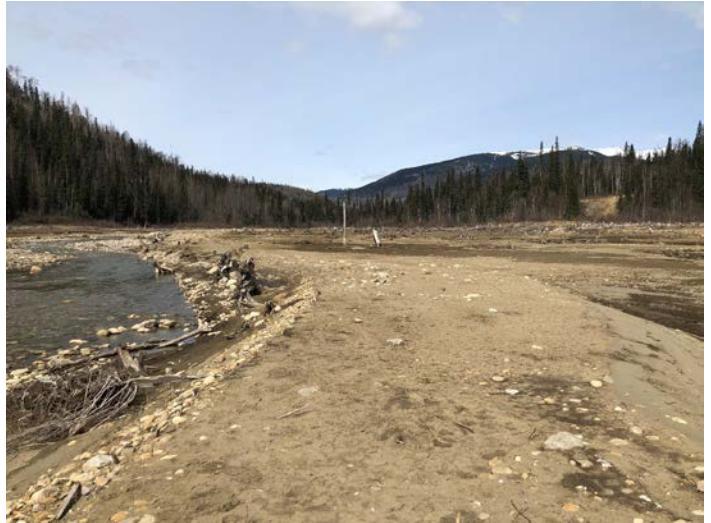
PHOTO 29: Looking Upstream at Berm 'D' (repeat of 2016 Ph#22)

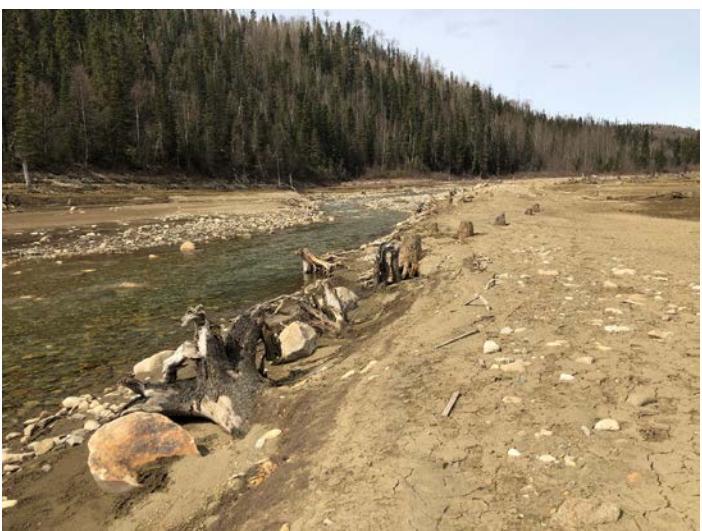
PHOTO 30: LWD at Berm 'D' (repeat of 2016 Ph#23)

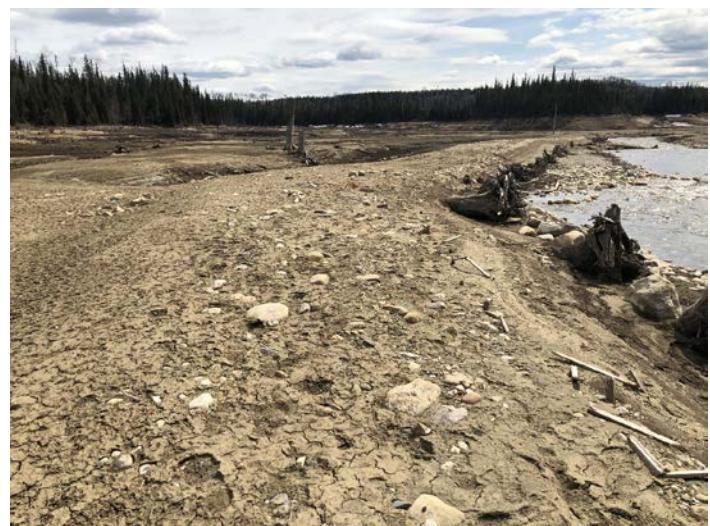
PHOTO 31: Material Used to Cover ECM When it Became Buoyant Still in Place, also Deposition (repeat of 2016 Ph#24)

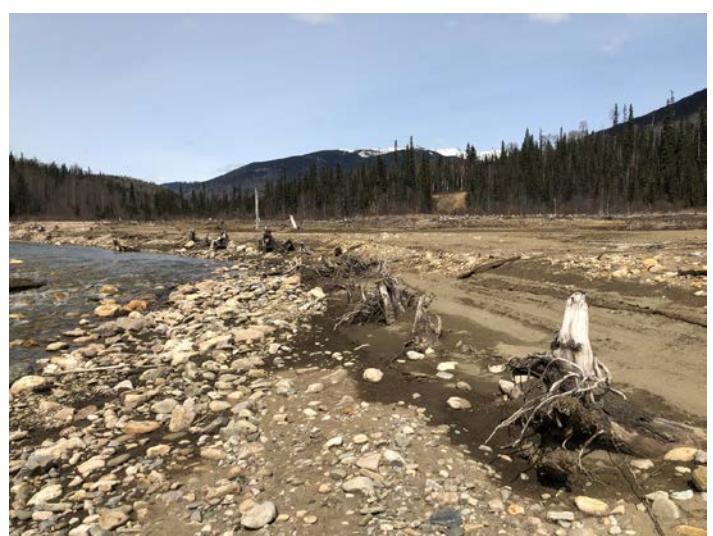
PHOTO 32: Deposition and Erosion Near LWD (repeat of 2016 Ph#25)

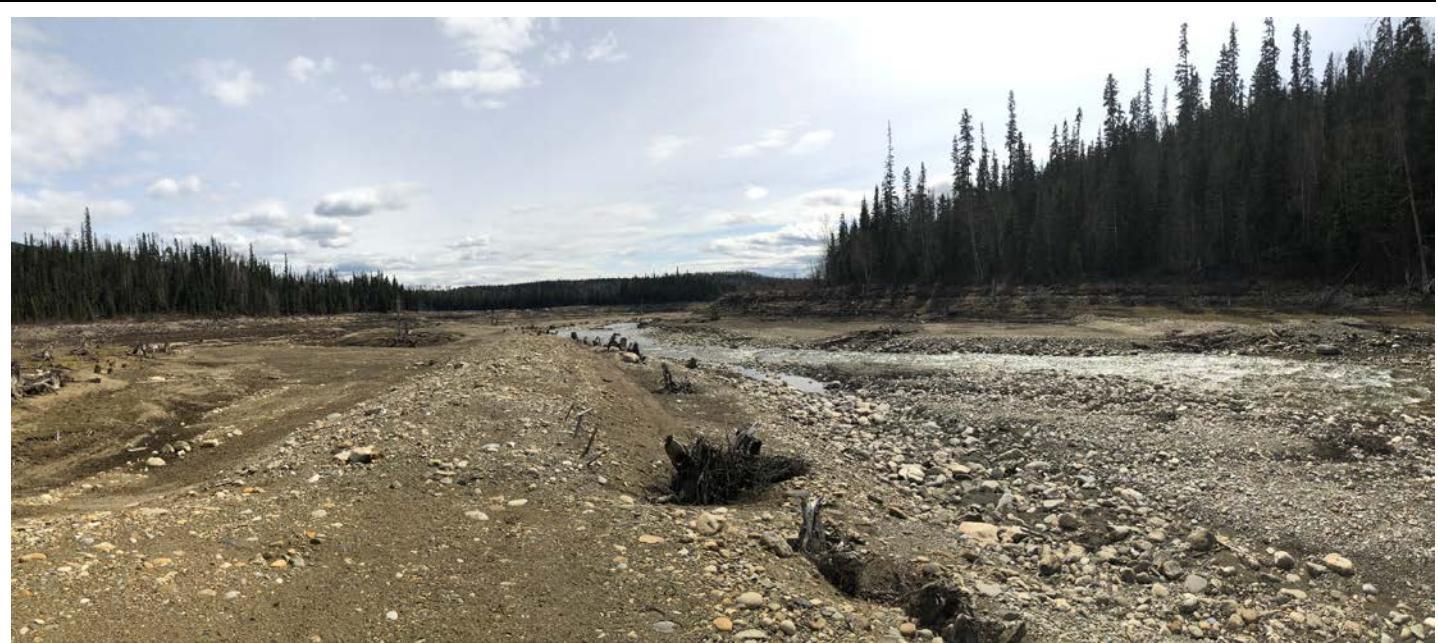
- Berm in good condition. No significant settlement or erosion observed in the field or noted in the survey (see Profile on DWG 1000-C1800063-R3, and Sections 0+540 and 0+560 on DWG 1000-C1800067-R1)
- LWD is in good condition and is not displaced.
- There appears to be some erosion near the toe and deposition mid-channel, which is confirmed on Section 0+540.
- The coir material in the soil wraps is in good condition.
- ECM is deteriorating where exposed (not covered with sand/cobble to prevent floating).
- Overland flow blockage / roughness (buried LWD) are not disturbed and in good condition (See Photos 37 and 38).

PHOTO 33 (Panoramic): Looking Downstream at Berm 'B' (repeat of 2016 Ph#26)

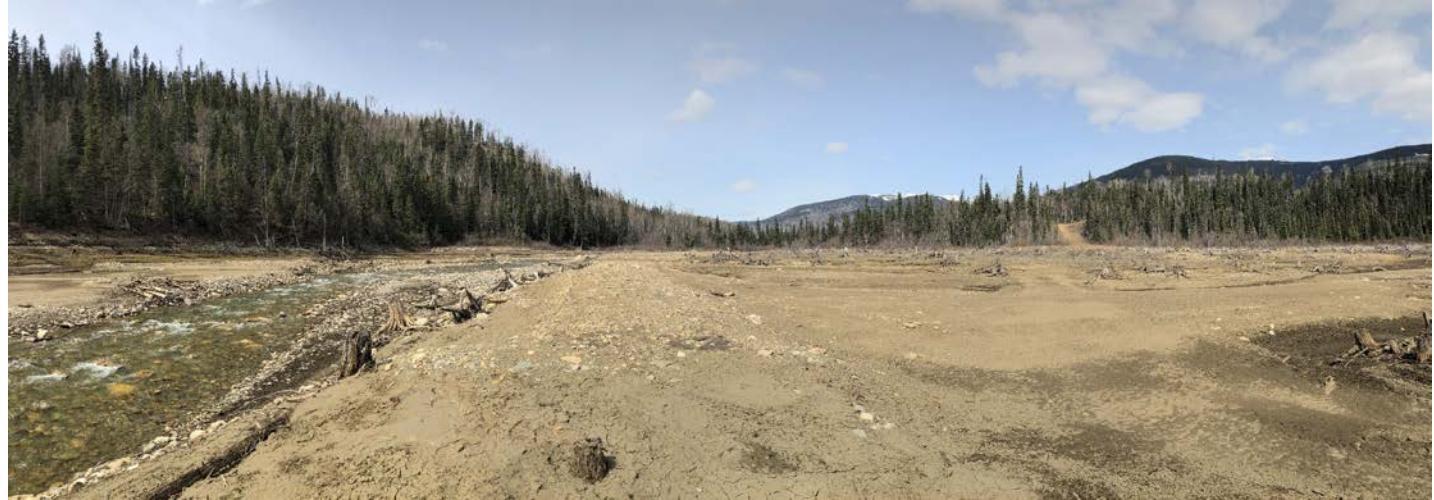
PHOTO 34 (Panoramic): Looking Upstream at Berm 'B' (repeat of 2016 Ph#27)

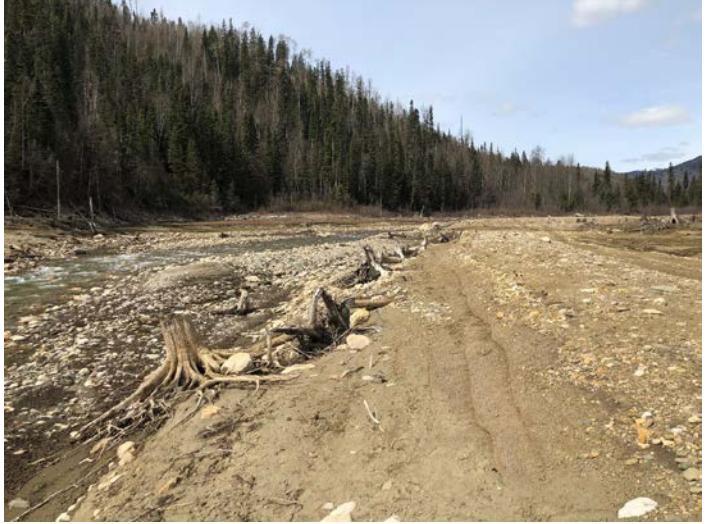
PHOTO 35: Coir Soil Wraps in Good Condition (repeat of 2016 Ph#28)

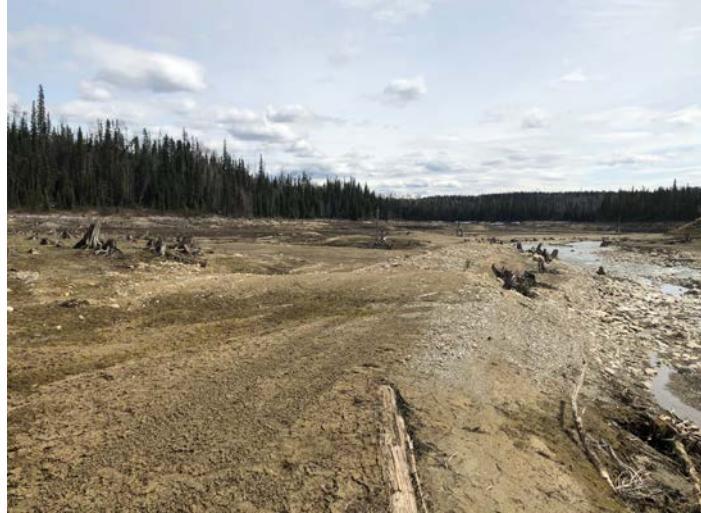
PHOTO 37: Downstream line of buried LWD

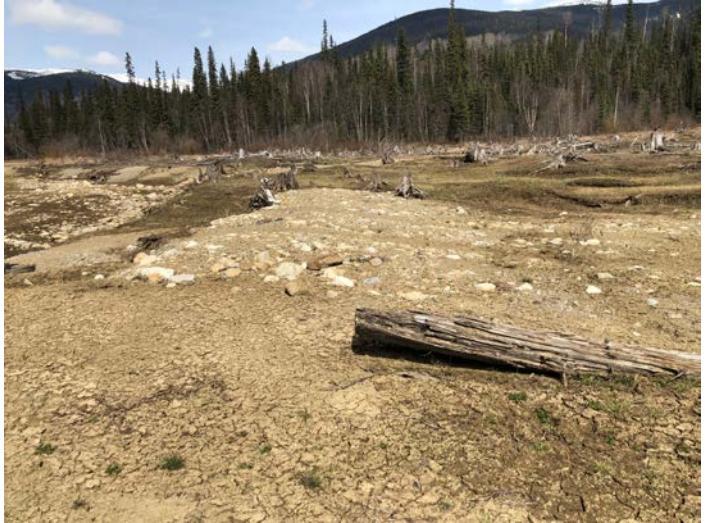
PHOTO 38: Upstream line of buried LWD

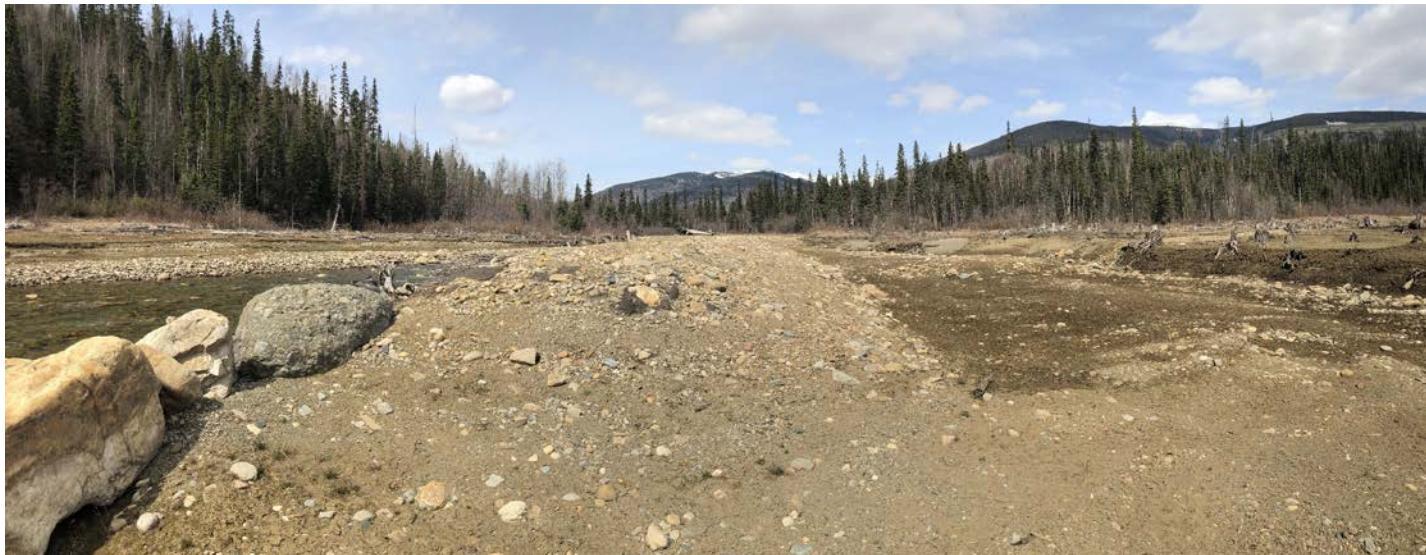
- Berm 'C' is in good condition with no significant settlement or erosion observed in the field or noted in the survey (see Profile on DWG 1000-C1800063-R3, and Sections 0+380 and 0+460 on DWG 1000-C1800067-R1)

PHOTO 39 (Panoramic): Downstream end of Berm 'C' looking upstream (repeat of 2016 Ph#30)
