Peace Project Water Use Plan

Williston Reservoir Trial Tributaries Implementation Year 9

2019 - 6 Mile Creek Engineering Inspection Report

Site Inspection Report

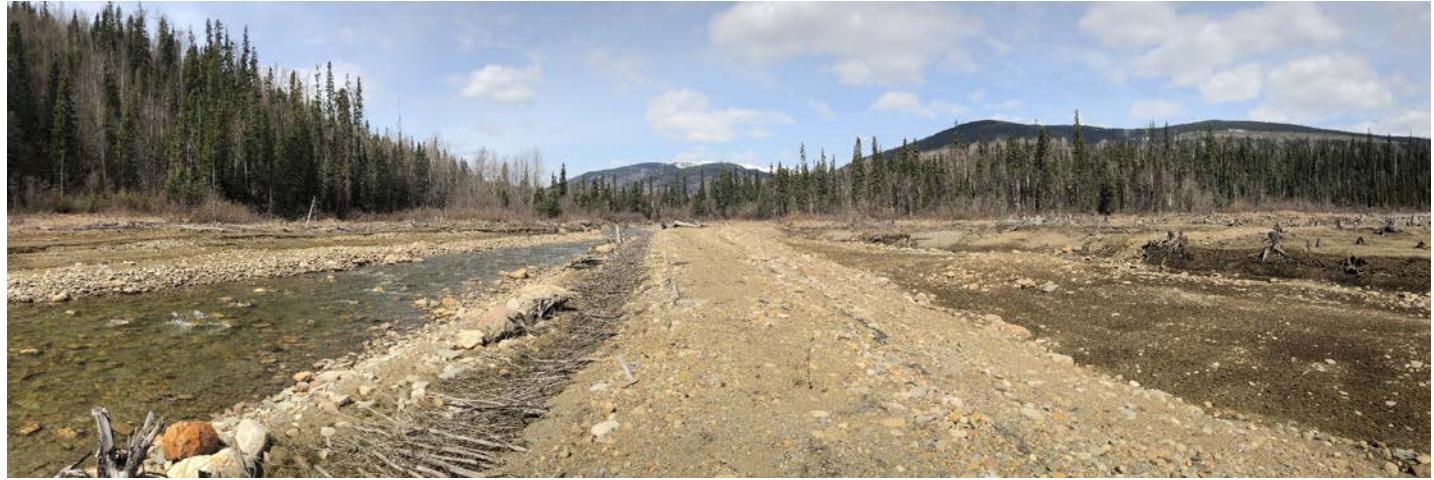
PHOTO 40 (Panoramic): Berm 'C' looking upstream from downstream end (repeat of 2016 Ph#31)

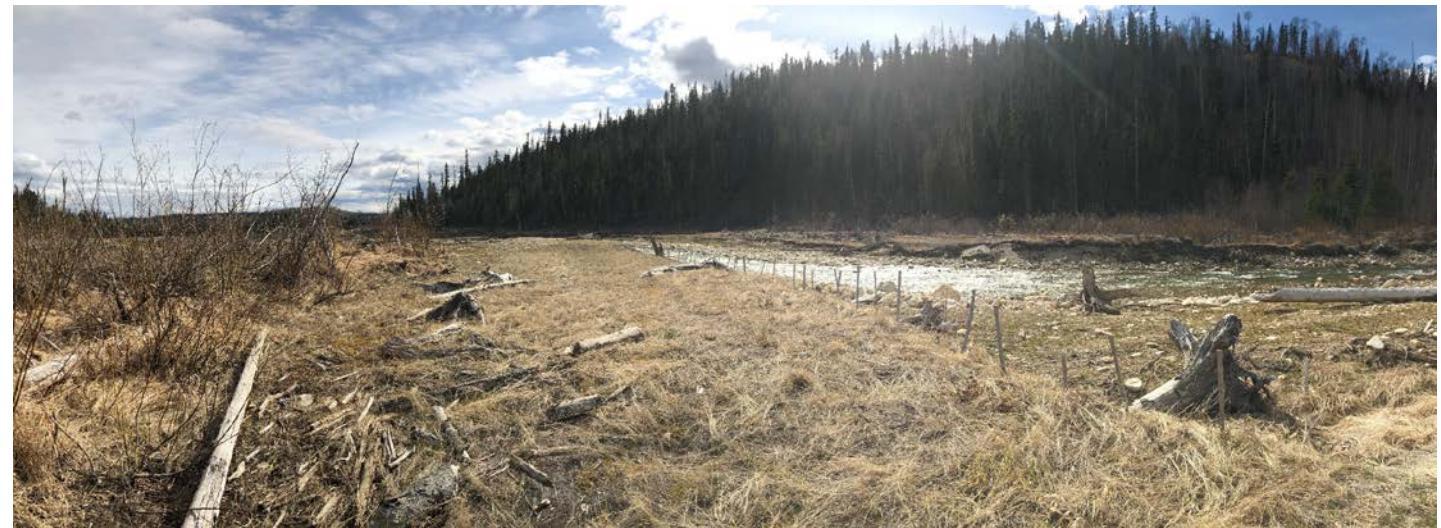
PHOTO 41 (Panoramic): Looking downstream from upstream end of Berm 'C' (repeat of 2016 Ph#32)

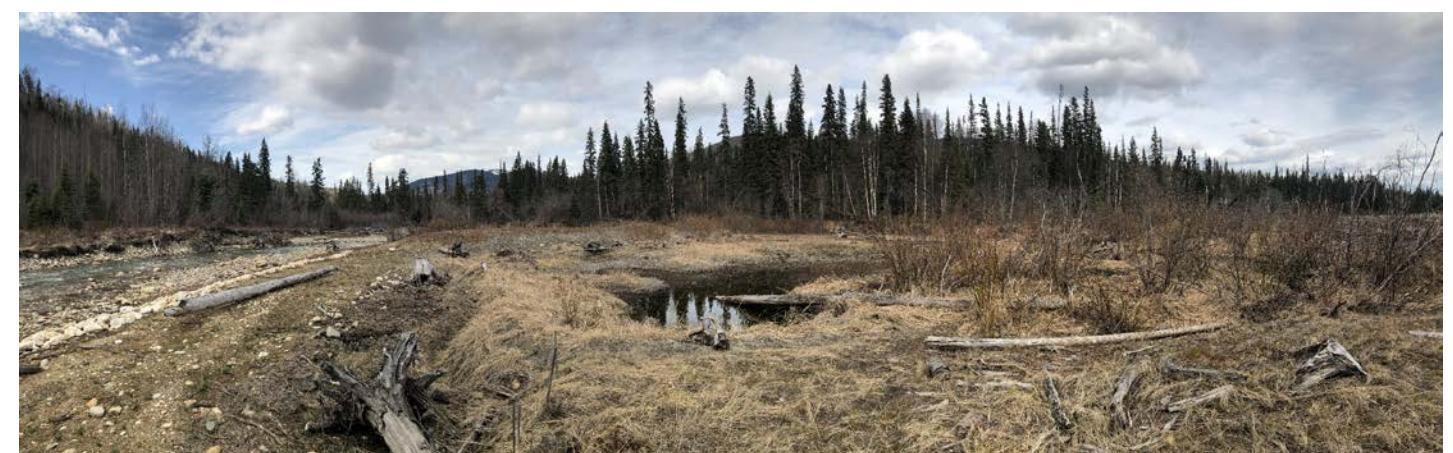
- The ECM, where exposed, has significantly deteriorated.
- The rock spur at the downstream end is still intact (see Photo 43).
- The upstream tie-in location for Berm 'C' to the beaver pond is stable and has not changed since construction.

PHOTO 42 (Panoramic): Intact beaver/habitat pond upstream of Berm 'C' (repeat of 2016 Ph#33)

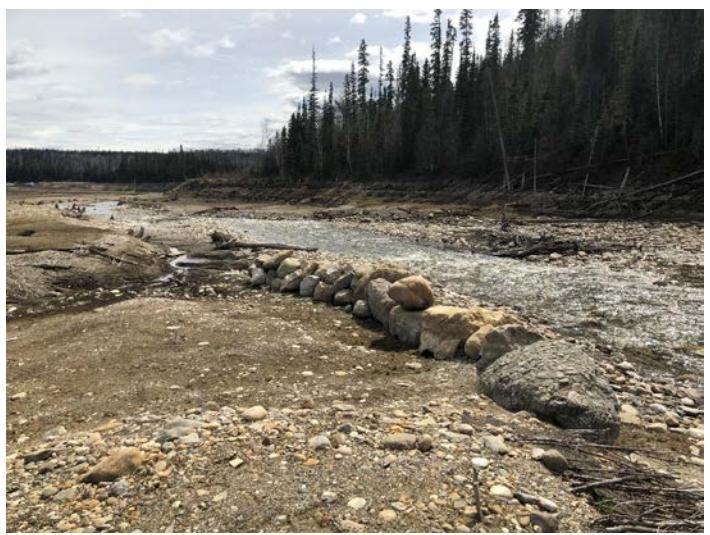
PHOTO 43: Downstream end of Berm 'C' looking downstream (repeat of 2016 Ph#34)

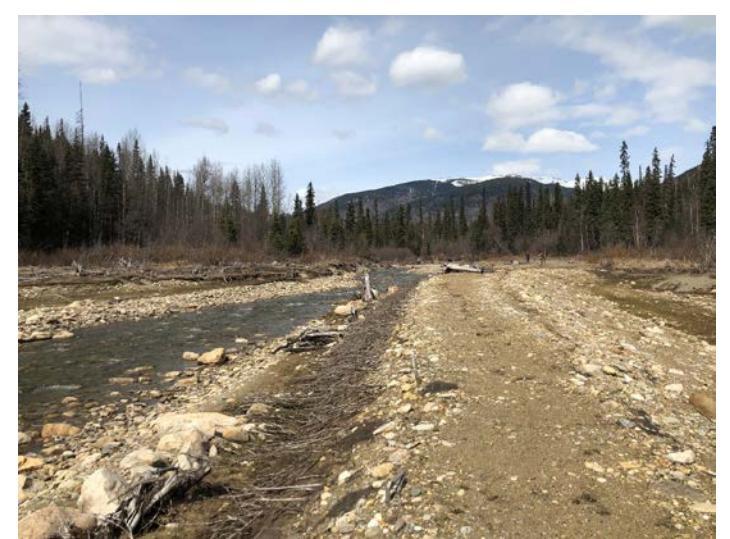
PHOTO 44: Downstream end of Berm 'C' looking upstream (repeat of 2016 Ph#35)

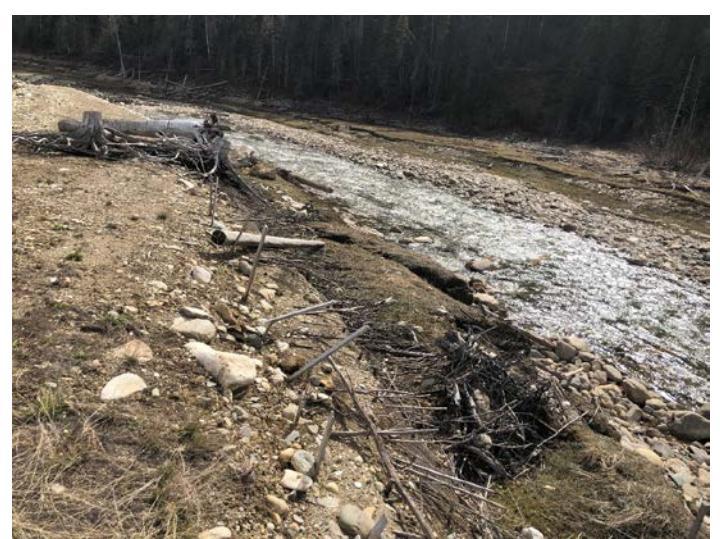
PHOTO 45: Coir soil wraps, willow brush layers along berm and native grasses/reeds at toe (repeat of 2016 Ph#36)

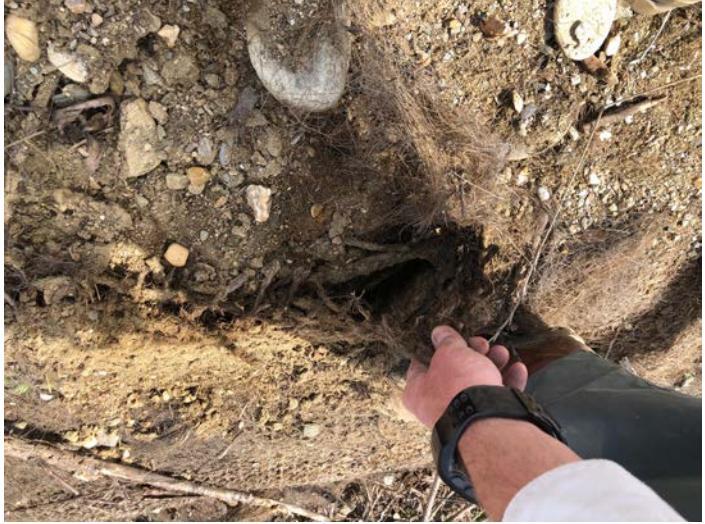
- The upstream half of the berm had good grass growth on the crest (see Photos 49 & 50).
- The coir geogrid is generally in good condition, however there is a section of damaged coir approximately 5 m long 3 to 4 m upstream from the downstream end of Berm 'C' (See Photo 46). The damage is potentially from ice, wave action, or debris. The damaged coir is considered to still be stable and it is not an issue at this time, however it should be monitored in future inspections.

PHOTO 46: Damaged coir, perhaps due to ice or waves

- In future inspections monitor the two areas of interest for the coir geogrid matting: at the exposed tie-in location between Berms 'D' and 'F'; and at the damaged coir at the downstream end of Berm 'C'.

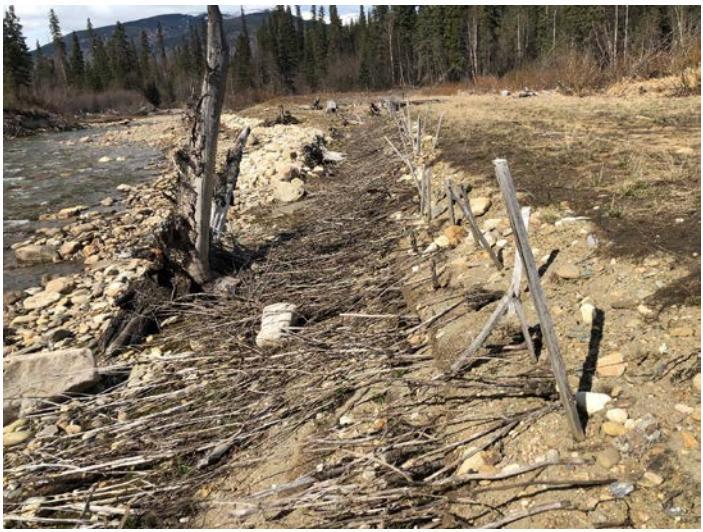
- The LWD is in good condition and has not displaced.
- Most of the willows (2014 live brush and stakes) do not appear to have survived however there are a few areas where the willow has taken (see Photo 47). It was also early in the season, so it is likely that additional growth will take hold above the reservoir this summer.

PHOTO 47: Few willow stakes took hold downstream berm area, but some growth (repeat of 2016 Ph#38)

- Consider installing additional planting on the upper berms (Berms 'C' and 'J') to further stabilize the upper works, particularly as the coir geogrid ages in the future. The potential extent and density of additional planting would best be determined in the early to midsummer, when the amount of existing planting can be better assessed.

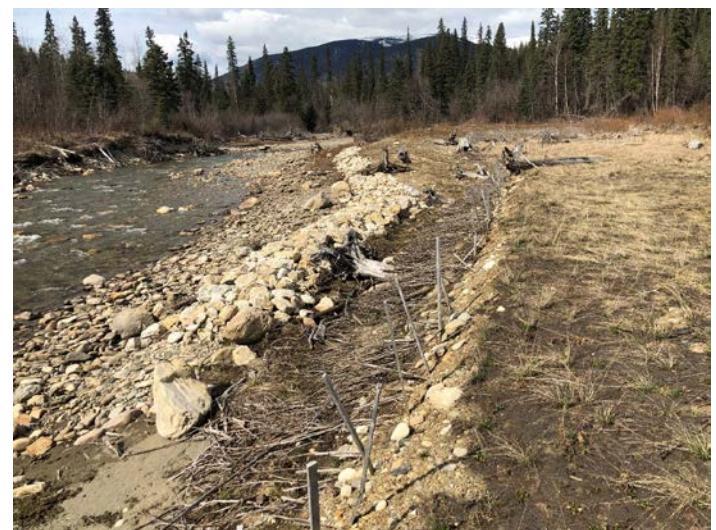
PHOTO 48: Looking upstream at willow layers in the lower berm and grasses on crest (no active growth given time of site visit) (repeat of 2016 Ph#39)

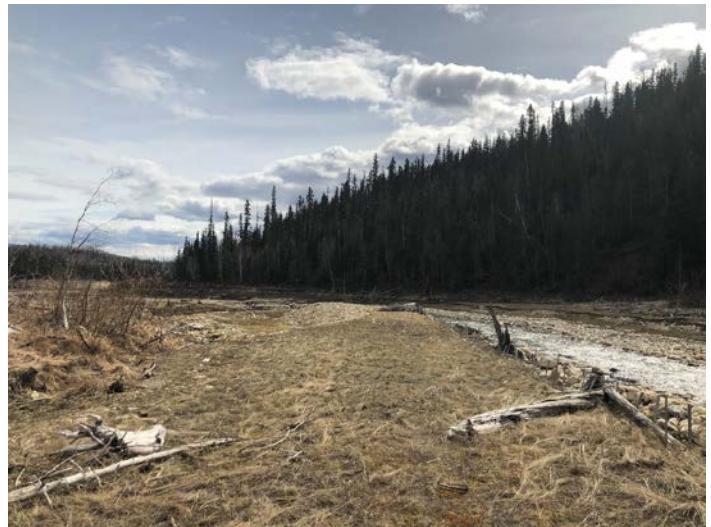
PHOTO 49: Looking downstream along Berm 'C' (repeat of 2016 Ph#40)

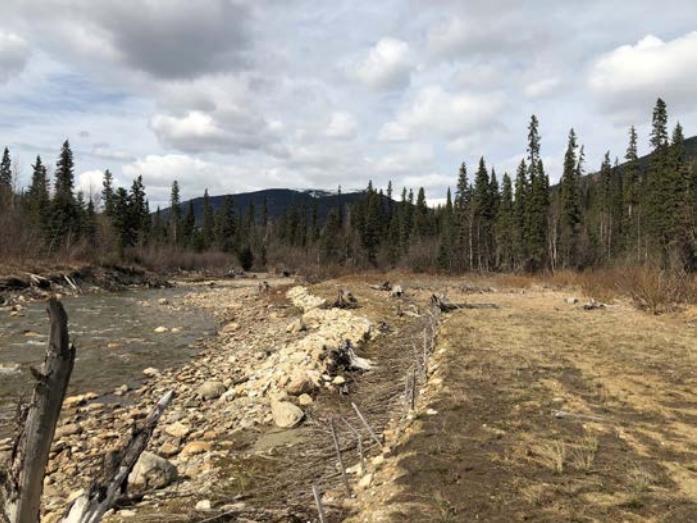
PHOTO 50: Looking upstream at upstream end of Berm 'C' (repeat of 2016 Ph#41)

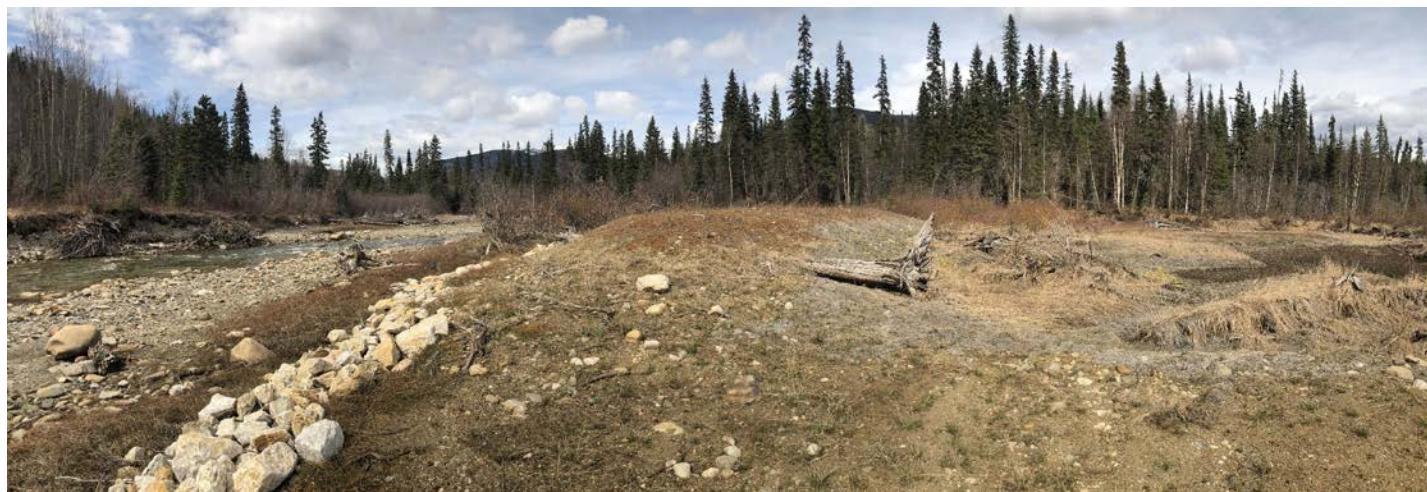
- Berm 'J' has effectively protected the bank and kept the creek from eroding behind the works. The berm is in good condition. No significant settlement or erosion observed in the field or noted in the survey (see Profile on DWG 1000-C1800063-R3, and Sections 0+300 and 0+320 on DWG 1000-C1800067-R1)

PHOTO 51 (Panoramic): Downstream end of Berm 'J' looking upstream (repeat of 2016 Ph#42)

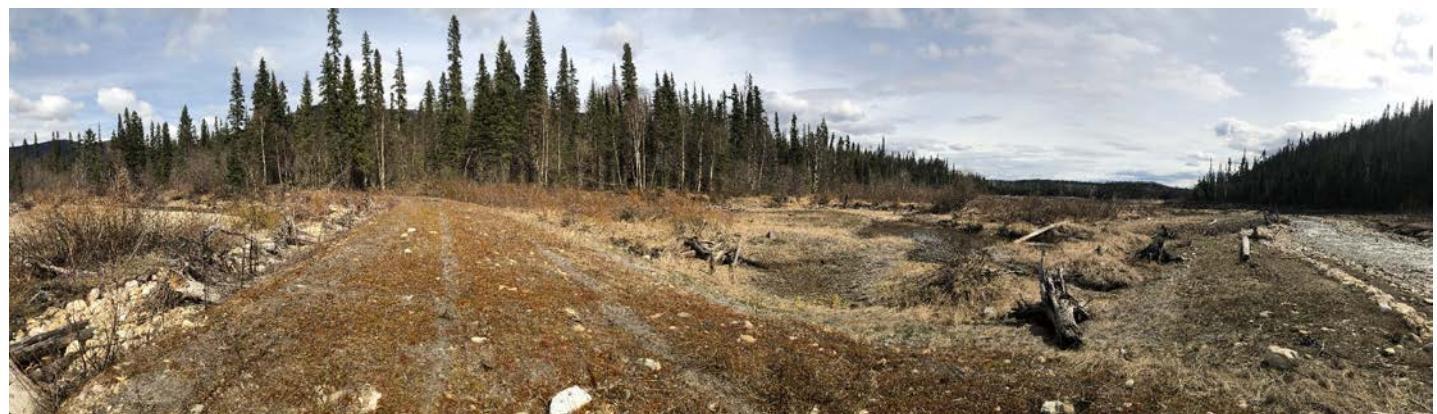
PHOTO 52 (Panoramic): Berm 'J' looking upstream. Beaver / habitat pond at right of the photo. (repeat of 2016 Ph#43)

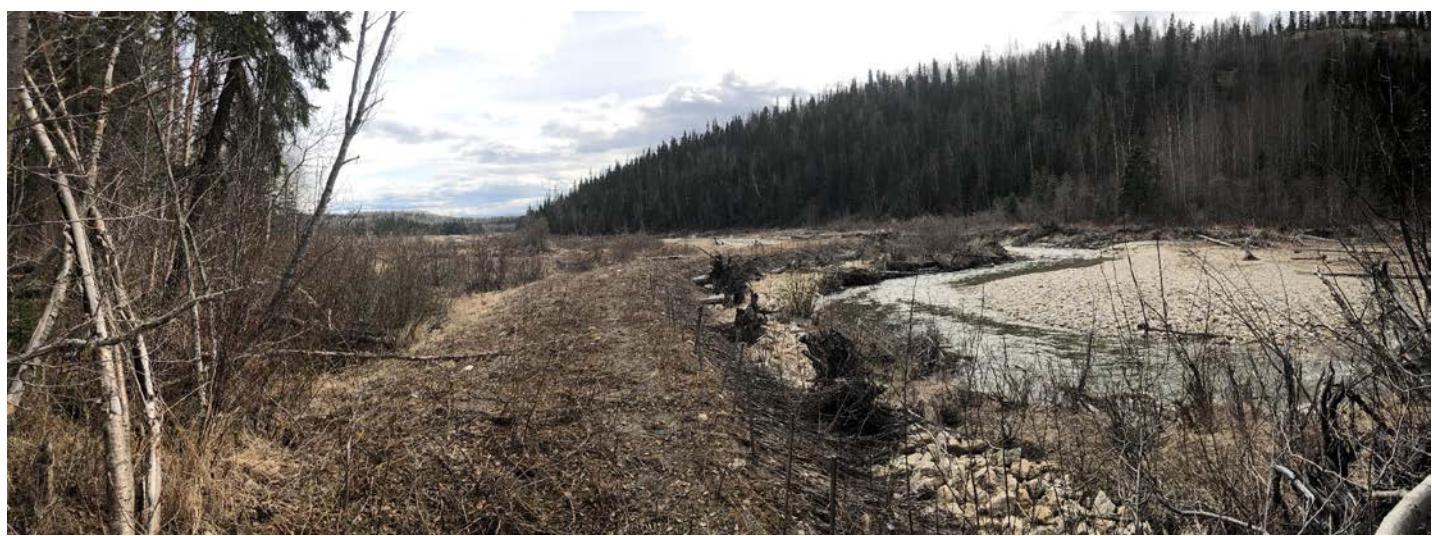
PHOTO 53 (Panoramic): Looking downstream at Berm 'J' (repeat of 2016 Ph#44)

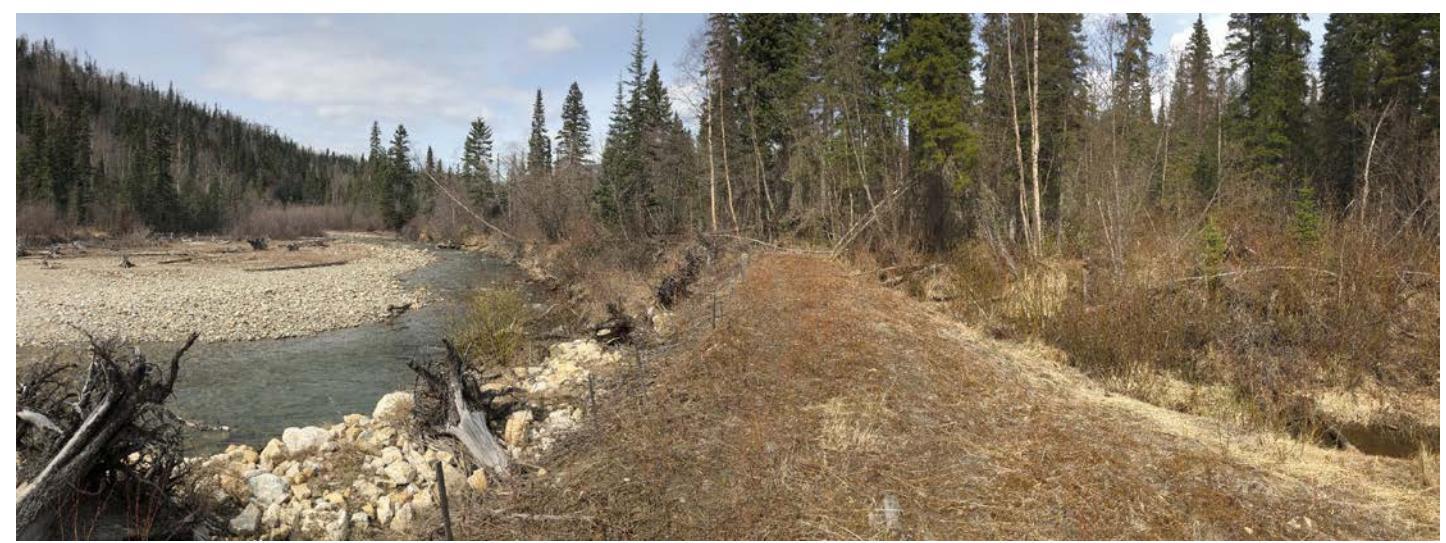
PHOTO 54 (Panoramic): Upstream end of Berm 'J' looking upstream (repeat of 2016 Ph#45)

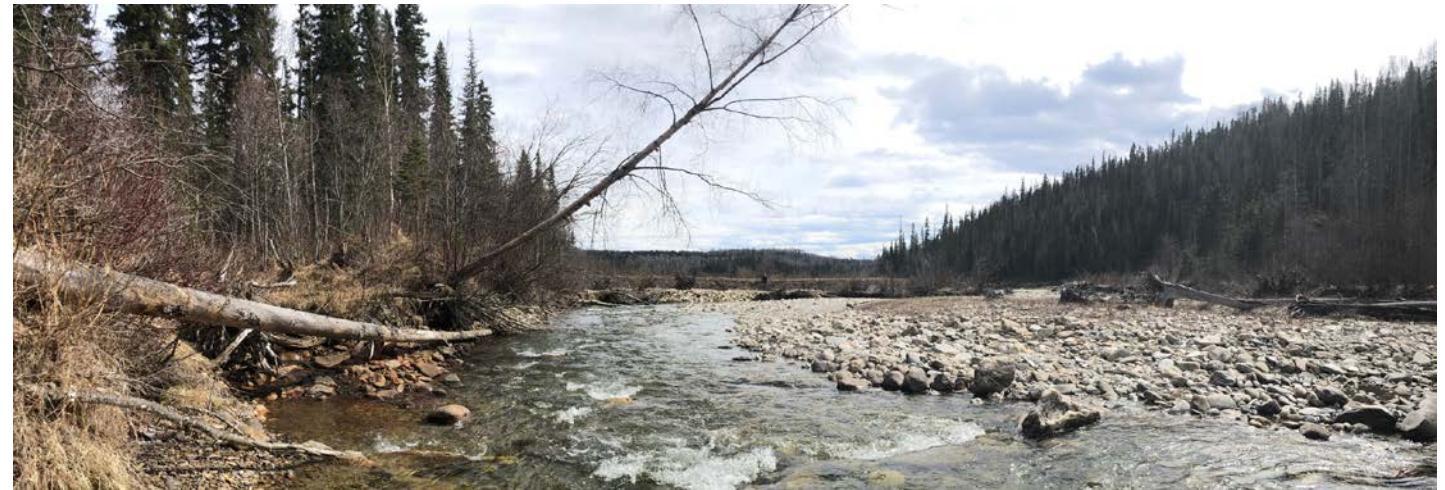
PHOTO 55 (Panoramic): Looking Downstream at Berm 'J' from Left Bank of Creek

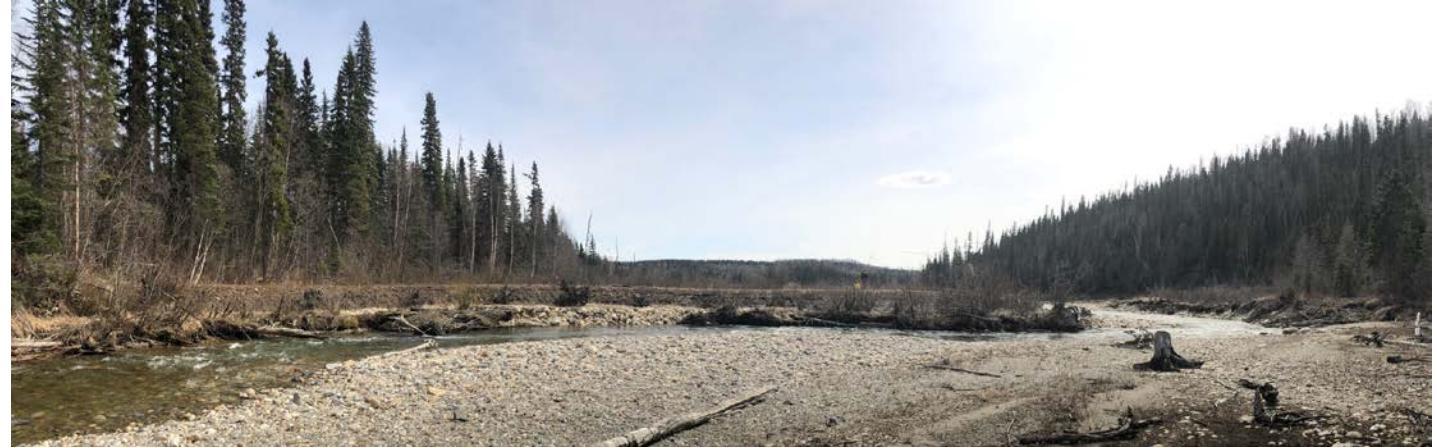
PHOTO 56 (Panoramic): Looking Downstream at Berm 'J' from Right Bank Bar

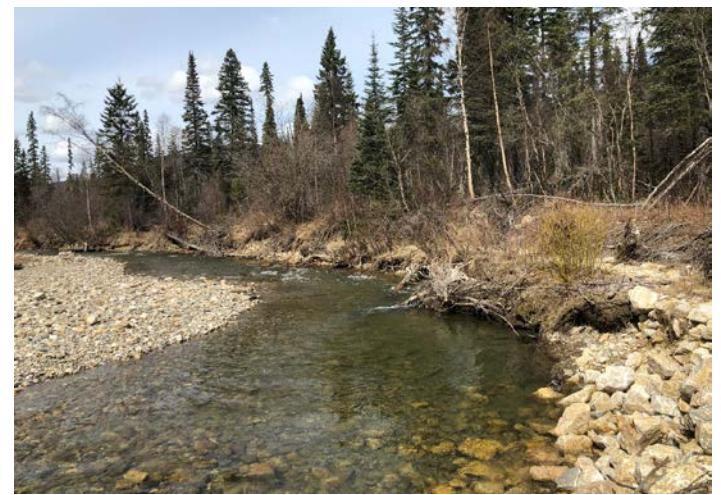
- The LWD is in good condition and has been not displaced.
- The creek has eroded away the bank in front of the berm and there is now an approximately 10 m long section of riprap exposed to the water (see Photos 57, 58 & 65).

PHOTO 57: Eroding Bank and 'launching' riprap toe trench looking upstream (repeat of 2016 Ph#46)

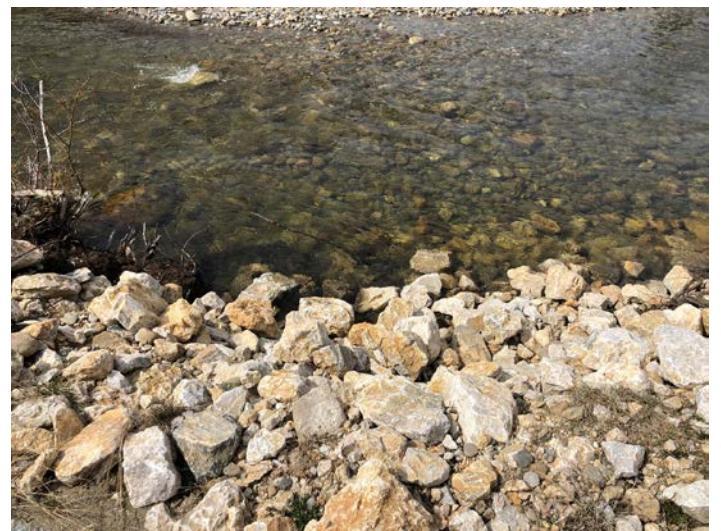
- Riprap launching toe trench has begun to 'launch' into eroded creek bank as expected and designed protecting the toe of Berm 'J' (see Photo 59).
- Willows are starting to come up and establish well all along berm at the time of the site visit (see Photo 63).

PHOTO 59: Launching riprap toe (repeat of 2016 Ph#48)

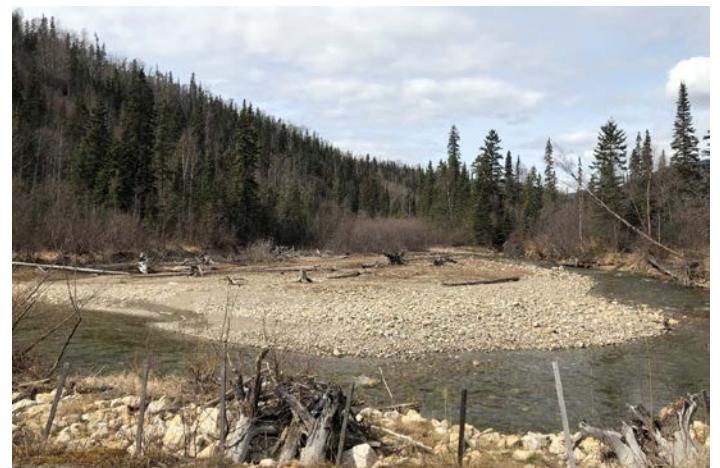
PHOTO 61: Gravel bar across from Berm 'J' (repeat of 2016 Ph#50)

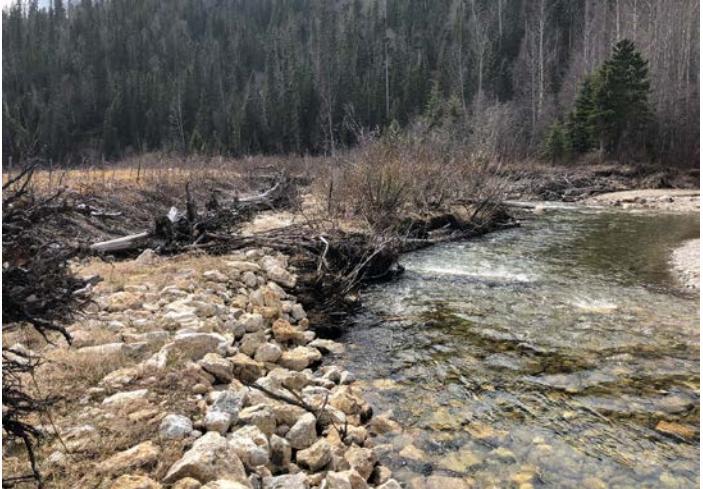
PHOTO 58: Eroding bank and 'launching' riprap toe trench looking downstream (repeat of 2016 Ph#47)

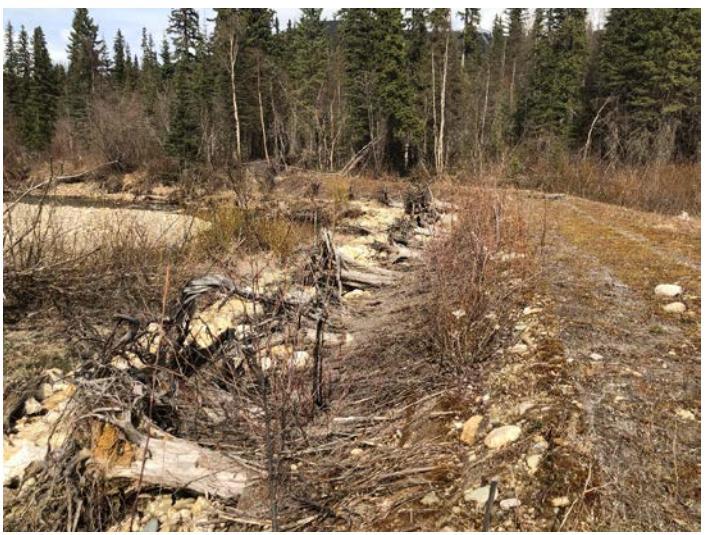
PHOTO 60: Coir Geogrid "Soil Wraps", willow, LWD, and riprap toe looking upstream (repeat of 2016 Ph#49)

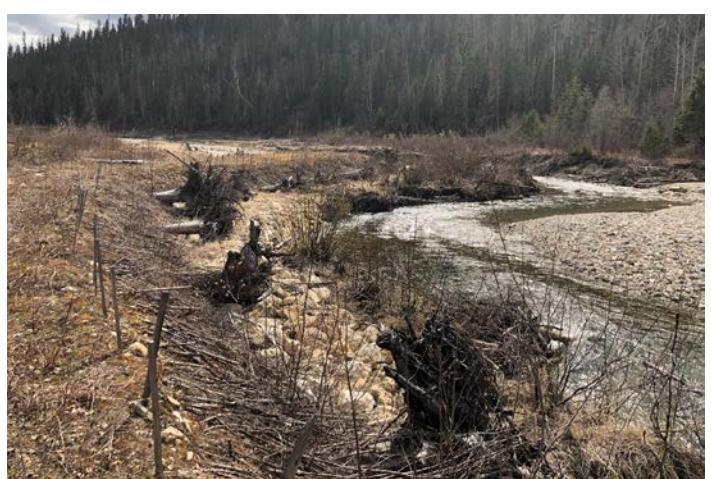
PHOTO 62: Soil wraps, willow brush layers, LWD and riprap looking downstream (repeat of 2016 Ph#51)

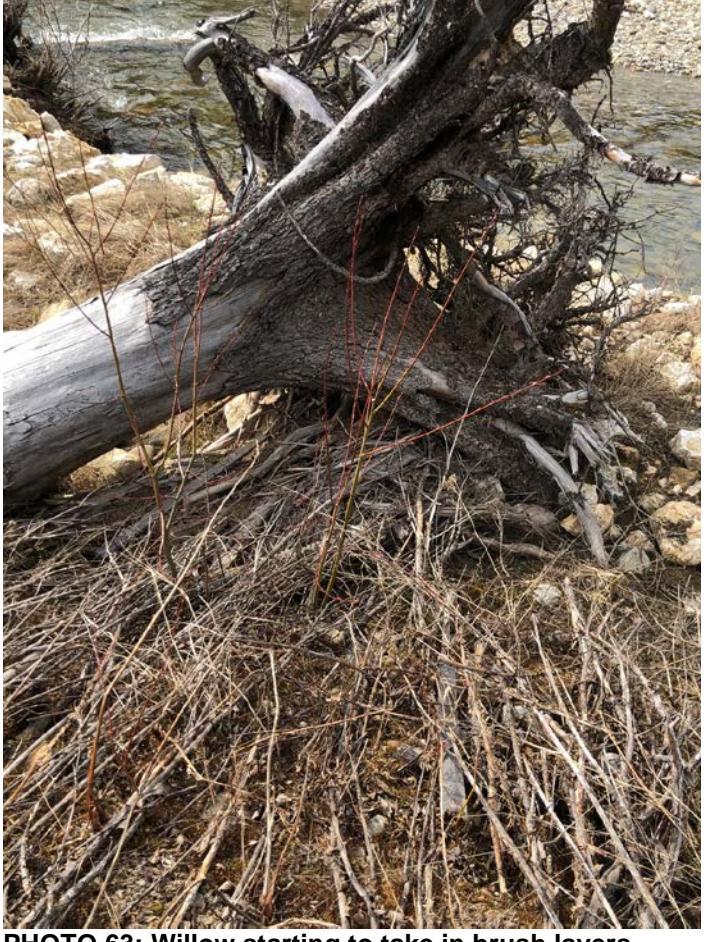
PHOTO 63: Willow starting to take in brush layers (repeat of 2016 Ph#52)

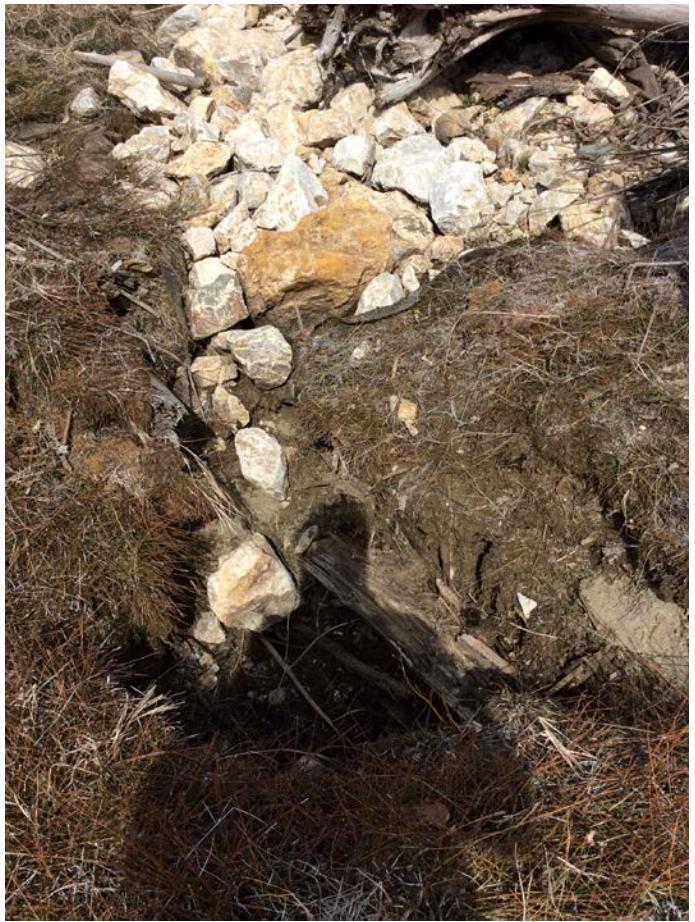
- Grass and other vegetation growing on top and on back side of berm.
- The ECM has almost completely deteriorated as expected.
- Some erosion was noted just downstream of the riprap on Berm 'J' (See Photo 64).

PHOTO 64: Erosion at downstream end of riprap toe protection

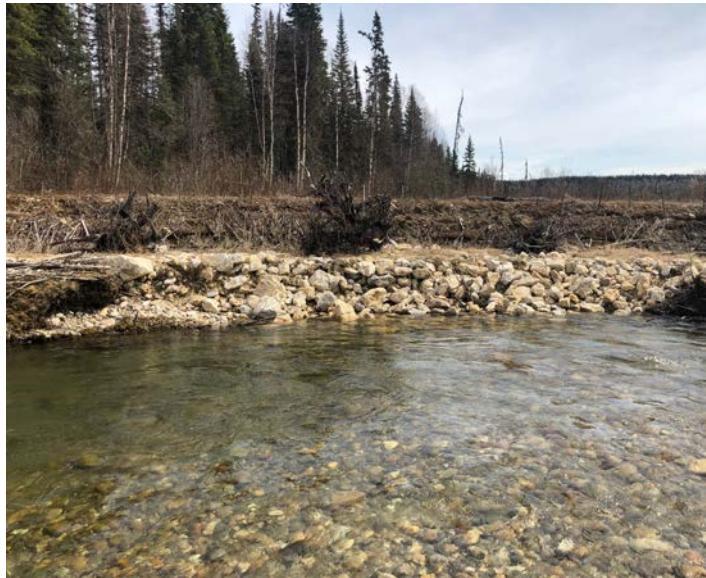
PHOTO 65: Launched Toe Riprap at Berm 'J'

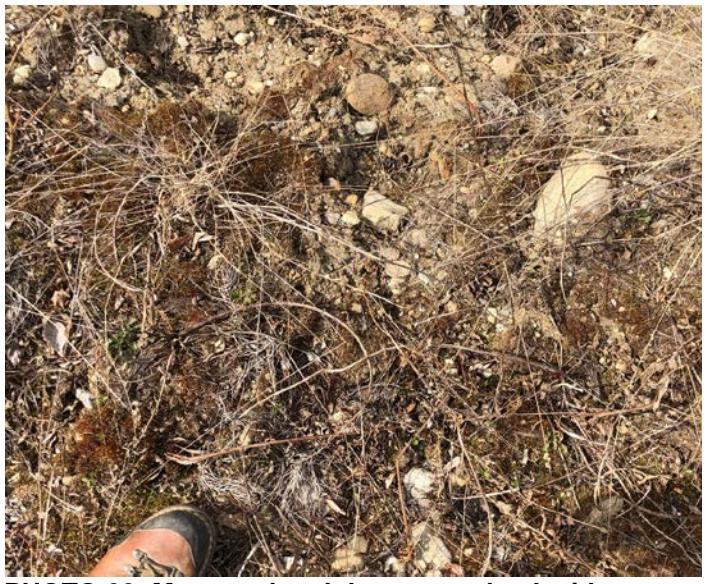
- Evidence of moose damage to crest of berm as noted in 2016.

PHOTO 66: Moose related damage on back-side slope of berm (repeat of 2016 Ph#55)
