Peace Project Water Use Plan

WILLISTON TARGETED DEBRIS MANAGEMENT

Reference: GMSWORKS-22

Study Period: 2019

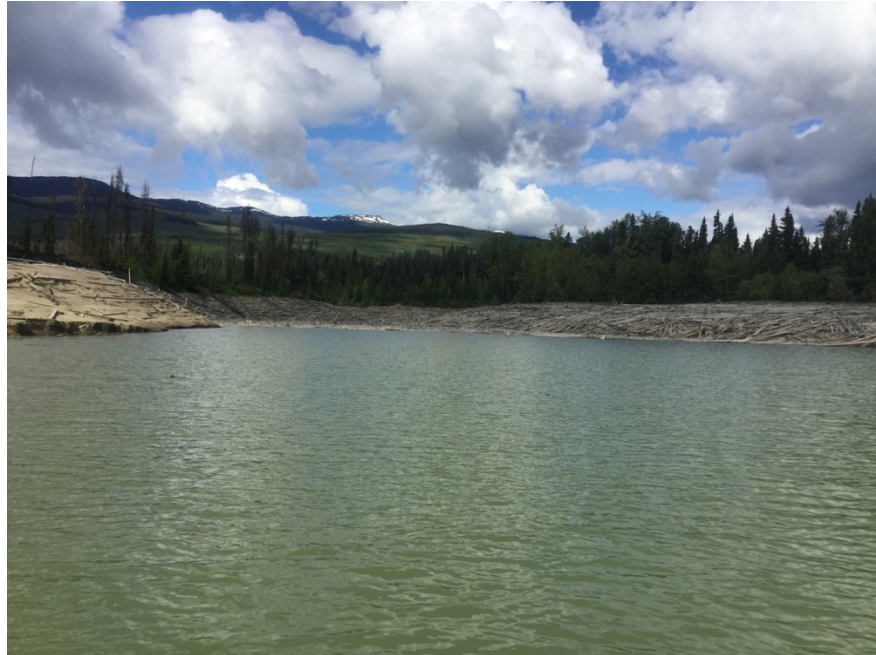
Figure 1: Corless / Tear Creek Beach prior to debris management.

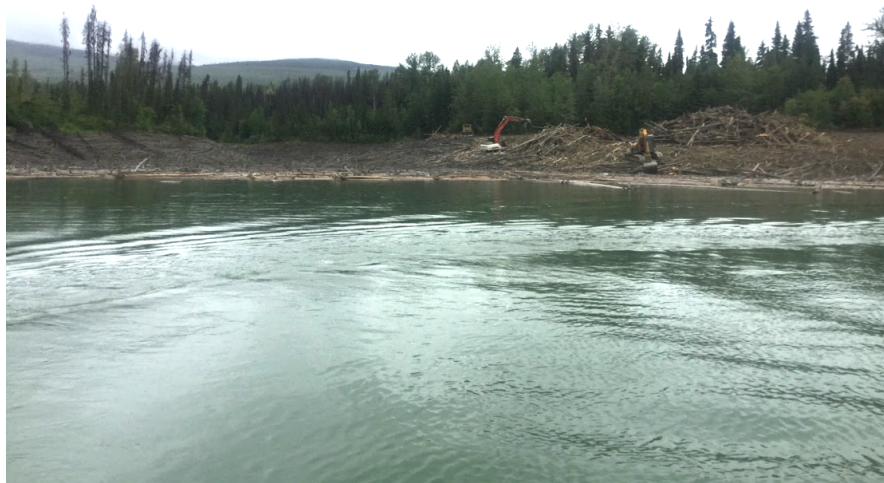
Figure 2: Corless / Tear Creek Beach during debris management.

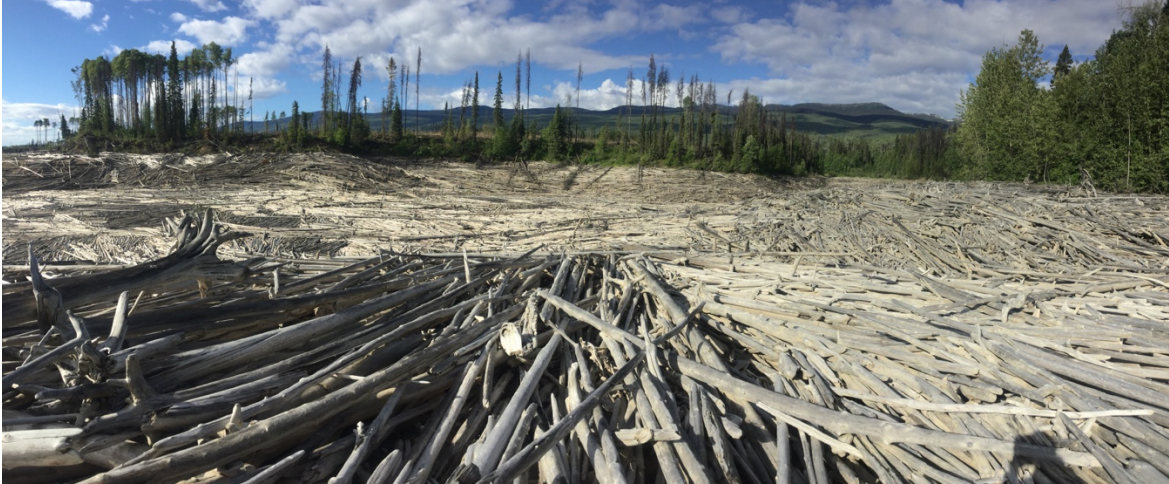
Figure 3: Corless plug before debris management.

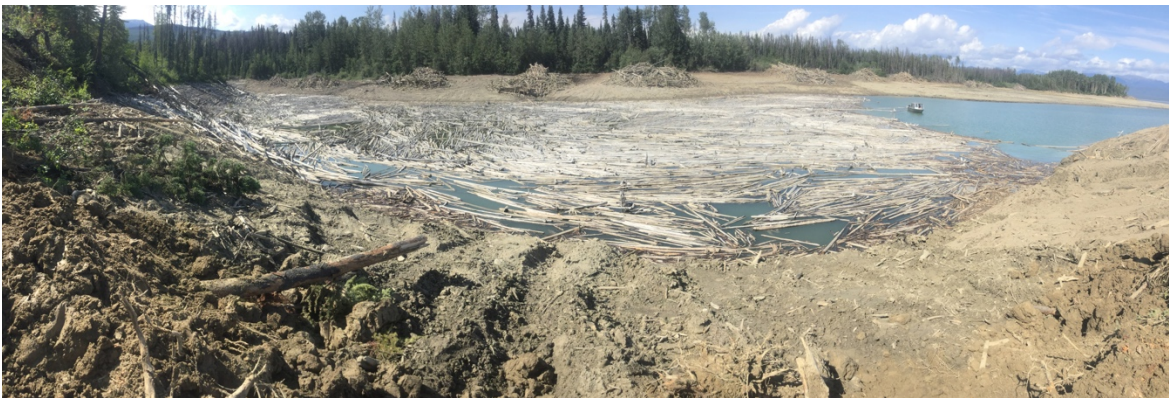
Figure 4: Corless Plug during debris management.

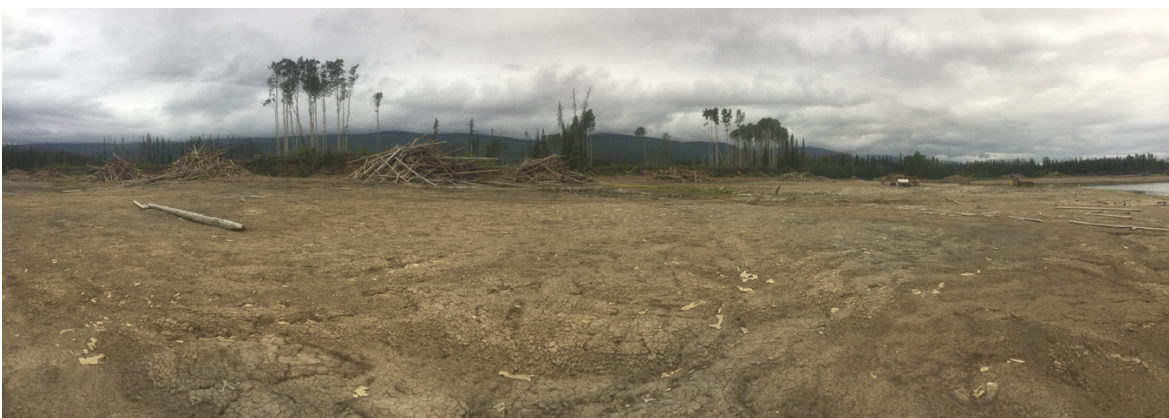
Figure 5: Debris piles on Corless Beach.

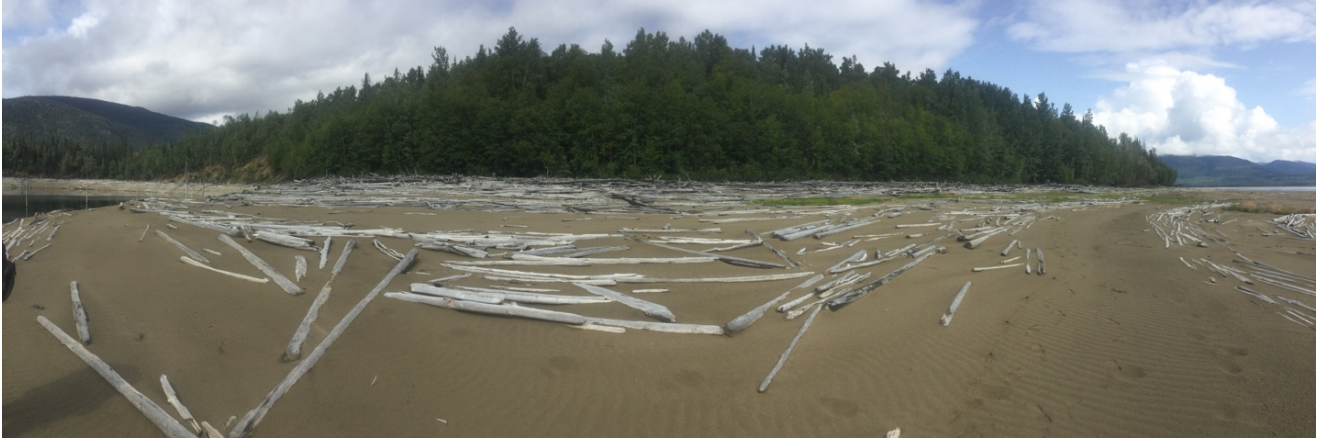
Figure 6: Stromquist before debris management.

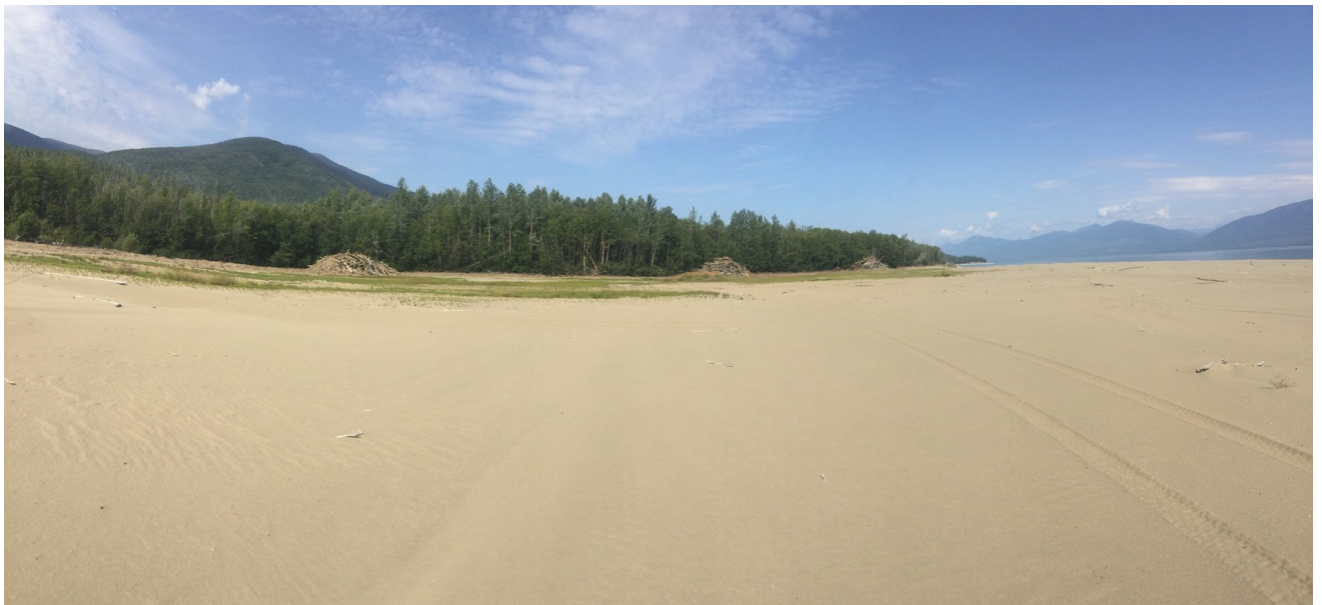
Figure 7: Stromquist after debris management.

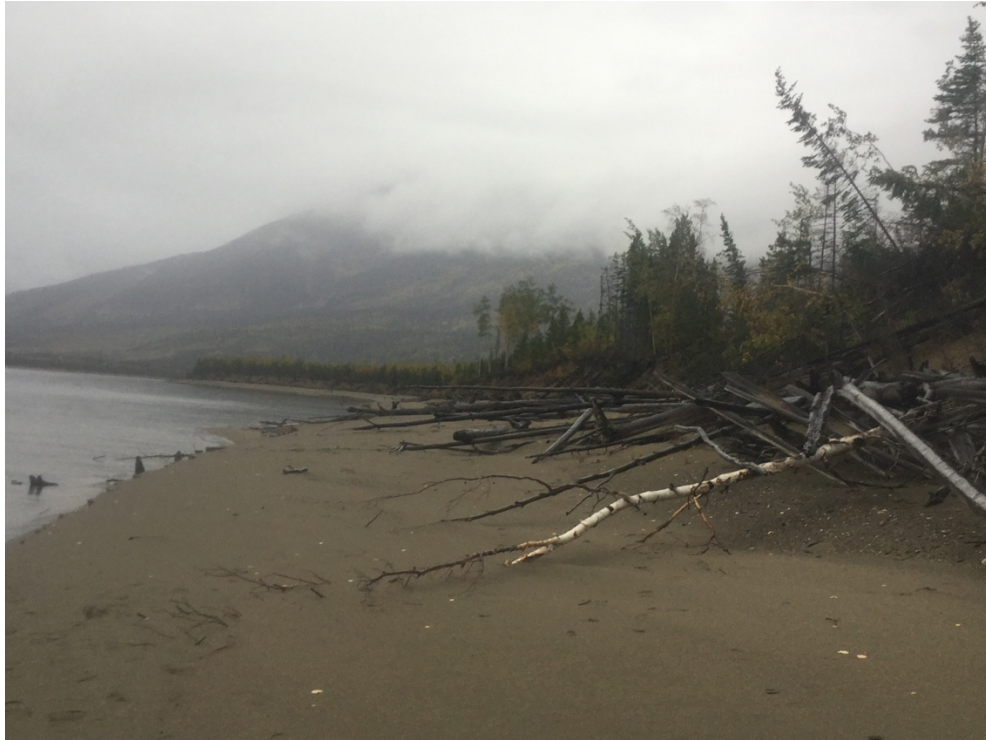
Figure 8: Middle Creek North / Horn Creek before debris management.

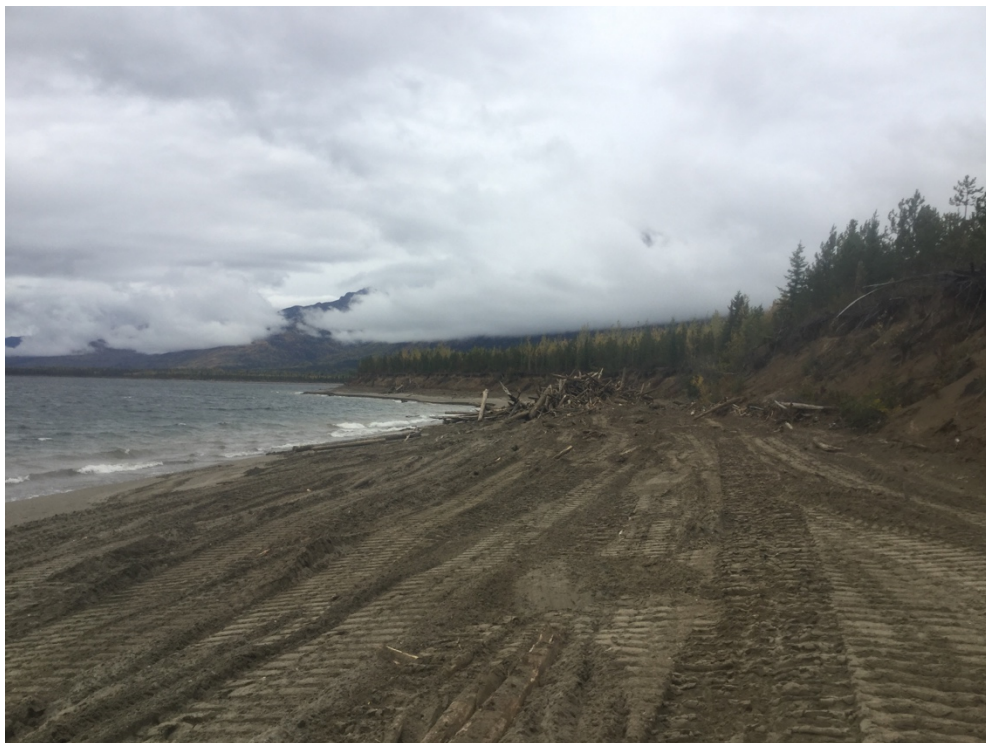
Figure 9: Middle Creek North / Horn Creek after debris management.

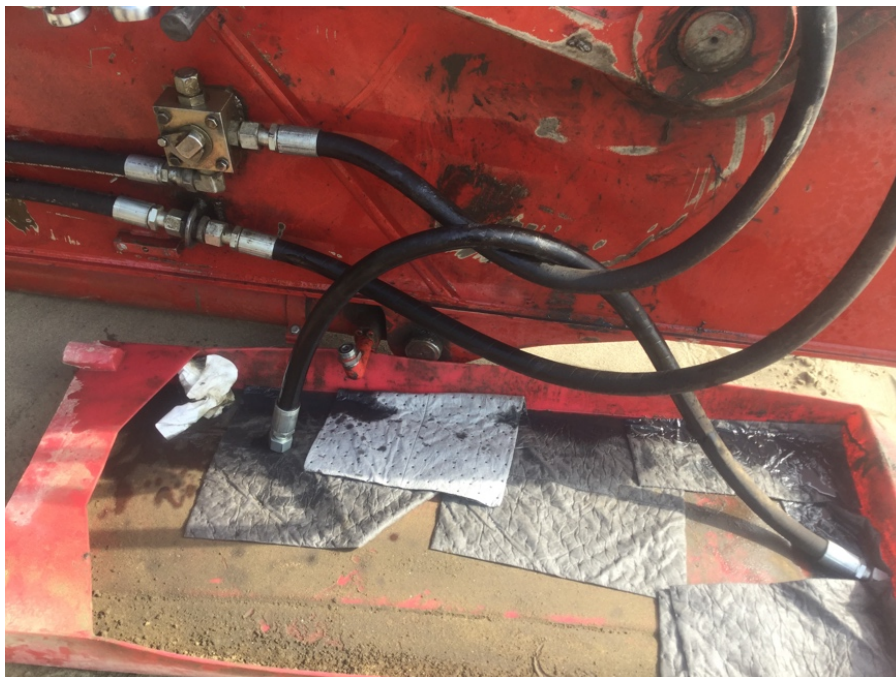
Figure 15: Managing and replacing leaking hoses with spill kit and tray.
