Construction Completion Report

BC Hydro – Williston Reservoir Wetland Demonstration Site 34 Beaver Pond Completion Report

BC HYDRO - WILLISTON RESERVOIR WETLAND DEMONSTRATION SITE 34 BEAVER POND

1414340003-001-R-Rev0

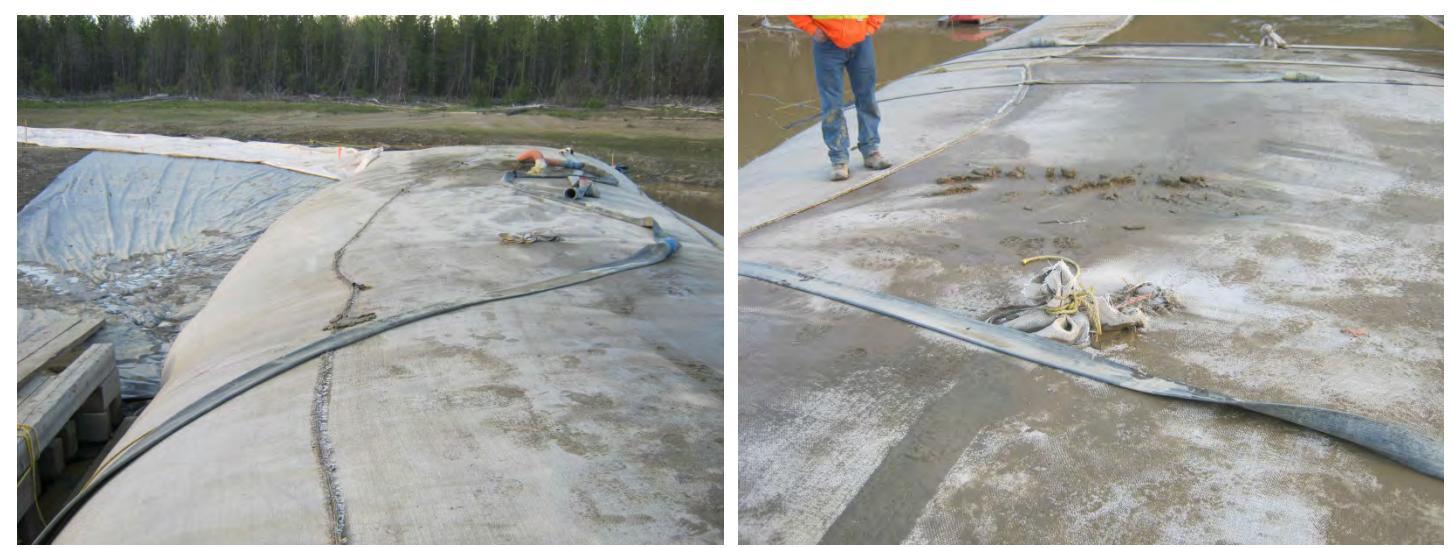
Bag Failure.

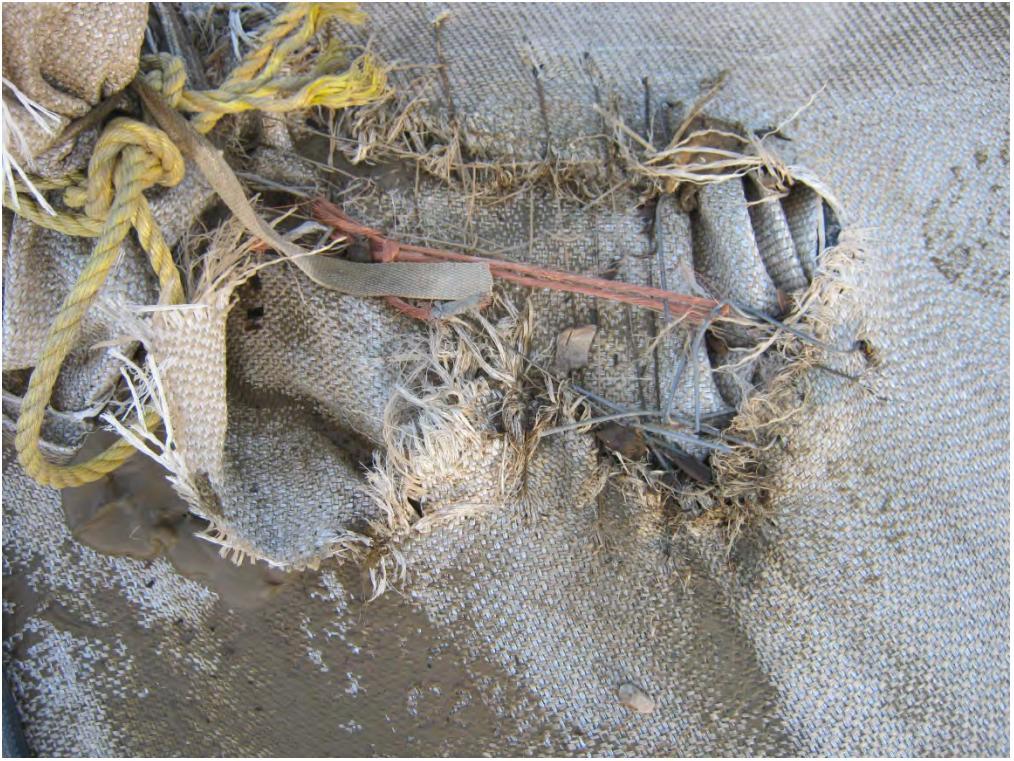
Unsuccessful patch

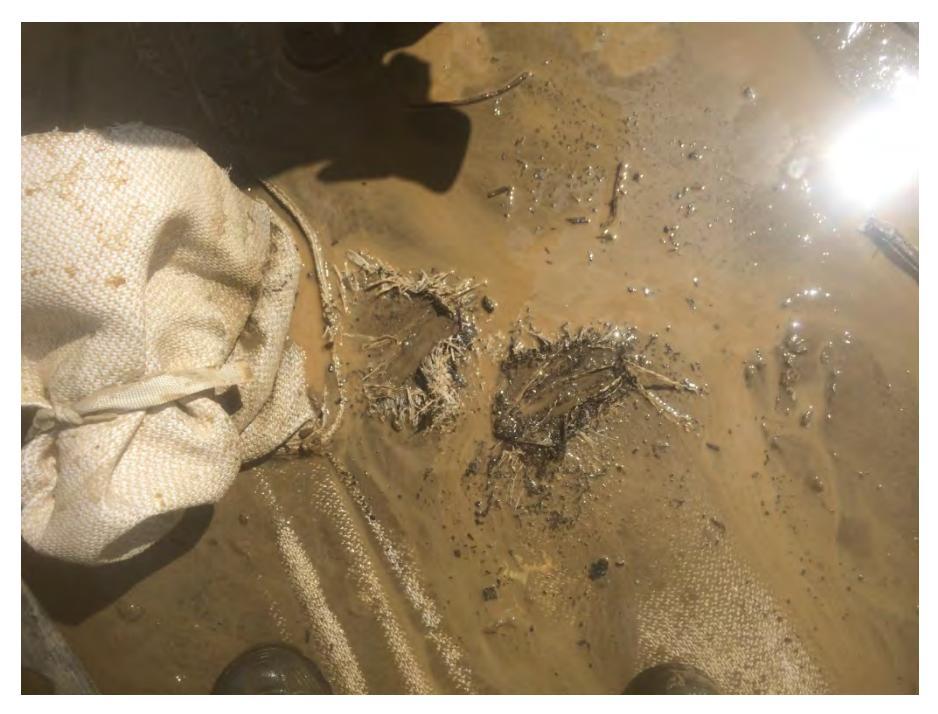
Photo 7: The two holes discovered in Mactube 1 were atypical of those observed by Golder Construction and the Mactube filling monitor in the past from over pressurization of the Mactube.

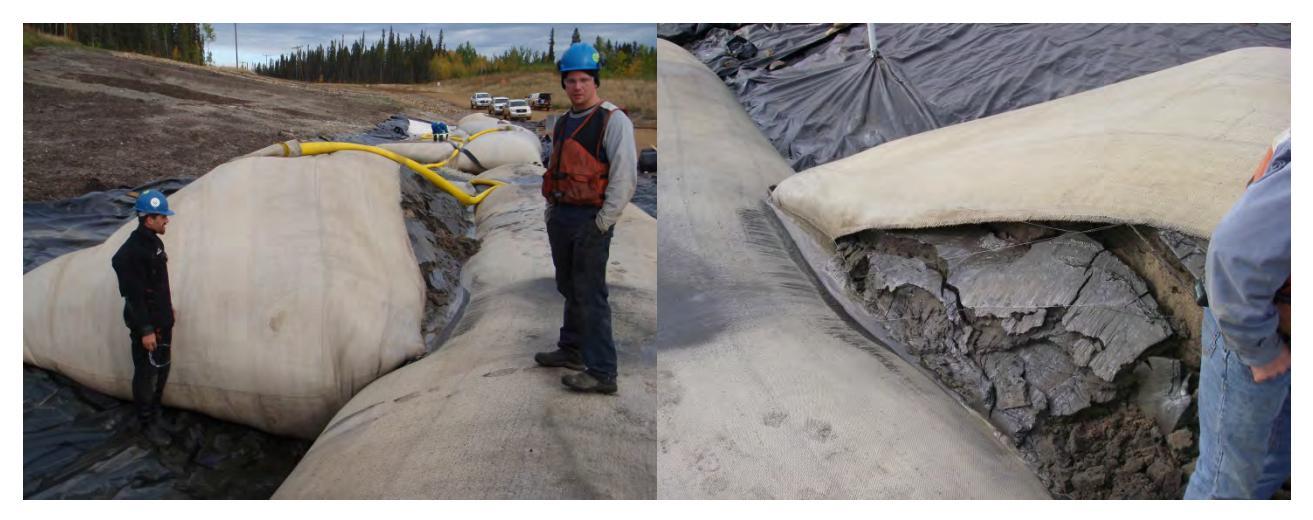
Photo 8: Over pressurization during filling of Mactubes typically results in longtitudinal tears along the seams of the bag (Courtesy of John Smith-Golder Construction).

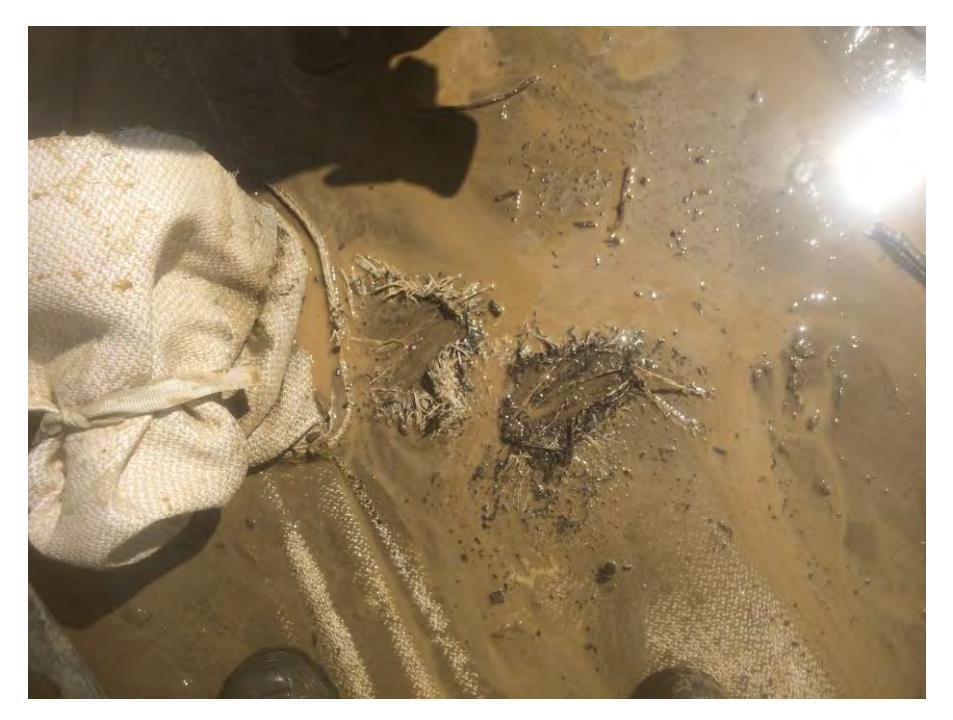
Photo 1 – when the ripped parts were noticed. Look and act like rotten/worn-out clothes

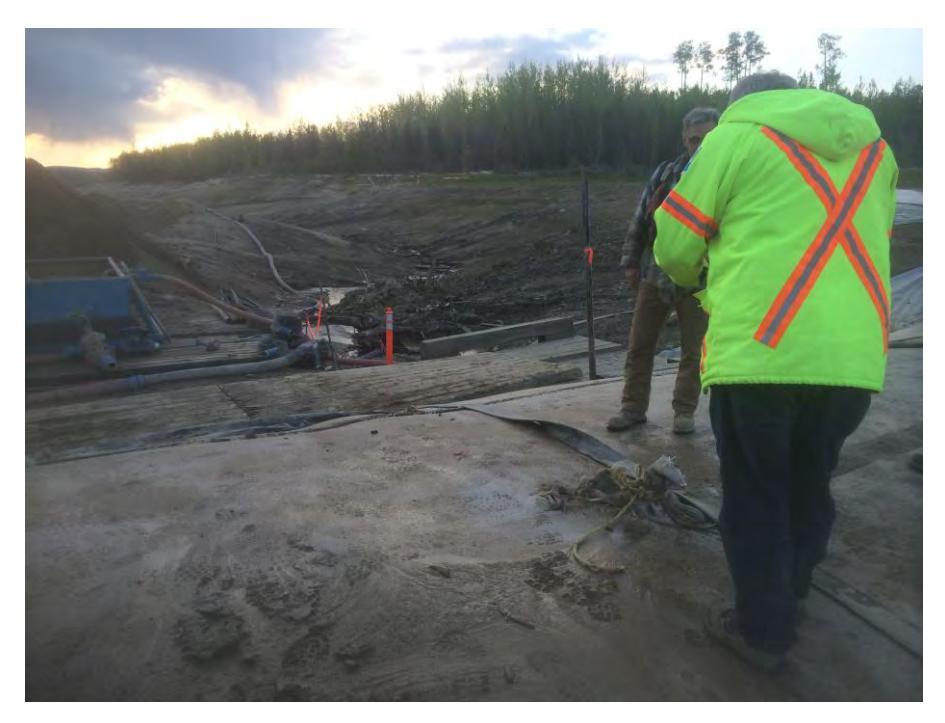
Photo 2 – Standing upstream and showing the ripped part in relation to downstream. (Spillway)
