Peace Project Water Use Plan

WILLISTON TARGETED DEBRIS MANAGEMENT

GMSWORKS#22 – 2022 Final Report

GMSWORKS#22 – 2022 Final Report: 2022

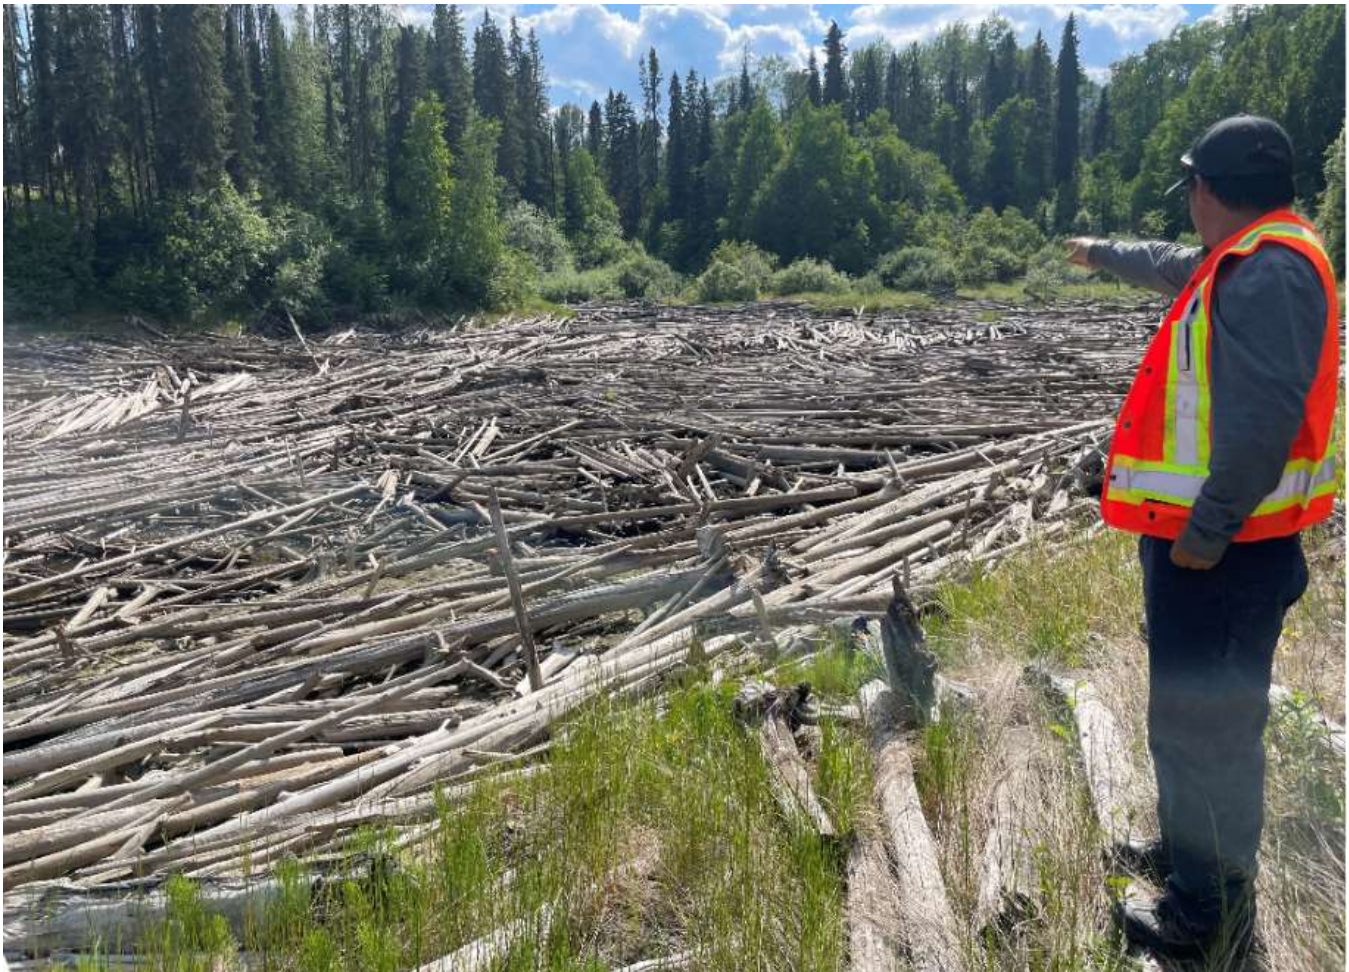
Noted lots of cobbles, boom logs, and lost processed wood bundles. Seen moose, bird, porcupine, sandhill cranes, and bear tracks. Marked no go zones where frogs were present and informed HEO to stay clear of area.

Figure 2: Before Debris piling on Tear Creek Recce

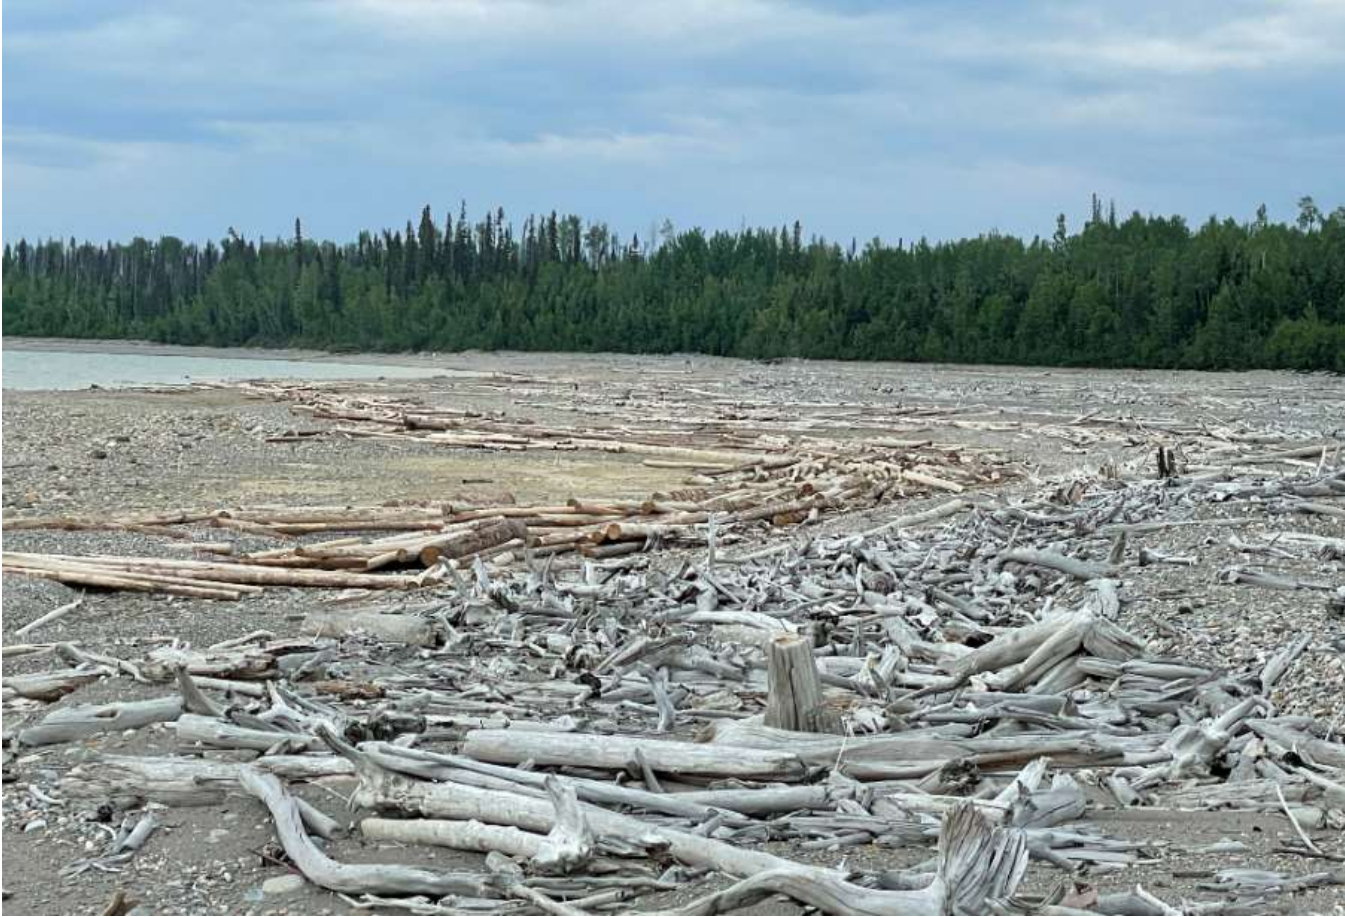
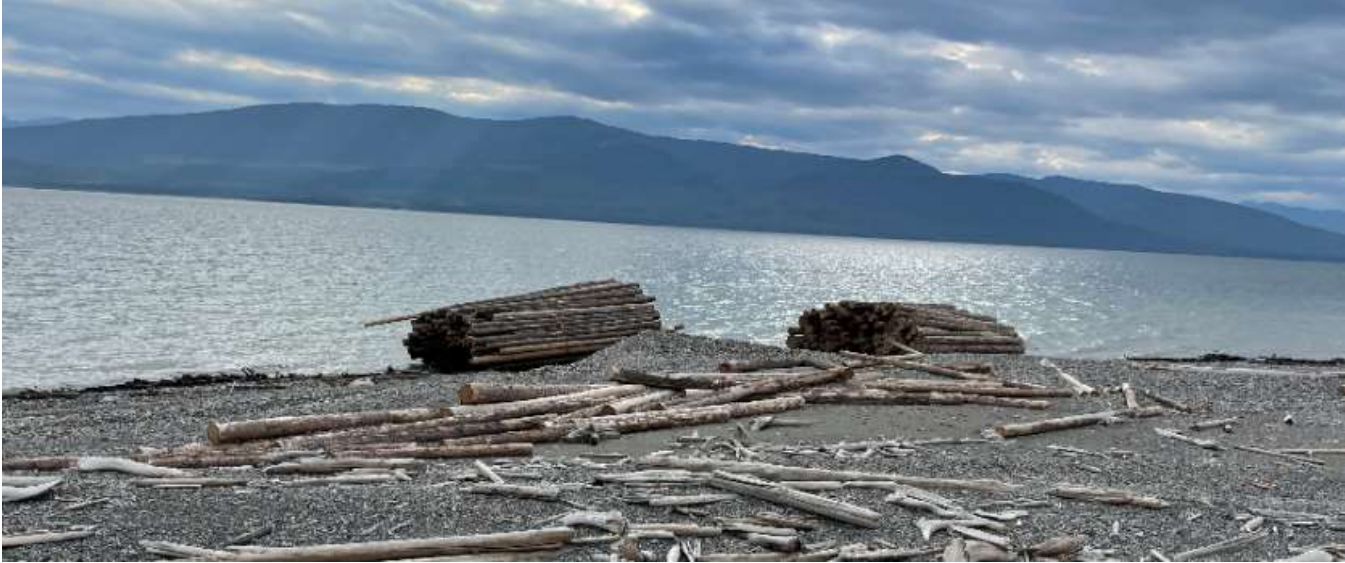
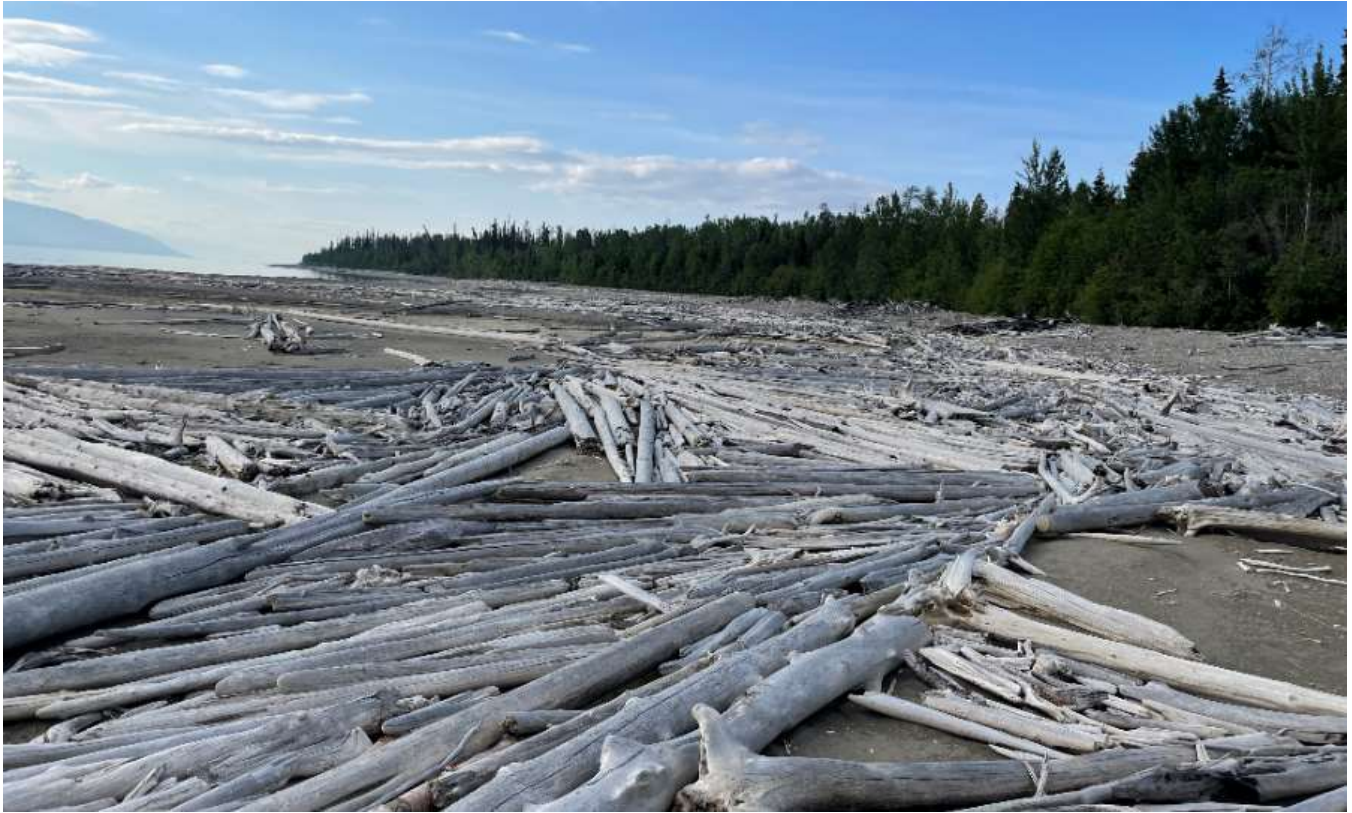
About 30 bundles that were lost from last year's tow to the mill in Mackenzie were noted during debris cleanup on Coreless.

Figure 5: Before Debris piling on Coreless

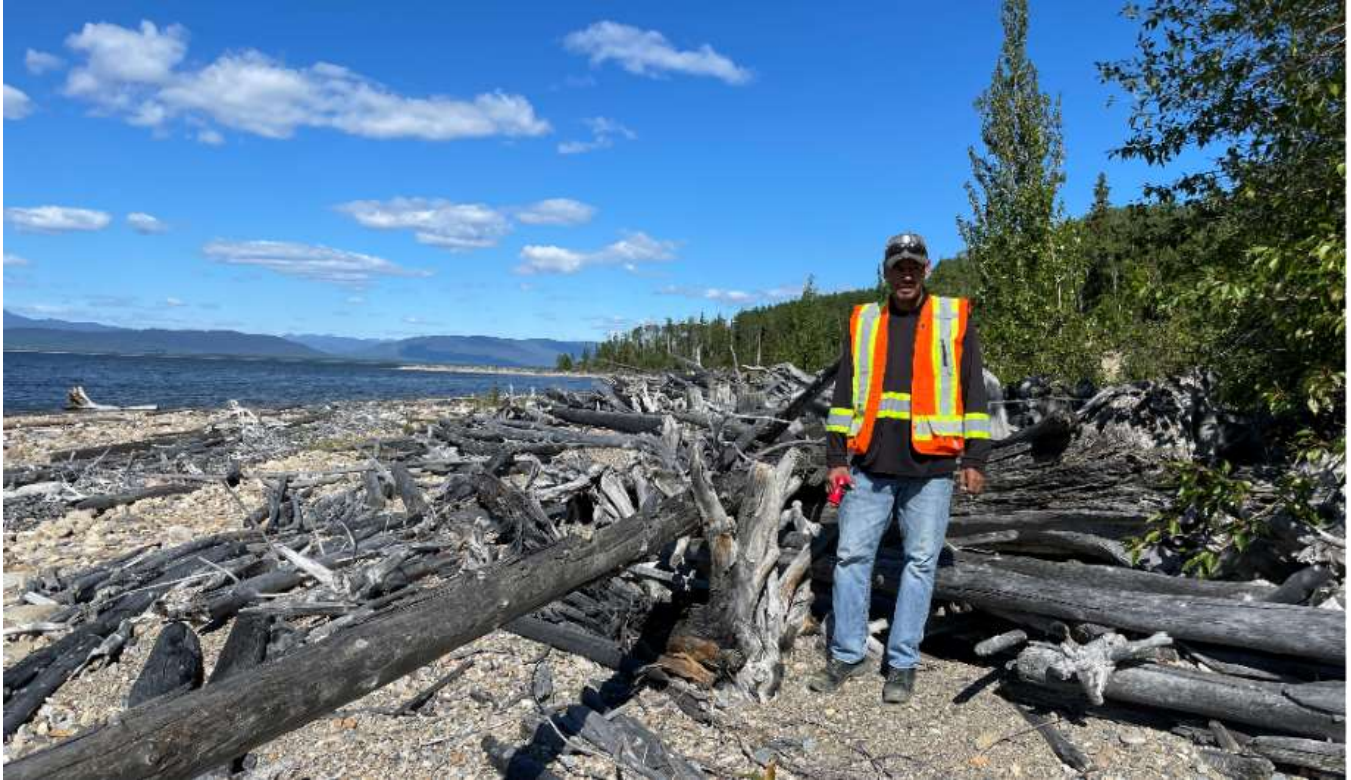
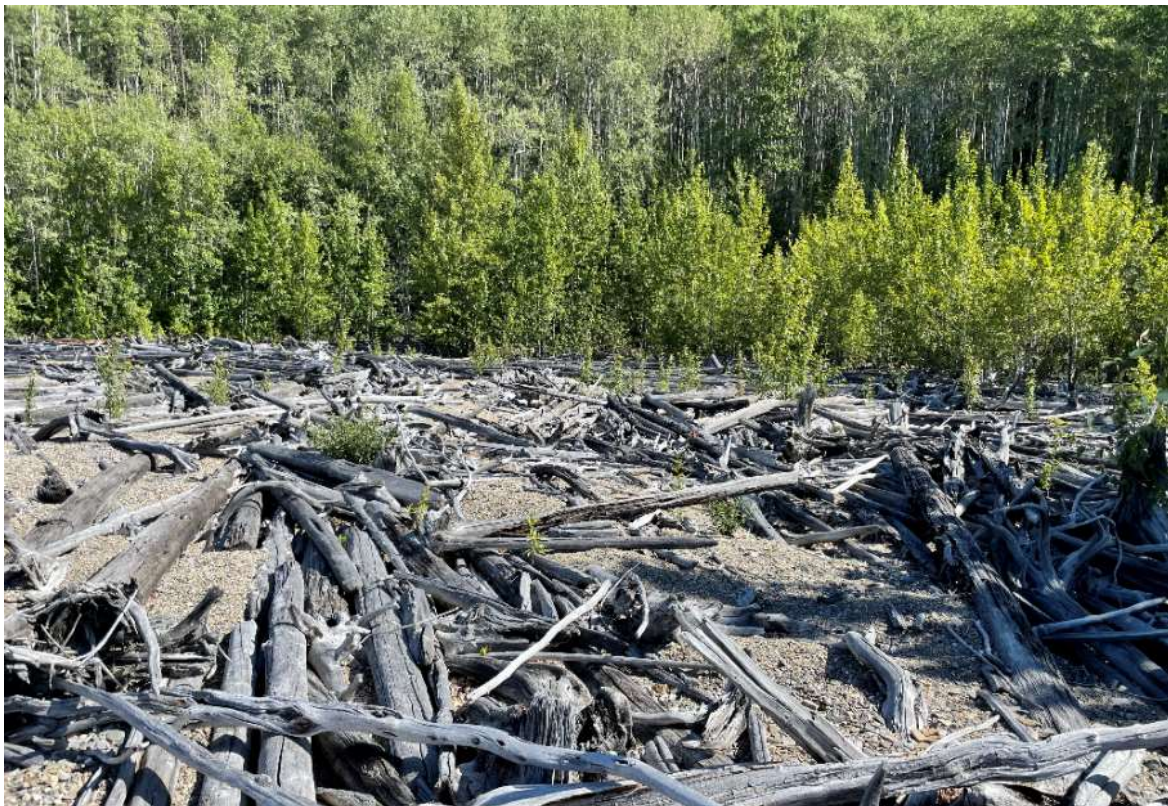
Figure 8 :Before Debris piling Bevel

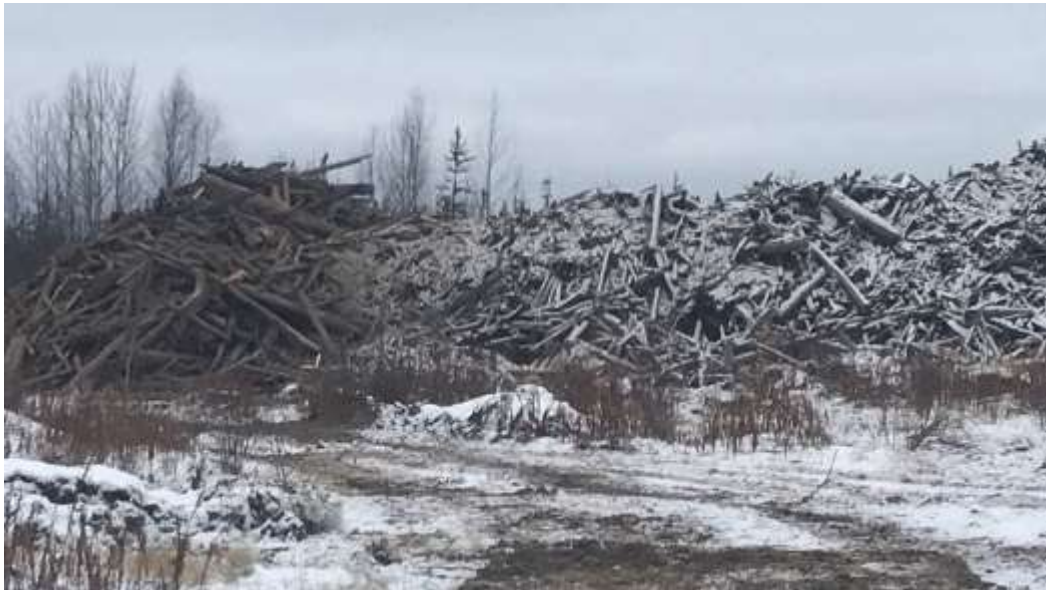
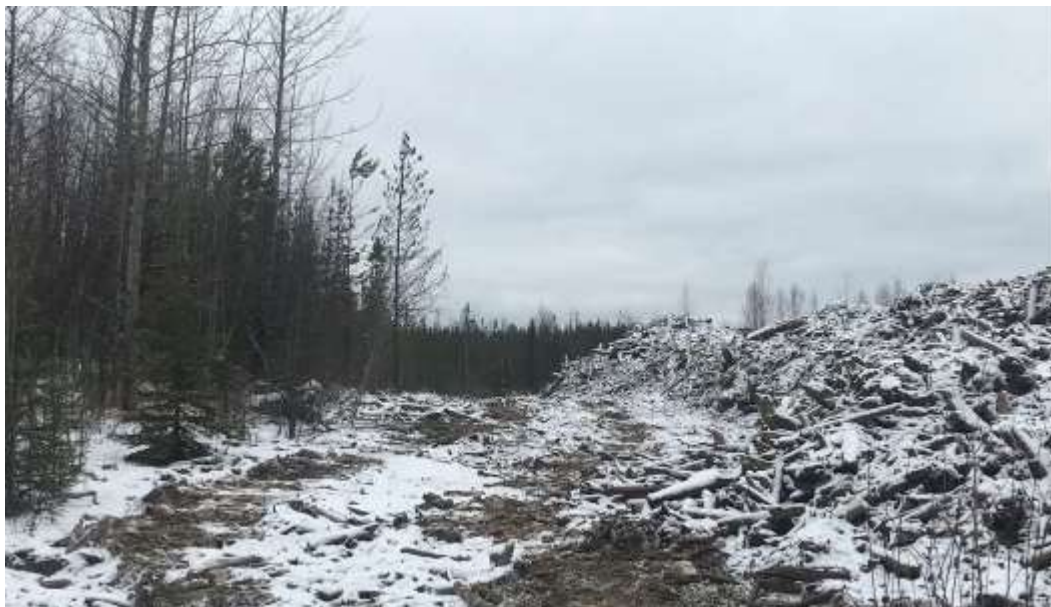
During the BC Hydro site visit to Tsay Keh Dene in August 2022, it was determined that the old debris piles at Deserter's Dump should be moved into themselves, and a fire guard placed between them and the timber edge.

Figure 24: Assorted After Debris Cleanup Deserter's Dump-fireguard between timber and debris pile (from previous years)

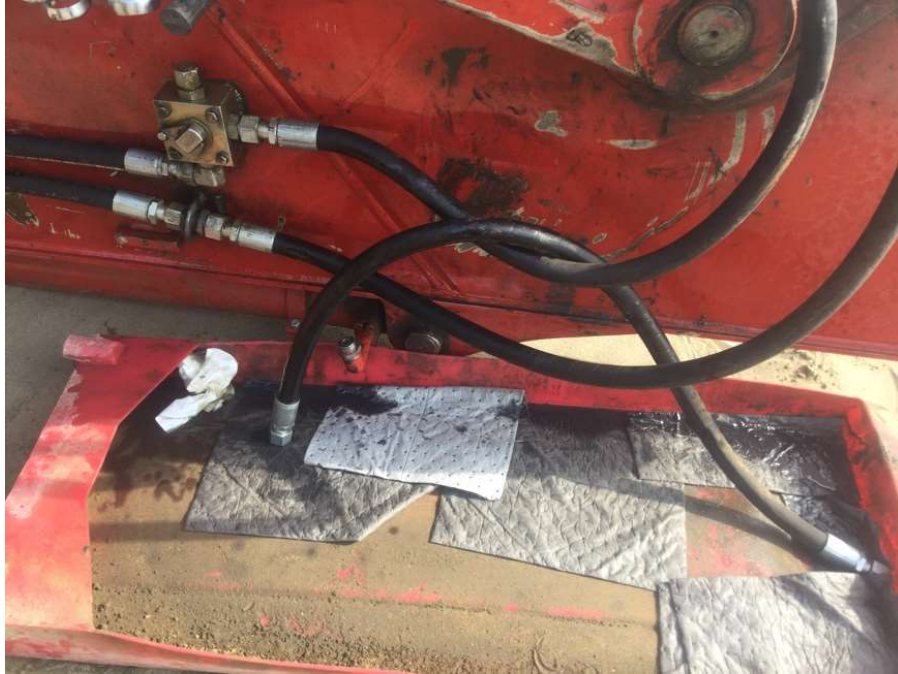
The following sequence of images shows some examples of good spill prevention management. During the 2022 season, there were no major fluid spills and 1 small reportable spill to water that were cleaned up by CCI. Figure 28 shows the spill kits being used during field-based repairs of the equipment.

Figure 28 : Managing and replacing leaking hoses with spill kit and tray.

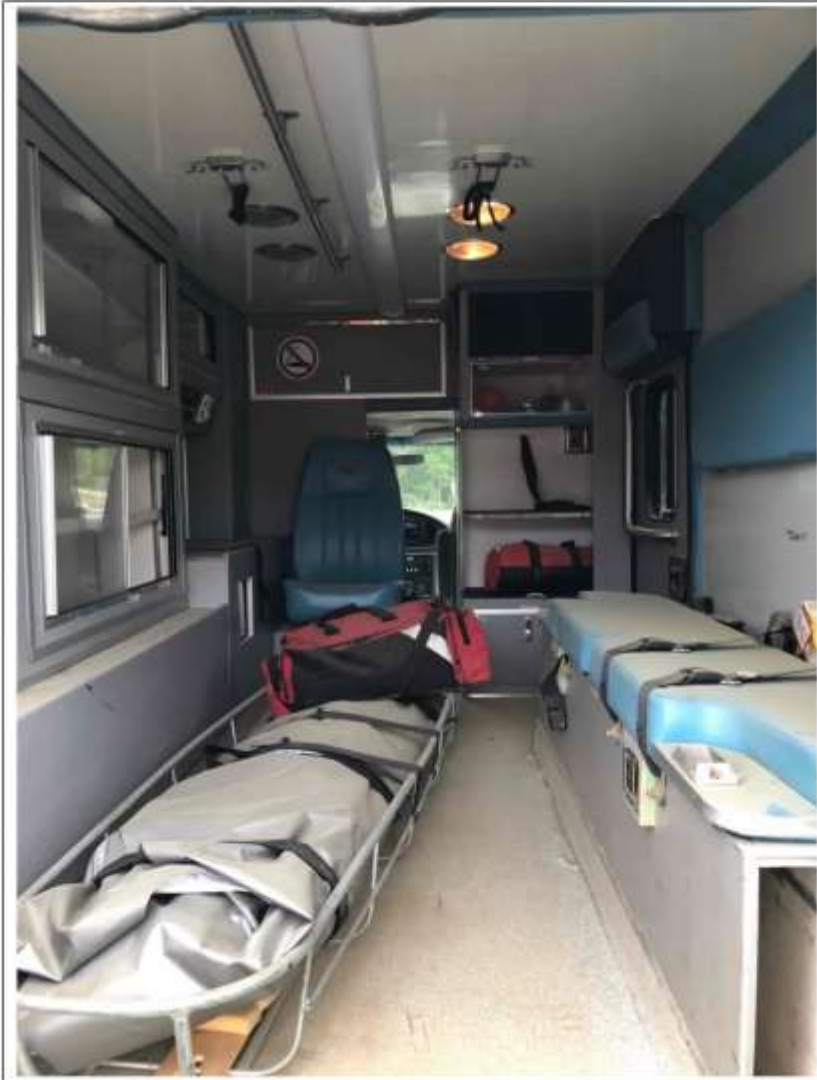
<p>First Aid requirements met?</p> <p>Comment: See compliance check. However ETV needs to be cleaned due to it being very dusty on the inside. First Aid Attendant will clean the interior of the ETV to remove dust. This was the first day back for crew and so it wasn't looked at till this morning.</p>	YES
<p>Ergonomic principles followed?</p> <p>Comment: Observed some good lifting, as well as team work for lifting a heavy object</p>	YES
<p>Safe driving habits practiced?</p> <p>Comment: When being driven to multiple locations around Collins Camp I observed the driver driving appropriately and following best practices for on FSRs and the in the use of Radios</p>	YES
Summary of Opportunities for Improvement and Feedback	
<p>Housekeeping effectively managed?</p> <p>Comment: Housekeeping on Barge Deck was appropriate, as well as on crew boat. ETV was very dusty inside and FAA will cleaned. See first aid requirements section</p>	NO

ETV with dusty interior.jpeg
