Columbia River Project Water Use Plan

Kinbasket Reservoir Monitoring of Revegetation Efforts and Vegetation Composition Analysis

Final Comprehensive Report

Study Period: 2008 - 2019

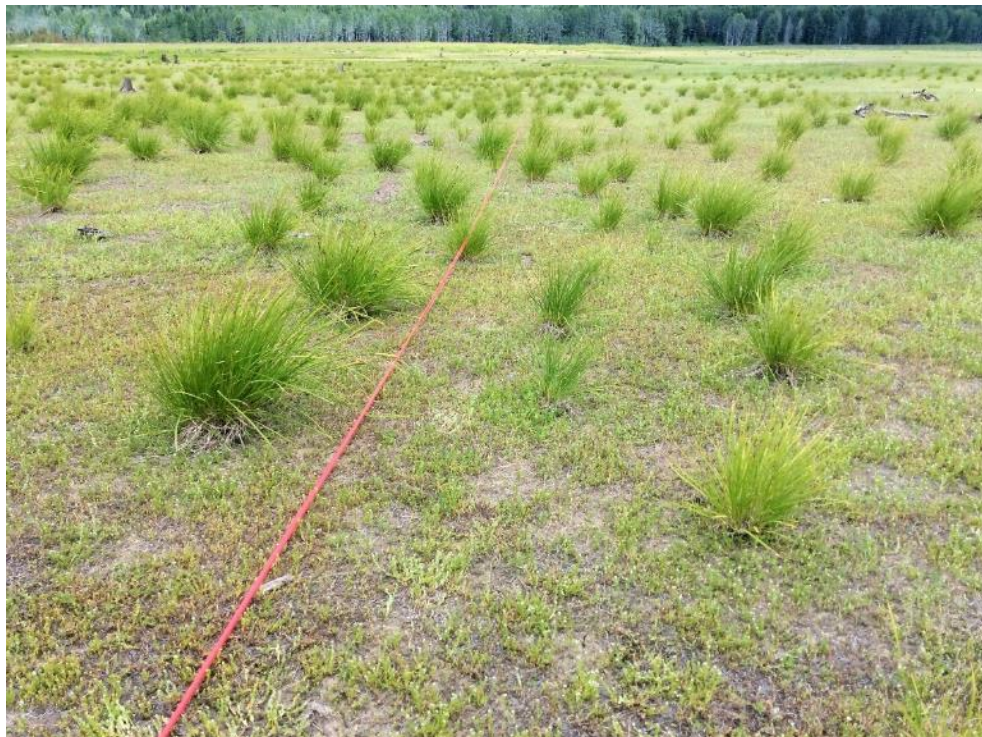
Figure 4-6: Sedge planting treatment at Km 88, Bush Arm. Planted plugs of Kellogg's sedge are visible mixed with an existing ground cover of annual forbs, primarily Scouler's popcorn flower (*Plagiobothrys scouleri*). Photographed 28 June 2018.

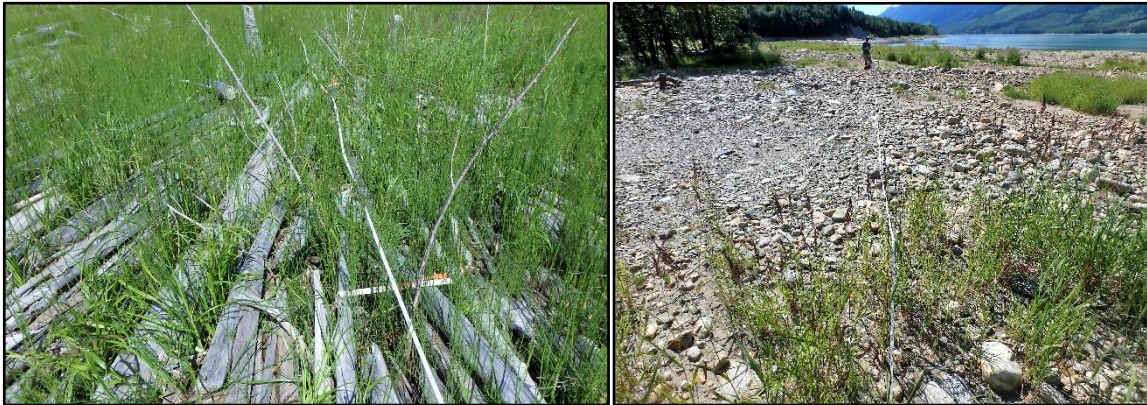
Figure 4-8: Left: vegetation growing through woody debris deposits at Yellow Jacket Creek control site, Canoe Reach, Kinbasket Reservoir. Right: regenerating treatment site, Yellow Jacket Creek. Photographed 21 June 2015

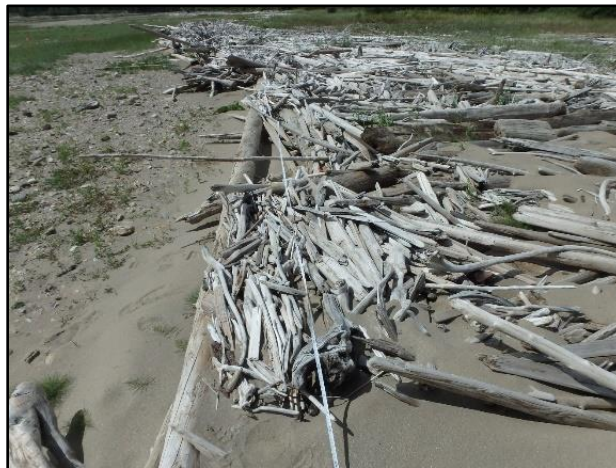
During the winter of 2014/2015, substantial amounts of woody debris were redeposited onto some previously cleared areas, especially at PS-N and PS-S (Figure 4-9). As a result, some of the 2014 gains with respect to species richness did not carry over into 2015. At PS-N, this trend was actually reversed; herb richness declined in the treated site relative to both the 2014 value and to the control (Appendix 9.4: Figure 9-14).

Figure 4-9: Fresh (winter 2014/2015) woody debris deposits on previously cleared site at Packsaddle Creek-South (PS-S). This site was mechanically cleared of debris in the spring of 2014. Photographed 21 June 2015.

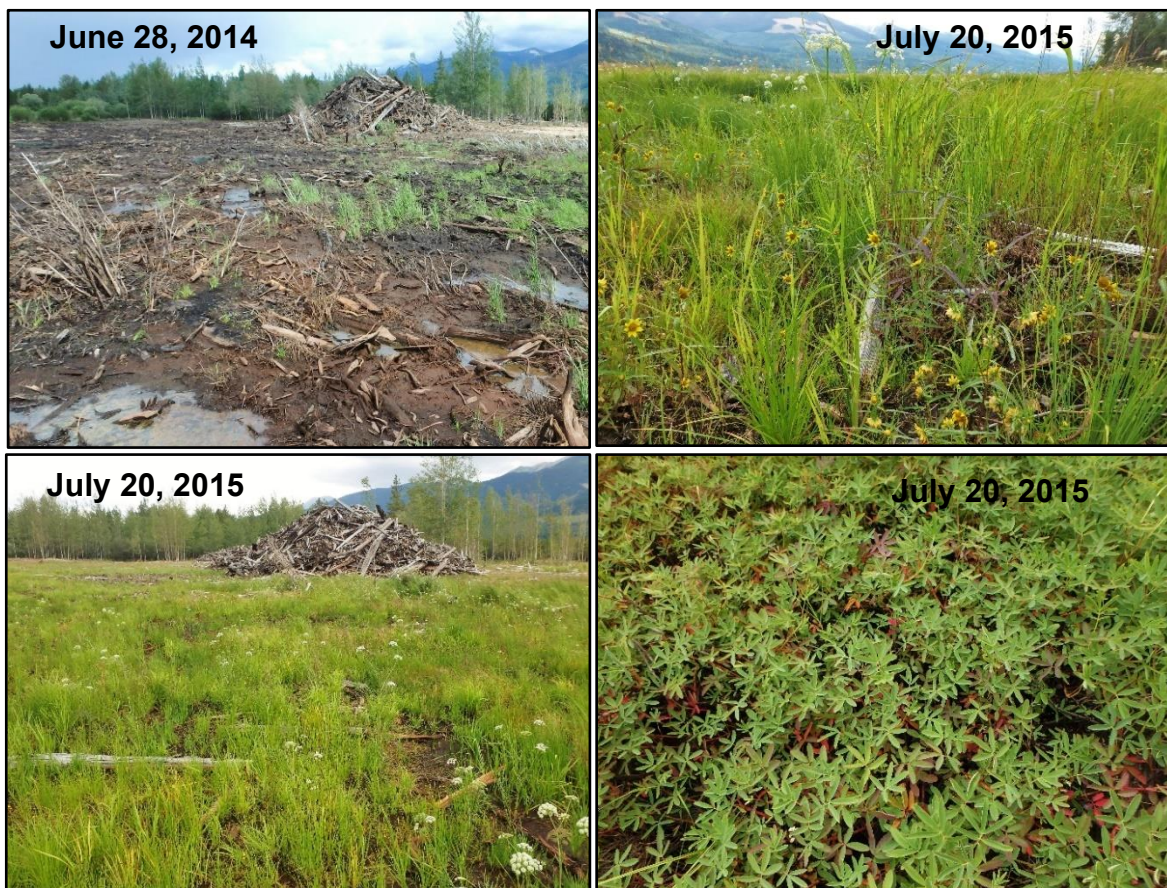
our observation that one year following debris removal, VP-N was beginning to show signs of rapid recovery toward a functioning semi-wetland community (Figure 4-10). A detailed floristic survey of the log-boom enclosure area, conducted on 20 July 2015, yielded a total of 62 established and regenerating vascular plant species. Subsequent surveys in 2017 and 2018, which encompassed slightly more area, added another 50 species for a total of 112 species (Appendix 9.4: Table 9-2).

Figure 4-10: Vegetation recovery two months (upper left panel) and 15 months (other panels) following removal of woody debris at the Valemount Peatland (North) (VP-N) site, Canoe Reach. Upper right panel: nodding beggarticks (*Bidens cernua*) and Douglas' water-hemlock (*Cicuta douglasii*). Lower right panel: marsh cinquefoil (*Comarum palustre*).

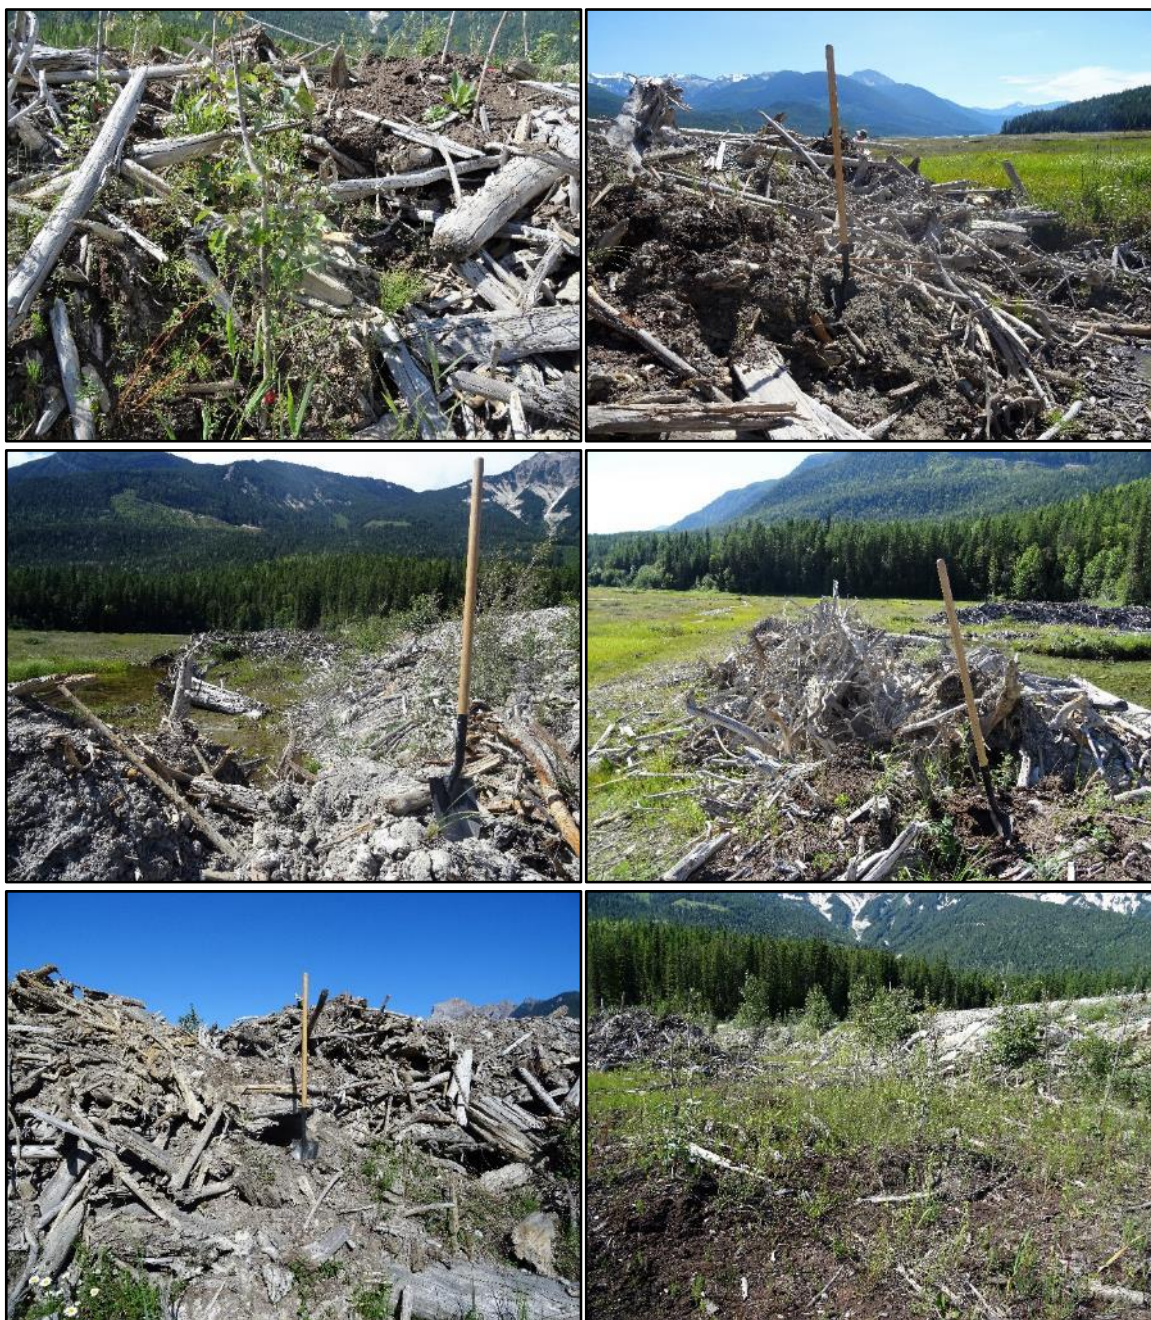
A total of 36 surviving, and 42 non-surviving, cottonwood stakes were counted within sample polygons on three constructed mounds (Figure 4-12), for an estimated stake survival rate (to date) of 46%.

Figure 4-12. Constructed mounds, Bush Causeway (north site), illustrating current state of establishing planted and natural vegetation. Leaf-bearing live stakes are visible in the top left and bottom right panels. Photographed July 2018.

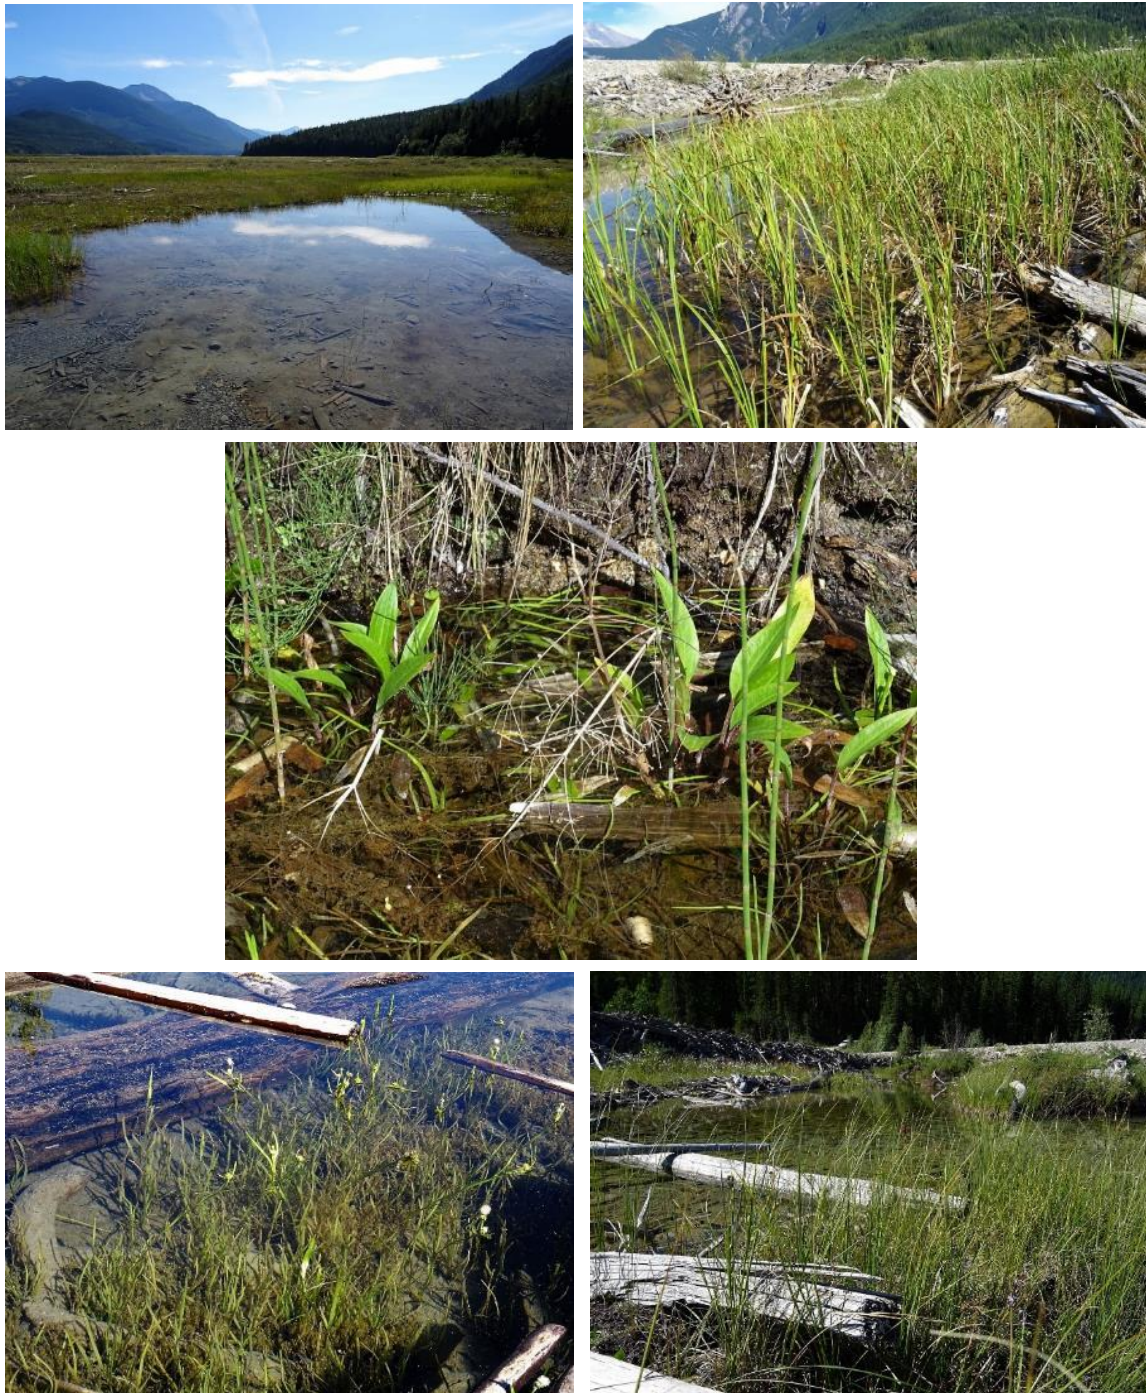
Figure 4-13. Regenerating wetland vegetation in ponds partially cleaned of large woody debris in 2015 at Bush Causeway. Clockwise from top left: overview of cleaned pond with log-boom (in background), *Carex utriculata*, *Alisma gramineum*, *Carex aquatilis*, *Sparganium* sp. Photographed July 2018.

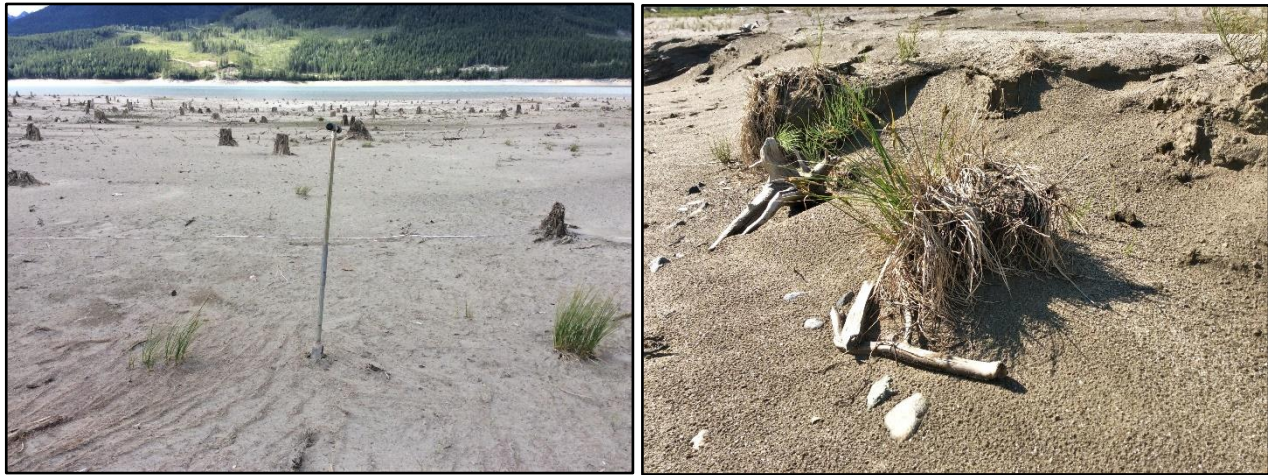
deposits of fine sediment transported during the course of inundation. In some areas, seedling plugs have experienced “pedestaling,” whereby the substrate around the plug bases erodes away exposing the root wads and killing the plants.

Figure 5-1. Examples of reduced sedge establishment success under conditions of sedimentation (left) and slope erosion leading to root pedestaling (right). Photographed in June 2018.

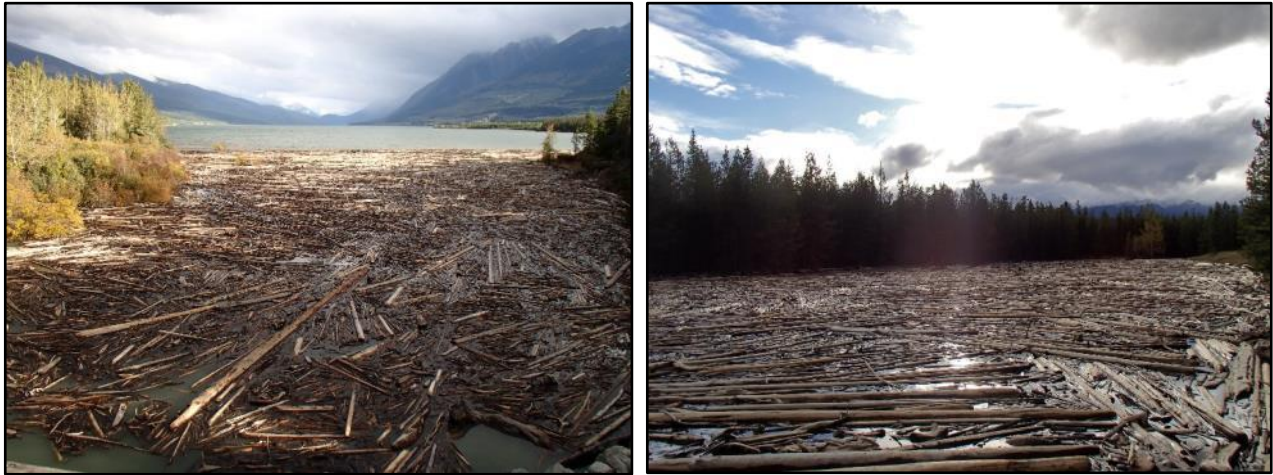
Figure 5-2. Woody debris accumulation zones in Canoe Reach, north Kinbasket Reservoir. Photographed in late summer of 2013.
