Columbia River Project Water Use Plan

Kinbasket Reservoir Monitoring of Revegetation Efforts and Vegetation Composition Analysis

2021 Post-Surcharge Survey of Vegetation Monitored Under CLBMON-9: Yearly Report

May 25,2022

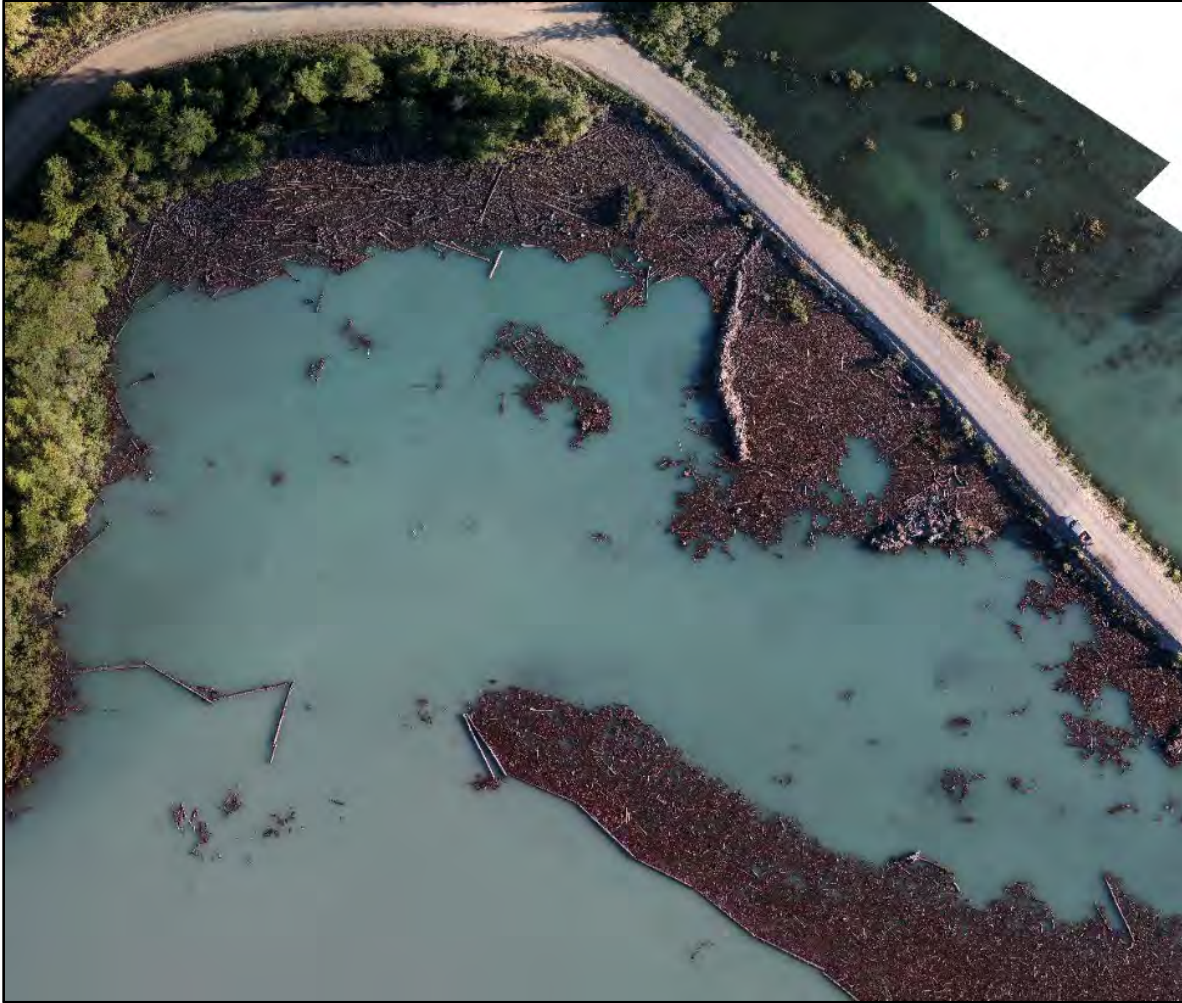
A windstorm event in August 2020, when the reservoir was in surcharge, led to a breakage in the log-boom at Bush Causeway (north). This breach resulted in a large volume of woody debris being redeposited around the area of the constructed mounds and previously cleared ponds (Figure 5). A supplementary clearing operation was undertaken in late 2020, resulting in the removal of much of the newly deposited debris. However, the subsequent 2021 survey revealed that the structural integrity of all mounds had been heavily degraded since the last site visits in June 2020. The soil on the sides of the mounds had mostly been washed away by the 2020 high-water (surcharge) event (Figure 1), leaving behind only the interlocking wood “skeleton” along with a thin veneer of soil on the mound tops. Due to the losses of incorporated mound soil, the overall volumes of the mounds also appeared to have been substantially reduced, resulting in noticeably narrower and lower structures (Figure 6, Figure 7).

Figure 5. Aerial image of the log-boom breach at Bush Arm following a windstorm in August 2020. Image obtained by Murray Chapple, Sterling Lumber Co Ltd.

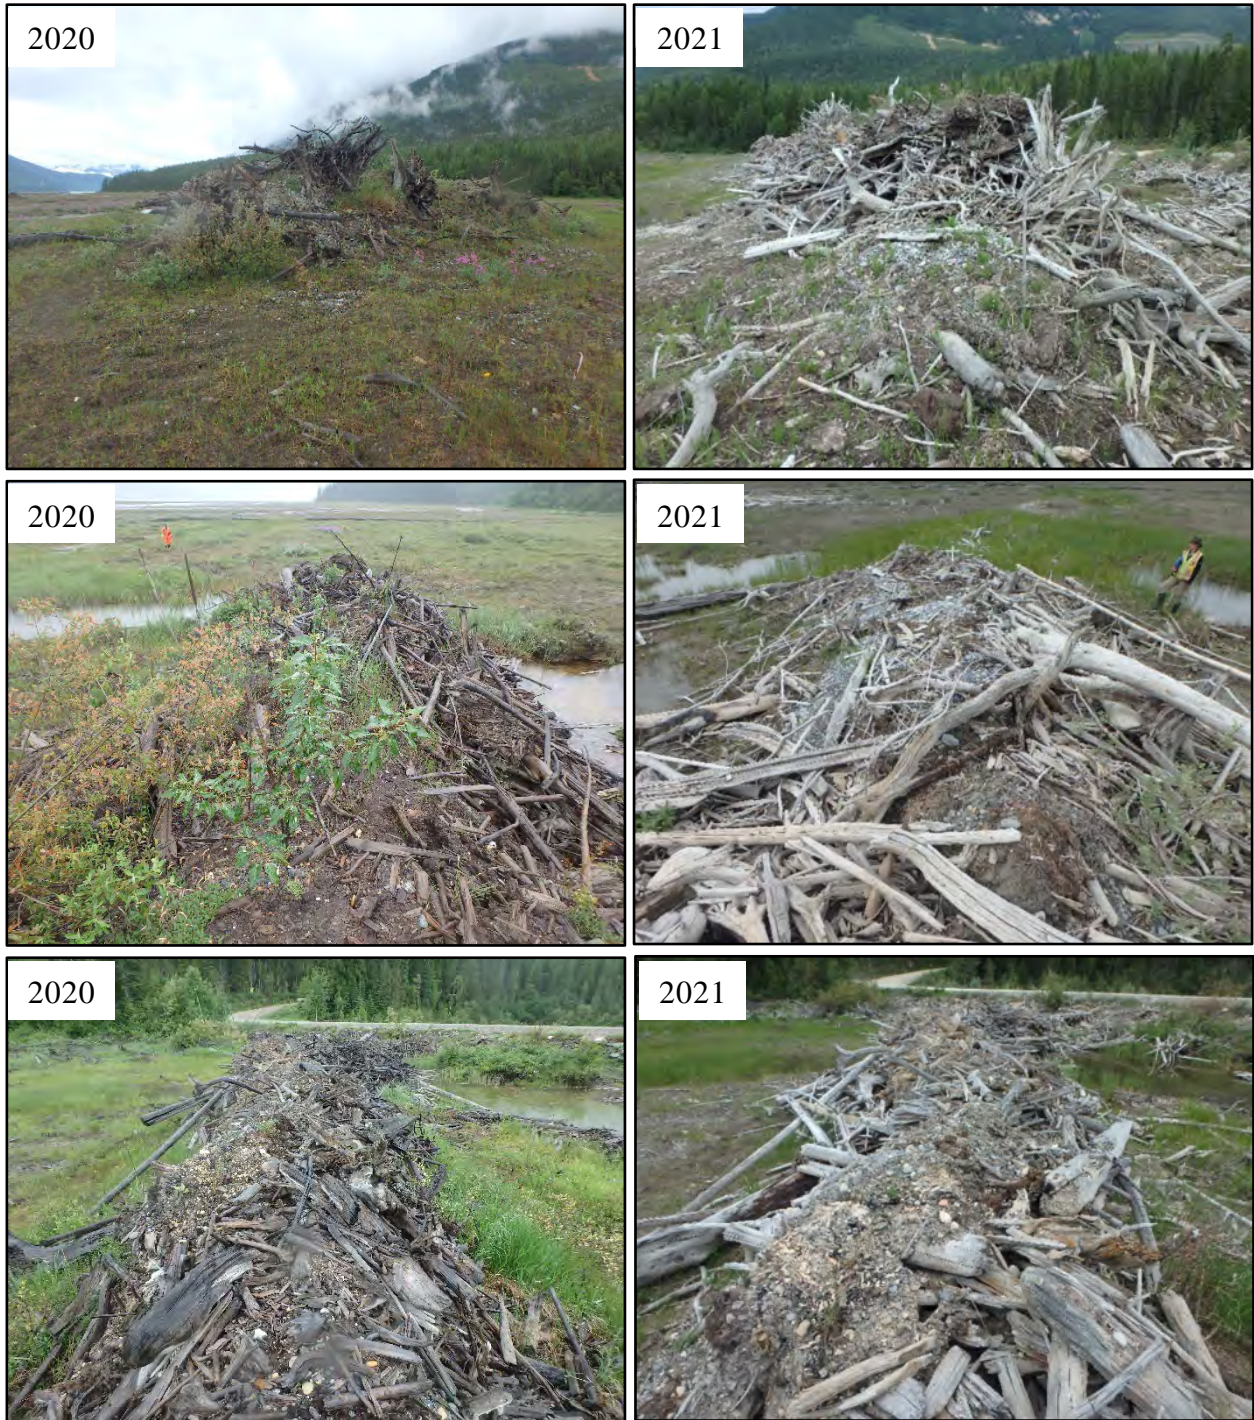
Figure 6. Constructed (2015) mounds at Bush Causeway (north), showing a side-by-side structural comparison in 2020 and 2021.

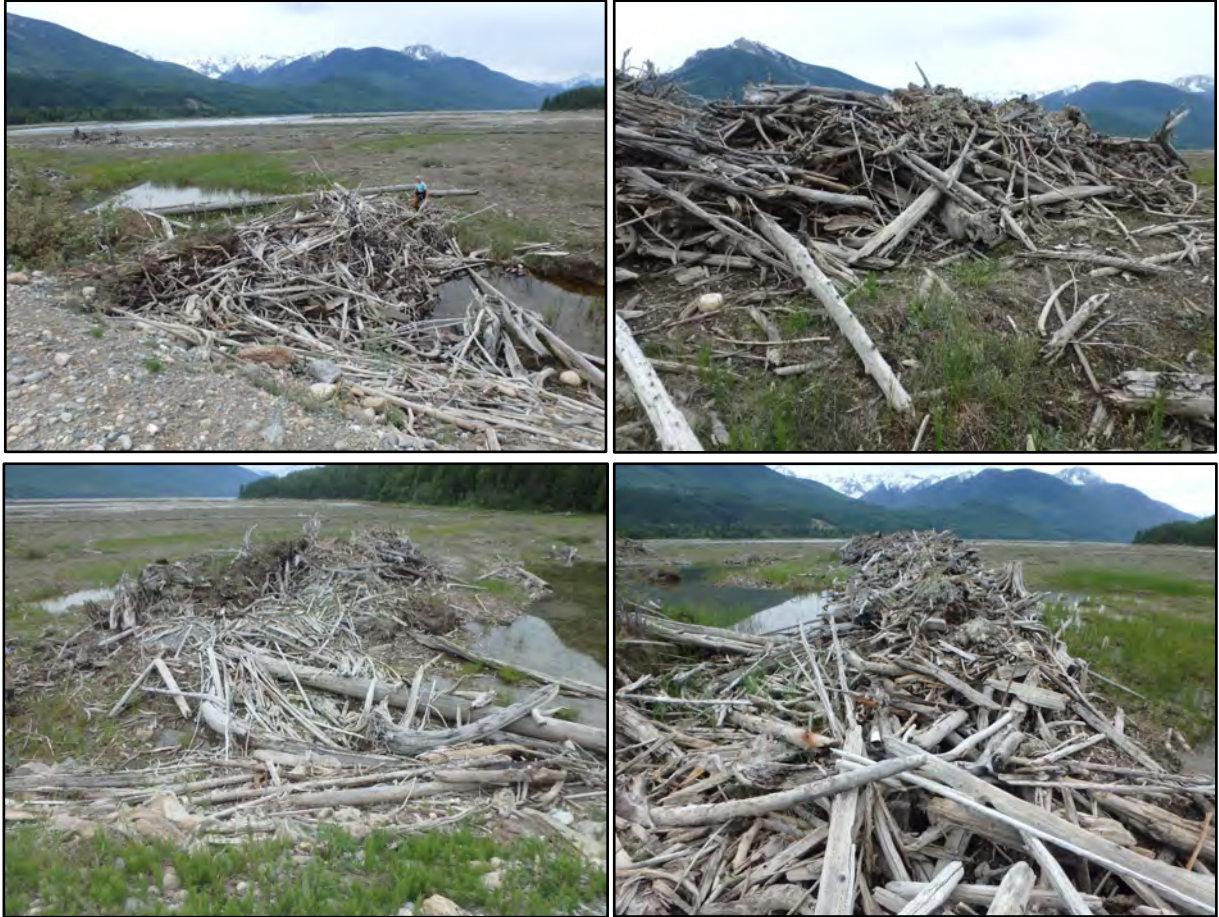
Figure 7. Constructed (2015) mounds at Bush Causeway (north), showing examples of the general condition in 2021.

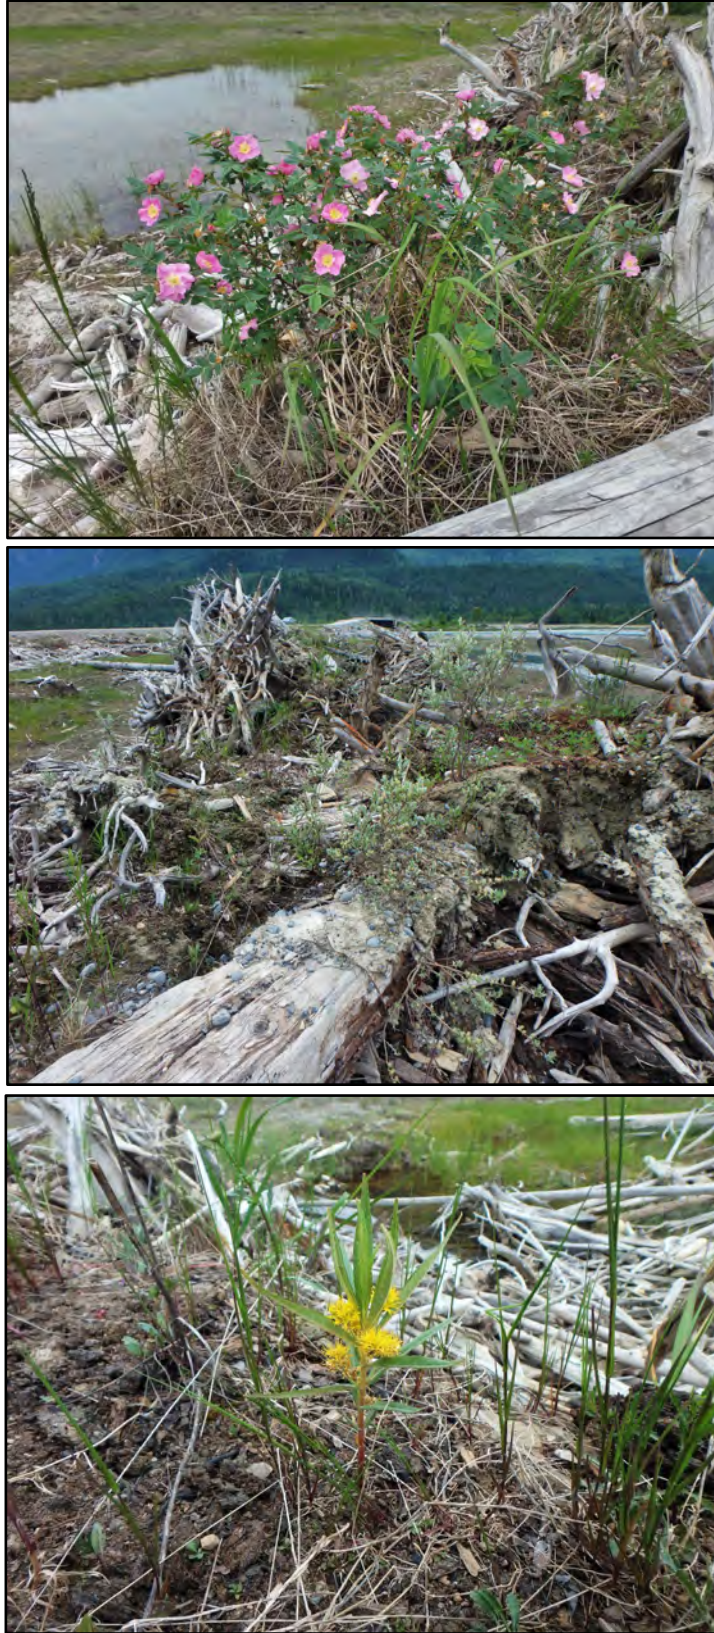
Most mounds continued to support a low-density cover of naturally established native and non-native vegetation (Figure 8, Appendix: Table 1), consistent with findings from previous survey years (Miller and Hawkes 2020, 2021). However, the canopy coverage of the different plant groups (forbs, graminoids, shrubs, etc.) was substantially reduced compared to 2020 as was the overall species richness of plant groups such as forbs, graminoids, and shrubs (Figure 9, Figure 10 [top panel]). Some naturally established woody species that were found still growing on the mound tops included red-osier dogwood (*Cornus stolonifera*), prickly rose (*Rosa acicularis*), red raspberry (*Rubus ideaus*), short-fruited willow (*Salix brachycarpa*), MacCalla's willow (*S. maccalliana*), dusky willow (*S. melanopsis*), and Mackenzie willow (*S. prolixa*).

Figure 8. Examples of naturally established vegetation still persisting on the summits of the Bush Causeway mounds in 2021.

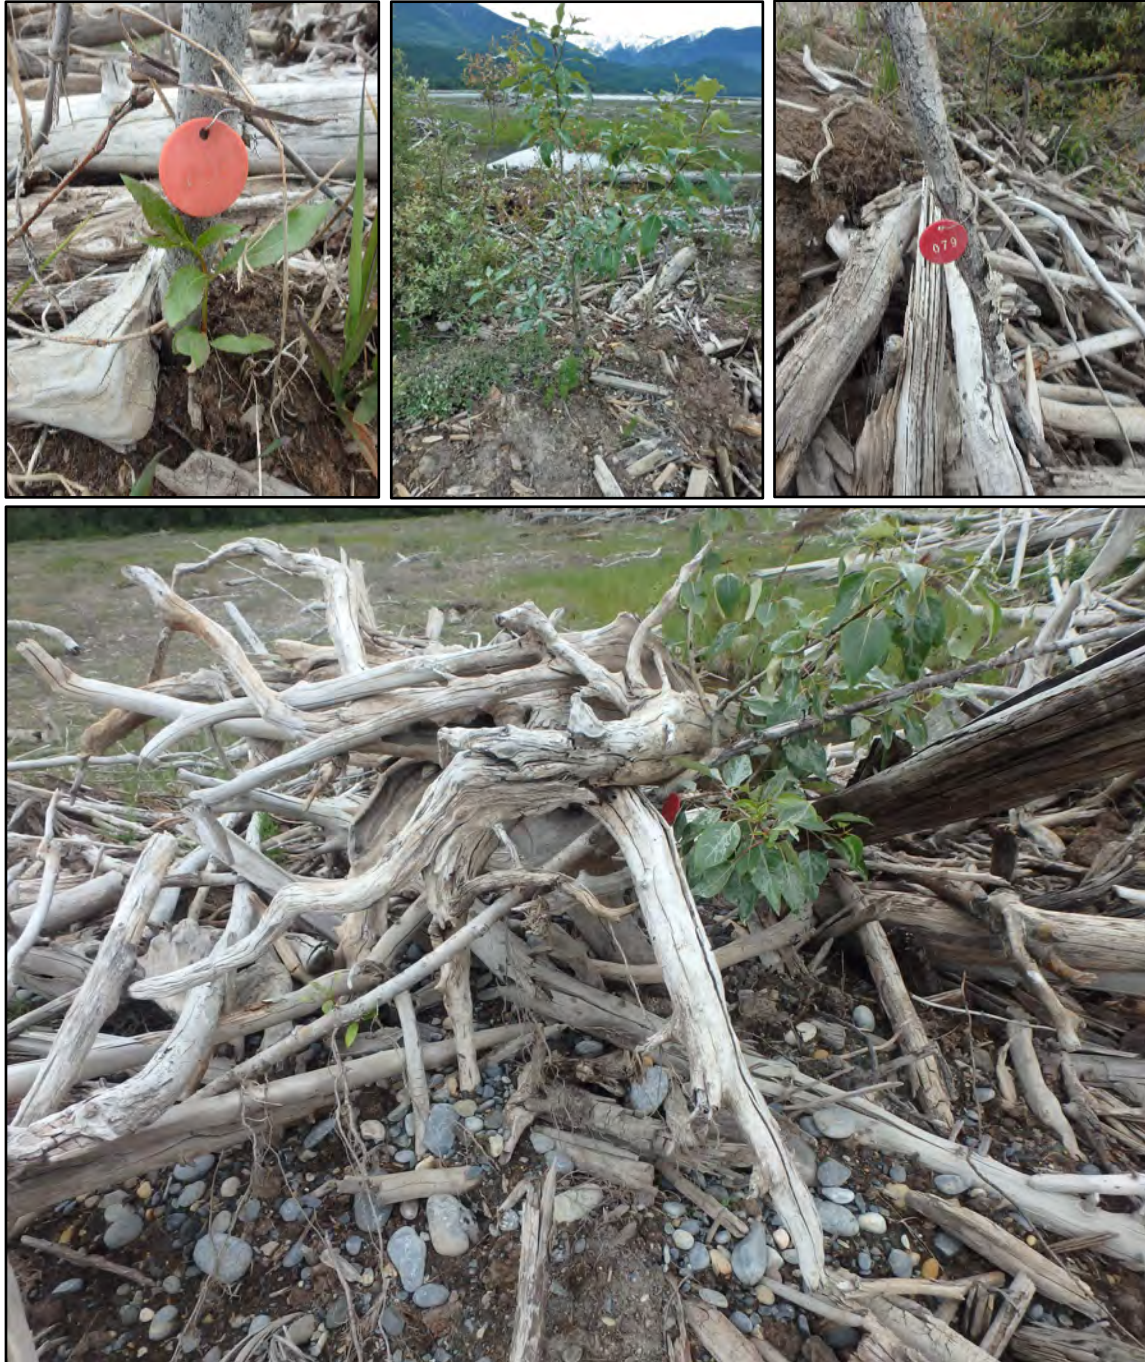
Overall, we recorded only seven living cottonwood stakes and four living willow stakes on two mounds (out of the original 40 planted; Figure 11). This compares to 12 cottonwood and 11 willow stakes recorded as alive in 2020 (Miller and Hawkes 2021), indicating a decline of 52 %.

Figure 11. Condition in 2021 of some of the live stakes (black cottonwood) planted in 2015.

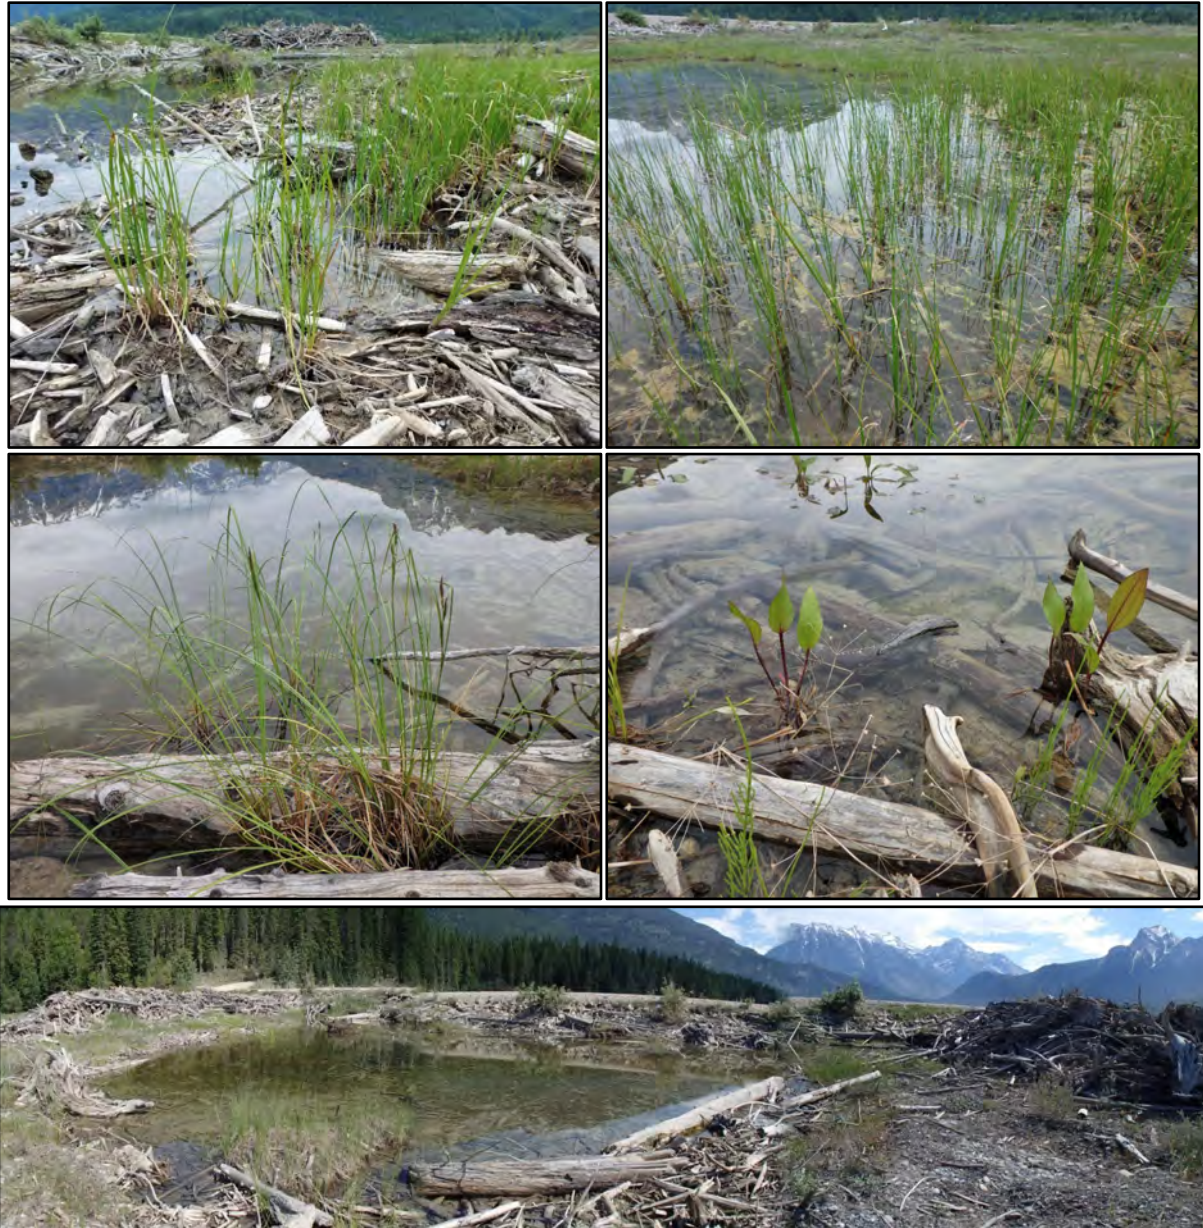
The 2020 high-water (surcharge) event (Figure 1) and associated woody debris deposition appeared to have set back somewhat the vegetation recovery of the ponds (Figure 15), as there was a substantial drop (of 40%) in the number of wetland species present from one year to the next (14 species in June 2021 compared to 23 in June 2020). Wetland species observed in 2021 included American waterplantain (*Alisma triviale*), water sedge (*Carex aquatilis*), yellow bog sedge (*C. gynocrates*), slender sedge (*C. lasiocarpa*), marsh cinquefoil (*Comarum palustre*), and common mare's-tail (*Hippuris vulgaris*). Species present in 2020 but not observed in 2021 included Crawe's sedge (*Carex crawei*), marsh horsetail (*Equisetum fluviatile*), tufted loosestrife (*Lysimachia thysiflora*), and seaside arrow-grass (*Triglochin palustris*) (Appendix: Table 2).

Figure 15. Examples of wetland vegetation in cleared ponds at Bush Causeway, June 2021.

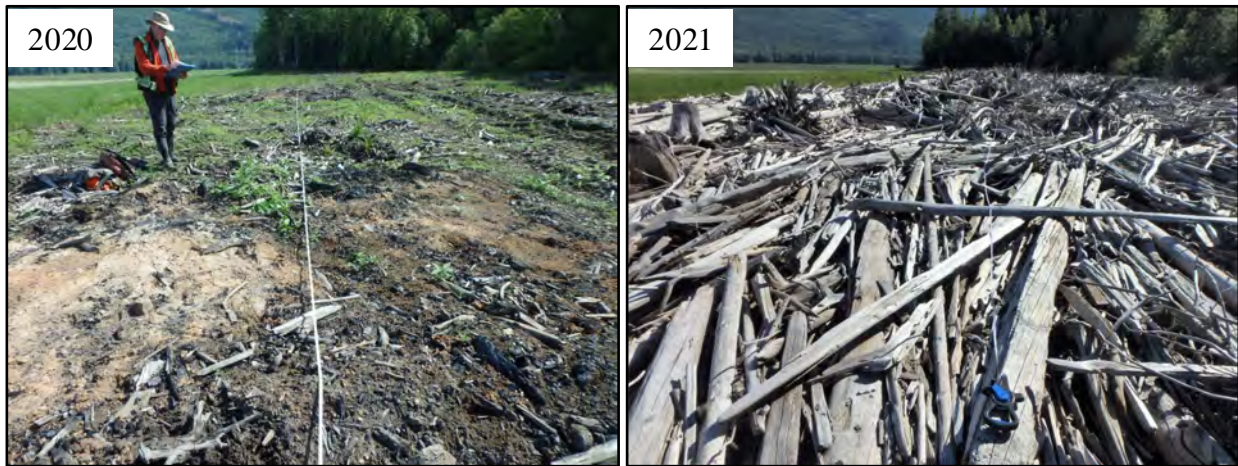
At Bear Island, the 2019-cleared site on the west side of the island had been completely re-covered by woody debris, rendering moot the follow-up transect sampling in 2021 (Figure 18). The 2019-cleared site on the north side of the island was still clear in 2021. Here, as in 2020, we observed a modest

Figure 18. Bear island woody debris removal site, showing condition in 2020 shortly after clearing and in 2021 following redeposition of wood.

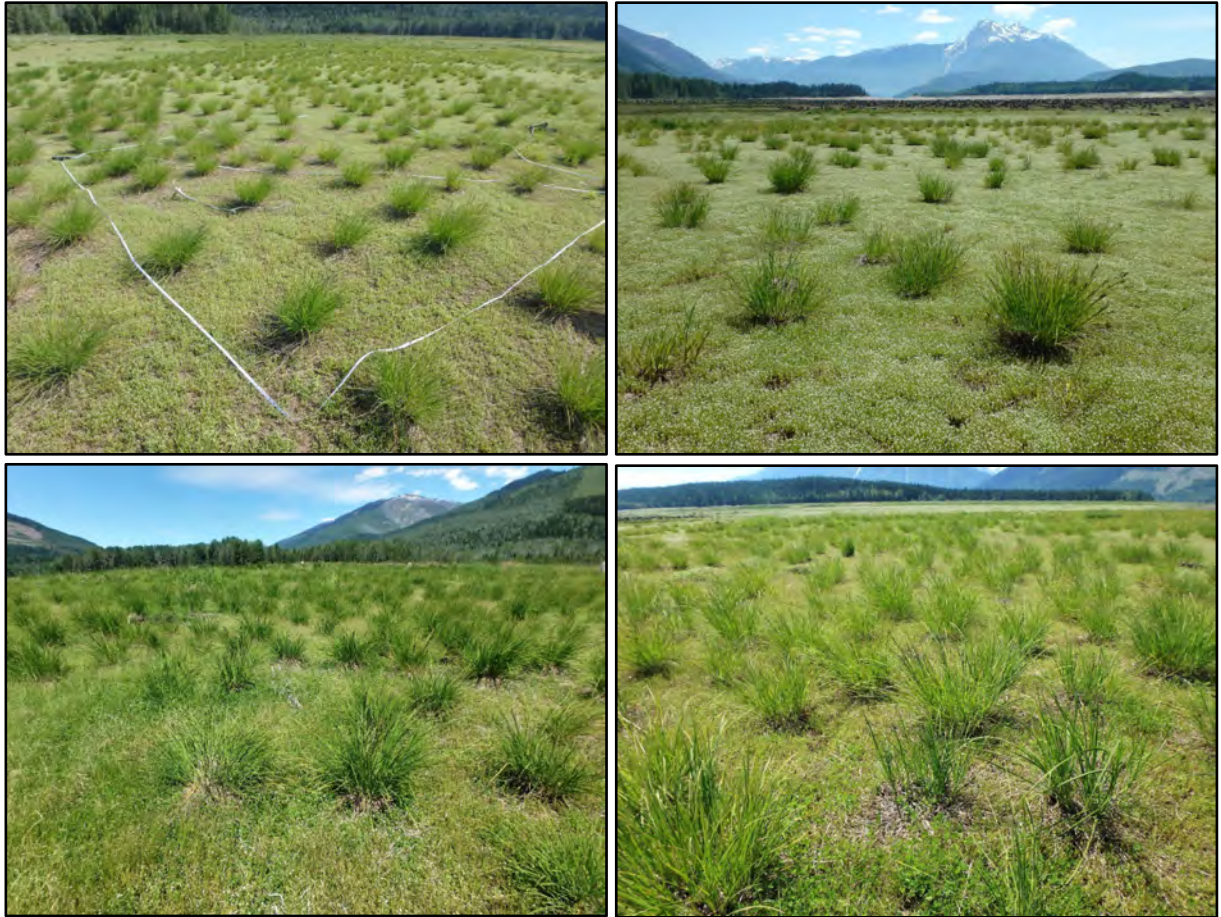
At Km88, plugs of Kellogg's and Columbia sedge continue to grow and seed vigorously eight years post-planting (Figure 19). In 2021, the estimated plug density (treatment units and species combined) was ~15,236 plants/ha. This compared favourably with estimated densities from 2020 (~16,160 plants/ha) and 2018, although, as might be expected, stem numbers appear to have declined somewhat since 2015 (Figure 20). However, the canopy cover provided by sedges has been on a significantly increasing trend since 2015, from ~2% cover in 2015 to ~11% cover in 2021 (Figure 21), reflecting a steady growth in the size of individual clumps as well as, perhaps, the lateral recruitment of new stems through rhizomatous spread or seedling recruitment. (Seedling recruitment was not directly assessed in 2021 but will be studied in more detail in 2022). The change in per cent cover since 2015 was significant (ANOVA: $F=15.9$, $p=0.0001$). A GLM (generalized linear model) fitted on $\log(\text{Cover}) \sim \text{Year}$, with year as a fixed factor, also indicated an increase in cover in 2018 and 2021 relative to 2015 (by a factor of 4.8x and 7.8x, respectively).

Figure 19. Planted sedges at Km88 (2013 revegetation treatment) in 2021.

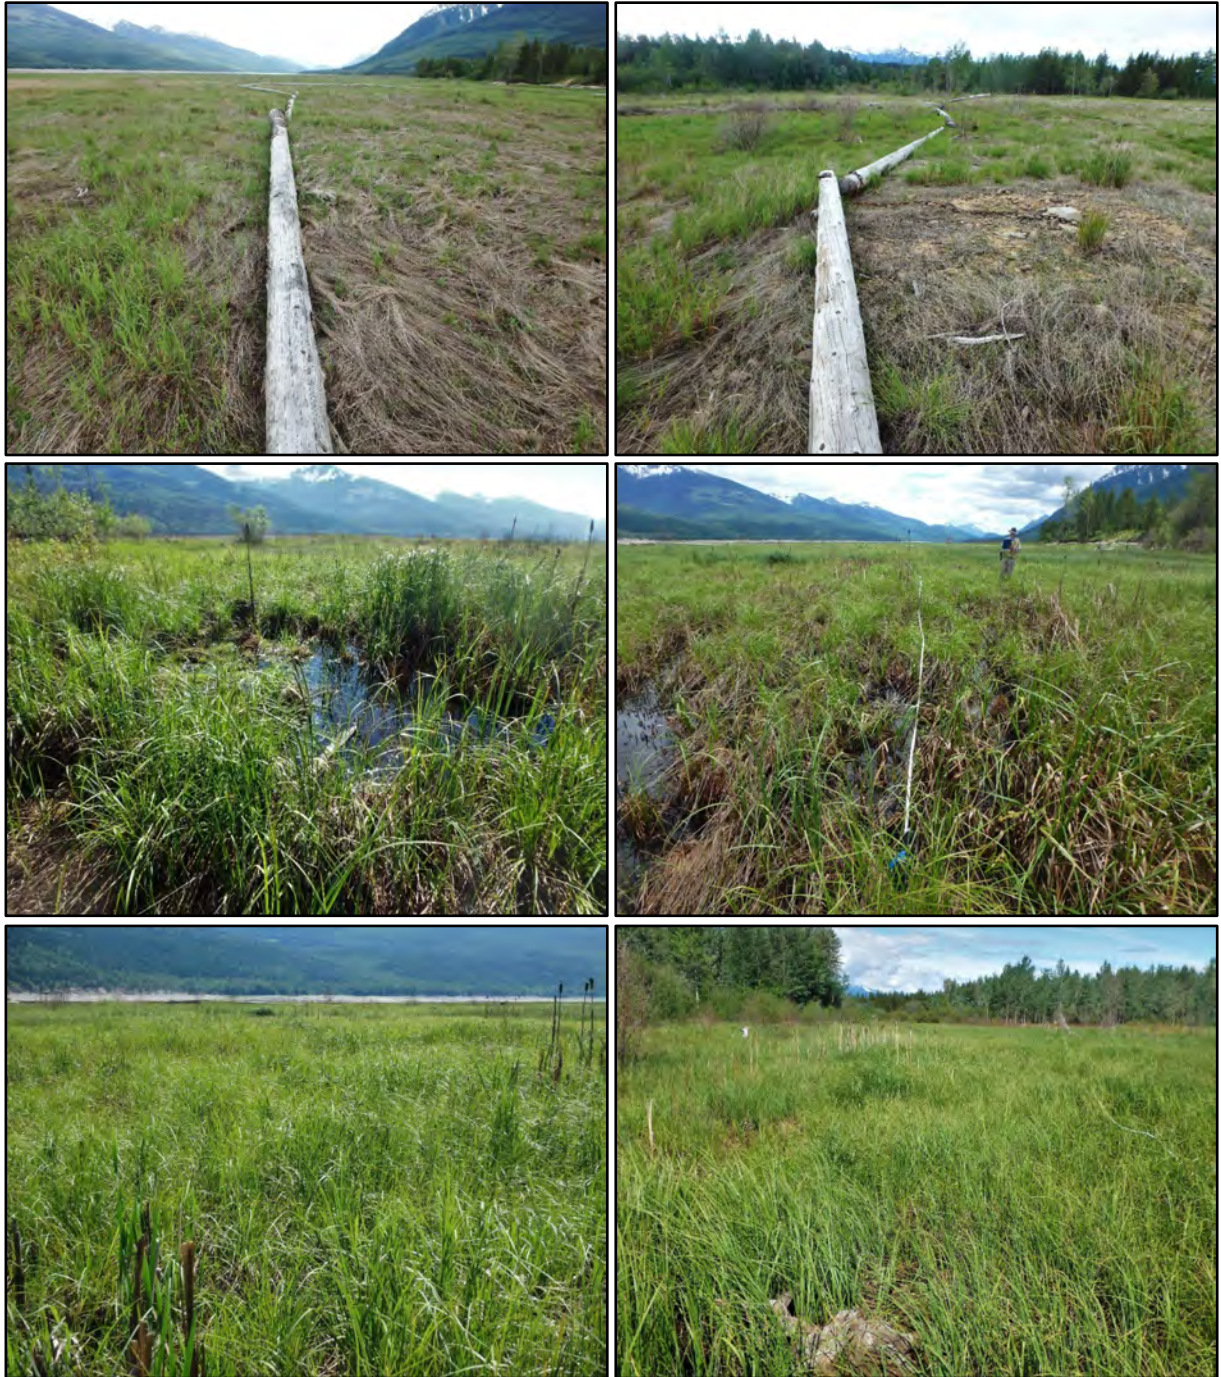
At Canoe Reach, the recovering log-boom wetland, which we have been monitoring since 2014 (Hawkes and Miller 2016; Miller and Hawkes 2020), was still wood-free in 2021 and in very good vegetation condition (Figure 22). A total of 36 different species were recorded in transects in 2021, down from 64 in 2020 and ~100 in 2017, the year when species richness peaked following several years of steady increase beginning in 2014 (the year of clearing; Appendix: Table 4). As in 2020, there was more standing water than in previous years and the community continues to be in the process (initially noted in 2020) of transitioning from a shallow, semi-terrestrial wet meadow with a diverse herb assemblage to a less diverse, deeper marsh habitat largely dominated by graminoids including water sedge, beaked sedge, and sporadic stands of common cattail.

Figure 22. Log-boom enclosure area at Valemount Peatland, resurveyed 24 June 2021. A selection of CLBMON-9 transects were resampled here. Expanding clumps of *Typha latifolia* (common cattail) (bottom left) as well as open water areas (middle) are indicative of increasingly hygric conditions at this site.

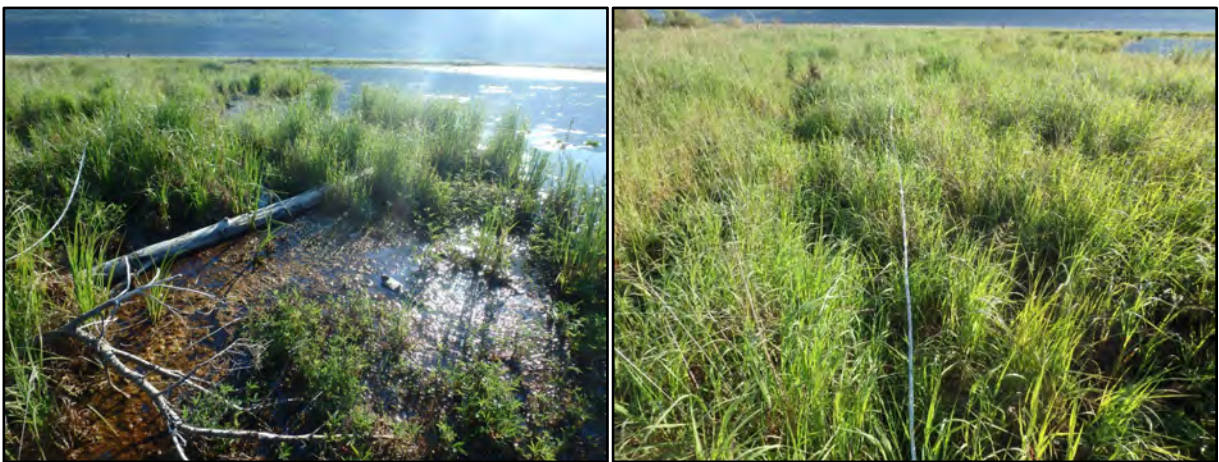
Transects sampled within the recovering riparian plant community at Pond 12 contained fewer species in 2021 (17) than in 2020 (41) (Appendix: Table 5). The immediate explanation for this reduction of richness in the predominantly herbaceous vegetation at this location is unclear, as the habitat appeared to be in otherwise healthy, vigorous condition with no notable signs of recent woody debris deposition (Figure 26). The prolonged inundation of 2020 could be a contributing factor. Another possible explanation for this result is that the transect locations established in 2020 were partially submerged in 2021 due to higher water levels in the pond at the time of the June survey, which made an accurate re-sampling of the transects more difficult (i.e., some species may have been present but unobserved in 2021).

Figure 26. Monitoring transects at Pond 12 (Canoe Reach). The high water level of the pond in June 2021 (relative to 2020) made resampling of some transects challenging (left photo).

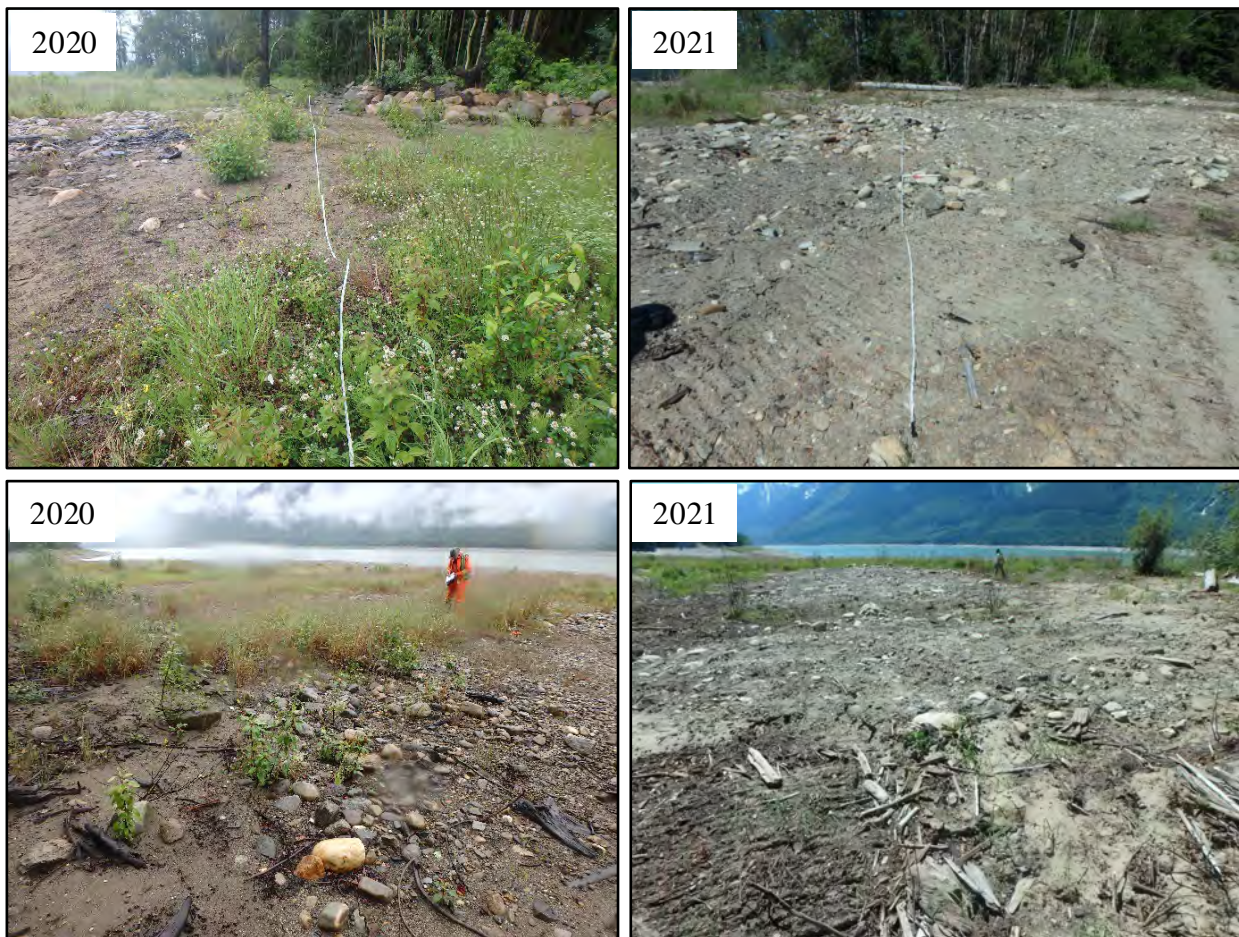
Yellowjacket Creek has been periodically monitored since 2014 when it was initially cleared of woody debris. While never a highly productive site, until 2021 it supported a developing plant community dominated by graminoids (native and exotic) and horsetails, along with a sparse cover of regenerating woody species consisting primarily of *Populus trichocarpa* (cottonwood), *Betula papyrifera* (birch), and *Rubus idaeus* (raspberry) (Appendix: Table 6). However, the site was re-treated for woody debris using heavy equipment in the spring of 2021, resulting in the scraping off or burying of most of the vegetation cover at this location (Figure 27). While BC Hydro debris removal planning includes avoidance of archaeology, key wildlife habitat timing (breeding season) and revegetation, at this particular location revegetation plots were not avoided during debris clearing work. The status of this site will be reassessed in 2022.

Figure 27. Woody debris removal site at Yellowjacket Creek (south), showing a side-by-side comparison in 2020 (site in recovery) and 2021 (following new disturbance from the 2021 woody debris removal operation).

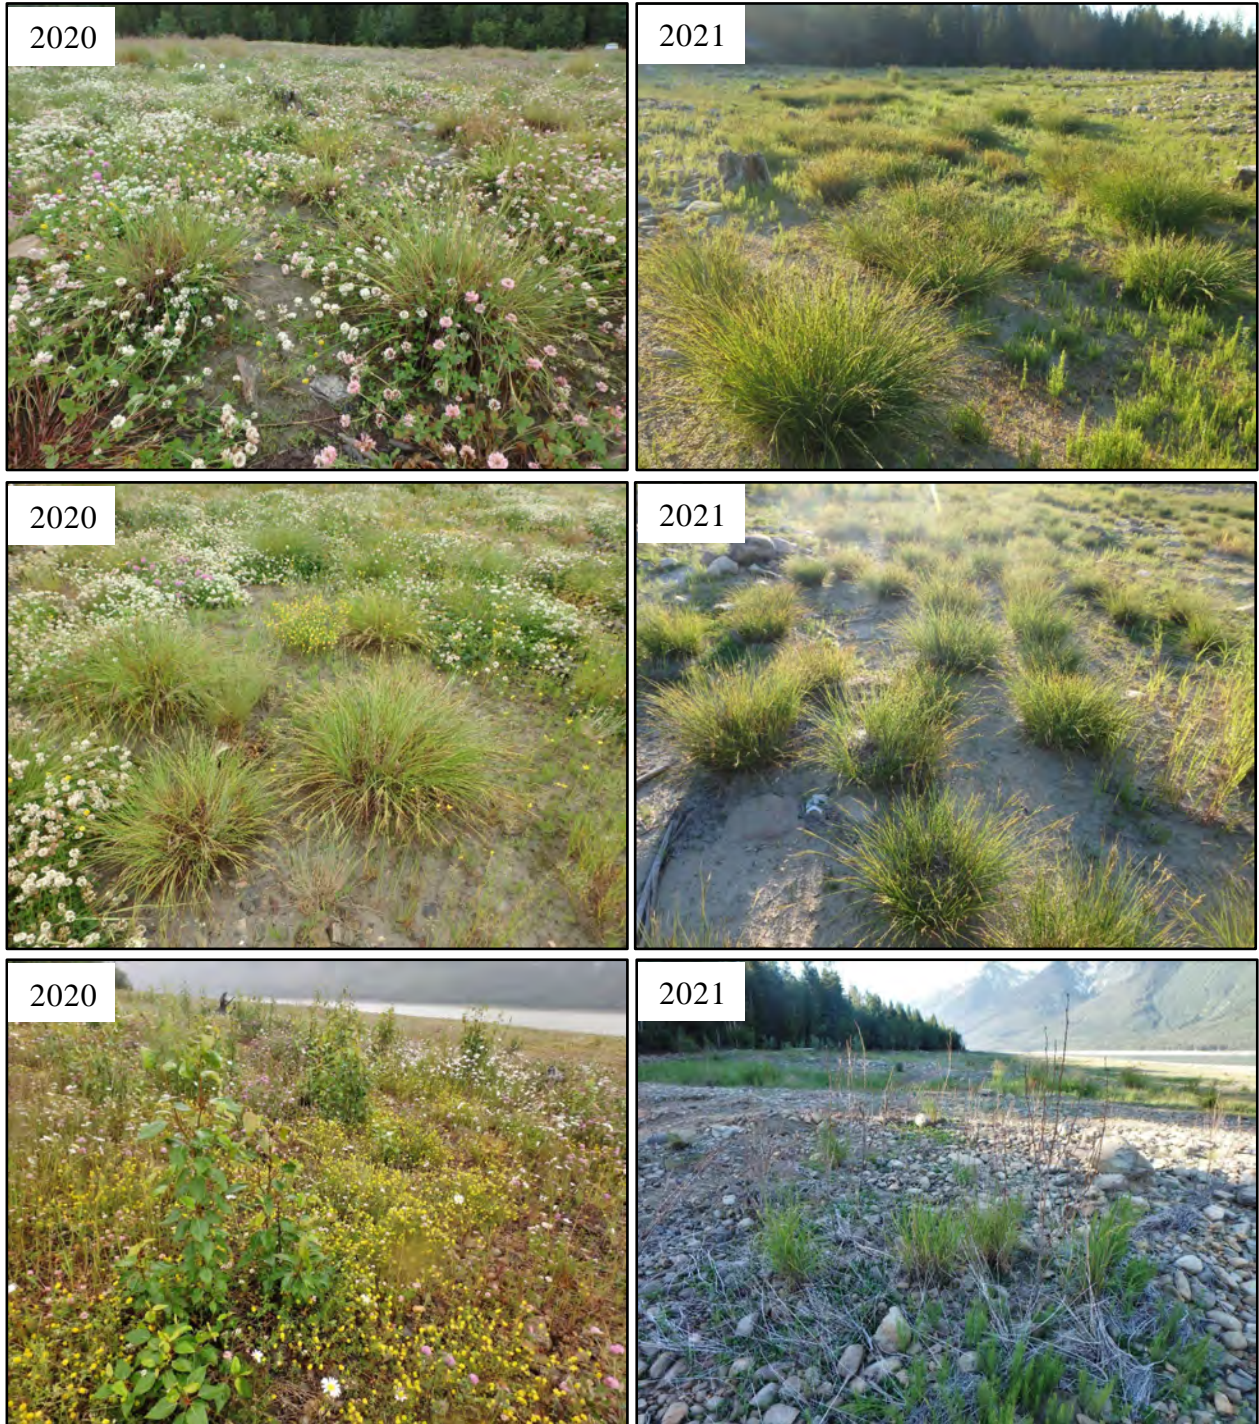
Consistent with our 2018 (Miller and Hawkes 2020) and 2020 (Miller and Hawkes 2021) observations, the original CLBWORKS-1 sedge plantings at this location continued to show very high vigour (Figure 28), making this location the best example of successful revegetation under the CLBWORKS-1 2008-2011 planting program.

Figure 28. 2009 sedge plantings at Yellowjacket Creek (north), showing a side-by-side comparison of conditions in 2020 and 2021. Note the reduced cover of associated herbaceous vegetation in 2021. At bottom left is natural shrub establishment in 2020, following several years of no inundation. At bottom right is the same site in 2021, after inundation in 2020.

In 2020, we had noted a newly-developed herbaceous community (consisting predominantly of clovers) occurring in association with the plantings here (Miller and Hawkes 2021). The recent establishment of this community was likely a response to the series of low water years occurring prior to 2020. We also noted, in 2020, substantial natural cottonwood and other tree and shrub regeneration at slightly higher elevations. However, in 2021, the clover community had been largely reduced and replaced by horsetail and a low ground cover of annuals, possibly in response to the recent high-water (surcharge) event (Figure 1). Similarly, we observed a significant level of woody stem dieback affecting both deciduous and coniferous species (Figure 28). Some of these woody stems had died back only to the base (indicating they might survive and regrow), but a substantial number appeared to be fully dead (presumably drowned).
