Columbia River Project Water Use Plan

Kinbasket Reservoir Monitoring of Revegetation Efforts and Vegetation Composition Analysis

Final Annual Report

Study Period: 2015

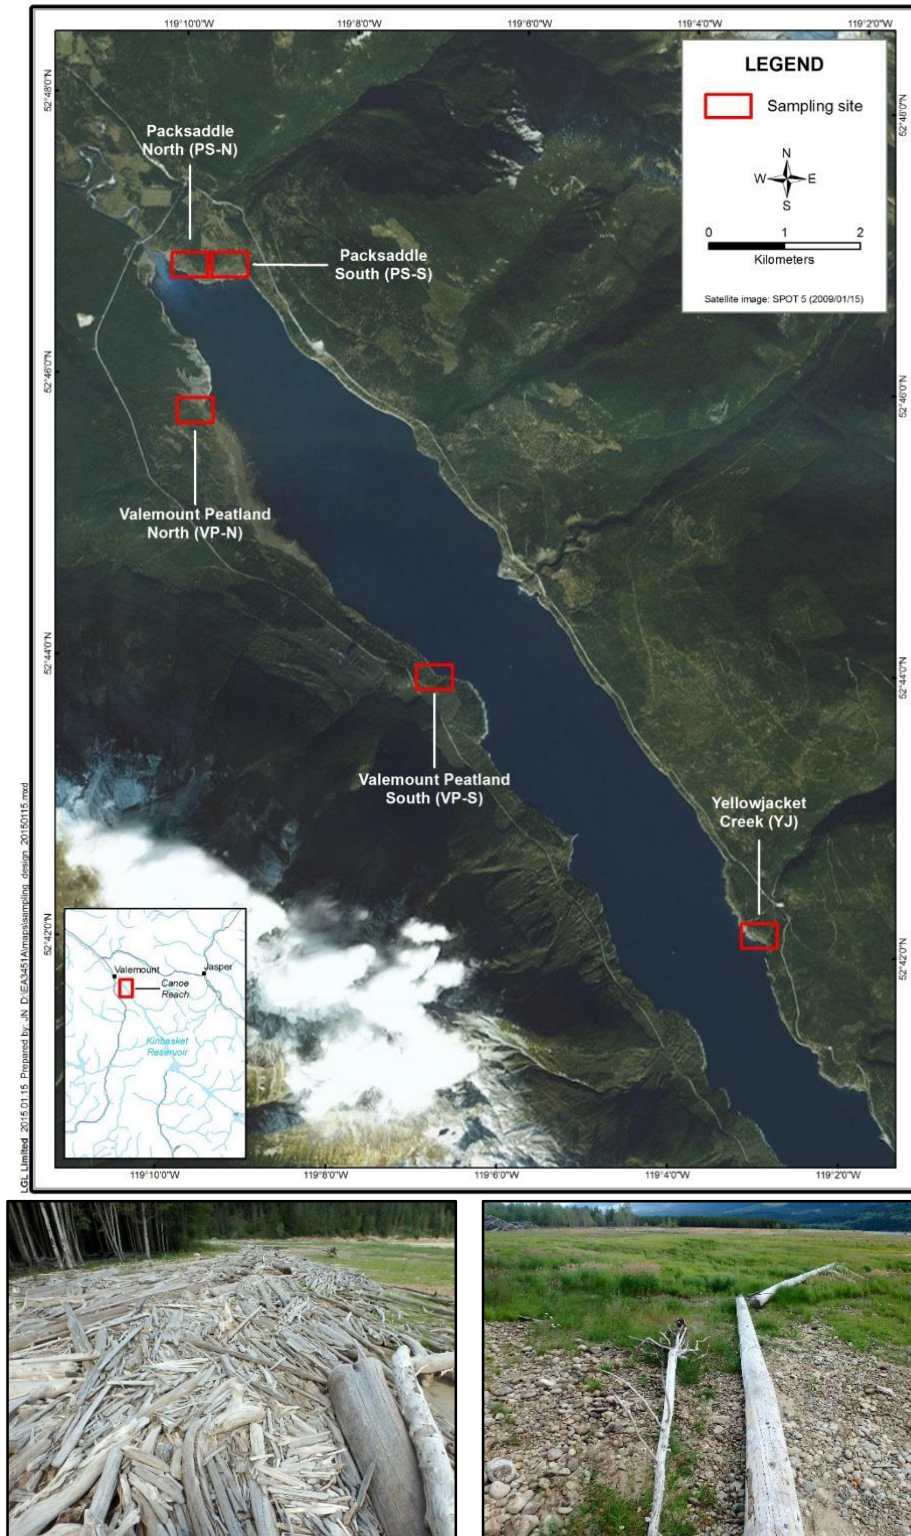
Figure 4-1: Location of wood debris removal sites in Canoe Reach, Kinbasket Reservoir, 2014. Lower left: wood debris accumulation at Packsaddle Creek. Lower right: log boom installation at Valemount Peatland-North to prevent re-encroachment of wood debris following spring wood removal. Wood debris pile from removal operation is partly visible at upper left of photo

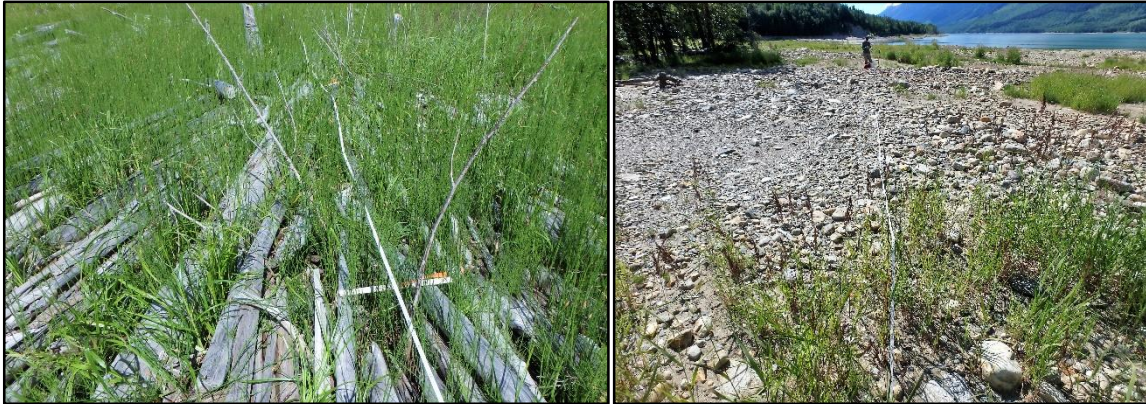
(Figure 5-4). Underneath the wood debris at this site, which occurs on a natural seepage area, the largely wetland vegetation was supported by moist to wet, organic soils. By comparison, the treated substrate was drier, rockier, lower in organic content (Figure 5-1), and relatively unproductive (Figure 5-4). One year following the debris removal (2015), the treated area was exhibiting a comparable level of species richness to the non-treated area (Figure 5-3). However, the year-to-year increase in overall herb cover lagged that of the non-treated area (Figure 5-2). These results suggest that the immediate effects of removing wood debris are likely to vary from site to site and will be strongly influenced by the initial starting conditions (e.g., presence/absence of a soil seed bank).

Figure 5-4: Left: vegetation growing through wood debris deposits at Yellowjacket Creek control site, Canoe Reach, Kinbasket Reservoir. Right: regenerating treatment site, Yellowjacket Creek. Photographed 21 June, 2015

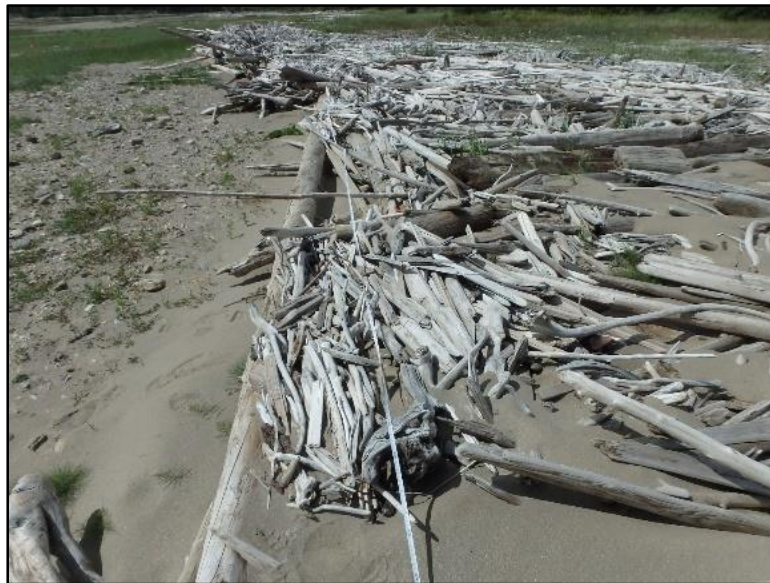
During the winter of 2014/2015, substantial amounts of wood debris were redeposited onto some previously cleared areas, especially at PS-N and PS-S (Figure 5-5, Figure 5-1). As a result, some of the 2014 gains with respect to species richness did not carry over into 2015. At PS-N, this trend was actually reversed; herb richness declined in the treated site relative to both the 2014 value and to the control (Figure 5-3).

Figure 5-5: Fresh (winter 2014/2015) wood debris deposits on previously cleared site at Packsaddle Creek-South (PS-S). This site was mechanically cleared of debris in the spring of 2014. Photographed 21 June 2015

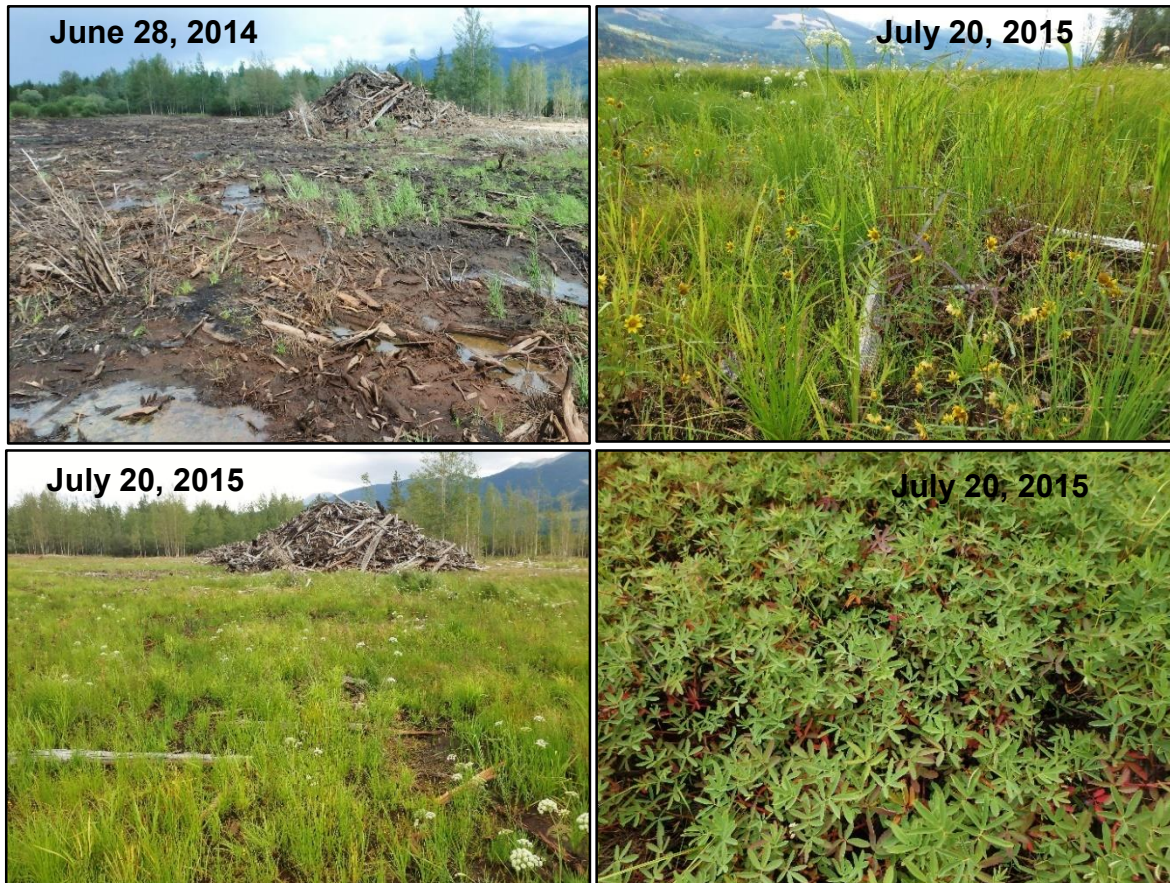
In contrast, at VP-N—the site where a log boom enclosure was installed in conjunction with wood debris removal—species richness was substantially higher in 2015, both compared to the control and to the 2014 values (Figure 5-3). Herb cover at this site also appeared to increase more rapidly in cleared than in non-cleared areas between 2014 and 2015 (Figure 5-2). This site, which receives seepage inflows from an existing shrubby wetland just outside the drawdown zone, is both wetter and more nutrient (N and K) rich than the other drawdown zone sites. The soil here is also very high in total organic carbon (TOC; Figure 5-6). These factors could help account for our observation that one year following debris removal, VP-N was beginning to show signs of rapid recovery toward a functioning semi-wetland community (Figure 5-7). A detailed floristic survey of the entire log boom enclosure area, conducted on 20 July 2015, yielded a total of 62 established and regenerating vascular plant species (Appendix 8.1).

Figure 5-7: Vegetation recovery two months (upper left panel) and 15 months (other panels) following removal of wood debris at the Valemount Peatland-North (VP-N) site, Canoe Reach. Upper right panel: nodding beggarticks (*Bidens cernua*) and Douglas' water-hemlock (*Cicuta douglasii*). Lower right panel: marsh cinquefoil (*Comarum palustre*)

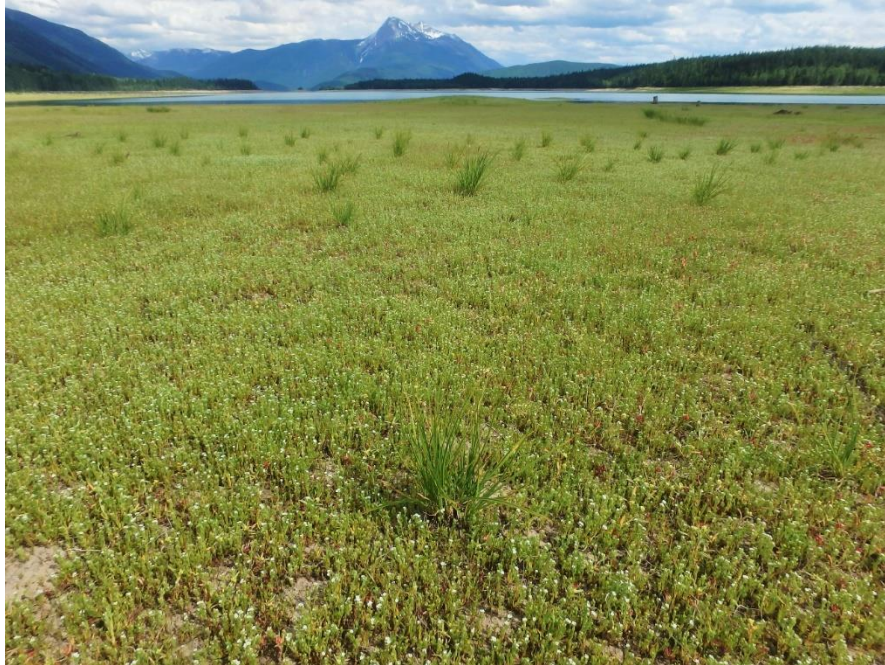
Two years following planting, the sedge seedling plugs at Km 88 (Figure 5-8) continue to perform well both in terms of survivorship and reproductive development. In random quadrat samples at each of the three treatment units (TU-1, TU-3, and TU-5; Figure 4-2), average estimated surviving plug densities (per ha) were approximately 29,000, 15,000, and 9,000 respectively (Table 5-3). In the case of TU-1, sample densities were similar to the original stocking densities reported by Adama (2015; Table 5-3), indicating that mortality has been negligible to date. The establishment rate at TU-1 appears thus far to be exceeding the targeted project goal of 10,000-20,000 individuals/ha (Figure 5-9).

Figure 5-8: Sedge planting treatment at Km 88, Bush Arm. Planted plugs are visible mixed with an existing ground cover of annual forbs, primarily Scouler’s popcorn flower (*Plagiobothry scouleri*). Photographed 11 June 2015
