Wind & Wave Analysis

Client	BC Hydro
Project name	Columbia River Project Water Use Plan
Document title	CLBWORKS-5A Kinbasket: Valemount Marina Ramp Extension
Document subtitle	Wind & Wave Analysis
Status	Report
Date	September 14, 2018
Project number	9598-01
File reference

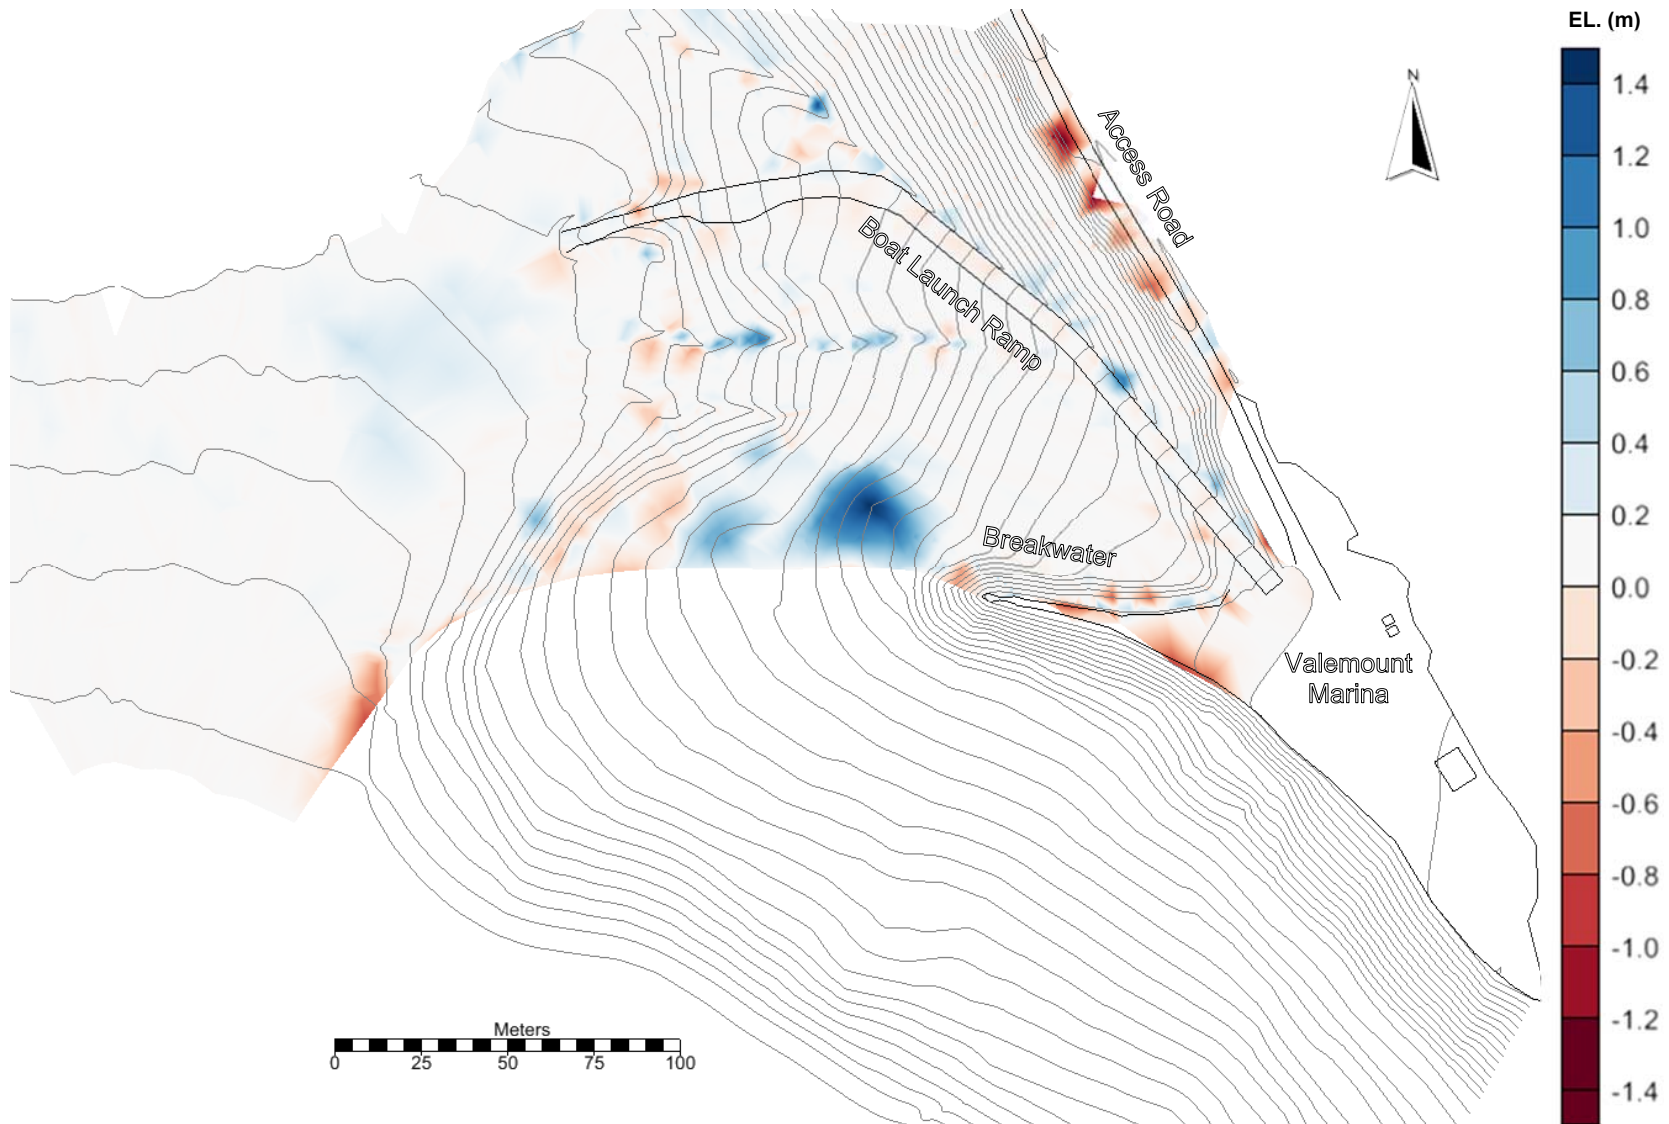
FIGURE 2-6: VALEMOUNT MARINA ELEVATION CHANGES BETWEEN ATEK 2007 AND 2008 SURVEYS.

Figure 2-6 shows the changes between 2007 and 2008. Areas of erosion or where elevations decreased are indicated with red, while areas of accretion or elevation increase are highlighted in blue. Outline elevation contours, the marina access road, and the boat launch ramp are shown for reference.

The figure shows that areas affected by erosion and pronounced elevation changes are along the rock slope of the breakwater and the rock slope along the marina access road.

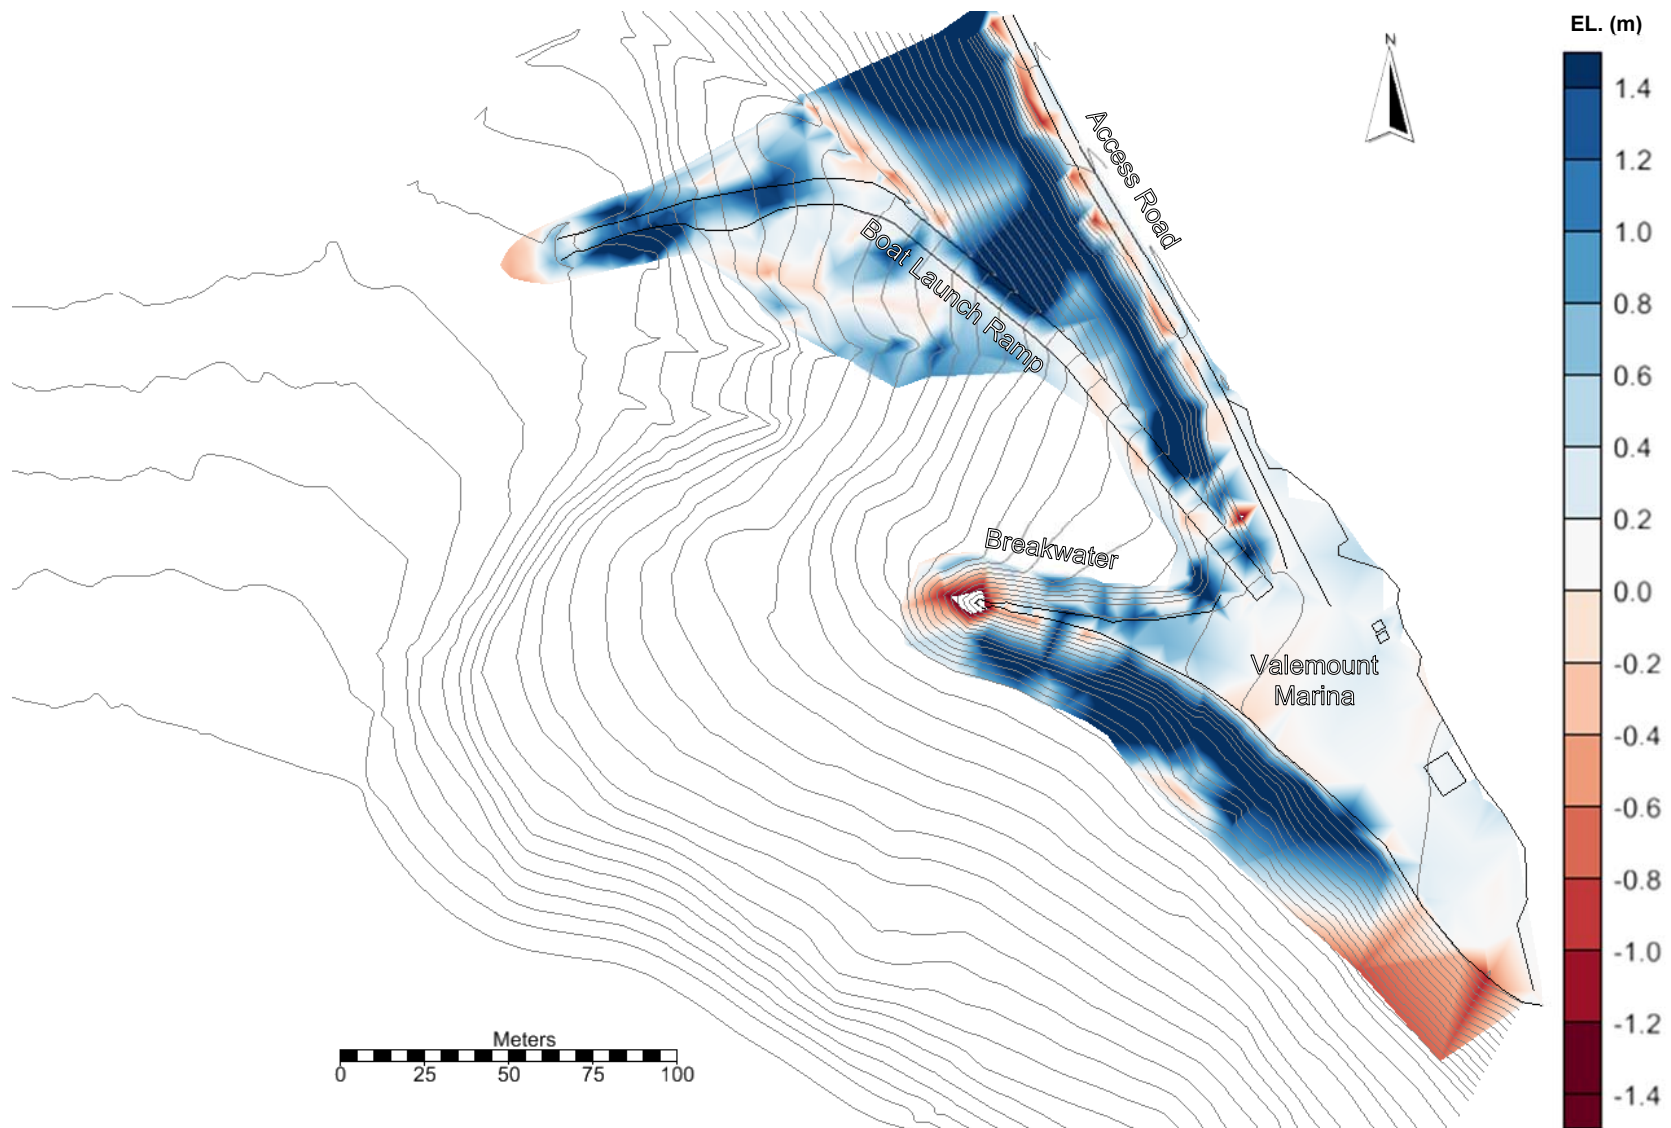
FIGURE 2-7: VALEMOUNT MARINA ELEVATION CHANGES BETWEEN ATEK (2008) AND MSG (2018) SURVEYS.

A new site survey was conducted in May 2018 to determine if the damage is progressive or if the material placed on the slopes has stabilized. Figure 2-7 shows elevation differences between the 2008 and 2018 surveys. The data indicates that the crest of the bank along the access road may have been subject to some erosion or slumping of the shore protection material. Another area of erosion or lowering of the lakebed elevation is at the toe of the launch ramp. It also appears that material has eroded or slumped around the tip of the breakwater. The recent survey shows other areas as having raised grades, which could be due to siltation or differences in survey techniques.

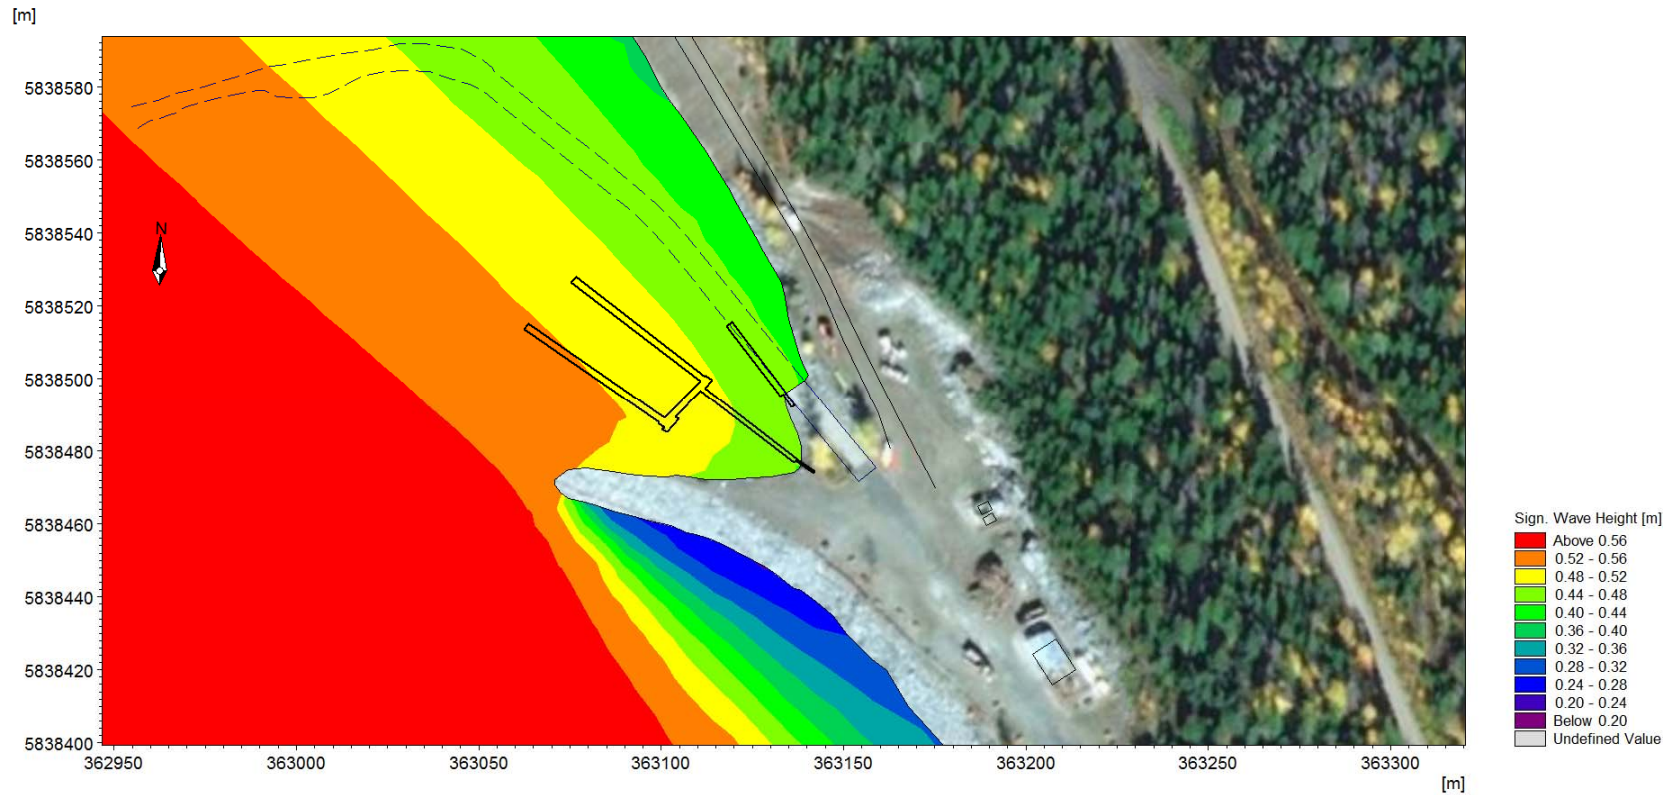
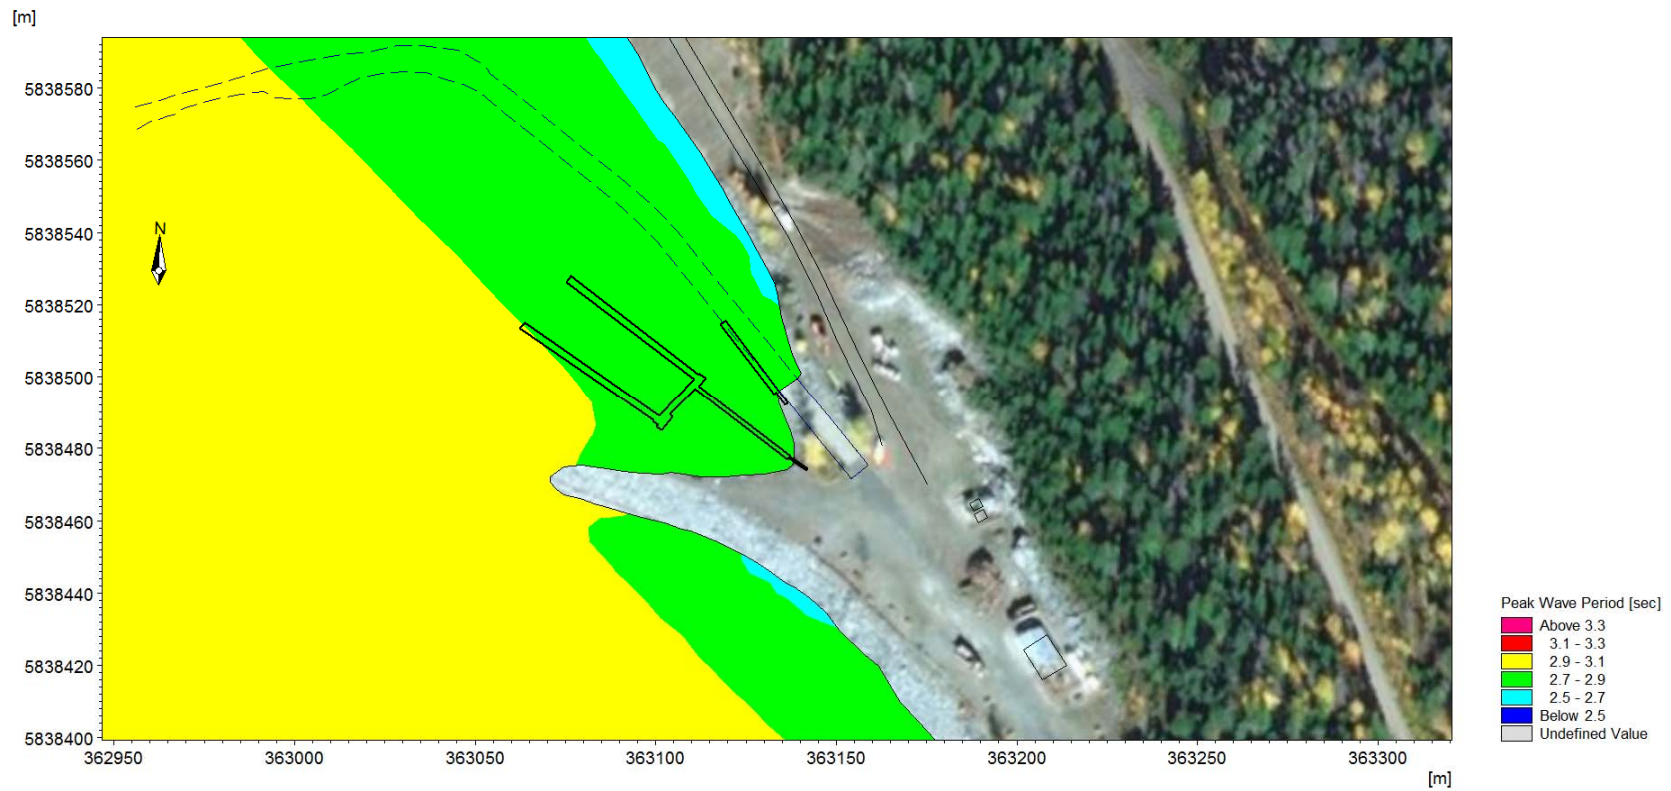
Figure 3-1 and Figure 3-2 shows the wave analysis results at the marina and its neighbouring shoreline for northwesterly wind. The results show that for this condition significant wave heights¹⁾ range between 0.4 m and 0.6 m around the breakwater, and inside the marina.

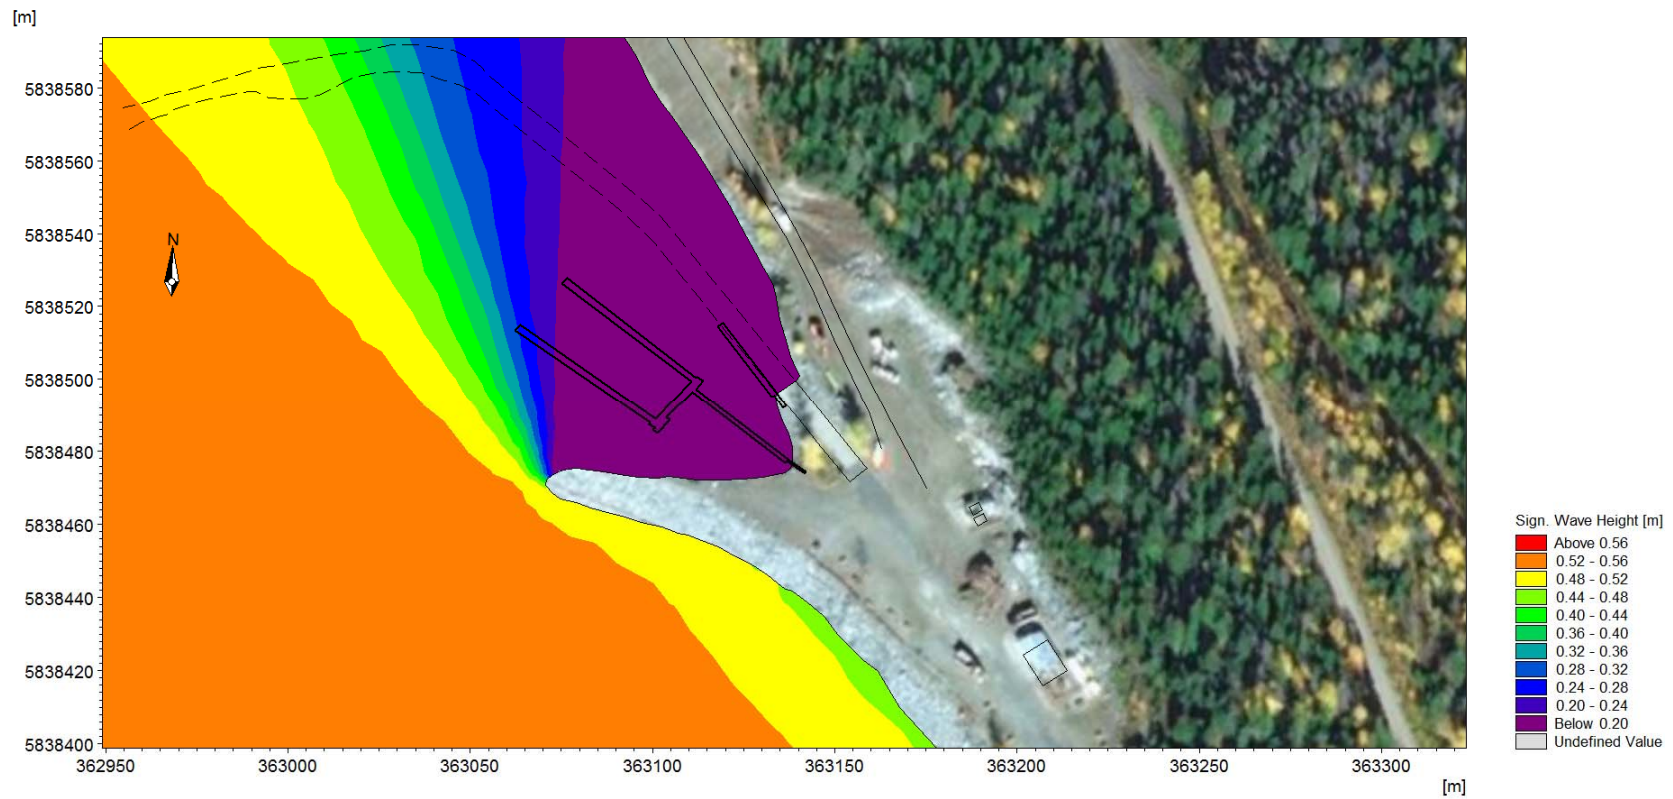
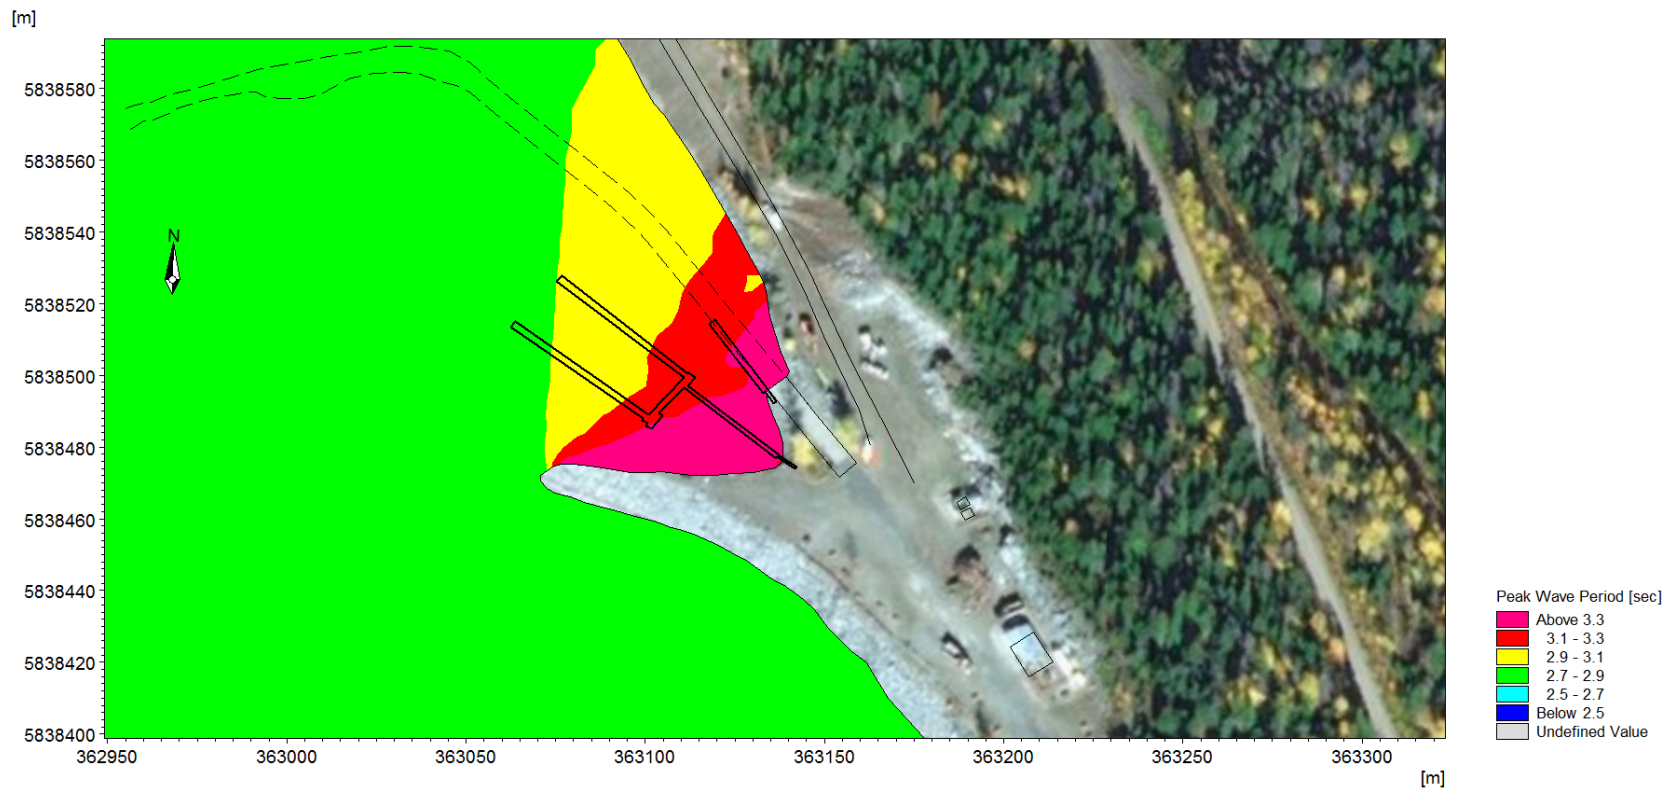
Figure 3-3 and Figure 3-4 shows the wave analysis results at the marina and its neighbouring shoreline for southeasterly wind. The results show that for this condition significant wave heights range between 0.5 m to 0.6 m on the outer side of the breakwater, with peak periods in the range from 2.7 to 3.3 seconds. As shown in Figure 3-3, the marina is sheltered from wave action at times of southeasterly wind and waves and significant wave heights within the marina are below 0.2 m.
