Campbell River Project Water Use Plan

Upper Campbell Reservoir Drawdown Zone

Revegetation Treatment Report – Year 3

Study Period: 2019

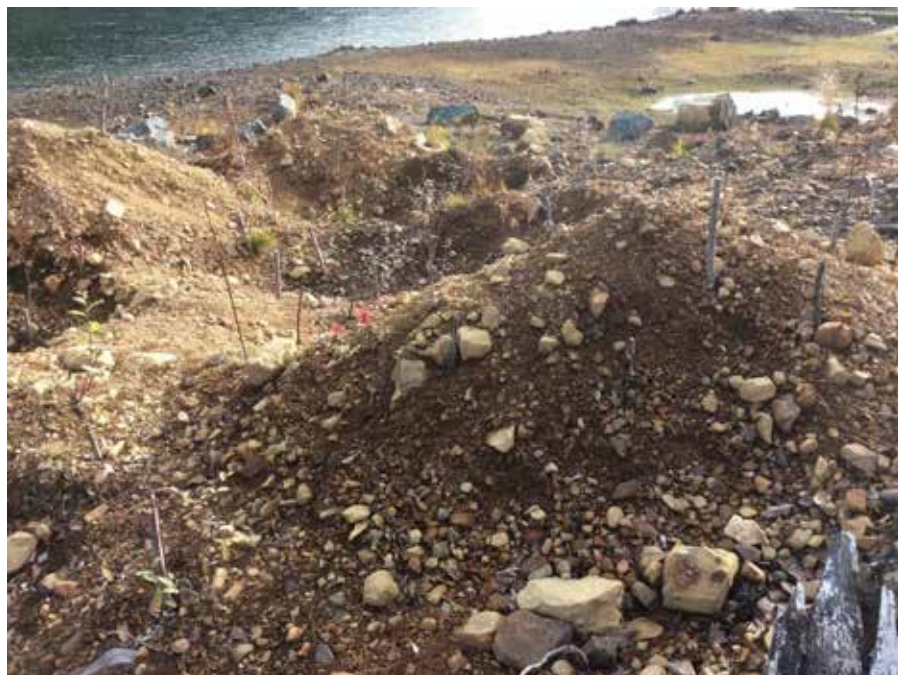
Figure 1. Machine loosened substrate in C-1ii polygon at JHT-RV02 within the islets (plot JHT-PRM29) on May 1, 2019. Hollow created for rough and loose egg carton pattern.

- C-1ii. The substrate was made rough and loose by excavator with loosened substrate in an egg carton pattern, stakes were planted into the prepared substrate, and stumps and rocks were added to stabilize the substrate and create microsites. Creating the egg carton pattern involved digging out hollows 1 to 1.5 m deep with the excavator bucket and depositing soil between the hollows. Stakes of native vegetation were planted into the hollows and sides of the hollows at a variety of elevations and aspects. Stumps were placed into dug holes by excavator and were then backfilled to anchor them, and rocks were placed around the stumps as ballast. Many of the stakes were up to 0.8 m deep. The western most islet was used as a control for the watering program and these stakes were planted 1 m deep with only 0.2 to 0.3 m of their length left above ground. A few scoops of fine textured lake bottom sediment were placed into the hole around the stump.

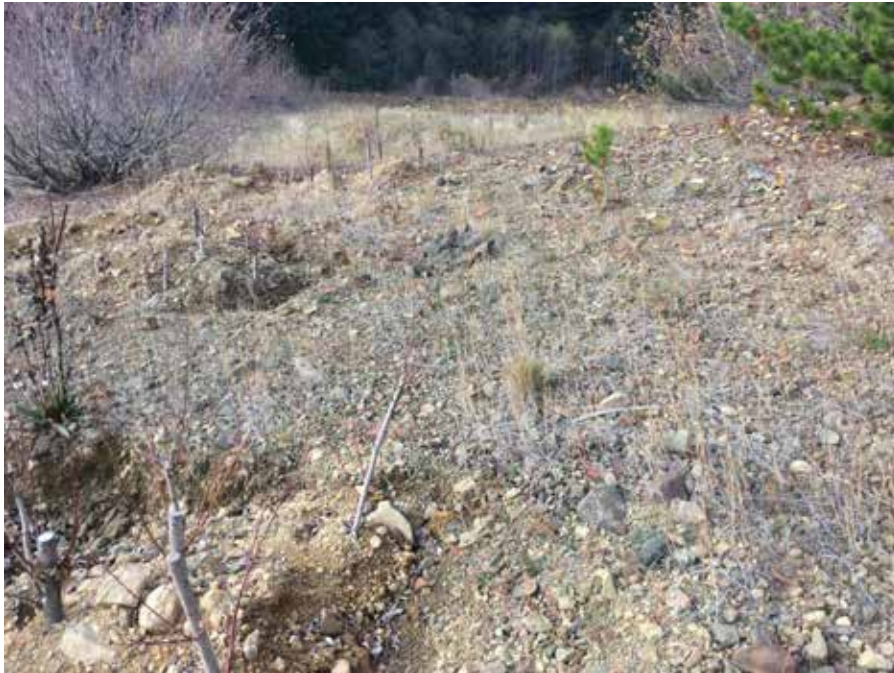
Figure 2. Machine loosened substrate staked with native vegetation in C-2i polygon at JHT-RV02 within the islets (plot JHT-PRM28) on May 1, 2019.

- C-2i. An excavator was used to loosen soil within which stakes of deciduous species were planted. Soil was loosened in circular craters (0.8 m deep by 1 m in diameter) spaced randomly about 2 m apart within which stakes were planted (five per crater).

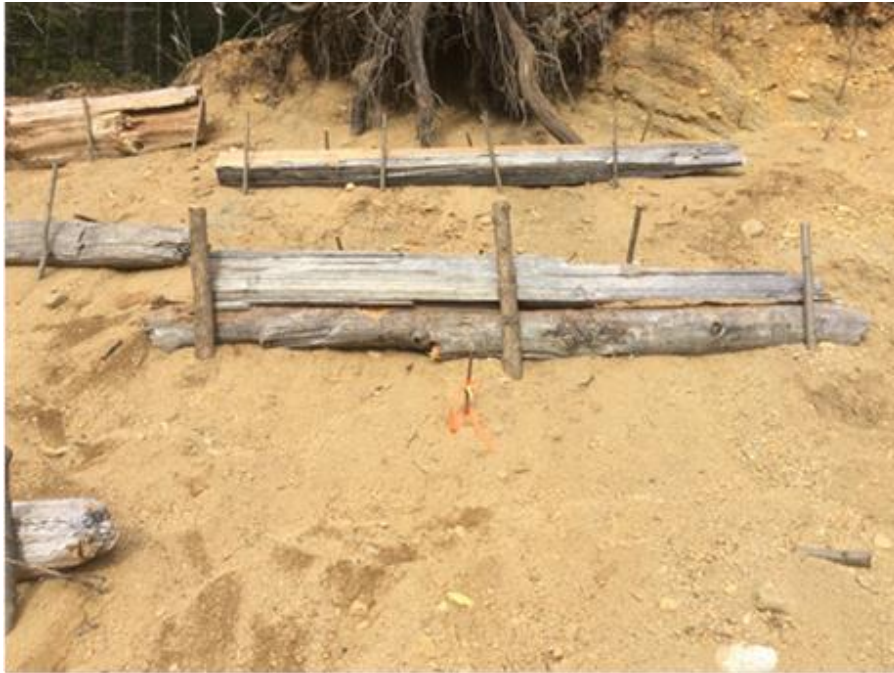
Figure 3. Slope stabilized with driftwood fences and stakes planted into terraces in D-1 treatment area at JHT-RV04 (plot JHT-PRM14) on November 6, 2019.

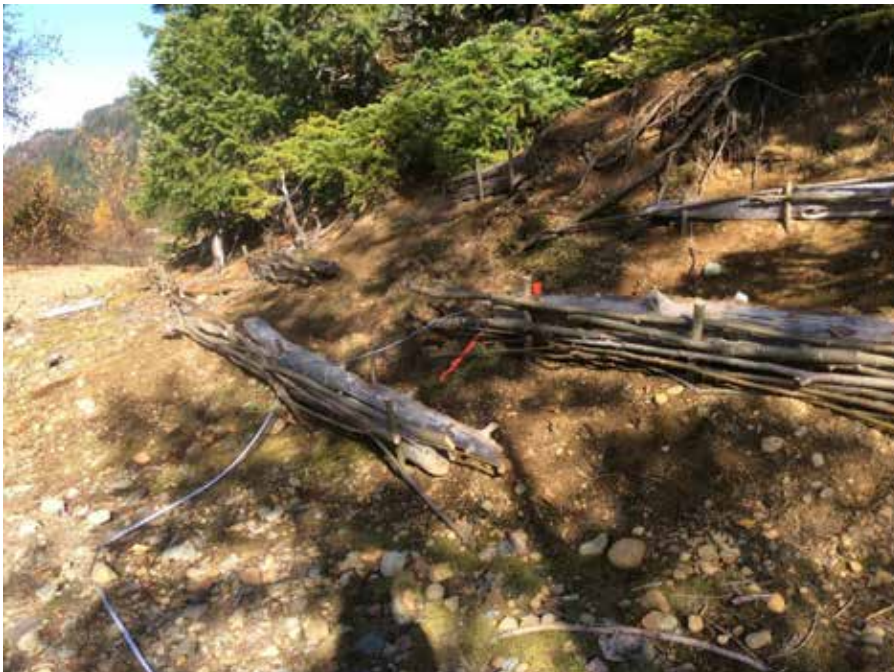
Figure 4. Slope stabilized with a combination of driftwood and wattle fences and stakes planted into terraces in D-3 treatment area at JHT-RV04 (plot JHT-PRM15) on October 28, 2019. Wattle fences are not woven around the stakes, but put on the up-hill side and backfilled with soil.

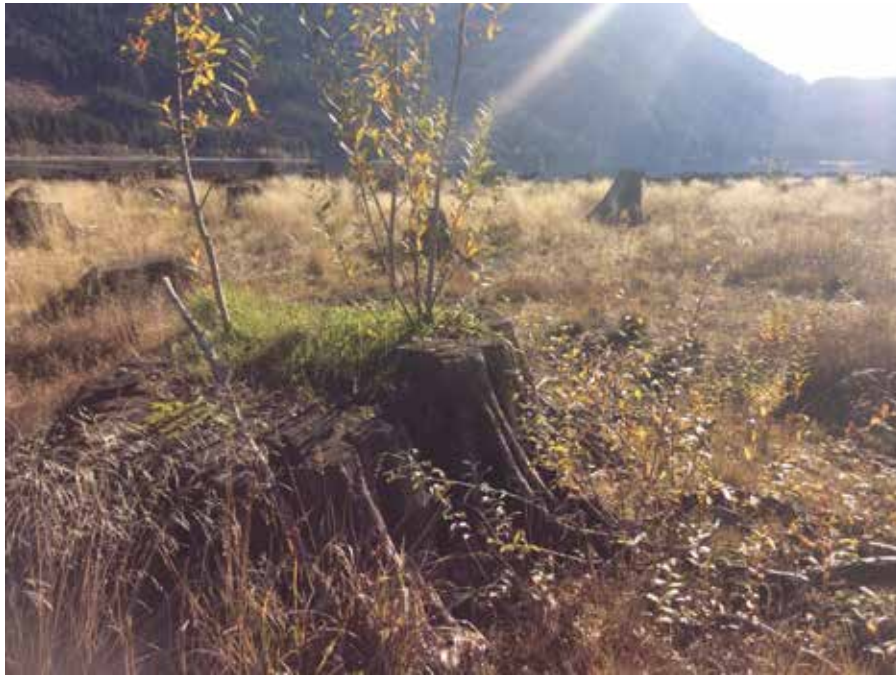
Figure 5. Stakes planted into decaying stumps in A-1 polygon at JHT-RV07 (plot JHT-PRM19) on May 3, 2019. The lateral branches are new growth since the stakes were planted in March.

- A-1. A total of 394 stakes (Sitka willow, black cottonwood, and red-osier dogwood) were planted into rotting stumps. Stakes were either planted into natural decay holes or into drilled holes (45 cm long, 4 cm in diameter). Stakes that were planted into decaying stumps were done so with a planting bar that often-allowed planting into the soil below the stumps. The hollow stumps were then filled with soil (which contained native fines and some Sea Soil). Thus, a large proportion of the length of each stake was planted within soil (often 2 to 2.5 m of the stake was in the soil and only 0.3 to 0.5 m was above). Stakes were planted into stumps to bring them to an appropriate elevation relative to water levels (i.e., ~217.8 – ~219.2 m). Some leftover stakes were also planted directly into the ground adjacent to stumps at elevations where stakes were naturally occurring (i.e., over 217.8 m). Stakes planted within stumps were watered approximately once every two weeks between mid-May and the first week of July (total four visits).

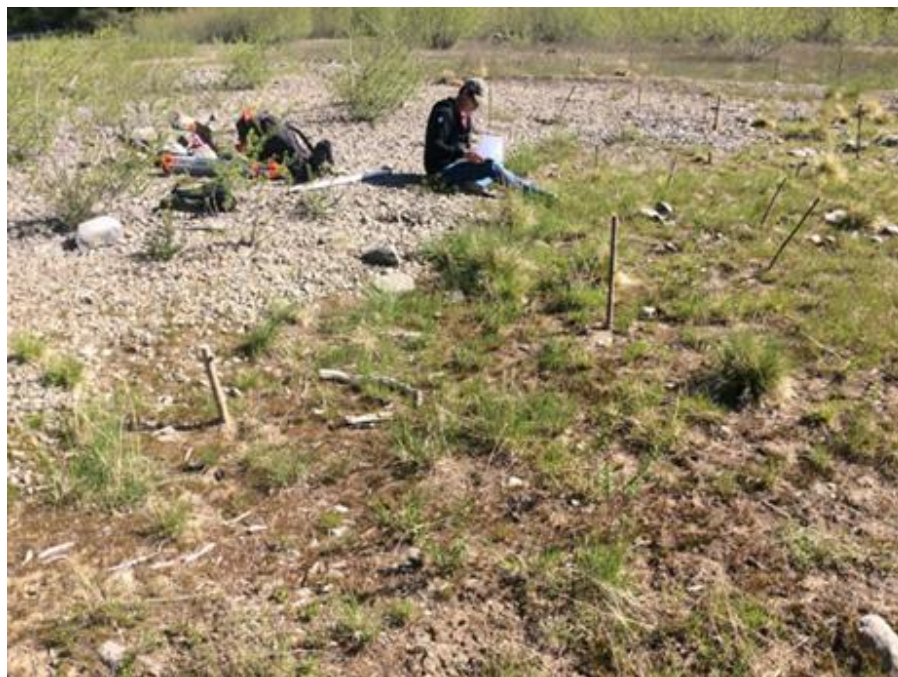
Figure 6. Stakes planted by hand without site preparation in B-2 polygon at JHT-RV08 (plot JHT-PRM40) on May 2, 2019.

- B-2. A total of ~210 stakes (black cottonwood, red-osier dogwood, and Sitka willow), approximately 0.8 m long, were planted by hand approximately 0.6 m deep (without site preparation). Hand planting was possible due to the soils being relatively loose.
- B-3. Control.

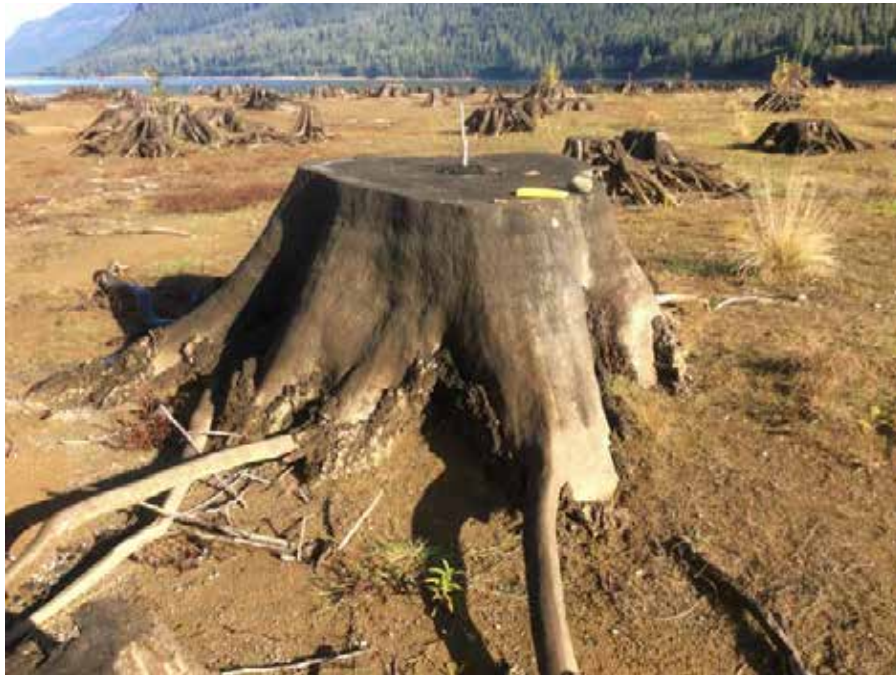
Figure 7. Stakes planted into decaying stumps in A-1 polygon at JHT-RV09 (plot JHT-PRM61) on October 25, 2019. Example at front of image shows stake that was placed into a hole drilled into the stump.

- A-1. A total of 725 stakes (black cottonwood, Sitka willow, and red-osier dogwood) were planted into decaying stumps that were hollow or drilled using the methods described in Section 3.1.3. In addition, a few western hemlock trees (*Tsuga heterophylla*) were planted on the highest elevation stumps. A few (~20) stakes were planted directly into the ground adjacent to stumps at ~218.0 m. These stakes were approximately 1 m long and were planted to a depth of approximately 0.8 m.
- A-3. Control
