Cheakamus River Water Use Plan

Monitoring Channel Morphology in Cheakamus River

Cheakamus River Hydrometric Monitoring

**Cheakamus Water Use Plan
Cheakamus River
Hydrometric Monitoring
Year 5 Reporting**

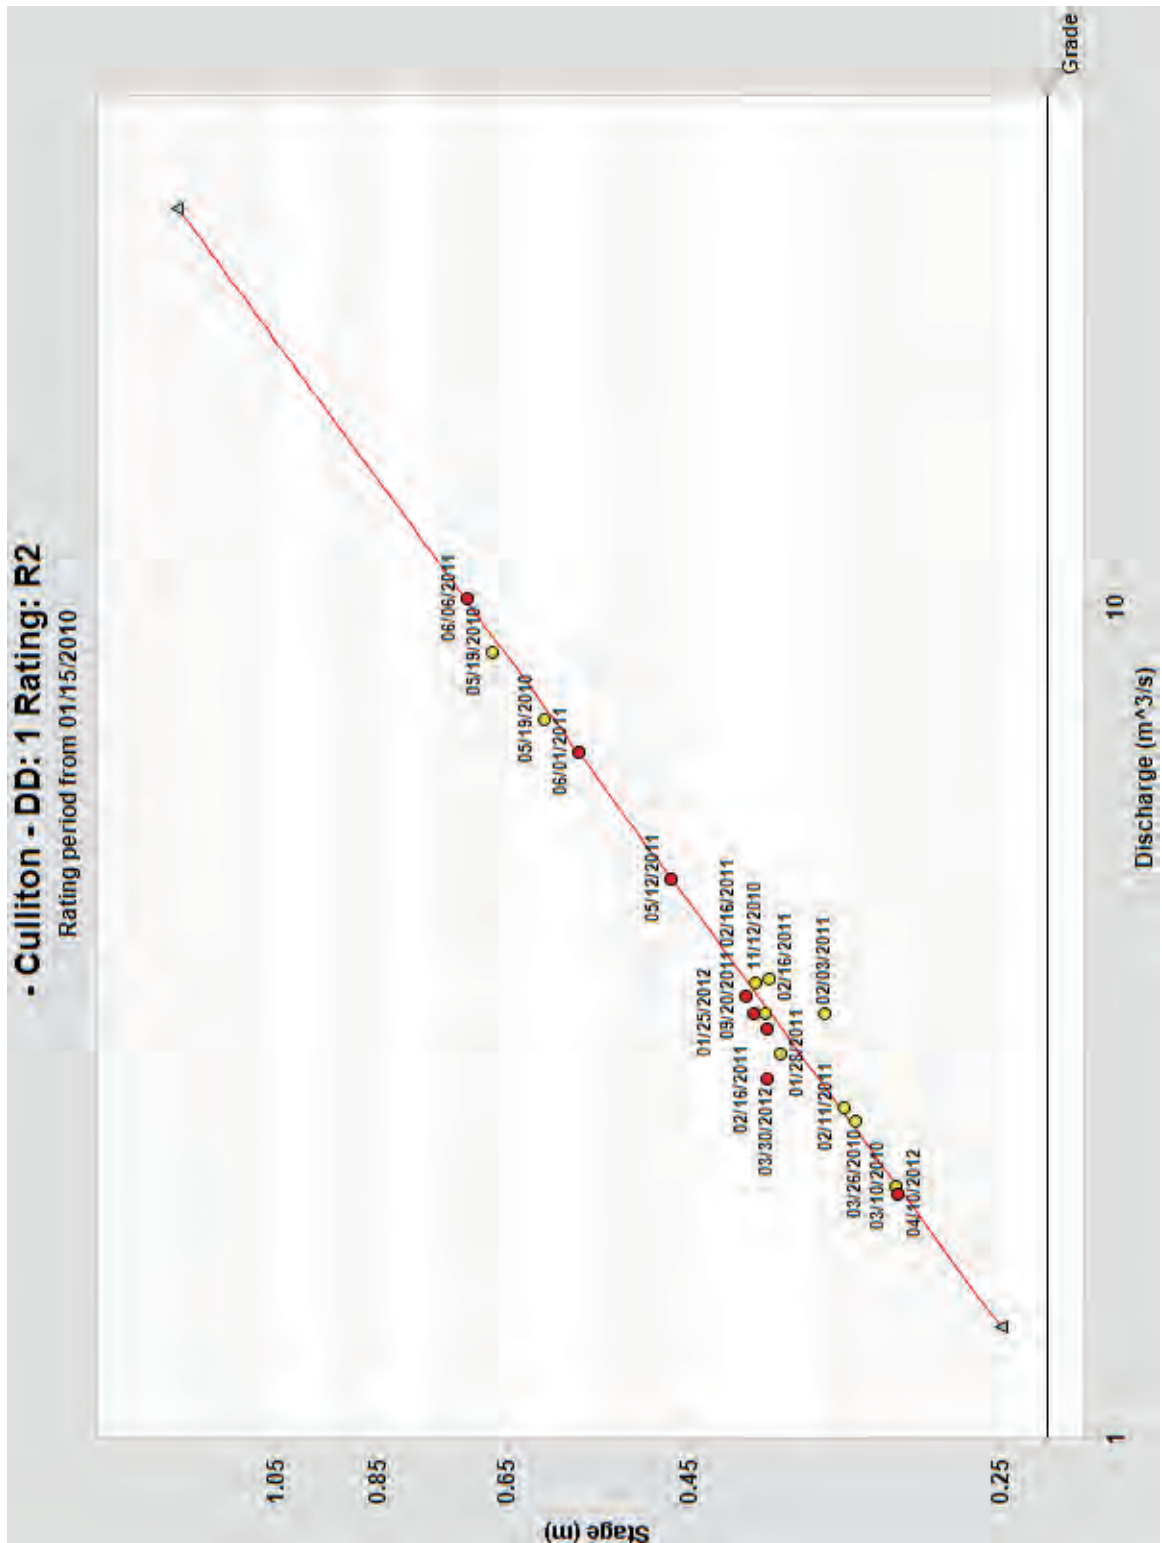
Figure 8. Current Rating curve R2 for Culliton Creek effective as of January 15, 2010. Discharge measurements made in the past hydrometric year are shown in red.

Only one rating curve shift is apparent at the Culliton Creek site over the period of record (**Figure 7**, **Figure 8**). The channel morphology at this site is controlled by large boulders, which have not been observed to mobilize during the largest events on record. The rating curve shift is likely due to bedload transport, which has led to deposition at this site. Unlike the Cheakamus River, however, it is difficult to correlate the rating curve shift with a single high flow event, and it is likely associated with a series of high flow events that occurred between late October 2009 and mid-January 2010.

$$Q(S)=20.61(S-0.05)^{1.689}$$

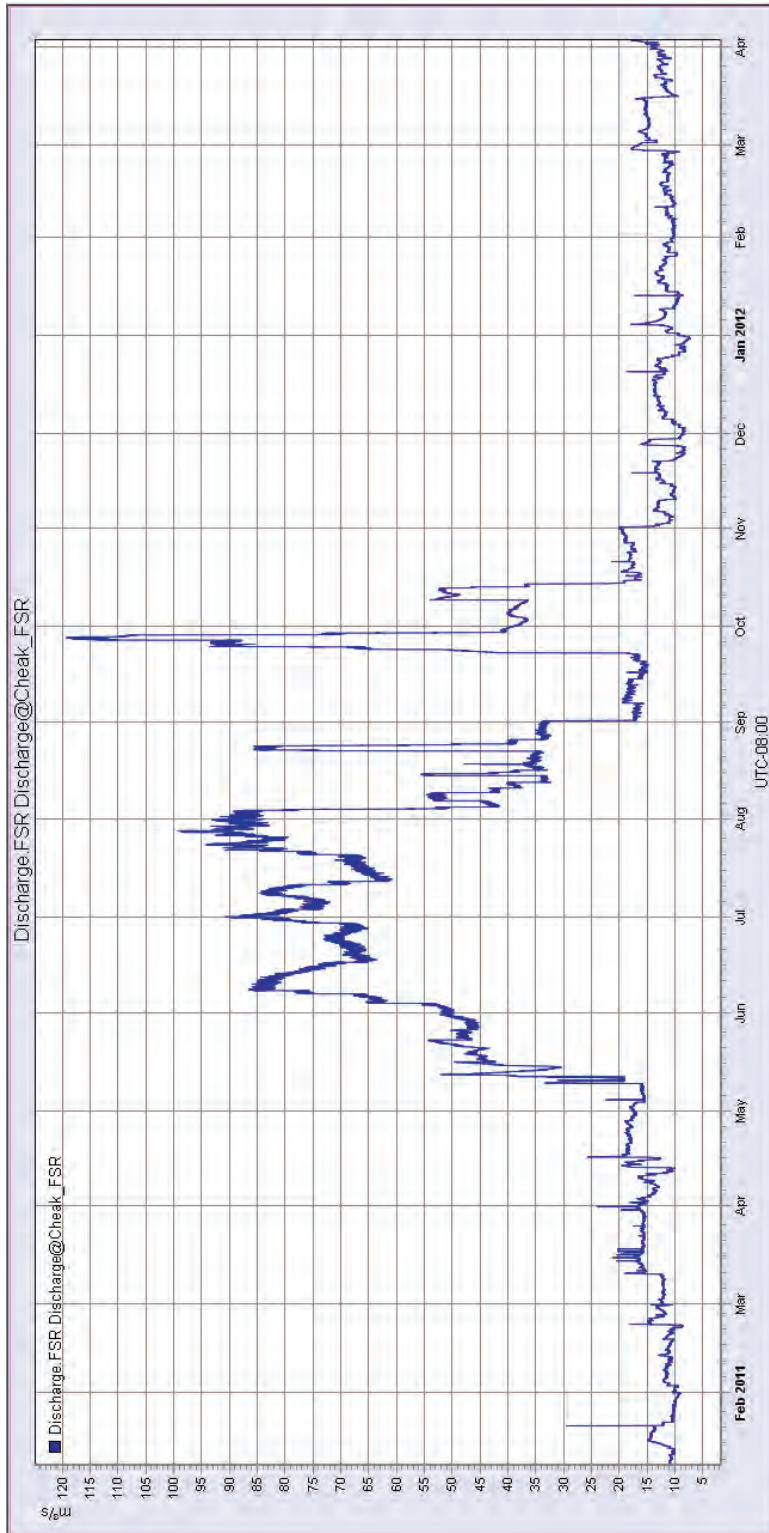
Figure 9. Discharge hydrograph for the Cheakamus River gauge at the Chance Creek Forest Service Road (FSR) Bridge crossing; estimates of flow over 75 m³/s are based on extrapolation of the rating curve beyond the highest gauged discharge.

Using the resulting stage-discharge relations from the rating curves (**Figure 2** to **Figure 7**), discharge and mean daily stream flow hydrographs were developed for each site (**Figure 9** to

Figure 11), with barometric pressure from the Culliton Creek site. Extrapolation occurs at the level above which estimates of flow are greater than measured flows. It is important to take this level into consideration when examining the hydrograph, as the rating curve above this level is undefined.

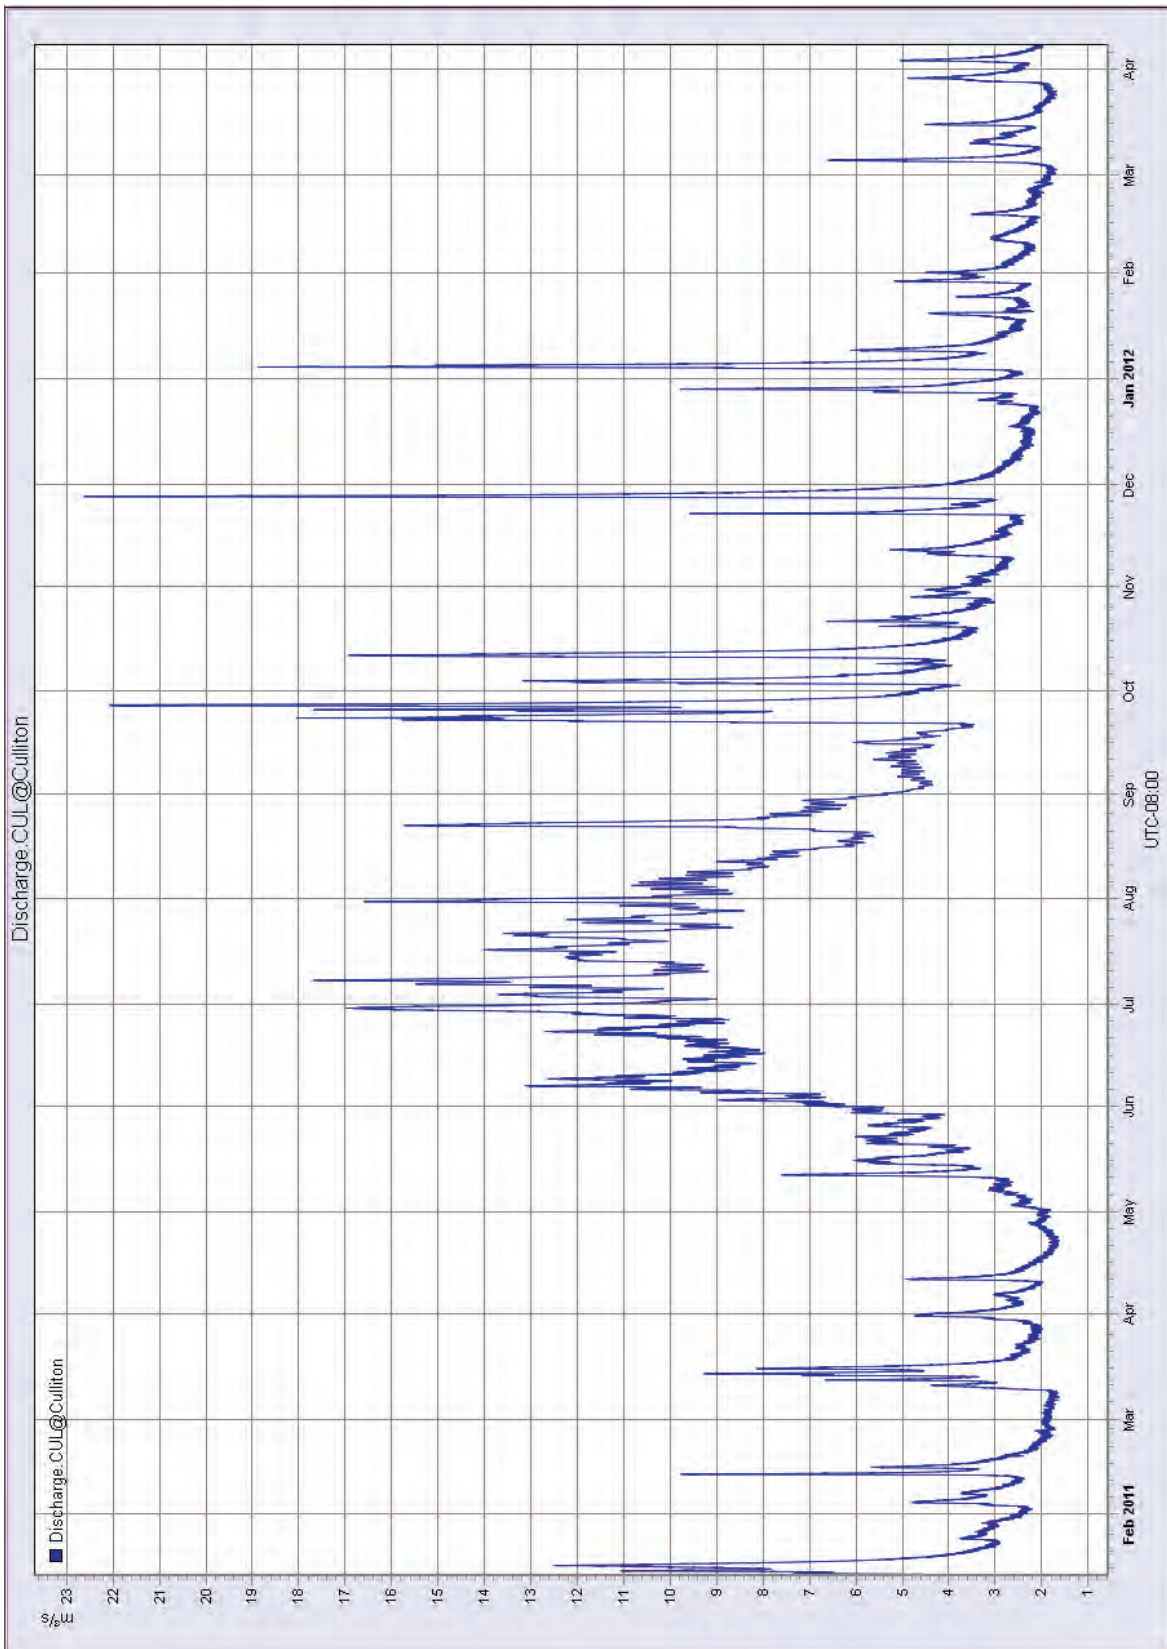
Figure 11. Discharge hydrograph for the Culliton Creek gauge upstream of the Culliton Creek-Cheakamus River confluence; estimates of flow over 23 m³/s are based on extrapolation of the rating curve beyond the highest gauged discharge

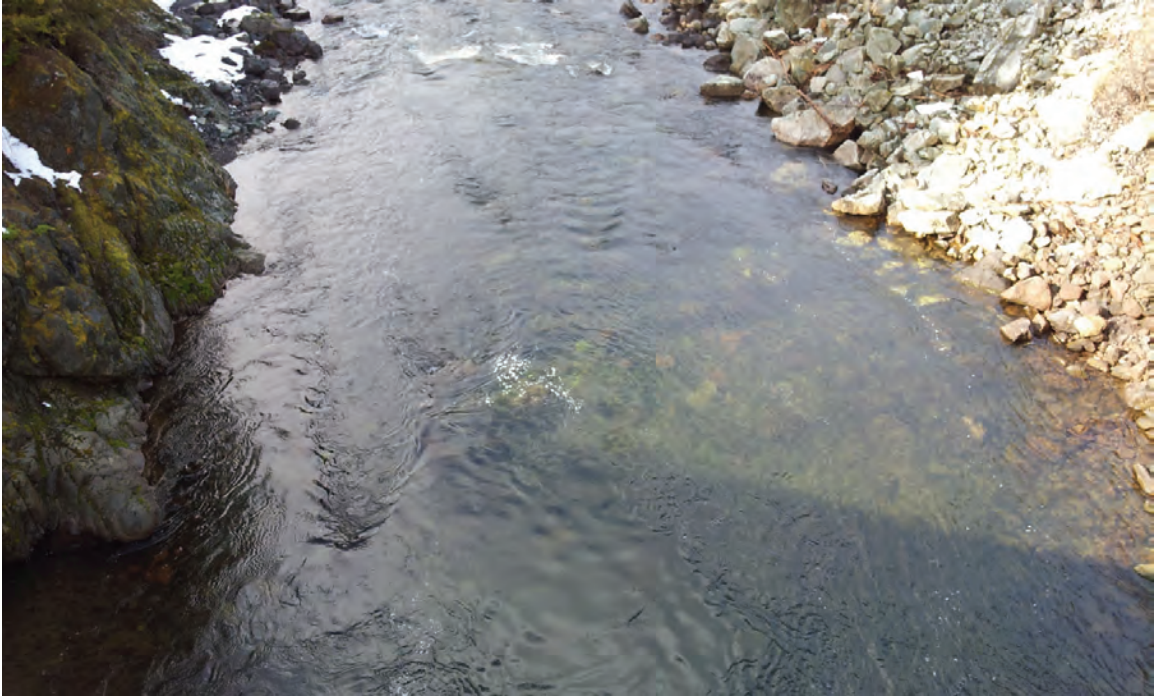
Photograph 1. Looking downstream from the Chance Creek FSR Bridge at the gauging cross section.

The Cheakamus FSR site is located at the Chance Creek Forest Service Road bridge crossing, which is situated below the Rubble Creek and above the Chance Creek confluences (**Figure 1, Photograph 1** and **Photograph 2**). The lower reach of Rubble Creek has an active fan at its confluence with the Cheakamus River, and does not provide a stable anchor point for the installation of a hydrometric station. Rubble Creek flow contributions can be estimated by subtracting Daisy Lake Dam flow releases from discharge estimated at Cheakamus FSR since other contributions to the river are negligible.

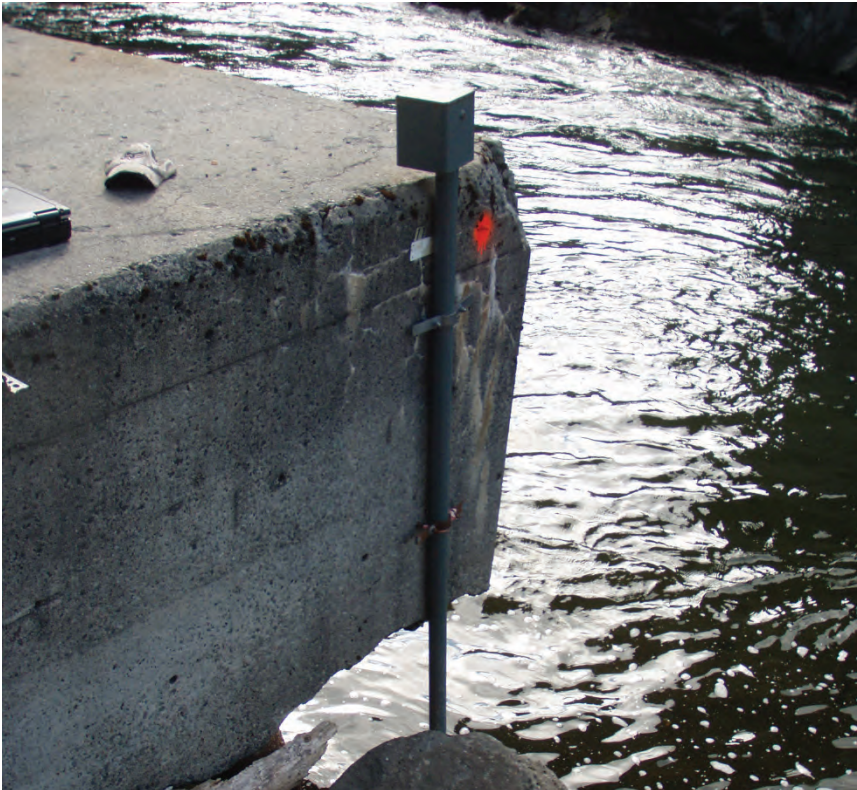
Photograph 2. Cheakamus FSR Hydrometric Station.

The Cheakamus FSR hydrometric station is secured to the downstream side of the bridge footing on the right bank. This site was selected for its close proximity to Rubble Creek and partial bedrock control of the channel, which minimizes possible changes in channel geometry. Flow gauging at this site is limited to use of an ADCP as there is insufficient lateral mixing across the channel for dilution methods and the channel is too deep to wade. During high flows there is significant localized turbulence at this section that can disrupt gauging with an ADCP due to air entrainment in the water column, and measurements in such conditions have had greater uncertainty. Between February 2011 and April 2012 the site was gauged 6 times (**Table 1**).

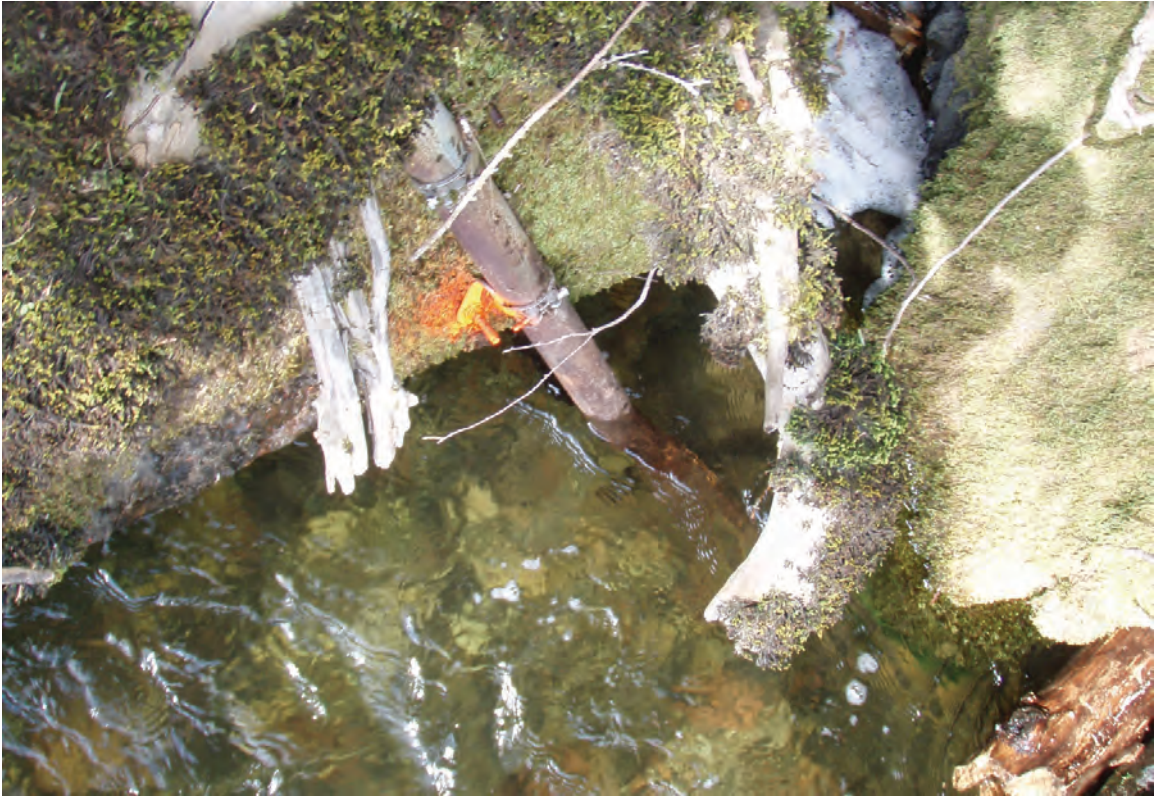
Photograph 3. Hydrometric station for the Cheakamus Pedestrian Bridge site.

This site is located at the pedestrian suspension bridge crossing the Cheakamus River approximately 500 meters upstream of its confluence with Culliton Creek (**Figure 1, Photograph 3, and Photograph 4**). The hydrometric station is anchored to bedrock on the right bank of the river, just upstream of the bridge. Several small tributaries flow into Cheakamus River between this site and Chance Creek.

The Cheakamus Pedestrian pressure transducer is housed in a thick-walled galvanized steel pipe with a standard lockable well cap, and this in combination with challenging access has been sufficient in preventing vandalism or tampering. The Cheakamus FSR and Culliton Creek stations are more exposed, and these stations have been fitted with a more robust thick steel housing. Thus far, these measures have proven to be adequate in preventing tampering or vandalism. A minimum of three benchmarks have been established at each site to provide vertical reference points for the pressure transducer (RISC, 2009).

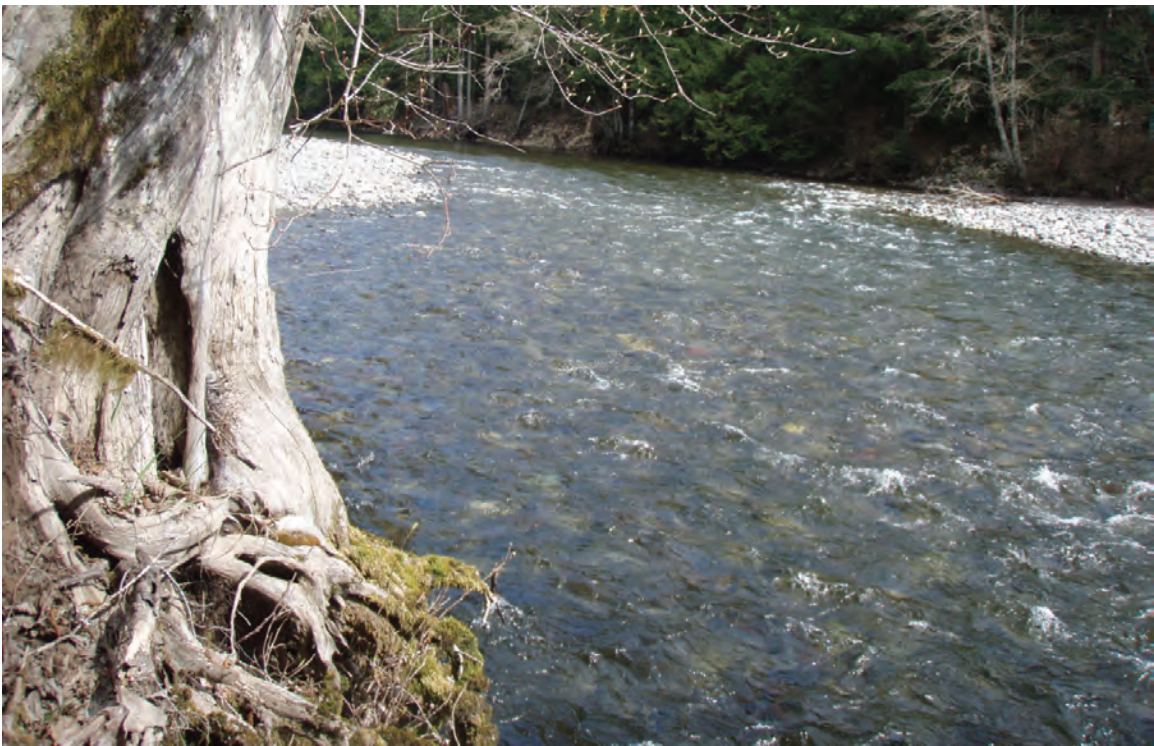
Photograph 4. Looking up from the Cheakamus Pedestrian Bridge hydrometric station.

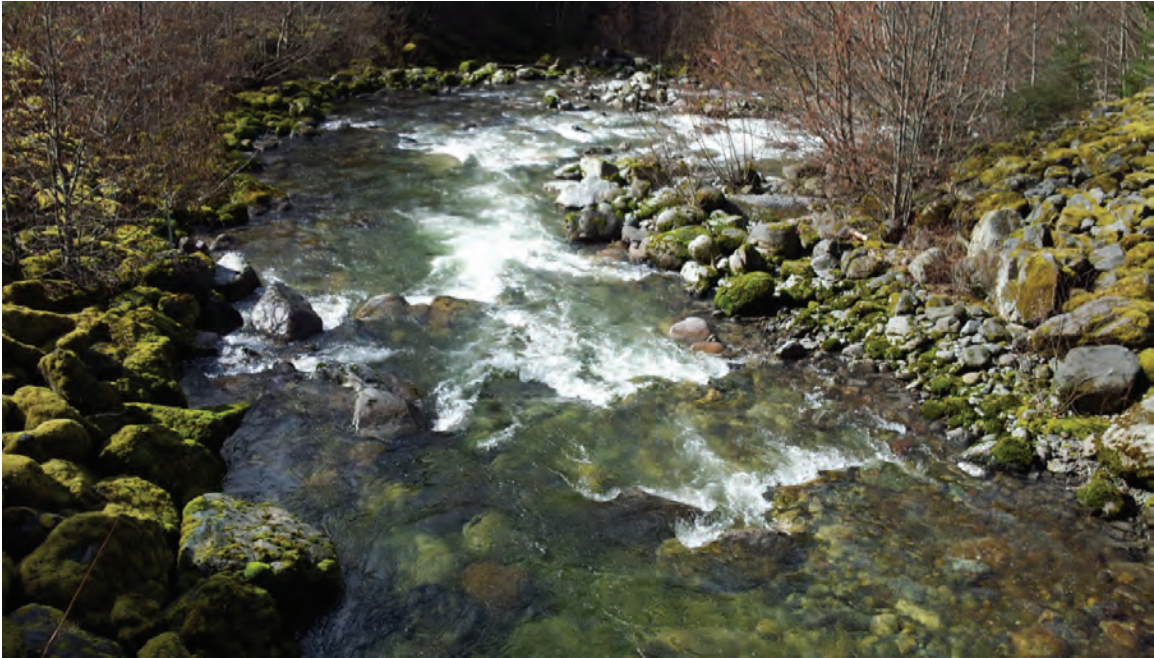
Photograph 5. Looking downstream from the Jack Webster Bridge to the Culliton Creek gauging station. The gauge is located on the left bank.

Culliton Creek is one of the main tributaries to the Cheakamus River and the catchment includes Conroy Creek and half of the Brohm Ridge glacier. The hydrometric station is installed on the left bank below the Jack Webster bridge crossing Culliton Creek (**Figure 1, Photograph 5, and Photograph 6**). A series of riffles and step pools that extend approximately 100 metres upstream and downstream of the bridge create turbulent conditions ideal for dilution methods during high flow.

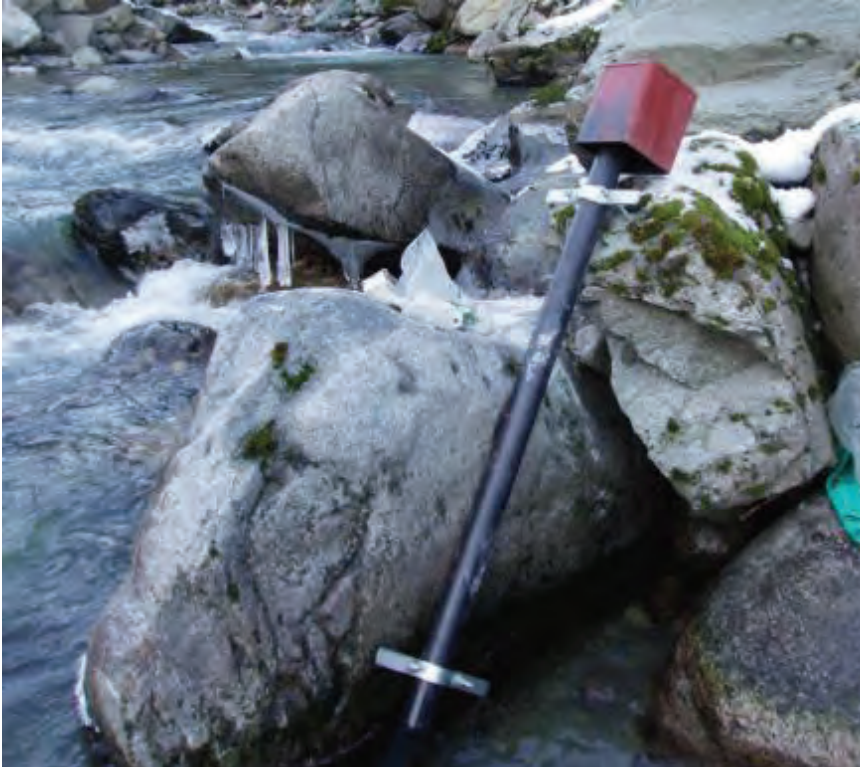
Photograph 6. Culliton Creek Hydrometric Station.

During low flow conditions, dilution injection solutions can become trapped in pools and discharge measurements with an ADV are preferred. A Barologger, measuring pressure and air temperature at a sheltered site in the nearby forest is used for compensating all Leveloggers on this project. This site has been successfully gauged seven times since February 2011 (**Table 1**).

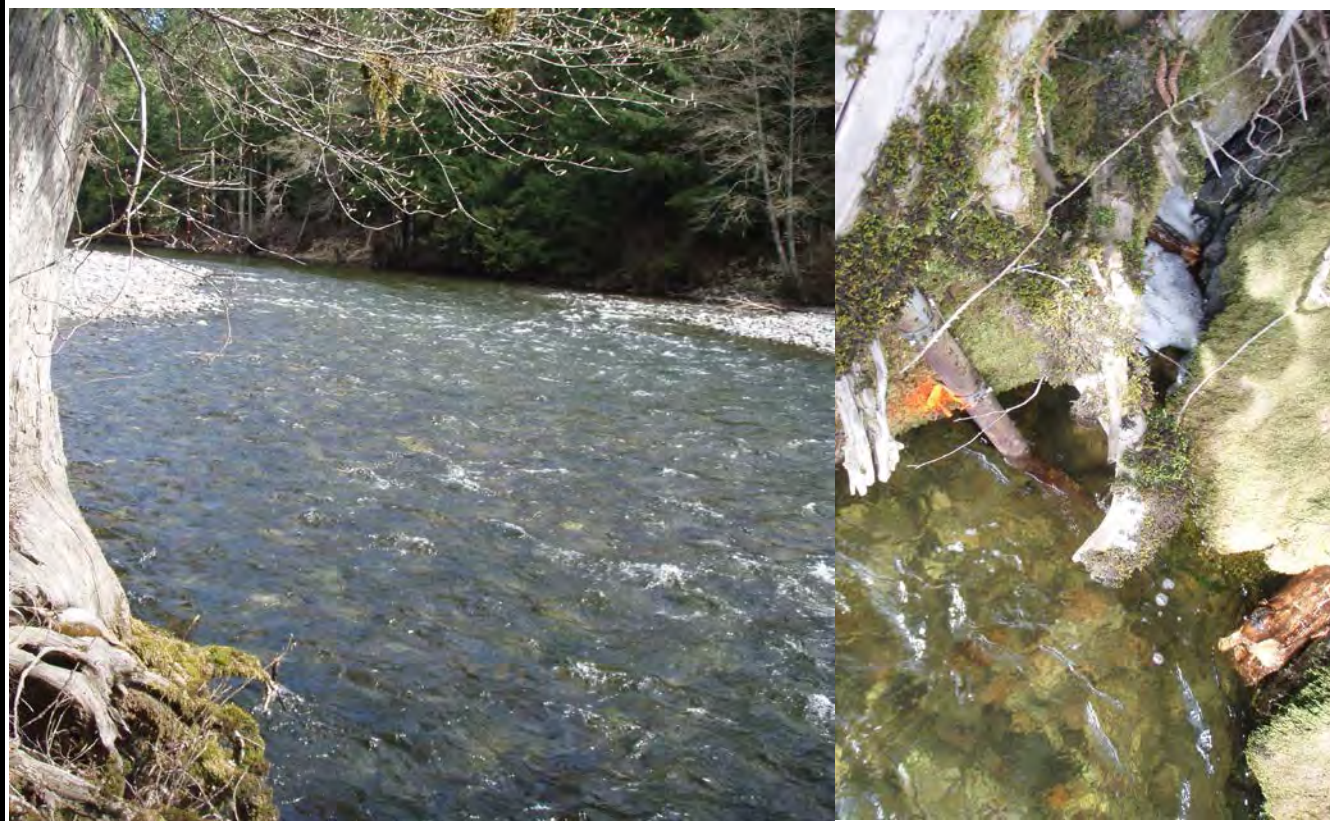
Location Photo:

Cheakamus River at Pedestrian Bridge

Barologger located at Culliton Bridge site (10 U 487322 5524428).

Logger mounting hardware beginning to corrode. Should replace in near future.

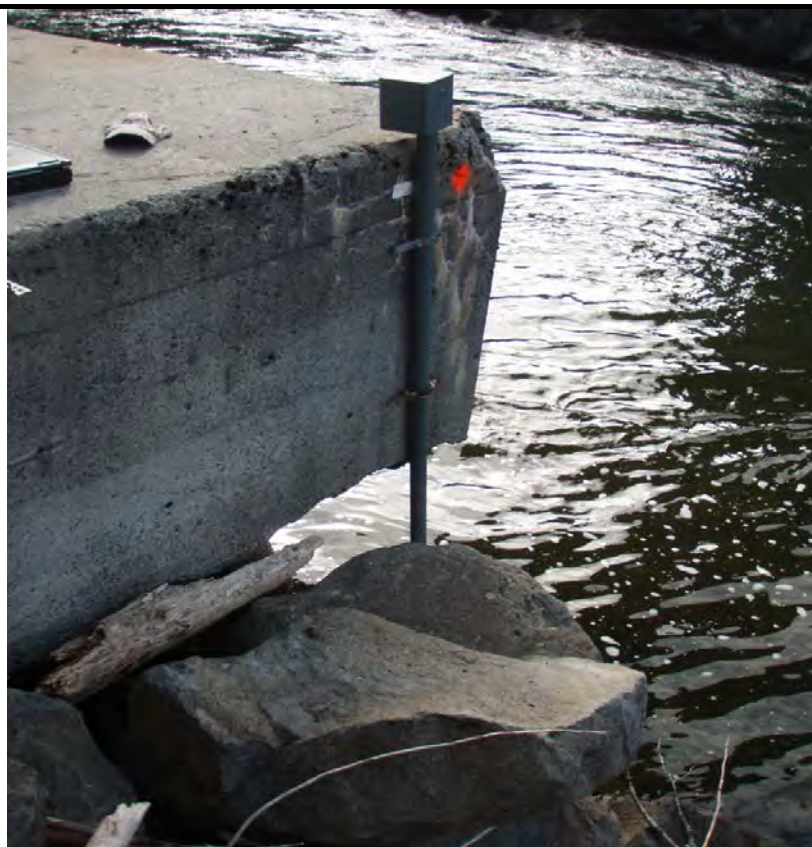
Location Photo:

Physical water level should be recorded from orange bolt down to WL as well as from PT bolt to WL
 PT sensor is located 3.5 cm above PT bolt.
 Barologger located at Culliton Bridge site (10 U 487322 5524428).

Logger mounting hardware beginning to corrode. Should replace in near future.

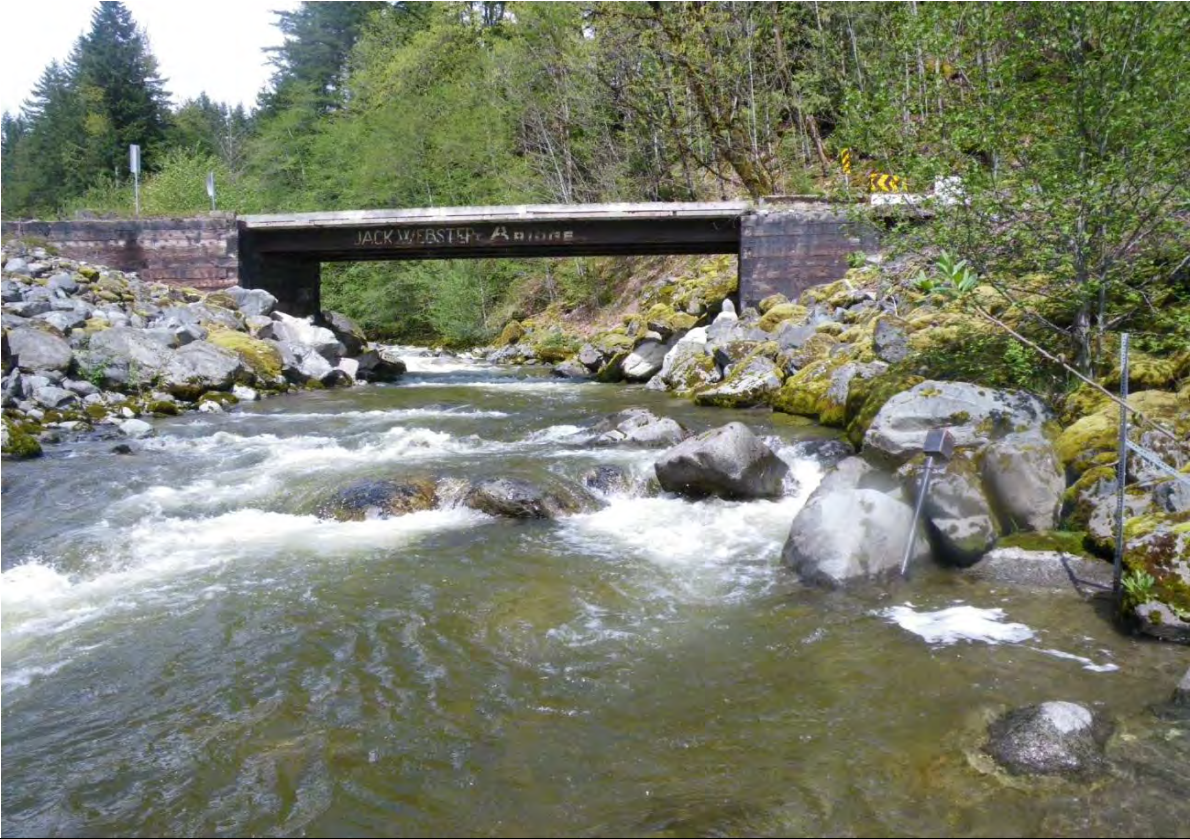
Culliton Creek at 'Jack Webster' Bridge		
Stream Name	Culliton Creek	
Installation Date	8-Feb-2008	
Installed By	P. Kuras, W. Skitmore	
Sensor/Data Logger	Solinst Levelogger Gold and Barologger	
Sensor/Data Logger Serial Number	1023536 (level) 1024987 (baro)	
Logger Location	Left bank of Culliton Creek 50 m downstream of bridge	
Logger UTM	10 U 487350 5524462 +/- 10m	
Program Header	N/A	
Logger Time	PST	
Sampling Frequency	15 minute (level), 15 minute (baro)	
Download Frequency	1/yr	
Geodetic Elevation	127m +/- 20m	
Elevation of sensor	0.037m	
Geodetic Datum	N/A	
Datum	Local (Spike)	
BM	Elev.	Geodetic Description
Spike	0	
NHC518	0.435	
NHC544	0.209	
Staff Gauge 'zero'	-6.211	
Orange Bolt	-5.599	spray painted bolt in rock
PT bolt	-6.281	bottom bolt in stand pipe
Install Document:		
Location Photo:

Notes		
PT sensor is located 3.7 cm above PT bolt. Barologger located at 10 U 487322 5524428		
Last visit		
June 3rd, 2013

Comments		
Logger mounting hardware beginning to corrode. Should replace in near future.
