# **Cheakamus River Water Use Plan**

## **Monitoring Channel Morphology in Cheakamus River**

**Reference: CMSMON-8**

**May 7, 2014**

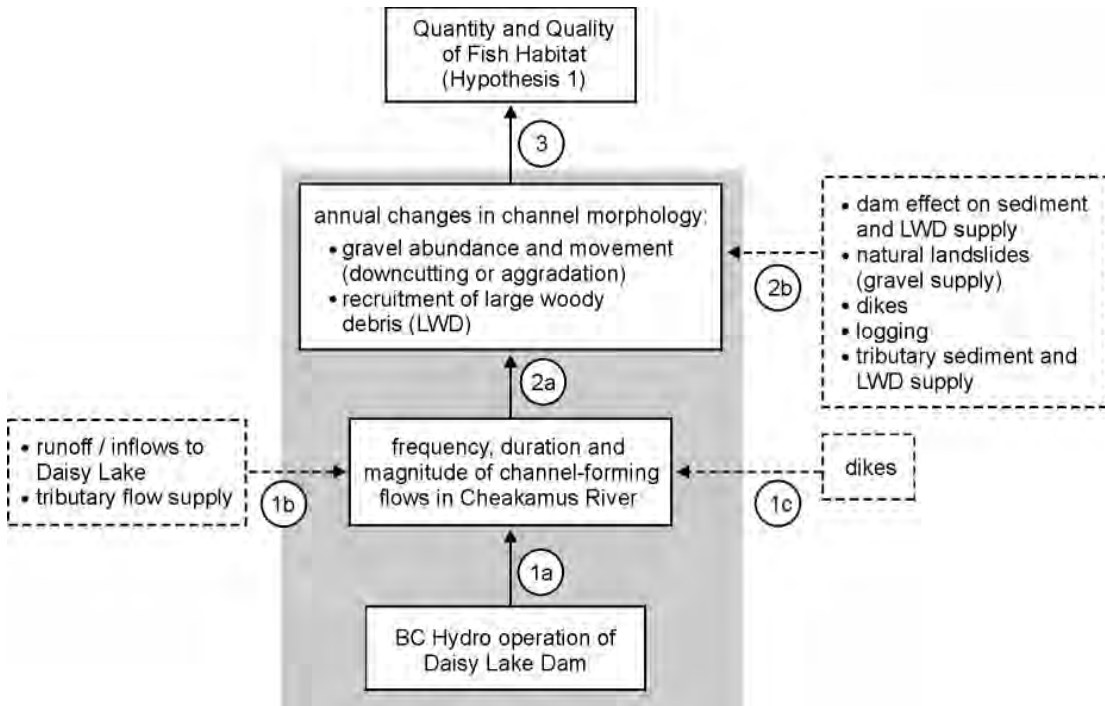
Figure 1-2 Impact Hypothesis 2 - Effect of Flow on Channel Morphology (BC Hydro, 2000)

Link	Description
1a.	Dam operations affect the frequency, magnitude and duration of channel-forming flows in the Cheakamus River.
1b	Inflow to Daisy Lake and runoff to the Cheakamus River downstream of the dam also affect the frequency of channel-forming flows.
1c	Dikes affect what flow is a channel forming flow.
2a	The frequency of channel-forming flows affects the movement of gravel, channel morphology and input of large woody debris.
2b	Other factors (dam as barrier, natural landslides, dikes, logging, tributary sediment and large woody debris supply) also affect year-to-year changes in gravel and channel morphology.
3	Changes in channel morphology affect the quantity and quality of fish habitat [see H.1] by altering: access to side channel habitat, channel diversity, and the quality and distribution of spawning and rearing gravel.

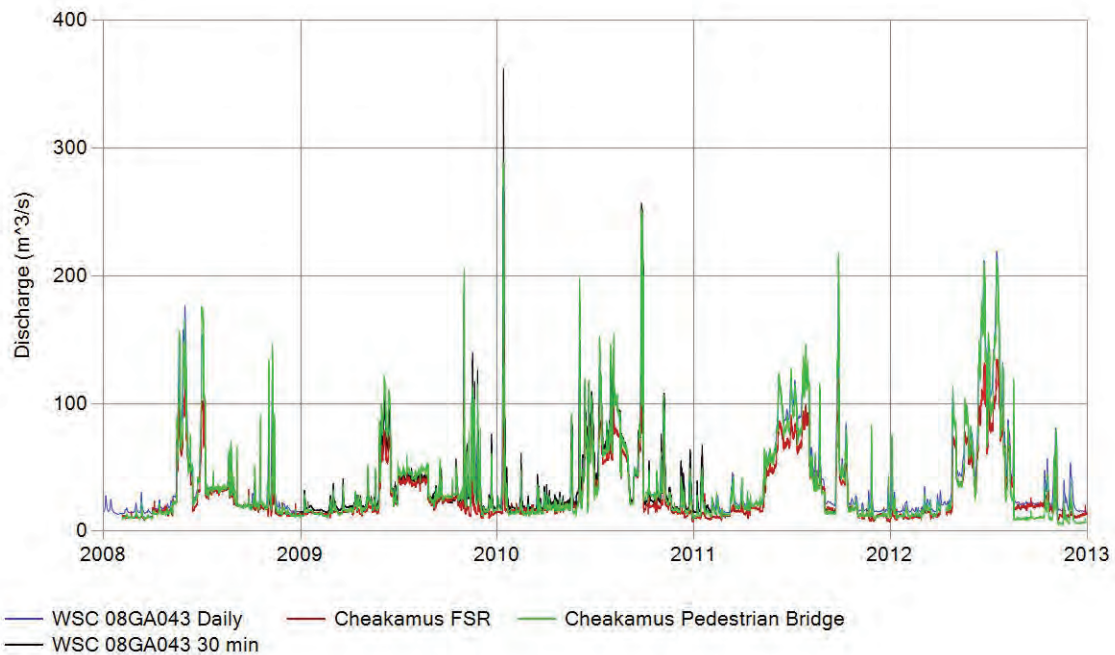
**Figure 3-1 Cheakamus River Flows 2008 to 2012**

Discharge records for the entire period of study are shown in Figure 3-1. All entries for the years 2008 and 2009 are mean daily discharges as provided by the Water Survey of Canada (WSC 08GA043, Cheakamus River near Brackendale). Water Survey Canada also provided flows for the period January 1, 2010 to January 31, 2011 but these values were recorded at 30 minute intervals. Short duration measurements reveal higher 'peak' flows than flows averaged over the course of an entire day.

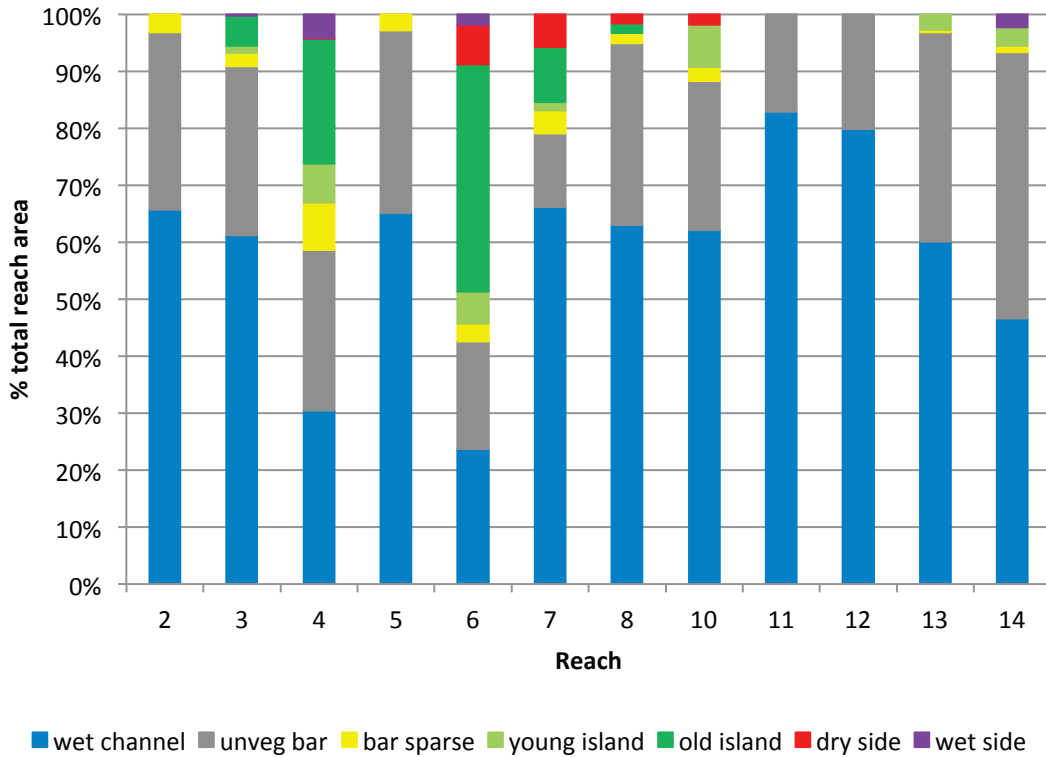
**Figure 4-1 Cheakamus River Geomorphic Mapping 2008**

The following reach designations was originally developed by the Department of Fisheries and Oceans who adapted it from earlier versions (NHC, 2000). Reach 1 (Cheakamus Fan) is outside of the study boundary and was not examined herein. A short canyon section (Figure 1) is also excluded as it is of limited value to fish (BC Hydro and Power Authority, 2007). The areal extent of each morphologic feature observed in the 2008 and 2012 imagery is summarized in **Table 4-1** and the data are shown in **Figure 4-1** and **Figure 4-2**. The baseline morphology mapping is found in **Appendix B**.

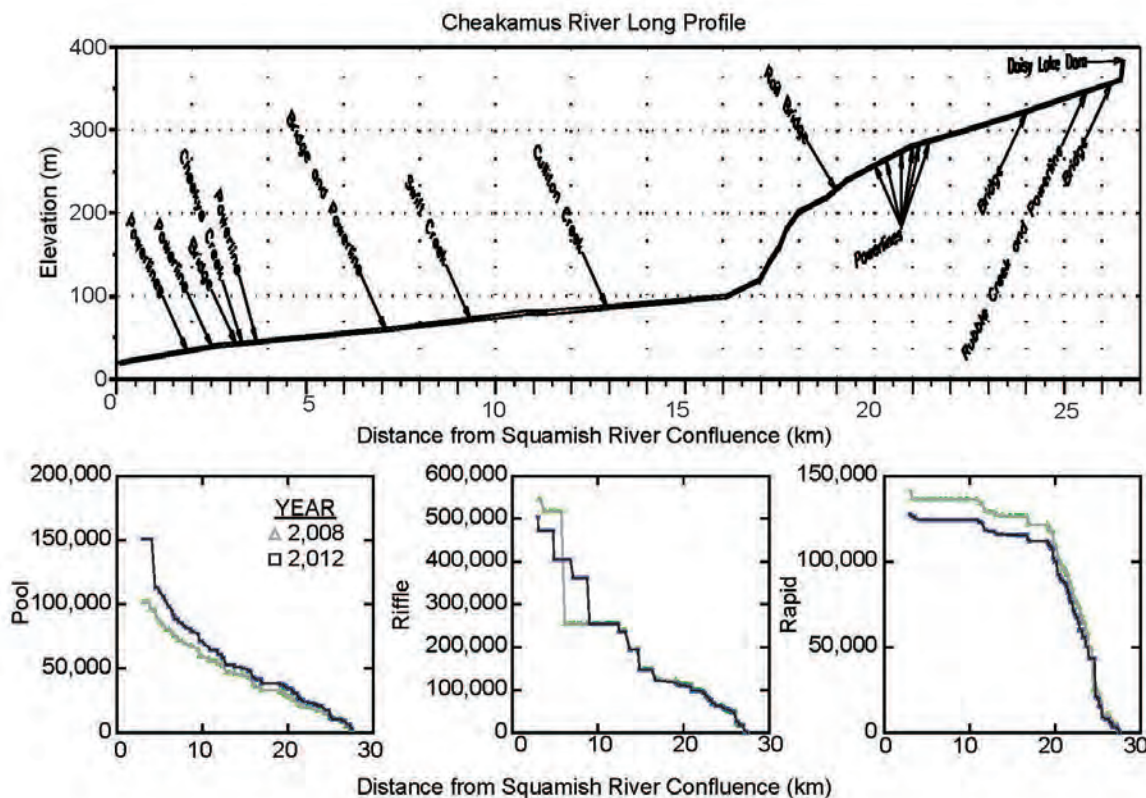
**Figure 4-4 Cumulative Area Associated with Habitat Units Starting at Daisy Lake and Proceeding Downstream as a Function of Channel Chainage.**

Above the Cheekye River the channel becomes more complex, with numerous side channels (see **Figure 4-4**) and locations where the channel splits around mature wooded islands. Woody debris is also common within Reaches 3, 4 and 6. Side channels are particularly prevalent within Reach 3 and 4 where many have been built or augmented for improved fish habitat. Reach 5 is a narrow, slightly sinuous transport zone with simple morphology. Reach 6 is characterized by a number of islands with mature or maturing vegetation. Many of these areas are currently connected to the channel banks at low flow.

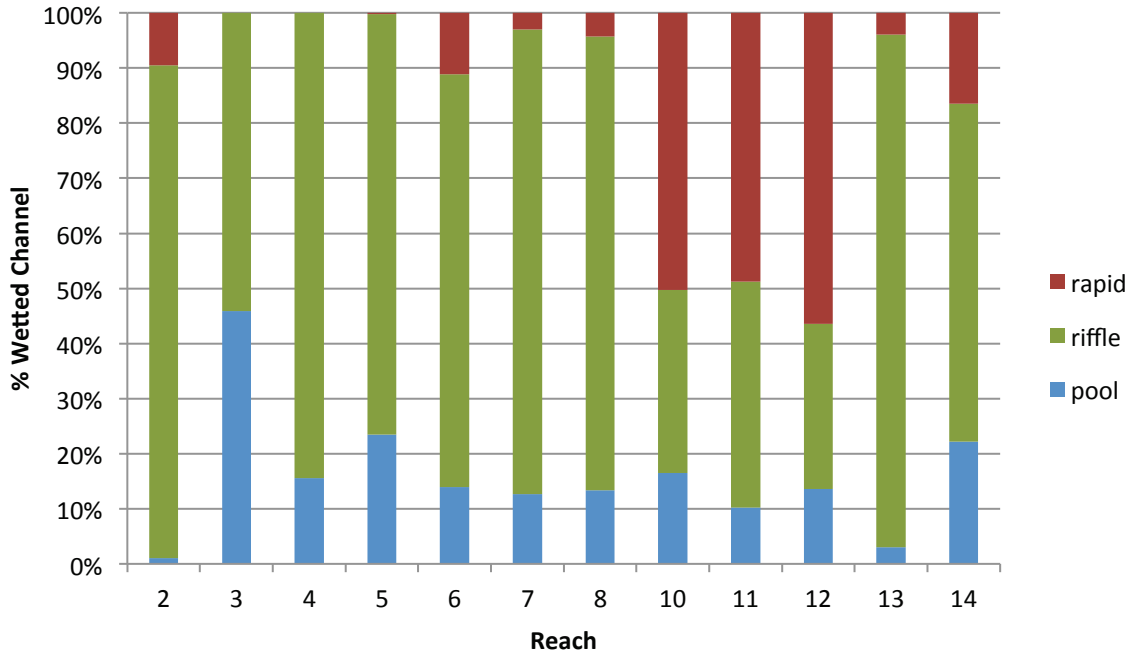
**Figure 4-6 2012 Cheakamus River Geomorphic Units**

Areas for each morphologic unit (riffle, pool, or rapid/cascade) are summarized by reach in **Table 4-2** and illustrated in **Figure 4-5** and **Figure 4-6**. The baseline mapping of the units is found in **Appendix B**. Together, these units correspond to the areal (wetted) fraction listed in **Table 4-1**. Outside of the bedrock canyon reaches the majority of the lower Cheakamus River is characterized as riffle. The riffles tend to be very long, connected features with smaller pool units located at the channel margins.

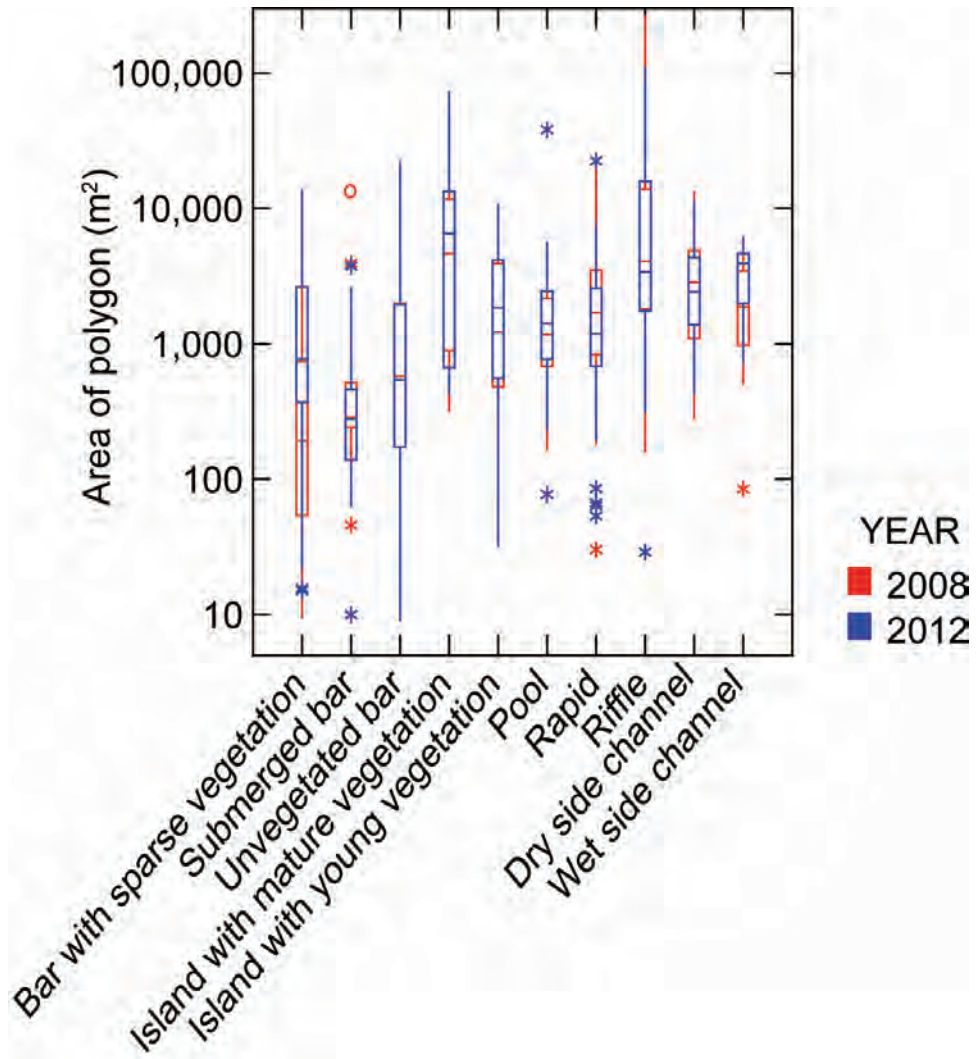
An increase in deviation from the mean signals increased morphologic complexity, while a decrease indicates that the channel is becoming more homogenous. Statistically the variance associated with each of the units was unchanged.

Figure 4-7 Box plot illustrating area of each habitat and morphological unit in 2008 and 2012

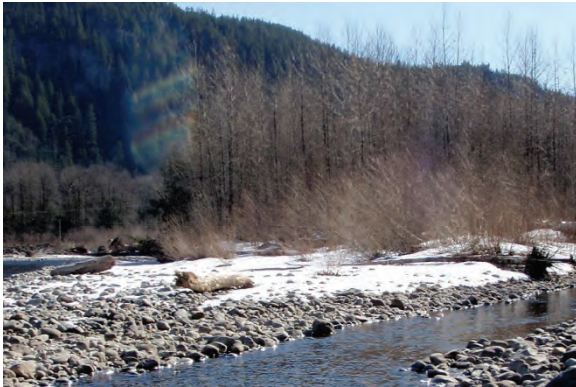
Sparse shrub in foreground with young island (immature trees) behind

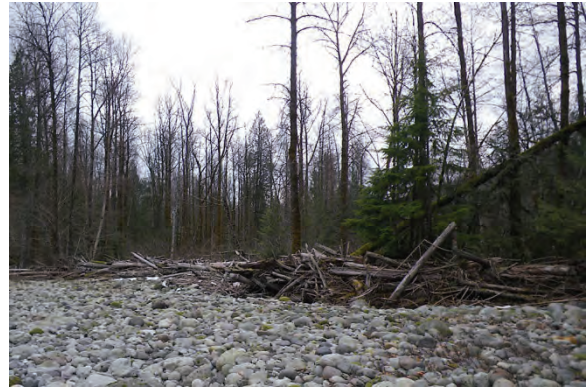
Mature island (mature trees) with woody debris in foreground

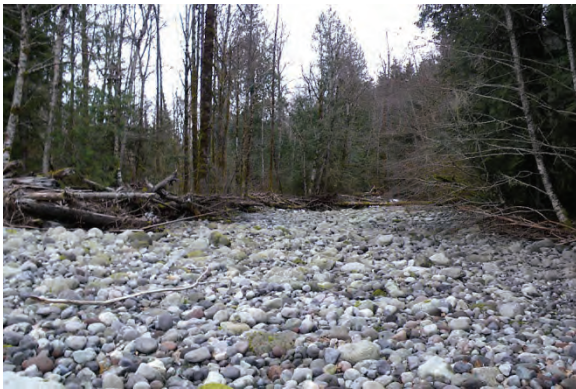
Start of side channel going off to right; dry at low flow (approx. 23 m<sup>3</sup>/s)

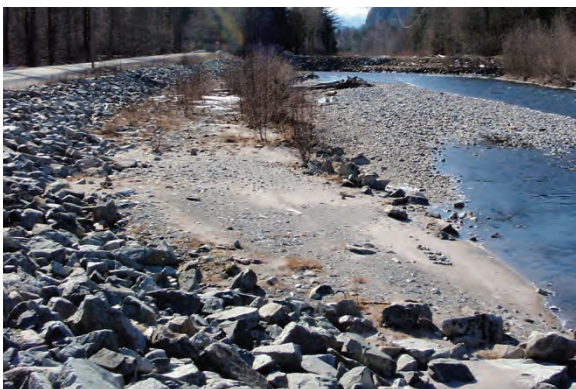
Typical riprap bank protection with adjacent bar displaying sparse shrub

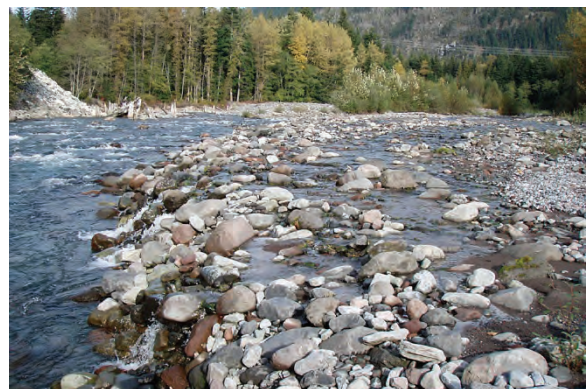
Edge of Rubble Creek alluvial fan showing water flowing over surface

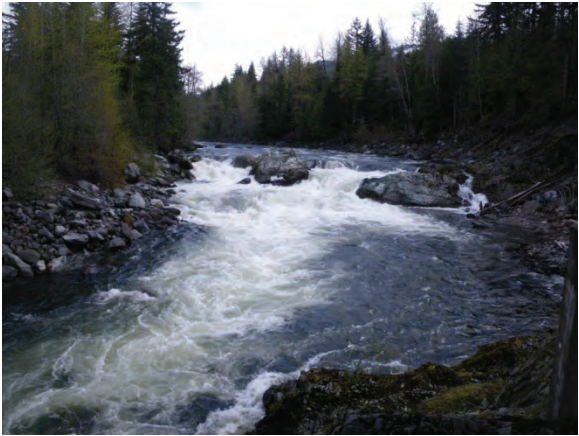
Rapid/Cascade

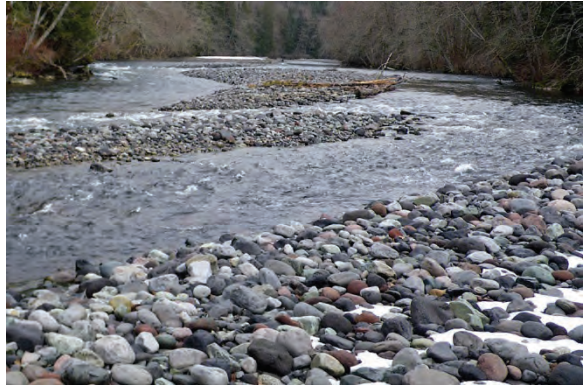
Riffle

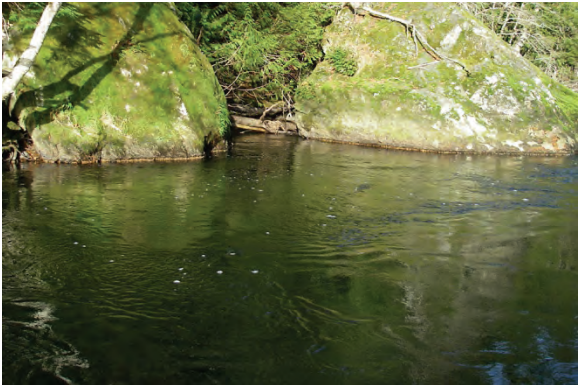
Pool
