Cheakamus Project Water Use Plan

Cheakamus River Channel Morphology Monitoring

Implementation Year 6

Annual Progress Report

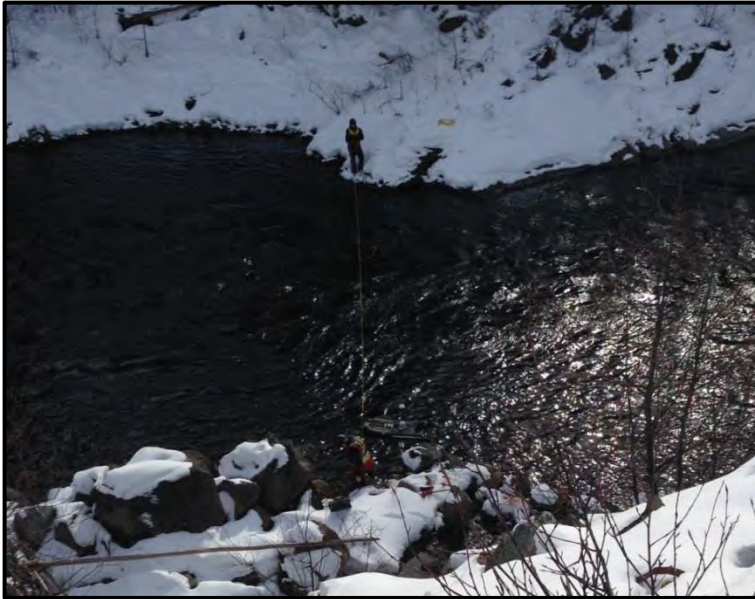
Photo 1: Discharge Measurement Cross-section at Cheakamus River Chance Creek FSR (Photo taken 2014-02-26)

KWL determined that the most reliable and safe cross section for ADCP discharge measurements is at a constriction approximately 300 m downstream of the bridge (see Photo 1, below).

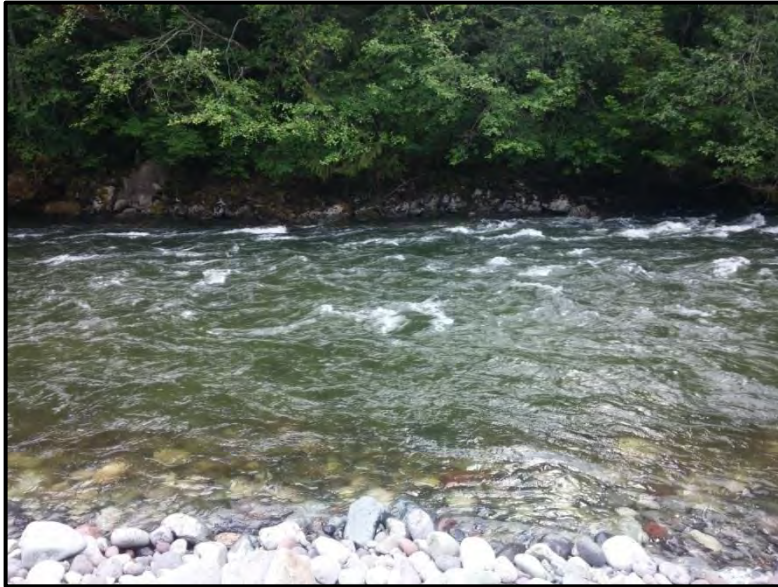
Photo 2: Original Cheakamus River Pedestrian Bridge Discharge Measurement Cross-section (Photo taken May 21, 2014).

All flow measurements were collected using a SonTek M9 ADCP. Measurements from January 18, 2014 to May 21, 2014 were collected just upstream of the Pedestrian Bridge. However, during a higher flow event KWL noted that standing waves began affecting the quality of the discharge measurement at this location. On May 22, a new cross-section was established for discharge measurements, located about 400 m downstream of the bridge. The downstream location provides much better GPS signal and had no significant standing waves in the range of flows measured. This location was used for all subsequent discharge measurements.

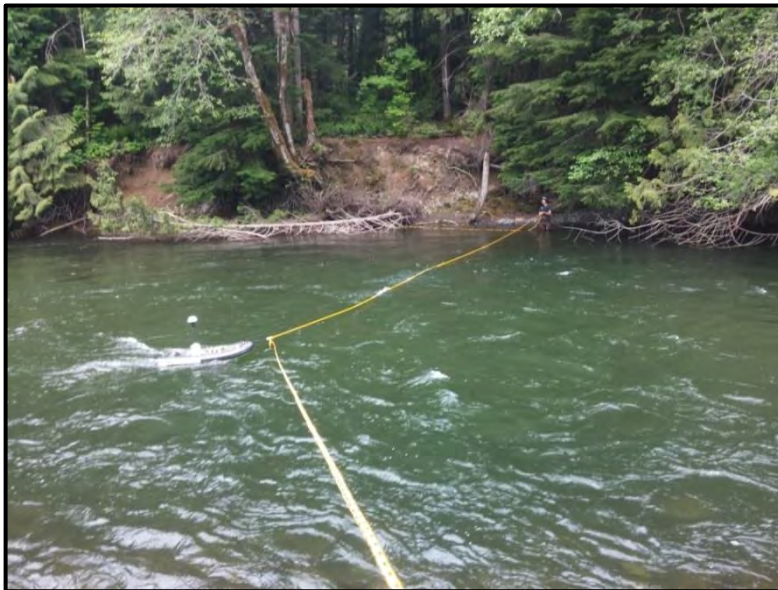
Photo 3: Re-located Cheakamus River Pedestrian Bridge Discharge Measurement Cross-section (About 400 m Downstream of Photo 2) (Photo taken May 22, 2014).

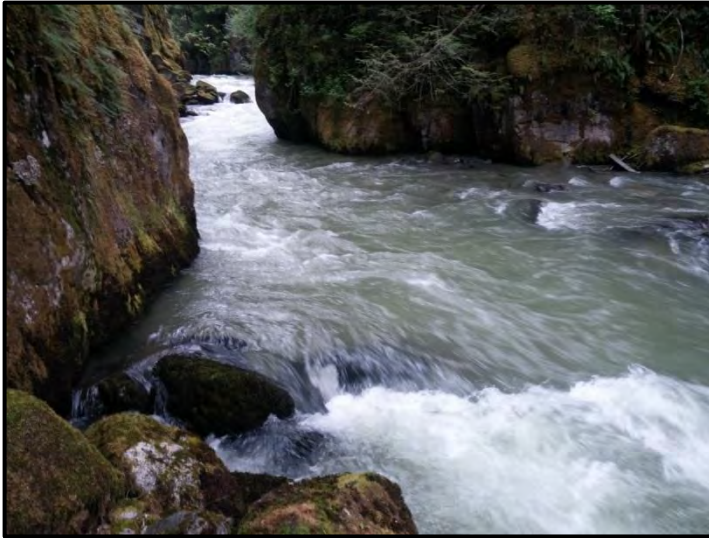
Photo 4: Culliton Creek Salt Injection Location (Photo taken May 21, 2014)

Flow measurements at this station were performed using salt dilution gauging, using a Sommer TQ-Tracer system. Salt was injected to the creek just below the Railway Bridge, and the resulting concentration signal was measured between 400 m and 600 m downstream relative to the injection location (see Photos 4 and 5, below).

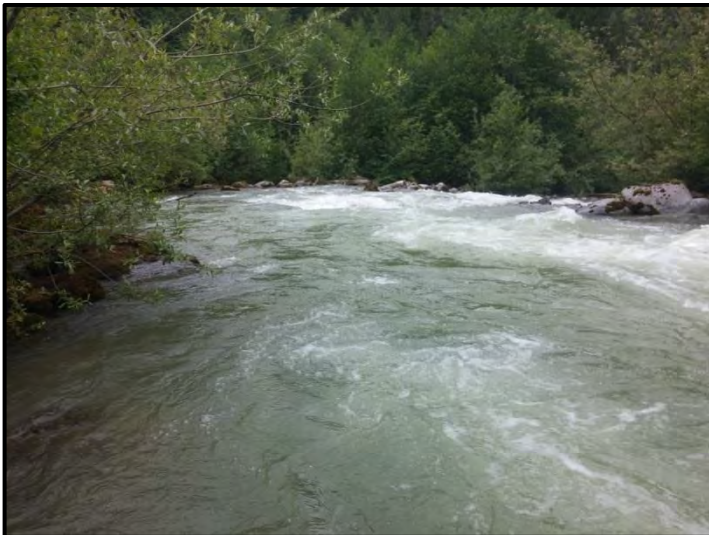
Photo 5: Culliton Creek Salt Concentration Measurement Location (Photo taken May 22, 2014)

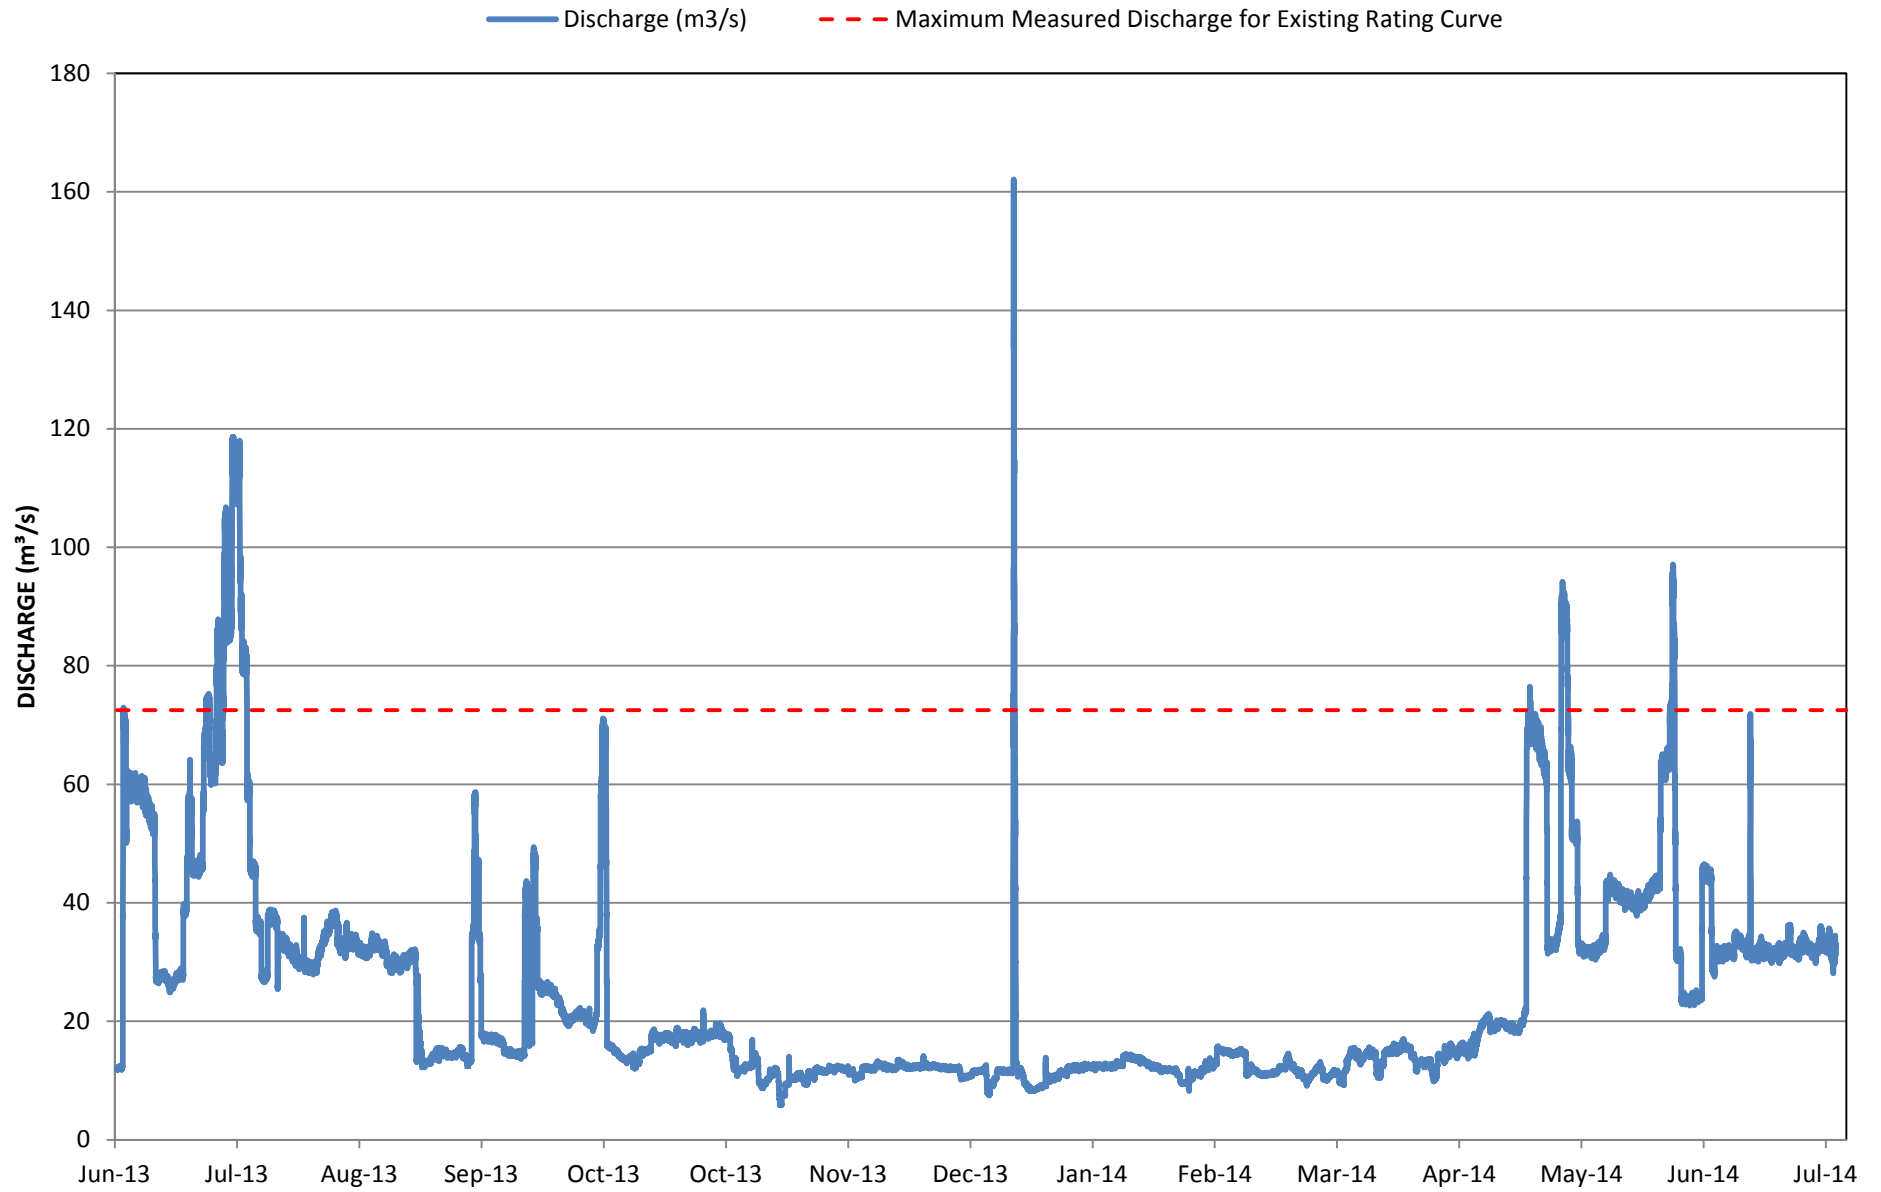
FIGURE B-1

Cheakamus at Chance Creek Discharge CMSMON-8 Year 6

Figure B-1 in Appendix B presents the discharge time series based on the available water level data downloaded during the Year 6 period.

As presented in Appendix B, the Cheakamus River Chance Creek FSR water level data available at the time of writing this report cover the period June 3, 2013 to July 30, 2014. No significant losses of data occurred in the Year 6 monitoring year.

As indicated in Figure B-1, flow at the Chance Creek station exceeded the recommended upper limit of applicability of the stage-discharge relationship 5 times during the Year 6 monitoring program. The majority of these exceedances were brief; however, on June 27, 2013 the limit was exceeded for 7.5 days.

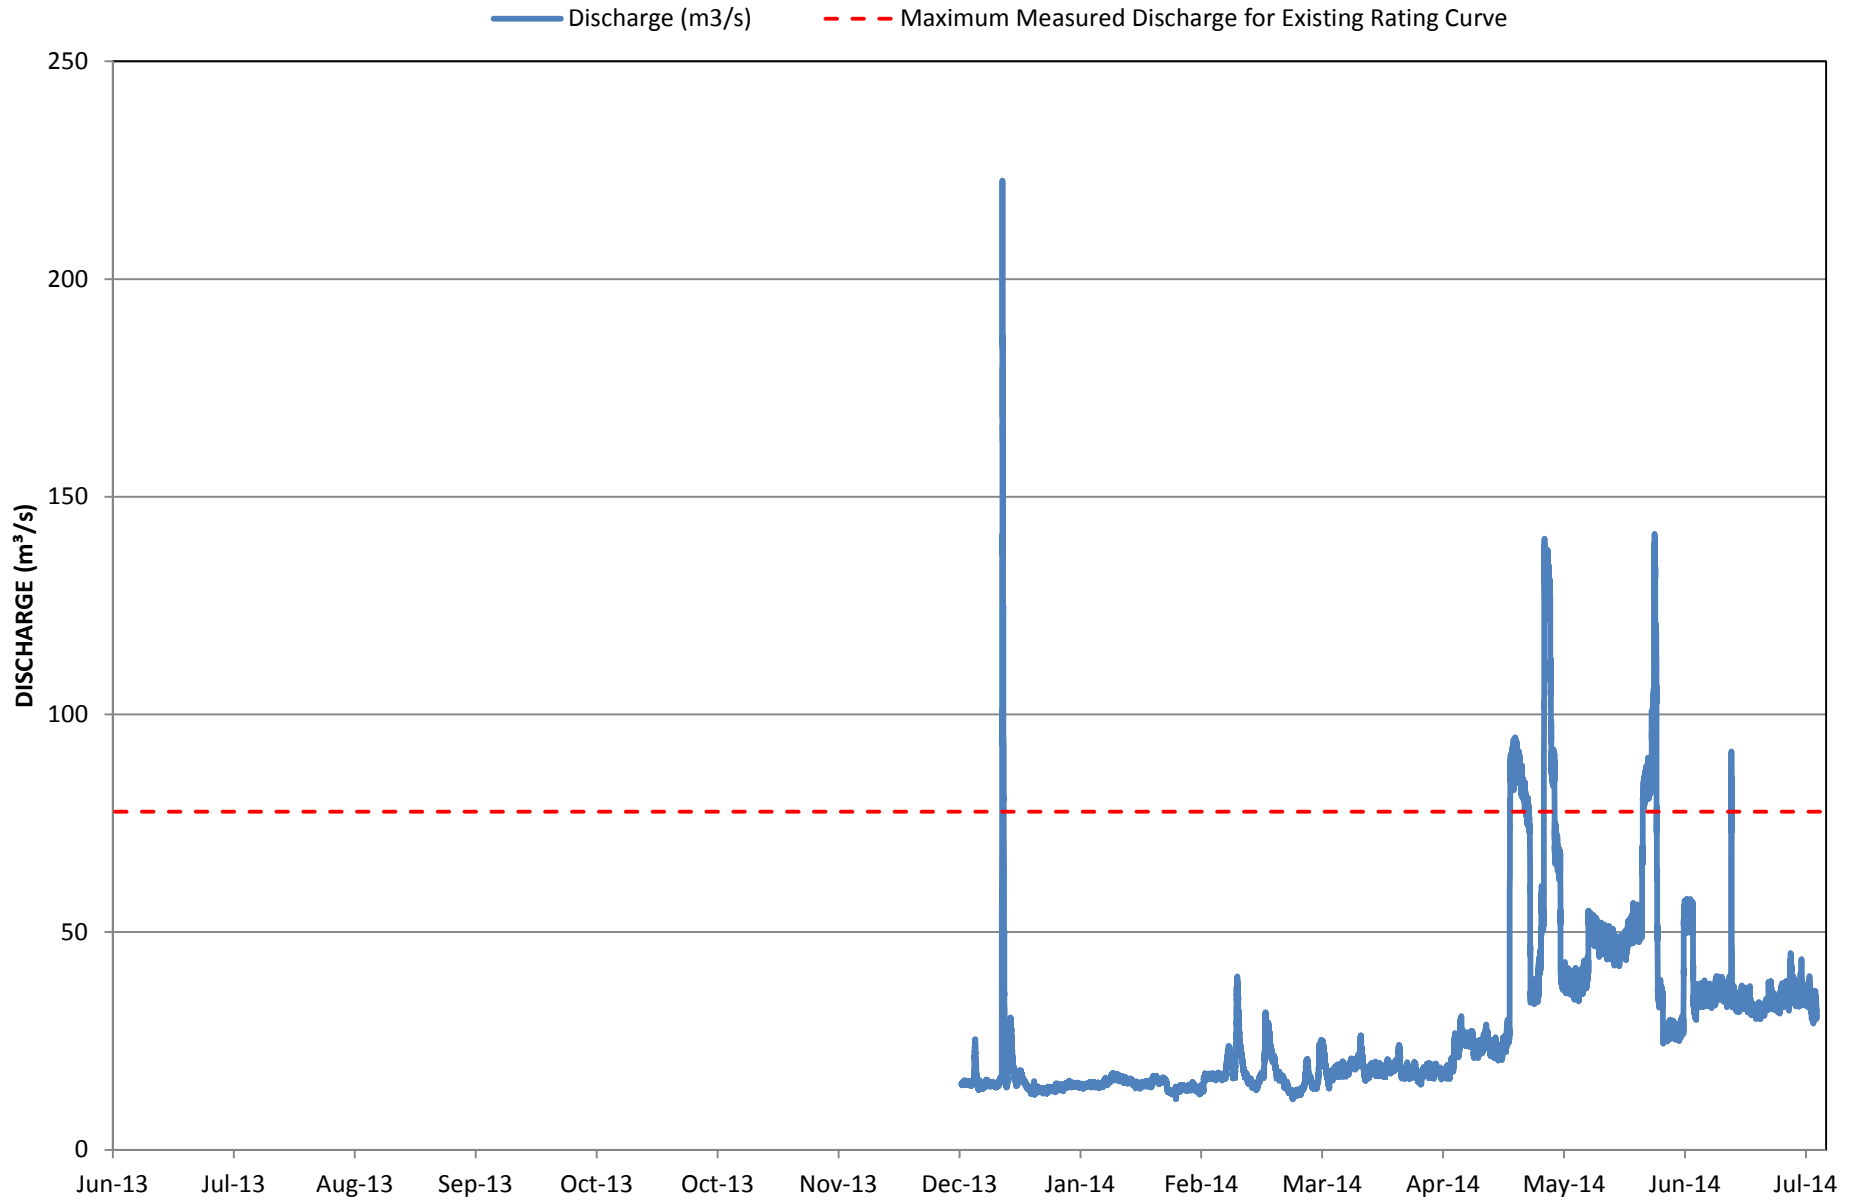
FIGURE B-3

New Cheakamus Pedestrian Bridge Discharge CMSMON-8 Year 6

Figure B-3 in Appendix B presents the discharge time series for the New Pedestrian Bridge station. The water level data available at the time of writing this report cover the period from December 30, 2013 to July 30, 2014.

The New Pedestrian Bridge station exceeded the recommended upper limit of applicability for the stage-discharge relationship 4 times during the 2013 monitoring program. Two of these instances were brief; however on May 15, 2014 the limit was exceeded for 4.5 days and on June 16, 2014 for 3.5 days.

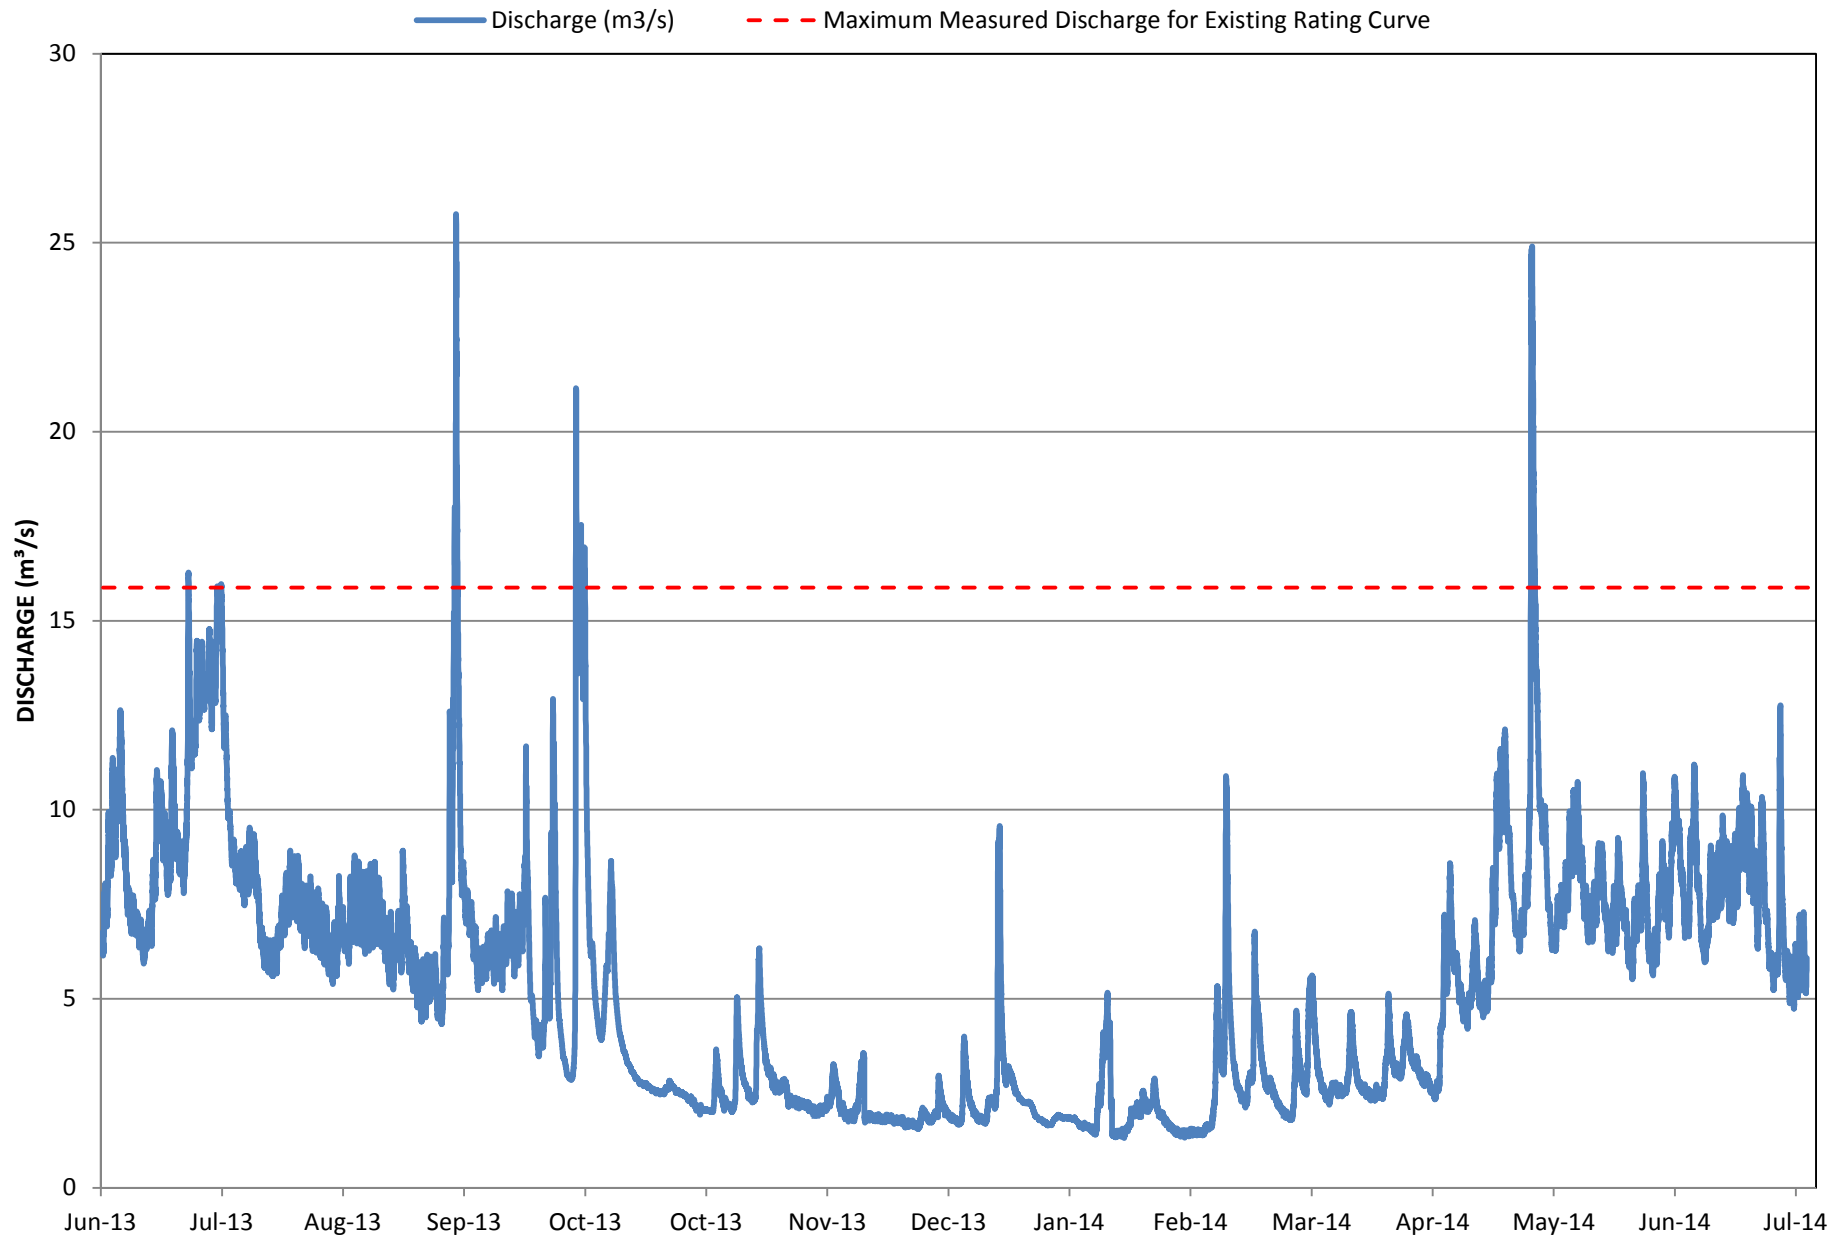
FIGURE B-4

Culliton Creek Discharge CMSMON-8 Year 6

Figure B-4 in Appendix B presents the discharge time series for the Culliton Creek station for the period of available record at the time of writing this report (June 3, 2013 to July 30, 2014). No significant losses of data happened in the Year 6 monitoring period.
