***BRIDGE COASTAL RESTORATION PROGRAM  
2002-2003***

***COQUITLAM RIVER  
Overland Off-Channel Habitat Development***

Coquitlam River Off-Channel Rehabilitation 2002-2003

BCH 02.CO.09

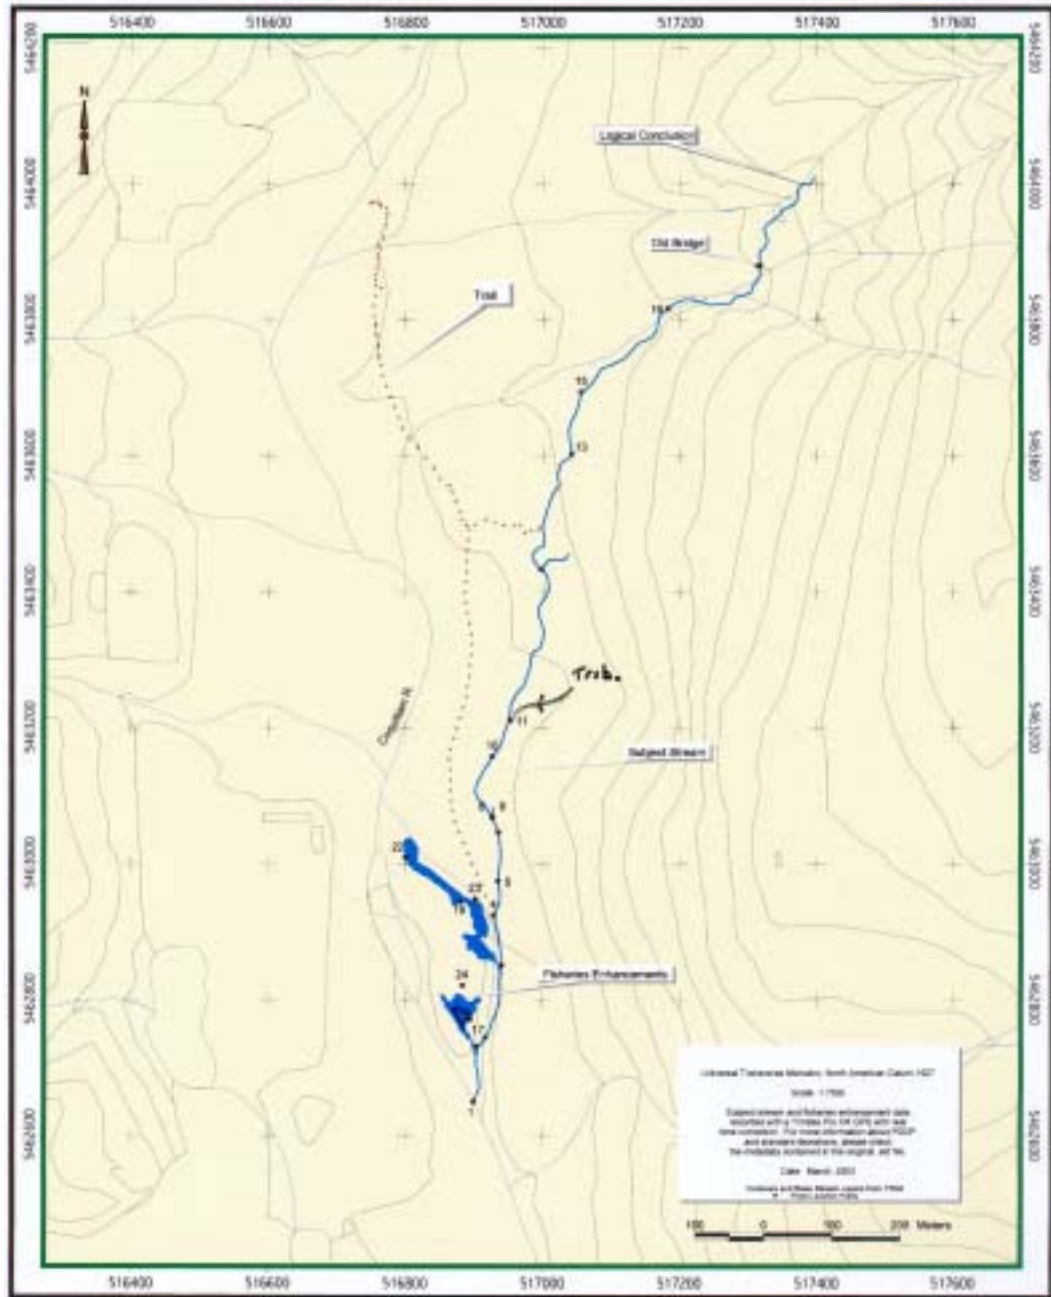
1

*Figure 1.  
GPS mapping  
of the site and  
adjacent  
habitat.*

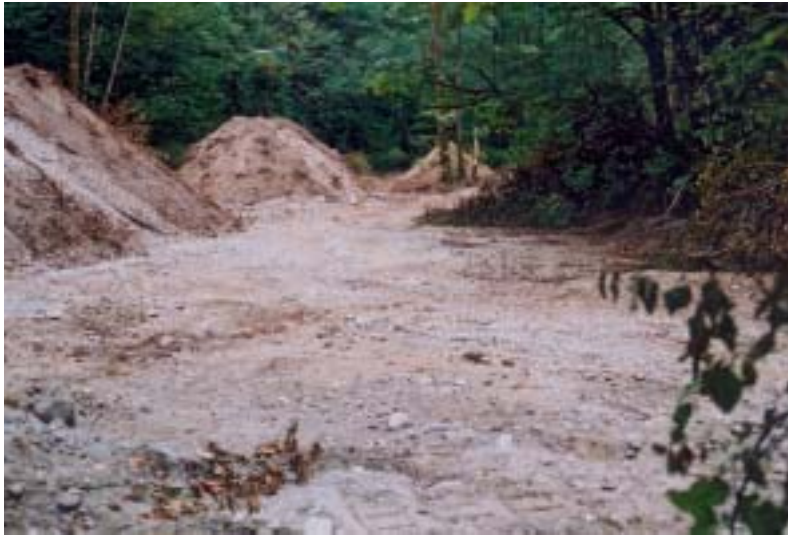
2

**Figure 2.**  
North end of  
site looking  
south to north  
pond after  
clearing brush  
and soil

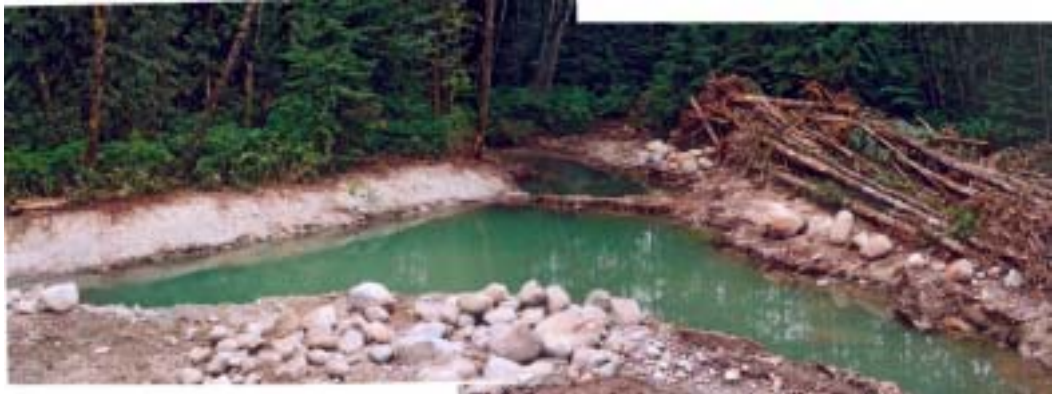
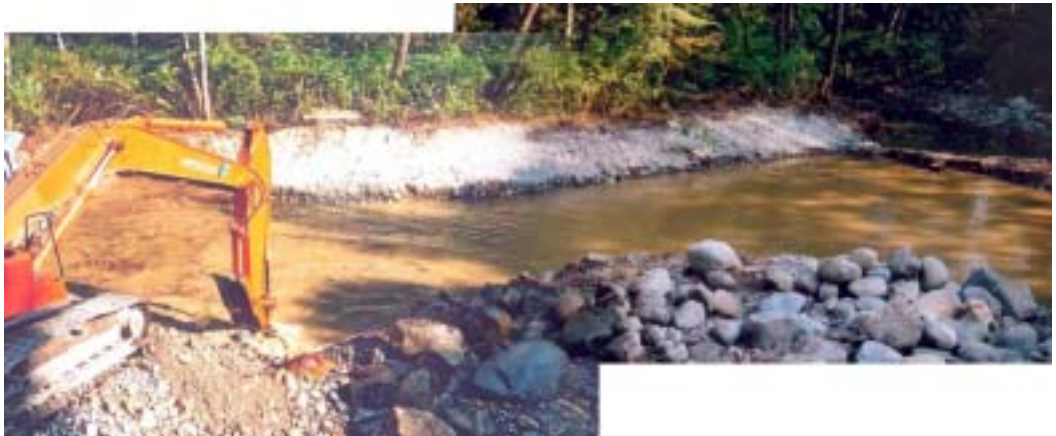
**Figure 3 & 4.**  
South Pond  
during  
construction  
showing  
separation  
berm after  
settling over  
night (3) and  
during  
construction  
(4)

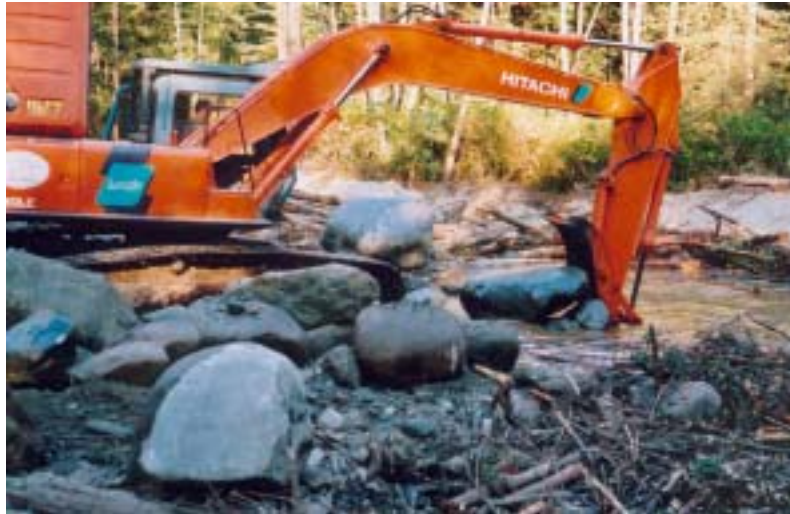
5

**Figure 5.**  
South pond  
during  
deepening  
work

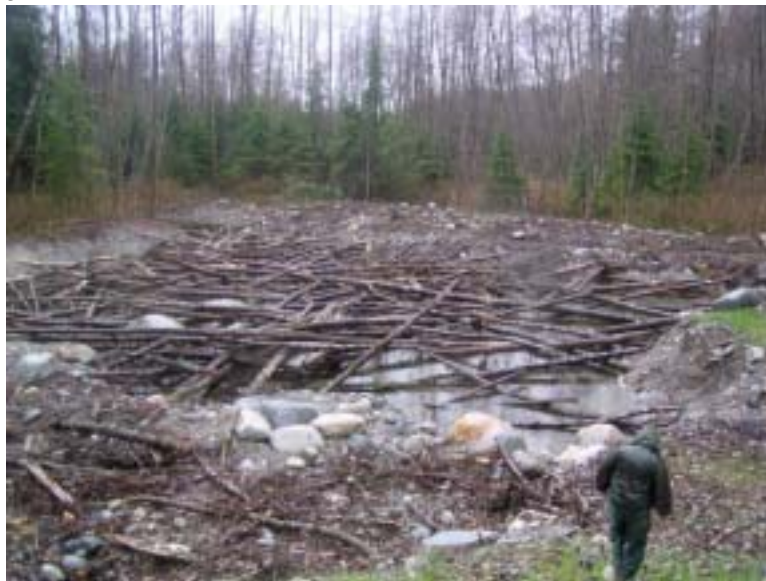
6

**Figure 6.**  
South pond  
several  
months after  
construction  
(looking  
south-  
southwest)

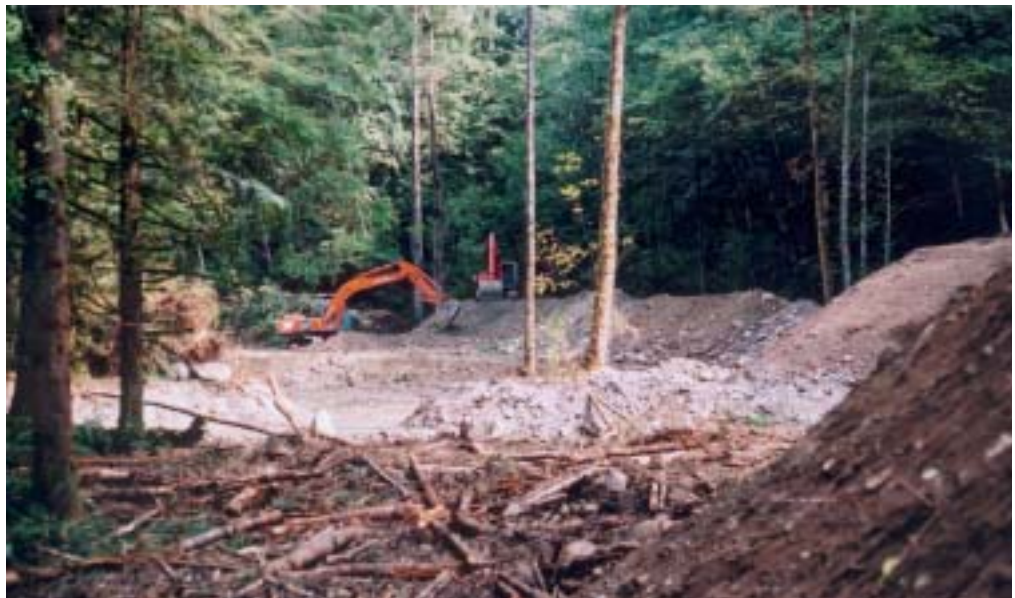
7

**Figure 7.**  
Looking east-  
northeast to  
the north half  
of the north  
pond.  
Machines are  
spoiling the  
shallow pass  
gravel onto a  
separator  
berm to  
protect the  
habitat from  
the Unnamed  
Creek to  
which it  
drains.

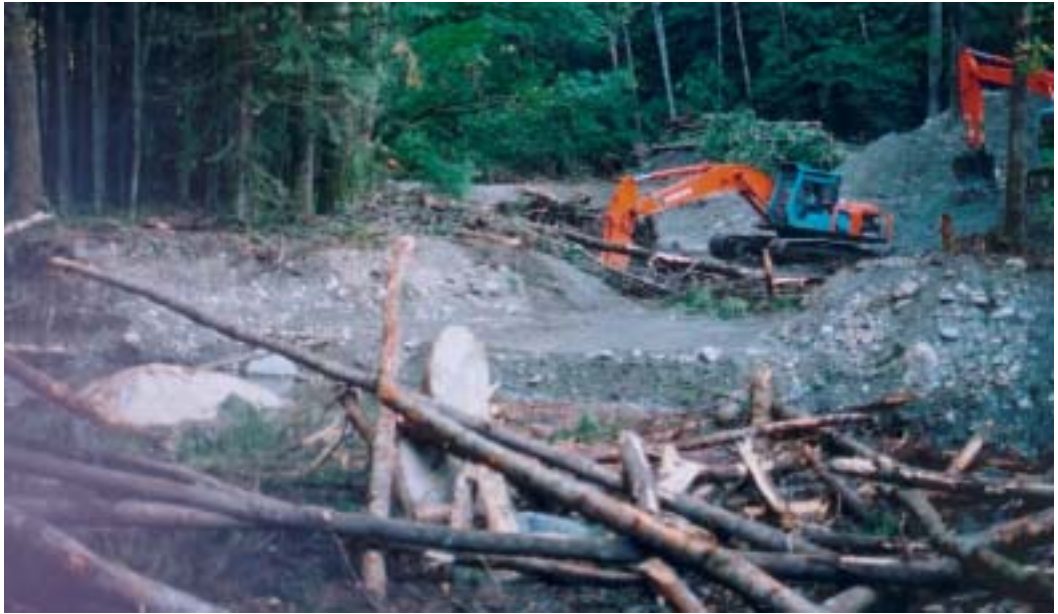
8

**Figure 8.**  
Excavators dig the deep portions of the north end of the north pond, as seen from south edge of the north pond.

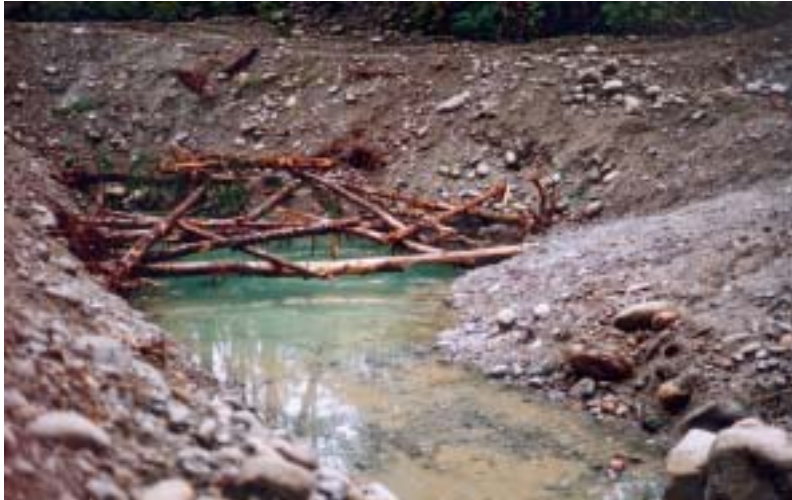
9

**Figure 9.**  
Upstream end of the groundwater channel before the final grading of the channel.

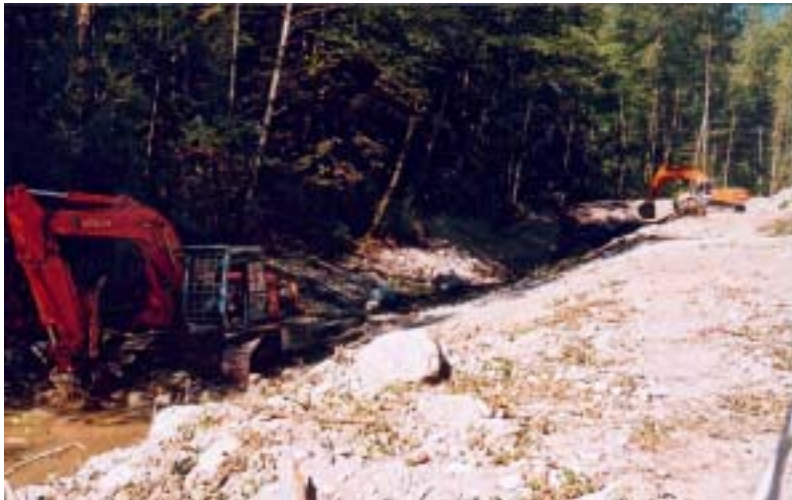
10

**Figure10.**  
Excavators dig the groundwater channel. Foreground machine is digging final grade and background machine digs the second pass to finish the width of the full channel and grading.

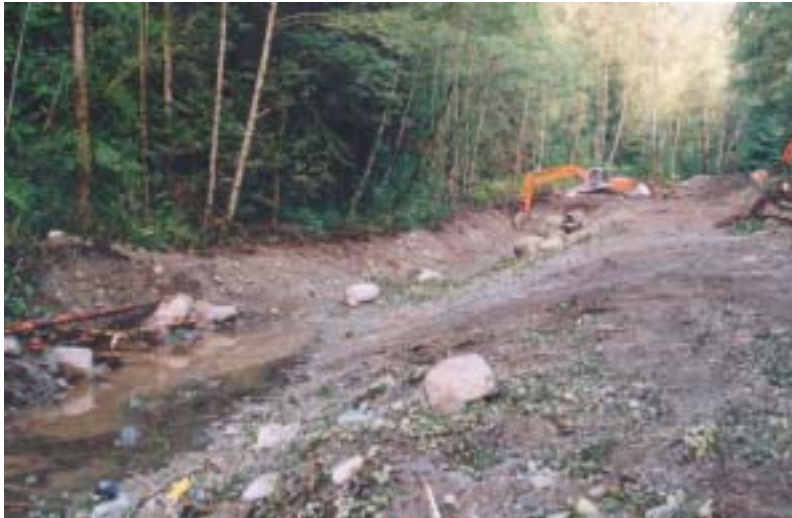
11

**Figure 11.**  
 This shows the channel in Figure 9 with the first 15 metres and an alcove complete. The machines are busy with grading and placing large woody debris at the far upstream channel end.

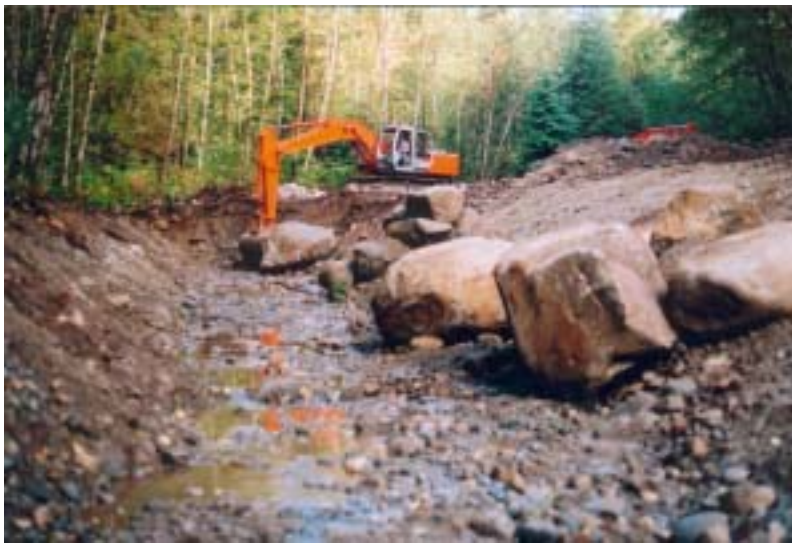
12

**Figure 12.**  
 During the first excavation pass work at the channel elbow slowed to move large diameter river boulders

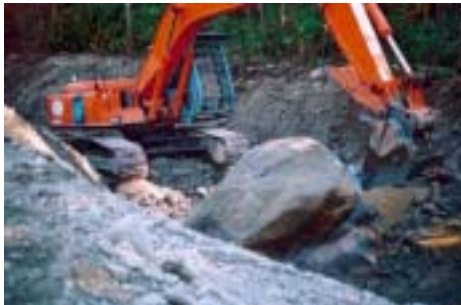
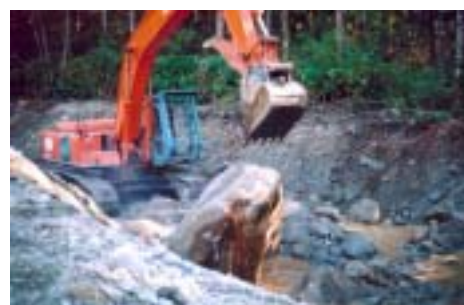
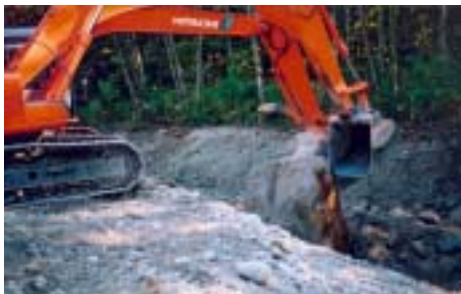
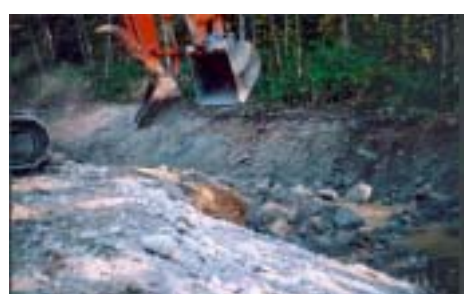
**Figure 13 to 16.** One of the boulders (8-10 foot size) required the two machines cooperating to move it so the channel elbow could pass.

**Figure 16.** Ultimately, the machines could only manage to place that large on the channel bank.

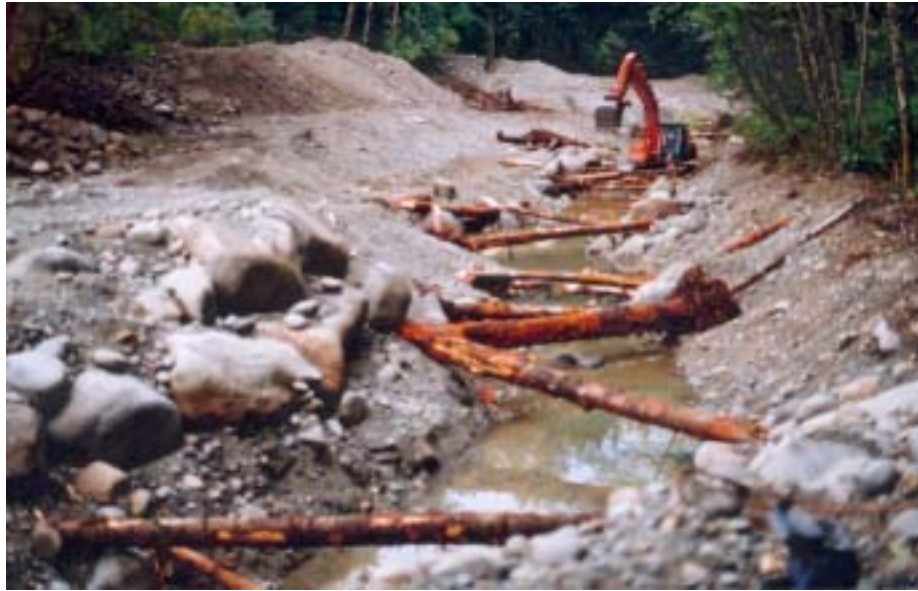
17

**Figure 17.**  
The groundwater channel nearly completed with wood and rock. The groundwater is half a foot deep (September, 2002).

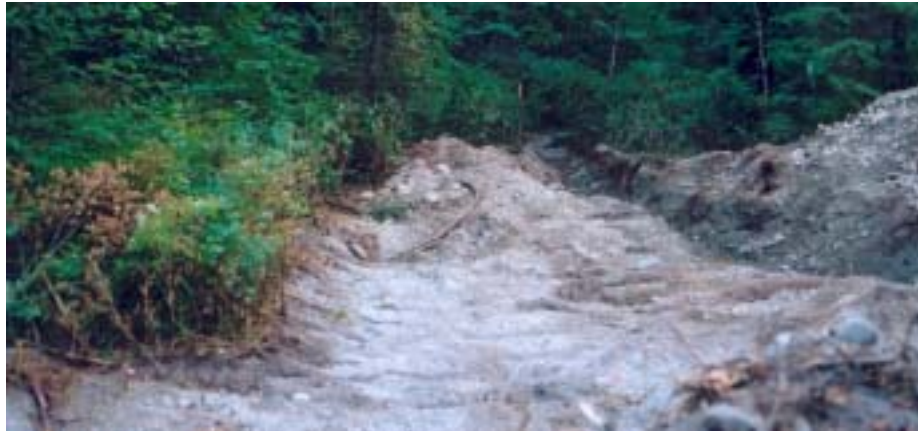
18

**Figure 18.**  
While digging the connection to the Unnamed Stream, we discovered an old rail and steel wire rope. They crossed the outlet roughly parallel to the Unnamed Stream.

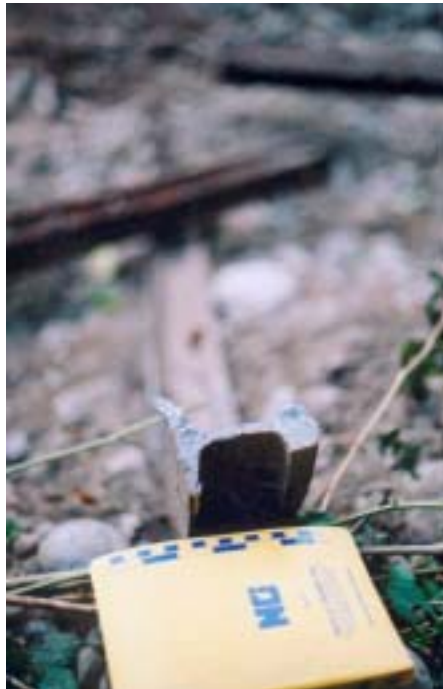
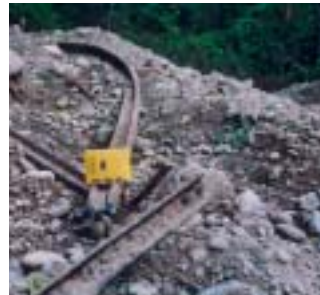
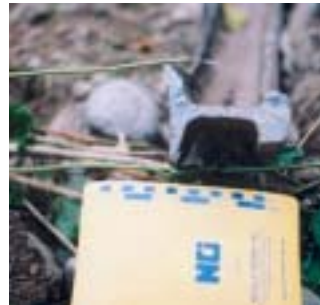
**Figures 19 to 21.** The rail segment we removed was 12 feet long and we broke it to remove it. The rail was three feet below ground, probably buried during the flooding of the mid 1950s.

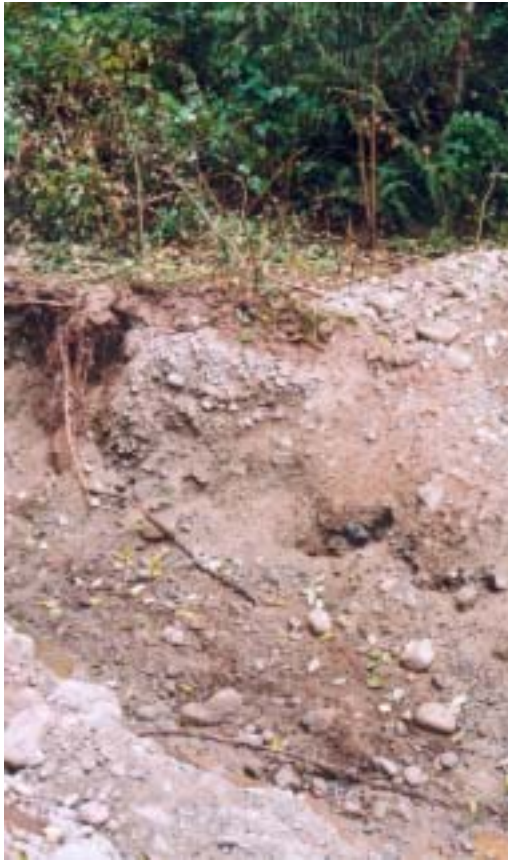
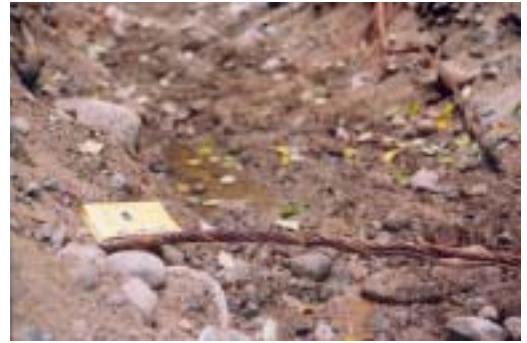
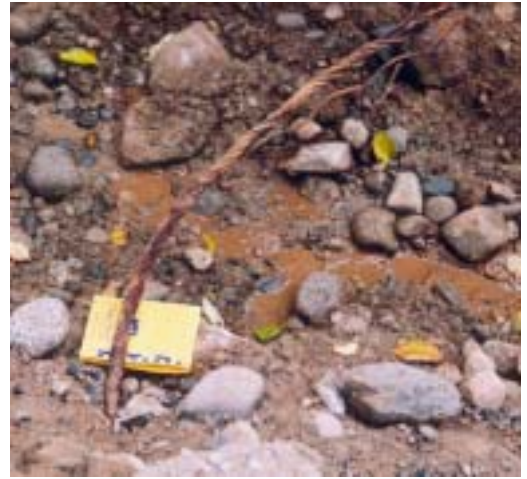
*Figures 22 to 24. The 1-inch diameter wire rope was near the rail but did not have a consistent depth.*

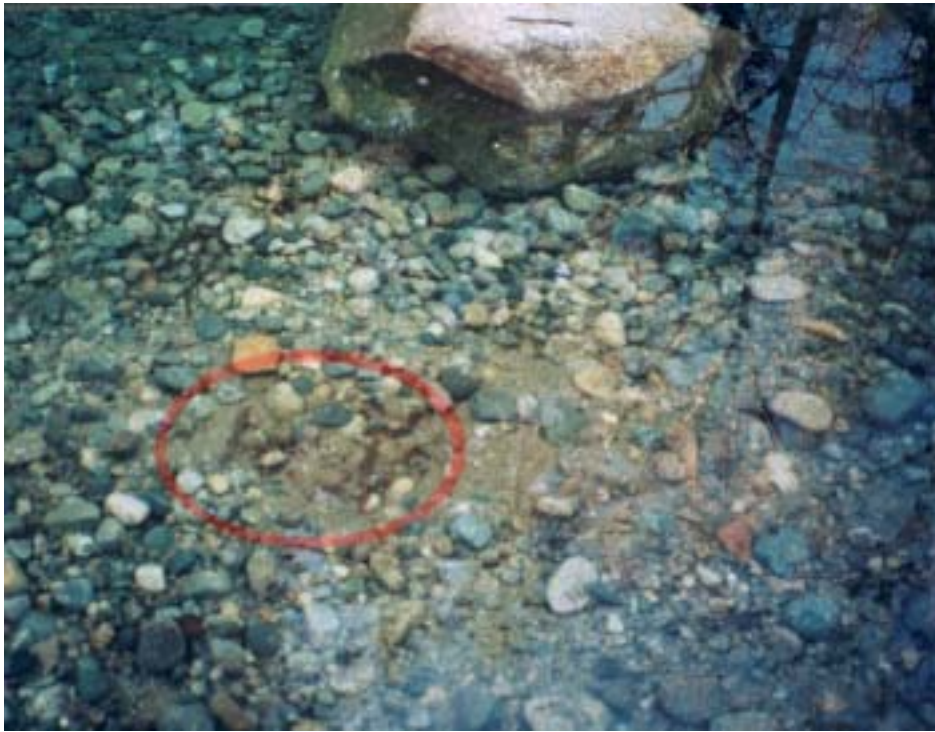
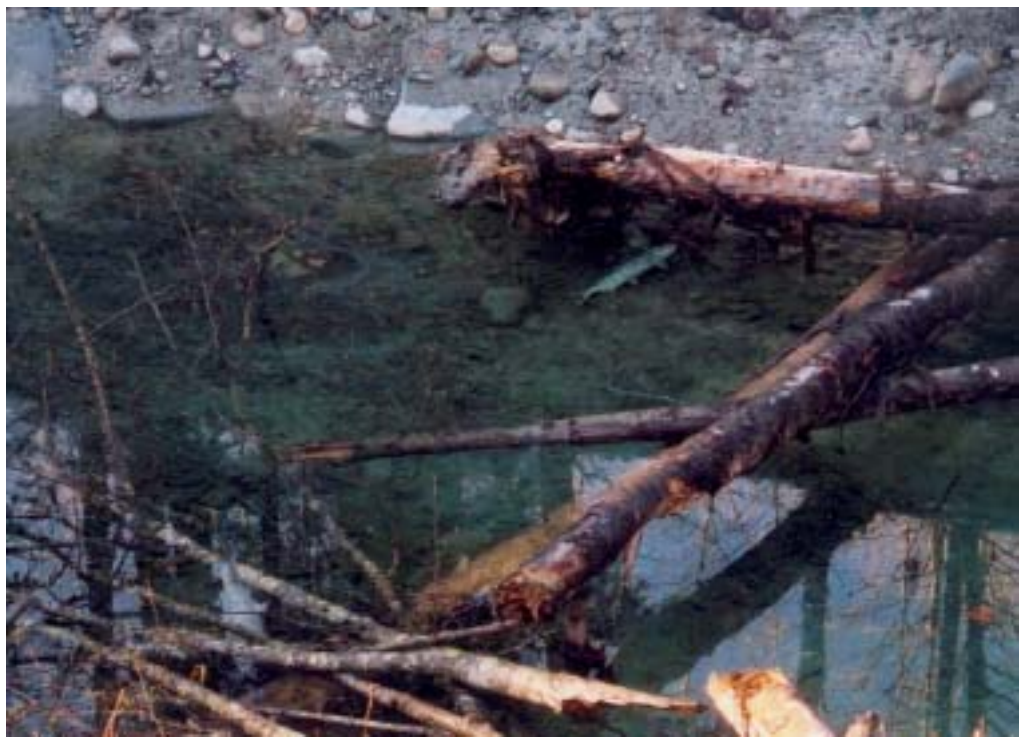
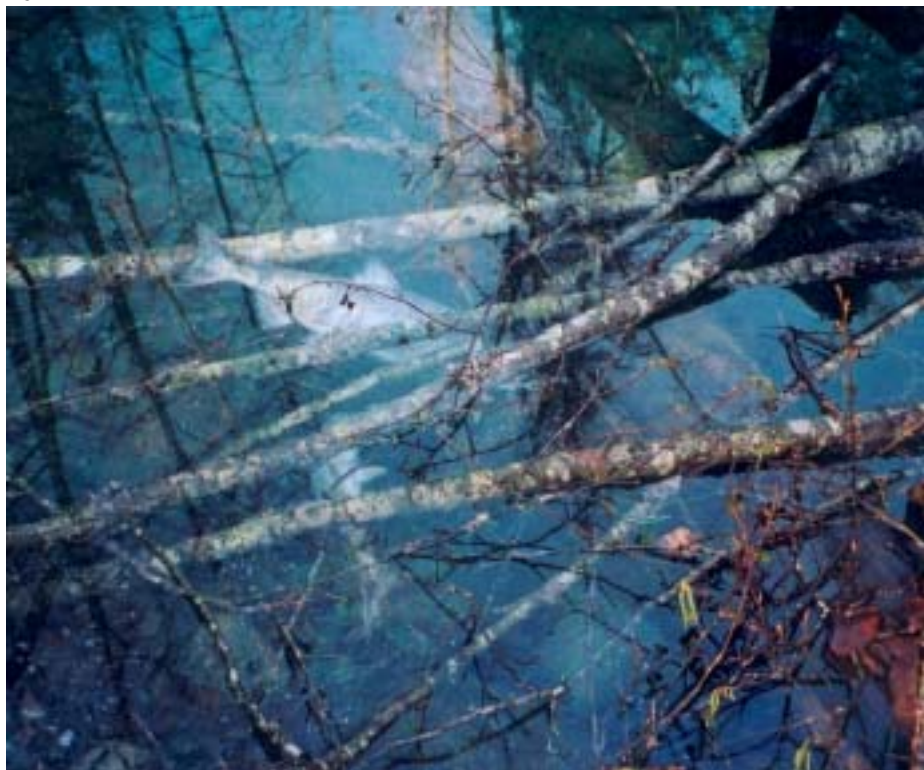
*Figures 25 to 27. We found fish carcasses and activity in the fall and spring.*

*Figures 26 and 27. Fish carcasses found in the north pond show access is OK.*

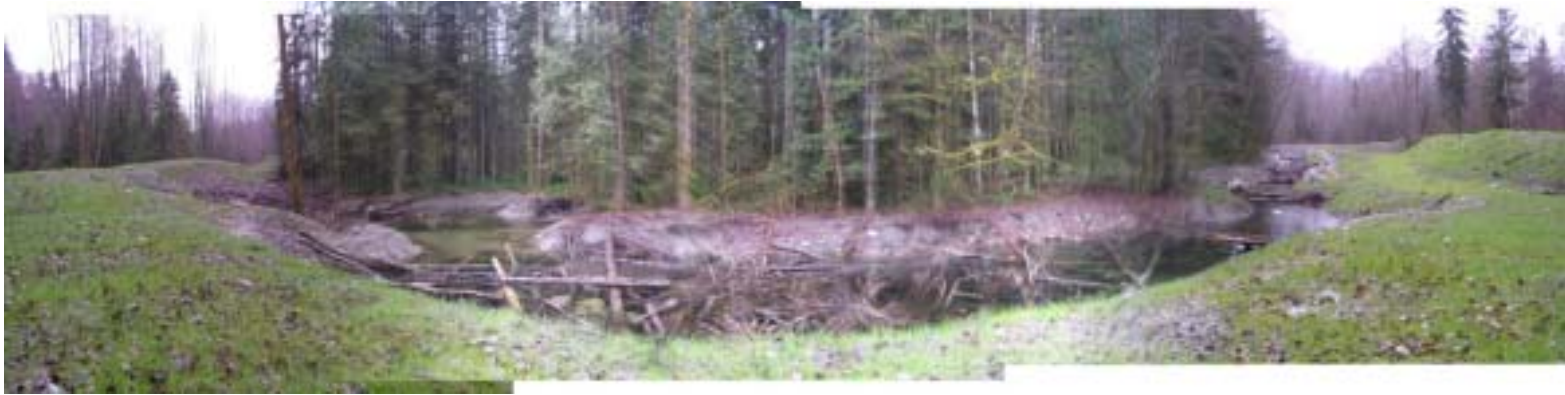
28

**Figure 28.**  
*Panorama pivoting on the north end of the north pond. The south half of the north pond is visible at left and the groundwater channel is visible at right.*

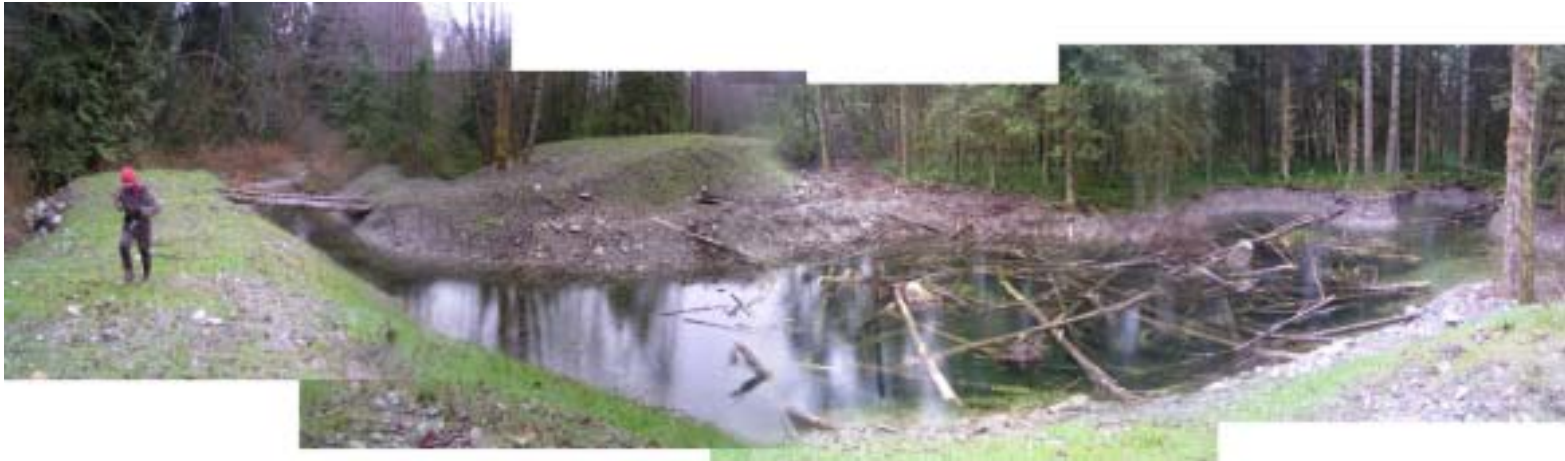
29

**Figure 29.**  
*Panorama pivoting on the east bank of the south end of the north pond. The outlet to Unnamed Stream is visible at left and the south half of the north pond is visible at right.*
