Huwer Groundwater
Channel Feasibility Study
04.Sh.04
Final Report

Prepared for:
Whitevalley Community Resource Centre Society

Prepared by:
Thomas Minor, BSc, CET

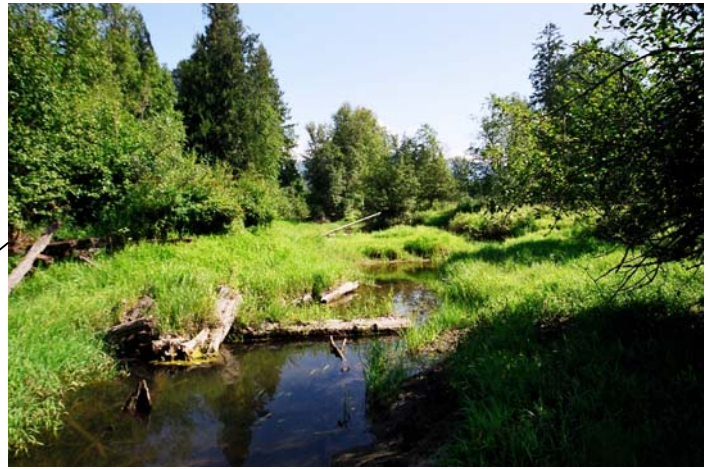
The groundwater creek has some riparian cover along approximately 80% of its length even though cows have full access.

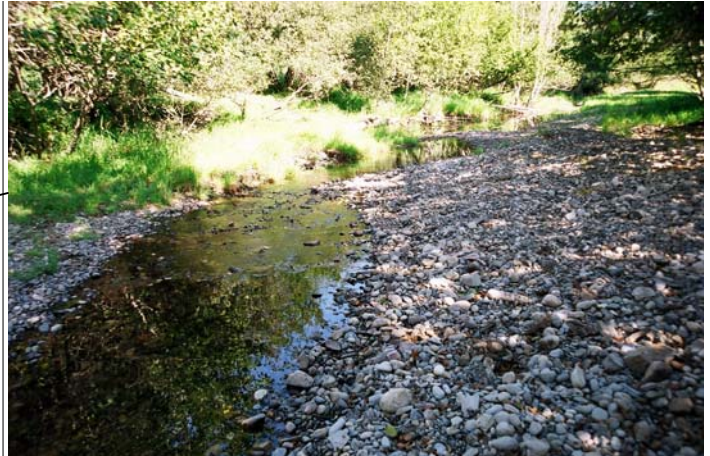
The substrate is largely gravel downstream of the beaver pond ranging from 0.5 – 6 cm.

At the head of the creek is an old beaver pond (Figure 3). The substrate of the creek is largely gravel downstream of the beaver pond ranging from 0.5 – 6 cm (Figure 4). The creek has some riparian cover along approximately 80% of its length even though cows have full access.

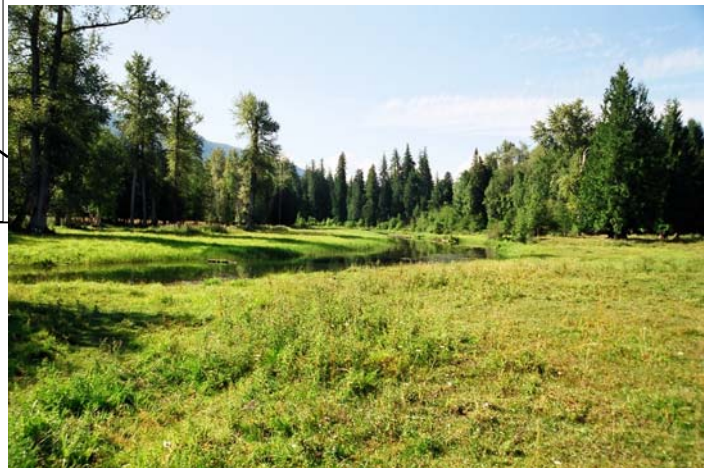
The beaver pond (right) is open and shallow. The intermittent channel upstream of the beaver pond (background) is heavily vegetated with trees and shrubs.

Figure 3: an illustrated map of the creek on the Huwer property showing some of the main features.

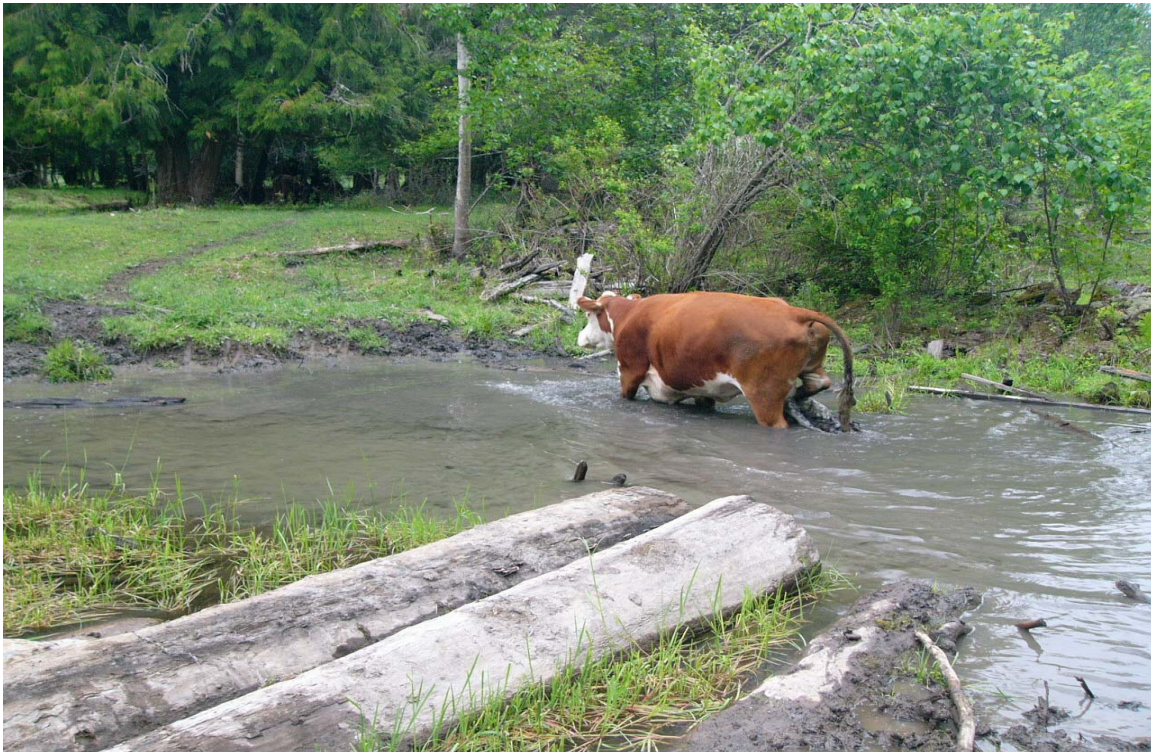
Figure 4: Cattle trample the banks and cause sedimentation and nutrient loading that has accelerated the eutrophication of the pond and the reduction of groundwater flow to the creek.

Currently cows have access to the majority of the creek and cause considerable sedimentation and bank trampling that has resulted in a wider, shallower creek in the areas of heavy congregation (Figure 4).

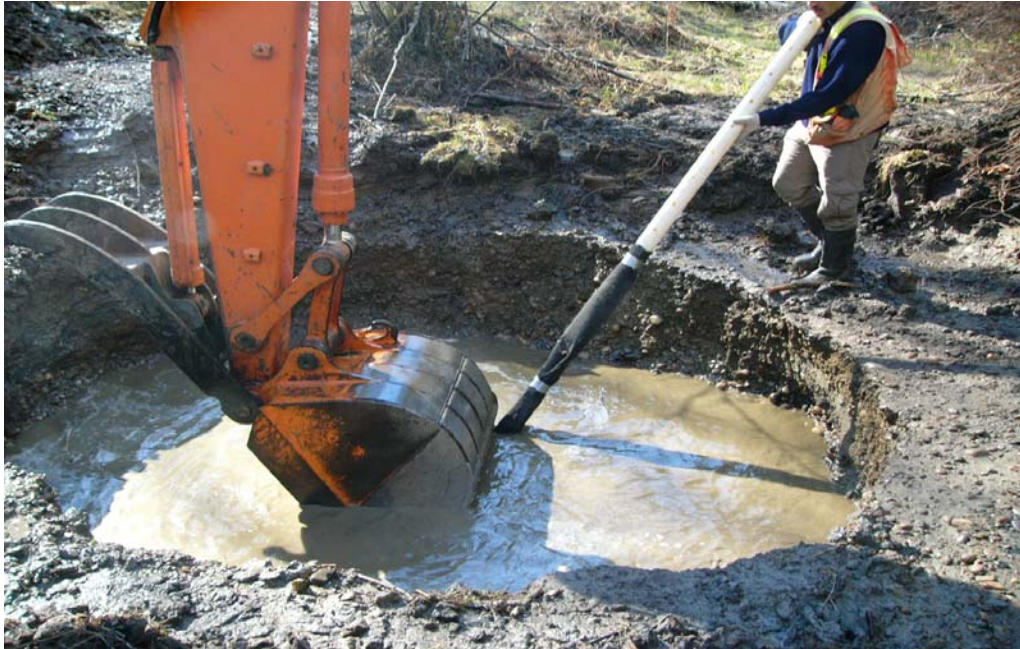
Figure 5: The monitoring wells were made of 3.05 m lengths of 10.2 cm perforated plastic pipe that was wrapped with filter cloth. They were buried about 2.8 m below ground level with 0.2 m of pipe exposed above ground.

The standpipes were made of 3.05 m lengths of 10.2 cm perforated plastic pipes placed approximately 2.8 m deep. The bottom half was wrapped in filter cloth to prevent sediment from filling the pipes when back filling. The holes were dug during the last week in April with a Hitachi 120 excavator.

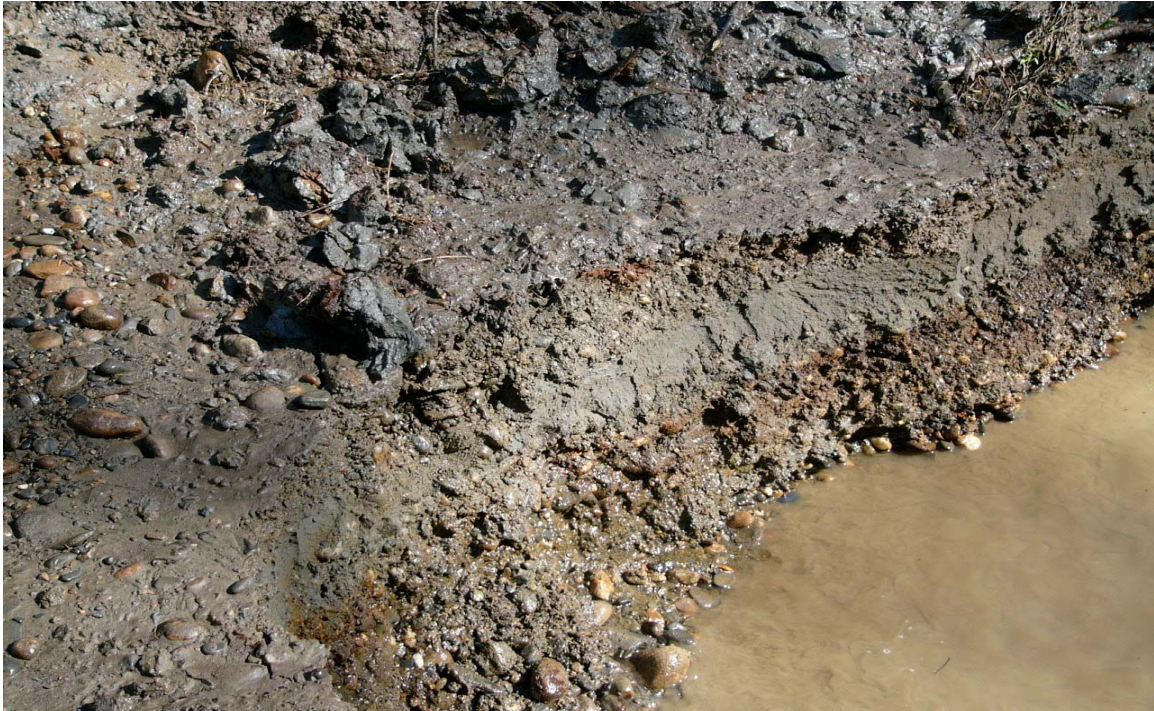
Figure 7: The soil at all 8 monitoring wells consisted of about 15 - 30 cm of organic soil covering layers of sorted sand and gravel.

The soil was similar at each well site. There was a top layer of organic material 15 – 30 cm deep. Below that were alternating layers of sand and gravel (Figure 7). The gravel was sorted and varied in size from 0.5 to 10 cm in different layers.

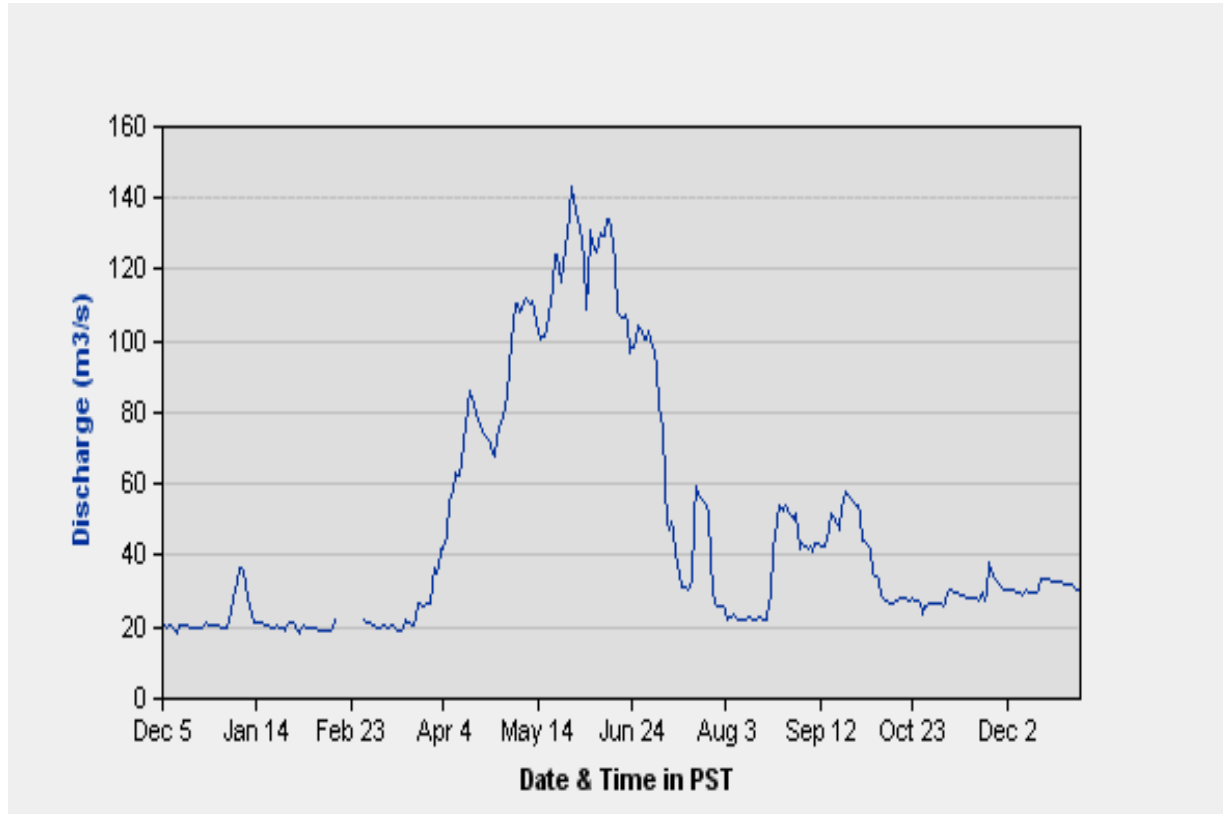
Figure 8: Shuswap River hydrograph measured below the Wilsey Dam from December 2003 to Jan 2005. The lowest river levels during the period of testing were in August.

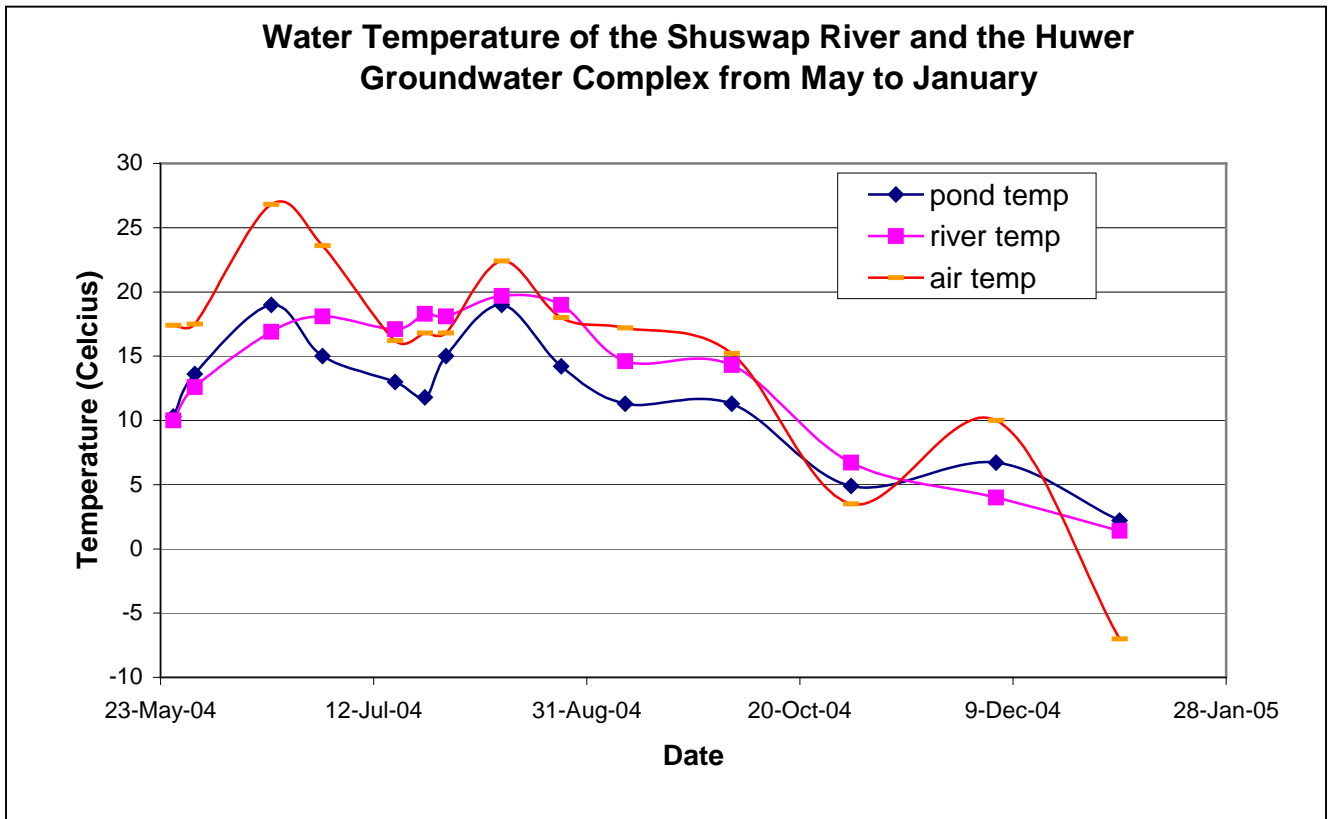
Figure 11: Graph showing the temperature and dissolved oxygen level of the pond compared to the river. Except for the brief hot period in June, the pond was slightly cooler than the river during the summer despite the shallowness and low flow in the pond. During the winter months, the pond is slightly warmer than the river.

The temperature and dissolved oxygen levels of the pond and the river taken throughout the year are shown in Figure 11. During the summer the pond stayed cooler than the river except for some very warm weather in June. At the time, the river flow was around 120 m³/s and influence more by the high rate of snowmelt rather than by the warm air temperatures. In November, the river temperature dropped below the pond temperature. The pond is shallow (< 1m) and open with a slow turnover rate and therefore susceptible to warming by insolation and high air temperatures.

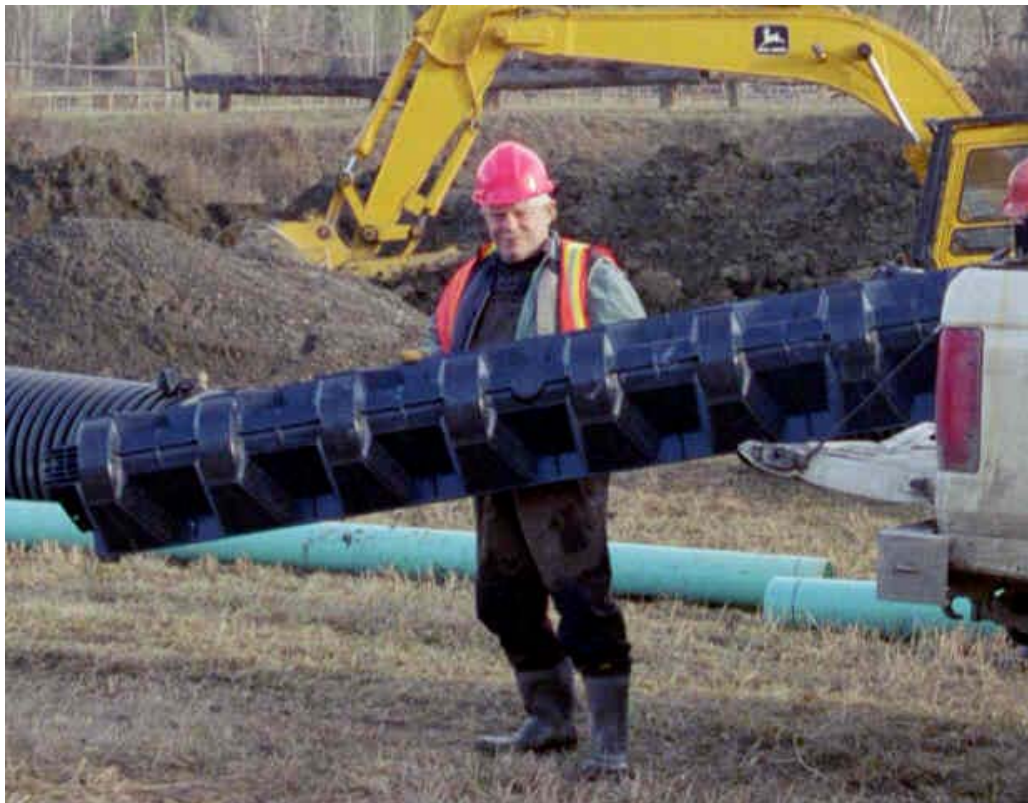
Figure 12: Worker holding a section of infiltration gallery. The infiltration galleries are shaped like an inverted “V” with an open bottom. The sides have fine louvered openings so that they are permeable to water but resist filling with sand (Figure 12). They have been used successfully by DFO and WCRC on several projects.

The hydraulic conductivity for well-sorted gravel ranges by several orders of magnitude, from 0.01 to 1.0 cm/s (C.W. Fetter, 1988). The open area of the equalizer 24 infiltration gallery is approximately 0.53 m² per linear meter giving in inflow rate of 5.3⁻⁵ m³/s to 5.3⁻² m³/s or 1.86⁻³ ft³/s to 1.85 ft³/s per linear meter of gallery. While this makes predicting the infiltration rate difficult, experience has shown that by following the clean gravel seams while installing the galleries, infiltration rates can be kept at the mid to high end of this range. In the plan designed by DFO, there is 327 m of gallery. This should be more than enough to keep the 375 mm pipe at the lower end of the gallery full. A full, smooth-walled 375 mm pipe at a 0.39% slope will deliver approximately 5.2 ft³/s (using a Hazen-Williams roughness coefficient of 140). DFO expects a minimum of 5 ft³/s. This would triple the current low flow of 1.2 ft³/s.
