BC HYDRO WINTER STORM REPORT

October 2006 – January 2007

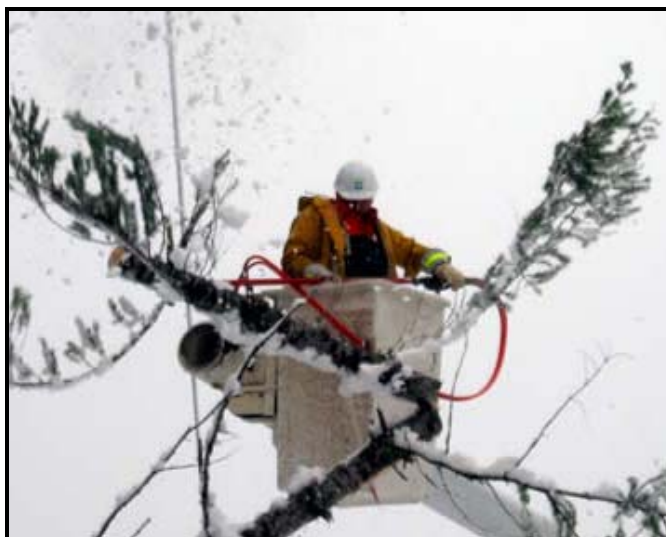
In Northern B.C., heavy, wet snow toppled trees and limbs onto distribution lines.

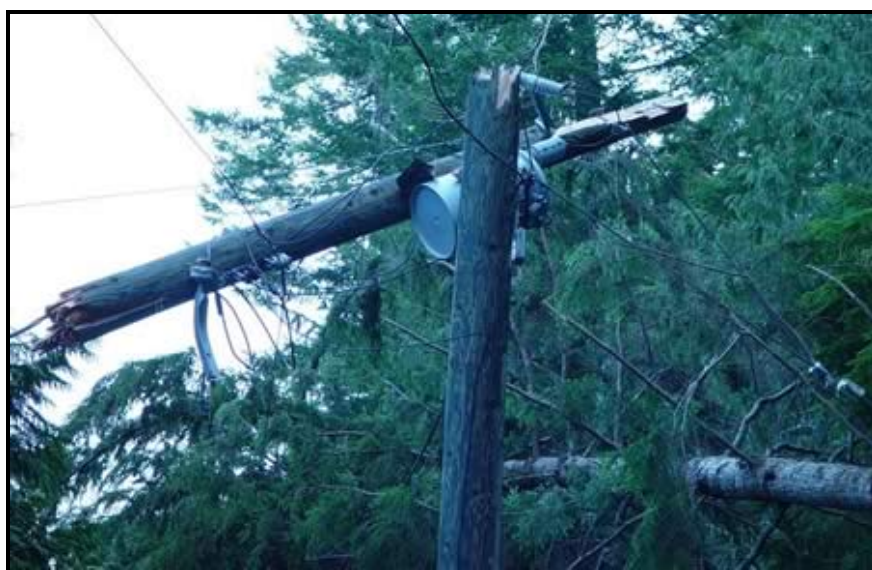
Trees and adverse weather are the most significant causes of outages, totaling 77% of all customer-hours lost for fiscal year 2007.

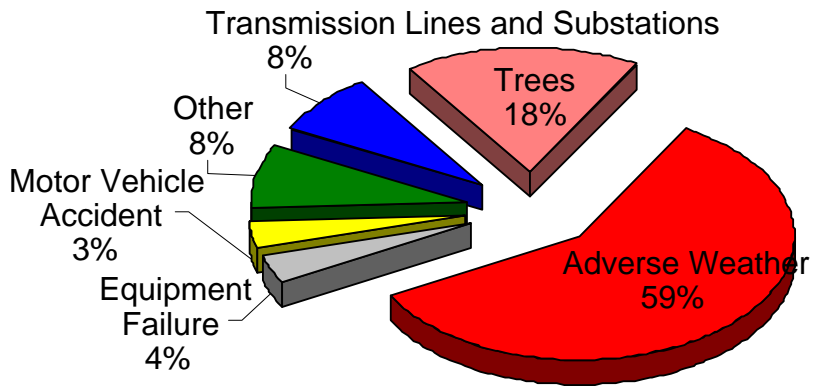
F2007 Causes of Outages (19.6 Million Customer Hours Lost)

The BC Hydro distribution system serves over 1.7 million customers in a service area encompassing 854,000 km² with about 48,000 km of overhead and 7,800 km of underground distribution lines. As shown in the graphs below, most power outages in fiscal year 2007 were caused by interference with the distribution system (92%), while the remainder related to transmission line and substation outages.

Trees and adverse weather are the most significant causes of outages, totalling 77% of all customer-hours lost for fiscal year 2007. This is up from 44% in the previous year. The power goes out when: trees or branches fall on power lines and either bring them down or short them out; when snow, wind and rain cause trees and other debris to fall on our lines or knock down our poles; when a car hits a pole; or when animals or people contact our lines.

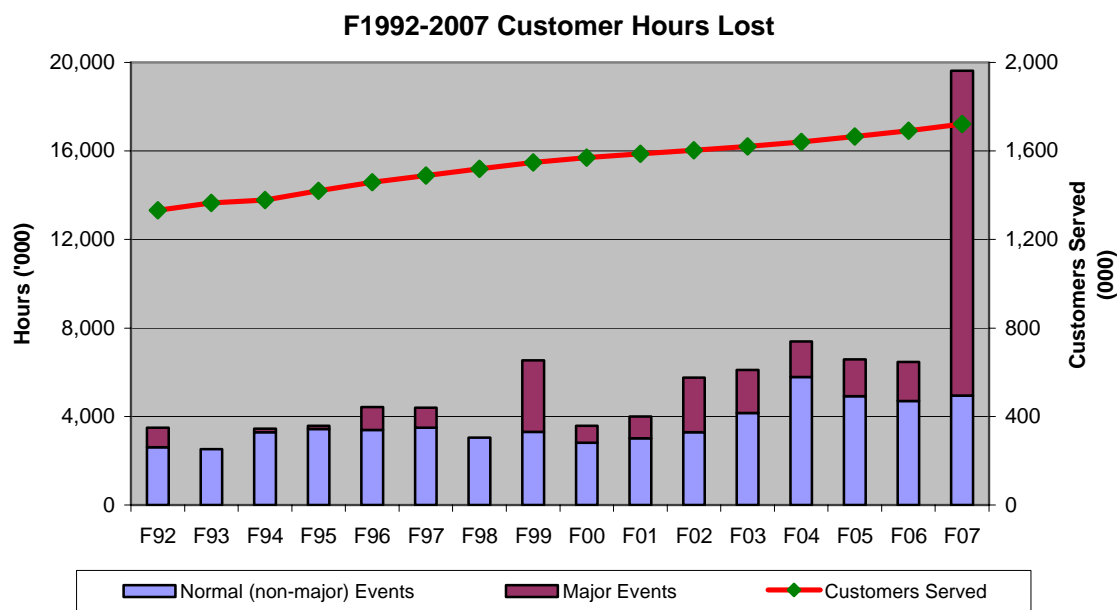
Chart 10.3.2: Customer Hours Lost (Normal and Major Events 1992-007)

The series of major wind and snow storms this winter caused widespread disruption to the distribution system, resulting in 14.7 million customer-hours lost. This represents 75% of the 19.6 million customer-hours lost in fiscal year 2007. Prior to this, as chart 10.3.2 indicates, the highest total customer-hours lost was 7.4 million in fiscal year 2004.

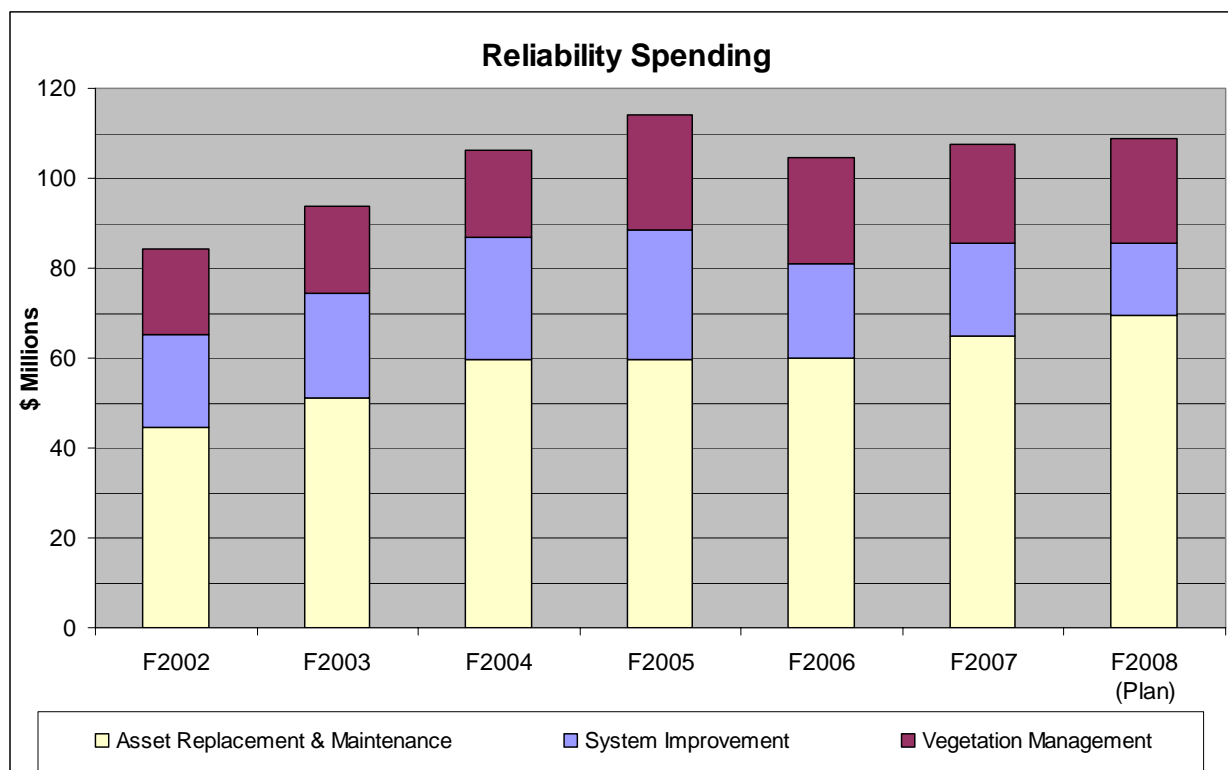
The following chart provides the portion of BC Hydro’s investment over the last seven years that contributed to distribution system reliability.

Spending to maintain the current level of system reliability has remained relatively constant at approximately \$100 million a year related to the following activities:

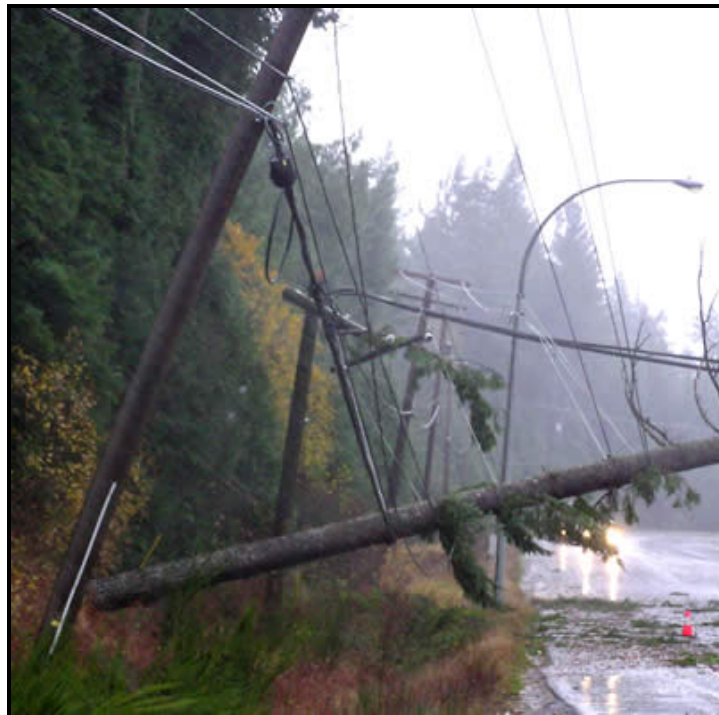
BC Hydro plans to identify and prioritize for removal trees that have a high potential to damage the distribution system.

- **Hazard Tree Program:** this program consists of identifying and prioritizing off-corridor trees that have a high potential for failure and therefore can damage our distribution system. This program is not intended to address threats from severe weather conditions such as hurricane-force winds, record rainfall events, ice storms, or earthquakes.
