Fish Habitat Enhancement Potential And Stocking Assessment of Sabai Lake

D. A. Jesson
1990

SABAI LAKE

WATERSHED: PARSNIP RIVER
DATE OF SURVEY: MAY 31, JUNE 1. and
AUGUST 24. 1990
FIELD CREW LEADER: D.A. JESSON
FIELD ASSISTANT: A. MCLEAN
REPORT PREPARED BY: D.A. JESSON

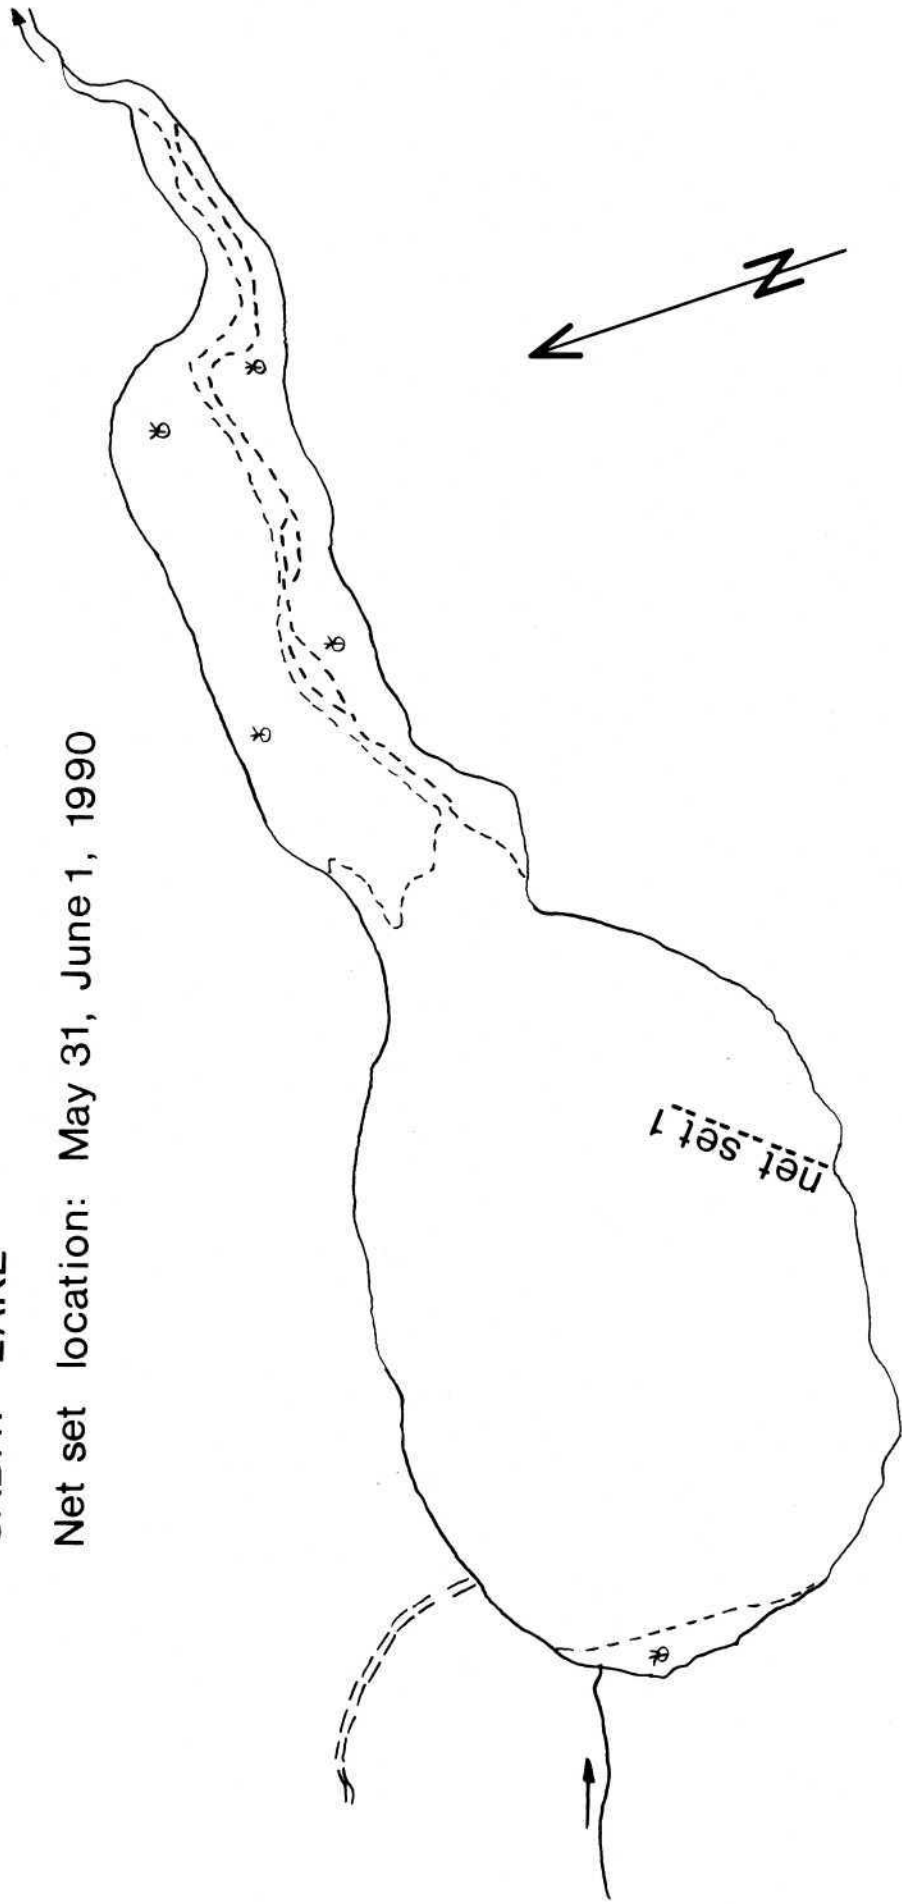
Net set location: May 31, June 1, 1990

NETTING SITE #1

All fish caught were in the 25 mm panel. One rainbow trout escaped.

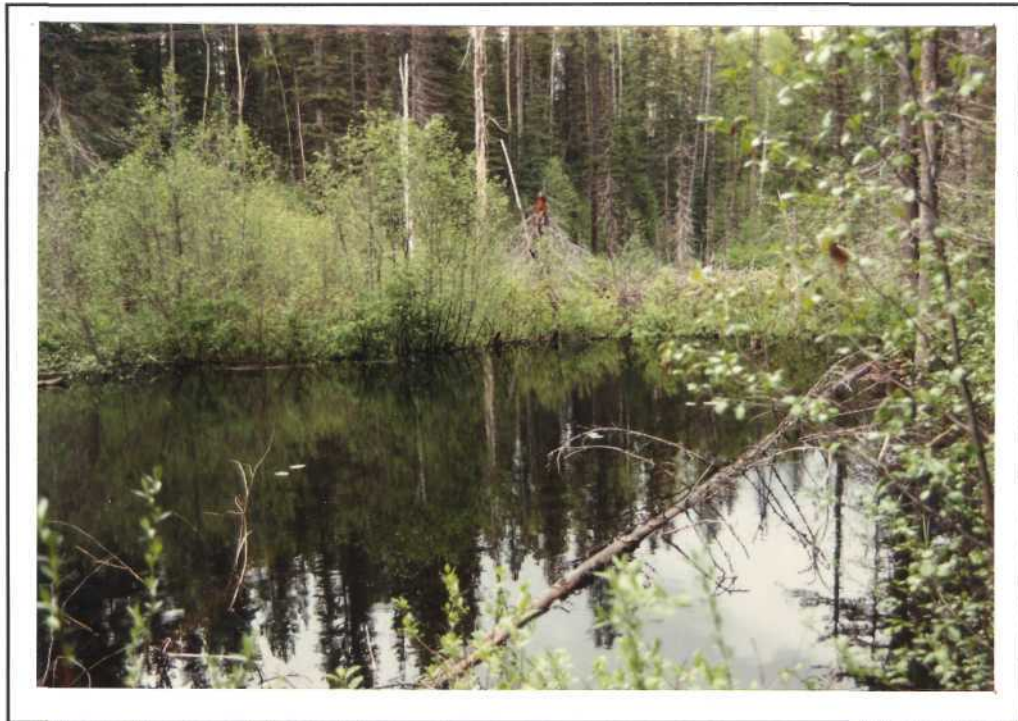
The lake has one inlet and one outlet. The outlet is blocked at the lake by an old, overgrown beaver dam (80.0 m in length and 0.55 m in height). The outlet offers no spawning potential downstream of the dam, with one other dam located 150 m downstream. Additional beaver dams and associated ponds are believed to occur downstream from the second dam, however, no investigation took place. The two dams are an obstruction to upstream fish migration, limiting movement upstream from Tudyah Lake.

| <u>Negative #</u> | <u>Plate #</u> | <u>Description</u> |
|---|---|--|
| R2:14 | 1 | View of outlet looking downstream, approximately 150 m downstream from lake. The outlet to this point from the lake is a series of beaver dams and resulting ponds, with no fisheries enhancement potential. |

Plate 1: View of outlet looking downstream, approximately 150 m downstream from lake. The outlet to this point from the lake is a series of beaver dams and resulting ponds, with no fisheries enhancement potential.

There is no enhancement potential in the outlet due to extensive beaver activity.

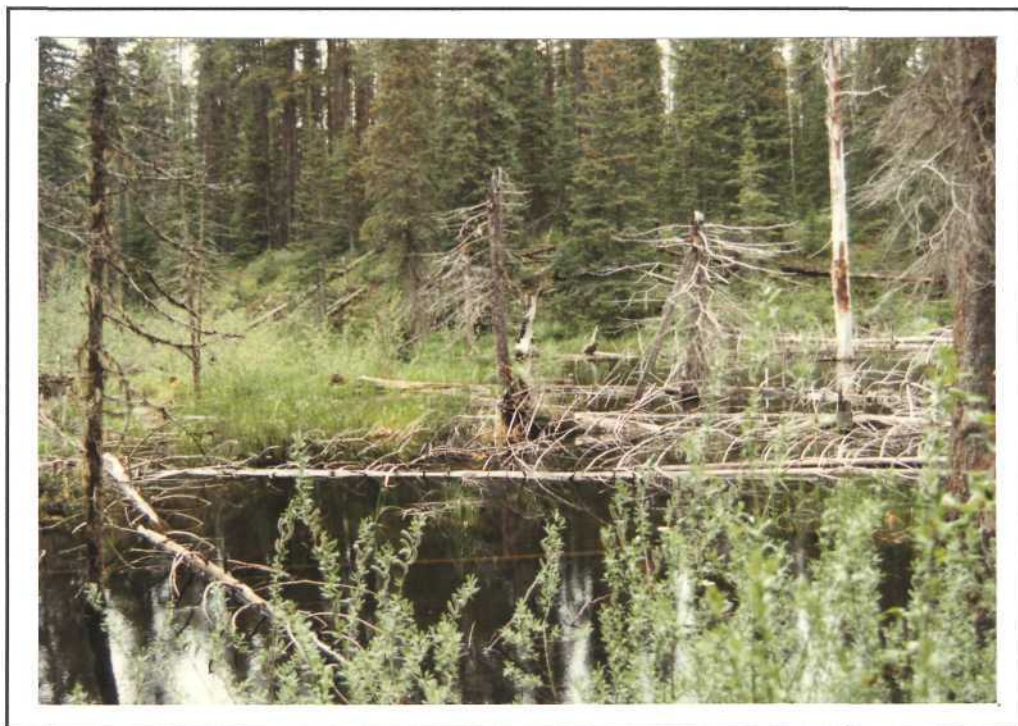
| <u>Negative #</u> | <u>Plate #</u> | <u>Description</u> |
|---|---|--|
| R2:15 | 2 | View across outlet at beaver pond and drowned trees, approximately 150 m downstream from lake. |

Plate 2: View across outlet at beaver pond and drowned trees, approximately 150 m downstream from lake.

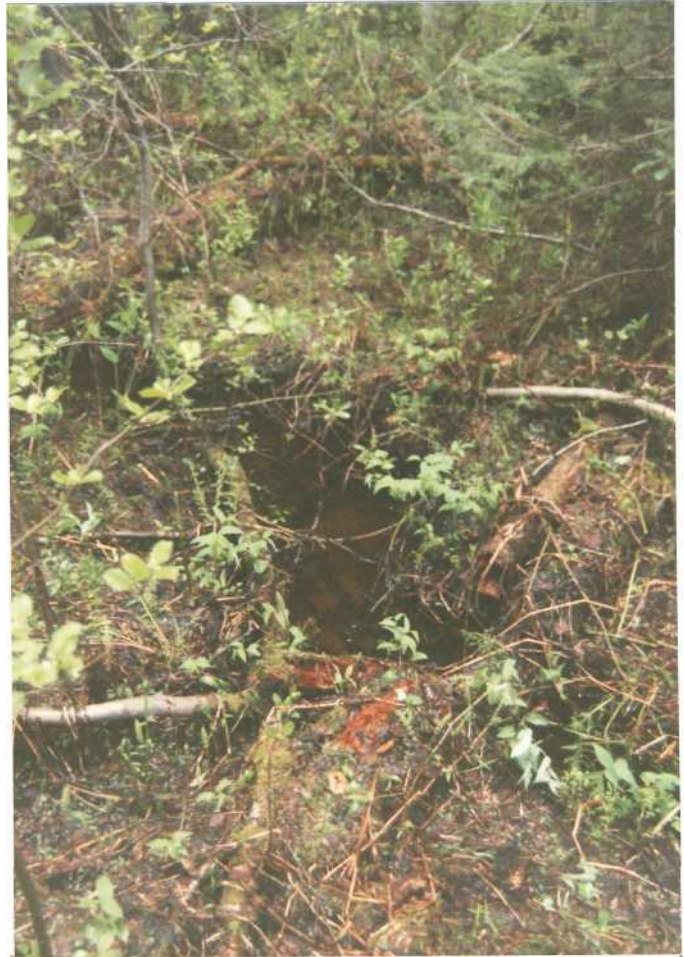
Plate 3:

The inlet was investigated twice during the spring/summer period to determine if flow varied between seasons. On May 31, 1990, at 250 m upstream from the lake, the inlet had a wetted width of 0.9 m and average depth of 20 cm. Stream velocity at this point was measured at 0.14 m/sec and water temperature was 13°C. At the same location on August 24, 1990, the wetted width was 0.7 m and average depth was 16 cm. Water temperature was recorded at 8.5°C.

| <u>Negative #</u> | <u>Plate #</u> | <u>Description</u> |
|---|---|--|
| R2:12 | 3 | View of inlet looking upstream from sample site #1, located 250 m upstream from lake. Photo taken May 31, 1990. |

View of inlet looking upstream
from sample site #1, located
250 m upstream from lake.
Photo taken May 31, 1990.

- Limited spawning habitat due to high percentage of fines.
- Some rearing with LOD and undercut banks providing cover.
- This is a very small creek.
- Heavy rain the last 2 days.

During fisheries assessment of the inlet, it was noticed that very little salmonid spawning habitat was present. There is some rearing habitat with large organic debris and undercut banks providing cover. It appears there is sufficient water in the inlet during summer low flows. The spawning potential of the inlet can be improved through the introduction of gravel and some stream clearance.

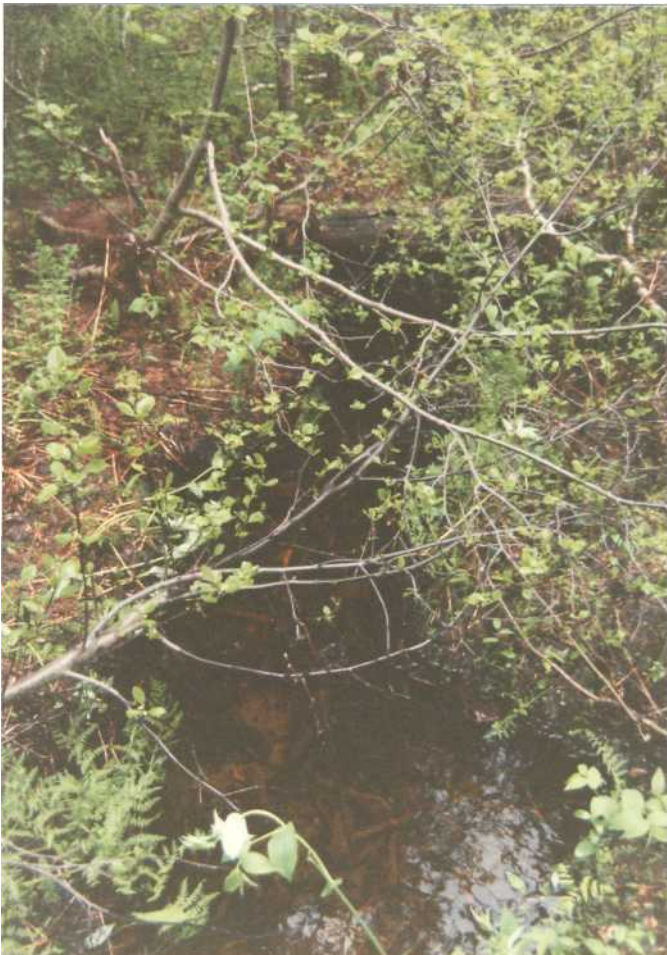
Plate 4:

| <u>Negative #</u> | <u>Plate #</u> | <u>Description</u> |
|---|---|--|
| R2:13 | 4 | View of inlet looking downstream from sample site #1, located 250 m upstream from lake. Photo taken May 31, 1990. |

View of inlet looking
downstream from sample
site #1, located 250 m
upstream from lake.
Photo taken May 31, 1990.

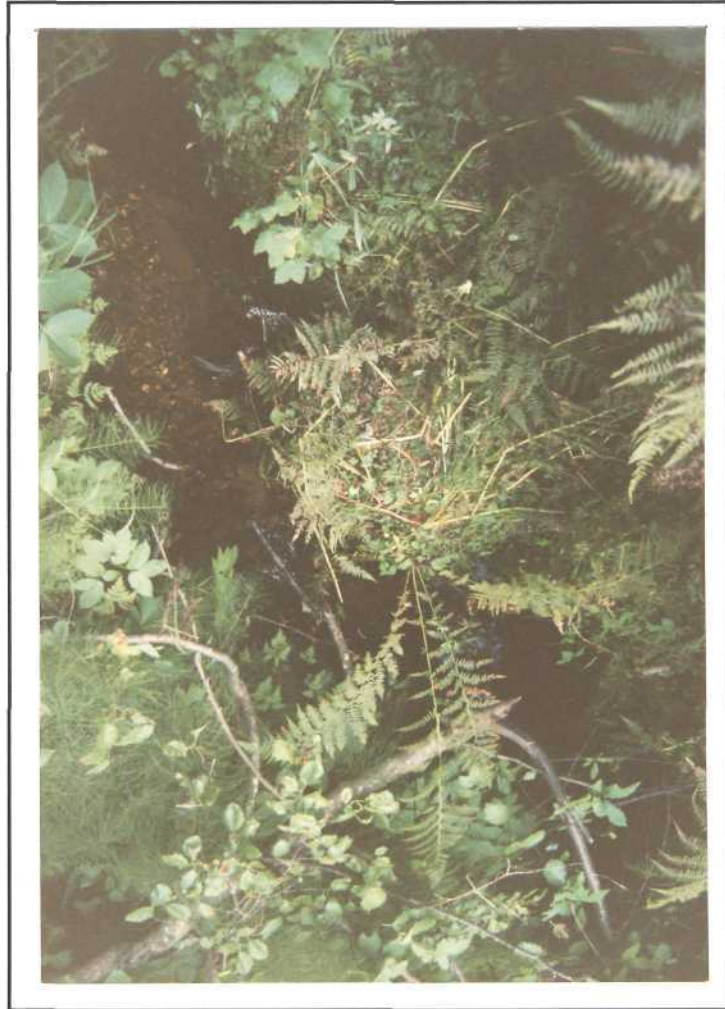
| <u>Negative #</u> | <u>Plate #</u> | <u>Description</u> |
|---|---|--|
| R5:22 | 5 | View of inlet looking upstream from sample site #1, located 250 m upstream from lake. Photo taken August 24, 1990. |

Plate 5:
View of inlet looking upstream from
sample site #1, located 250 m upstream
from lake. Photo taken August 24, 1990.
