**Wahleach Project Water Use Plan**

**Herring Island Chum Spawning Success  
Monitor**

**Study Period: 01 September 2006 – 30 April 2007**

**Herrling Island Sidechannel Chum Salmon  
Spawning Success Monitoring,  
2006 Annual Report**

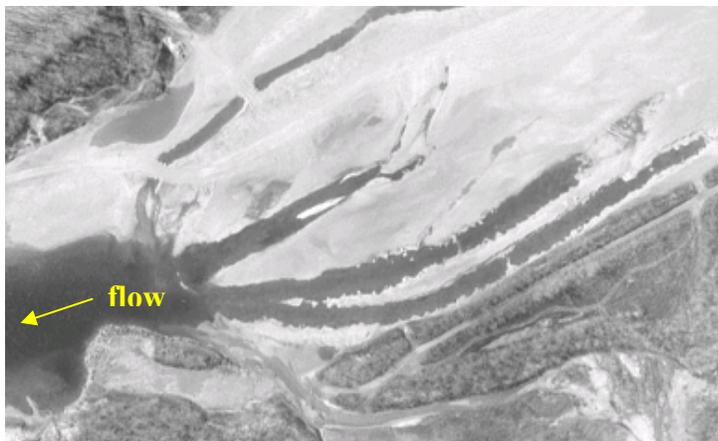
Figure 8. The uppermost index site (site 1) used to monitor chum salmon spawning in the Herrling Island sidechannel, 2006 (photo: 28 March 1998, 0 MW, 0 m<sup>3</sup>/s).

The first index site (site 1) was located at the head of the WAH GS tailrace pool approximately 2 km downstream from the inlet of the Herrling Island sidechannel and 0.5 km upstream from the WAH GS tailrace (Figure 8; Photo 1, Photo 2, Photo 3). Scott Paper Limited constructed three chum salmon spawning channels (or “fingers”) when they removed gravel from the sidechannel for road construction on Herrling Island (Parsonage and Leake 1999). Site 1 extended from the top of the fingers downstream to the mouth of a small tributary that drained into the sidechannel on the east (left) bank. Access to the site was via the Herrling Island off-ramp (Exit 146) off Highway 1 approximately 1.5 km east of the WAH GS. This was also a popular area for recreational motorcyclists and four-wheelers.

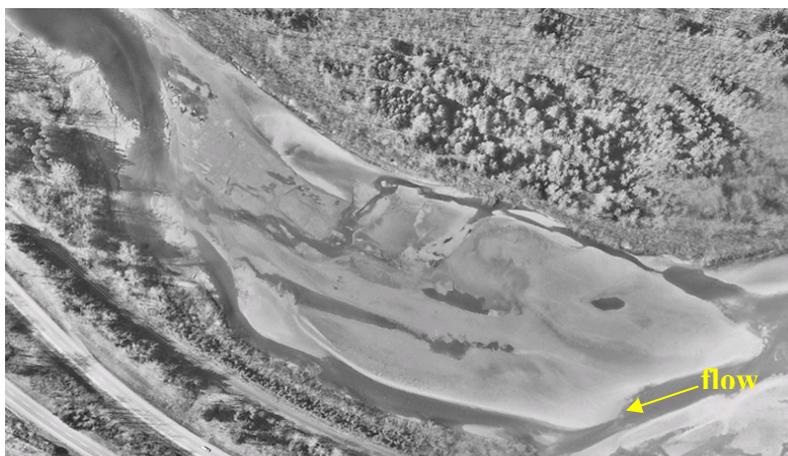
Figure 9. The middle index site (site 2) used to monitor chum salmon spawning in the Herrling Island sidechannel, 2006 (photo: 28 March 1998, 0 MW, 0 m<sup>3</sup>/s).

The second index site (site 2) was located approximately 2 km downstream of the WAH GS tailrace and 200 to 400 m upstream of the mouth of an unnamed creek (herein called Unnamed Creek) that drains into the sidechannel from the left bank (Figure 9 , Photo 4). Site 2 was accessed from an unmarked exit off Highway 1 at the “Popkum Road 2500 m” road sign approximately 2.5 km south on Highway 1 from site 1.

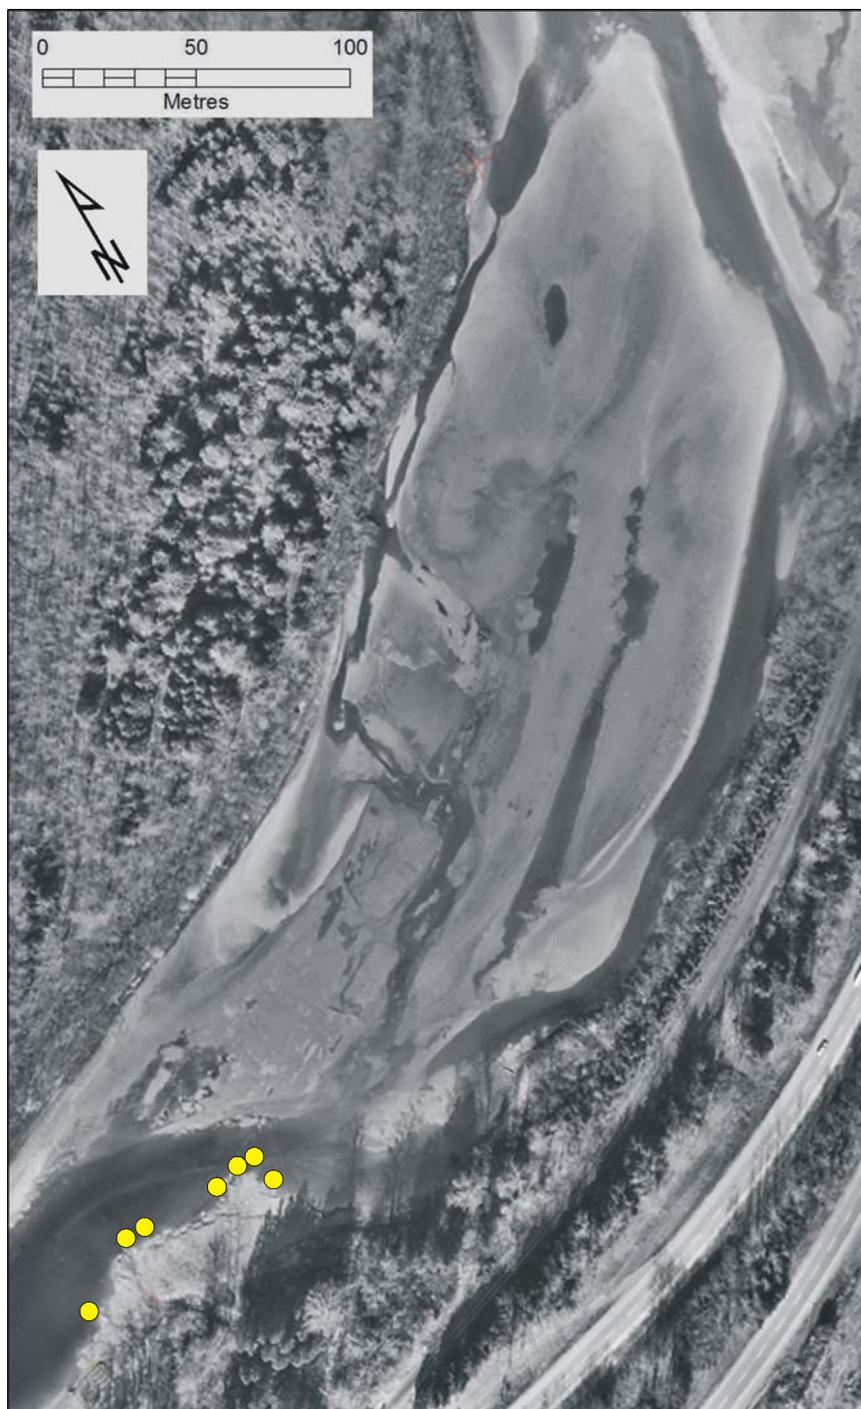
Figure 23. Location of chum salmon redds (yellow circles) observed at site 2 in the Herrling Island sidechannel, 2006.

Seven redds were measured for depth at site 2 (Figure 23). These redds were classified as partial, although due to poor visibility it was difficult to assess their true condition. None of the redds were observed dewatered during field observations. Visits to site 2 were sporadic and thus the relationship between water depths measured at the redds and hydrometric station 2 were weak. However, based on the range of pit (0.13-0.94 m) and bed (0.03-0.89 m) depths encountered it is unlikely that the redds at site 2 dewatered during egg incubation or fry emergence.

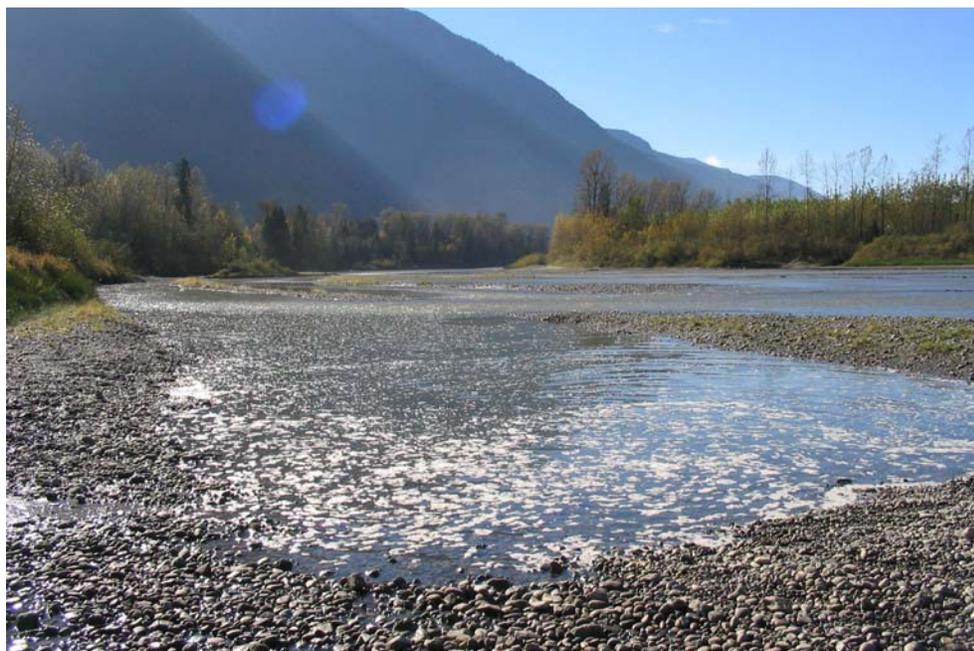
Photo 2. Index site 1 in the Herrling Island sidechannel, 24 October 2005. This photo was taken from the left bank of the sidechannel looking downstream.

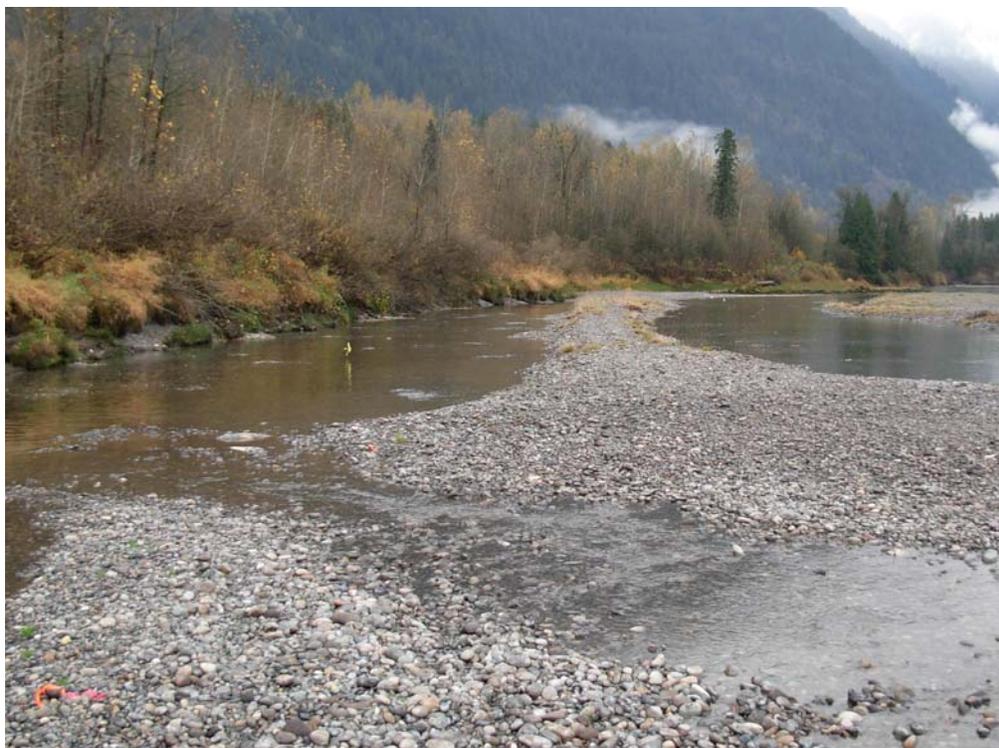
Photo 3. Index site 1 in the Herrling Island sidechannel, 14 November 2006 (1000 hours). This photo was taken from the left bank looking downstream prior to a WAH GS shutdown.

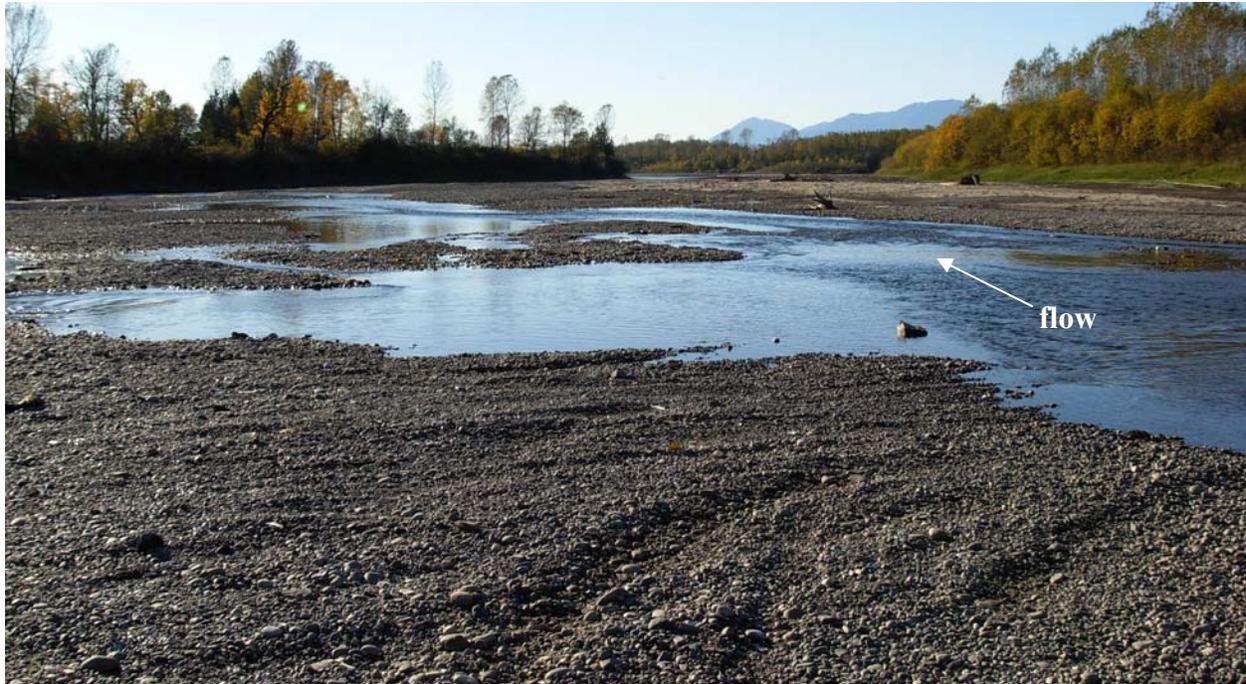
Photo 5. Index site 3 in the Herrling Island sidechannel, 30 October 2006 (1540 hours). This photo was taken from the left bank looking downstream during a WAH GS shutdown.

On 30 October, up to 14 live chum salmon (holding) and 50 carcasses were observed at site 3 (Photo 9). No spawning activity was observed between the lower boundaries of sites 2 and 3.

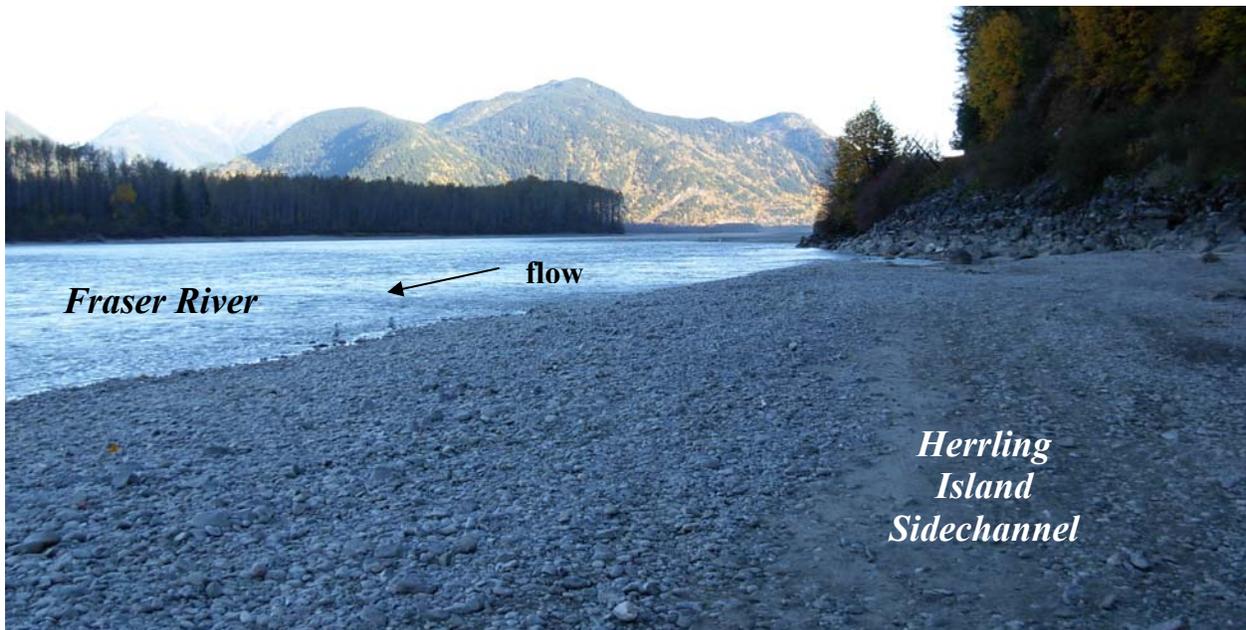
Photo 6. Confluence of the Fraser River and the upper end of the Herrling Island sidechannel (looking upstream), 30 October 2006. At this stage height, there is no surface flow from the Fraser River into the sidechannel.

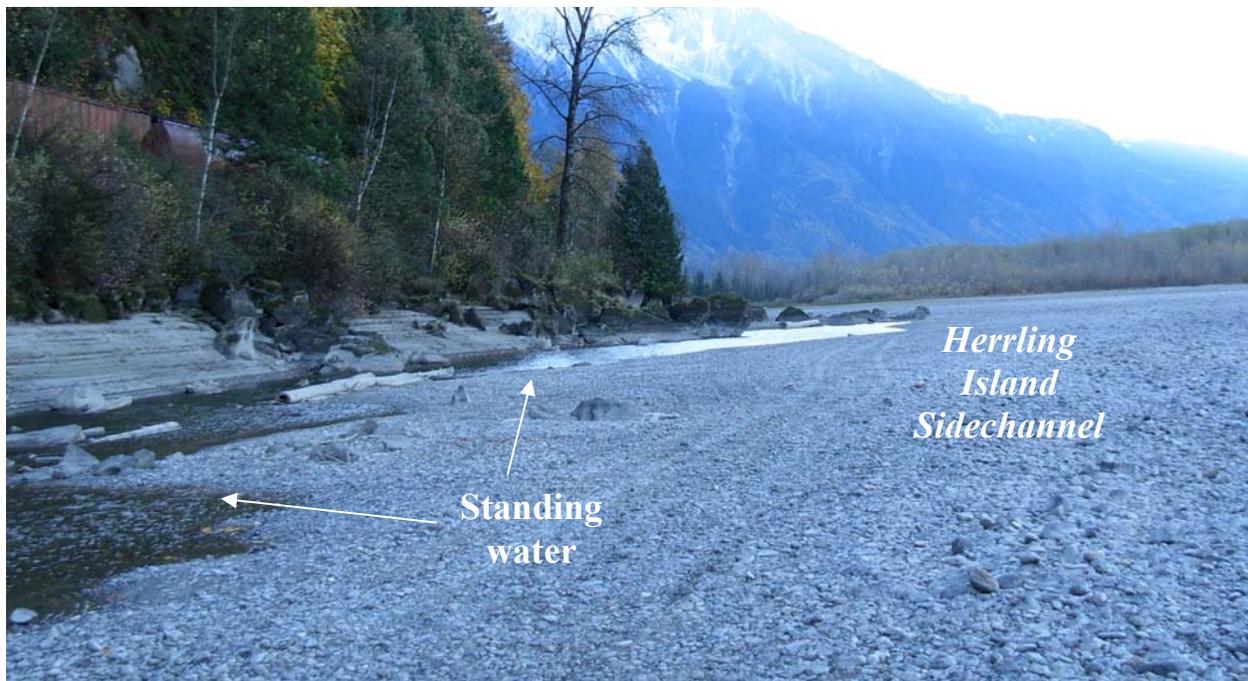
Photo 7. Confluence of the Fraser River and the upper end of the Herrling Island sidechannel (looking downstream), 30 October 2006.

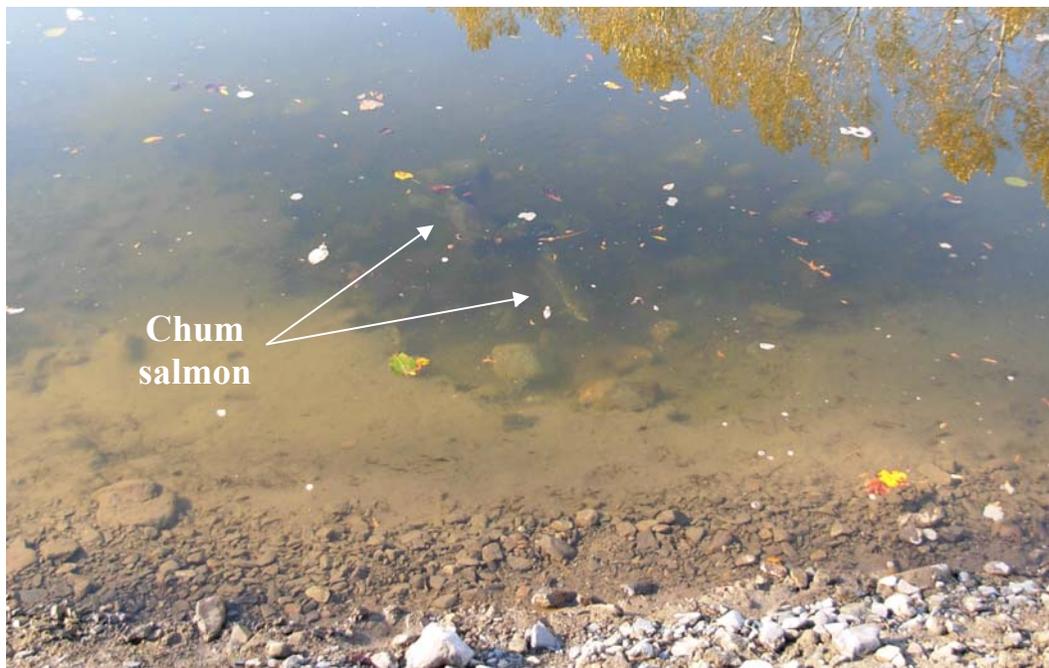
Photo 8. Chum salmon observed spawning at site 2 along the left bank of the Herrling Island sidechannel near the mouth of Unnamed Creek. This photo was taken on 30 October 2006 (1410 hours) during a WAH GS shutdown.

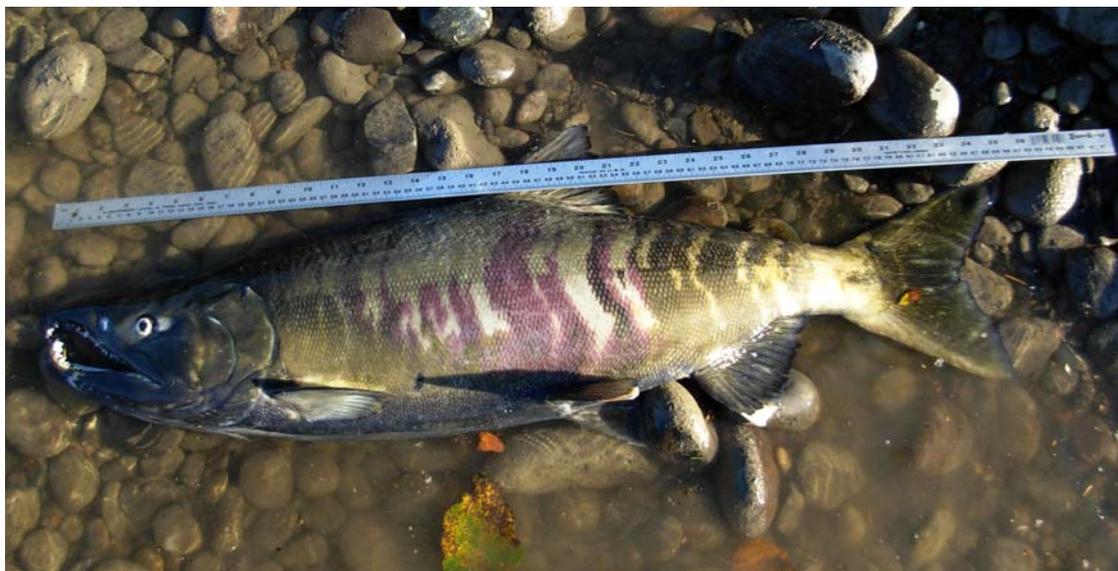
Photo 9. Adult male chum salmon in the Herrling Island sidechannel, 30 October 2006.

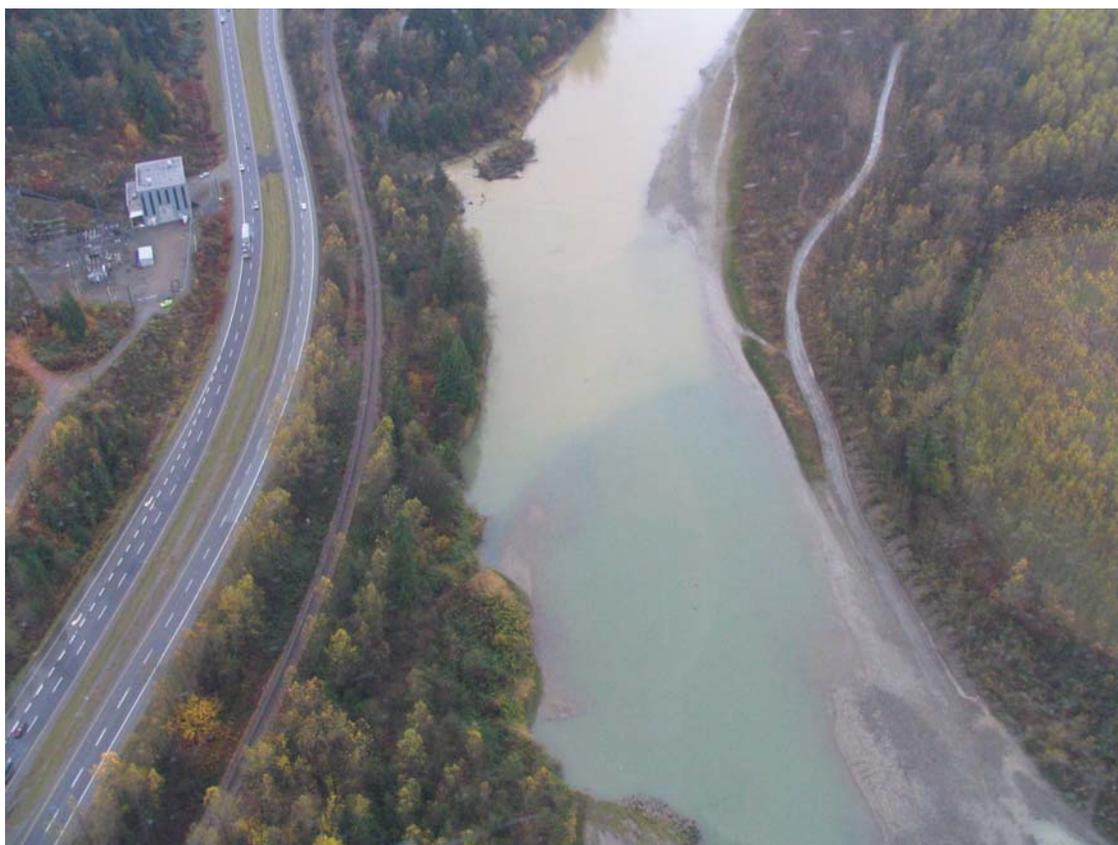
Photo 10. Aerial photograph showing sediment-laden water being released from the WAH GS on 11 November 2006 (photo courtesy of Vince Busto, DFO).
