Coquitlam – Buntzen Project Water Use Plan

**ASSESSMENT OF PINK SALMON PASSAGE IN
LOWER COQUITLAM RIVER**

Implementation Year 3

Reference: COQMON #4

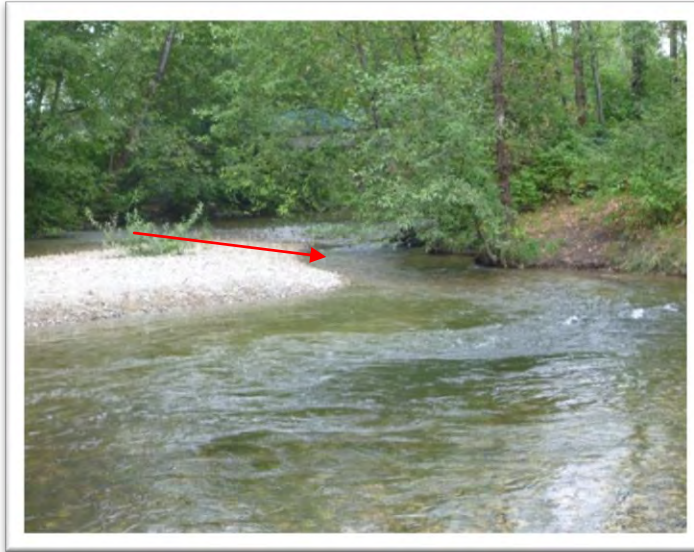
Figure 5 – Index site 1- upstream view, Aug.29.11
Discharge rate = 3.19cms (WSC Port Coquitlam)
The arrow indicates access point

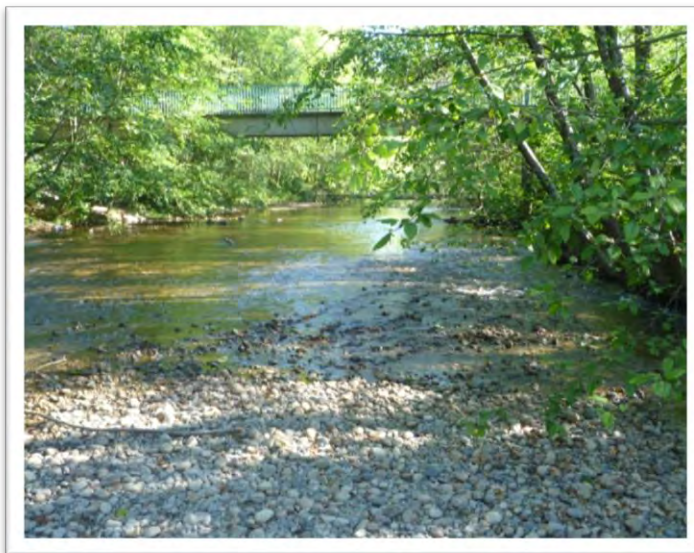
Figure 6 – Index site 1 – upstream view of shallow depth, Sept.5.11
Discharge rate = 2.82cms (WSC Port Coquitlam)

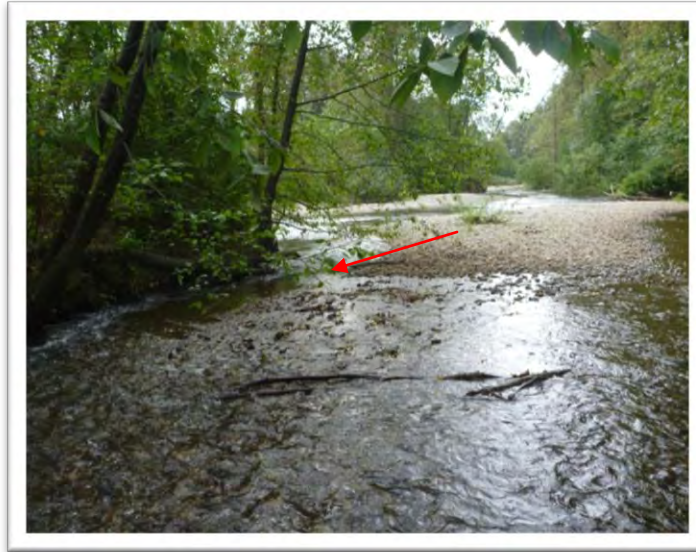
Figure 7 – Index site 1 – downstream view, Sept.13.11
Discharge = 3.36cms (WSC Port Coquitlam)
The arrow identifies the channel access and gravel bar

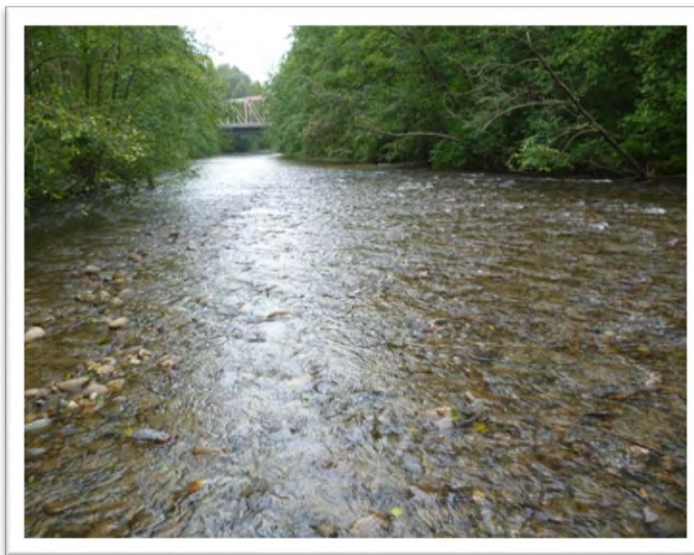
Figure 8 - Index site 2a - downstream view of shallow riffle, Aug.29.11
Discharge = 3.19cms (WSC Port Coquitlam)

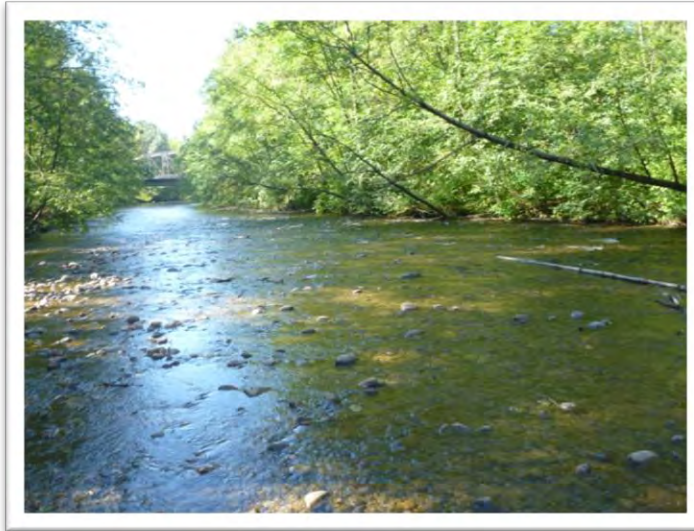
Figure 9 - Index site 2a - downstream view, Sept.5.11
Discharge = 2.82cms (WSC Port Coquitlam)
Low depth, riffle area

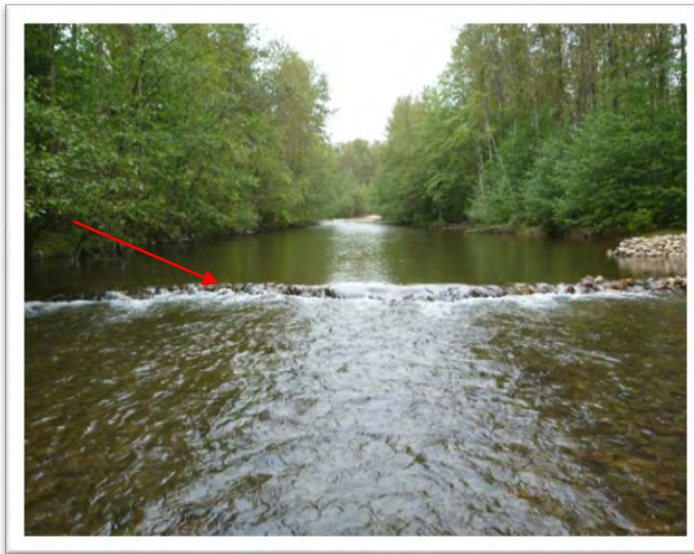
Human interference occurred in 2009 and in 2011 with the construction of a weir (Figure 10) that could result in an potential migration barrier at low flows however, it was not considered to be a barrier to migration at a discharge value of 2.62cms (WSC, Port Coquitlam) as observed during the 2011 assessment period. During the lowest monitored discharge of 2.82cms (WSC, Port Coquitlam) the average plunge pool depth was 0.33m and the average jump height over the weir was 0.19m indicating that the weir was adequate for passage. Pink Salmon were not observed at this index site during the monitoring period, however 130 were observed upstream of this index site after September 10th by the BC Hydro adult enumeration crew during the lowest discharge rate recorded at 2.62cms (WSC, Port Coquitlam) (Table 2). Migrating Pink Salmon are most likely not observed at this index site due to the lack of stream complexity, such as pools, woody structures and shallow water depths. Migrating Pink Salmon would likely navigate through this index site quickly and would not use it as a staging or spawning area.

Figure 10 - Index site 2a - upstream view of weir, Sept.13.11
Discharge = 3.36cms (WSC Port Coquitlam)
The arrow identifies the constructed weir

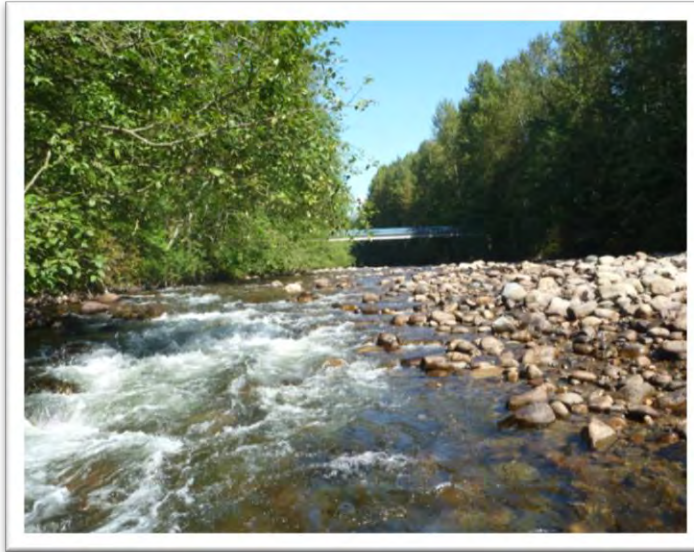
Figure 11 - Index site 2b - upstream view, Sept.5.11
Discharge = 2.82cms (WSC Port Coquitlam)

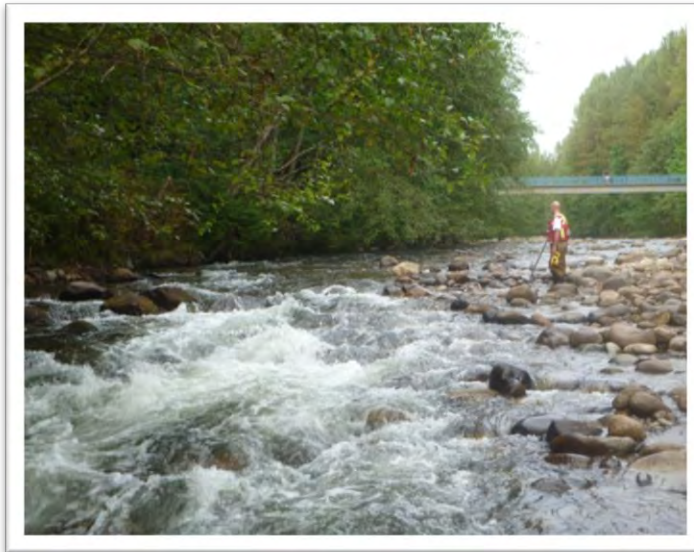
Figure 12 - Index site 2b - upstream view, Sept.13.11
Discharge = 3.36cms (WSC Port Coquitlam)

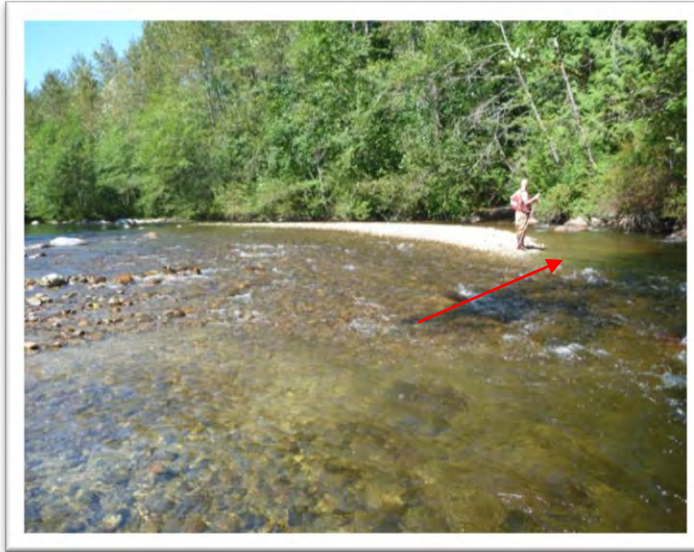
Figure 13 – Index site 2c - upstream view, Sept.5.11
Discharge = 2.82cms (WSC Port Coquitlam)
The arrow identifies the access channel

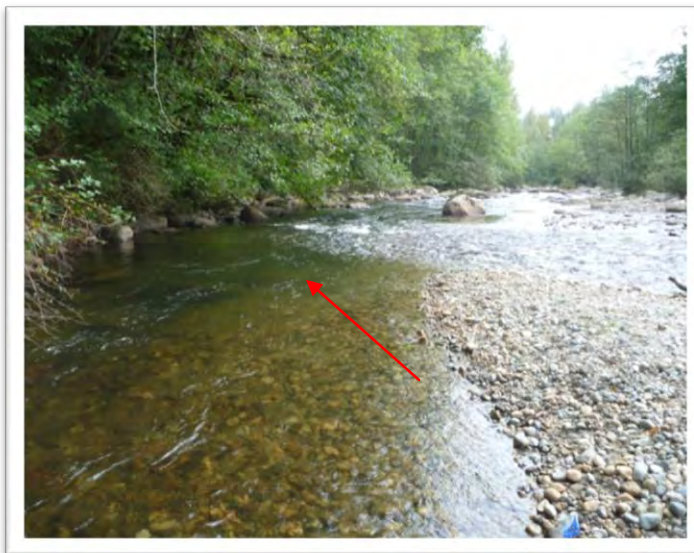
Figure 14 – Index site 2c - downstream view, Sept.13.11
Discharge = 3.36cms (WSC Port Coquitlam)
Arrow identifies access route

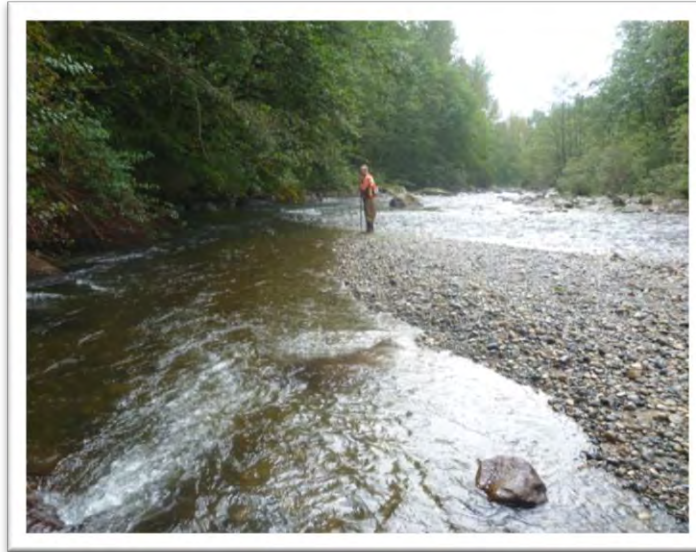
Figure 15 - Index site 2c - downstream view, Sept.24.11
Discharge = 5.7cms (WSC Port Coquitlam)
View of gravel bar and LB channel

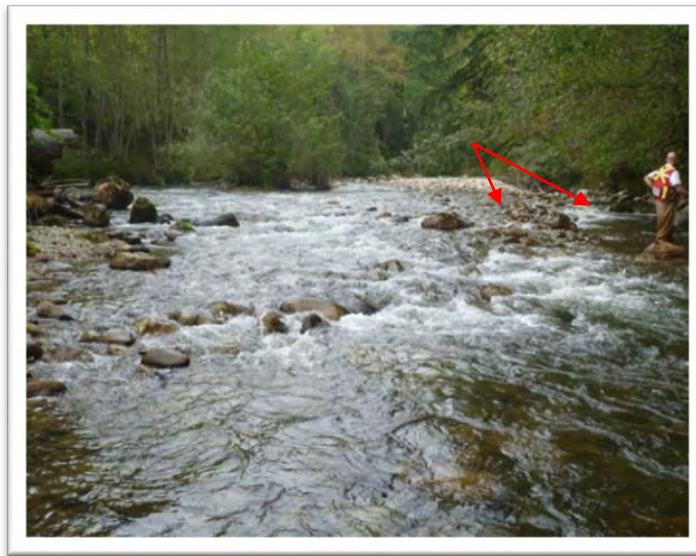
Figure 16 - Index site 3a - upstream view, Sept.13.11
Discharge = 3.36cms (WSC Port Coquitlam)
The arrows indicate the chute and exposed gravel bar

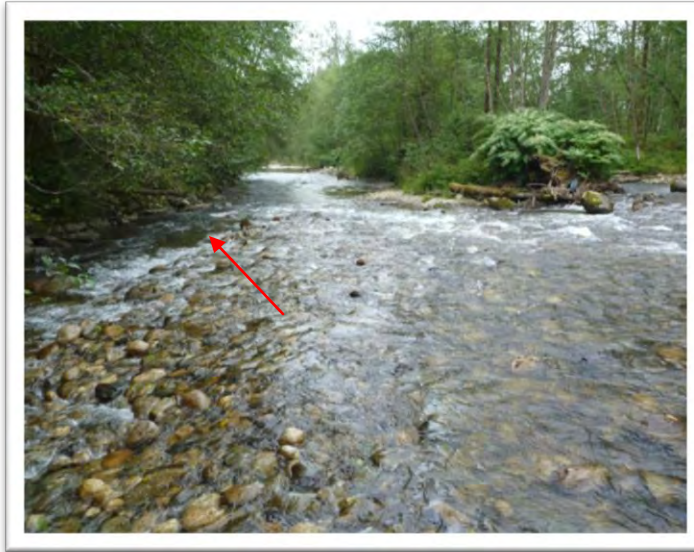
Figure 17 - Index site 3a - upstream view, Aug.29.11
Discharge = 3.19cms (WSC Port Coquitlam)
The arrow indicates the chute which is accessible at present flow

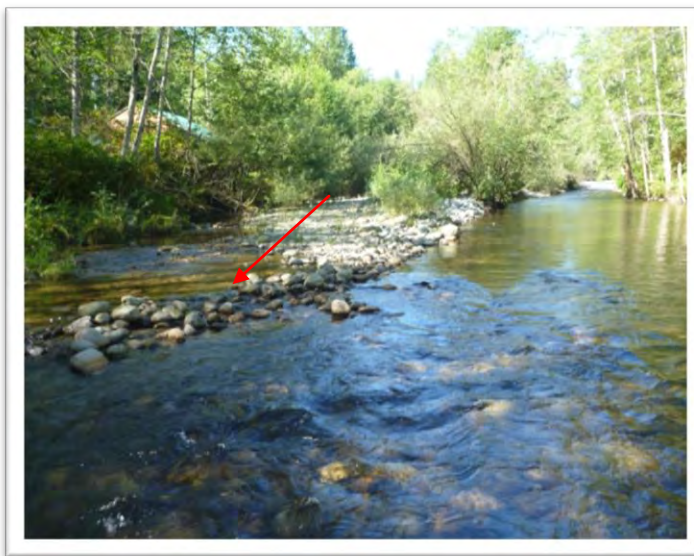
Figure 19 – Index site 3b - upstream view, Sept.5.11

Discharge = 2.82cms (WSC Port Coquitlam)

The arrow indicates the channel outlet, lower portion presently wet from hatchery effluent

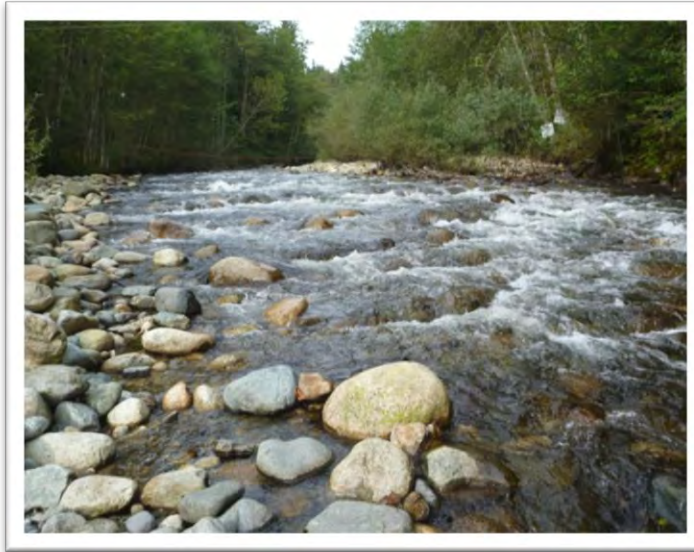
Figure 21- Index site 3b - upstream view, Sept.19.11
Discharge = 5.14cms(WSC Port Coquitlam)

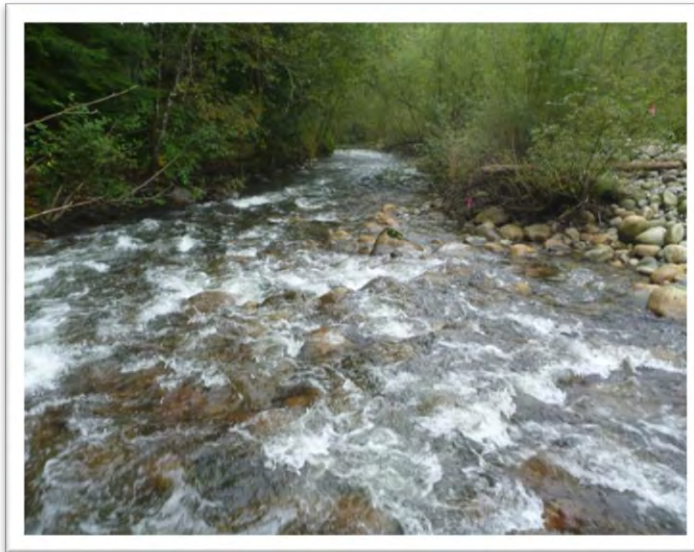
Figure 22- Index site 3b - downstream view, Sept.24.11
Discharge = 5.7cms (WSC Port Coquitlam).

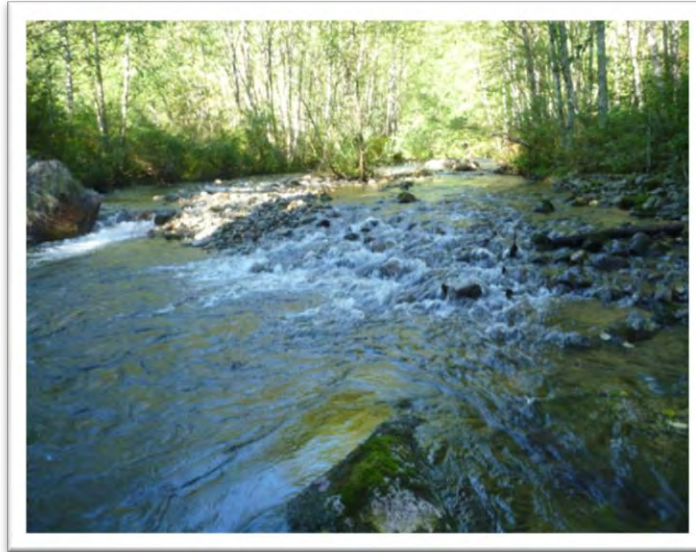
Figure 23 - Index site 4 - upstream view, Sept.5.11
Discharge = 2.16cms (Dodd, BC Hydro)

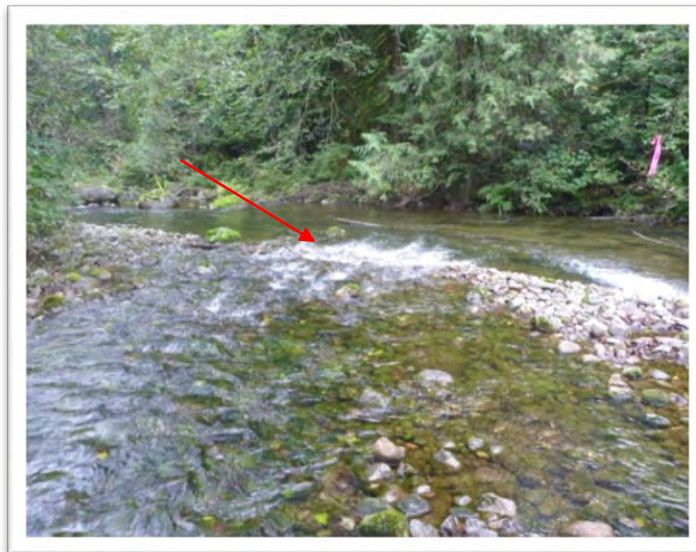
Figure 24 - Index site 4 - downstream view, Sept.24.11
Discharge = 2.07cms (Dodd, BC Hydro)
Arrow identifies, access point and jump.

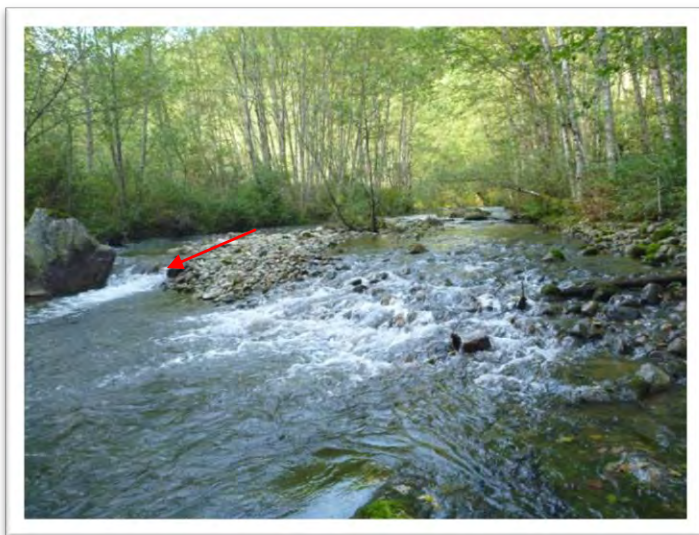
Figure 25 – Index site 4 - upstream view, Sept.19.11
Discharge = 2.09cms (Dodd, BC Hydro)
Arrow identifies access point at low flow
