Bridge River Power Development Water Use Plan

Carpenter Reservoir Drawdown Zone Re-Vegetation Program

Implementation Year 1

Reference: BRGWORKS-1

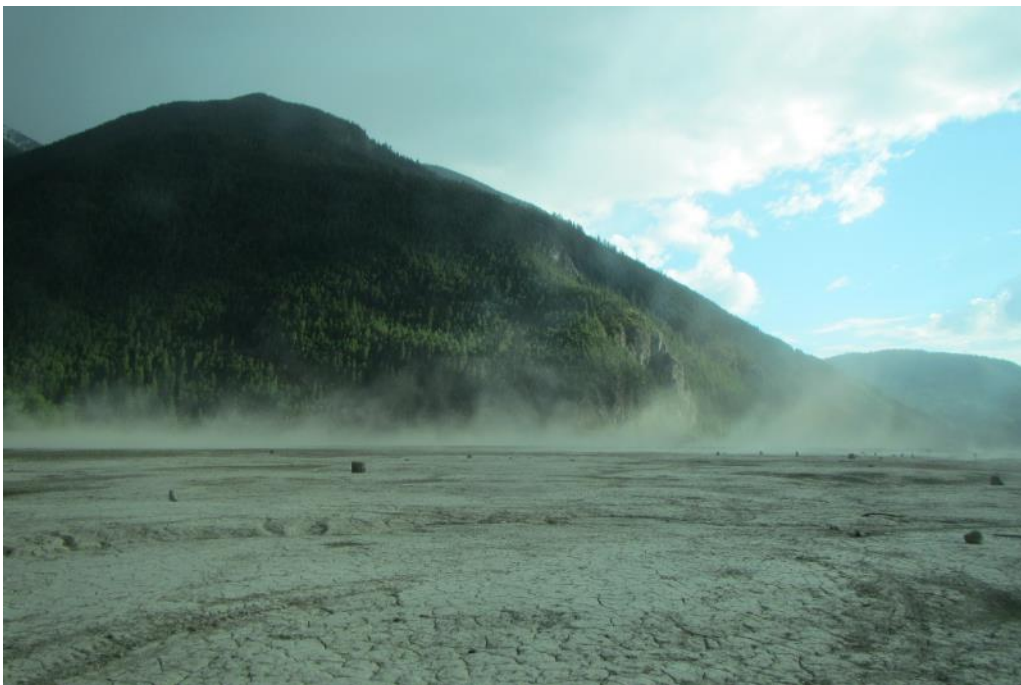
Figure 5 Typical site on the Lower mud flats in 2014 near the Gun Creek Fan, note old stumps, silt substrate and dust.

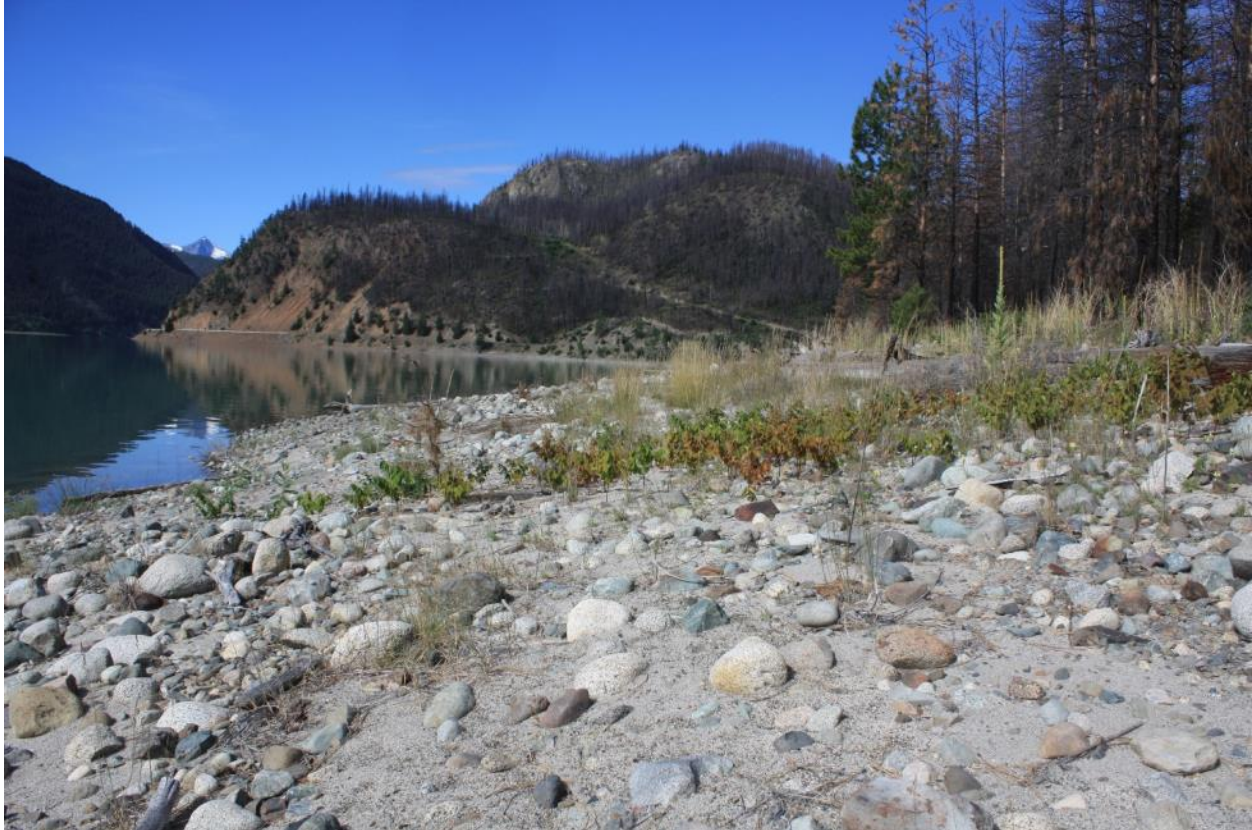
Figure 6 Steep Beach polygon upper elevations with a very coarse substrate and an encroaching patch of dogbane *Apocynum androsaemifolium*.

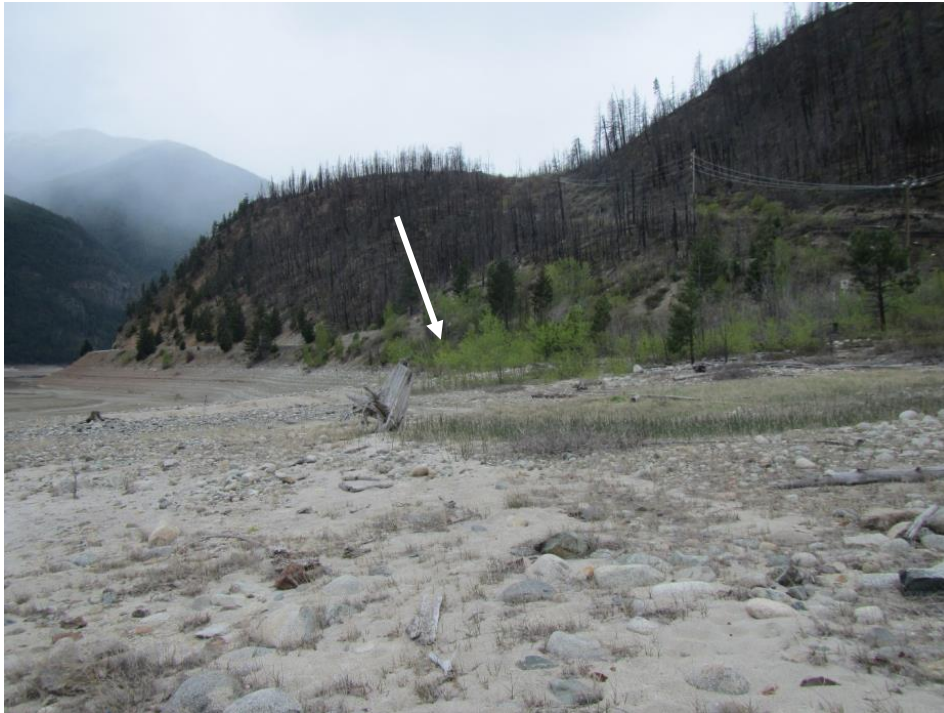
Figure 8 Trembling aspen encroaching into the drawdown zone on the Shallow Beach site.

trembling aspen (*Populus tremuloides*) (Figure 8). The aspen was observed to be suckering down into the drawdown zone of the shallow beach. The natural tendency of the poplars to spread via aggressive suckering may be an advantageous quality to exploit in the upper drawdown zone re-vegetation effort. *P. tremuloides* planted and established higher up in the drawdown zone could naturally spread down into lower drawdown elevations. In this way, high water years may kill back some of the suckers but the parent trees would remain at the higher elevations providing the vegetation material with the ability to recolonize when suitable conditions permit (Figure 9). It was notable that there was a high amount of old garbage on the beach in the form of old rusting metal and broken glass. It is likely there was some kind of historical industrial use of the site, or perhaps a dumping ground. The easy access from the highway makes this a likely spot for recreational use. The site itself appears as though it was at one time a fluvial out flow from water coming from Mowson pond and the surrounding drainages. There is currently no sign of a historical channel between the shallow beach and Mowson pond.

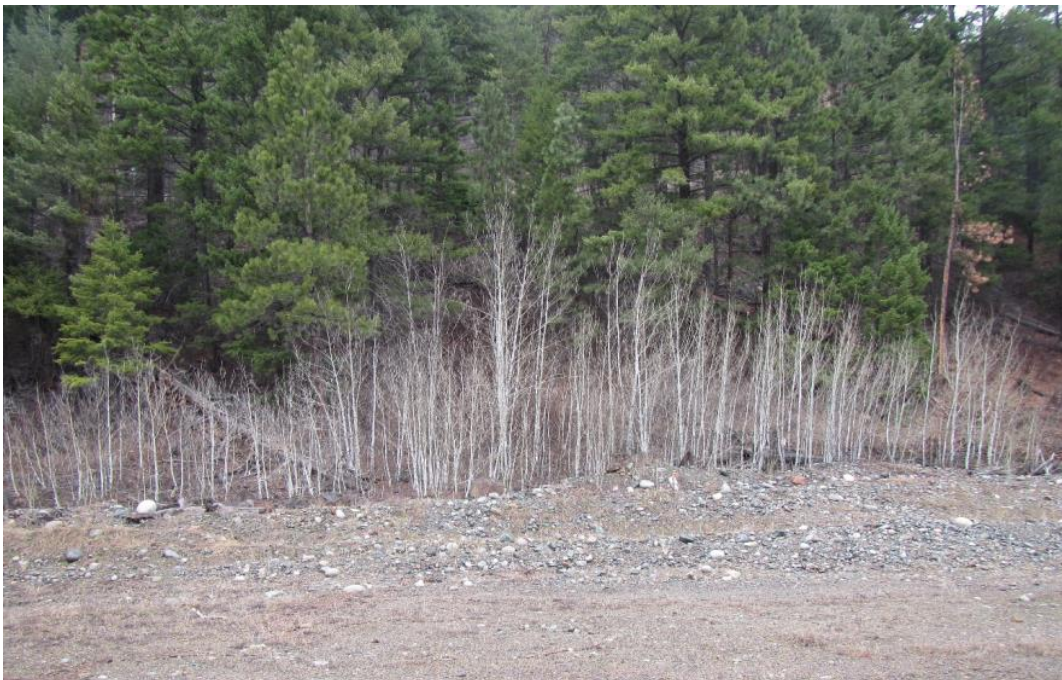
Figure 9 Clonal stand of aspen (*Populus tremuloides*) growing at the north east end of the Gun Creek fan.

season by locals and visitors. The upper elevations on the west side of the fan is a Ministry of Transportation and Infrastructure gravel pit. Both East and west sides of the fan have vehicle access down to the water's edge. Both aspects of the fan have been observed to be utilized for recreation including 4X4ing, atving, fishing, boating, kite flying, and camping. At least one horse has been observed on the site. The east side of the fan is also the historic town site of Minto. Evidence of the town is still apparent from the air photos where historic roads are visible; from the ground old cement building foundations, fire hydrants, pipes, wires and metal and glass debris of all kinds are found. Tree stumps from pre reservoir times are found throughout the fan on both the east and west sides of the Gun Creek fan.

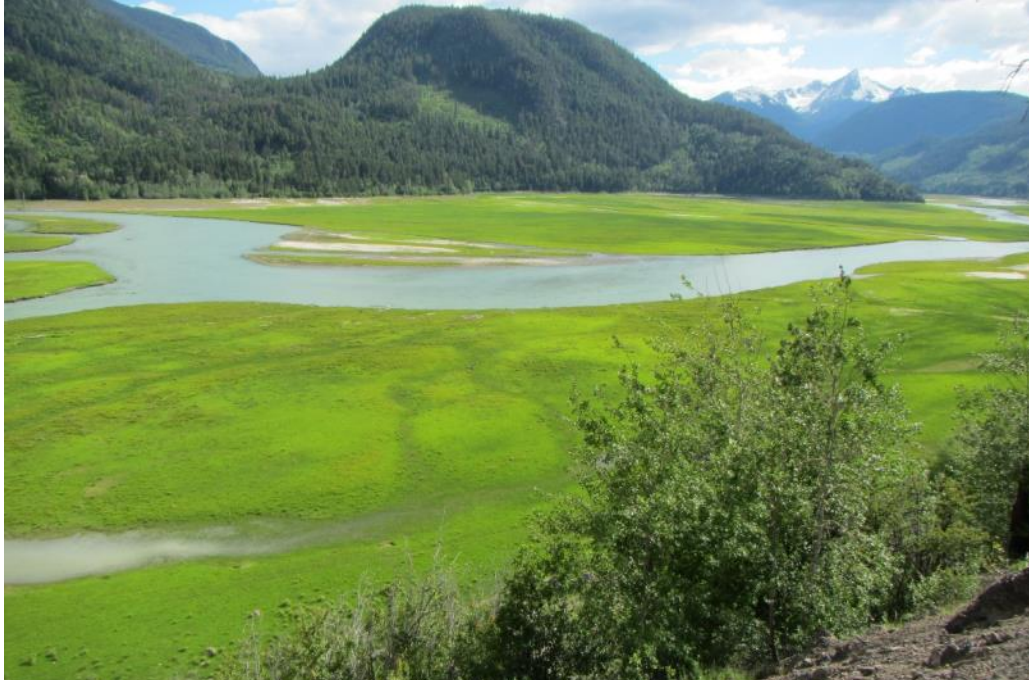
Figure 13 Looking out over the Mid Mud Flat area >643m elevation naturally vegetated with a mix of horsetail, sedges, grasses and annuals.

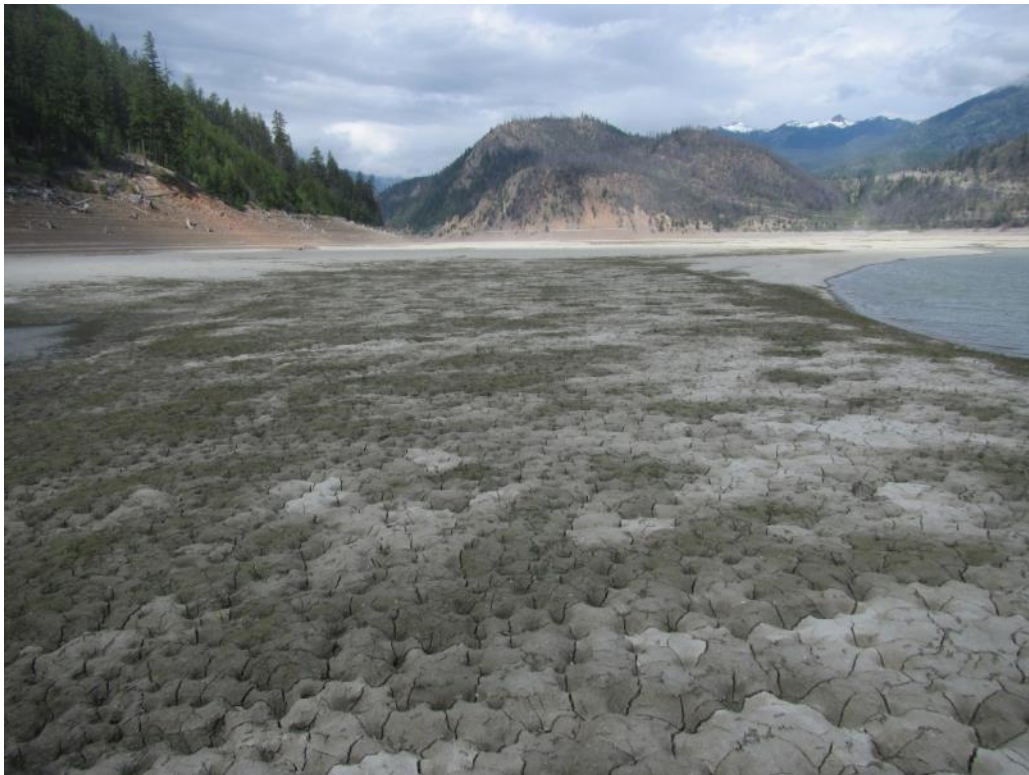
Figure 14 Pocked surface of the 636m elevation on the mudflats, an elevation that is most years largely inhospitable to vegetation due to duration of inundation and short growing season.

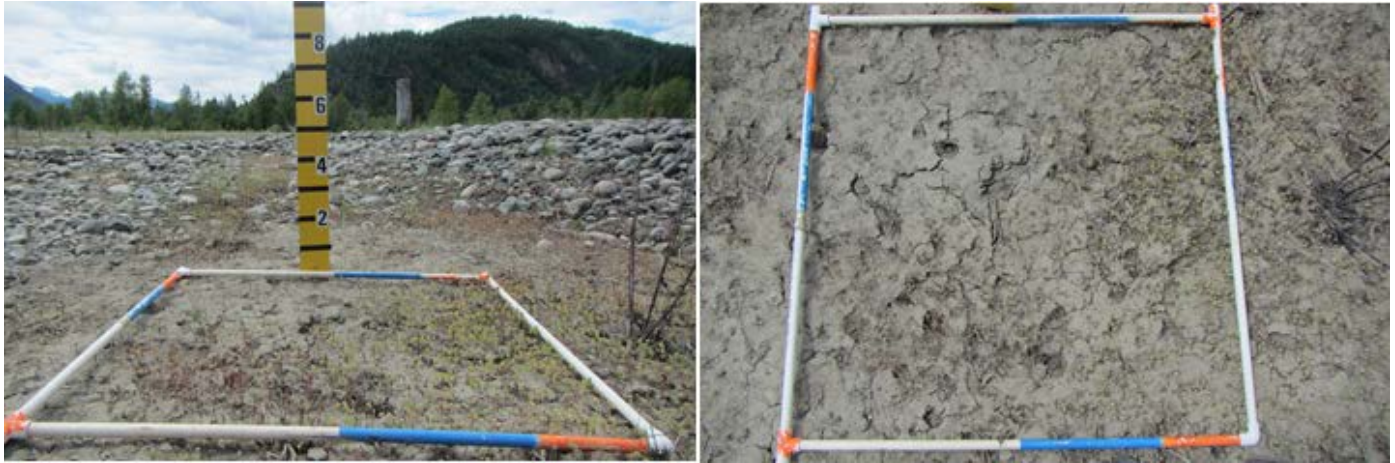
Figure 16 Example of before photographs that were captured for each plot that was planted.

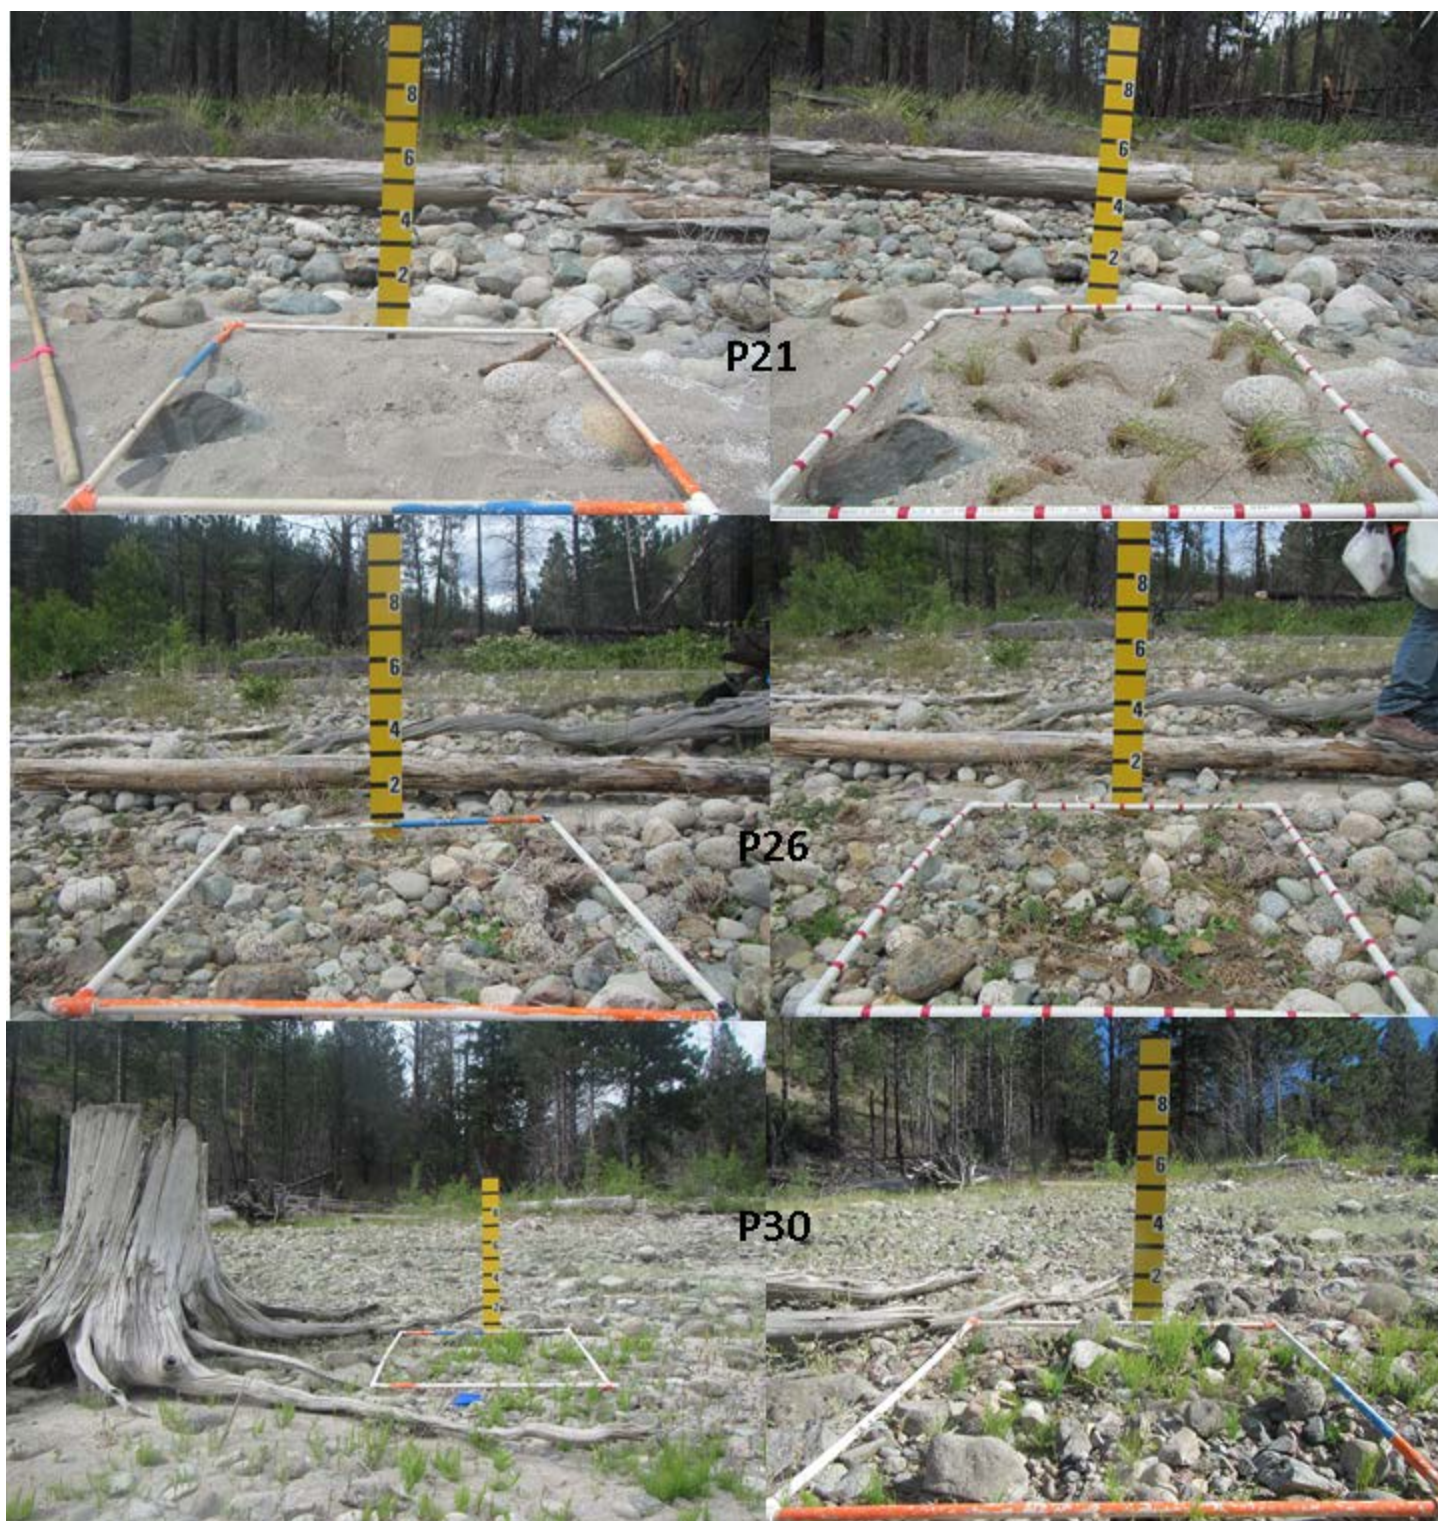
Figure 19 The Images represent examples of 1mX1m plots planted across the 6 microsites of the Steep Beach zone in June 2014. Photos span from east to west along the beach with left images before planting and right after.

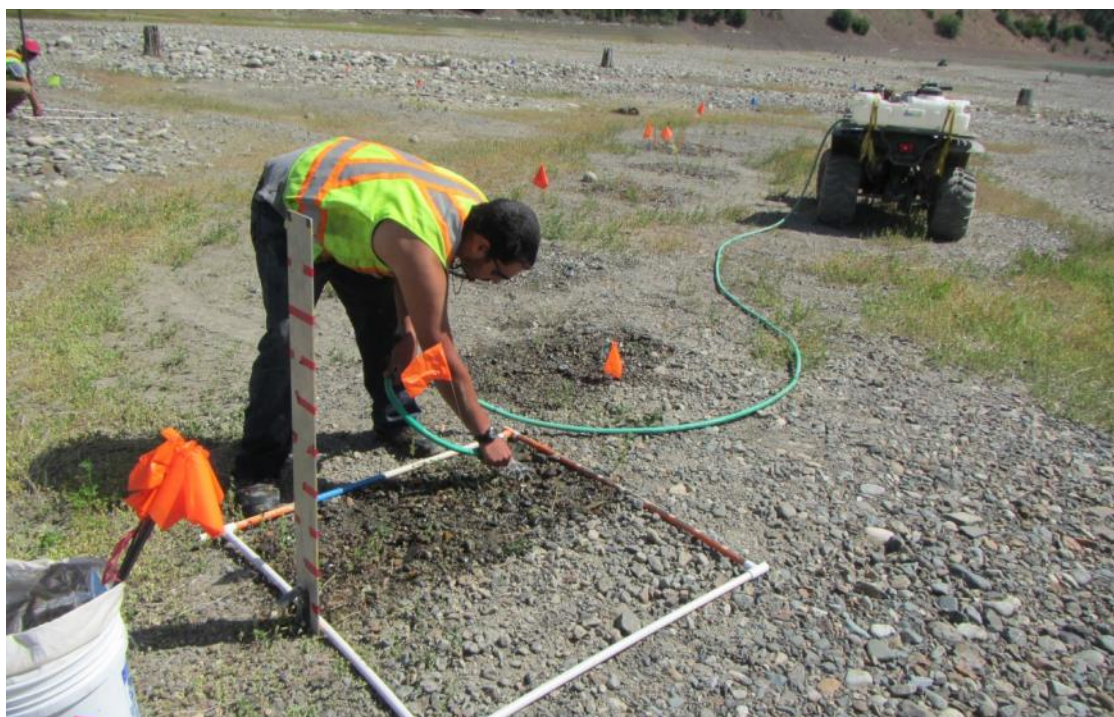
Figure 20 Watering half of seeded plots on the Gun Creek Fan.

An additional 29 plots were planted with 5 species of grasses and 1 rush (Figure 18). Twelve plots were sown with two species of grass. Nine plants were planted into each grass plot for a total of 261 plants. Seeds of bluejoint (*Calamagrostis canadensis*) and Canada wildrye (*Elymus canadensis*) were hand sown into plots and raked in. Half of each of the seed plots was watered in (Figure 20).

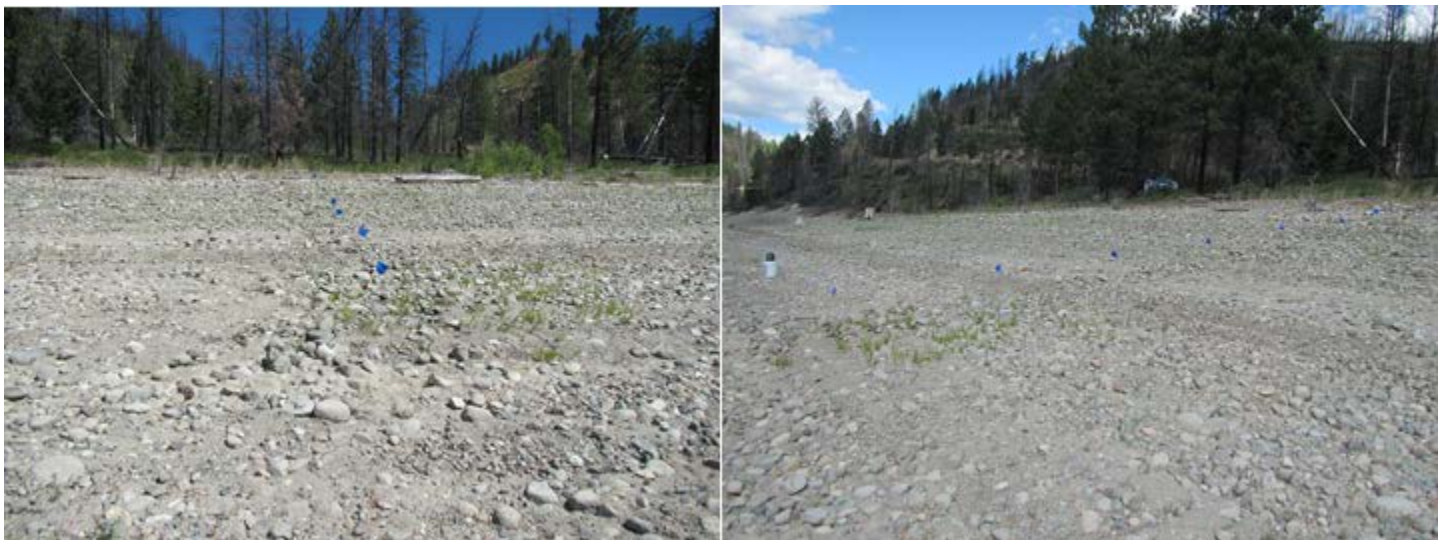
Figure 21 Blue flags mark the centre of the Strip Plot STB01 July 03 2014, 162 plants were planted in two parallel rows into the sand cobble substrate.

In addition to 1mX1m plots a paired continuous strip of *Carex lenticularis* plugs were planted on the STB spanning between 644m and 648m. Plugs were spaced 0.5m apart up the slope; in total 162 plants were planted in the strip. The site of the strip of sedges on the steep beach was a 12.25° slope, the planted strip was 19.38m in length with an aspect of 180° (Figure 21). Plants planted in the strip were grown in 6 inch bookcase containers, it was noted that the upper half of the plugs were root bound but the lower half fell apart as the plants were planted. Several extra plants were planted above and below the lower and upper ends of the strip. The substrate at the strip planting site was a coarse cobble sand. It was observed at the reservoir water's edge that

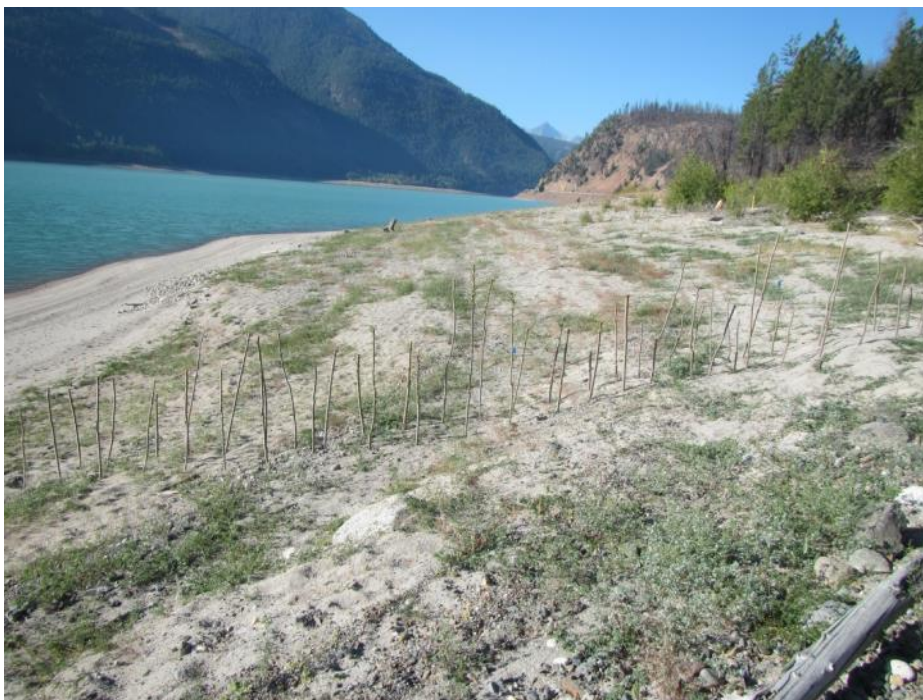
Figure 24 Live Stake cuttings at the west end of the STB site.

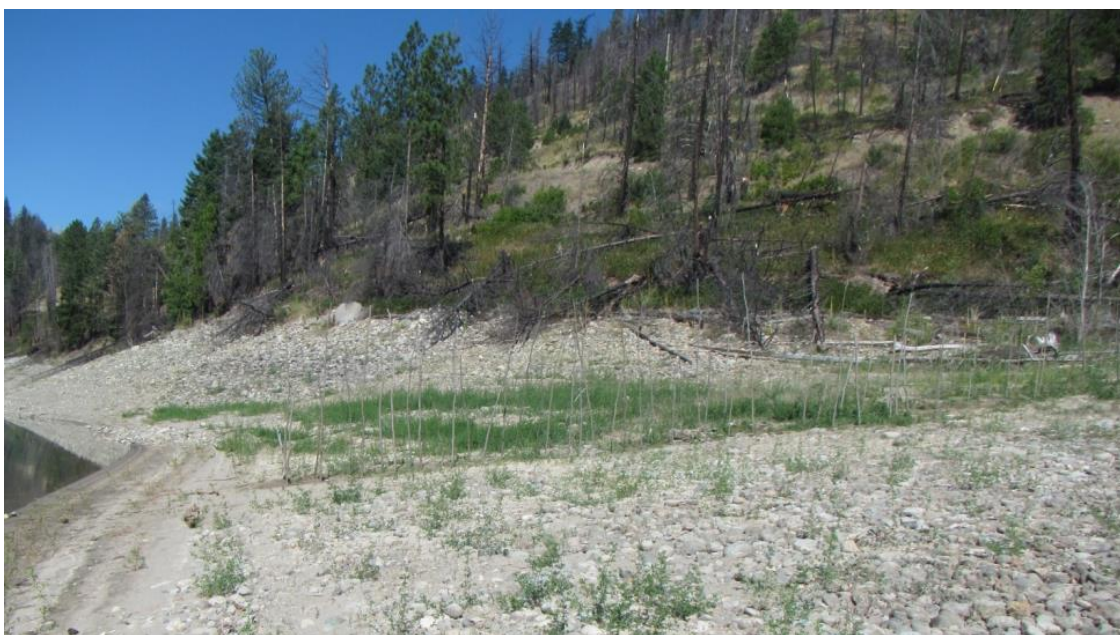
Figure 23 Live stake cuttings at the West end of the steep beach polygon STB02.

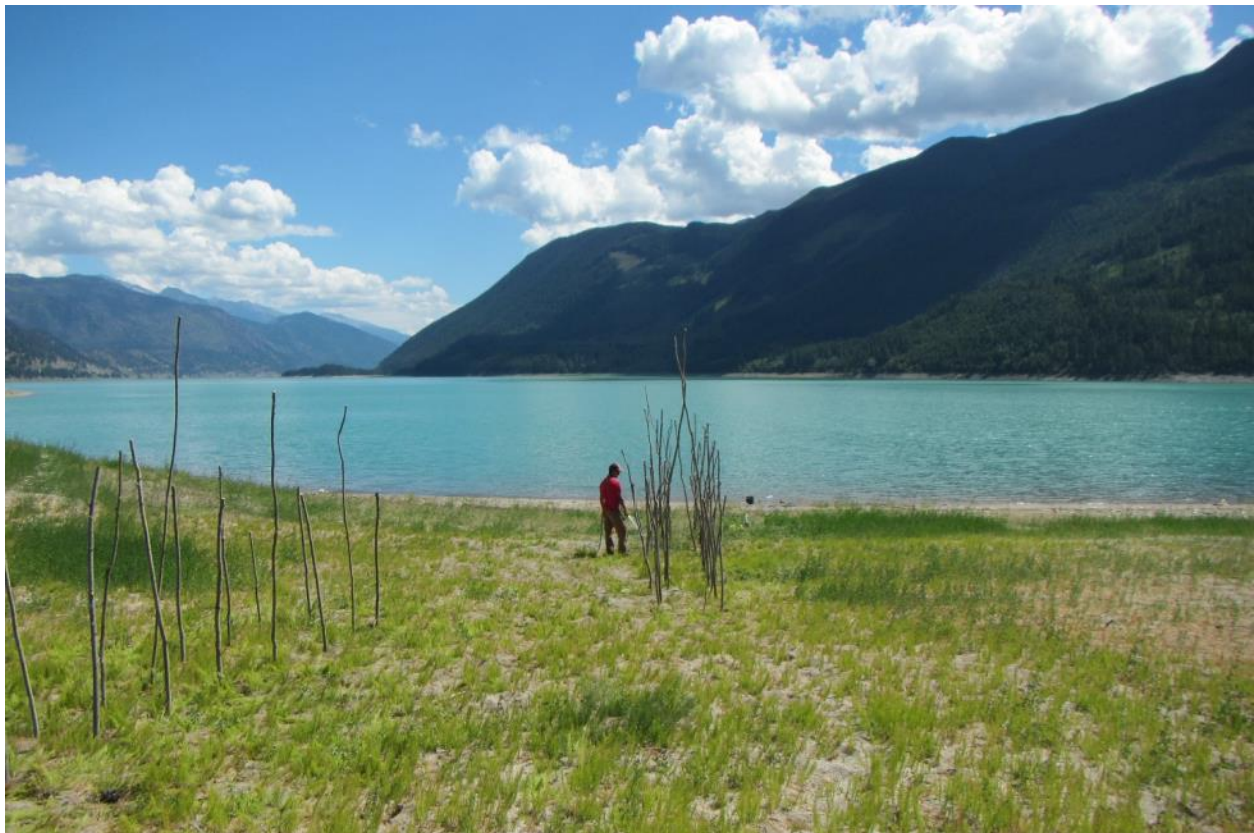
Figure 27 Watering in cutting on the shallow beach site September 2014.

Live stake cuttings of willow (*Salix sp.*) were planted on August 6th, using the iron bar hand planting technique at the east end of the beach (Figure 26). In total 86 cuttings were planted into two sections 44 at the 644-645m elevation and 42 between 645-646m. Given the easy access to the beach from Hwy 40 and the fact that people had been observed recreating on the beach zone cuttings were placed at one side of the beach and a large gap was maintained between sections to allow for easy passage around the cuttings. A long continuous strip of cuttings would pose a barrier of sorts to access across the beach which may not be desirable in such a unique site given the fact that there is obvious public use. Mule deer (*Odocoileus hemionus*)

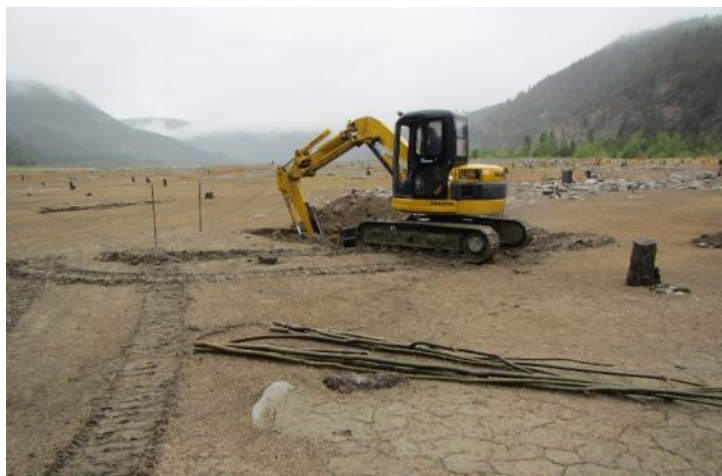
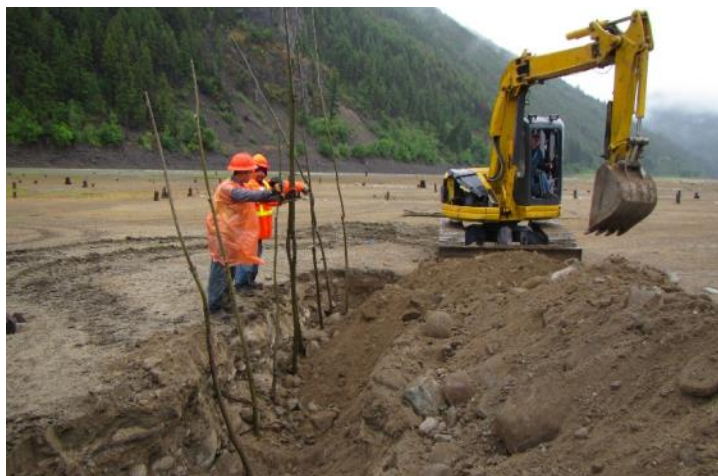
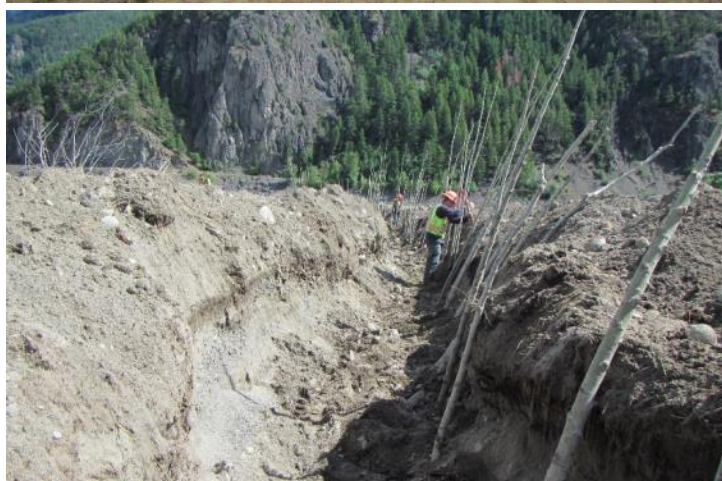
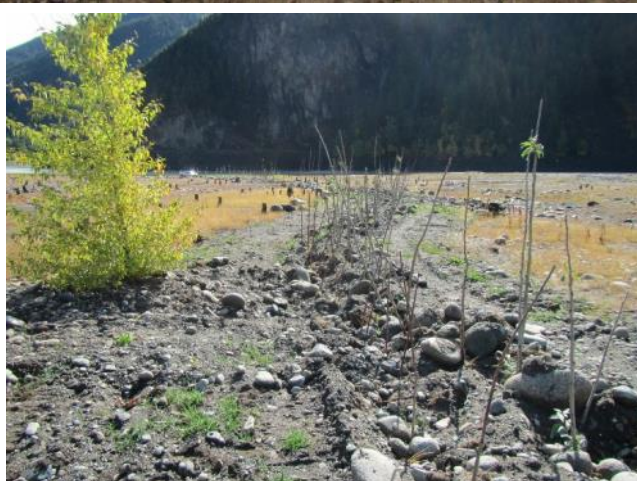
Figure 29 Live stake cuttings at the Gun Creek Fan east side, planting with a combination of machine and manual labour.

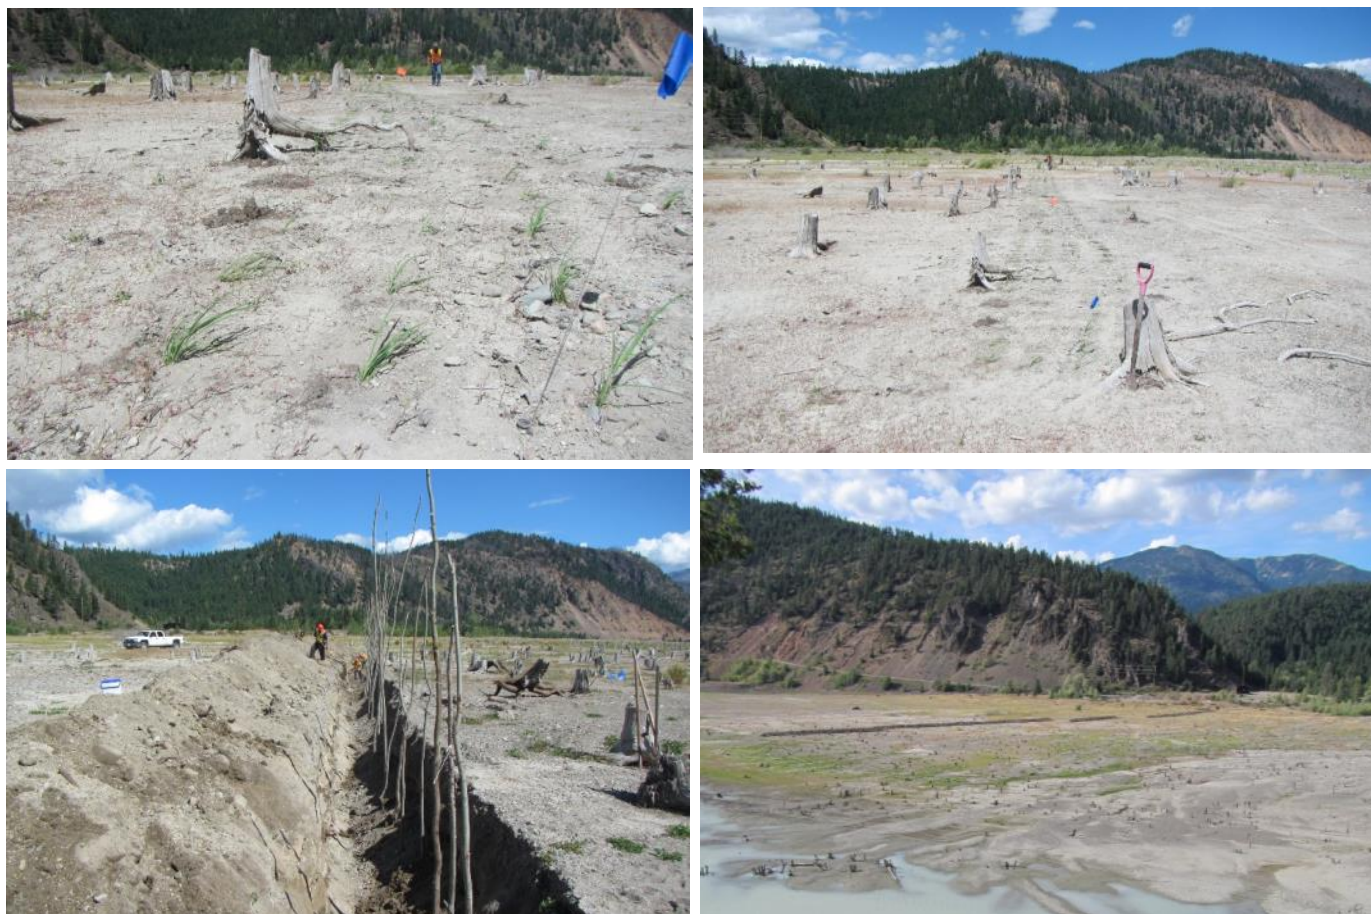
Figure 30 Gun Creek Fan west sedge strip planting and live stake cuttings trenches. Lower right photo taken from Truax FSR as machine was backfilling planted trenches.

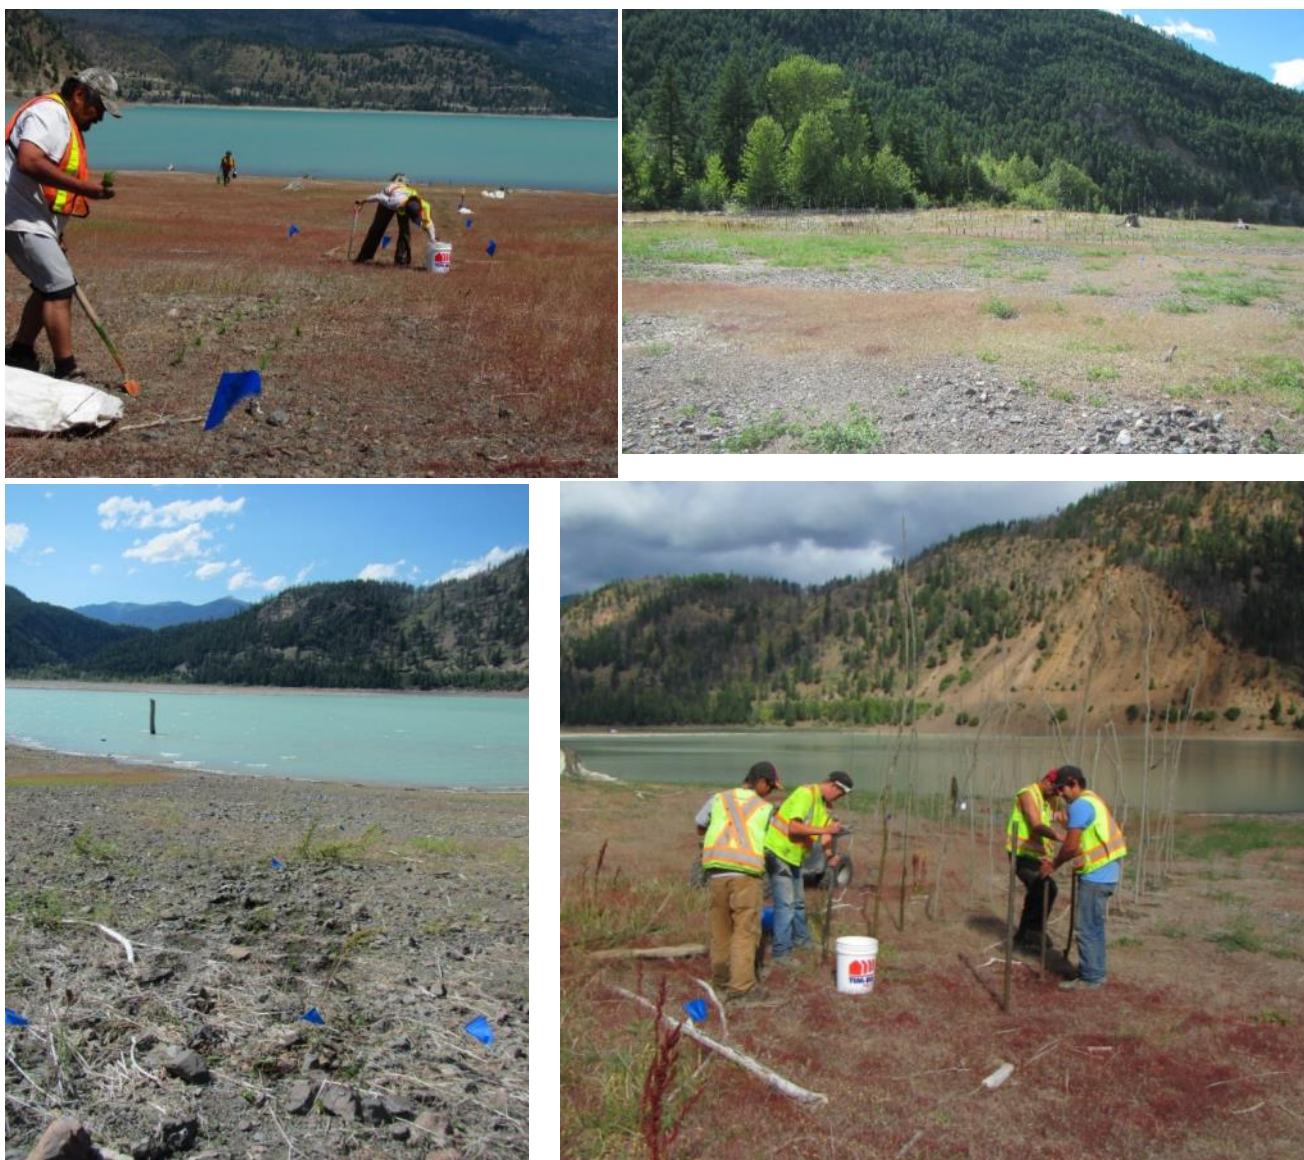
Figure 32 Alluvial Fan Planting Trials 2014.

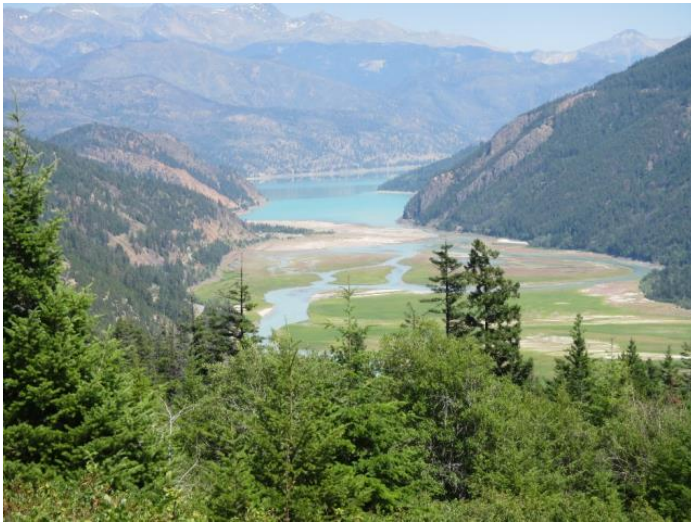
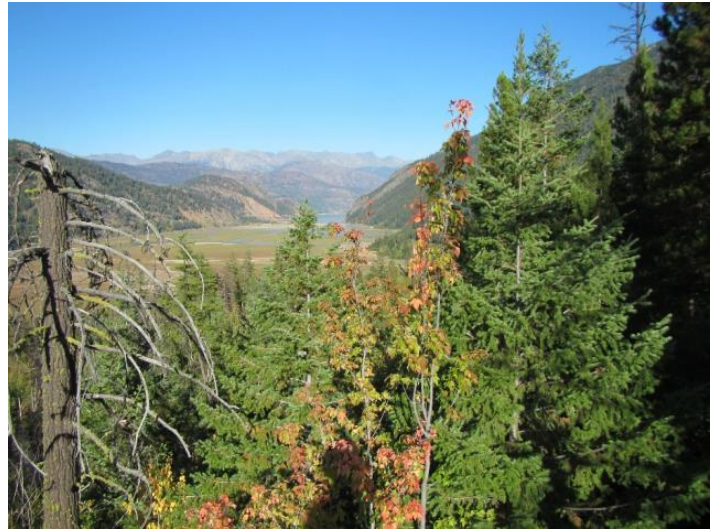
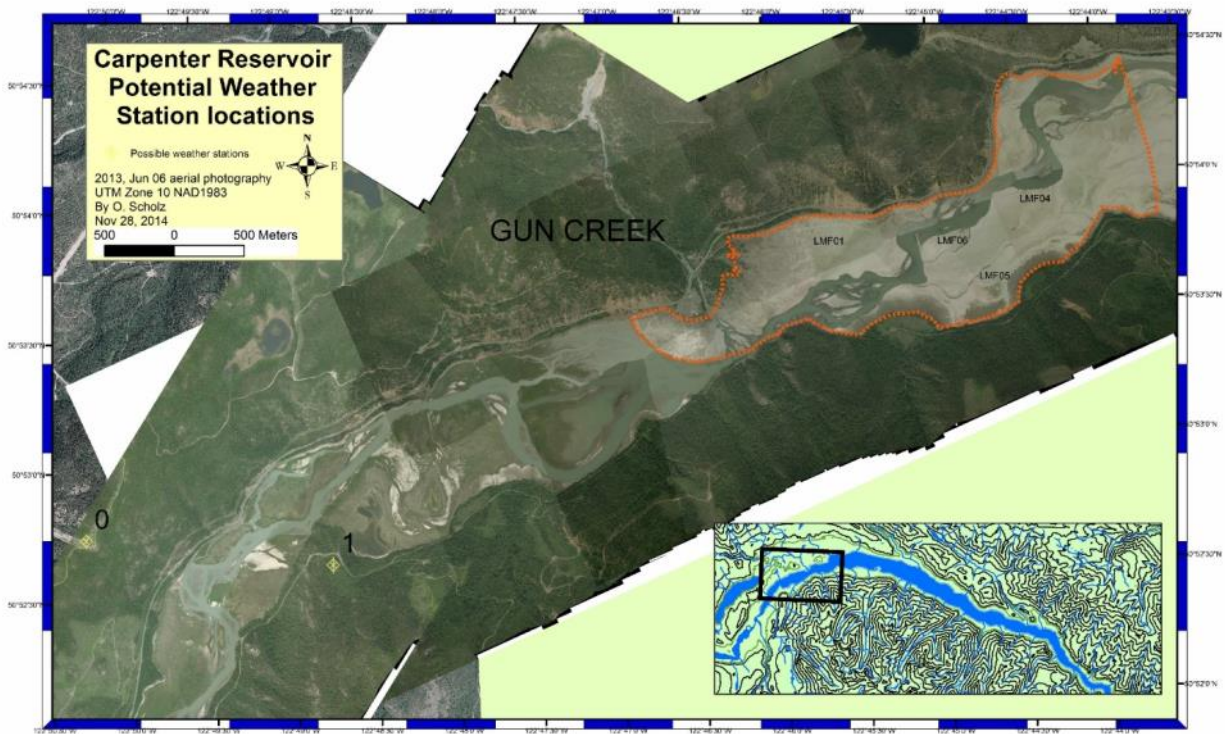
Figure 34 Possible locations for dust monitoring station, top left image from site (0), and top right image from site (1) with the revegetation target area outlined in red.

In 2014 consultation was carried out with BC Hydro dust monitoring specialists, and out of this it has been agreed that effective monitoring of dust storm frequency could be obtained through the setup of a weather station equipped with a digital camera to record images of the reservoir. Captured images could be analyzed to establish a frequency of dust event occurrences on the Carpenter Reservoir. This would allow a comparison over time to see if there is a reduction in occurrence after the revegetation effort. A programmable meteorological equipment station was ordered to enable logging temperature, wind speed, wind direction, precipitation, as well as being able to take photos at regular intervals in any weather conditions. The station will be powered by solar panels and batteries on site and will be downloaded on a monthly basis. Suitable locations for installing the camera were searched out with a sample view from investigated locations depicted in Figure 34.
