Bridge River Project Water Use Plan

Carpenter Reservoir Drawdown Zone Re-Vegetation Program

Implementation Year 3

Reference: BRGWORKS-1

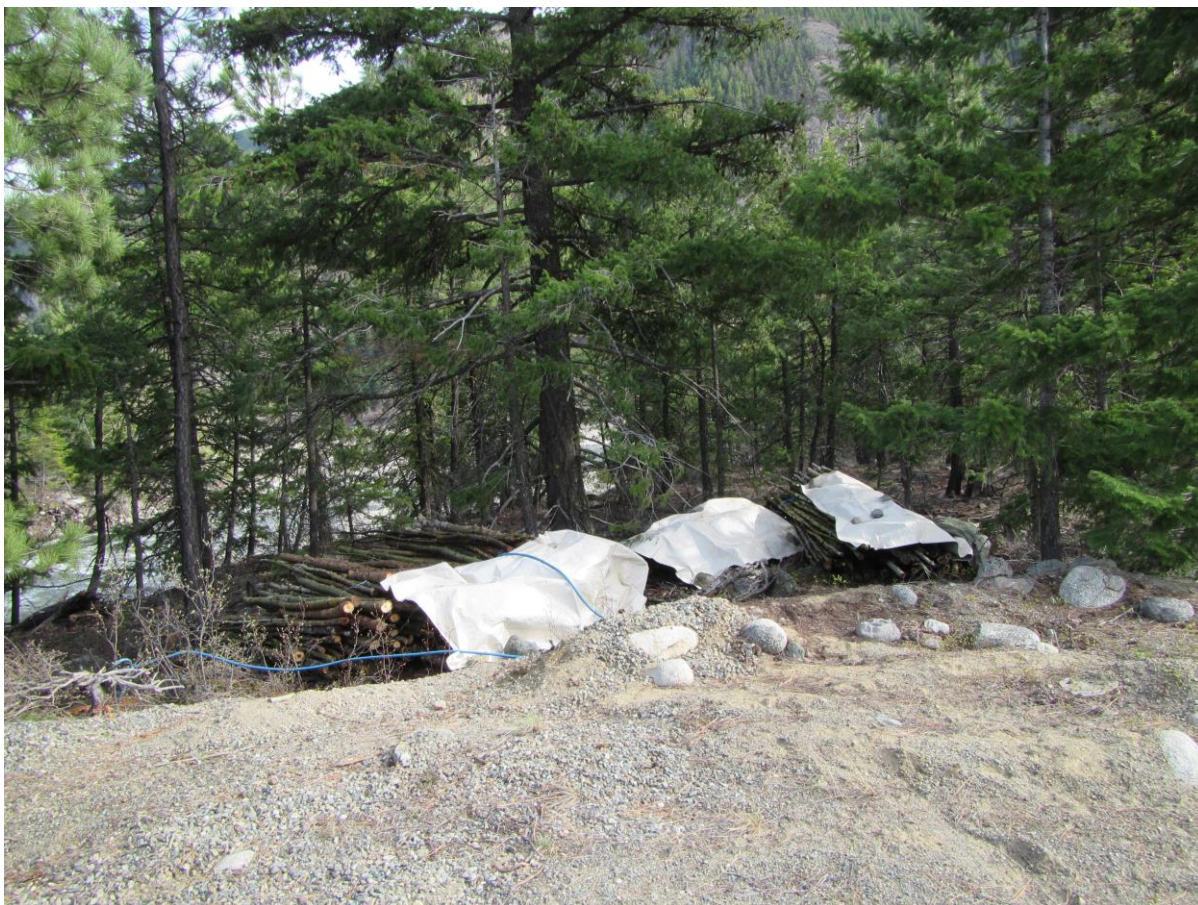
Figure 1 live stake cutting staged on the GCFW just prior to planting. 13 May 2016

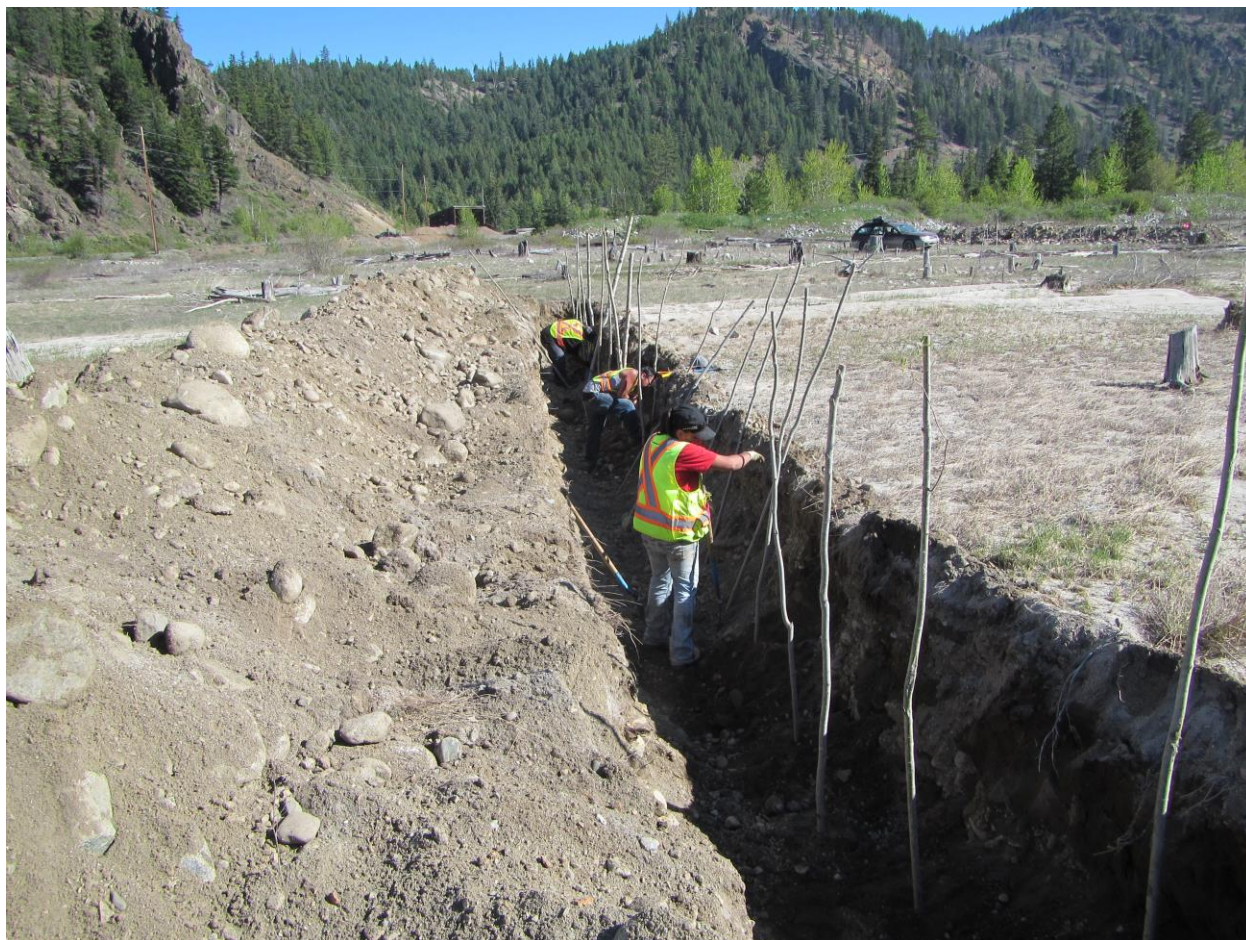
Figure 2 Planting cuttings in the bottom of trenches 20 April 2016.

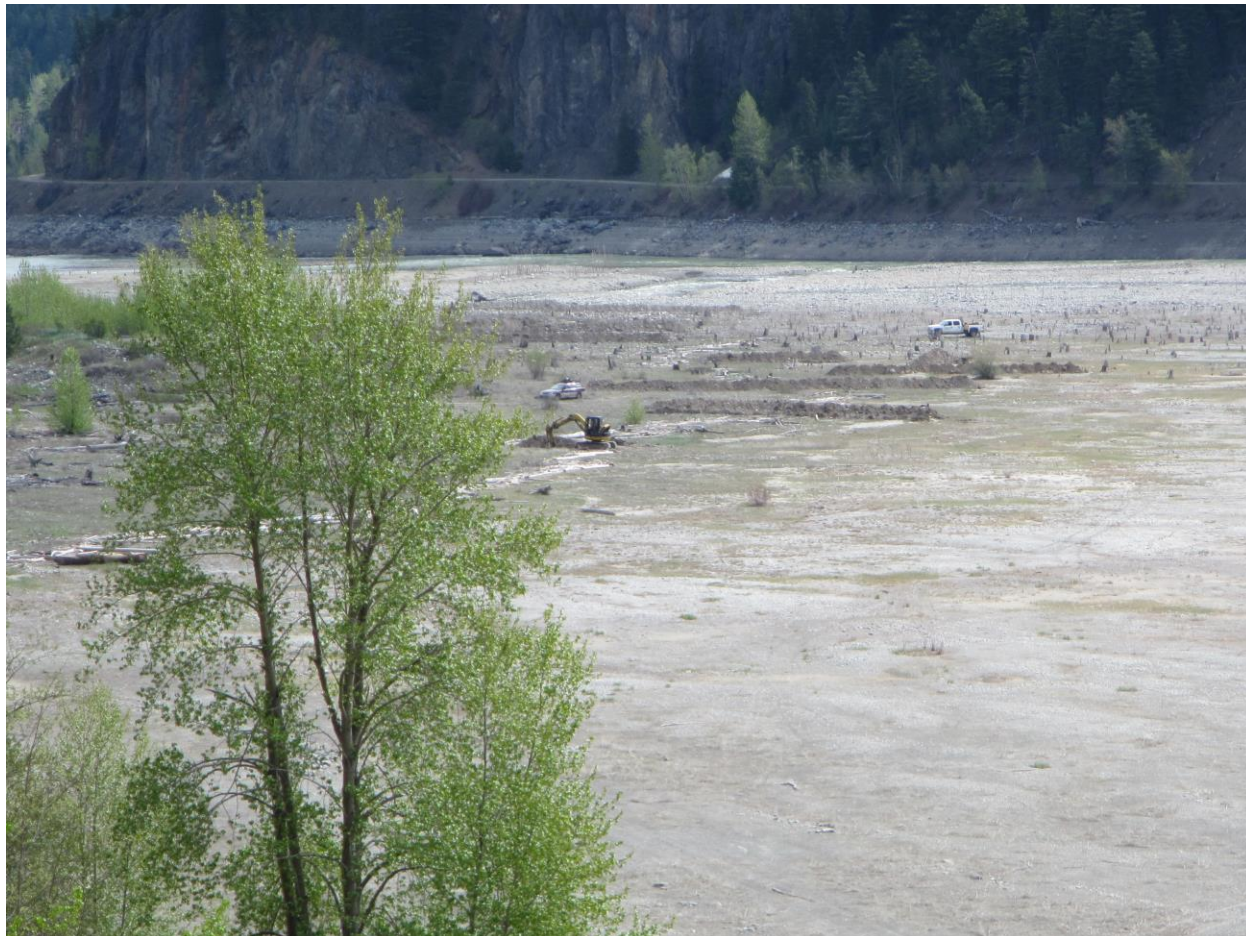
Figure 3 Gun Creek Fan West side, excavator digging trench for live stake cutting planting. 18 May 2016.

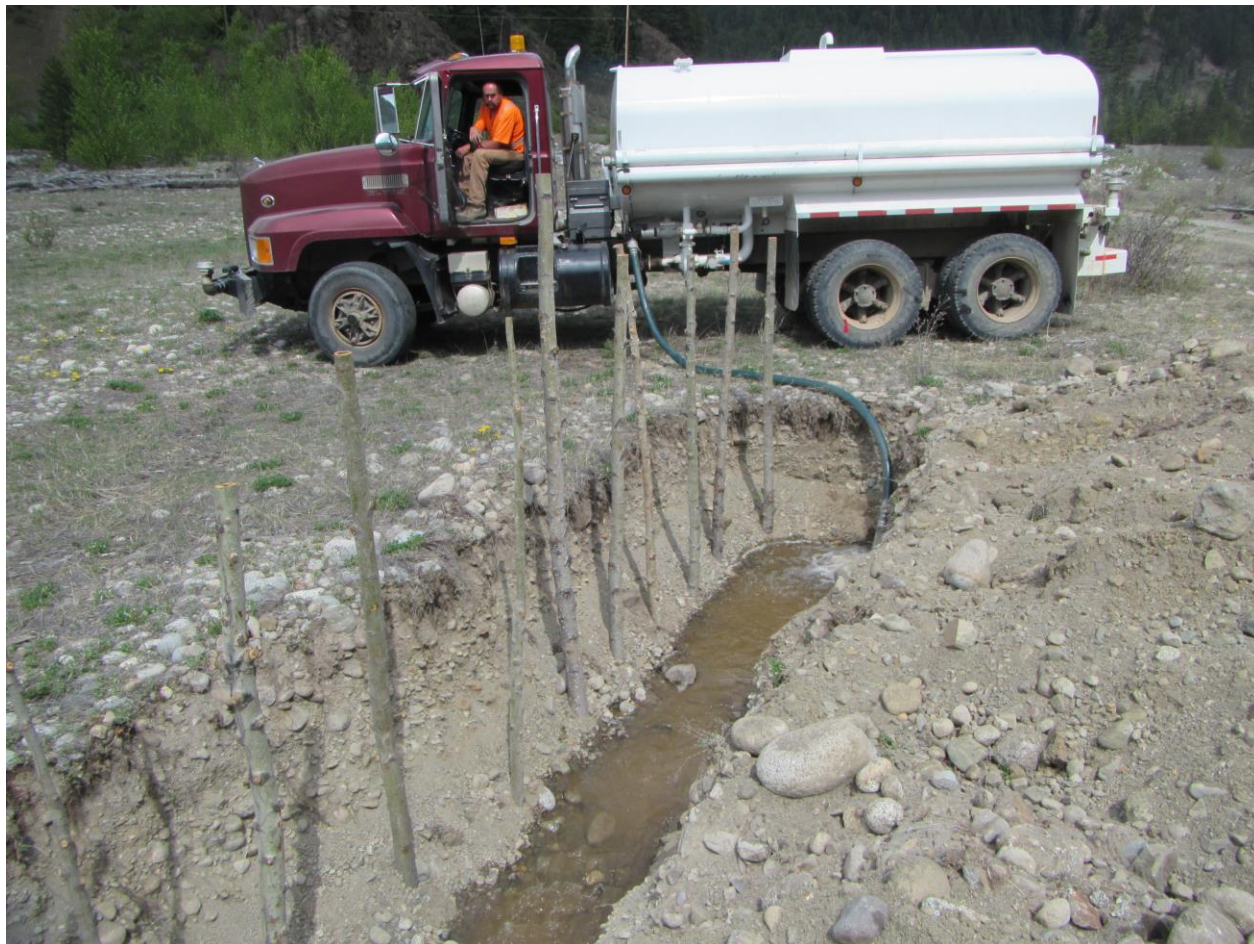
Figure 4 Watering cuttings trenches on the Gun Creek Fan West, prior to backfilling with excavator. 20 April 2016

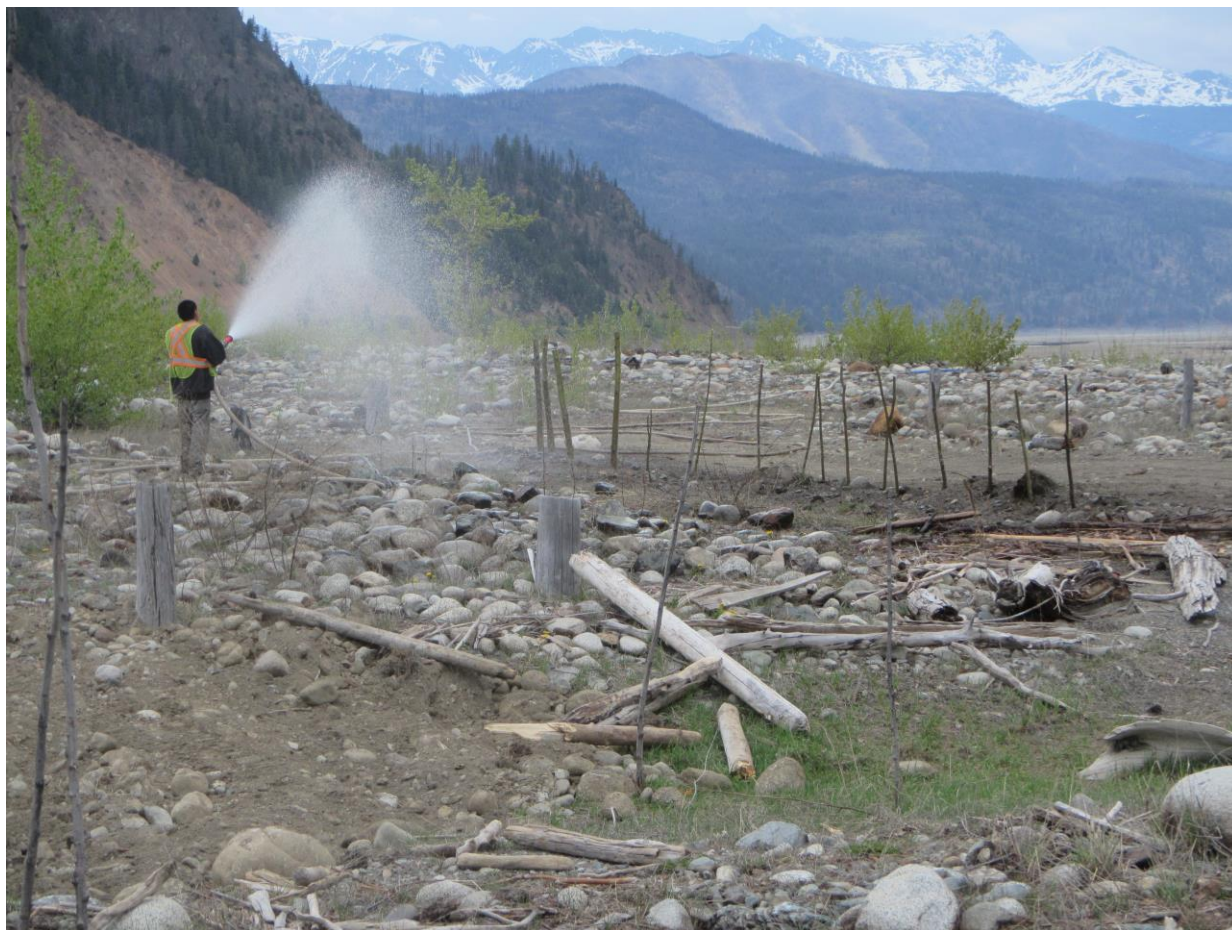
Figure 5 Watering cuttings after they were backfilled by excavator.20 April 2016.

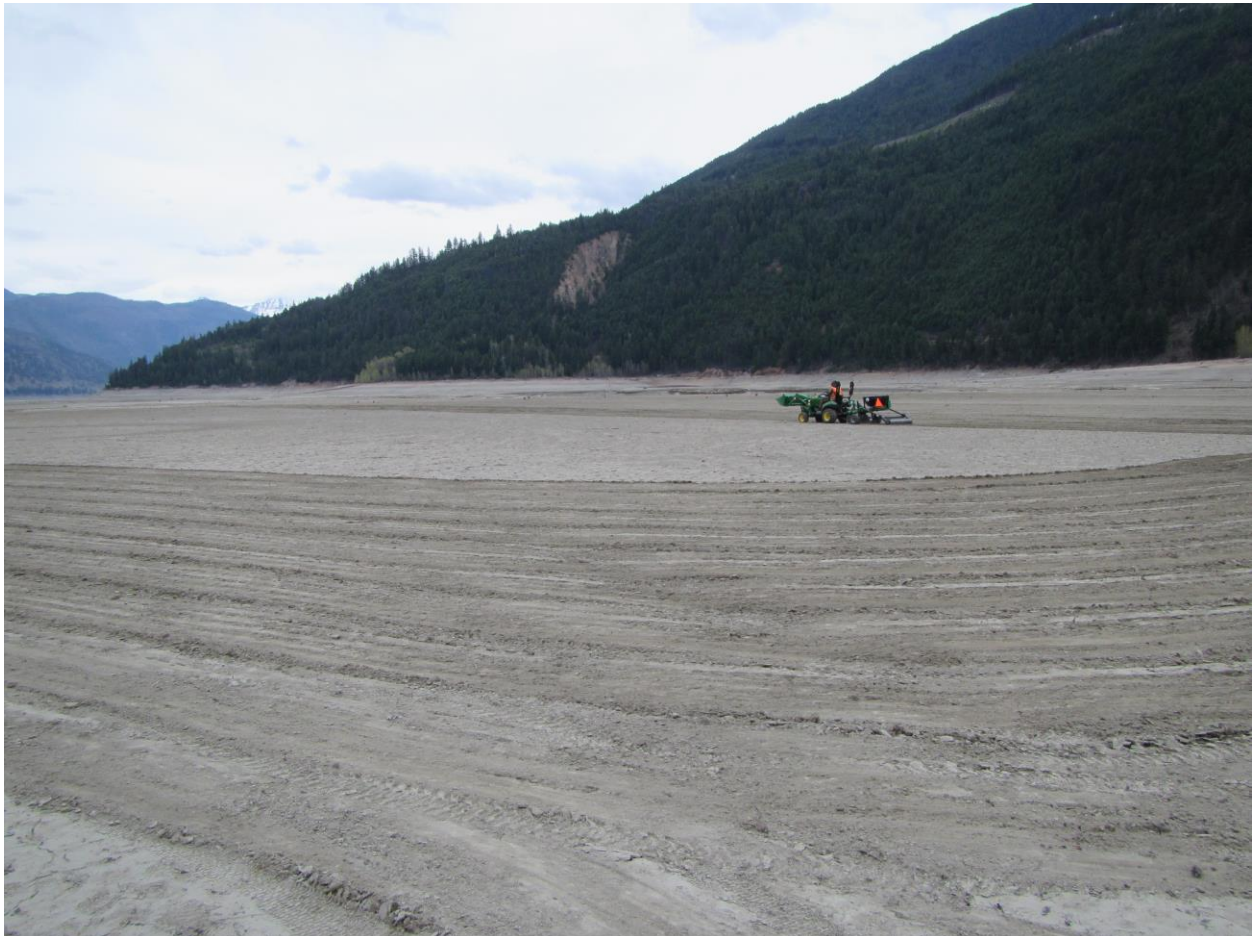
Figure 6 Tractor with seeder sowing fall rye on Low Mud Flat 13 April 2016.

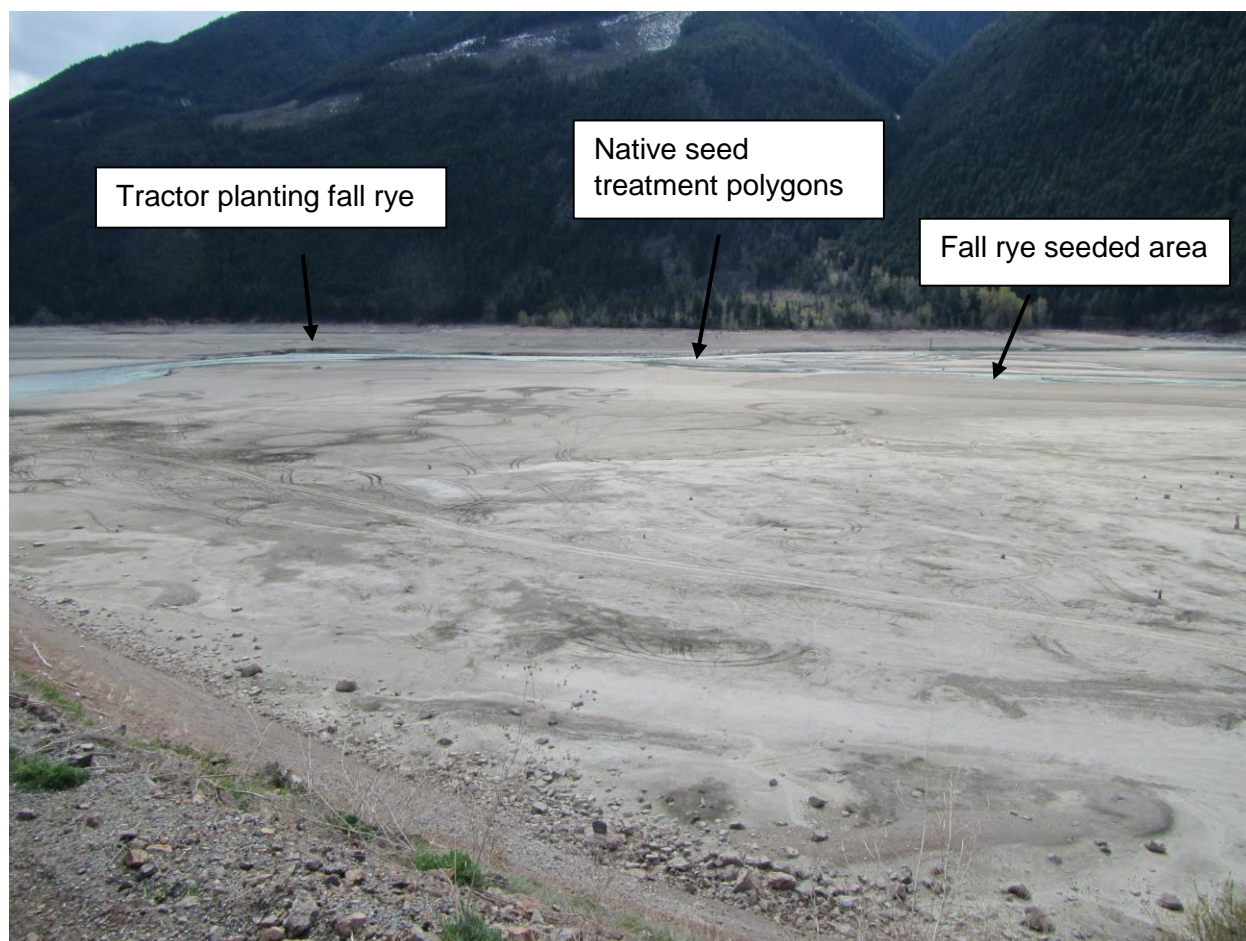
Figure 7 Photo taken of tractor seeding in progress. Photo taken from side of Hwy 40 overlooking LMF 13 April 2017.

In 2016 seeding trials were expanded from 2015 trials out across the 640m elevation on the Low Mud Flat accessed from the Gun Creek Fan East side (MAP 1). Seeding was carried out using a tractor with a pull-behind seeder (Figure 6). The seeder was equipped with a seed hopper, plough discs, a chain grid harrow and compactor.

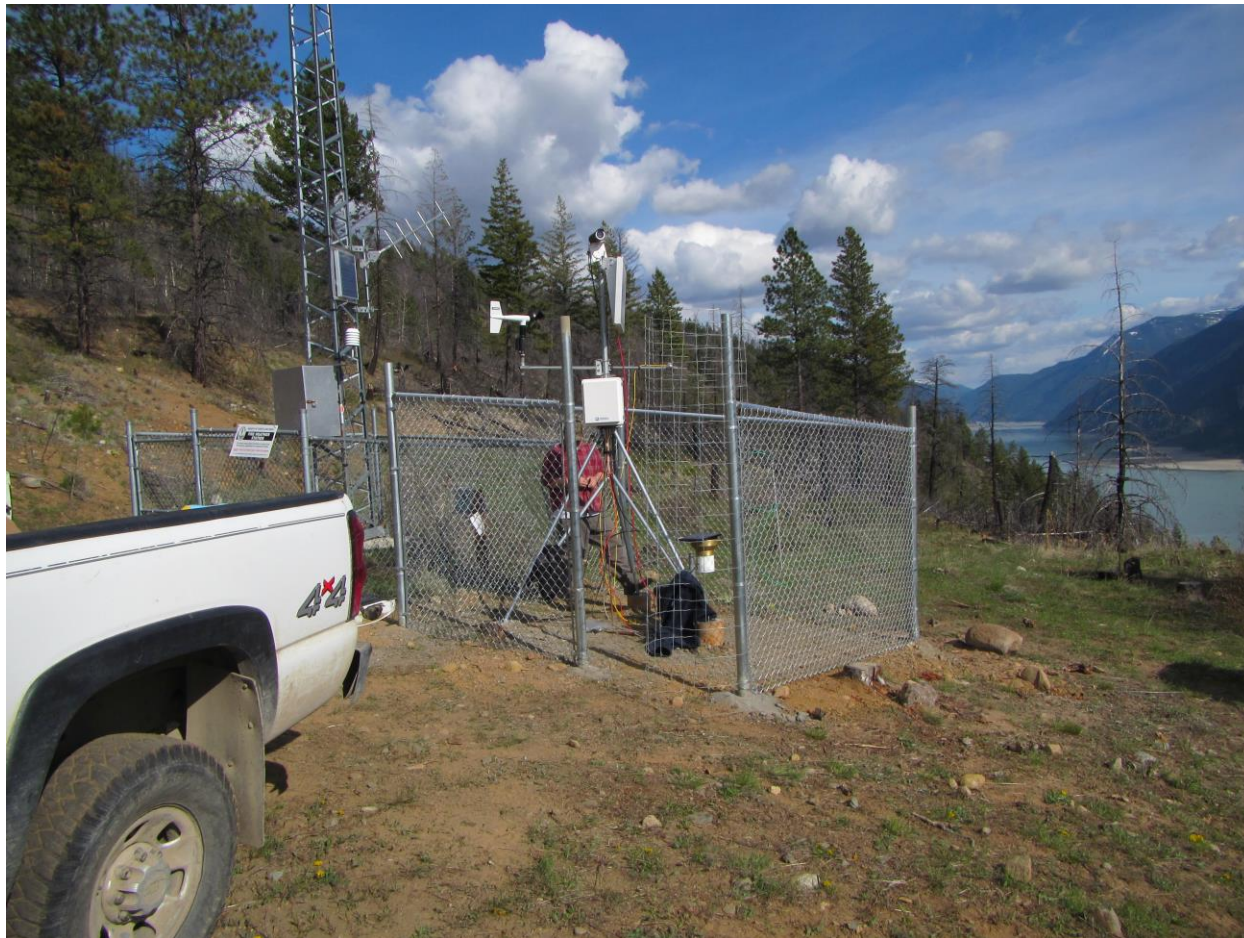
Figure 8 Weather station being installed 13 April 2017.

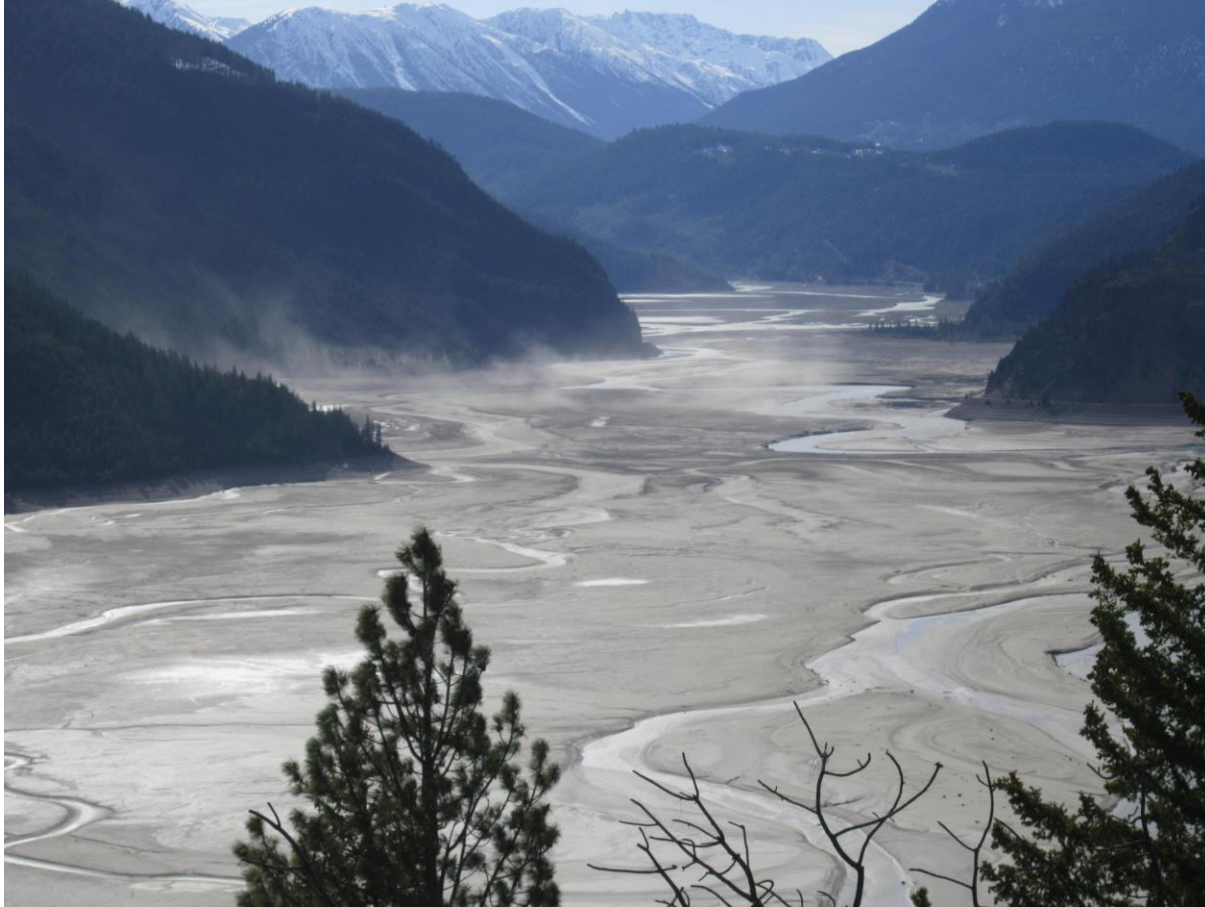
Figure 9 Example of photo capture from weather station camera, this image was from 8 April 2017.

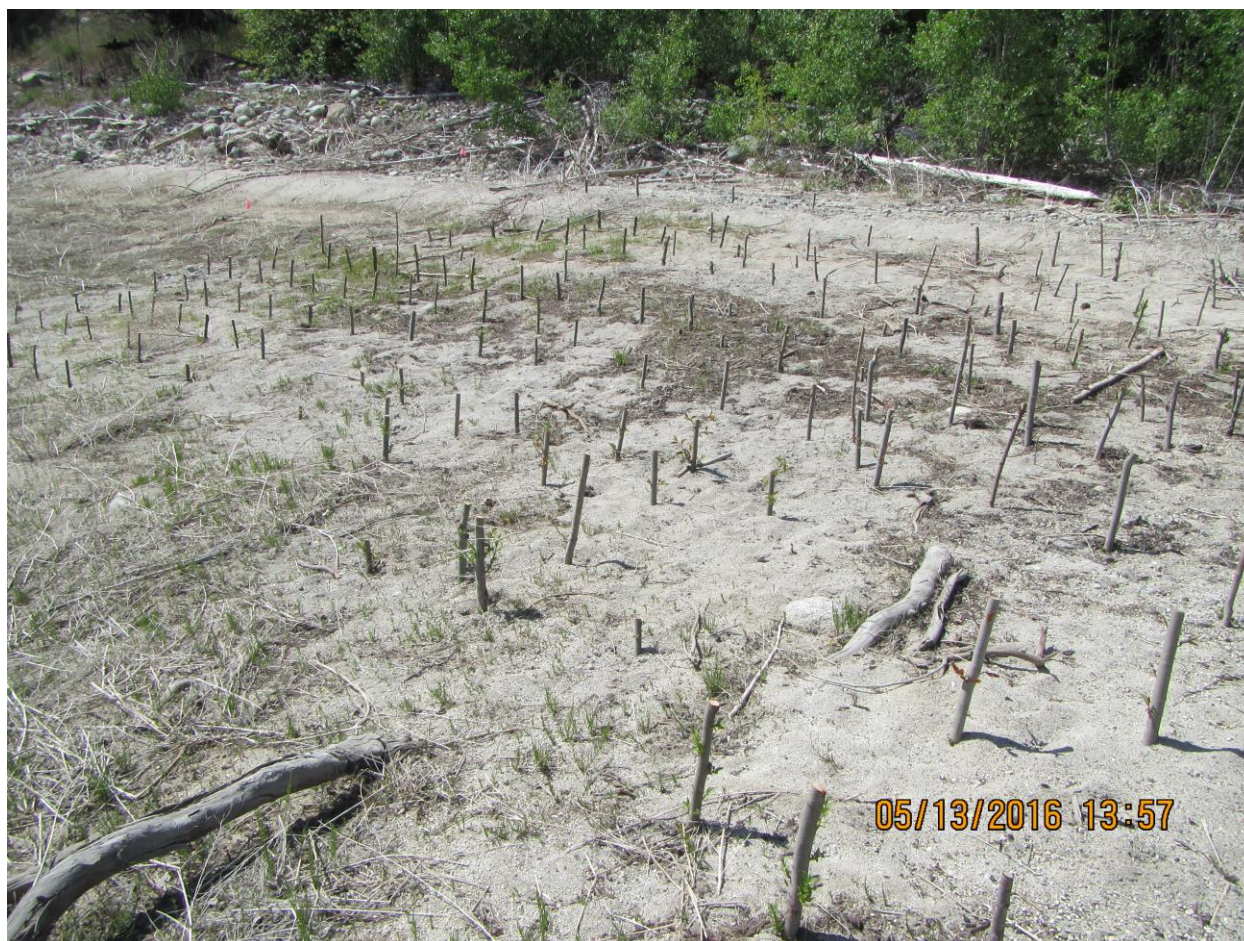
Figure 11 SHB west end polygon of live stake cuttings photographed 13May 2016 a month after planting , green shoots are noted sprouting from the stakes.

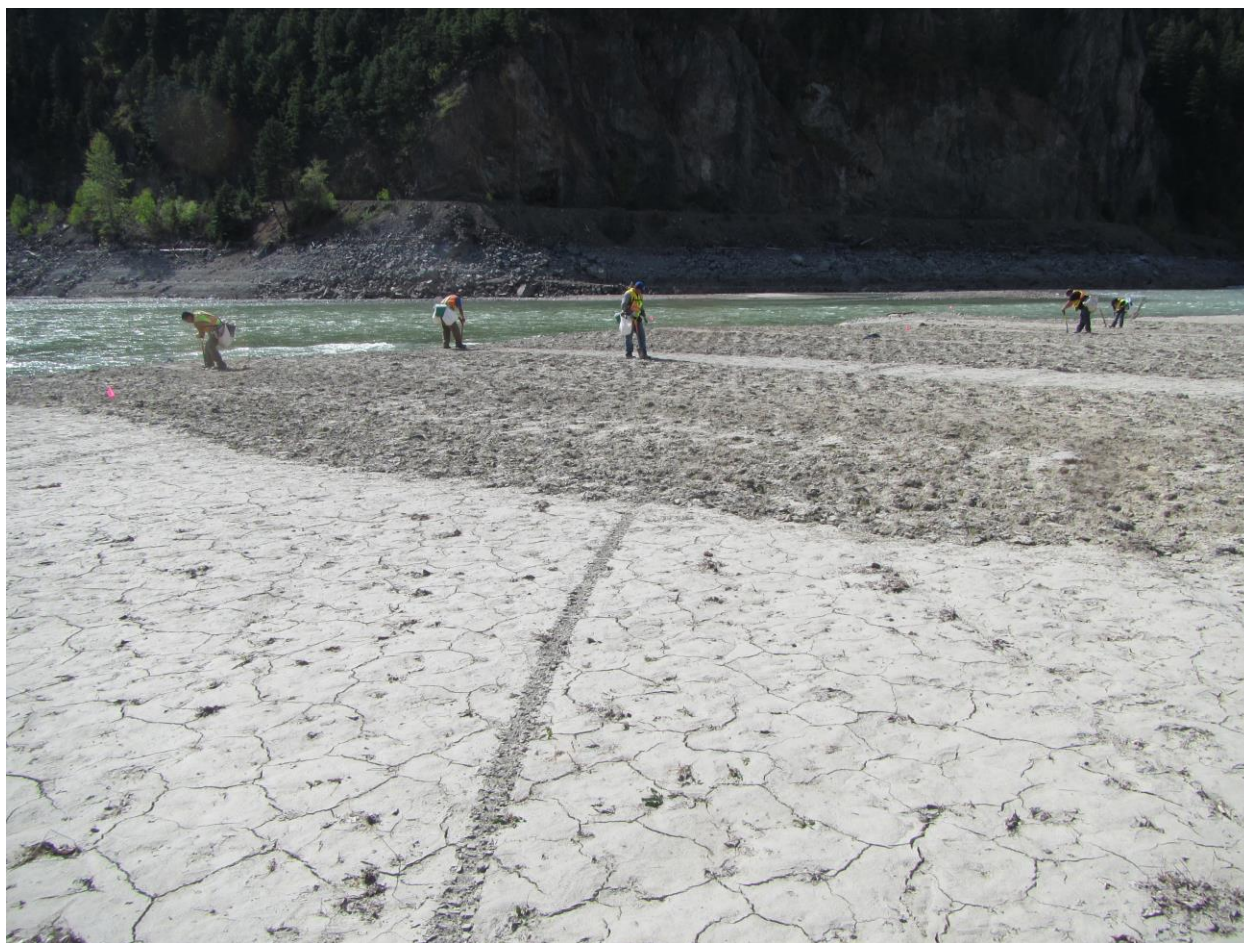
Figure 12 Planters planting lakeshore sedge in polygon PLG01, 25 April 2016.

Seeding and planting treatments were carried out across the Low Mud Flat in 2016. Trials expanded on seeding and planting test plots from 2015. Six polygons totalling .4 ha in area were laid out and planted with lakeshore sedge plugs (MAP 4). Planting polygons were situated along the banks of the Bridge River on the level mud flat. Polygons were located at elevations between 640m and 643m. Polygons ranged in size from 202m² to 1270m². Planting densities ranged from just over 1 plant per square metre to over 4 plants per square metre (Table 3). Polygons PLG01, PLG04,05-06 were planted to an even dense spacing (Figure 12). Polygons PLG02 and PLG03 were planted in dense strips with similar spacing to PLG01, however in PLG02 strips approximately 2m wide were spaced apart with unplanted gaps of a similar width to the planted strip (Figure 13). The gaps were left between strips with the intention to monitor if the strips could have an influence in the neighbouring non-planted ground with increased vegetation recruitment potential. Gaps would also allow more ground to be treated by fewer plants, potentially stretching limited resources. When planting the two different aged batches of lakeshore sedge, plants were tracked separately to allow future assessment to see if there was any benefit to planting slightly older vs younger plants. Early season observations of 2015 planting trials on the LMF pointed to older planting stock attaining significantly larger growth than younger planted stock. This increased production in older vs younger planting stock was reportedly observed in other studies on the Upper Arrows by Anne Moodie (personal communication). Plants were all watered in after planting (Figure 14).

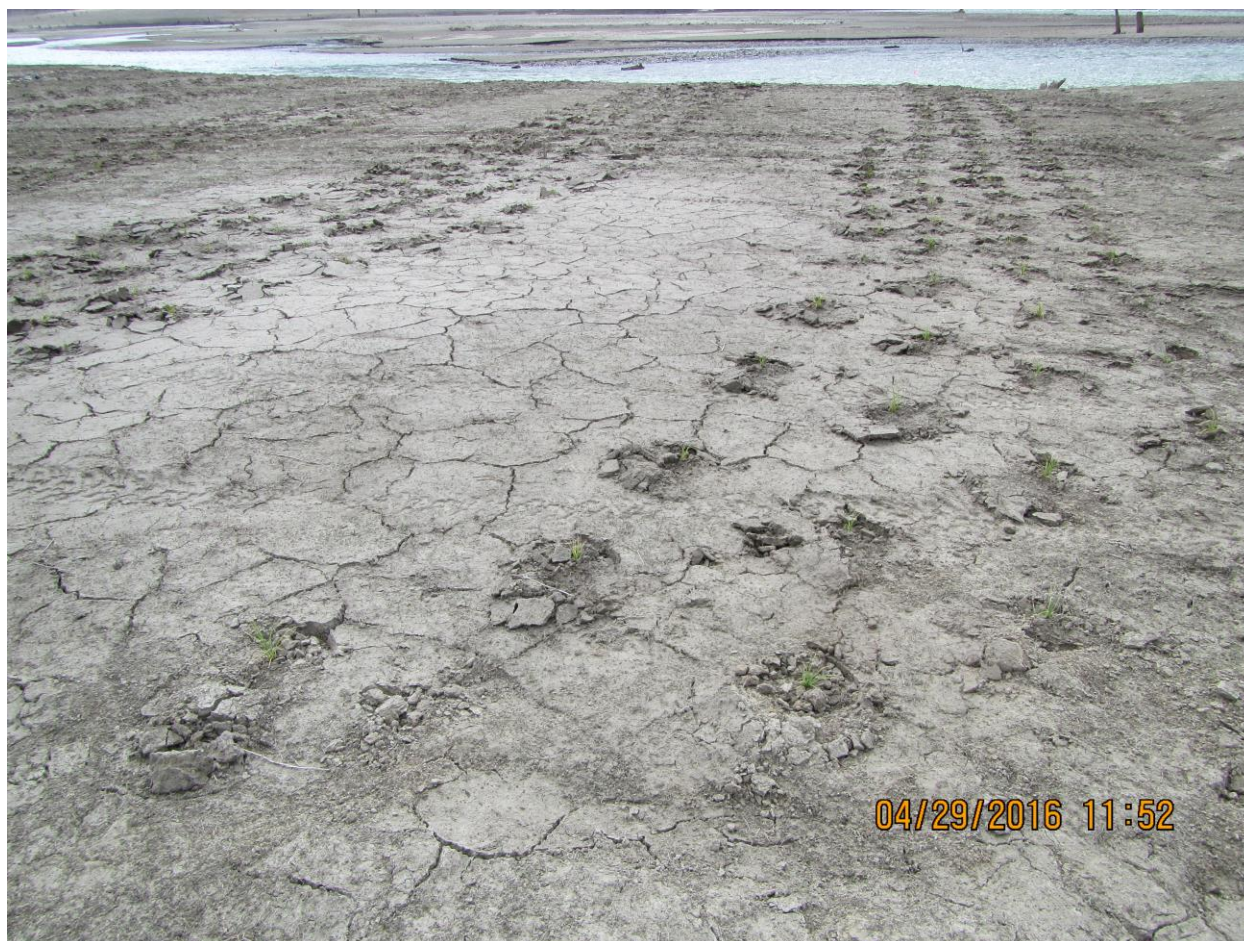
Figure 13 PLG02 with gaps left between planted strips. Photo taken one day after planting, 29 April 2016.

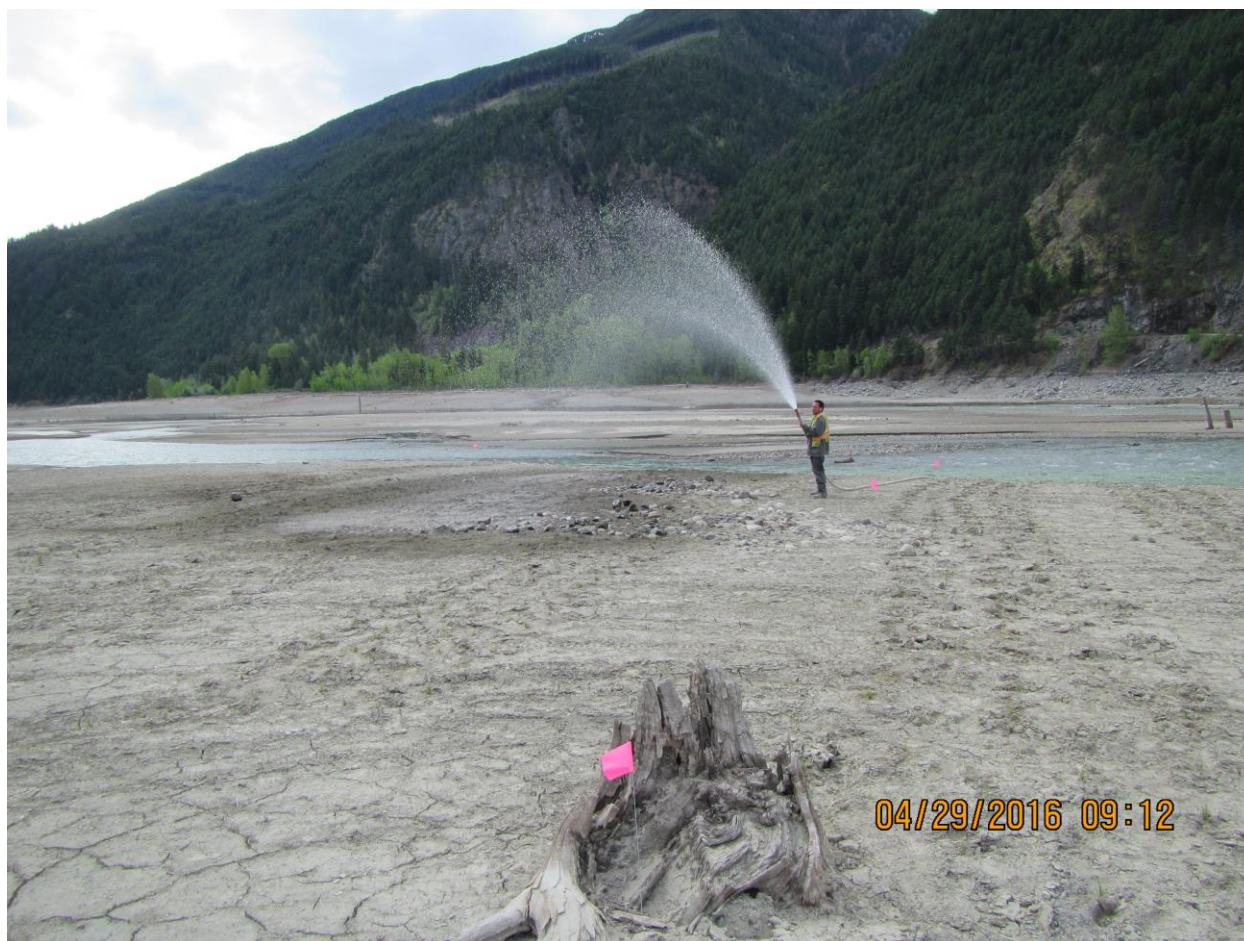
Figure 14 PLG02 watering one day post planting. 29 April 2016. Water pumped from a 2 inch water pump and fire hose.

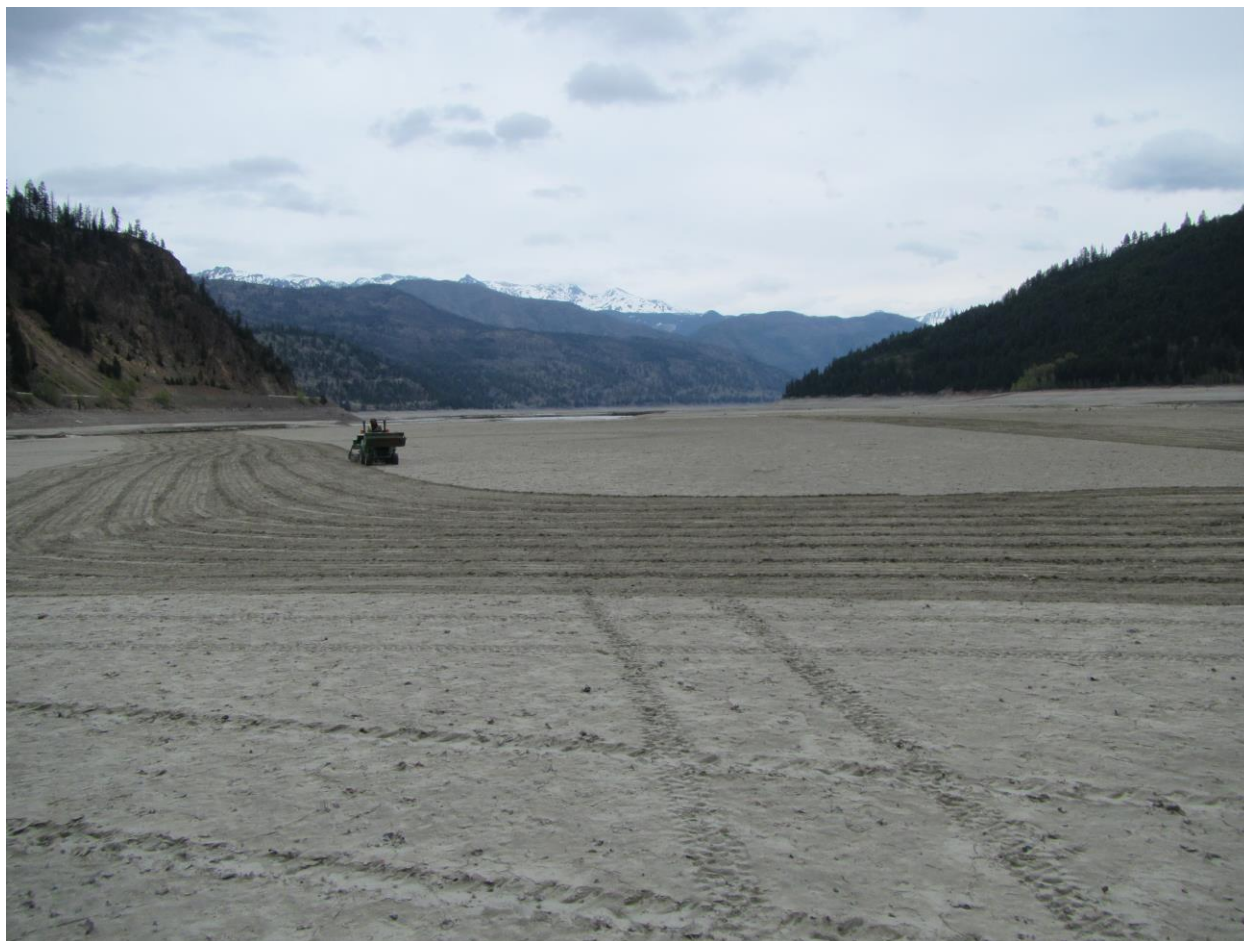
Figure 15 Tractor seeding LMF with fall rye. 14 April 2016.

Two large polygons were seeded with fall rye at about 50kg per hectare (Figure 15). Three smaller polygons were treated to compare responses to;

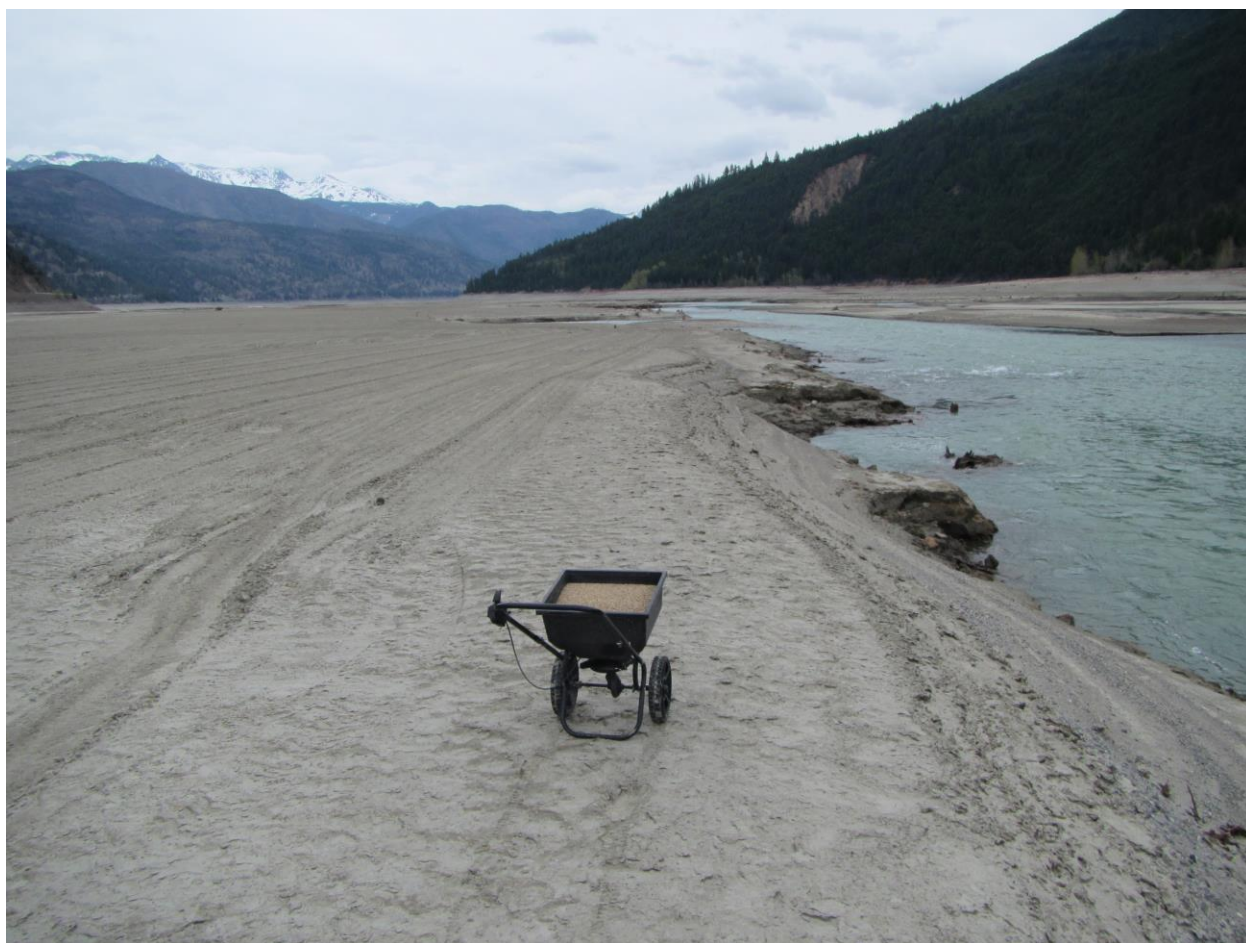
Figure 17 Walk behind seeder poised along the inaccessible edge between tractor seeding and Lower Bridge River. 14 April 2016.

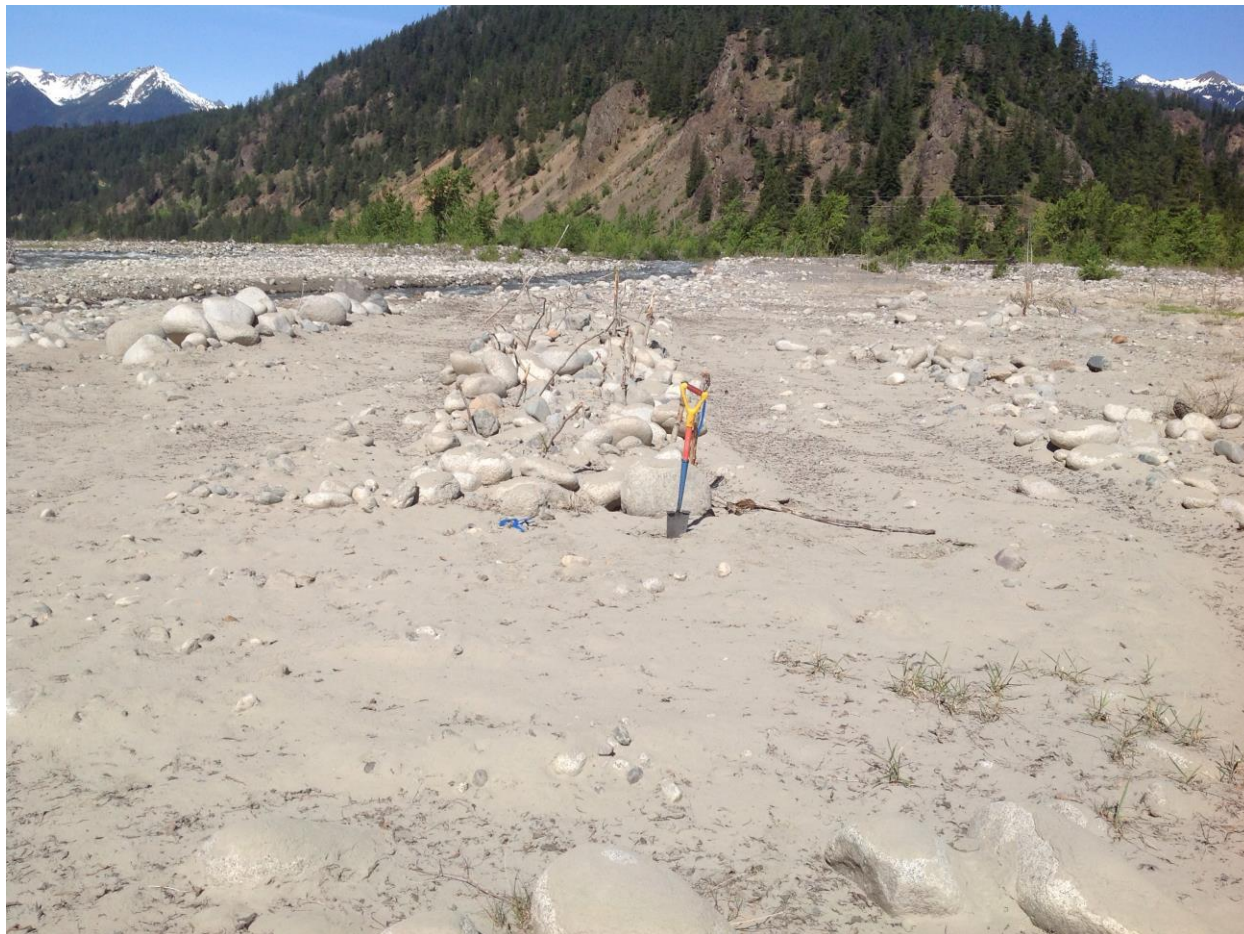
Figure 18 Polygon HH with surface cover of fine sands that are easily elevated by winds. The area surrounding the 2015 cuttings trench was planted with bluejoint reedgrass plugs in 2016.

sources of dust generation with few other species growing (Figure 18). Scattered natural stands of bluejoint reedgrass were observed thriving in the area close to Gun Creek indicating a high likelihood of establishment success. Having stands of bluejoint reedgrass colonize this area would provide dust control, ground level wind breaks and both aquatic and terrestrial habitat complexity.

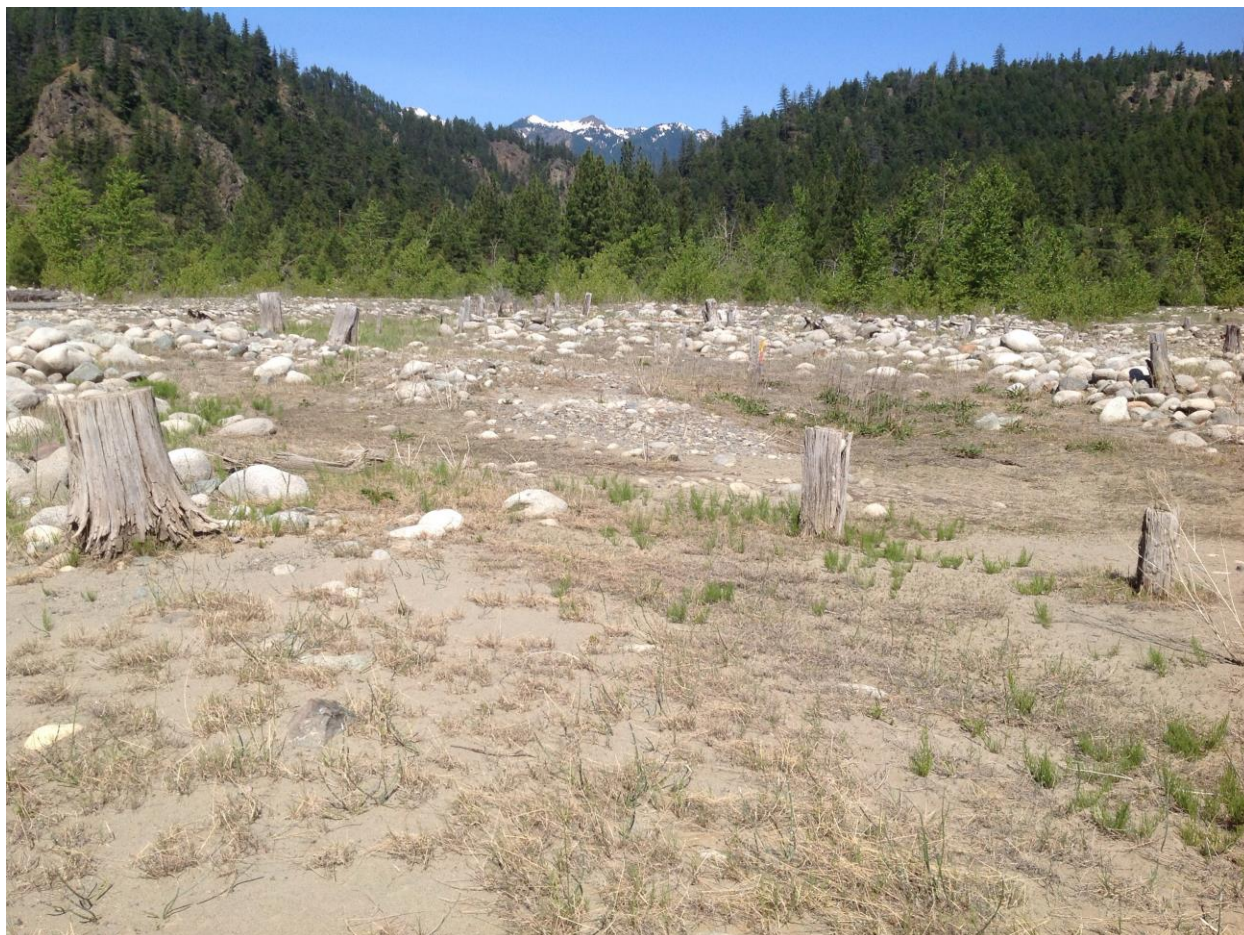
Figure 19 Site of natural stumps targeted for microsite conditions imposed by the stumps structure and decomposition function.

Rooted cottonwood trees were planted into two polygon areas on the Gun Creek Fan East side. Up to this point in the WORKS program rooted cottonwoods had not been used. It has been noted that it is a struggle to get live stakes of cottonwoods to survive planting in the upper drawdown zone (Scholz and Gibeau, 2015). The low survival of cottonwood stakes was in part motivation to try rooted stock. Cottonwoods were targeted for planting in the upper drawdown and lower buffer zone where prolonged flooding and the associated flood damages are reduced. Black cottonwoods are observed growing naturally down to these elevations though in low numbers. One polygon CT16 was chosen for planting due to the fairly regular distribution of old stumps across the site (Figure 19). Cottonwood trees were planted on the north side of each of 50 stumps in the polygon. The intention being to place the cottonwood seedlings into a pre-existing beneficial microsite. Stumps would provide seedlings with shade from sun and wind, and also provide organic matter subsurface from decomposing roots. Decomposing roots hold more moisture than the surrounding substrate providing unique subsurface conditions. The

stump will also capture and funnel precipitation toward the planting site. Stumps have been observed as regular perches and pluck sites for numerous birds including peregrine falcon (*Falco peregrinus ssp. anatum*), bald eagle (*Haliaeetus leucocephalus*), crows (*Corvus brachyrhynchos*), ravens (*Corvus corax*), that brings nutrients to the site in the form of feces, bones and feathers.
