Bridge River Project Water Use Plan

Carpenter Reservoir Drawdown Zone Re-Vegetation Program

Implementation Year 3

Reference: BRGWORKS-1

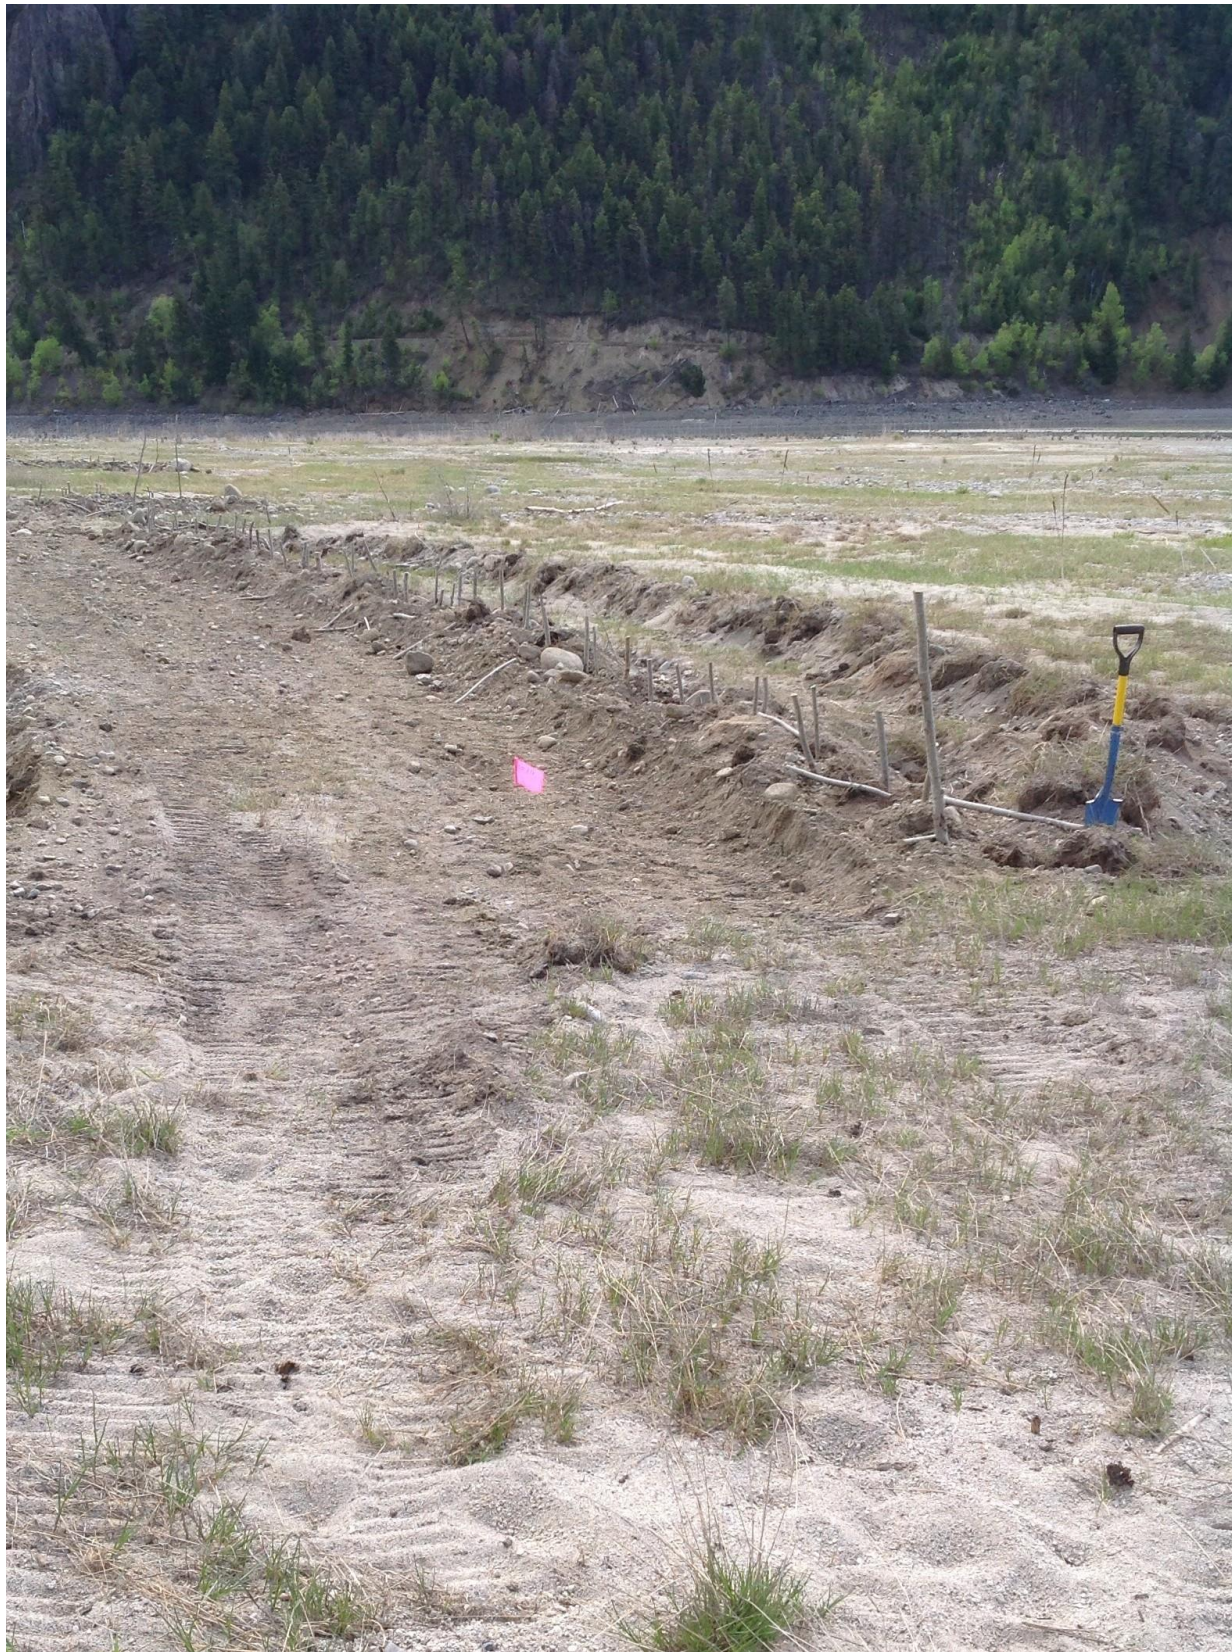
Figure 20 Trench G with mound and trench below planted cuttings.

Gun Creek Fan West side was the target of planting and live stake cutting treatment trials in 2016. Twenty-four trenches were excavated and cuttings planted into them as described in the methods. Based on observations from previous trials from 2014 and 2015 and the damage sustained to the cuttings it was decided to retreat to the higher elevation of the drawdown zone, including the buffer zone, to escape the brunt of damage caused by flooding and freezing. Cutting trenches spanned elevations from 647-649.5m (MAP 6). In total 492 willow and 702 cottonwood cuttings were planted into the trenches on the GCFW. The majority of the trenches ran with the slope of the fan, with three trenches running across the slope (O, F and G MAP 6). Polygons O, F and G were constructed with small mounds running across the slope directly below the planted cuttings. The berms were a mound of mixed soil and rock with ditches on either side. The microsites created by the mounds and ditches was constructed to offer protective microsites for the cuttings and to potentially support better growth of planted grasses and promote colonization by native species (Figure 20, Figure 21).

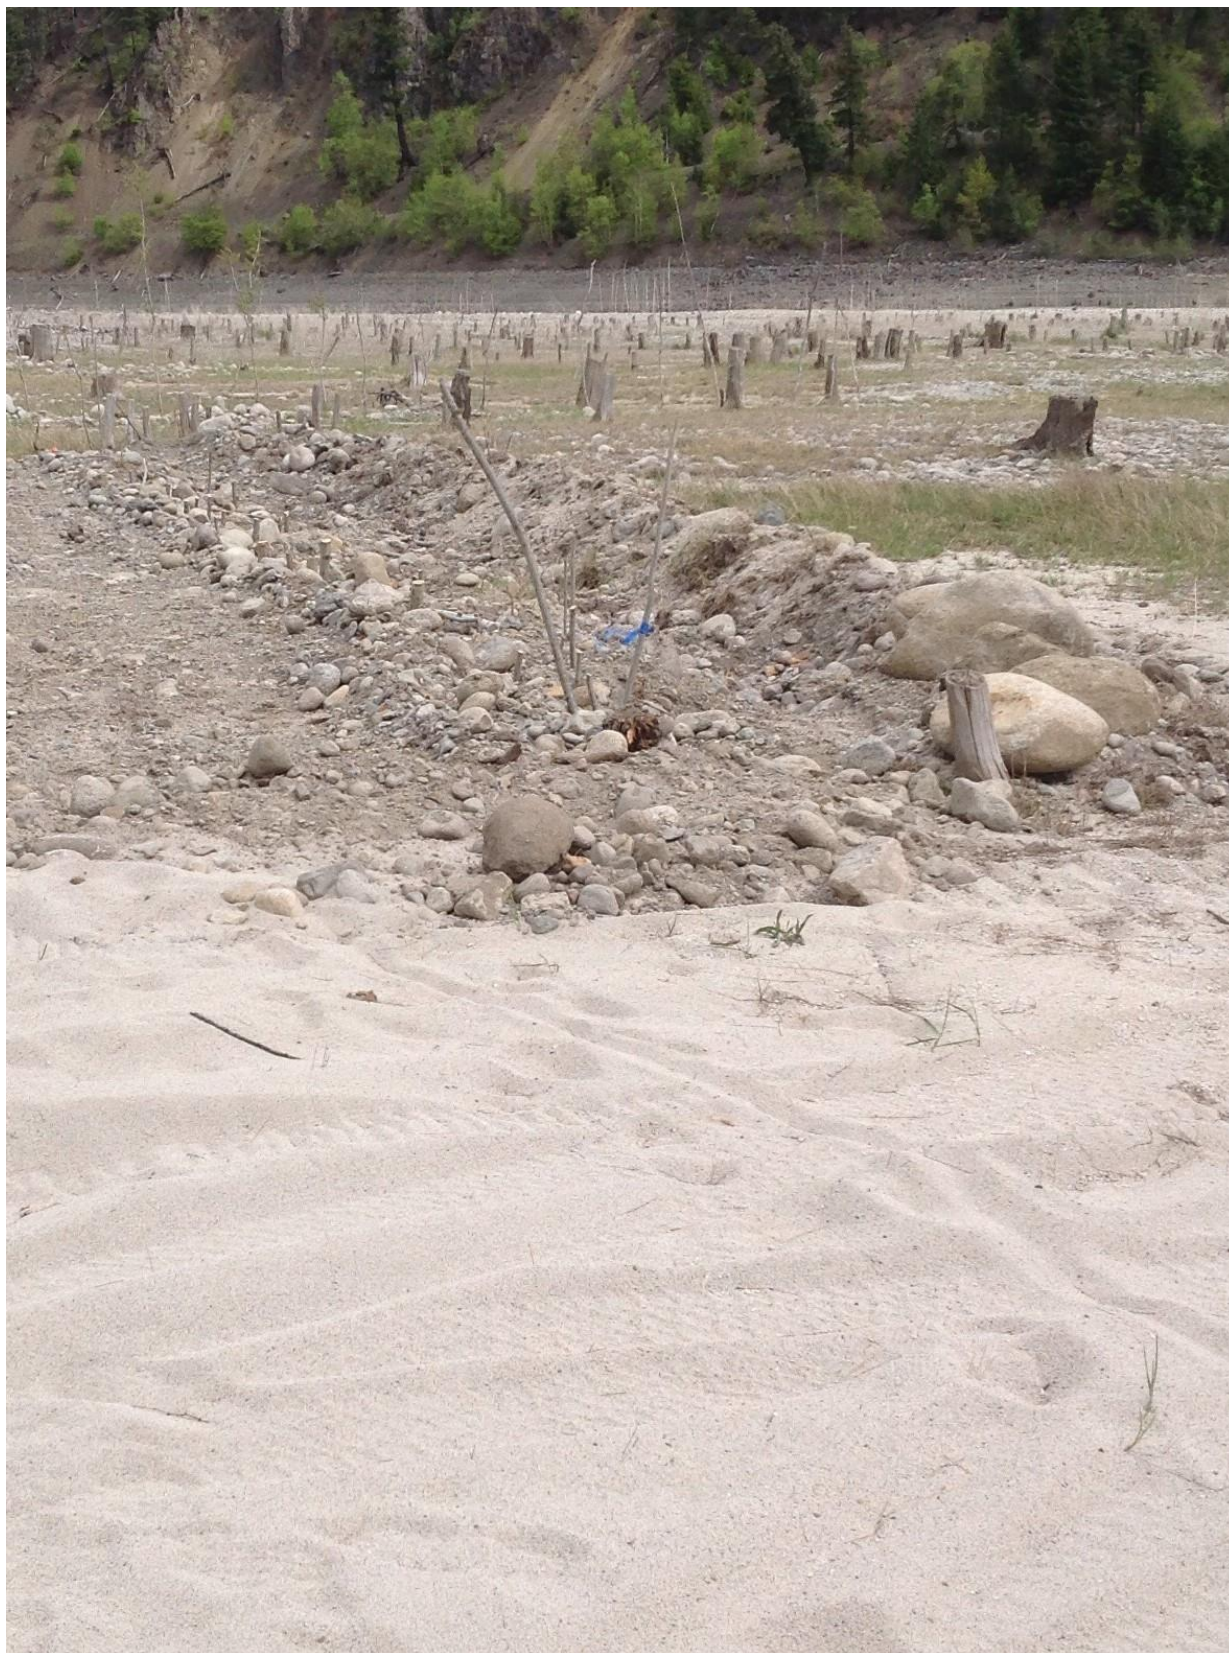
Figure 21 Trench O on the GCFW with mound and ditches on the downslope side of the cuttings.

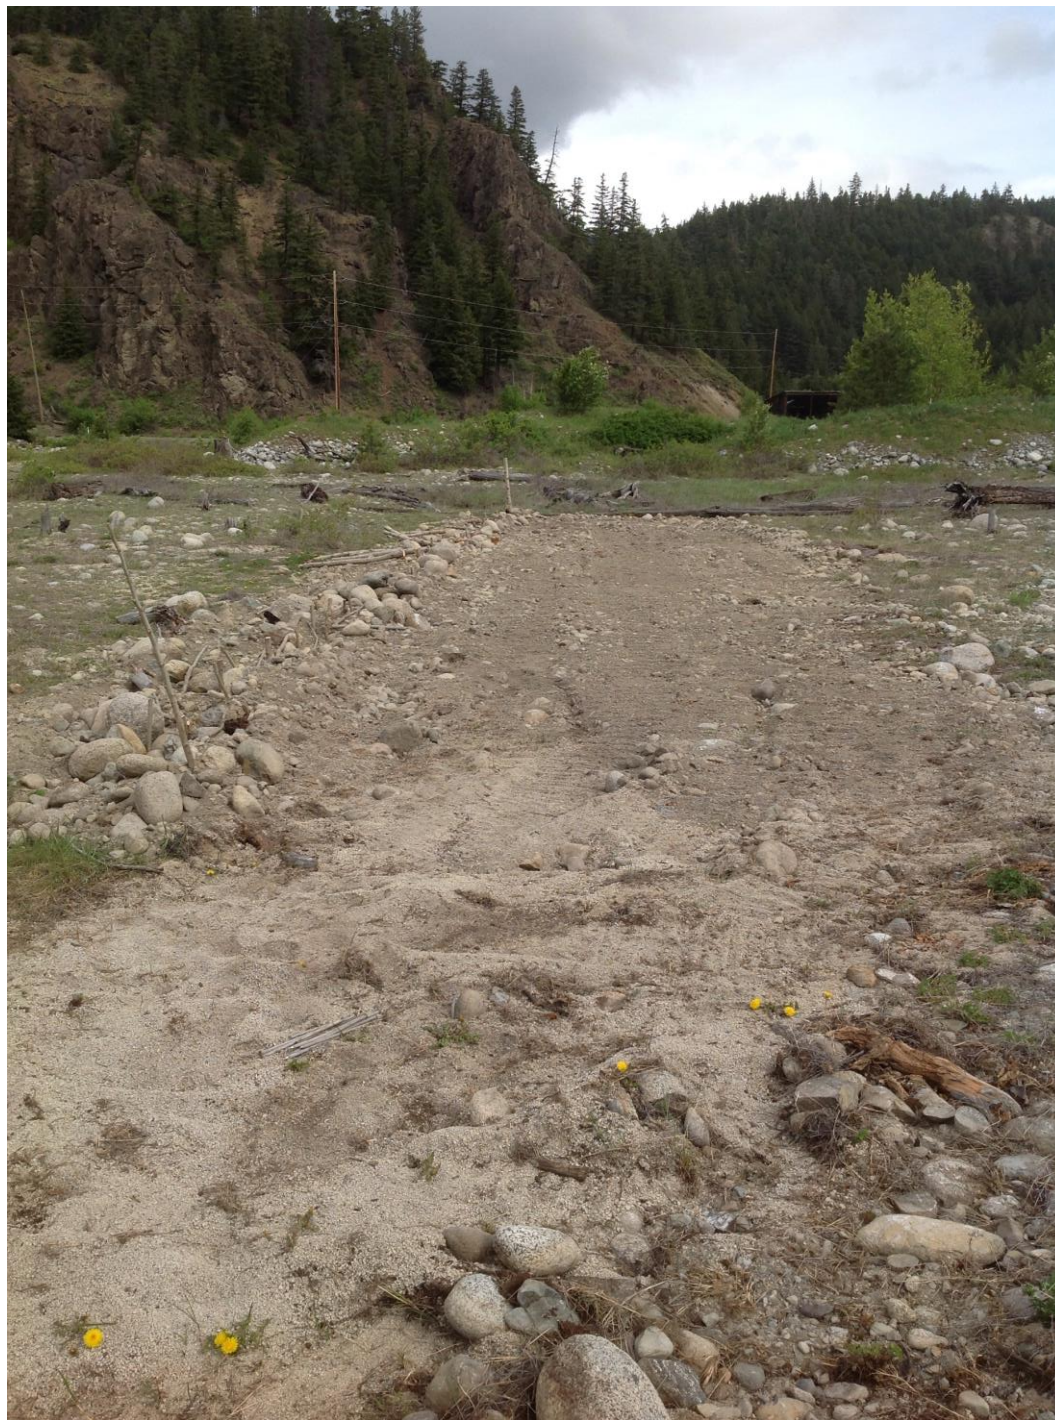
Figure 22 Disturbed soils alongside planted cuttings trench, site was planted with bluejoint plugs.

The West side of the fan has more mineral soil and fines in the substrate than are typically found on the east side. Digging trenches and back filling to plant cuttings created surface disturbance around the trenches with exposed mineral soil (Figure 22), it was decided to plant the disturbed areas around the planted cutting with native grasses. Bluejoint reedgrass was the target species used on the Gun Creek Fan West side. Bluejoint occurs naturally in sporadic clumps West side of the fan (Figure 23). Additional polygons were planted with bluejoint reedgrass lower down into the drawdown zone, going as low as 643.5m elevation.

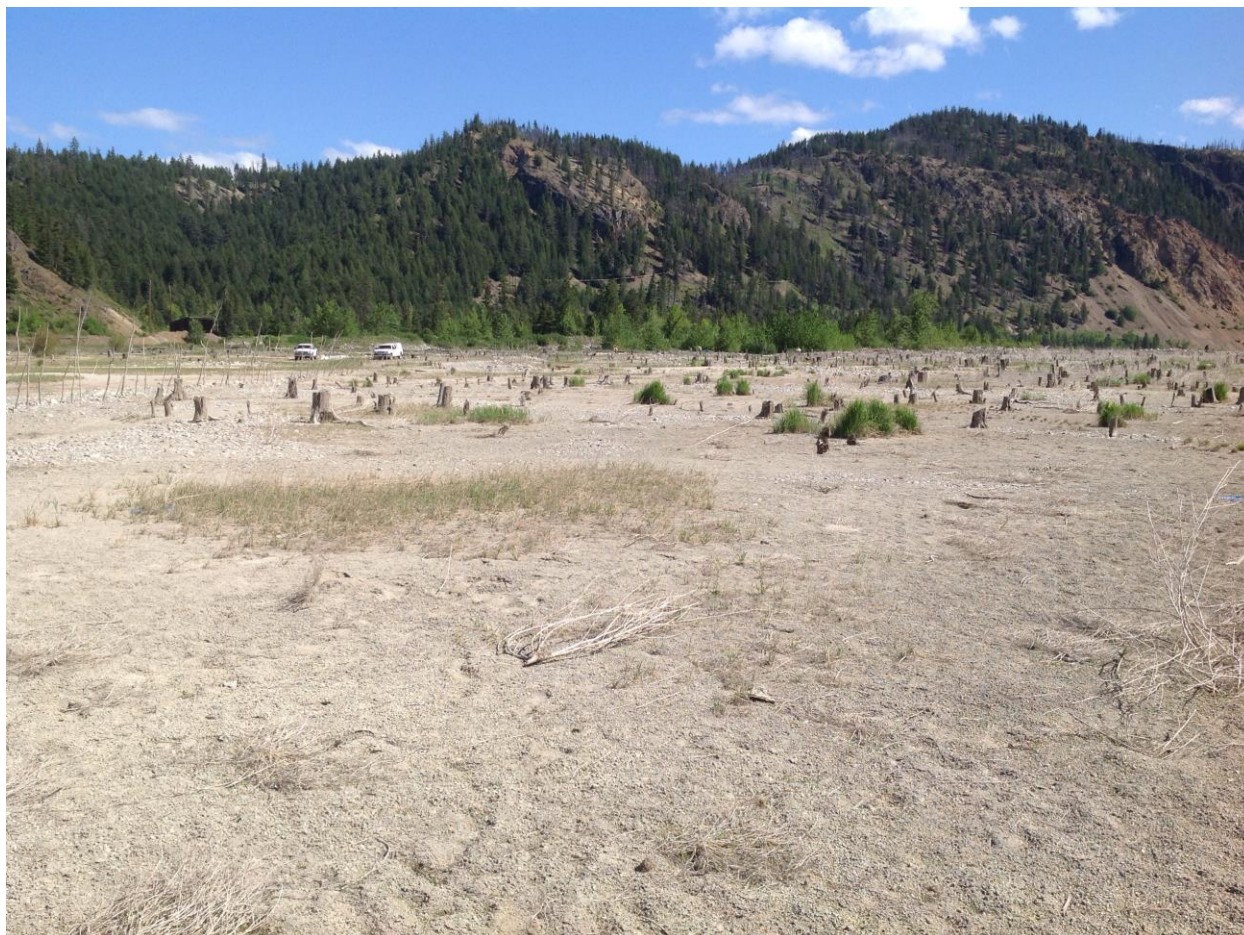
Figure 23 Photo looking the GCFW with sparse natural clumps of bluejoint reedgrass. Note patch of low growing grass in foreground is the exotic quack grass (*Elytrigia repens*).

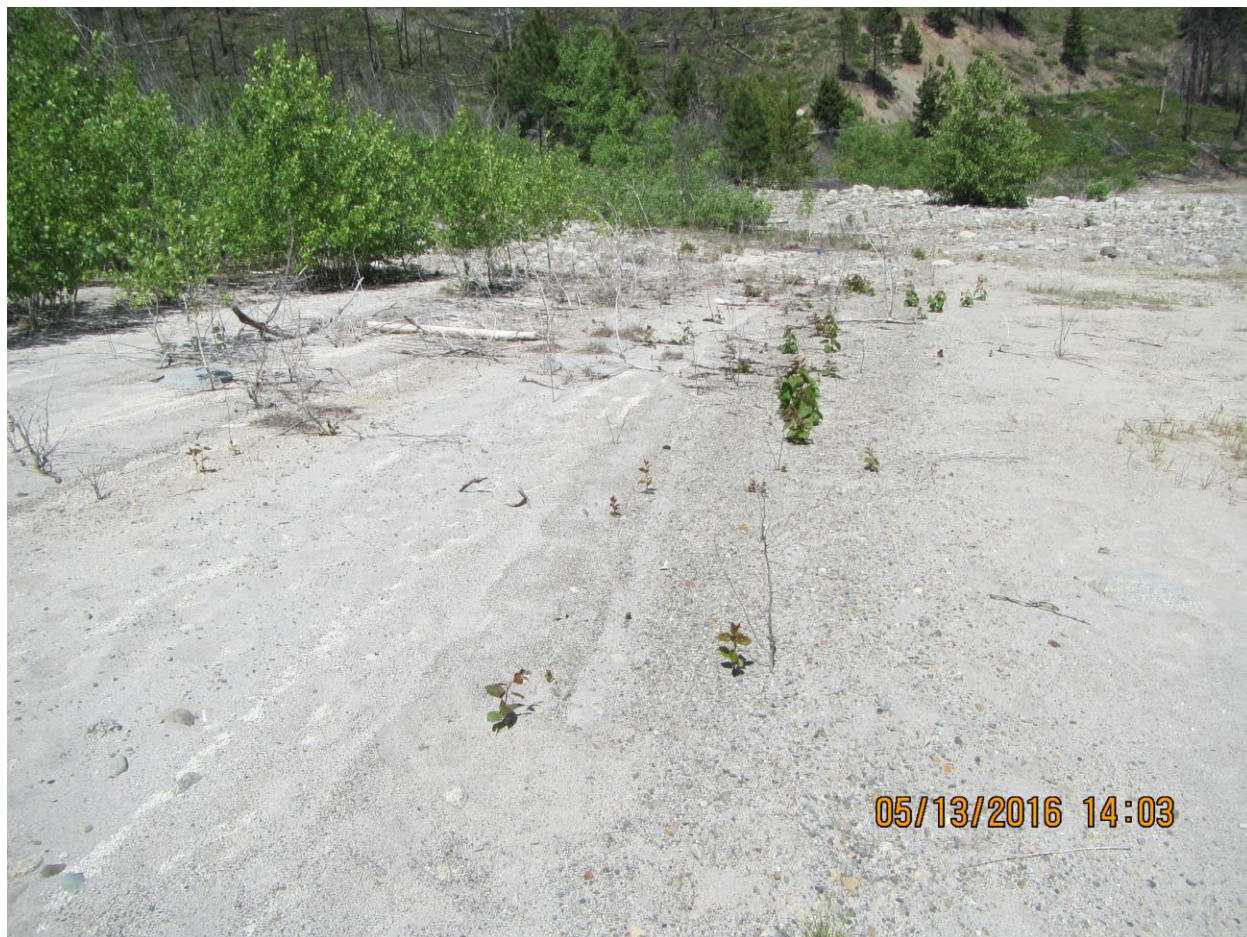
Figure 24 Trembling aspen suckers sprouting from buried roots. Visible are dead stems of aspen sprouts killed back by the previous year's full pool. Sprouts have at least two months of growth prior to flooding with some years flood levels will not reach this high.

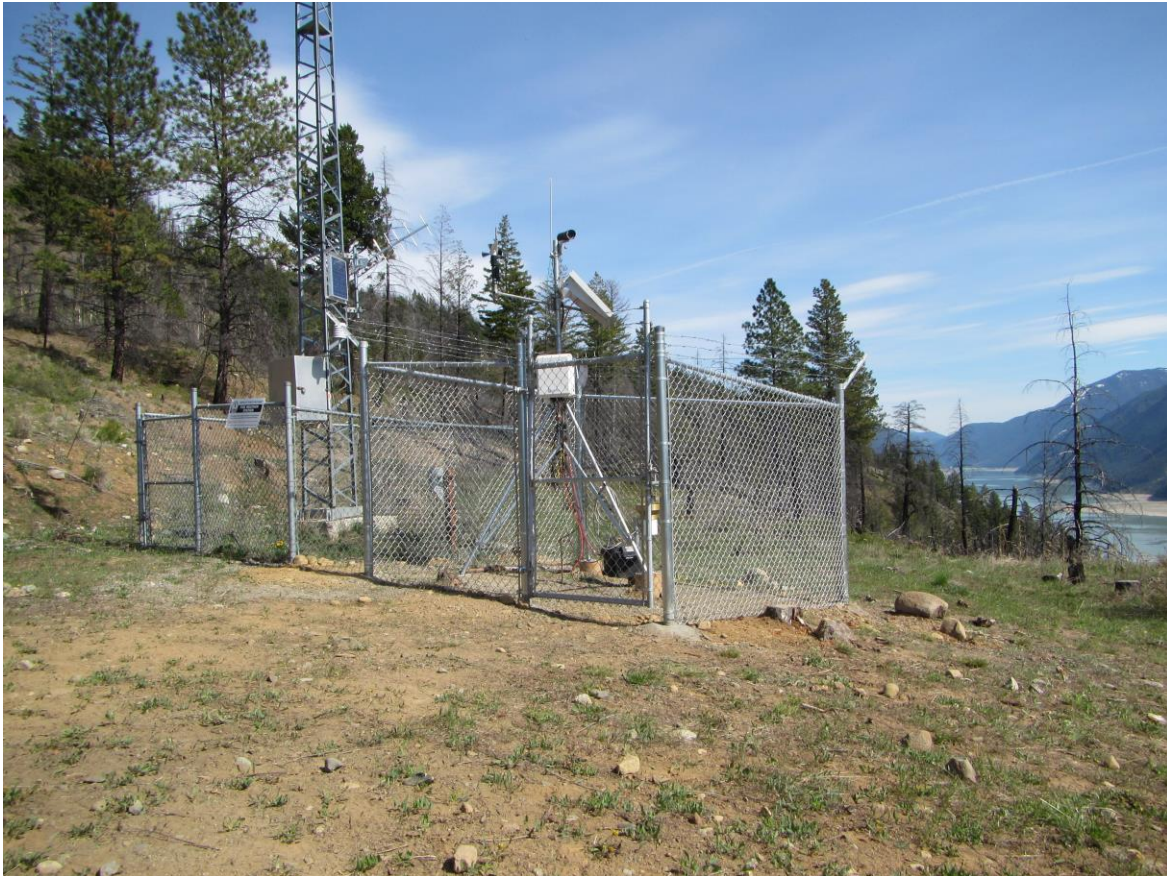
Figure 25 Completed weather station and camera on five mile ridge 17 April 2016.

The weather station equipped with solar panel and camera was installed on 5-Mile Ridge in mid April 2016. A chain link fence was constructed around the station installation. The fence was topped with barbed wire as a security precaution (Figure 25). The station required monthly visits to the site to download camera imagery data. The camera was programmed to take an image of the site every 5 minutes during daylight hours. Camera images were analysed and the number of images with positive observation of dust events was recorded.

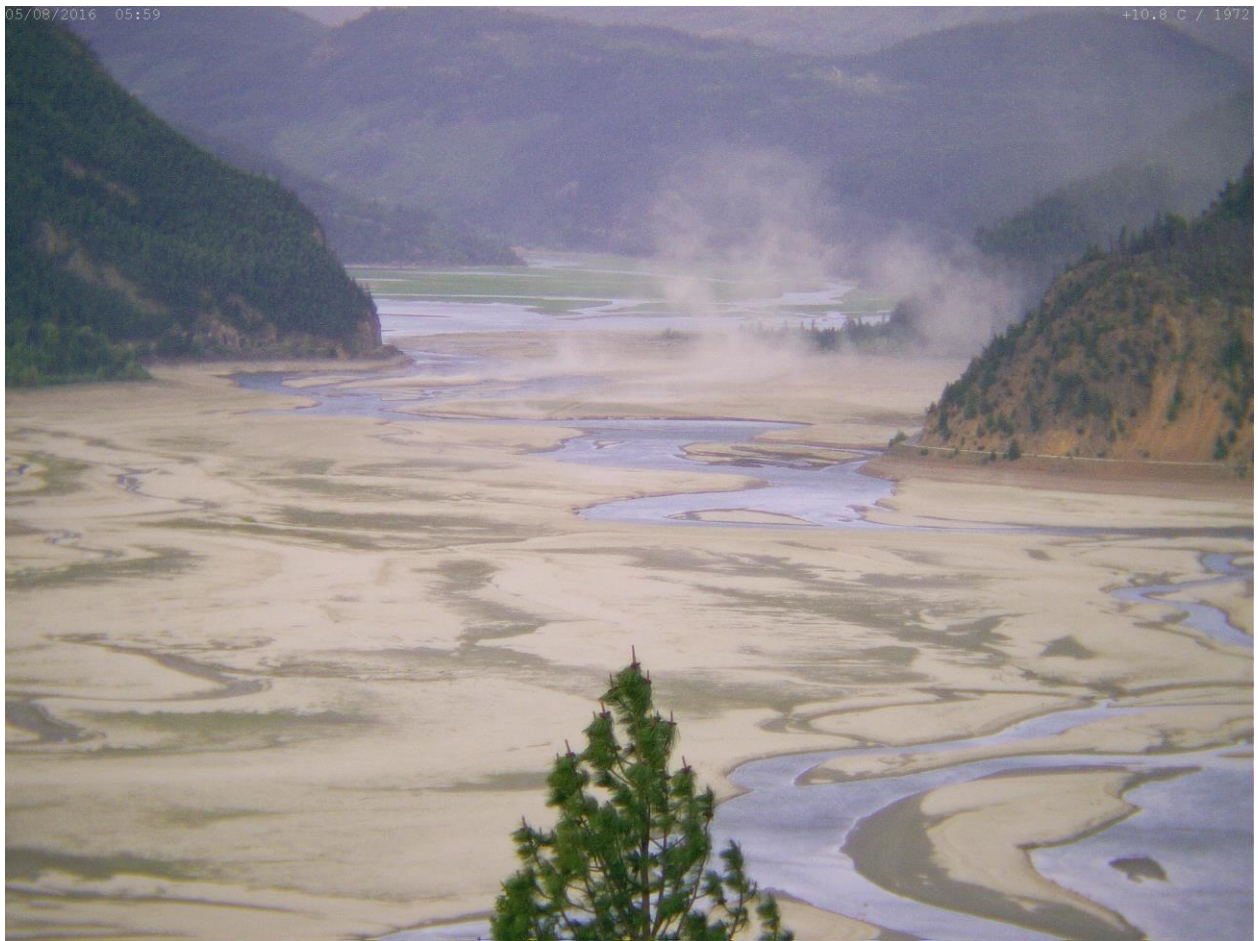
Figure 26 9% of dust events were classified as large - example from 8 May 2016 6am.

In 2016, 14991 images were collected by the camera and analysed for dust events. Five hundred and thirty-six images or 4%, were observed to capture a dust event. Dust events were considered part of the same storm if they occurred within a half hour of each other. When time frames were analysed it was assessed that 93 individual storm events were recorded throughout the sampling period¹. The greatest number of events were recorded in June. June was also the month with the highest number of sampling days. The month of May had a higher percentage of dust events relative to the number

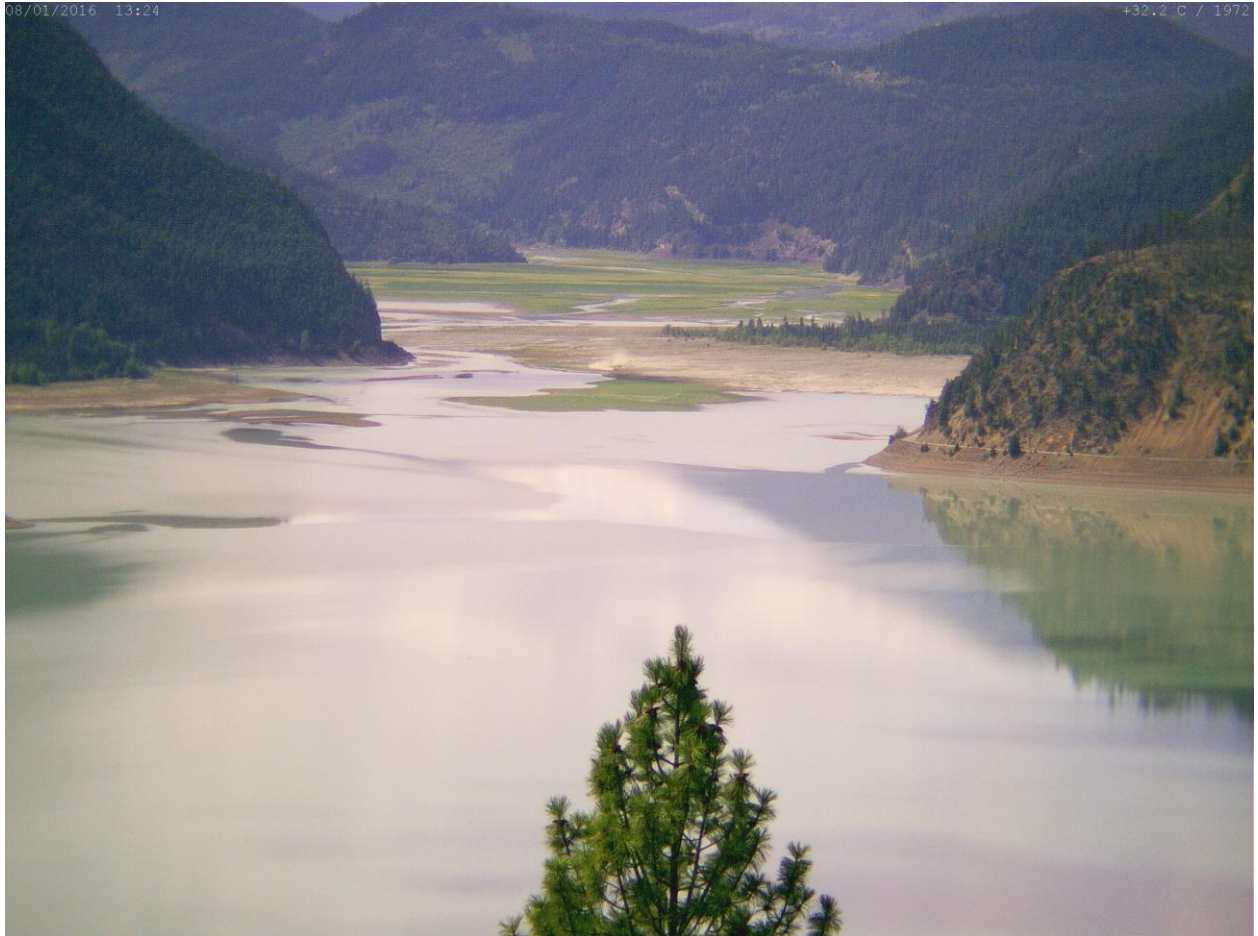
Figure 27 last dust event captured in 2016 on 1 August. Localized event may be result of a vehicle on the site. Note inundation of green fall rye treatment area.

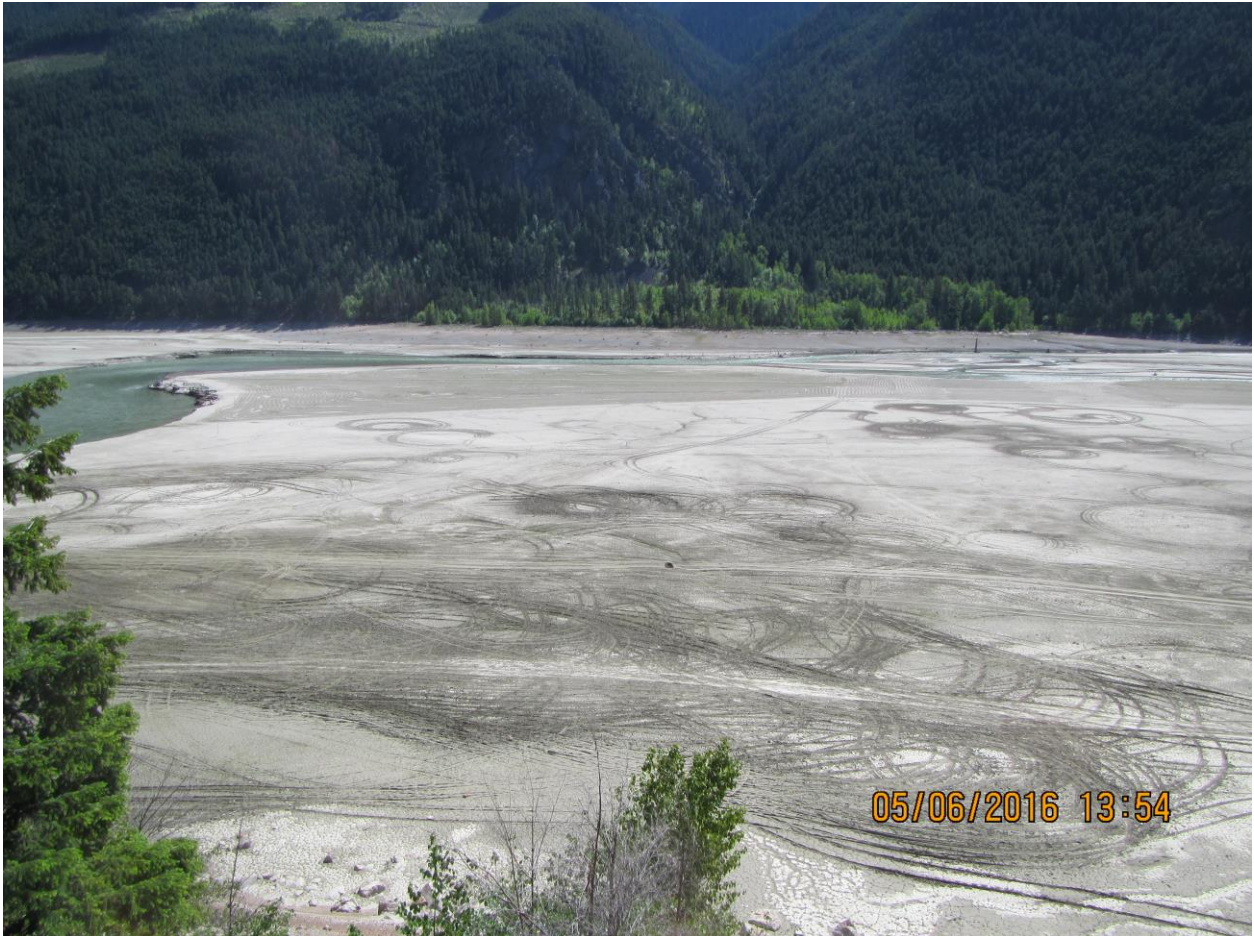
Figure 28 LMF with numerous tracks from off road vehicle use of the site 5 June 2016.

No additional surveys were conducted in 2016. Off road vehicle driving was observed to be one of the most common recreation activities engaged in within the target revegetation area (Figure 28). For details refer to the 2015 WORKS 1 report for overview of recreation use at the site as compiled from the public survey. The author received numerous comments from locals that the fall rye treatment was visually appealing.
