Cheakamus Project Water Use Plan

Cheakamus River Channel Morphology Monitoring

Implementation Year 7

Annual Progress Report

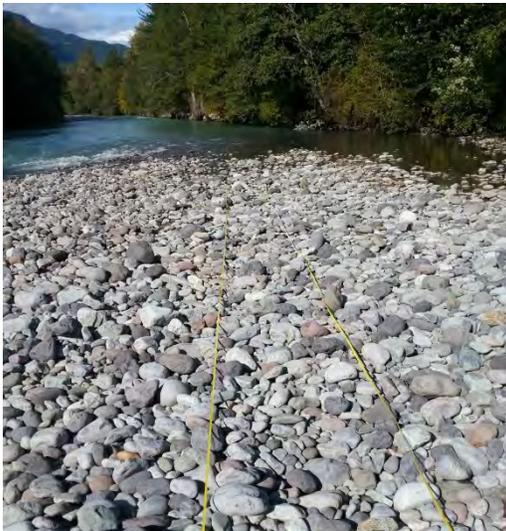
Surface grain size sampling followed the grid procedure (e.g., Kondolf et al, 2003), using a 30 m tape (Photo 1).

Photo 1: Sample Lines for Surface Grain Size Sample (Pedestrian Bridge, Sep. 16, 2015).

Approximately 100 points were collected for each sample and spacing between sampling points was determined as roughly three times the maximum grain size (based on visual observation of the sample area). Sample results were truncated below 4 mm prior to calculating the median.

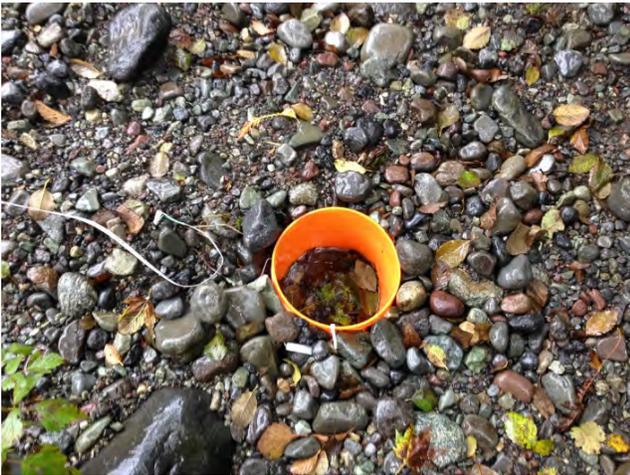
Photo 3: Mostly Organic Matter in Temporary Sediment Trap at Pedestrian Bridge Bar, near Spawning Area (Sep. 24, 2015).

- Pedestrian Bridge MQ 1 site:
 - The bar top trap could not be located, and may have been removed. A new trap was re-installed at the old location.
 - The trap near the spawning area was mostly empty except for organic matter (Photo 3): the small amount of sediment was removed from the bucket for later analysis and the trap was re-set.
- Eagle Point MQ 1 site:
 - The bar top trap was empty.
 - The trap near the spawning area was about 2/3 full with a mixture of sand and gravel (Photo 4). The trap was emptied and re-set.

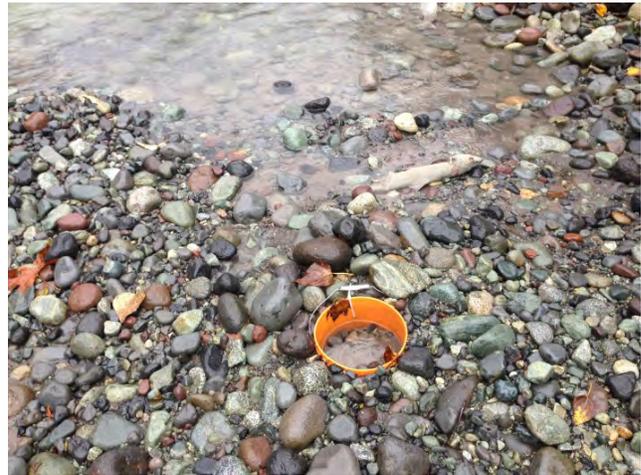
Photo 4: Sediment in Temporary Sediment Trap at Eagle Point Bar, near Spawning Area (Sep. 24, 2015).

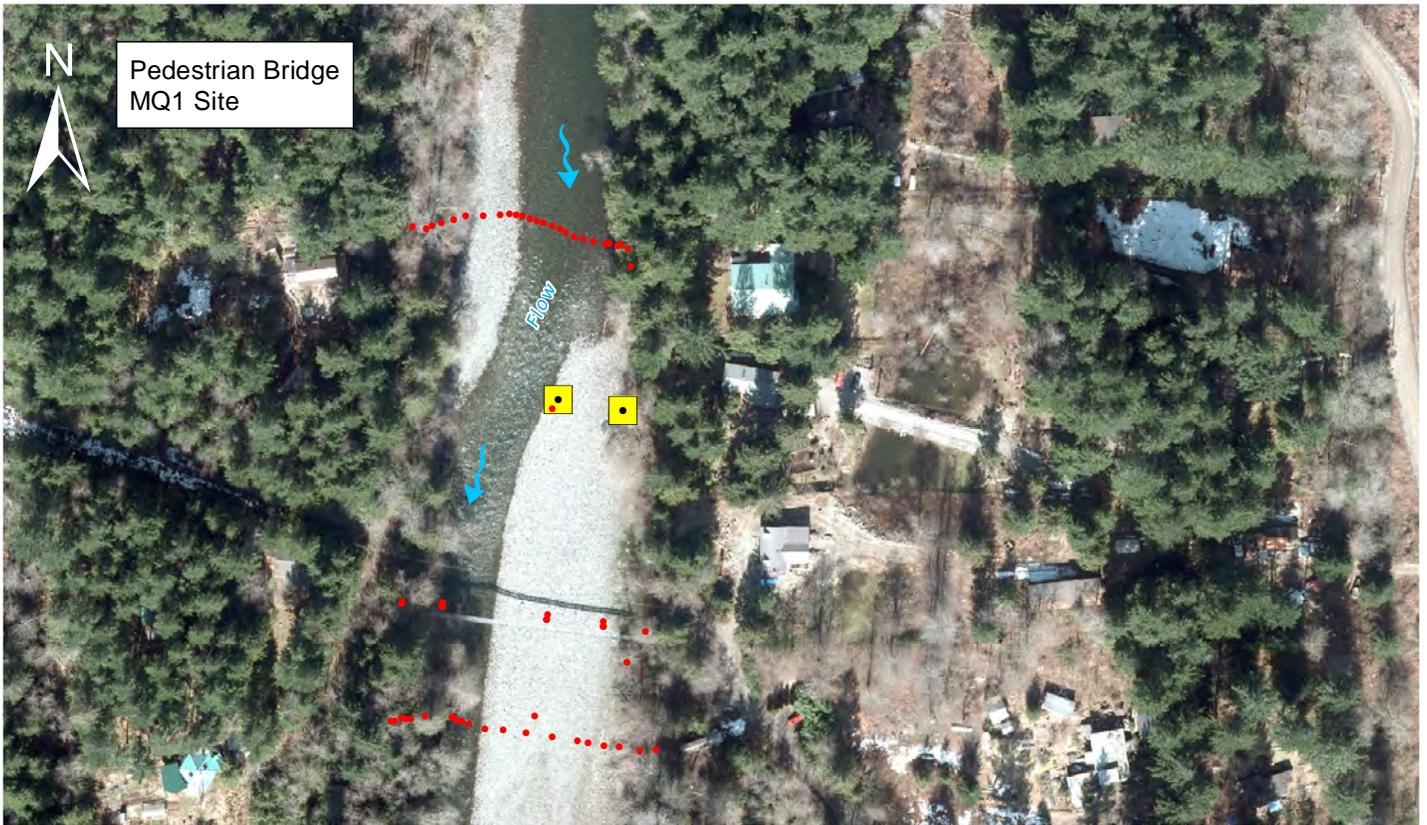
Figure 2-2

MQ1 Field Site Layout

The location of the sites is shown in Figure 2-1. Site layout is shown in Figure 2-2, including proximity to the 2011 surveyed channel bathymetry.

Two surface grain size samples were collected at each site: one to characterize the sediment in the immediate spawning location, and one to characterize the generally-coarser gravel bar sediments in the nearby vicinity. Sediment traps were installed to correspond with these locations also (see Figure 2-2).
