Coquitlam-Buntzen Project Water Use Plan

Lower Coquitlam River Substrate Quality Assessment

Implementation Year 7

Final Report

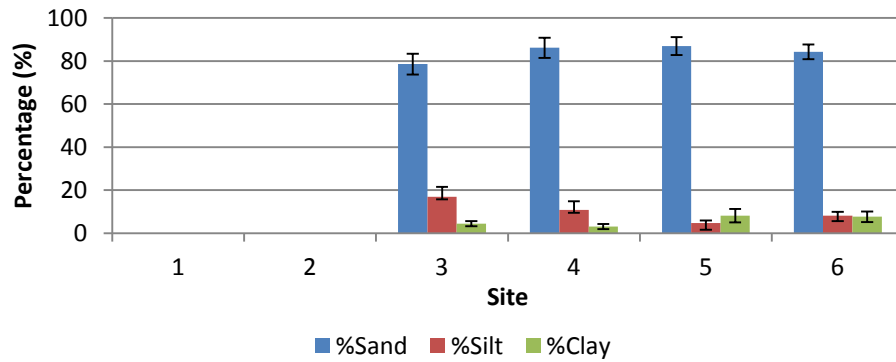
Figure A7. Average Composition of Surficial Sediment - October 2013

Note: Samples were not collected at Sites 1, 2 and downstream at Site 5 due to high salmon reproductive activity in the area.

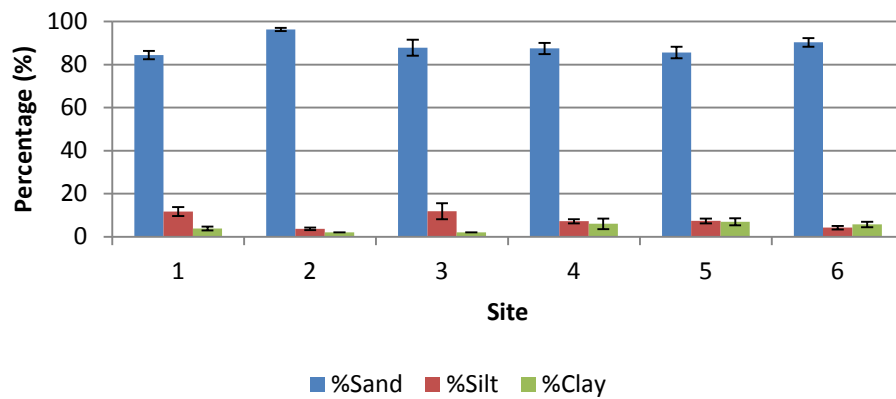
Figure A8. Average Composition of Surficial Sediment - January 2014

In samples collected in January 2014 there was some noted variation in mean surficial sediment composition between sites (Figure A6, Appendix 1). Site 2 had a higher mean proportion of sand ($96.3\% \pm 0.8\%$) and corresponding decrease in the proportion of silt ($3.7\% \pm 0.6\%$), compared to the other sites ($84.5\% \pm 1.9\%$ to $90.3\% \pm 2.0\%$). At Sites 2 and 3 (January 2014) the mean percentage (%) of clay was below detection limit ($< 2.0\%$). In comparing Site 2 between sampling events (January and May 2014) there was also significantly greater mean sand percentage in January ($96.3\% \pm 0.8\%$) compared to May 2014 ($83.7\% \pm 4.1\%$; $p < 0.01$) and a corresponding decrease in the mean percentage (%) of both silt (January: $3.7\% \pm 0.5\%$, May: $7.5\% \pm 1.3\%$; $p < 0.05$) and clay (January: non detect, May: $8.8\% \pm 1.4\%$; $p < 0.01$).

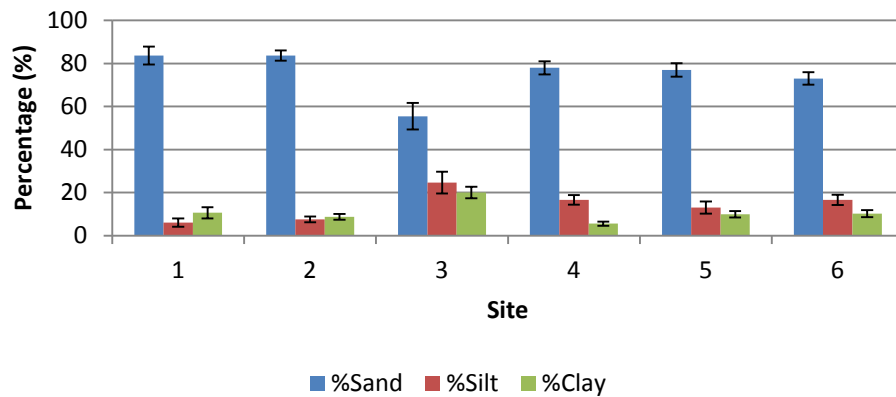
Figure A9. Average Composition of Surficial Sediment - May 2014

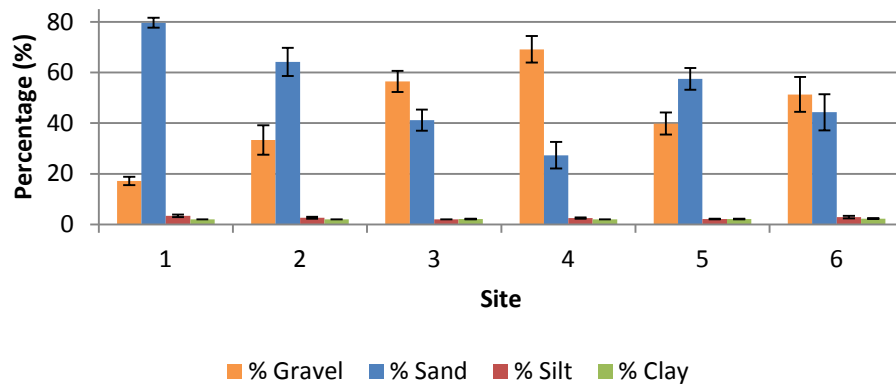
Figure A11. Average Composition of Subsurface Sediment (<10 mm) - January 2014

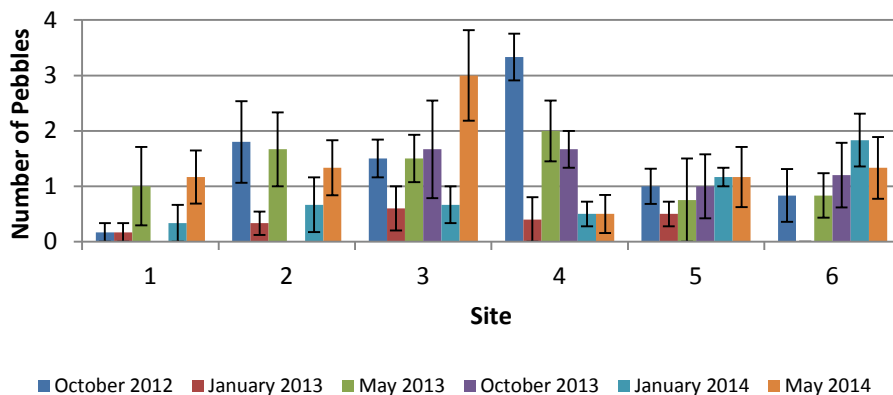
**Figure A13. Average Large Cobble Counts
(Subsurface Sediment)**

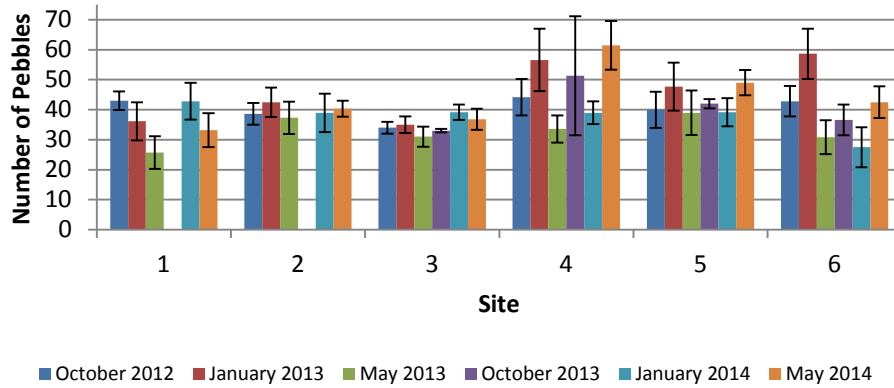
**Figure A16. Average Very Coarse Gravel Counts
(Subsurface Sediment)**

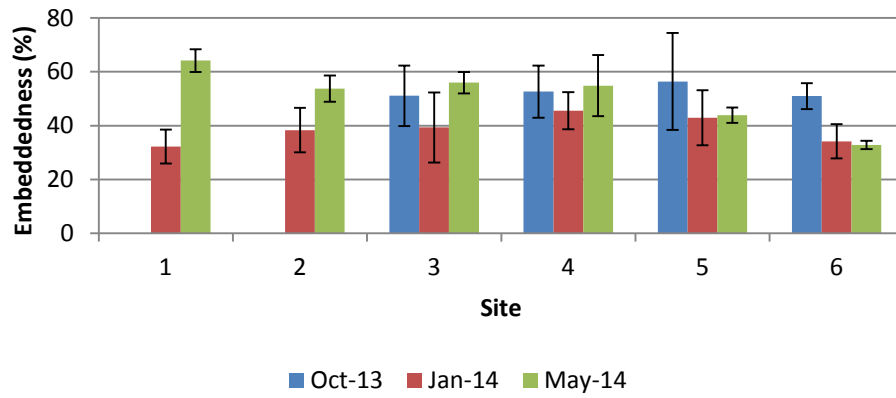
Figure A25. Average Embeddedness (%) - October 2013 to May 2014

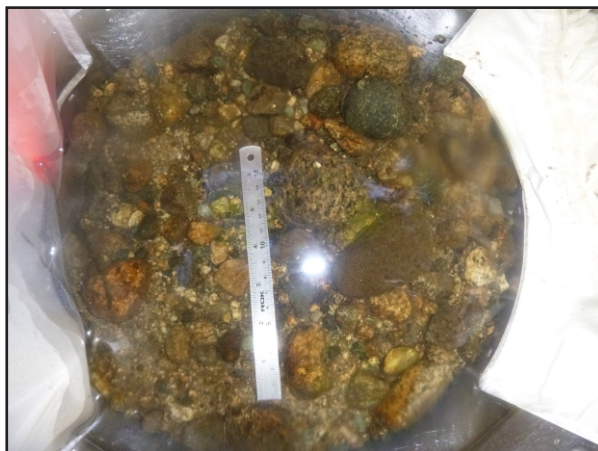
Photo A14: Subsurface sample inside Hess Sampler (Site 1 May 2014).

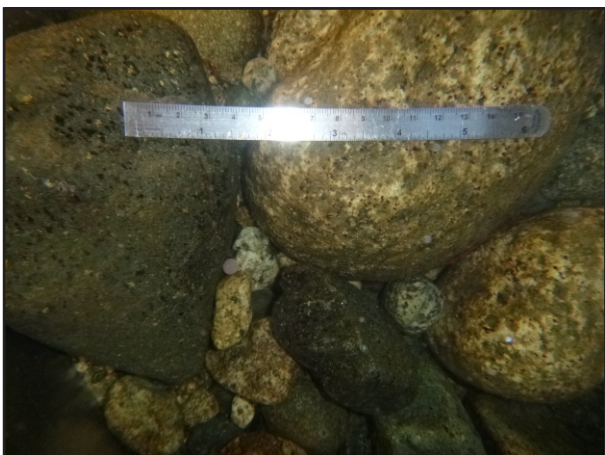
Photo A15: Subsurface sample inside Hess Sampler (Site 6 May 2014).

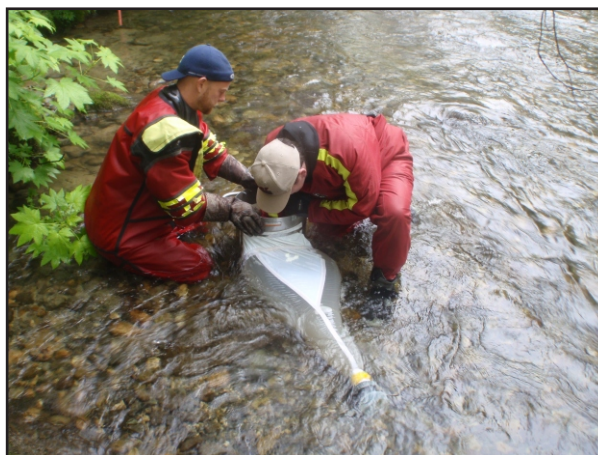
Photo A18: Hess Sampler being churned over 20 times with trowel.

Surficial samples were obtained by churning over substrates within the Hess sampler 20 times using a small hand trowel (Photo A18, Appendix 2). Surficial sediments were flushed by the river flow through the downstream 20 μ m mesh tunnel and rinsed into a labeled container (Photo A18, Appendix 2). Samples were sent to Maxxam laboratories (Burnaby) in coolers with accompanying chain of custody (COC) forms for percent (%) particle size distribution analysis.

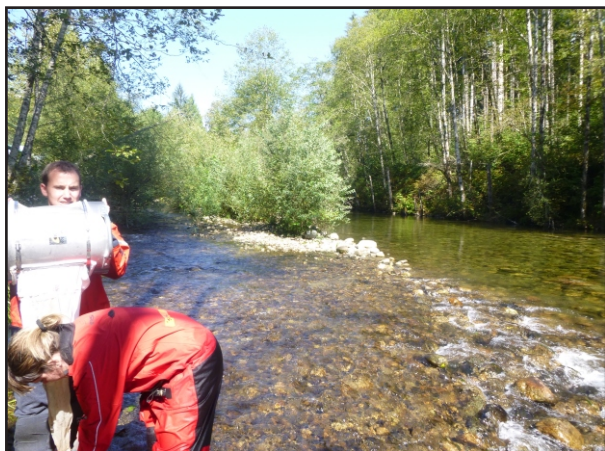
Photo A 19: Rinsing mesh tunnel between samples (Site 6 downstream September 2014).

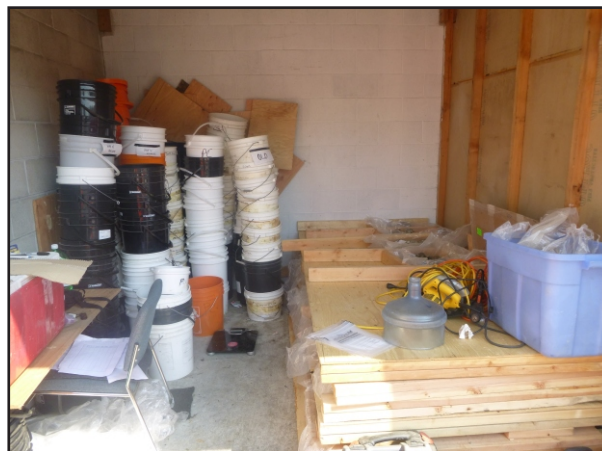
Photo A 20: Sampling equipment and drying rack (August 2014).

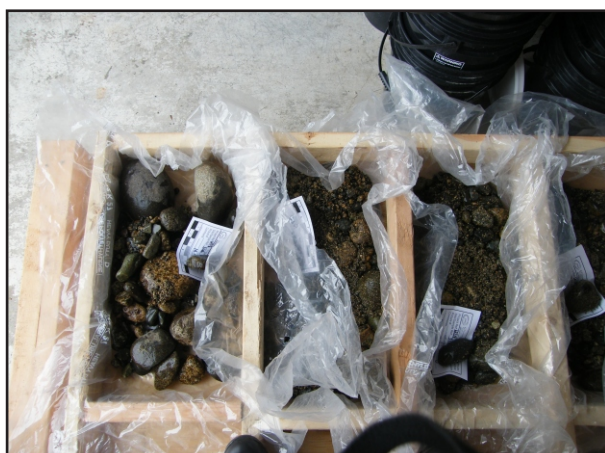
Photo A 23: Subsurface samples placed on clean polyethylene sheets in drying rack (October 2013).

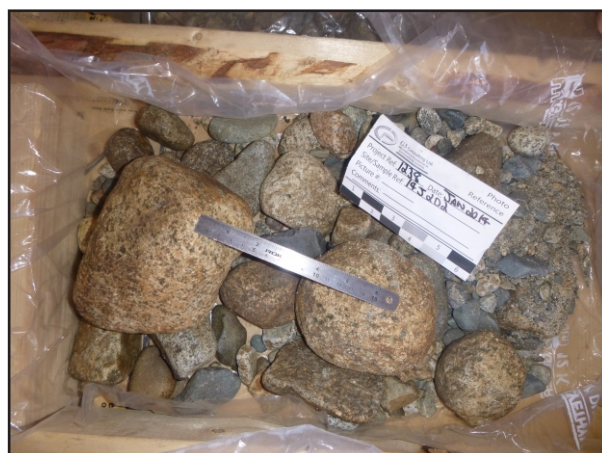
Photo A 24: Dried labeled sample in drying rack (January 2014).

Once samples were completely dry (Photo A24, Appendix 2), weights were recorded and samples sieved through a 10.0 mm sieve (Photo A25, Appendix 2). Particles <10.0 mm, which passed through the sieve, were placed in a pre-labeled sample bag, weighed using a calibrated analytical balance (Photo A26, Appendix 2) then sent to Maxxam laboratories (Burnaby), with accompanying COC forms, for percent (%) particle size distribution analysis.

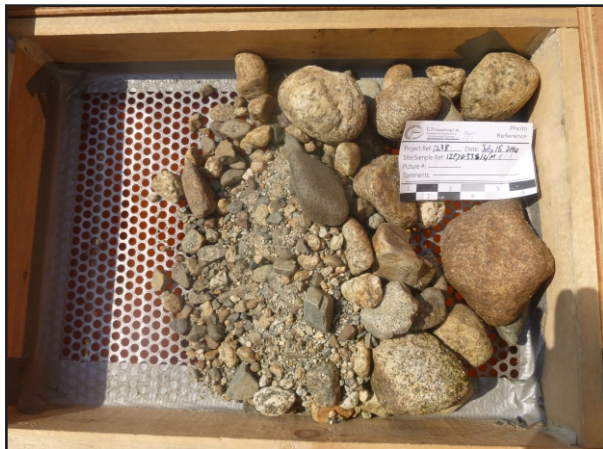
Photo A 25: Rocks in sifter box in preparation for sorting (August 2014).

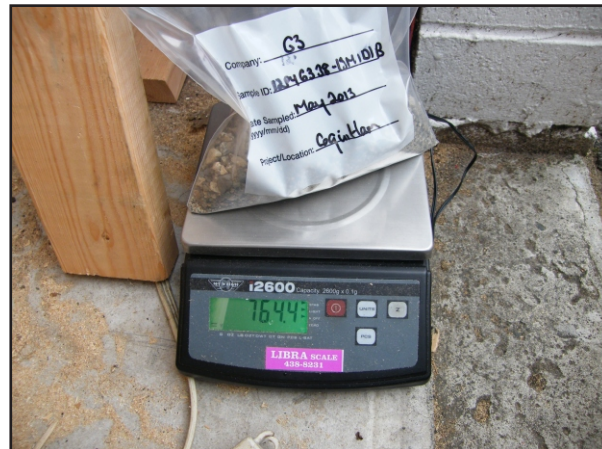
Photo A 26: Subsurface <10 mm sample weighed before sending to laboratory for particle size analysis (October 2013).

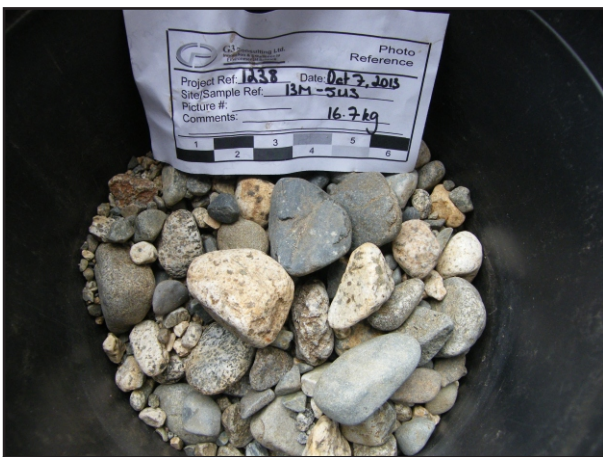
Photo A 27: Dry sample >10 mm in pail with identification label (October 2013).

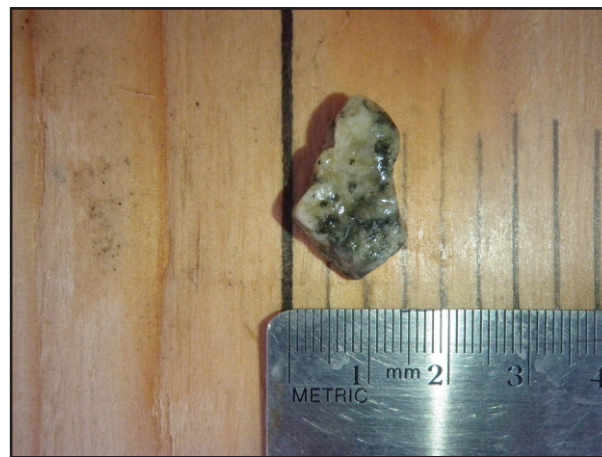
Photo A 28: Rock measured >10 mm (May 2013).
