Coquitlam-Buntzen Water Use Plan Monitoring Program

Assessment of Pink Salmon Passage in Lower Coquitlam River

COQMON -4

Study Period: August 25 - September 30, 2013

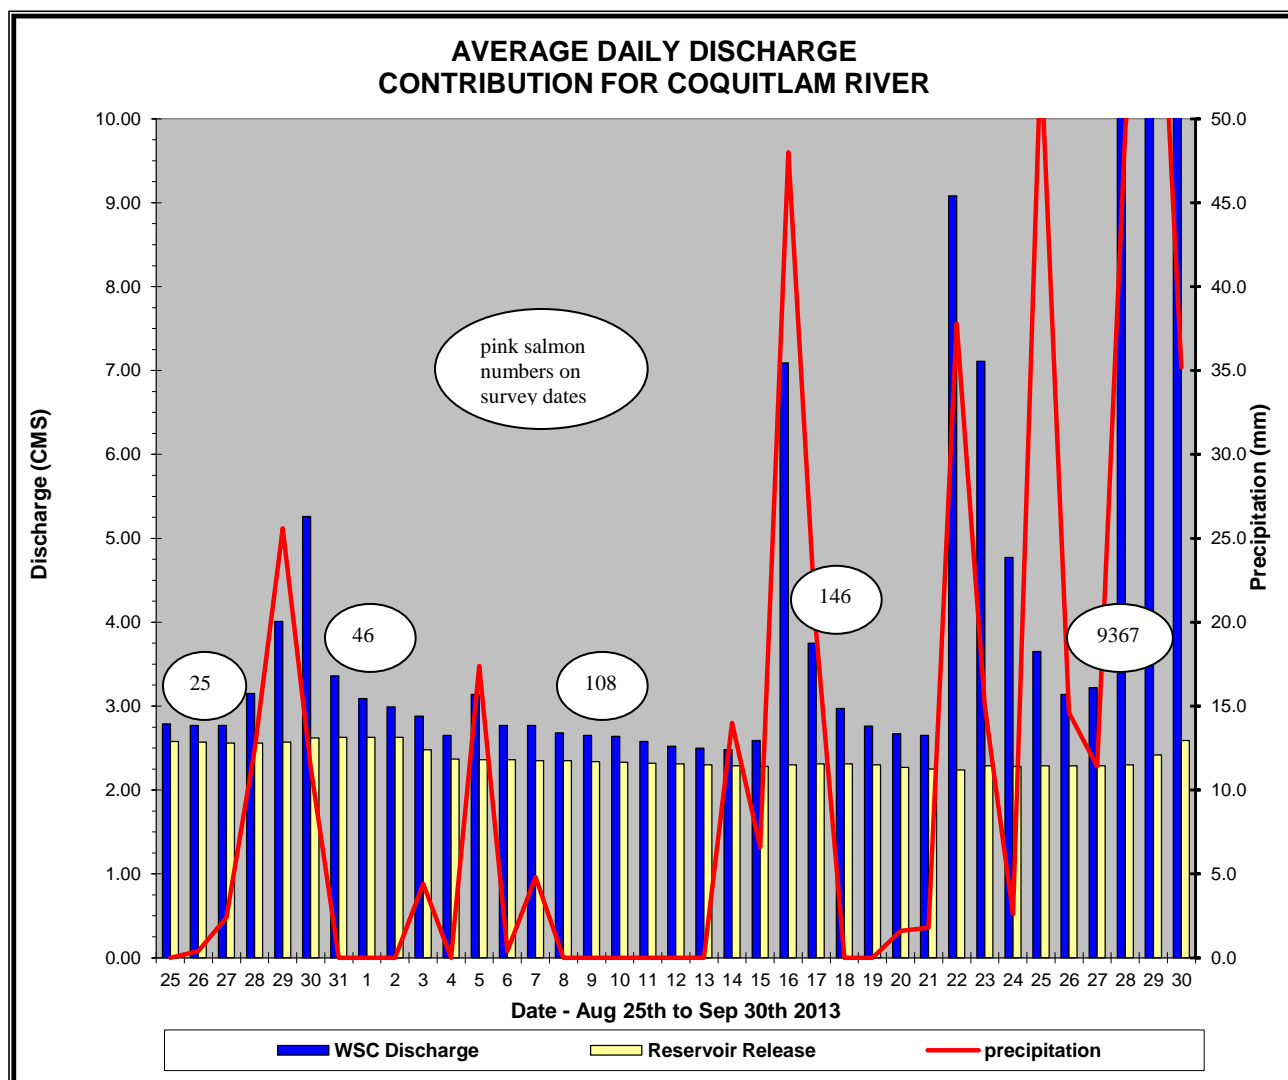
Figure 4 – Coquitlam Dam valve release, precipitation and average daily river discharge, Aug 25th to Sept 30th, (source: WSC Port Coquitlam, Dunkley 2013, Macnair 2013)

Sixteen days of precipitation were recorded during the monitoring period for a total of 383mm recorded at the Coquitlam Dam weather station which represents the upper and mid river area (3a to index site 4) and during the same period 250mm was recorded at the Como Lake weather station (Environment Canada, 2013) representing the lower river, 1A to 2C index sites. The peak of the Pink Salmon migration was observed after the ramp down from spill

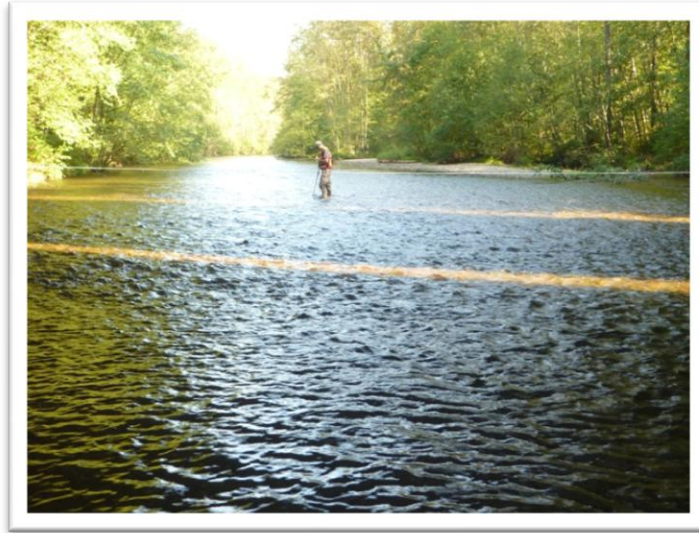
Figure 5 – Index site 1a- upstream view, Sept.09.13
Discharge rate = 2.65cms (WSC Port Coquitlam)

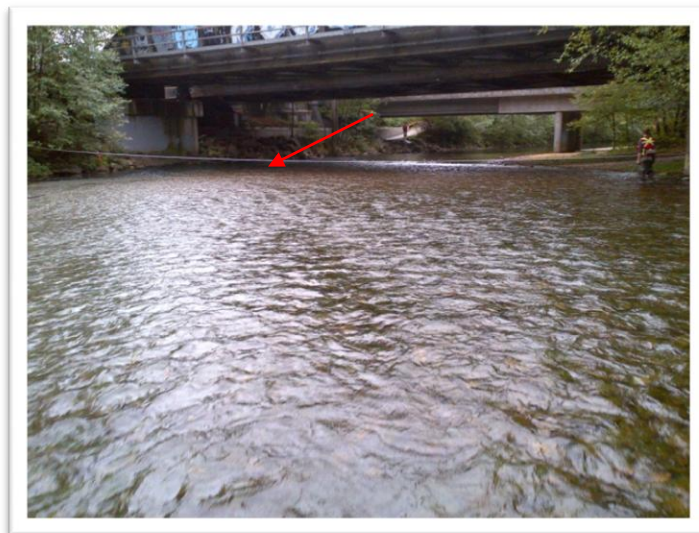
Figure 6 – Index site 1a – downstream view of shallow depth, Sept.15.13
Discharge rate = 2.59cms (WSC Port Coquitlam). The arrow indicates probable migration route in a left channel deep slot.

Pink Salmon were not observed migrating however, 20 were holding at index site 1A on September 25th during a discharge of 3.56cms. During the lowest discharge of 2.59cms, 202 Pink Salmon were enumerated upstream of this index site on September 17, 2013 by the BC Hydro adult monitoring crew and indicated that depth and velocity were adequate for passage through this index site (Table 3) (WSC, Port Coquitlam).

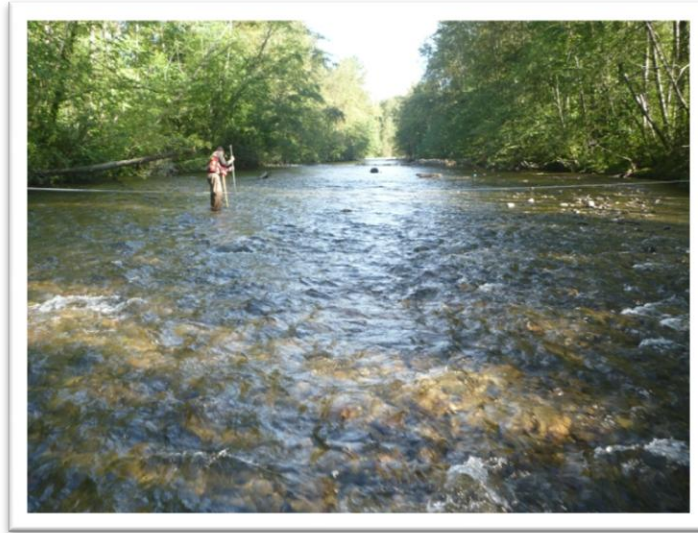
Figure 7 – Index site 1a – upstream view, Aug.31.13
Discharge = 3.36cms (WSC Port Coquitlam)

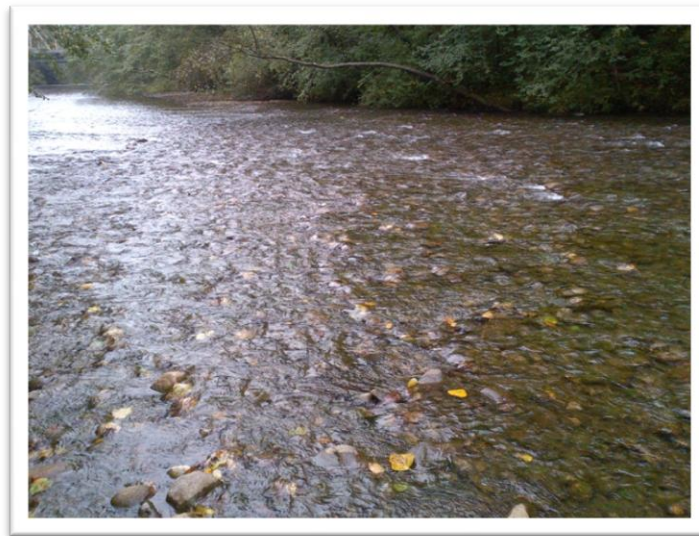
Figure 8 - Index site 2a - downstream view of shallow riffle, Sept.15.13
Discharge = 2.59cms (WSC Port Coquitlam)

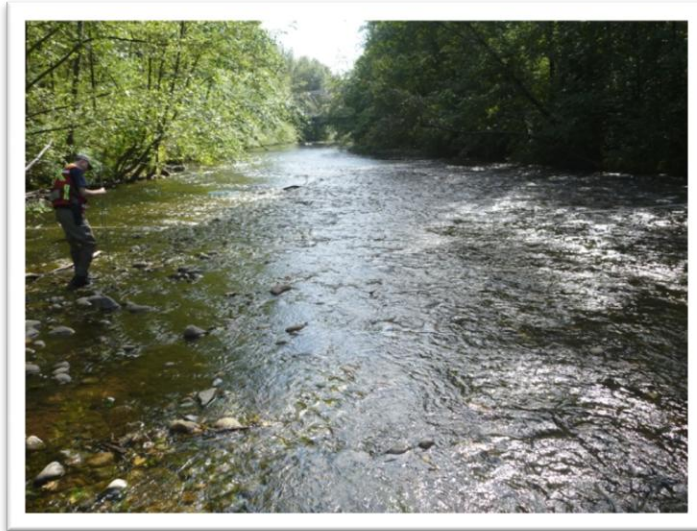
Figure 9 - Index site 2a - downstream view, Aug.25.13
Discharge = 3.65cms (WSC Port Coquitlam)

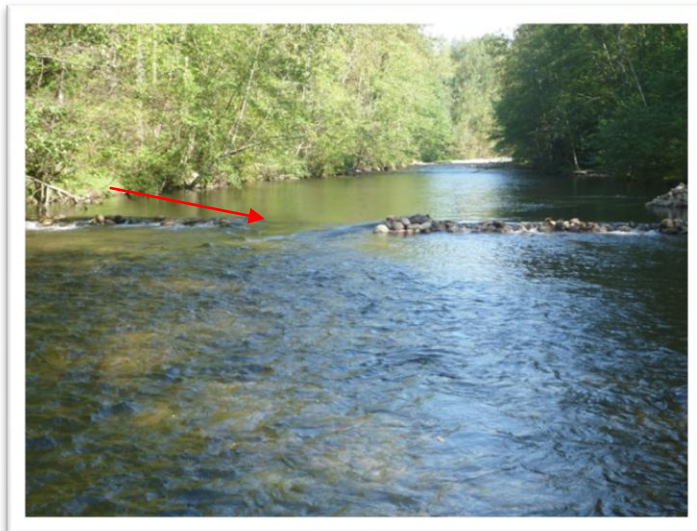
Figure 10 - Index site 2a - upstream view of weir, Sept.09.13
Discharge = 2.65cms (WSC Port Coquitlam)
The arrow identifies breached access point over weir.

Human interference occurred in 2009, 2011 and 2013 with the construction of a cobble weir that could result in a potential migration barrier at low flows, however it was not considered to be a barrier to migration if breached (Figure 10) as observed during the 2013 assessment period. During the lowest monitored discharge of 2.59cms (WSC, Port Coquitlam) the average plunge pool depth at the weir was 0.27m and the average jump height over the weir was 0.19m indicating that the weir was adequate for passage

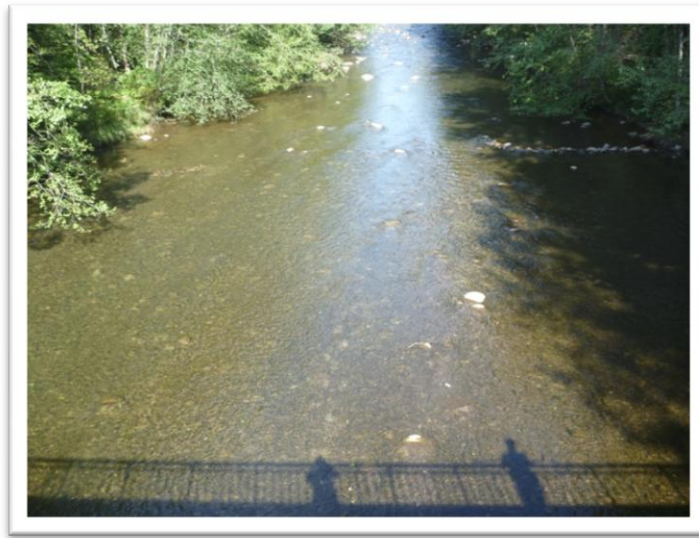
Figure 11 - Index site 2b - upstream view of shallow glide, Sept.9.13. Discharge = 2.76cms (WSC Port Coquitlam)

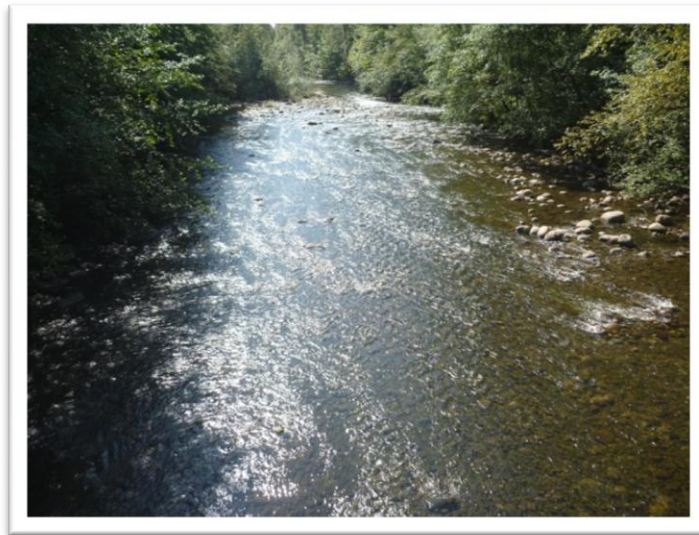
Figure 12 - Index site 2b - downstream view, Sept.09.13
Discharge = 2.76cms (WSC Port Coquitlam)

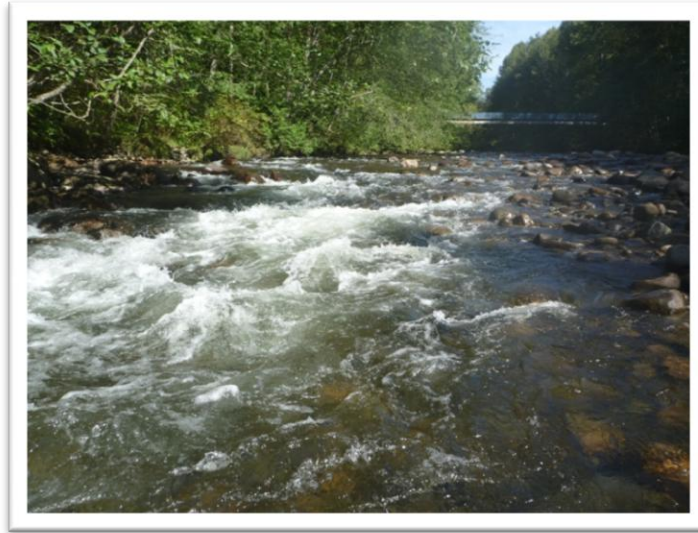
Figure 13 - Index site 2b - upstream view of the high velocity chute, Aug.31.13. Discharge = 3.36cms (WSC Port Coquitlam)

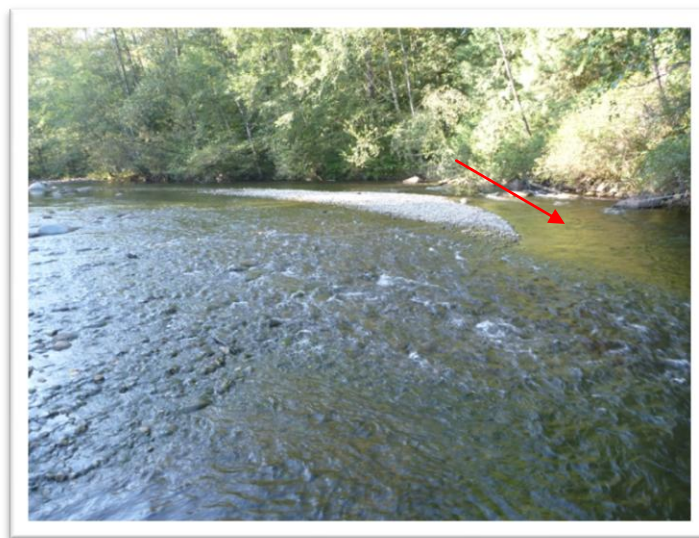
Figure 14 – Index site 2c - upstream view, Sept.9.13
Discharge = 2.45cms (WSC Port Coquitlam)
The arrow identifies the access channel

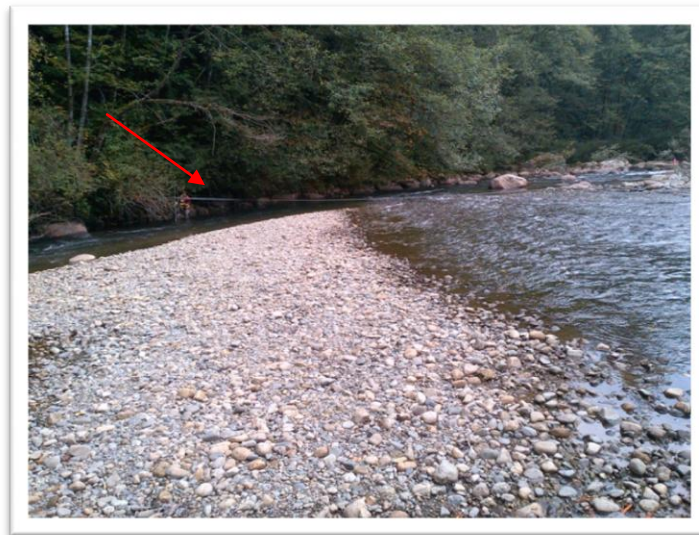
Figure 15 – Index site 2c - downstream view, Sept.15.13
Discharge = 2.59cms (WSC Port Coquitlam)
Arrow identifies main access route

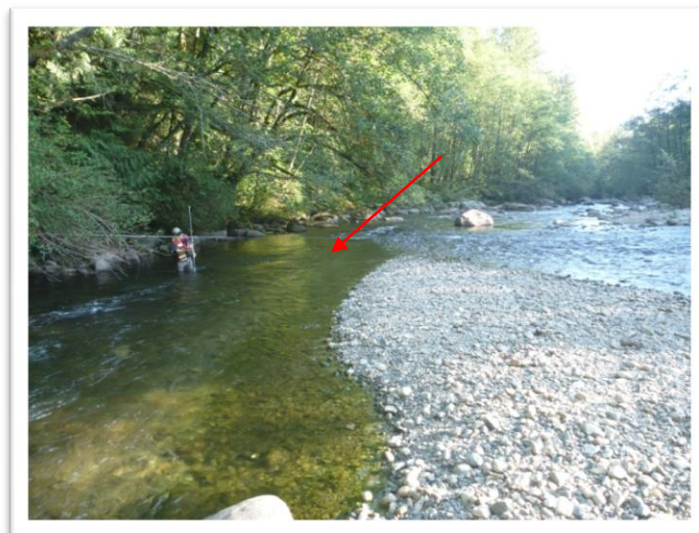
Figure 16 - Index site 2c - downstream view, Sept.9.13
Discharge = 2.68cms (WSC Port Coquitlam)
View of gravel bar and the red arrow indicates the left channel migration route

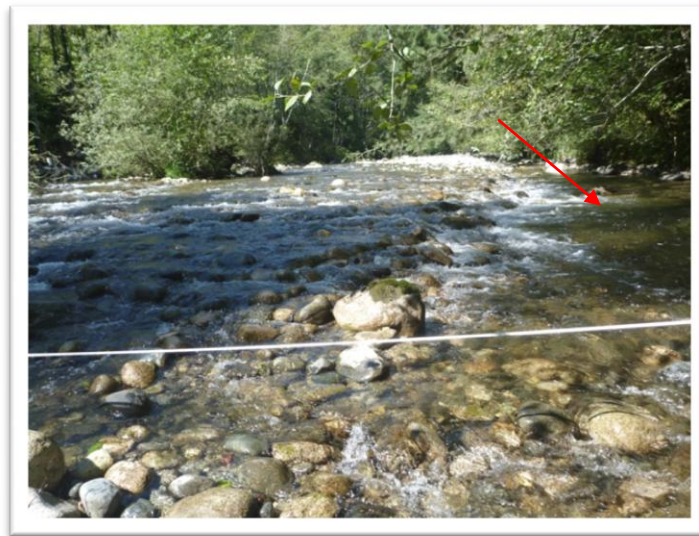
Figure 17 - Index site 3a - cross sectional view, Aug.31.13
Discharge = 3.36cms (WSC Port Coquitlam)
The arrows indicate the slot used for passage

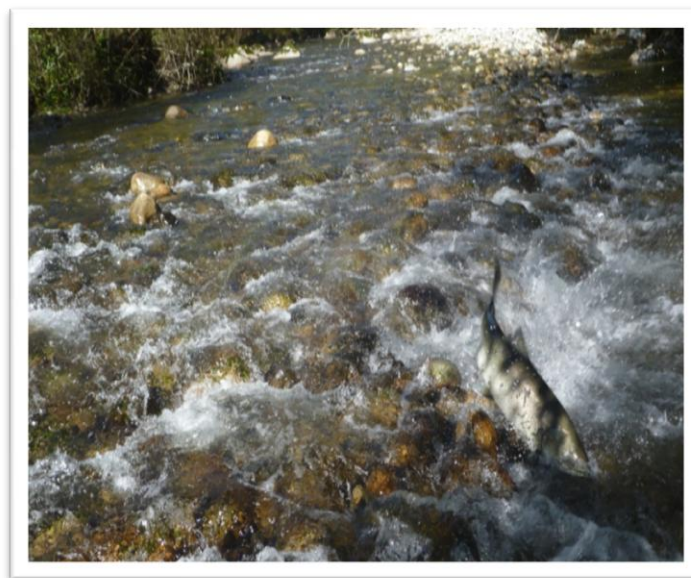
Observed fish distribution upstream of this index site indicates that depth and velocity for passage was adequate during the lowest discharge value of 2.59cms (Figure 28) (WSC, Port Coquitlam). Although not an impediment to migration, lower discharge rates can present a challenge to the Pink Salmon as they migrate upstream through the cascading cobble riffle (Figure 18).

Figure 18 - Index site 3a - passage attempt, Sept 25.13

Discharge = 3.65cms (WSC Port Coquitlam)

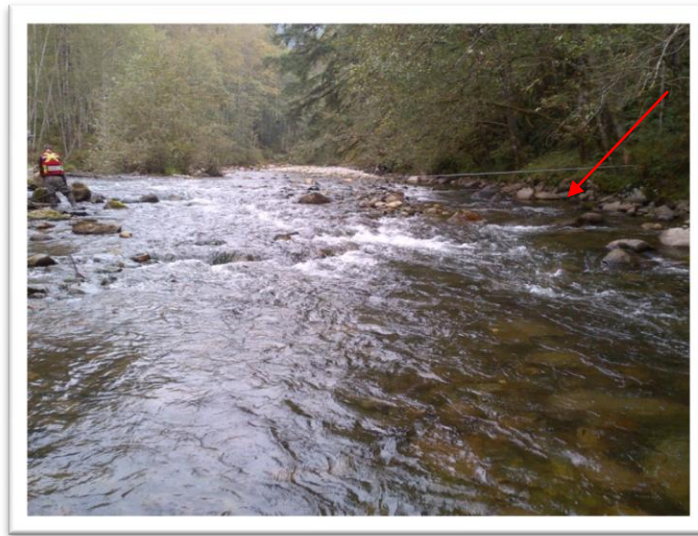
Figure 19 - Index site 3a - upstream view, Sept 15.13
Discharge = 2.59cms (WSC Port Coquitlam)
The arrow indicates the chute which is accessible at present flow

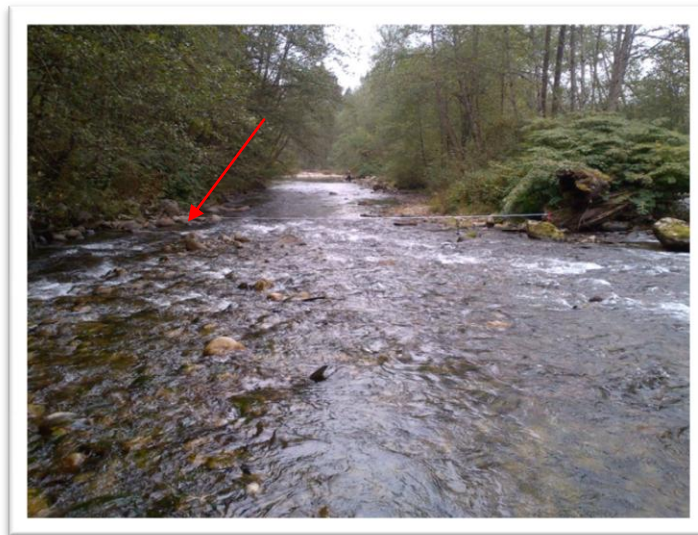
Figure 20 - Index site 3a - downstream view, Sept.15.13
Discharge = 2.59cms (WSC Port Coquitlam)
The arrow identifies observed migration route

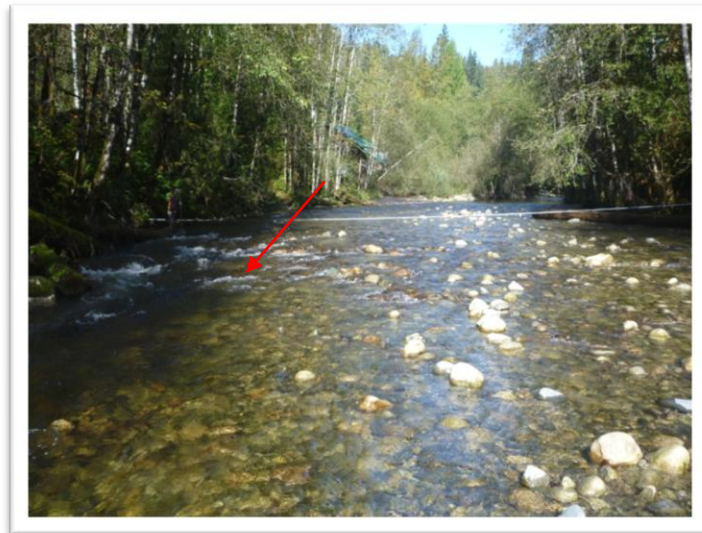
Figure 21 – Index site 3c - upstream view, Sept.25.13
Discharge = 3.65cms (WSC Port Coquitlam)
The arrow indicates the main access with adequate depth and velocity

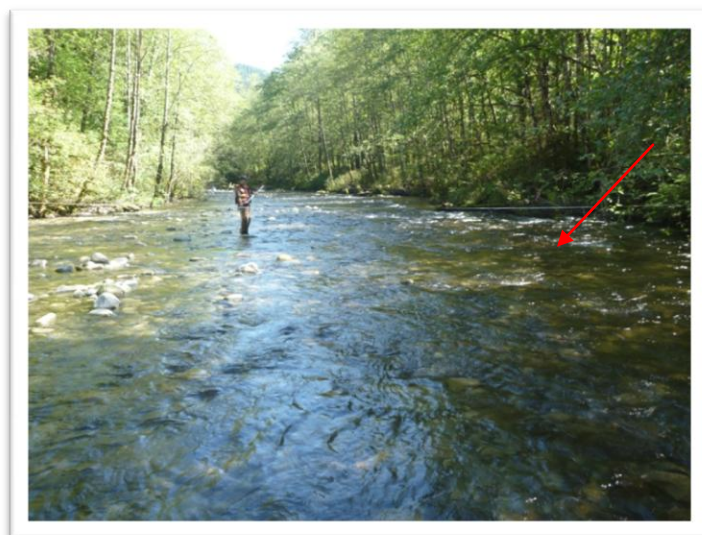
Figure 22 – Index site 3c - downstream view, Aug.31.13
Discharge = 3.36cms (WSC Port Coquitlam)
The arrow identifies the migration route

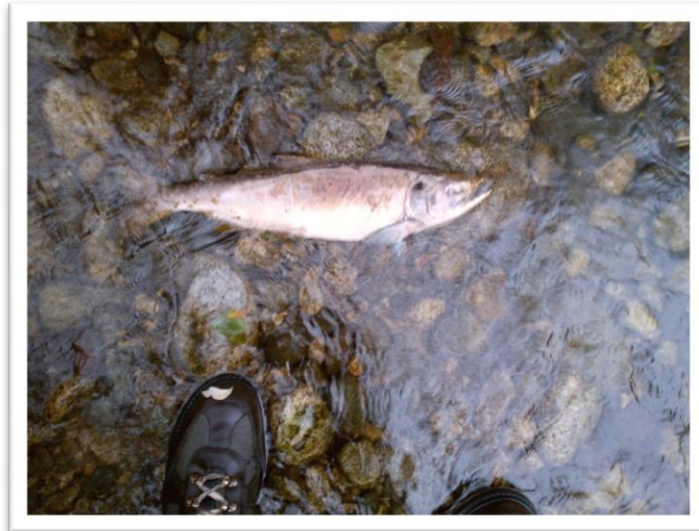
Figure 23 - Index site 3c - salmon carcass, Sept.25.13
Discharge = 3.65cms(WSC Port Coquitlam)

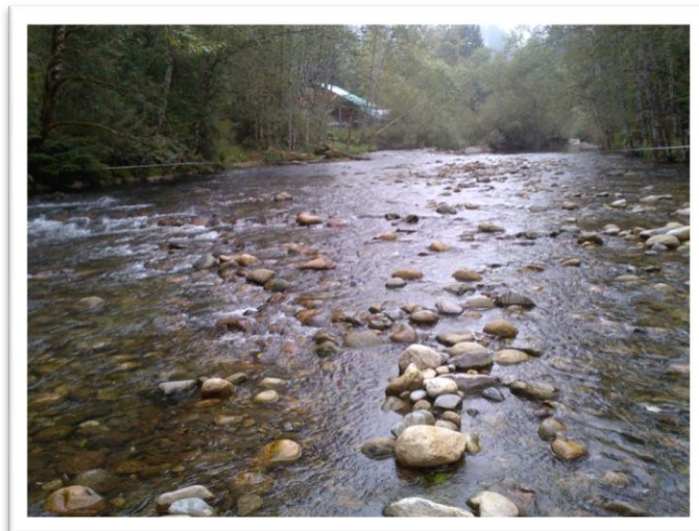
Figure 24 - Index site 3c - upstream view, Sept.15.13
Discharge = 2.59cms (WSC Port Coquitlam).

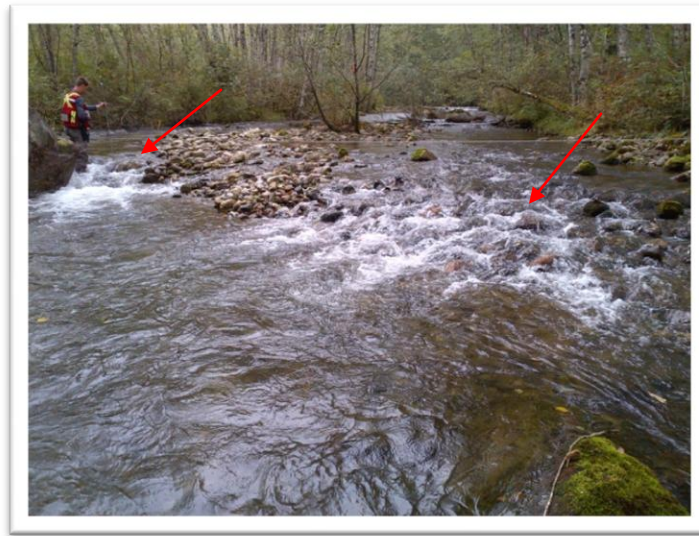
Figure 25 - Index site 4 - upstream view, Sept.15.13
Discharge = 2.59cms (WSC Port Coquitlam)
The arrows indicate access points

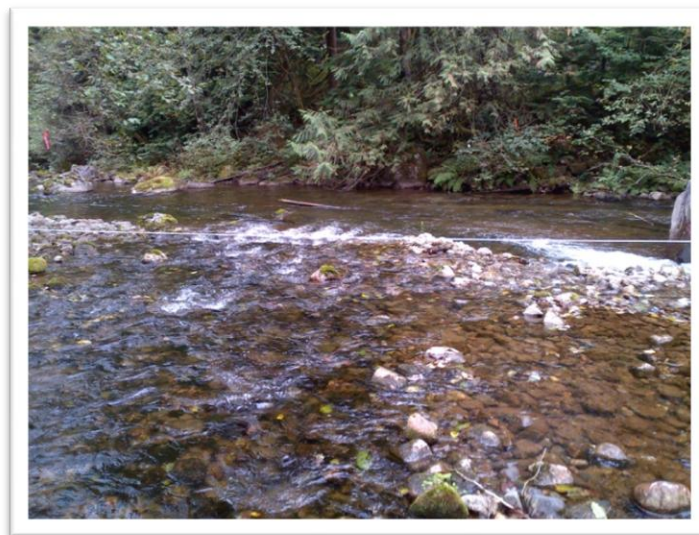
Figure 26 - Index site 4 - downstream view, Sept.15.13
Discharge = 2.59cms (WSC Port Coquitlam)

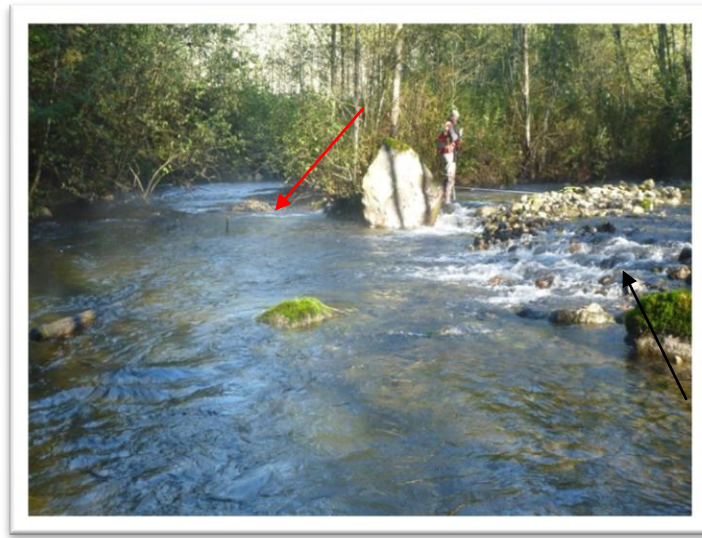
Figure 27 – Index site 4 - upstream view, Sept.25.13
Discharge = 3.65cms (WSC Port Coquitlam)
The black arrow indicates the mainstem Coquitlam,
the red arrow indicates Swoboda channel access.

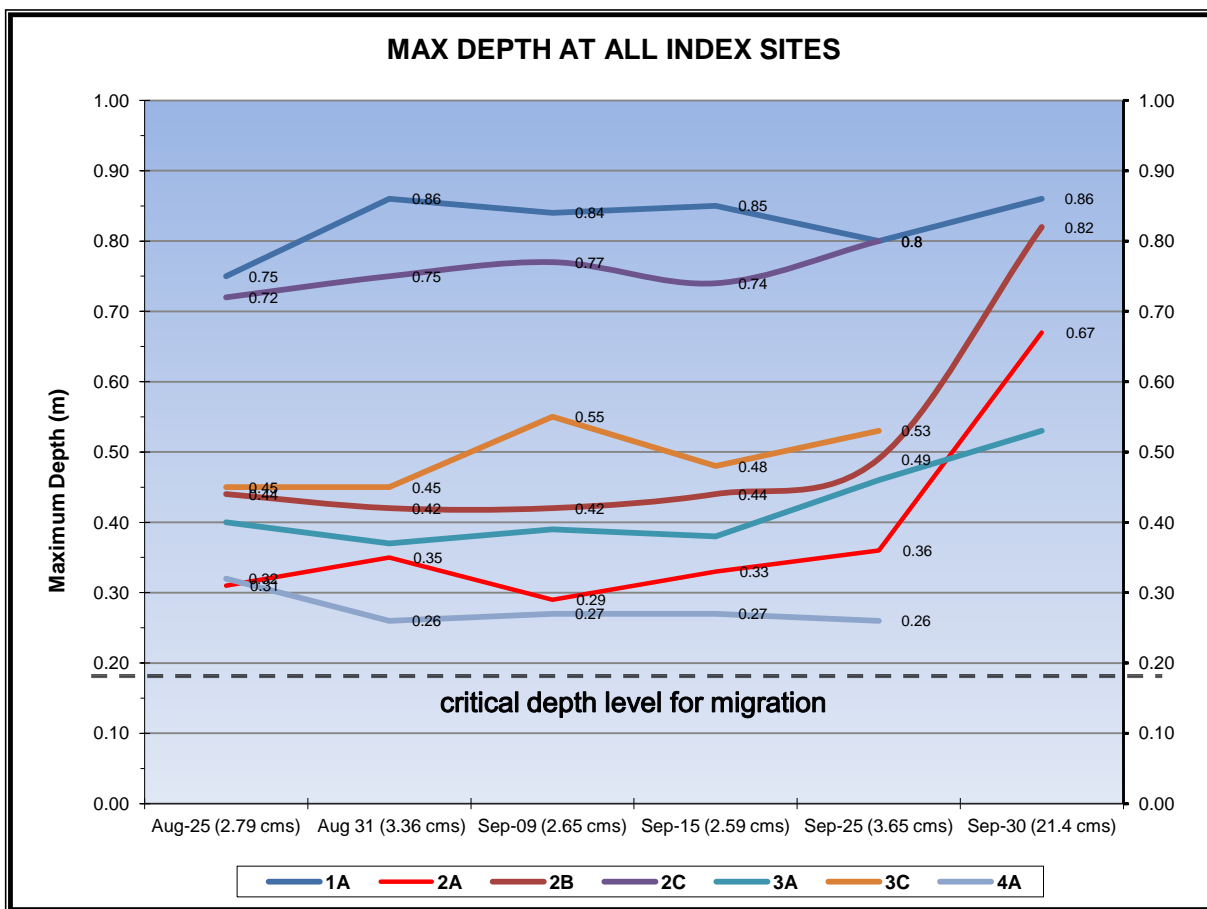
Stream depth (Table 4 to 10) at all index sites were identified to be adequate for Pink Salmon passage and was above the threshold limit for Pink Salmon migration requirements (Appendix 1) (Figure 28) (Bjornn and Reiser 1991). Observations of migrating Pink Salmon did indicate some challenges at Index site 3A and index site 4 during the lowest flow of 2.59cms (WSC, Port Coquitlam) however, these index sites were not an impediment to passage as indicated with the maximum depth and velocity being adequate for passage (Figure 28). Index site 4 data indicates that passage could potentially become an issue with flows below 2.59cms (WSC Port Coquitlam) as this site is primarily influenced by Dam discharge and minimal tributary contribution.

Figure 28 - Illustrates the maximum depth at each index site over the survey period.

21 Pink Salmon were observed upstream of the index site on August 25th during a discharge rate of 2.79cms indicating depth and velocity was adequate for passage through this index site (WSC, Port Coquitlam). The first Pink Salmon carcass was observed upstream of this site September 15th and physical characteristics indicated that it had been in the system for a few weeks with discoloration and scale loss (Figure 23). The BC Hydro adult enumeration crew first observed 12 Pink Salmon upstream of this index site during the September 9th survey when minimal precipitation and a lower discharge rate of 2.65cms occurred (WSC, Port Coquitlam). Fish observations and distribution upstream of this index site throughout the monitoring period indicated that at the lowest discharge flow of 2.59cms migration was not impeded and depth levels were sufficient for migration (Figure 28) (WSC, Port Coquitlam).
