Wahleach Project Water Use Plan

Herrling Island Chum Spawning Success

Reference: WAHMON-3

A Synthesis of the Herrling Island Side Channel Spawning Success Monitoring

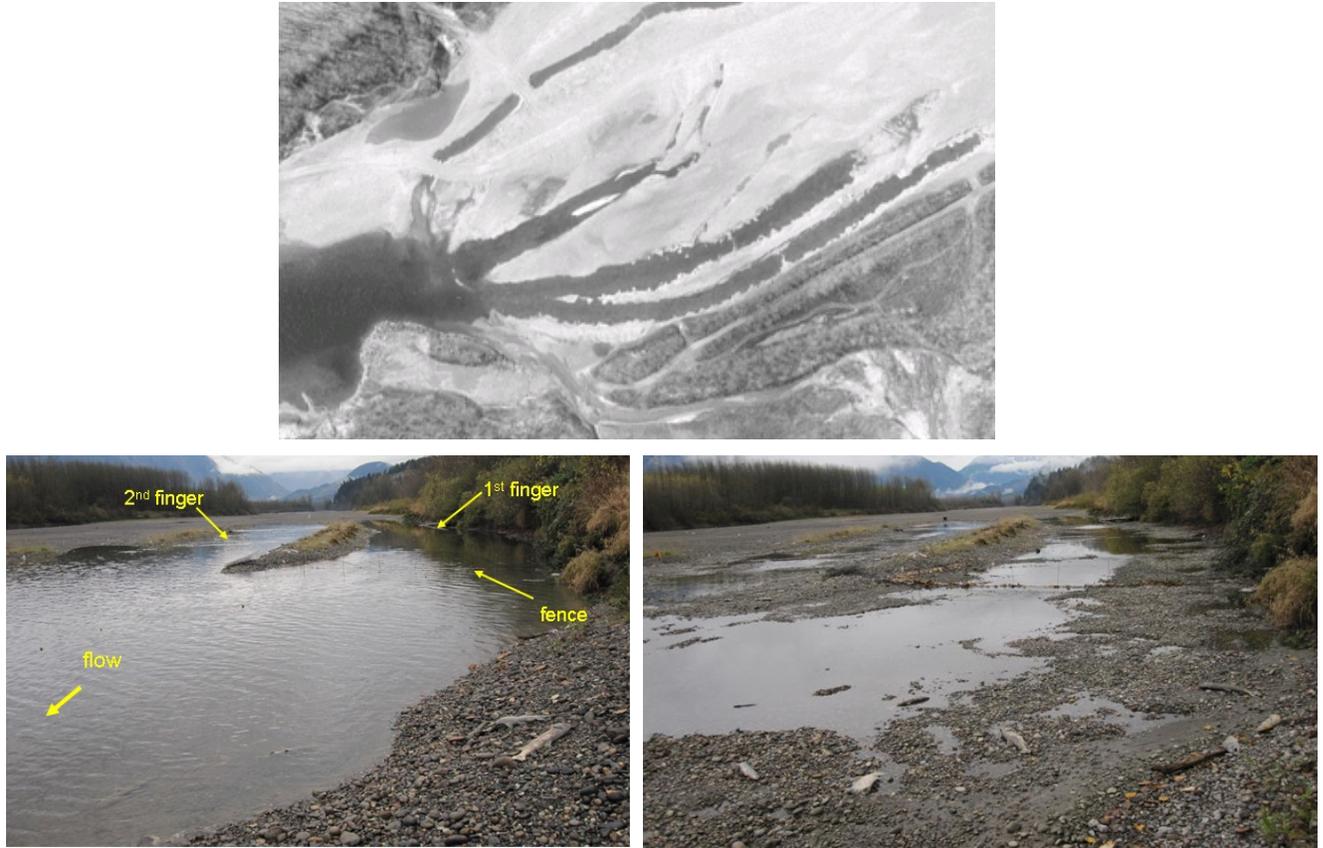
Figure 15 Aerial photography (top) and on the ground photographs (bottom) of Site 1 with the characteristic “fingers” prone to dewatering (bottom right) during WAH GS outages.

Examples of sites prone to dewatering include “the fingers” in Site 1 (Figure 15) and sites with similar characteristics to Site 4 or Site 7 (Figure 16).

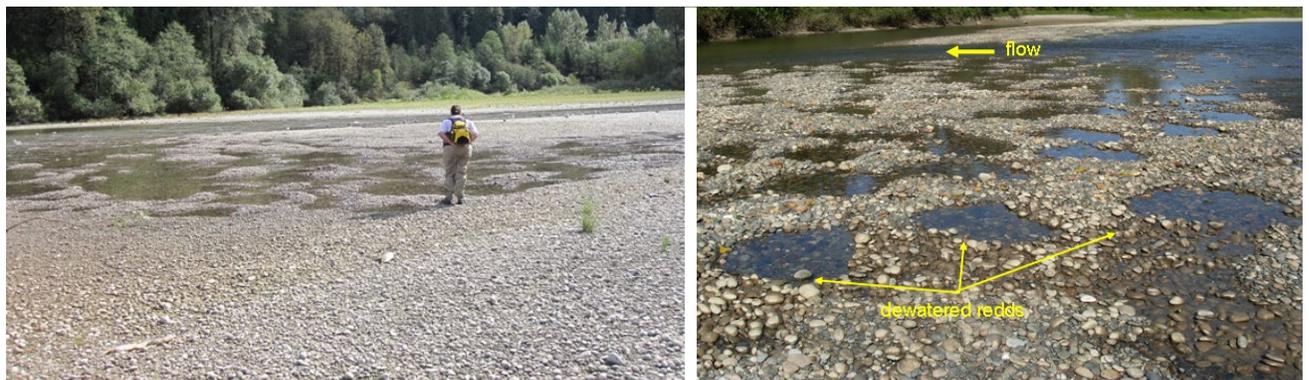
Figure 16 Photographs of dewatered redds taken at Site 7 (left) and Site 4 (right) during WAH GS outages.

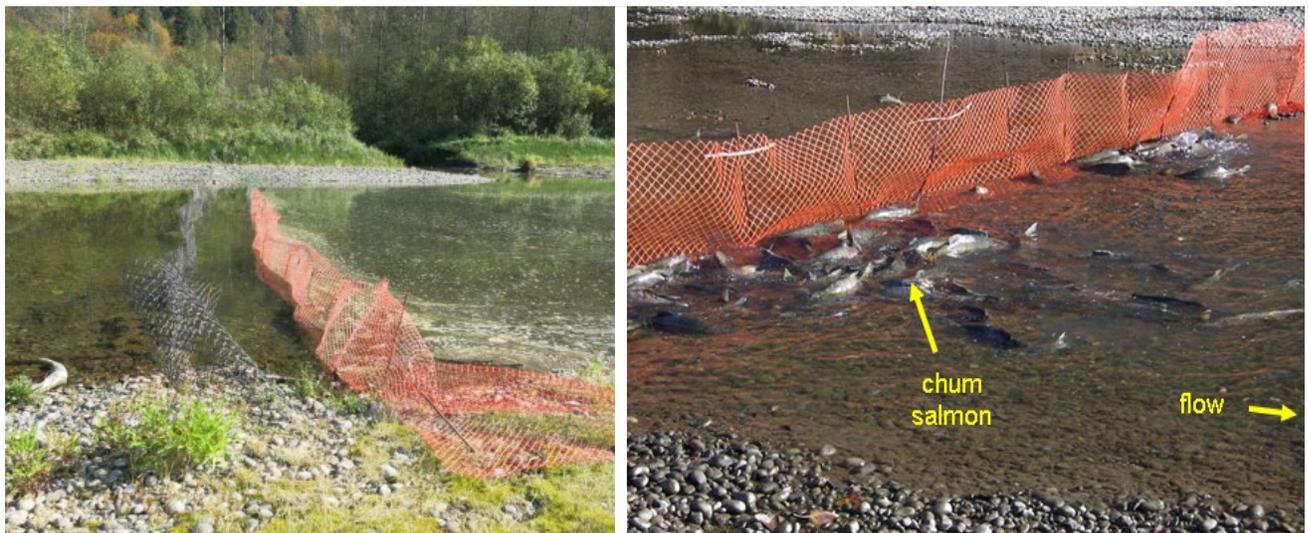
Figure 17 Exclusion fencing installed on the Herrling Island Side Channel in its initial (right panel) and more advanced progression (left panel) (Source: Living Resources 2013).

Under these conditions, exclusion fencing can prevent Pink and Chum Salmon spawners from entering spawning areas that dewater during WAH GS outages (see right panel of Figure 17). It is likely that most of the Chum Salmon shown in this picture would have spawned upstream of the fencing had it not been installed. Chum Salmon redd distribution in an area prone to dewatering, compared across years with and without the use of exclusion fencing, supports the notion that exclusion fencing was able to prevent spawning in those areas (Figure 18).

All exclusion fencing installed from 2010 to 2013 by Living Resources was of a temporary nature. However, the double-fence design shown in the left panel of Figure 17 appeared to be more effective in excluding salmon, while not being breached.

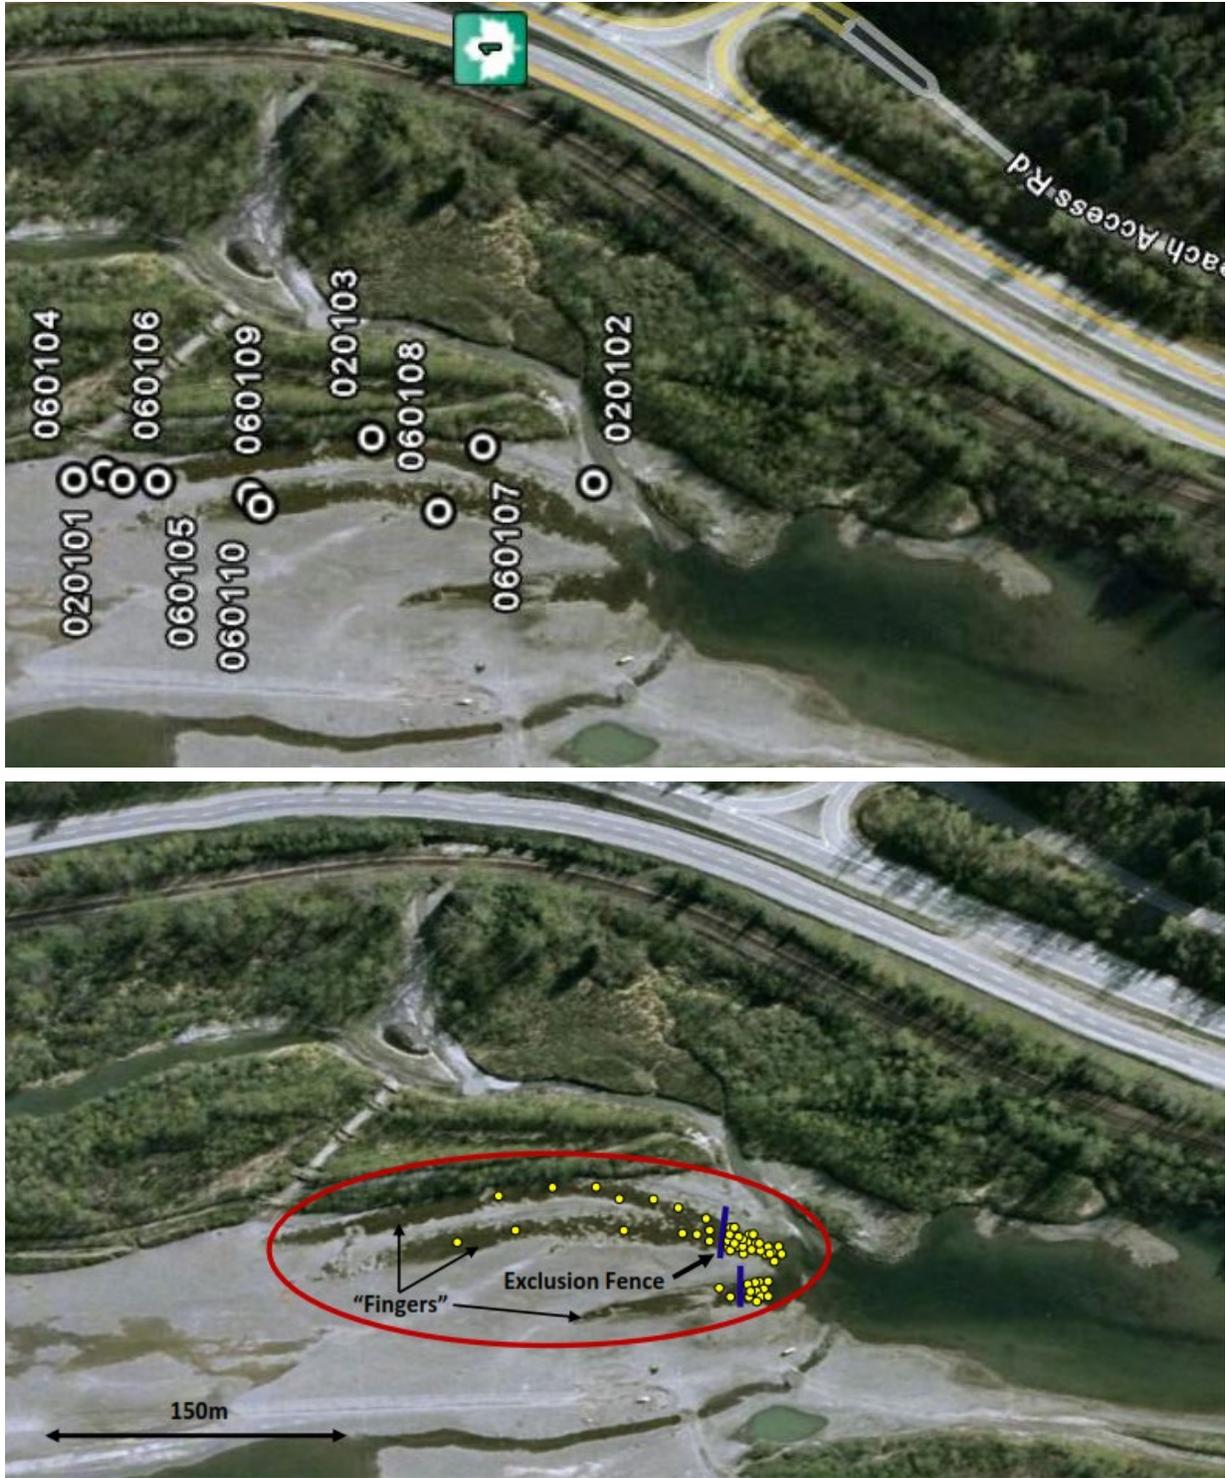
Figure 18 Chum Salmon redd distribution in the upstream end of Section 1 of the Herrling Island Side Channel, also called “the fingers” without (top panel) and with exclusion fencing installed (bottom panel) (Sources: top panel, Smith 2008; bottom panel, Living Resources 2012).

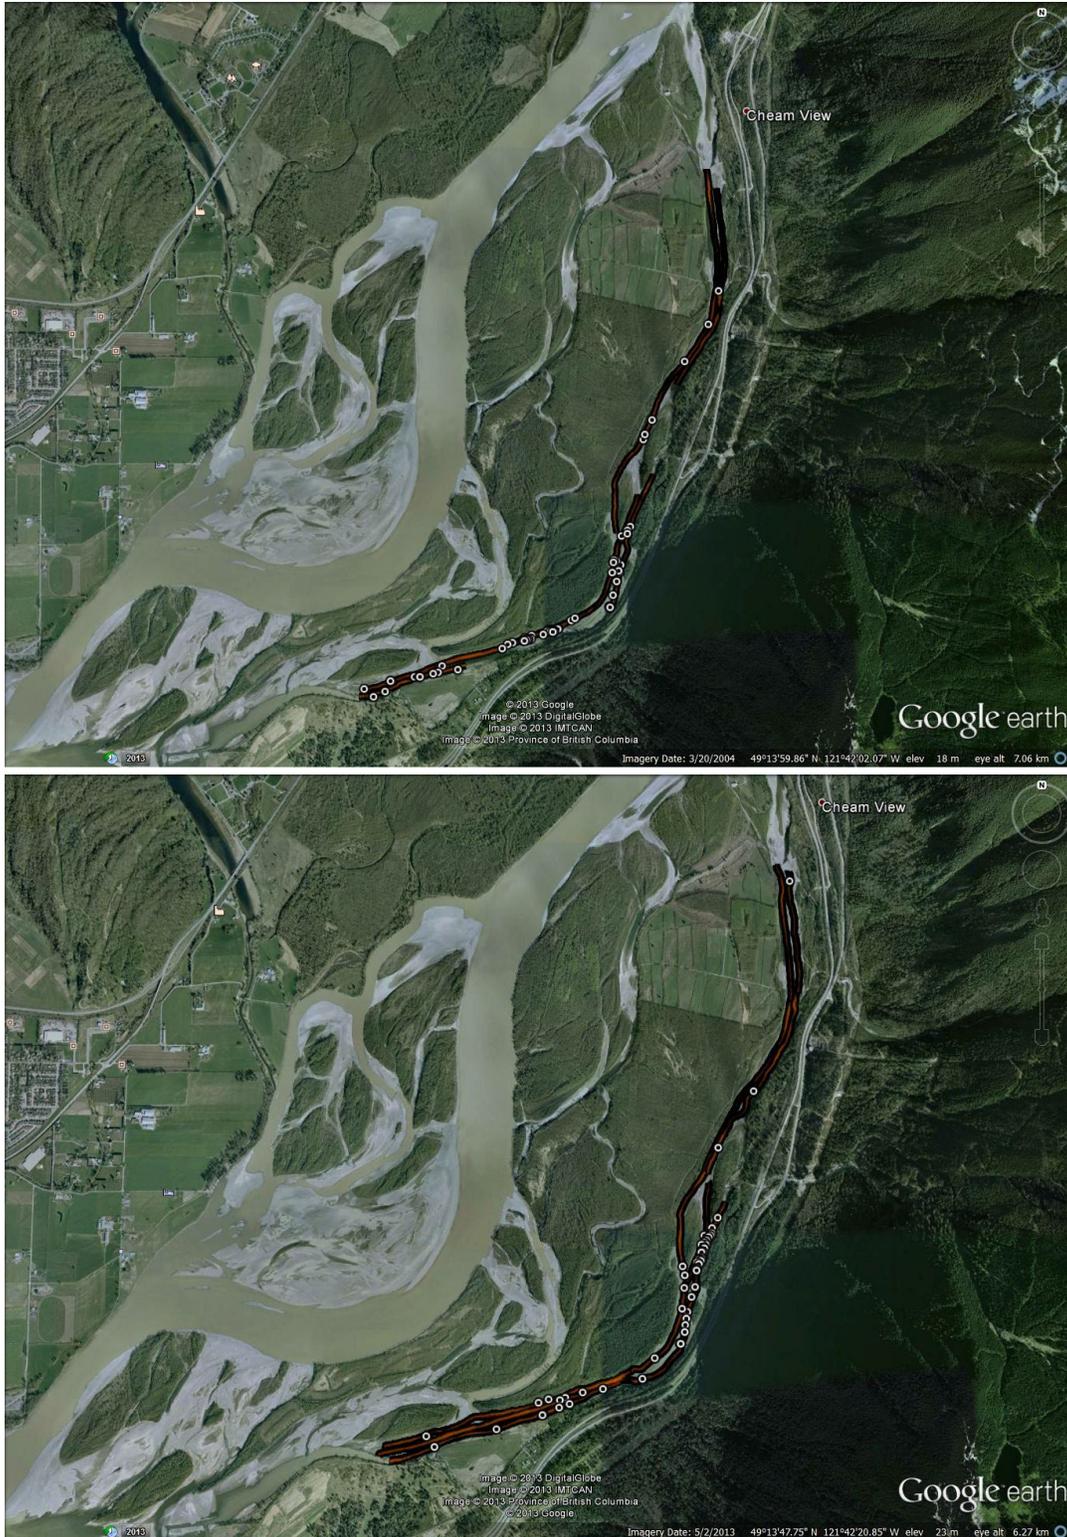
Figure 20 Distribution of large (>160 cm) White Sturgeon (white circles) throughout the Herrling Island Side Channel on June 4, 2013 (top panel) and June 25, 2013 (bottom panel).

number of White Sturgeon (>160 cm) were found to be in the Herring Island Side Channel (Table 2). Within the Herring Island Side Channel, large White Sturgeon (>160 cm) were observed holding upstream and downstream of the WAH GS outlet (Figure 20).

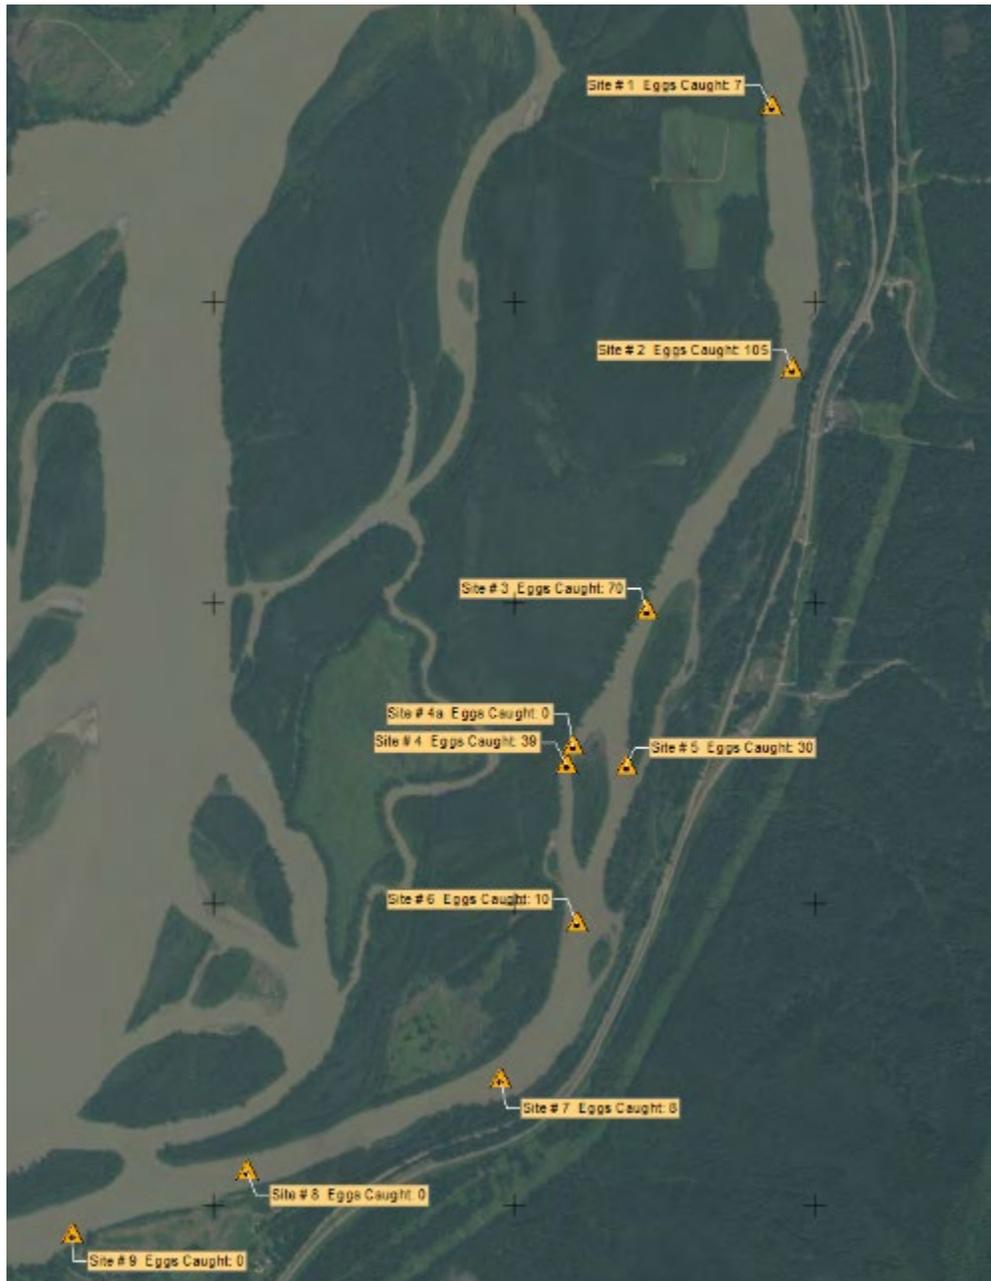
Figure 21 Sampling sites where egg mats were located in the Herring Island Side Channel and the number of White Sturgeon eggs caught at each site in 2013 (Source: Triton 2013).

In addition to the observation of large White Sturgeon throughout the side channel, earlier studies caught freshly laid White Sturgeon eggs on egg mats deployed throughout the Herring Island Side Channel. Specifically, egg mats located upstream and downstream of the WAH GS outlet between Site #1 and Site #2 on Figure 21 had the highest numbers of White Sturgeon eggs deposited on them (Triton 2013).

Based on the 2013 egg mat results, White Sturgeon eggs were also found deposited in the thalweg, as well as the more marginal areas, of the Herrling Island Side Channel (Triton 2013).
