Peace Project Water Use Plan

WILLISTON RESERVOIR WOOD DEBRIS TREND ANALYSIS

**By:
AECOM**

Williston Reservoir Wood Debris Trend Analysis 2009 – 2018

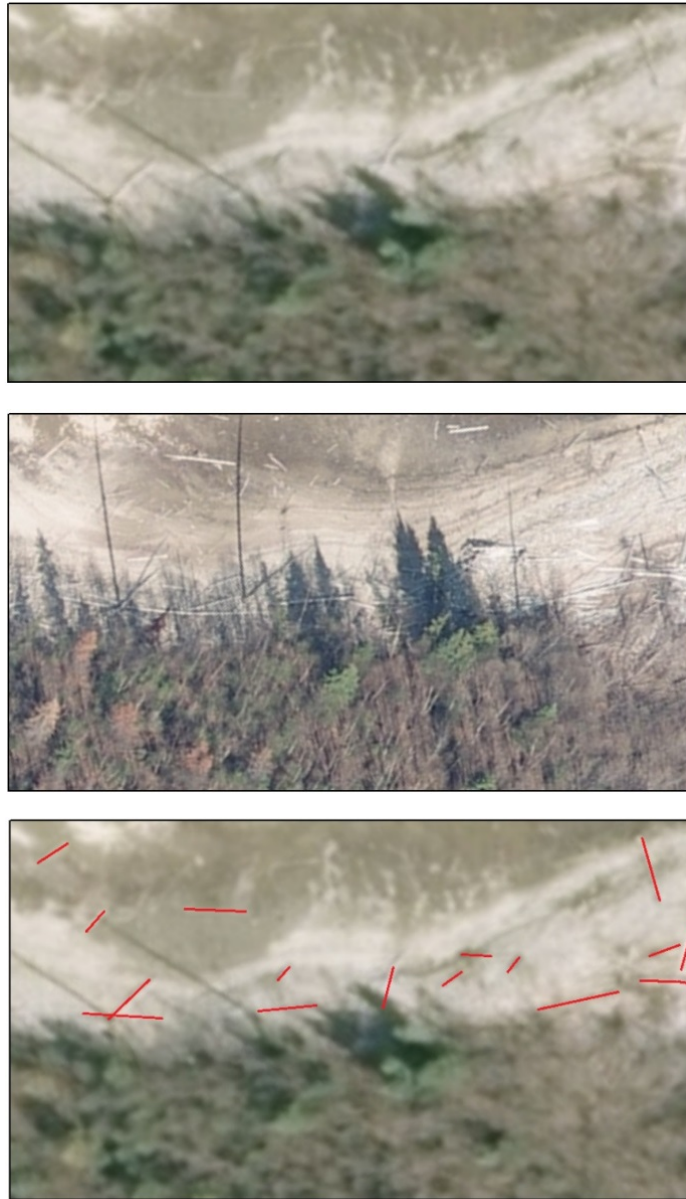
Figure 2 Example of the Re-Analysis of Lower-Resolution 2009 Imagery (Upper Image) by Using 2011 Imagery (Middle Image) to Confirm the Presence of Woody Debris (highlighted in the Lower Image)

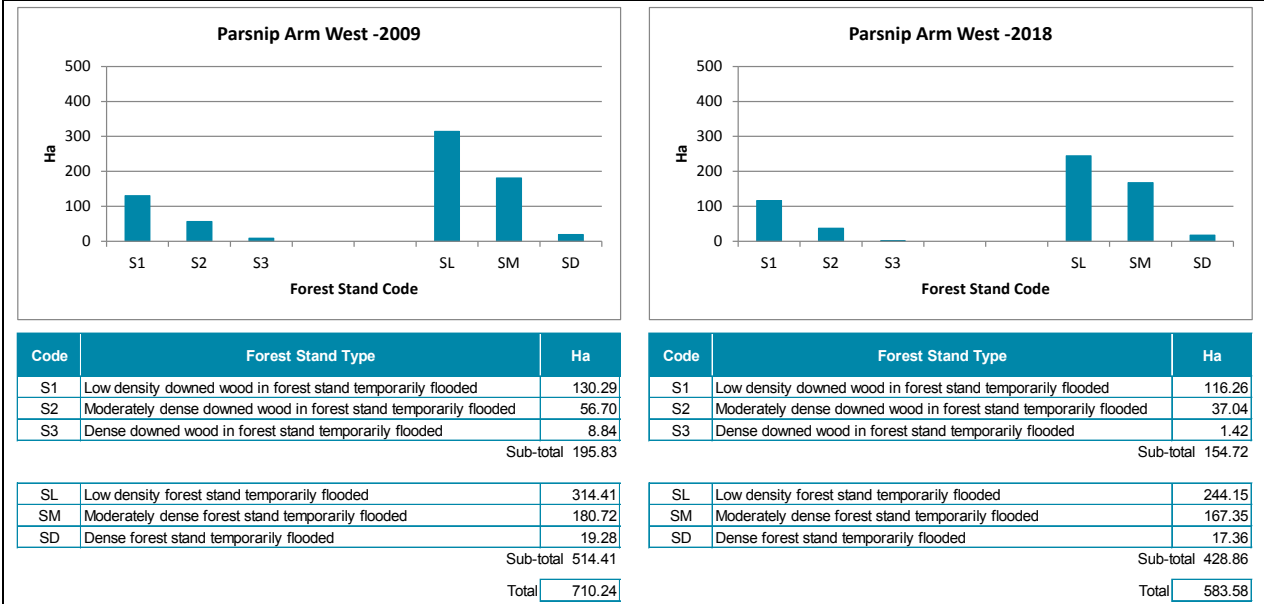
Figure 4 Extent (ha) of Forest Stands in 2009 and 2018, by Sector and Type

In Figure 4, we observe that the proportion of forest stands with downed wood remained quite low in both 2009 and 2018, except in Finlay Arm East & West and Parsnip Arm West.

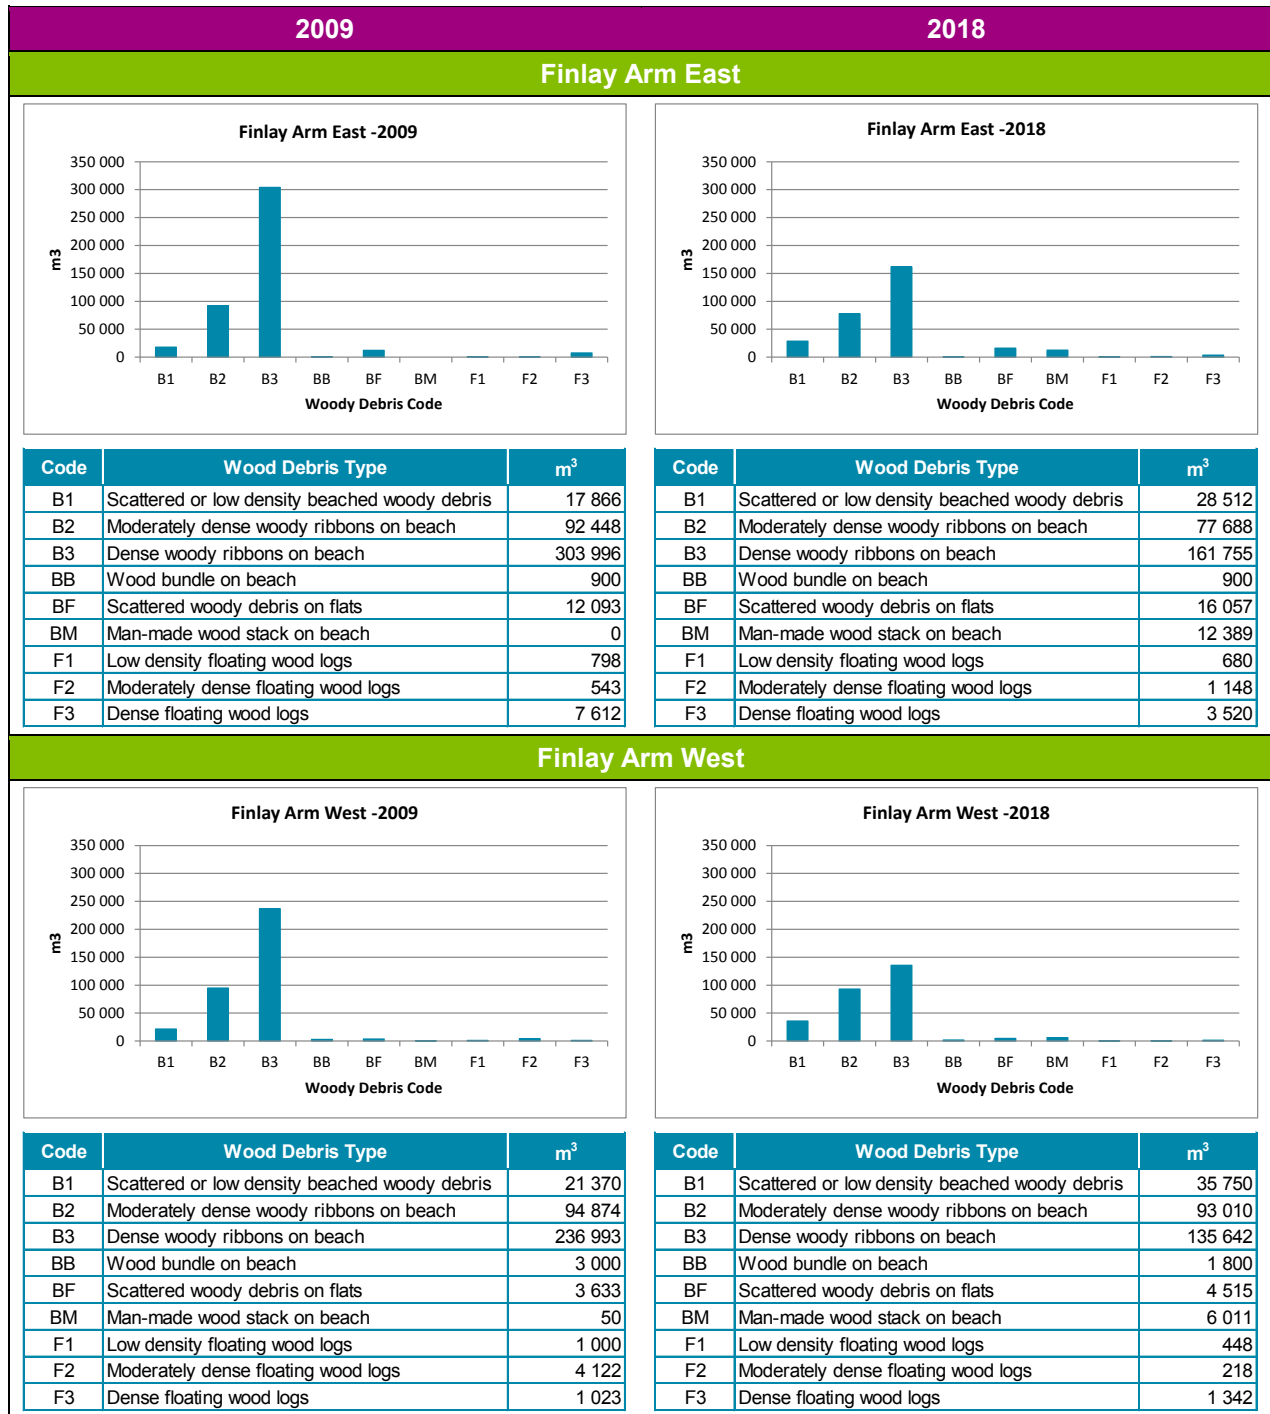
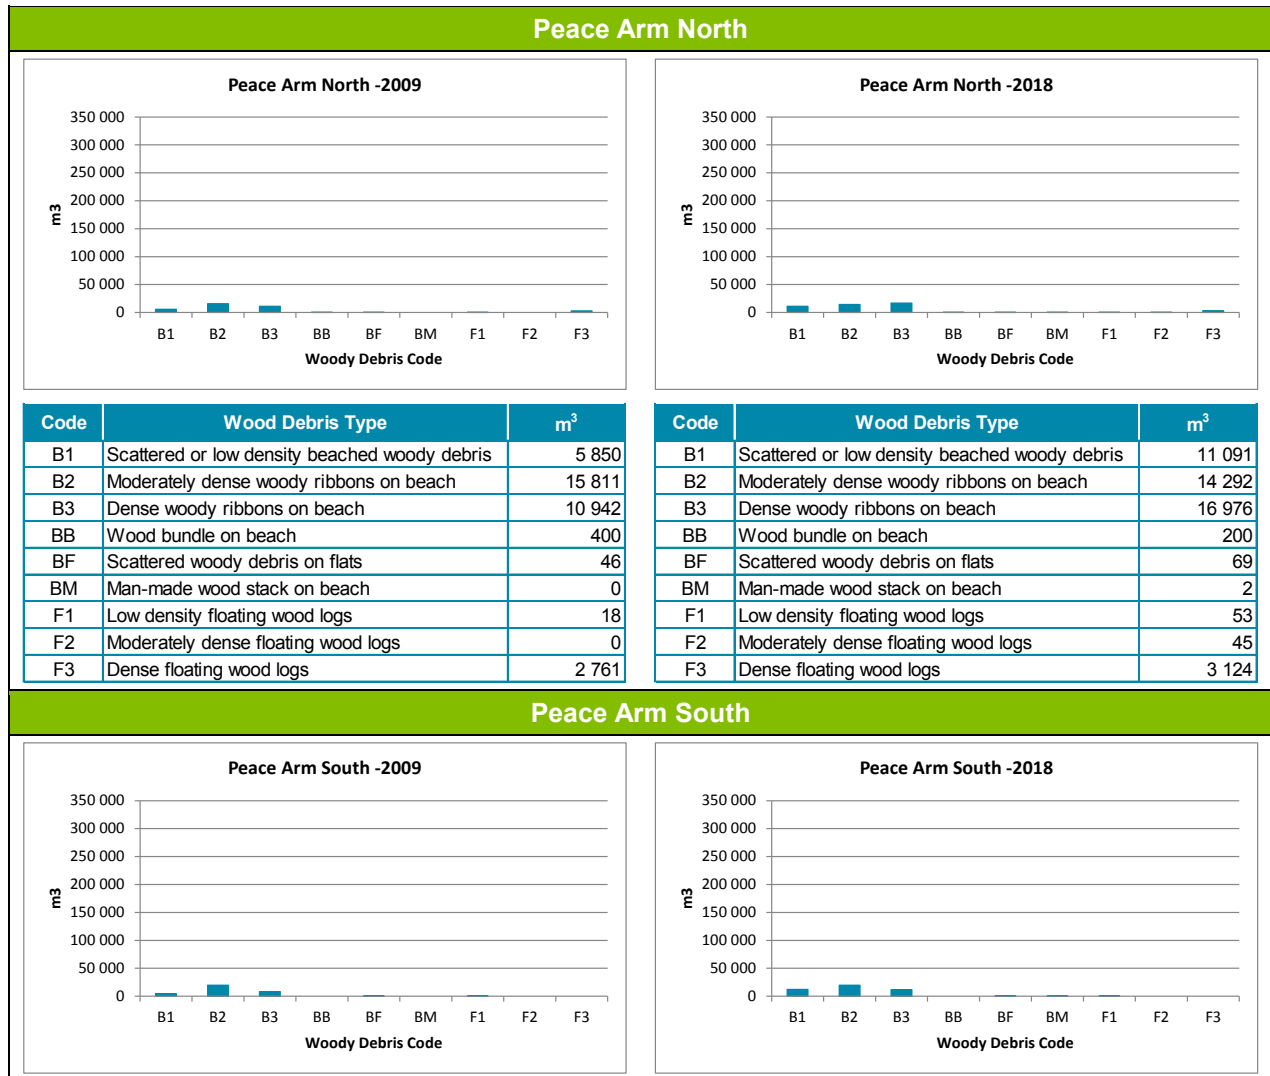
Figure 5 Volume of Large Woody Debris in 2009 and 2018, by Sector and Type

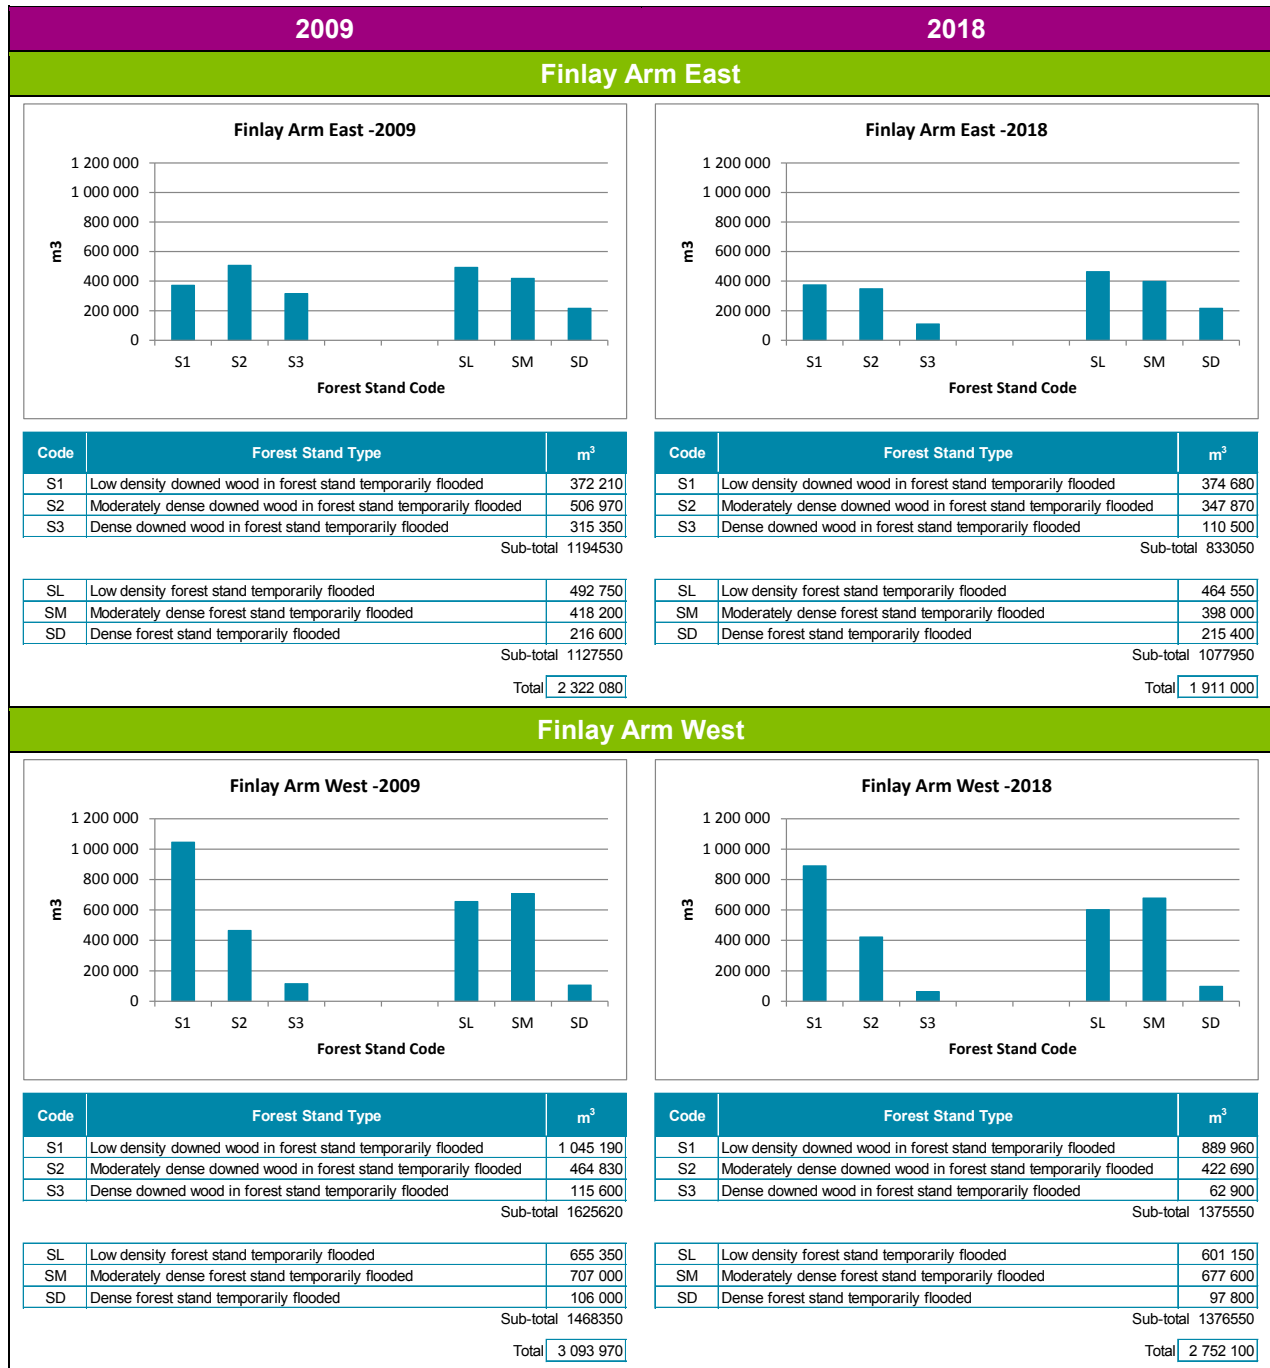
Figure 6 Volume of Wood of Forest Stands in 2009 and 2018, by Sector and Type

We also observed in Figure 6 that the volumes in the degraded forests are quite important, in Findlay Arm East & West and Parsnip Arm West which represent a potential source of debris that could be mobilized to the main shoreline.

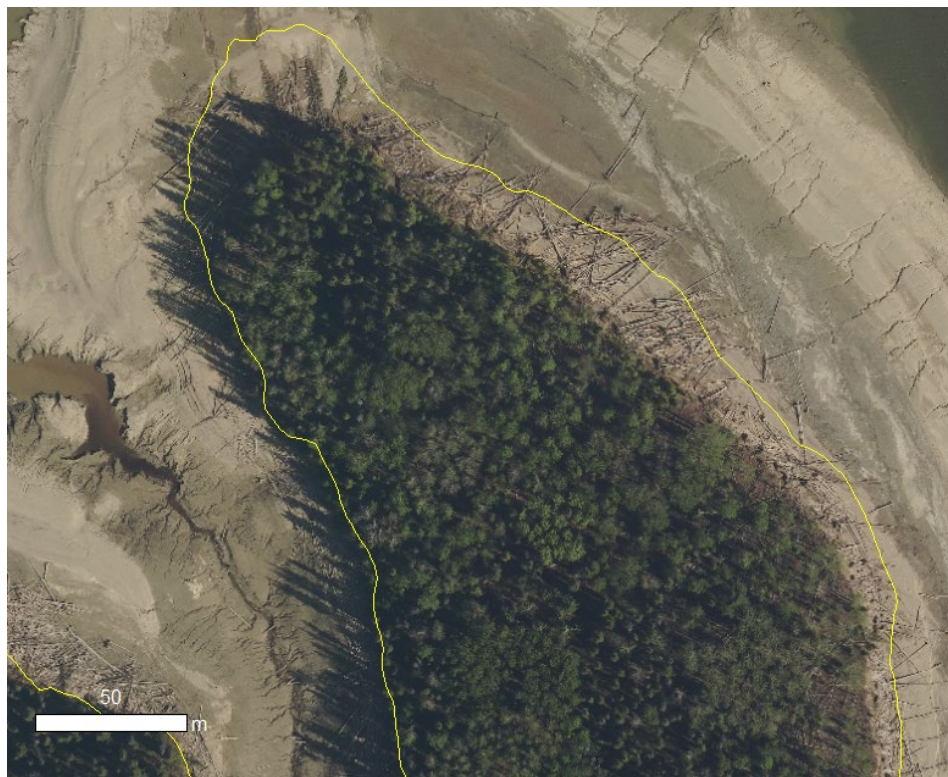
Figure 7 Accumulation of Woody Debris from Forest Stands Downed by Erosion in Parsnip Arm West, 2018 with 2009 shoreline (in yellow).

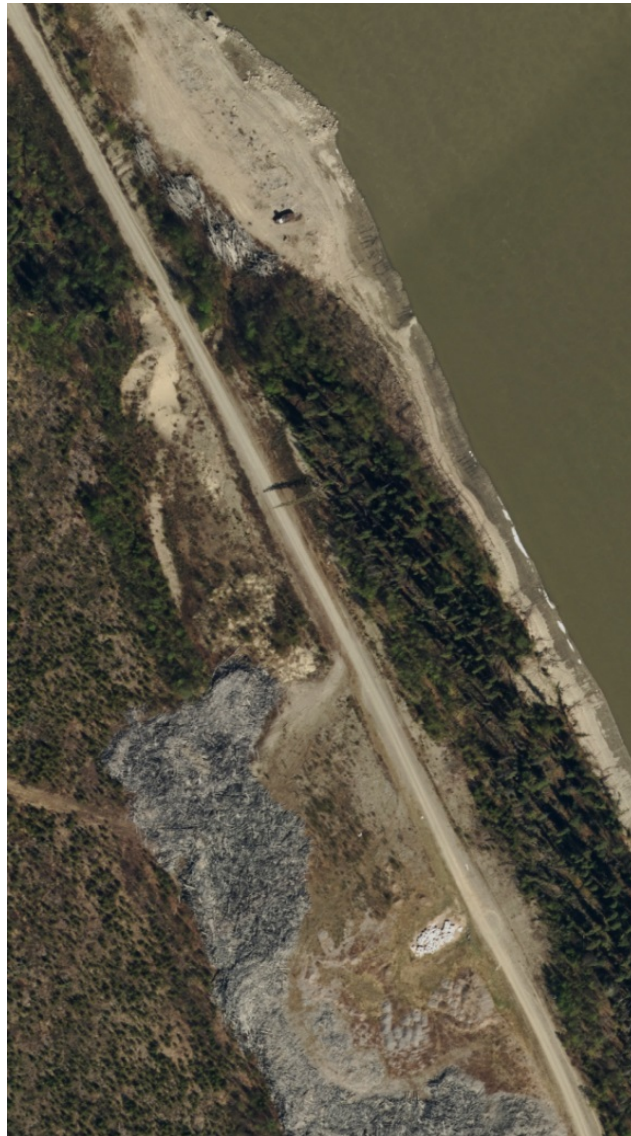
Figure 8 **Indications of Debris Removal Activities in Finlay Arm West, 2018**

- About 20,000 m³ to 21,700 m³ of woody debris is recollected annually as part of the removal program (Table 6 and Appendix D, Table D15) (Figure 8). This program is very effective at reducing the amounts of woody debris in the reservoir, as it can be observed when comparing Maps 6 and 7, along with the location of the main areas of harvesting (Map 1). This positive effect is particularly obvious for the dense woody ribbons, since those contain most of the volume of wood in the reservoir.

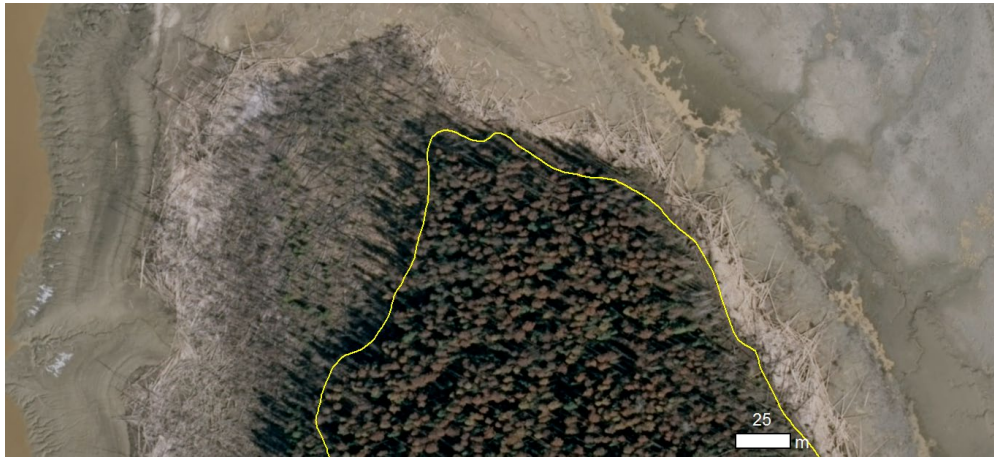
Figure 9 Intensive Coastal Erosion in Finlay Arm West during the Monitoring Period with 2009 shoreline (in yellow).

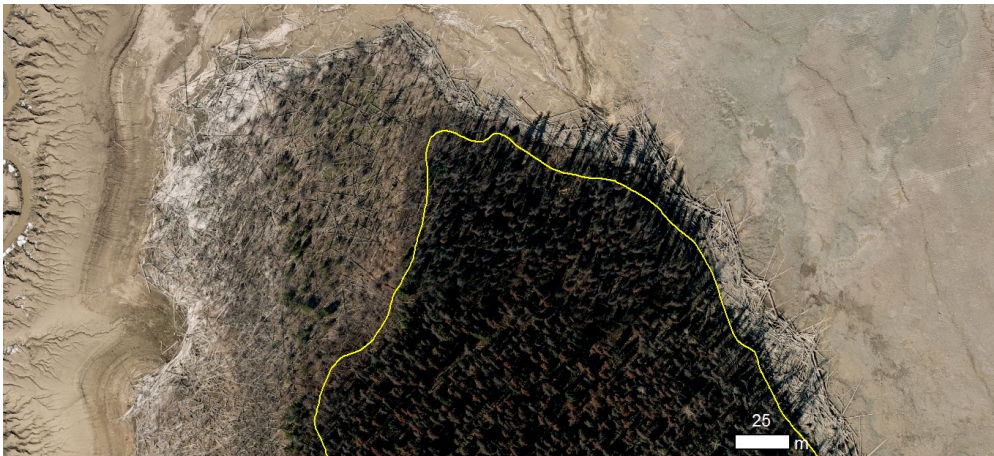
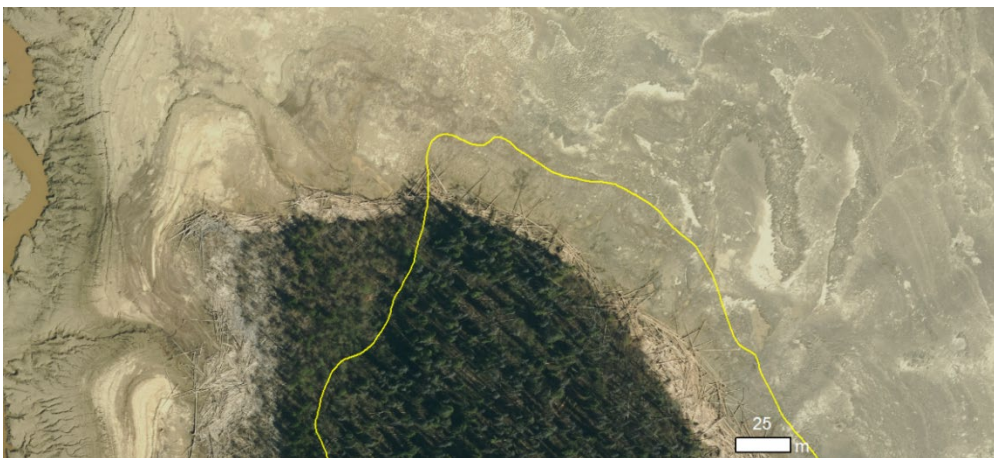
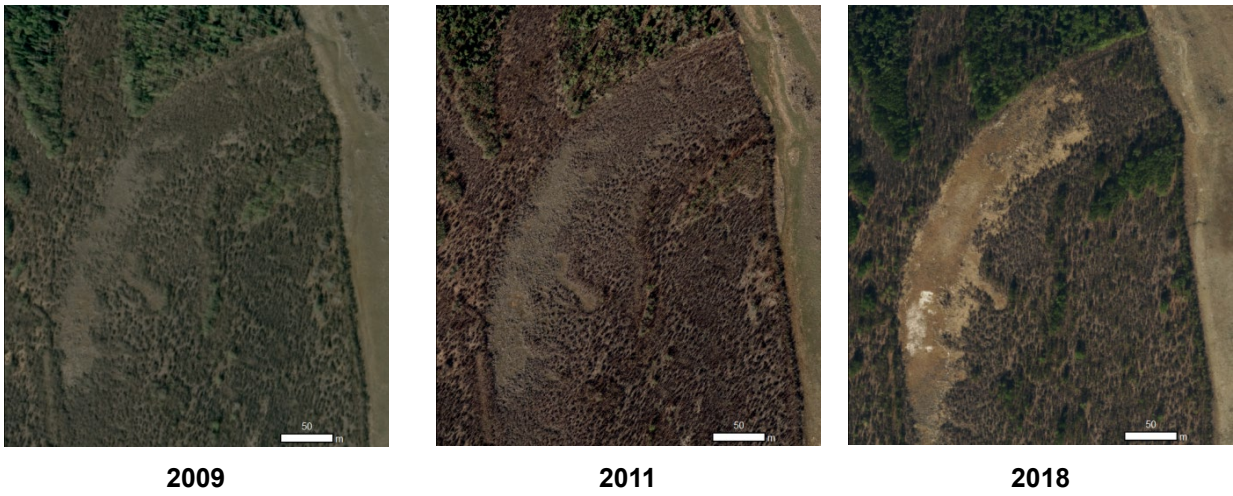
Figure 10 Gradual Degradation of Forest Stands in an Old Channel over the Monitoring Period

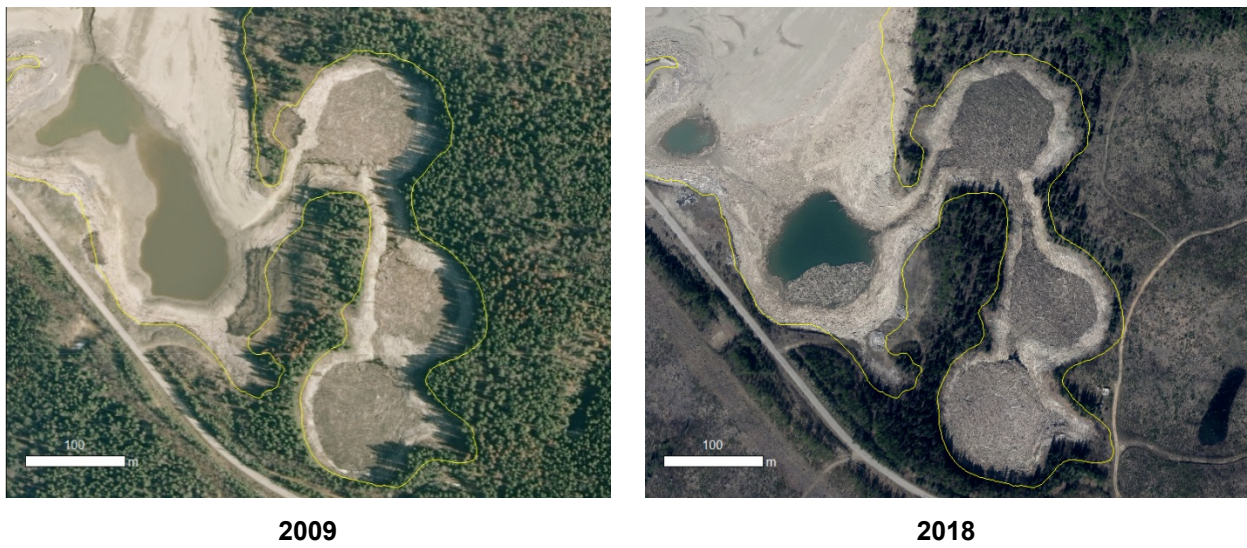
Figure 11 Shoreline Configuration that Favour Woody Debris Accumulation (Class B3) in the Bay Close to the Dam in Peace Arm North with 2019 shoreline (in yellow).

- The rate of debris recruitment from Parsnip River and Pack River appears to be less important than arrivals from Finlay River (Figure 16).
- The sub-watersheds of Peace Arm contribute less debris than those of Finlay and Parsnip Arms and, therefore, the rate of recruitment of wood logs from tributaries there is much lower. Floating debris could arrive from other arms, but the rate of transportation appears slow. An important agglomeration of dense floating debris is observed close to the dam, at the end of Peace Arm North. Debris removal activities are performed here (Figure 11).

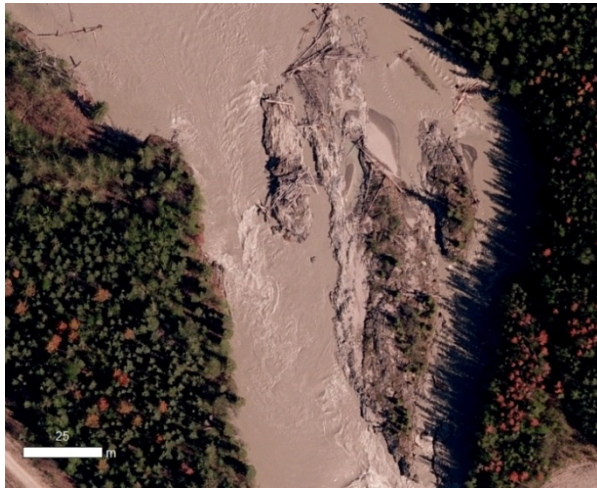
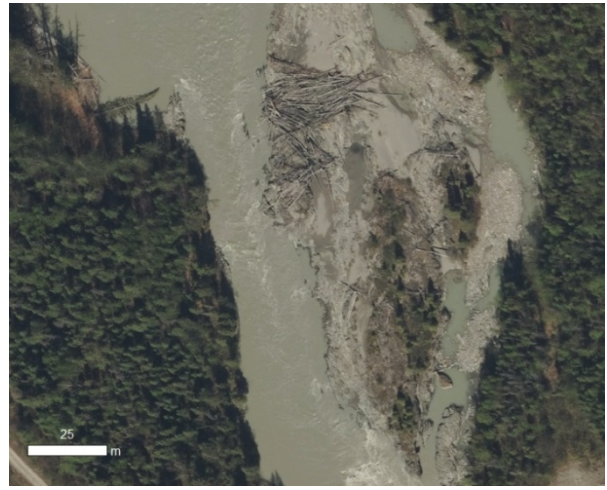
Figure 12 Arrival of Wood Logs from Ospika River (Ospika Arm within Finlay Arm East)

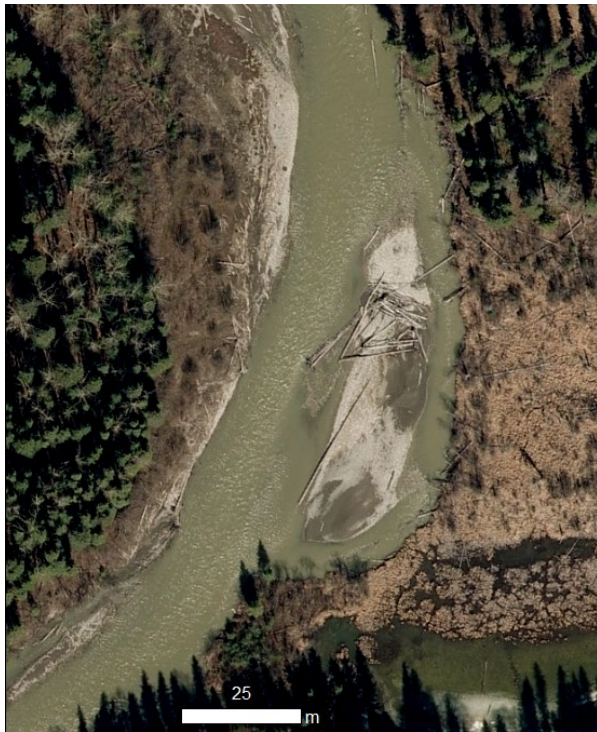
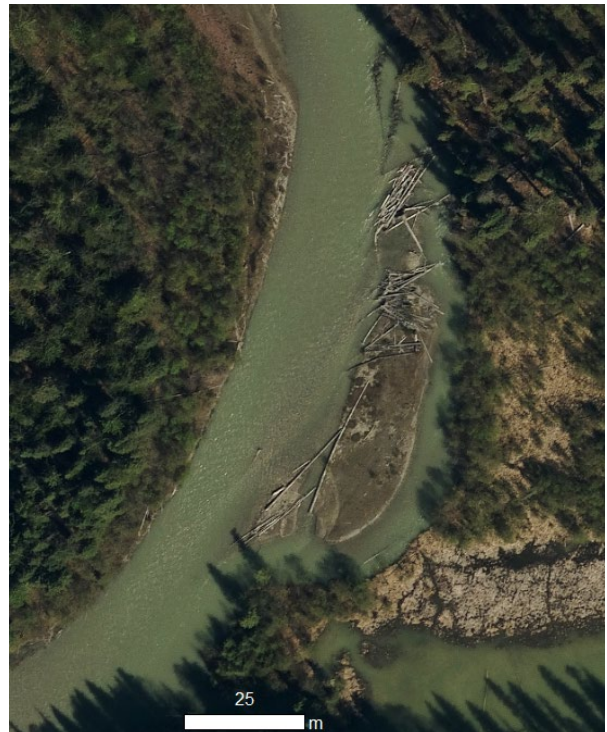
Figure 13 Arrival of Wood Logs from Pesika Creek, a Tributary at the Upper Head of Finlay Arm East

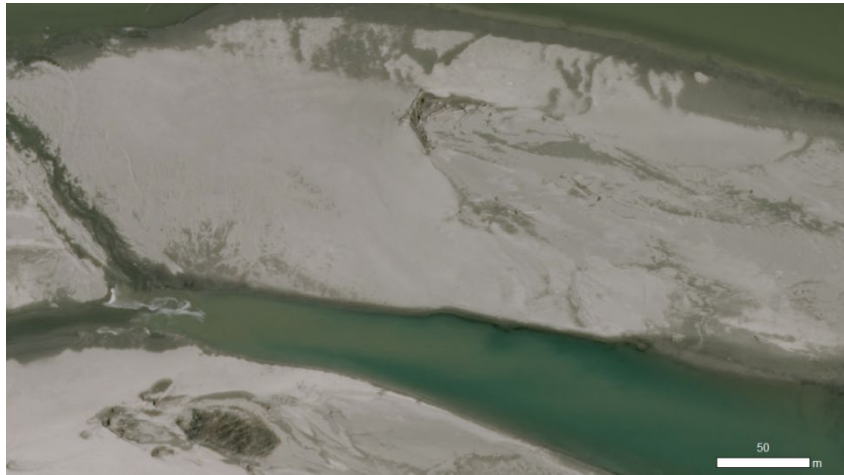
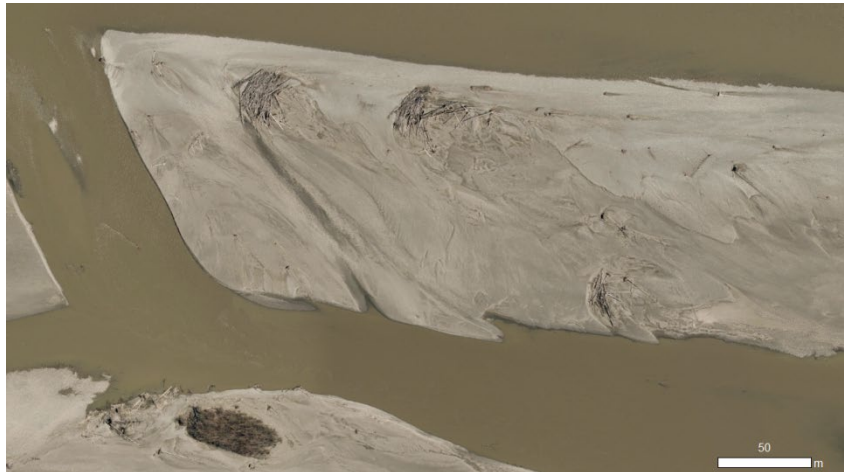
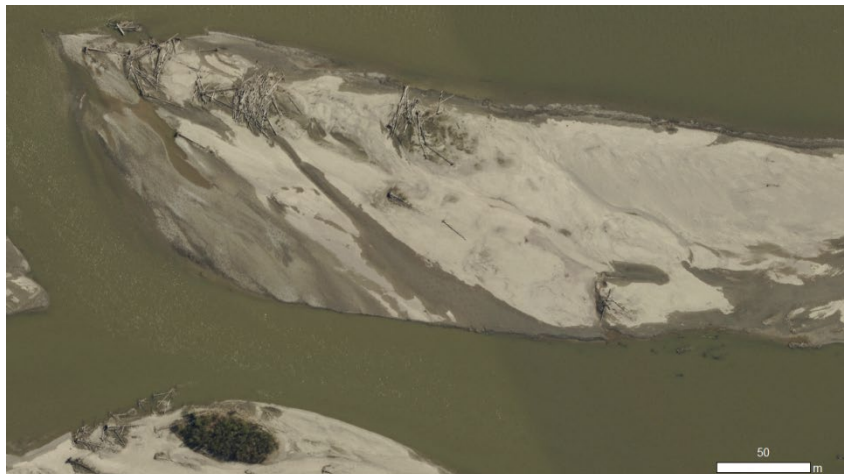
Figure 14 **Arrival of Wood Logs from Finlay River**

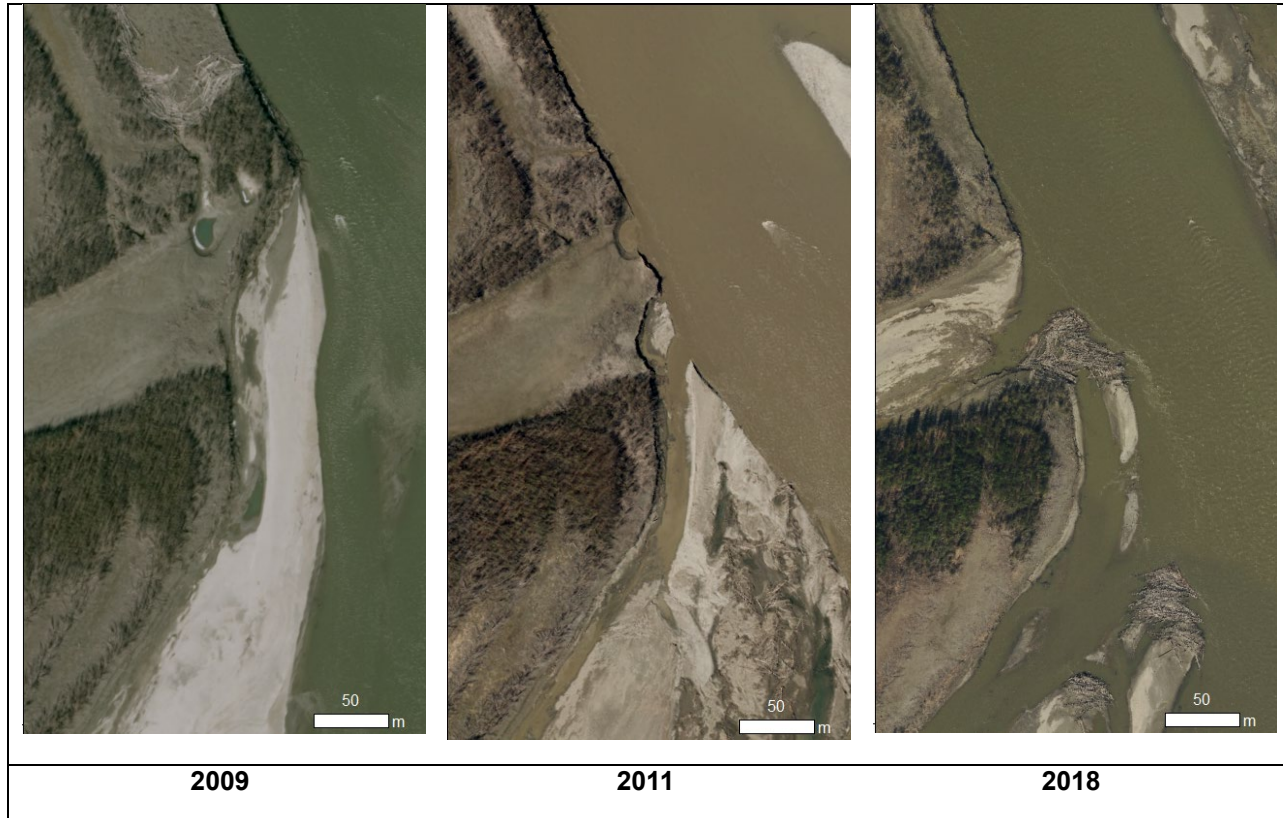
Figure 15 Woody Debris Likely to Originate from Both the Upstream Reservoir area, via the Finlay River, and from Riverbank Erosion

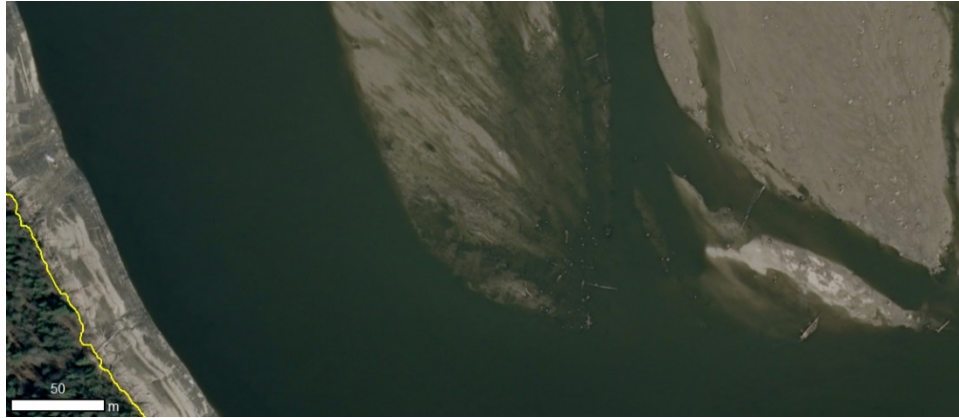
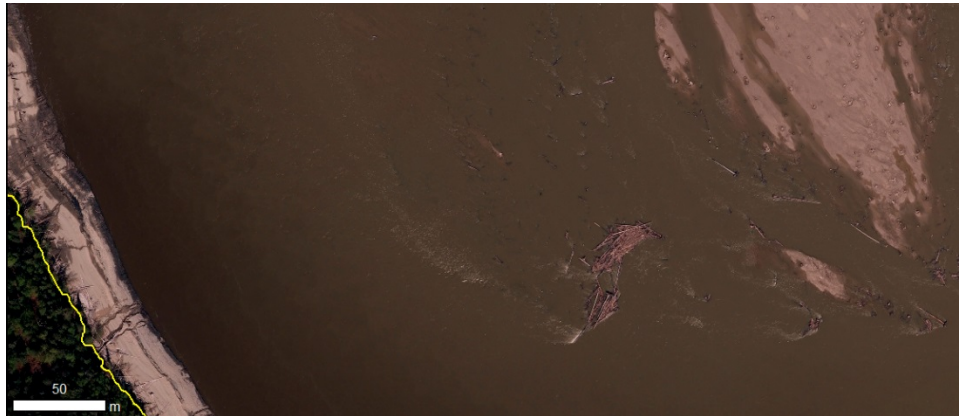
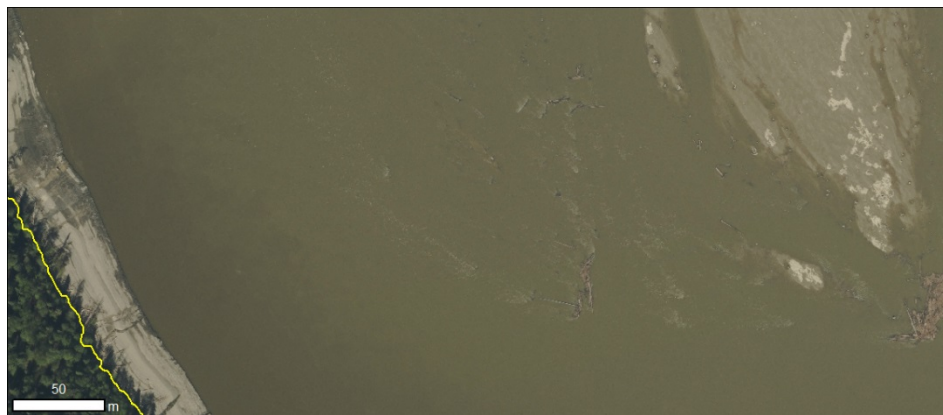
Figure 16 Arrival of Few Wood Logs from Parsnip River and Pack River with 2009 shoreline (in yellow).

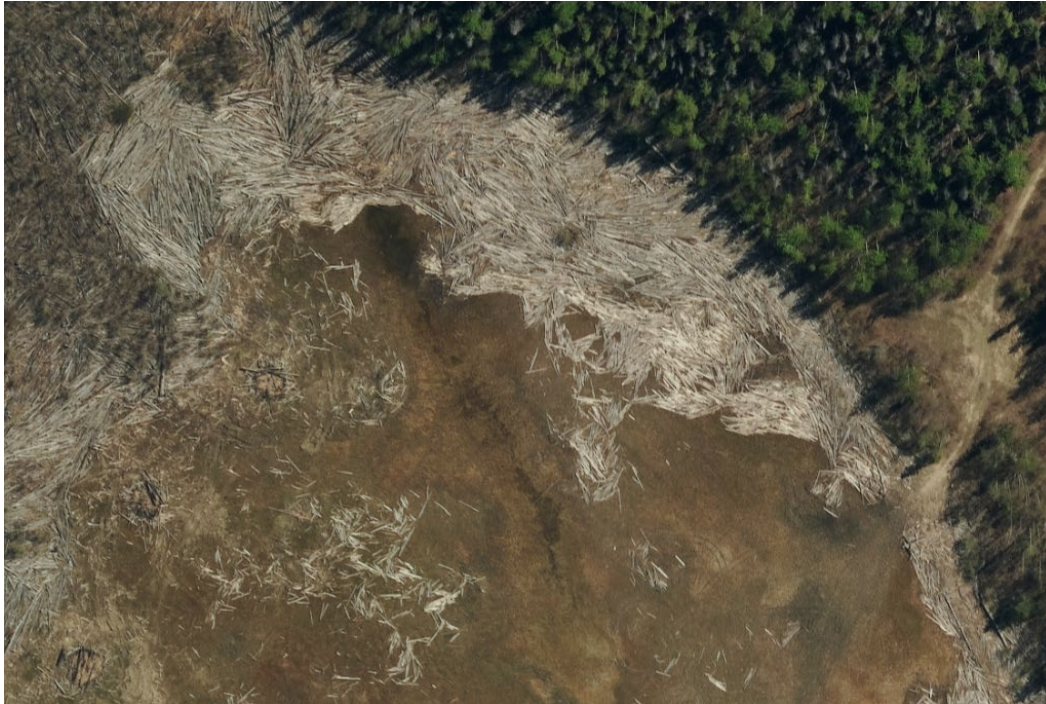
Figure 17 Recent Accumulation of Woody Debris in a Sector Previously Cleaned as Part of the Debris Removal Program, 2018

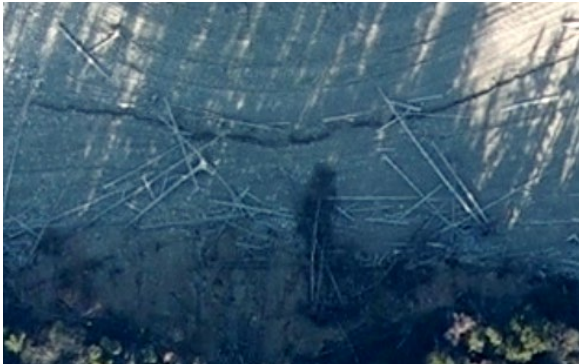
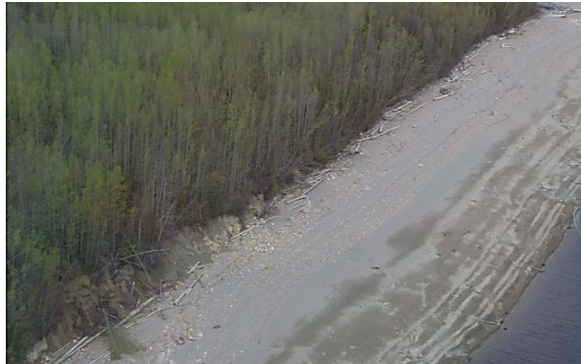
Beached debris is defined as accumulations of woody debris gathered in long ribbons or in piles along the coastline. Three classes of woody debris density are used: B1, scattered; 2) B2, moderately dense; and B3, dense. Scattered debris on the drawdown plain is identified by the code BF. Usually, denser accumulations are observed in shallow natural bays near the upper elevation limits of the reservoir.

Imagery of 2011	Oblique aerial picture
Scattered or low-density beached woody debris (B1)

The next figures depict the various types of beached woody debris that are mapped for the assessment of their sources and quantity, and for the trend analysis (Figure A-1 and Figure A-2).

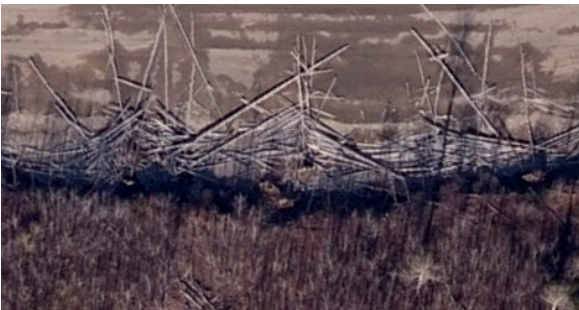
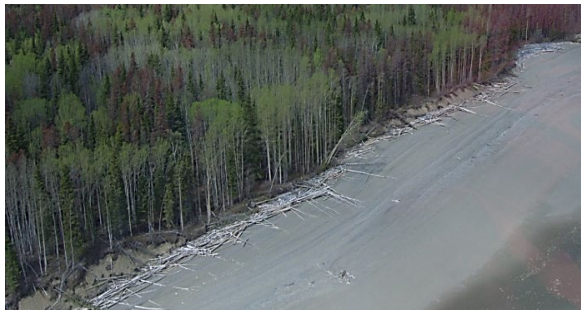
Moderately dense woody ribbons on beach (B2)

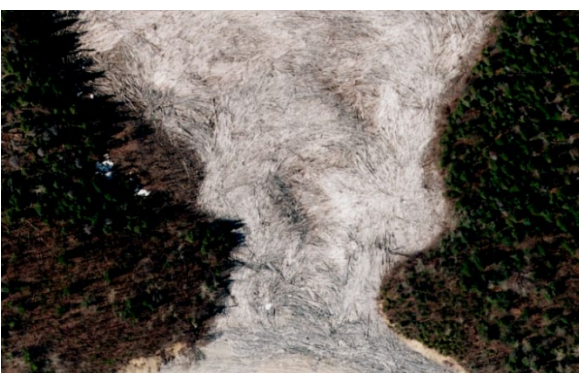
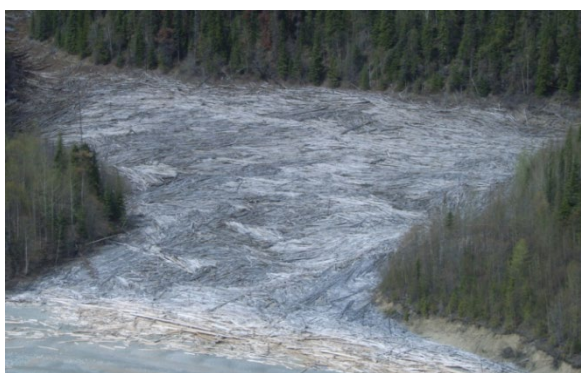
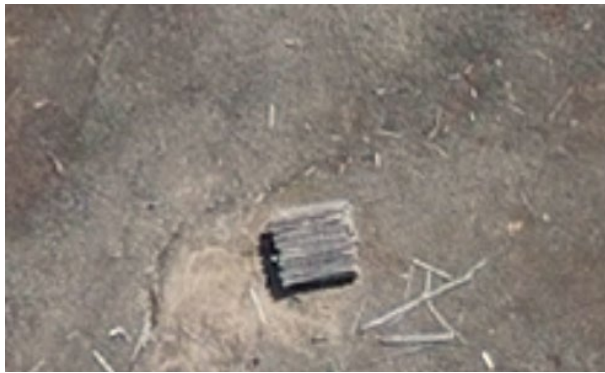
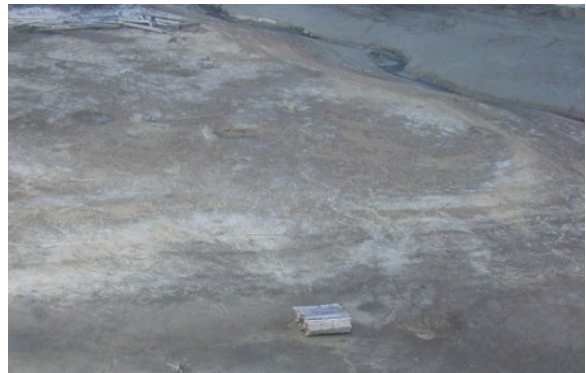
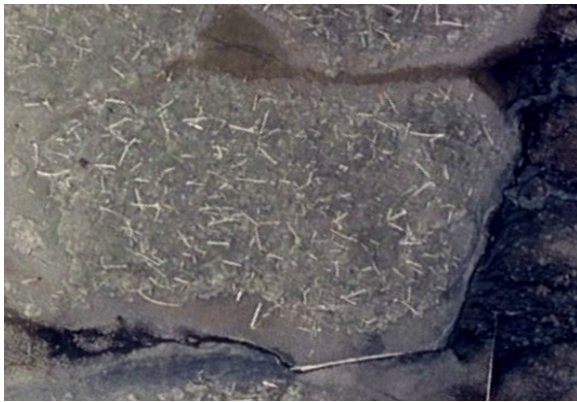
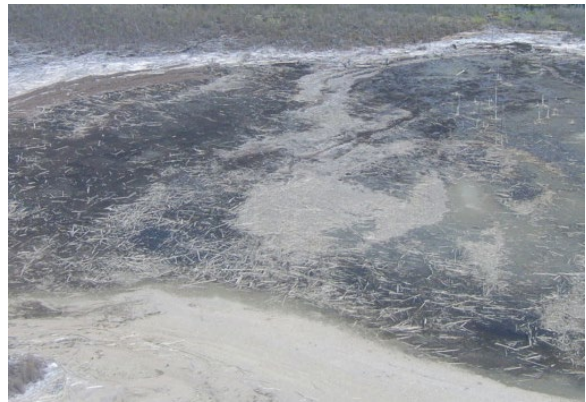
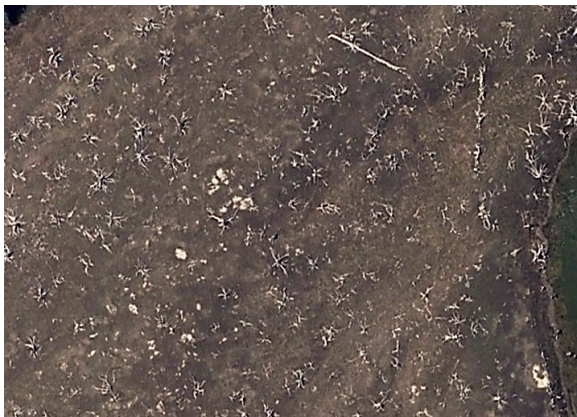
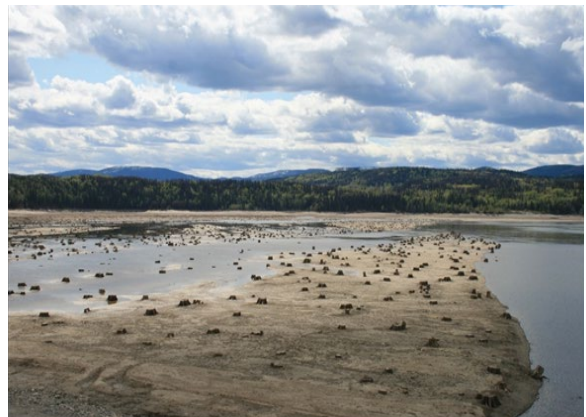
Dense woody ribbons or piles on beach (B3)

Wood bundle on beach (BB)

Scattered woody debris on flats (BF)

Stumps on beach or drawdown area (BS)

Figure A-1 **Examples of the Various Classes of Woody Debris on Beach or Flats**

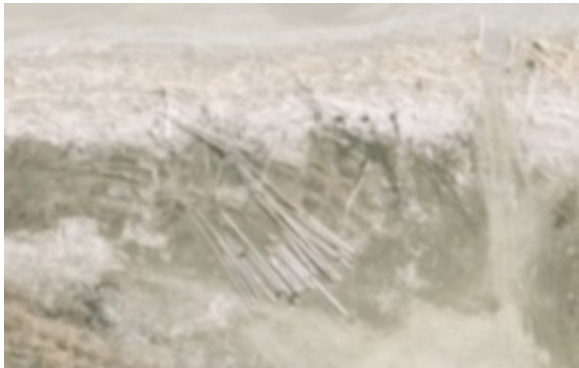
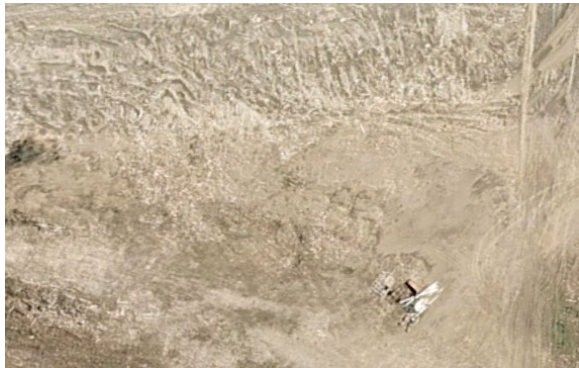
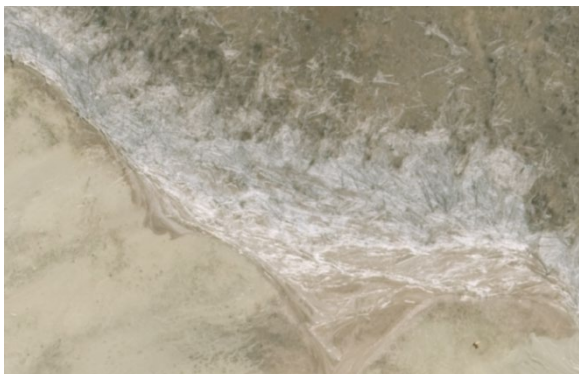
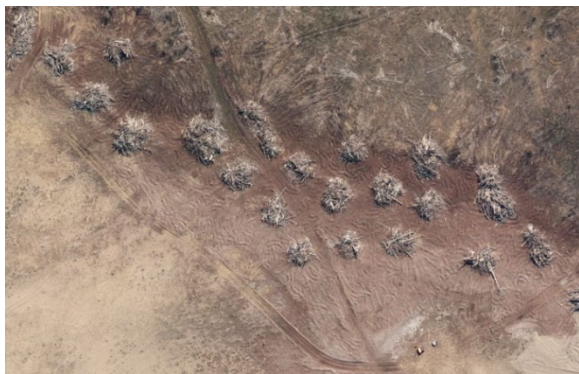
<p data-bbox="289 1184 704 1213"><i>Woody debris before removal activities</i></p>

<p data-bbox="932 1184 1321 1213"><i>Same area during removal activities</i></p>

Figure A-2 Examples of the Classes used for Areas where Wood Logs are Being Removed

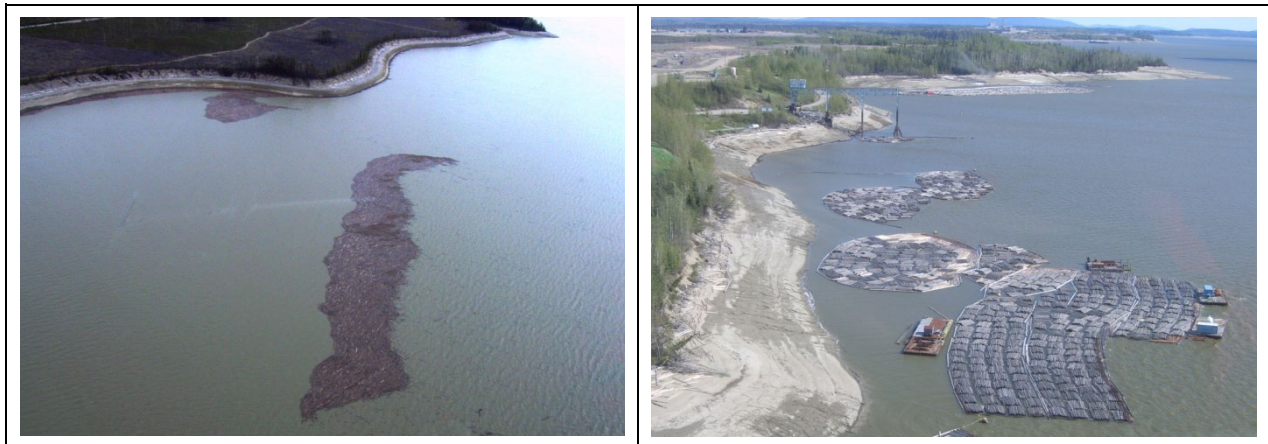
Figure A-3 Large floating debris (F3) and log booms (FO) managed during the cleaning program

Floating debris is found over the main waterbody, typically in the form of large patches of wood. However, most of it has been regrouped in log booms and recovered during the cleaning activities (Figure A-3). As a result, little floating debris was observed on the reservoir during the baseline study.
