Peace Project Water Use Plan

WILLISTON RESERVOIR WOOD DEBRIS TREND ANALYSIS

**By:
AECOM**

Williston Reservoir Wood Debris Trend Analysis 2009 – 2018

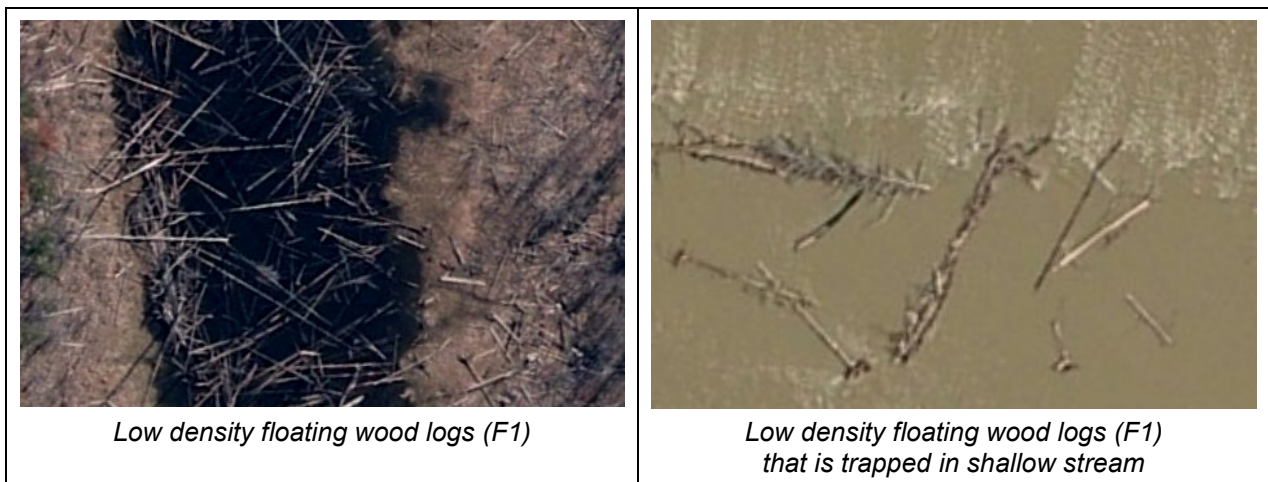
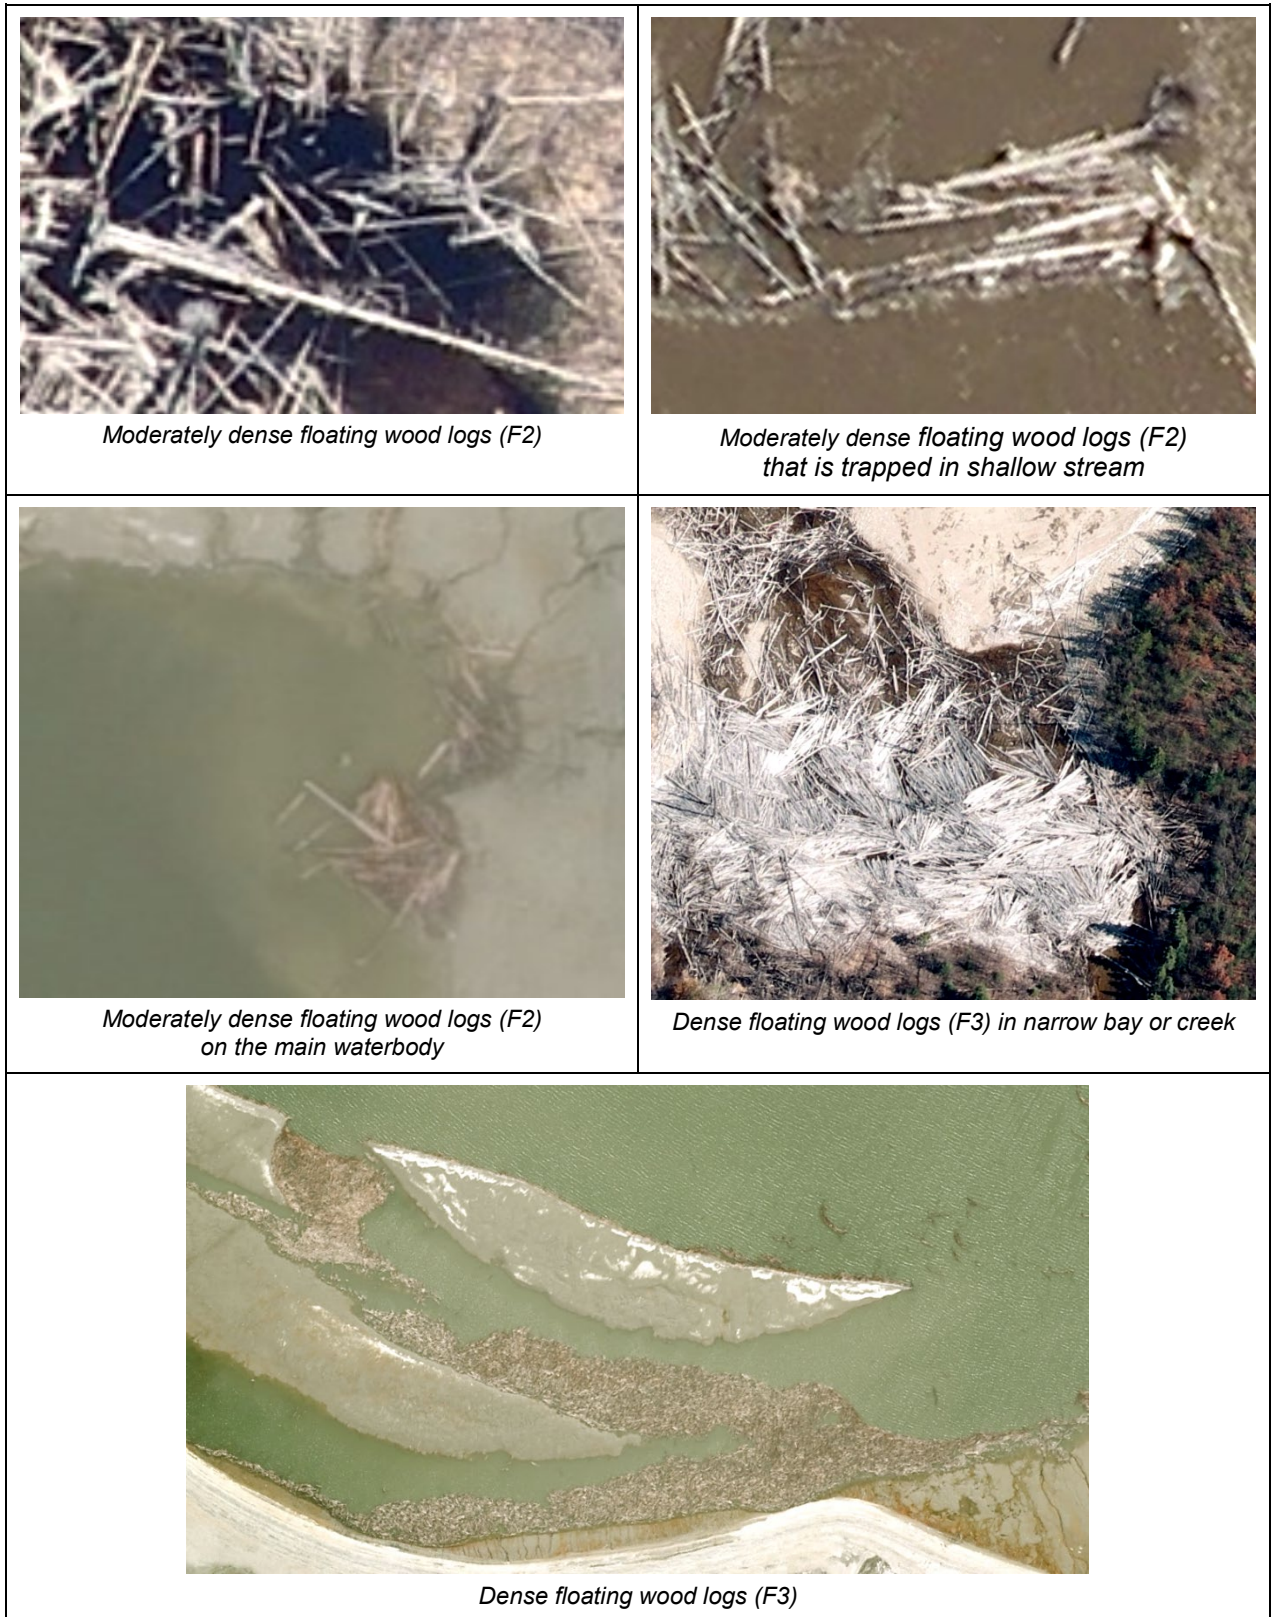
*Low density floating wood logs (F1)
that is trapped in shallow stream*

Figure A-4 **Examples of the Various Classes of Floating Woody Debris**

The next figures depict the various types of floating woody debris that were identified on the mosaics of 2009 and 2011 for the assessment of their sources and quantity, and for the trend analysis (Figure A-4).

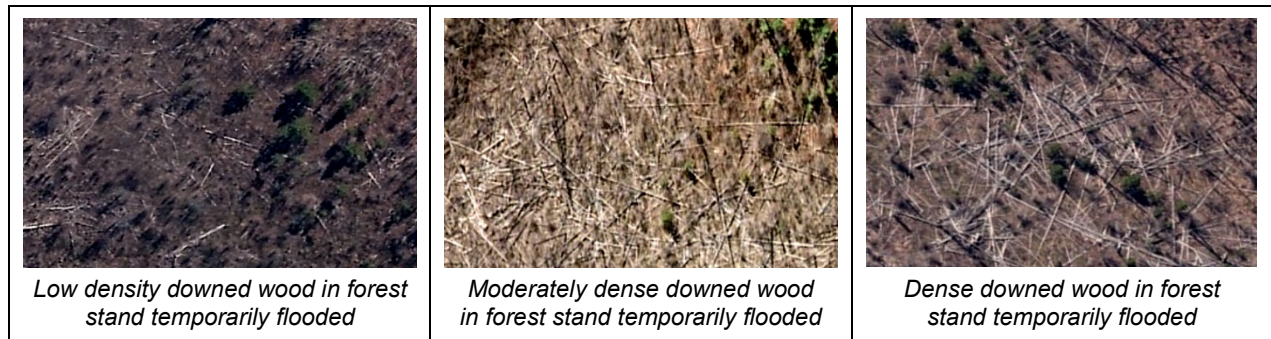
Figure A-5 **Examples of the Various Classes of Downed Wood in Forest Stands Temporarily Flooded**

The forested areas have been delineated and characterized in accordance with the density of their standing trees (SL, SM and SD) and, when existing, in accordance with the density of large woody debris on ground (S1, S2 and S3) (Table A-1 and Figure A-5 and Figure A-5). Realignment of logs by wave action to form discontinuous ribbons is observed in areas containing downed wood, mainly for the denser class (S3).
