Peace Project Water Use Plan

WILLISTON TARGETED DEBRIS MANAGEMENT

Implementation Year 10

GMSWORKS#22 – FINAL REPORT
2018

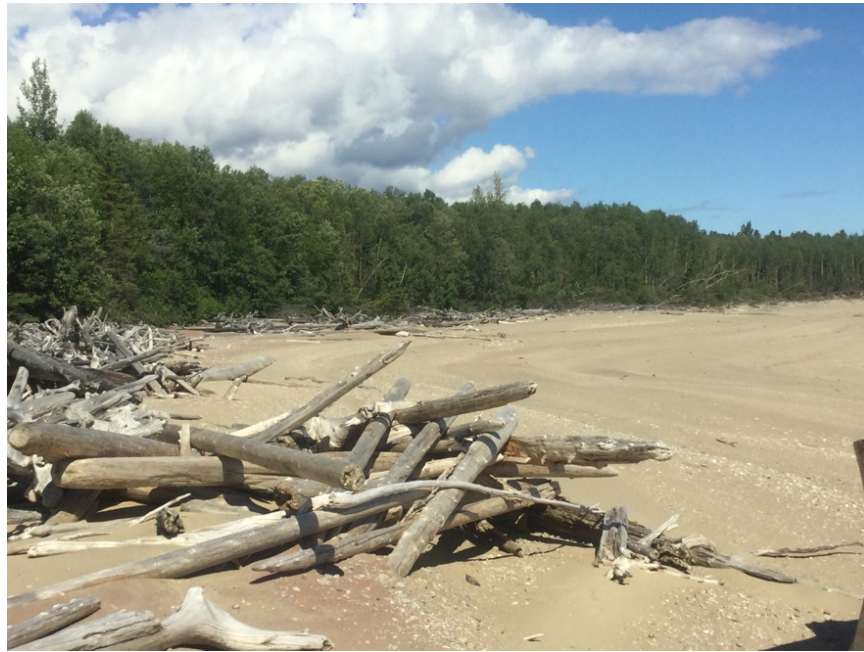
Figure 1: Collins Beach South prior to debris management.

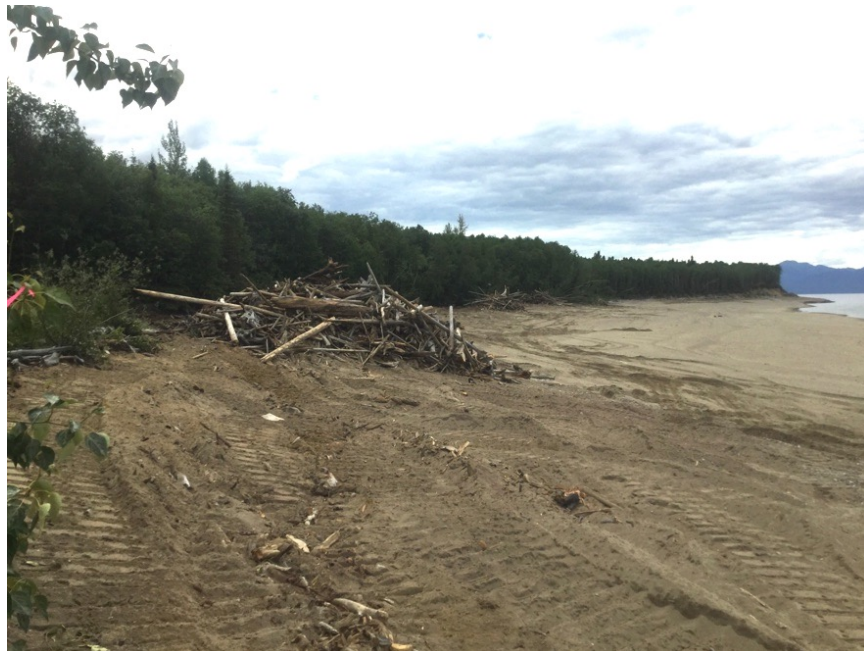
Figure 2: Collins Beach South after debris management.

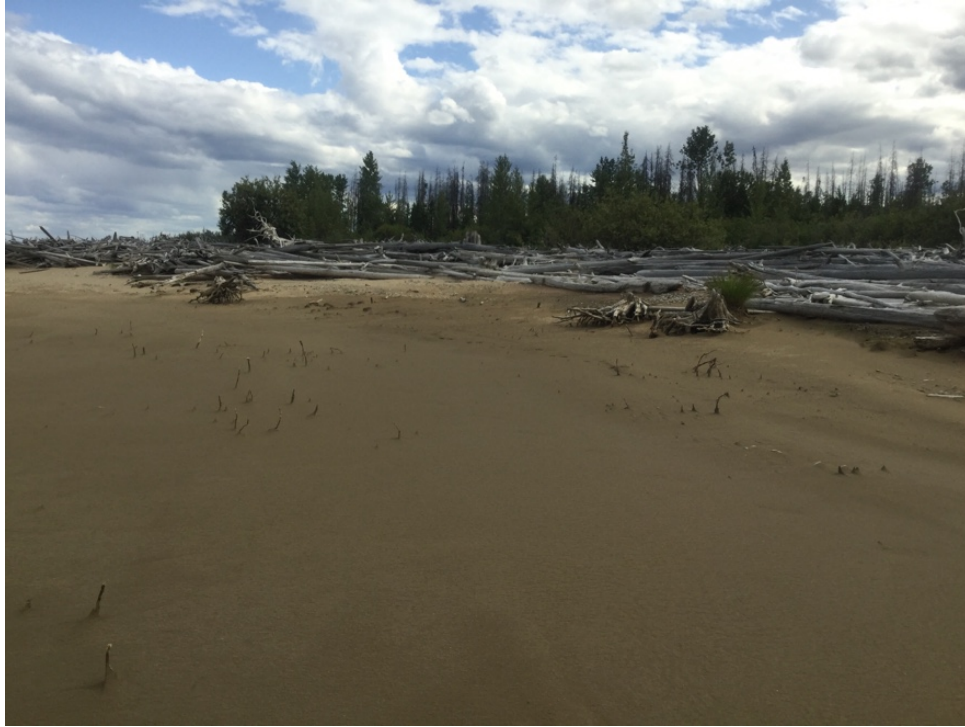
Figure 3: Ole Creek beach before debris management.

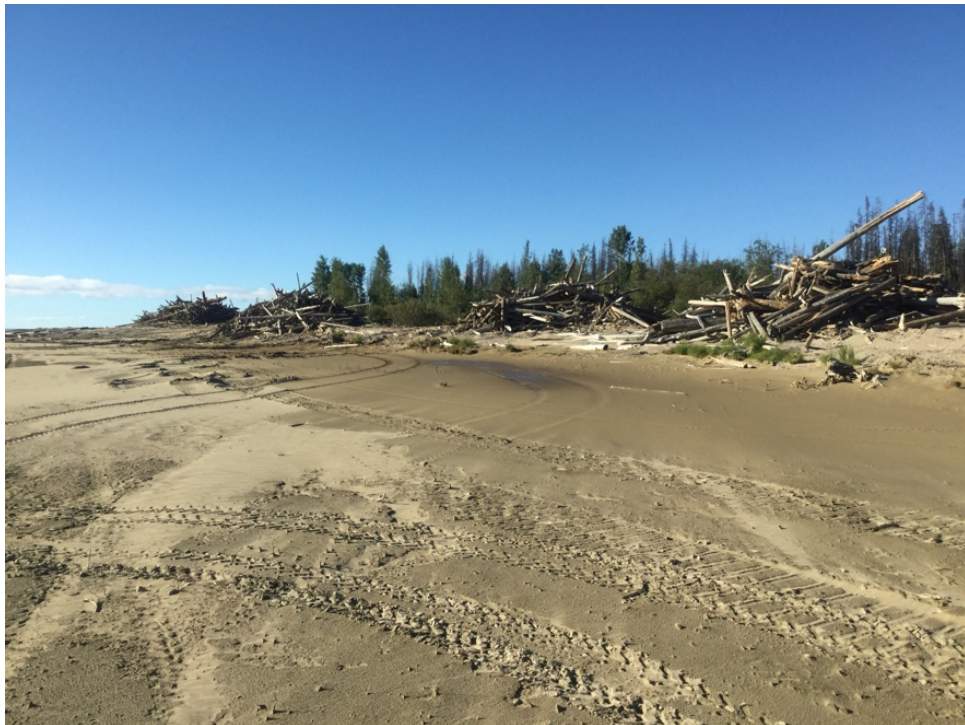
Figure 4: Ole Creek beach after debris management.

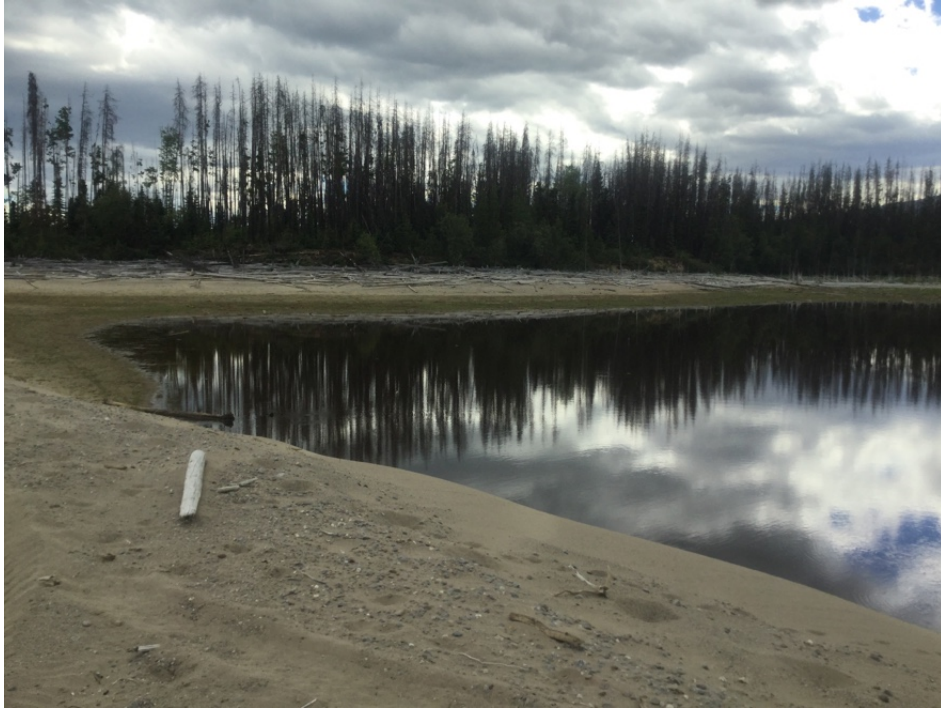
Figure 5: Stromquist before debris management.

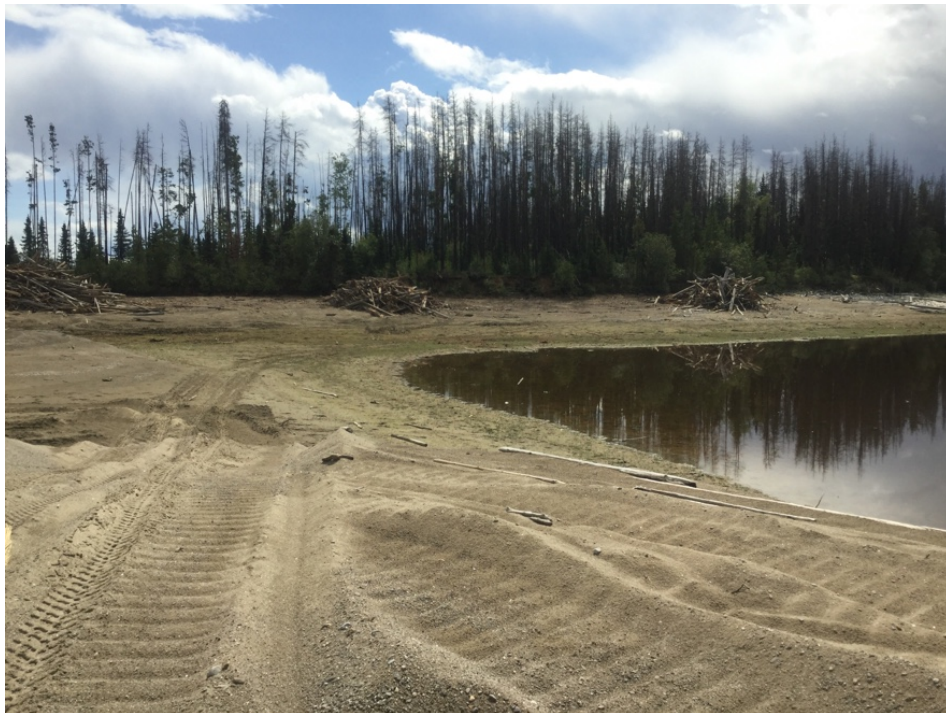
Figure 6: Stromquist after debris management.

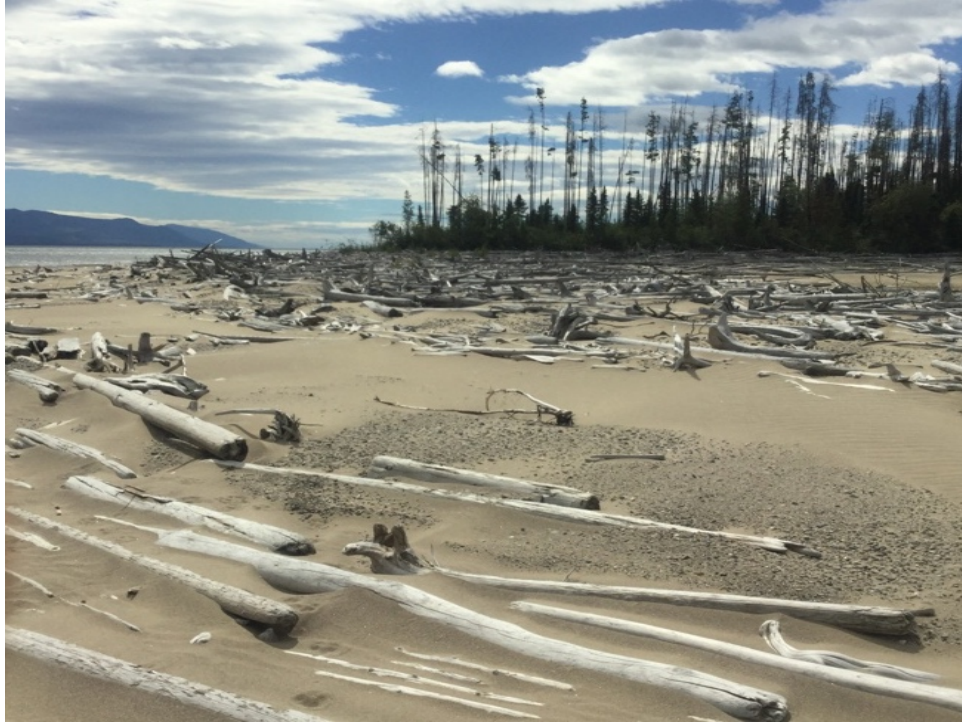
Figure 7: Corless A before debris management.

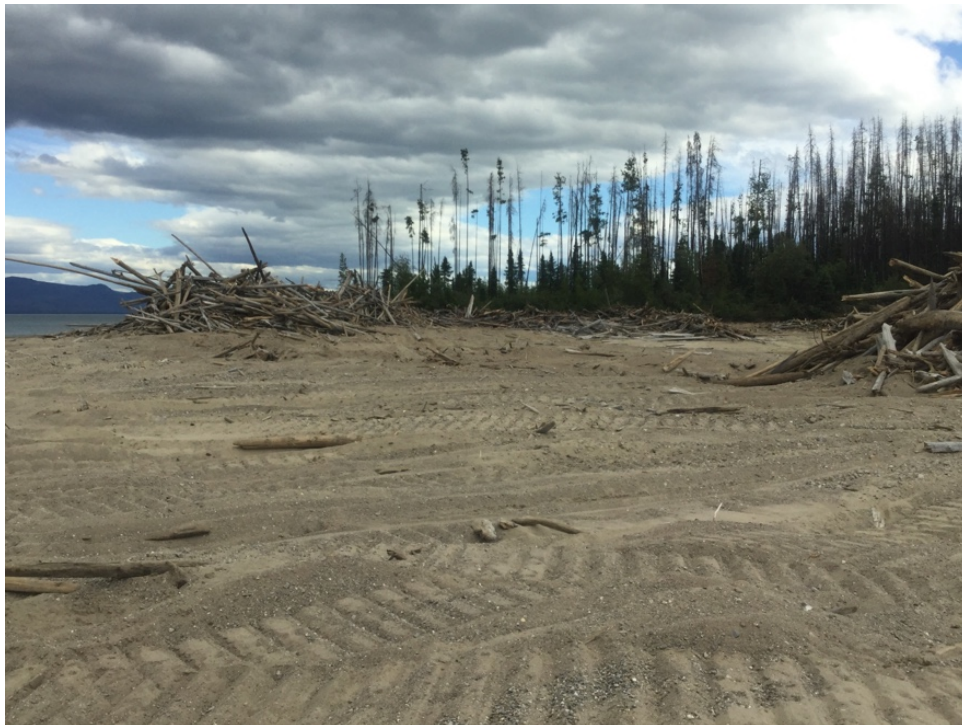
Figure 8: Corless A after debris management.

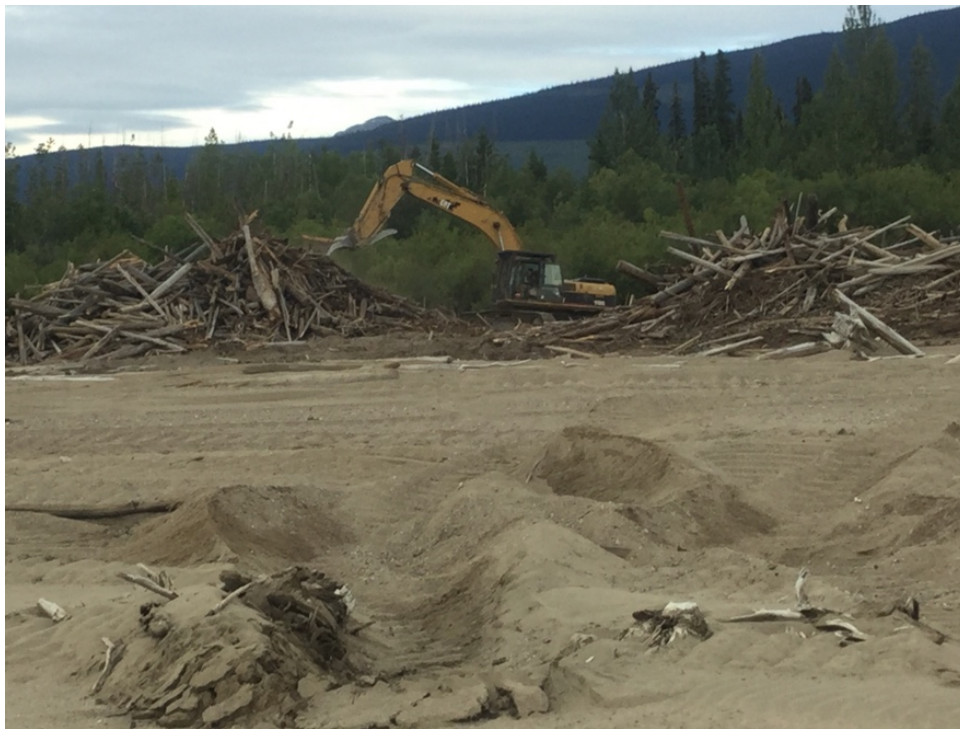
The following series of images shows an overview of work locations for typical beaches within the Finlay Arm of the reservoir. Figure 9 shows an excavator piling debris on Corless A. Figure 10 shows the barge heading into Ole Creek to pick up equipment.

Figure 9: Excavator working on Corless A.

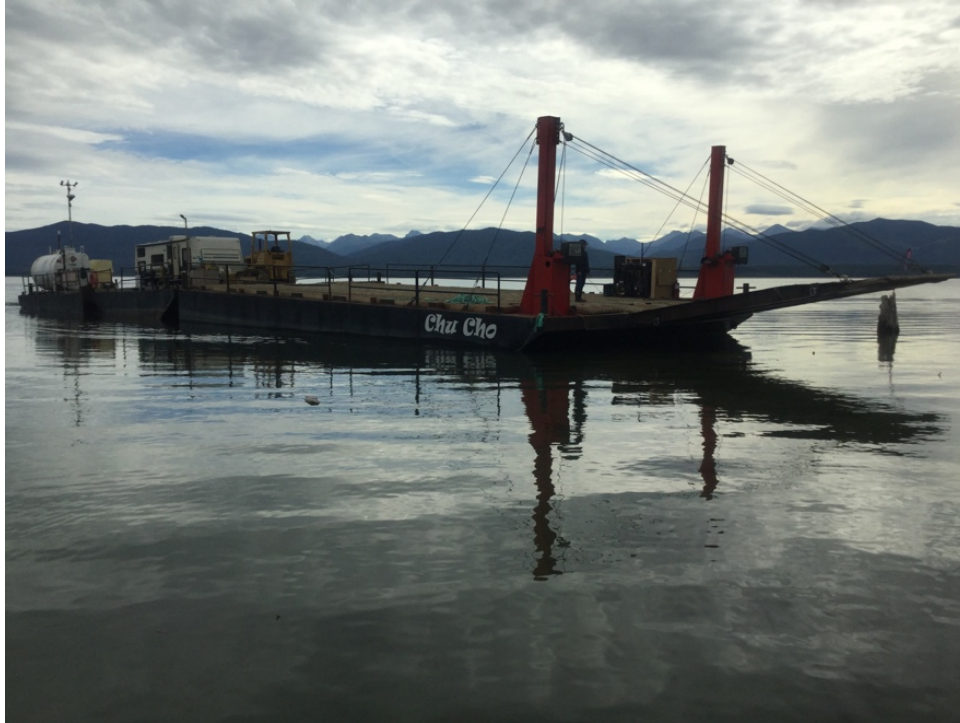
Figure 10: Barge travelling towards Ole Creek.

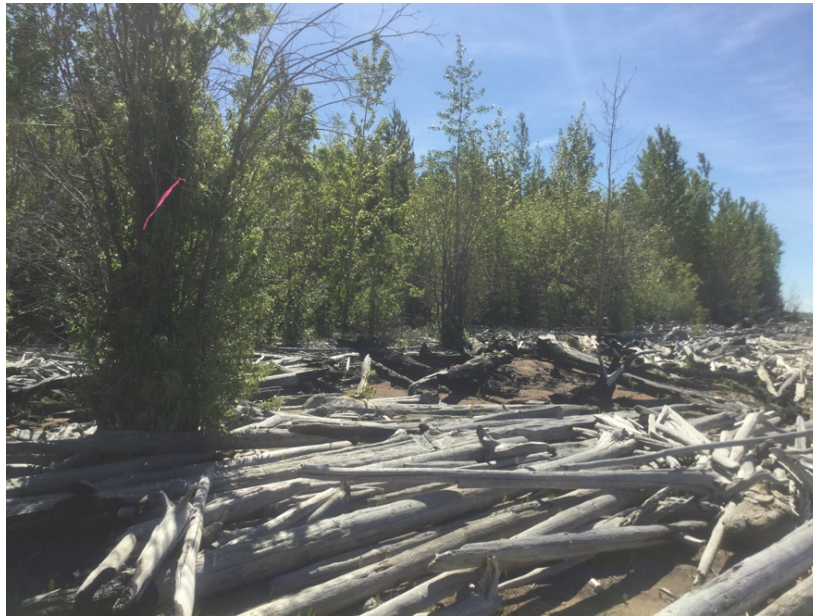
The amphibian management plan is based on avoidance through surveying and flagging no work zones. The avoidance based plan is meant to reduce the potential harm to amphibians and to avoid all handling. Prior to conducting debris removal, each beach is surveyed for amphibians and reptiles. On a typical beach there may be 5 – 10 zones where amphibians are either found or where there is good amphibian habitat. There were amphibians found on all beaches in 2018 but due to the dry conditions their prevalence was reduced relative to 2017. Where they are found, a 30m no work zone is flagged in order to protect the amphibians and or reptiles. In addition to amphibians, other reptiles and wildlife are observed regularly. These include, garter snakes, grizzly bears, black bears, moose, elk, wolves and other small carnivores. Figure 11 shows an example of a zone flagged for no-work where an amphibian was discovered.

Figure 11: Pink flagging indicates discovery of an amphibian and marks a no-work zone.

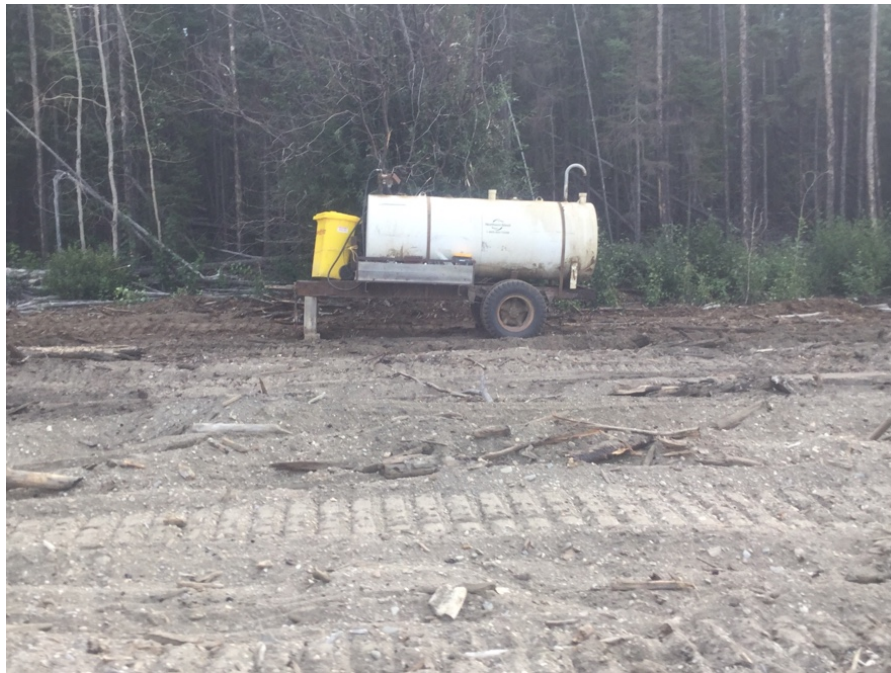
Figure 12: Fuel bowser with large spill kit.

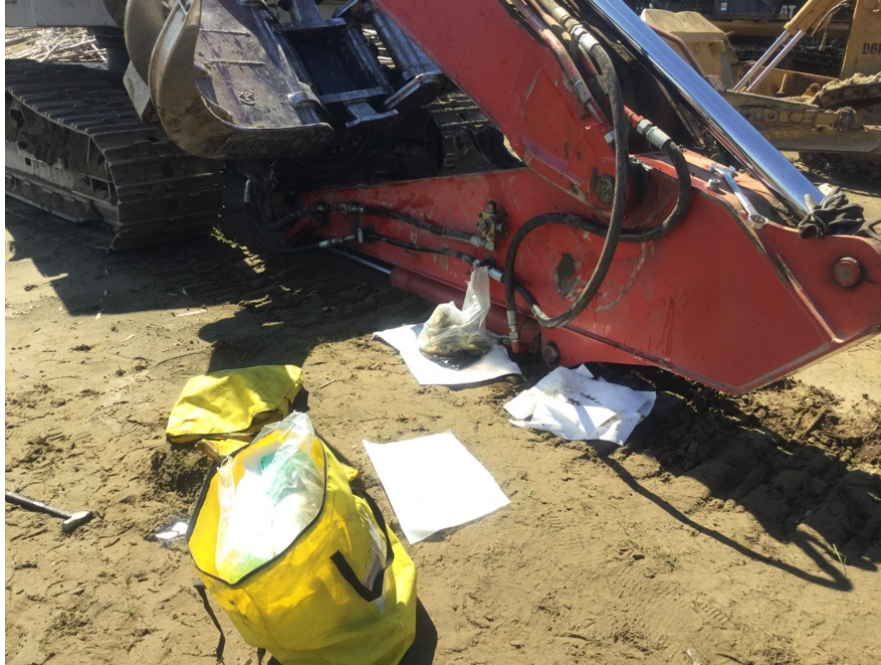
Spill prevention and management is an ongoing process that CCI takes seriously and goes to great lengths to ensure that there are zero spills to ground. Good spill prevention management is rooted in good equipment management through maintenance and regular checks. All equipment is inspected before, during and after each shift to ensure that hydraulic lines and other potential leak points are all secure. The vehicle inspections are completed using a standard form, which is stored in the field office for the program. Regular maintenance occurs before during and after each crew shift. The following sequence of images shows some examples of good spill prevention management. During the 2018 season there were no major fluid spills and 8 small non-reportable spills to ground that were cleaned up by CCI. There were no spills to watercourses or the reservoir. Figure 12 shows the fuel bowser located along the shore away from the reservoir an outfitted with a large spill kit for use while refueling as well as repairs. Figures 13 and 14 show the spill kits being used during field based repairs of the equipment.

Figure 13: Repair of hydraulic line with attention to spill potential.

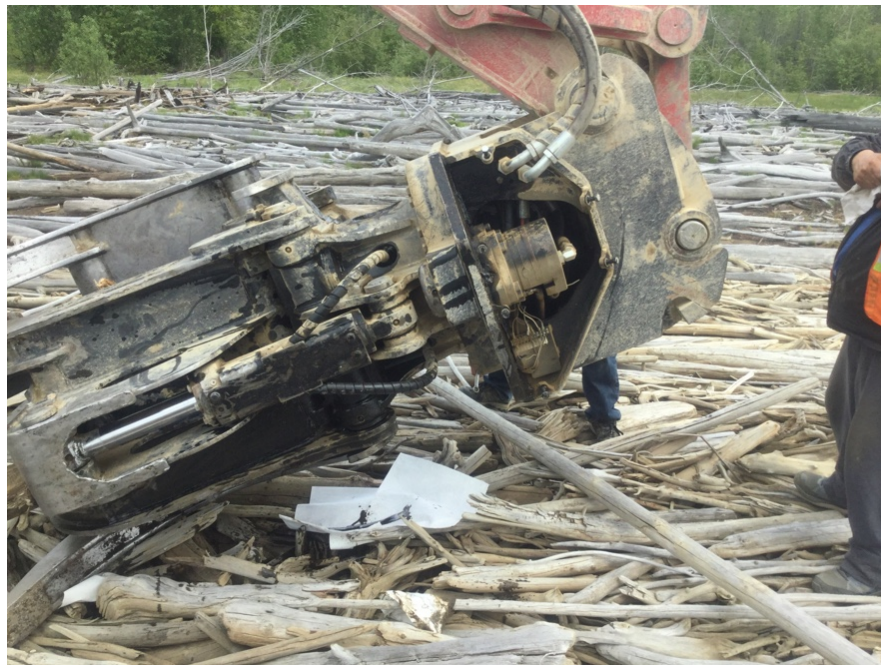
Figure 14: Grapple implement in resting position during repair with spill pads below.

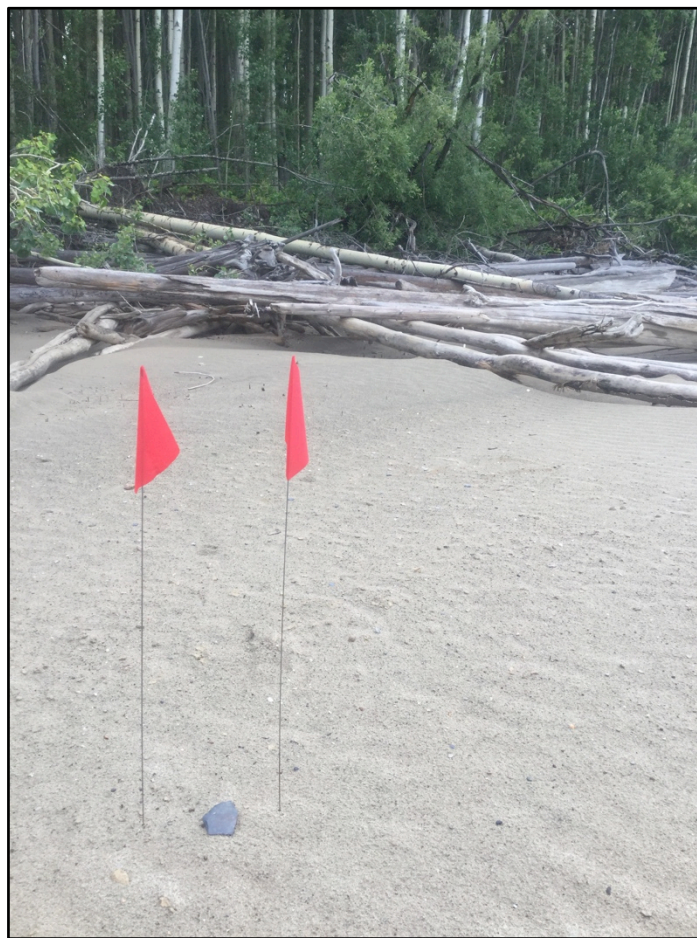
The archaeological monitor uses a GPS loaded with archaeological site data that were supplied by Millennia Archaeology. The GPS helps the monitor identify areas that are marked as no work zones as well as areas where artifact collection has occurred or where artifacts have been identified but not collected. Figure 15 below shows a previously recorded but not collected artifact on Middle Creek North Beach. This artifact was discovered using the GPS and was flagged so that crews would not work in this area.

Figure 15: Previously marked but uncollected artifact on Middle Creek South.

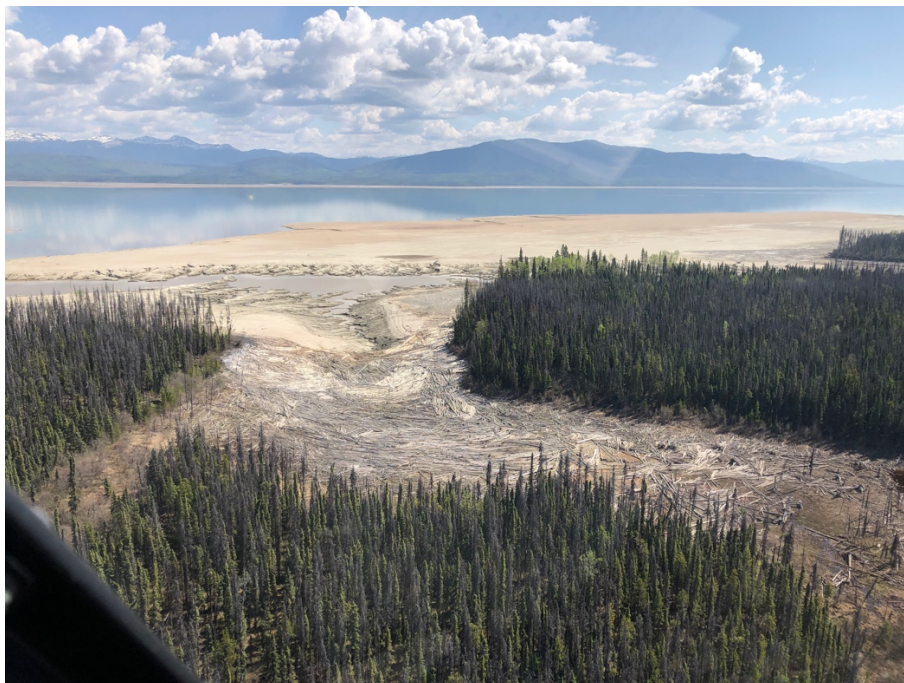
During the reconnaissance flight in May 2018 it was identified that there are still numerous areas where debris accumulations exist in both the Parsnip and Finlay arms of the reservoir. Figures 16 and 17 show two specific locations where there are dense debris accumulations. Figure 18 shows an additional issue that was noted during the reconnaissance flight; that is that piles which were ignited during the winter of 2018 were still smoldering in May 2018. CCI sent crews over to respond to this issue immediately using water pumps to extinguish the smoldering fires.

Figure 16: Significant debris accumulation in Corless B area.

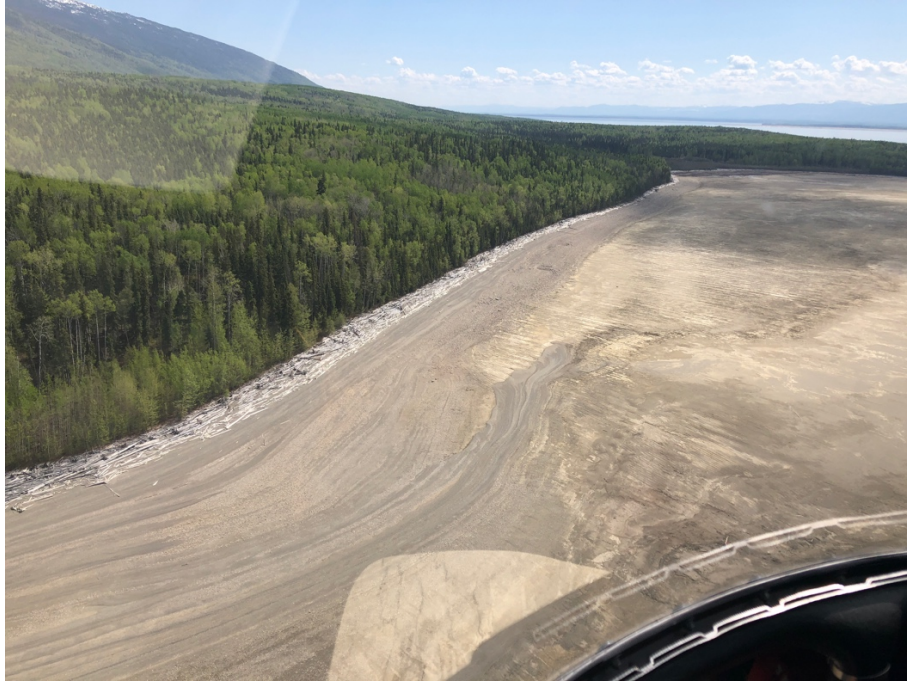
Figure 17: Longshore debris accumulations in the Chowika-Middle Creek North area.

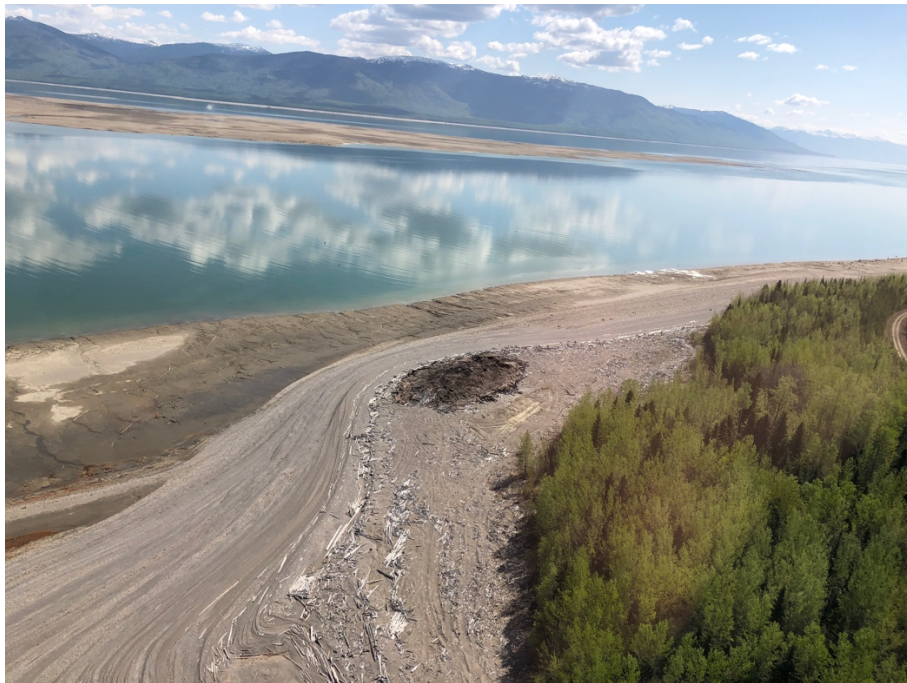
Figure 18: Large pile near Ospika burned in winter 2018 still smoldering in May 2018.
