Falls River Project Water Use Plan

Big Falls Reservoir Sedge Habitat Maintenance Monitoring

Final Year Report

Study Period: 2017

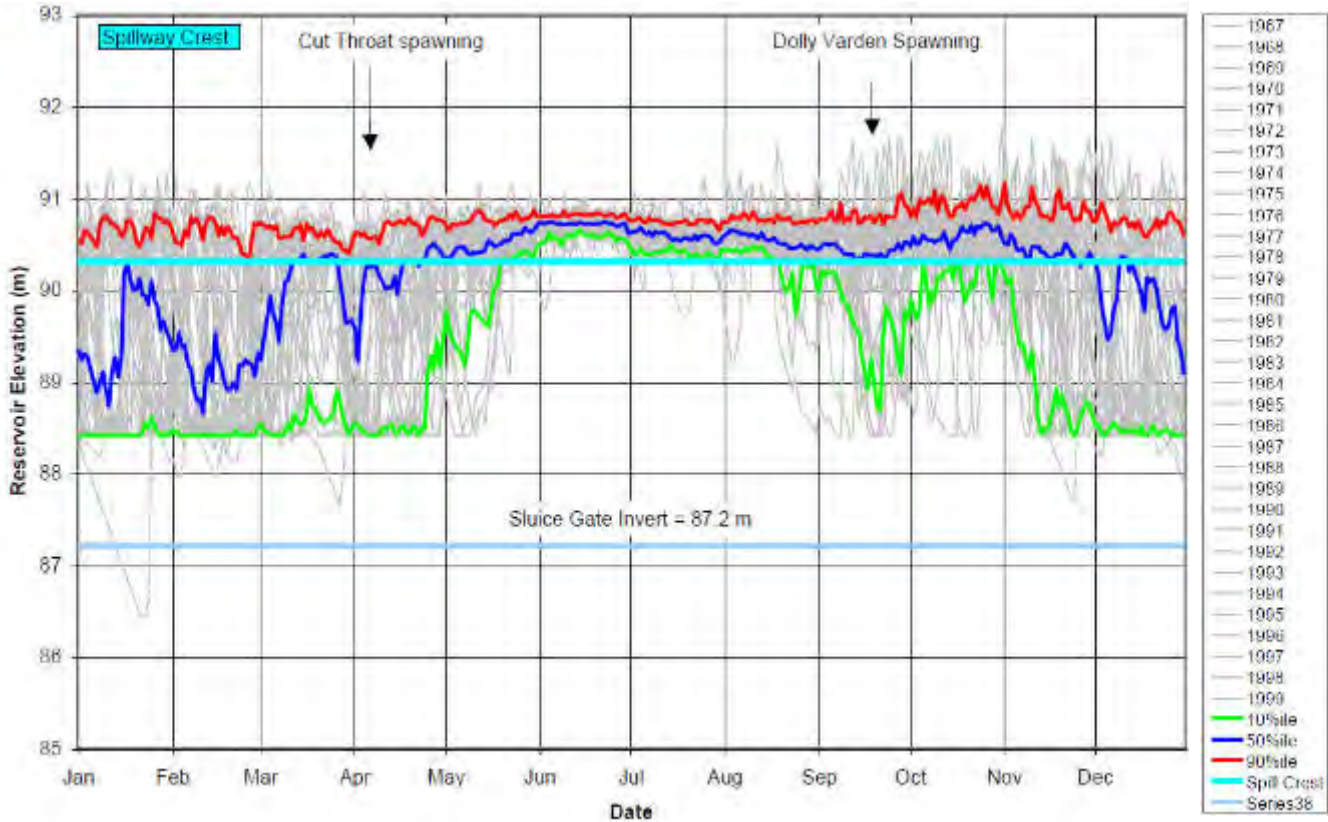
Figure 2. Big Falls Reservoir elevations under the Post-2002 Dam Safety Review Operations Regime based on modelled historic inflows

However, in 2002 a dam safety review of operations at the Big Falls Reservoir identified a safety concern related to the flashboards. The installation period was initially reduced to a short period of time; however, a further examination of the economics of flashboard installation led to a discontinuation of their use from 2002 to early 2007. The spillway crest was at a constant approximate elevation of 90.4 m (Figure 2). In response, the reservoir elevations fluctuated less than the pre-2002 historic operations.

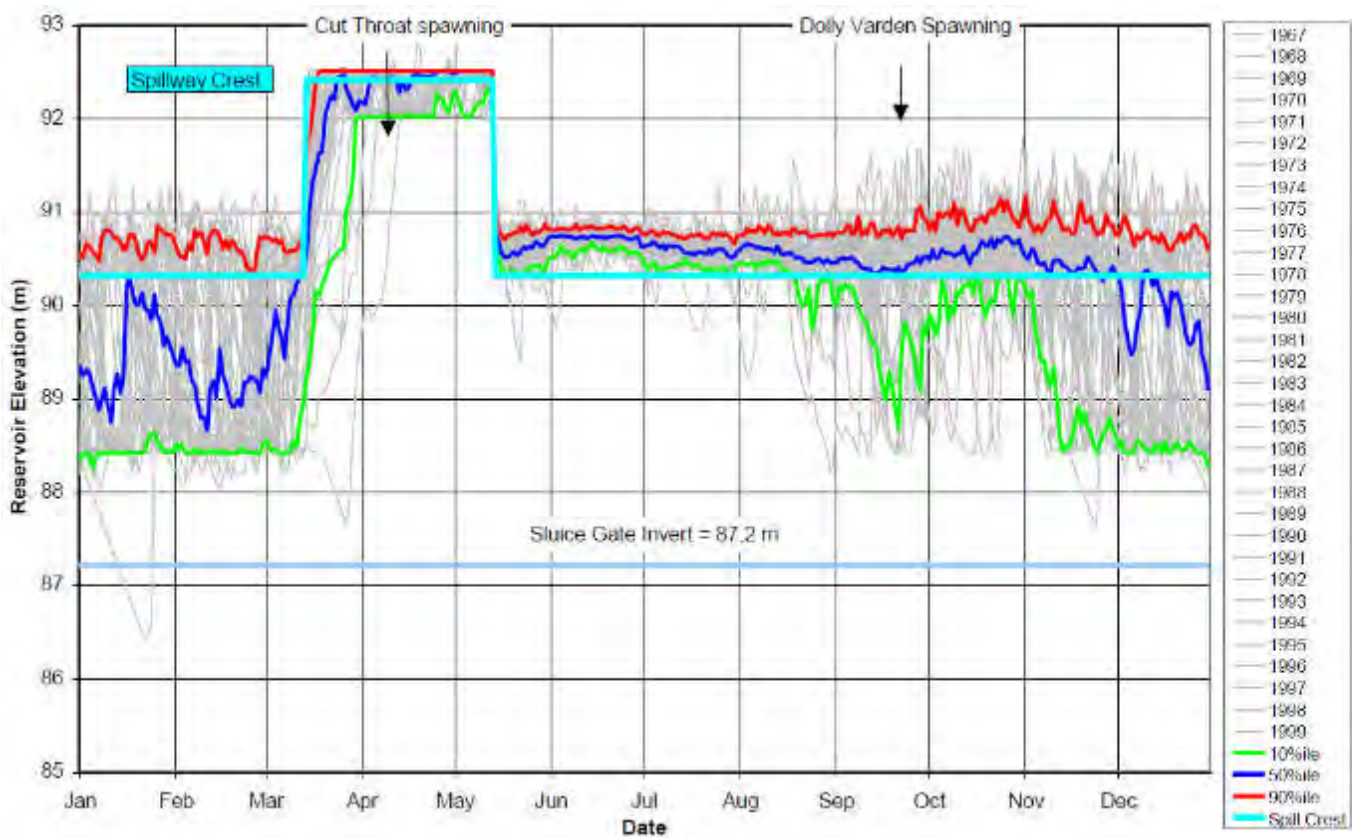
Figure 3. Big Falls Reservoir elevations under the Mid-2006 to 2006 WUP operations regime based on modelled historic inflows

The flashboards were installed during a short period of time in early 2007 (Figure 3). However, mechanical issues were encountered while the flashboards were installed. A dam safety review of the use of flashboards concluded that their use was unsafe and they were discontinued indefinitely post-2007. Consequently, the reservoir operations recommended by the CC were not possible to implement.

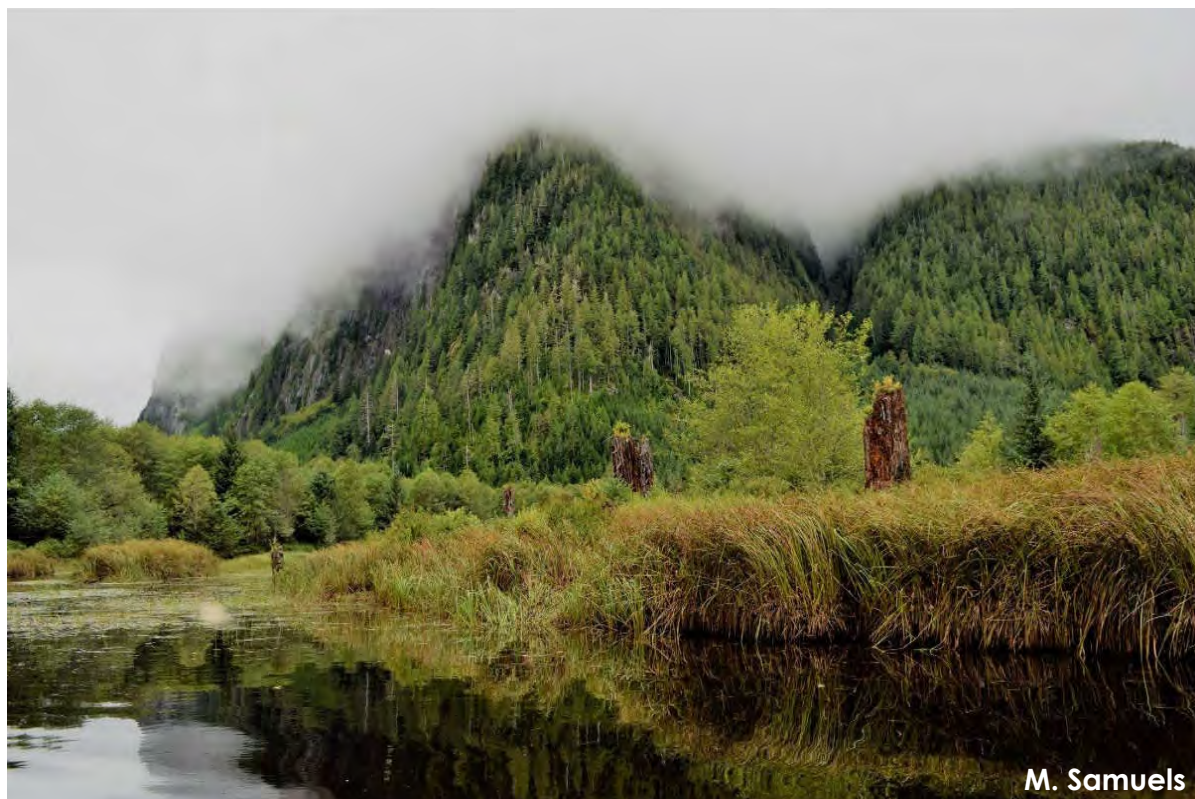
Figure 8. Steep mountainous slope of the Big Falls Reservoir (2017)

Most of the Big Falls Reservoir contains steep, mountainous slopes (Figure 8). However, the Study Area is located within the eastern portion of the Big Falls Reservoir which is gently sloped, containing mostly marsh and low-lying shrub habitat. The Study Area is located on the fluvial fan that has developed at the inflow of Hayward, Big Falls, and Carthew Creek into the reservoir. The sedge habitat that developed in this region is located within a thin elevation band of approximately 1.5 to 2.0 m (Cambria Gordon Ltd., 2007) throughout the Study Area.

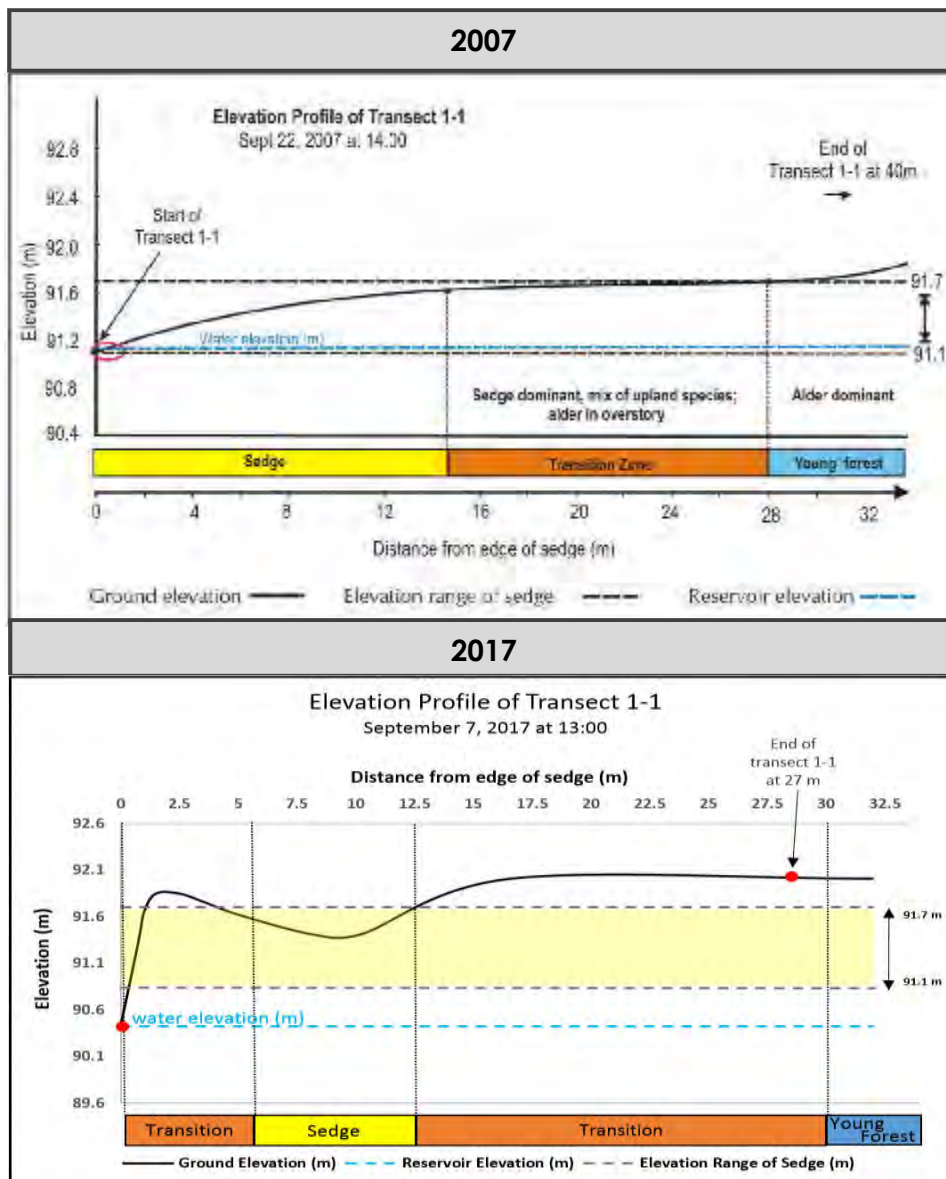
Figure 9. Comparison of Transect 1-1 2007 and 2017 cross-sectional profiles

In 2017, Transect 1-1 started at the water's edge and from 0 to 6 m went through a transition zone of grasses intermixed with shrub species (Figure 10). After the transition zone, the transect ran through a small sedge community and then transitioned into a young forest community. The elevation range of the sedge community was between 91.1 m and 91.7 m. The reservoir elevation at the time of the transect survey was 90.42 m (Figure 9).

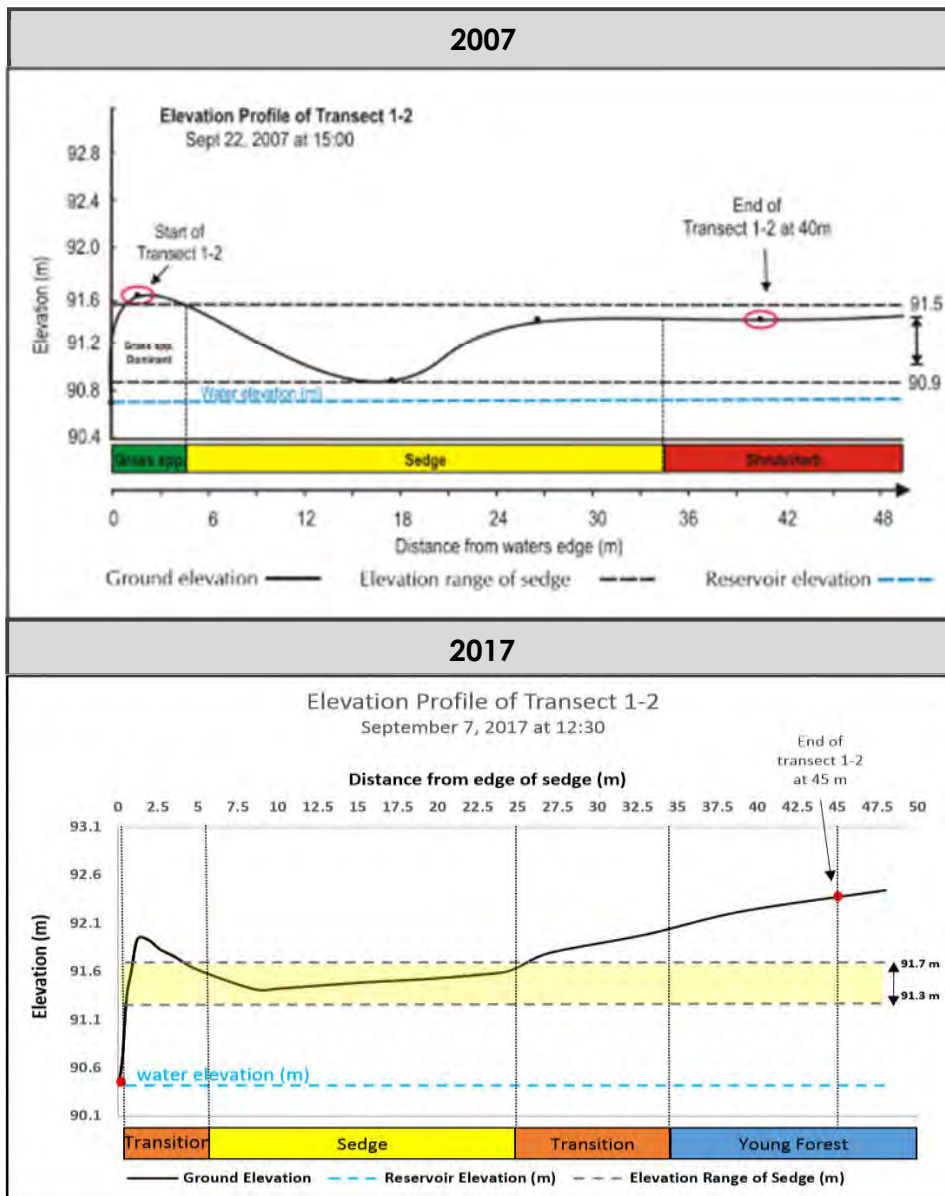
Figure 11. Comparison of Transect 1-2 2007 and 2017 cross-sectional profiles

In 2007, Transect 1-2 started in a small grass band, passed through a sedge community, and ended at a shrub/herb dominated polygon. The elevation range of sedge habitat was between 90.9 m and 91.5 m. The reservoir elevation was approximately 90.7 m (Figure 11).

In 2017, Transect 1-2 started at the water's edge and from 0 to 5 m went through a transition zone of grass species intermixed with a spiraea dominated shrub community. Then the transect went through a sedge meadow and transitioned into a young forest community. The elevation range of the sedge community was 91.3 to 91.7 m. The reservoir elevation at the time of the survey was 90.42 m (Figure 11).

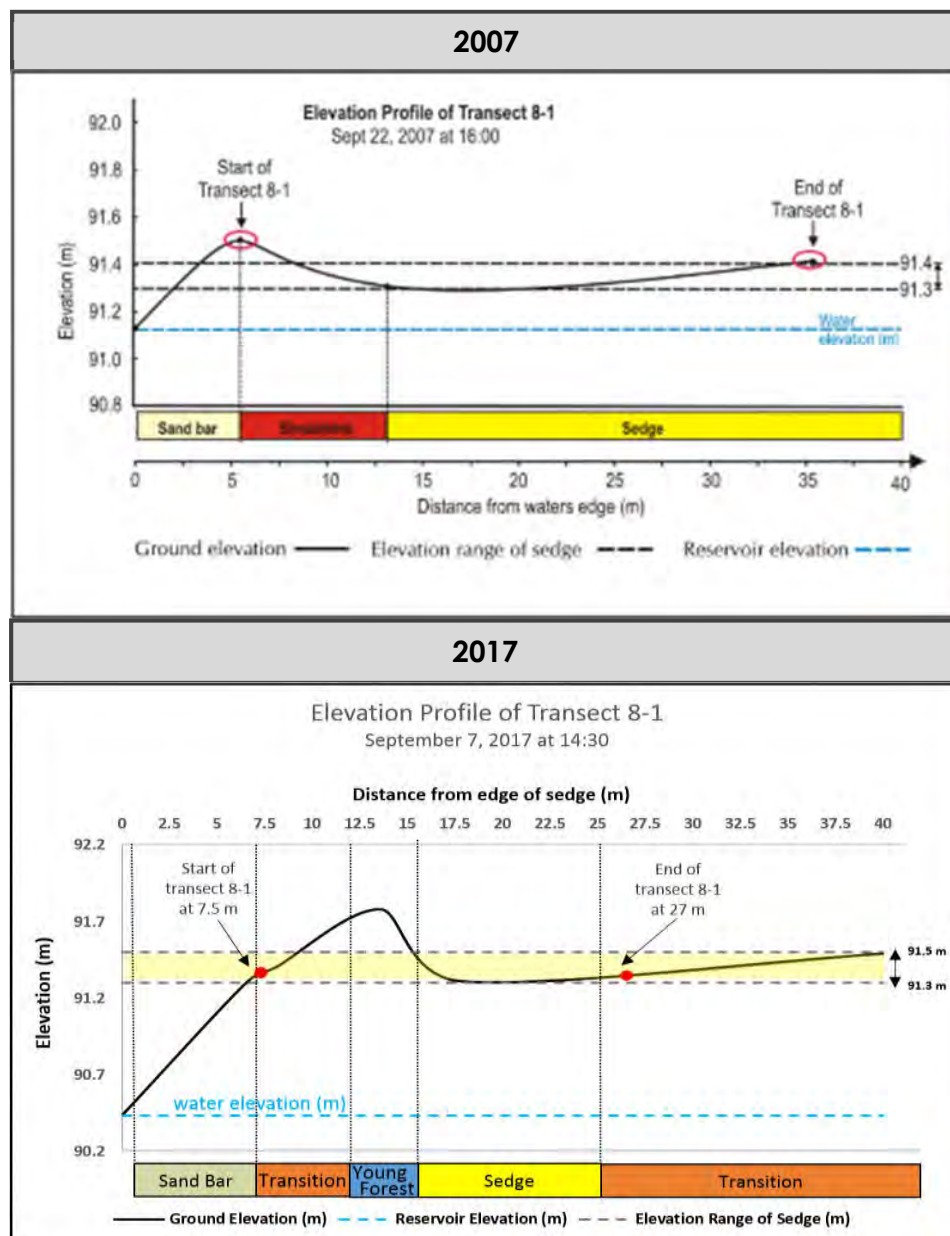
Figure 12. Comparison of Transect 8-1 2007 and 2017 cross-sectional profiles

In 2007, Transect 8-1 started after the sand bar, went through a shrub/herb community, and finally through a large sedge community. The elevation range of the sedge community was between 91.3 m and 91.4 m. The reservoir elevation was approximately 91.15 m (Figure 12).

The 2017 survey started after the sand bar, went through a transition into an alder dominated young forest, through a sedge meadow, and ended in a transition area of spiraea intermixed with sedges. The elevation range of the sedge community was between 91.3 m and 91.5 m. The reservoir elevation was 90.43 m (Figure 12).

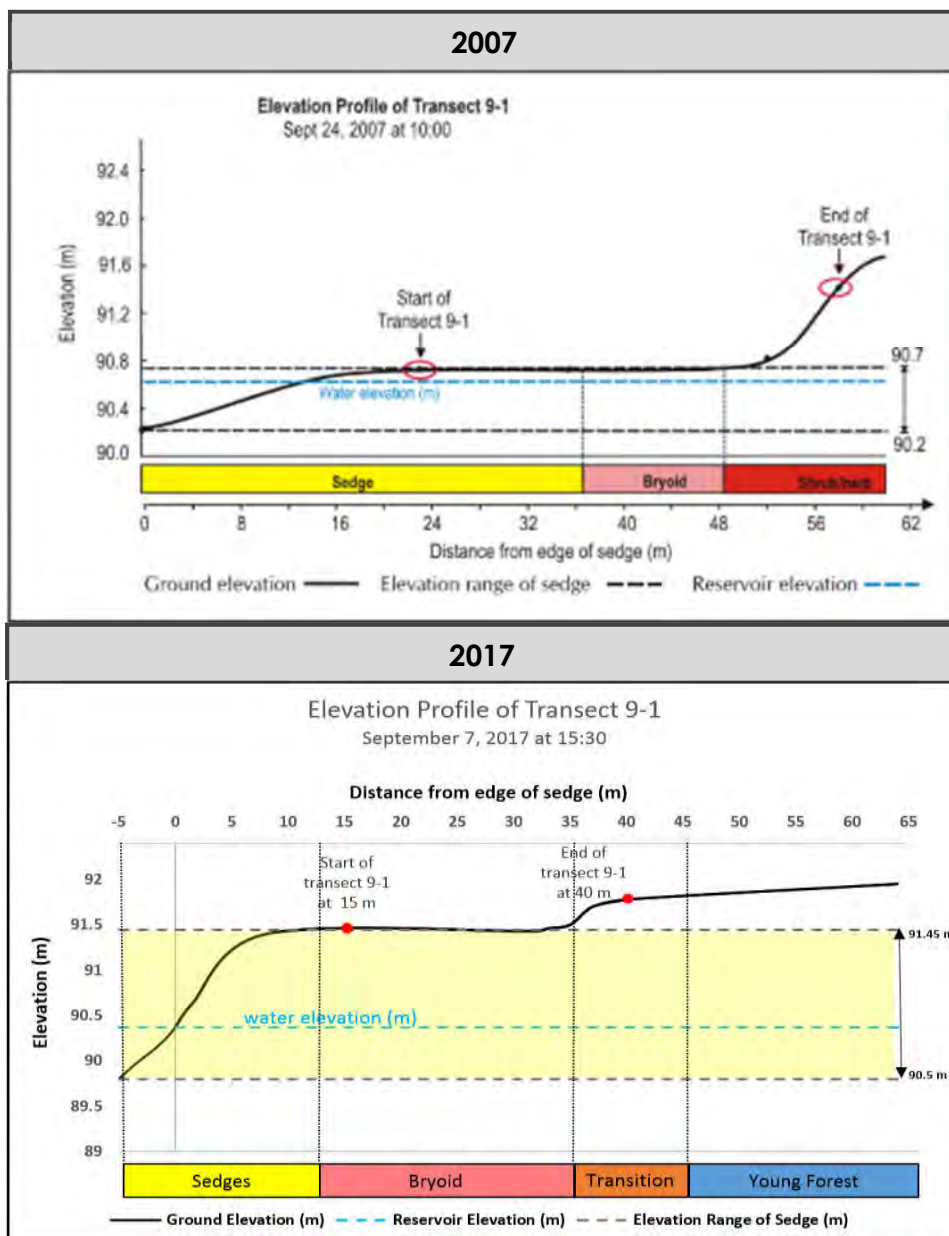
Figure 13. Comparison of Transect 9-1 2007 and 2017 cross-sectional profiles

In 2007, Transect 9-1 started in a sedge dominated community, went through a bryoid community, and finally ended in a shrub/herb community. The elevation range of the sedges was between 90.2 m and 90.7 m. The reservoir elevation was approximately 90.7 m (Figure 13).

In 2017, Transect 9-1 started at the start of the sedges (i.e., 5 m within the reservoir from the shoreline), went through a sedge band and bryoid community, and then ended at the start of a young forest community. The elevation range of the sedge community was between 89.8 and 91.45 m. The reservoir elevation survey was 90.37 m (Figure 13).

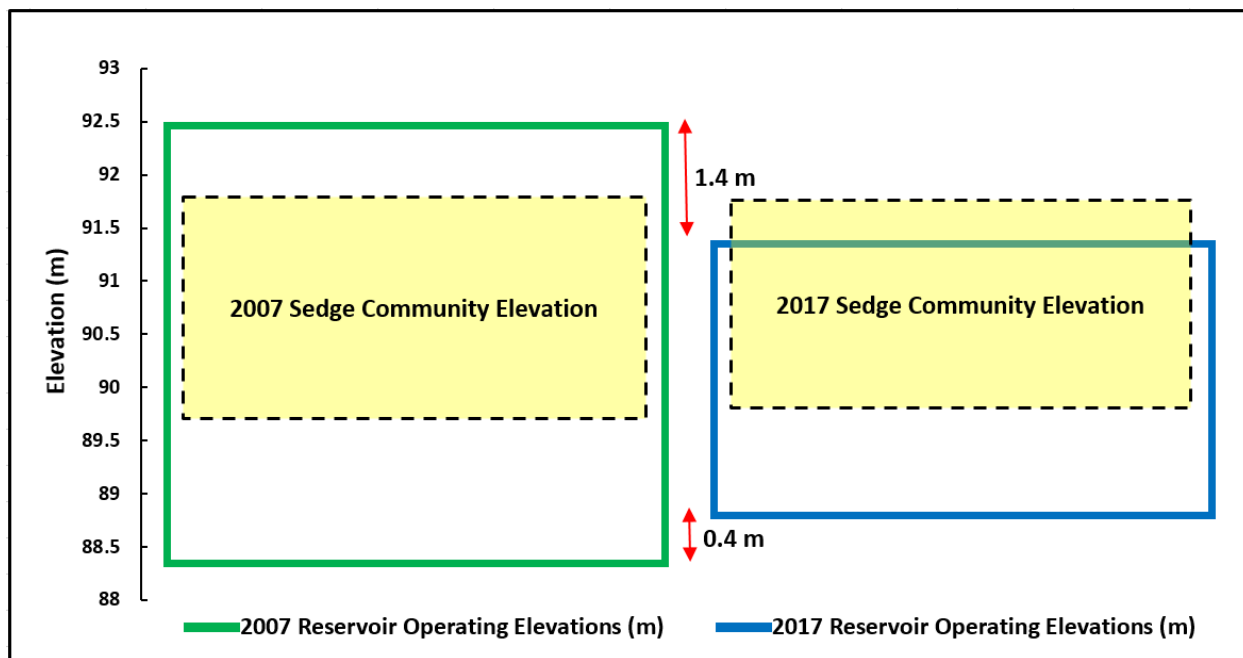
Figure 15. 2007 and 2017 reservoir operating elevations and sedge community elevations

The actual average operating regime from 2006 to 2017 was between 88.9 m and 91.0 m (BC Hydro, 2016). The use of flashboards was discontinued in 2007 resulting in a constant weir crest height (i.e., spillway crest height) of 90.3 m. The sedge community that was ground-truthed in 2017 occurred in an elevation band of 89.8 m and 91.7 m (Table 6).

Reservoir operations between 2007 and 2017 decreased the average maximum reservoir water level by 1.4 m and the average minimum reservoir water level by 0.4 m. In 2017, the sedge community upper limit was consistent with 2007; however, the lower limit had contracted by 0.1 m to 89.8 m.

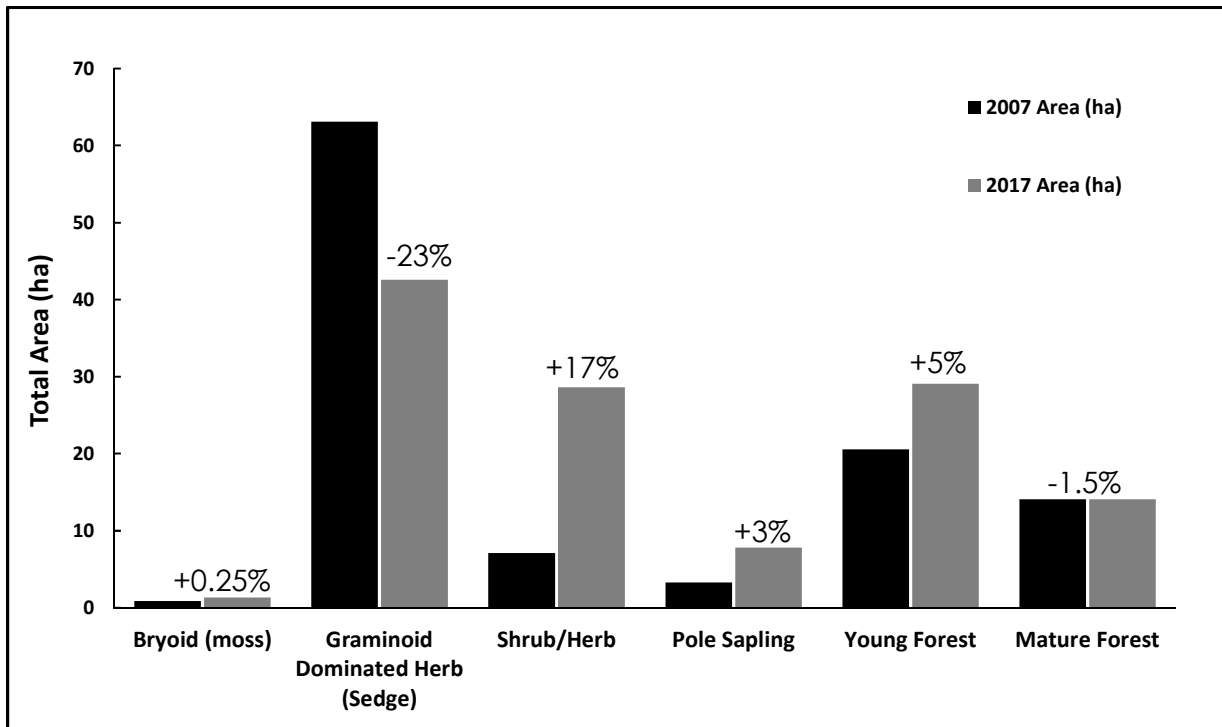
Figure 16. 2007 and 2017 total vegetation community polygon areas (ha)

Excluding the mature forest community, all other vegetation communities increased in size (i.e., mature forest decreased by 1.5% from 2007 to 2017) (Figure 16). The largest increases were in the shrub/herb and young forest polygons (i.e., increased 17 and 5% respectively). Less than a 1% change was observed in the bryoid community.

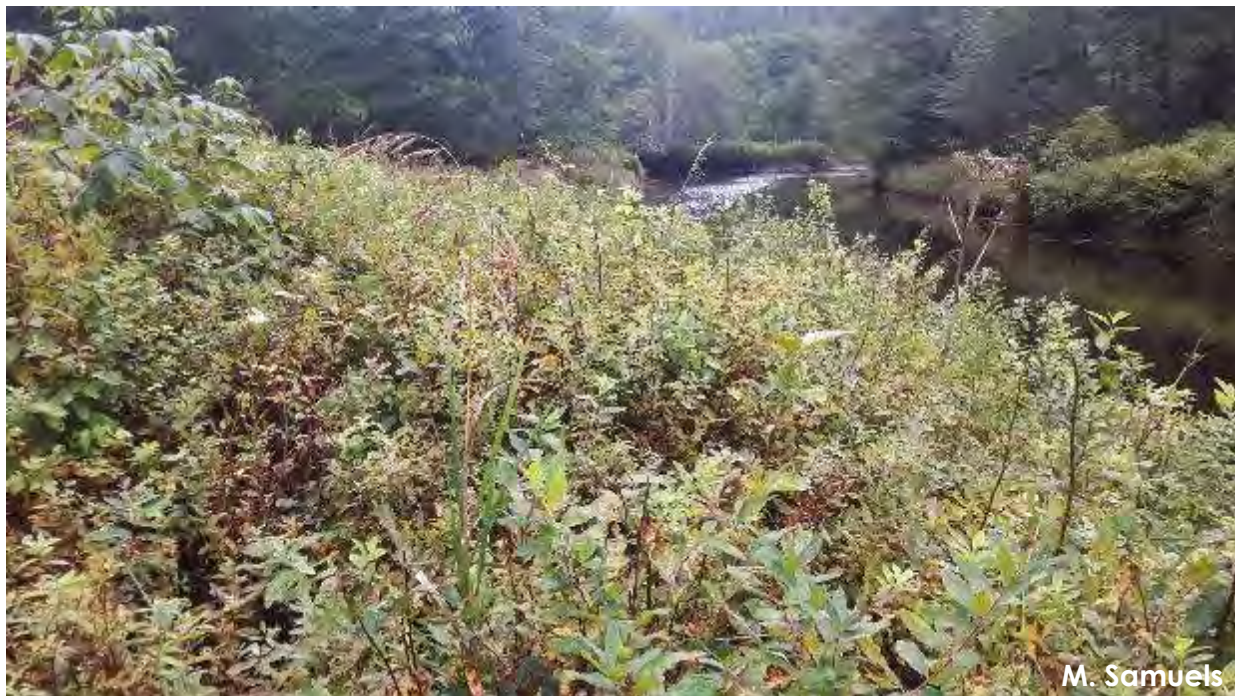
Figure 18. Shoreline community of sedges intermixed with shrub/herb species (2017)

The 2017 sedge community elevation was within the same elevation range as the 2007 findings; however, the lower elevation range had contracted by 0.1 m. This indicates that the sedge community is still present within the same elevation range and has not shifted in elevation range considerably as a response to the lower water level within the reservoir. During the 2017 field study, the sedge dominated vegetation communities were not as prevalent along the water's edge as during the 2007 study. In many instances, sedges were intermixed with shrub and herb species such as spiraea (Figure 18).

This indicates that although the elevation range of the sedge community has not shifted significantly within the last decade, the species composition within the previously sedge dominated communities has shifted toward a mixture of shrub and sedge communities.

This is a result of natural succession as the previously wetted areas became drier and the vegetation community shifted to a shrub and young forest ecosystem.

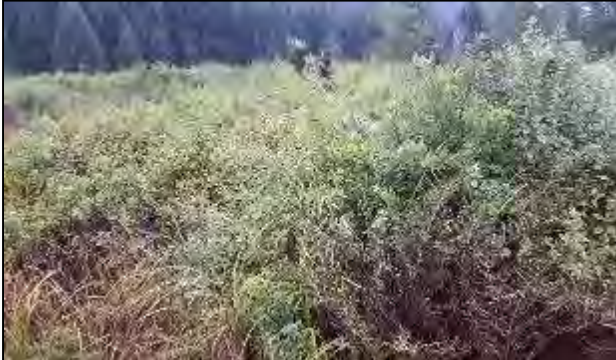
| PHOTO POINT 1 | |
|--|--|
| <p>Photo 1: Facing north at transition from polygon 1 to 2. September 7, 2017 10:00.</p> | <p>Photo 2: Facing east at transition from polygon 1 to 2. September 7, 2017 10:00.</p> |
| | <p>Description Located 35 m east (i.e. bearing of 87°) from the edge of Carthew Creek. Near the transition from the sedge bench to spiraea dominated shrub/herbs.</p> <p>Polygons North and East view = polygon 2 West and South view = polygon 1</p> <p>UTM Coordinates Easting: 454956.43 m Northing: 5983789.70 m</p> |

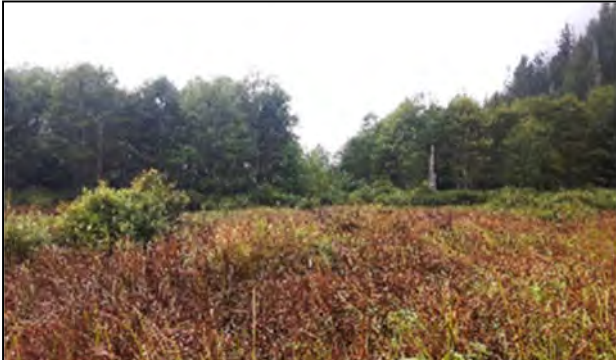
| PHOTO POINT 1 | |
|--|--|
| <p>Photo 3: Facing west at transition from polygon 1 to 2. September 7, 2017 10:00.</p> | <p>Photo 4: Facing south at transition from polygon 1 to 2. September 7, 2017 10:00.</p> |

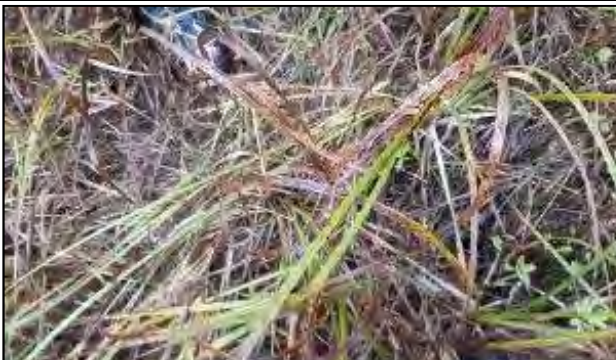
| PHOTO POINT 1 | |
|--|--|
| <p>Photo 5: View of groundcover at transition to shrub/herb species. September 7, 2017 10:00.</p> | |
