**Peace Project Water Use Plan**

**Williston Debris Field Survey**

# Williston Debris Field Survey

## Inventory and Contribution Analysis Report

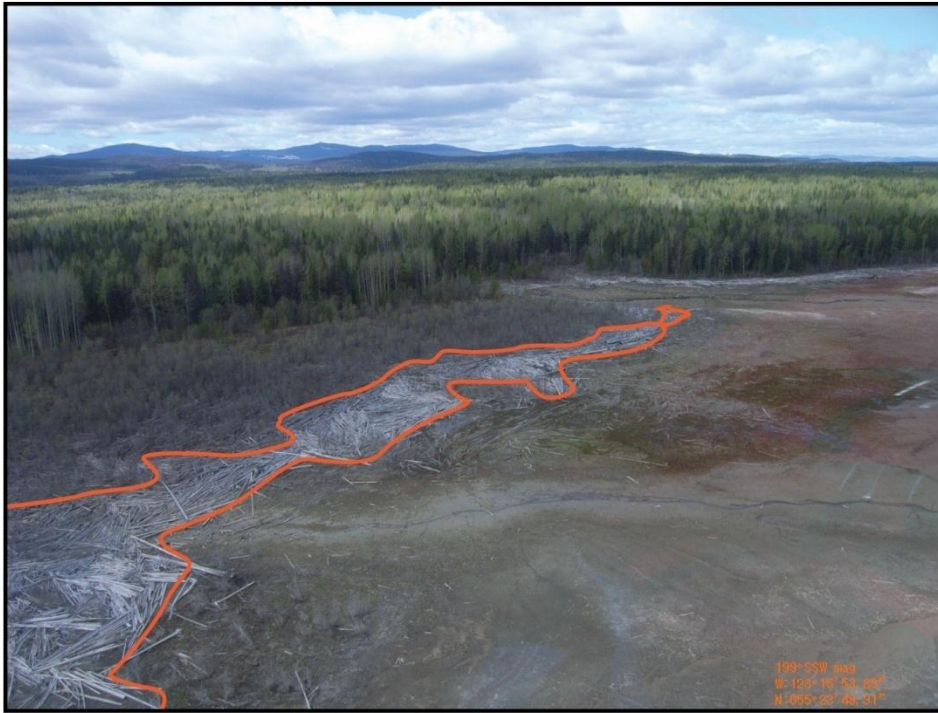
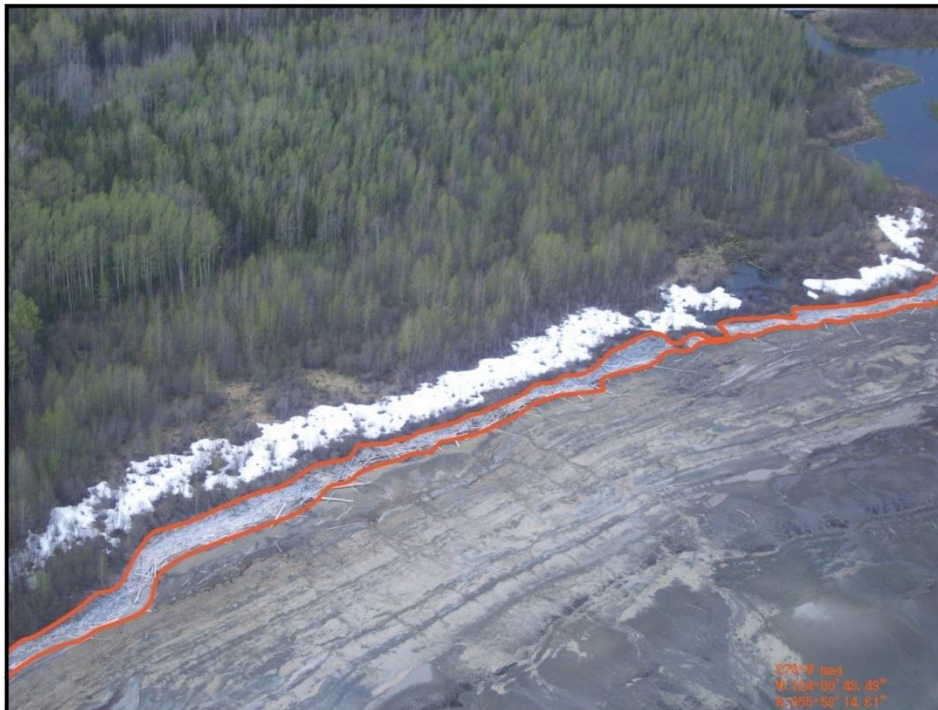
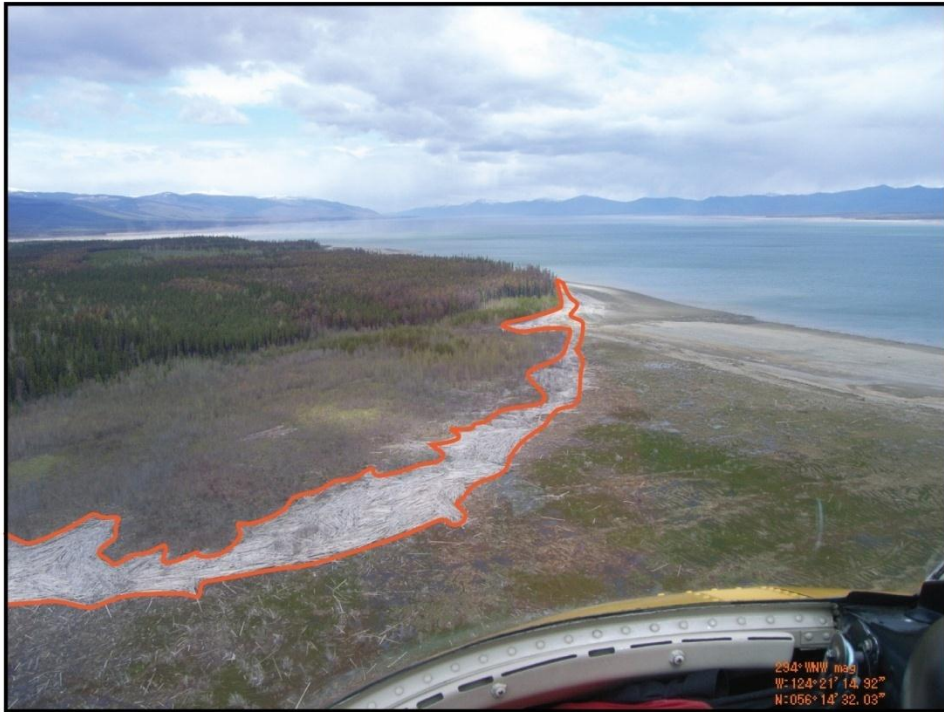
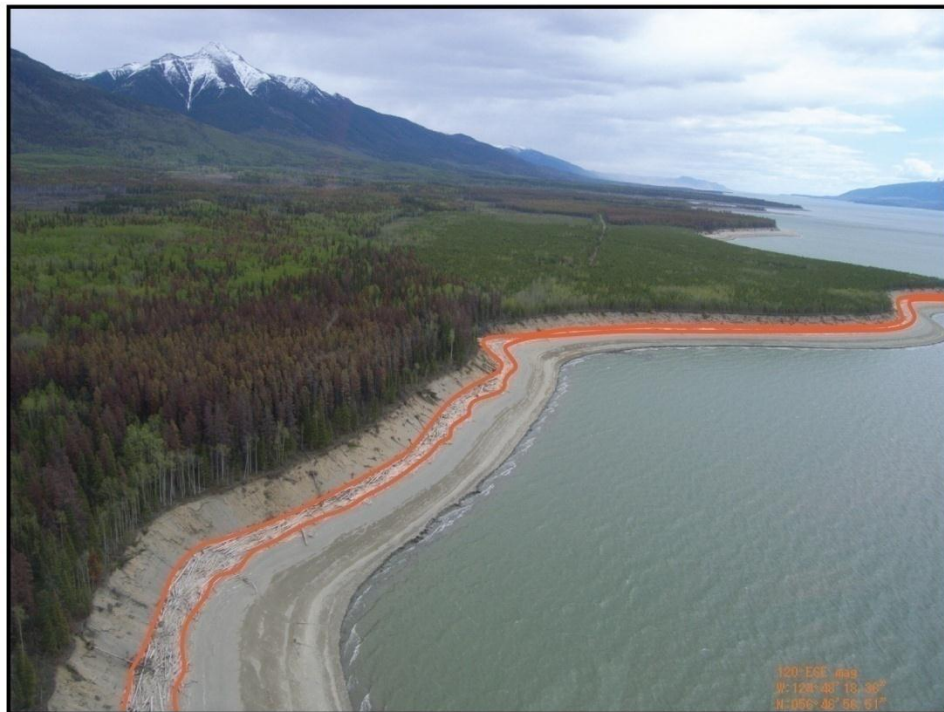
Figure 3 Photos showing ribbons of beached woody debris

The distribution was not uniform throughout the reservoir. Debris was divided between the three arms of the reservoir as follows: Finlay Arm (1,940 ha), Parsnip Arm (3,726 ha) and the Peace Arm (96 ha).

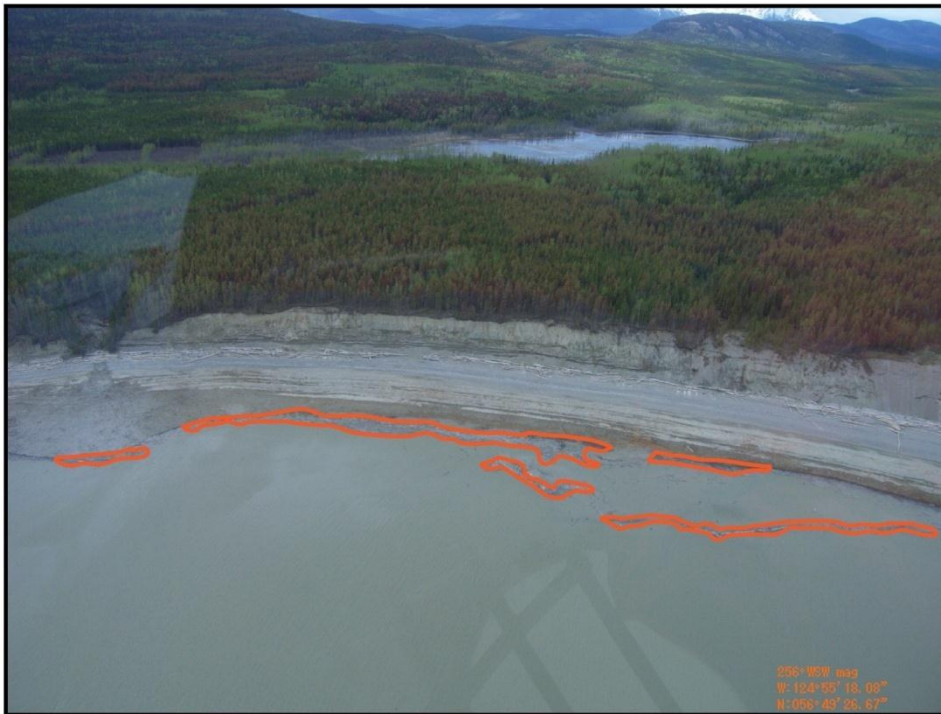
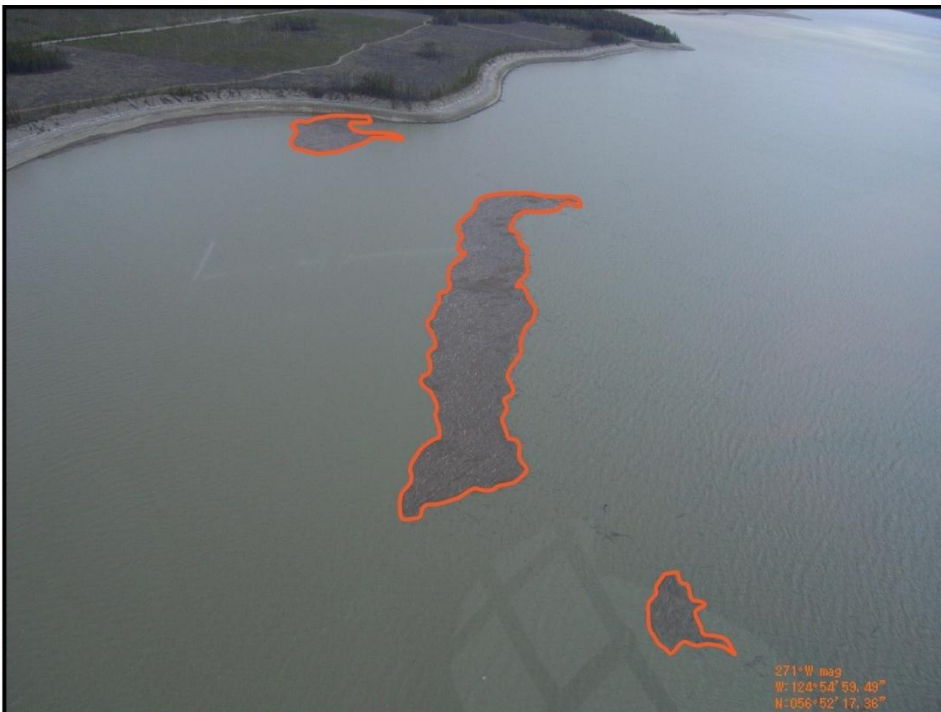
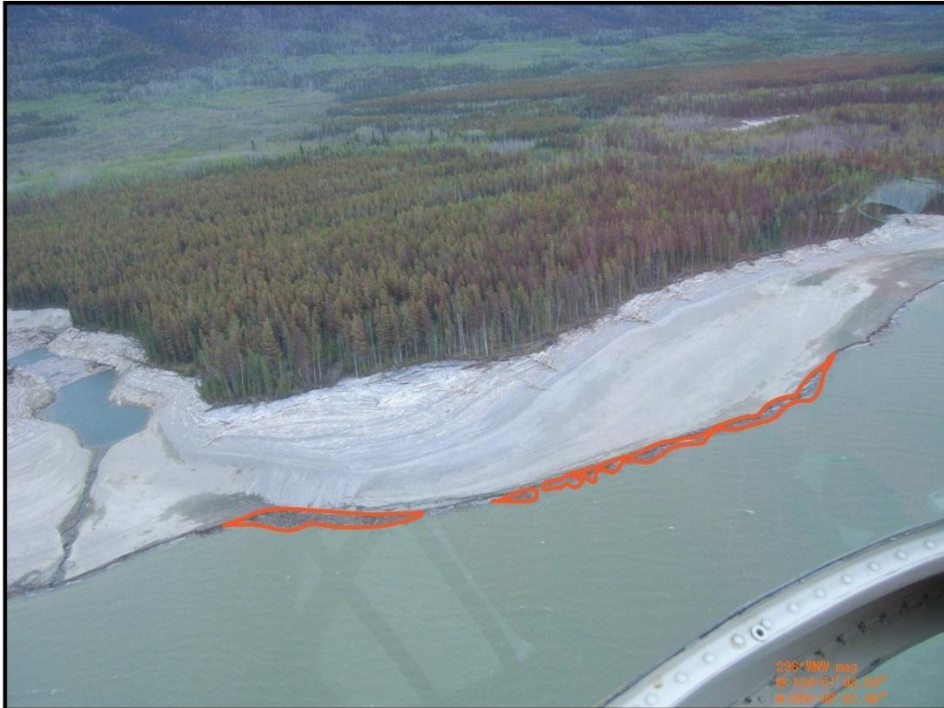
Figure 5 Photos showing floating debris

The results from the helicopter survey suggested that masses of debris were not present in Finlay Arm and that in general, very little floating debris was present in the reservoir at the time of the survey. Debris was found at the periphery of the water near the shore, and this has subsequently been validated in the interpretation of digital aerial photographs.

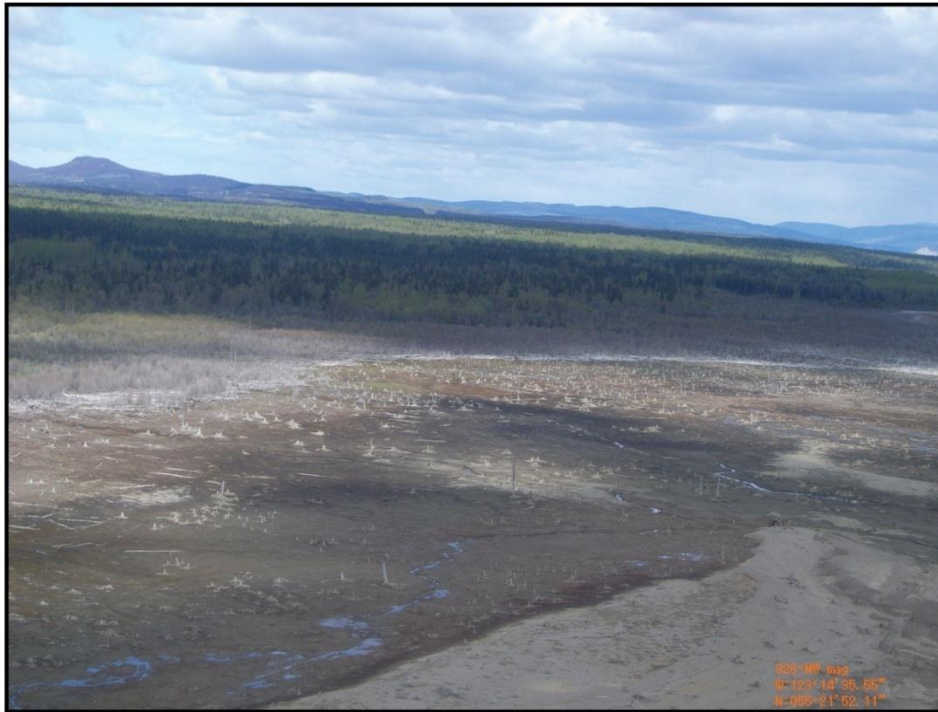
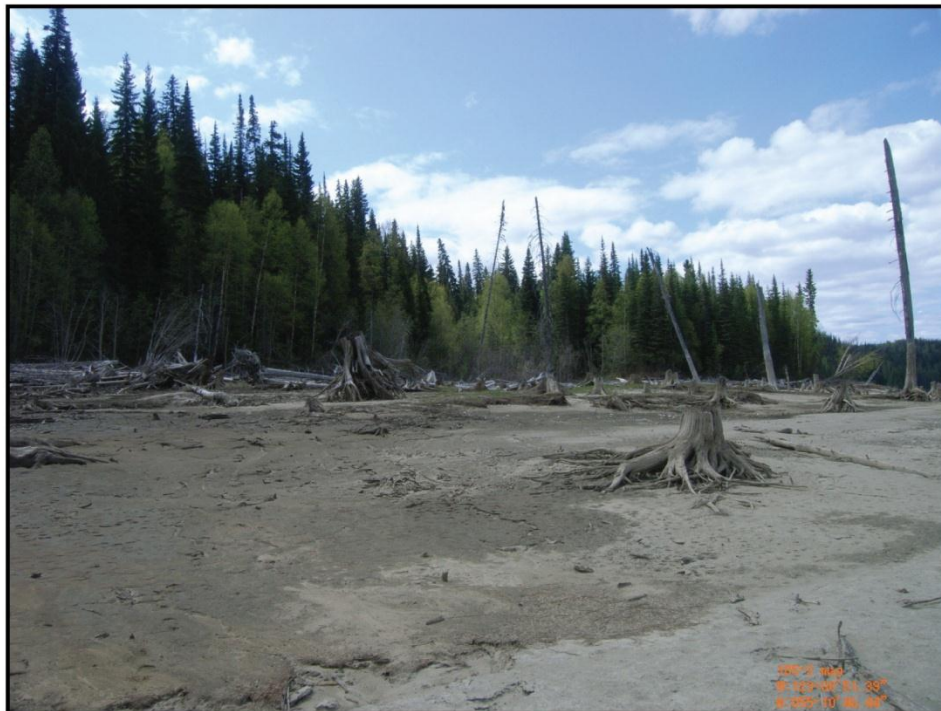
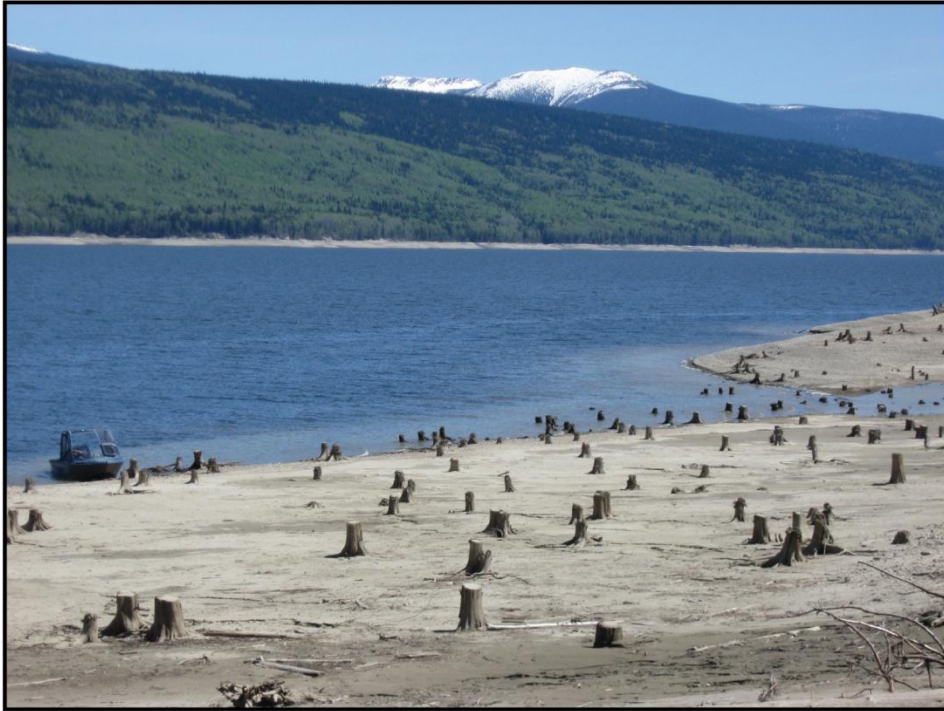
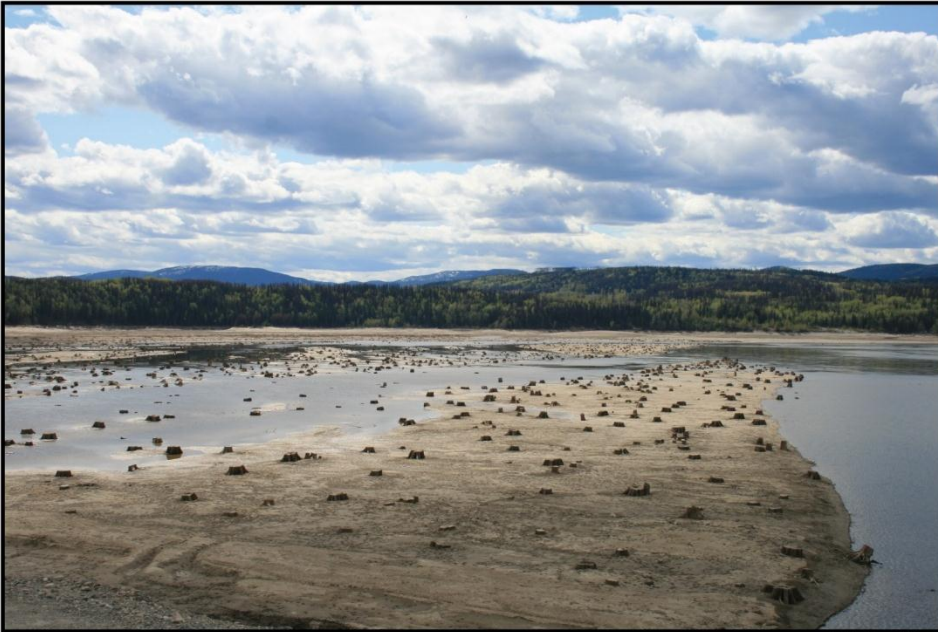
Figure 7 Photos showing stumps and snags

Stumps and snags, principally tree trunks and root bases were found in many of the shallow bays. Even though they are unlikely to become floating debris, these constitute a hazard to recreational use of the reservoir.

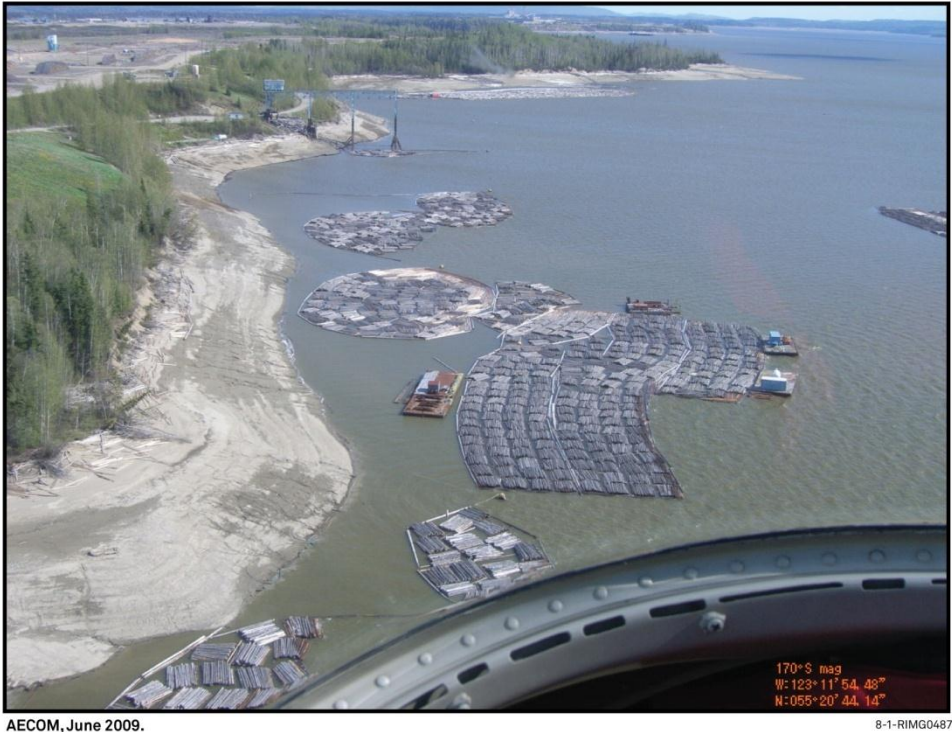
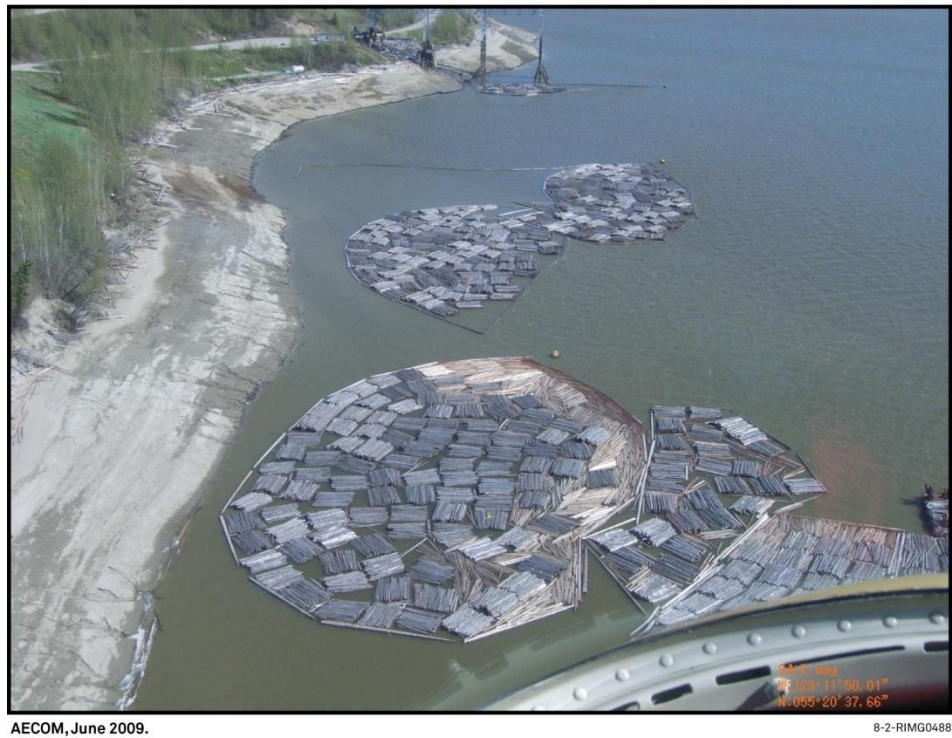
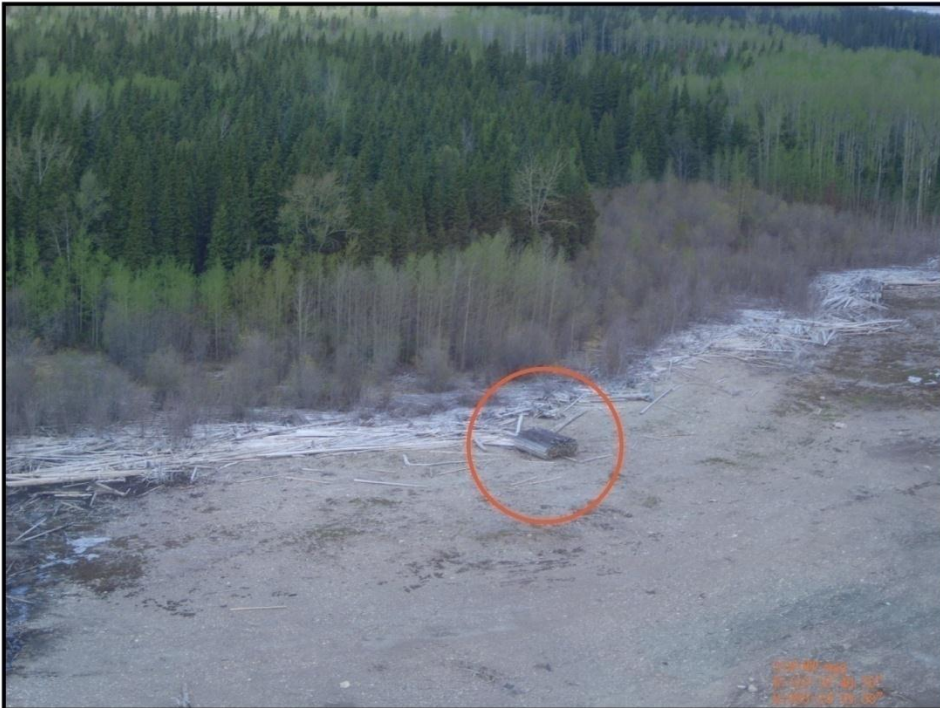
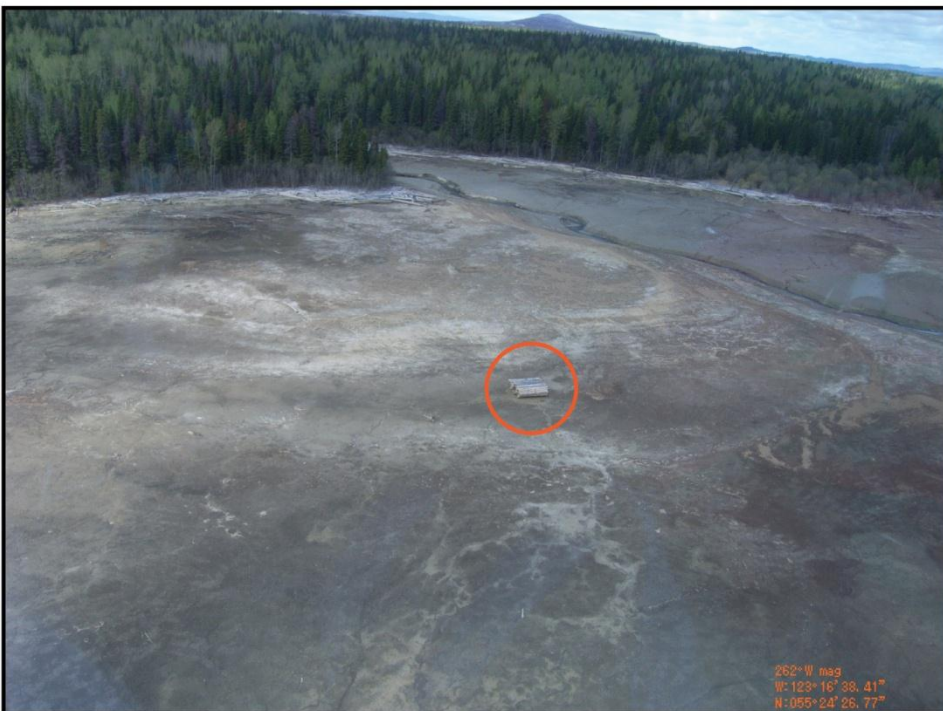
Figure 8 Photos showing commercial booms and lost bundles

Commercial logs are logs lost during boom transport. While not active at the time of the study, boom transport was in operation on the reservoir for many decades and significant quantities of logs have broken away from the rafted logs and now form a component of the wood debris on the reservoir

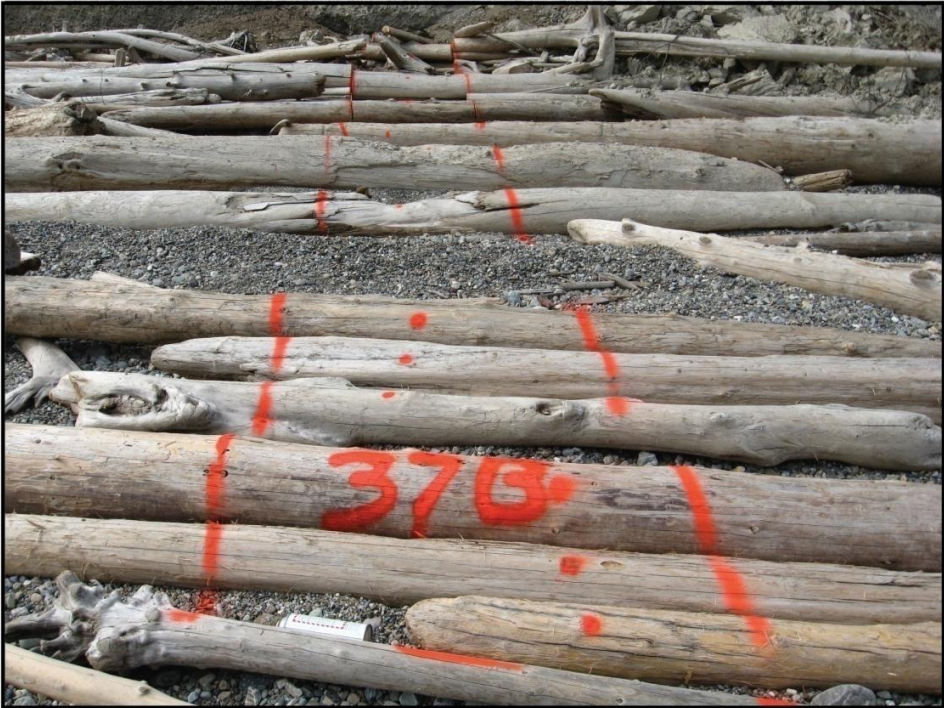
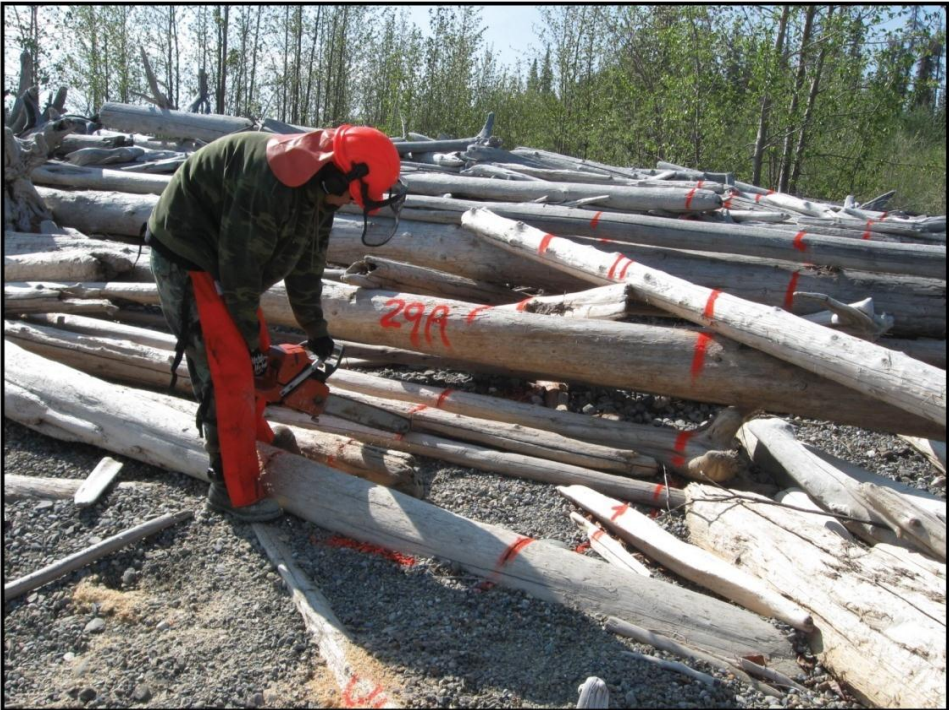
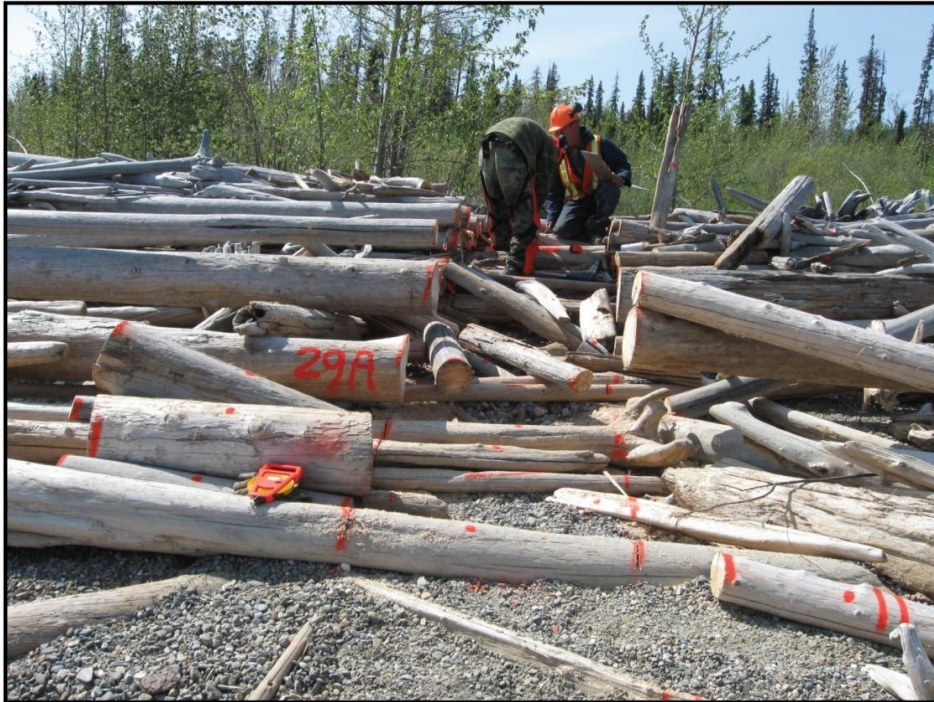
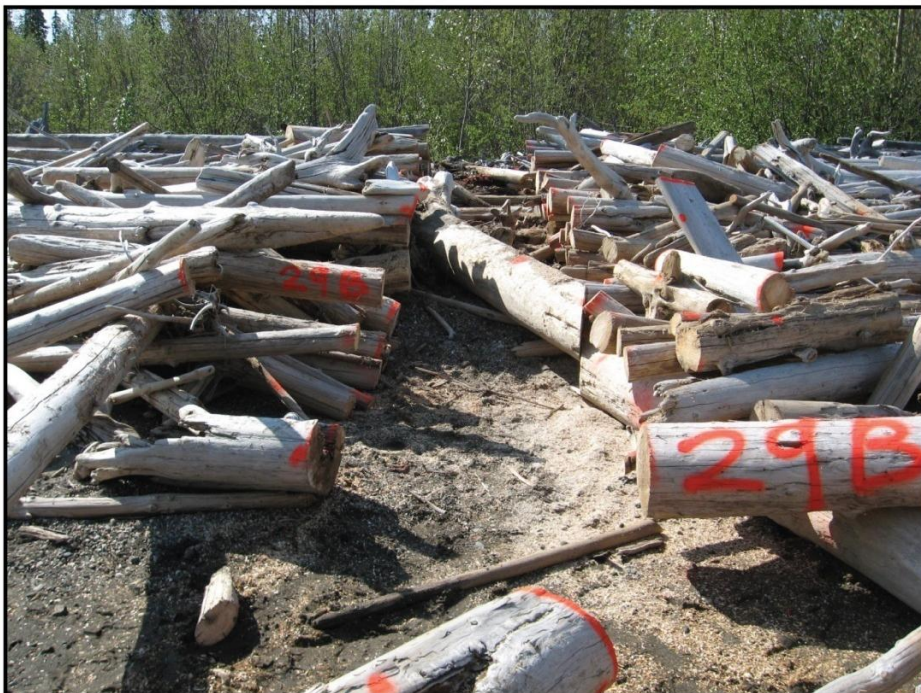
Figure 10 Photos illustrating the sampling method used to establish the unitary volume of the debris ( $m^3/m^2$ )

Sample plots were laid directly over the debris pile, as per the photographs provided in Figure 10. The plots were one meter wide with a length equal to the debris pile width (Figure 10a). The debris stems located within the boundaries of the plot were then cut into lengths using a chainsaw (Figure 10b).

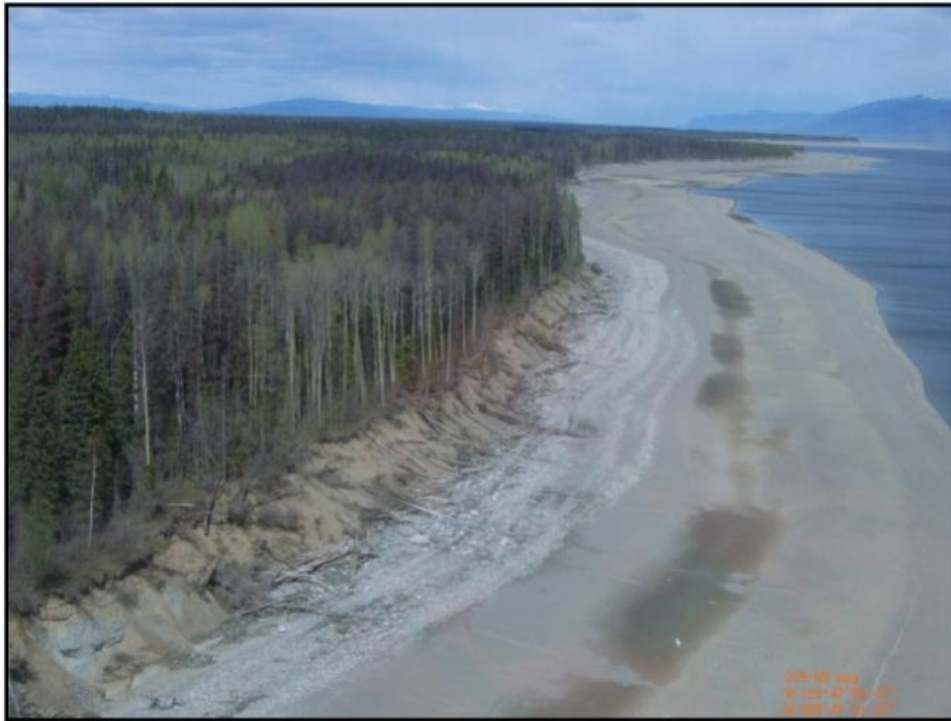
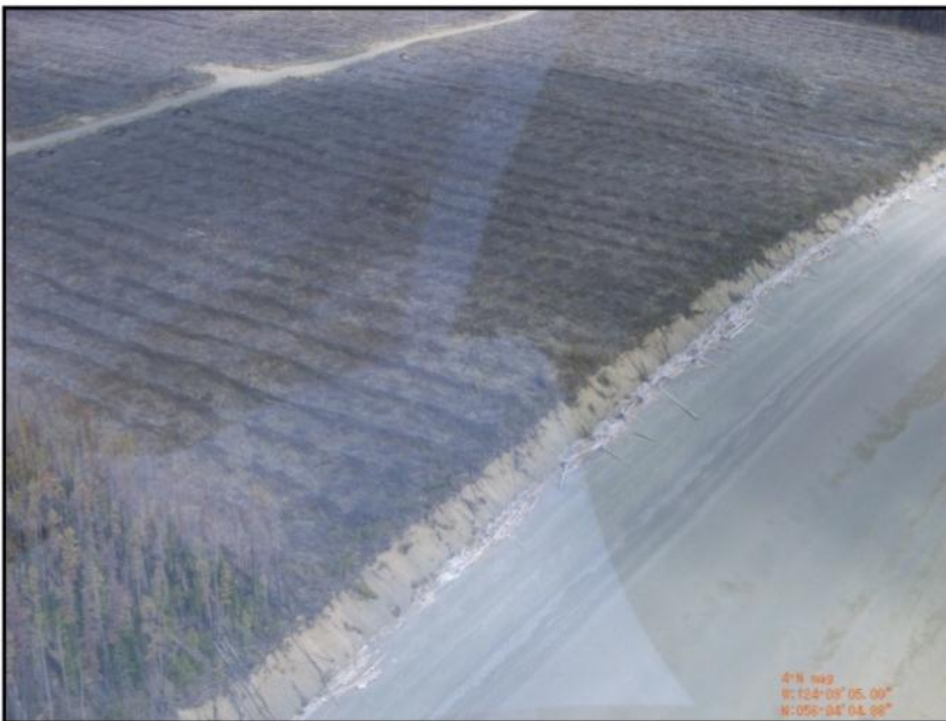
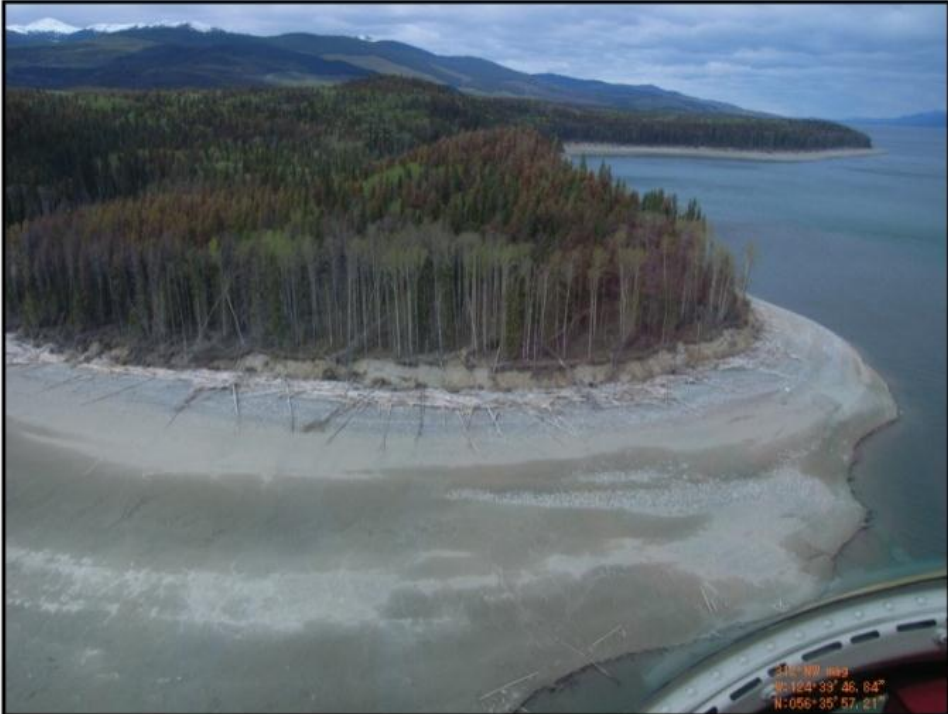
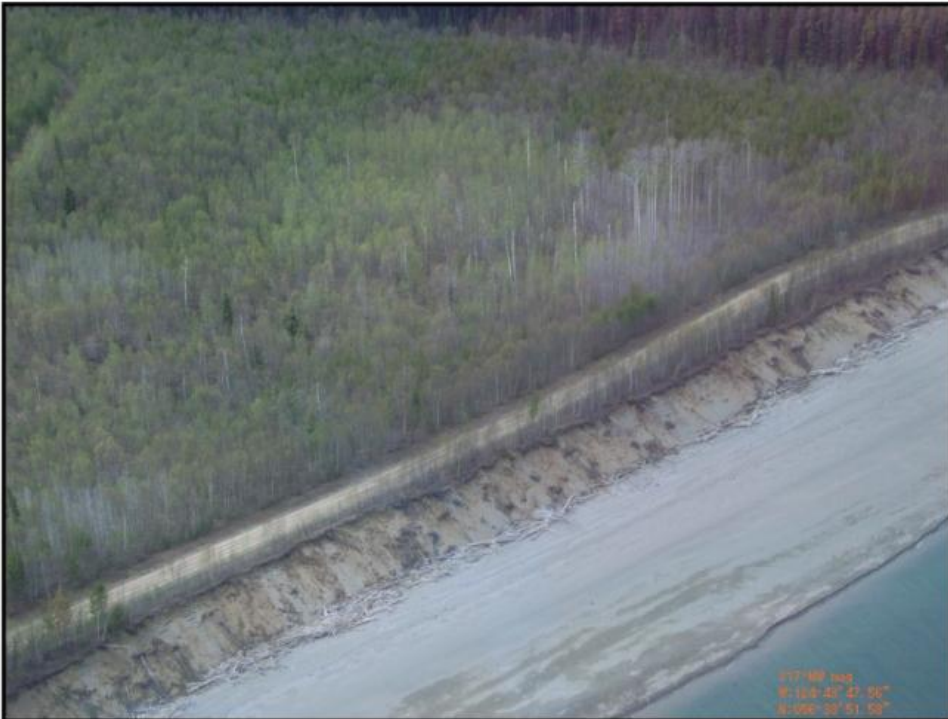
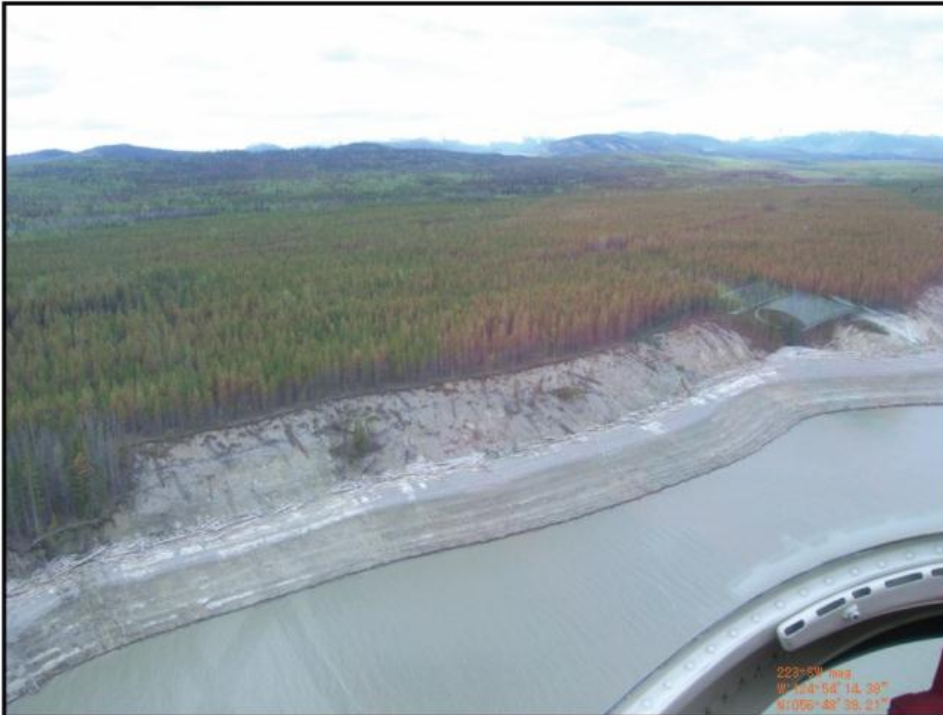
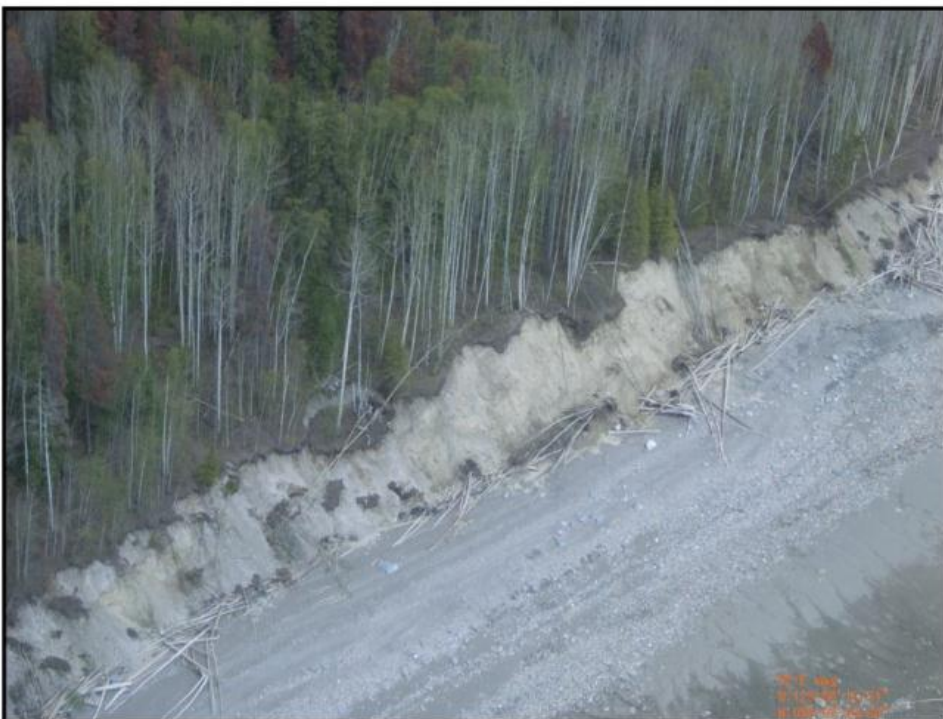
Figure 18 Photos showing shoreline erosion on the Williston Reservoir

Shoreline erosion is very active in the Williston Reservoir. The importance of this phenomenon was observed during the over flight of the reservoir conducted in June, 2009. Many areas of erosion are visible in the photographs collected during the survey. These photos were sent under separate cover to BC Hydro. They are also identified on the inventory map presented in Appendix 2 entitled "Debris Inventory - Field Sampling and Ground Truthing" and can be viewed digitally using Arc Map.

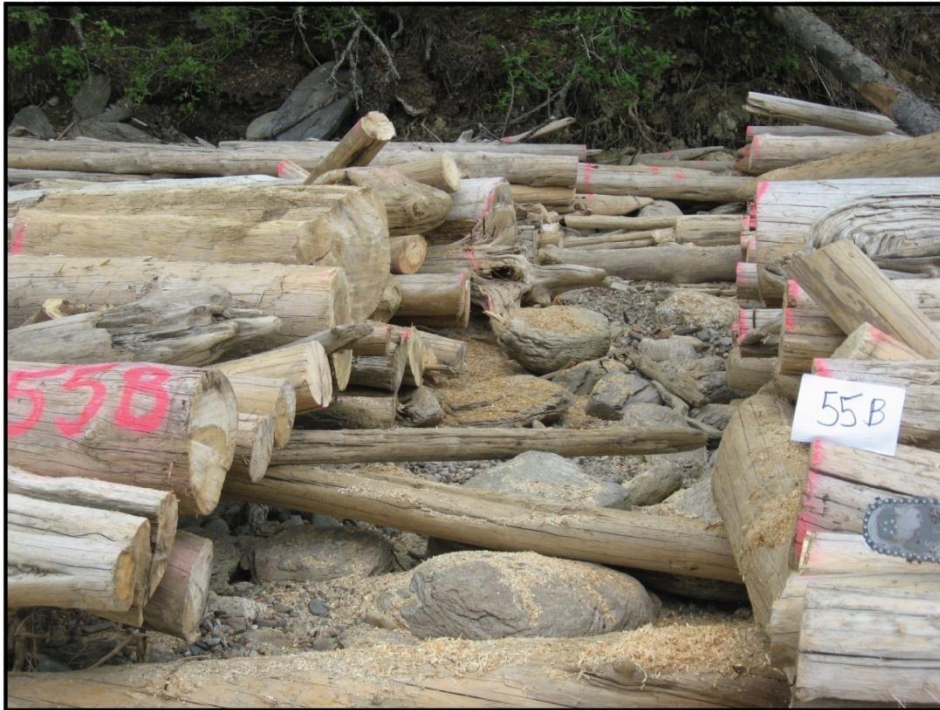
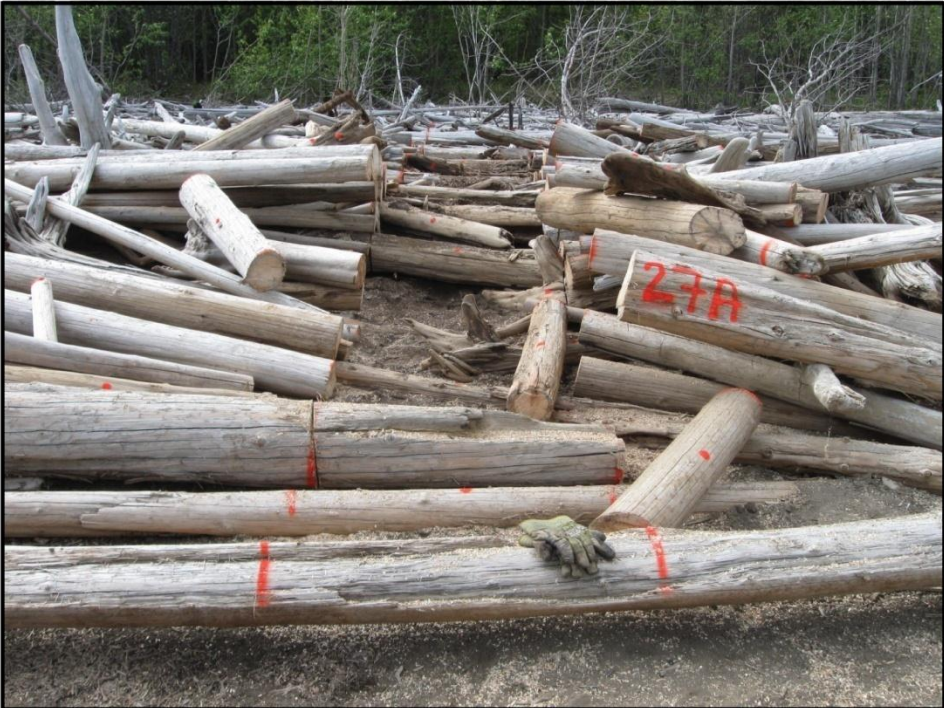
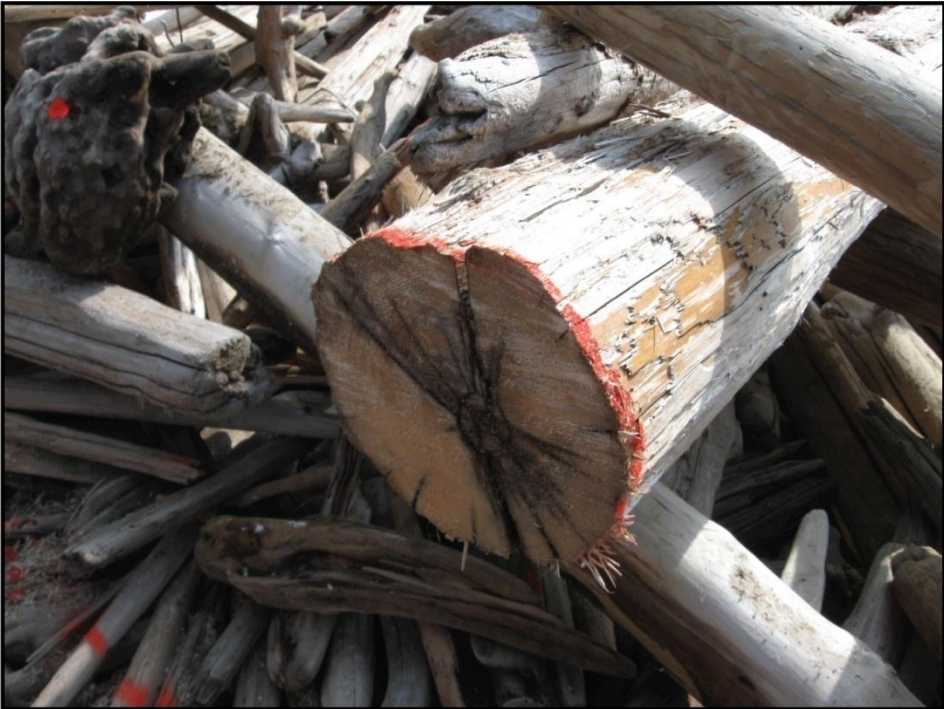
Figure 22      Photos showing logs affected by cracks in the Williston Reservoir

The analyses of photographs from different sample plots show that a large number of logs are affected by cracks. These cracks are a major obstacle for the supply of a sawmill. The phenomenon is illustrated in Figure 22.
