Peace Project Water Use Plan

GMSMON-16 Williston Debris Trends

Williston Wood Debris Trend Analysis 2009-2011

Project number: 60558464

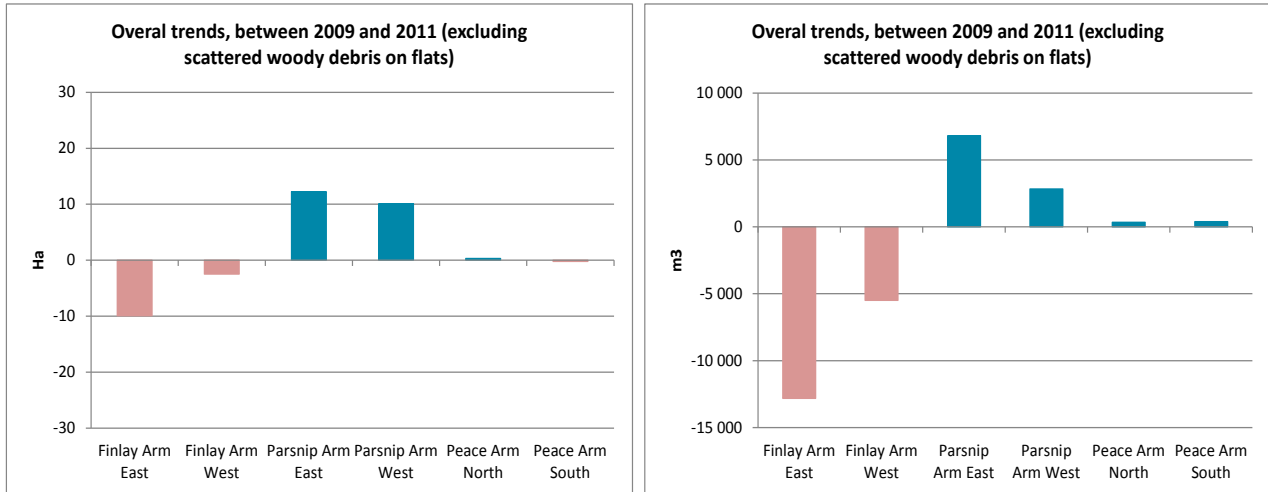
Figure E1 Graphs of the overall balance of woody debris trends in the Williston Reservoir, between 2009 and 2011, in terms of hectares and cubic meters

In terms of wood volumes, the overall trends indicate a decrease in Finlay Arm East (-12 159 m³ or -18.5 %) and Finlay Arm West (-5 295 m³, or -7.1 %), in the sampling cells (Figure E1). The exclusion of the volume of scattered woody debris on flats (BF) does not significantly affect these trends, contrary to what was observed when analyzing the areas including scattered woody debris (Figure E1).

For the other sectors, the overall balance results in an increase of woody debris with the majority found in Parsnip Arm East (6 959 m³ or 23.9 %), and at a lesser extent for Parsnip Arm West (2 926 m³ or 4.6 %). Finally, the amounts of woody debris have also increased in Peace Arm North and Peace Arm South, but not significantly. Specifically, 341 m³ (7.0 %) and 392 m³ (4.7 %) were added between 2009 and 2011 for these two sectors respectively (Figure E1).

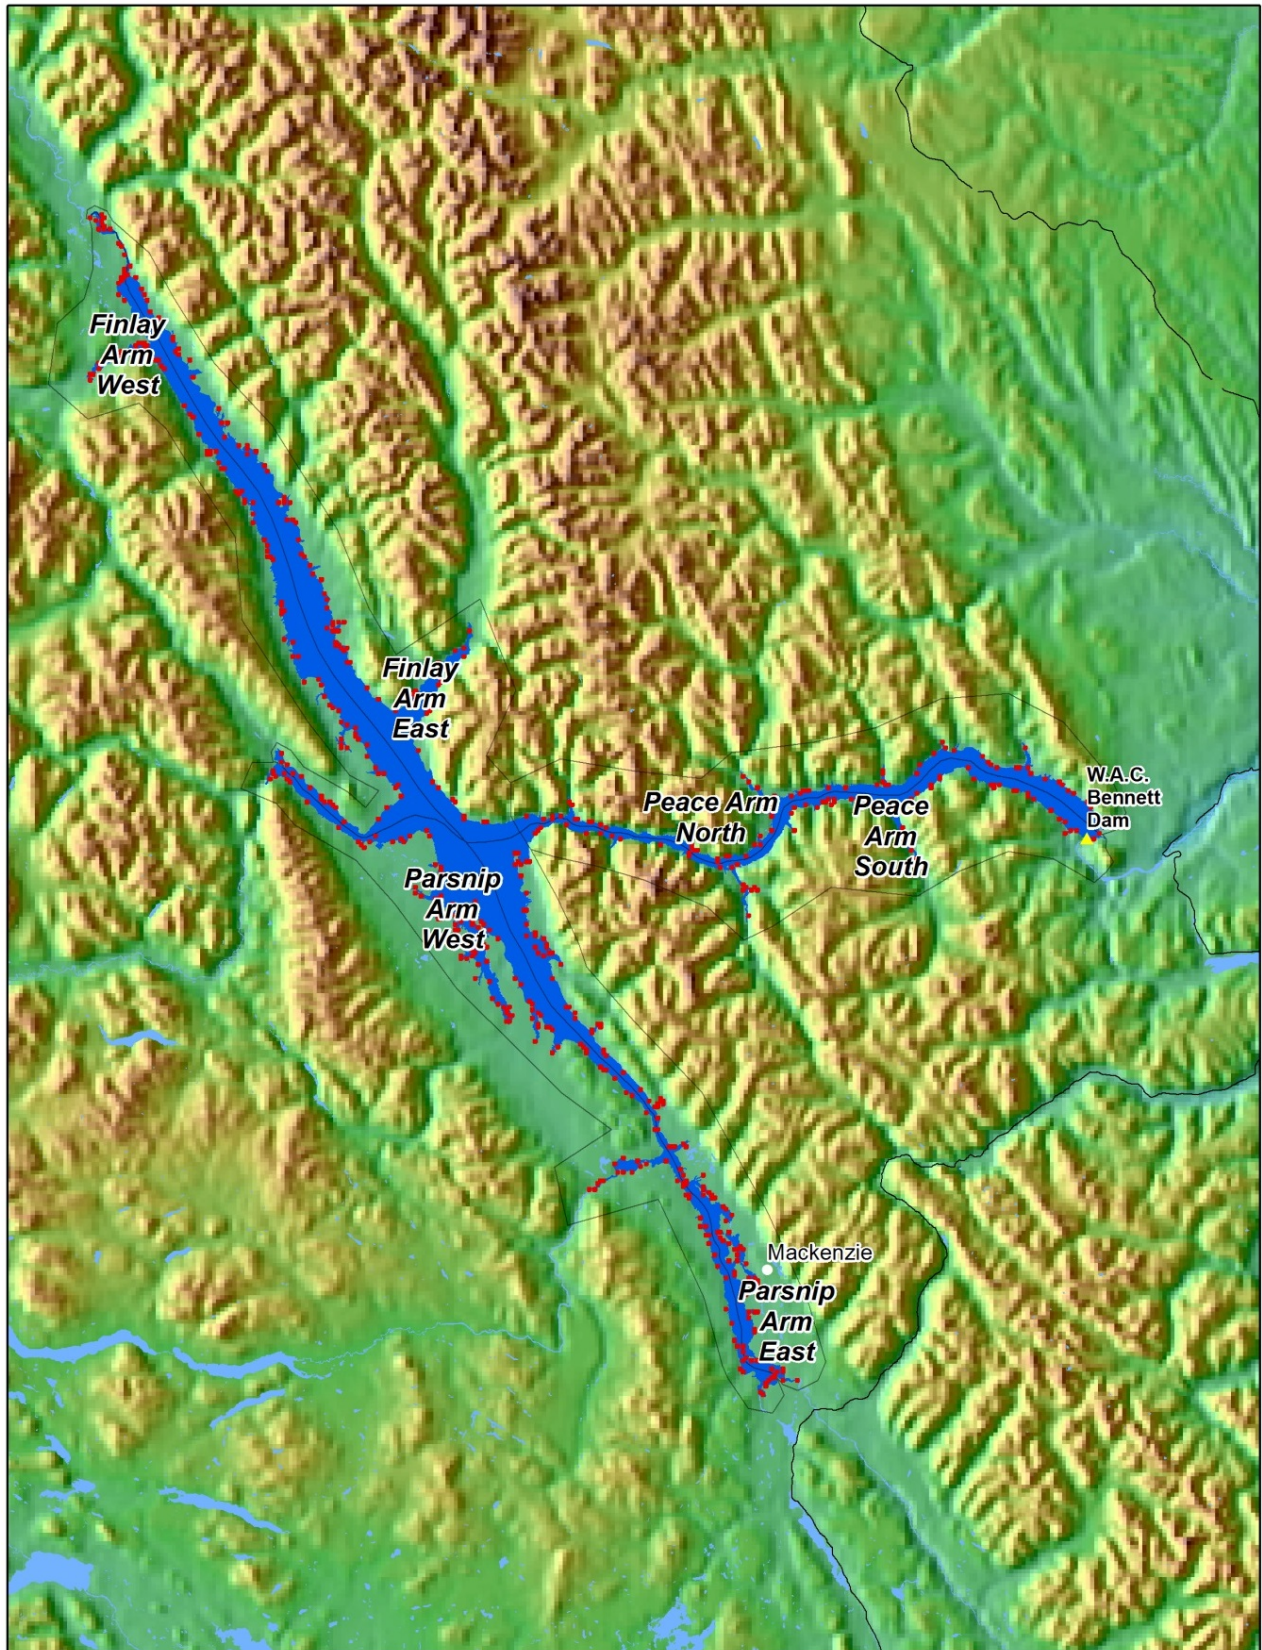
Figure 2-1 Location of the sampling areas (red dots) in the six sectors of Williston Reservoir

BC Hydro has recently contracted AECOM to perform a monitoring study consisting of mapping and analyzing the extent of woody debris in 2011 against the baseline of 2009. A statistical approach was applied to compare both conditions. More specifically, 620 sampling areas were randomly selected in an array of 500 m x 500 m cells that cover the whole reservoir (Figure 2-1). The sampling cells were selected, per arms and sectors, in accordance with the following proportions:

- 15 % of the cells that are touching the reservoir coastline and where woody debris were mapped in 2009;
- 15 % of the cells that are touching the coastline and where no debris were observed in 2009;
- 15 % of the cells that do not touch the coastline and that has floating debris in 2009;
- exclusion of cells that do not touch the coastline and that are without floating debris in 2009;
- 100 % of the priority sites (10) targeted by BC Hydro.

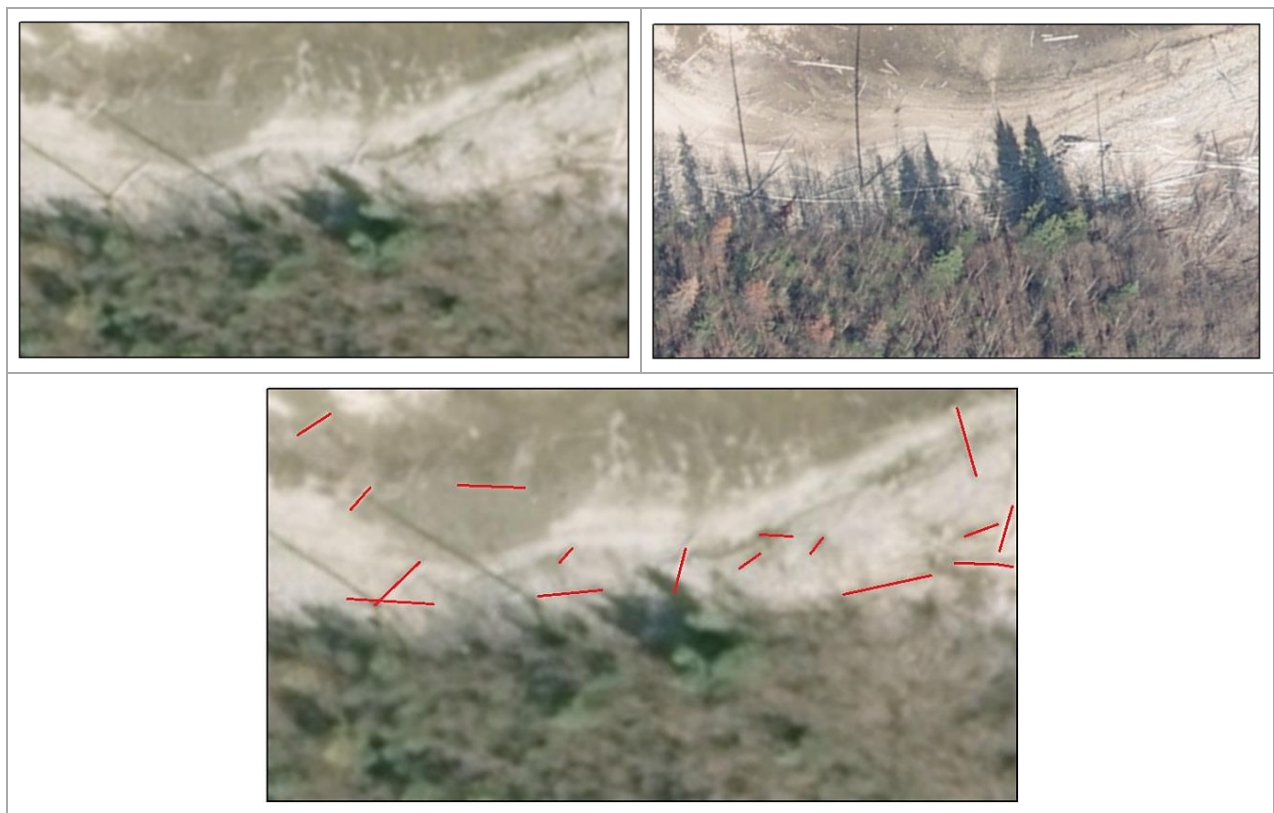
Figure 3-1 Example of the analysis of faint details on the imagery of 2009, by using the new set of 2011 to confirm the existence of woody debris

The resolution of the 2011 imagery is almost double that of the imagery used in the 2009 study. More precisely, the pixel size is 20 cm, while it is 33 cm for the older set. At least, this higher resolution ensures not to miss details that were observed during the baseline study. However, it was noticed that false changes are detected when the newer interpretation is compared with the baseline study, given that many faint details were undetected on the coarser imagery. In order to avoid false trends, it was decided to review the whole baseline study of 2009 by reinterpreting faint details, using the 2011 imagery to confirm if these faint clues really correspond to wood logs, and if additional debris areas have to be delineated (see example presented in Figure 3-1).

This procedure allowed the photo-interpreter to delineate and classify many debris areas that have been missed during the first study, given the coarser pixel size. It was also possible to review beach segments that were partly hidden by tree shadows or by higher features in oblique view. The same woody debris classification applied for the first version of the baseline of 2009 has been used for the revision, except that scattered logs along the coastline and on the drawdown plain were distinguished. The density of fallen trees in forest stands were also characterized in three different classes, given they indicate the rate of degradation and a potential source of debris that could be mobilized and transported to the waterbody. In order to follow more closely the dynamic of woody debris and to explain the changes that will be observed when the images of 2011 are interpreted, the classes "Water (hiding potential woody debris area detected in the other study)" and "River (new branch cutting a former woody debris area)" were added to the original classification used for the first version of the baseline survey.

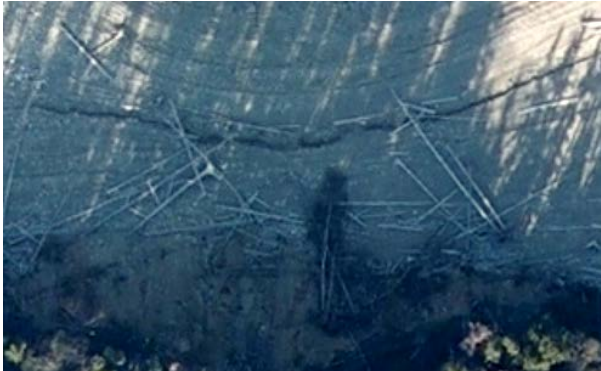
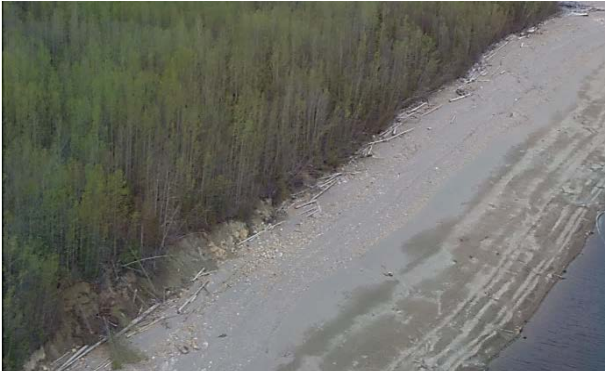
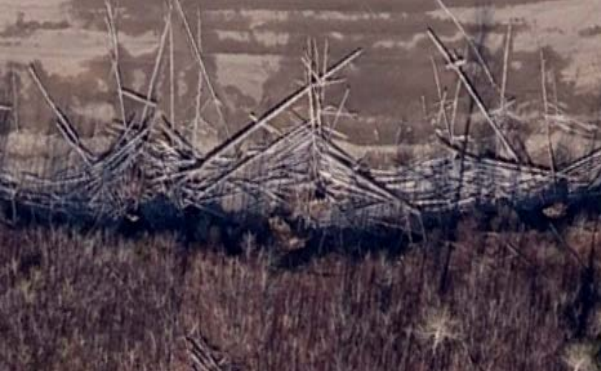
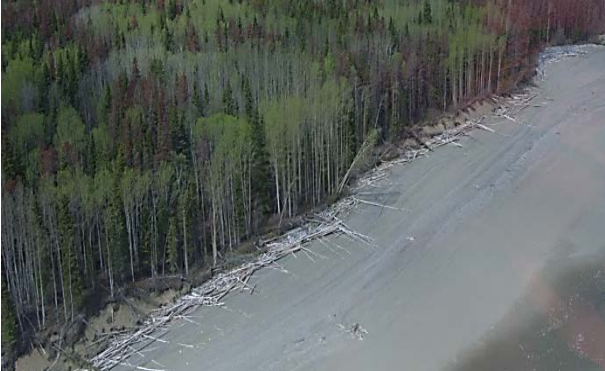
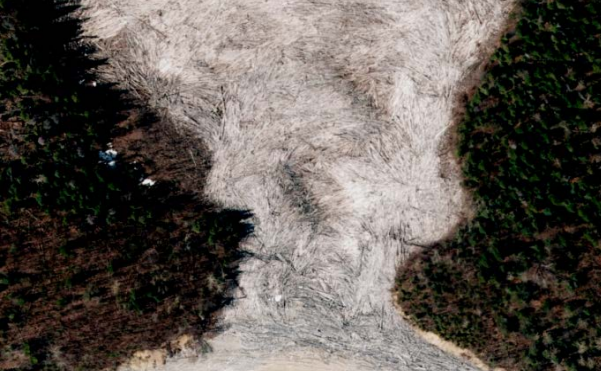
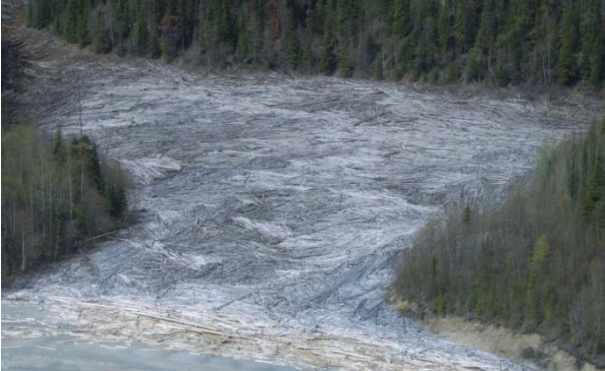
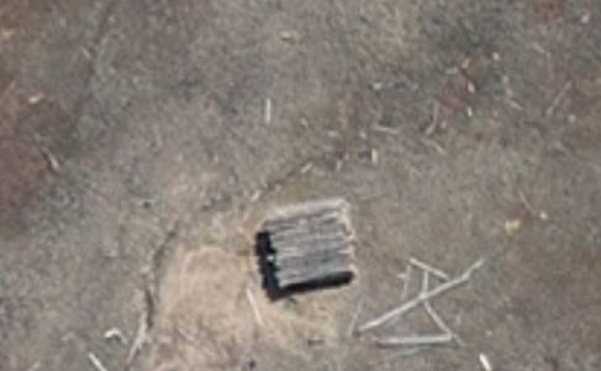
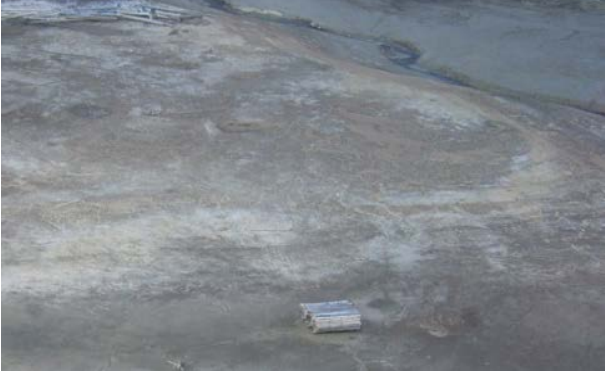
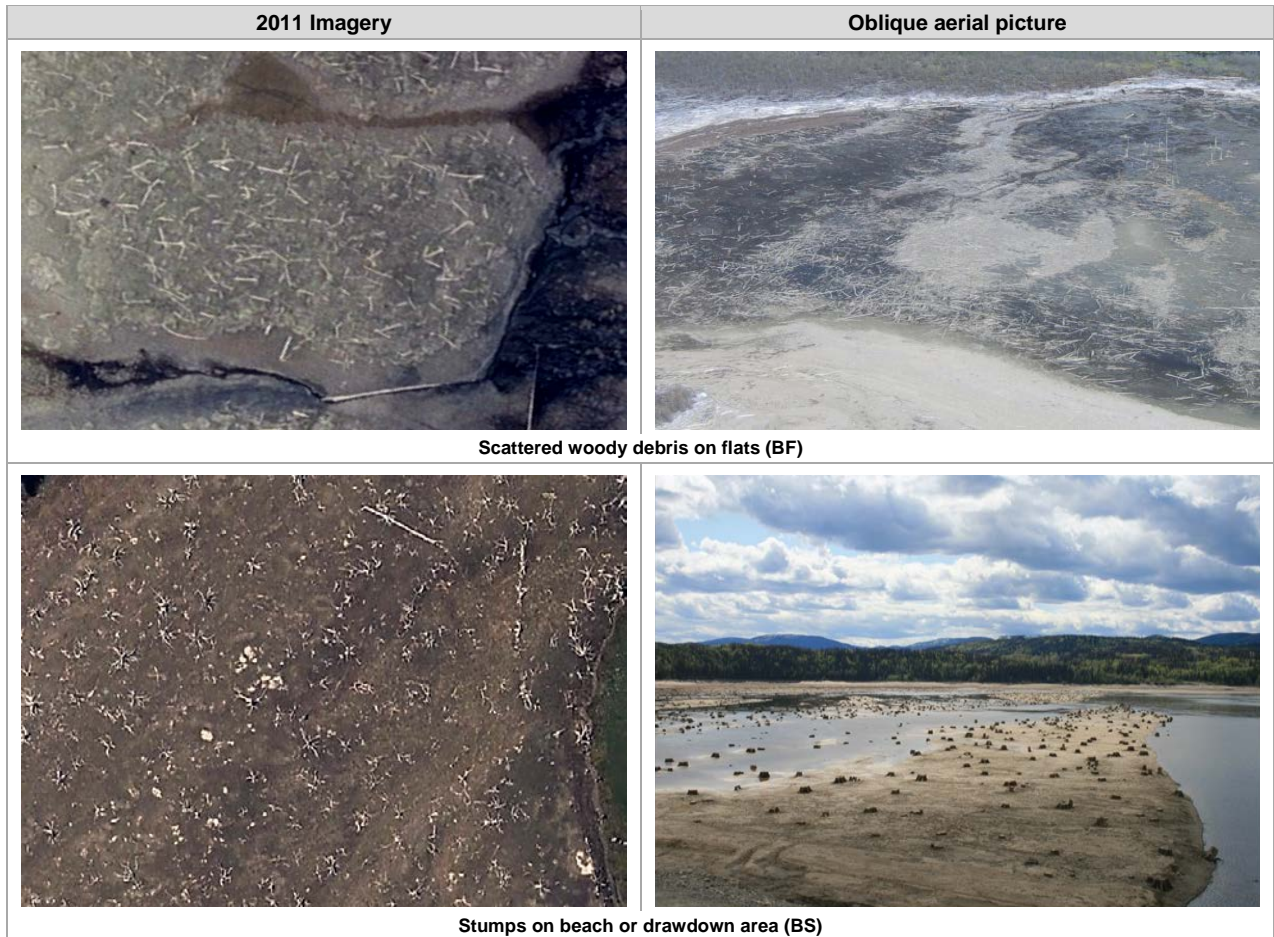
Figure 4-1 Examples of various classes of woody debris on beach or flats

Beached debris is defined as accumulations of woody debris gathered in long ribbons or in piles along the coastline. Three classes of density are used: 1) Scattered (code: B1), 2) Moderately dense (B2) and 3) Dense woody debris (B3). For the first class, the scattered debris on the drawdown plain is identified by the code BF. Usually, the denser accumulations are observed in shallow natural bays near the upper water limits of the reservoir.

This main group of debris on beach of flats also include stumps (code BS; most of the time, former snags in these areas were already lying on the ground on the 2009 imagery). Quite often these are cut-stumps. Even though they are unlikely to become floating debris, these constitute a hazard to recreational use of the reservoir.

A few lost wood bundles (BB) could be observed, mostly on the drawdown plain. They are easily identified given that logs are cut at both ends and piles in rectangular shape. The classes "Man-made wood stack on beach" (BM) and "Harvested woody debris area" (BH) were added, given that important woody debris removal activities are conducted in the reservoir.

<p>Scattered or low density beached woody debris (B1)</p>

<p>Moderately dense woody ribbons on beach (B2)</p>

<p>Dense woody ribbons or piles on beach (B3)</p>

<p>Wood bundle on beach (BB)</p>

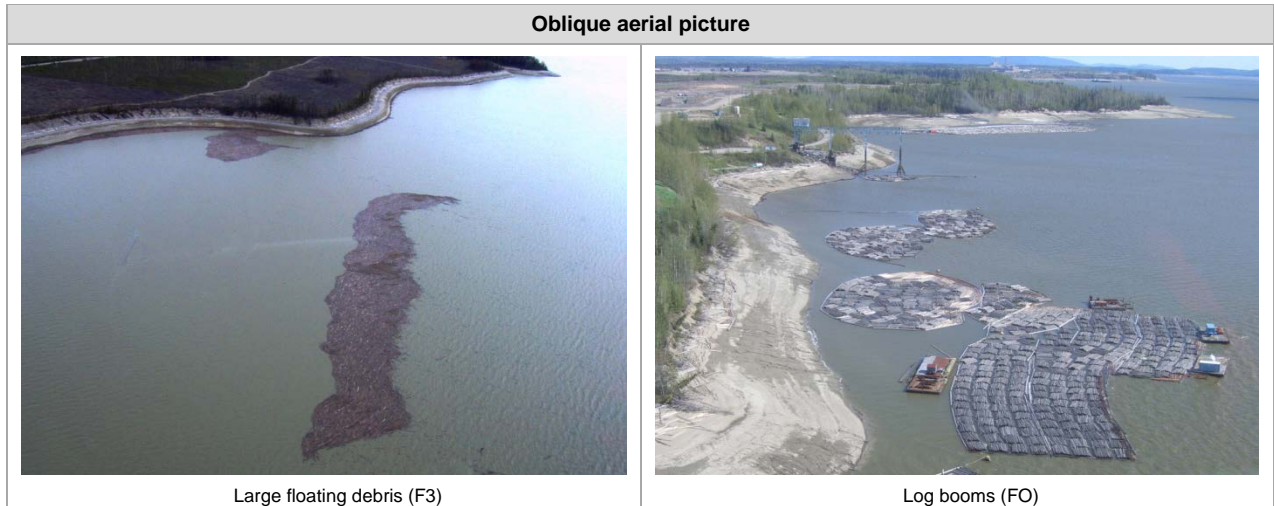
Figure 4-3 Large floating debris (F3) and log booms (FO) managed during the cleaning programme

Typical floating debris is found over the main waterbody, in forms of large patches of wood. However, most of them have been regrouped in log booms and recuperated during the cleaning activities (Figure 4-3). So, very little free-floating debris is observed on the reservoir during the baseline study.

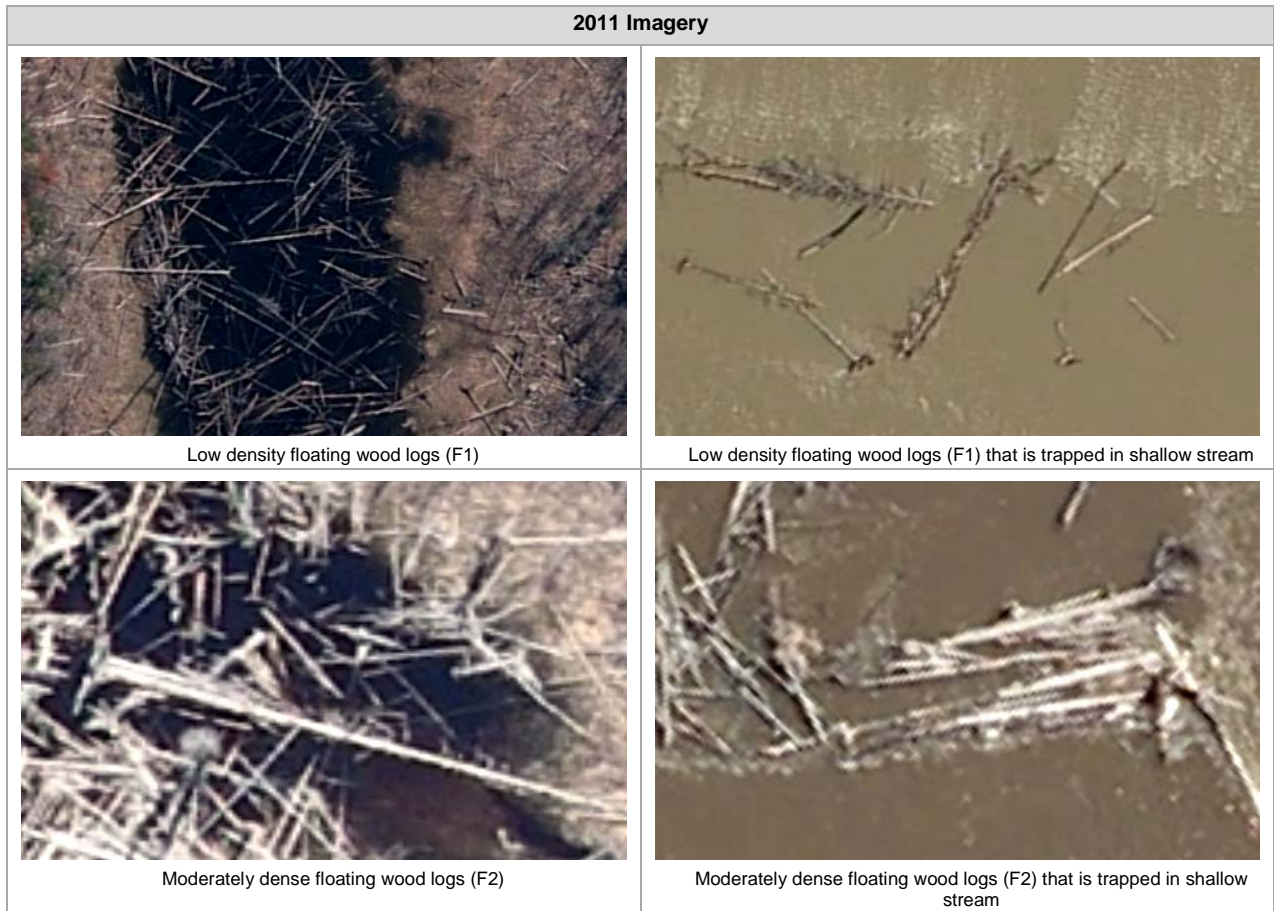
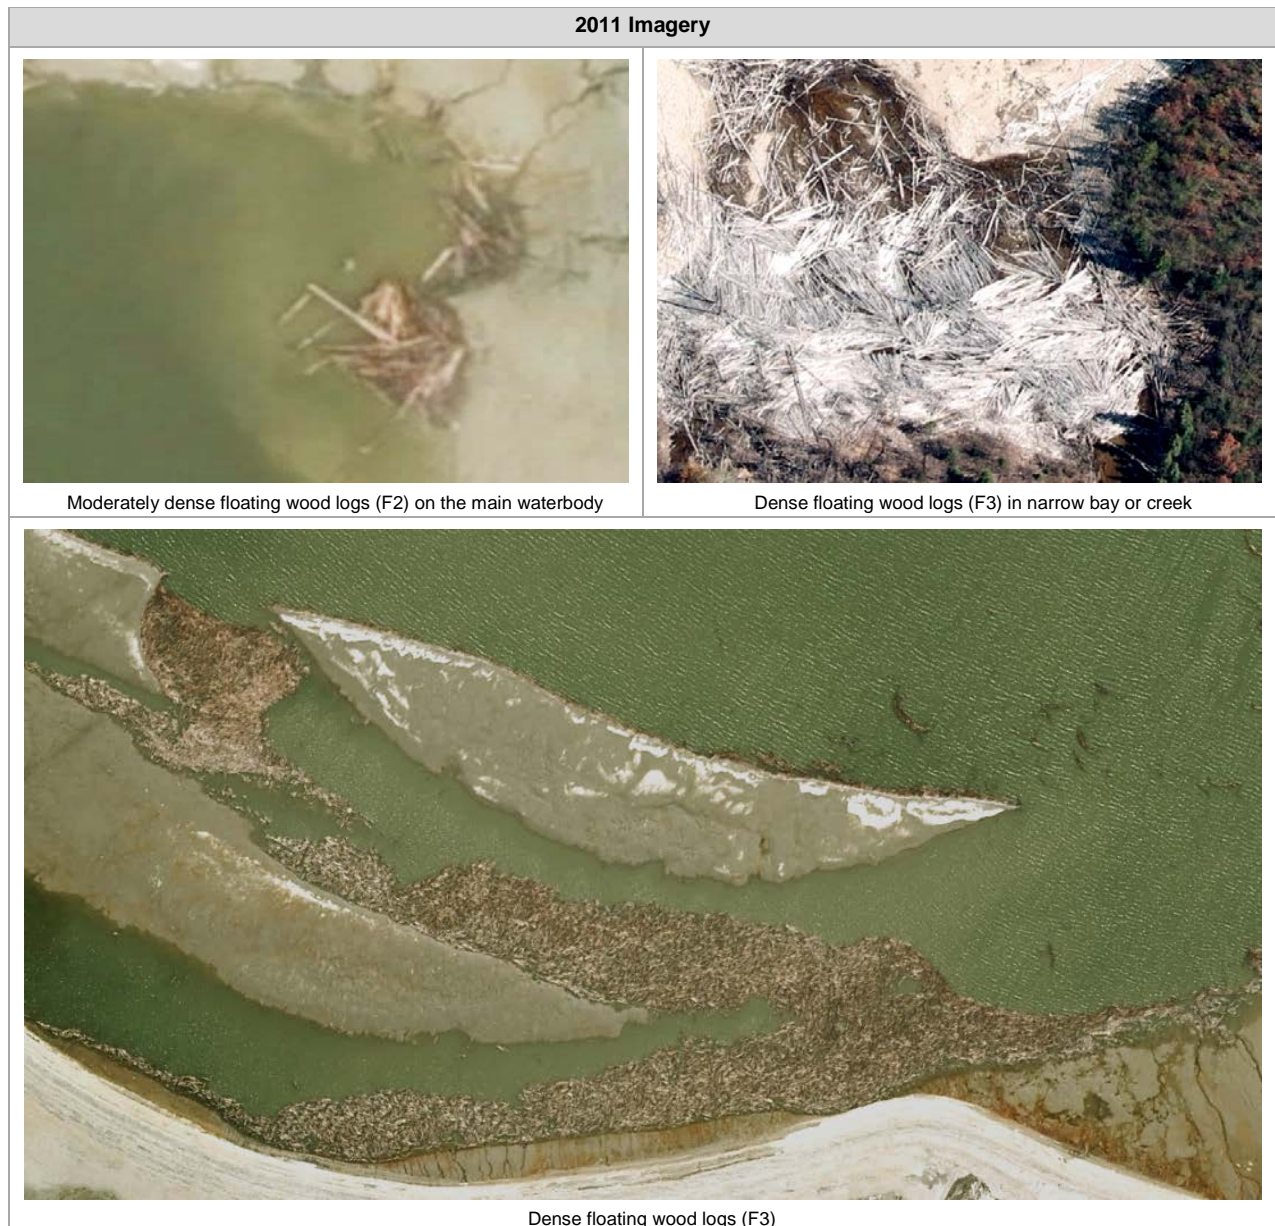
Figure 4-4 Examples of the various classes of floating woody debris

The next figures depict the various types of floating woody debris that were identified in the mosaics of 2009 and 2011 for the assessment of their sources and quantity, and for the trend analysis (Figure 4-3).

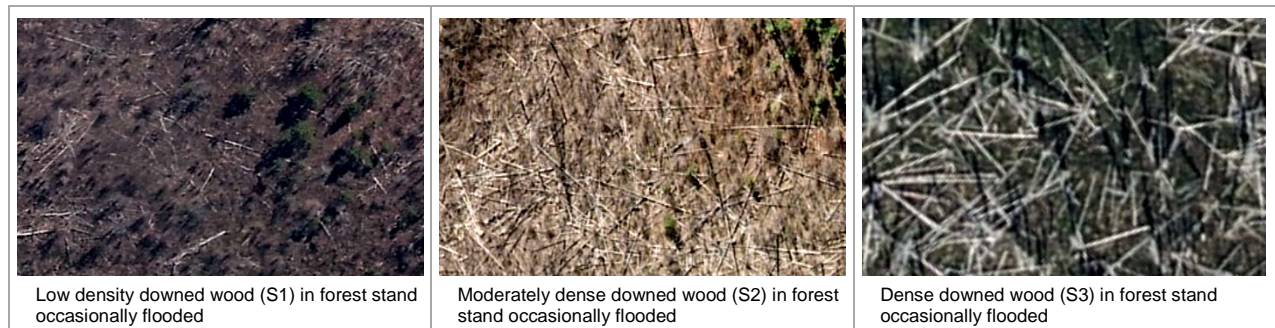
Figure 4-5 Examples of various classes of downed wood in forest stand occasionally flooded

Stands of dead or living trees remain at the periphery of the reservoir above the main ribbons of woody debris and the upper limit of the main drawdown zone. These stands are located in flat areas that are occasionally flooded during the maximum level of the reservoir. They are seasonally affected by waterlogging and ice, mainly in the area close to beached ribbons. As a consequence, downed trees can be observed where natural agents are more effective.

The forested areas have been delineated and characterized in accordance with the density of their standing trees (SL, SM and SD) or in accordance with the density of large woody debris on the ground (S1, S2 and S3; Table 4-1 and Figure 4-5). Realignment of logs in the form of discontinuous ribbons by wave actions is observed in the areas containing downed wood, mainly for the denser class (S3).
