Peace Project Water Use Plan

GMSMON-16 Williston Debris Trends

Williston Wood Debris Trend Analysis 2009-2011

Project number: 60558464

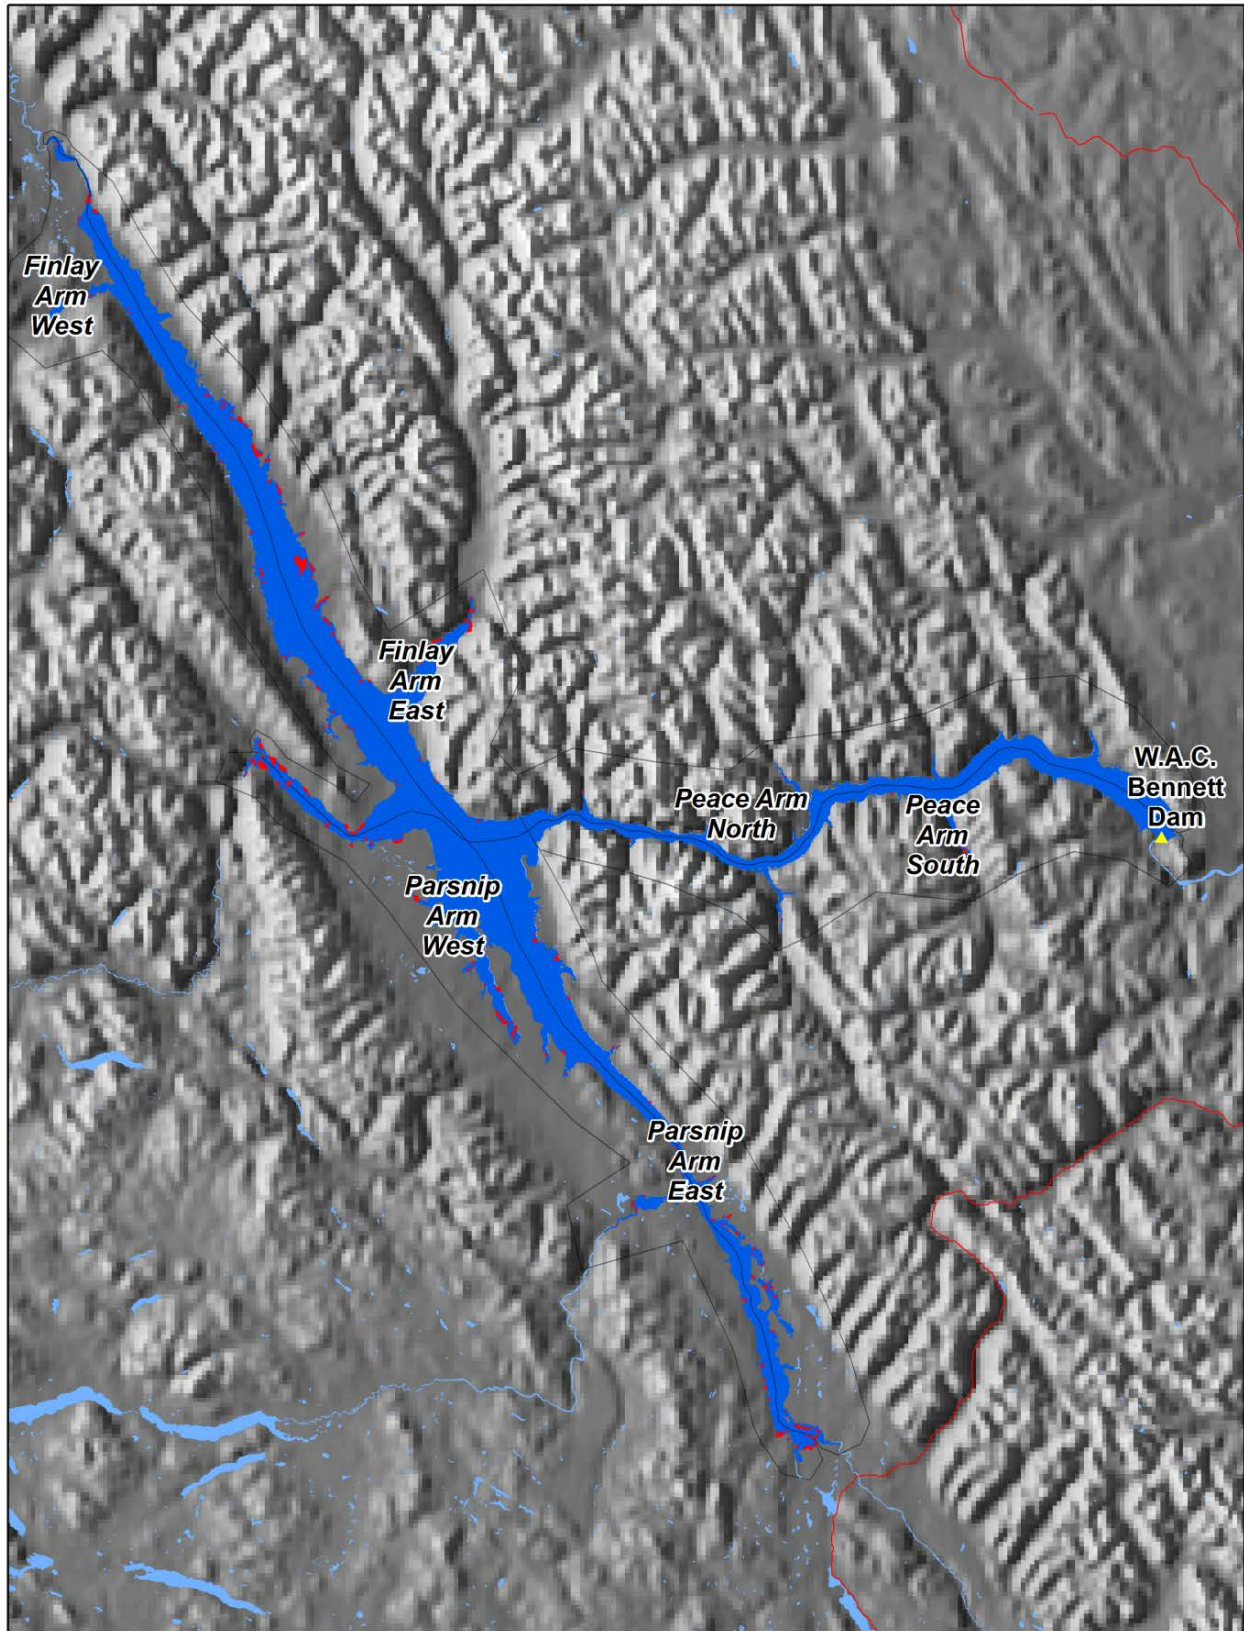
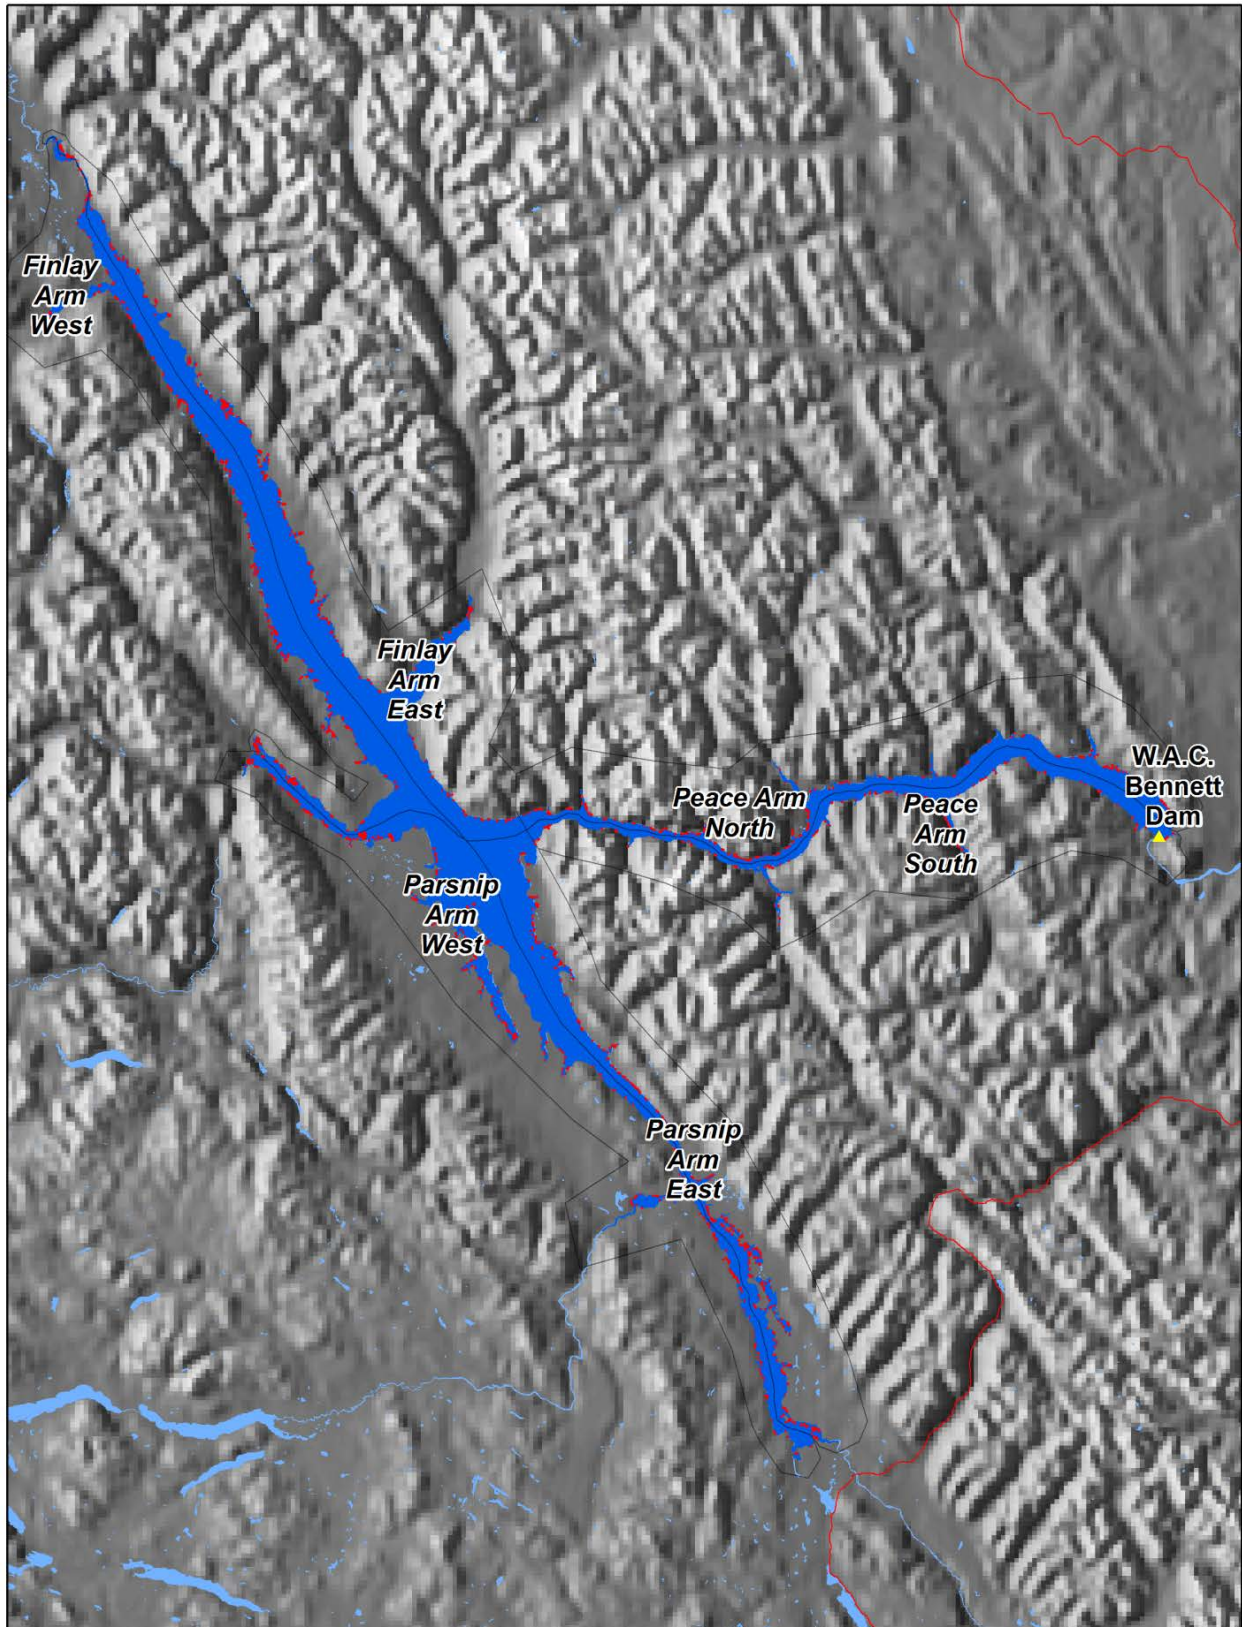
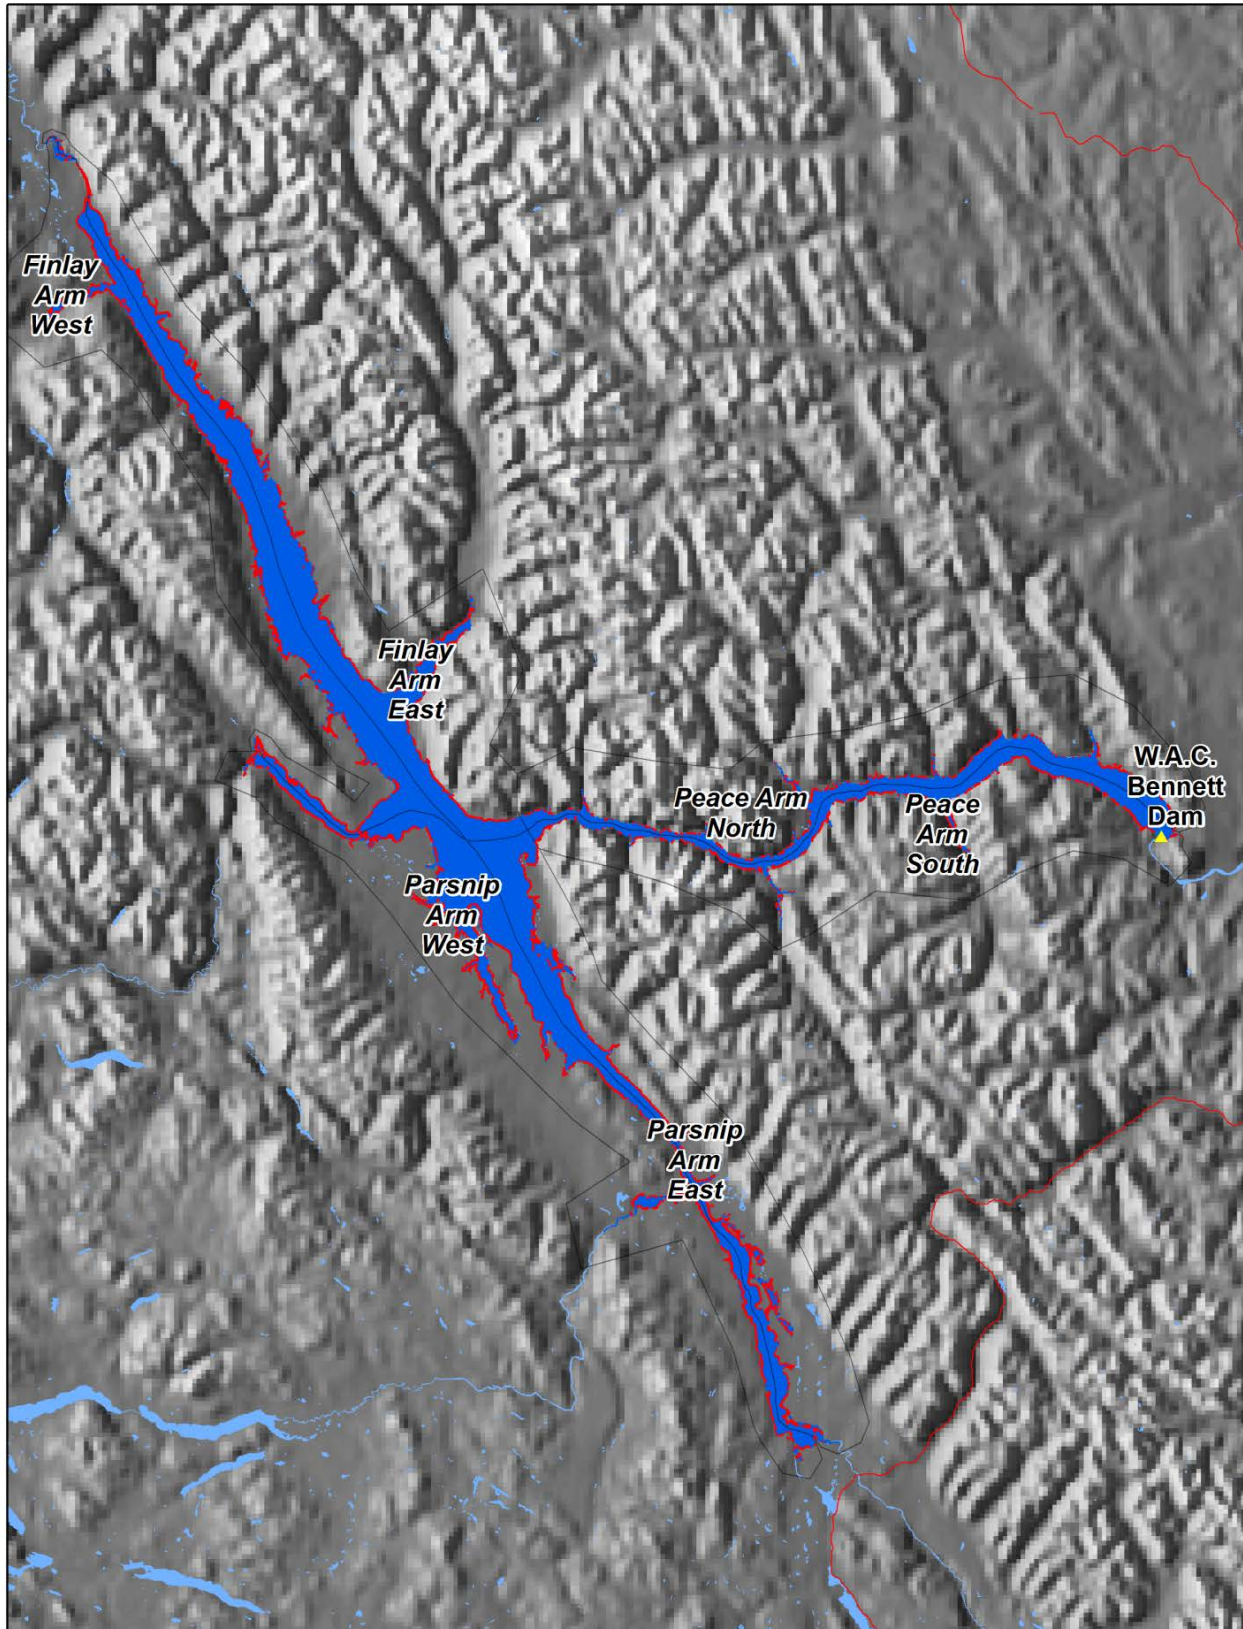
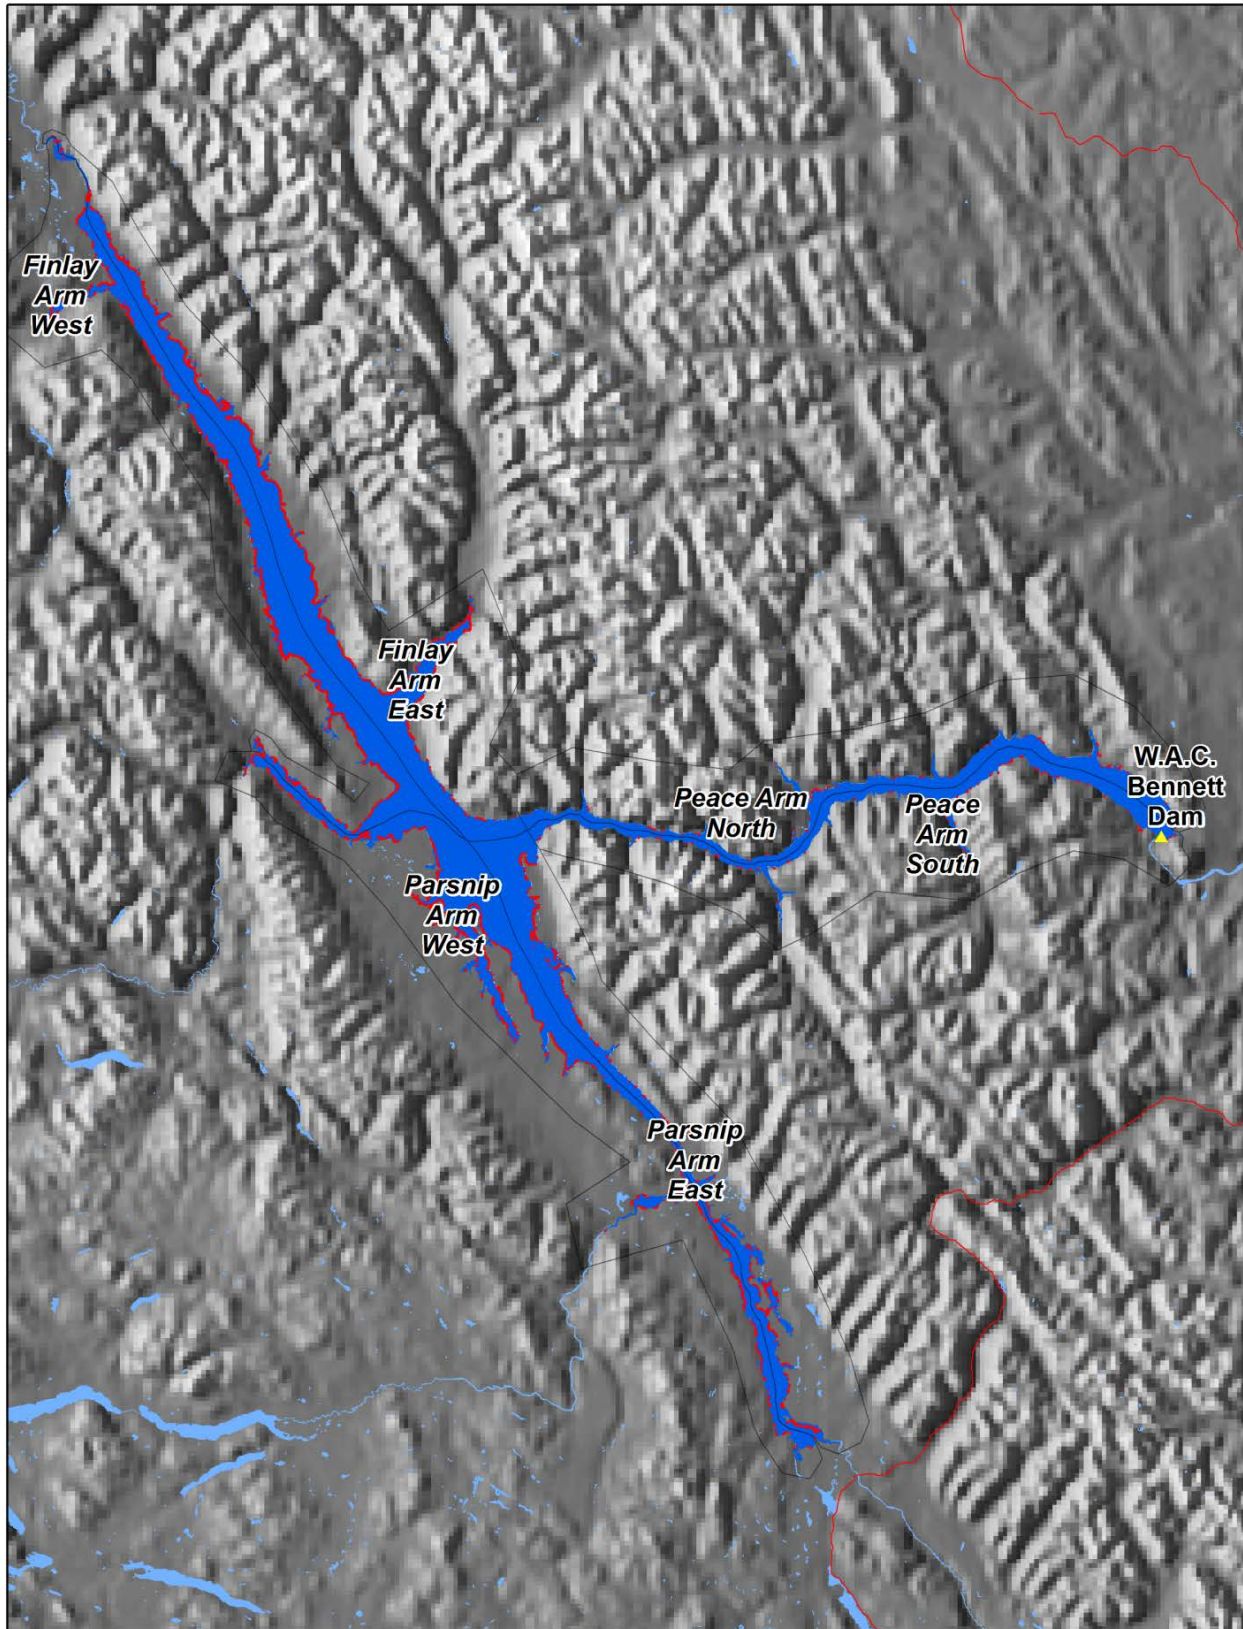
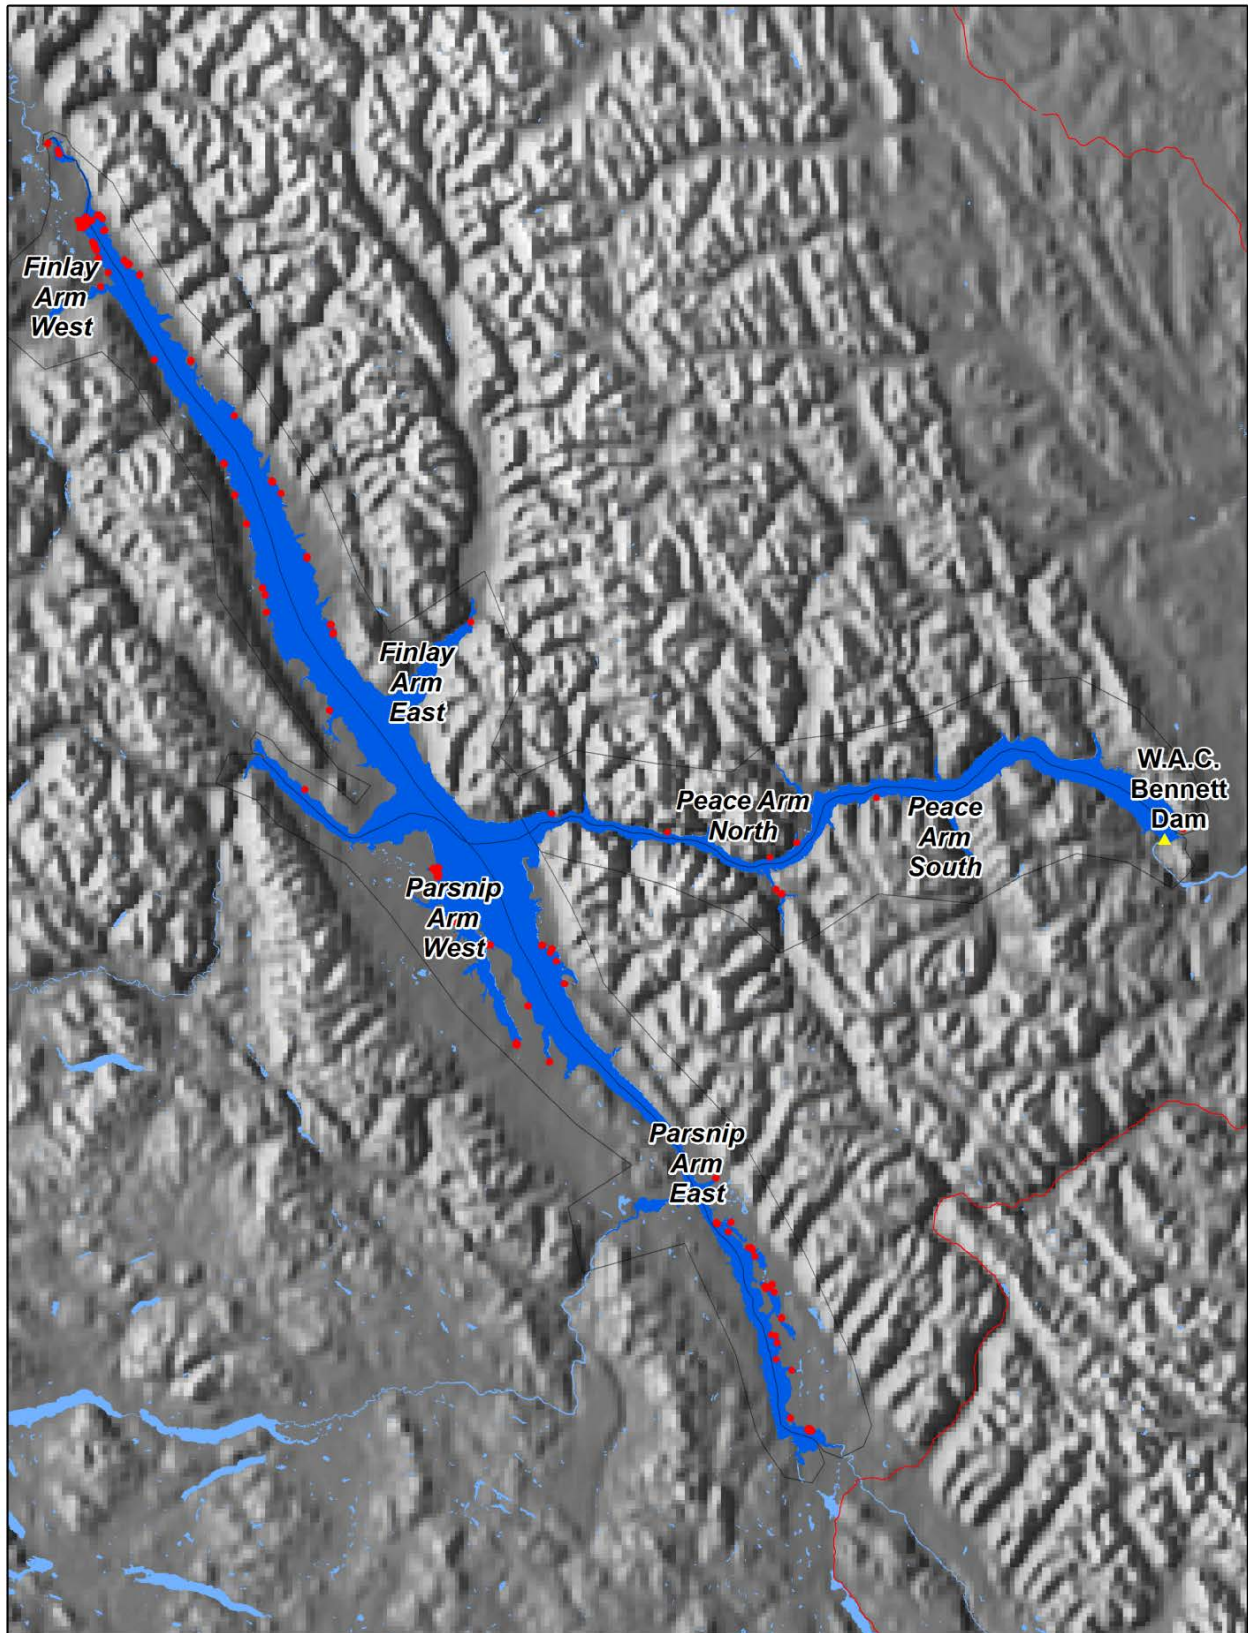
The next set of figures depicts the location of the woody debris on beach and flats (B1, B2, B3 and BF) and the floating woody debris in the Williston Reservoir (Figure 4-8, Figure 4-9, Figure 4-10, Figure 4-11 and Figure 4-12). Figure 4-8 shows the Scattered woody debris on flats (BF). The Scattered woody debris on flats are more frequent in Finlay Arm East, Parsnip Arm West and Finlay Arm West, while almost absent in Peace Arm North and South. Scattered or low density beached woody debris (B1) covers approximately the same total area in Finlay Arm East and West, and in Parsnip Arm East and West (Figure 4-9). It is important to mention that the class B1 has been added in the revised baseline for characterizing more accurately the density of woody ribbons.

Although the Moderately dense woody ribbons on beach (B2) totals larger areas than the Scattered woody debris on flats (BF) or along the beach (B1), its relative distribution remains very similar: this type of debris is more frequent in Finlay Arm East and West, then in Parsnip Arm East and West (Figure 4-10). For Peace Arm South, the Moderately dense woody ribbons on beach (B2) are about twice more frequent than the Scattered or low density beached woody debris (B1), and only 20 % more frequent in the North sector. The same pattern is observed for the Dense woody ribbons on beach (B3), although they are more abundant in Finlay Arm East (Figure 4-11). Finally, Floating woody debris (F1, F2 and F3 presented together) are located throughout the Reservoir (Figure 4-12).

Figure 4-8 Location of Scattered woody debris on flats (BF) in the Williston Reservoir in 2009

Figure 4-9 Location of the Scattered or low density beached woody debris (B1) in the Williston Reservoir in 2009

Figure 4-10 Location of Moderately dense woody ribbons on beach (B2) in the Williston Reservoir in 2009

Figure 4-11 Location of Dense woody ribbons on beach (B3) in the Williston Reservoir in 2009

Figure 4-12 Location of Floating woody debris (F1, F2 and F3) in the Williston Reservoir in 2009

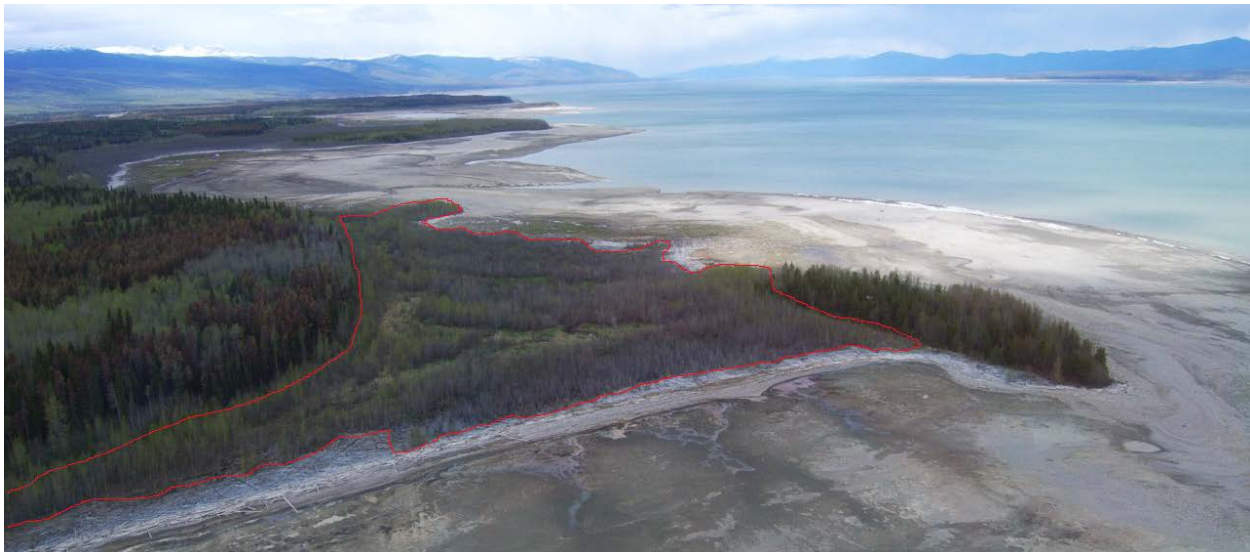
Figure 4-13 Forest stand (residual trees) periodically flooded in Williston Reservoir

The extent of the forest stands (Figure 4-13) is presented in Table 4-6, Figure 4-14 and Figure 4-15. The majority of the stands remaining in the flooded area are of low density (SL), although moderately dense stands (SM) are also present. In all cases, forest stands are more frequent in the West region of the reservoir, more specifically in Finlay Arm West, followed by Parsnip Arm West (Figure 4-16). The East sector of Finlay Arm also contains forest areas, but at a lower degree. However, due to the small size of Parsnip Arm West when the forest cover is expressed as a ratio of the total area or in relation to the coastline length the amount of forest cover is greater (Figure 4-15).

The unharvested forest stands in the reservoir are gradually affected by the waterlogging periods. Downed trees are frequently observed close to ribbons of woody debris, along tributaries and in lower depressions remaining flooded for longer periods. As a consequence, fallen trees are observed where natural agents (wind, wave or ice) are more effective. In general, about 25 % of the remaining flooded forests contain fallen trees in 2009. These woods would probably be mobilized and transported to the main waterbody. Some realignment of fallen stems is already observed in stands where the degradation is at moderate or high levels (S2 and S3). The other phenomenon that could affect the forest stands and that participates in the recruitment of woody debris is related to the shoreline erosion. This process has been characterized for the 2009 baseline. Shoreline erosion is active in the Williston Reservoir, based on the 2009 baseline it affects approximately 60 % of the reservoir shorelines, however based on the 2011 sample analysis this may be an over estimate (1,320 km / 2,148 km, Figure 4-17). During the 2009 baseline study, the annual shoreline retreat was established at 1.0 m, which represents an area of 132 ha per year. It is recommended that the 2018 assessment reassess the level of shoreline erosion.

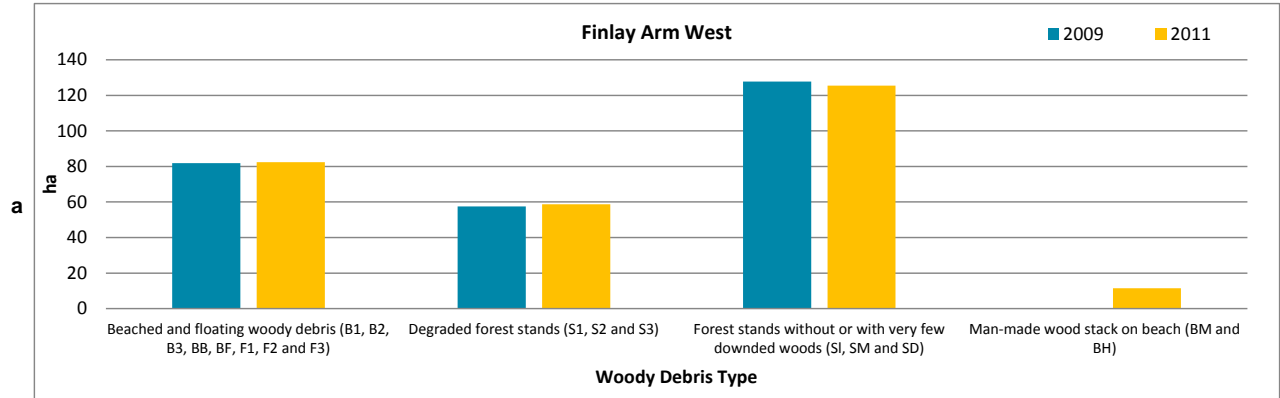
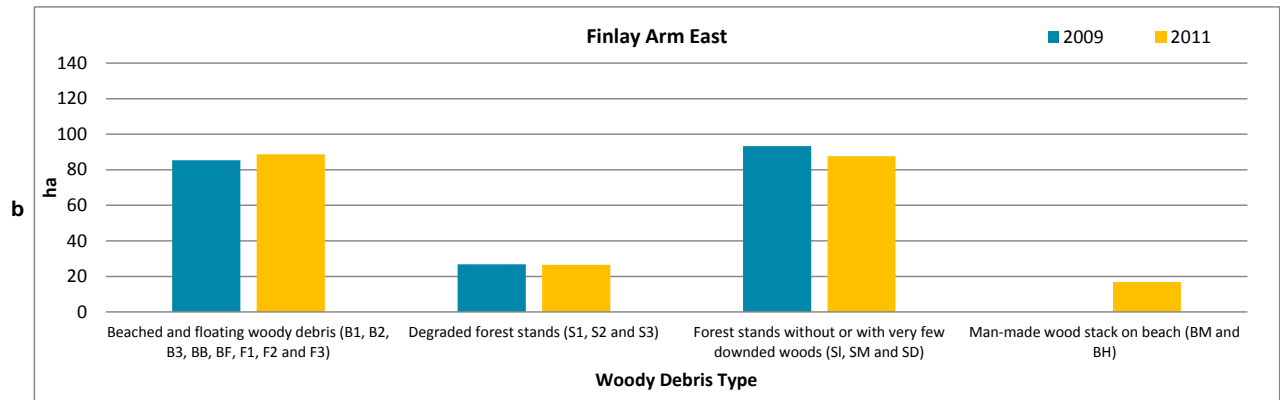
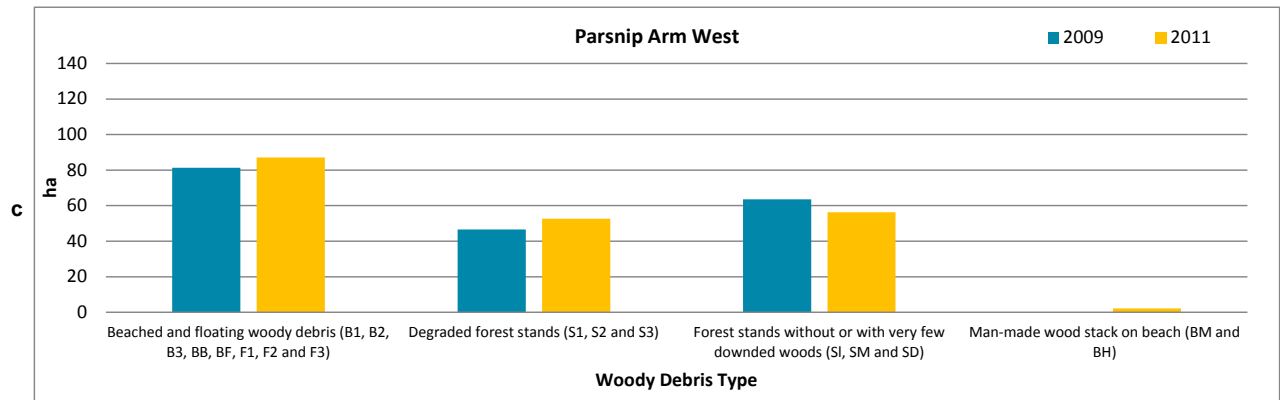
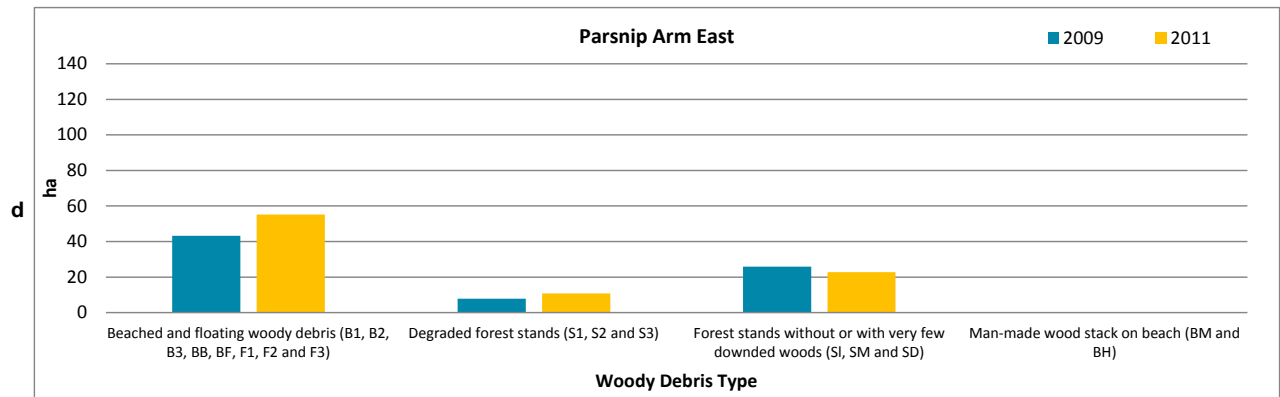
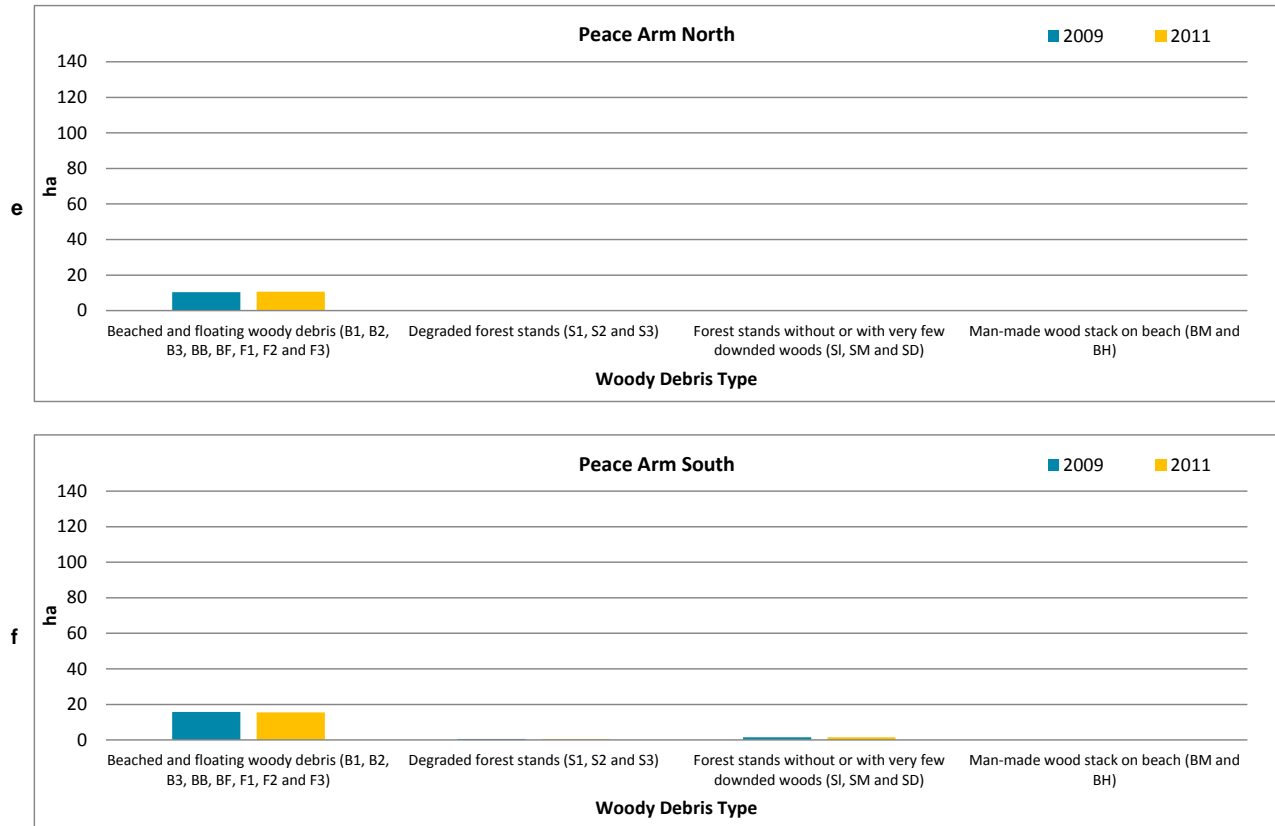
Figure 5-3 Graphs of the general trends of the dynamics of woody debris per sector, between 2009 and 2011 (including the scattered woody debris on flats (BF))

The most important changes of woody debris areas are observed in Parsnip Arm East where beached and floating debris have increased by 12 ha (Table 5-3d and Figure 5-3d). This sector is also characterized by an increase of 3 ha in the extent of degraded forest stands. In counterparts, the extent of unaffected forest stands has decreased in a similar proportion, since the areas of degraded stands were delineated from them.

Parsnip Arm West is the second sector of importance for an increase of extent of woody debris (Table 5-3c and Figure 5-3c). The extent of beached and floating debris and the degradation of forest stands have increased respectively by 5.8 and 6.1 ha. Conversely, the extent of unaffected forest stands has decreased by 7.2 ha. The overall balance in the increase of the extent of woody debris has been greatly lowered by removal activities. In fact, 2.2 ha of beached debris were converted to man-made wood stacks (Table 5-3c). This area represents about 40 % of the total increase of beached and floating debris in the sector.

Finlay Arm East is the third sector in terms of increase of 3.5 ha, for the total area of beached and floating woody debris (Table 5-3b and Figure 5-3b). However, the overall balance corresponds to a reduction of woody debris in this sector, given that a large amount of beached debris (16.9 ha) are under removal. A similar trend is observed for Finlay Arm West where 11.3 ha of beached debris are being removed, and where only 0.5 ha of beached and floating debris have been added elsewhere (Figure 5-3a and Table 5-3a).

Peace Arm North and South contain very little wood debris compared with other sectors. For both sectors no removal activities were observed. However, the overall balance for Peace Arm South indicates a total reduction of 0.23 ha (- 1.4 %). In fact, the extent of beached and floating debris was reduced by 0.25 ha, while 0.02 ha of forest stands was degraded in this sector (Table 5-3f and Figure 5-3f). For Peace Arm North, the remaining forest stands remained stable, but 0.32 ha of beached and floating debris were added (Figure 5-3e and Table 5-3e).

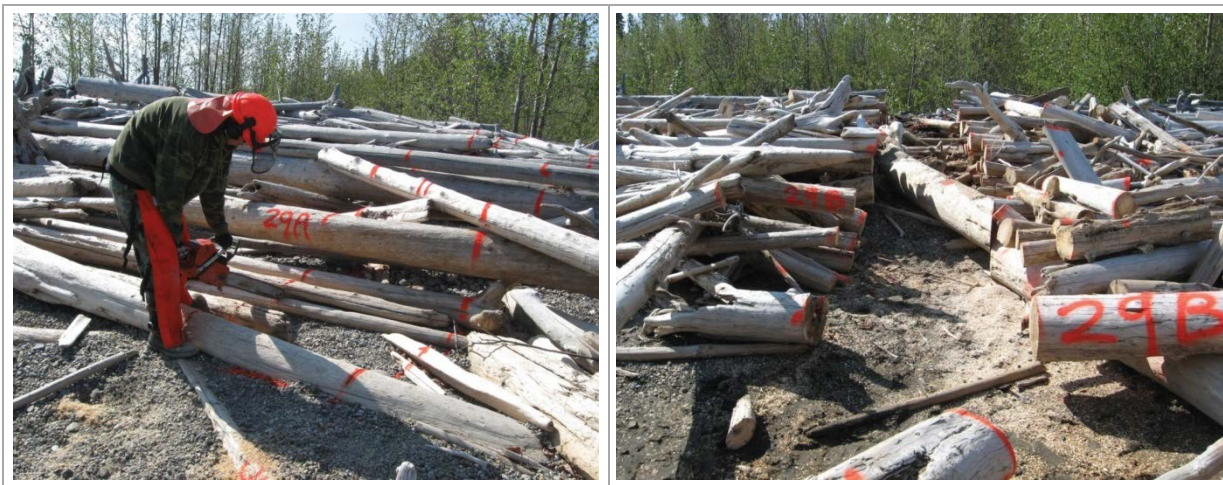
Figure 6-1 Measurement of woody debris

108 sampling plots were measured in the field, giving a precision of 92 % with a 90 % level of confidence. In general, the thickness of debris within the sample plots was less than 50 cm and the average diameter of logs was 18 cm (Table 6-1). On this basis, the m^3/m^2 ratio must be less than 1 m^3 per mapped squared meter, as illustrated in Figure 6-2.

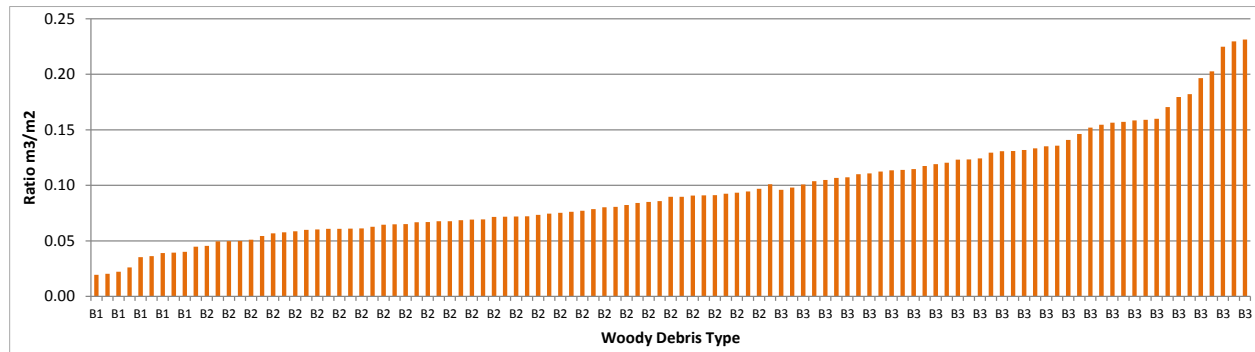
Figure 6-3 Ratio (m³/m²) obtained from the various sample plots in relation to the type of debris identified on the map

The coordinates of each sample plot was recorded in the field with a GPS. These coordinates were then displayed in ArcGIS for identifying the woody debris type to which they correspond (Figure 6-3). This procedure allowed the forester to calculate the average stock per woody debris along the coastline, that is 0.03, 0.07 and $0.14 m^3/m^2$, respectively for the revised classes B1, B2 and B3 ("scattered or low density beached woody debris", "moderately dense woody ribbons on beach" and "dense woody ribbons on beach").

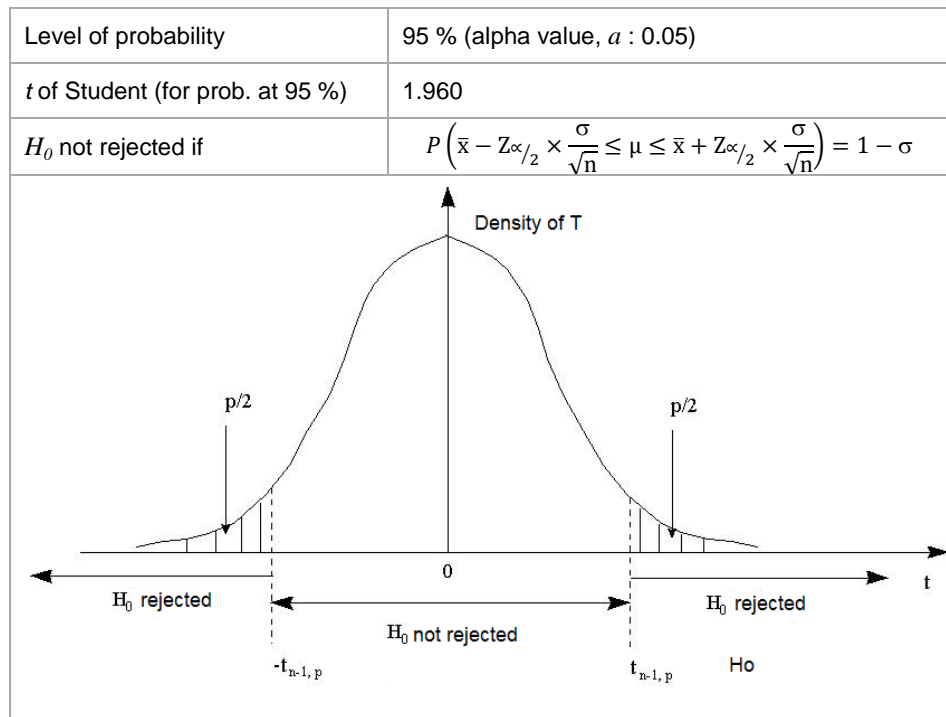
The results of the paired sample t-tests indicate that the average value of the differences of woody debris mapped in 2009 and 2011 falls outside of the range statistically defined for confirming the null hypothesis (H_0) using a $\alpha = 0.05$ (Table 8-3). Therefore, the null hypothesis can be rejected meaning that there is a significant difference between the amounts of woody debris mapped in 2009 and 2011 in the 620 sampling squares. We can conclude that the average amount of wood debris has decreased between 2009 and 2011 over the whole project area with a level of confidence of 95 %.
