**Peace River Project Water Use Plan**

**Peace Spill Protocol**

***Peace River Fish Stranding Survey Summary Report***

**March 2013**

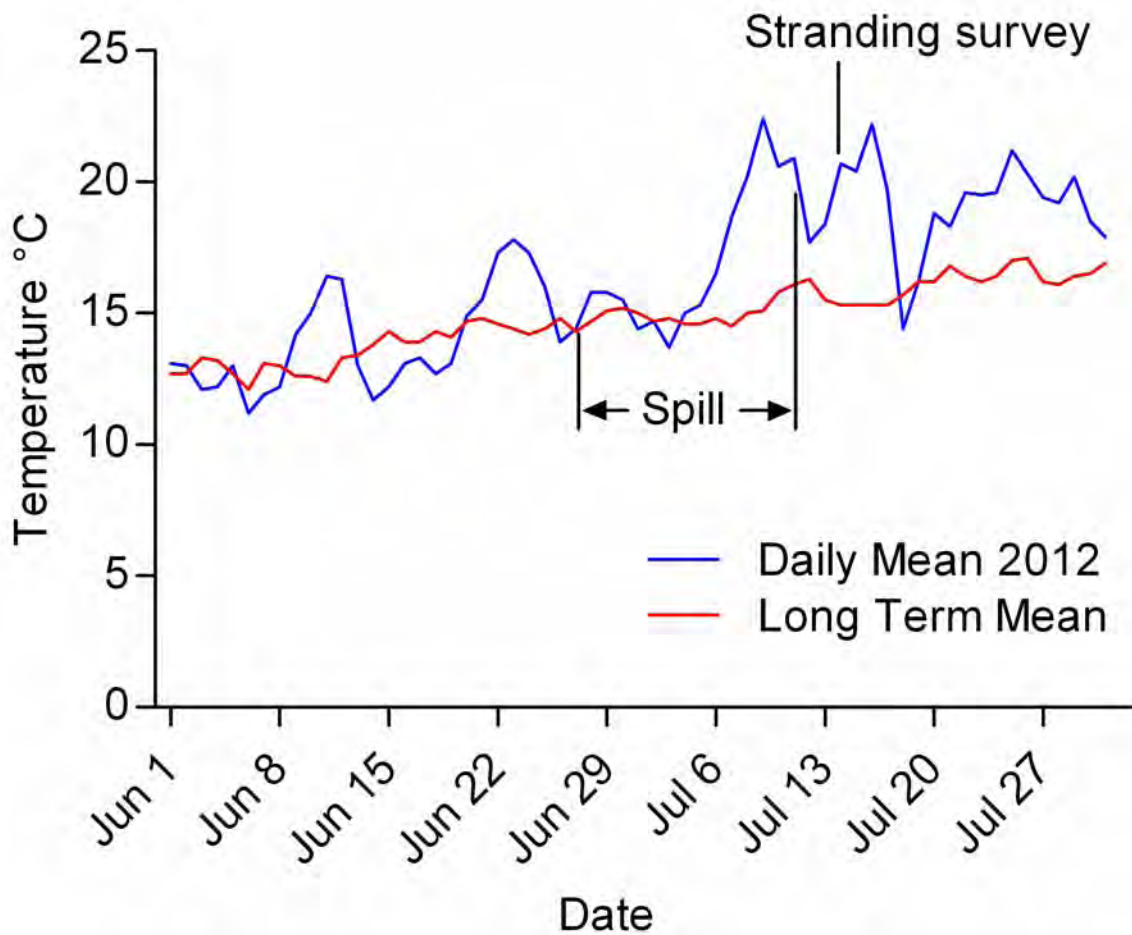
Figure 2. Daily mean temperature for June and July 2012 and the long term means in the study region. Data from Environment Canada and observed at the Fort St. John Airport weather station (Station name: Fort St. John A).

Weather conditions during the stranding survey were clear and dry with above average temperatures. Air temperatures were average during the first half of the spill and above average during the second half of the spill (Figure 2). Air temperatures also remained above average for the remainder of July following the stranding survey (Figure 2). Precipitation was above the 20 year average for values recorded in June and below average in July in the region (Table 4). At the Mackenzie weather station precipitation was approximately 50% above normal in June and

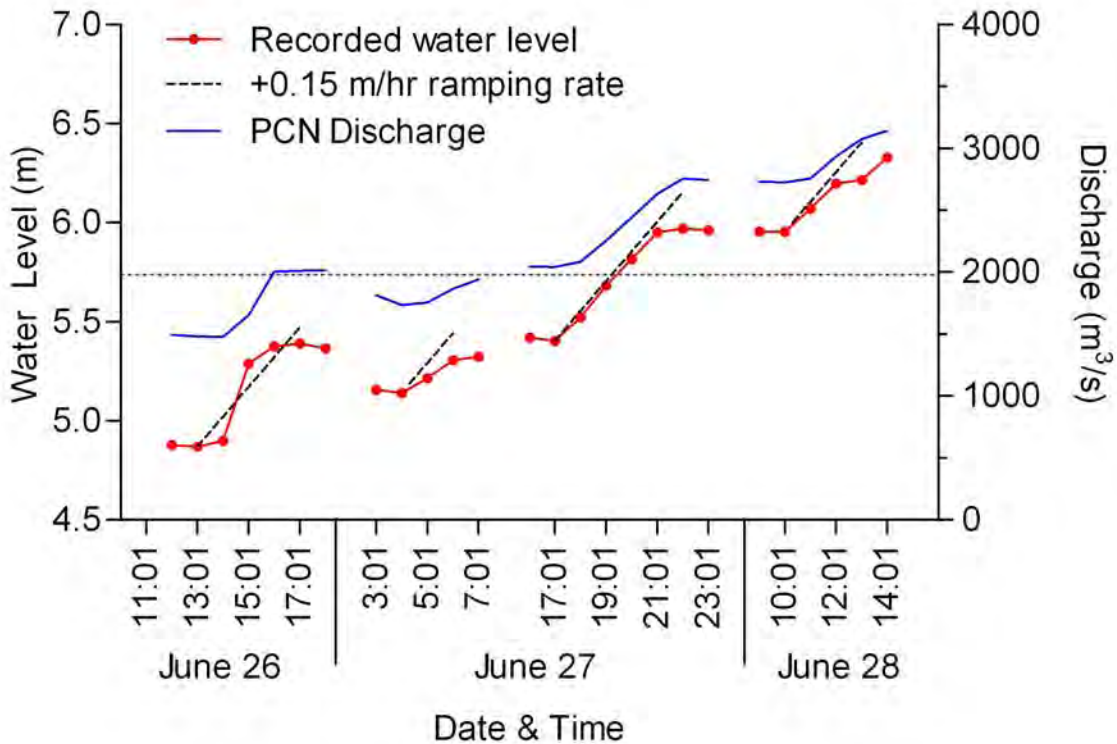
Figure 3. Water level increases observed at Hudson's Hope at the start of the spill. The black lines represent the spill ramping rate of +0.15 m/hr. Only periods with large increase in water level are shown. The horizontal line indicates the maximum normal discharge of 1982 m<sup>3</sup>/s. Data from the Water Survey of Canada stations 07EF001 and 07EFX01.

The spill began on the morning of June 27 when the discharge from the PCN first exceeded 2,000 m<sup>3</sup>/s and continued until the morning of July 11, 2012, a total of 15 days (BC Hydro). The requirement under the Peace Spill Protocol to conduct the stranding survey was not triggered until June 29 when the PCN discharge had exceeded 2,000 m<sup>3</sup>/s for two days. Ramping rates at the beginning and end of the spill were consistent with the Peace Spill Protocol licensed rates of +0.15 m/hr and -0.10 m/hr change observed at Hudson's Hope (Figure 3 and 4). Increases in water occurred over a period of three days while flow was decreased over the course of a single day. The discharge from PCN during the spill ranged from 2,005 m<sup>3</sup>/s to 3,289 m<sup>3</sup>/s. The highest and lowest values occurred early in the spill with the discharge at PCN being consistently close to 2,700 m<sup>3</sup>/s (median 2678 m<sup>3</sup>/s) for most of the spill duration (BC Hydro). This was reflected in the discharge and water levels observed at the downstream Water Survey of Canada hydrometric stations at Hudson's Hope (Peace River at Hudson Hope [07EF001 and 07EFX01]) (Figure 5) and above the Pine River (Peace River above Pine River [07FA004]) (Figure 6).

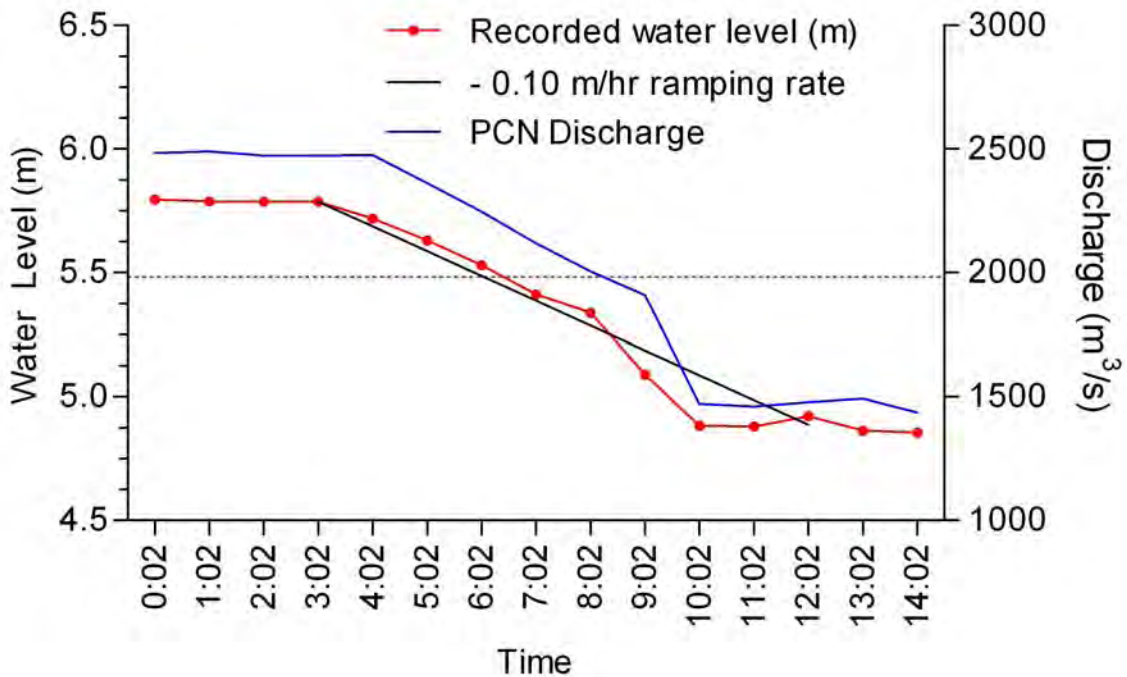
Figure 4. Water level decreases observed at Hudson's Hope at the end of the spill on July 11, 2012. The black line represents the spill ramping rate of -0.10 m/hr. The horizontal line indicates the maximum normal discharge of 1982 m<sup>3</sup>/s. Data from the Water Survey of Canada stations 07EF001 and 07EFX01.

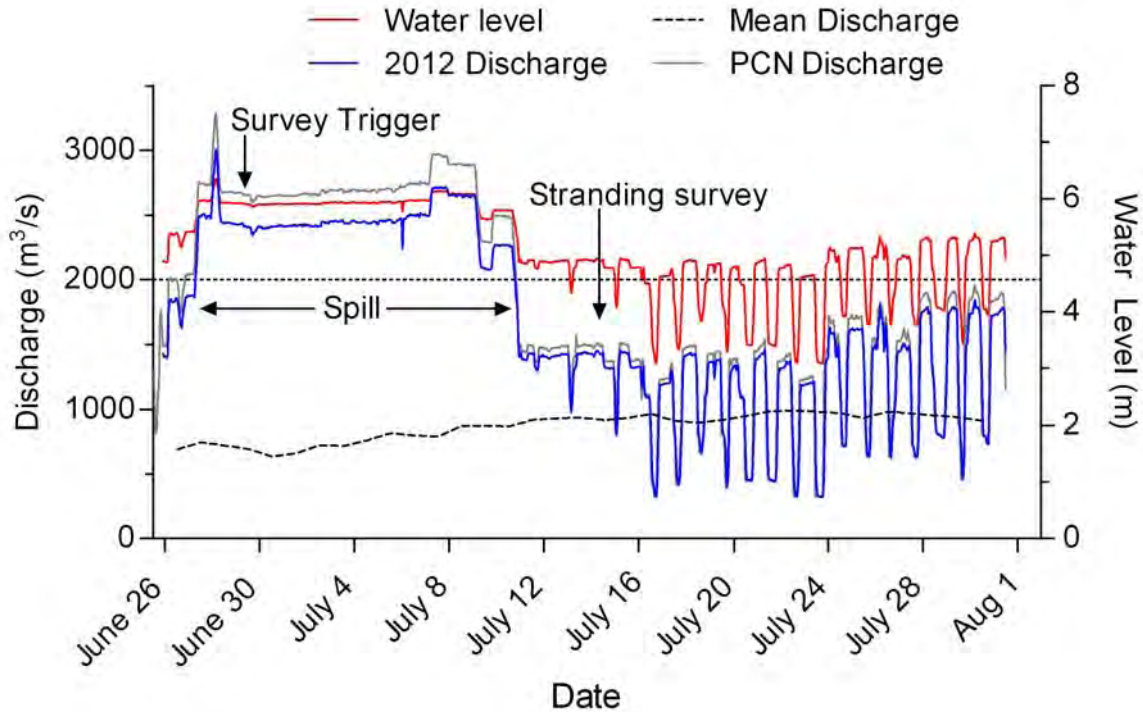
**Figure 5. Discharge and water level in the Peace River at Hudson's Hope during and after the spill including the average discharge for this period and PCN discharge. Data are from the Water Survey of Canada stations 07EF001 and 07EFX01 and BC Hydro. Water level and 2012 discharge are hourly values. The mean discharge is the mean daily discharge from 1980 – 2010 (1996 excluded). No June 2012 data was available for these stations for the period prior to the spill.**

Water levels in the Peace River at Hudson's Hope during the spill ranged from 5.14 – 6.35 m with an average level of 5.88 m (median 5.93 m) (Figure 5). Water levels at this station ranged from 3.09 – 5.38 m after the spill with a mean level of 4.61 m (median 4.81 m) (Figure 5). Water levels at the downstream end of the study area (Peace River above Pine River [07FA004]) during the spill ranged from 2.91 – 4.20 m with an average level of 3.63 m (median 3.66) (Figure 6). At the time of the stranding survey flows had returned to within normal values but without the fluctuation typical of normal operations (Figure 5 and 6). Discharge ranged from 1,408 – 1,450 m<sup>3</sup>/s at Hudson's Hope and 1,037- 1,663 m<sup>3</sup>/s above the Pine River during the fish stranding survey. The water levels during the stranding survey ranged from 4.89 – 4.94 m at Hudson's Hope and 1.39 – 2.19 m above the Pine River. Water and spill levels observed during the stranding survey were consistent with these values with the spill level estimated to be one to two meters above the water level at the time of the survey, depending on the location.

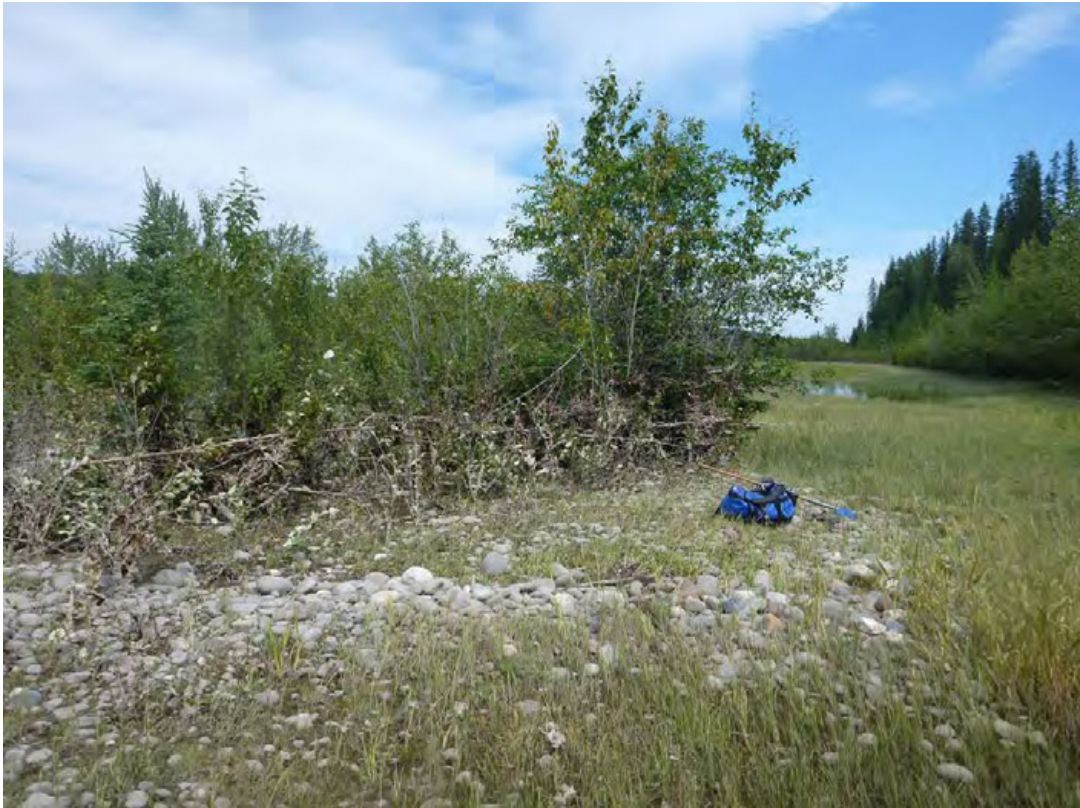
**Photo 1. Rafted debris near Pool A, Stratum 1.**

The flood signs observed in all three strata during the stranding survey included rafted debris (leaves, vegetation and small woody debris), bent vegetation, and uniform deposition of a sediment film on the substrate and vegetation (Appendix 5). In stratum 3, downstream of the Halfway River, additional flood signs included areas with extensive sediment deposition and large woody debris (LWD) jams. The LWD jams were a combination of new debris and a remobilization of existing LWD. Some of the observed LWD may have originated from the Halfway and Moberly Rivers during high flows in early June. High flows in the Halfway and Moberly Rivers are also the likely source of the large sediment deposits observed in Stratum 3 that were not present in either Strata 1 or 2, located upstream of the Halfway River.

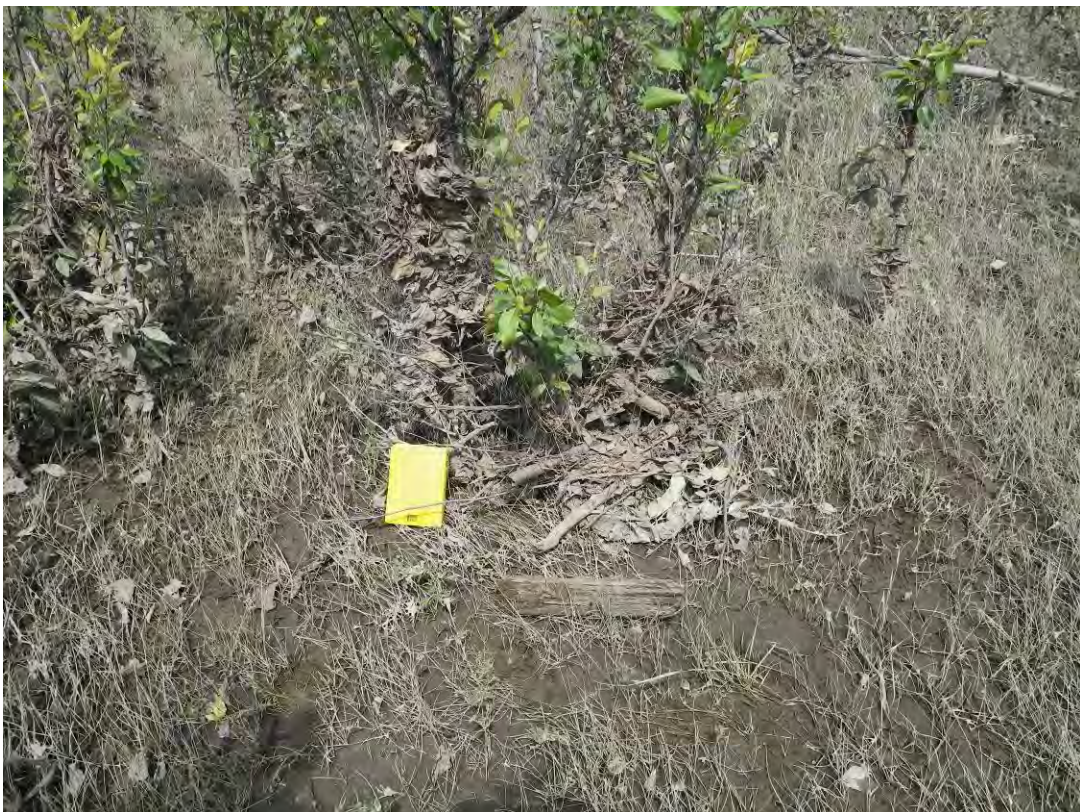
**Photo 2. Rafted debris on Transect 31, Stratum 2.**

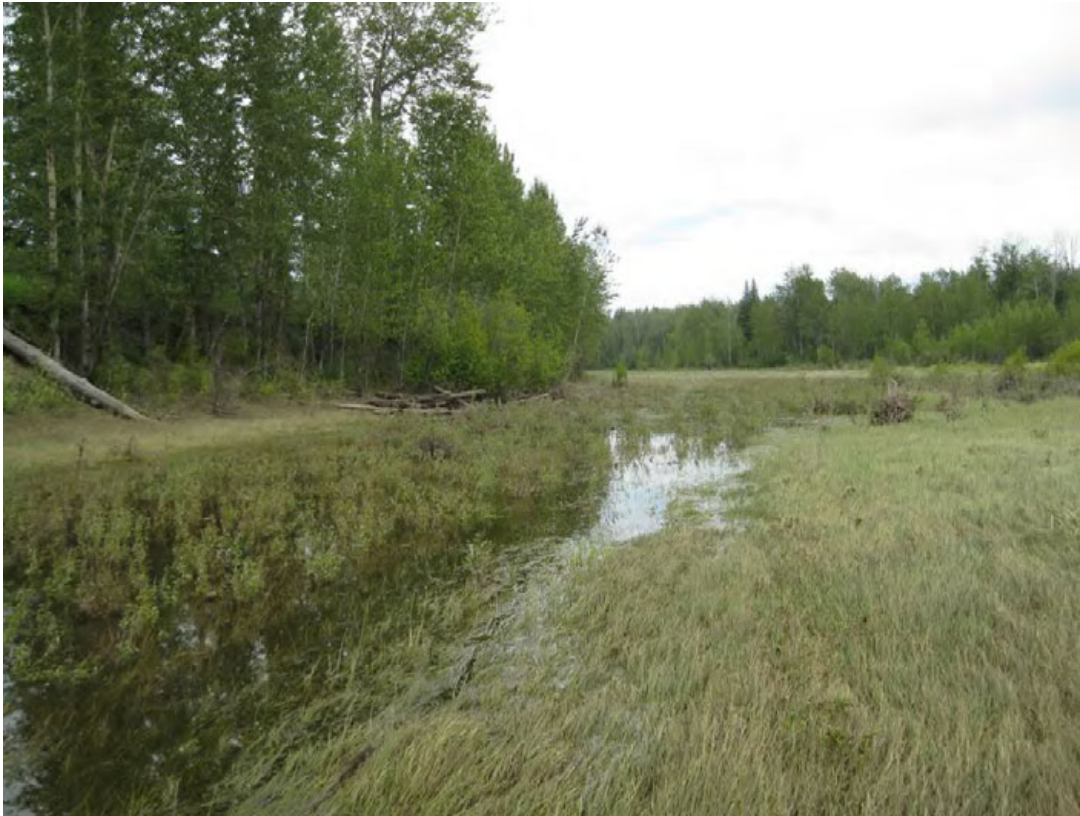
**Photo 3. Bent vegetation in a flooded side channel on Transect 59, Stratum 3.**

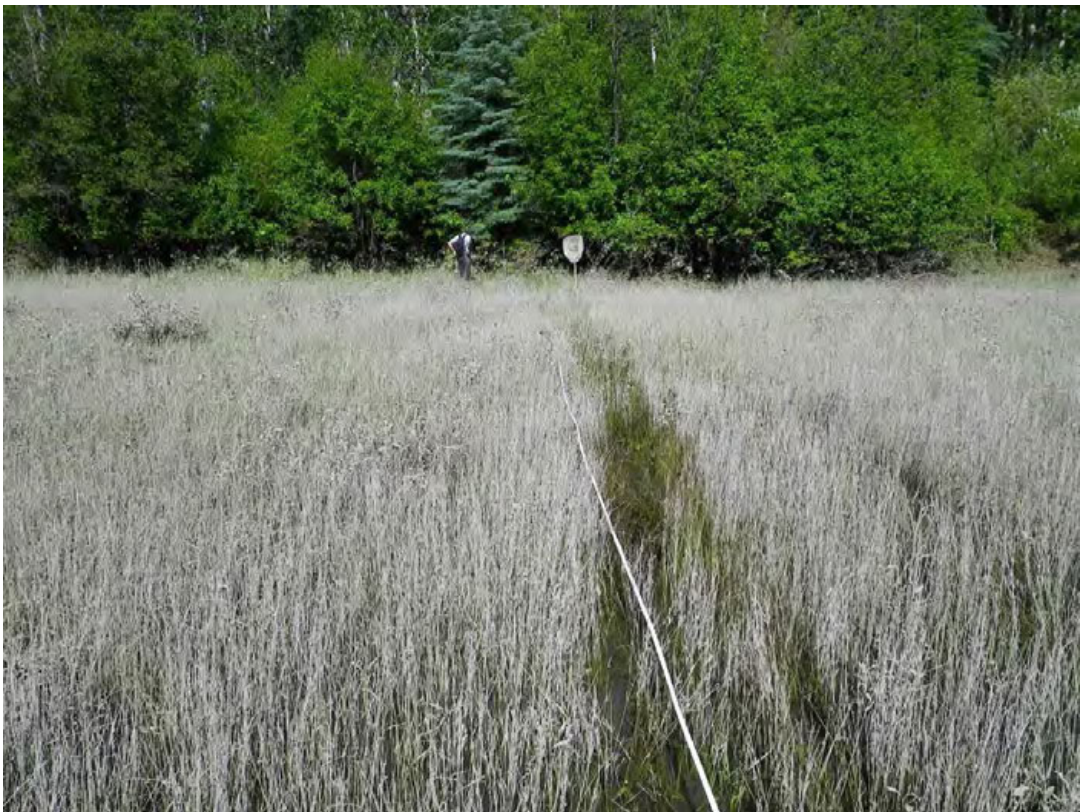
**Photo 4. Sediment film on sedges at Transect 25, Stratum 2.**

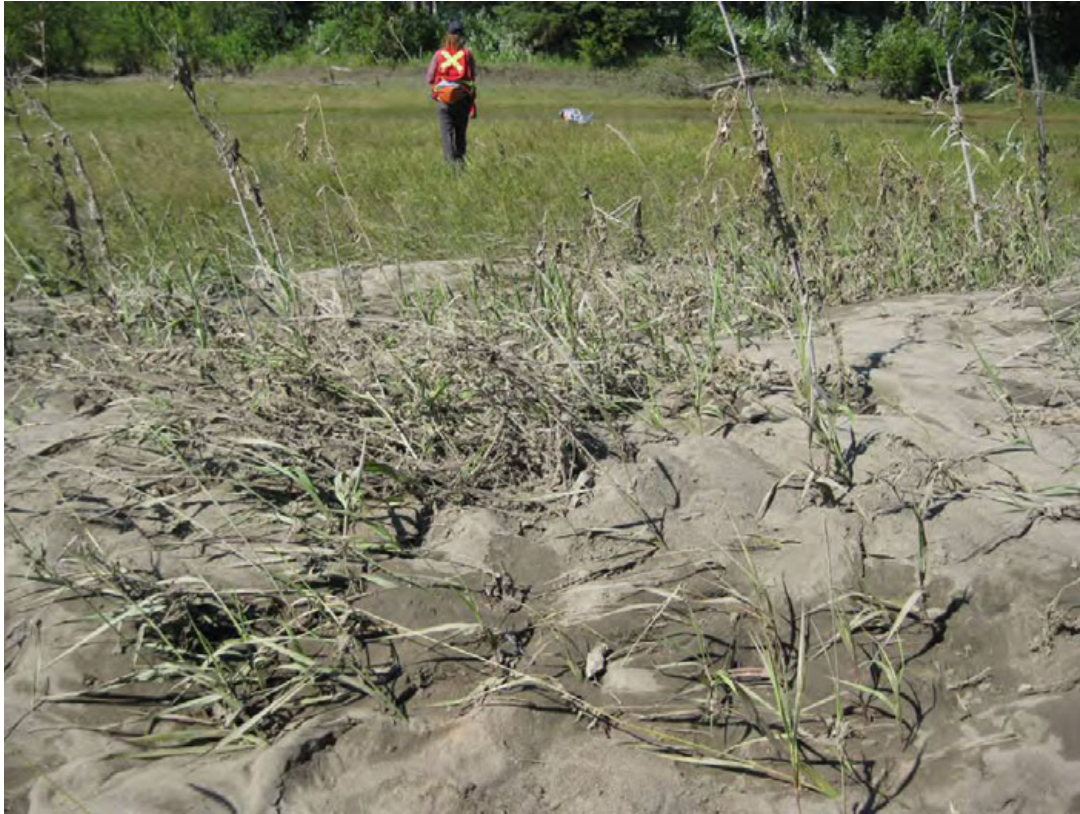
**Photo 5. Sediment deposition on Transect 69, Stratum 3.**

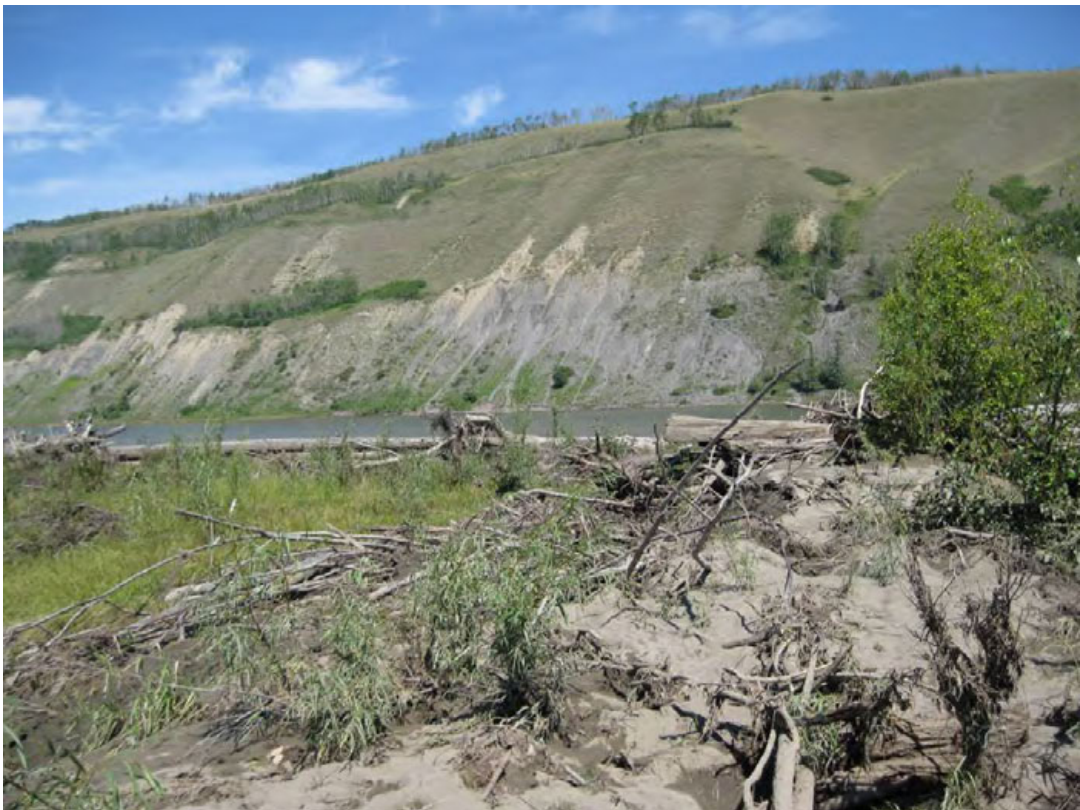
**Photo 6. Sediment deposition and LWD near Transect 70, Stratum 3.**

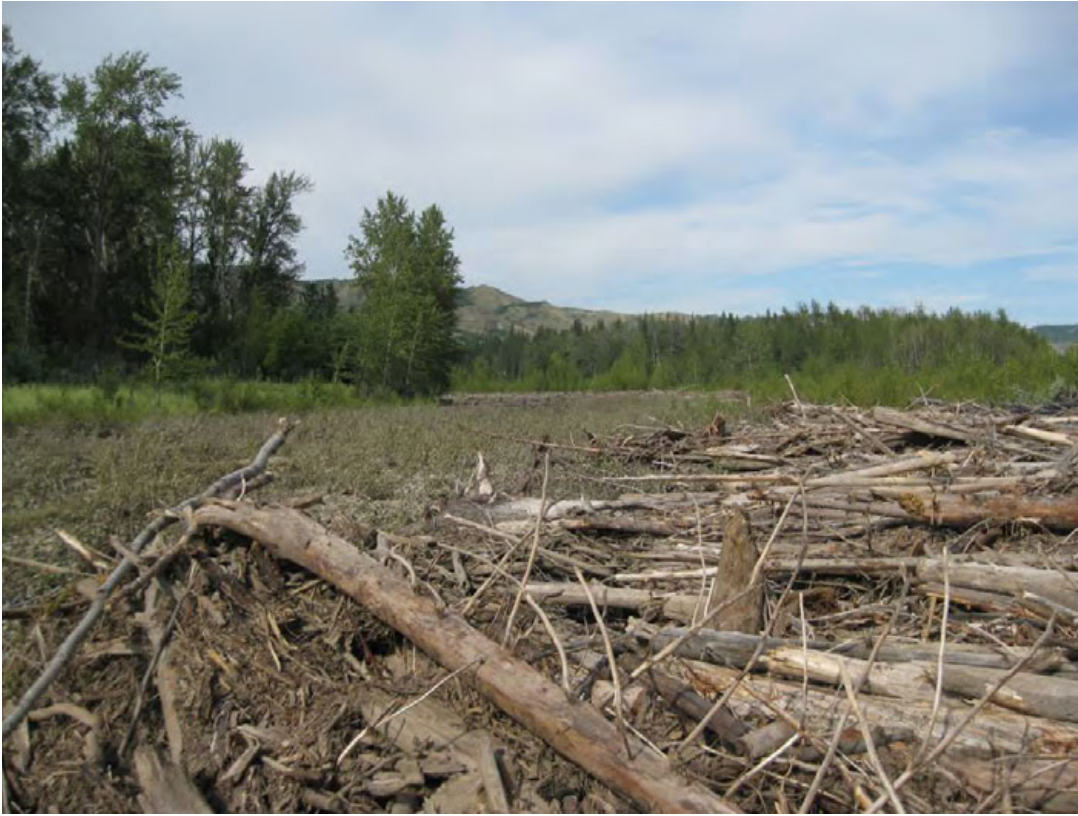
**Photo 7. Recently deposited LWD near Transect 61, Stratum 3.**
