**Peace River Project Water Use Plan**

**Peace River Side Channel Monitoring**

**Reference: GMSMON-7**

## GMSMON-7 PEACE RIVER SIDE CHANNEL MONITORING 2013 STUDY

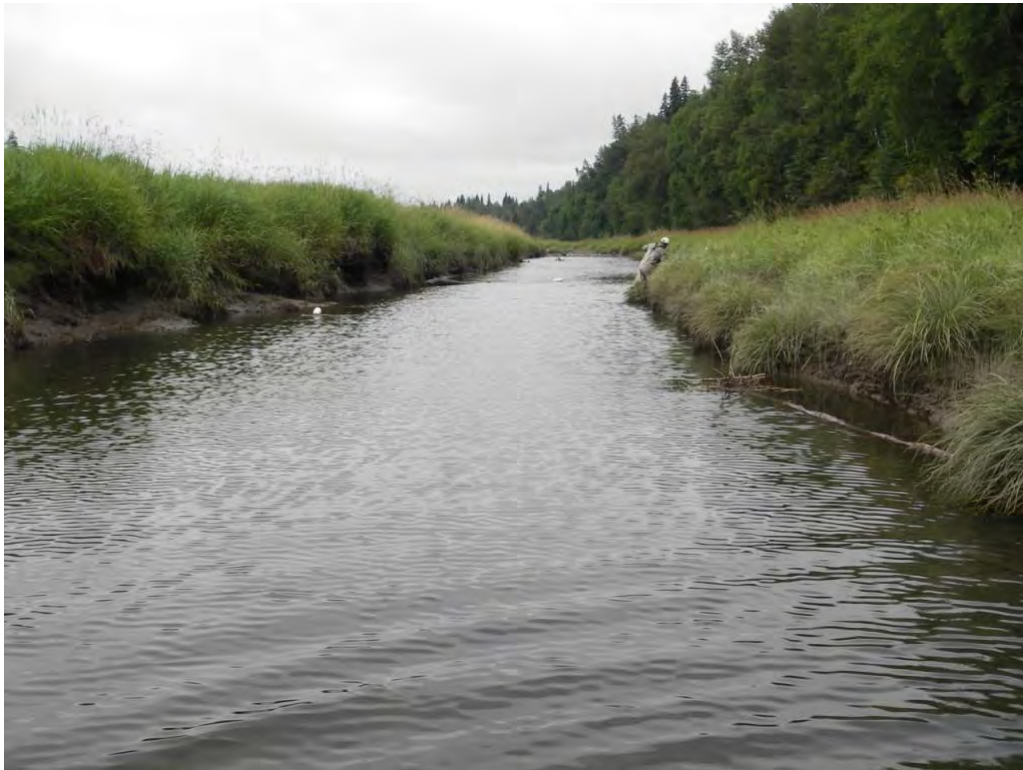
**Photo 1** Example of Flat habitat in Side Channel 32L.

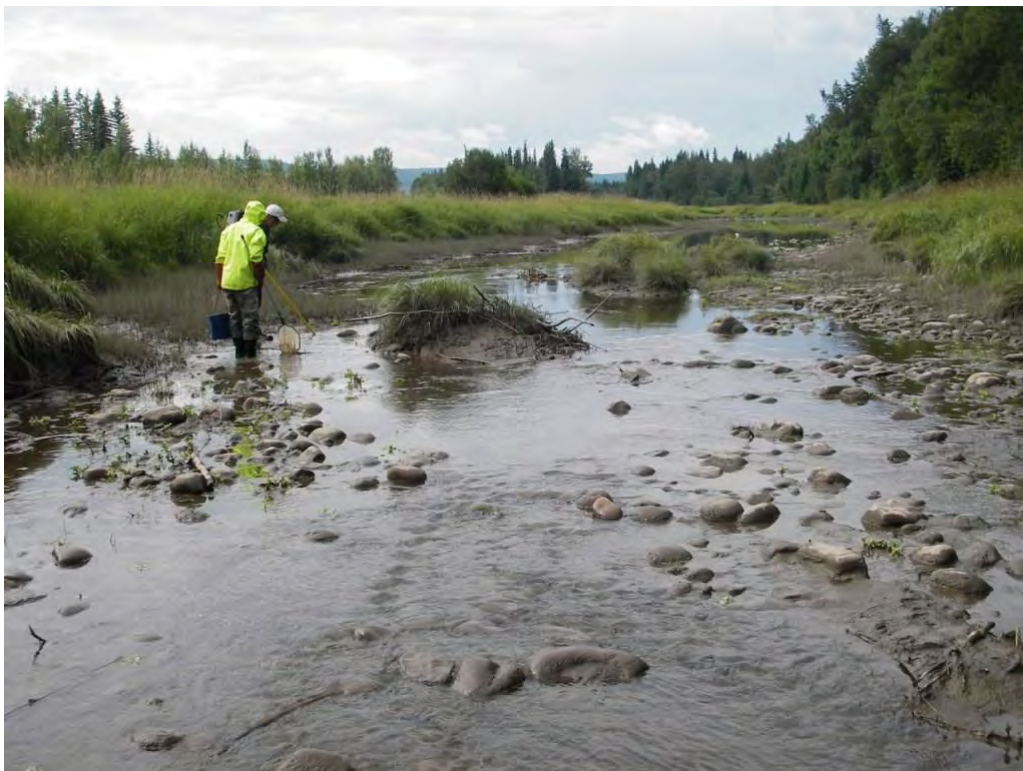
**Photo 2** Example of Riffle habitat in Side Channel 32L.

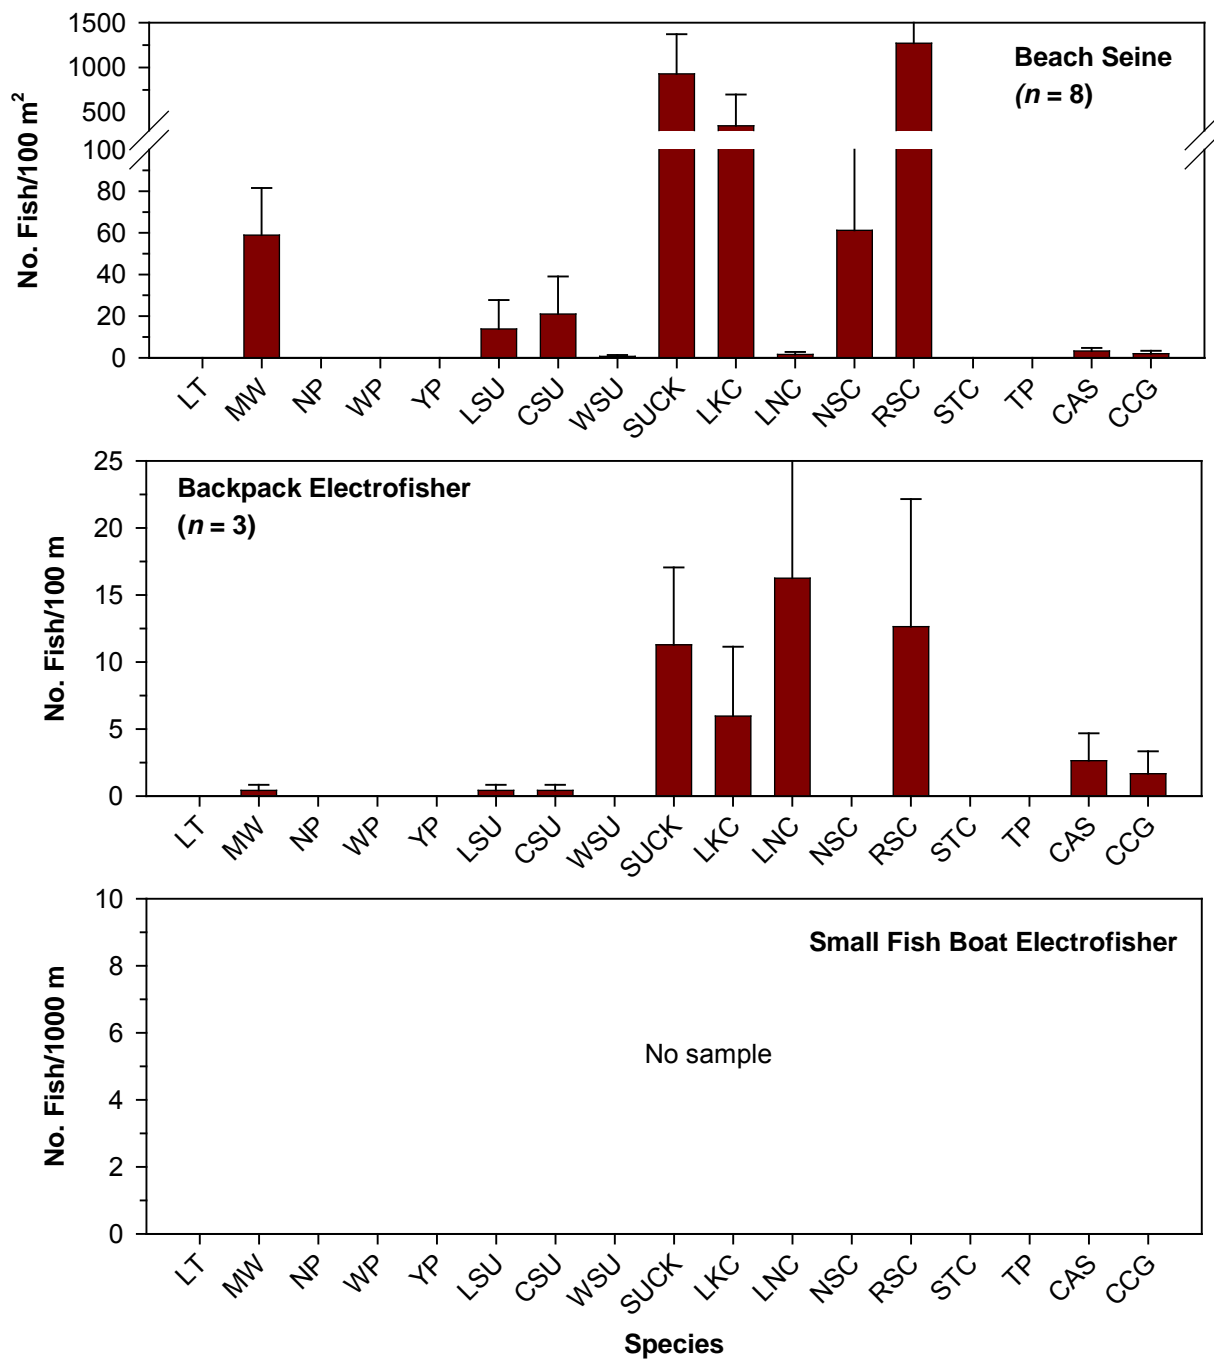
**Figure 4 Average ( $\pm$  SE) catch rates of fish species/groups in Side Channel 32L.**

Mean backpack electrofisher catch rates for all species were low ( $\leq 16$  fish/100 m). Similar to the beach seine results, Redside Shiner and unidentified young-of-the-year suckers were among the more abundant species. The highest average catch, however, was recorded for Longnose Dace (16 fish/100 m). In the sculpin group, Prickly Sculpin and Slimy Sculpin were not abundant (< 3 fish/100 m<sup>2</sup>).

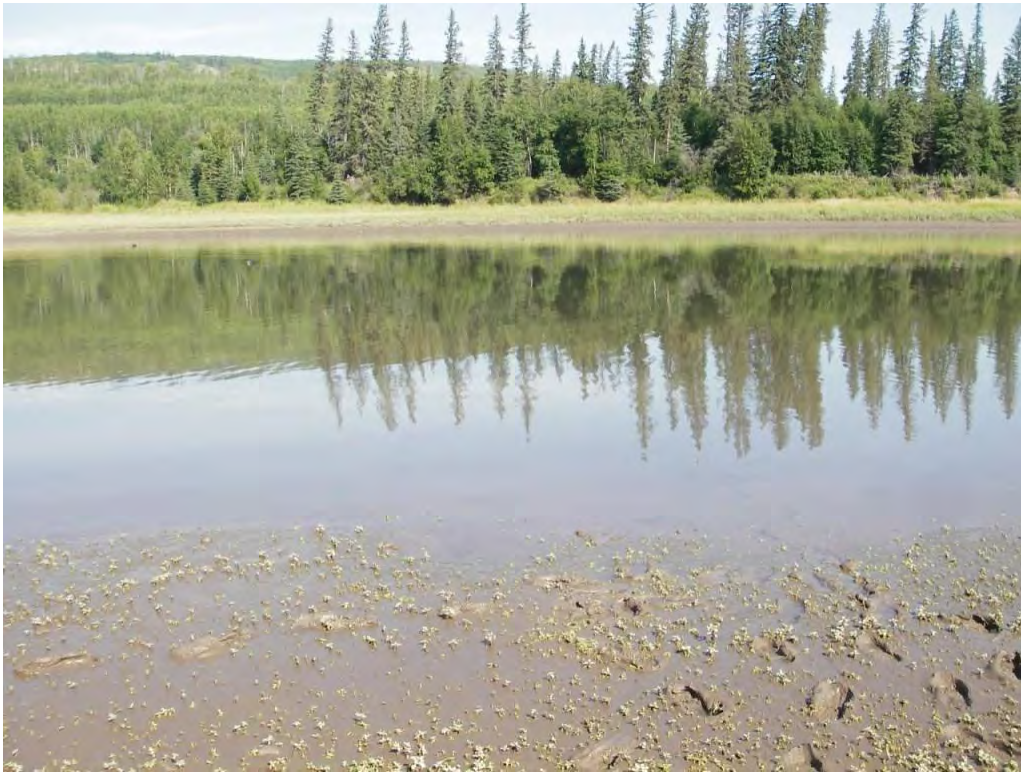
**Photo 3** Example of Flat habitat in Side Channel 40L.

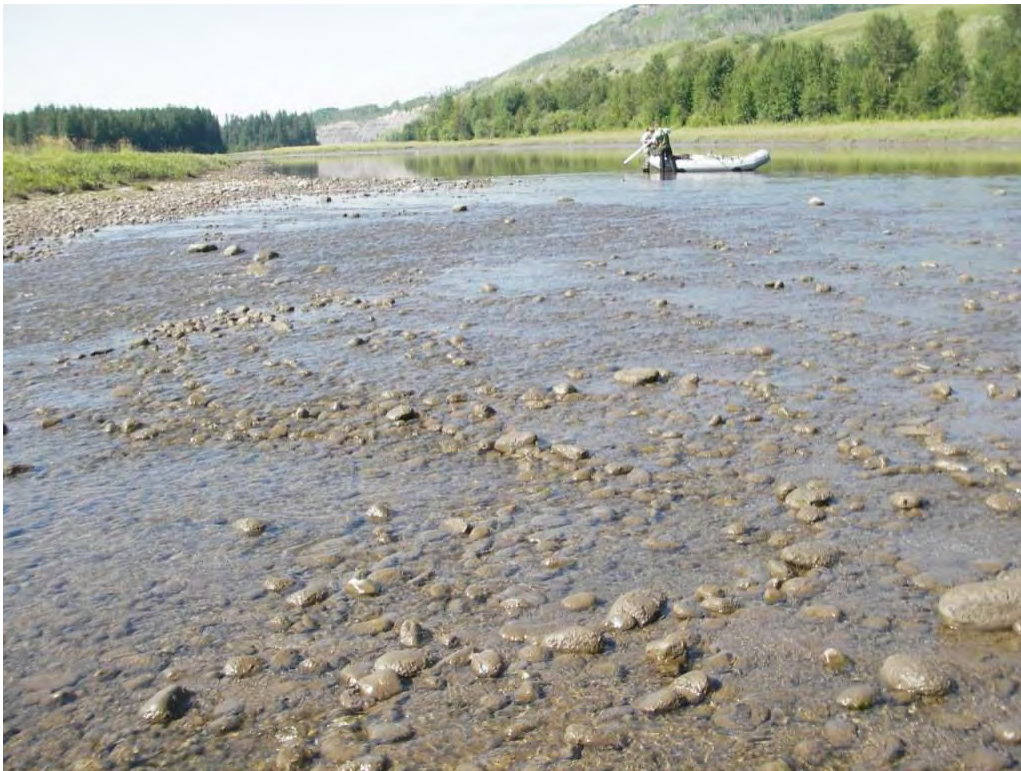
**Photo 4** Example of Riffle habitat in Side Channel 40L.

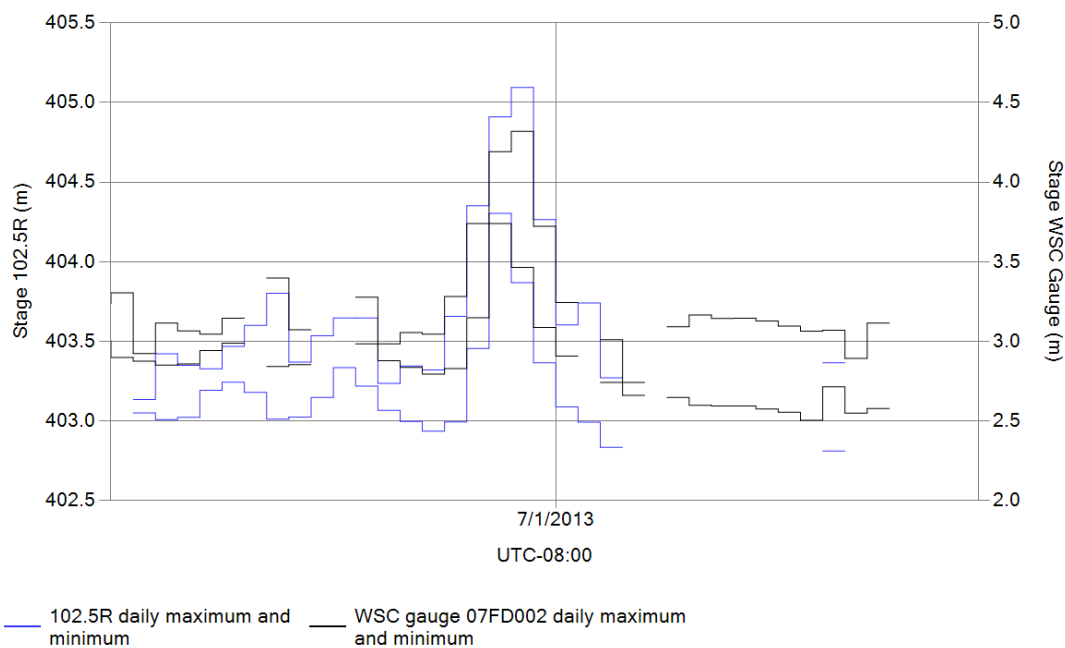
**Figure 8 Maximum and minimum daily stage for site 102.5R Channel compared to the preliminary maximum and minimum daily stage from WSC site 07FD002 Peace River near Taylor, located on the main channel of Peace River.**

The maximum and minimum daily stage for sites 102.5R Channel and WSC gauge *07FD002 Peace River near Taylor* are shown in **Figure 8**. Discharge records for WSC gauge *07FD002 Peace River near Taylor* are not currently available for the period of record for 102.5R Channel discharge.

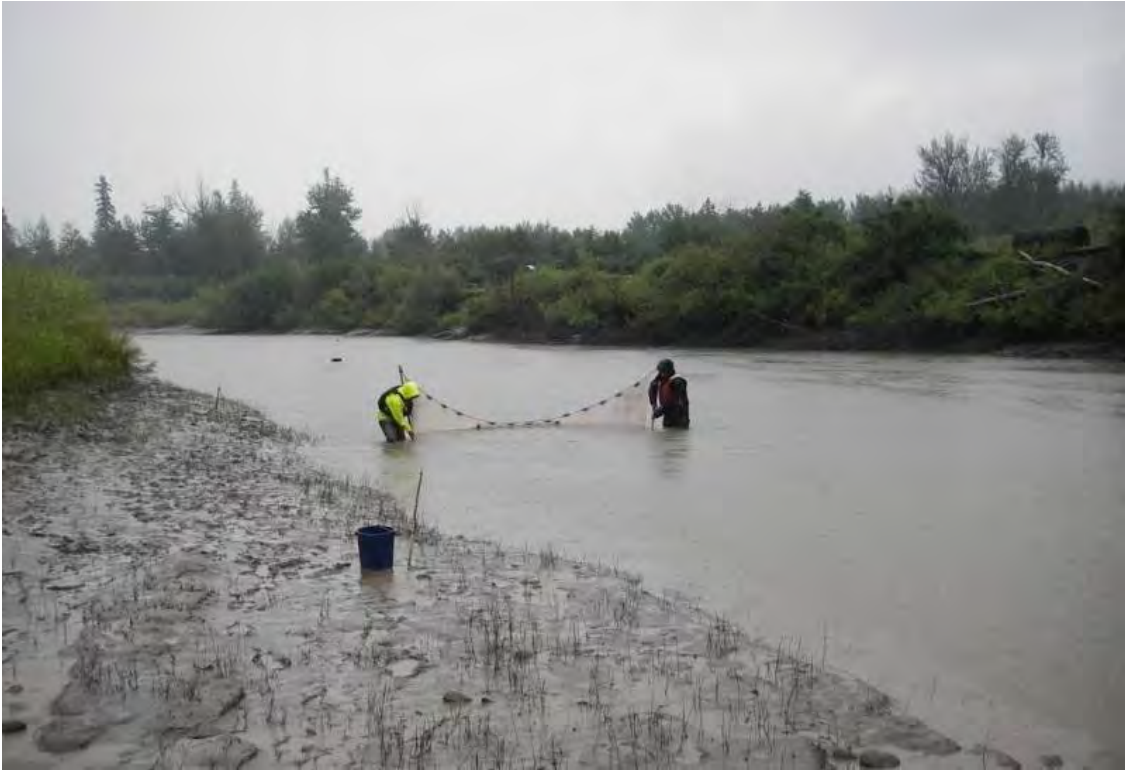
**Photo 5** Example of Flat habitat in Side Channel 102.5R.

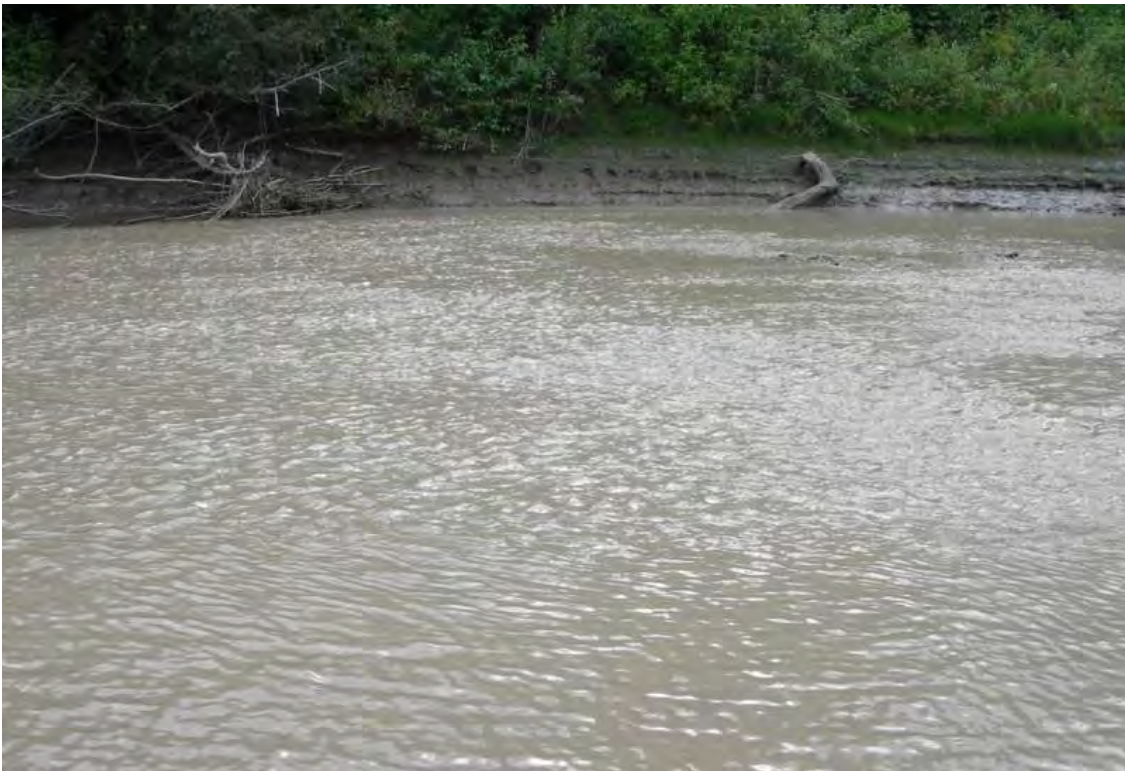
**Photo 6** Example of Riffle habitat in Side Channel 102.5R.

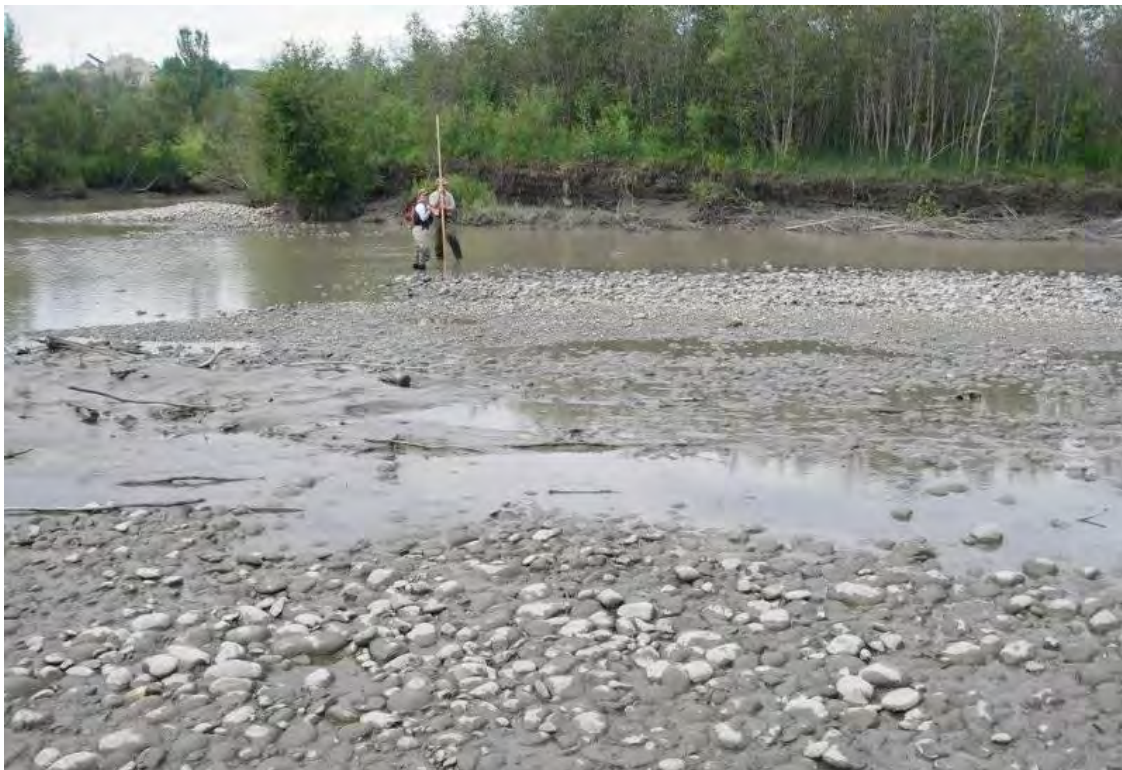
**Photo 7** Example of Run habitat in Side Channel 102.5R.

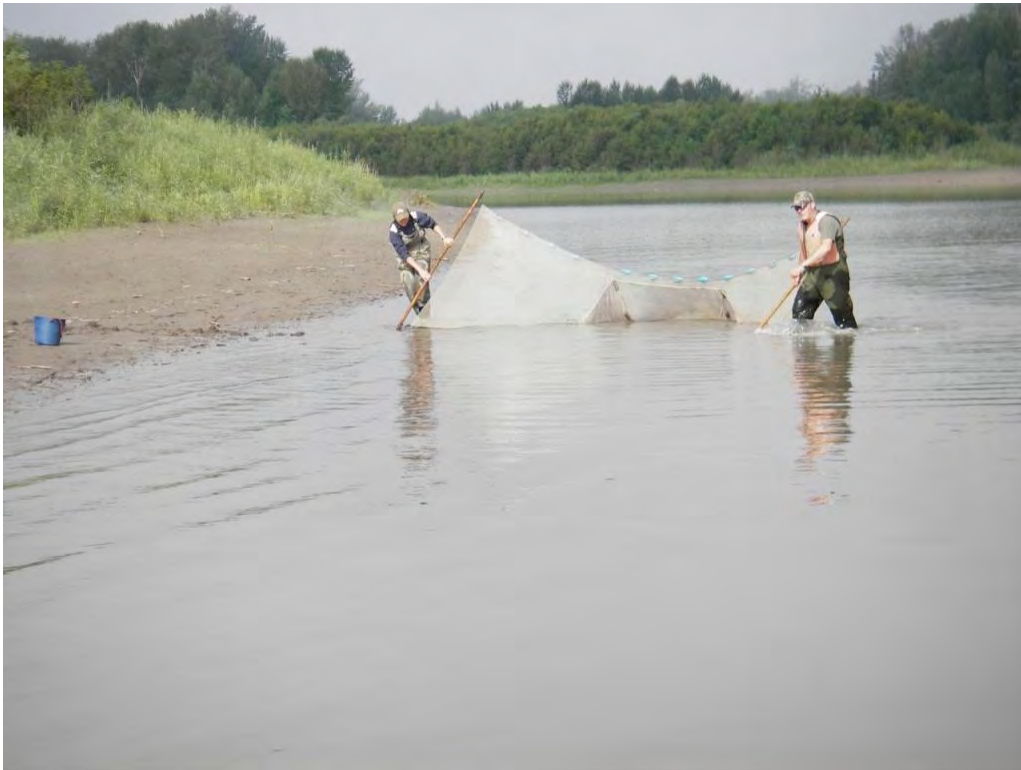
**Photo 8** Example of Flat habitat in Side Channel 112L.

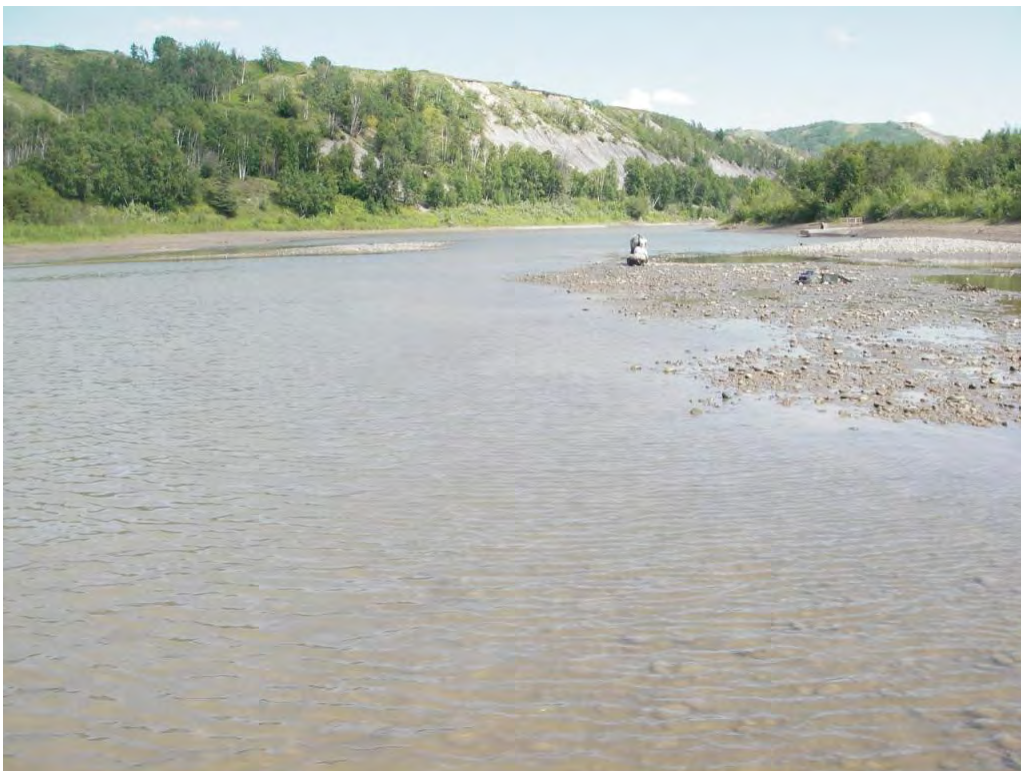
**Photo 9** Example of Run habitat in Side Channel 112L.

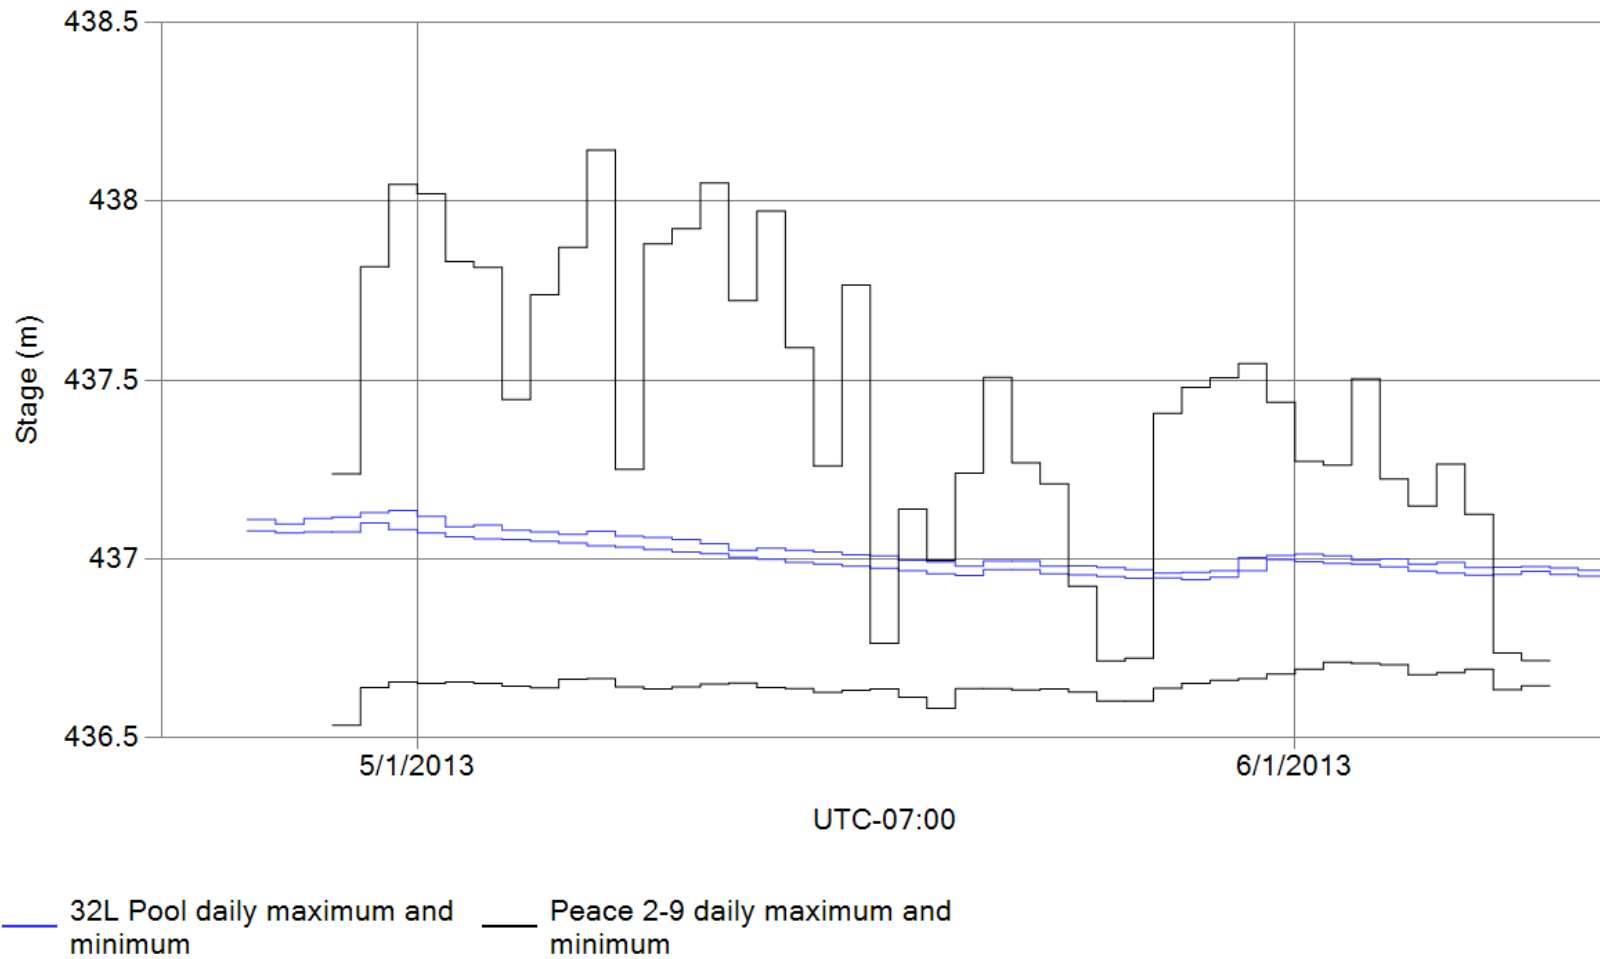
**Figure 22** Maximum and minimum daily stage for site 32L Pool compared to the maximum and minimum daily stage for Peace 9, located approximately 1.75 km upstream on the main channel of Peace River.

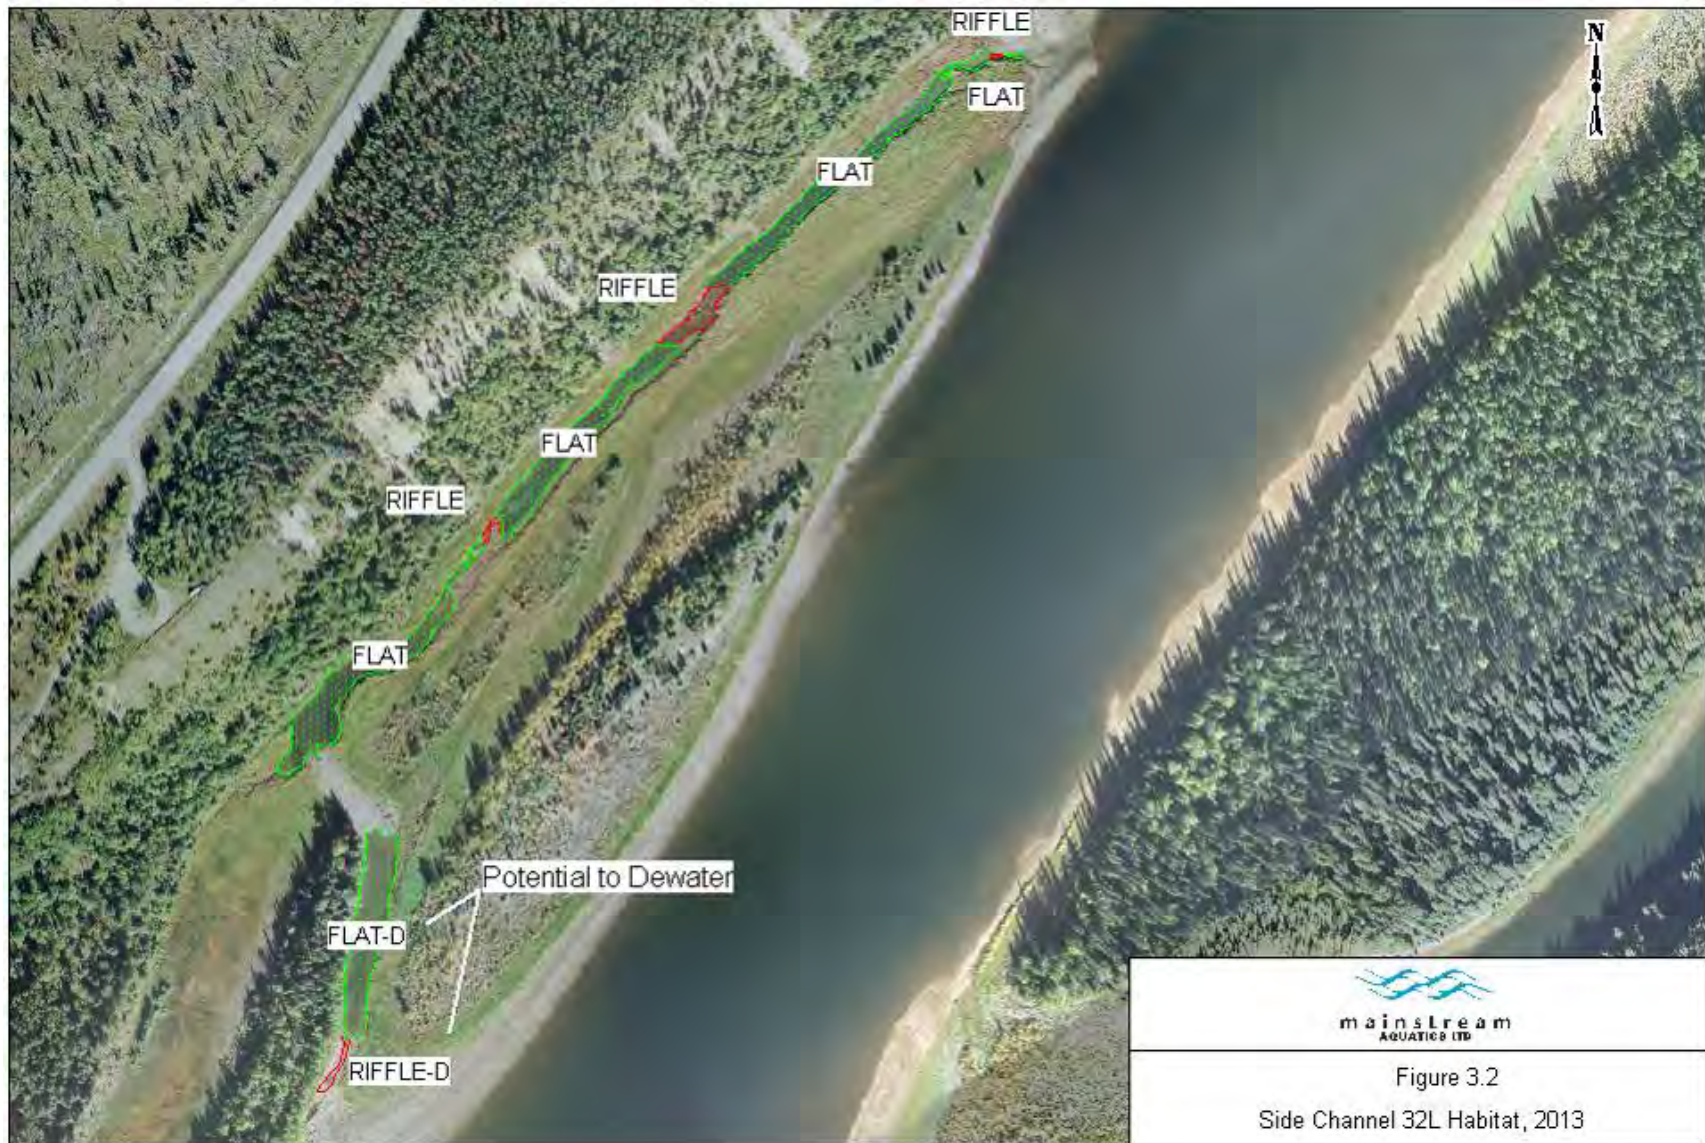
Figure 23 Fish habitats identified in Side Channel 32L.

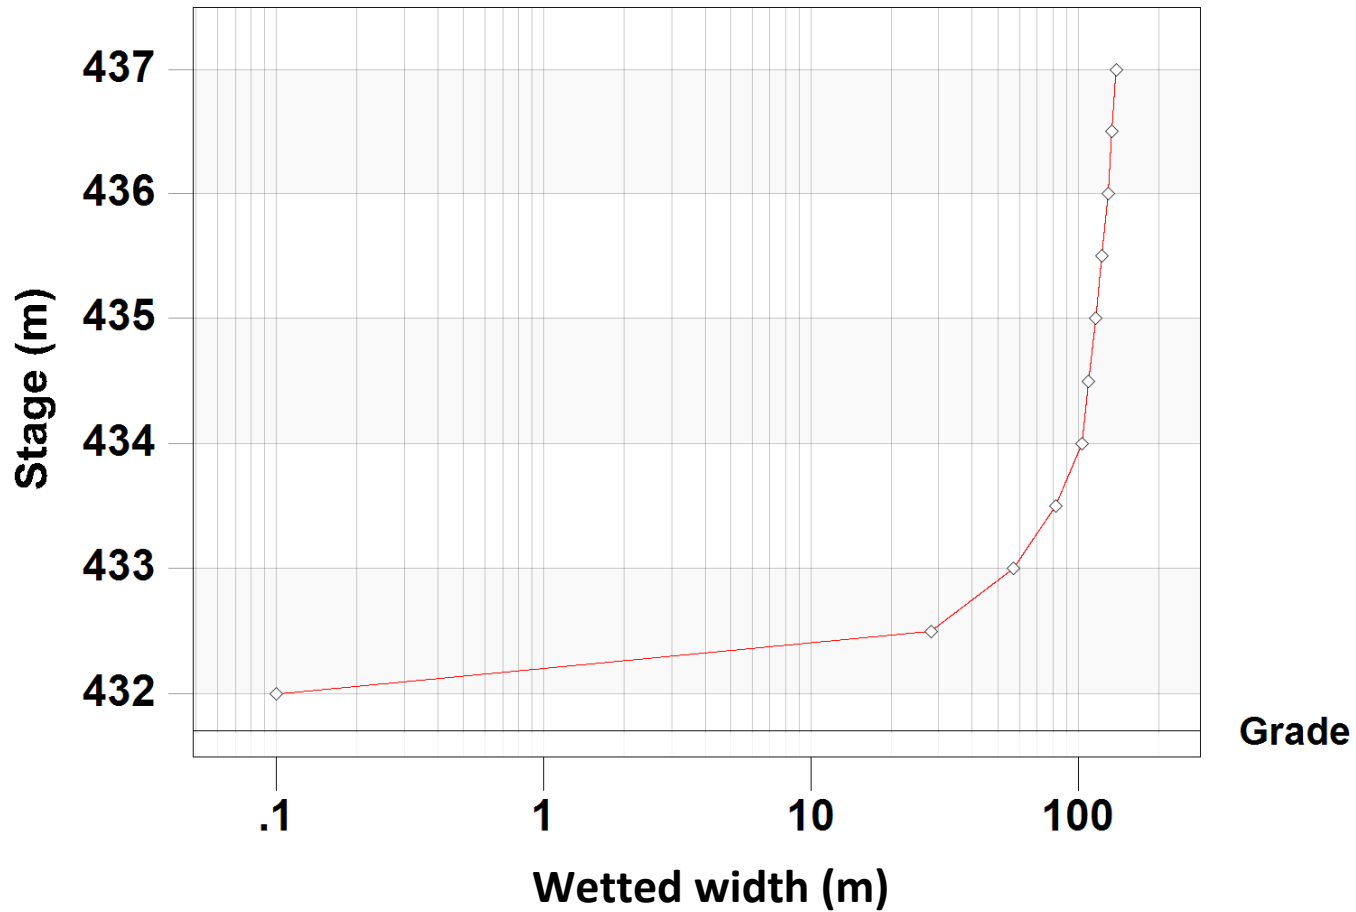
**Figure 29** Stage-wetted width rating curve for cross section 1, the cross section closest to site 40L Upstream. Rating points are based on elevations and widths surveyed along the cross section.

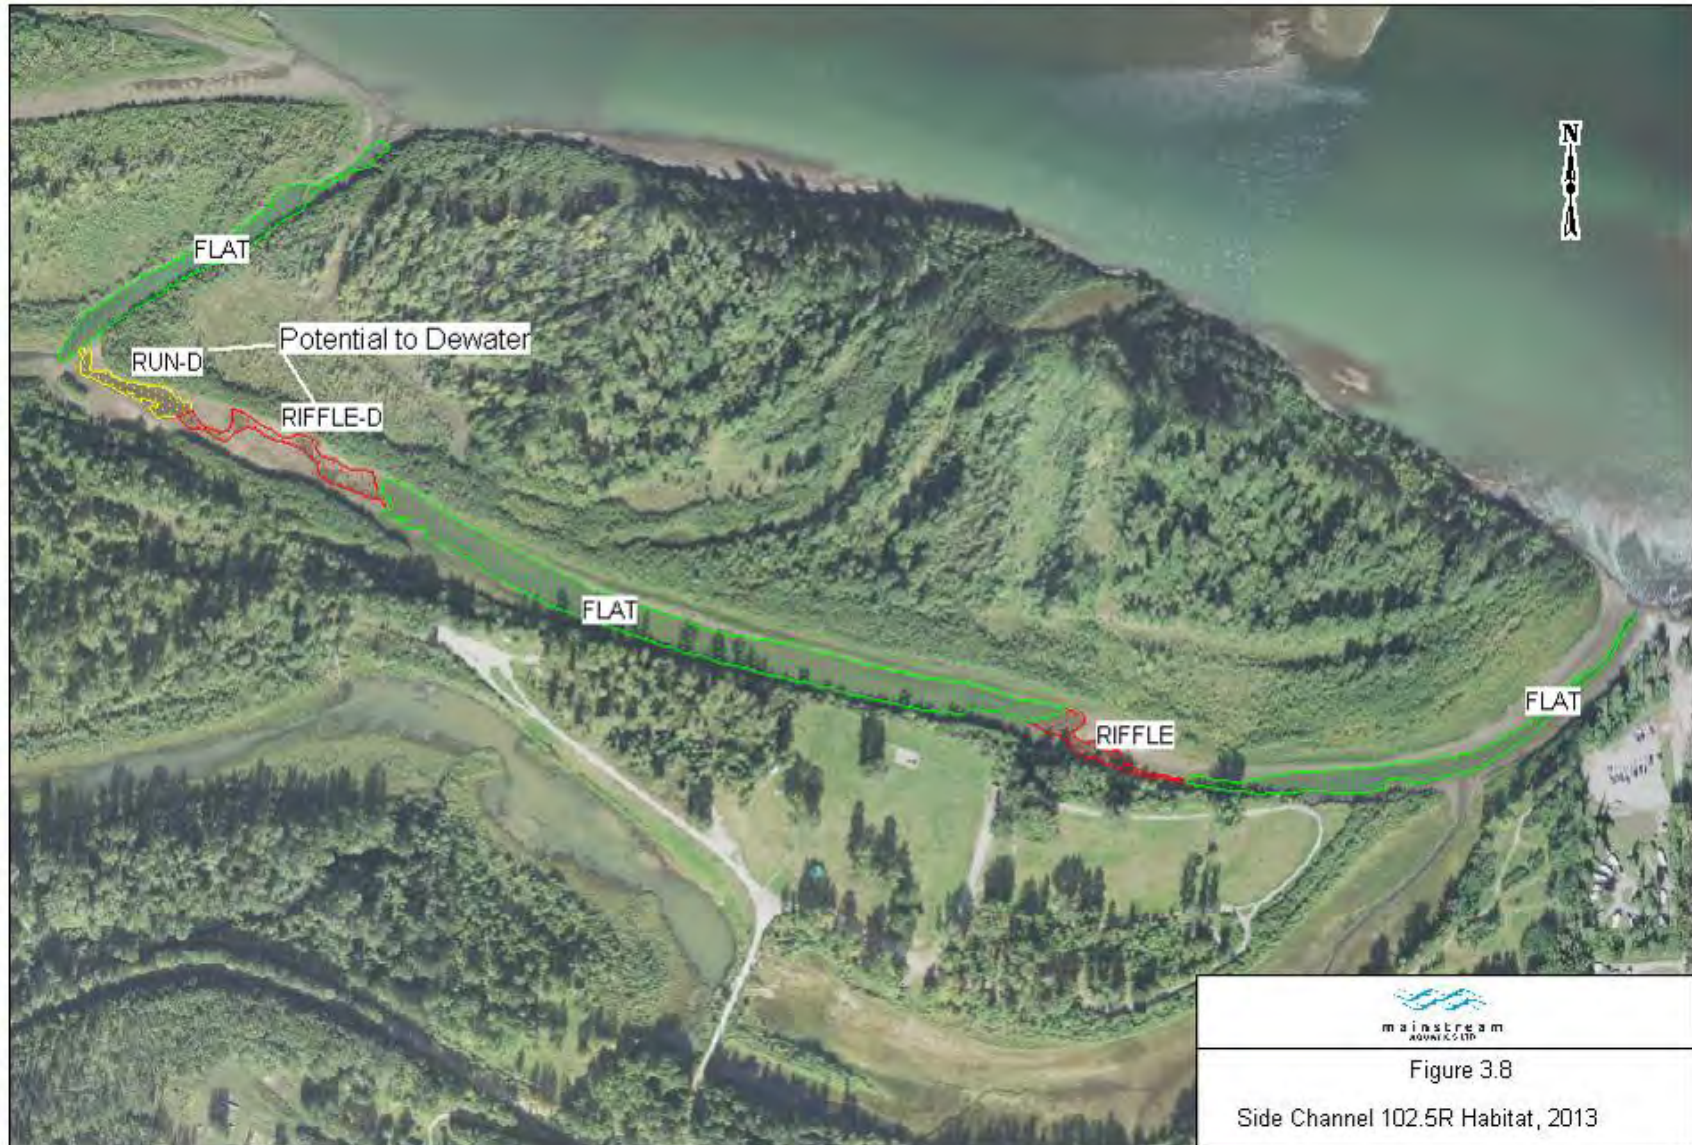
Figure 35 Fish habitats identified in Side Channel 102.5R.

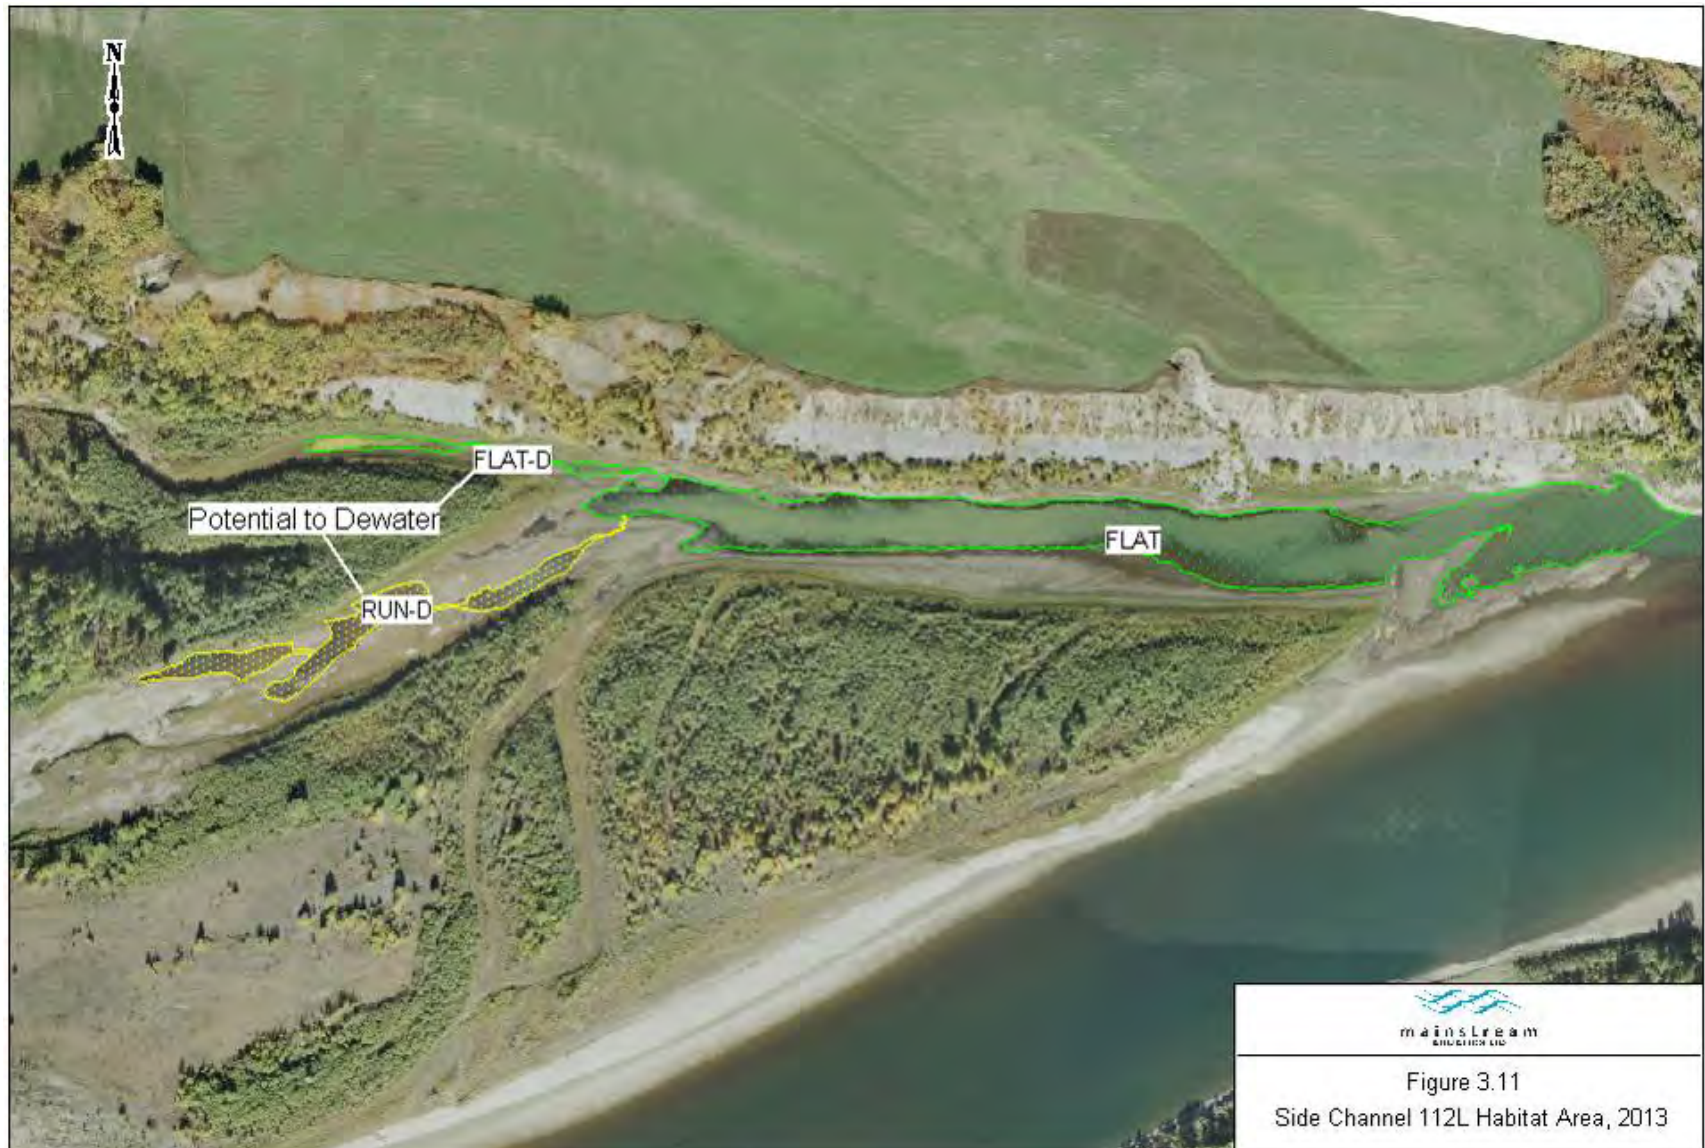
Figure 39 Fish habitats identified in Side Channel 112L.
