Peace Project Water Use Plan

Peace River Side Channel Monitoring

Peace River Side Channel Monitoring 2014 Study

Final Report
2015 February 13

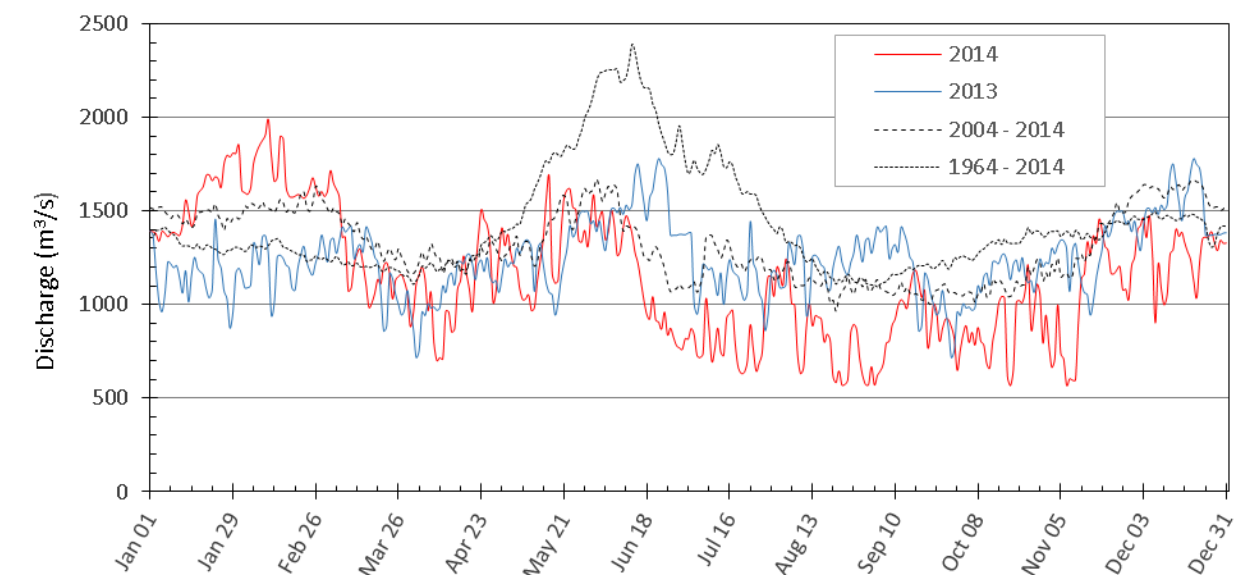
Figure 1-1 Peace River annual hydrograph (WSC 07FD002 Peace River near Taylor)

Snowpack and resulting freshet flows were not extraordinarily high in 2014. Flow release from W.A.C Bennett Dam and downstream PCN dam were within normal operating range (less than 2,000 m³/s) throughout 2013 and spill protocol was not initiated. The following figure presents a plot of Peace River flow as measured by the Water Survey of Canada gauge near Taylor WSC (07FD002). The figure shows 2014 summer flow was generally less than 2013 flow and the average from the past 10 years.

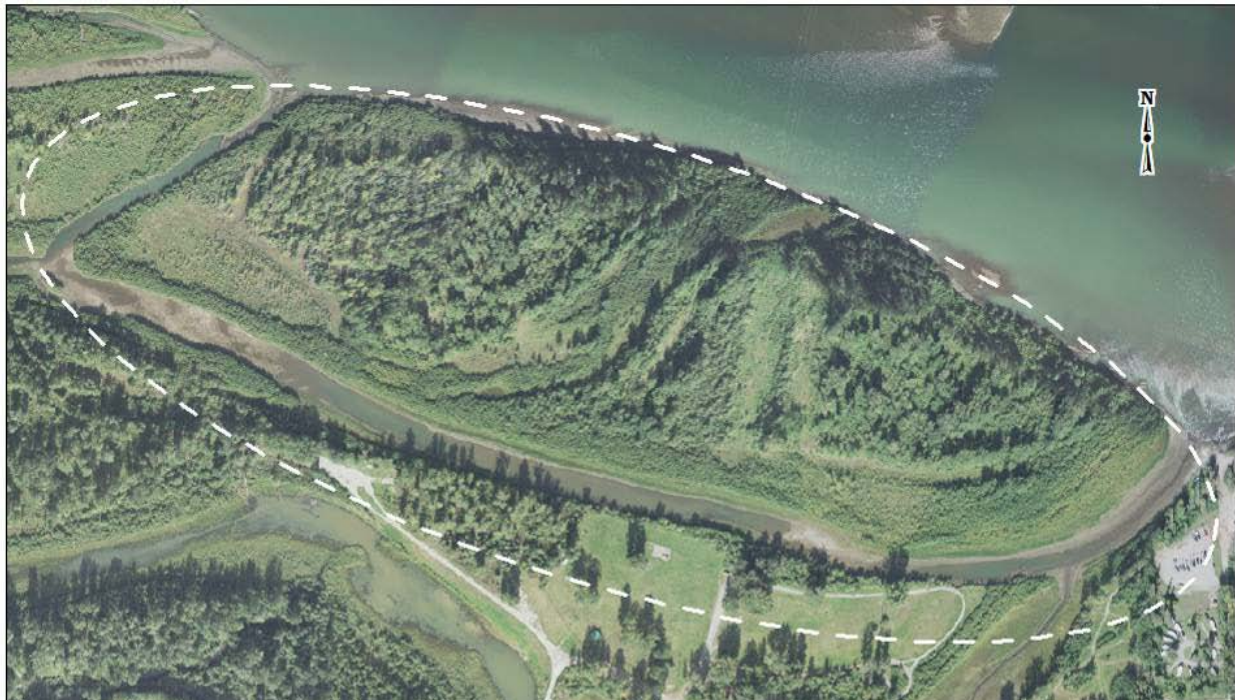
Figure 1-3 Side Channel 102.5R study area, flow is from left to right

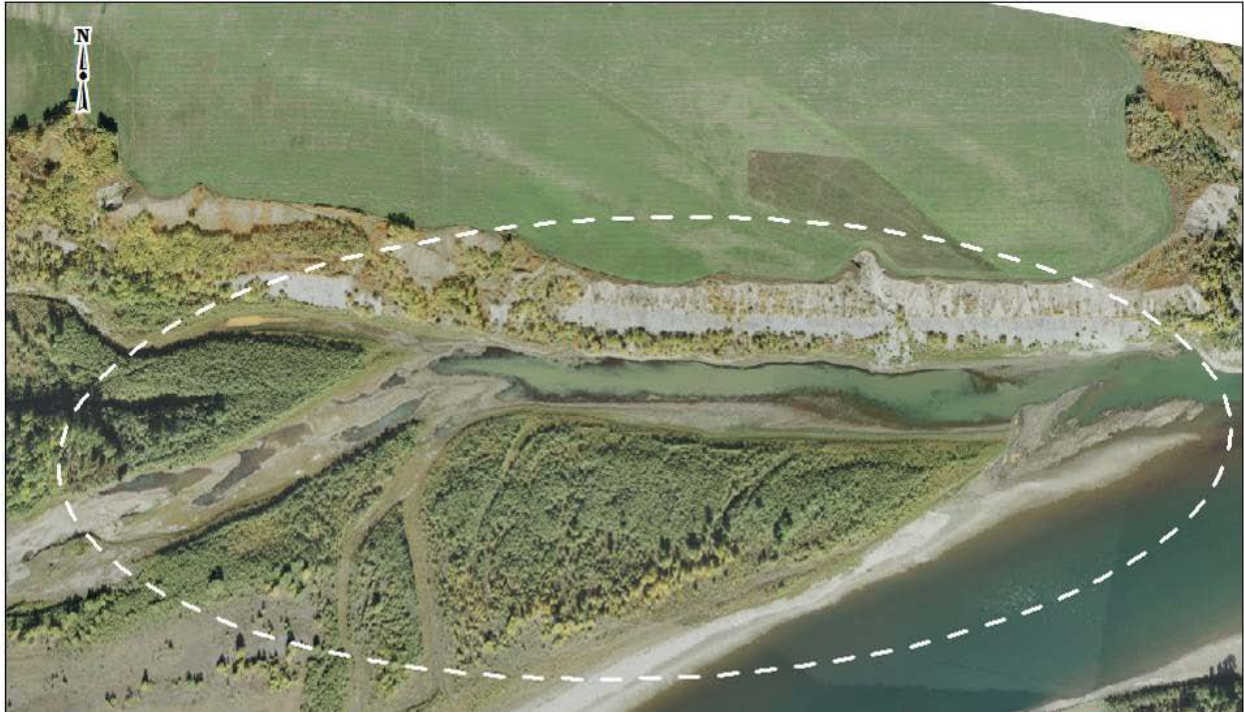
Figure 1-4 Side Channel 112L study area, flow is from left to right

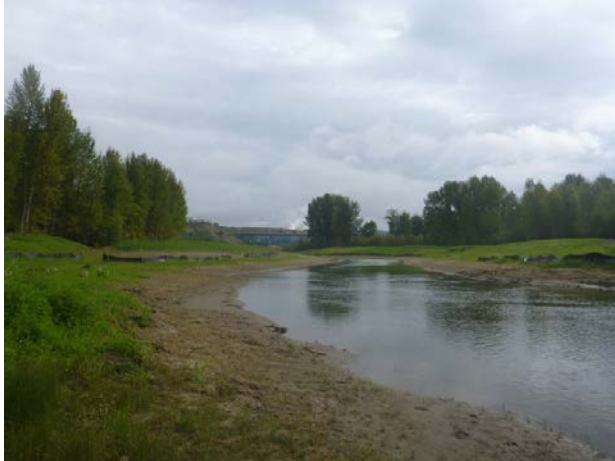
Photo 3-1 Constructed 102.5R channel, view towards mainstem

The following photographs of the site (Photo 3-1 to Photo 3-6) taken September 2014 present the constructed (i.e. re-established) and pre-existing side channel, the sediment distribution within the

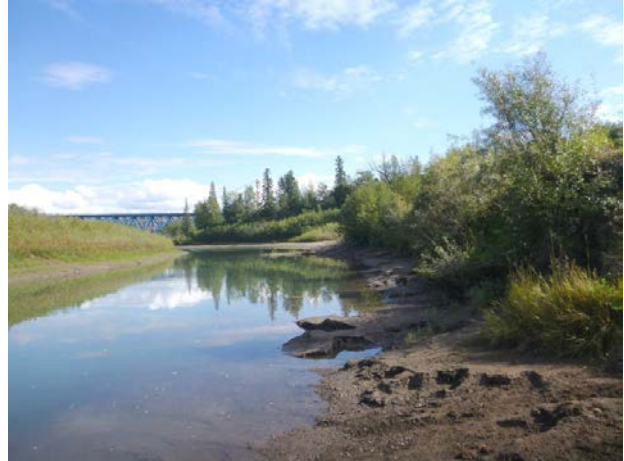
Photo 3-2 Pre-existing 102.5R side channel, downstream view

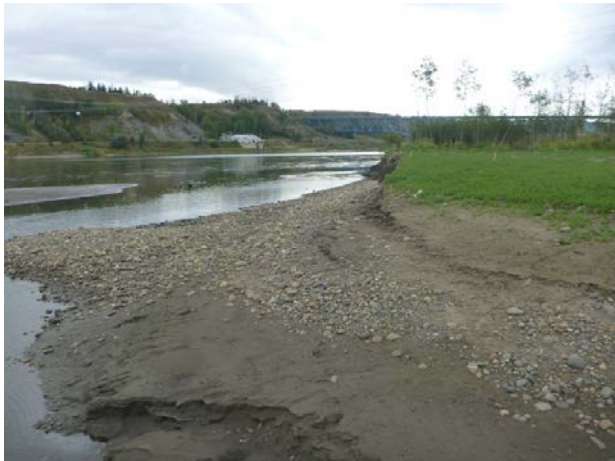
Photo 3-3 Erosion at NE corner of constructed 102.5R channel

constructed channel (primarily fine material with localised lenses of gravel), and erosion along the northeast end of the channel as well as at unaffected areas along the north side of the island.

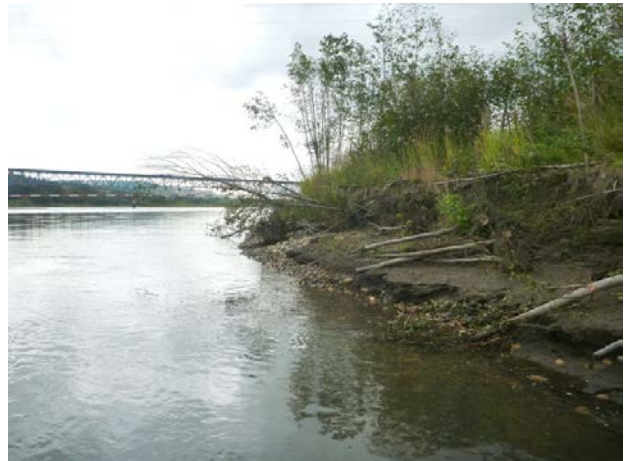
Photo 3-4 Erosion on north side of 102.5R island downstream of constructed channel

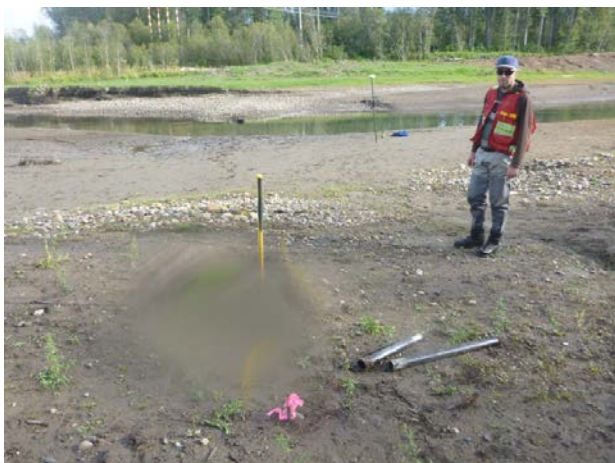
Photo 3-5 Bed substrate (fine sandy loam to gravel) across 102.5R constructed channel

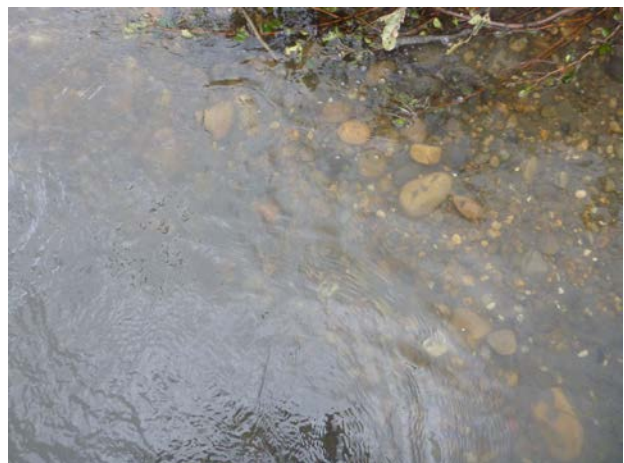
Photo 3-6 Gravel substrate lenses within 102.5R constructed channel

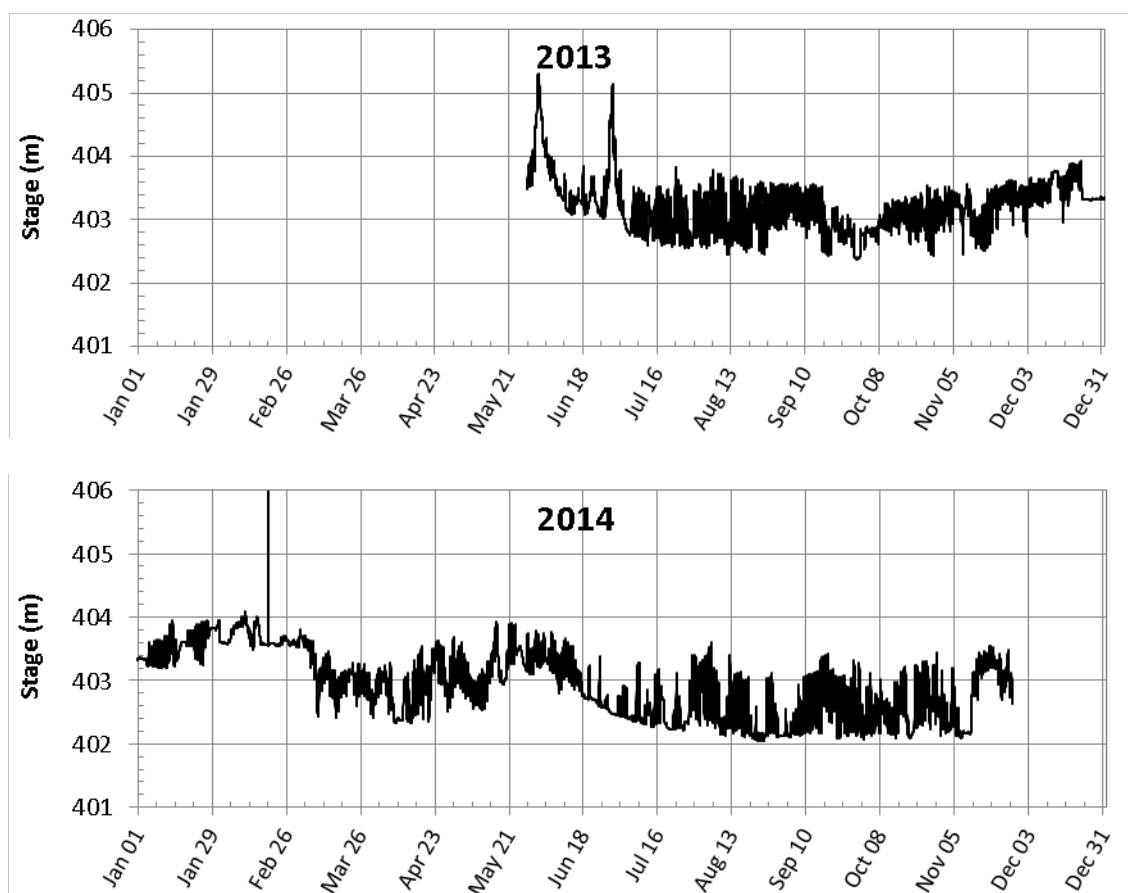
Figure 3-4 Stage record for 102.5R Channel (pre-existing channel) as transposed from WSC 07FD002

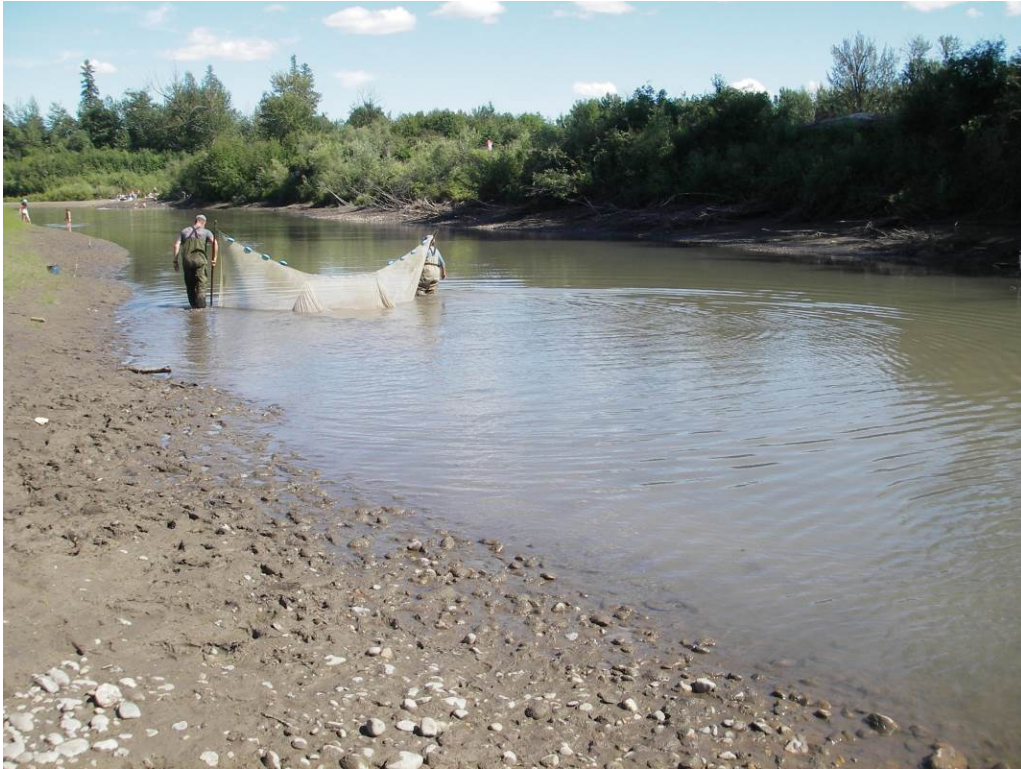
Photo 3-7 Site CBS10; example of sedimentation in Side Channel 102.5R

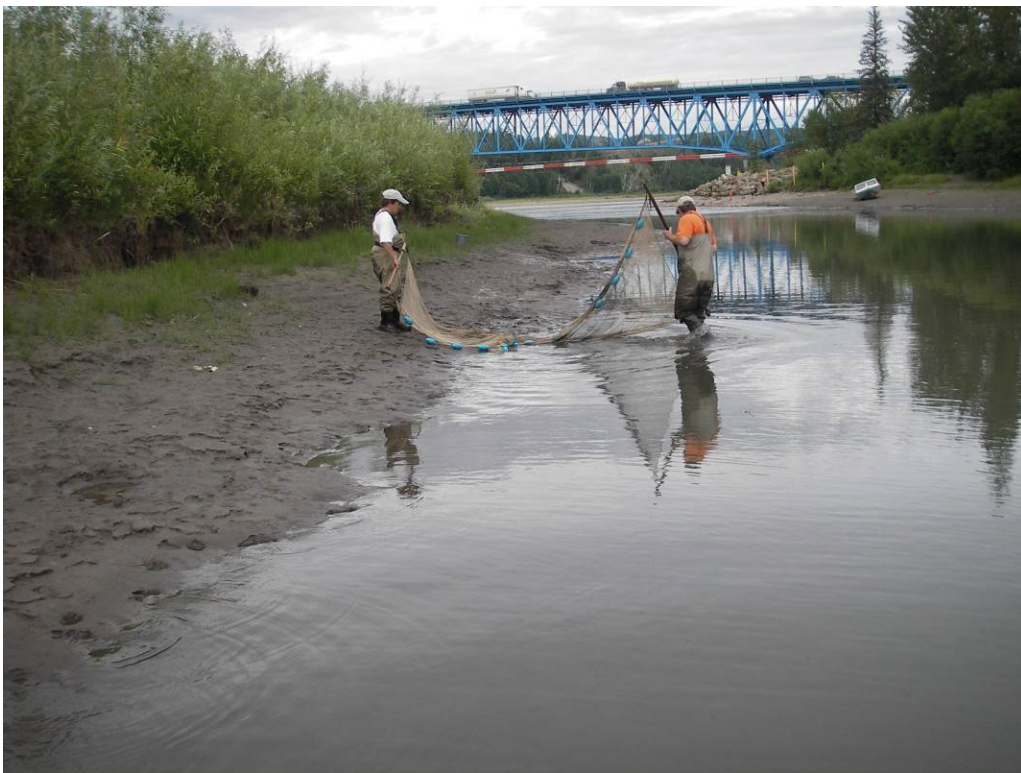
Photo 3-8 Site CBS13; low water level sampling condition in Side Channel 102.5R

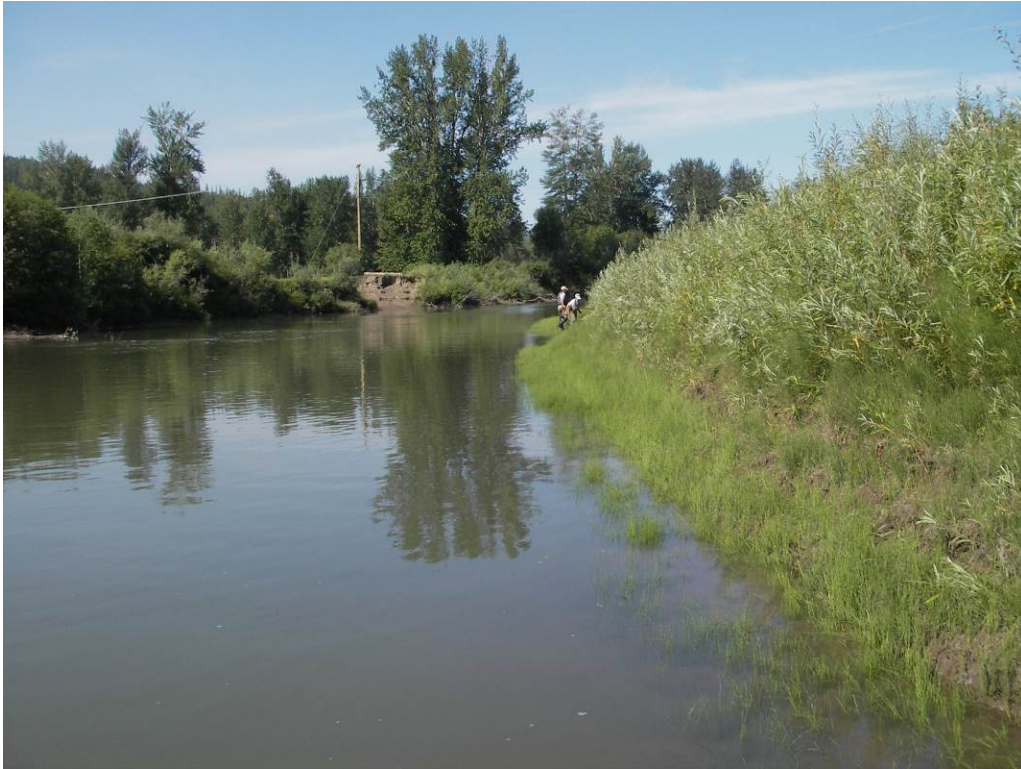
Photo 3-9 Site CBS13; high water level sampling condition on Side Channel 102.5R

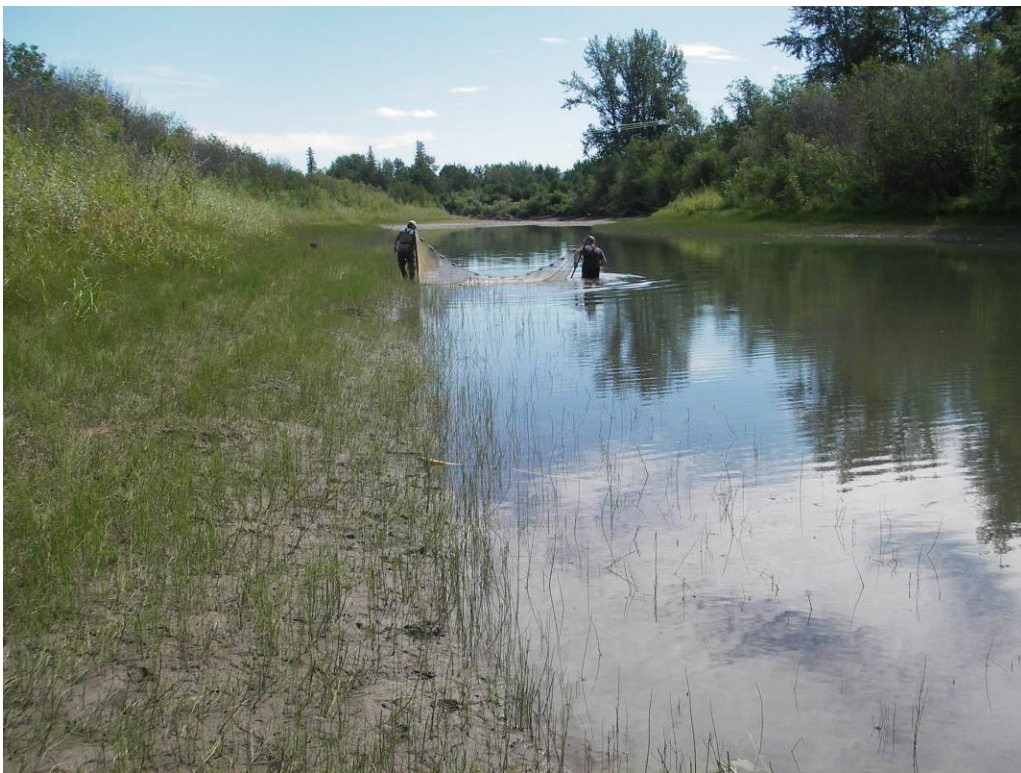
Photo 3-10 Site CBS11; example of emergent vegetation in Side Channel 102.5R

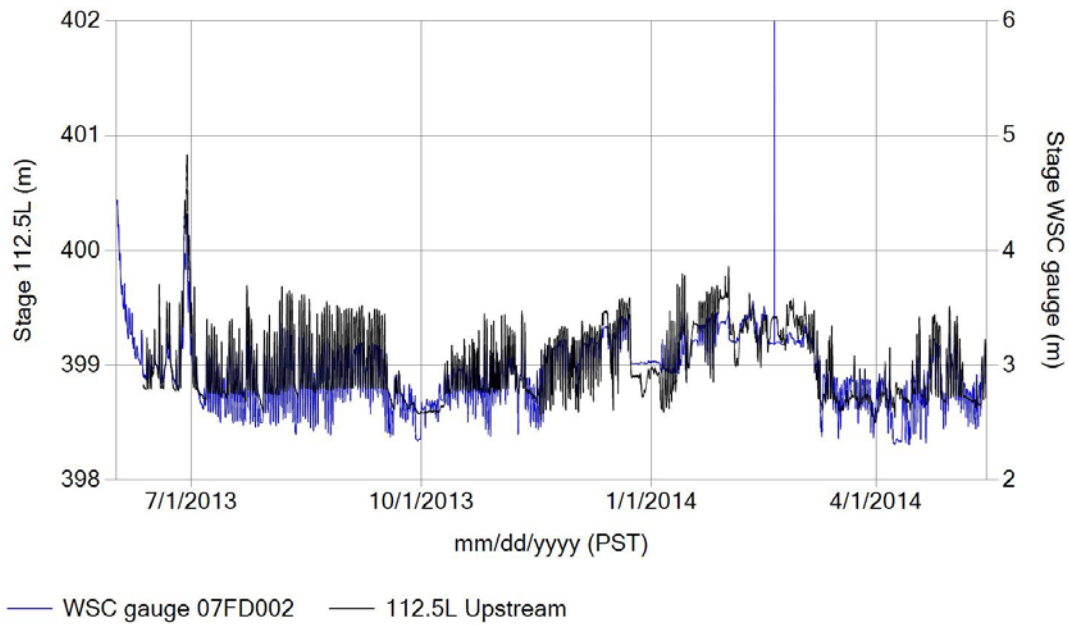
Figure 3-8 Stage record for sites 112.5L Upstream compared to preliminary stage from Water Survey of Canada site 07FD002 Peace River near Taylor

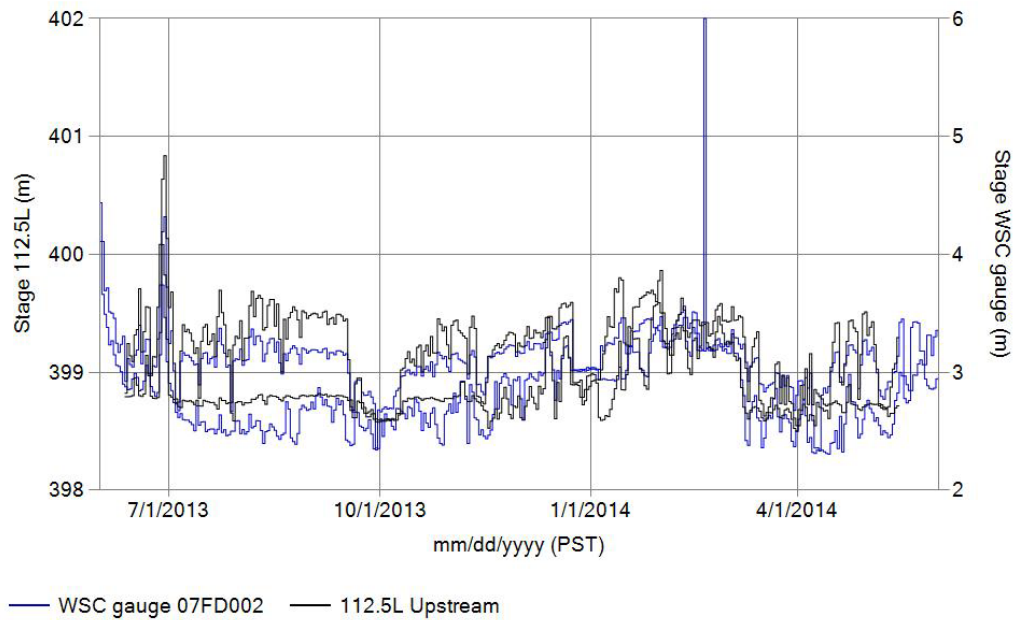
Figure 3-9 Maximum and minimum daily stage for site 112.5L Upstream compared to the preliminary maximum and minimum daily stage from WSC site 07FD002 Peace River near Taylor

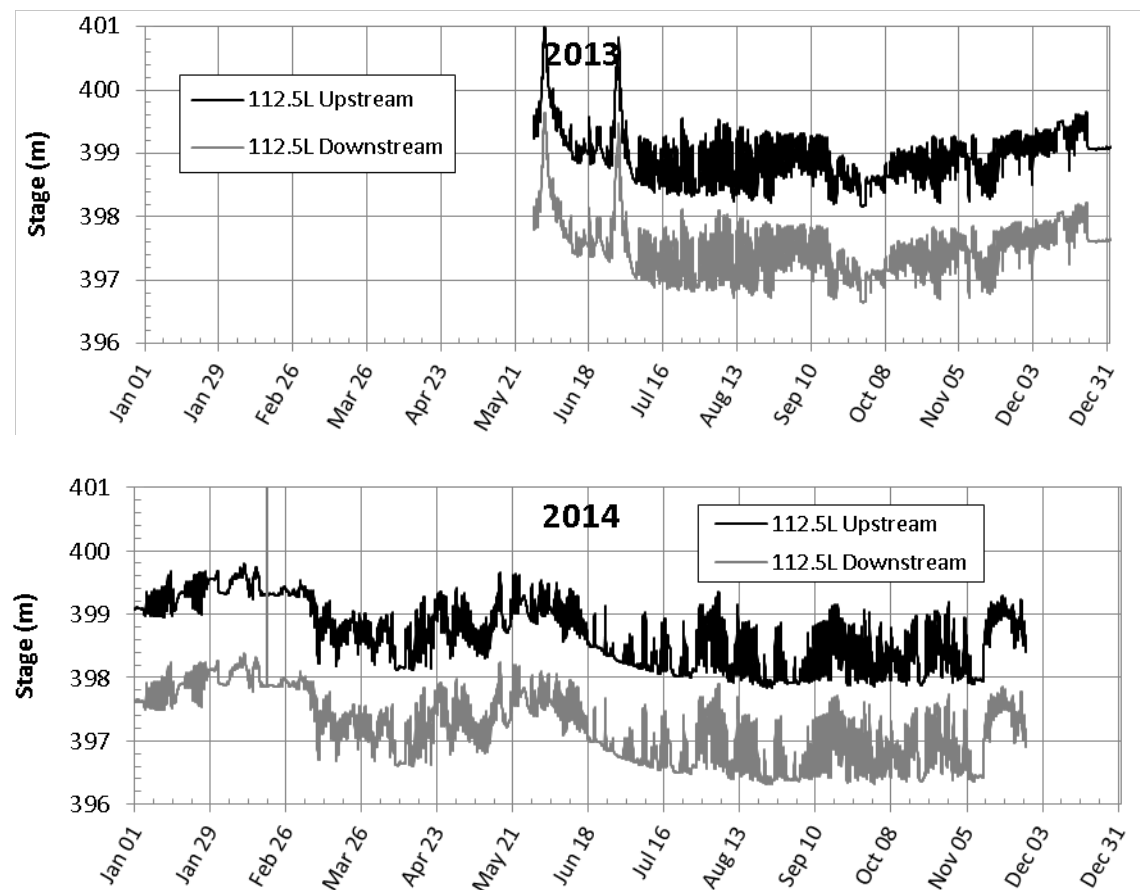
Figure 3-11 Stage record for 112.5L Upstream and 112.5L Downstream as transposed from WSC 07FD002

Using the regression the stage record was generated for 2013 and 2014 (Figure 3-11). Visual comparison of the stage record suggests that low flow was on average 0.3 m lower for the summer of 2014 than for the summer of 2013.

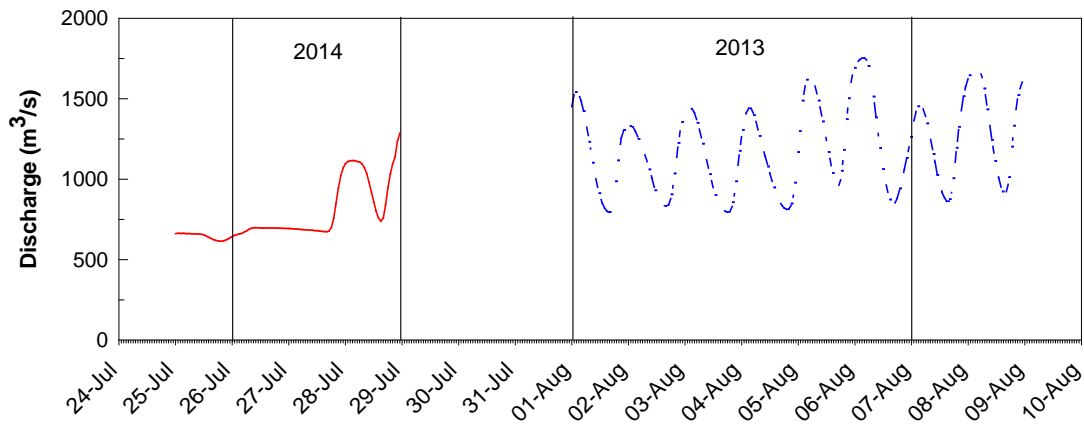
Figure 3-12 Peace River hourly discharge at Taylor during the 2013 and 2014 field programs

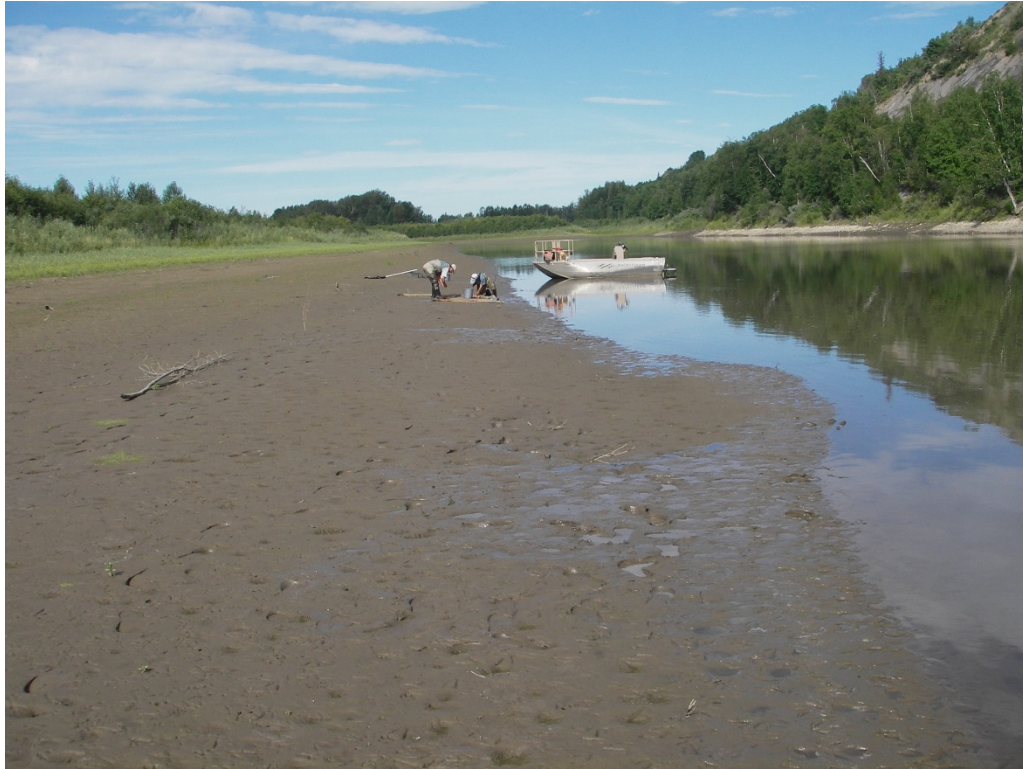
Photo 3-11 Site DBS15; example of fine sediments in Side Channel 112.5L

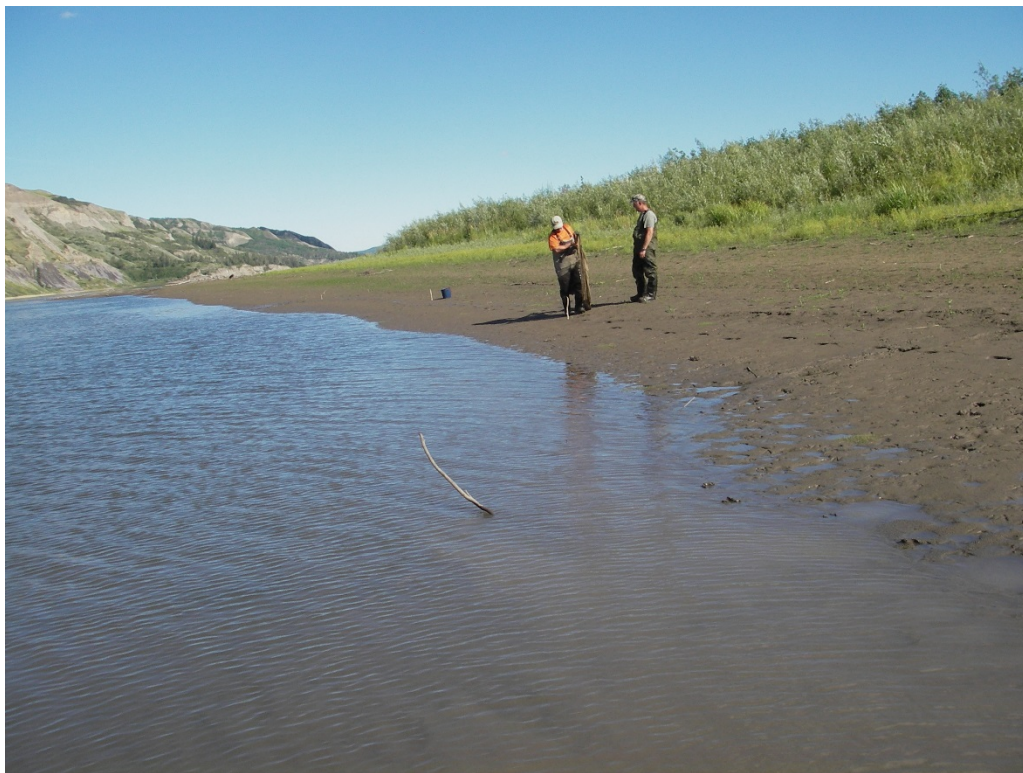
Photo 3-12 Side DBS09; low water level sampling condition in Side Channel 112.5L

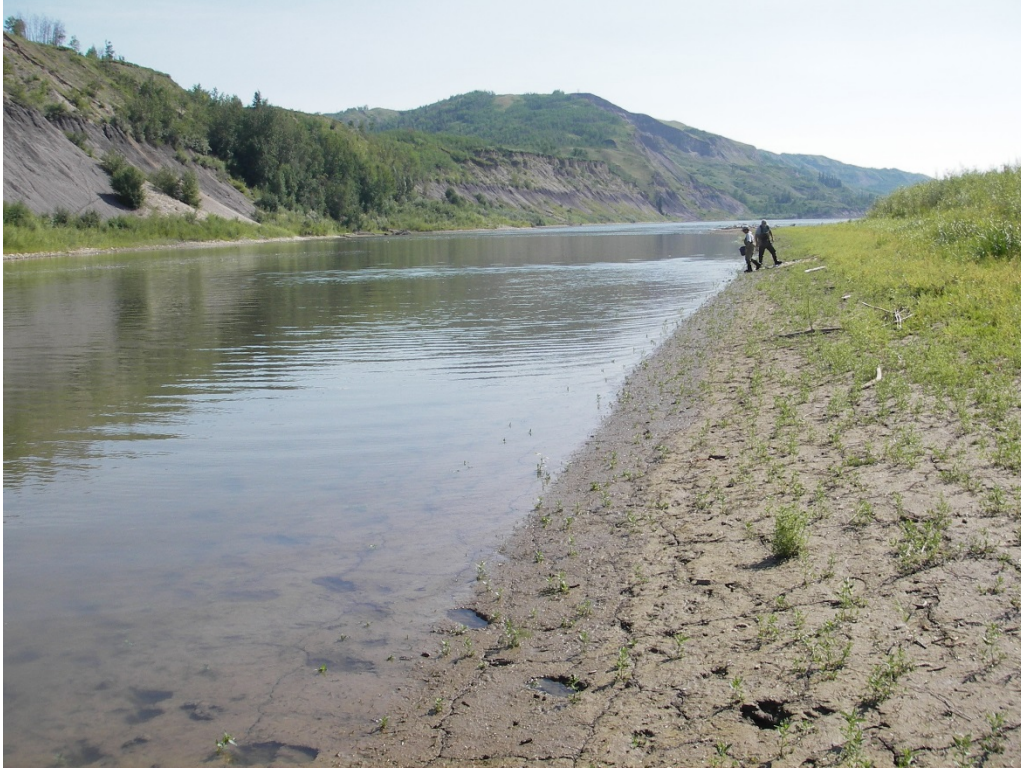
Photo 3-13 Side DBS09; high water level sampling condition in Side Channel 112L

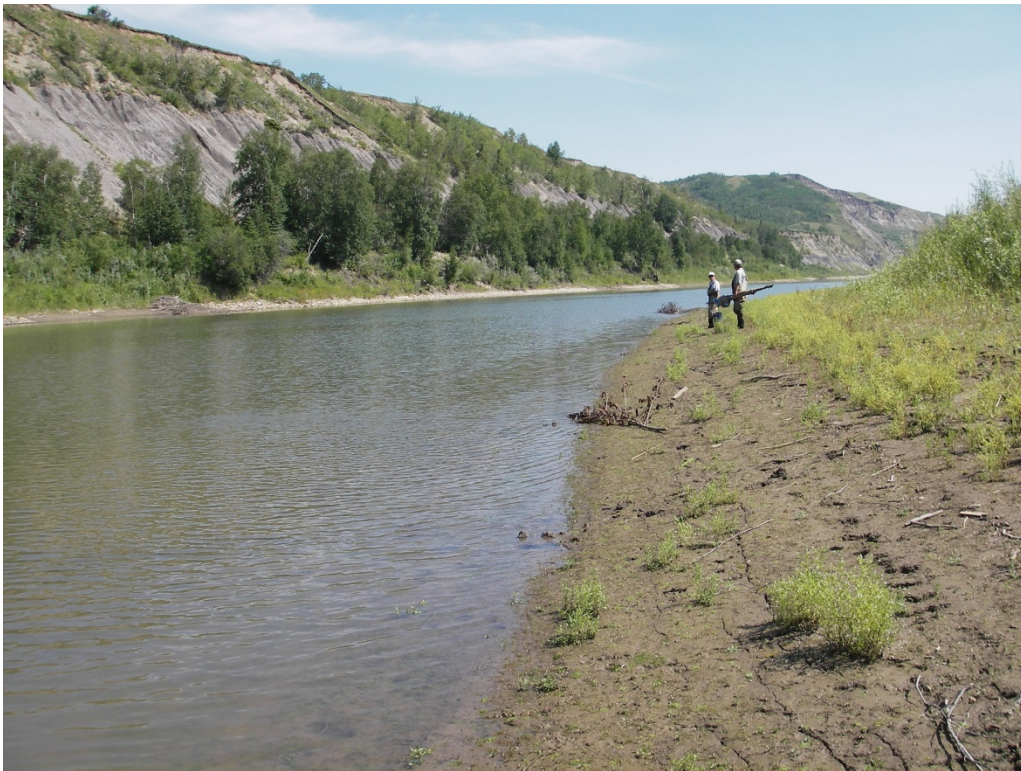
Photo 3-14 Site DBS11; example of submergent vegetation in Side Channel 112.5L
