Peace River Project Water Use Plan

Peace River Side Channel Response

Reference: GMSMON-8

**GMSMON-8 Peace River
Side Channel Response**

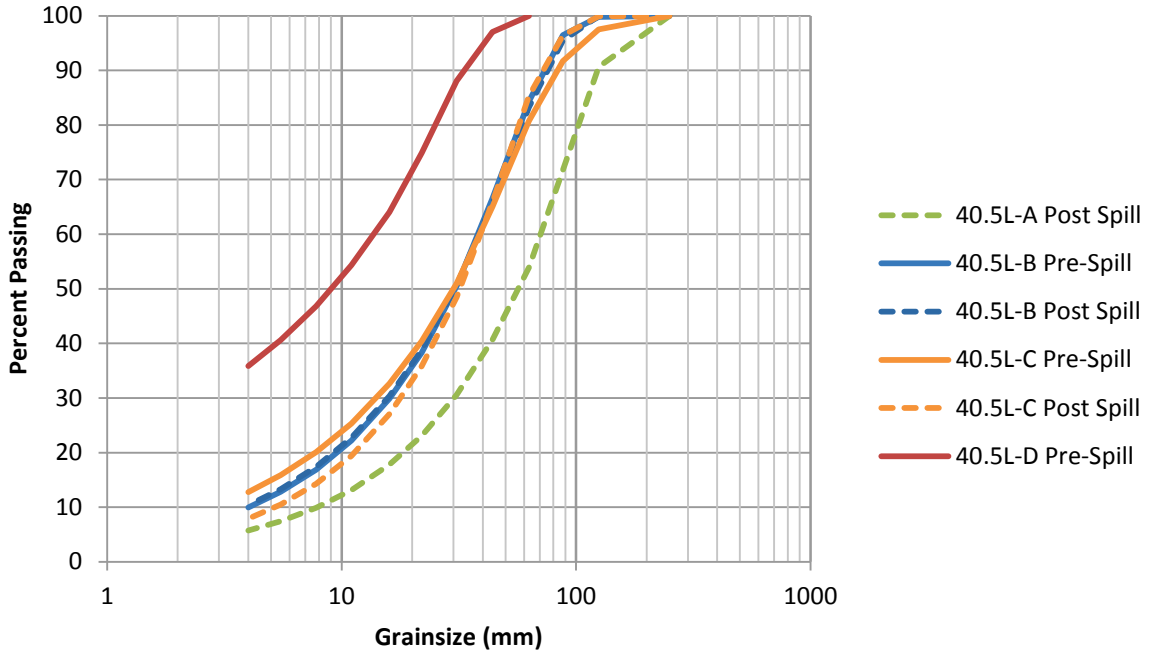
Figure 3-6. GSD for site 40.5L. No post-spill analysis was done for 40.5L-D as it was submerged. Only fines were observed at site 40.5L-A pre-spill.

The cumulated grain size distribution results for each side channel are presented in **Figure 3-4** to **Figure 3-11**. At each site a series of photographs were taken of the bed sediment at random points along a transect transverse to the channel. Each of the photos were analysed using digital image processing techniques developed by SplitNet Engineering to determine the grain size distribution (GSD) of the sediment in each photograph.

Several of the sites that were covered in fines pre-spill (40.5L-A 49.9L-D, 65.0L-C), had measureable clasts post-spill, so only one curve is present for each of those sites. Side channels 83.3L and 88.7L had all sites submerged both before and after the spill. Side channels 73.0L, 98.2R and 102.5R only had one site with exposed sediment before the spill and no sites with exposed sediment after the spill. At sites 32.0L-D, 65.0L-D and 69.1L-B, only fine bed material was observed both pre and post spill, and they are not included in the results.

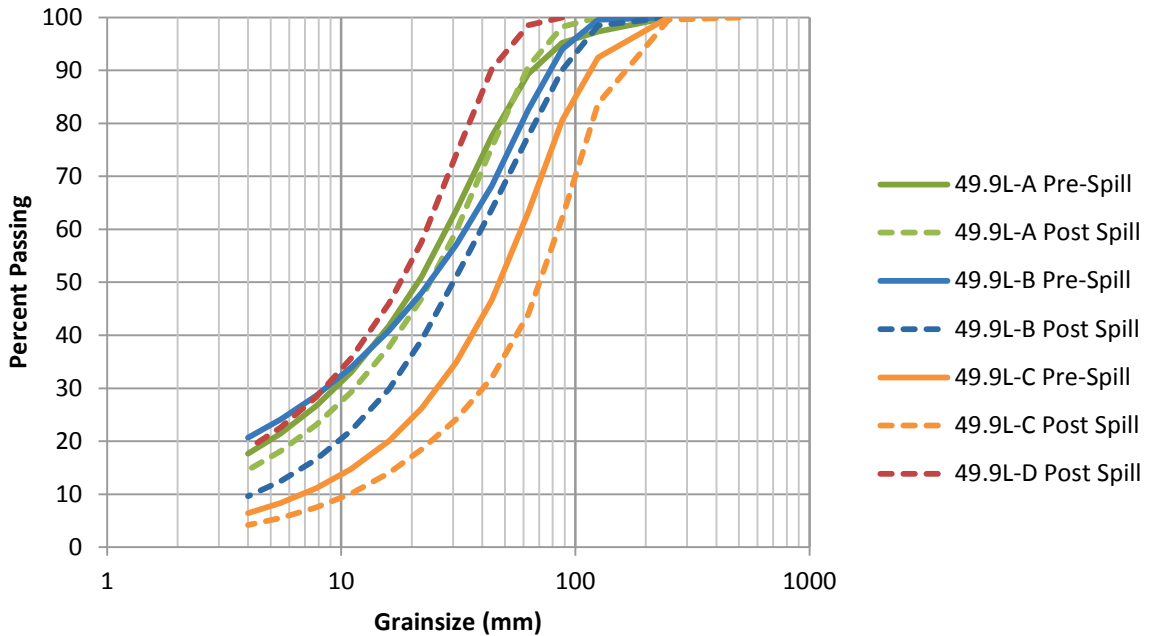
Figure 3-7 GSD for site 49.9L. Only fines were observed at 49.9L-D pre-spill.

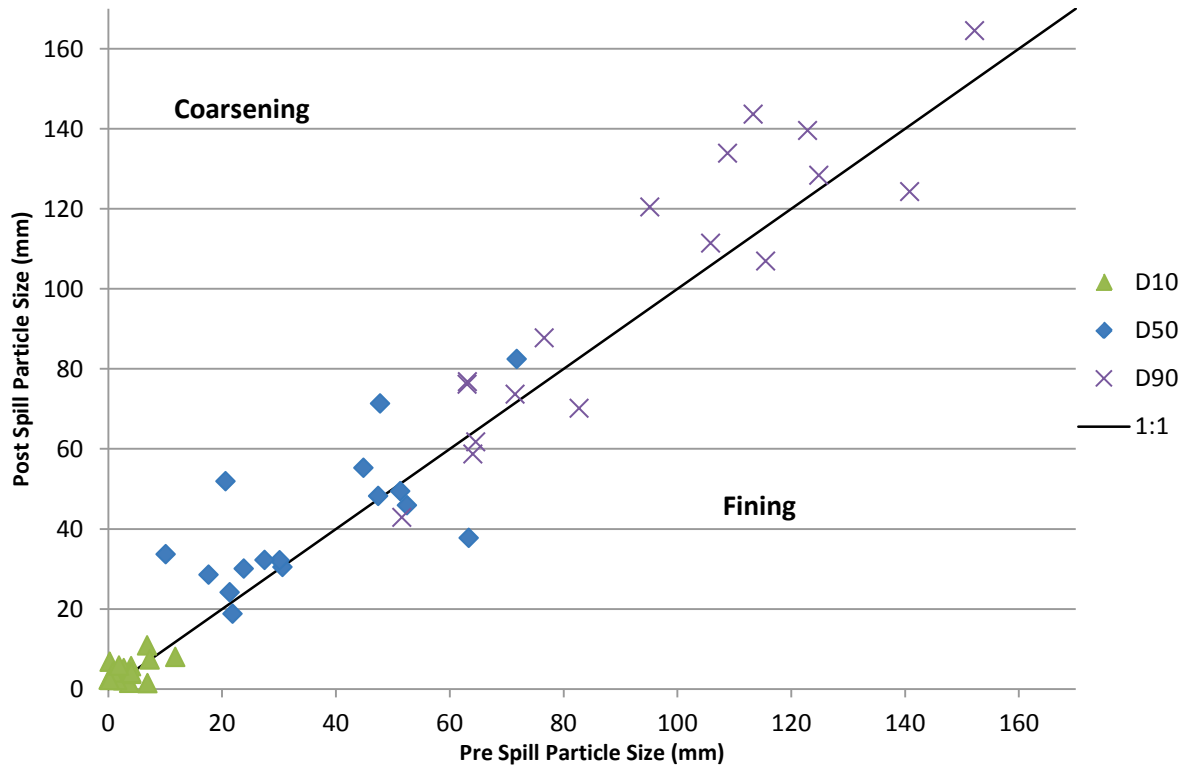
Figure 3-12 Comparison of the D_{10} , D_{50} and D_{90} between pre and post spill.

This plot confirms what is seen in the other GSD plots that most sites showed a relatively minor but consistent increase in grain size. Again, this is attributed to removal of fine sediment that was on top of the coarser bed material. In addition to shifting the low end of the GSD, fine material can partially obscure larger gravel and cobbles, skewing the results of the photogrammetric analysis. Furthermore, several of the sites had measureable sediment post-spill where only fines were observed pre-spill. This conclusion is substantiated by the lack of any geomorphic change observed between the pre and post-spill field visits.

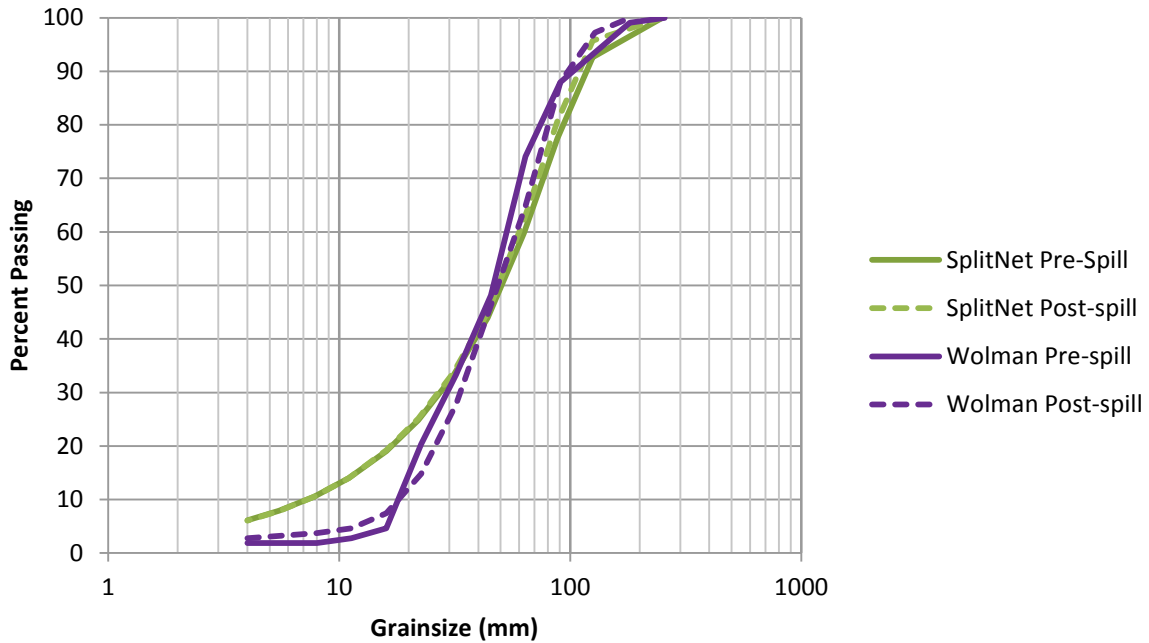
Figure 3-13 Comparison of the SplitNet digital image technique with the Wolman stone count for Site 40.5L-B

A common trend observed across most sites was towards a coarsening of the bed, seen as a shift of the curve towards the right from the pre to post spill grain size curves. When compared with the Wolman stone counts, the SplitNet analysis gives a good estimate of the D_{50} and coarser sediment. Wolman stone counts are known to yield coarser grain size distributions as they tend to under sample fine sediments (Wolman 1954). A bulk sample would likely produce a closer GSD to the SplitNet results.

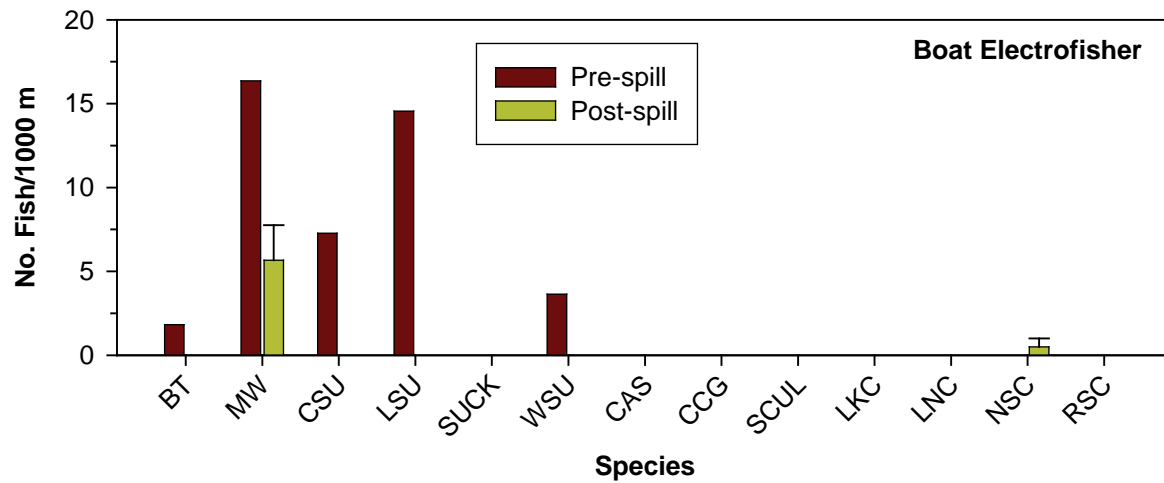
Figure 4-2 Average summer boat electrofisher catch rates (\pm SE) of fish species/groups Side Channel 32L.

A comparison of boat electrofisher pre and post-spill mean catch rates also indicated low precision (i.e., large standard error); however, there was a distinct trend of lower species relative abundance in the post-spill summer sample (**Figure 4-2**). Of the five species for which boat electrofisher catch rates were generated, all were lower post-spill summer compared to pre-spill summer (Bull Trout, Mountain Whitefish, Largescale Sucker, Longnose Sucker, White Sucker, and Northern Pike/minnow). The largest difference was recorded for Longnose Sucker (14.6 fish/1000 m pre-spill versus 0.0 fish/1000 m post-spill).

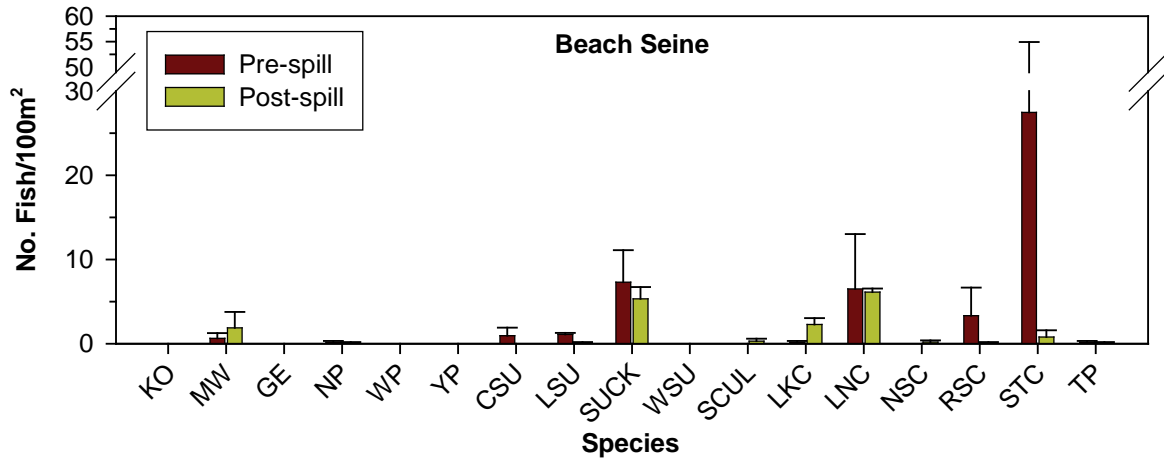
Figure 4-5 Average summer beach seine catch rates (\pm SE) of fish species/groups Side Channel 102.5R.

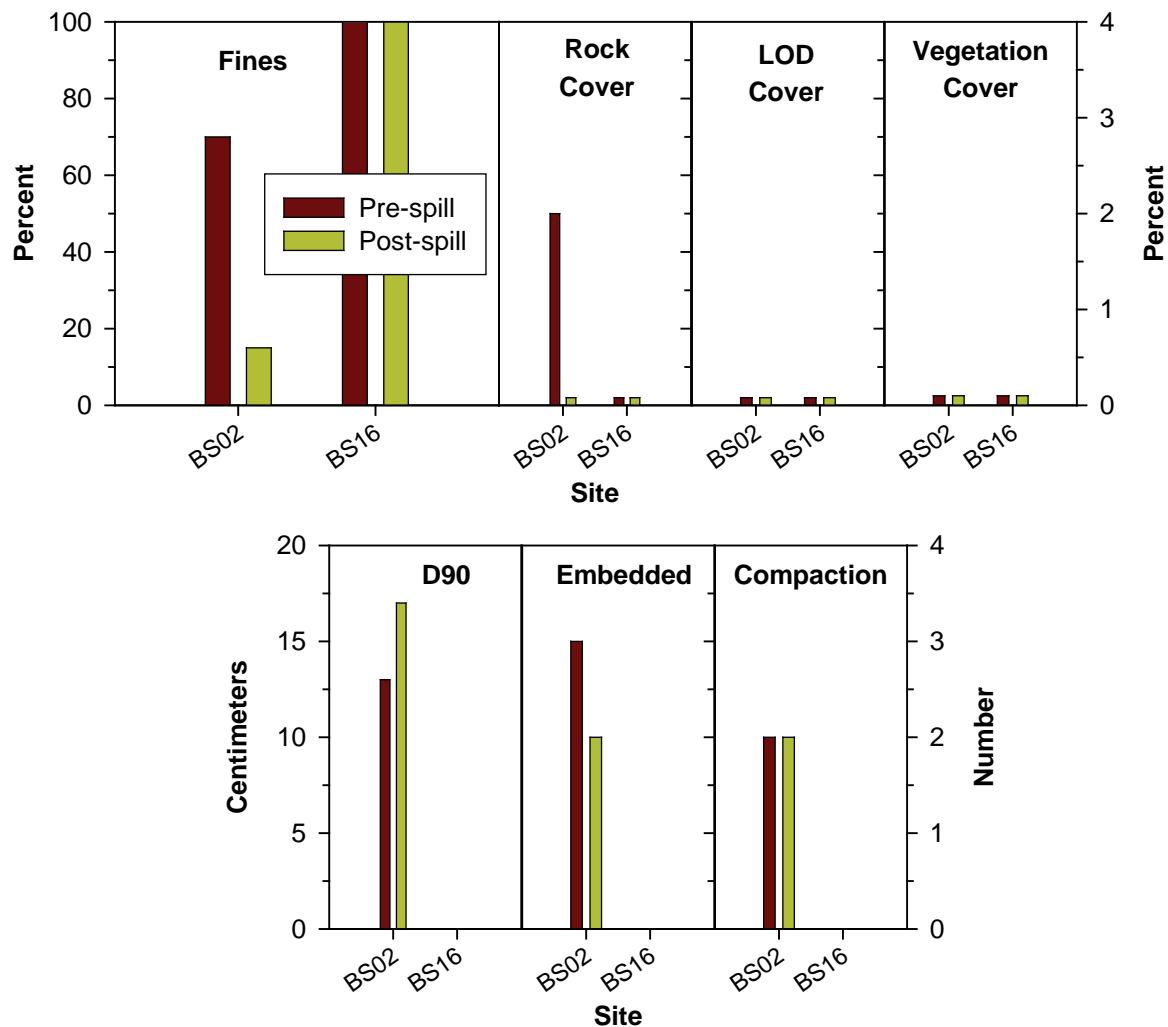
Figure 4-7 Habitat characteristics of fish sample sites in Side Channel 102.5R.

Physical characteristics measured at fish sample sites during the post-spill study were compared to data collected at the same locations during pre-spill studies. Two fish sample sites that were sampled pre-spill and post-spill were BS02, BS16. All raw site data are presented in Appendix H. Substrate composition differed between pre-spill and post-spill at Site BS02 (**Figure 4-7**). The percentage of fines was higher pre-spill compared to post-spill (70% versus 15%). There was no difference at Site BS16 (100% fines). The results for Site BS02 suggest that the spill flows may have removed some of the overlaying fines to expose the underlying gravel and cobble substrate.

There was minimal physical cover available to fish at Sites BS02 and BS16. The amount of rock cover decreased at Site BS02 from 2.5% to 0.0%. Other cover types (LOD cover and vegetation cover) were not recorded at these sites pre and post-spill.

The size of the channel substrates increased slightly at Site BS02 between pre-spill and post-spill (from 13 to 17 cm); no gravels or cobble were recorded at Site BS16. Embeddedness at Site BS02 was higher pre-spill compared to post-spill (3.0 versus 2.0); compaction did not change at Site BS02.
