Peace Project Water Use Plan

Industry and Taylor Water Quality Assessment

**GMSWORKS #10 – INDUSTRY AND TAYLOR
WATER QUALITY ASSESSMENT**

YEAR THREE REPORT

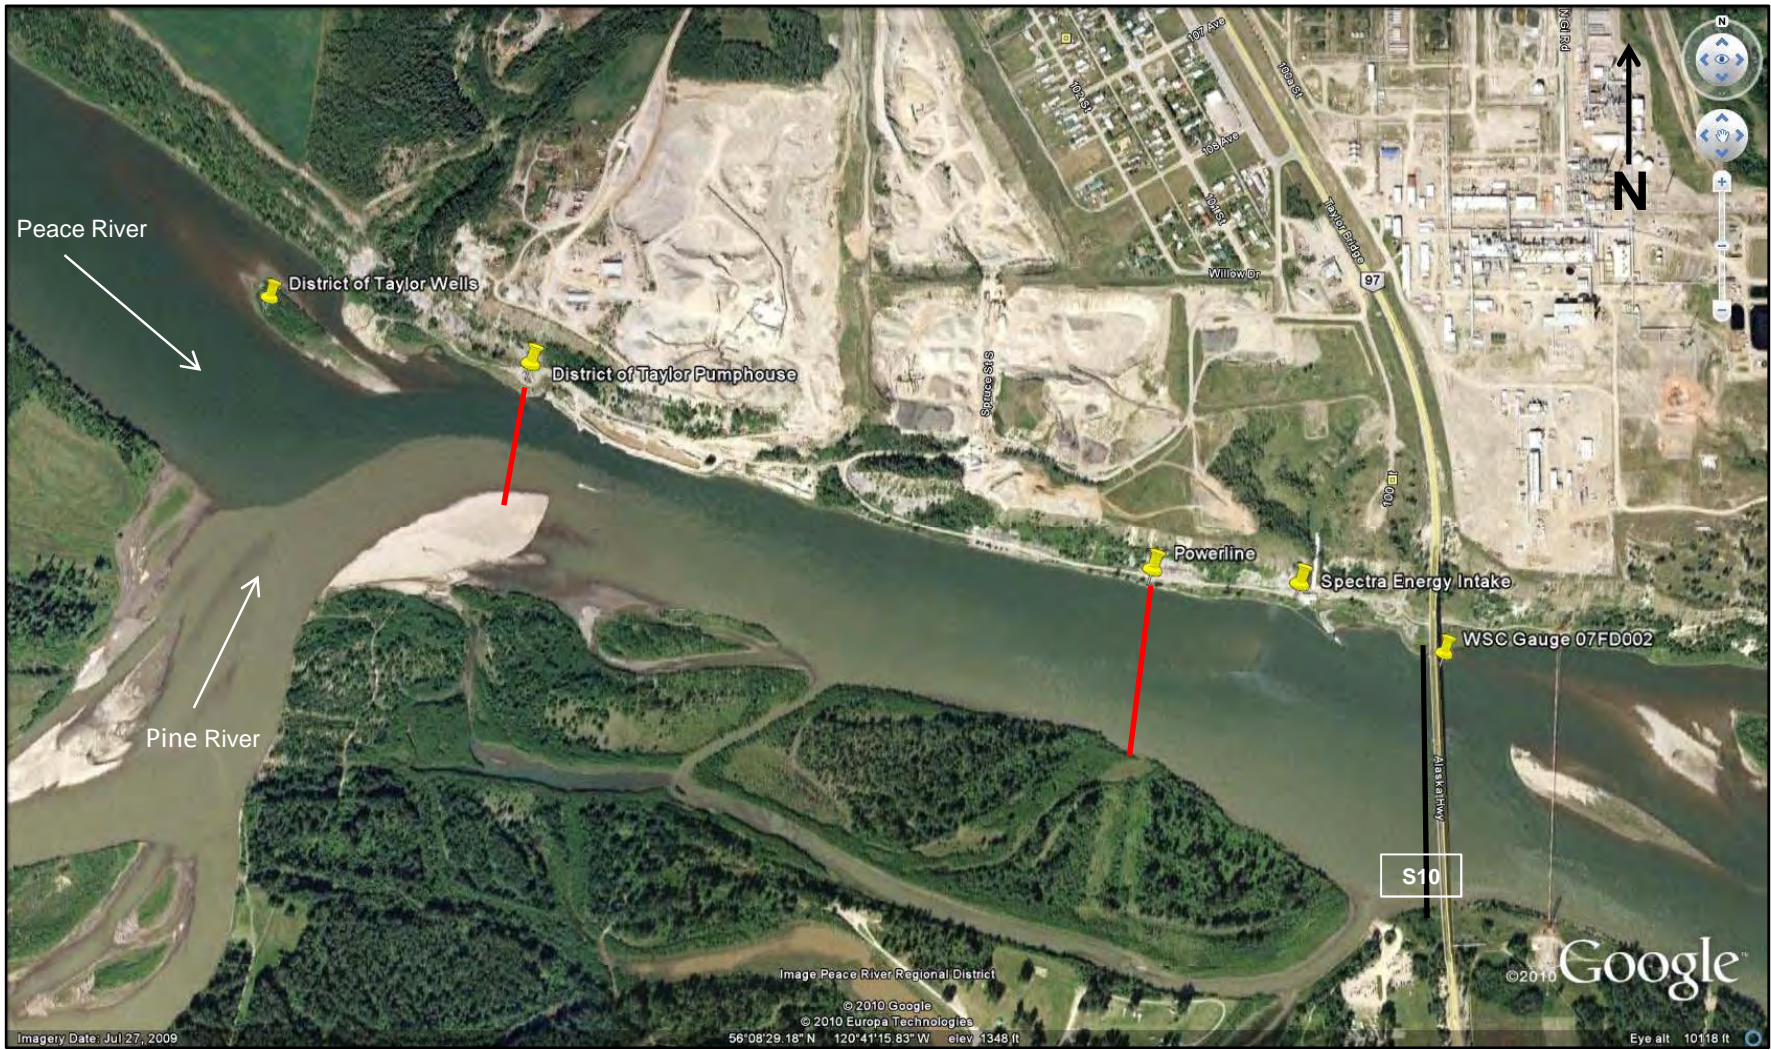
BC HYDRO		
GMSWORKS #10 - INDUSTRY AND TAYLOR WATER QUALITY ASSESSMENT		
STUDY AREA MAP		
<i>Knight Piésold</i> CONSULTING	P/A NO. VA103-14/30	REF. NO. 1
	FIGURE 2.2	
		REV 0

1. GOOGLE EARTH AIR PHOTO DATE: JULY 27, 2009.
2. AIR PHOTO SCALE AS PRESENTED: 1:12,500 (APPROX).
3. PINE/PEACE FLOW RATIO ON AIR PHOTO DATE: 0.020.

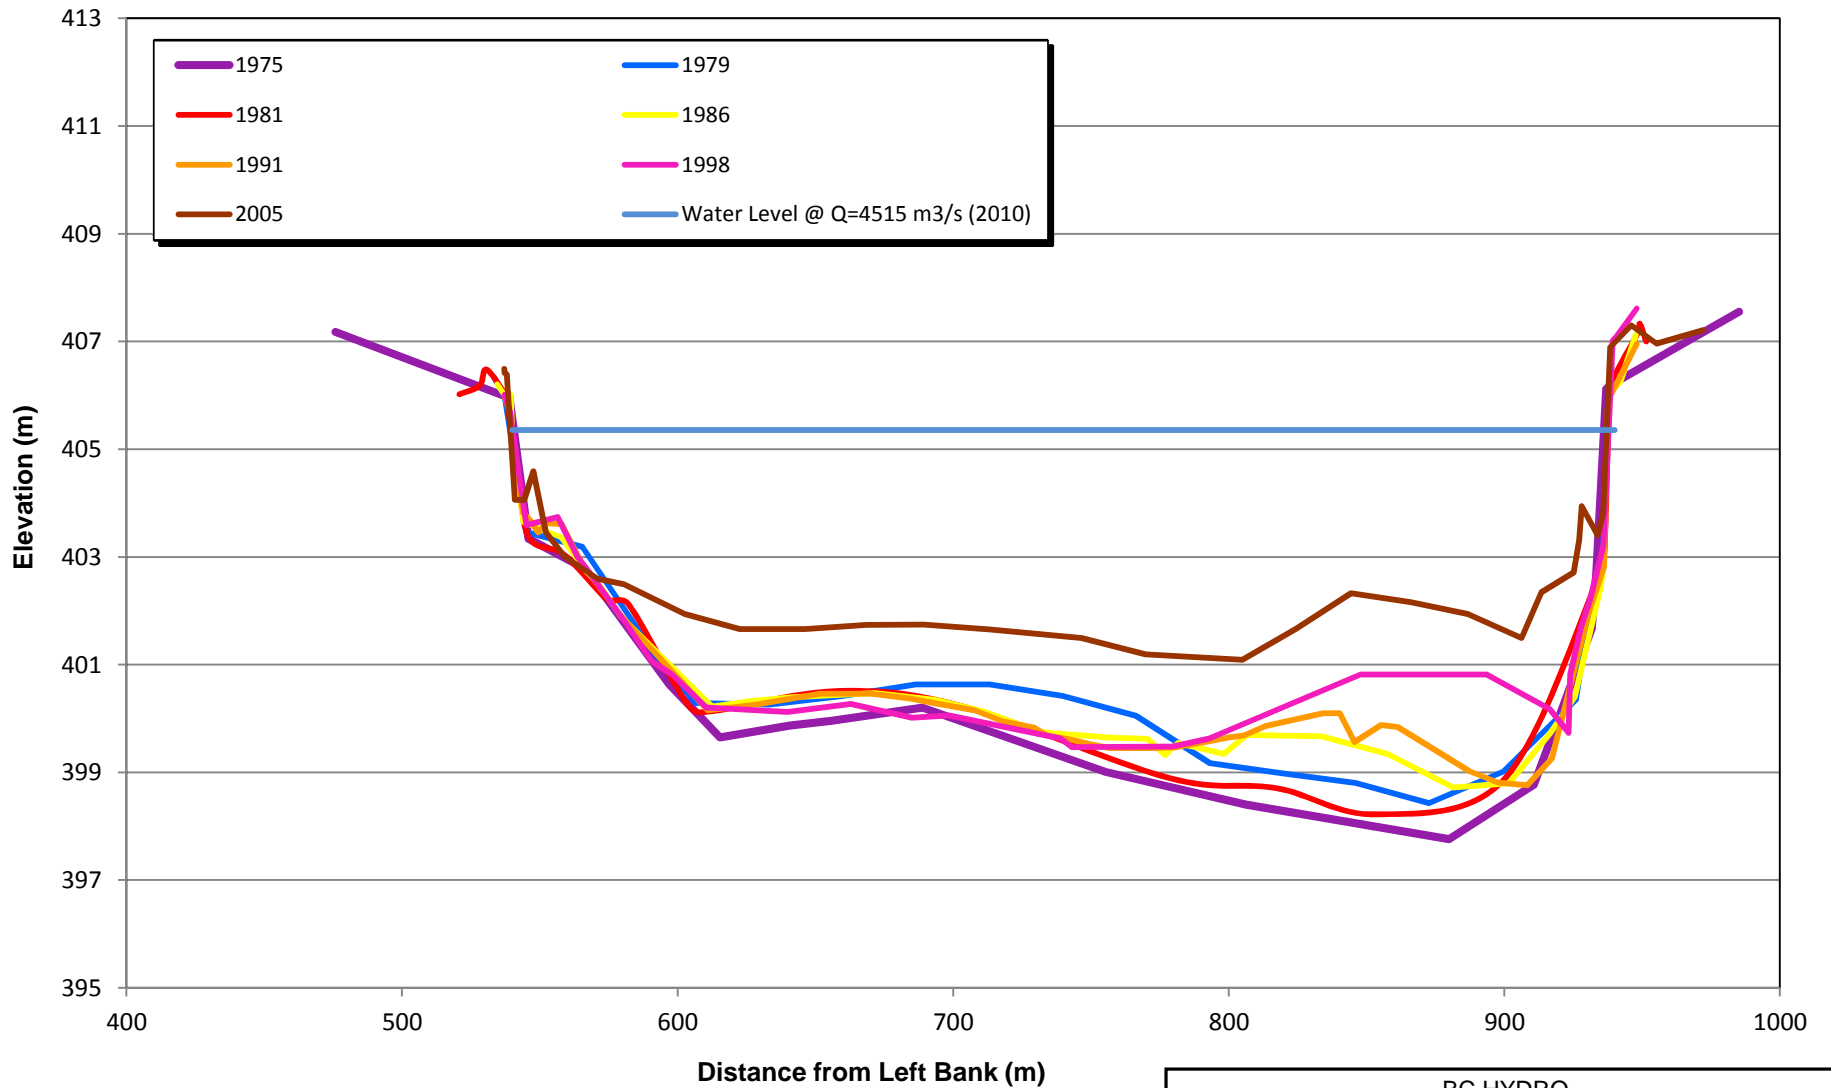
BC HYDRO	
GMSWORKS #10 - INDUSTRY AND TAYLOR WATER QUALITY ASSESSMENT	
HISTORICAL CROSS SECTION ANALYSIS SECTION 125	
<i>Knight Piésold</i> CONSULTING	P/A NO. VA103-14/30
	REF. NO. 1
FIGURE 6.3	
REV 0

NOTE:
 1. WATER LEVEL CALCULATED FOR A DISCHARGE RATE OF 4515 m³/s USING THE 2010-02-25 RATING TABLE FOR WSC GAUGE 07FD002.

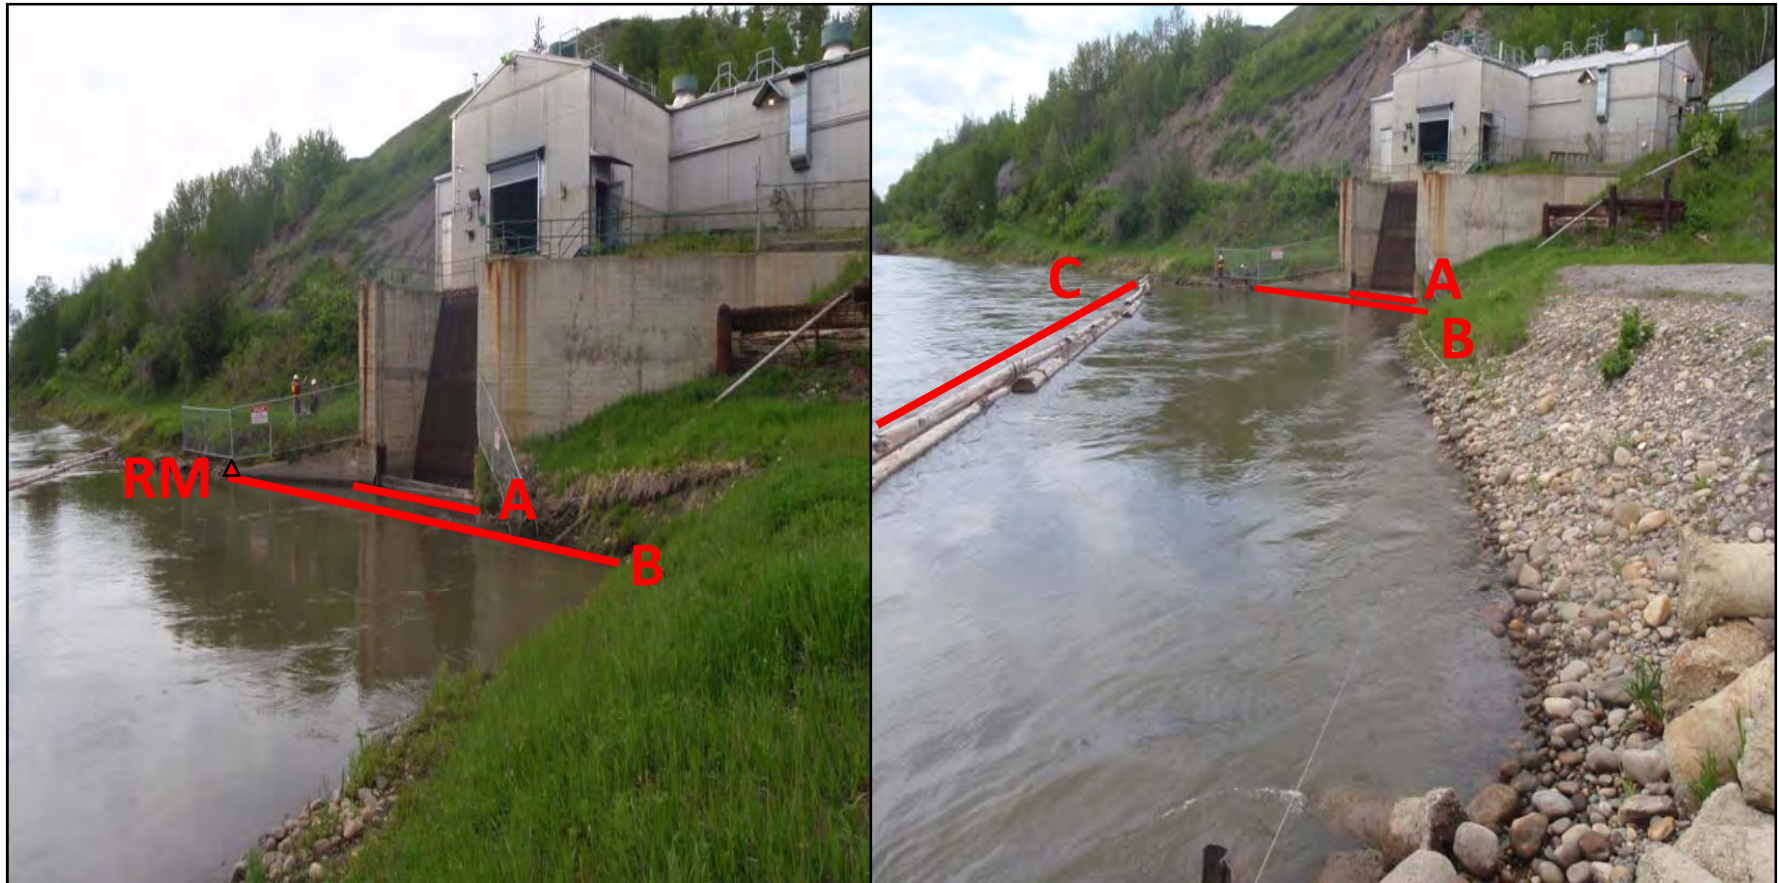
1. A - INNER FOREBAY TRANSECT
2. B - MID FOREBAY TRANSECT
3. C - LOG BOOM TRANSECT
4. RM - ELEVATION REFERENCE MARK (TOP CORNER OF CONCRETE AT END OF UPSTREAM WING WALL)

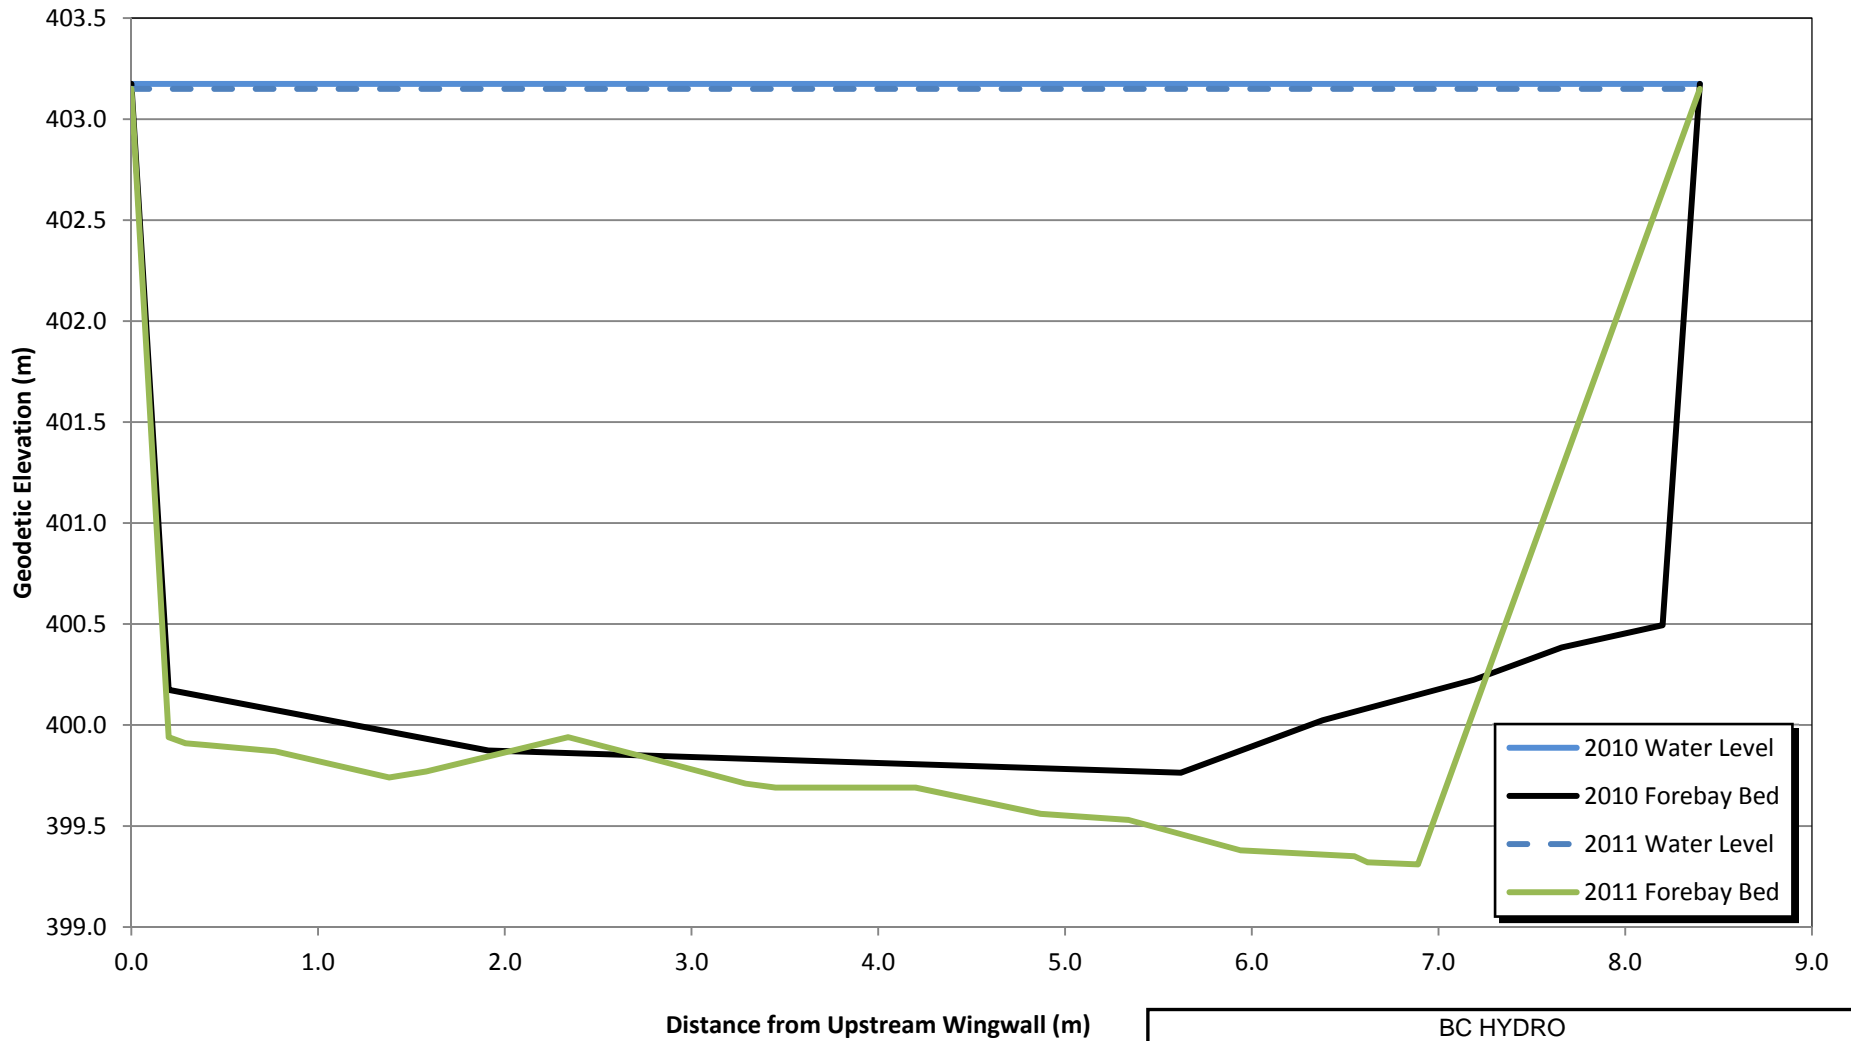
1. THE INNER FOREBAY TRANSECT WAS SURVEYED ON JUNE 1, 2010 AT 14:30 MST AND ON MAY 3, 2011 AT 9:40 MST.
2. THE TRANSECT LOCATION IS DEPICTED IN THE PHOTOS SHOWN ON FIGURE 8.1.

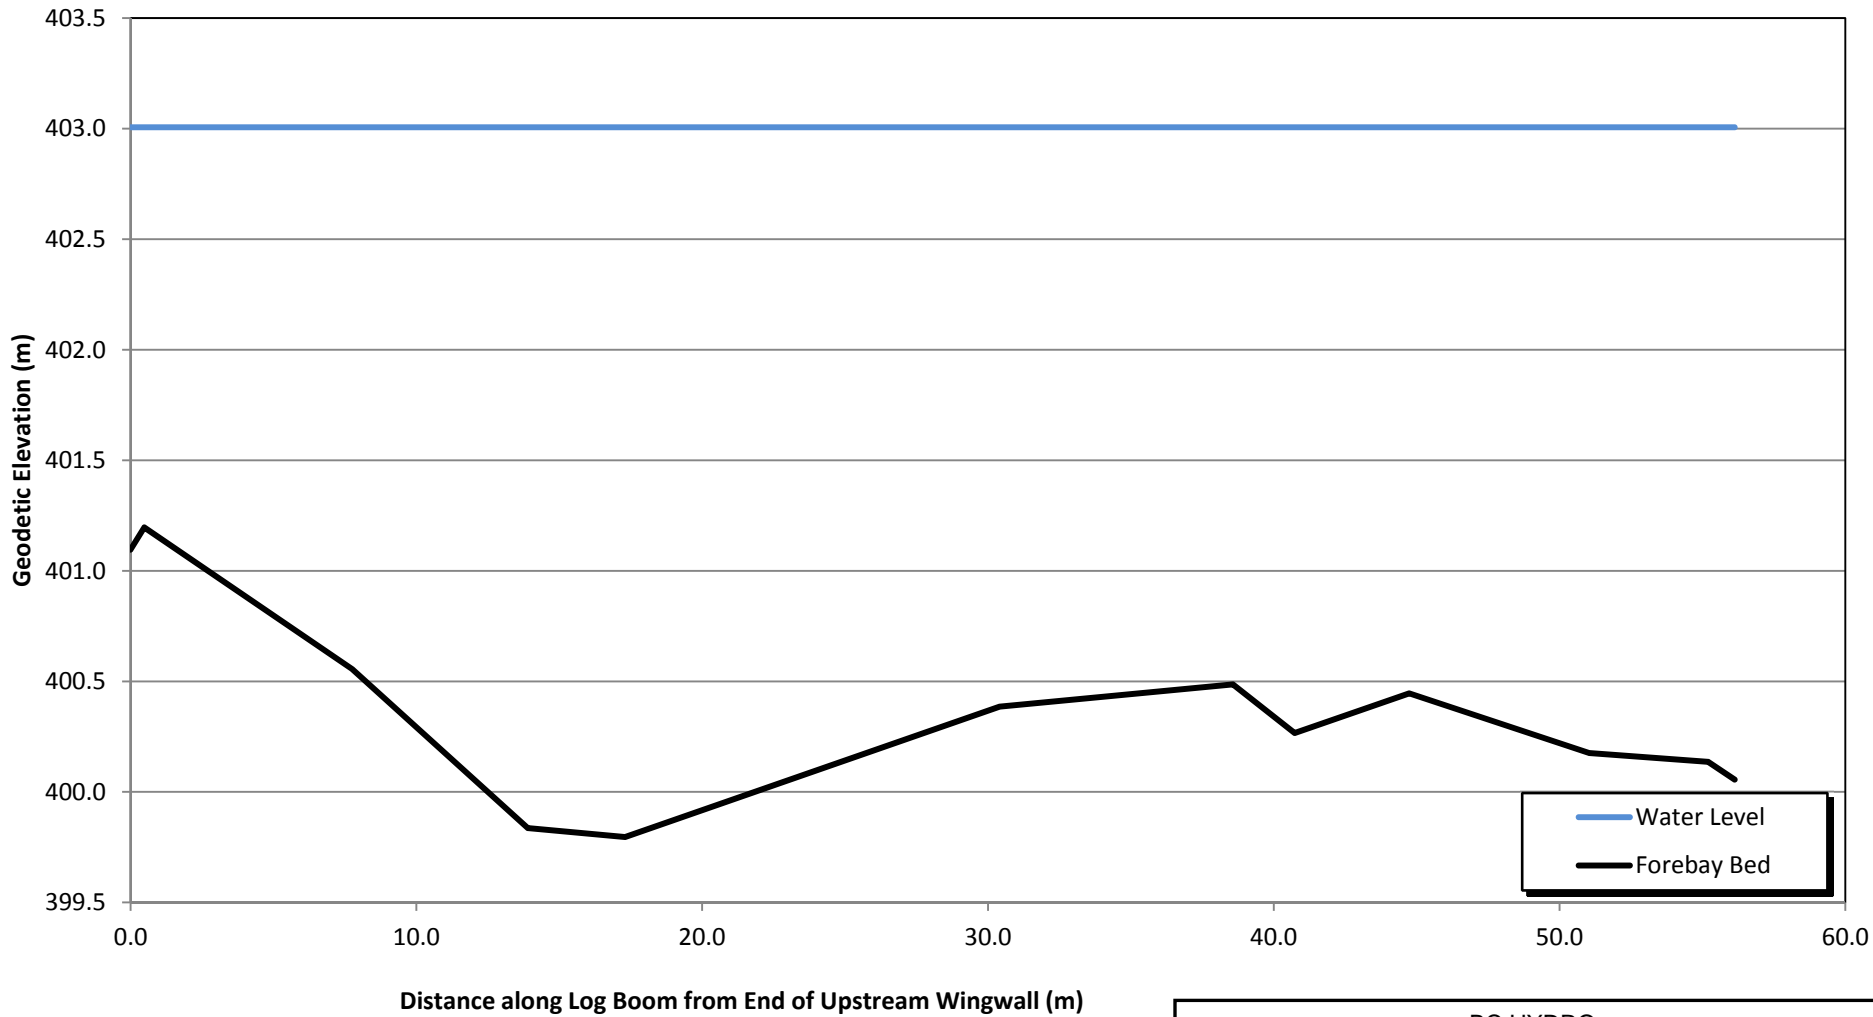
BC HYDRO	
GMSWORKS # 10 - - INDUSTRY AND TAYLOR WATER QUALITY ASSESSMENT	
SPECTRA INTAKE BATHYMETRY LOG BOOM TRANSECT	
<i>Knight Piésold</i> CONSULTING	P/A NO. VA103-14/30
	REF. NO. 1
FIGURE 8.4	
REV 0

NOTES:
 1. THE LOG BOOM TRANSECT WAS SURVEYED ON JUNE 3, 2010 AT 16:40 MST.
 THE SURVEY WAS NOT REPEATED IN 2011.
 2. THE TRANSECT LOCATION IS DEPICTED ON THE PHOTOS SHOWN IN FIGURE 8.1.

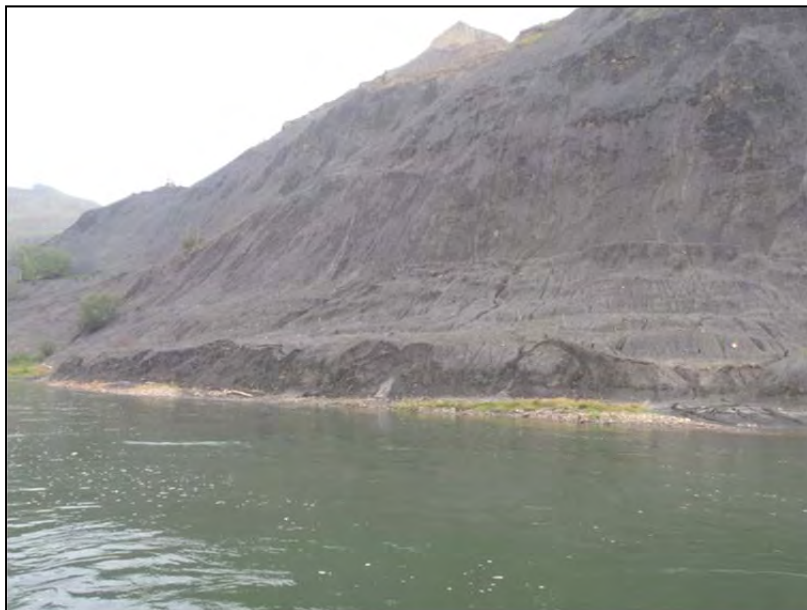
PHOTO 1 – Peace River above the Pine River confluence – typical sidewall landslide deposit.

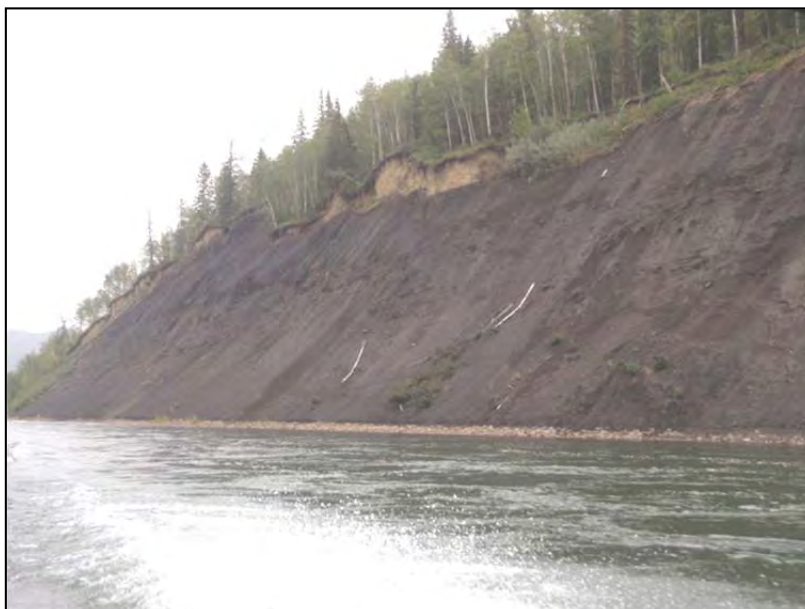
PHOTO 2 – Peace River above the Pine River confluence – typical eroding shale sidewall.

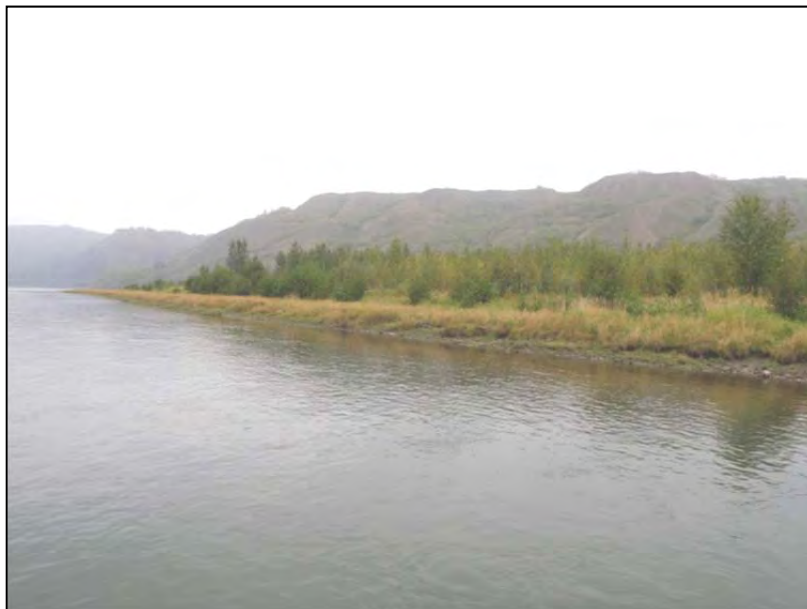
PHOTO 3 – Peace River above the Pine River confluence – typical vegetated gravel bar.

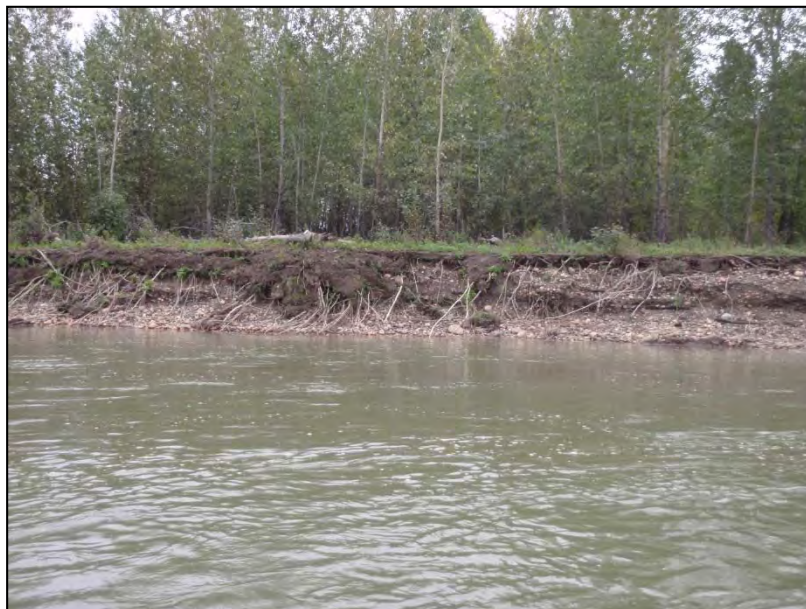
PHOTO 6 – Lower Pine River – typical site of active bank erosion.

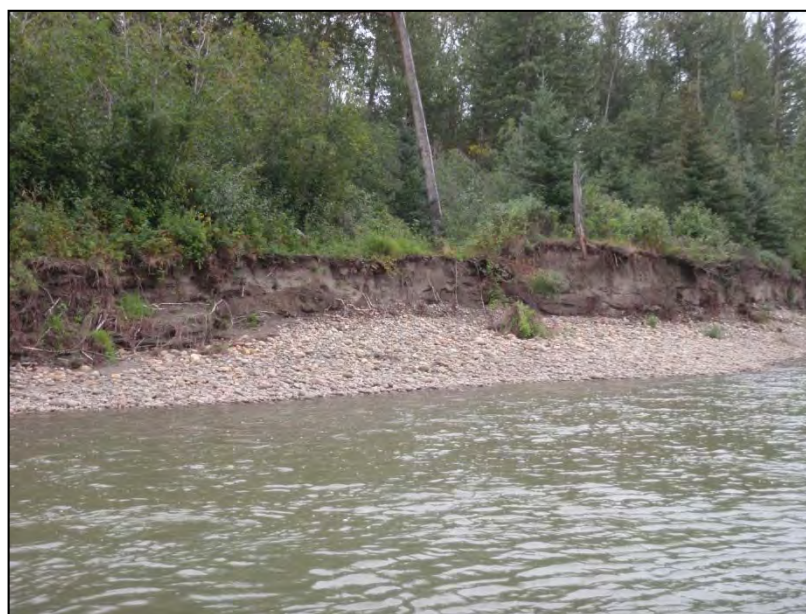
PHOTO 7 – Lower Pine River – typical alluvial bank materials.

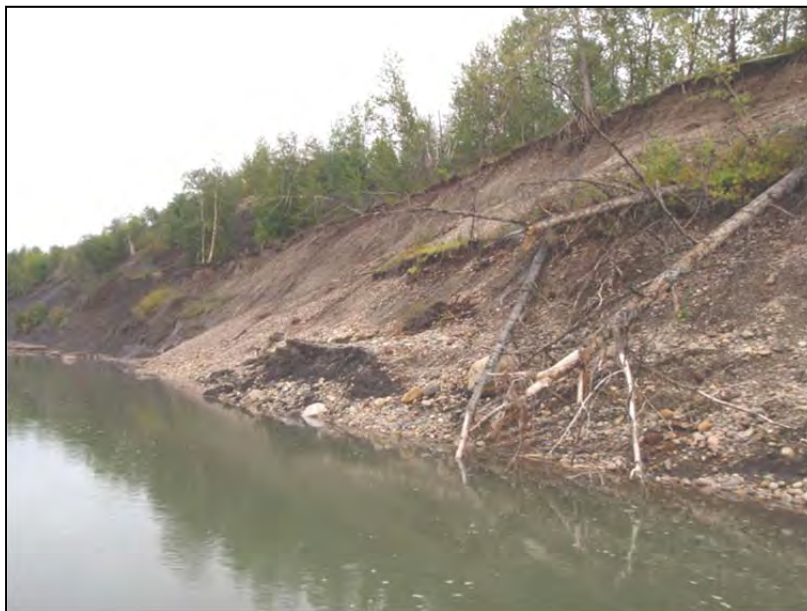
PHOTO 8 – Lower Pine River – typical glacio-fluvial bank materials.

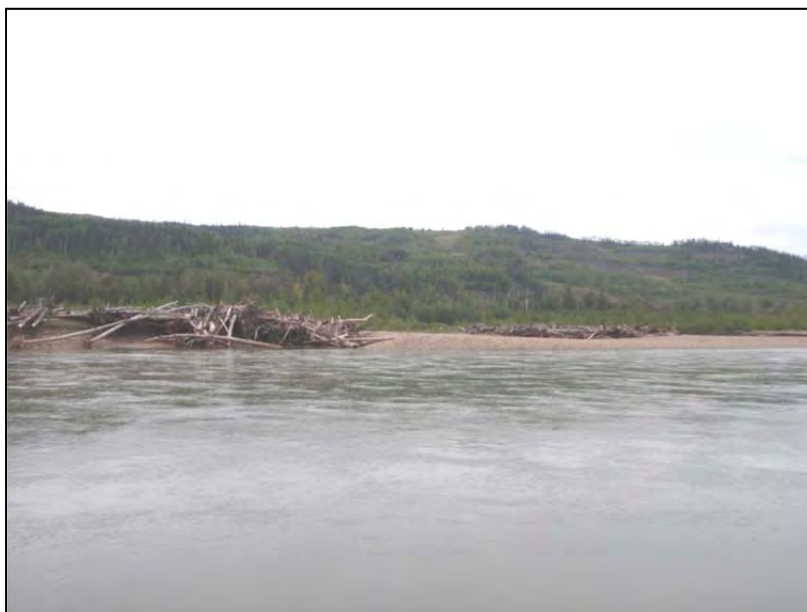
PHOTO 9 – Lower Pine River – typical gravel bar.

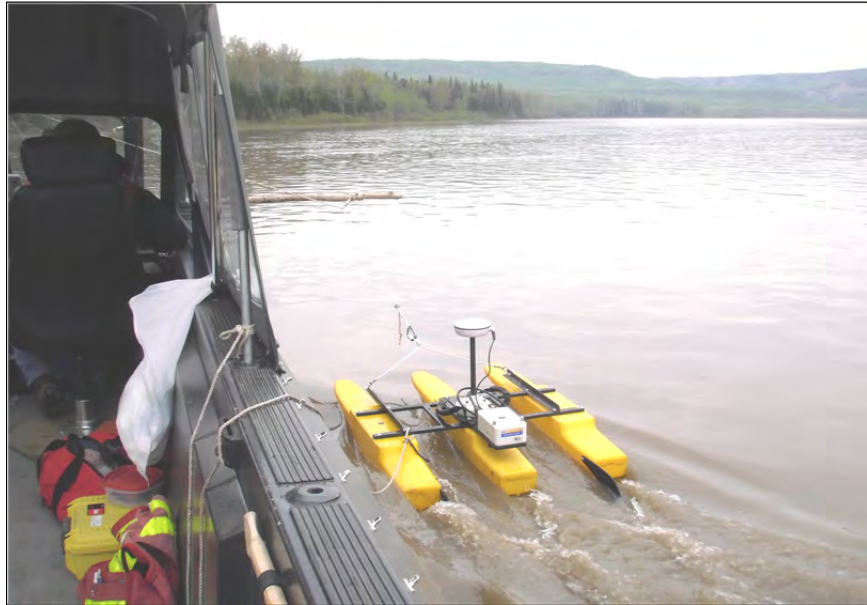
PHOTO 10 – Sontek RiverSurveyor S5 Acoustic Doppler Current Profiler attached to a boom and held off the bow of the jet boat.

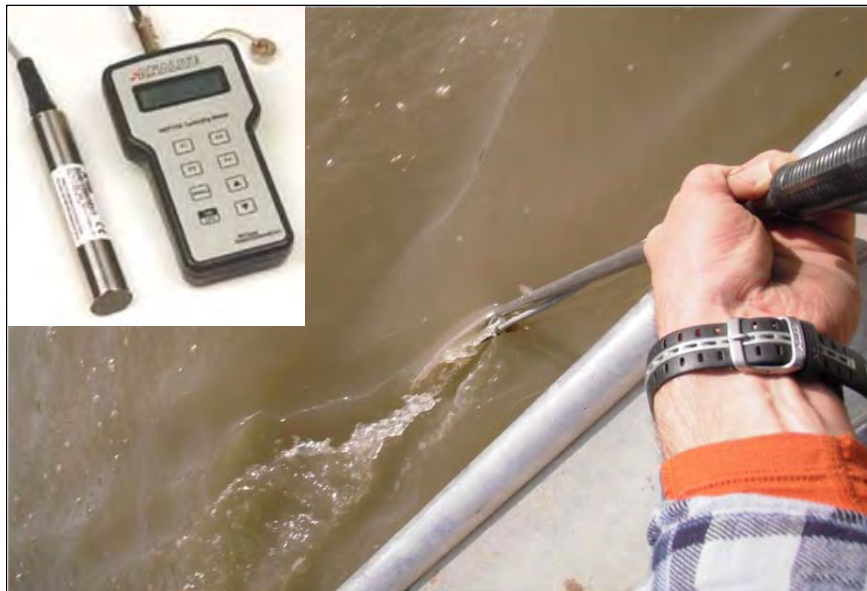
PHOTO 11 – Analite NEP 160 turbidity sensor attached to a 1 m rod and held 20 cm below the water surface from the side of the jet boat.

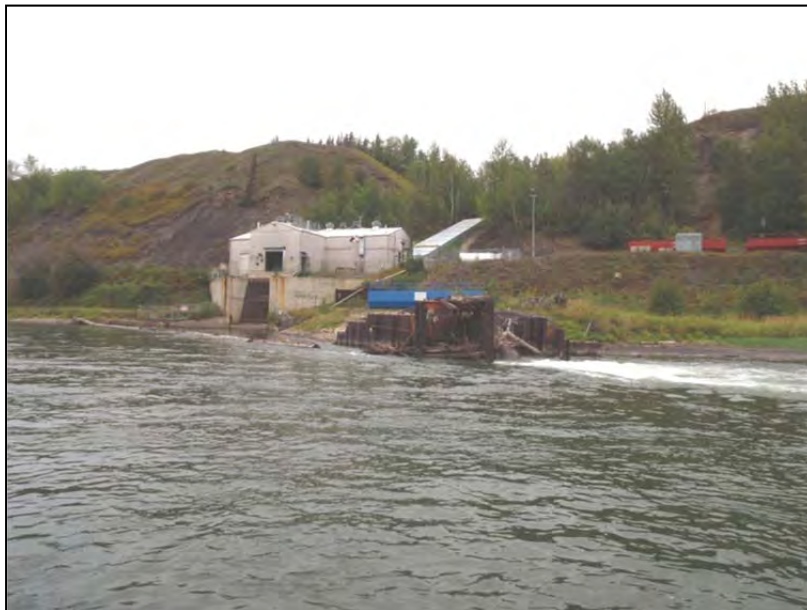
PHOTO 12 – Spectra Energy intake facility.

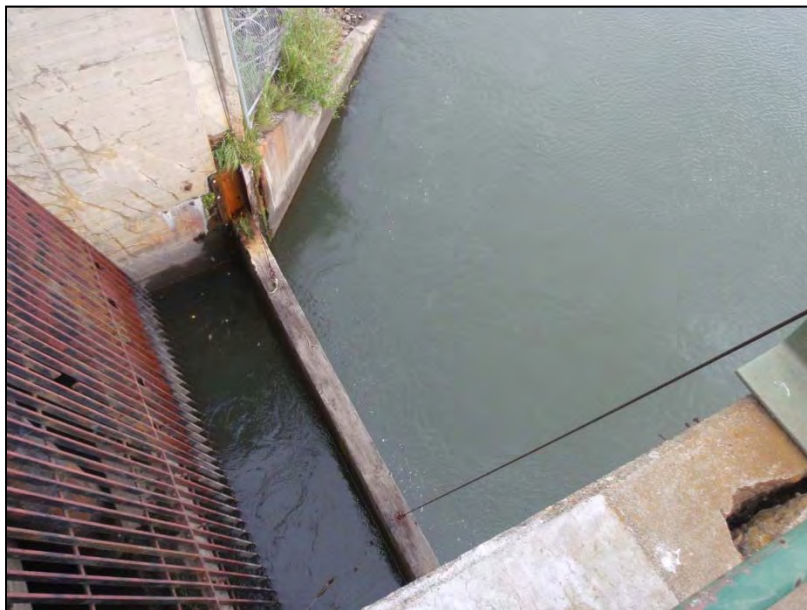
PHOTO 13 – Spectra Energy intake forebay.

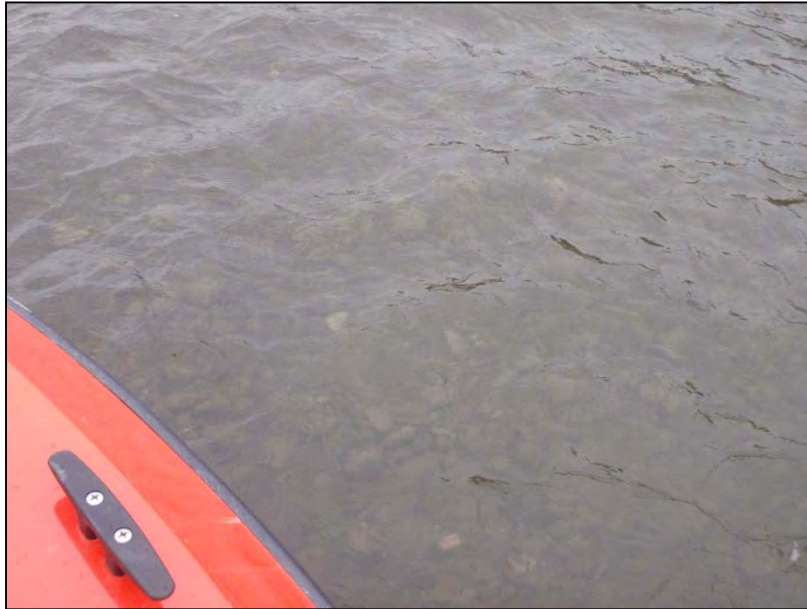
PHOTO 14 – Spectra Energy intake – typical bed material in mid-channel gravel shoal.

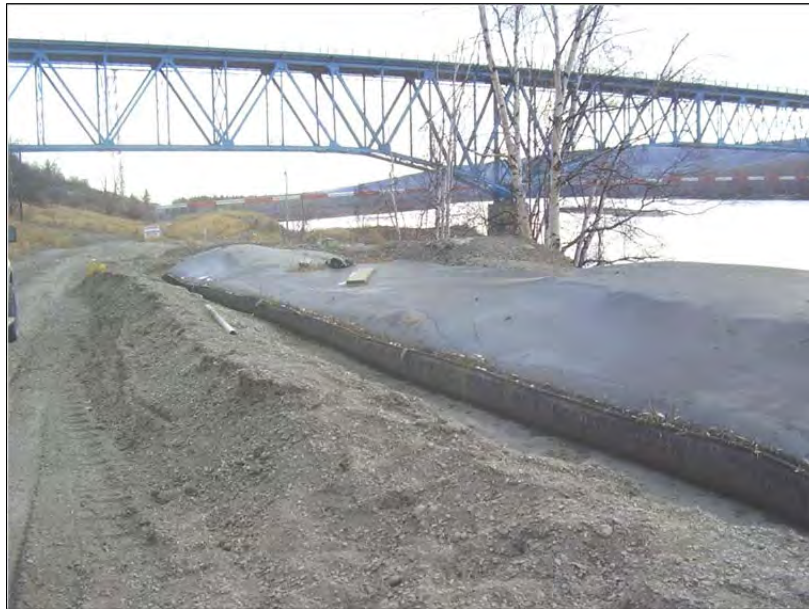
PHOTO 16 – Container of dredged material from Spectra Intake - looking downstream.

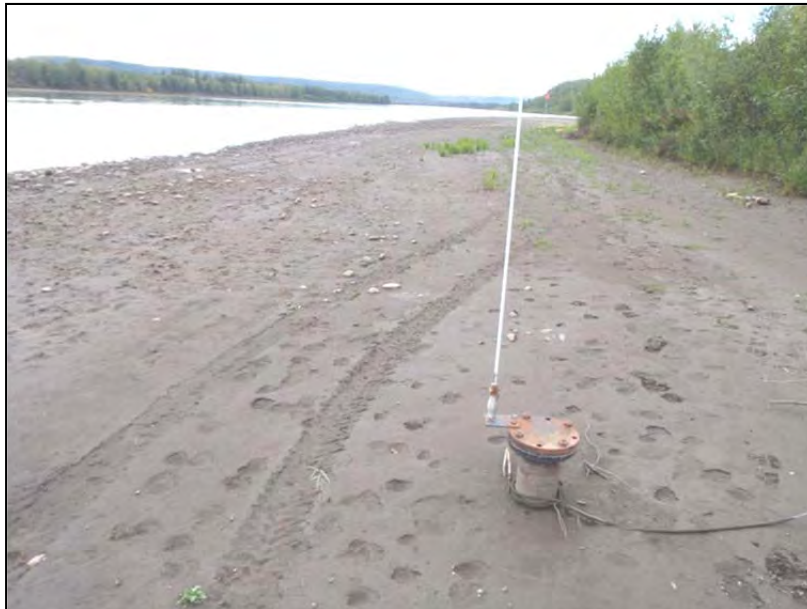
PHOTO 18 – District of Taylor intake site – looking upstream at the two test wells.
