Peace Project Water Use Plan

Williston Debris Field Survey

Williston Debris Field Survey: Inventory and Contribution Analysis Report

AECOM Tecresult Inc.

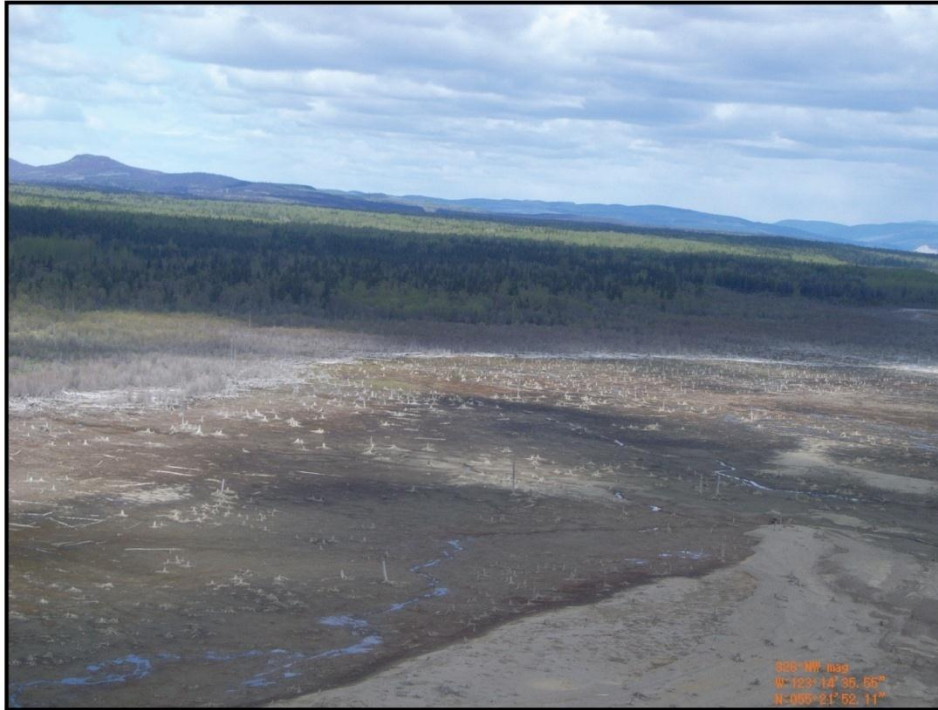
Figure 7 Photos showing stumps and snags

Stumps and snags, principally tree trunks and root bases were found in many of the shallow bays. Even though they are unlikely to become floating debris, these constitute a hazard to recreational use of the reservoir.

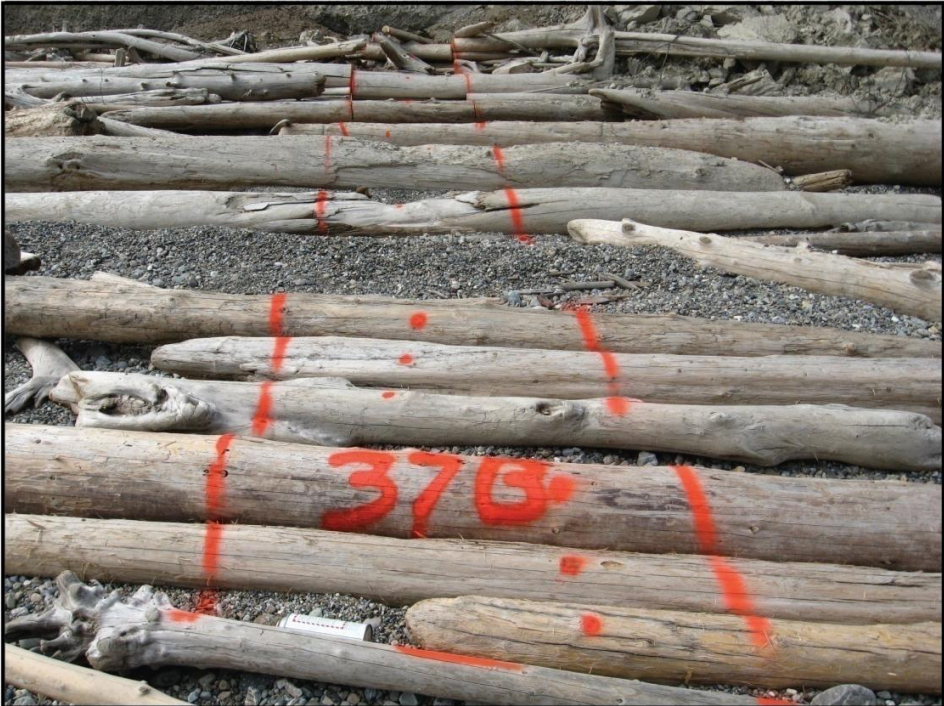
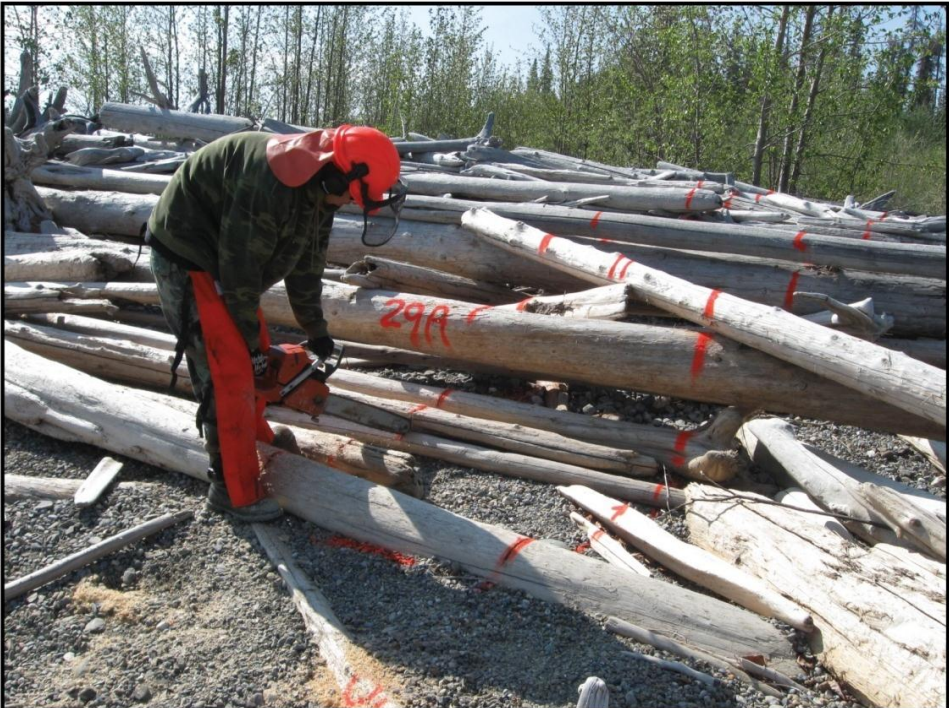
Figure 10 Photos illustrating the sampling method used to establish the unitary volume of the debris (m^3/m^2)

Sample plots were laid directly over the debris pile, as per the photographs provided in Figure 10. The plots were one meter wide with a length equal to the debris pile width (Figure 10a). The debris stems located within the boundaries of the plot were then cut into lengths using a chainsaw (Figure 10b).

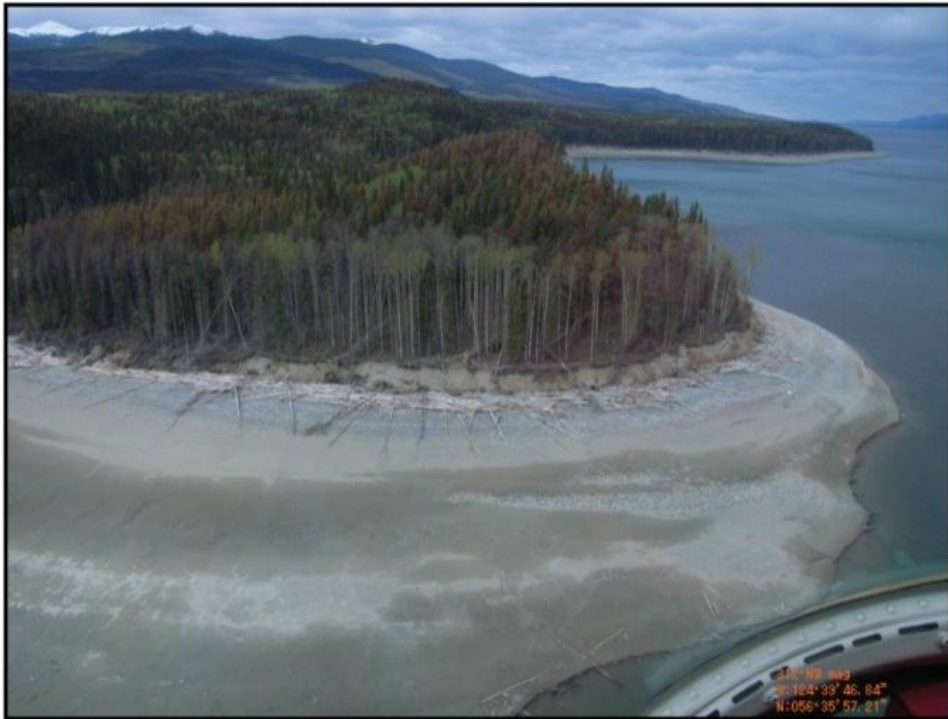
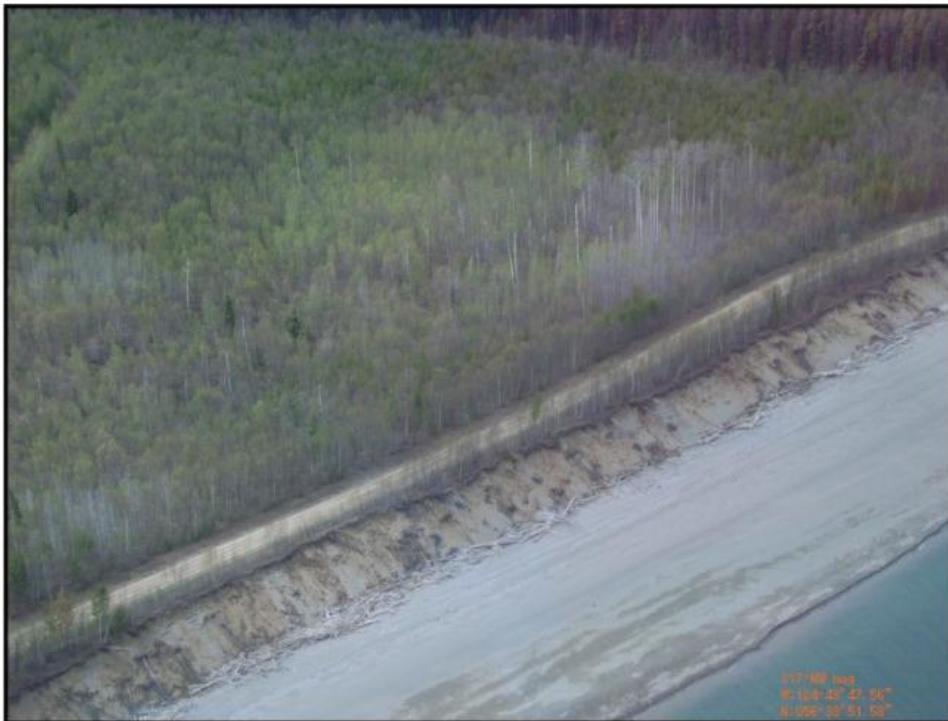
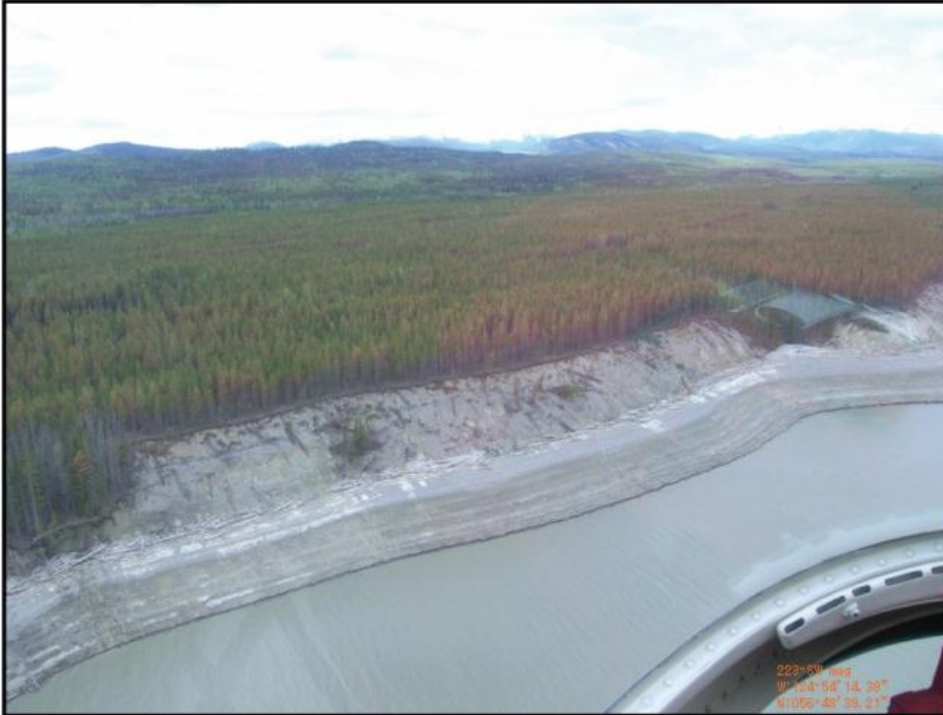
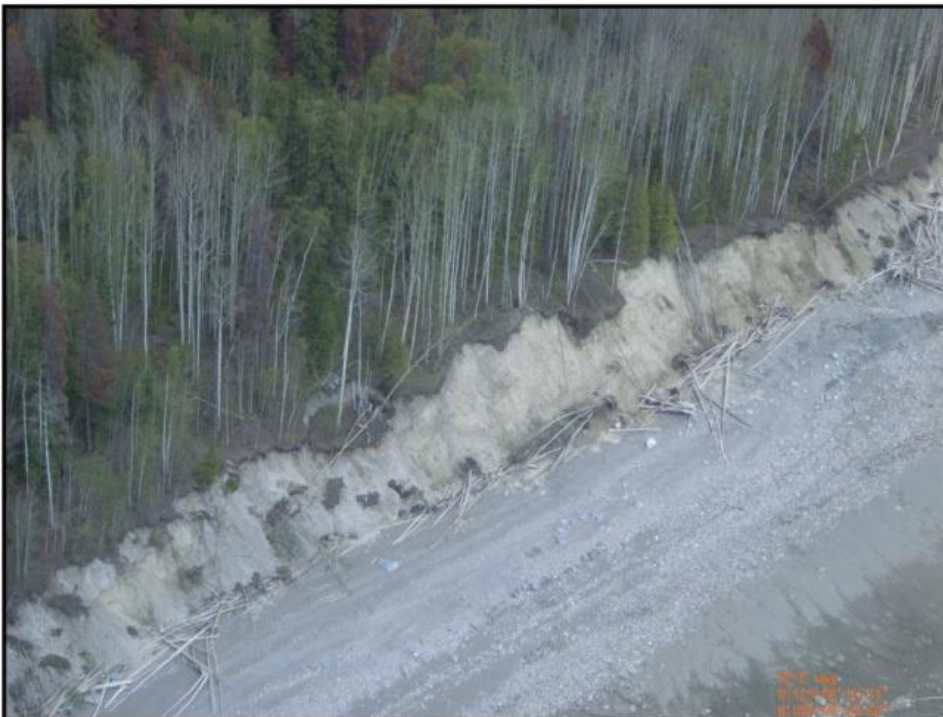
Figure 18 Photos showing shoreline erosion on the Williston Reservoir

Shoreline erosion is very active in the Williston Reservoir. The importance of this phenomenon was observed during the over flight of the reservoir conducted in June, 2009. Many areas of erosion are visible in the photographs collected during the survey. These photos were sent under separate cover to BC Hydro. They are also identified on the inventory map presented in Appendix 2 entitled "Debris Inventory - Field Sampling and Ground Truthing" and can be viewed digitally using Arc Map.
