Peace Project Water Use Plan

WILLISTON TARGETED DEBRIS MANAGEMENT

Reference: GMSWORKS-22

Study Period: 2020

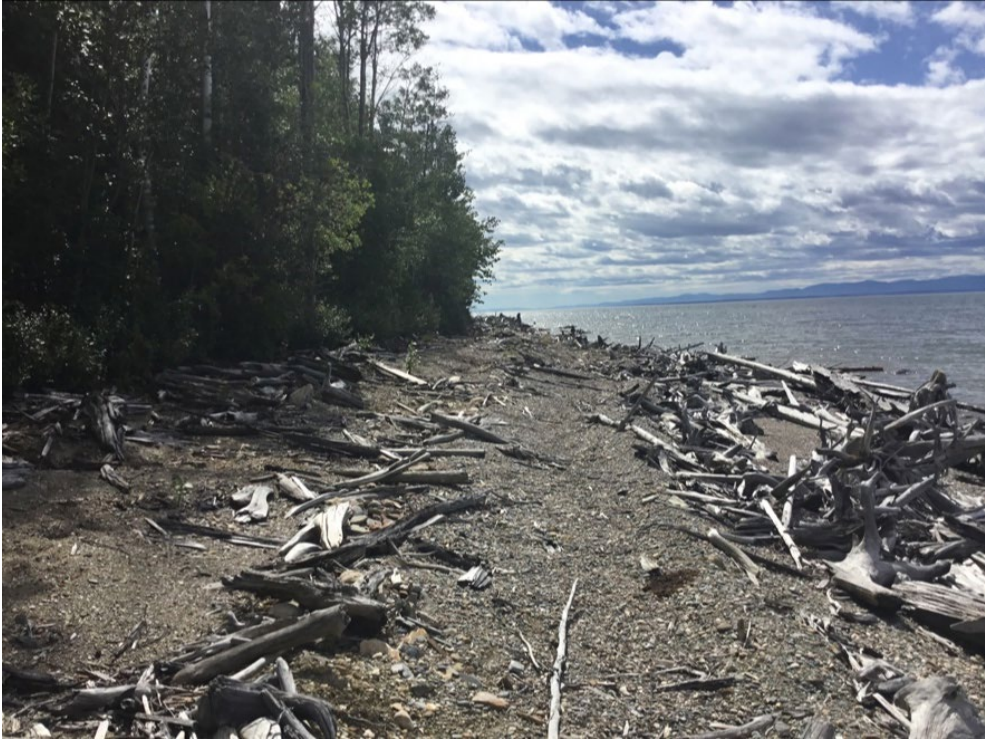
Figure 1: Bevel Beach before debris management, July 27, 2020.

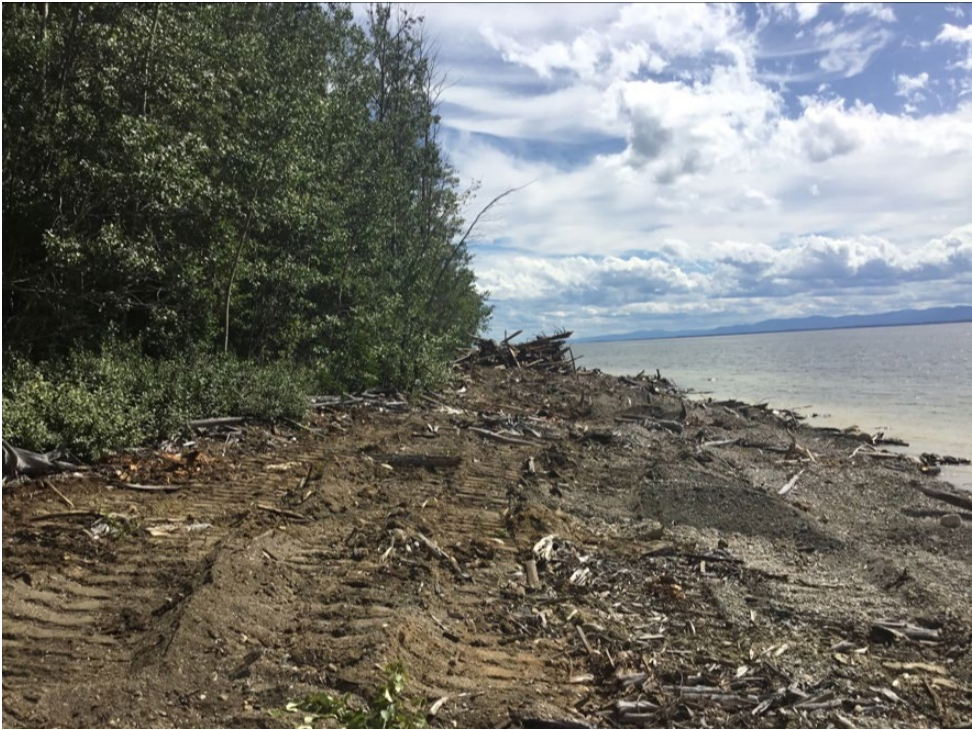
Figure 2: Bevel Beach after debris management, July 27, 2020.

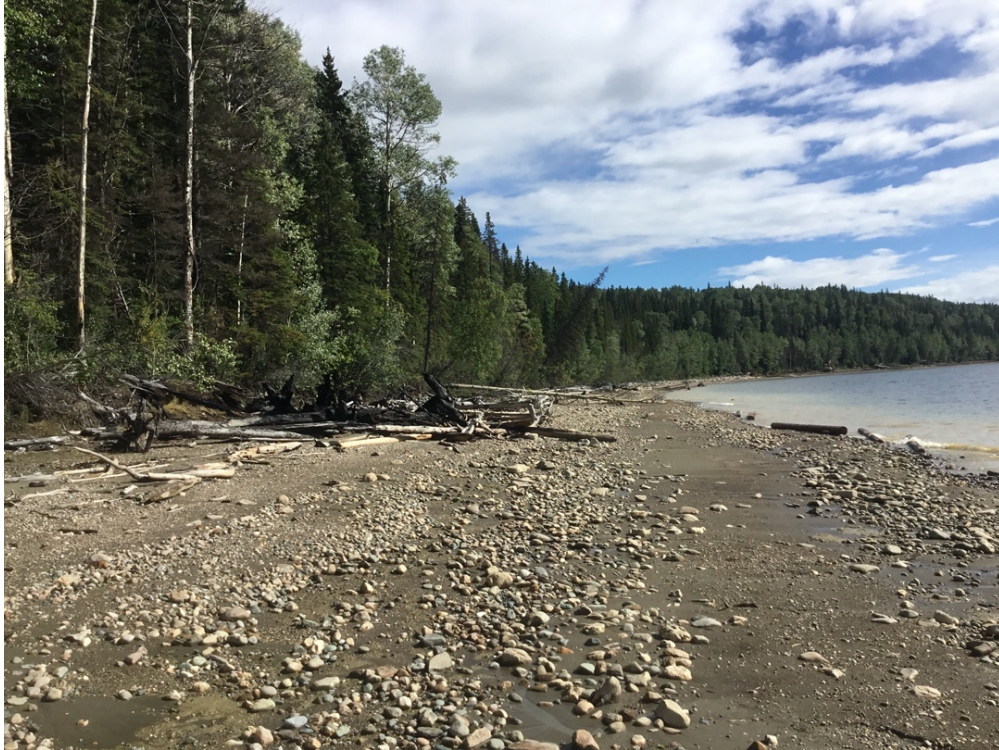
Figure 3: Davis South Beach before debris management, August 23, 2020.

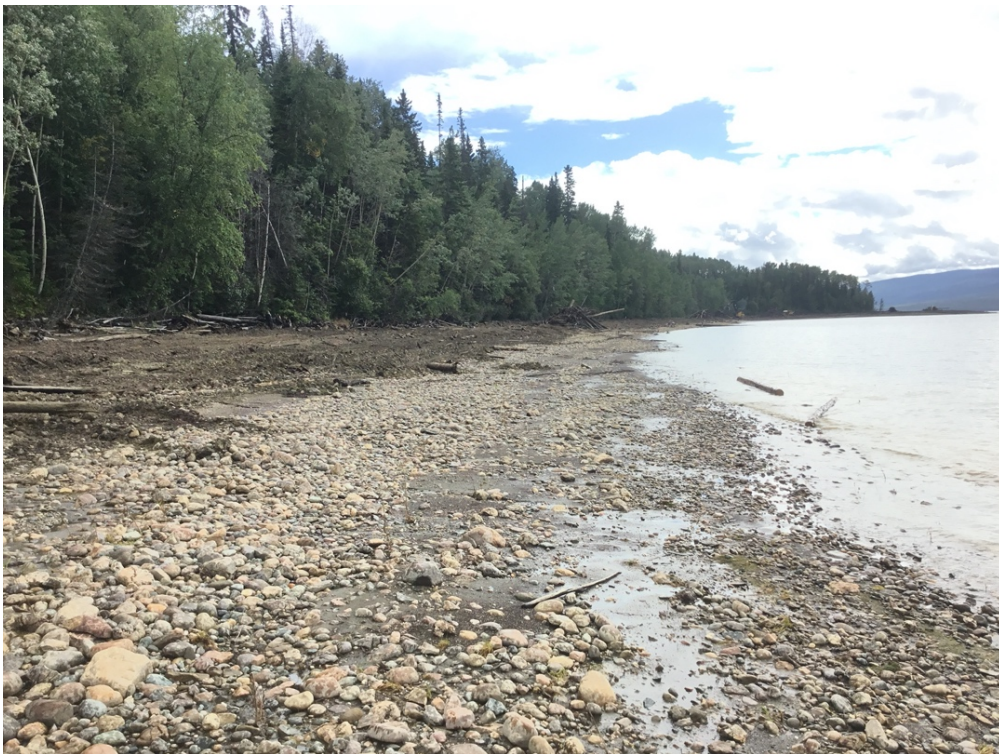
Figure 4: Davis South Beach after debris management, August 23, 2020.

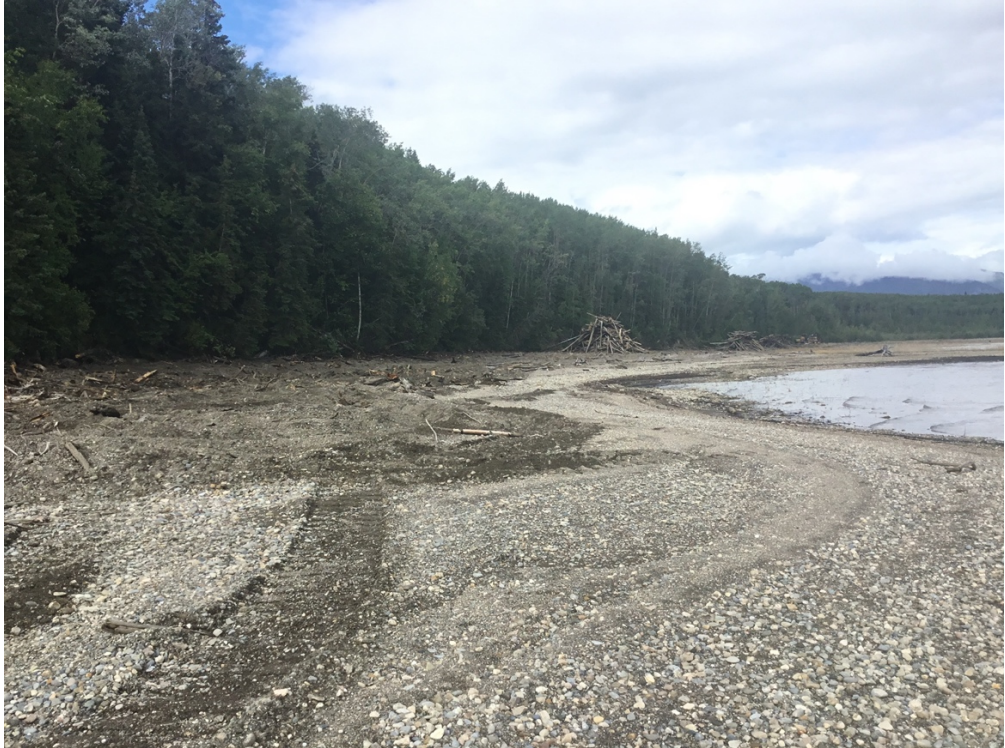
Figure 5: Debris piles on Ospika Beach, August 18, 2020.

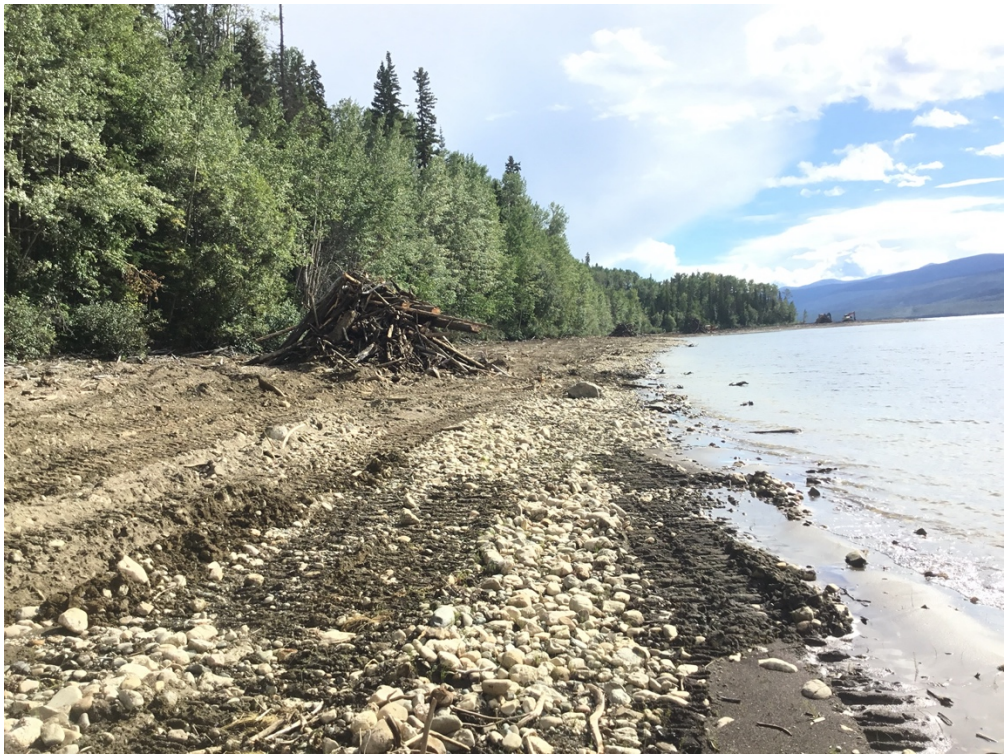
Figure 6: Davis North Beach after debris management, August 24,2020.

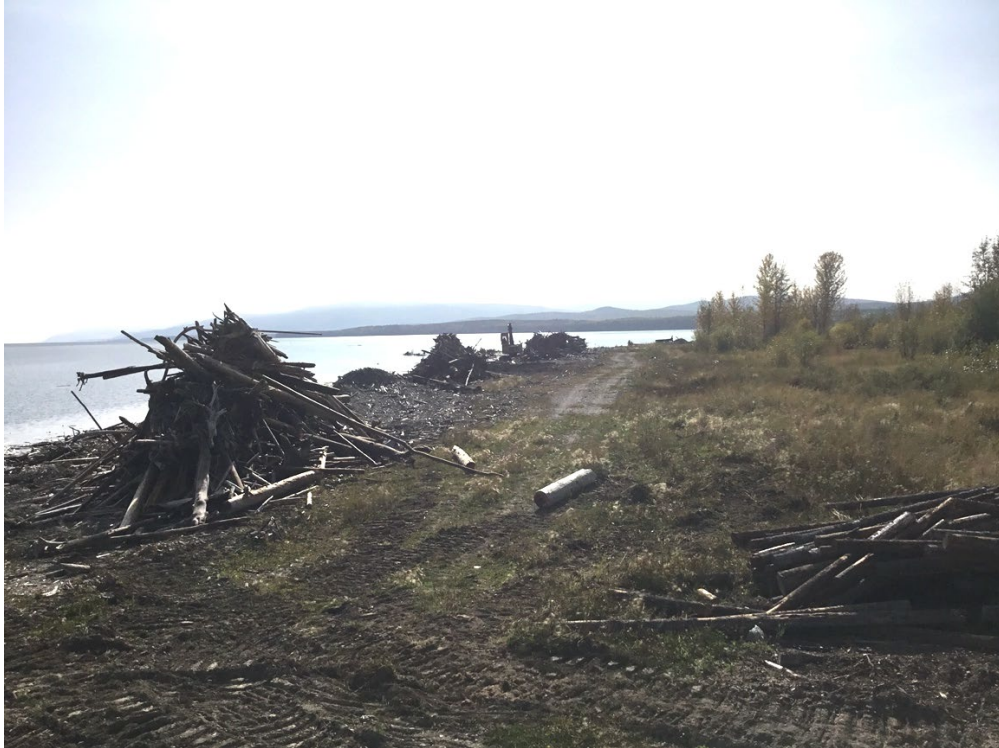
Figure 7: Debris piling at Tsay Keh Beach, September 17, 2020.

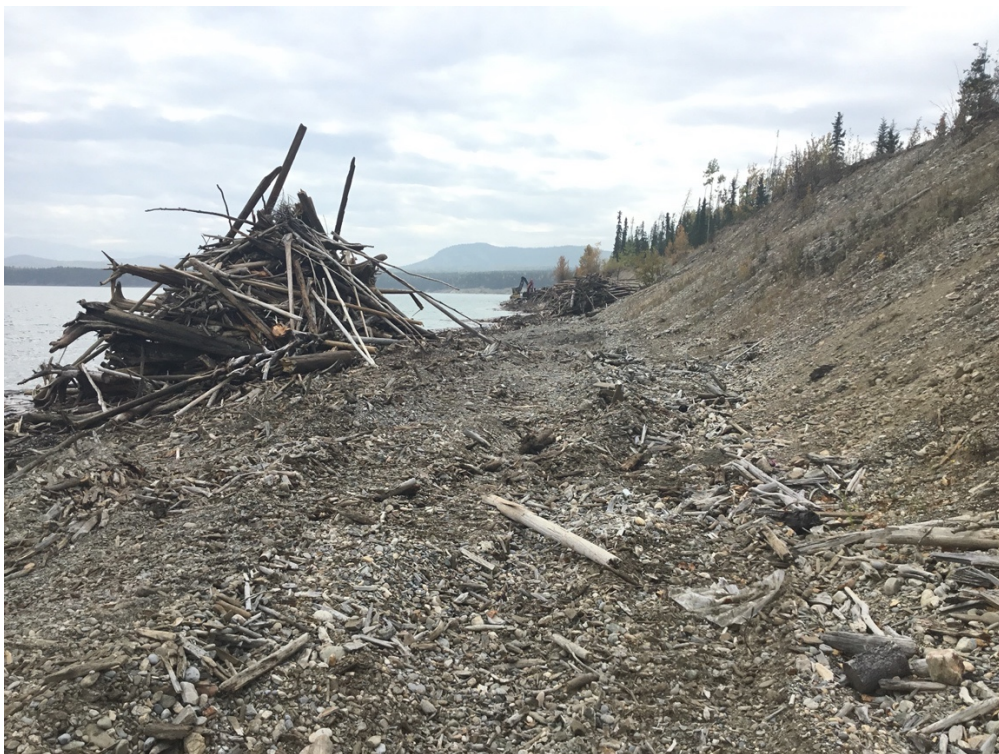
Figure 8: Debris piling at Tsay Keh Beach, September 19, 2020

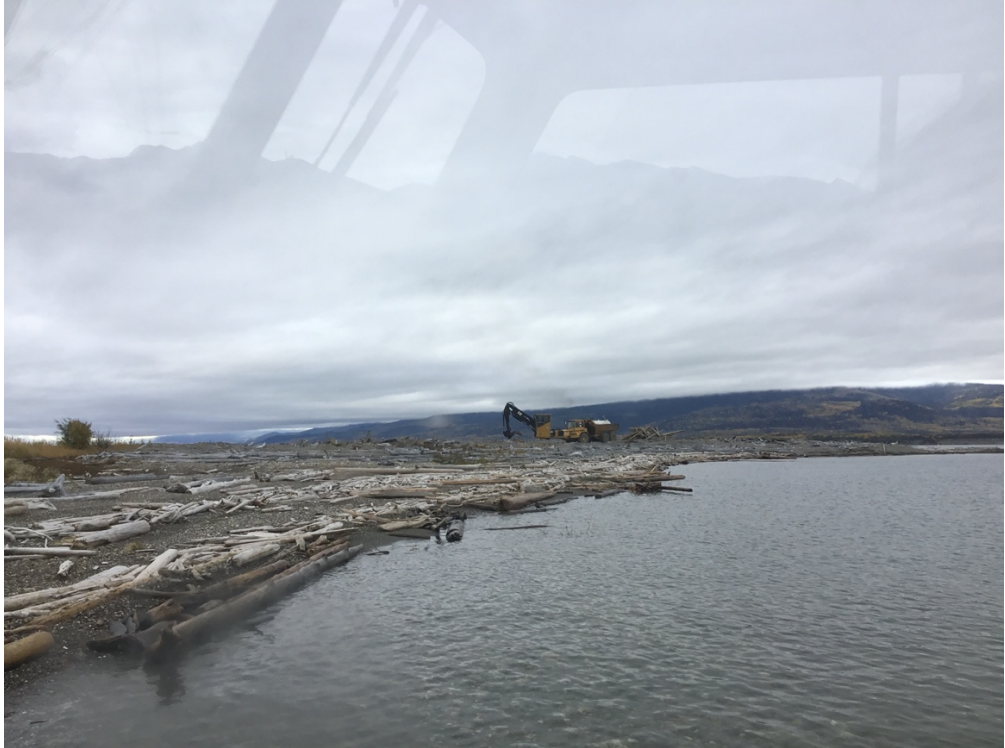
Figure 9: Debris piling at Van Somers Beach, September 22, 2020.

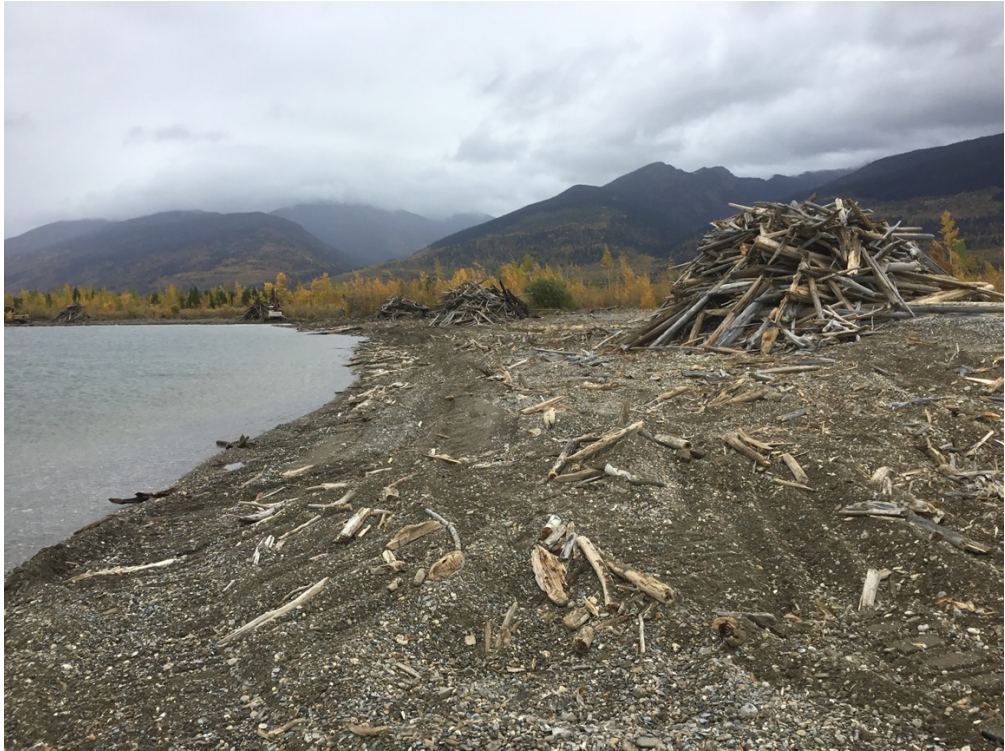
Figure 10: Debris piling at Van Somers Beach, September 23, 2020.

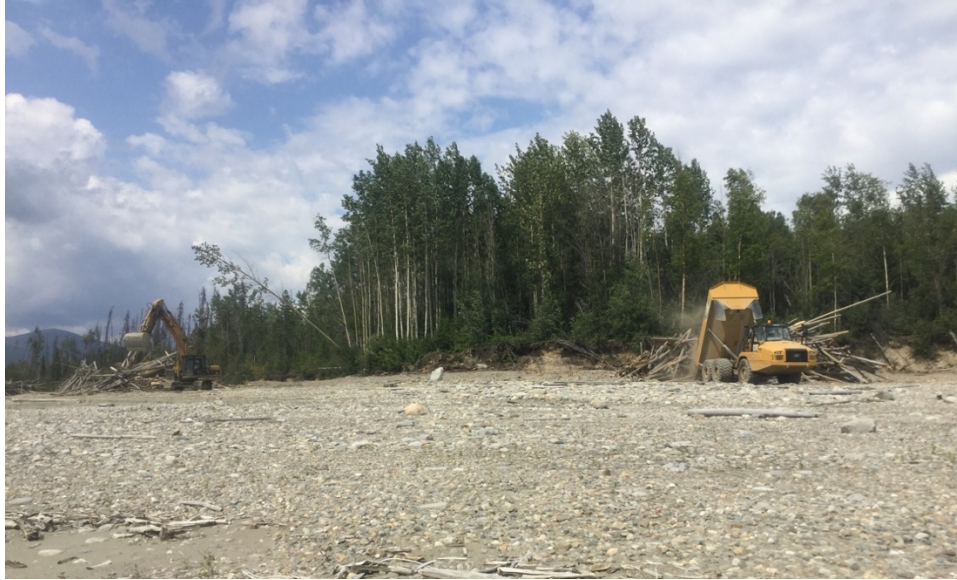
The following series of images shows an overview of work locations for typical beaches within the Finlay Arm of the reservoir. Figure 11 shows an excavator and rock truck piling debris on Corless Beach. Figure 12 shows two excavators and a dozer piling debris on Stromquist Beach.

Figure 11: Debris piling by excavator and rock truck on Corless Beach.

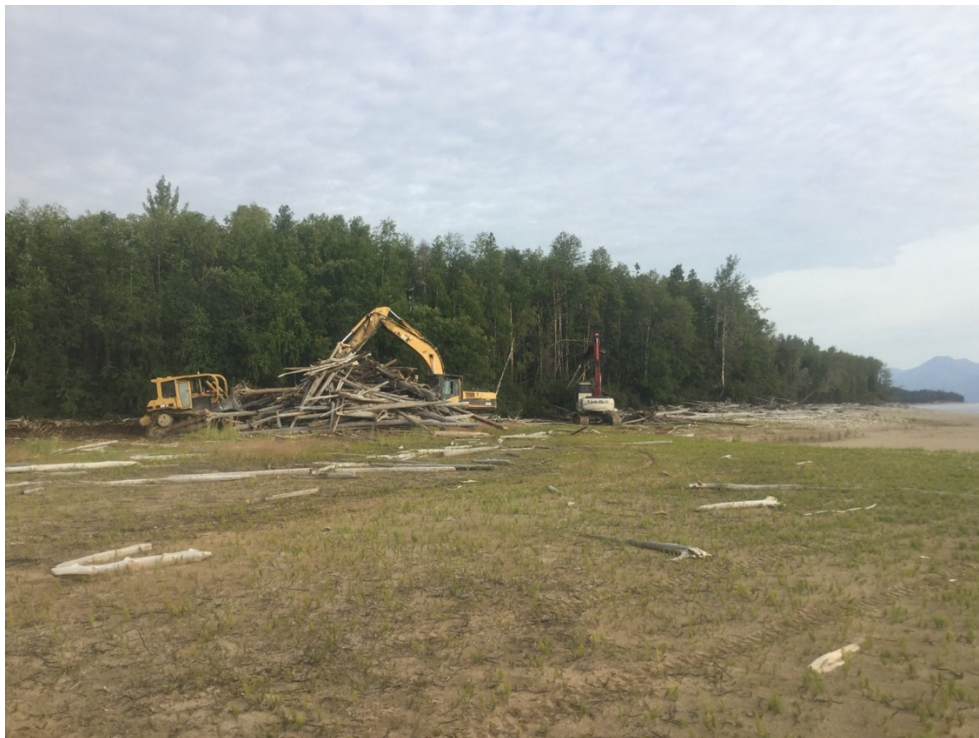
Figure 12: Stromquist Beach during debris management.

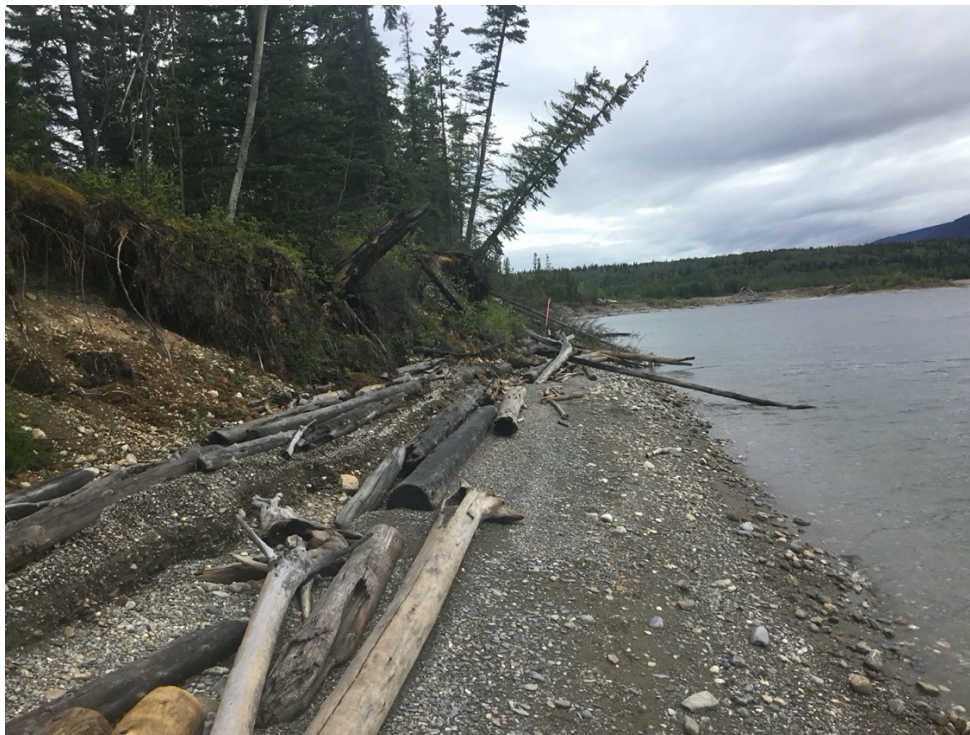
Few frogs and tadpoles were found during the environmental monitor walk through prior to machines. When they are found, a 30 m no work zone is flagged in order to protect the amphibians and or reptiles. In addition to amphibians, other reptiles and wildlife are observed regularly. These include garter snakes, grizzly bears, black bears, moose, elk, wolves and other small carnivores. Figure 13 shows an example of a zone flagged for no-work where an amphibian was discovered.

Figure 13: Pink flagging indicates discovery of an amphibian and marks a no-work zone.

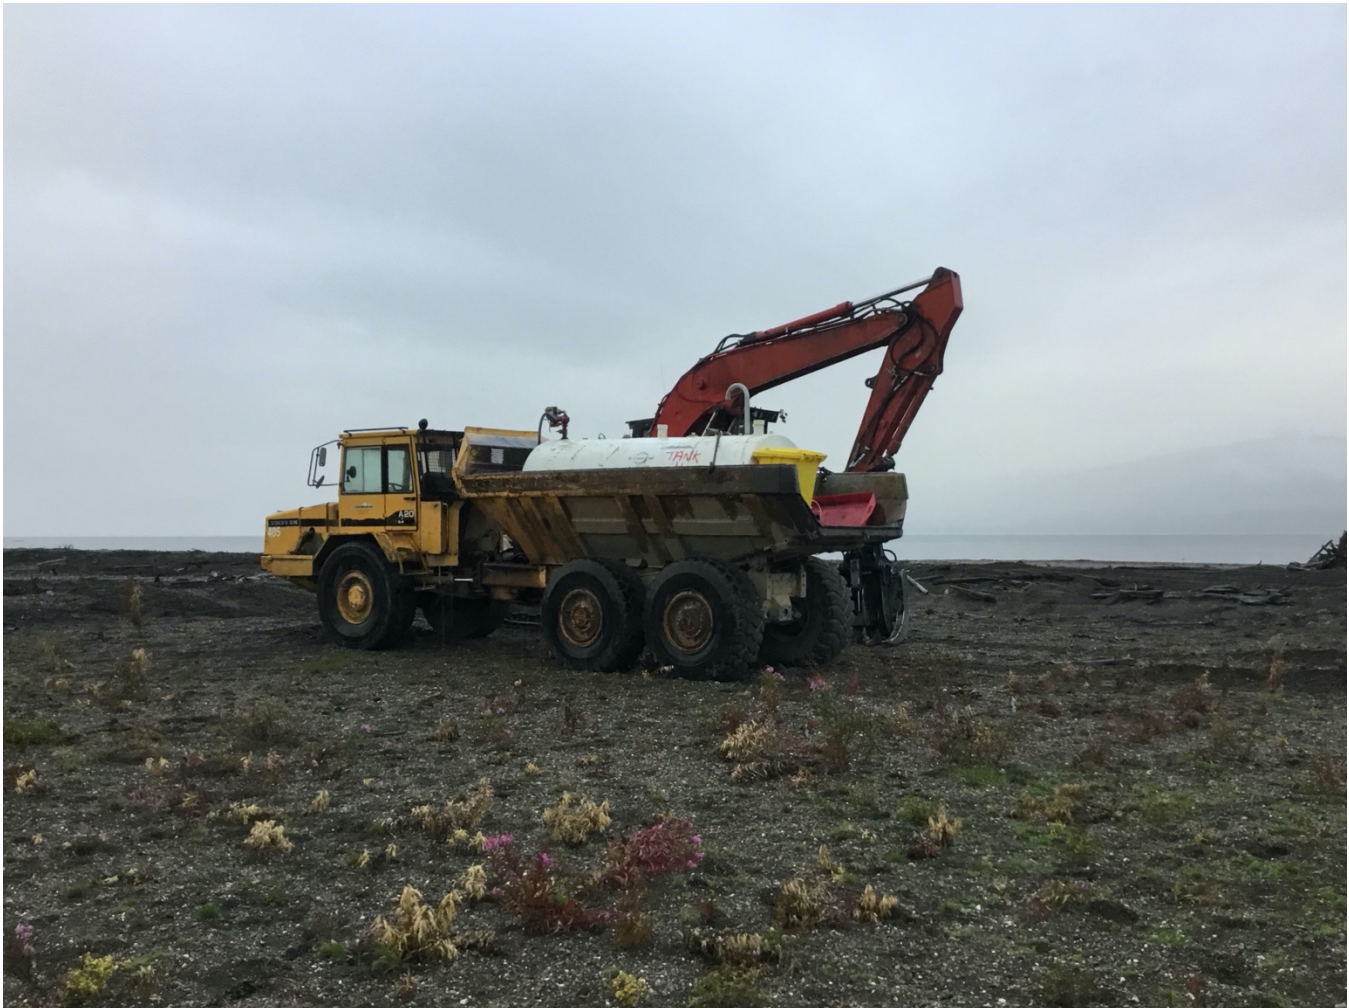
Figure 14: Fuel bowser with large spill kit.

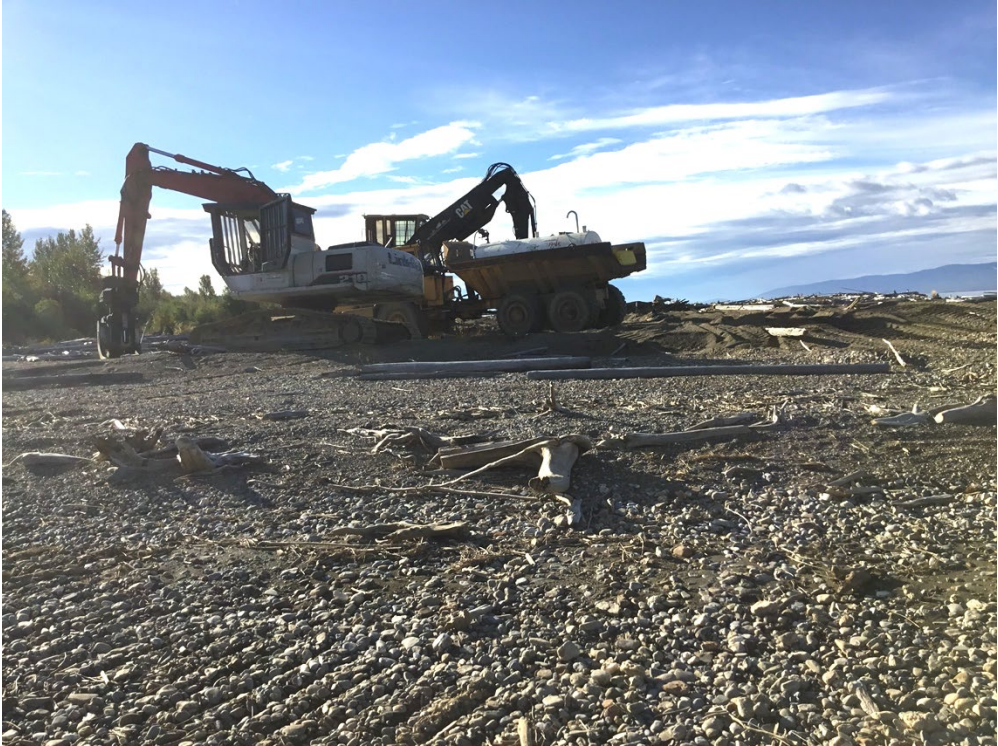
Figure 15: Refueling away from water with a spill kit next to refueling.

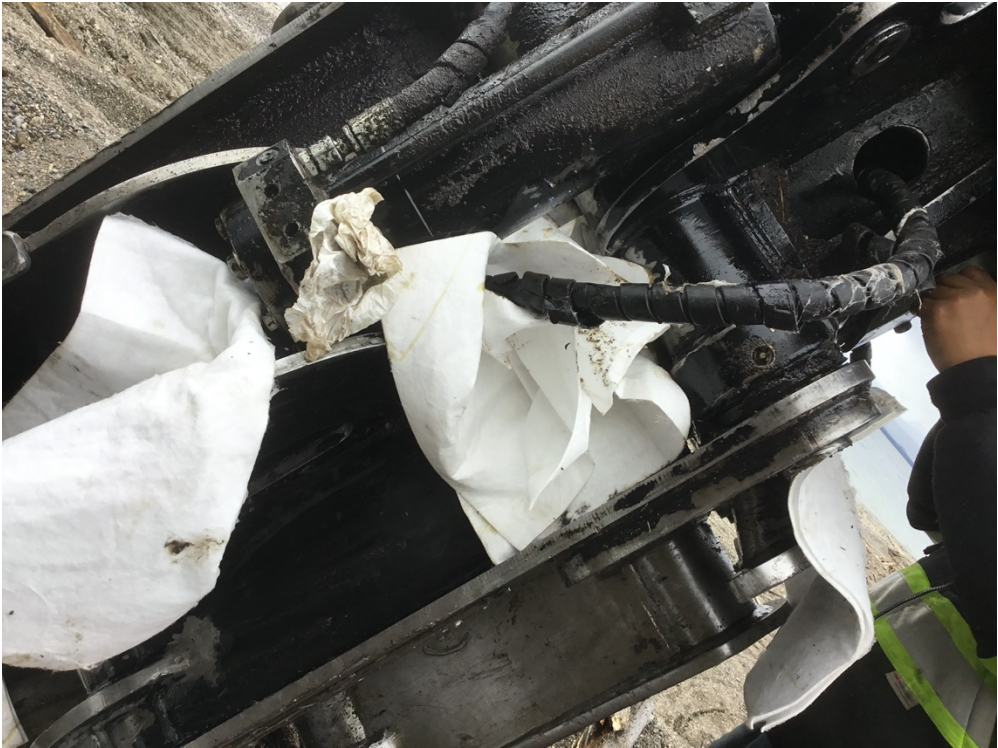
Spill prevention and management is an ongoing process that CCI takes seriously and goes to great lengths to ensure that there are zero spills to ground. Good spill prevention management is rooted in good equipment management through maintenance and regular checks. All equipment is inspected before, during and after each shift to ensure that hydraulic lines and other potential leak points are all secure. The vehicle inspections are completed using a standard form, which is stored in the field office for the program. Regular maintenance occurs before during and after each crew shift. The following sequence of images shows some examples of good spill prevention management. During the 2020 season, there were no major fluid spills and 3 small non-reportable spills to ground that were cleaned up by CCI. There were no spills to watercourses or the reservoir. Figure 14 and Figure 15 show the fuel bowser located along the shore away from the reservoir and outfitted with a large spill kit for use while refueling as well as repairs. Figure 16 shows the spill kits being used during field-based repairs of the equipment.

Figure 16: Managing and replacing leaking hoses with the spill kit.
