**Peace Project Water Use Plan**

**WILLISTON TARGETED DEBRIS MANAGEMENT**

**Implementation Year 13**

**Reference: GMSWORKS-22**

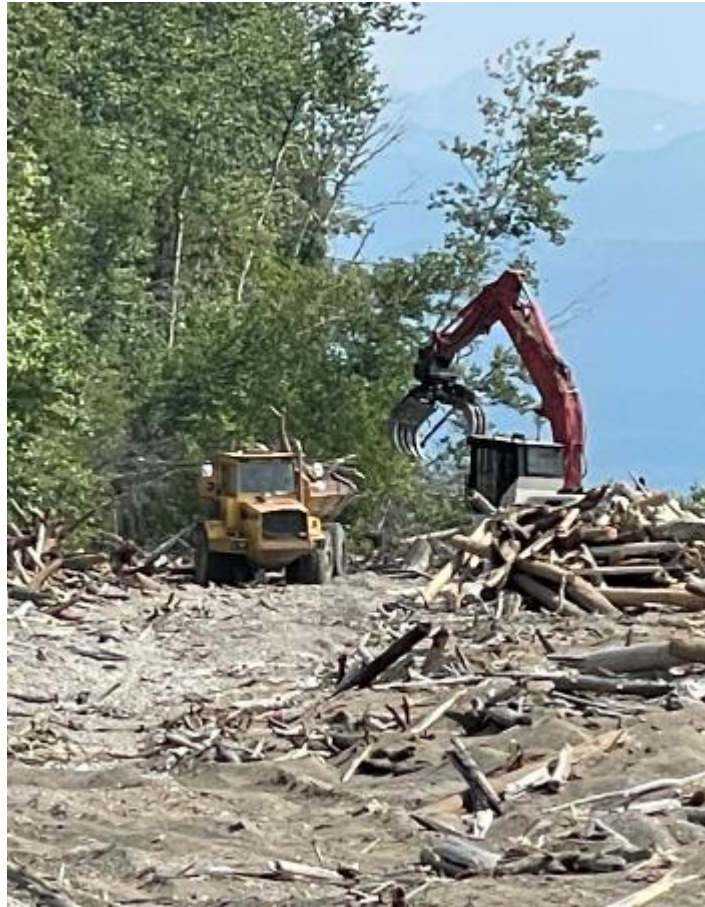
Figure 14 : Debris piling by Link Belt on Peace Point beach

The following series of images shows an overview of work locations for typical beaches within the Finlay/Peace Arm of the reservoir. Figure 14 shows a button top and rock truck piling debris on Peace Point Beach.

The debris tends to accumulate along the shoreline of the reservoir. Debris is piled using excavators fitted with a rotating grapple (Linkbelt- button top) or a bucket and a thumb. The rotating grapple can circle through 360 degrees and can open and shut to grab and move debris, the bucket and thumb are similar but cannot rotate through 360 degrees. The button top loads the rock truck with debris especially in tight areas with a lot of debris but no room for piles. The rock truck moves the debris and unloads it in areas better suited for piling and burning away from the high-water mark of the reservoir. The excavators are used to pile debris after the rock truck is completed or in areas where the rock truck is not needed. This year only Collins Bay Beach used the D6 Cat that was fitted with a rake blade to push the stray debris towards the center of the

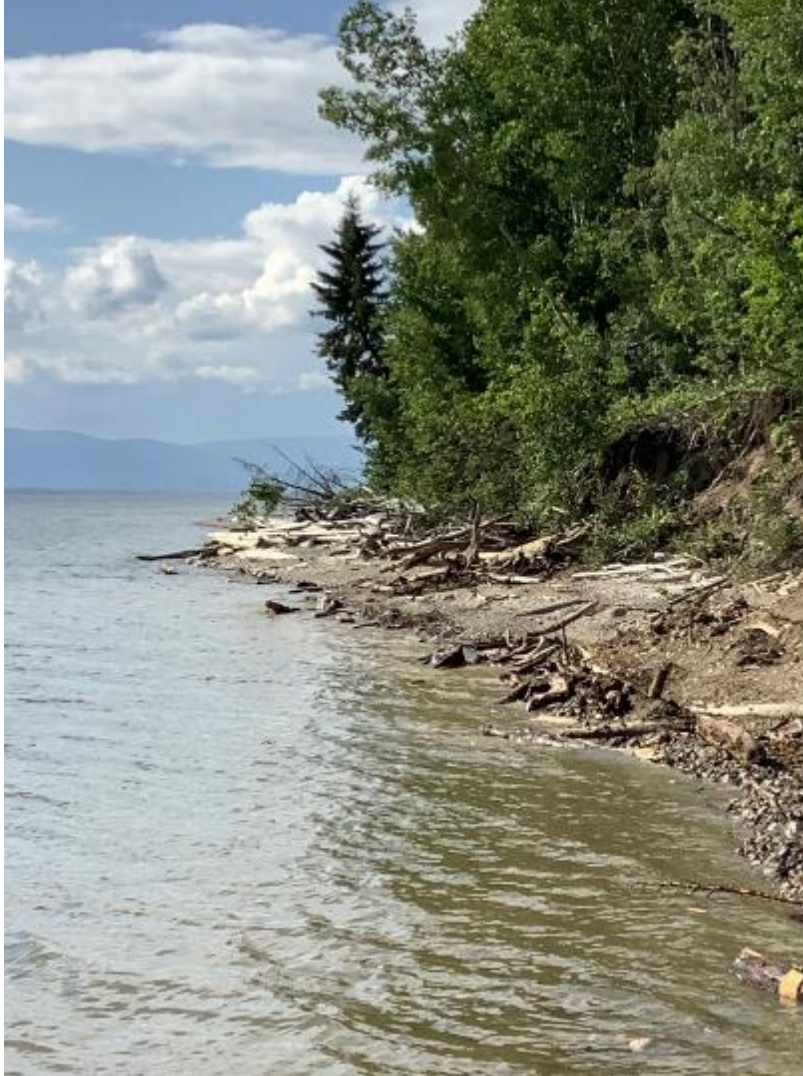
Figure 25: Debris on Peace Arm Beach that was too narrow to pile due to high reservoir levels

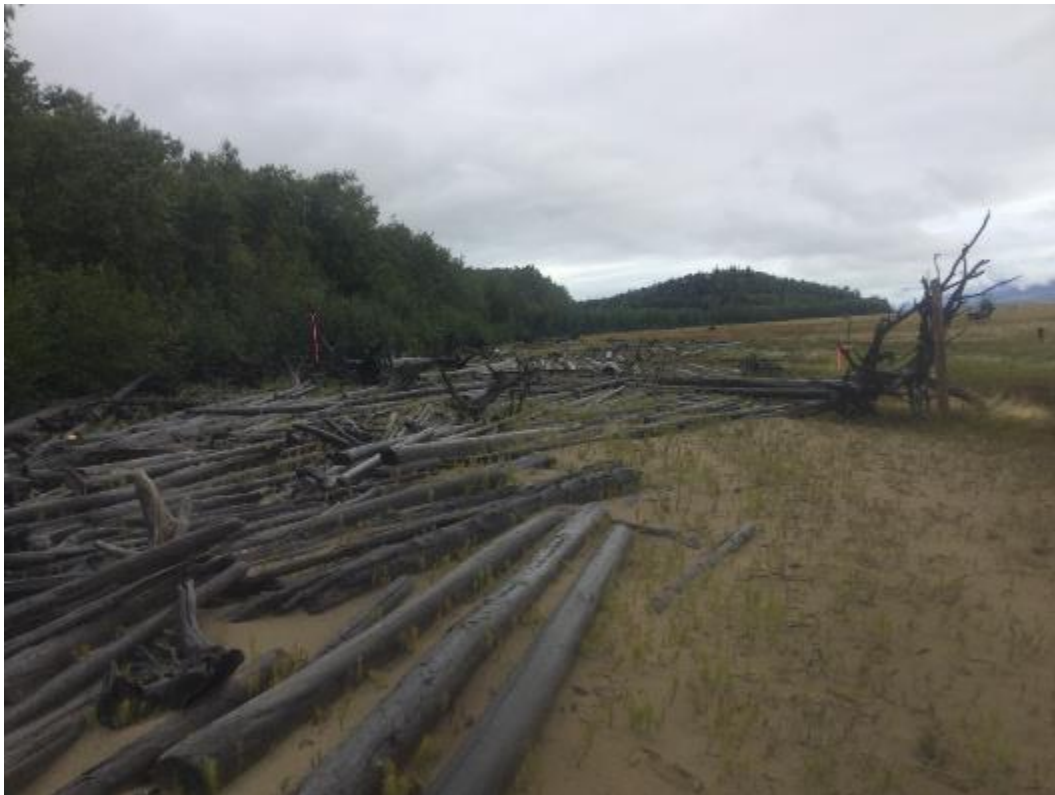
Figure 28 : Pink flagging indicates discovery of an amphibian and marks a no-work zone.

The amphibian management plan is based on avoidance through surveying and flagging no work zones. The avoidance-based plan is meant to reduce the potential harm to amphibians and to avoid all handling. Prior to conducting debris removal, each beach is surveyed for amphibians and reptiles. On a typical beach there may be 5 – 10 zones where amphibians are either found or where there is good amphibian habitat. Where they are found, a no work zone was flagged around them in order to protect the amphibians and or reptiles. In addition to amphibians, other reptiles and wildlife are observed regularly or just their tracks. These include, garter snakes, grizzly bears, black bears, moose, elk, whitetail deer, wolves and other small carnivores. Figure 28 shows an example of a zone flagged for no-work where an amphibian was discovered in the 2019 debris season.

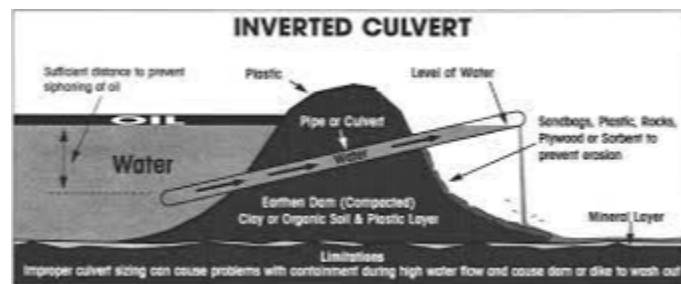
Figure 29 : Example of an Inverted Culvert that was replicated in course

In spring of 2021, a spill response training course was put on for CCI employees living in Tsay Keh Dene who would be working on Debris in 2021. The course featured creating an inverted culvert. The participants installed an inverted weir using PVC pipe and an earthen berm. As the creeks were still frozen during the time of the training, the students used a water pump to pump water up a hill and let it flow down the ditch simulating a spill in moving water, the berm was then constructed to contain the water, the purpose of the PVC pipe is to allow subsurface water to flow through while containing the floating surface oil. The students used canola oil during the exercise to simulate an oil spill. Below are some pictures taken during the course.

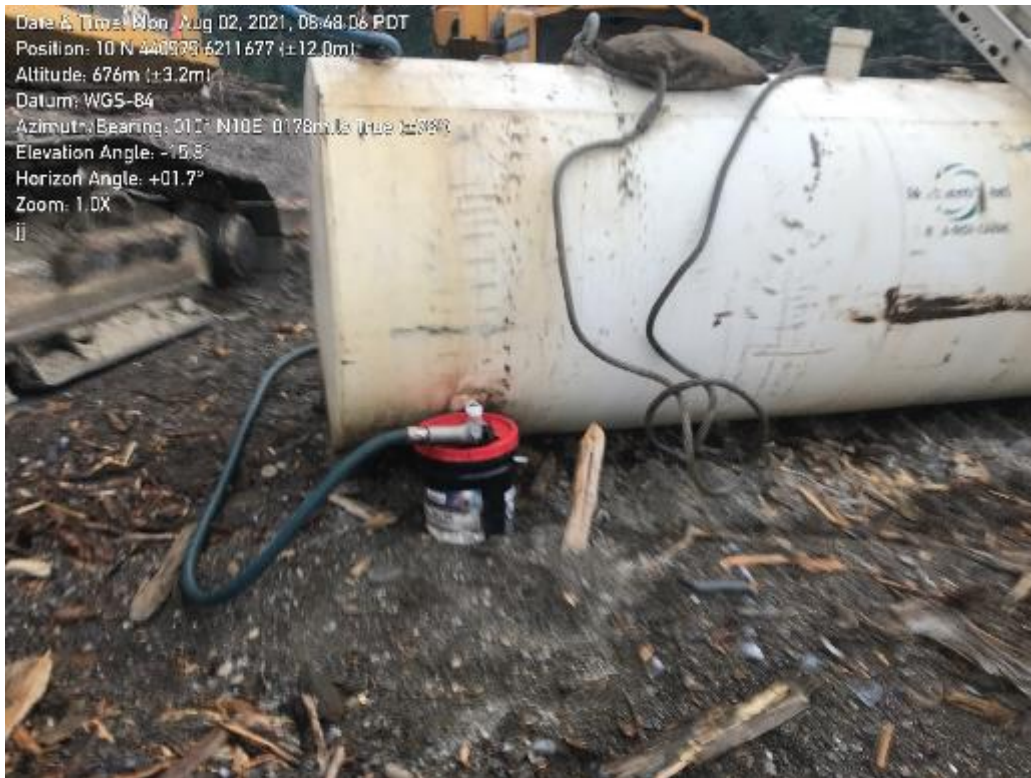
Figure 32: Fuel tank with drip containment at Peace Point

The following sequence of images shows some examples of good spill prevention management. During the 2021 season, there were no major fluid spills and 1 small non-reportable spill to ground that was cleaned up by CCI. There were no spills to watercourses or the reservoir. Figure 32 show the fuel tank on the Peace Point beach with proper drip containment. Figure 33 shows the spill kits being used during field-based repairs of the equipment.

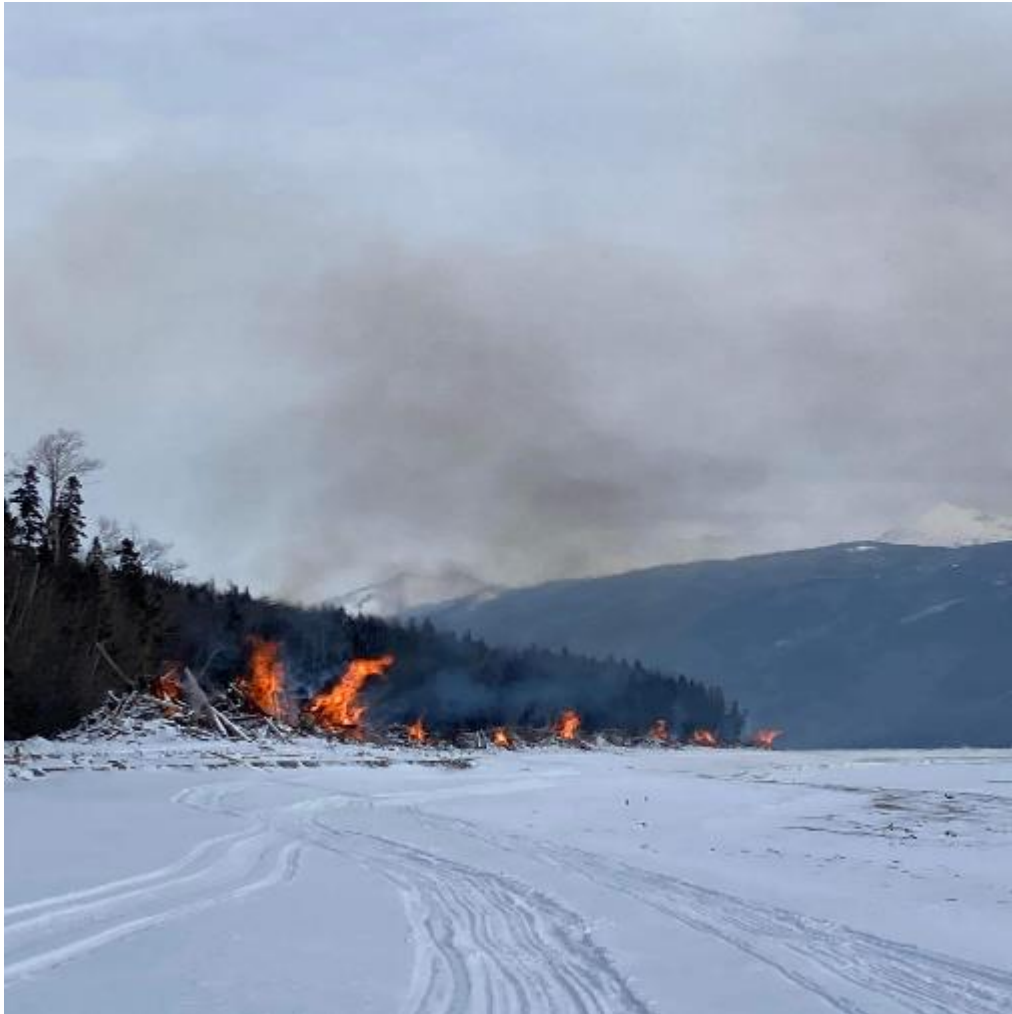
Figure 34 : Winter 2021 Pile Burning

Debris pile burning was completed during the winter of 2020/2021 for most of the piles that have been piled in recent years. Debris burning occurred only on sites where there are gravel or sand surfaces. Burning occurred on the following beaches: Tsay Keh Dene, Parsnip, Omineca, North Ospika, various sites along the Chunnamon, Davis and Bruin. Sites with organics were communicated to the crew as No Burn Sites prior to the 2020/2021 burn season.
