**Peace Project Water Use Plan**

**Peace River Mainstem Stage Discharge**

*Mainstem Stage Discharge 2013 Study*

**GMSWORKS-6**  
**PEACE RIVER MAINSTEM STAGE DISCHARGE**  
**- 2013 STUDY -**

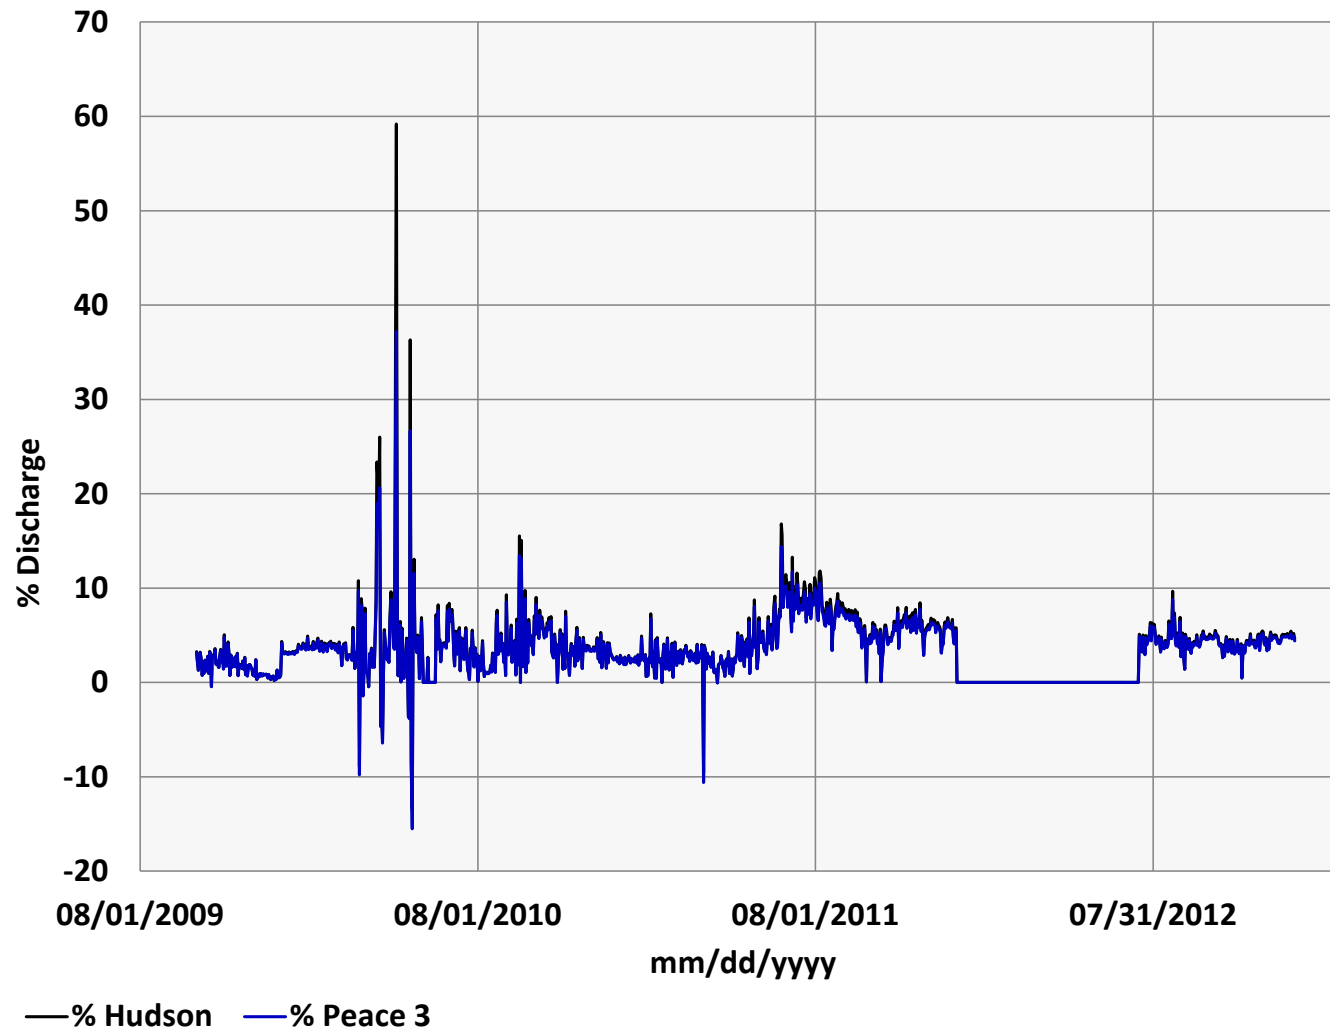
**Figure 2** Calculated daily inflows between WSC Hudson and Peace 3 from October 1, 2009 to December 31, 2012 as a percent of WSC Hudson and Peace 3 flows.

Peace 3 is 10.1 km downstream of the WSC Hudson gauge with a 393 km<sup>2</sup> increase in contributing watershed area. Lynx Creek (288 km<sup>2</sup>)<sup>2</sup> is the only major tributary between the two gauges. Comparison of overlapped daily hydrographs from WSC Hudson and Peace 3 track well visually with higher flows observed at the lower gauge (Peace 3).

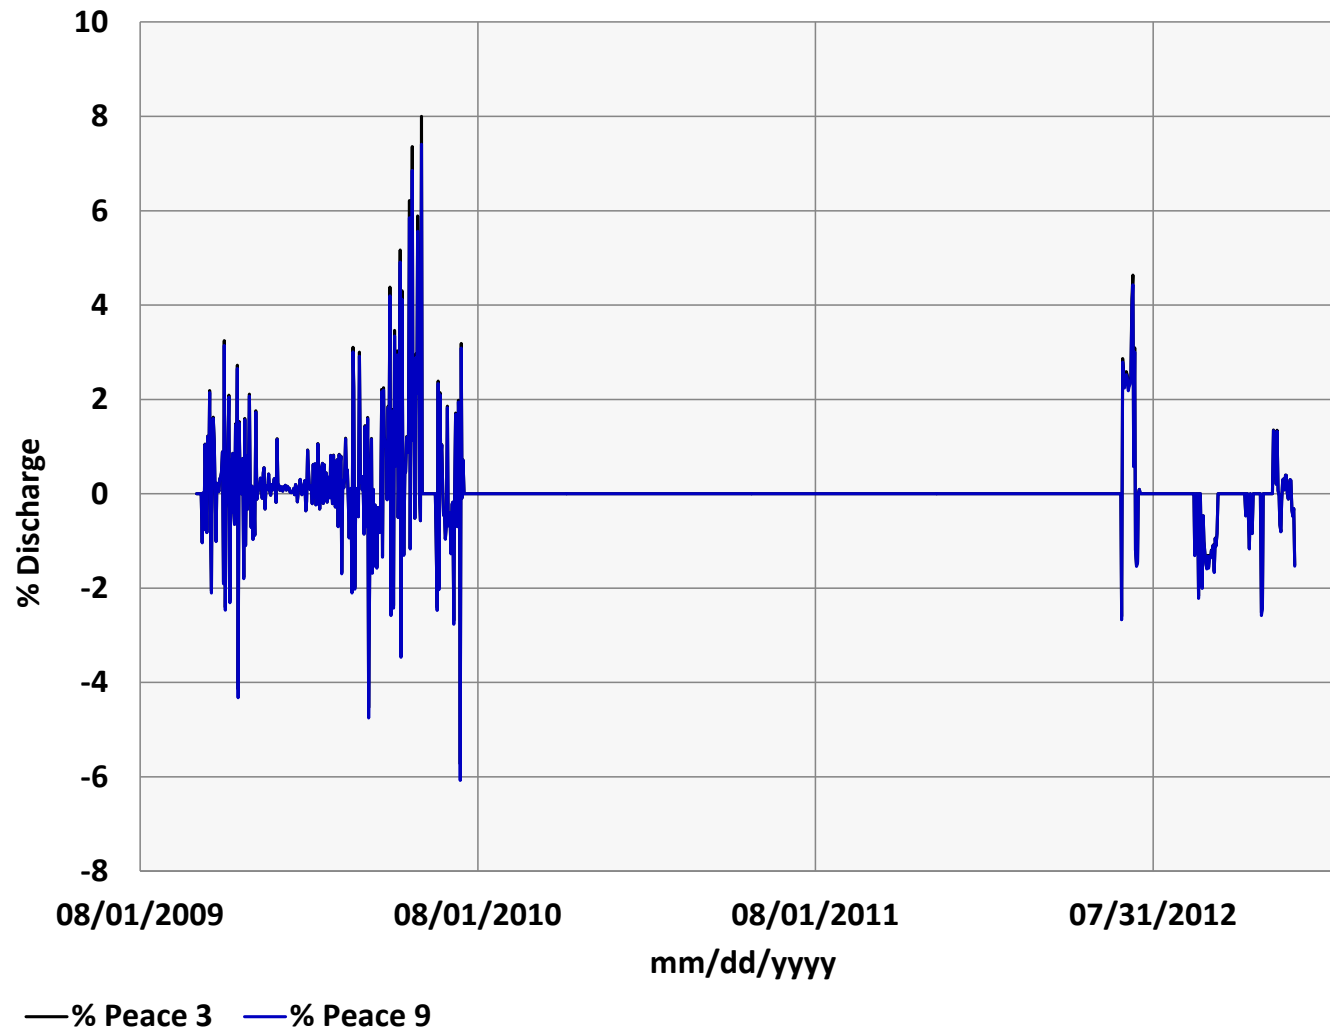
**Figure 3** Calculated daily inflows between Peace 3 and Peace 9 from October 1, 2009 to December 31, 2012 as a percent of Peace 3 and Peace 9 flows.

Peace 9 is 12.6 km downstream of Peace 3 with a 796 km<sup>2</sup> increase in contributing watershed area. Farrell Creek (617 km<sup>2</sup>)<sup>2</sup> is the only major tributary between the two gauges. Limited data coverage at Peace 9 constrains the assessment of inflows between Peace 3 and Peace 9; data are available for both gauges for 28% of the time between October 1, 2009 and December 31, 2012 (**Table 4**). Comparison of overlapped daily and high frequency hydrographs from Peace 3 and Peace 9 show flow attenuation between the gauges with lower, broader peaks observed Peace 9. A -0.15 m offset was applied to Peace 9 stage values from November 23, 2012 onwards to account for a discrepancy in the relation between Peace 3 and Peace 9. The shift is expected to be a result of the temporary levellogger position shifting and hence only the stage data was adjusted (i.e. not adjustments were made to the stage-discharge rating curve).

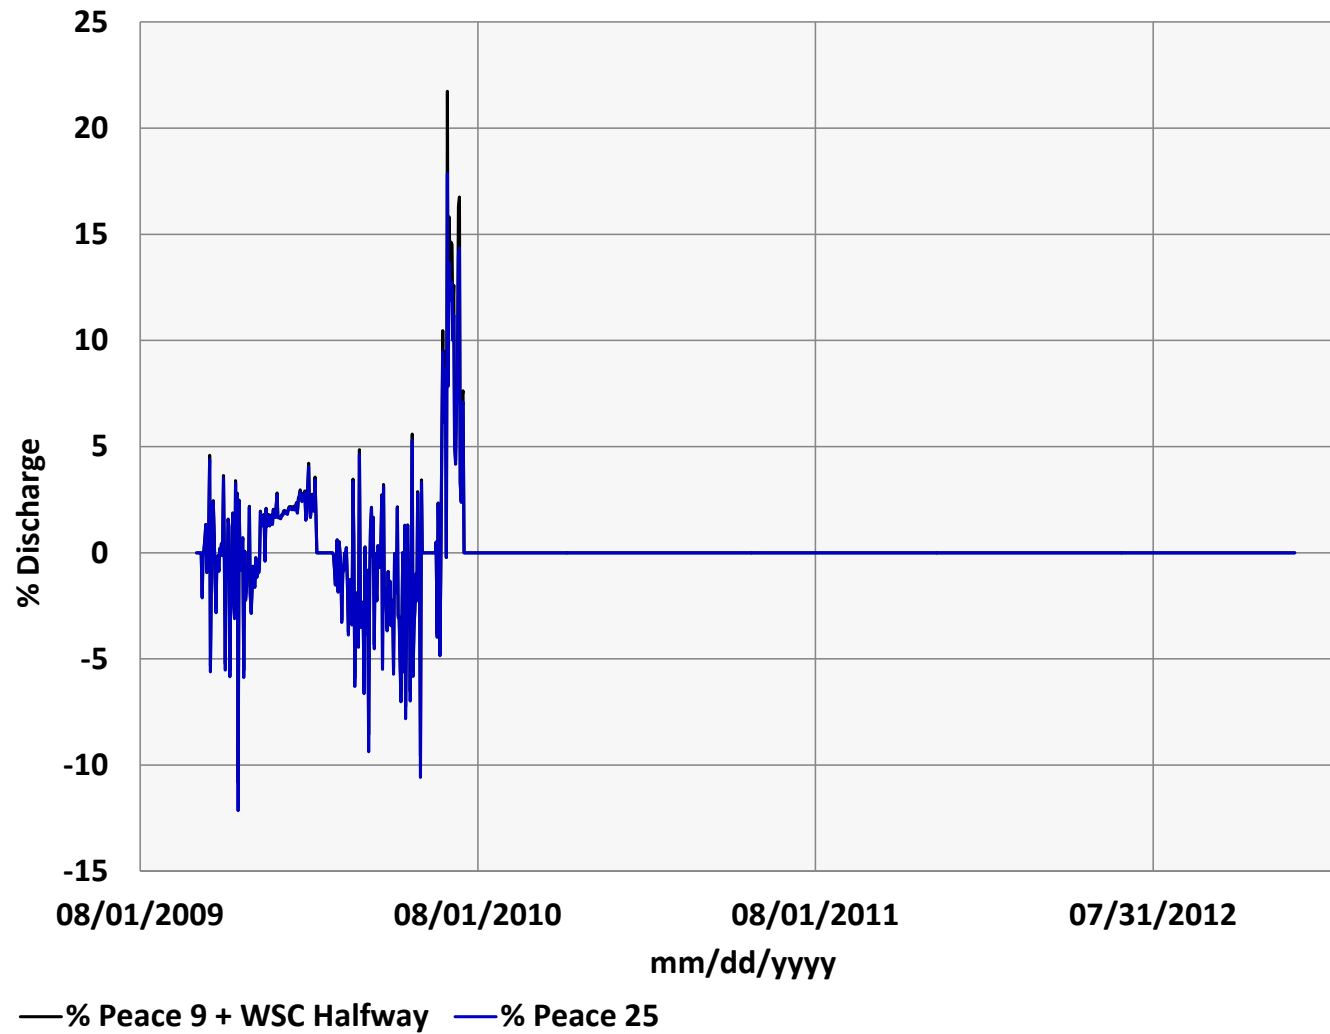
**Figure 4** Calculated daily inflows between Peace 9 and Peace 25 minus WSC Halfway flows from October 1, 2009 to December 31, 2012 as a percent of Peace 9 plus WSC Halfway and Peace 25 flows.

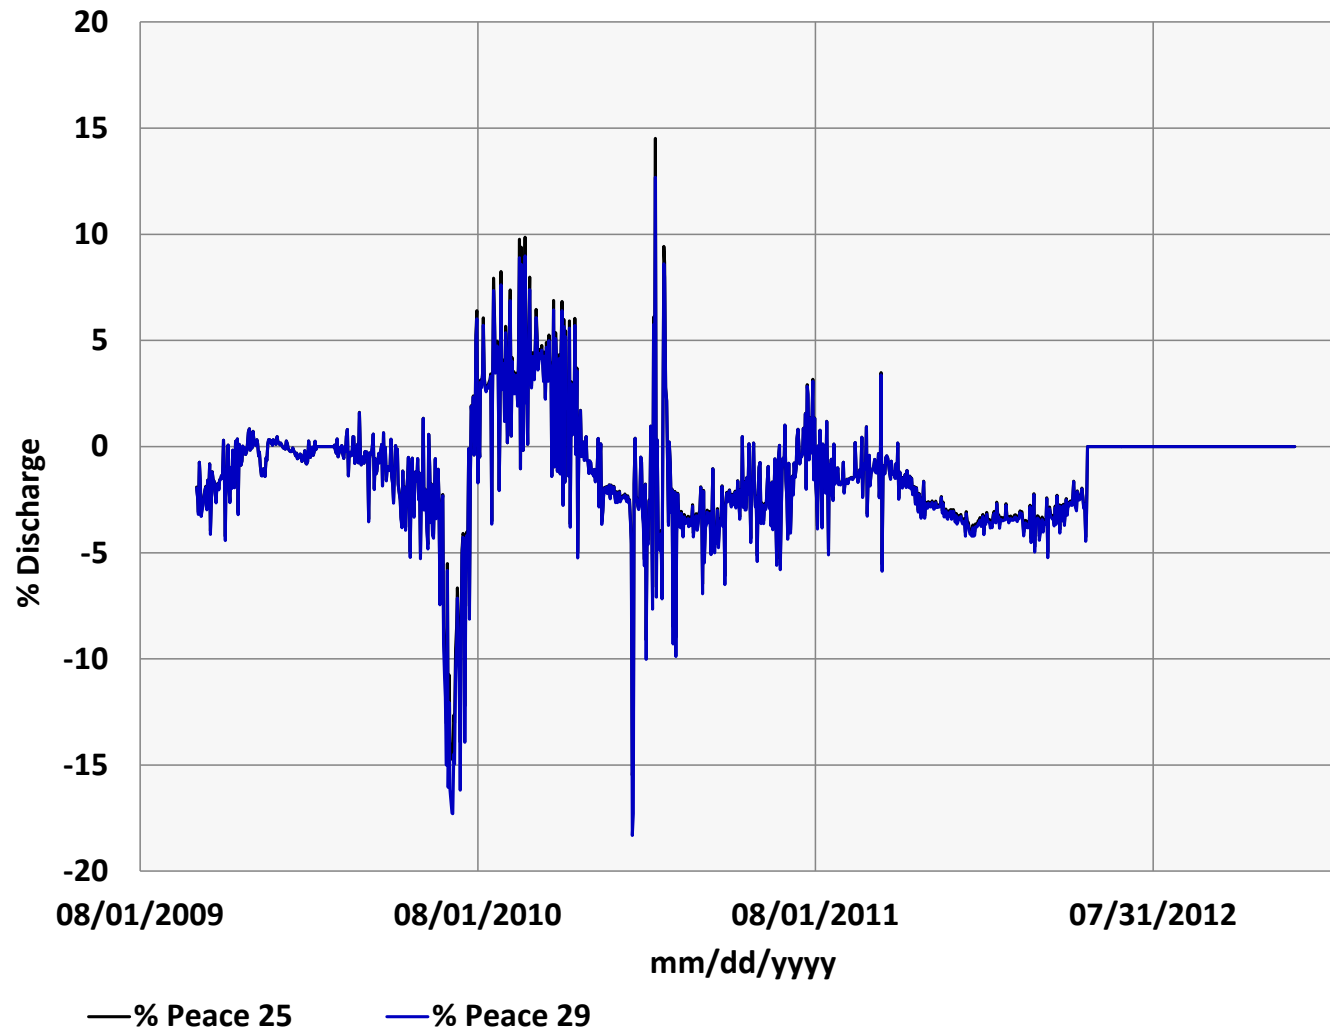
Figure 5 Calculated daily inflows between Peace 25 and Peace 29 from October 1, 2009 to December 31, 2012 as a percent of Peace 25 and Peace 29 flows

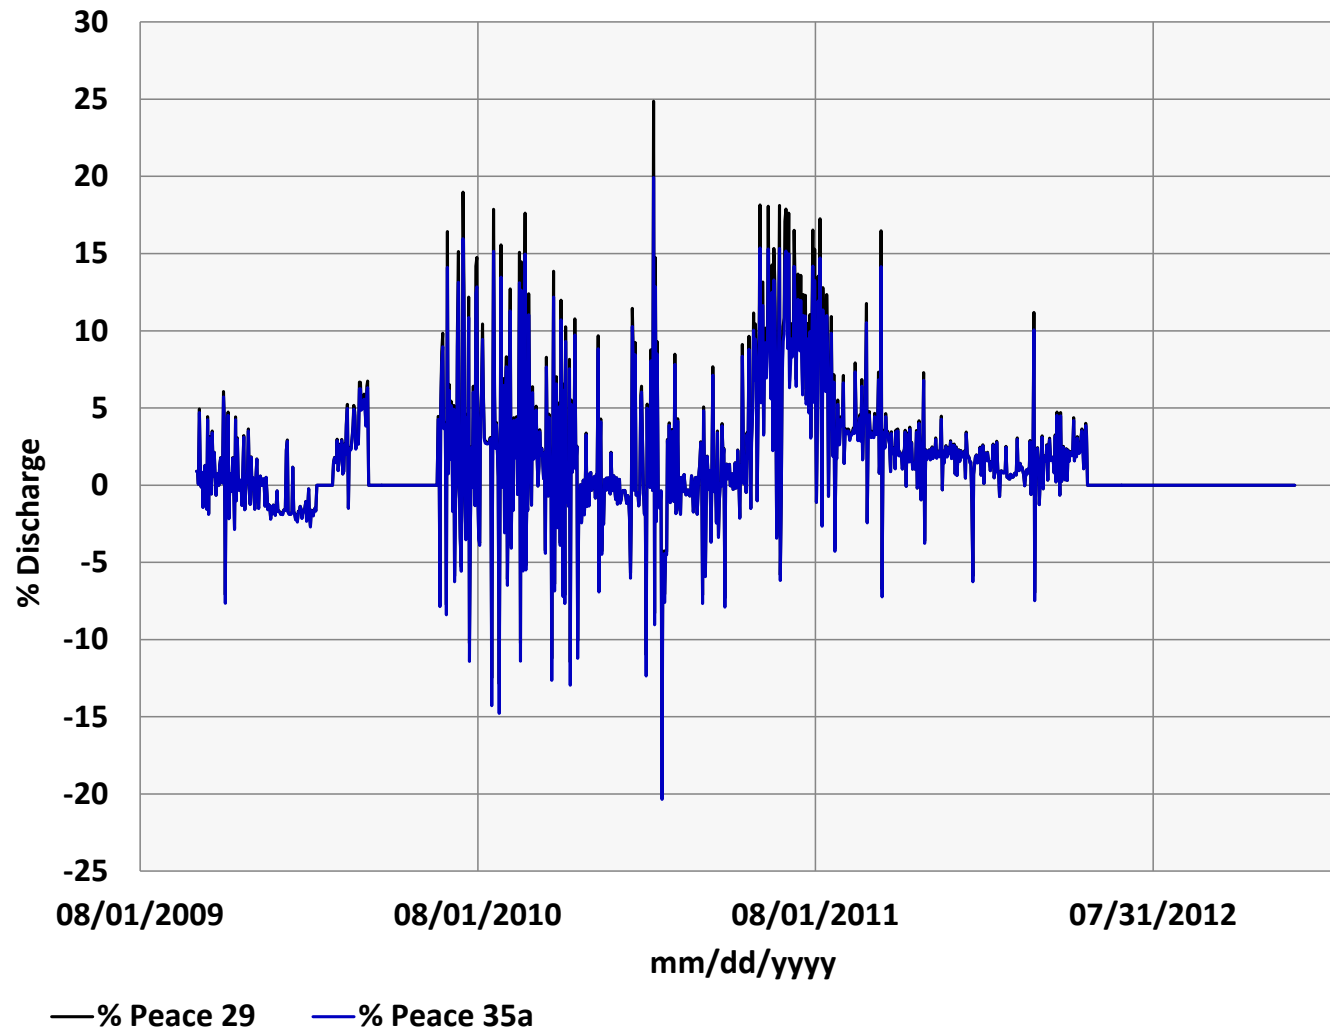
Figure 6 Calculated daily inflows between Peace 29 and Peace 35a from October 1, 2009 to December 31, 2012 as a percent of Peace 29 and Peace 35a flows

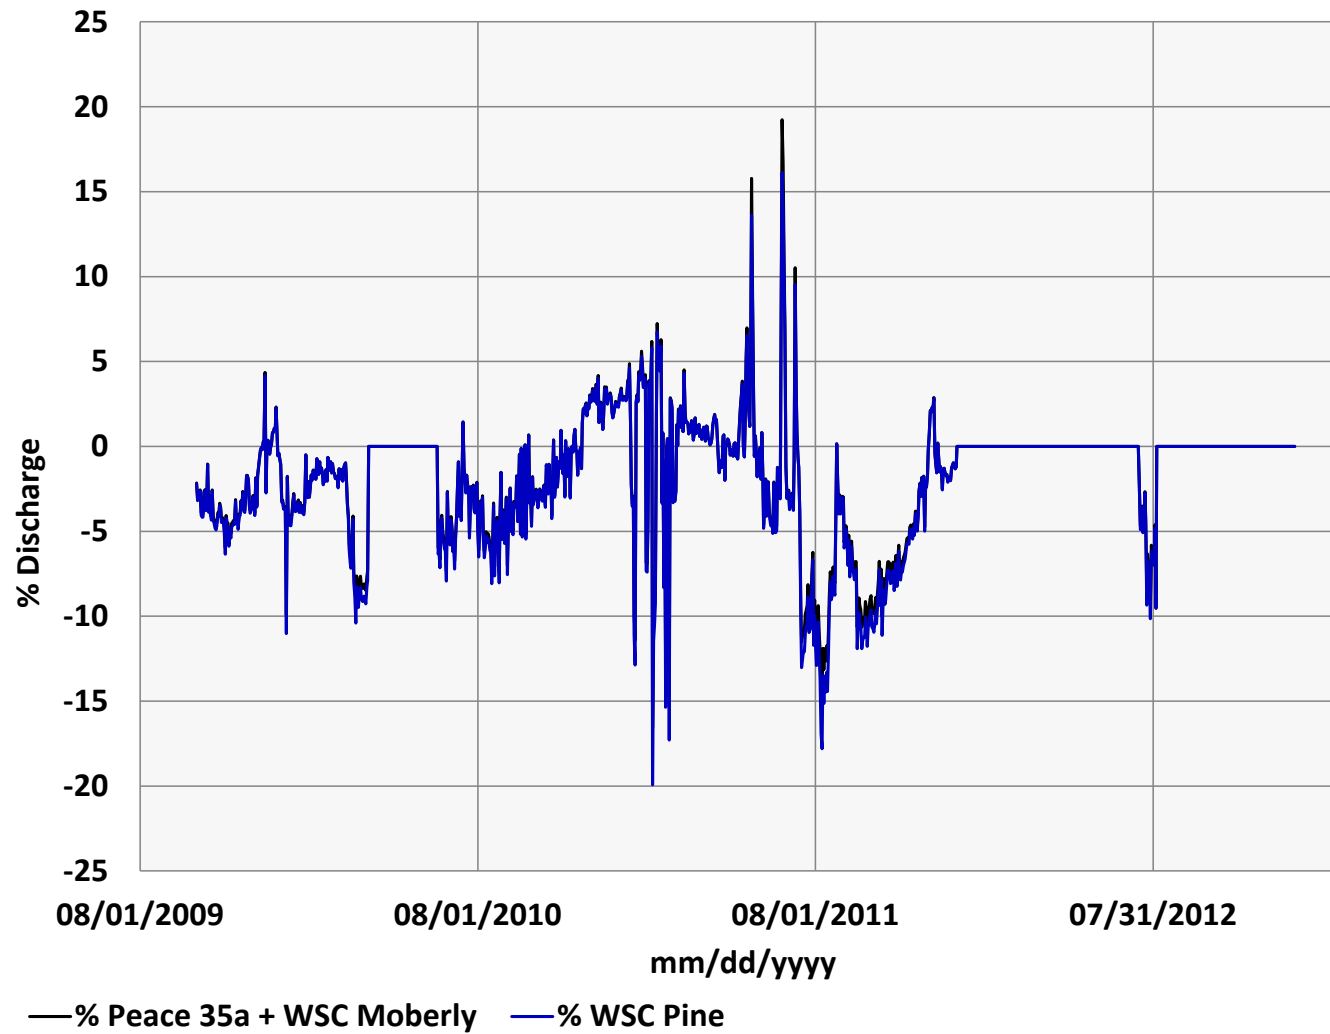
**Figure 7** Calculated daily inflows between Peace 35a and WSC Pine minus WSC Moberly flows from October 1, 2009 to December 31, 2012 as a percent of Peace 35a plus WSC Moberly and WSC Pine flows.

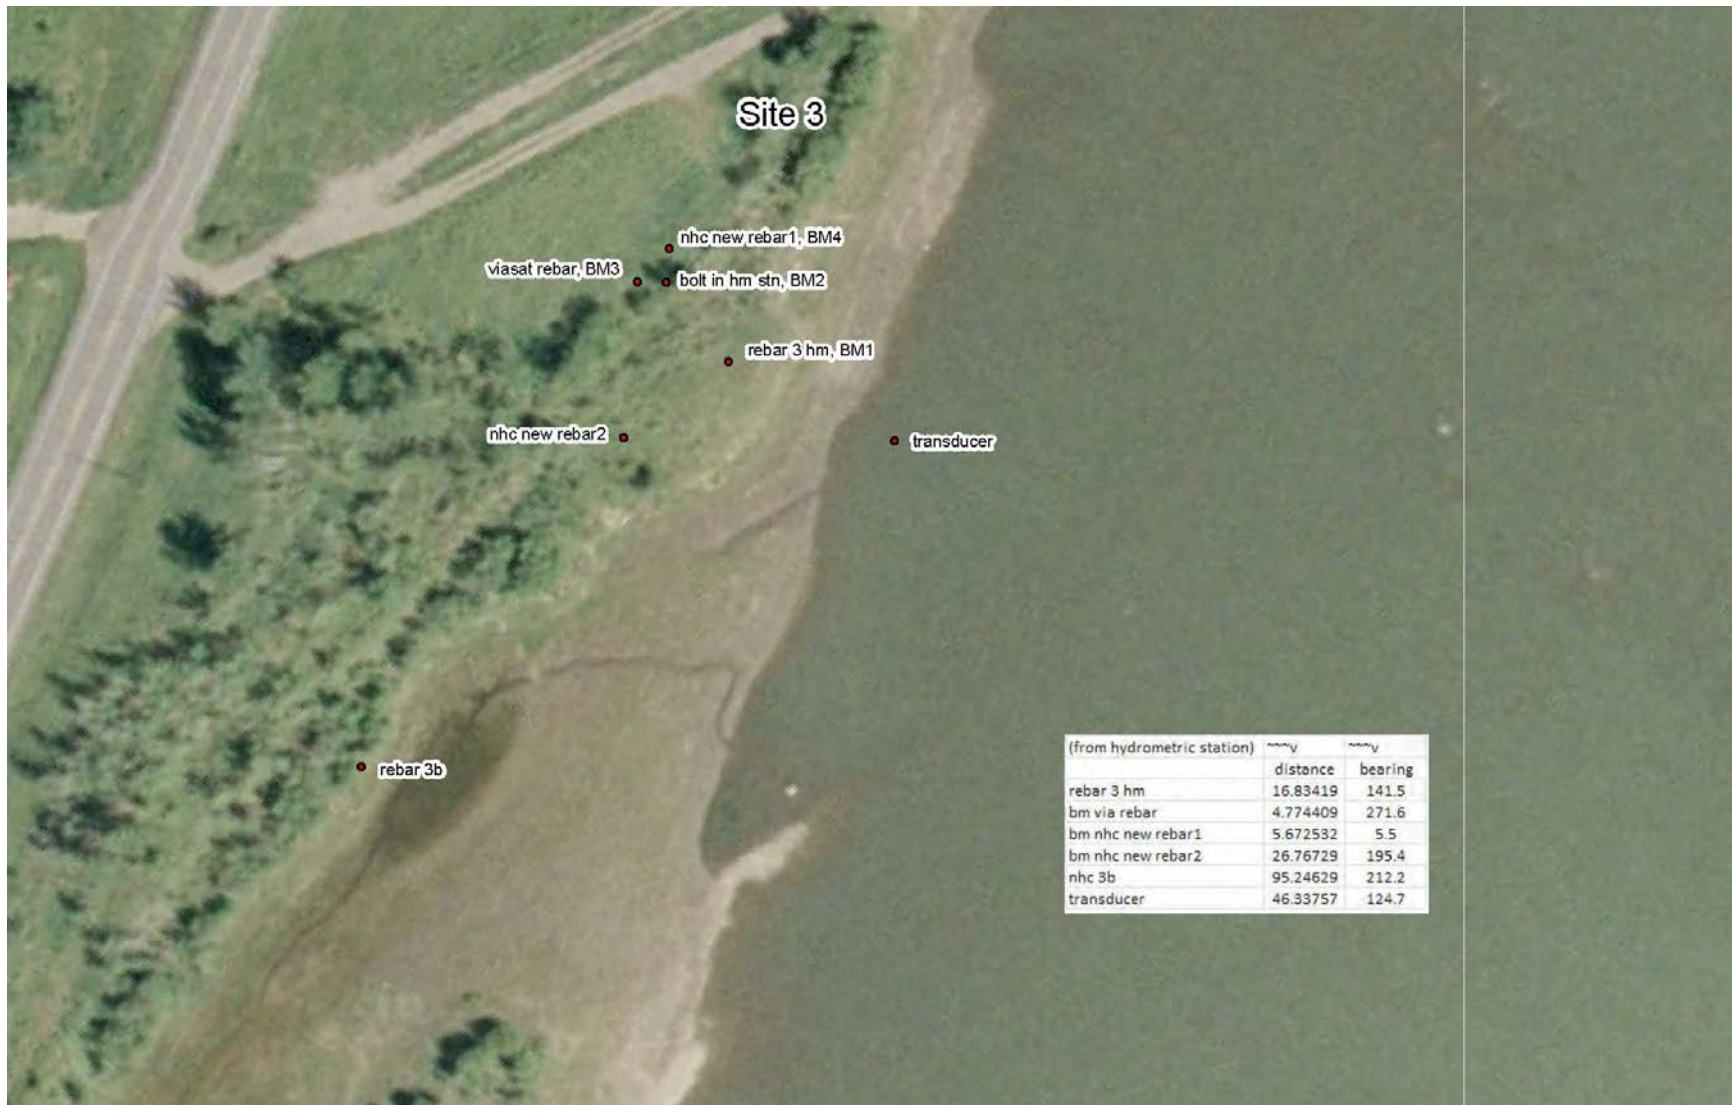
Figure 8 Peace 3 benchmark locations.

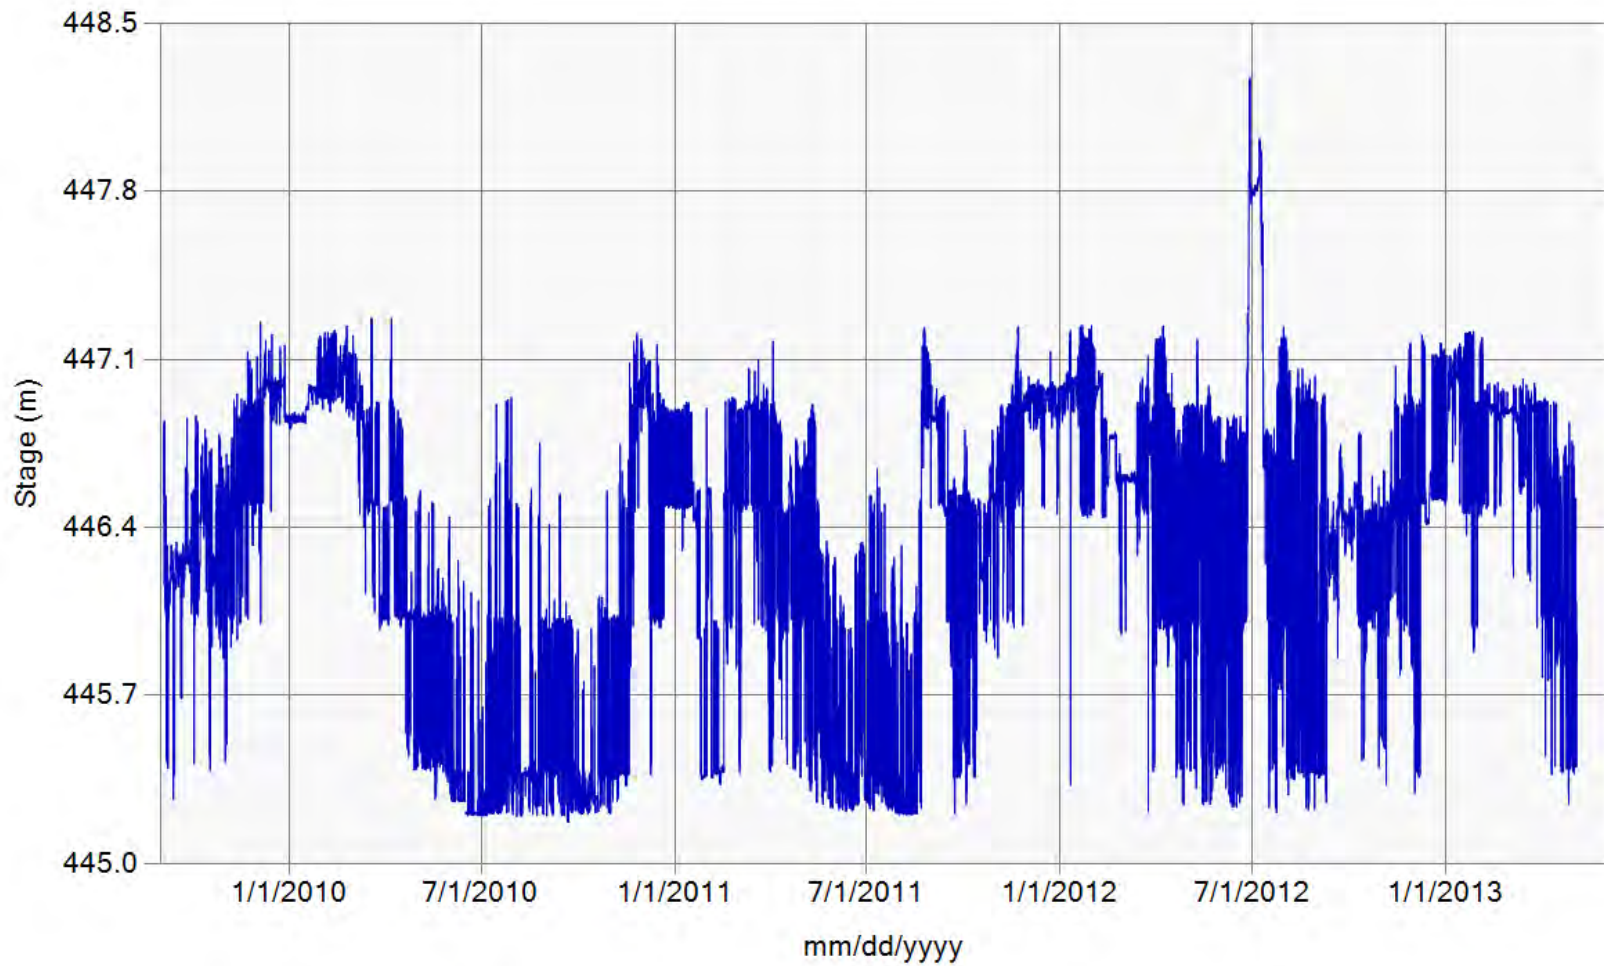
Figure 9 The stage record for Peace 3. The sampling interval is 15 minutes. Gaps in the stage record are given in Table 7.

The current Peace 3 stage time series extend from September 3, 2009 to May 4, 2013 (**Figure 9**). Between September 3, 2009 and June 16, 2010, water levels lower than 445.259 m were below the sensor, resulting in missing data (**Table 7**). Data from the temporary levellogger (installed on August 11, 2013) are expected to be available spring of 2014 following manual download.

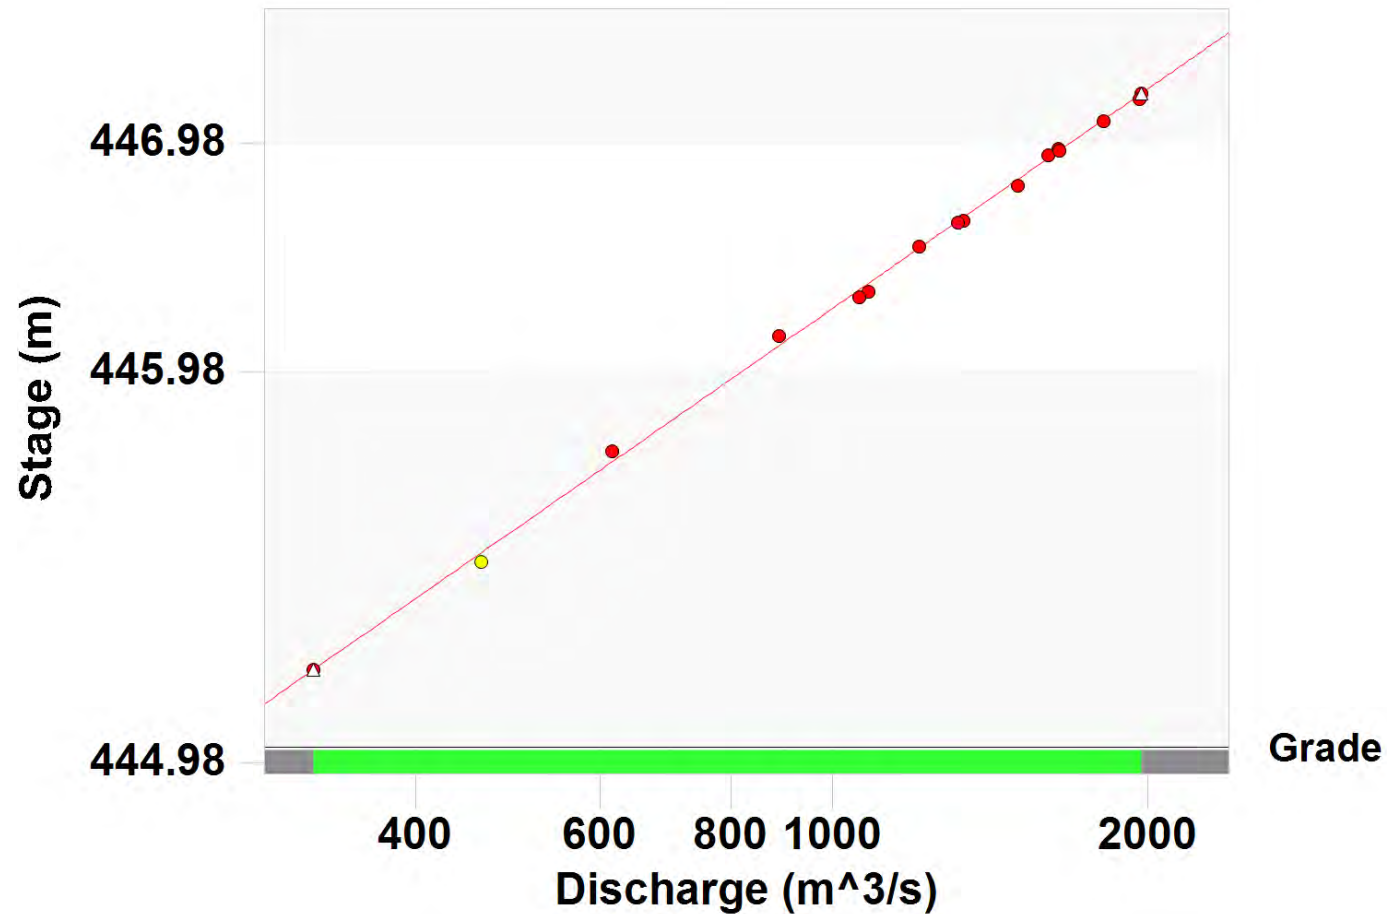
Figure 10 The rating curve for Peace 3. Within the gauged range, the rating curve shows excellent fit (1.8% root mean square of errors) meeting RISC grade A standards (Resources Information Standards Committee, 2009), represented by a green bar below the curve. Discharge values calculated using the extrapolated portion of the rating curve (outside the highest and lowest gauged flow) are RISC Grade E, represented by grey bars below the curve. Gauged stages range from 445.159 m to 447.259 m; the current stage record ranges from 445.173 m to 448.273 m. Flow measurements collected in 2013 are shown in yellow.

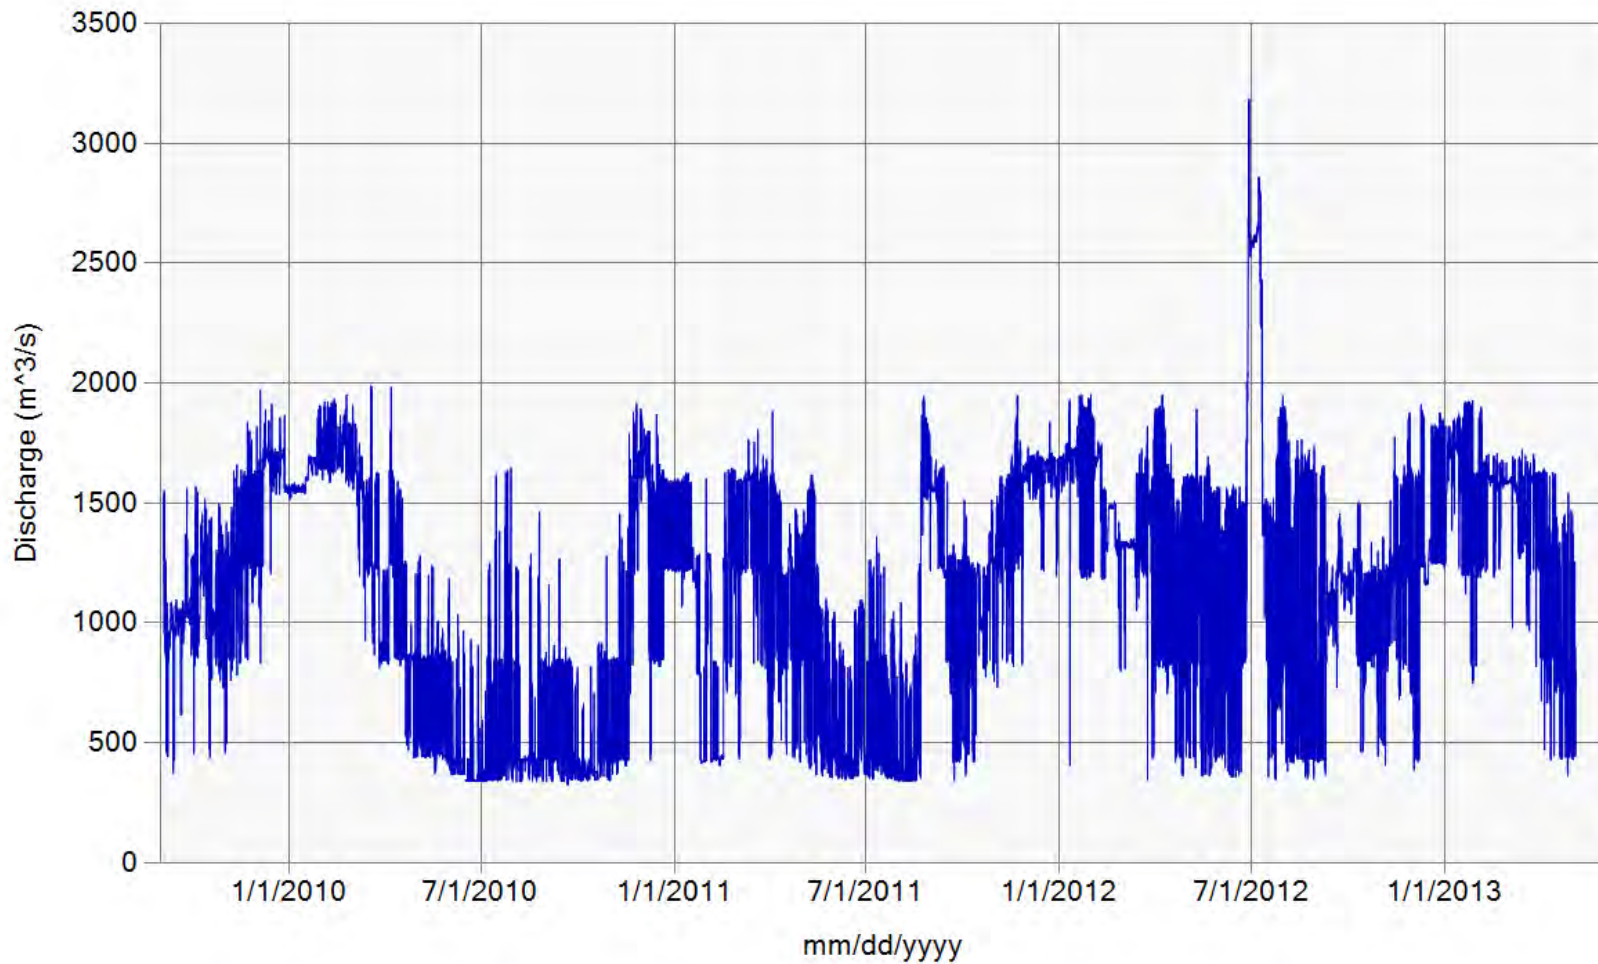
Figure 11 The discharge record for Peace 3. The sampling interval is 15 minutes. Gaps in the discharge record are given in Table 7.

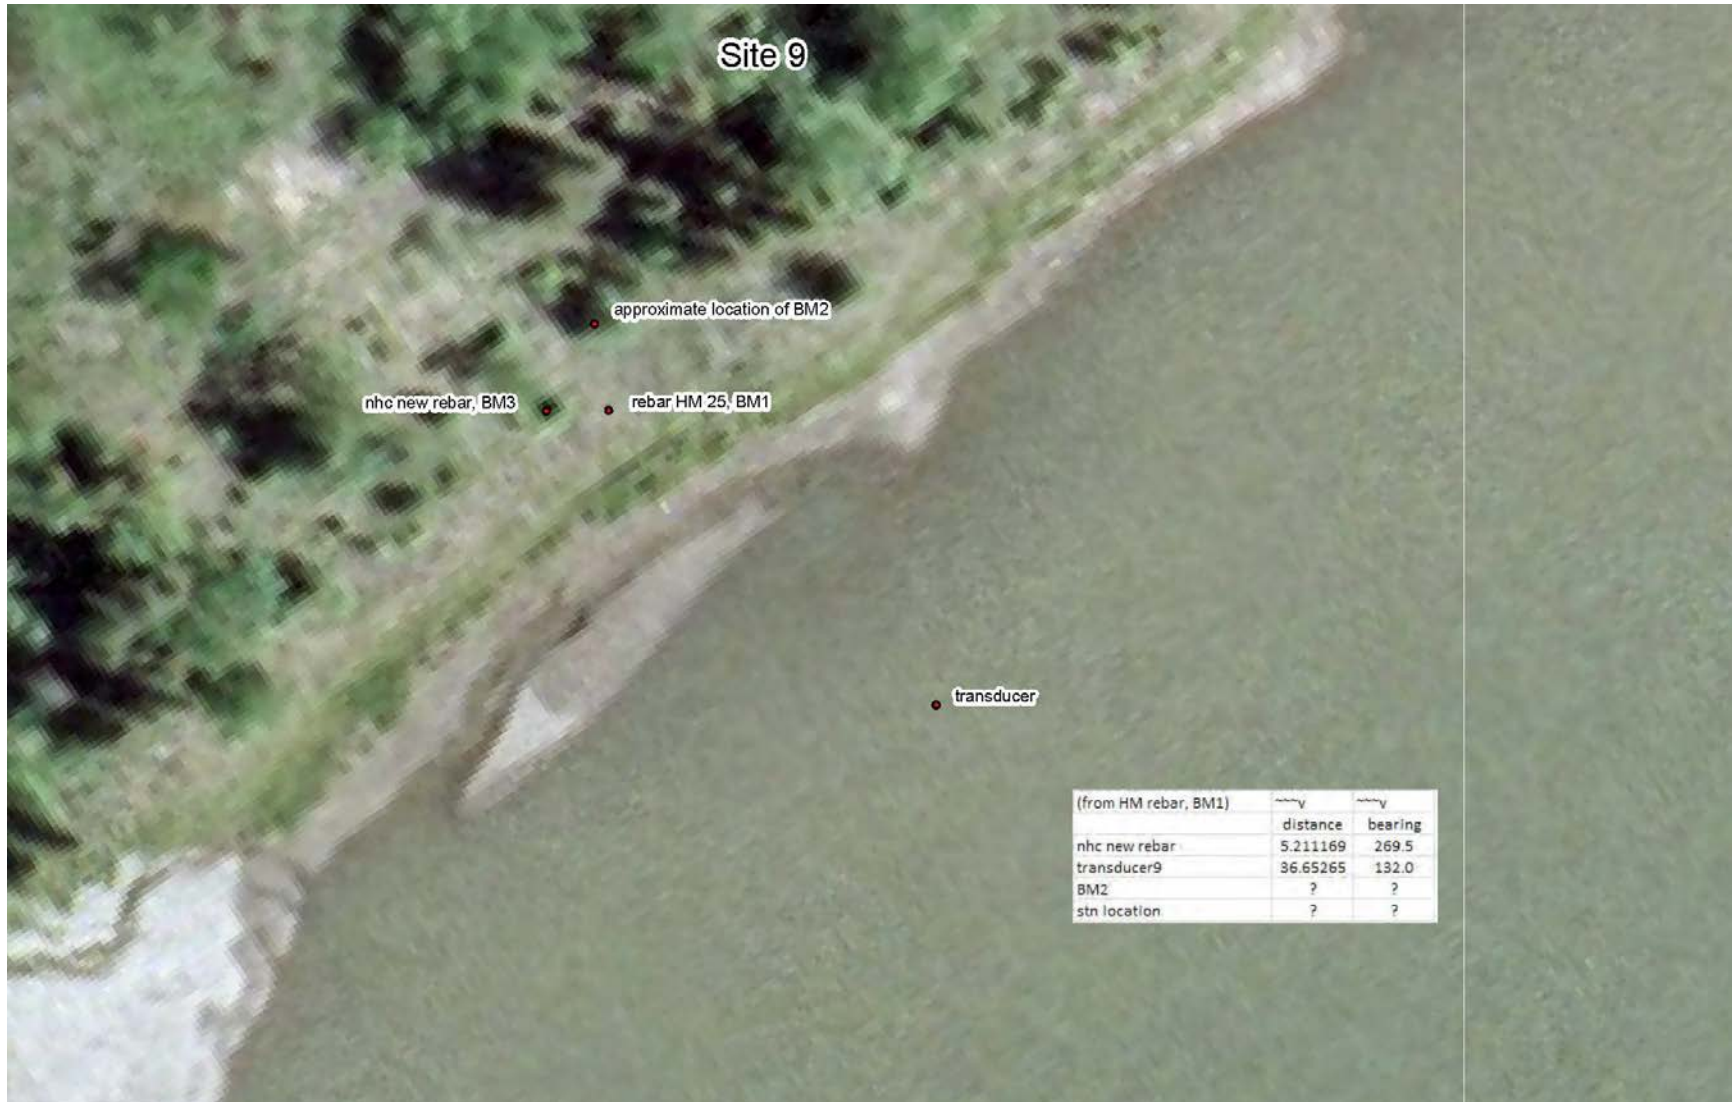
Figure 12 Peace 9 benchmark locations.

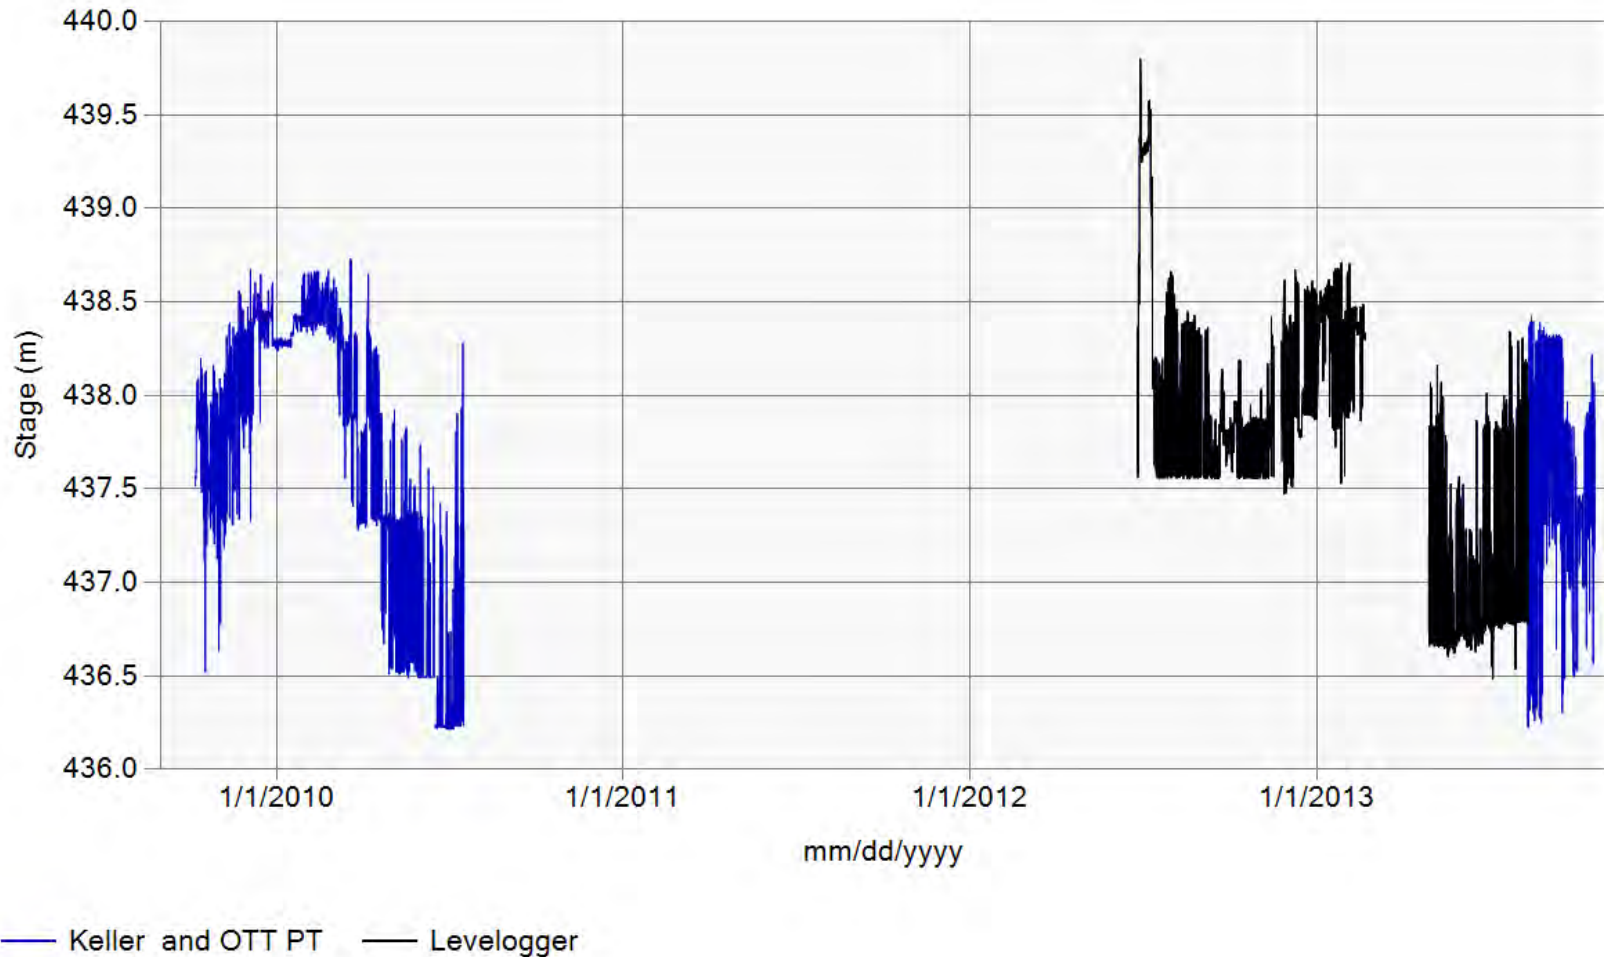
**Figure 13** The stage record for Peace 9. The sampling interval of the Keller and OTT PT are 15 minutes and the sampling interval of the temporary levelogger is 5 minutes. Gaps in the stage record are given in Table 10.

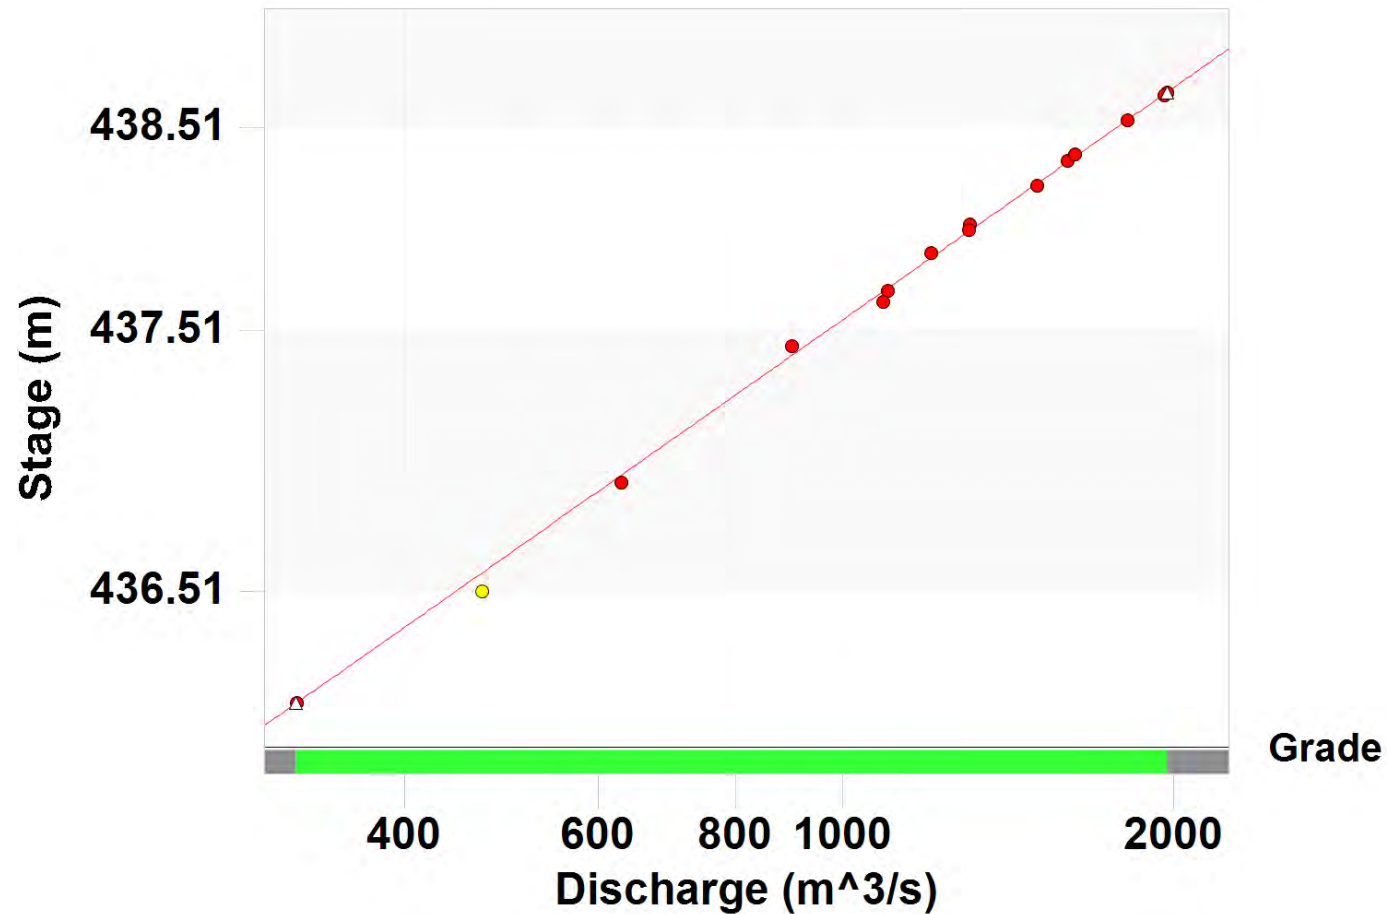
Figure 14 The rating curve for Peace 9. Within the gauged range, the rating curve shows excellent fit (2.0% root mean square of errors) meeting RISC grade A standards (Resources Information Standards Committee, 2009), represented by a green bar below the curve. Discharge values calculated using the extrapolated portion of the rating curve (outside the highest and lowest gauged flow) are RISC Grade E, represented by grey bars below the curve. Gauged stages range from 436.163 m to 438.709 m; the current stage record ranges from 436.214 m to 439.800 m. Flow measurements collected in 2013 are shown in yellow.

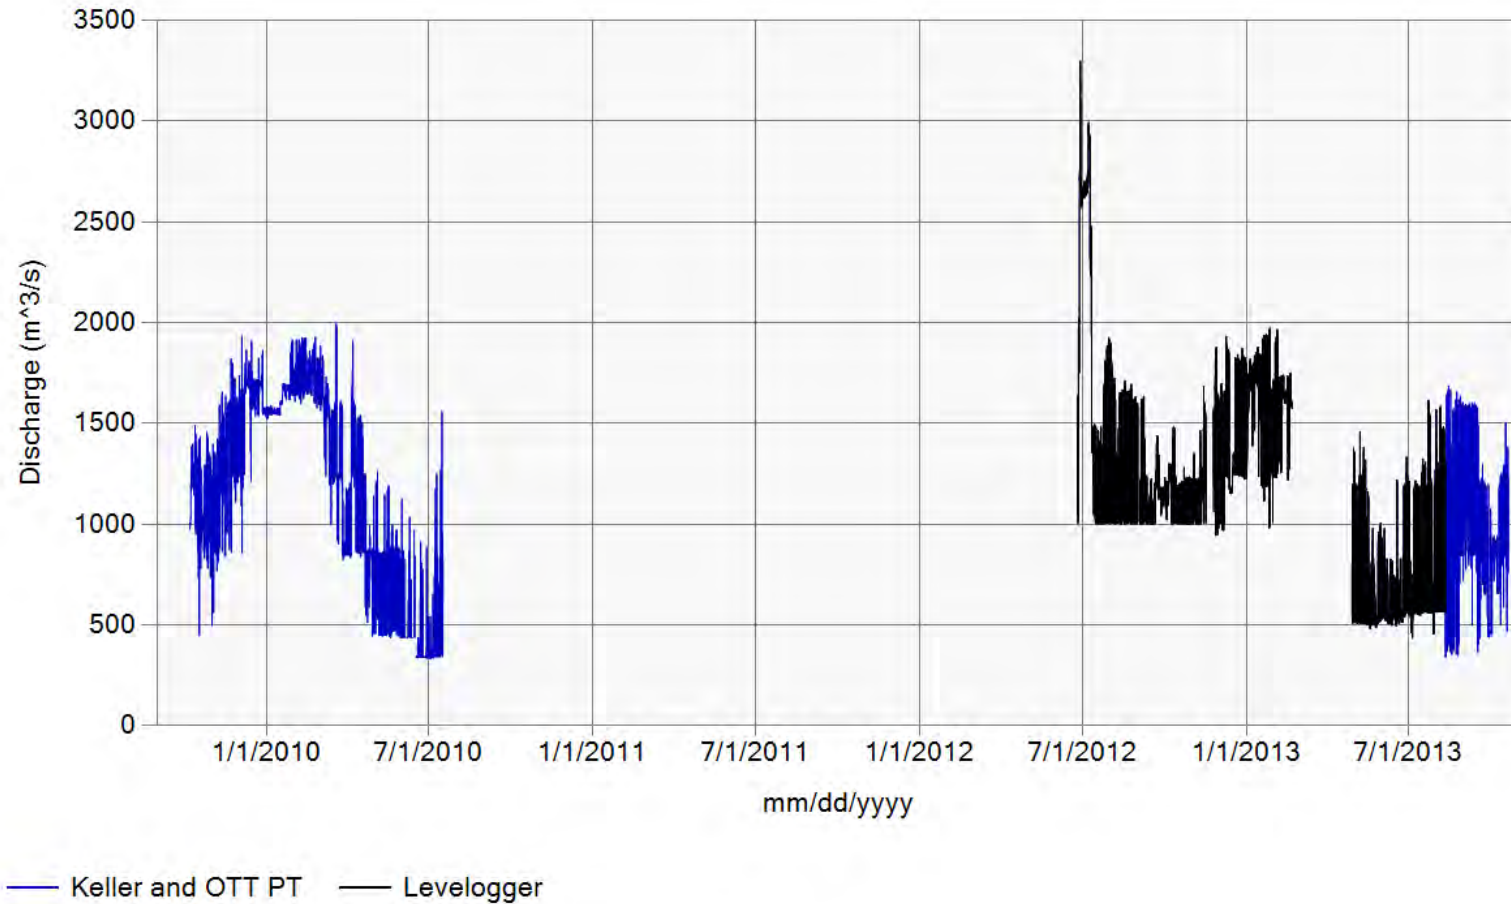
**Figure 15** The discharge record for Peace 9. The sampling interval of the Keller and OTT PT are 15 minutes and the sampling interval of the temporary levelogger is 5 minutes. Gaps in the discharge record are given in Table 10.
