**Peace Project Water Use Plan**

**Peace River Mainstem Stage Discharge**

*Mainstem Stage Discharge 2013 Study*

**GMSWORKS-6**  
**PEACE RIVER MAINSTEM STAGE DISCHARGE**  
**- 2013 STUDY -**

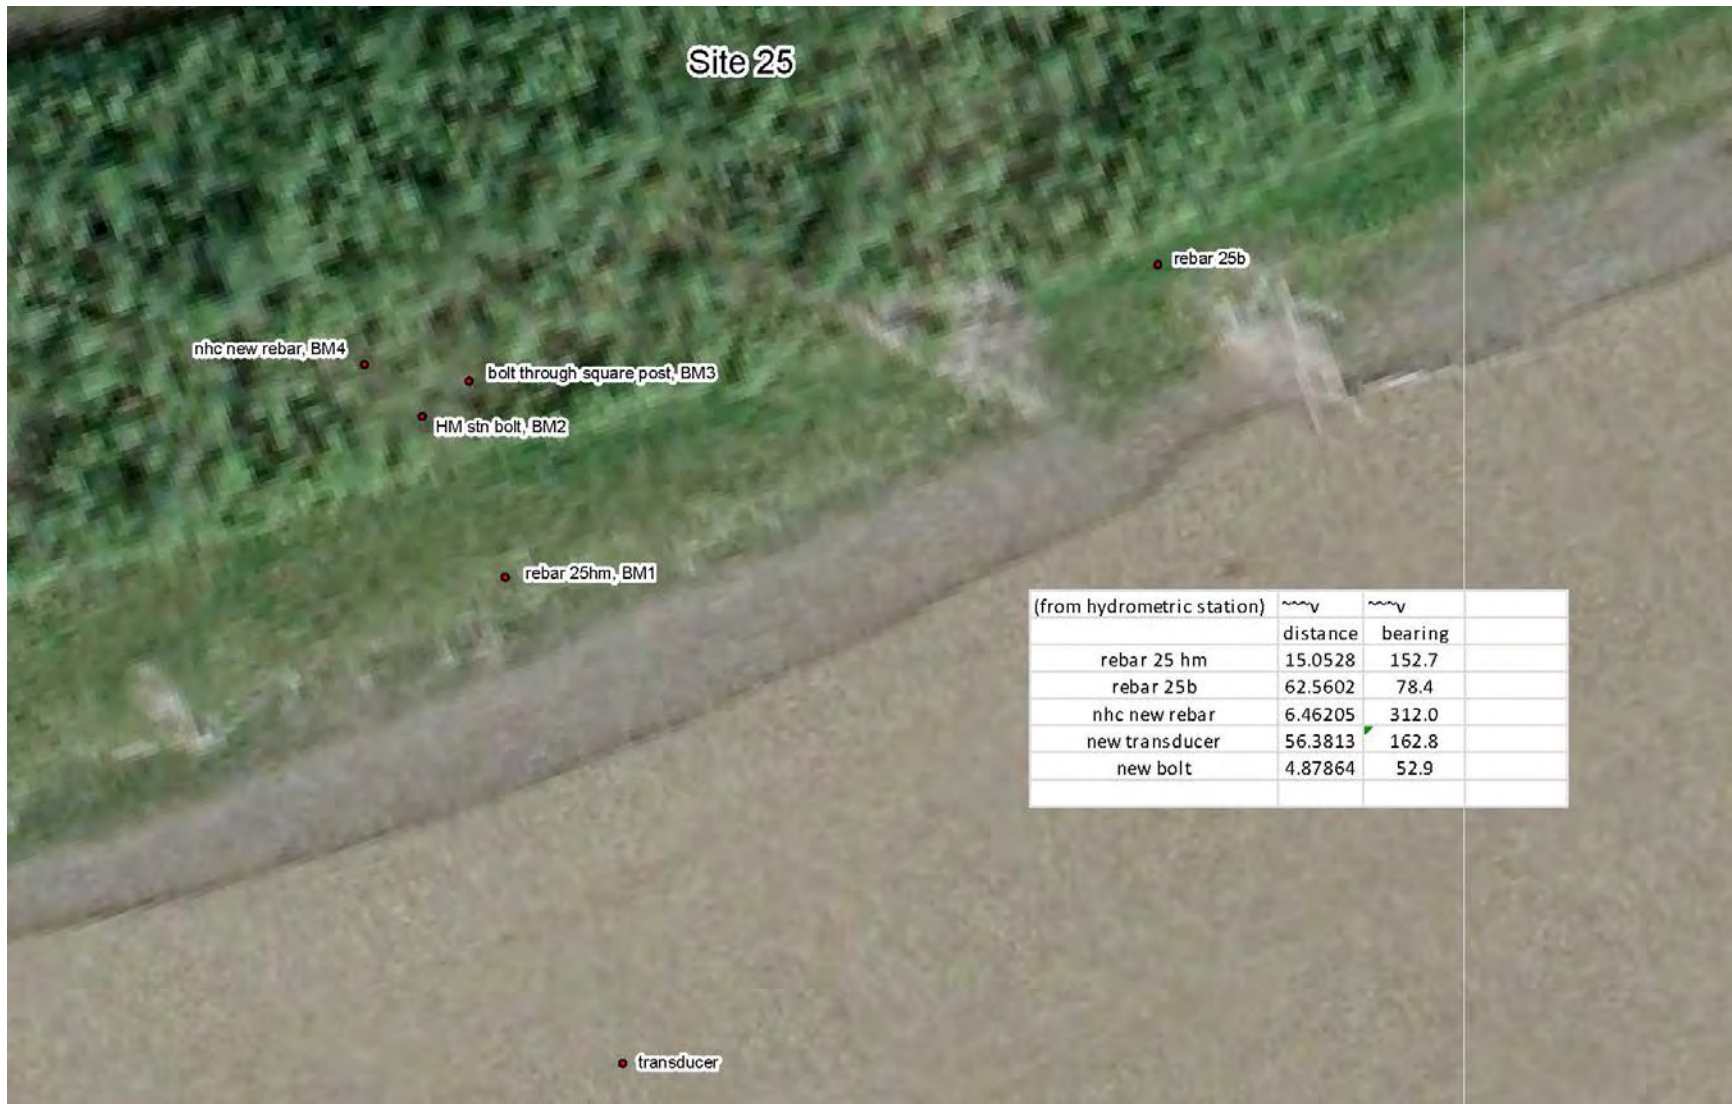
Figure 16 Peace 25 benchmark locations.

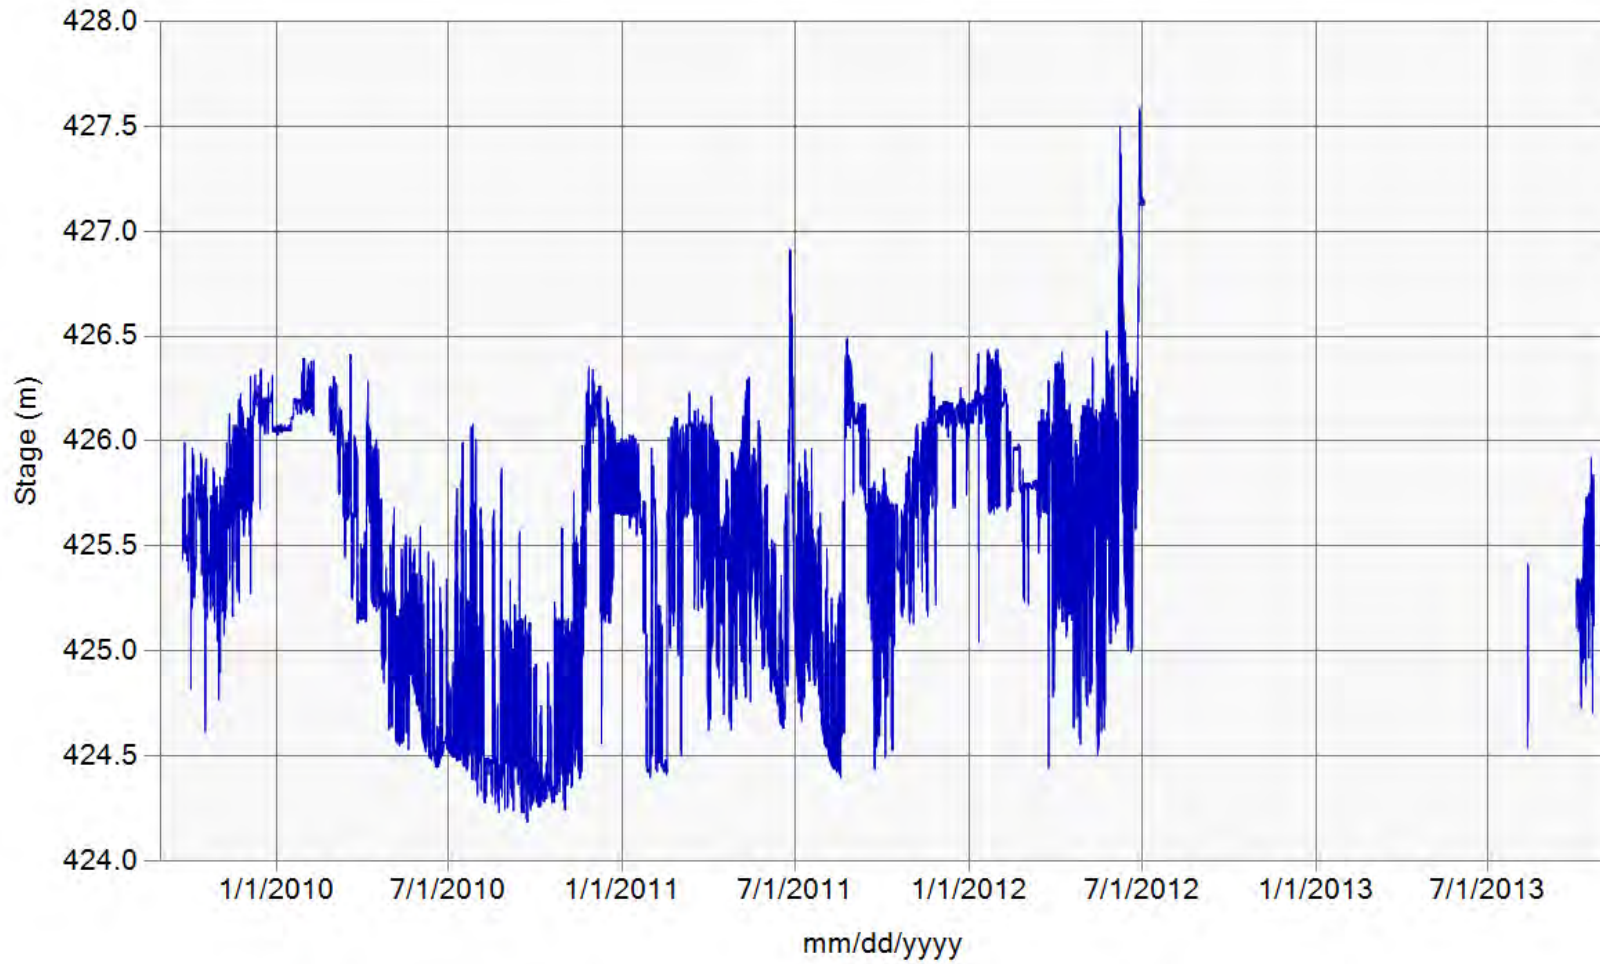
Figure 17 The stage record for Peace 25. The sampling interval is 15 minutes. Gaps in the stage record are given in Table 13.

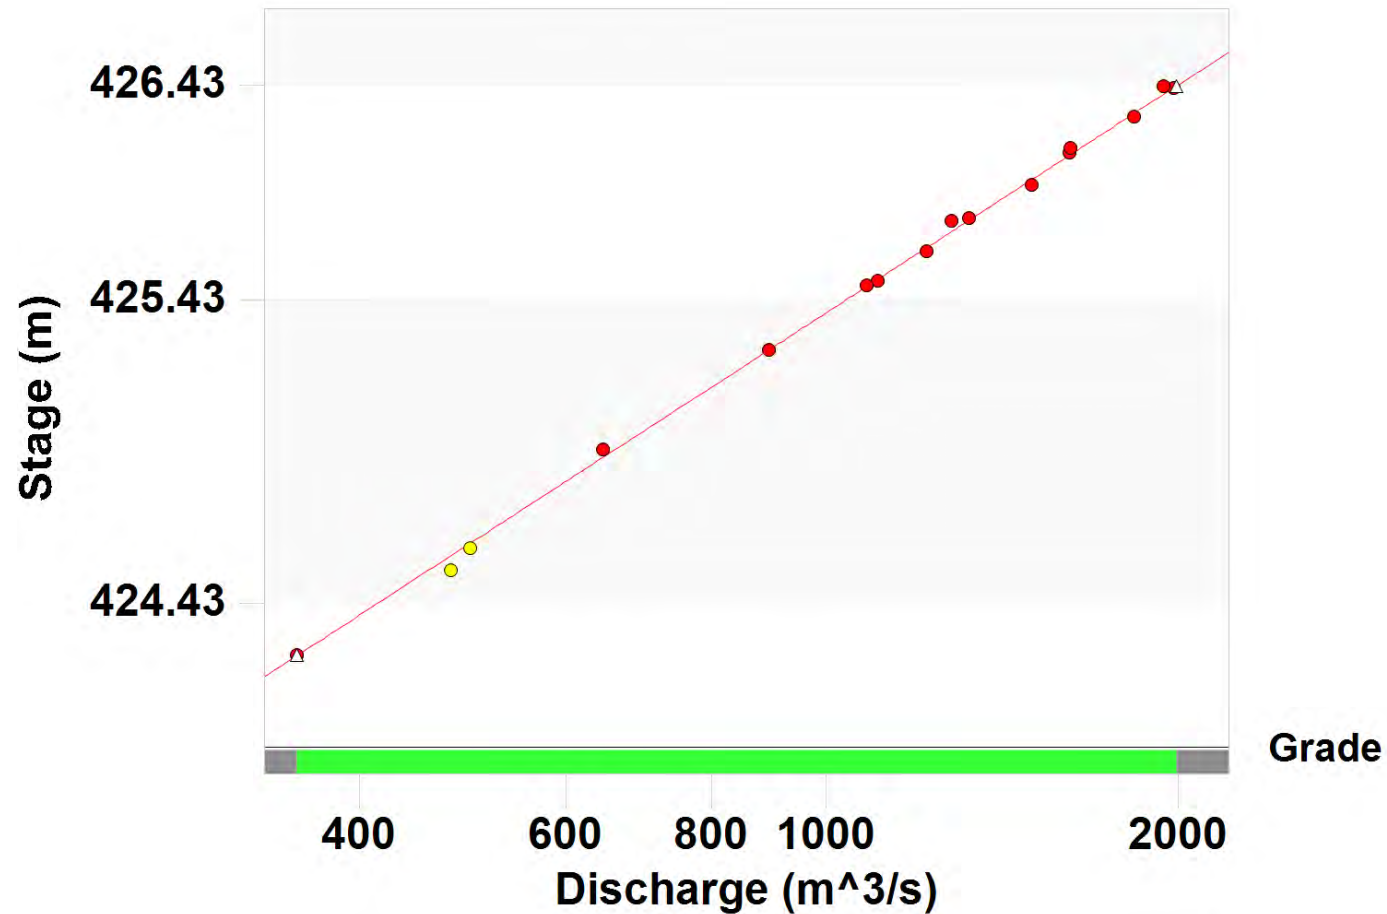
Figure 18 The rating curve for Peace 25. Within the gauged range, the rating curve shows excellent fit (1.8% root mean square of errors) meeting RISC grade A standards (Resources Information Standards Committee, 2009), represented by a green bar below the curve. Discharge values calculated using the extrapolated portion of the rating curve (outside the highest and lowest gauged flow) are RISC Grade E, represented by grey bars below the curve. Gauged stages range from 424.296 m to 426.416 m; the current stage record ranges from 424.184 m to 427.588 m. Flow measurements collected in 2013 are shown in yellow.

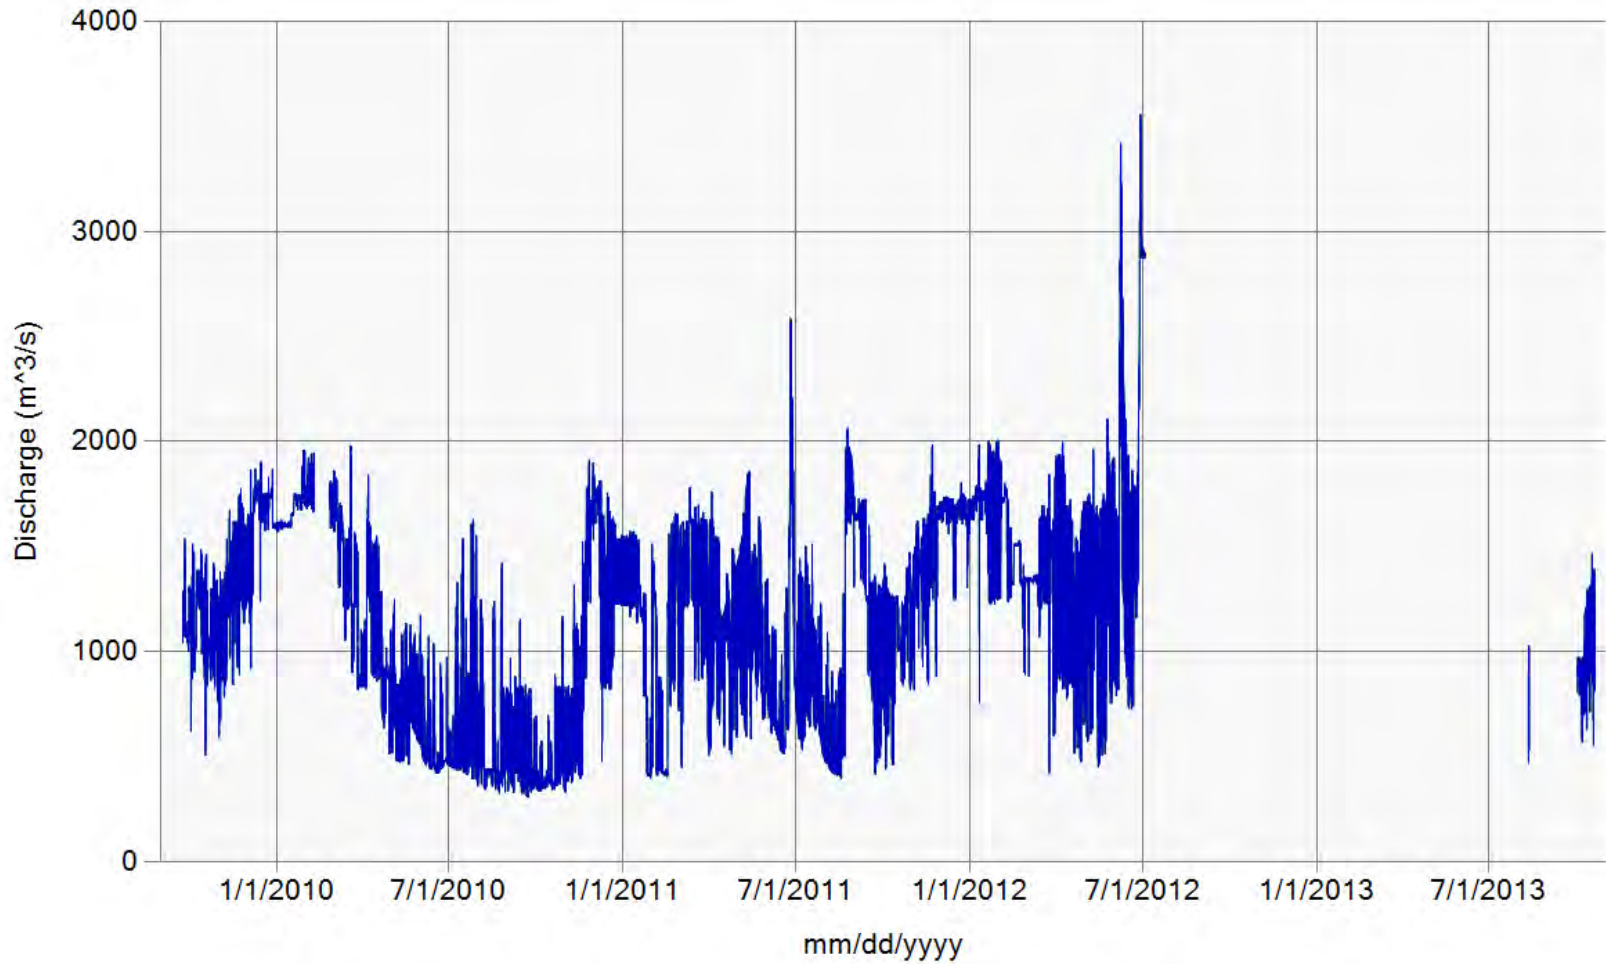
Figure 19 The discharge record for Peace 25. The sampling interval is 15 minutes. Gaps in the discharge record are given in Table 13.

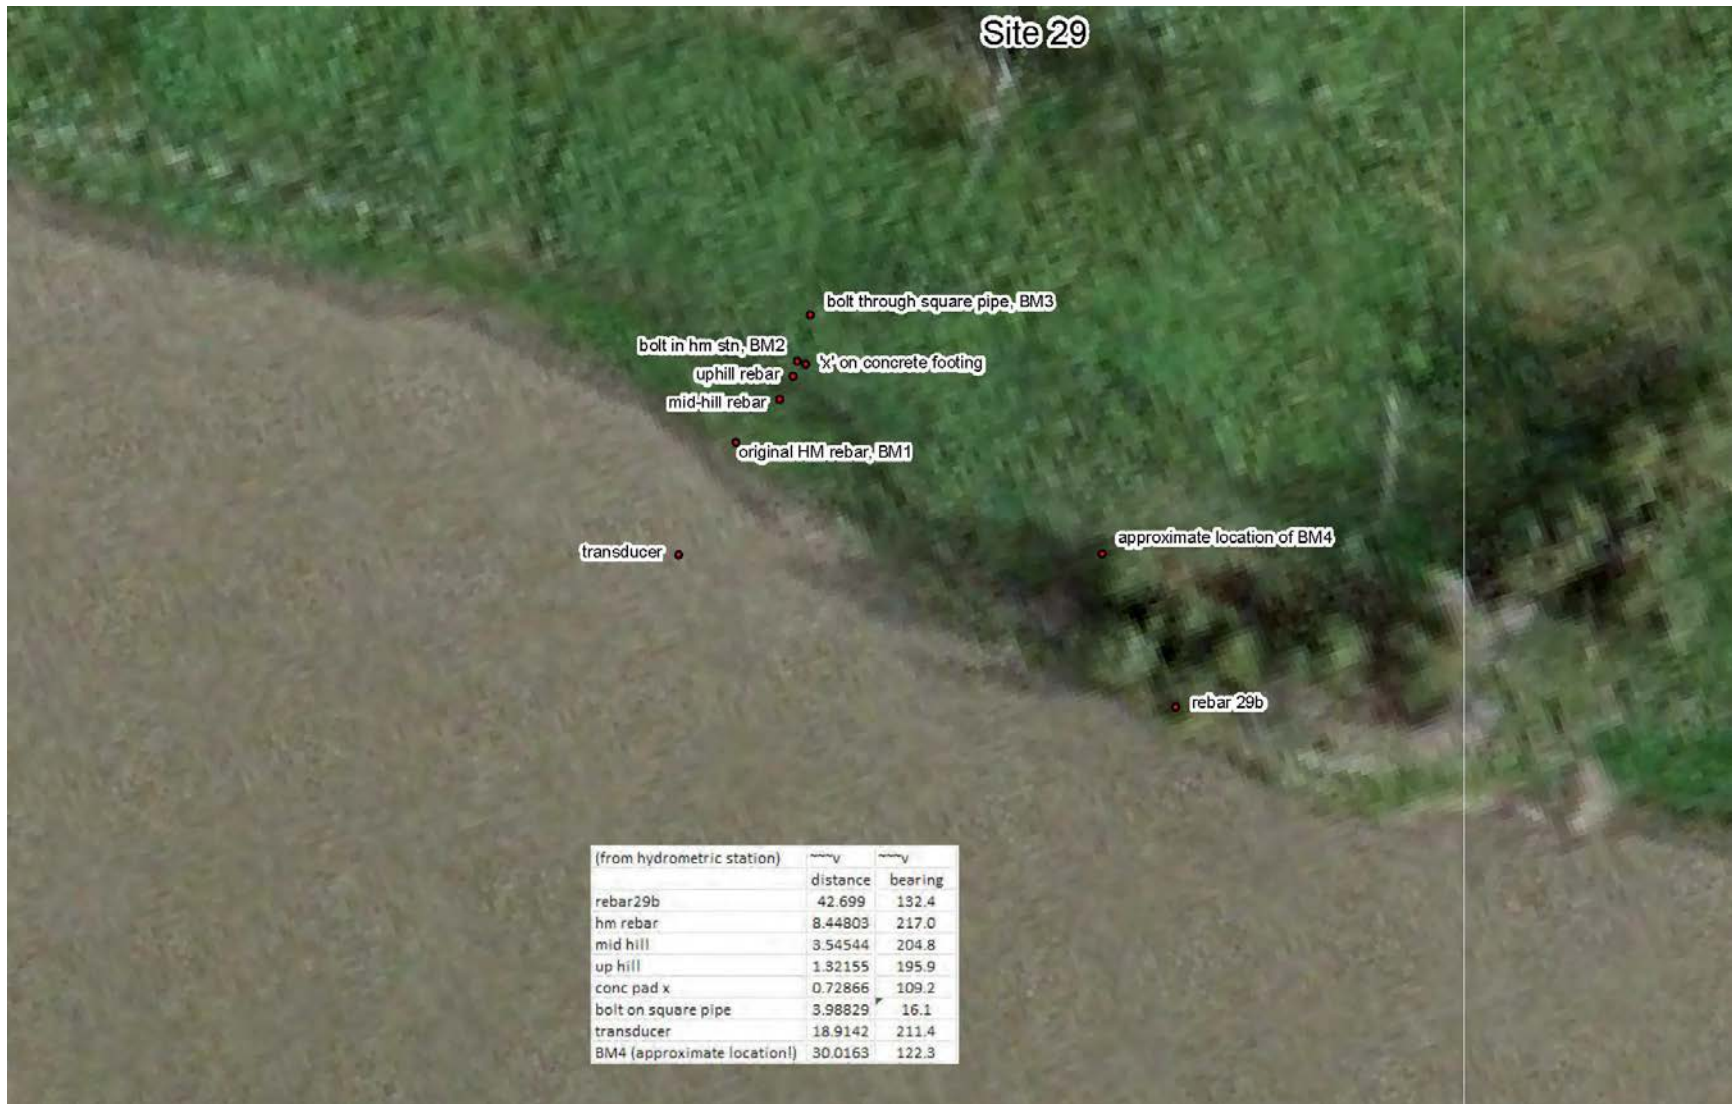
Figure 20 Peace 29 benchmark locations.

Eight benchmarks have been installed near Peace 29 (**Table 21**). Two of these benchmarks were found to be unstable. Benchmark locations are shown in **Figure 20**.

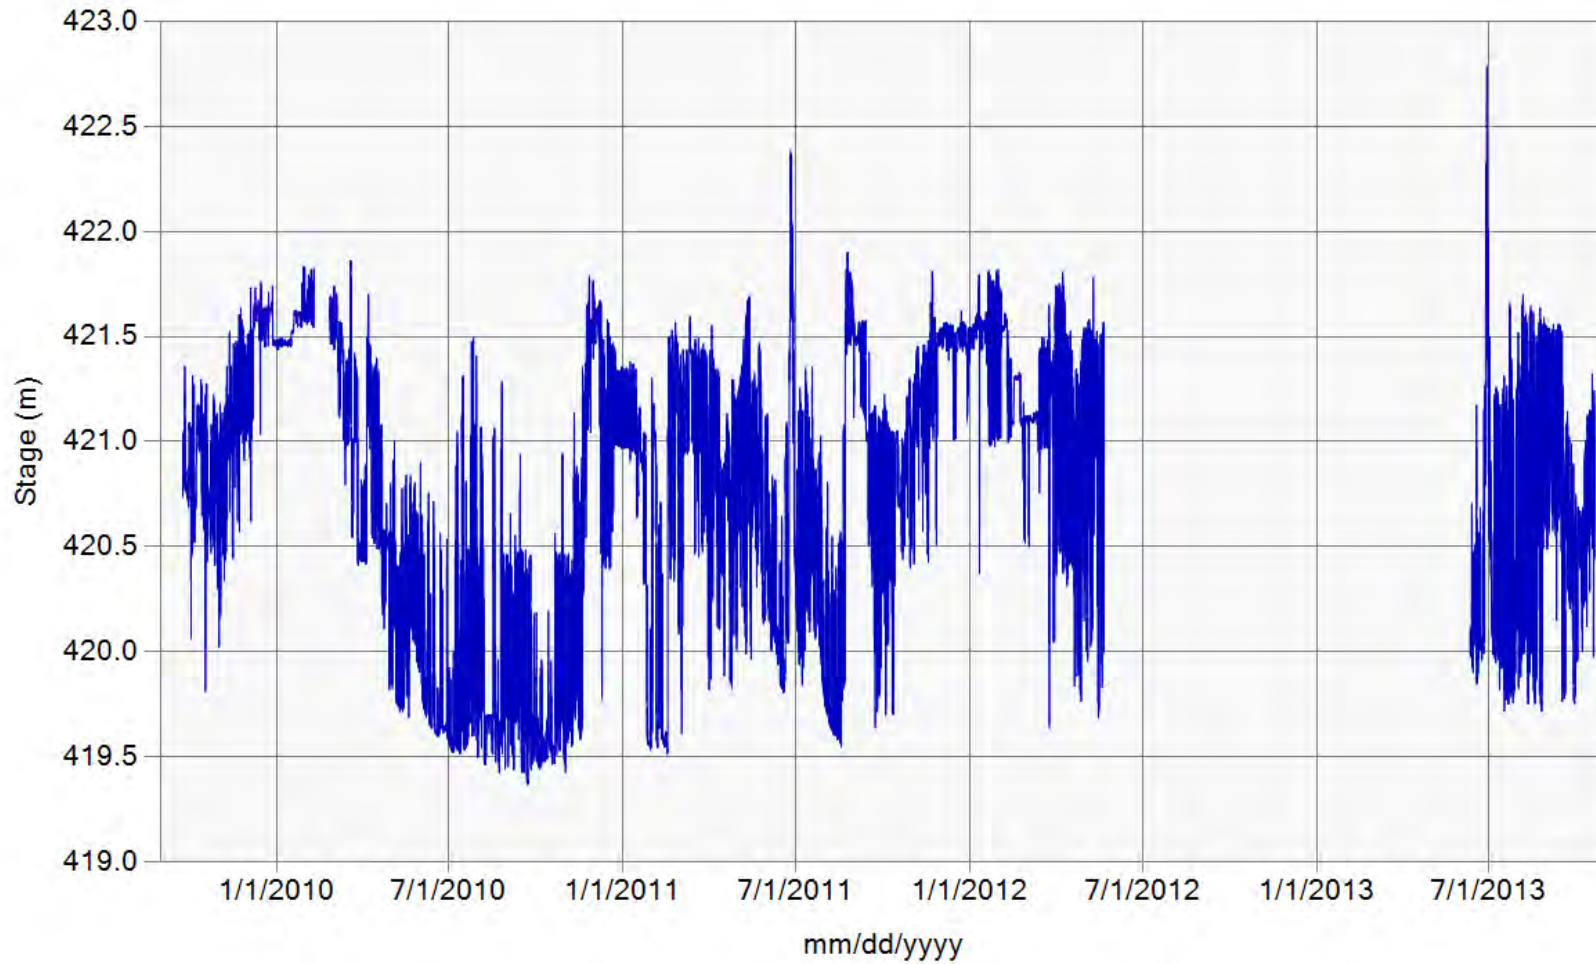
Figure 21 The stage record for Peace 29. The sampling interval is 15 minutes. Gaps in the stage record are given in Table 16.

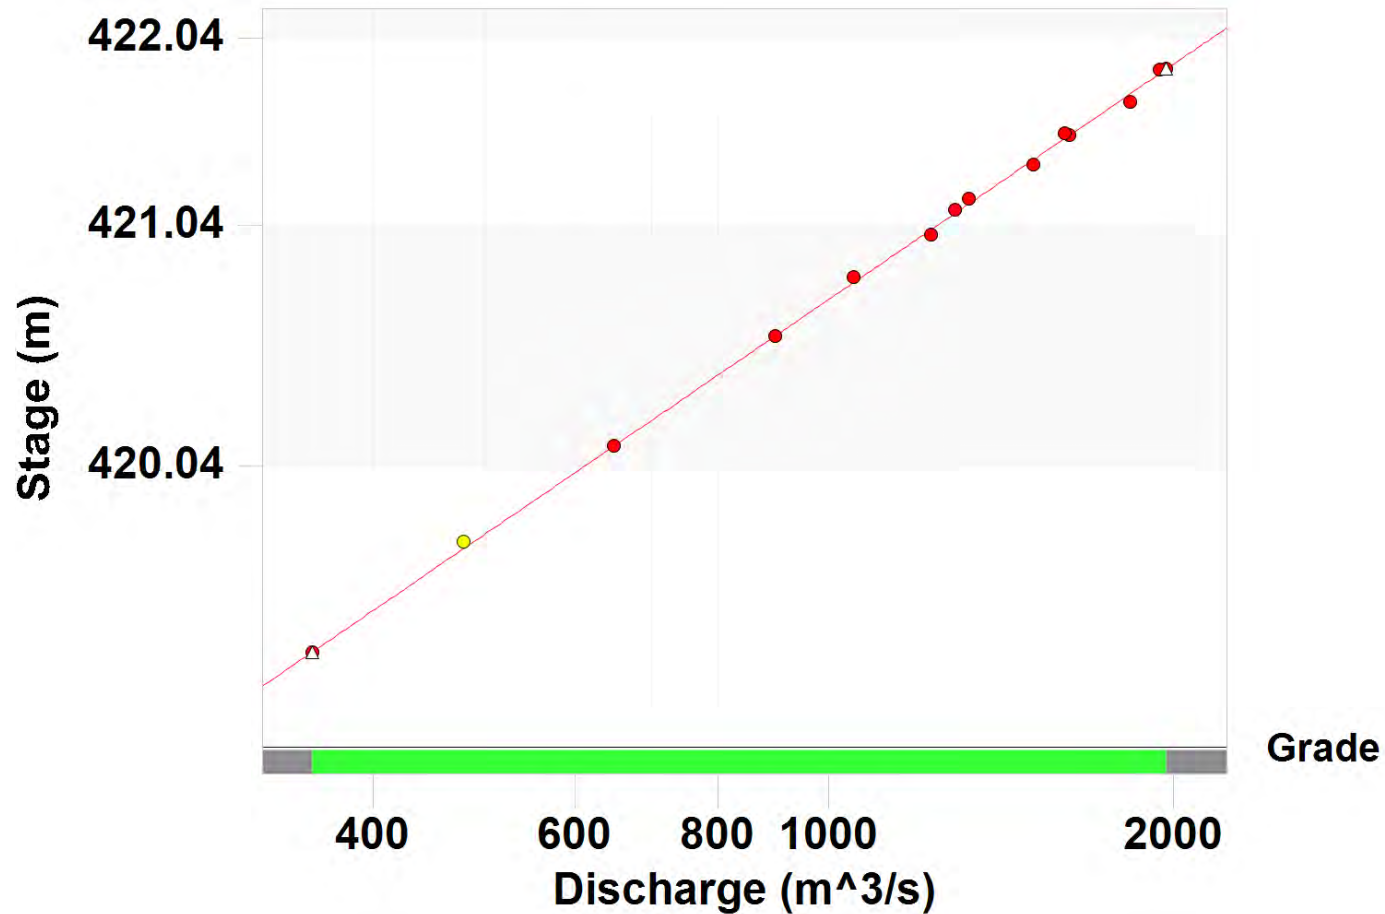
**Figure 22** The rating curve for Peace 29. Within the gauged range, the rating curve shows excellent fit (1.3% root mean square of errors) meeting RISC grade A standards (Resources Information Standards Committee, 2009), represented by a green bar below the curve. Discharge values calculated using the extrapolated portion of the rating curve (outside the highest and lowest gauged flow) are RISC Grade E, represented by grey bars below the curve. Gauged stages range from 419.443 m to 421.860 m; the current stage record ranges from 419.367 m to 422.787 m. Flow measurements collected in 2013 are shown in yellow.

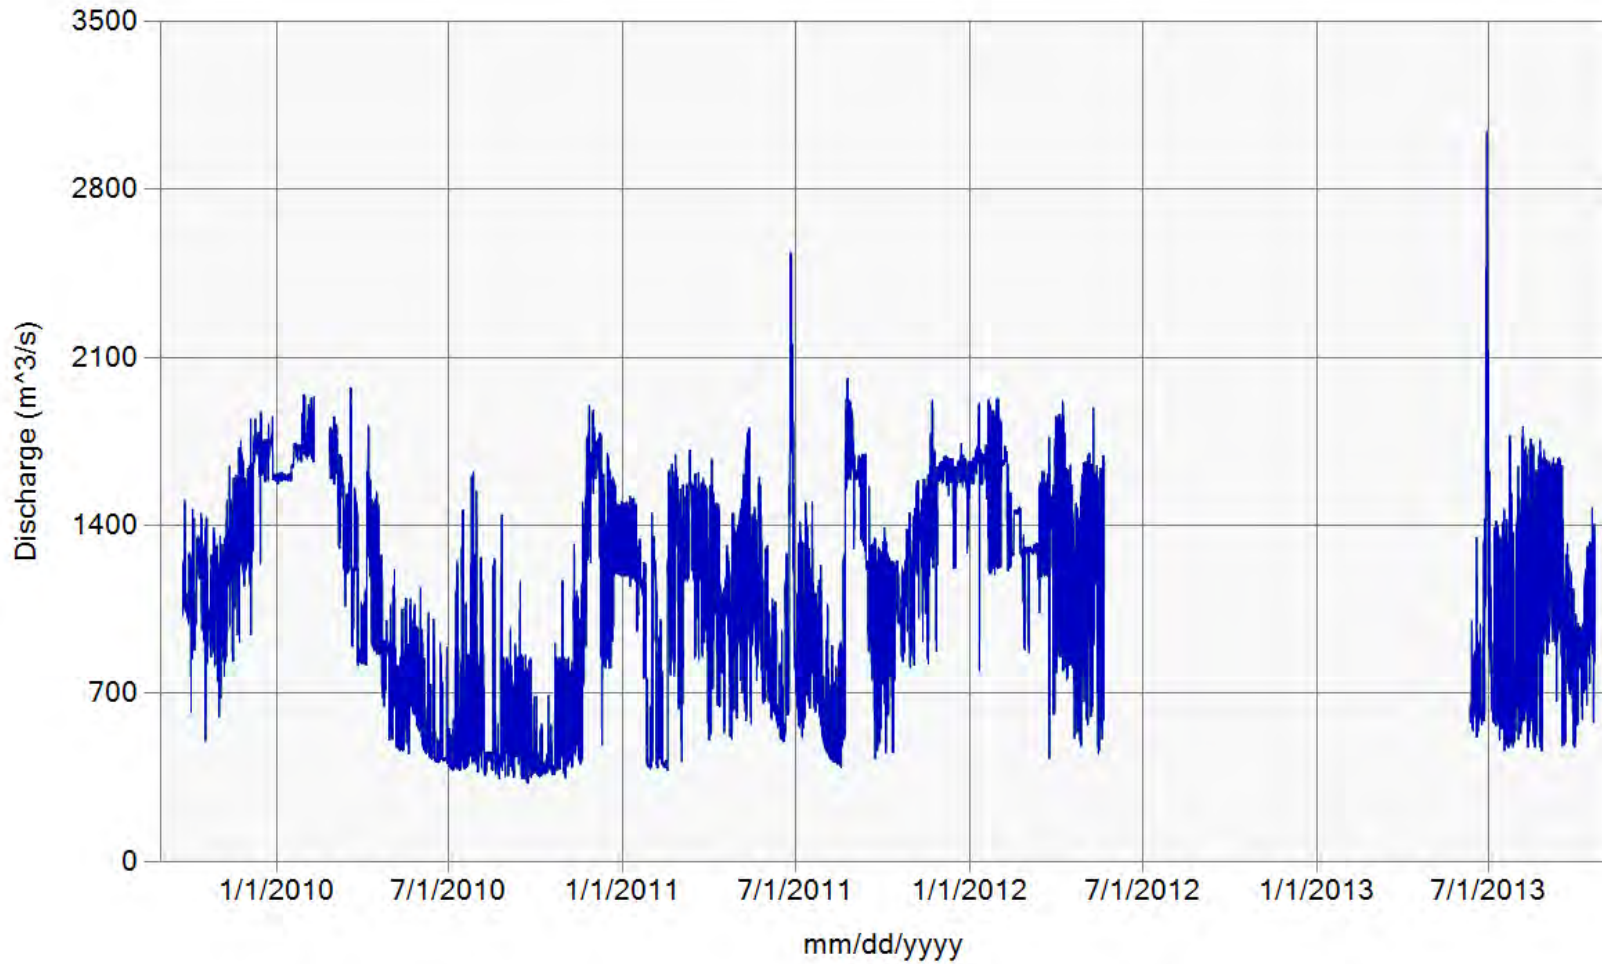
Figure 23 The discharge record for Peace 29. The sampling interval is 15 minutes. Gaps in the discharge record are given in Table 16.

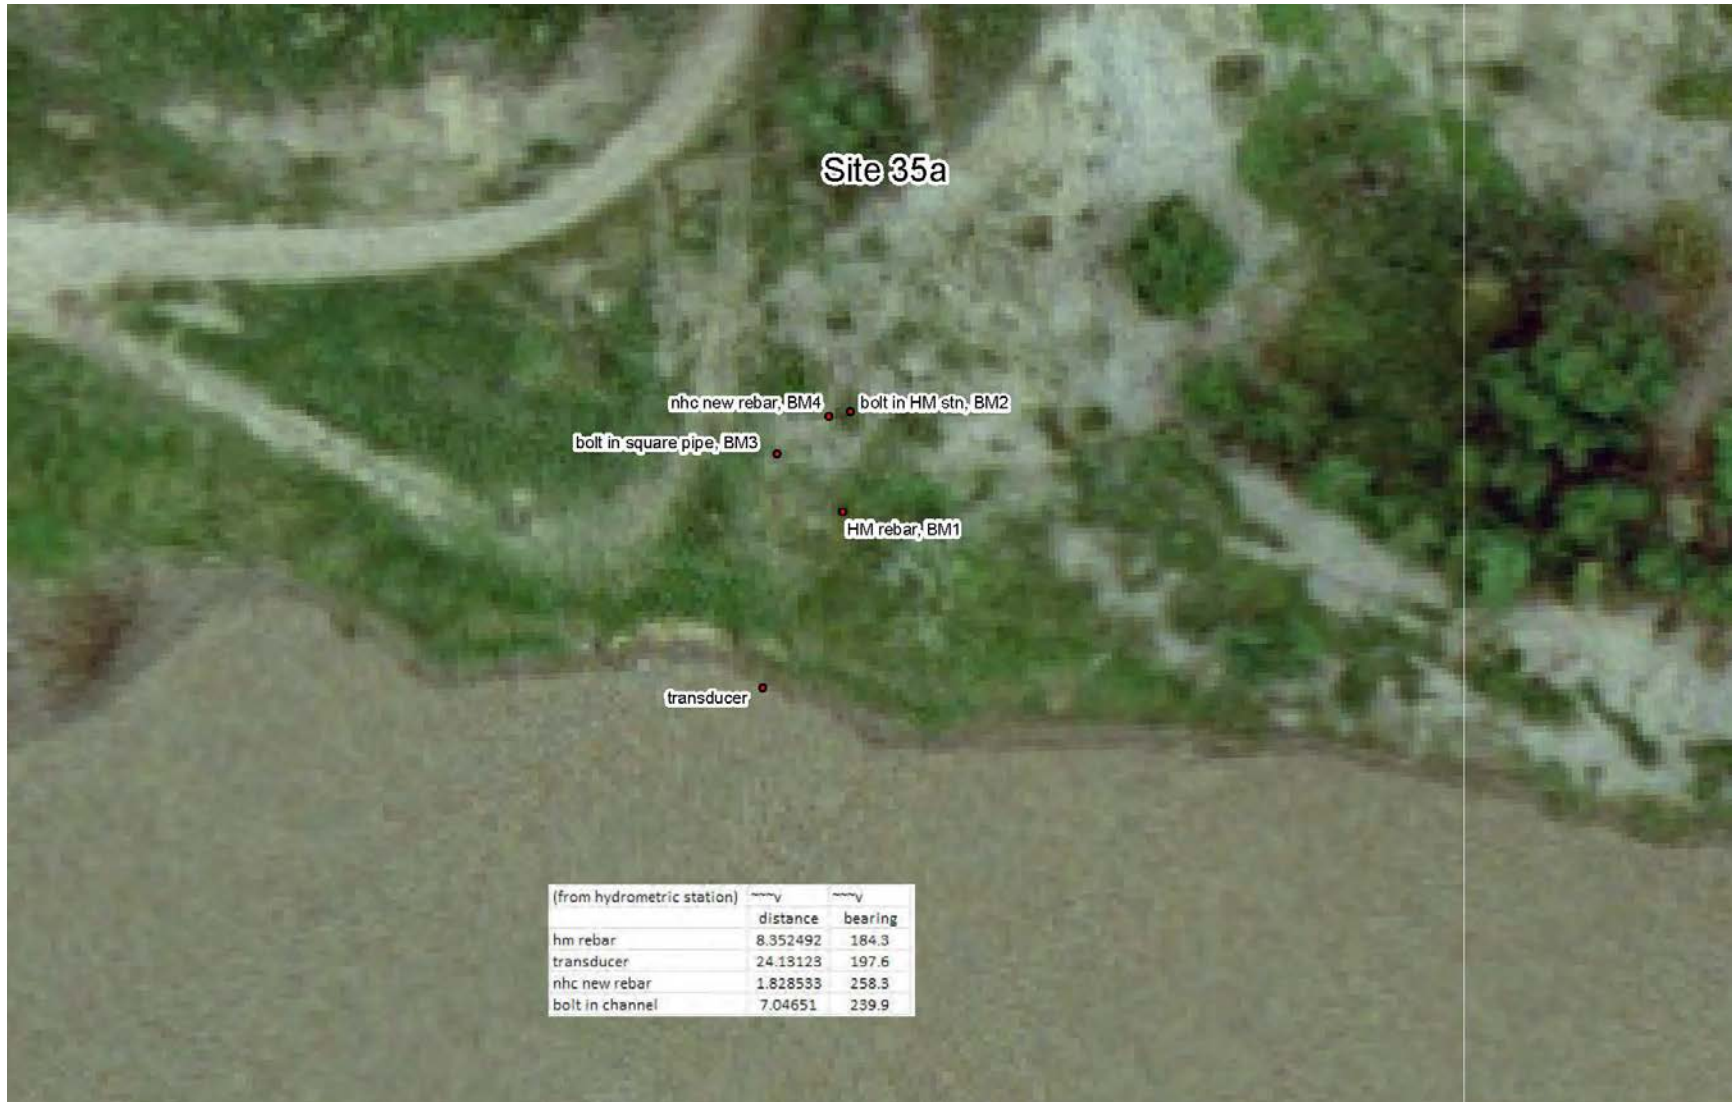
Figure 24 Peace 35a benchmark locations.

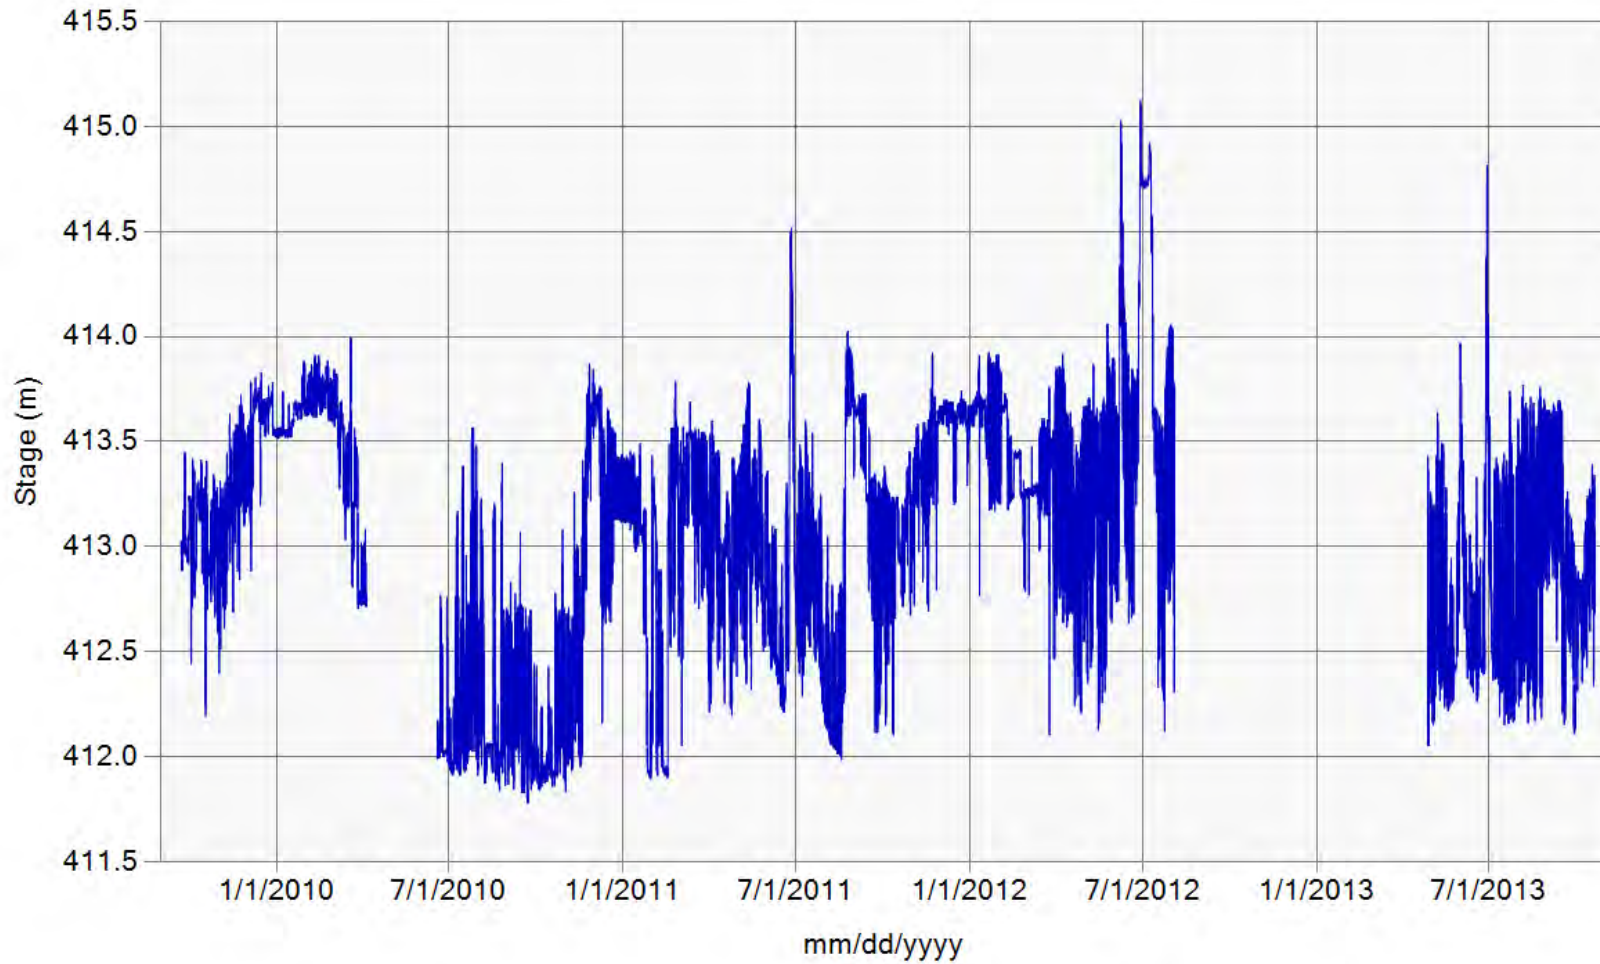
Figure 25 The stage record for Peace 35a. The sampling interval is 15 minutes. Gaps in the stage record are given in Table 19.

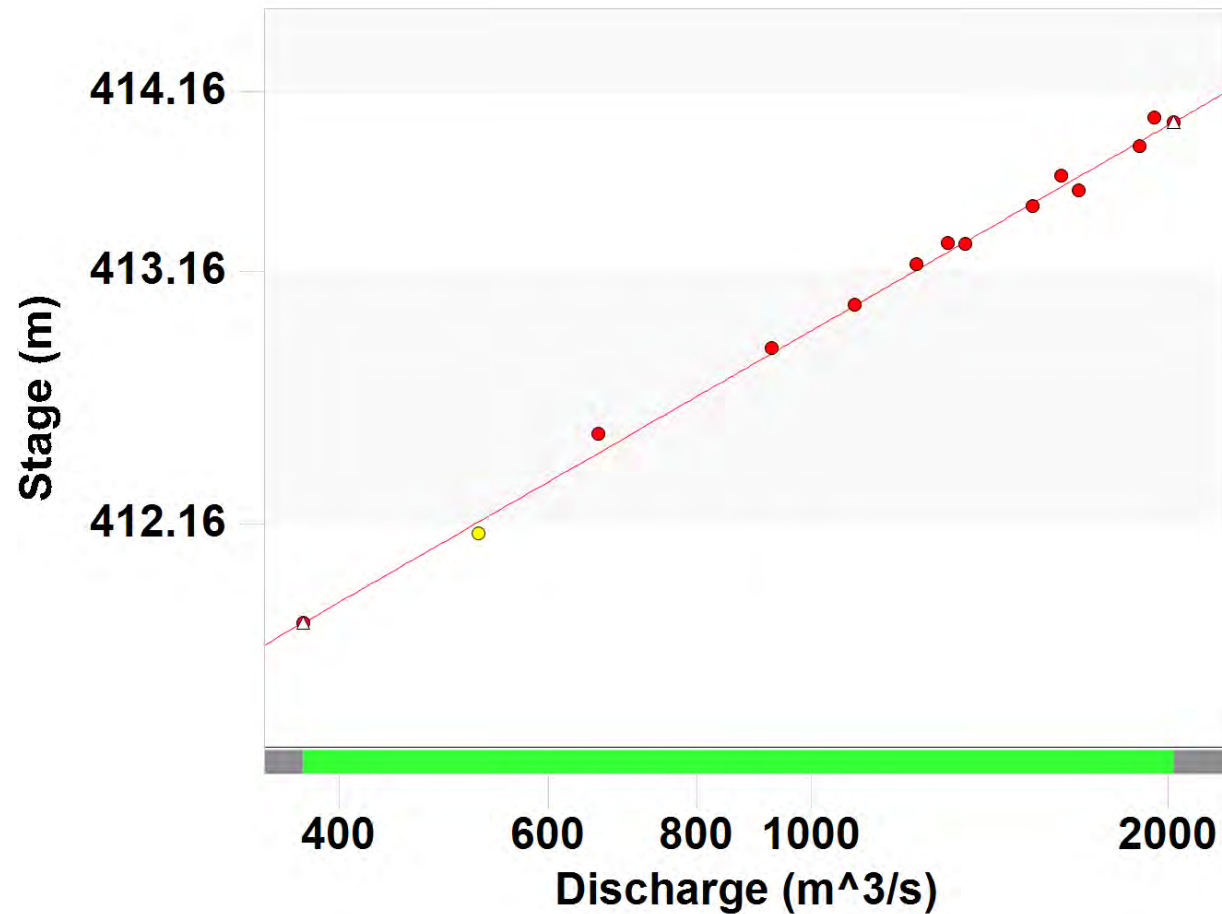
Figure 26 The rating curve for Peace 35a. Within the gauged range, the rating curve shows excellent fit (3.1% root mean square of errors) meeting RISC grade A standards (Resources Information Standards Committee, 2009), represented by a green bar below the curve. Discharge values calculated using the extrapolated portion of the rating curve (outside the highest and lowest gauged flow) are RISC Grade E, represented by grey bars below the curve. Gauged stages range from 411.869 m to 413.969 m; the current stage record ranges from 411.779 m to 415.123 m. Flow measurements collected in 2013 are shown in yellow.

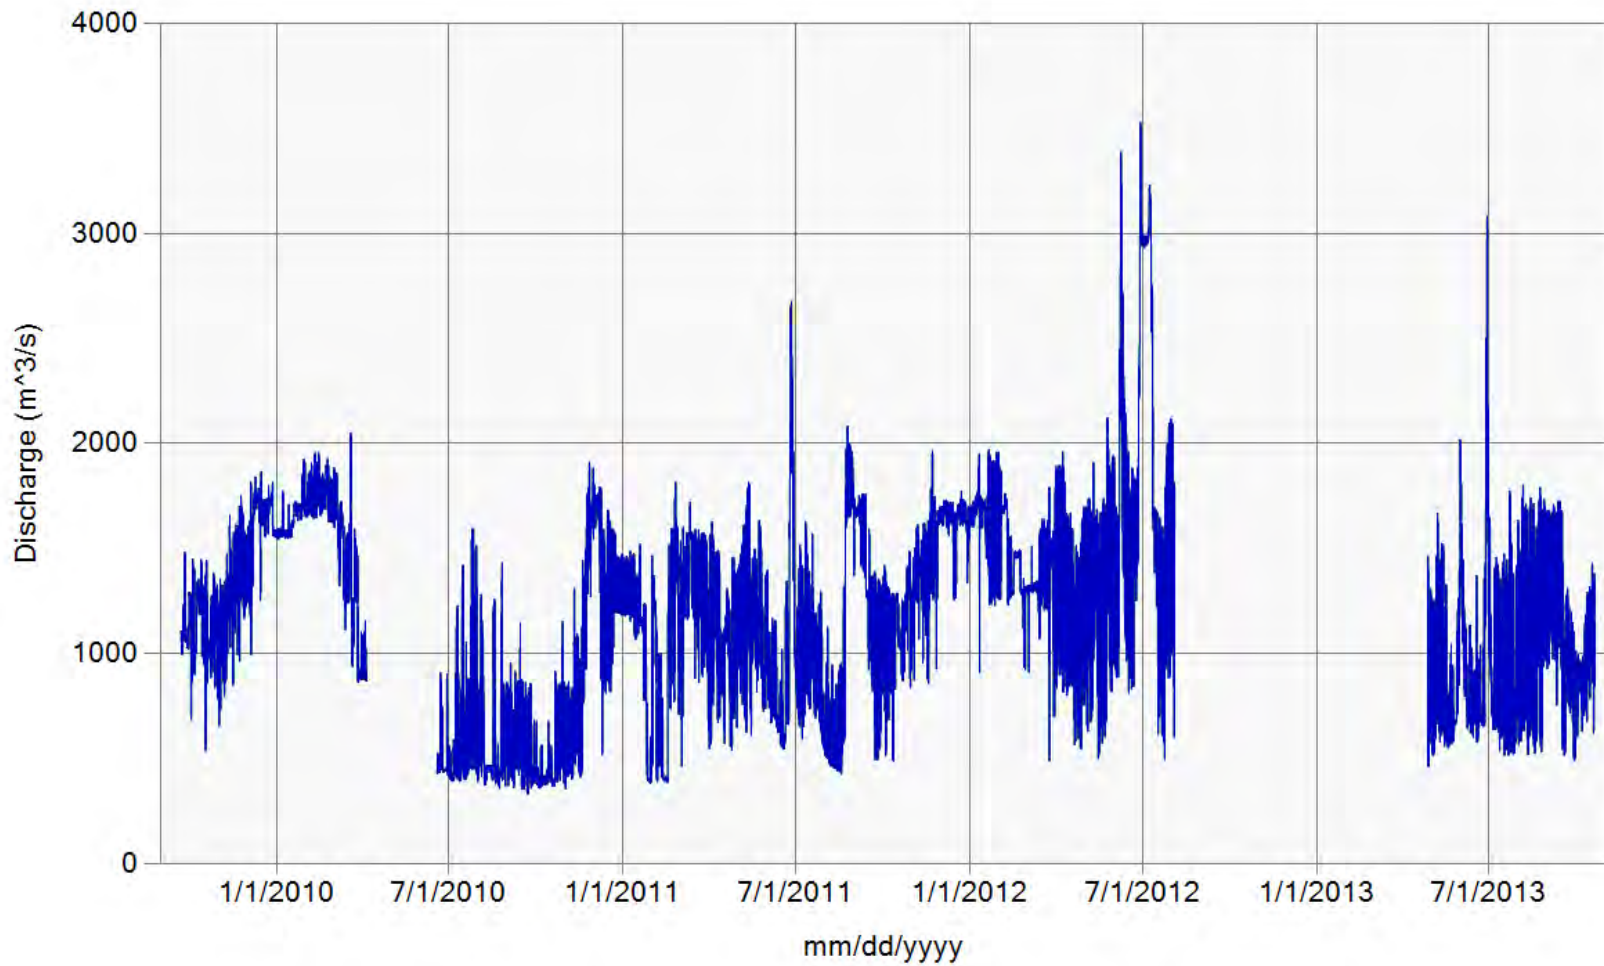
Figure 27 The discharge record for Peace 35a. The sampling interval is 15 minutes. Gaps in the discharge record are given in Table 19.
