Peace Project Water Use Plan

Peace River Mainstem Stage Discharge

Mainstem Stage Discharge 2014 Study

GMSWORKS-6
PEACE RIVER MAINSTEM STAGE DISCHARGE
- 2014 STUDY -

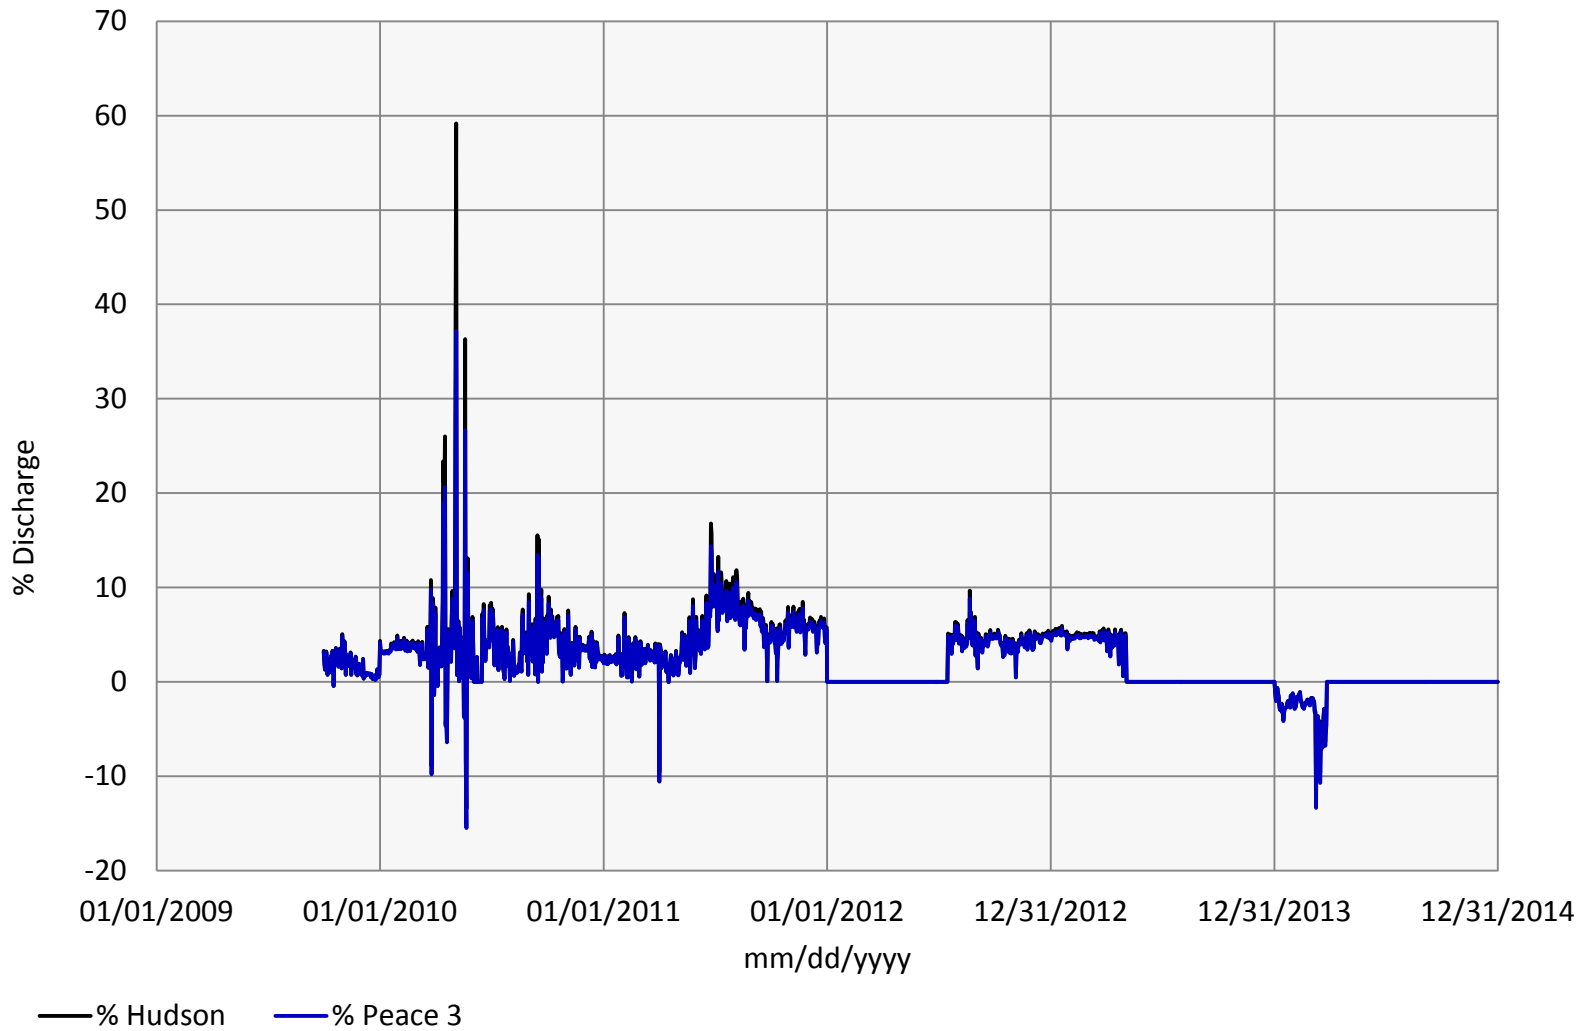
Figure 2 Calculated daily inflows between WSC PR-Hudson and Peace 3 from October 1, 2009 to March 27, 2014 as a percent of WSC PR-Hudson and Peace 3 flows.

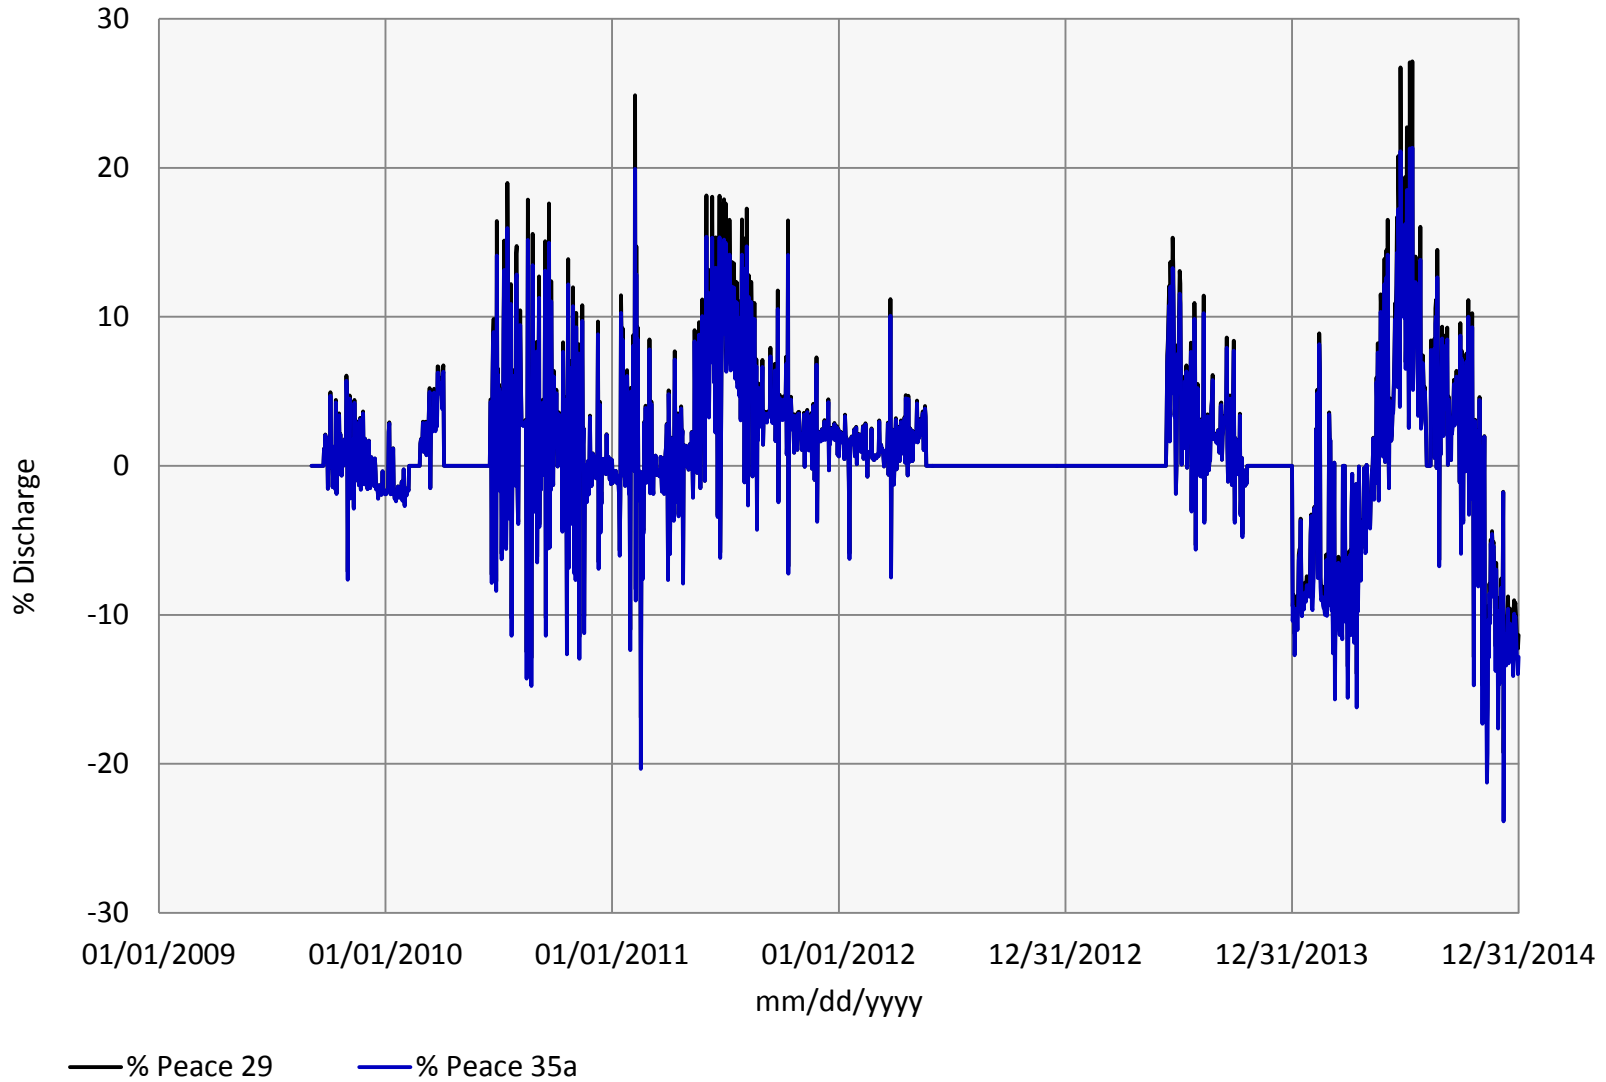
Figure 5 Calculated daily inflows between Peace 35a and Peace 29 from September 24, 2009 to December 31, 2014 as percentages of Peace 35a and Peace 29 flows.

Calculated daily inflows ranged from -193 to 144 m³/s (-24 to 21% of the discharge at Peace 35a **Figure 5**), while high frequency inflows ranged from -216 to 274 m³/s (-23 to 25% of the discharge at Peace 35a). Negative values were noted 55% of the time in the daily record, and 57% for the high frequency record. Considering the increase in contributing watershed area is only 0.3% for this reach of the Peace River, negative inflows are not expected to the magnitude observed (coupled with large positive inflows).

Further inspection of the inflow record for this reach (**Figure 5**) shows a distinct trend; inflows begin 2014 being notably negative but move to be more positive until July, where the inflows begin drifting towards negative values again. This movement of the inflow record suggests a continually shifting discharge record at Peace 29 or 35a; as this movement was not noted between Peace 29 and Peace 9, this has been attributed to Peace 35a. Without further inspection of the Peace 35a gauge, the cause of this shifting cannot be determined but it is likely the result of sensor drift. The Peace 35a record should be used with caution and has been prescribed an uncertainty +/- 25%.

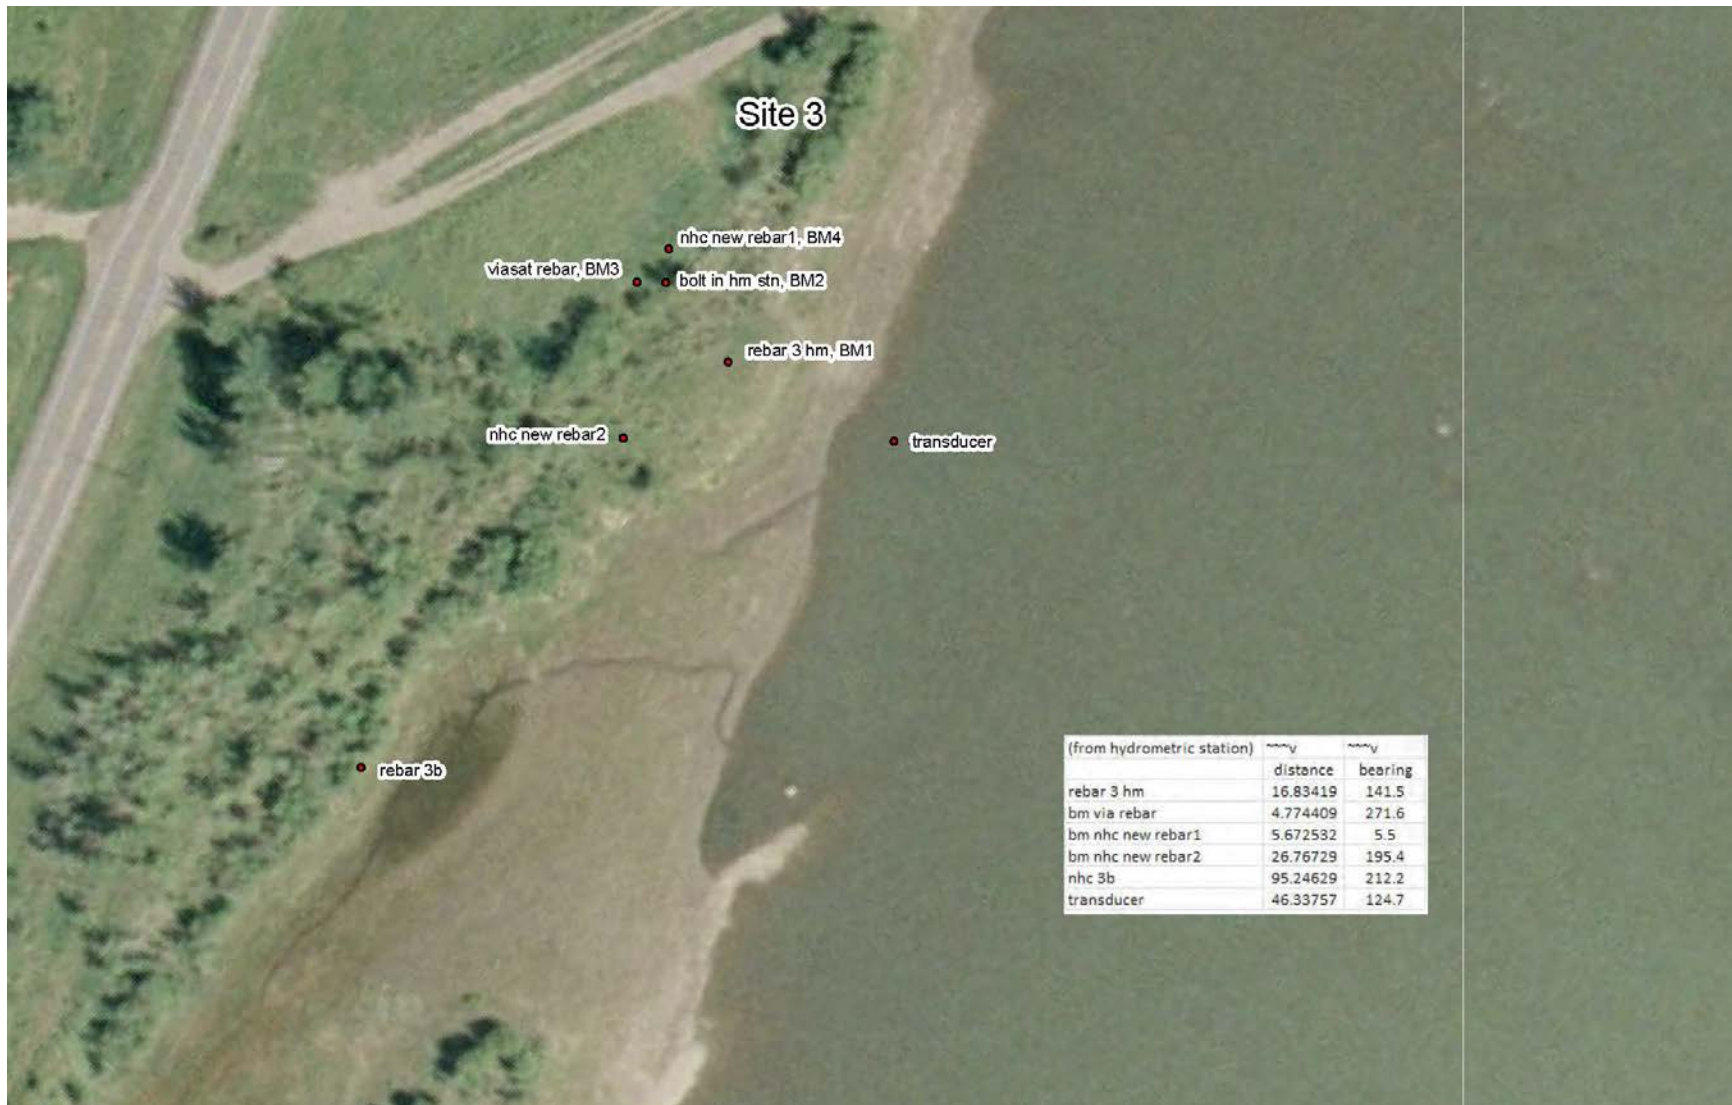
Figure 8 The 2014 stage record for Peace 3. The sampling interval is 5 minutes. Gaps in the stage record are detailed in Table 7.

The current Peace 3 stage time series extends from September 3, 2009 to March 27, 2014 (**Figure 8**). No data is available between March 27 and September 3, 2014 due to the loggers' memory being filled. The logger was redeployed on September 3, 2014 and the remaining 2014 data will be available after the next manual download. Gaps are detailed in **Table 7**. Data from August 11, 2013 to March 27, 2014 have been compared to one surveyed water level elevation.

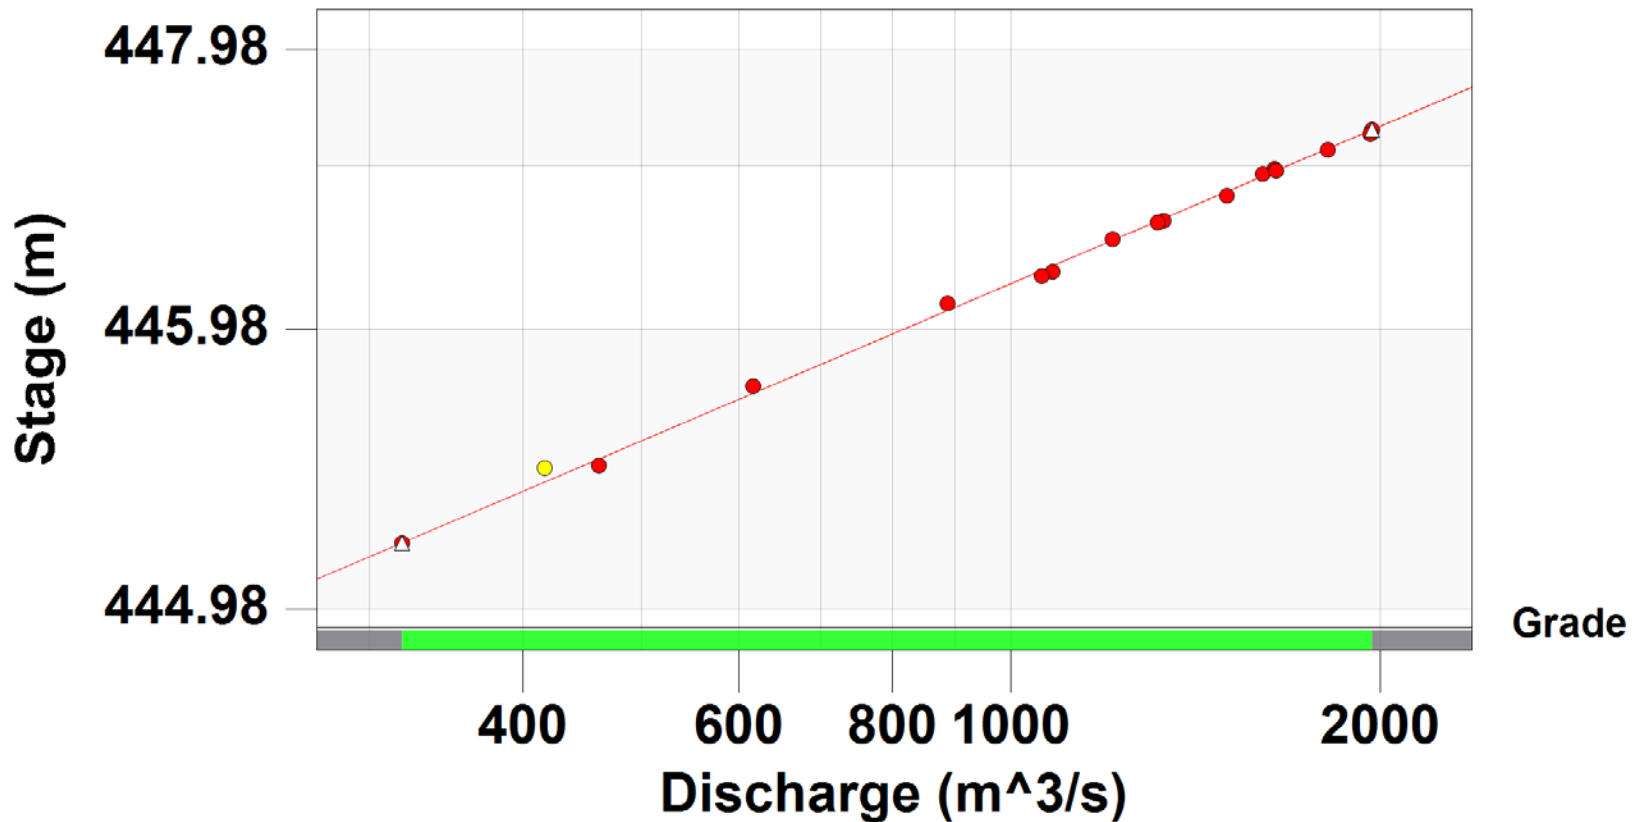
Figure 9 The rating curve for Peace 3. Within the gauged range, the rating curve shows excellent fit (2.3% root mean square of errors) meeting RISC grade A standards (Resources Information Standards Committee, 2009), represented by a green bar below the curve. Discharge values calculated using the extrapolated portion of the rating curve (outside the highest and lowest gauged flow) are RISC Grade E, represented by grey bars below the curve. Gauged stages range from 445.159 m to 447.259 m; the current stage record ranges from 445.085 m to 448.273 m. The flow measurement collected in 2014 is shown in yellow.

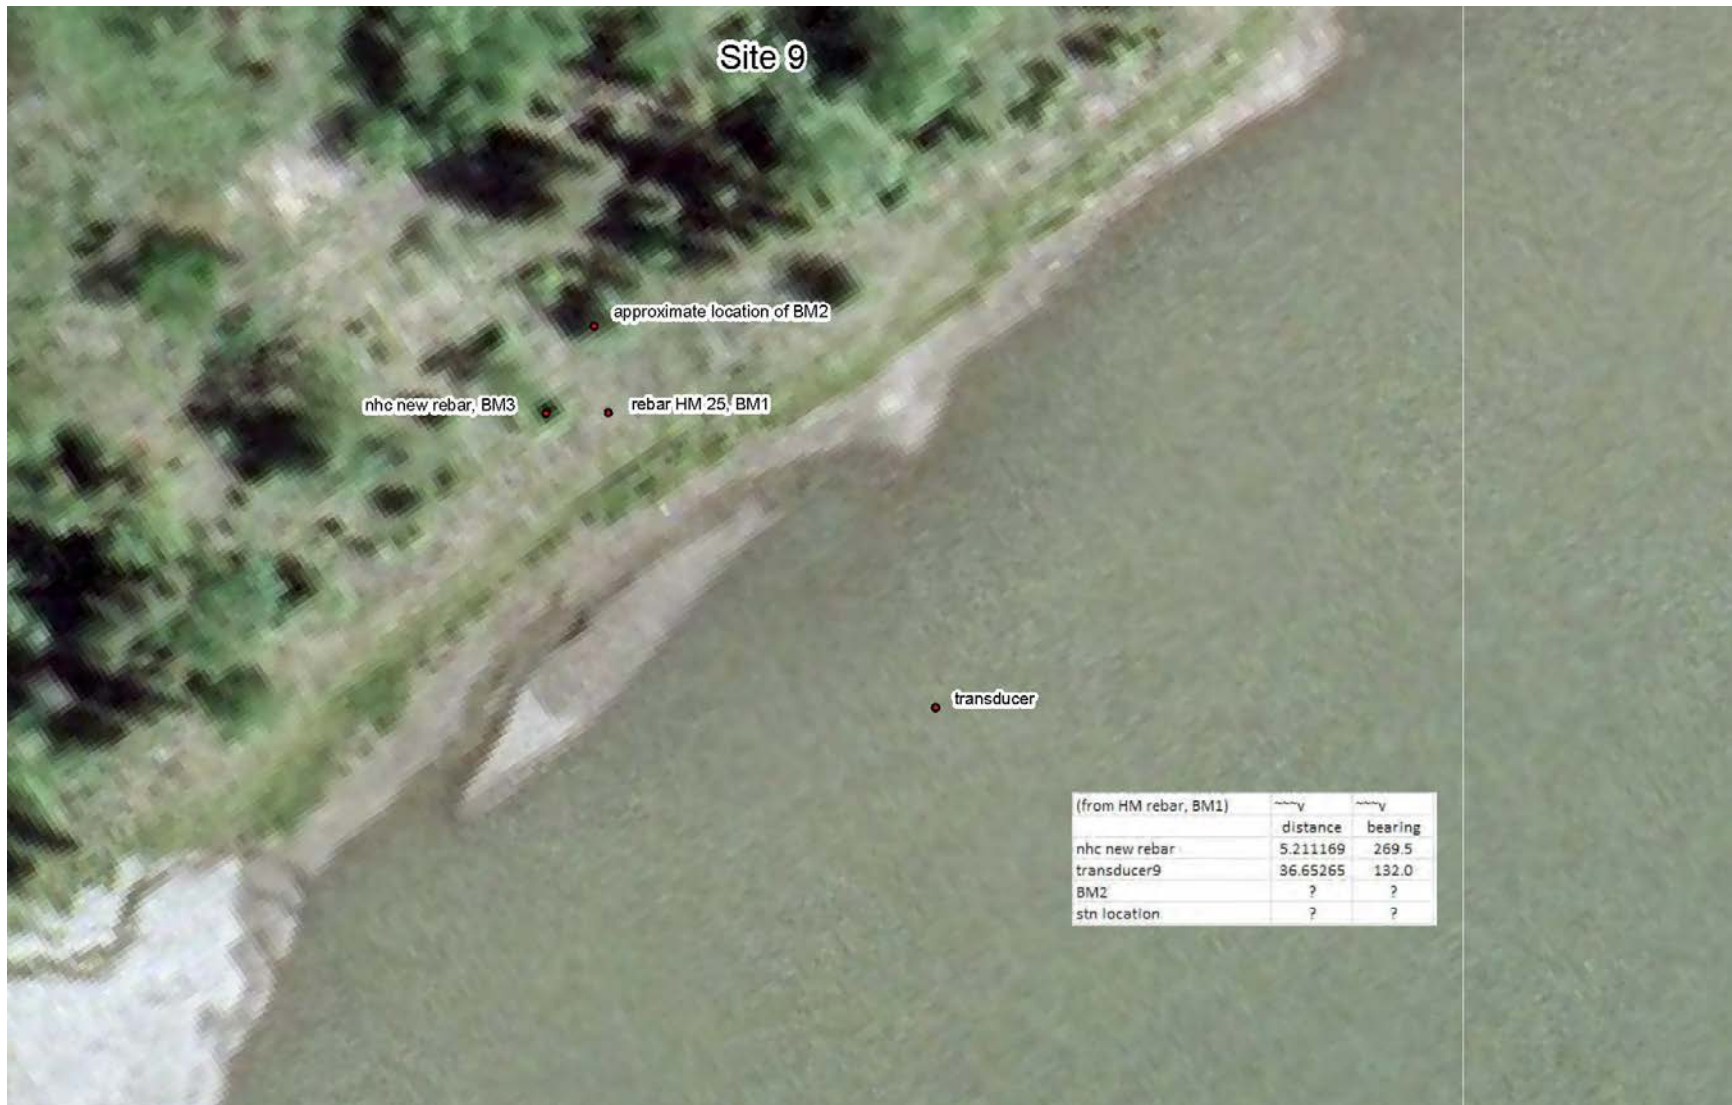
Figure 12 The 2014 stage record for Peace 9. The sampling interval is 15 minutes. Gaps in the stage record are given in Table 10.

The current Peace 9 stage time series extends from October 6, 2009 to December 31, 2014 with several data gaps (**Figure 12**). The data gaps in 2014 appear to be attributed to logger communication error with the GOES system. Gaps are detailed in **Table 10**.

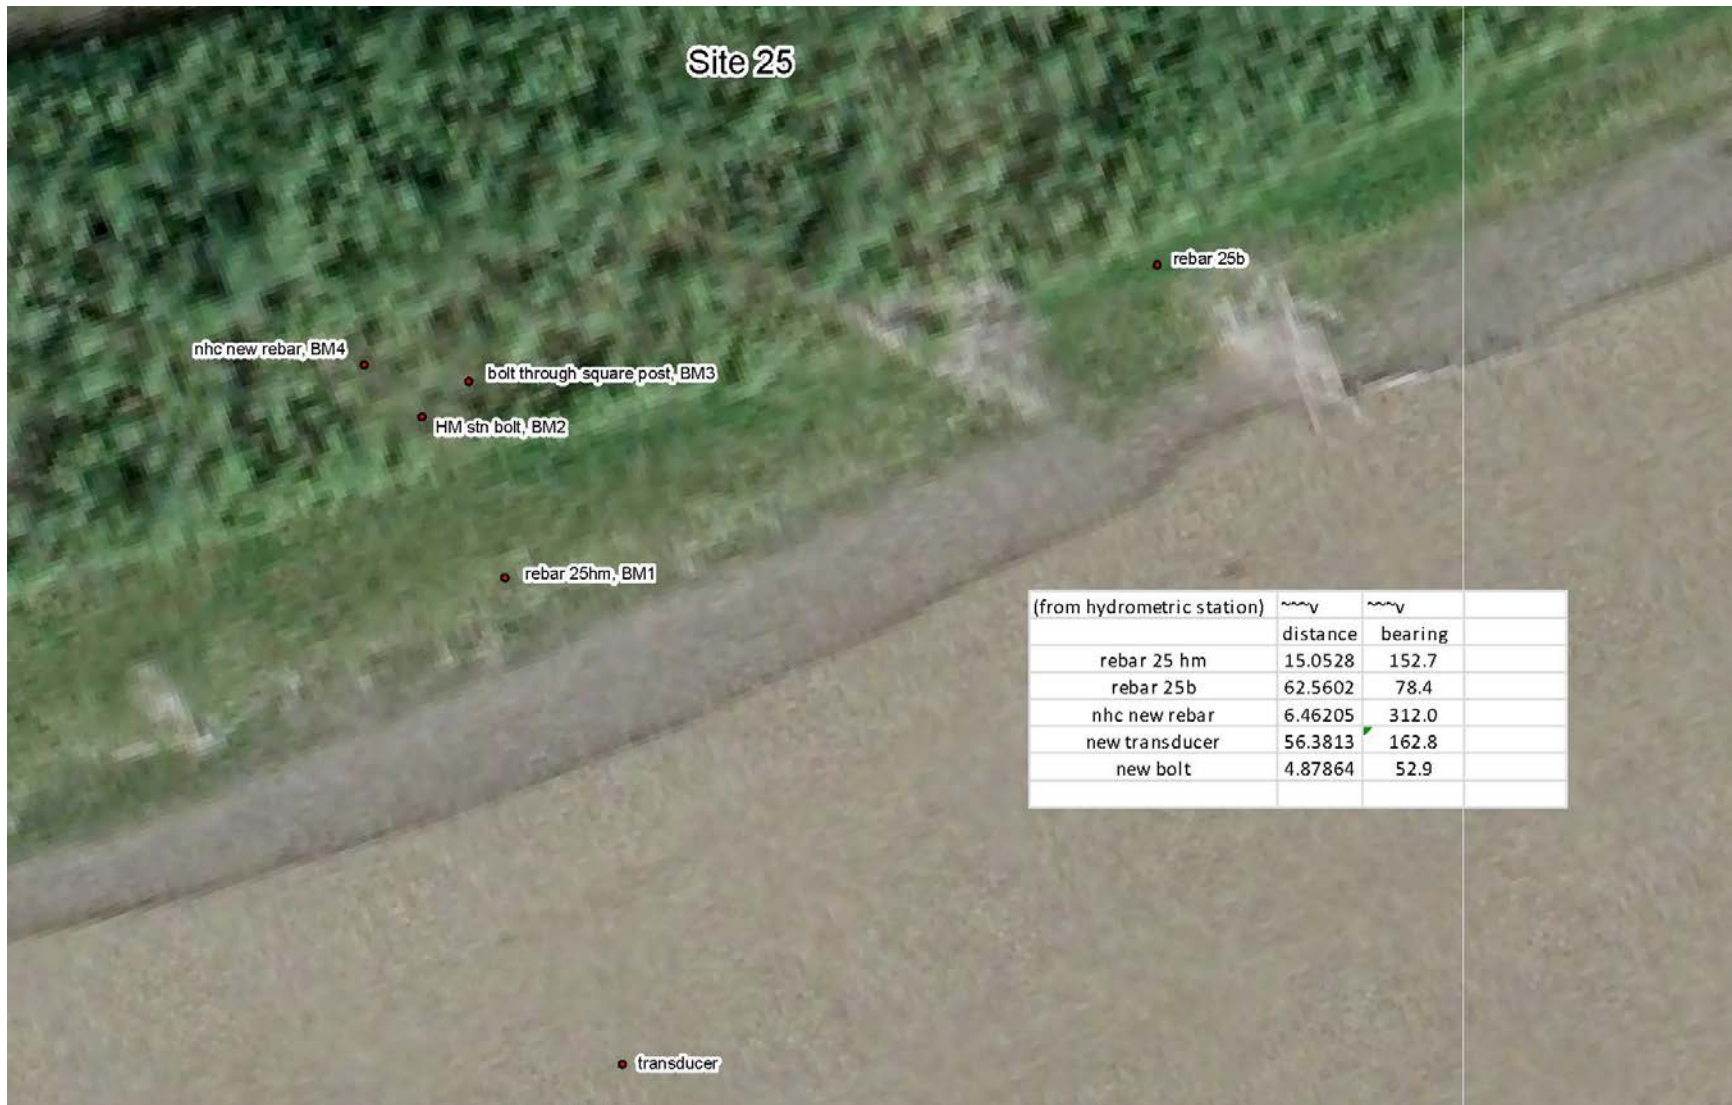
Figure 16 The 2014 stage record for Peace 25. The sampling interval is 15 minutes. Gaps in the stage record are given in Table 13.

The current Peace 25 stage time series extends from September 23, 2009 to January 13, 2014 with three data gaps (**Figure 16**) including February 8, 2010 to February 25, 2010 (16 days of gauge instability), and July 3, 2012 to October 2, 2013 (456 days of logger malfunction). Gaps are detailed in **Table 13**.

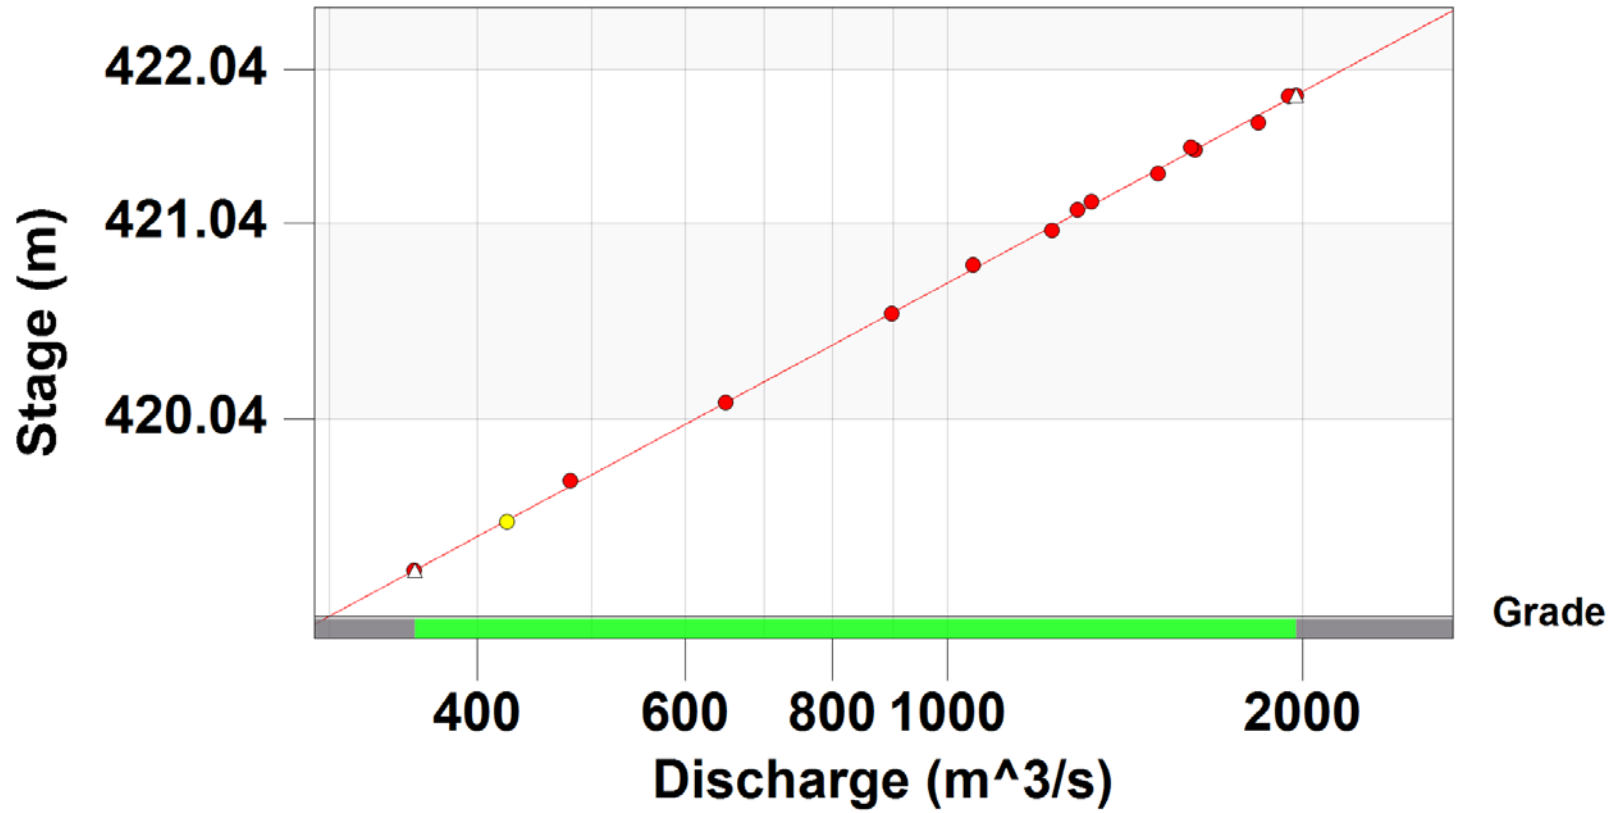
Figure 21 The rating curve for Peace 29. Within the gauged range, the rating curve shows excellent fit (1.3% root mean square of errors) meeting RISC grade A standards (Resources Information Standards Committee, 2009), represented by a green bar below the curve. Discharge values calculated using the extrapolated portion of the rating curve (outside the highest and lowest gauged flow) are RISC Grade E, represented by grey bars below the curve. Gauged stages range from 419.443 m to 421.860 m; the current stage record ranges from 419.367 m to 422.787 m. The flow measurement collected in 2014 is shown in yellow.

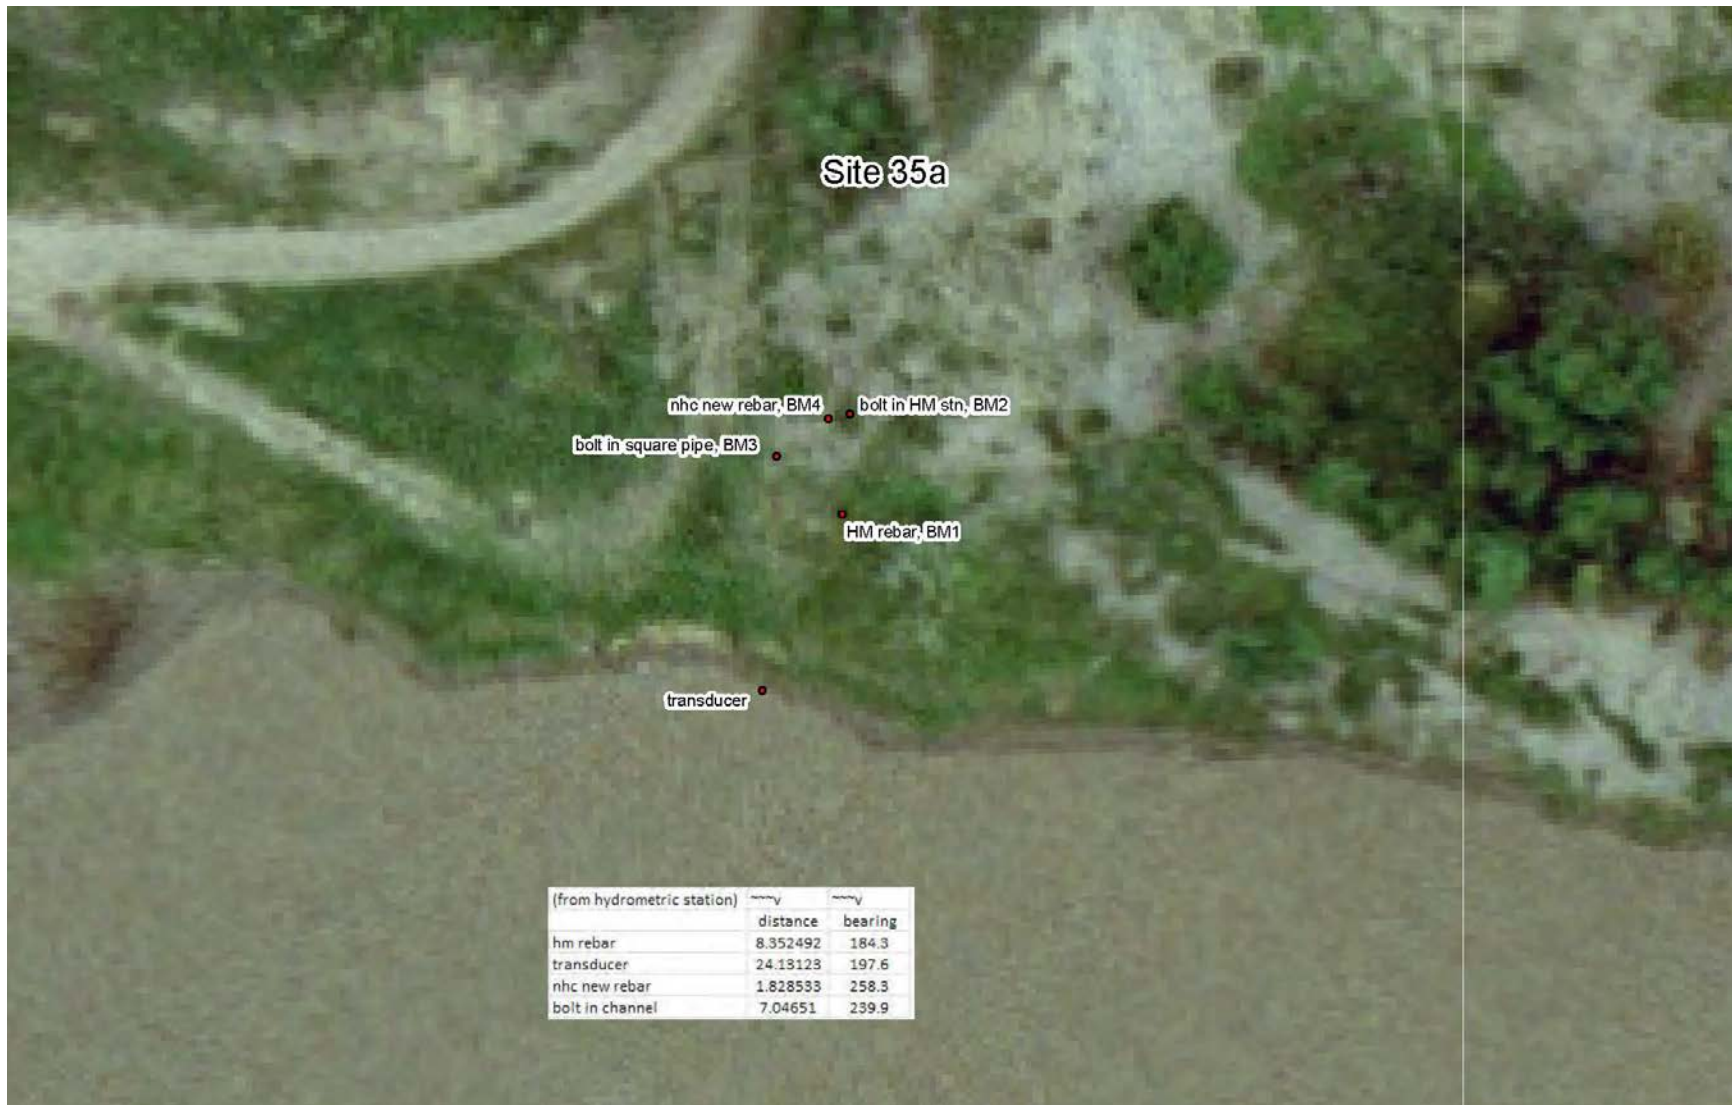
Figure 24 The 2014 stage record for Peace 35a. The sampling interval is 15 minutes. Gaps in the stage record are given in Table 19.

The current Peace 35a stage time series extends from September 21, 2009 to December 31, 2014, with six data gaps (**Figure 24**). Data gaps are detailed in **Table 19**.

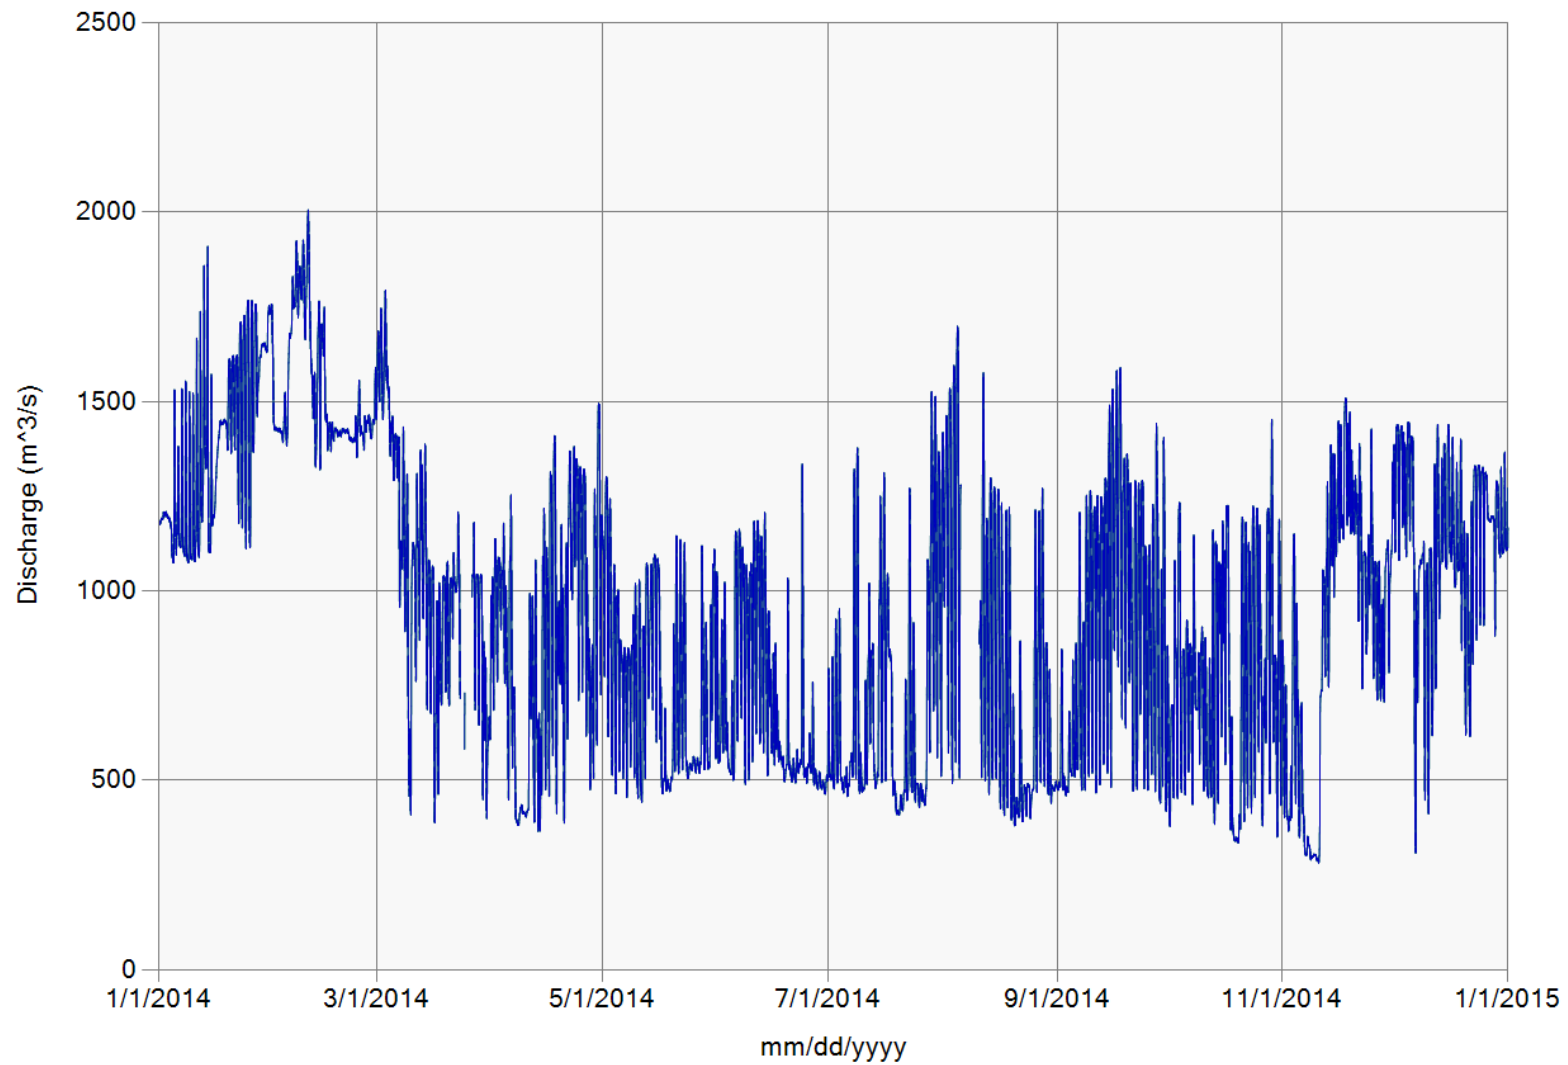
Figure 26 The 2014 discharge record for Peace 35a. The sampling interval is 15 minutes. Gaps in the discharge record are given in Table 19
