**Peace Project Water Use Plan**

**Peace River Wildlife Stranding Survey**

**Final Report**

# ***BC Hydro Peace River Wildlife Standing Survey, GMSMON 12 2010 Pre-spill and 2012 Post-spill Survey Results***

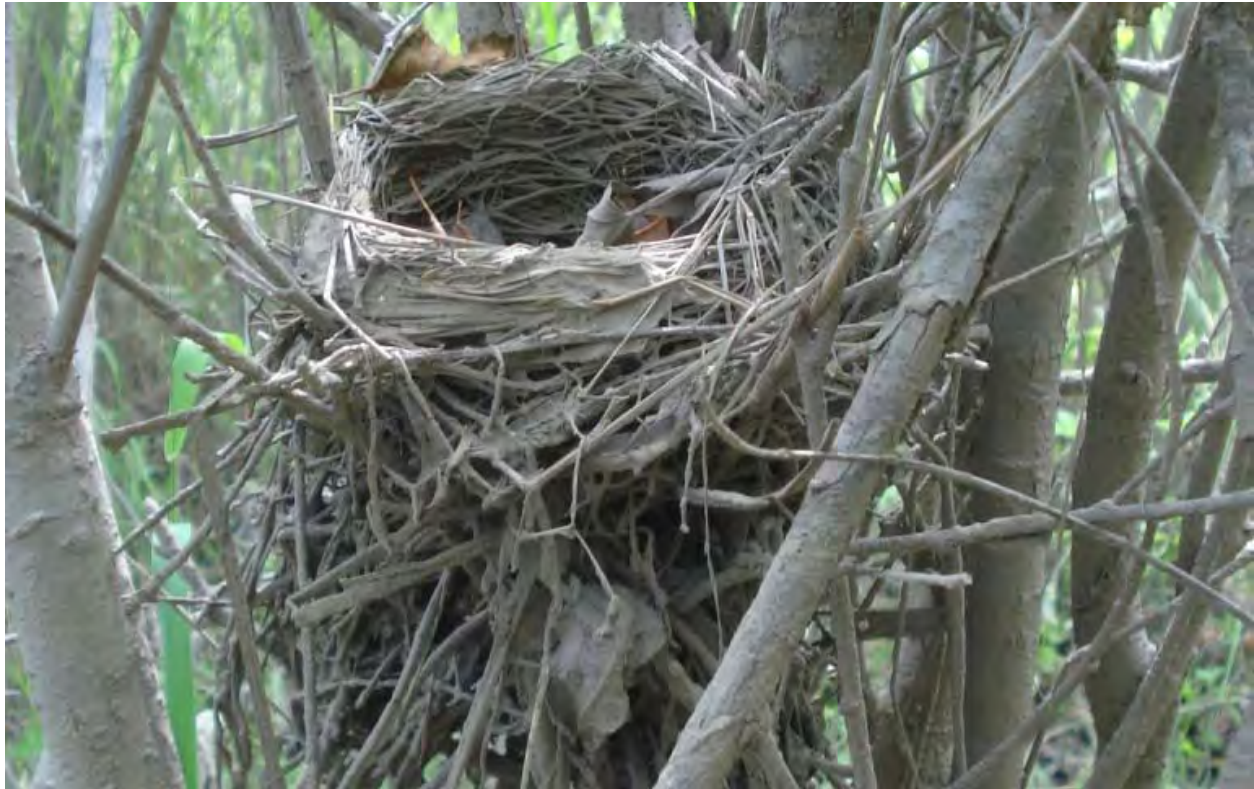
**Figure 7. Flooded American Robin nest low in alder shrub, Peace River valley, BC. Note heavy layer of sediment coating nest structure.**

Of the 77 nest sites found during pre-spill nest searches (in 2010), 29 were checked to confirm the flood status (in 2012). Nests were only counted as flooded if there was obvious evidence of flood damage or debris to the nest structure (Figure 7) or nest site in general. Of these 29 nests, 14 were unoccupied and not assigned to a species. Of the 15 nests where the nesting species was identified, only 3 ground nests were confirmed as flooded: a Spotted Sandpiper nest, a Tennessee Warbler nest, and an unidentified (probably Savannah) sparrow nest.

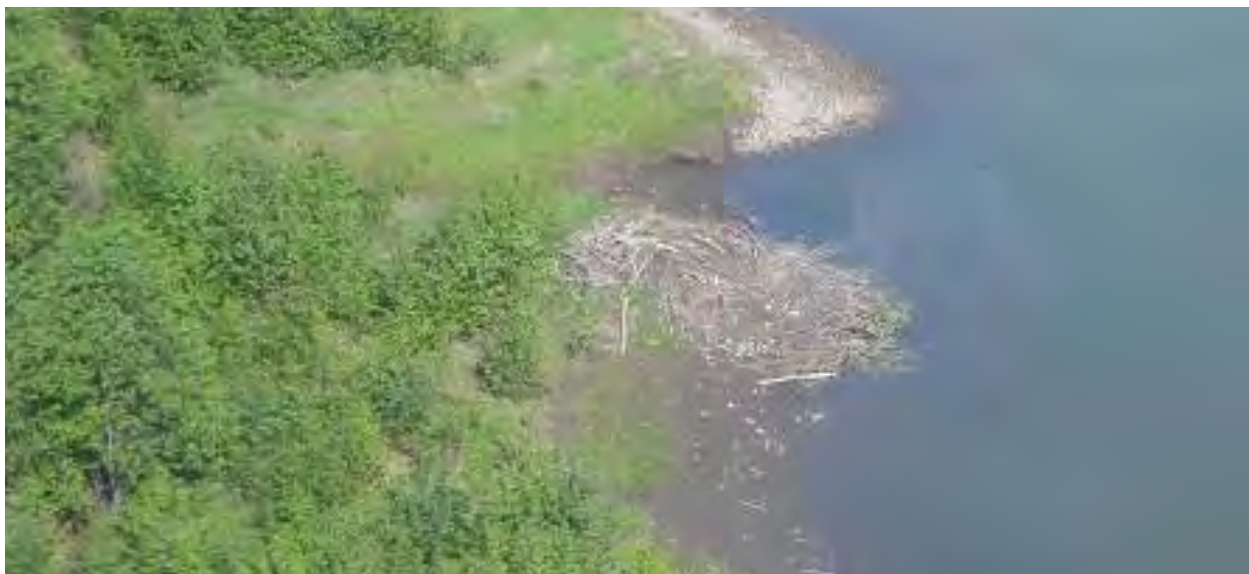
Figure 8. Beaver food cache on main stem of the Peace River, B.C. Note fresh green material added to edge of cache.

In total, 99 observations were made of beaver structures (Table 8, Figure 8, Appendix 10). Three individual animals were observed, 2 on lodge structures and one swimming mid-stream. By using an assumption of 5 individuals per active lodge/bank lodge, the population estimate for the study area is 100 animals (Table 8).

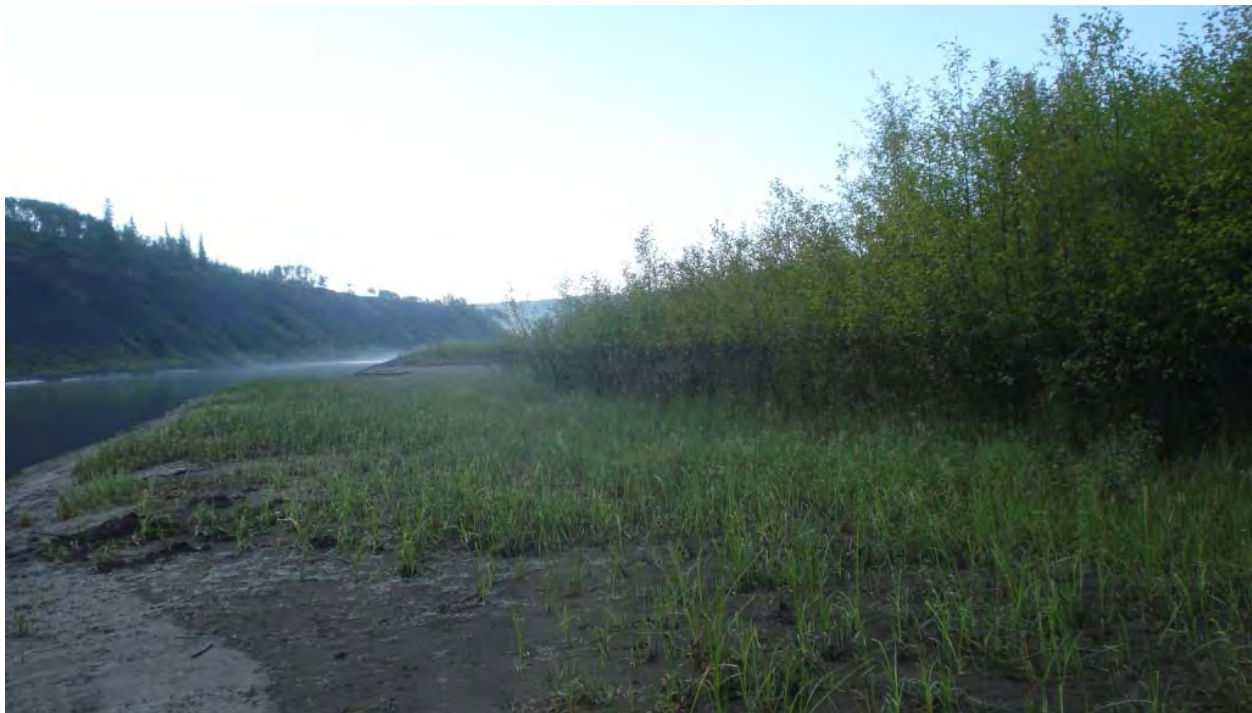
Our field observations suggested that the maximum water height reached roughly 2.0 – 2.5 metres above the normal level of the river (Figure 11). In some places (large low lying islands), flood water had extended inland over 100 m from the wetted line at normal flows. Sediment deposition is possibly the most pervasive of the physical effects, with a layer of fine silt deposited ( $\leq 50$  cm deep) in nearly all flooded riparian areas, in places extending into older cottonwood groves. The ground surface in these areas consisted of a hard drying mud, sometimes with a thin grass cover; few forbs and very little ground cover vegetation or litter remained. Areas exposed to stronger currents during the spill have less sediment deposition.

**Figure 11. Sediment on willow shrubs indicating maximum inundation depth on an in-channel island, Peace River valley, BC.**

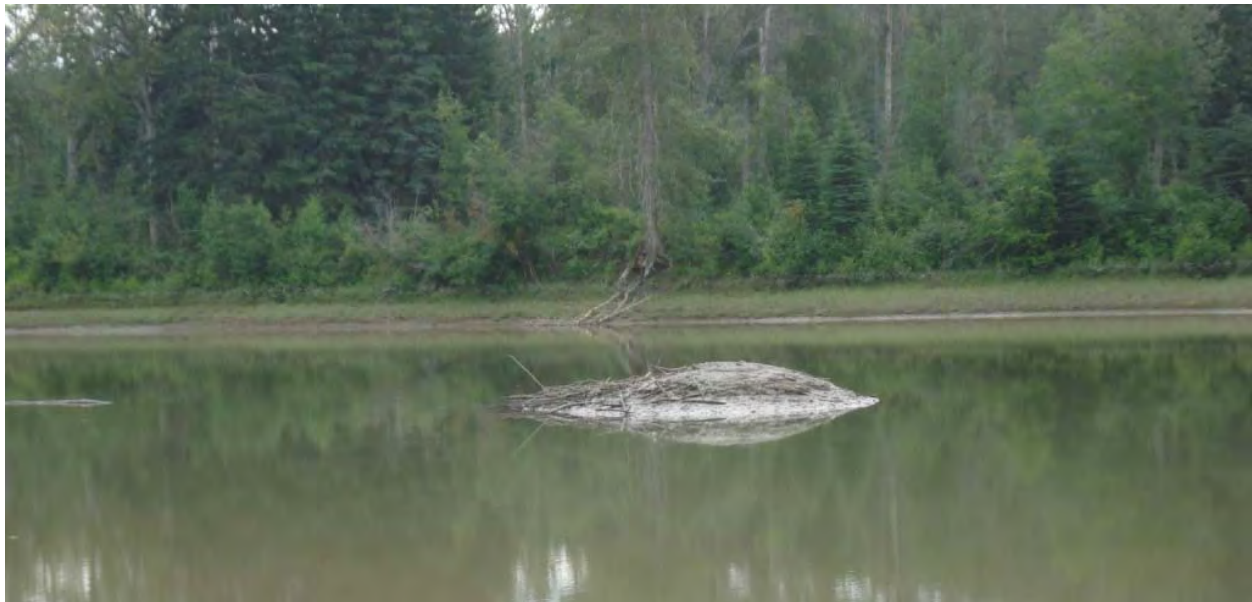
During ground surveys, it was noted that a layer of fine fluvial sediment had accumulated on vegetation, driftwood, and structures like beaver dams and lodges (Figure 12). This layer of fine sediment likely made it difficult to identify the fresh green vegetative material added to active lodges and dams during aerial surveys, unless it was added immediately post-spill. We suspect this is the reason that we did not identify any active structures during our post-spill survey. Although we could not positively confirm the active status of beaver structures during the survey, the observation of swimming individuals indicated that obviously some percentage of colonies were still active.

**Figure 12. Heavy layer of flood deposited sediment on beaver lodge in the Peace River valley, BC.**

These losses, however, are unlikely to have a long-term impact on the local beaver population. Beaver will readily re-colonize an area and can quickly repair/re-build structures and food caches. The magnitude of the spill was not high enough to physically remove riparian vegetation (e.g., balsam poplar stems adjacent to water). During riparian bird and western toad surveys, we noted areas of fresh vegetation harvesting in areas still covered in moist flood-deposited sediment.

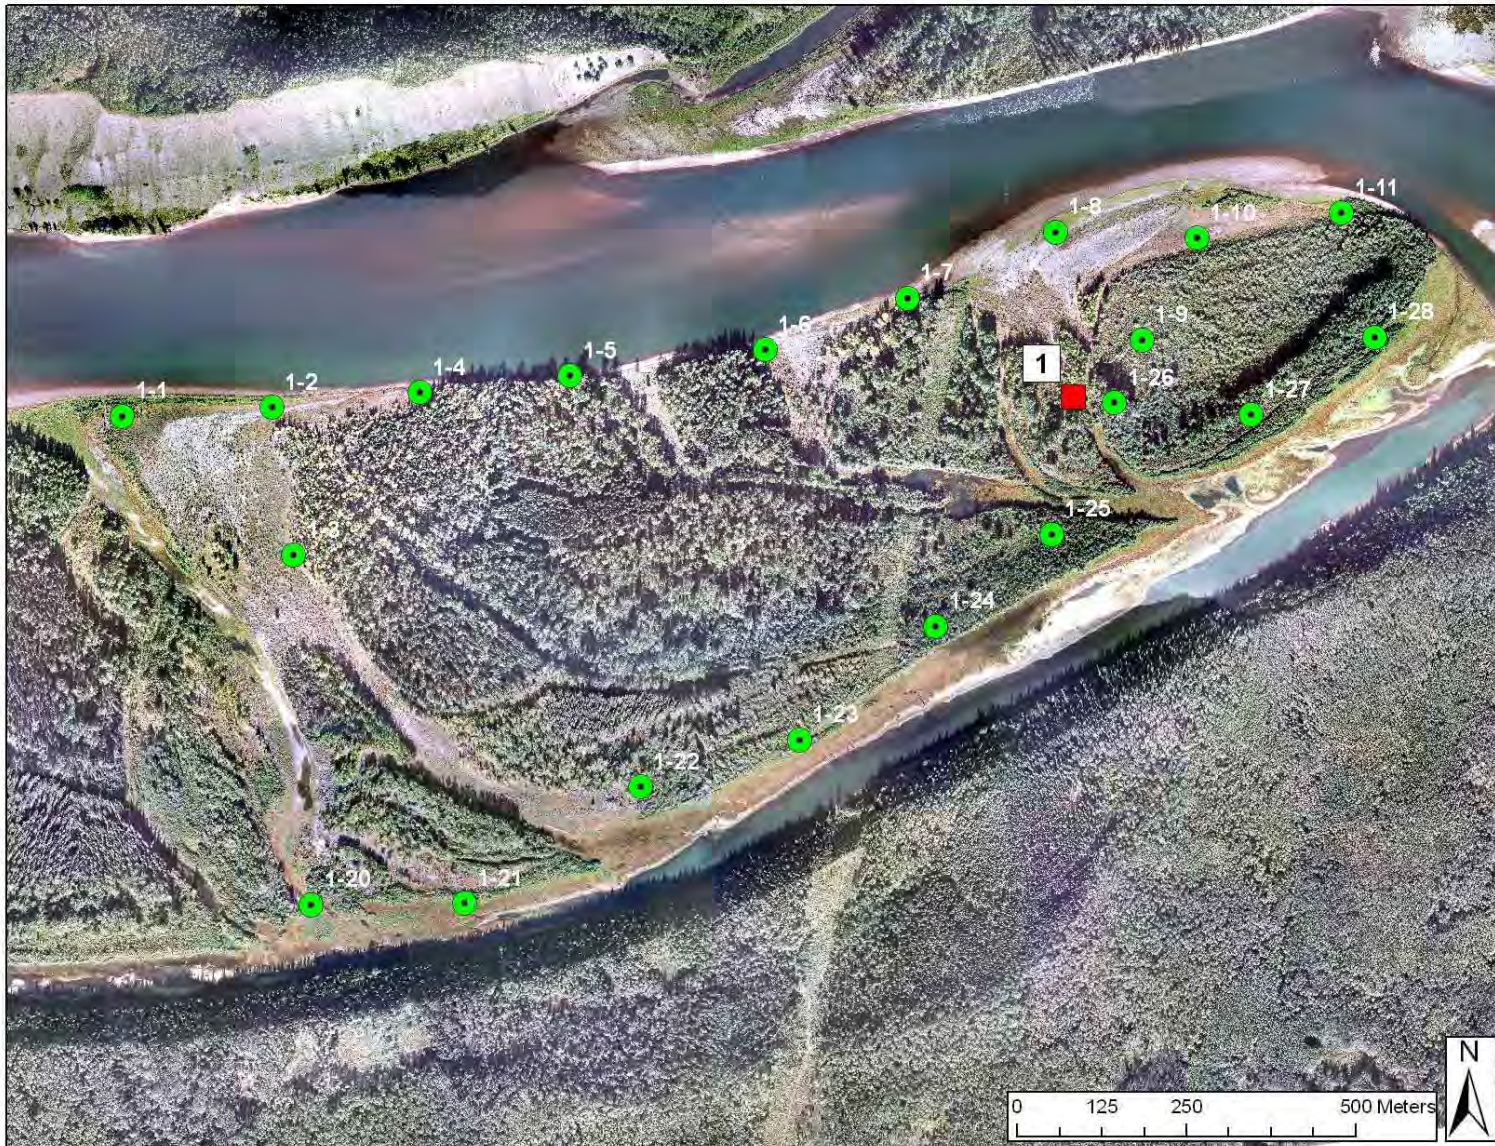
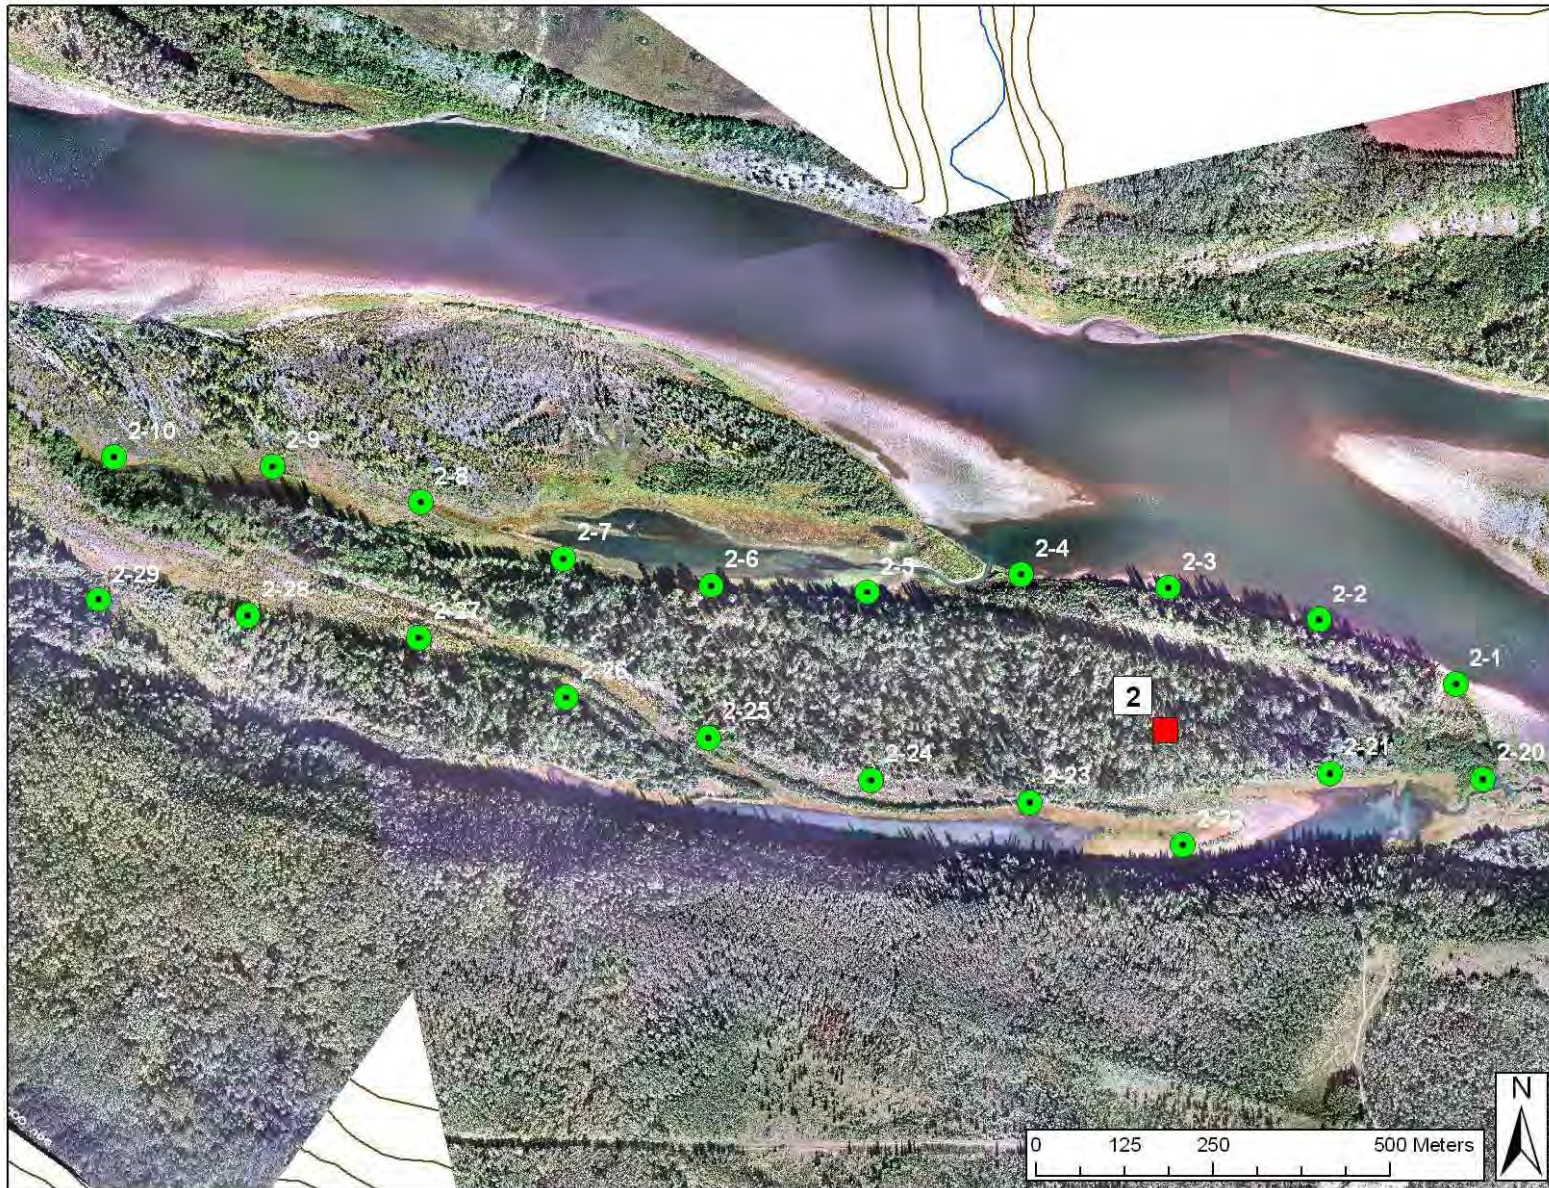
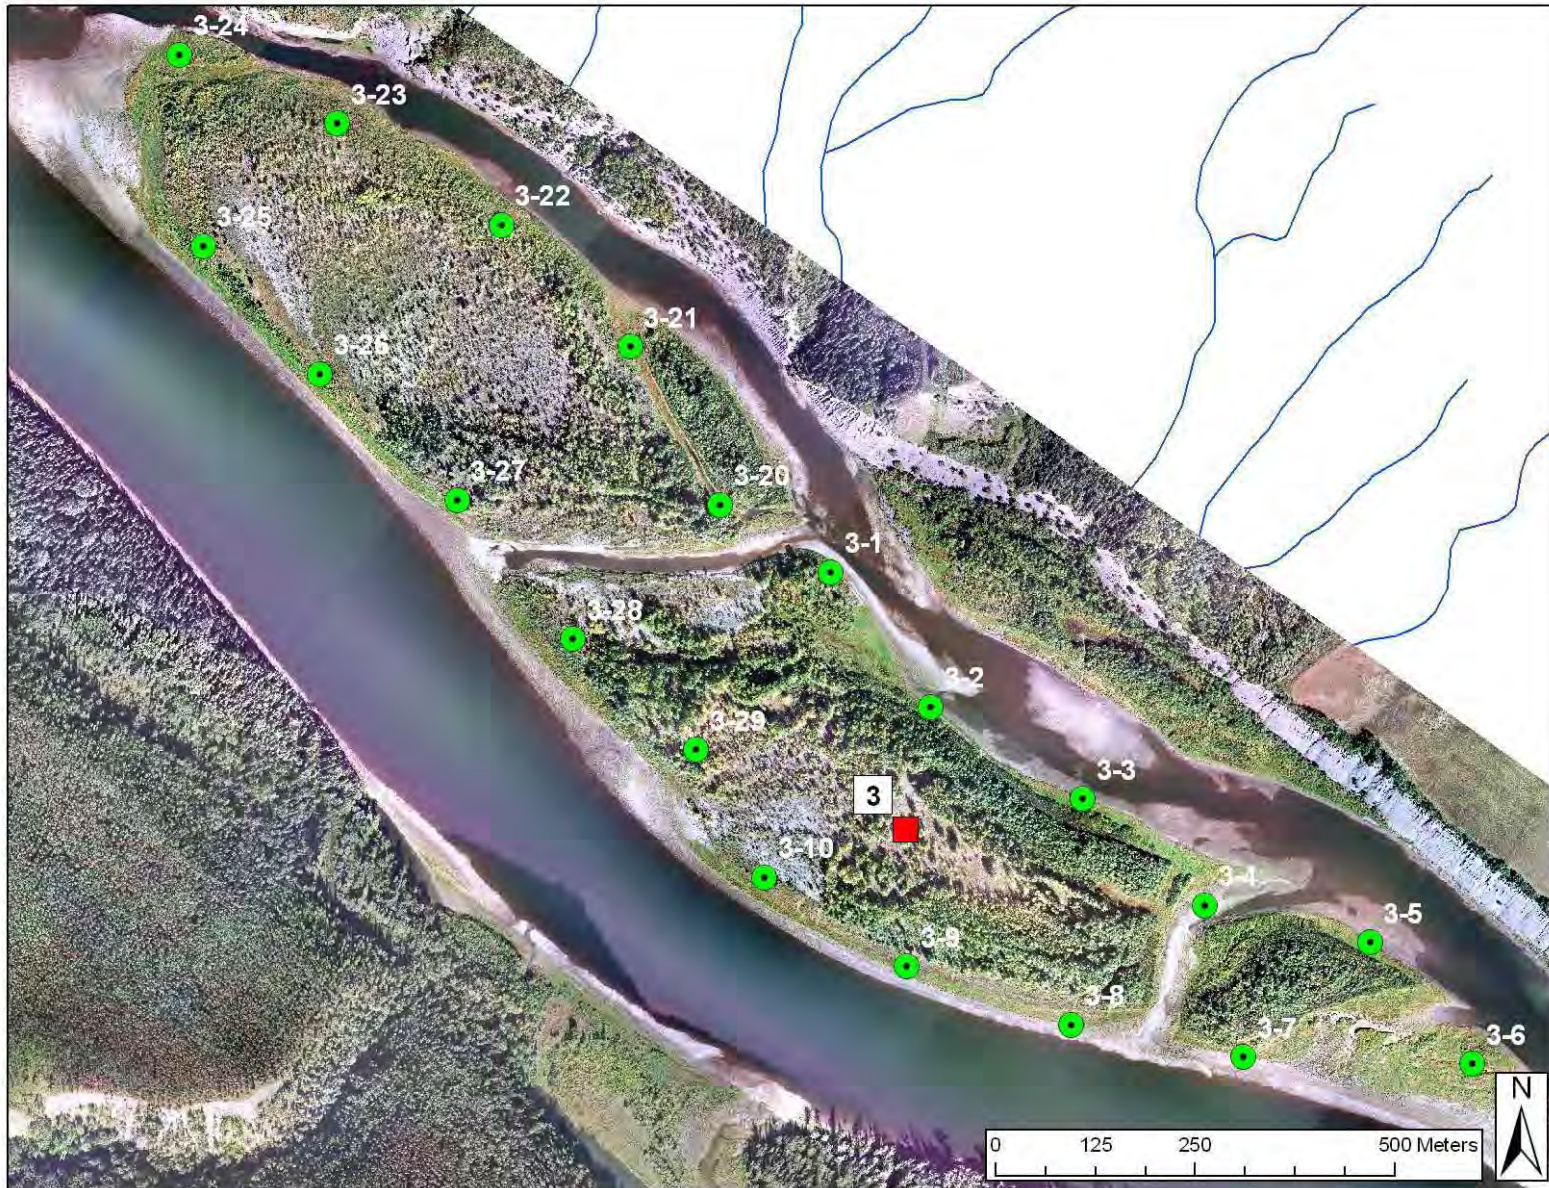
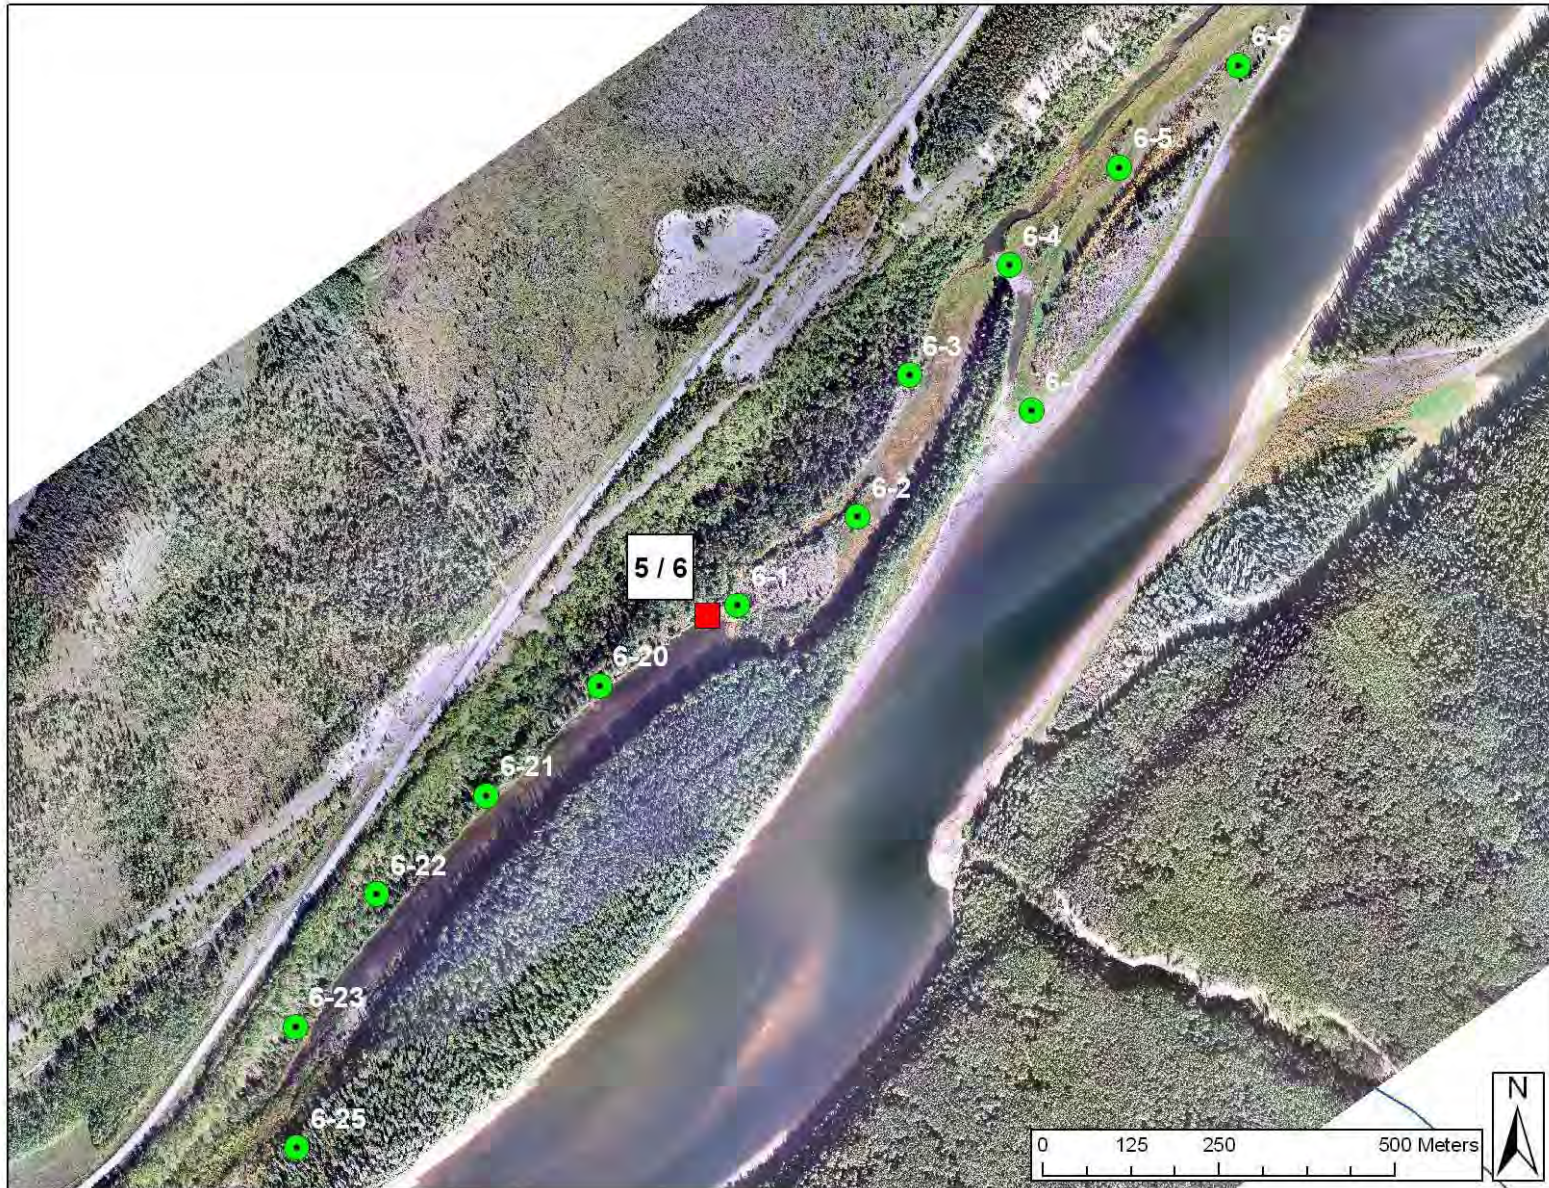
**Appendix 7. Maps of point count station locations at index sites in the Peace River valley, B.C. Green circles are point count stations; red squares are index site labels.**
